2024 ROUTINE INSPECTION REPORT
BRIDGE NO: HAM-75-0022R, SFN 3108805
VAR-DISTRICT 8 Bridge Inspections
Brent Spence Approach Bridges

Cincinnati, Ohio

August 19th – September 11th, 2024

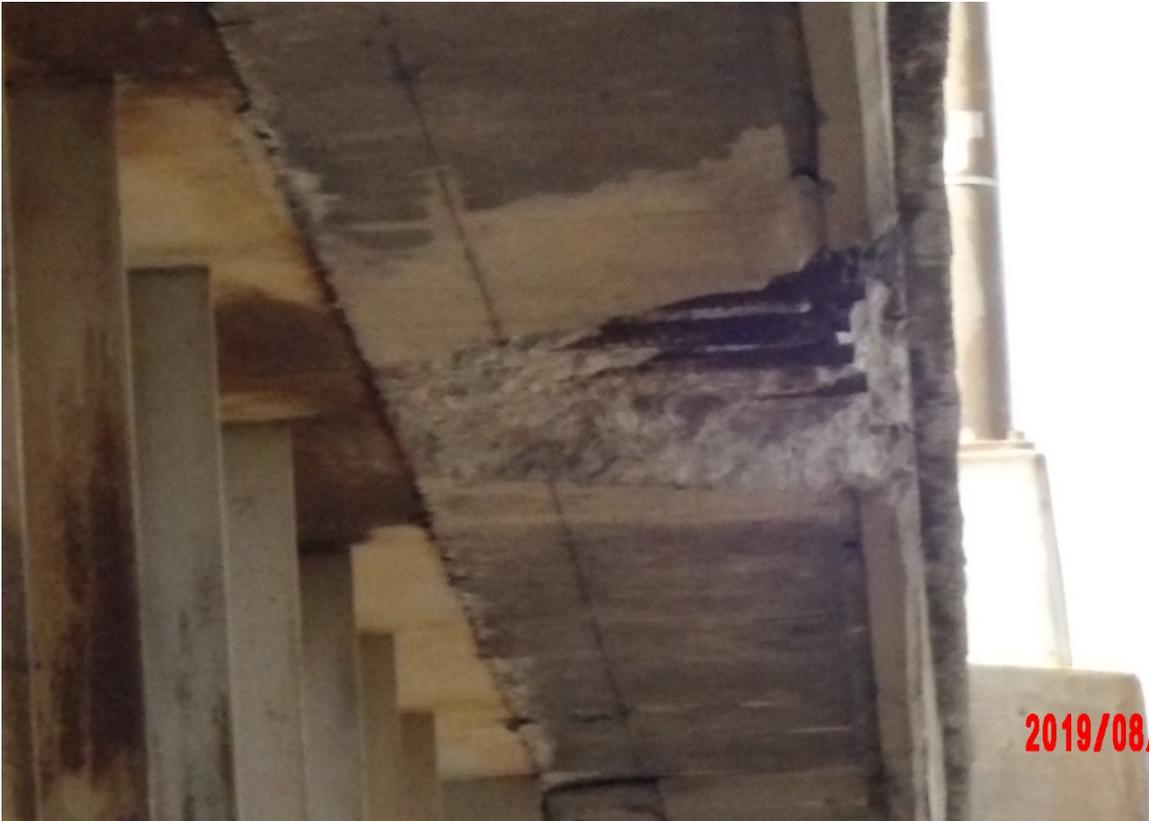
- There is a 6'L x 2'W x 5" deep spall with exposed rebar on the east overhang near Pier 17C.
- A 6" diameter x 1" deep spall is present in the west overhang in Span 19C.
- A continuous set of spalls up to 1" deep are present in the east overhang of Span 19C.
- There is a 4 square foot spall with exposed rebar that is covered up with plywood in Bay 4 of Span 19C.
- A 3' long by 2' wide by 10" deep spall is in the west overhang of Span 22C.
- There are two 3'L x 1'W x 1 1/2" deep spalls with exposed rebar on the west overhangs at Span 23C and Span 24C.
- There is a 4' long by 2' wide area of delaminated concrete in the west overhang of Span 27C.
- There is a 3 square foot spall with exposed rebar in Bay 5 of Span 29C.
- There are also 3 separate spalls with exposed rebar in Bay 5 of Span 29C, accounting for 6 square feet in total.

PHOTO 1. DECK SPAN 17C, OVERHANG SPALL WITH EXPOSED REINFORCEMENT

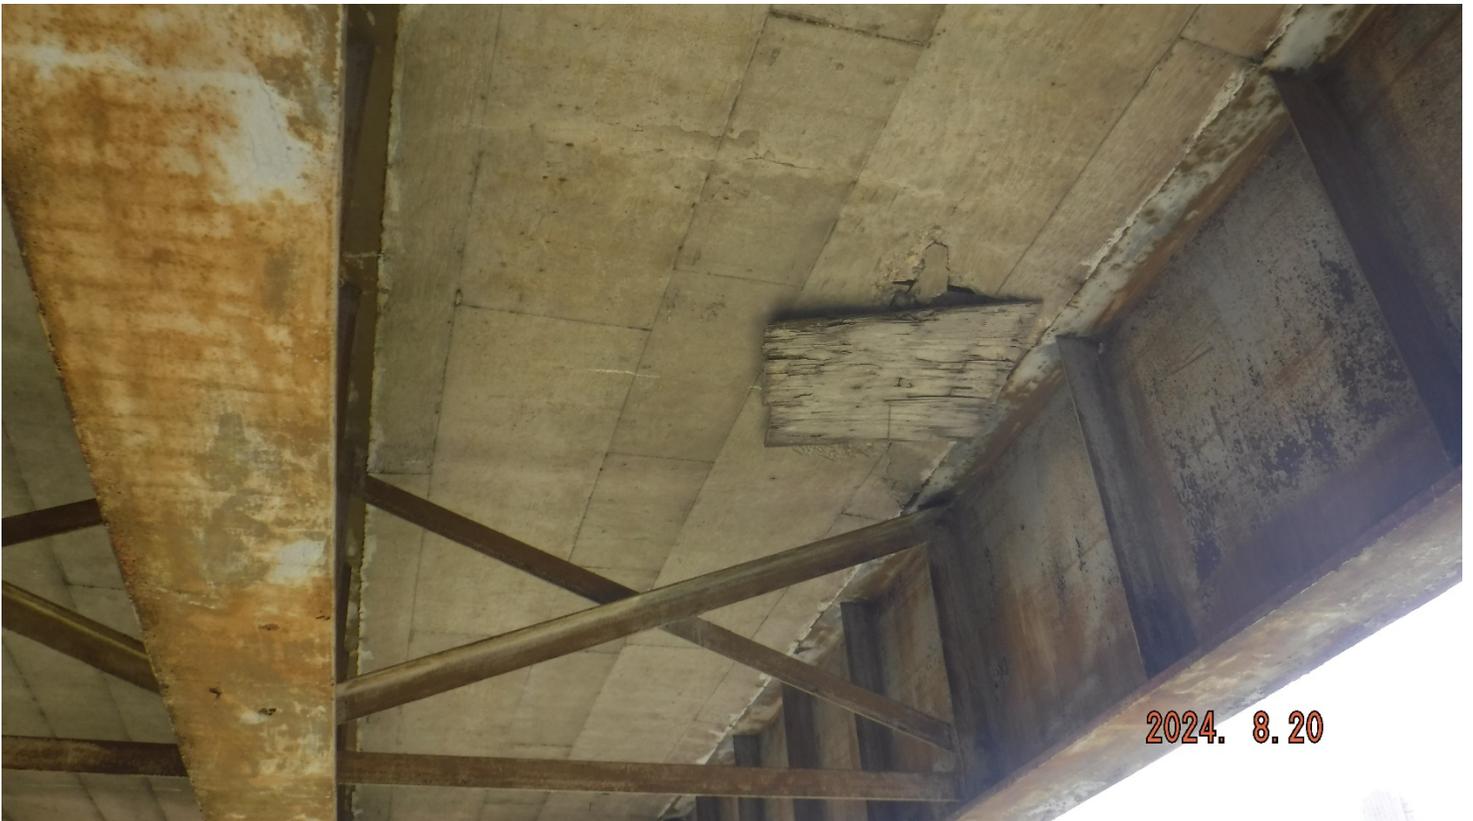
PHOTO 2. DECK SPAN 19C BAY 4, 4 SQFT SPALL W/ EXT REINFORCEMENT, COVERED BY PLYWOOD

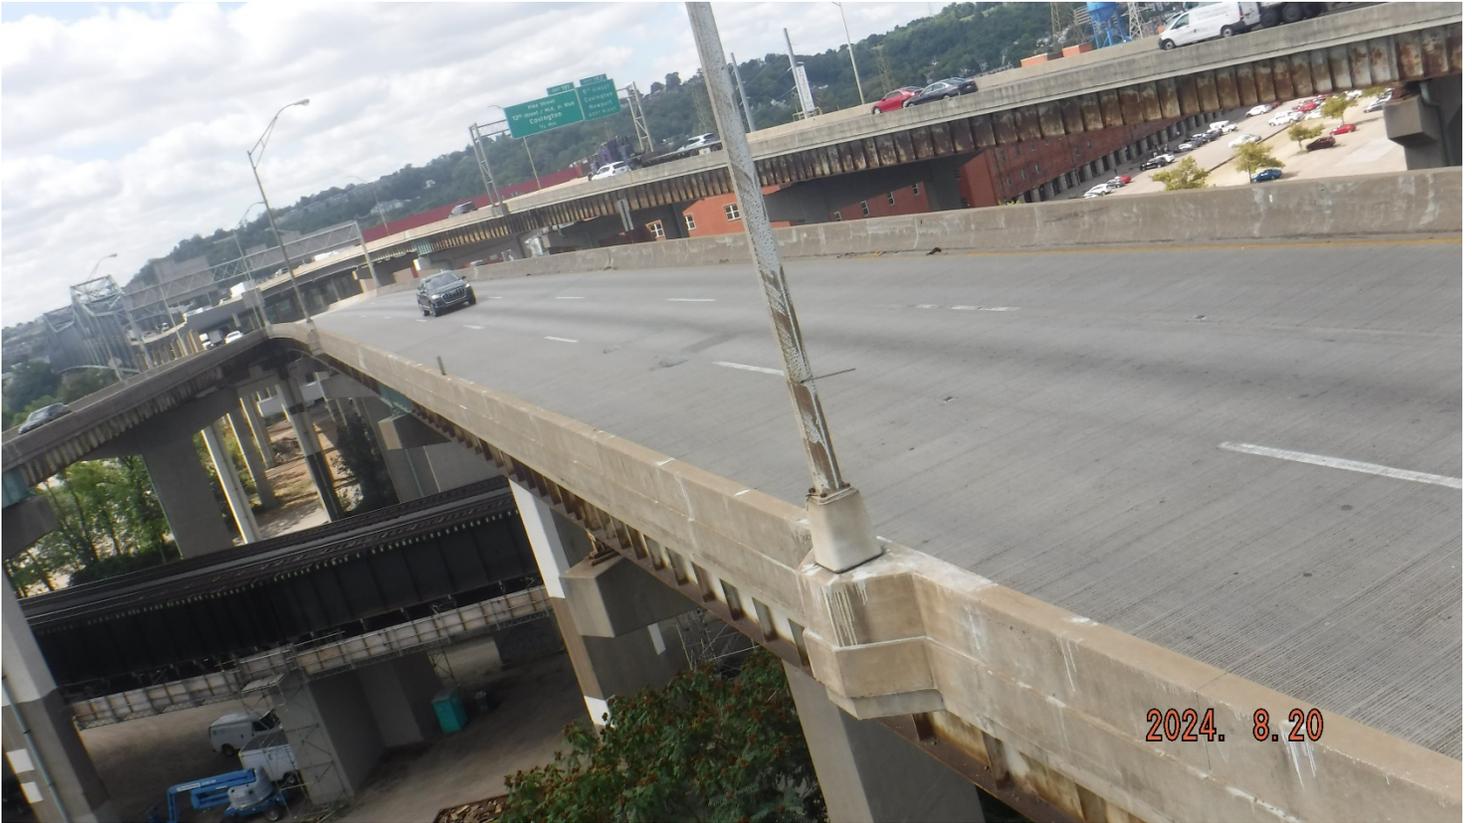
PHOTO 3. DECK SPAN 19C & 20 C WEARING SURFACE, CONCRETE PATCH

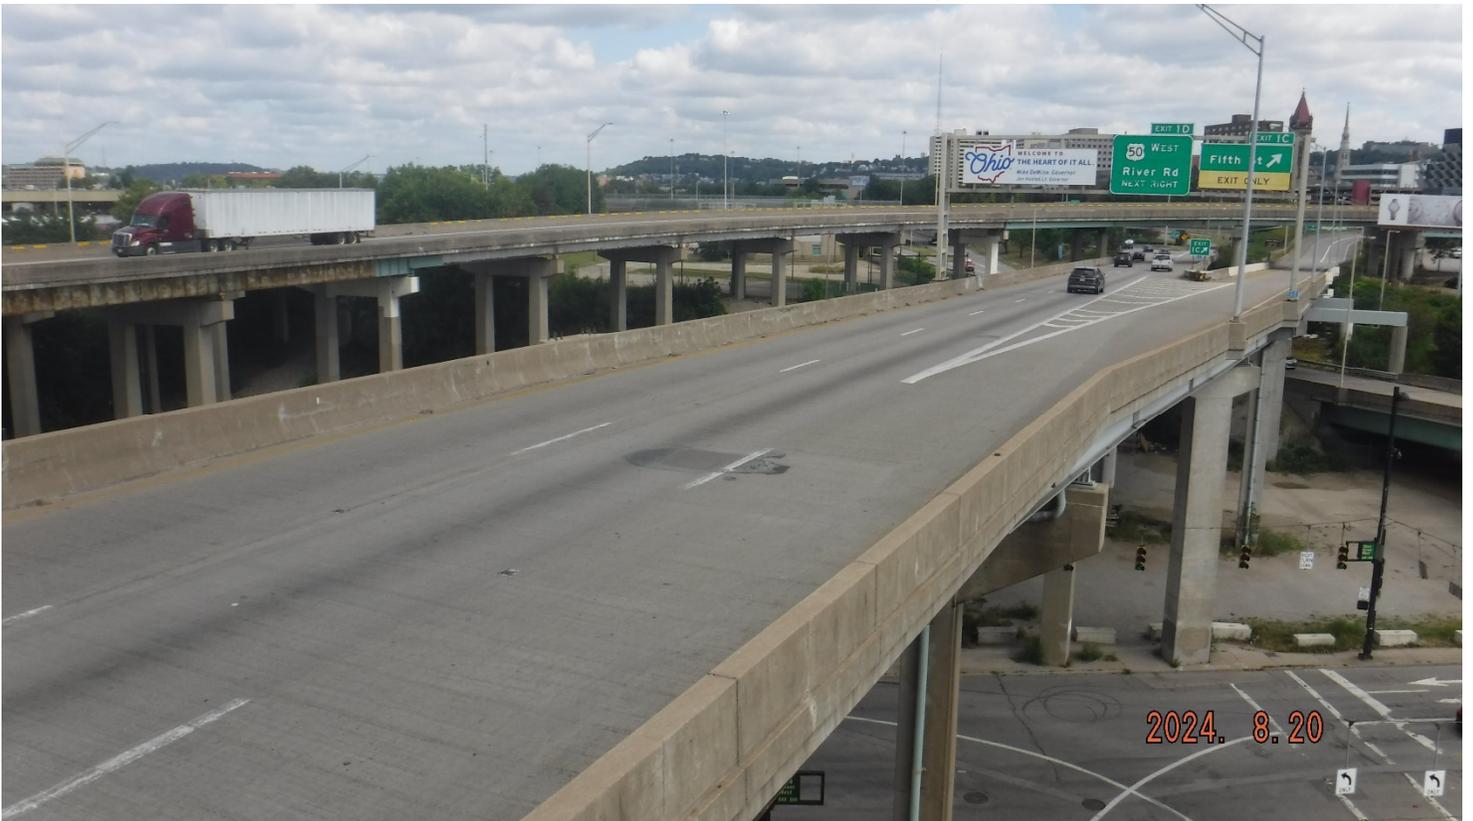
PHOTO 4. DECK SPAN 21C WEARING SURFACE, CONCRETE PATCH

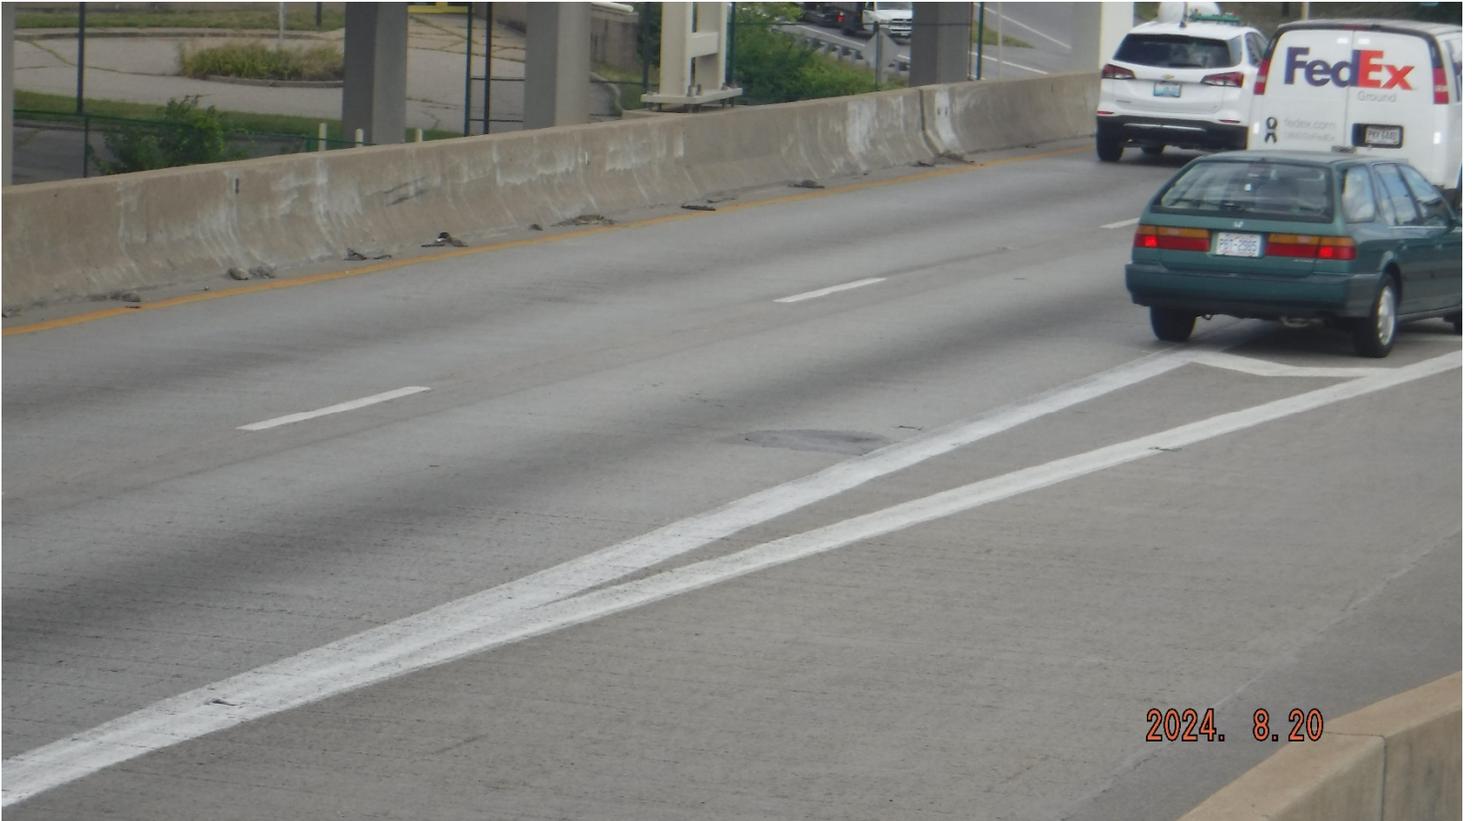
PHOTO 5. DECK SPAN 22C, ASPHALT PATCH SHOWING WEAR

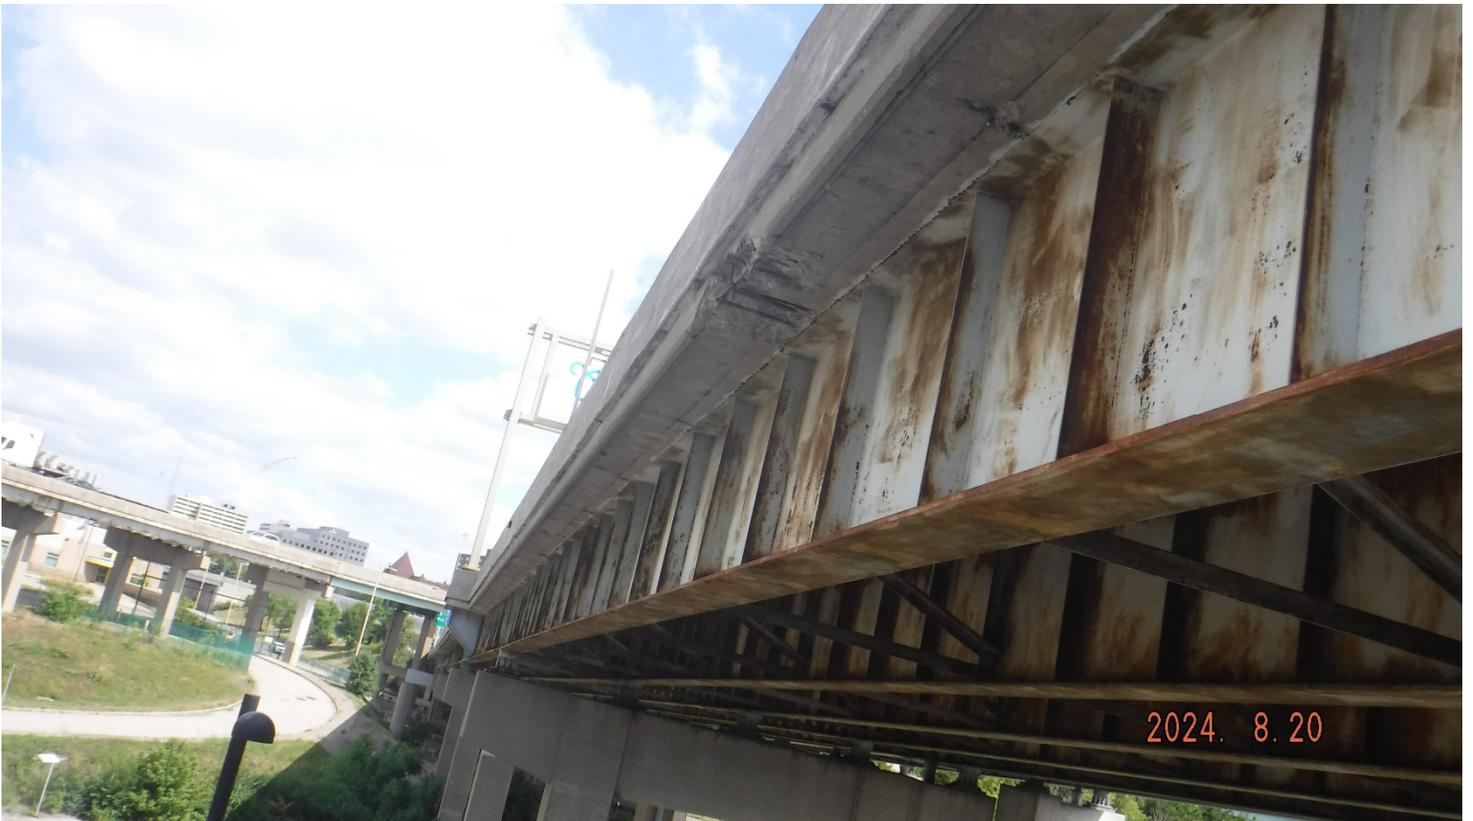
PHOTO 6. SPAN 22C CENTER LANE WEST OVERHANG, LARGE SPALL W/ EXPOSED REINFORCEMENT

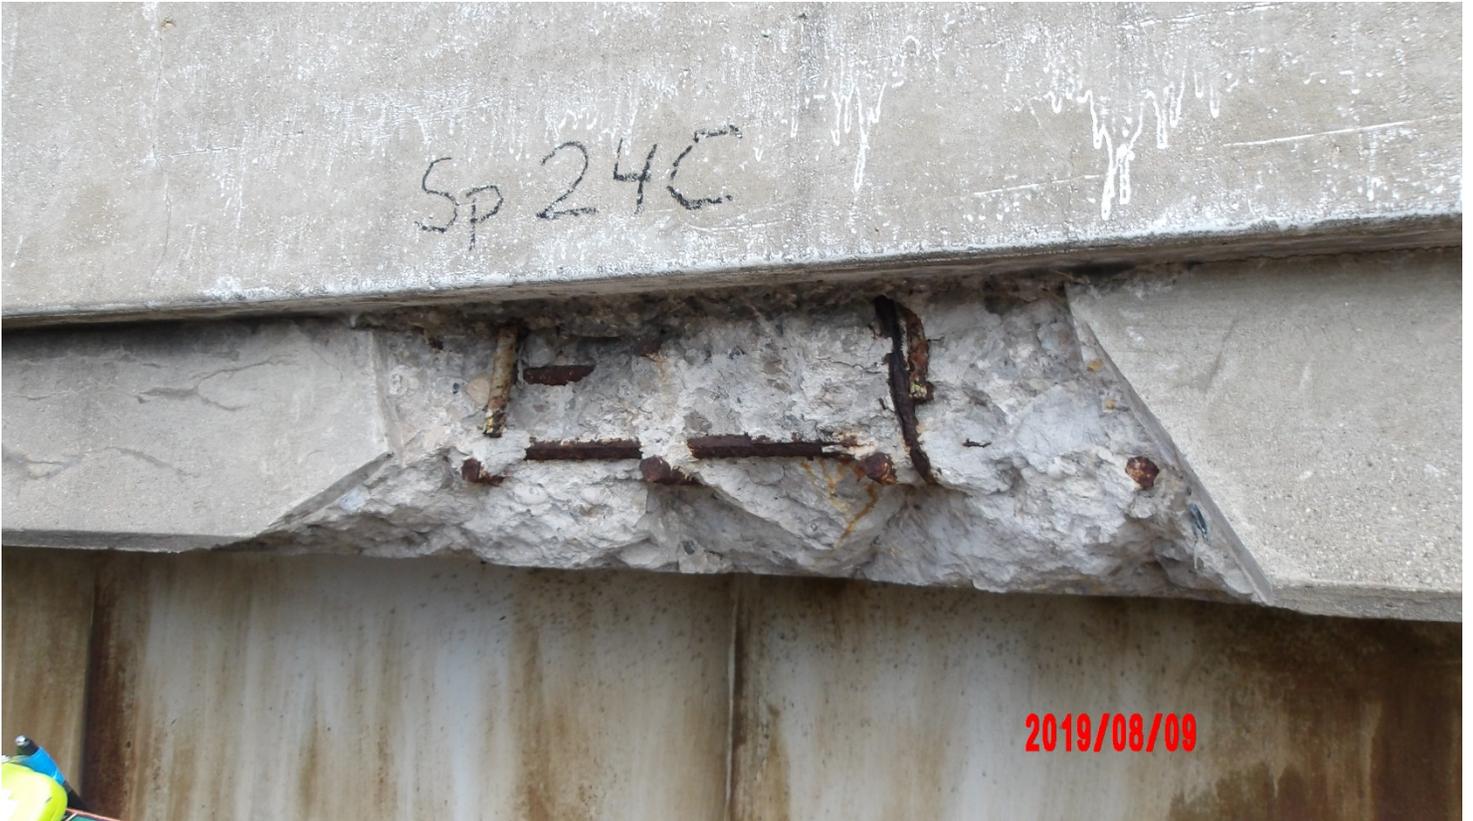
PHOTO 7. DECK OVERHANG SPAN 24C, SPALL WITH EXPOSED REINFORCEMENT

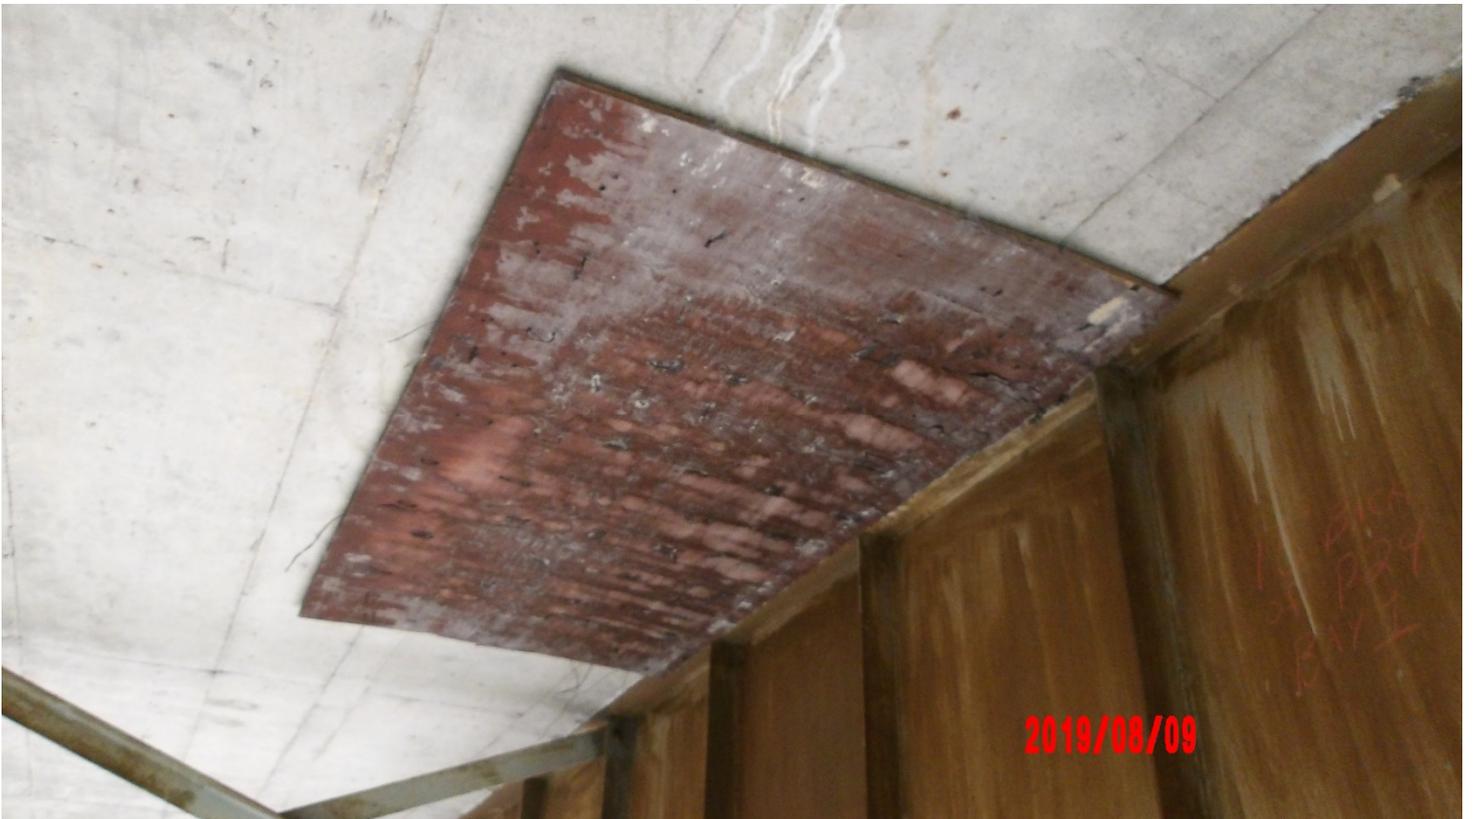
PHOTO 8. DECK UNDERSIDE SPAN 24C, WOOD FROM LEFT IN PLACE

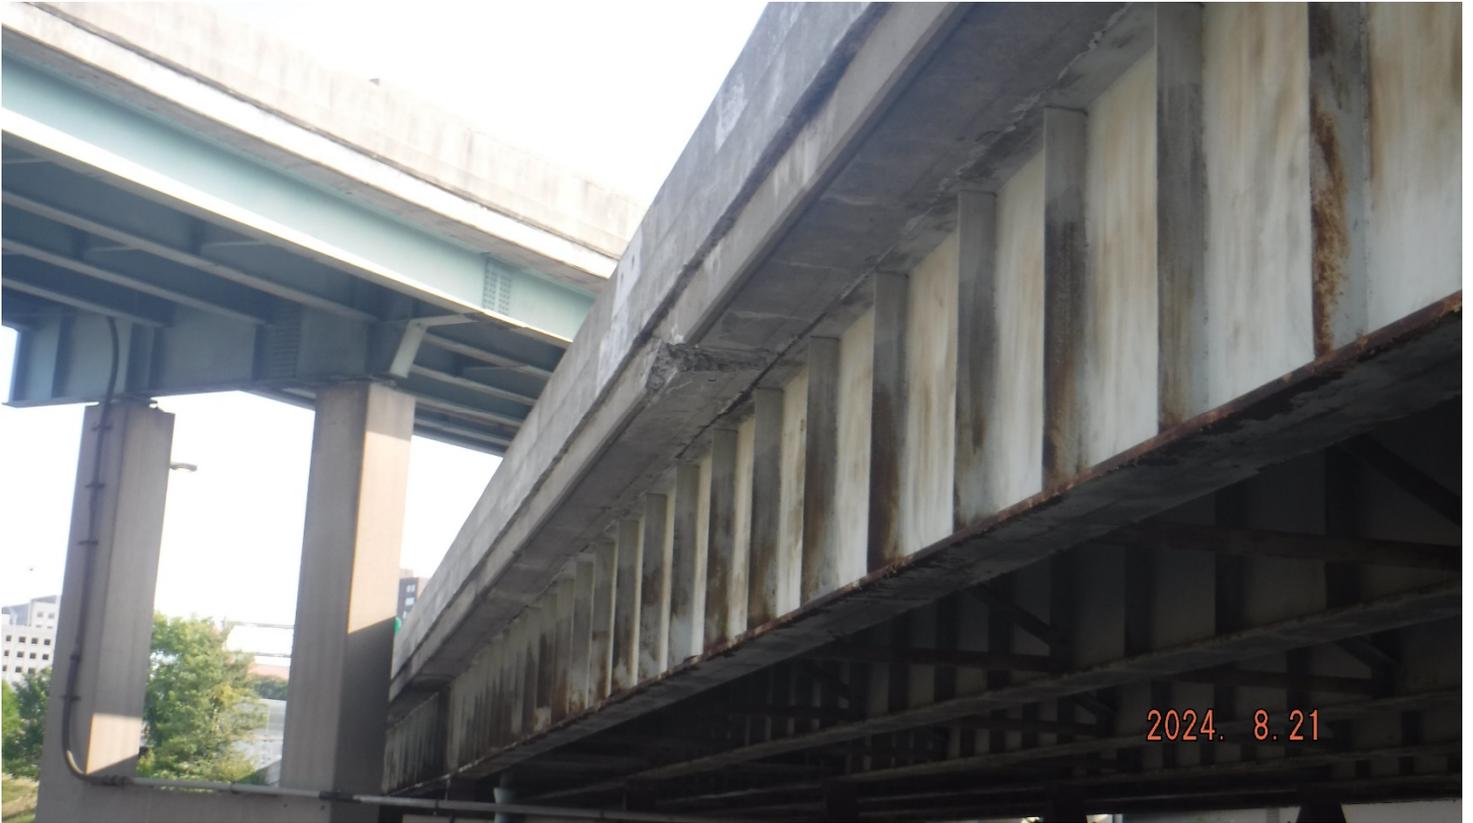
PHOTO 9. DECK SPAN 27C, 4'LX 2'W DELAMINATED CONCRETE

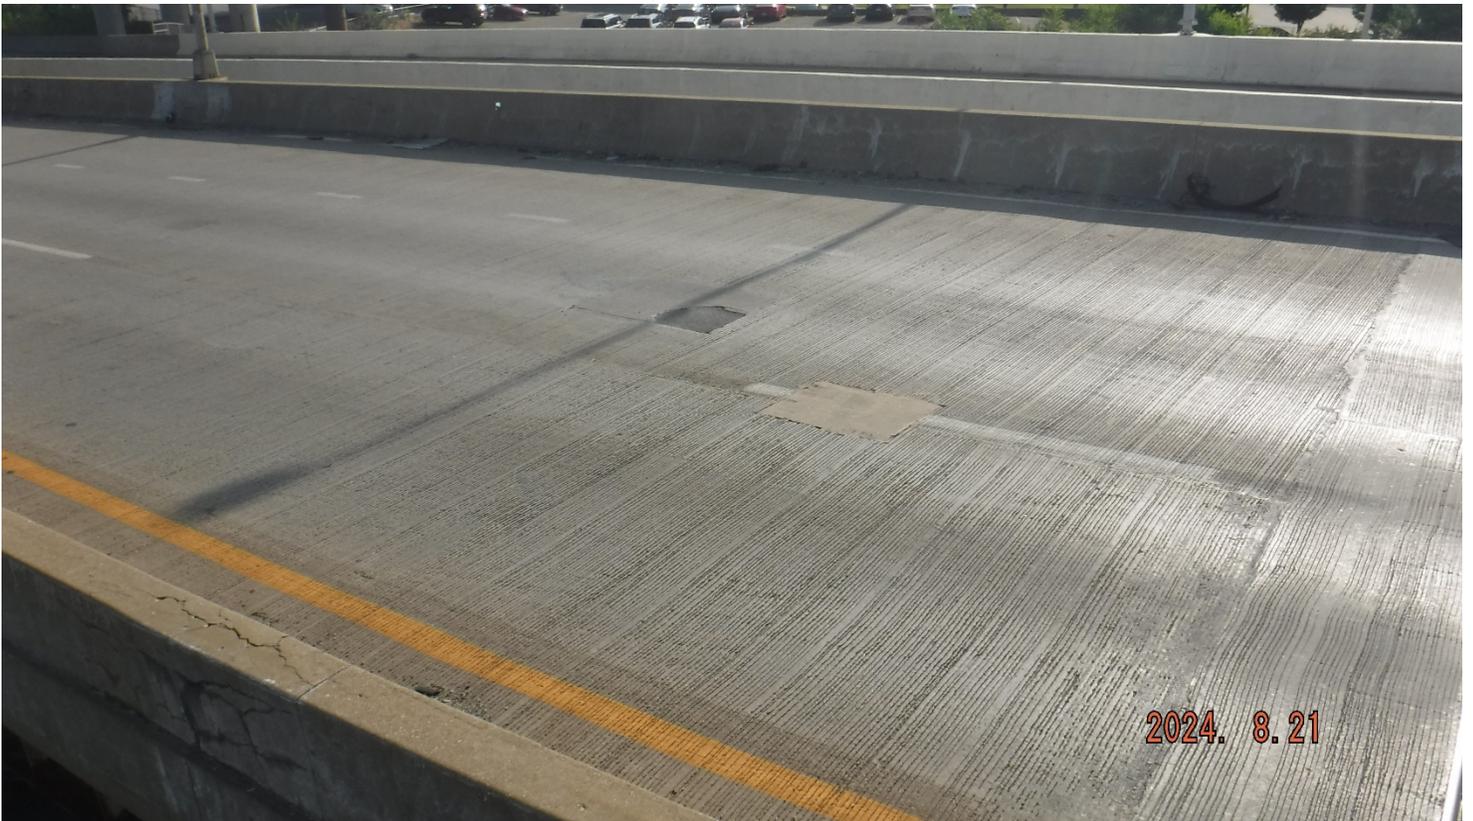
PHOTO 10. WEARING SURFACE SPAN 27C CENTER LANE, 3 PATCHES, LARGEST PATCH IS VISBLY CRACKING

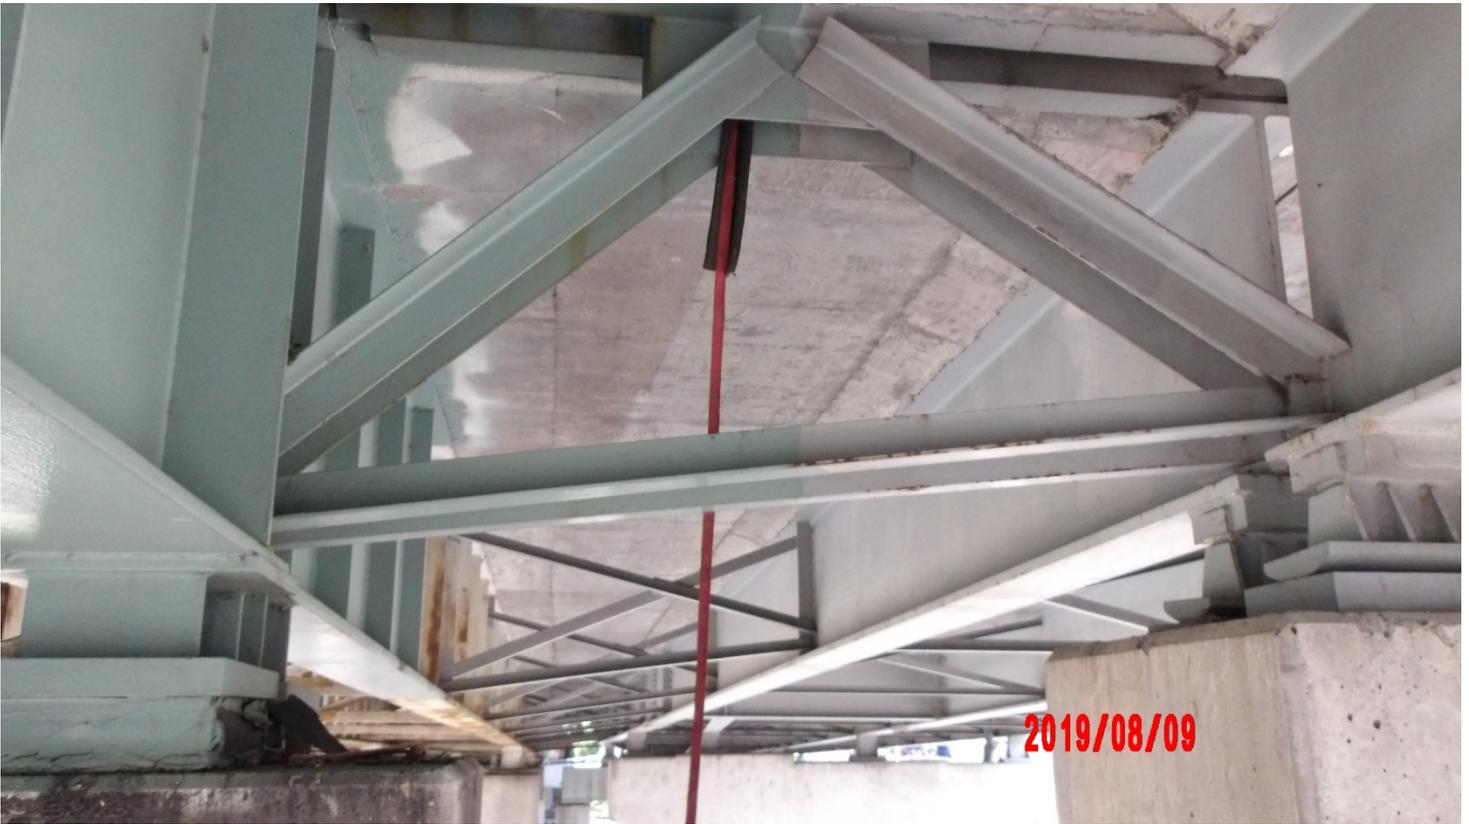
PHOTO 12. JOINT PIER 23C, STRAP AND DEBRIS HANGING FROM JOINT

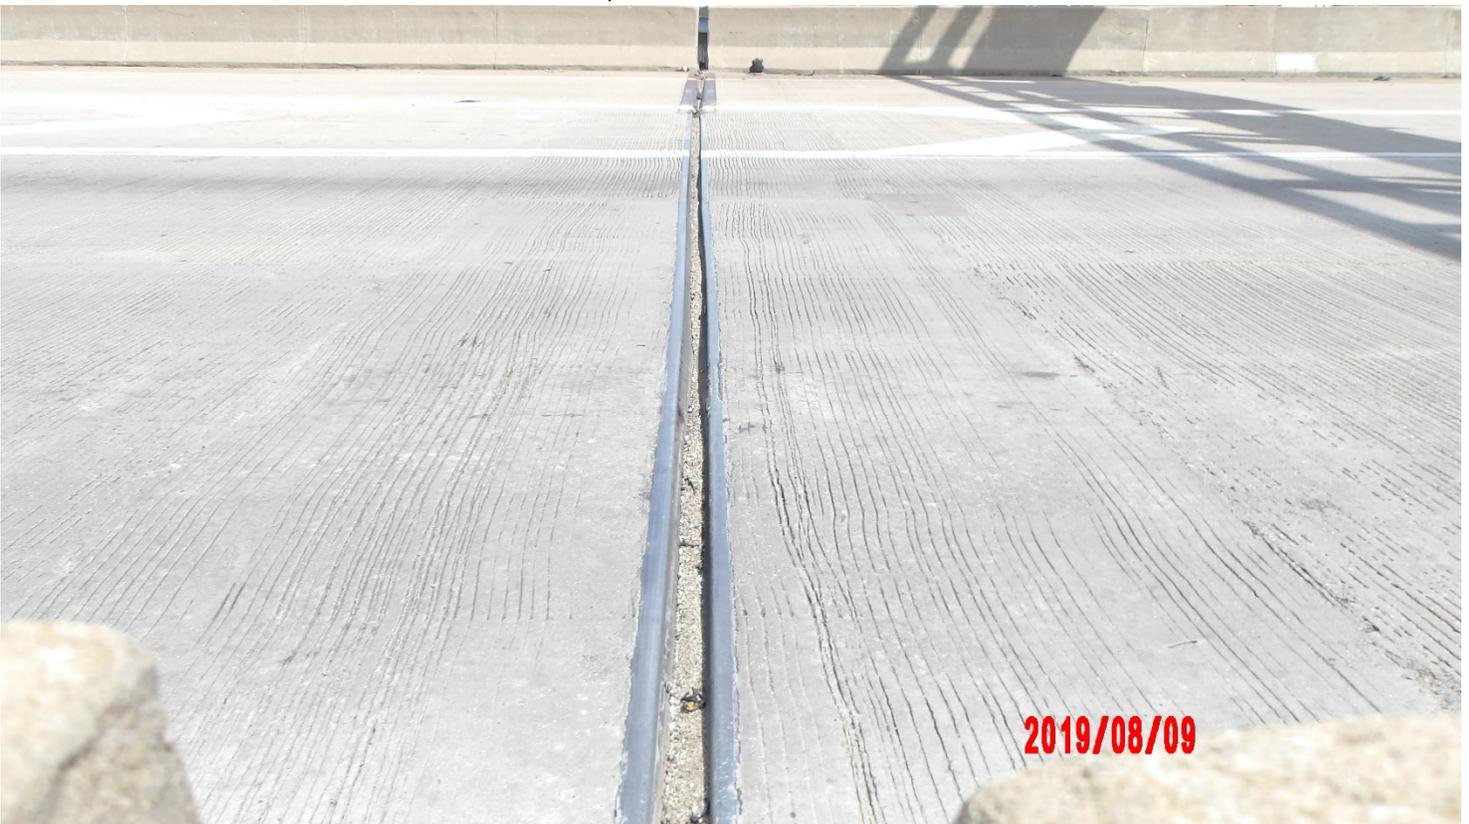
PHOTO 13. JOINT PIER 23C, DEBRIS IN JOINT AND DEPRESSION WHERE DEBRIS IS HANGING THROUGH, TORN.

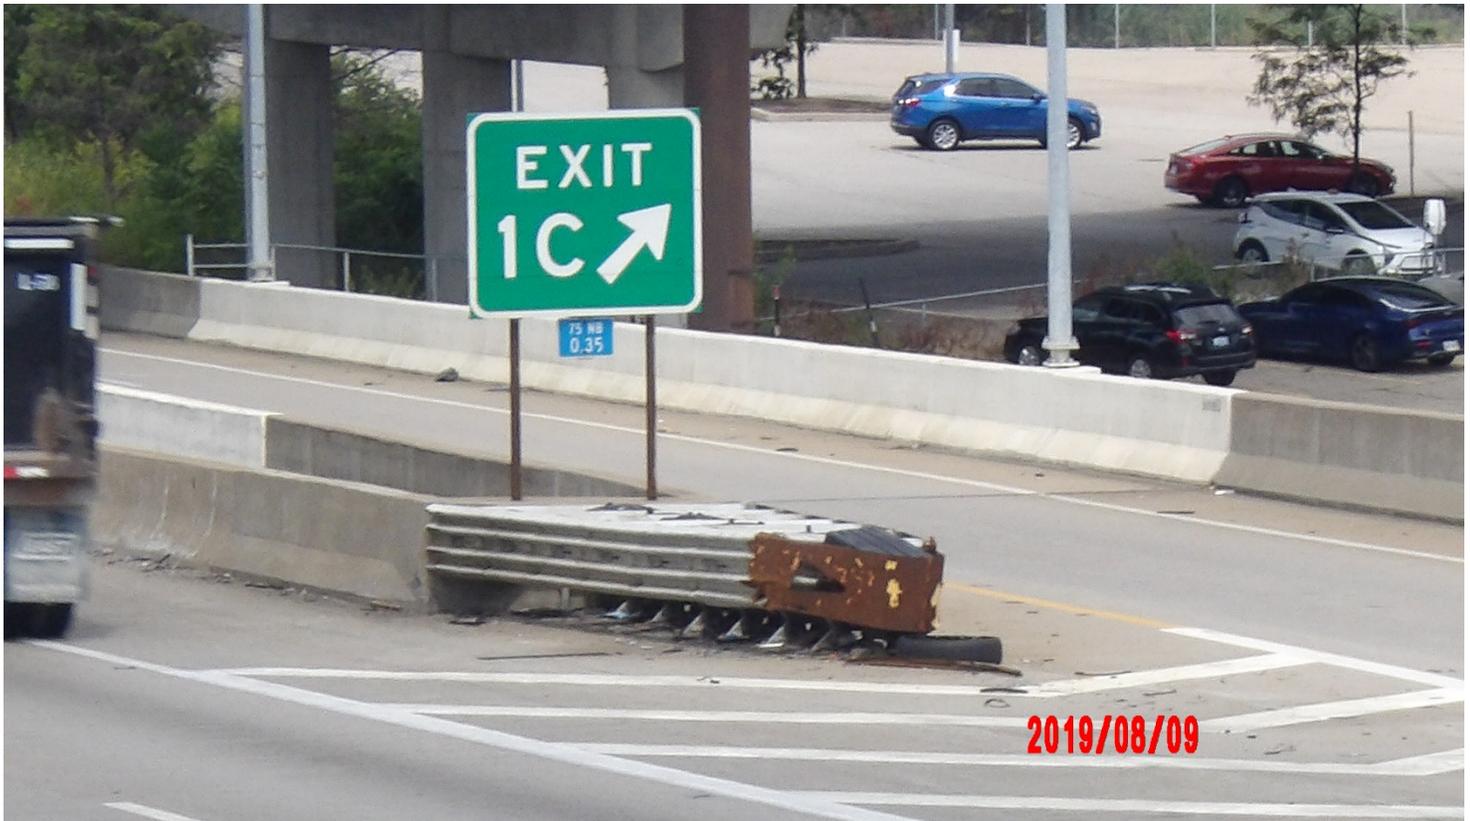
The reinforced concrete bridge railings are in FAIR CONDITION [5-NBIS] overall. Vertical and transverse hairline cracks with efflorescence as well as isolated small spalls are typical throughout the railings. A horizontal crack is present in the east railing near the light post in Span 20C. There is a map cracking in the top of the west railing near Pier 23C. There is a smashed attenuator on the guardrail near Exit 1C.

PHOTO 14. BARRIER, ATTENUATOR RETROFIT

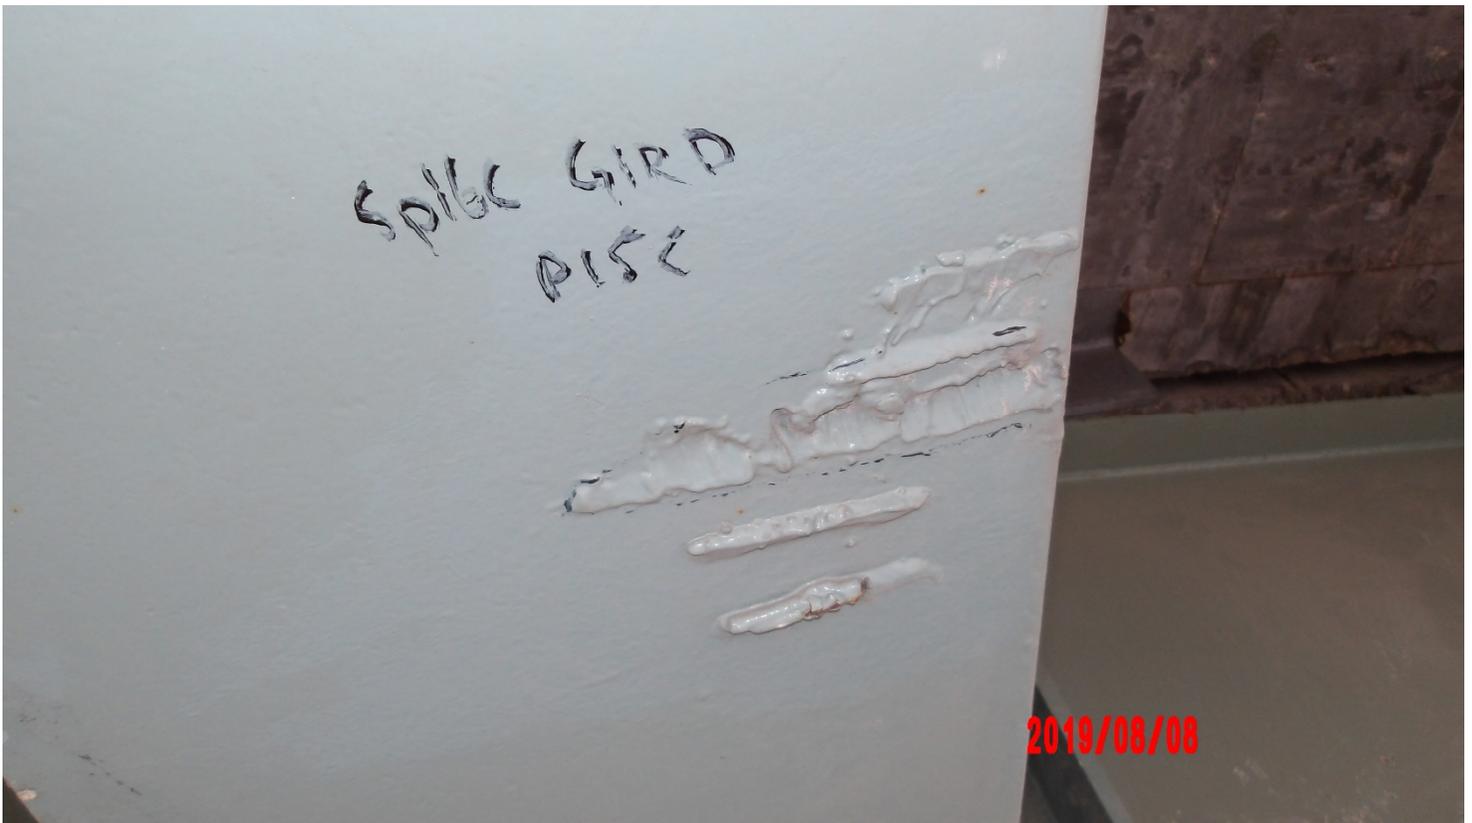
PHOTO 15. GIRDER D SPAN 16C, WELD REMNANTS AND GOUGES TO BOTTOM FLANGE

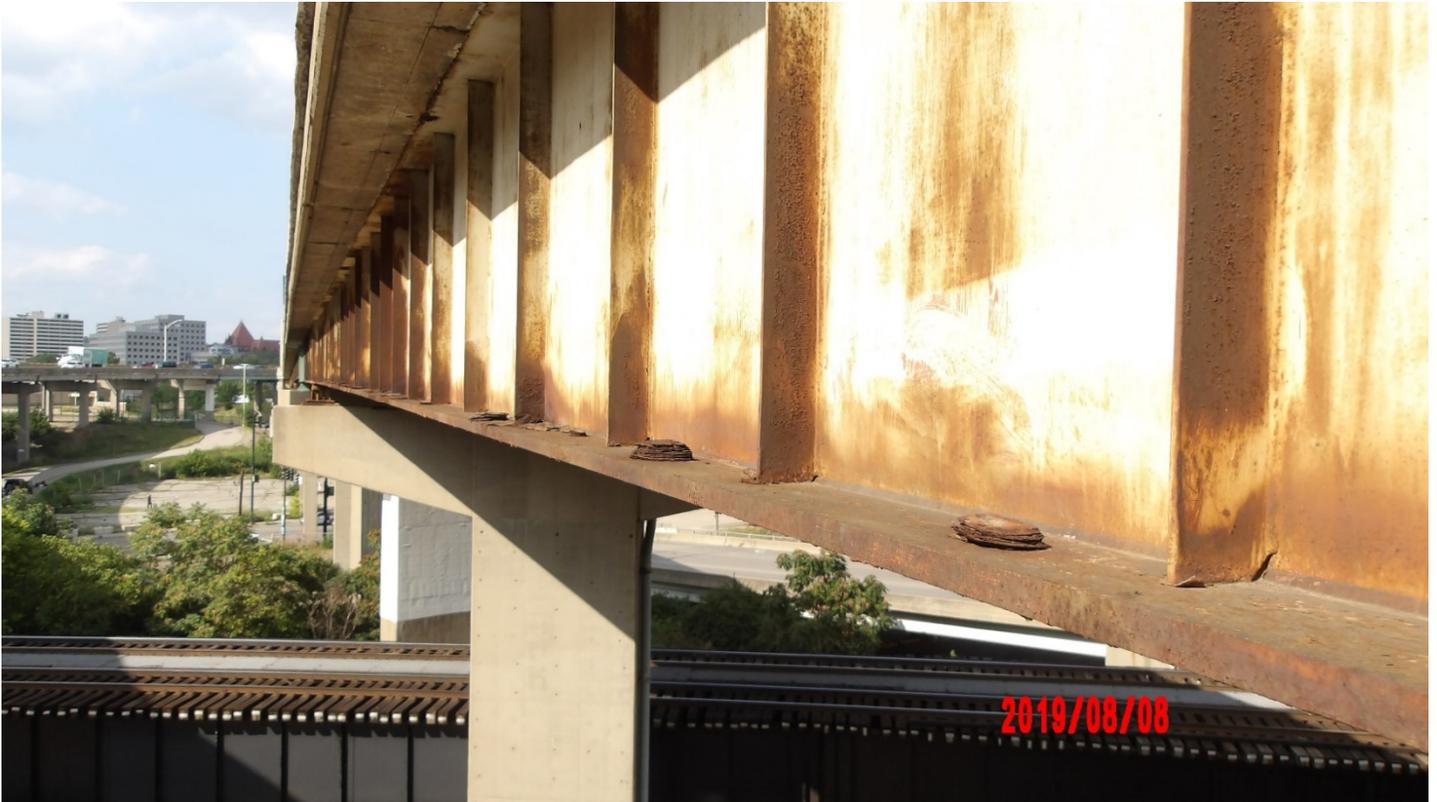
PHOTO 16. GIRDER A SPAN 17C BOTTOM FLANGE, INTERMITTENT SECTION LOSS WITH LAMINAR CORROSION ON BOTTOM FLANGE OF FASCIAS

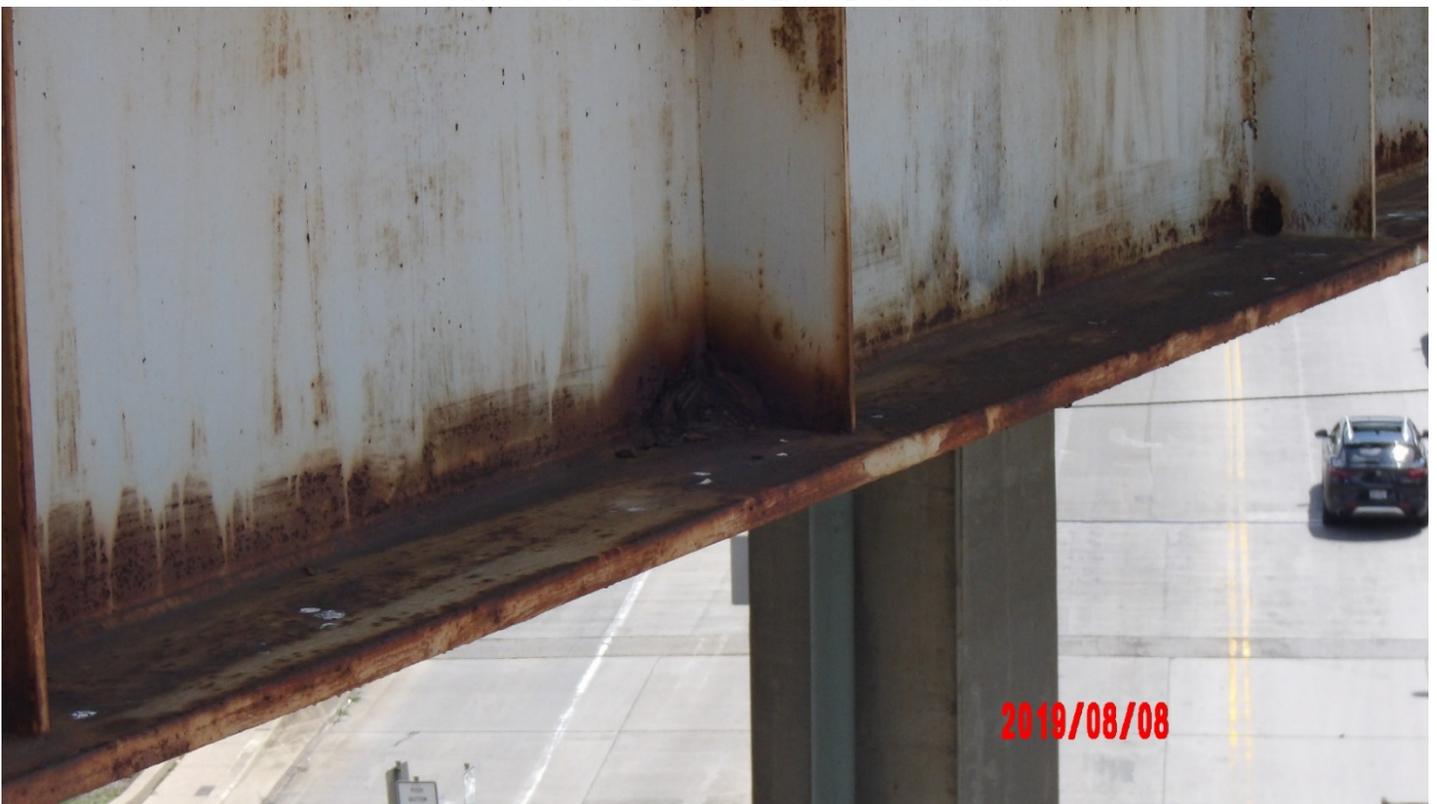
PHOTO 17. GIRDER SPAN 24, TYPICAL LAMINAR CORROSION AT STIFFENERS ON FASCIAS

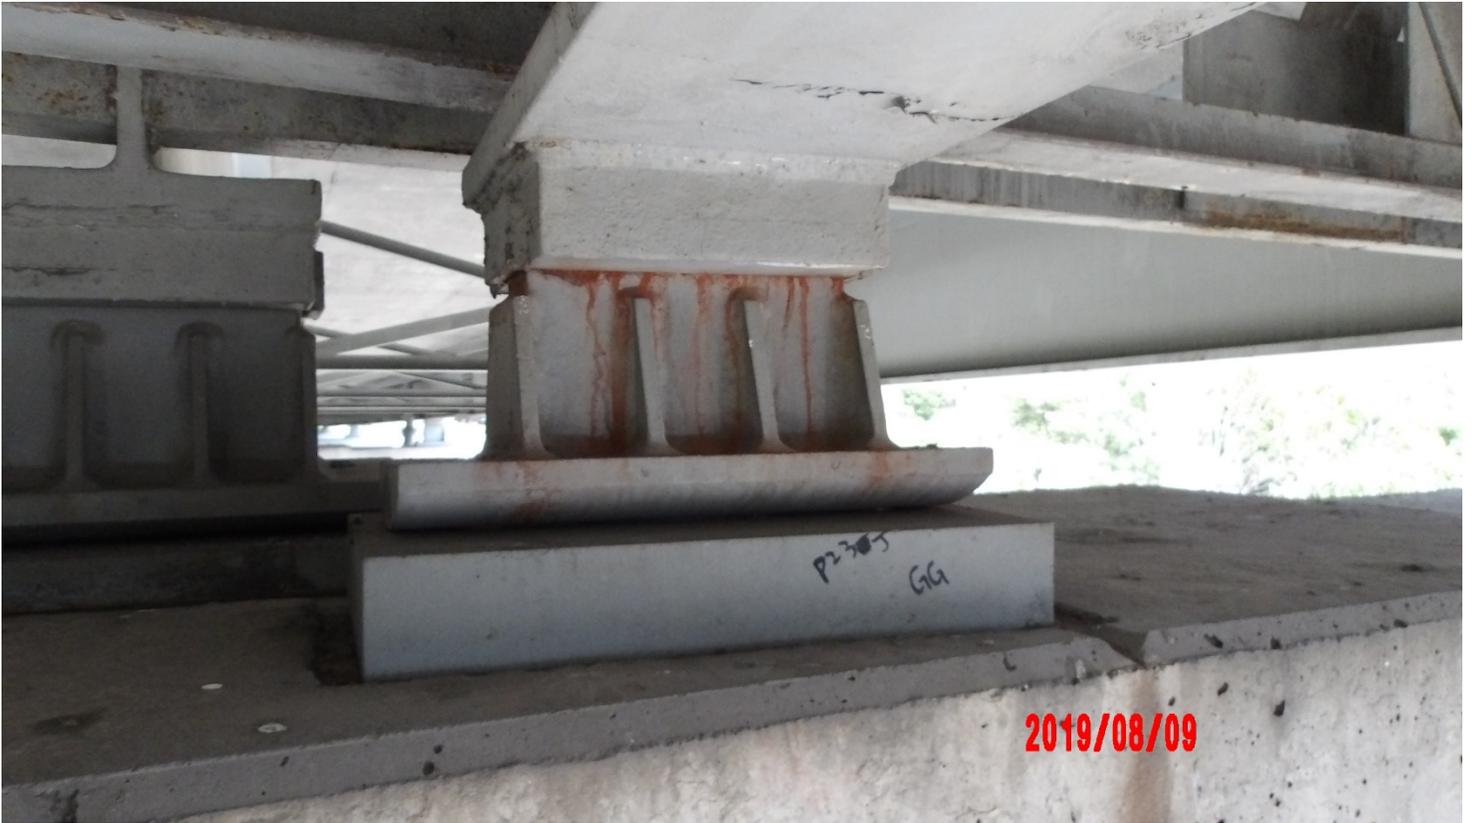
PHOTO 21. MOVABLE BEARING G PIER 23C, FRETTING RUST

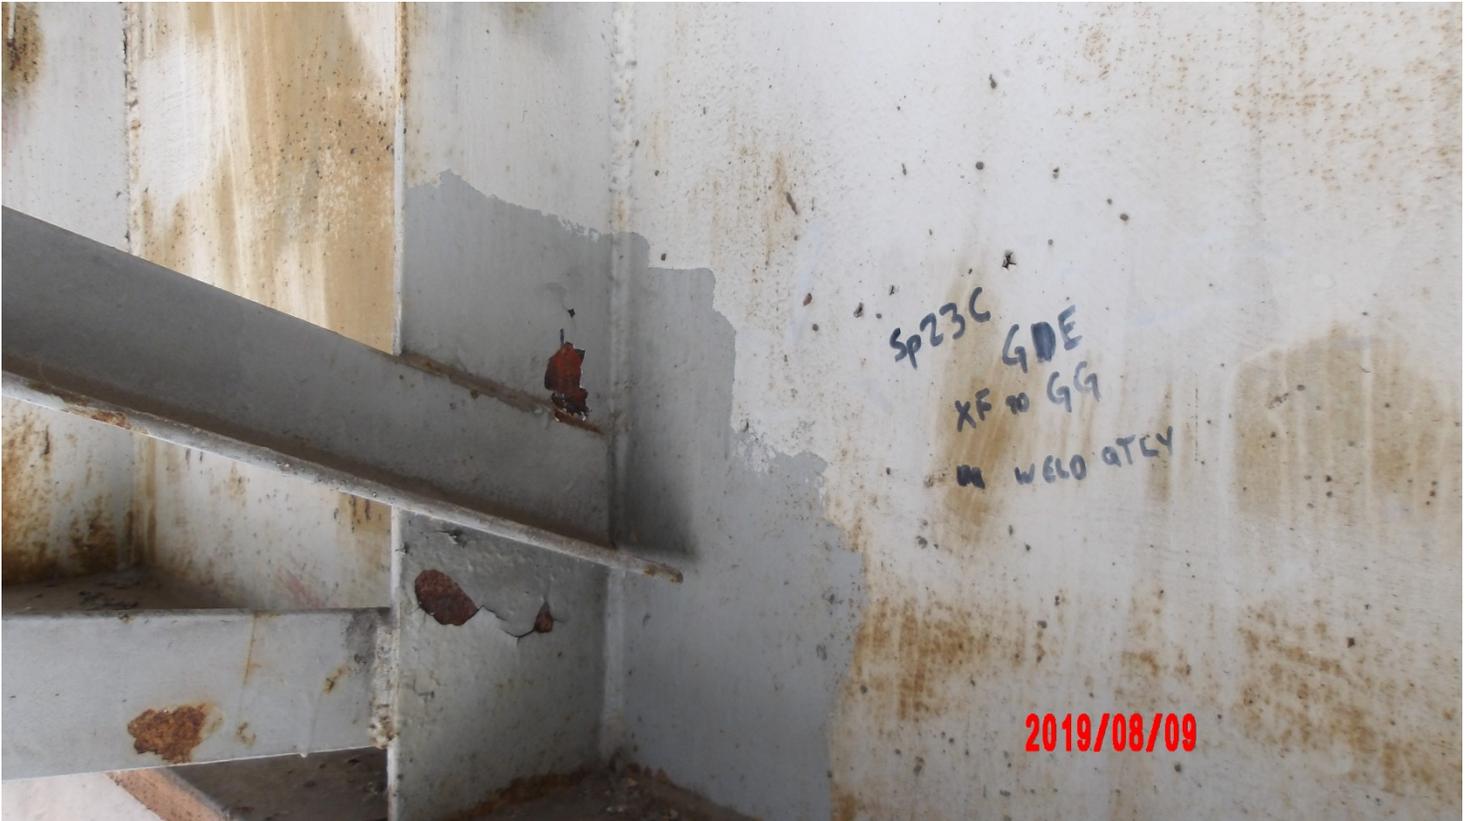
PHOTO 28. POOR WELD QUALITY FOR DIAPHRAGM TO GIRDER G STIFFENER

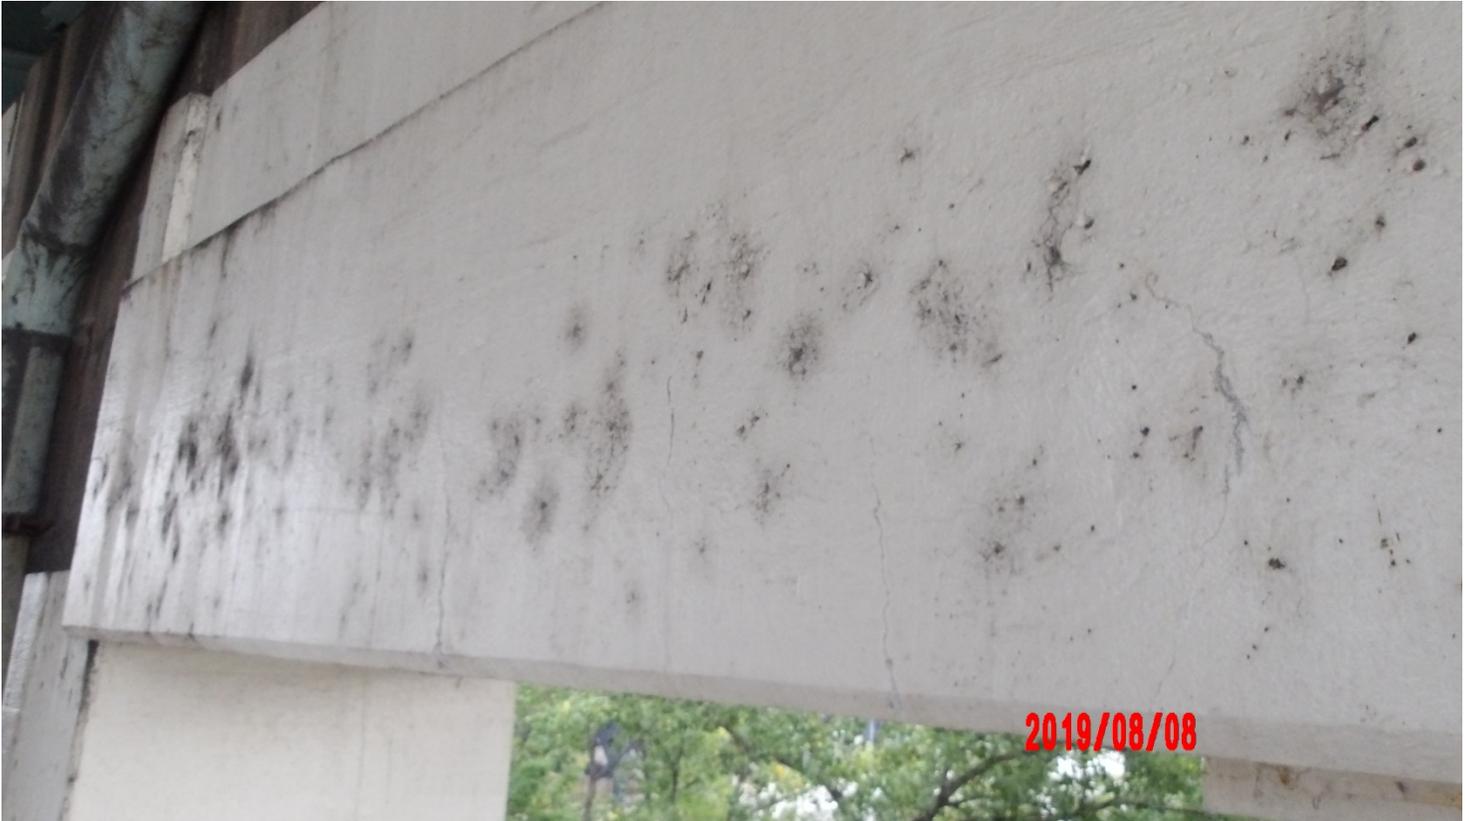
PHOTO 29. PIER 15C NORTH FACE, TYPICAL STAINING
