2024 ROUTINE INSPECTION REPORT
BRIDGE NO: HAM-75-0022R, SFN 3108805
VAR-DISTRICT 8 Bridge Inspections
Brent Spence Approach Bridges

Cincinnati, Ohio

August 19th – September 11th, 2024

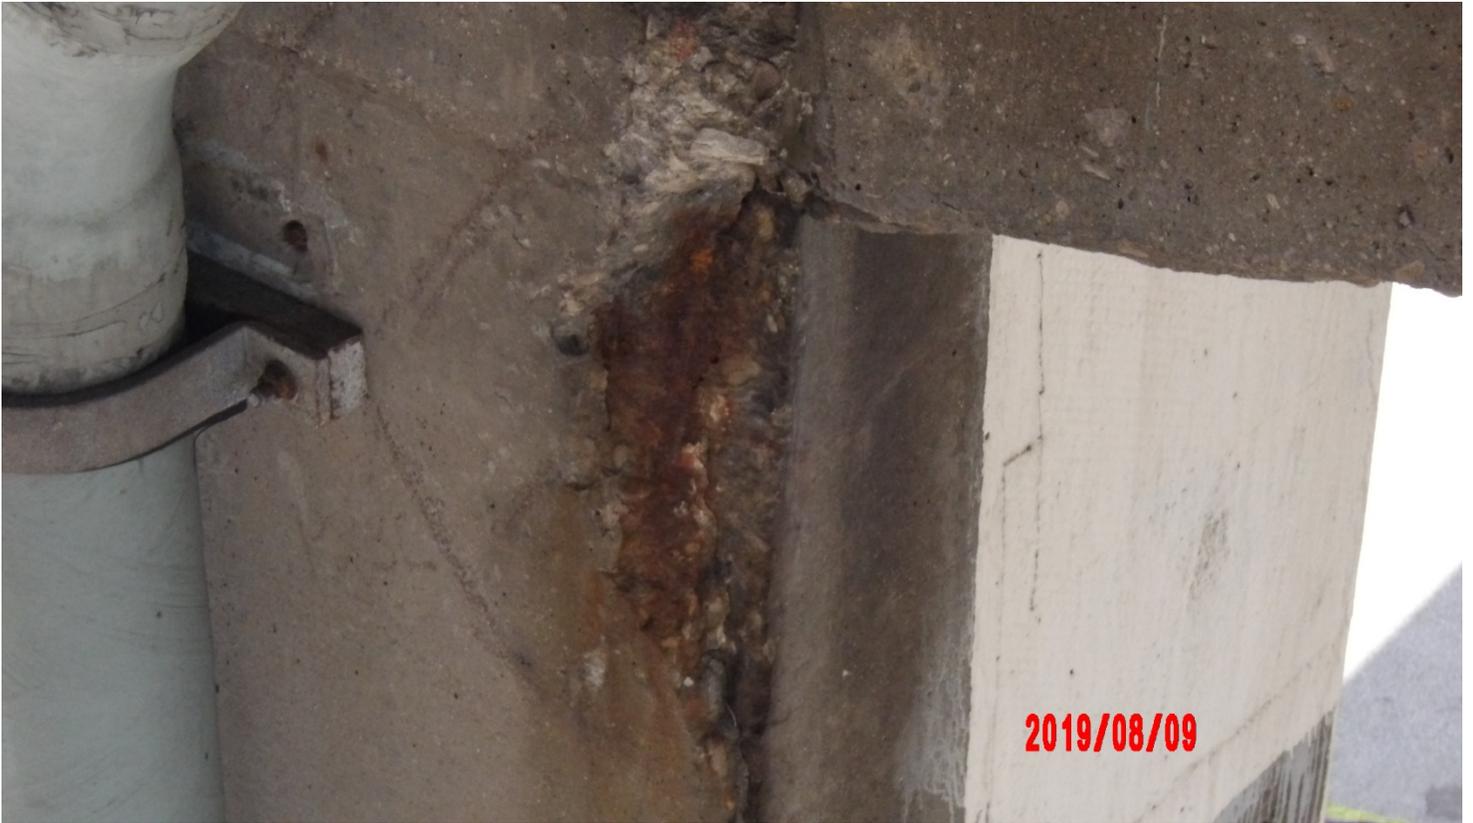
PHOTO 32. PIER 23C, SPALL IN COLUMN AND CAP

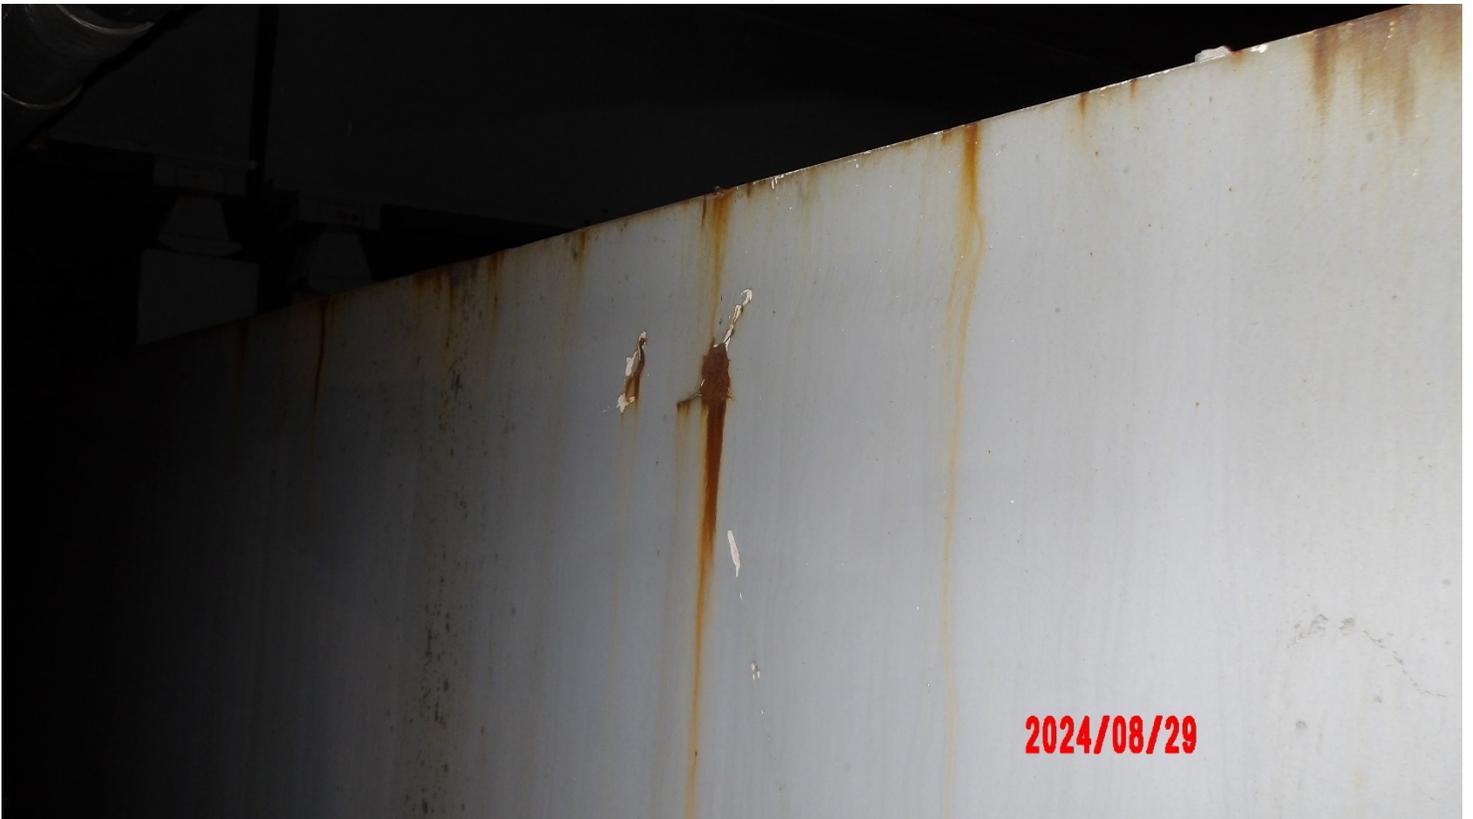
PHOTO 35. PIER 25C, WEB IMPACT WITH ACTIVE CORROSION

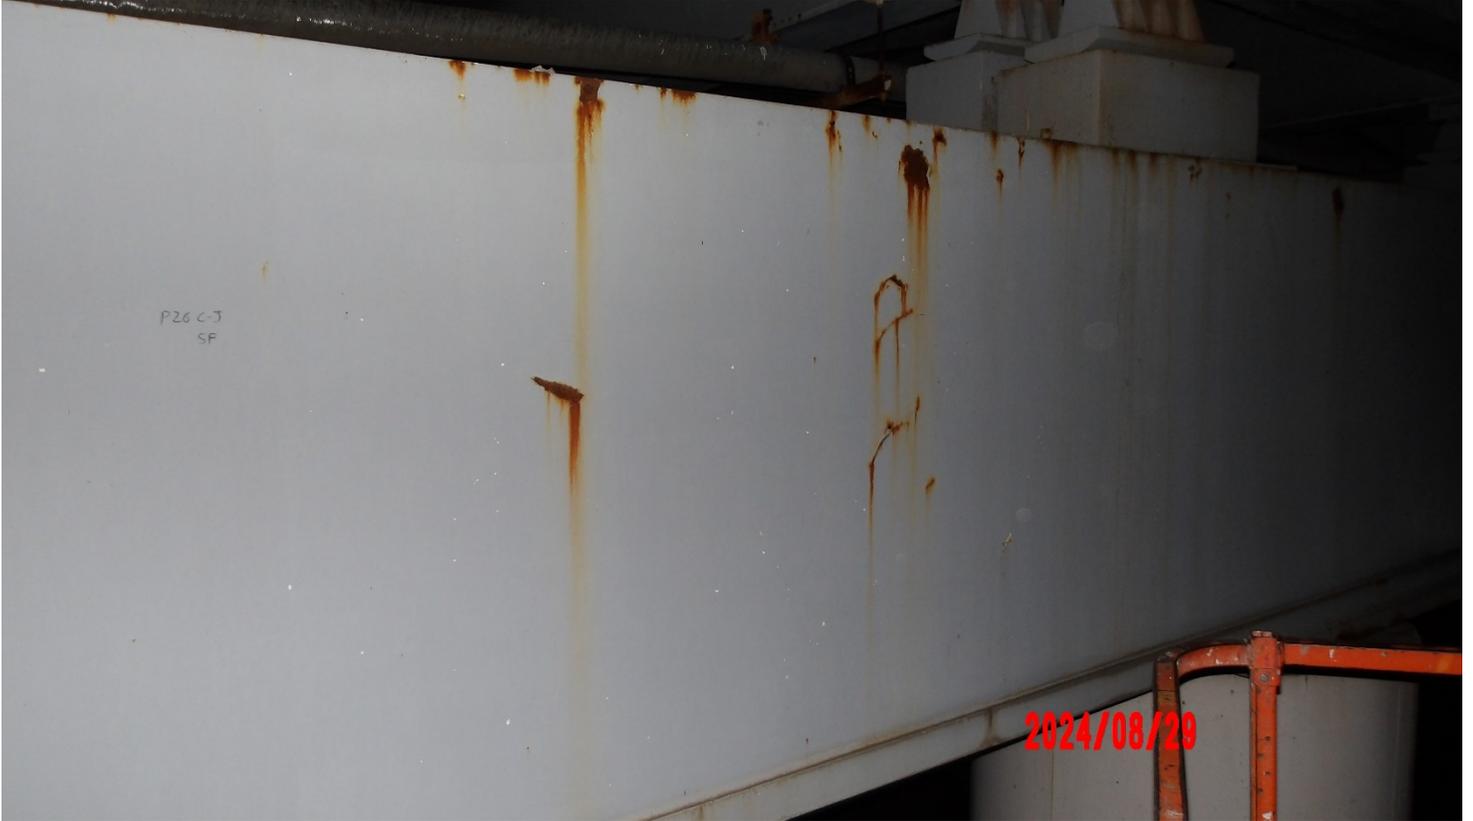
PHOTO 36. PIER 26C/J WEB ACTIVE CORROSION

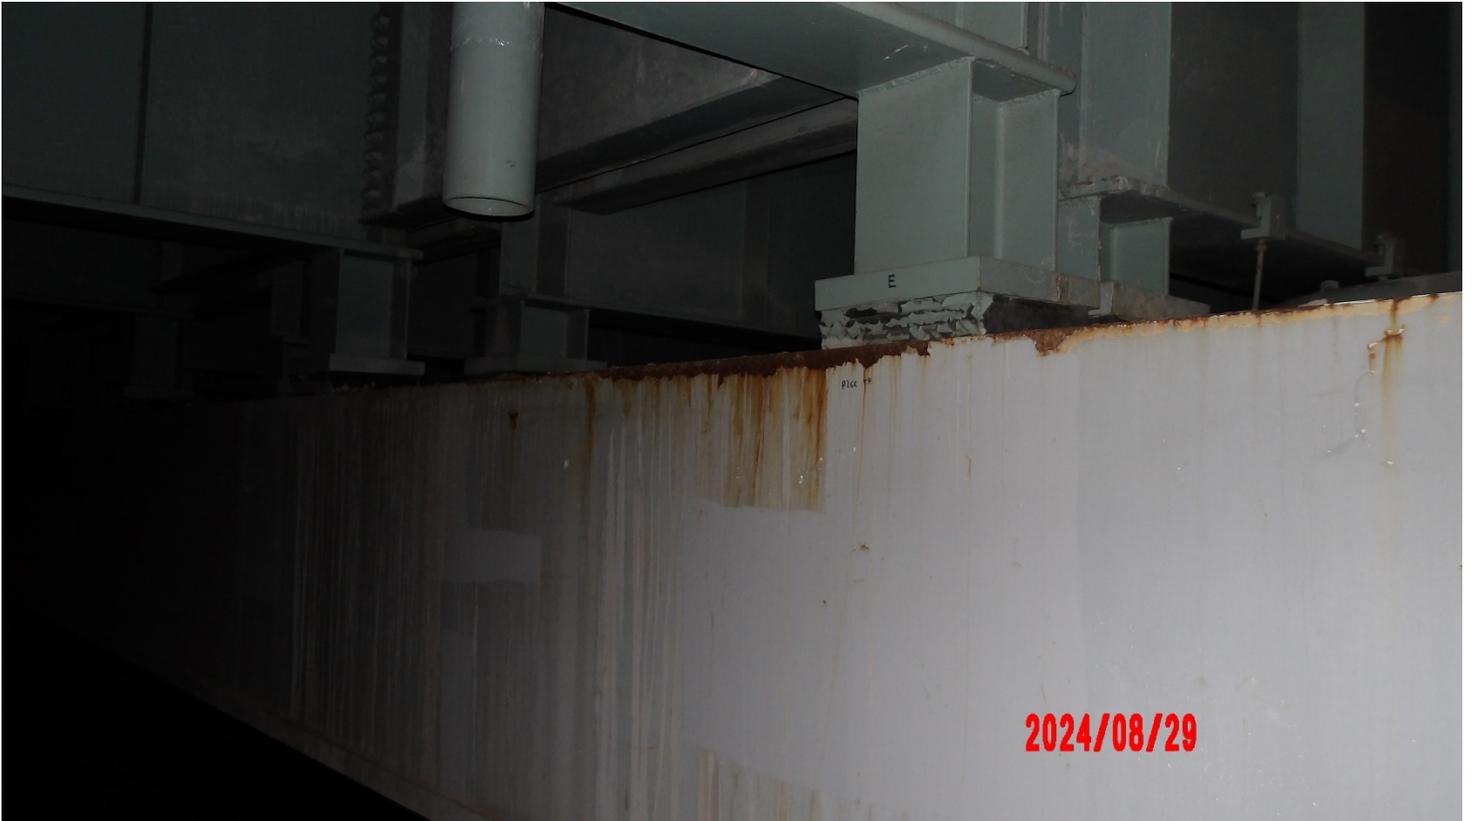
PHOTO 37. PIER 26C/J TOP FLANGE, DEBRIS AND ACTIVE CORROSION

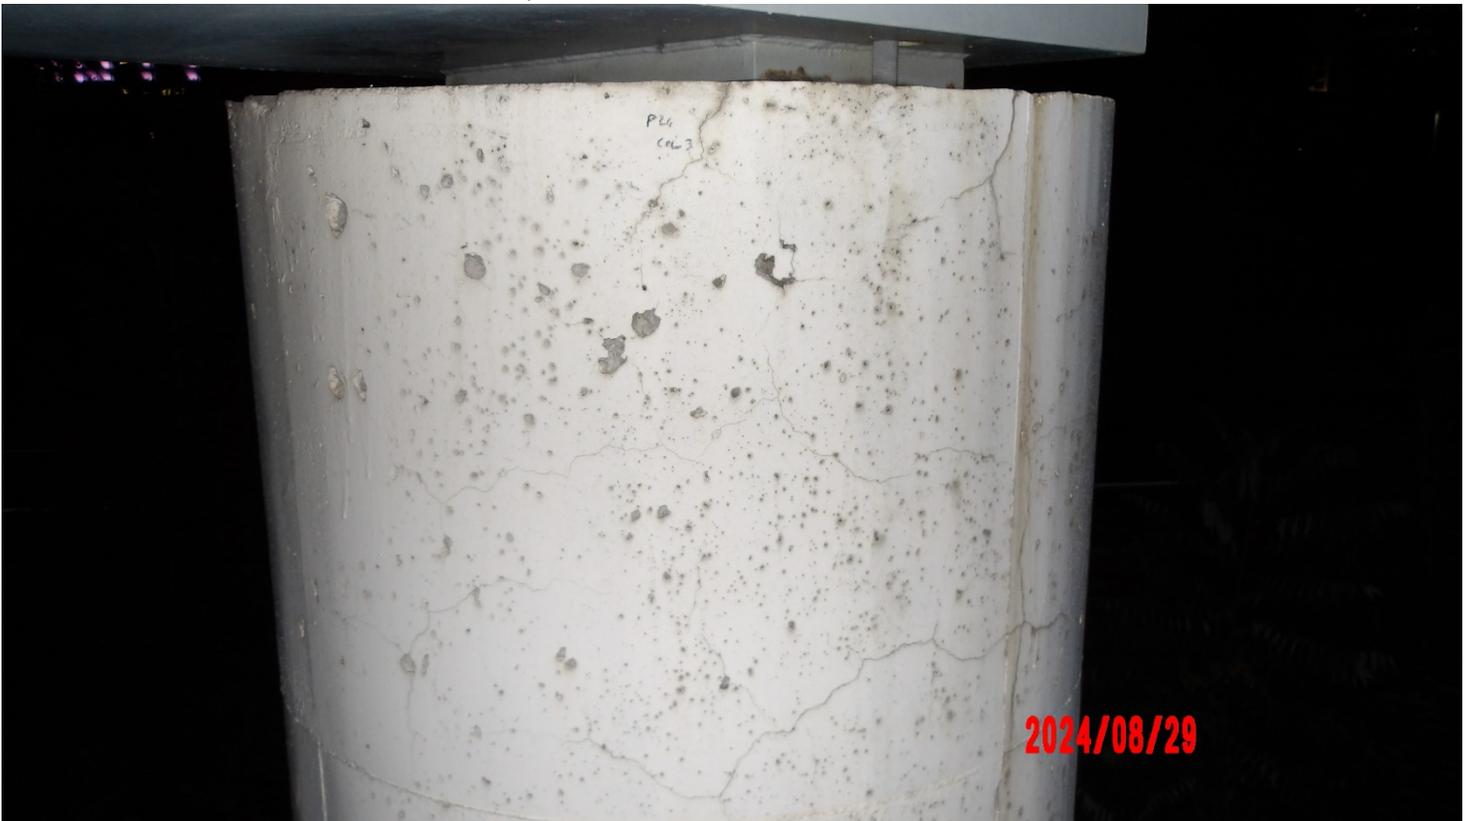
PHOTO 38. PIER 26C/J COLUMN 3, MAP CRACKING, MINOR WIDTH
