ODOT District 8
2023 In-Depth Element Level
Inspection Report

Bridge No. HAM-75-0022L
SFN: 3108791

**2023 IN-DEPTH ELEMENT LEVEL
PHYSICAL CONDITION REPORT**

Inspected on:
September 22, 2023

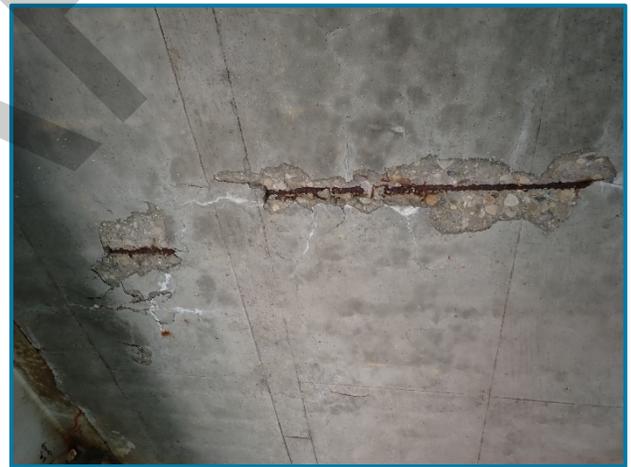
Photo 1 – Isolated delamination/spall with exposed reinforcement and adjacent typical hairline transverse cracks in the deck underside (looking up and south between Girders B and C in Span 23A).

The reinforced concrete deck is in SATISFACTORY condition [6-NBIS] with isolated spalls and exposed reinforcement, isolated minor delaminations, and typical hairline transverse cracks with efflorescence in the underside of the deck (see Photo 2). The transverse cracks are typically spaced 4'-6' apart in all spans but were predominantly noted in the interior bays. Numerous isolated spalls are present throughout the deck underside. There are four (4) spalls in Span 21A, two (2) in Span 22A, three (3) in Span 23A, and four (4) in Span 24A (see Photo 3). Minimal section loss of less than 1/16" is typical to the exposed reinforcement at all spall locations. Some of the most notable locations include:

1. Patch the spalls and delaminations throughout the underside of the deck, concrete wearing surface, and railing.

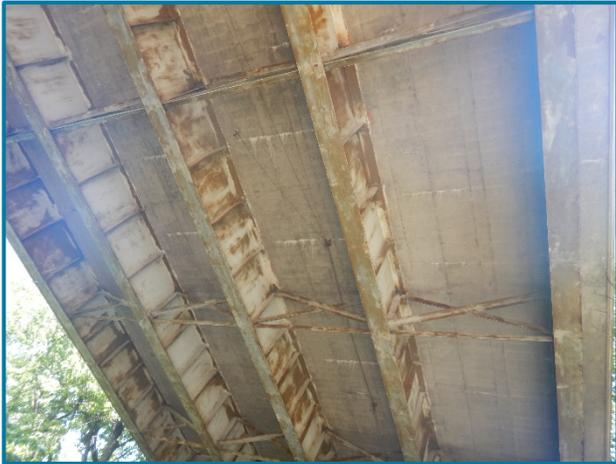
Photo 2 - Typical transverse cracks throughout the deck underside in the interior bays in Span 24A (looking northwest).

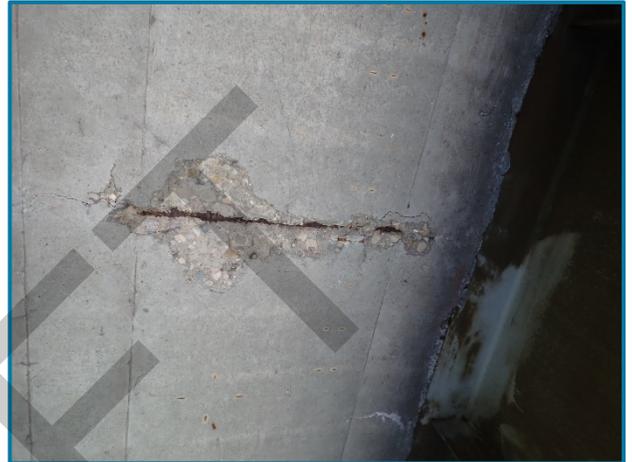
Photo 3 - 24" wide by 12" long by 1" deep spall with exposed reinforcement in the deck underside between Girders D and E in Span 24A (looking south).

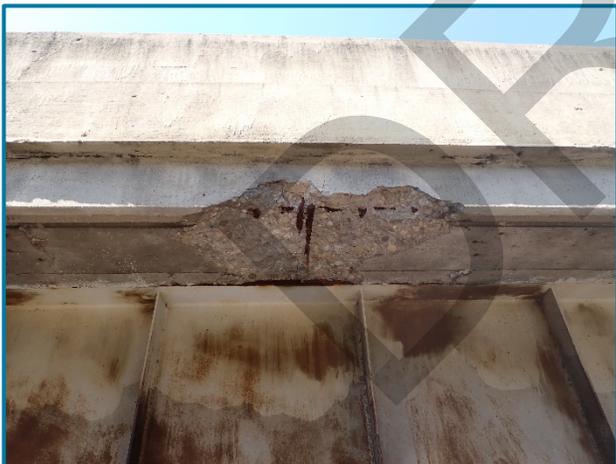
- A 3' long by 2' wide by up to 4" deep spall with one longitudinal and five transverse reinforcing bars exposed in the east overhang underside of Span 22A near the first crossframe from Pier 21A (see Photo 4).

Photo 4 - 36" long by 24" wide by 4" deep spall with exposed reinforcement in the east overhang in Span 22A (looking west).

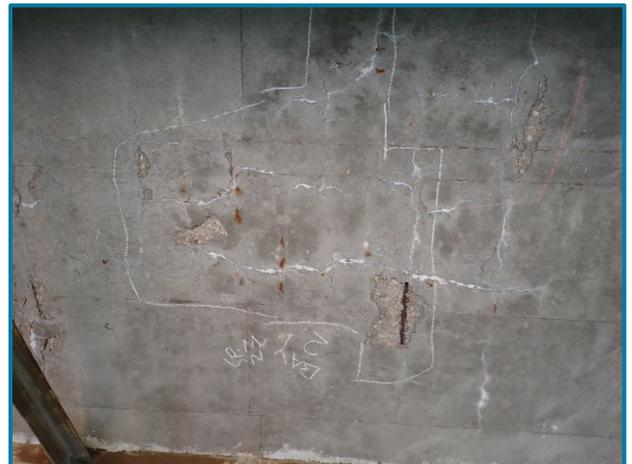
- An 8' wide by 8' long by up to 1" deep area of spalling and delamination is present between Girders B and C in Span 23A. One transverse reinforcing bar is exposed and has minimal section loss (see Photo 5).

Photo 5 - 8' long by 8' wide by 1" deep spall with exposed reinforcement and surrounding delaminations in the deck underside between Girders B and C in Span 23A (looking south).

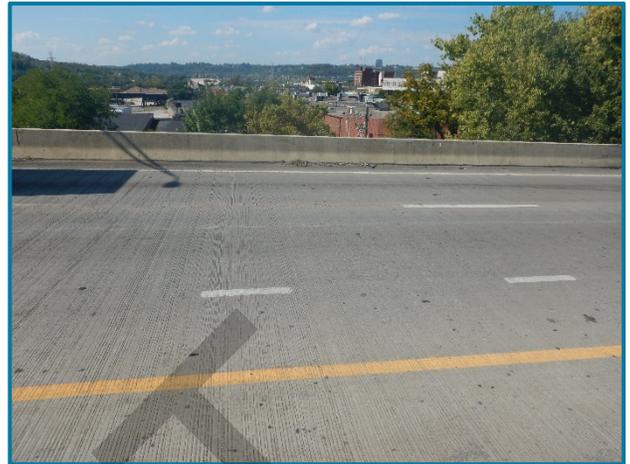
The integral concrete deck wearing surface is in GOOD condition [7-NBIS] overall (see Photo 6) with minor spalls and hairline longitudinal and transverse cracks throughout. There is a 6" diameter spall in the right lane of Span 22A near Pier 21A and a 1' by 1' spall previously patched in the right lane of Span 22A near midspan.

Photo 6 – Typical wearing surface (looking west in Span 24A at midspan).

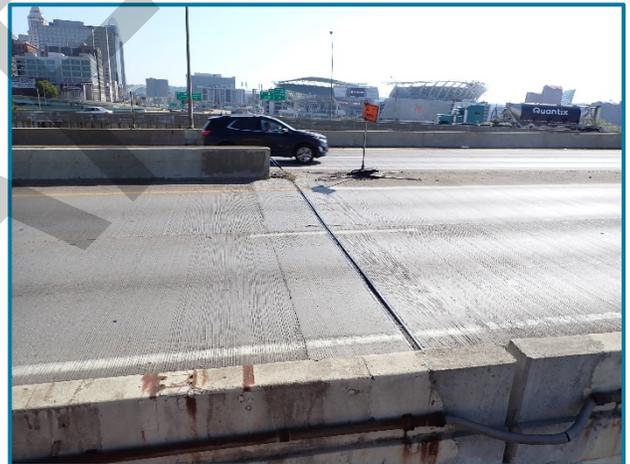
The expansion joints (located at Abutment A and Pier 19A) are in GOOD condition [7-NBIS] overall (see Photo 7) with minor debris impactation throughout the entire length of the joint. The expansion joints were replaced in 2017 and no signs or indications of water leakage were noted at the time of inspection. No joint opening measurements were taken at deck level.

Photo 7 – Typical expansion joint at Pier 19A (looking east).

6. Clean debris from clogged drainage scuppers in Spans 22A and 23A.
7. Remove debris from strip seal expansion joints at Pier 19A and Abutment A.
8. Repair/replace the broken drainage downspout gasket near the base of Column 1 at Pier 23A.

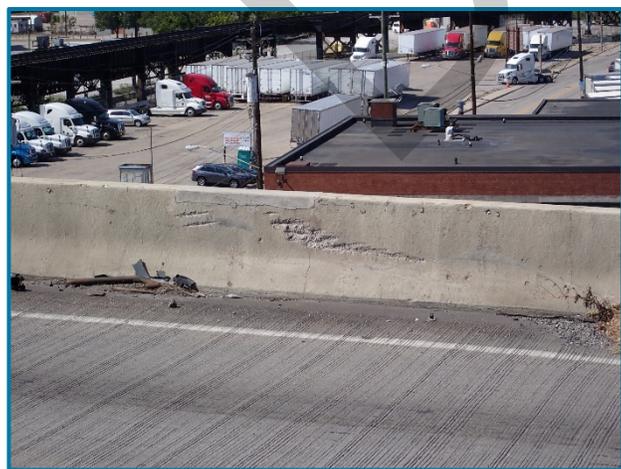
The reinforced concrete bridge railings are in SATISFACTORY condition [6-NBIS] overall with isolated minor spalls, isolated minor delaminations, and full height hairline vertical and transverse cracks throughout. There is a 5' long by 1' high by 1" deep spall on the left railing near midspan of Span 22A (see Photo 8). Both railings have concrete patches near Pier 19A and Abutment A as well as at isolated locations throughout. The concrete patches are in good condition overall.

Photo 8 – Shallow spall on the interior face of the west railing in Span 22A at midspan (looking west).

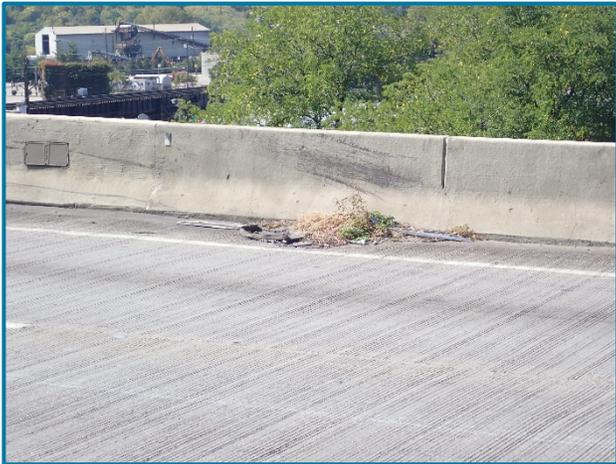
The bridge deck drainage is in SATISFACTORY condition [6-NBIS]. The deck level scuppers at Piers 22A and 23A were noted to be 100% clogged with debris accumulated over top (see Photo 9). The gaskets for the drainage downspout on Column 1 of Pier 23A are bulging and/or completely cracked causing leakage at the base (see Photo 10). There is minor corrosion at the end of the drainage downspout at Abutment A between Girders A and B.

Photo 9 – Clogged scupper in the west shoulder on the top of deck at Pier 23A (looking southwest).

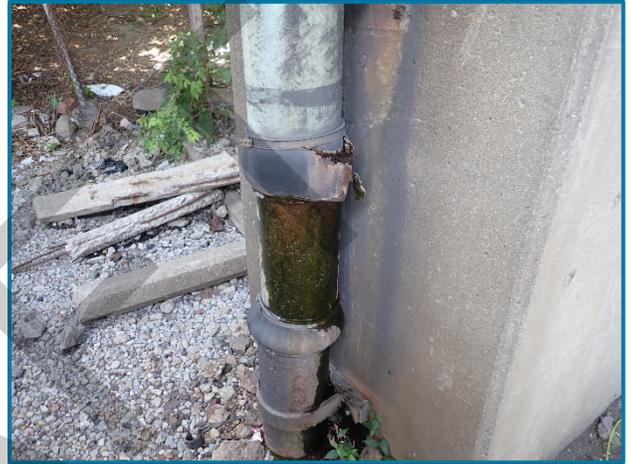
Photo 10 – Bulging and cracked drainage coupling gasket at the base of Column 1 on the south face of Pier 23A (looking northwest).

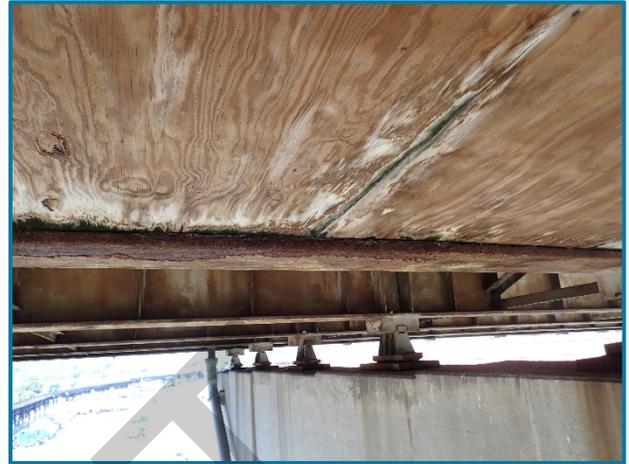
Photo 11 – Laminate corrosion with up to 1/8" section loss in the bottom flange of Girder E in Span 20A near Pier 20A (looking east).

2. Clean and paint the entire superstructure.
3. Replace the broken anchor bolt of the Girder C bearing at Pier 22A.

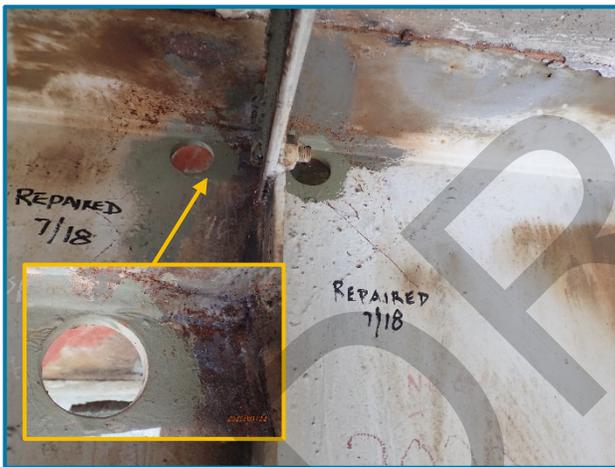
The steel plate girders are in SATISFACTORY condition [6-NBIS] overall. There is typical freckling and minor surface corrosion throughout the girder webs and flanges, particularly noted the most significant at the fascia girders. Laminate corrosion is present on the bottom flange of the exterior girders and the bottom flange of Girder E adjacent to the timber falsework between HAM-75-0022L and HAM-71-0000L. While most instances of laminate corrosion only exhibit minor section loss, there is an isolated area of up to 1/8" deep section loss on the west edge of the bottom flange of Girder E in Span 20A (see Photo 11). Inspectors attempted to remove the timber falsework in order to gain access to the east face transverse stiffeners of Girder E in Span 20A, however it could not be removed at the time of inspection. Therefore, the previously noted corrosion holes at this location were not accessible and not verified. There are typical cracks in the web of Girder C in Spans 23A-25A that have been previously repaired with arrest holes. These cracks and arrest holes are present at the weld between the web and transverse stiffener near the top flange at the midspan crossframe locations. There were no indications of crack propagation beyond the arrest holes at the time of inspection (see Photo 13).

Photo 13 – Typical crack arrest hole in the web of Girder C near top flange (looking west in Span 23A at midspan).

13. Continue to monitor the crack arrest hole repairs in the web of Girder C in Spans 23A-25A.

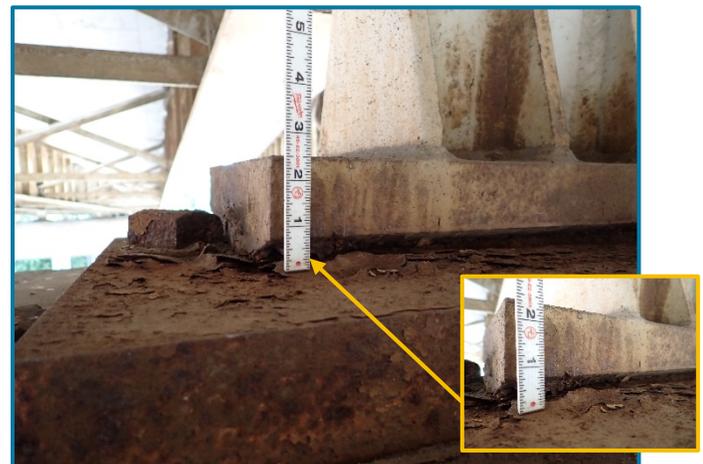
The bearing devices are in SATISFACTORY condition [6-NBIS] overall with surface corrosion and isolated locations of pack rust between the rockers and masonry plates (see Photo 12). Areas of surface corrosion are most prominent at the fascia bearings. There is up to 1/4" thick

Photo 12 – 1/4" thick pack rust between the masonry plate and rocker bearing of Girder E at Pier 20A (looking southwest).

pack rust between the rocker and the northeast corner of the masonry plate at Girder E in Span 20A. The northeast anchor bolt at the Girder C bearing at Pier 22A remains broken (see Photo 14).

9. Remove the pack rust between the Girder E rocker bearing and masonry plate at Pier 20A.

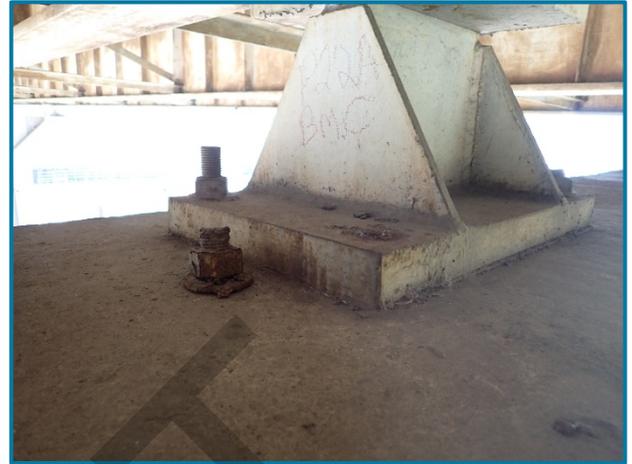
Photo 14 – One broken anchor bolt at the northeast corner of the Girder C bearing at Pier 22A (looking southwest).

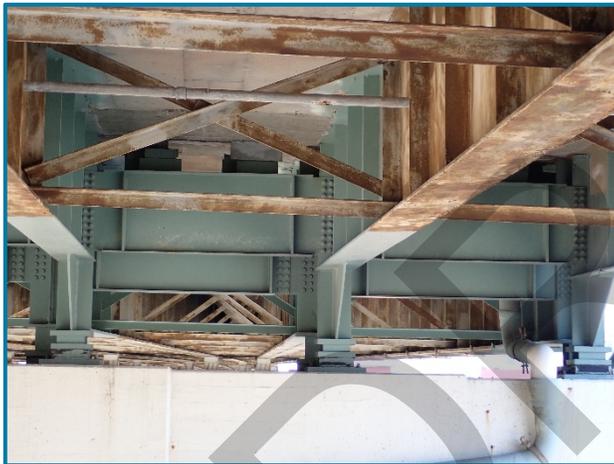
The steel protective coating is in CRITICAL condition [2-NBIS]. As part of the 2017 expansion joint replacement at Pier 19A and Abutment A, the end 10' of the existing girders were cleaned and painted. The protective coating at these locations is in good condition overall (see Photo 15). Otherwise, the protective coating system is ineffective or has completely failed throughout all steel members. Chalking, peeling, and cracking paint is typically widespread throughout the interior bearings, crossframes, and girders (see Photo 16). The system has failed notably on the fascia girders, exhibiting completely exposed steel and areas of minor surface corrosion.

Photo 15 – Typical steel protective coating condition of the girder ends at Pier 19A (looking southeast).

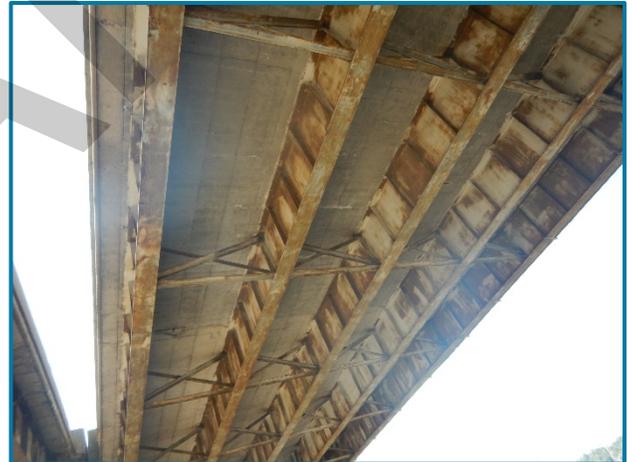
Photo 16 – Typical steel protective coating condition of all steel members in Span 21A (looking southwest).

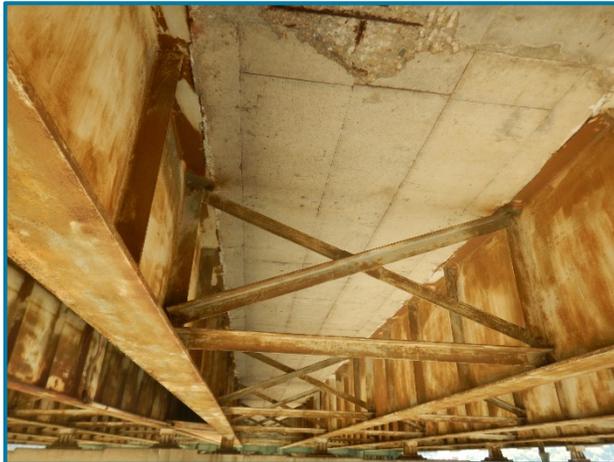
The diaphragms and crossframes are in satisfactory condition with only minor surface corrosion and paint failure throughout (see [Photo 17](#)). The end crossframes at Pier 19A were replaced with jacking diaphragms and the end crossframes at Abutment A were cleaned and painted when the joints were replaced in 2017. There is a newly noted isolated 3' long area of damage along the bottom horizontal member of the end crossframe between Girders C and D at Abutment A (see [Photo 18](#)). The damage appears to have been caused by a fire set on the abutment seat.

Photo 17 – Typical crossframe with minor surface corrosion and paint failure (looking south in Span 21A between Girders D and E).

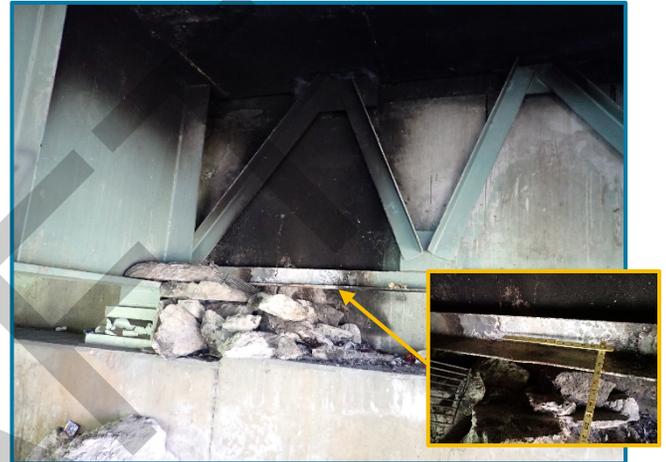
Photo 18 – Fire damage to the end crossframe between Girders C and D at Abutment A (looking northwest).

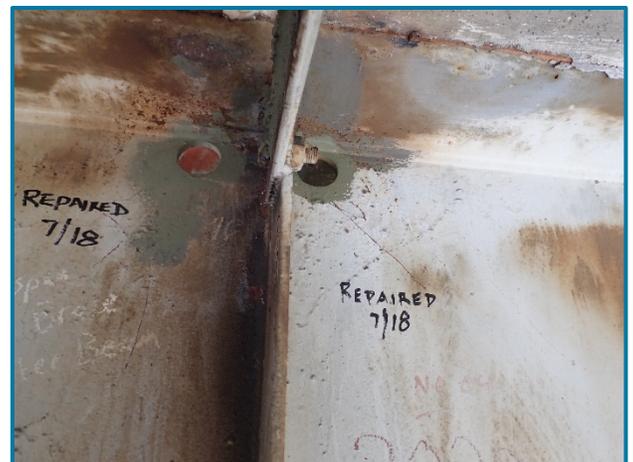
The fatigue details of the bridge are in good condition overall. The cracks in the weld between the web and transverse stiffeners of Girder C in Spans 23A-25A were previously repaired with arrest holes and there are no signs of crack propagation beyond the repairs at any location (see [Photo 19](#)).

Photo 19 – Typical crack arrest hole repairs in east face web of Girder C at the midspan crossframe connection (looking west in Span 23A).

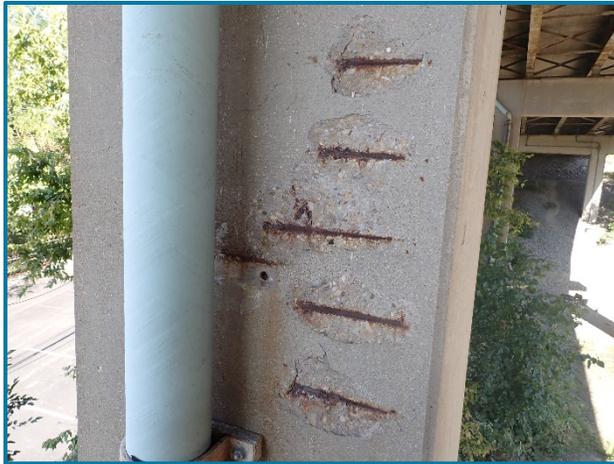
Photo 20 – Spalls with exposed reinforcement on the south face of Column 1 at Pier 22A (looking north).

4. Patch the spalls and delaminations throughout the substructure units.

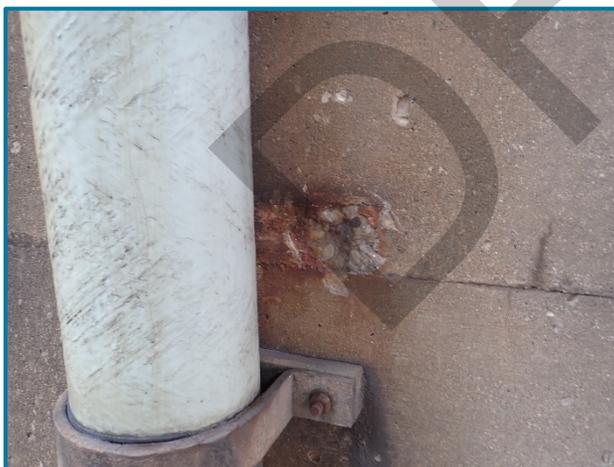
Photo 21 – 6" diameter spall near the drainage support bracket on the south face of Column 1 at Pier 23A (looking north about 15' above the ground).

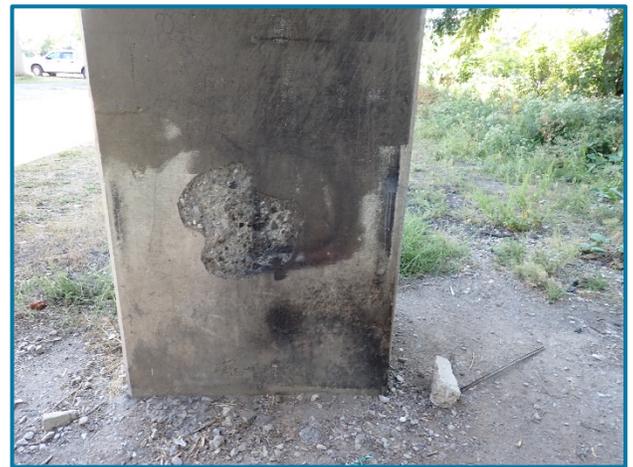
- Pier 22A, Column 1 – Multiple spalls up to 3' high by 16" wide by 1/2" deep with five exposed reinforcing bars with minor section loss typical on the south face about 12' below the pier cap (see Photo 20).
- Pier 23A, Column 1 - 6" diameter by 1" deep spall near the drainage support bracket on the south face of Column 1 about 15' above the ground line (see Photo 21).
- Pier 23A, Column 2 - 20" diameter by 1" deep spall on the north face of Column 2 about 3' above ground line (see Photo 22).

Photo 22 – 20" diameter by 1" deep spall on the north face of Column 2 at Pier 23A (looking south near the base).

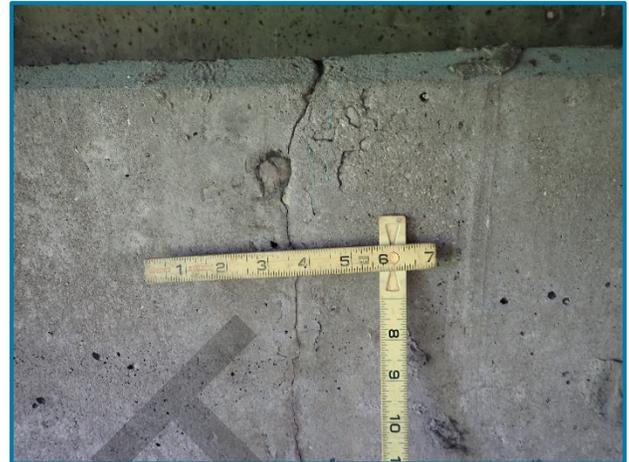
Photo 23 – Isolated vertical hairline crack in the abutment seat below Girder B in Span 25A (looking north at the south face of Abutment A).

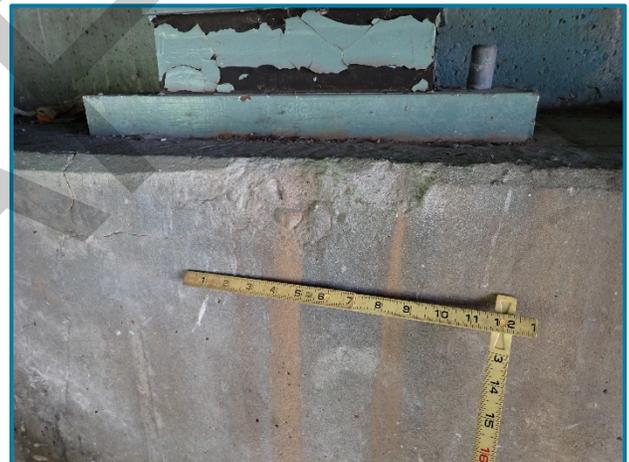
Photo 24 – Shallow edge spall on the Abutment A bearing seat at Girder D (looking north).

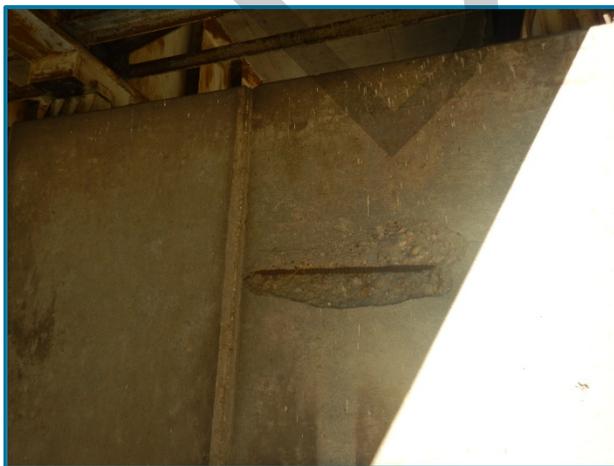
Photo 25 – 2' wide by 1' high by 2" deep spall with exposed reinforcement on the south face of the Pier 21A cap between Girders D and E (looking north).

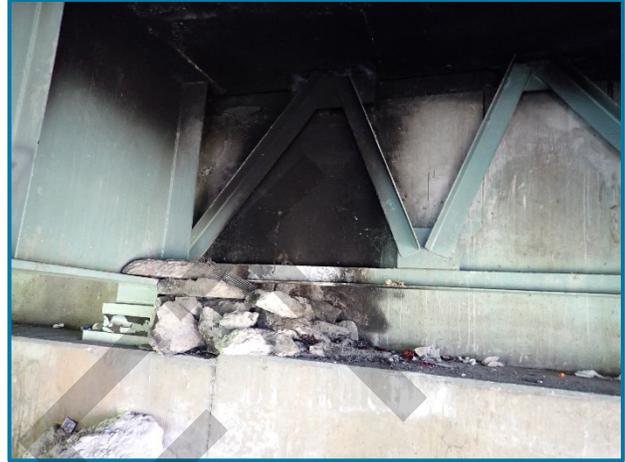
The Abutment A backwall is in FAIR condition [5-NBIS] with isolated spalls, delaminations, and hairline cracking throughout. There are minor delaminations throughout the concrete patches between Girders A and B and between Girders D and E. A 2' diameter by 1" deep spall is present behind the bearing of Girder A. There is discoloration in the backwall between Girders C and D caused by a suspected fire. Hairline vertical and horizontal cracks are present throughout the discolored area and concrete debris is piled up on the abutment seat and bottom flange of Girder C in front of the backwall (see Photo 27).

Photo 27 – Fire damage with discoloration and cracking on the Abutment A backwall between Girders C and D (looking northwest).

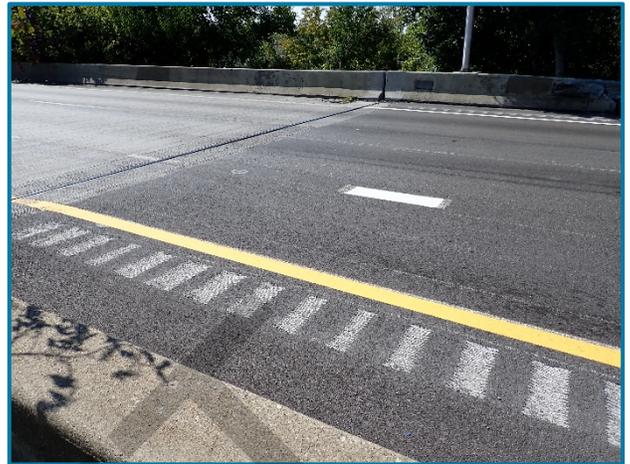
The north approach slab is in SATISFACTORY condition [6-NBIS] and is covered with a new asphalt wearing surface overlay (see Photo 28). Previous cracks and patches are covered, and no new deficiencies were noted in the new asphalt wearing surface.

Photo 28 – New asphalt wearing surface overlay on the north approach slab (looking southwest).

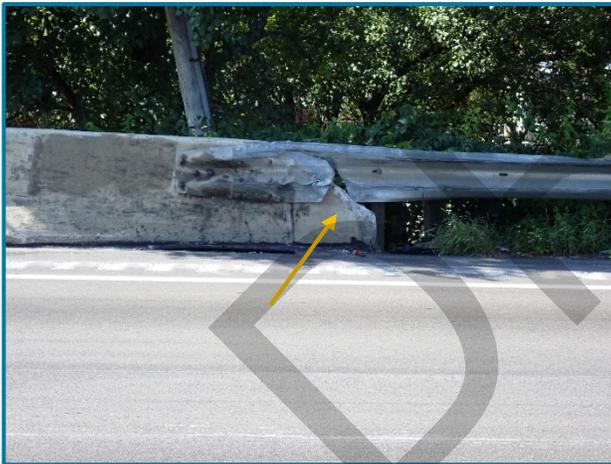
Photo 29 – Impact damage to the approach guardrail at the transition to the concrete railing on the west side of the north approach (looking west). Note the spall at the end of the concrete railing.

The approach guardrail is in fair condition. The metal guardrail at the connection to the concrete railing at the northwest corner of the bridge is torn with crumpling, bending, and twisting (see Photo 29). The damage appears to have gotten worse since the previous inspection as there is only a small portion of the guardrail at the top that is still connected to the concrete railing. Adjacent to the railing impact damage, there is a full width by full height by 3' long spall with exposed and deformed reinforcement on the end of west approach railing (see Photo 29).

5. Patch the spall at the north end of the west concrete approach railing.

12. Replace the west guardrail at the north approach.

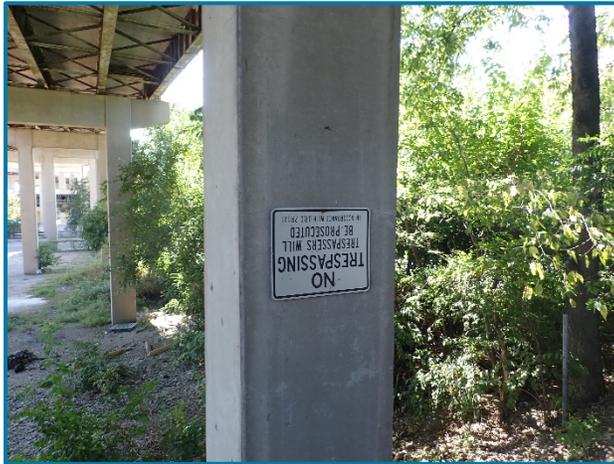
Photo 30 – “No Trespassing” sign partially detached and hanging upside down on the north face of Column 1 at Pier 24A (looking south).

There is only one mile marker sign present on this bridge at deck level. The sign is located atop the east railing near Pier 23A in Span 23A and has no defects. The “No Trespassing” sign at Pier 24A on the north face of Column 1 is partially detached and hanging upside down (see Photo 30).

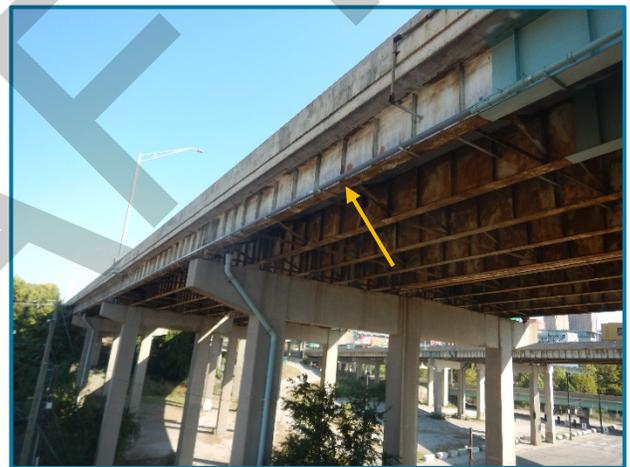
Photo 31 – Conduit along the exterior bottom flange of Girder A (looking northeast).
