FRACTURE CRITICAL PIER CAP INSPECTION REPORT

SFN3102246 (HAM-42-0000)
US-42/US-127 OVER SMITH
STREET/MEHRING WAY/WATER
STREET/W PETE ROSE WAY
HAMILTON COUNTY, OH
DISTRICT 8

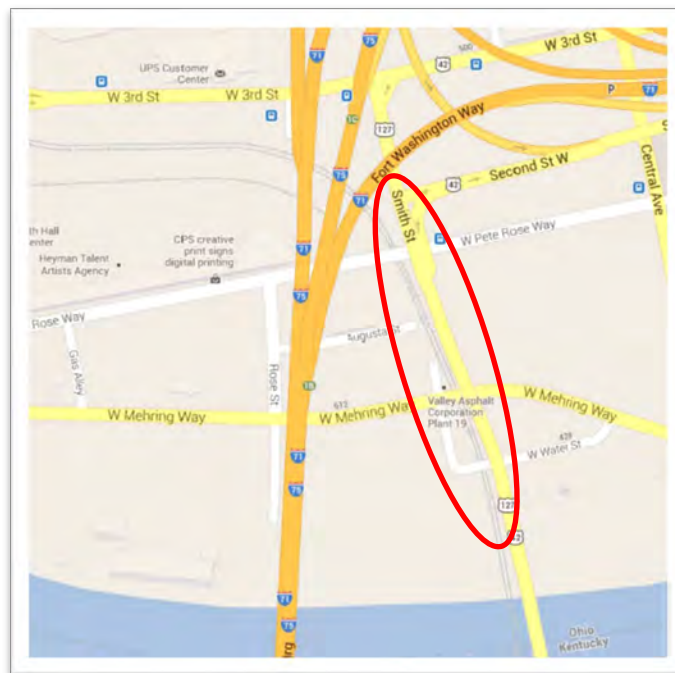
Figure 1: General Bridge Location

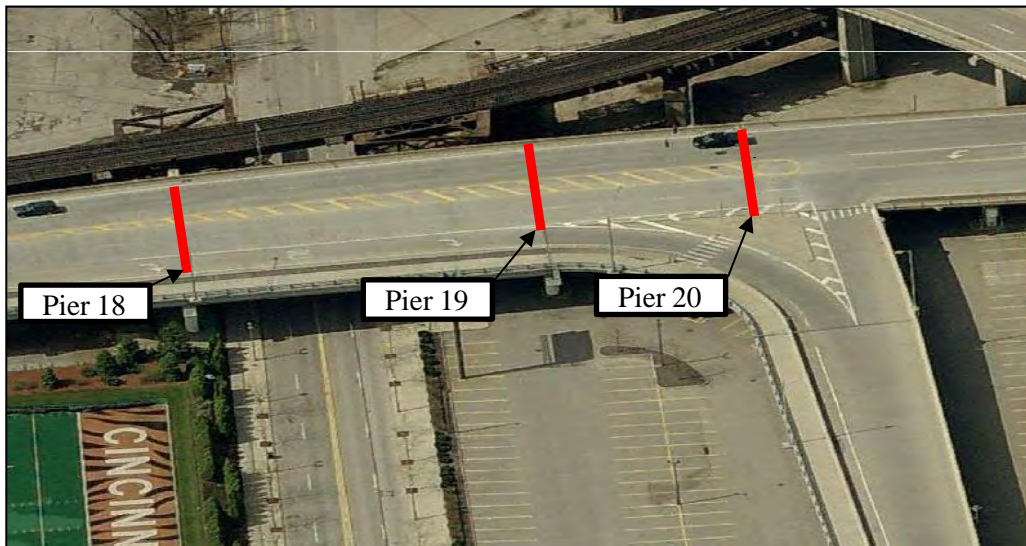
Figure 2: SFN3102246 (HAM-42-0000) Location Map

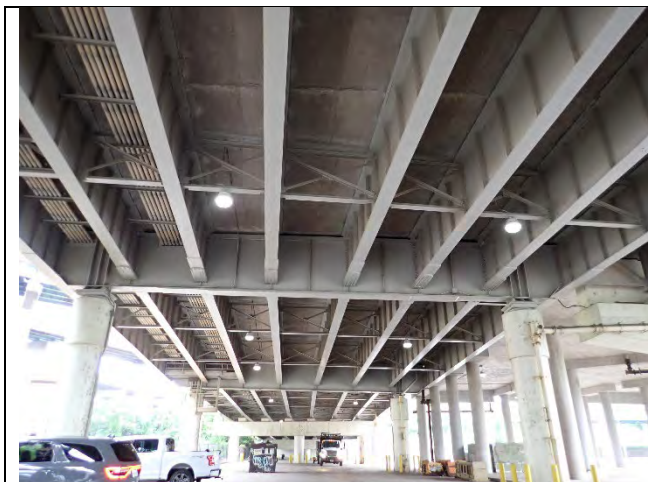
Photograph 1: General Elevation, Looking North.

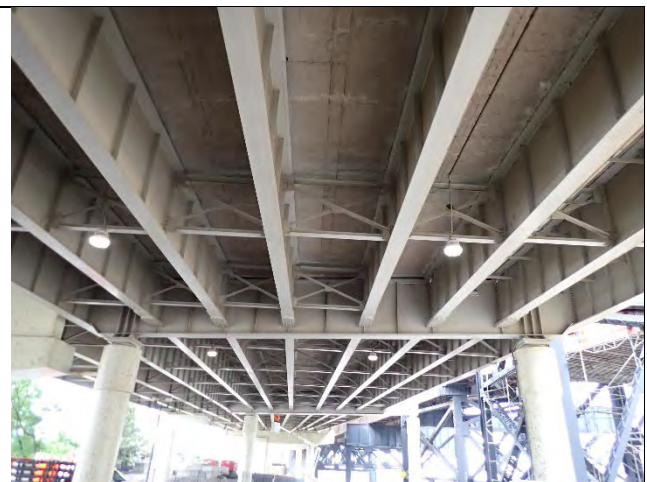
Photograph 2: General Elevation, Looking South.

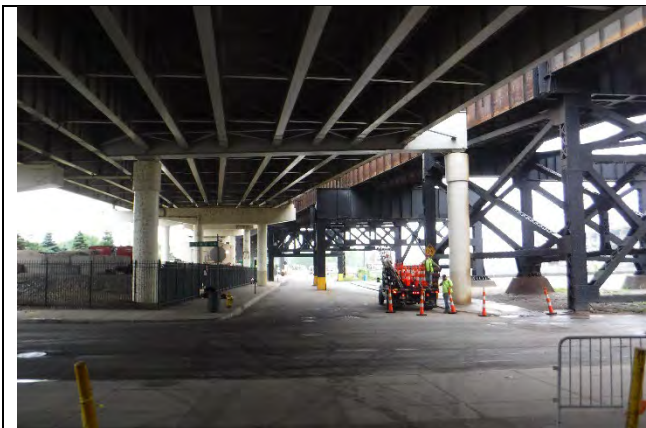
Photograph 3: Overall Elevation, Looking South.

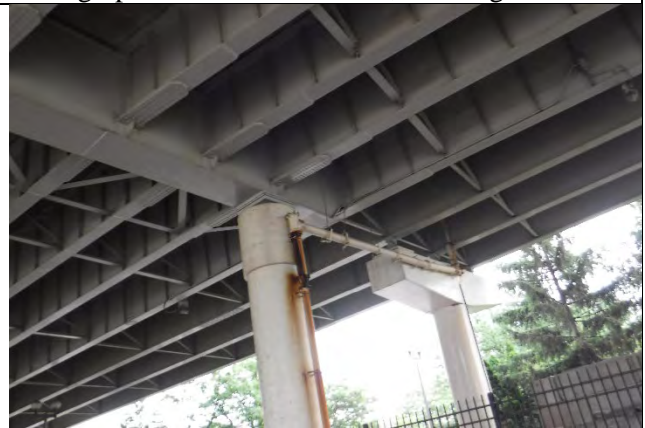
Photograph 6: Pier 18 Underview, Looking Southwest.

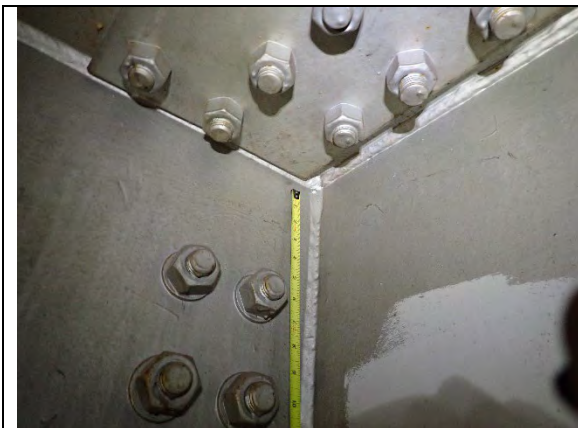
Photograph 7: View of West Face of Diaphragm 2 Under Tie Plate. Typical Triaxial Detail on Pier Cap Interior, Looking East.

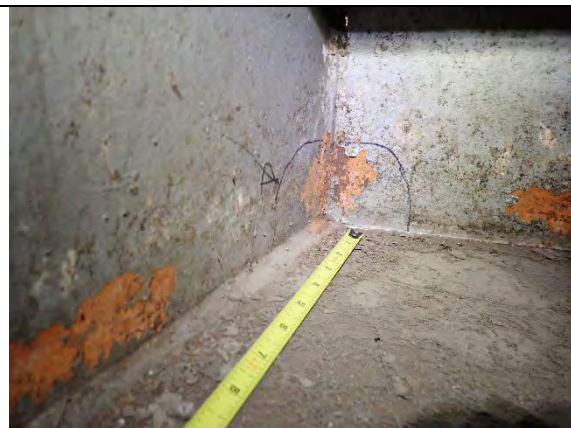
Photograph 8: View of West Face of Diaphragm 2 on Top of Tie Plate. Typical Triaxial Detail on Pier Cap Interior, Looking East.

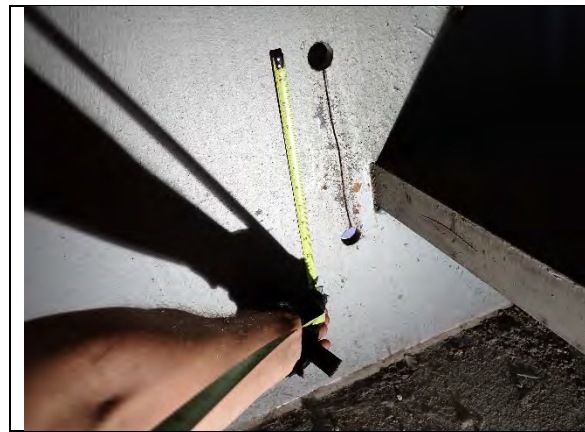
Photograph 9: Overall View of Typical Stress Relief Hole Retrofit in the East Face of Diaphragm 1, Looking South.

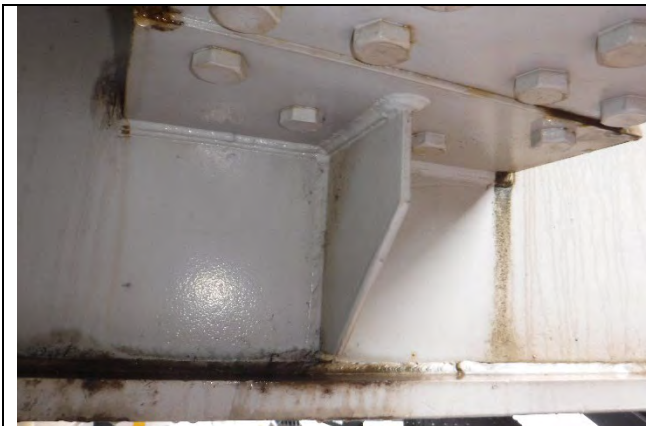
Photograph 12: Typical Example of Triaxial Welds at the Exterior of the Pier Cap. North face of the Cap at the Girder 1 Connection, Looking South.

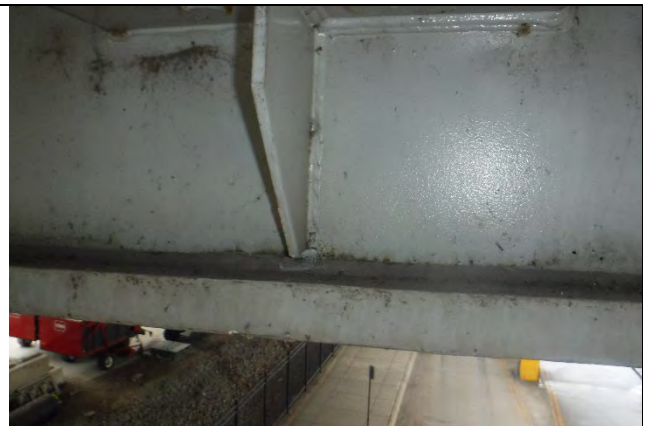
Photograph 13: Typical Example of Bottom of Knee Brace Weld Intersecting the Bottom Pier Cap Plate at Girder 4 North Side, Looking South.

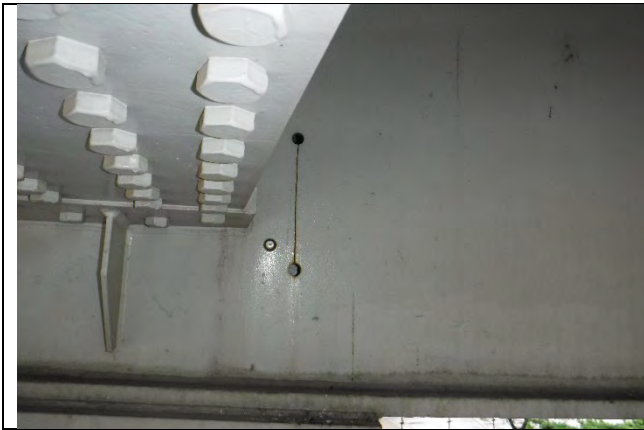
Photograph 14: View of Misdrilled Bolt Hole for Retrofit on South Side of Pier Cap in the East Face of Girder 1 with No Change, Looking North.

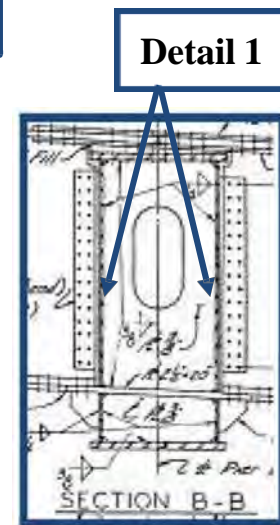
Figure 4: Section of Pier Cap 18

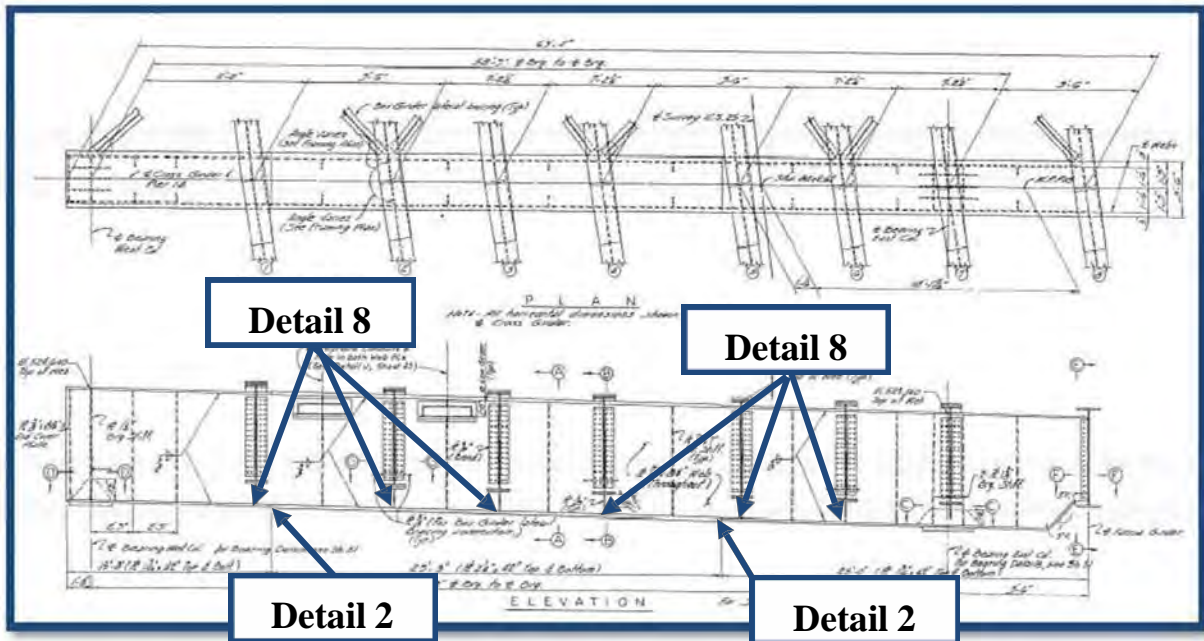
Figure 5: Plan and Elevation of Pier Cap 18

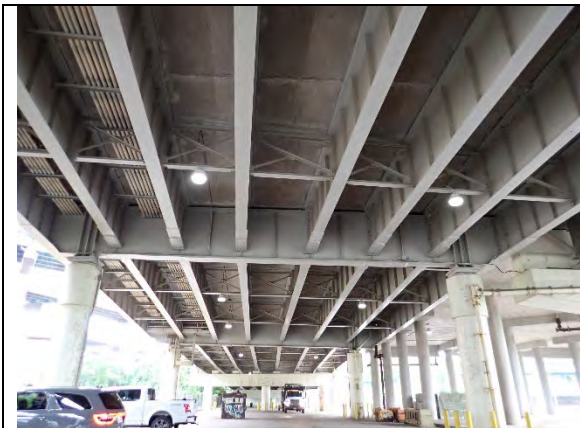
Photograph 16: Pier 19 Elevation, Looking North.

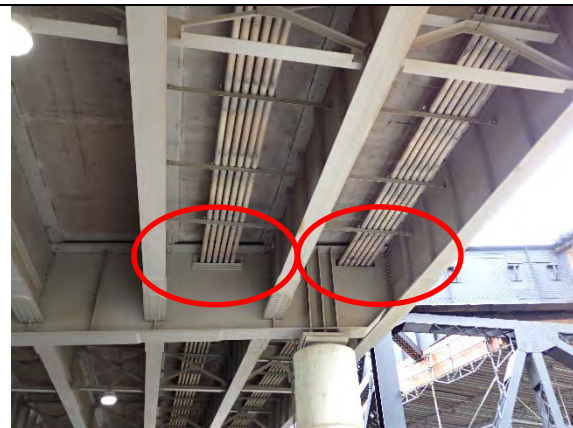
Photograph 17: View of West End of Pier 19, North Face. Note Cut Out Portion of Cap Web for Conduit. No Change.

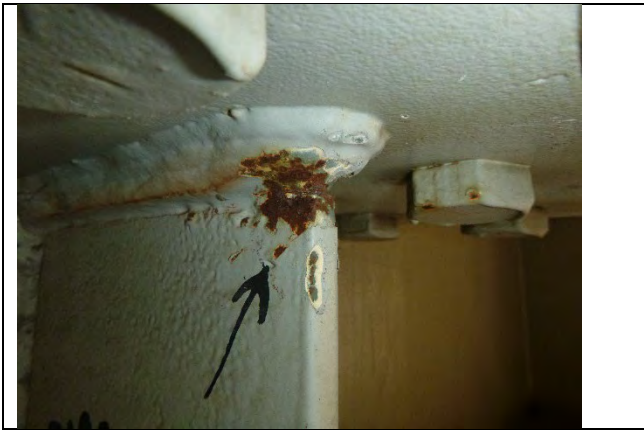
Photograph 18: 1/2 in. crack in the intersecting welds between the seat plate and the north side of the pier cap web plate at Girder 2, Looking Northeast.

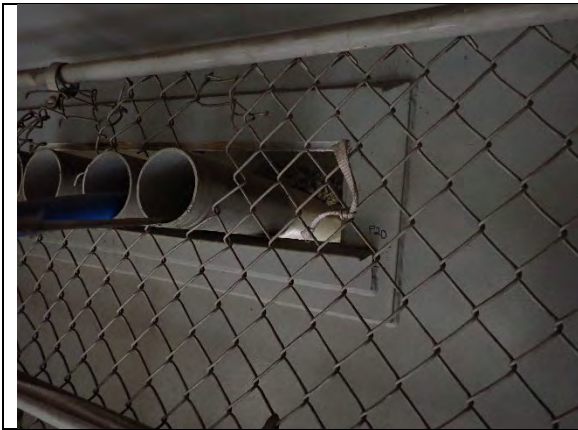
Photograph 19: Perspective View of 1 in. Crack to Fillet Weld Between Utility Support Angle and the Reinforcement Plate at the East End of the Angle, South Side of Cap Web Between Girders 2 and 3, Looking North.

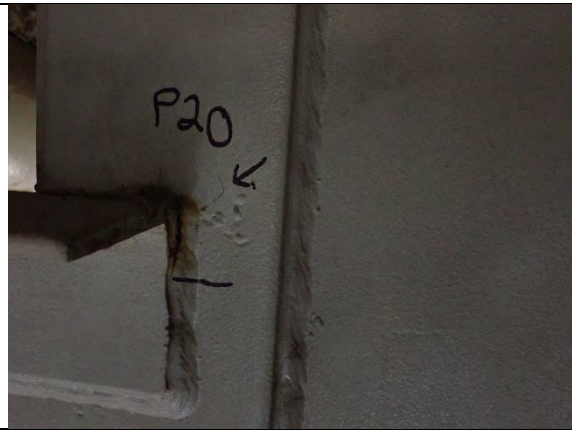
Photograph 20: Close Up View of 1 in. Crack to Fillet Weld Between Utility Support Angle and the Reinforcement Plate at the East End of the Angle, South Side of Cap Web Between Girders 2 and 3, Looking North.

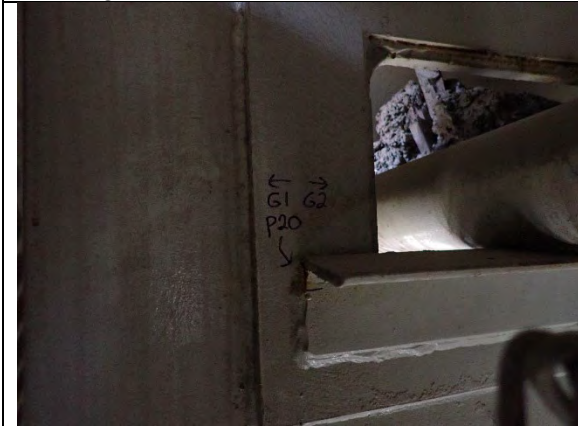
Photograph 21: Perspective View of 3/4 in. Crack to the Fillet Weld Between the Utility Support Angle and the Reinforcement Plate at the West End of the Angle, South Side of Cap Web Between Girders 1 and 2, Looking North.

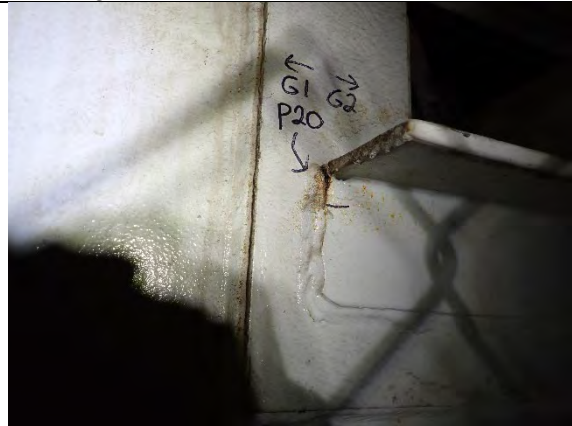
Photograph 22: Close Up View of 3/4 in. Crack to the Fillet Weld Between the Utility Support Angle and the Reinforcement Plate at the West End of the Angle, South Side of Cap Web Between Girders 1 and 2, Looking North.

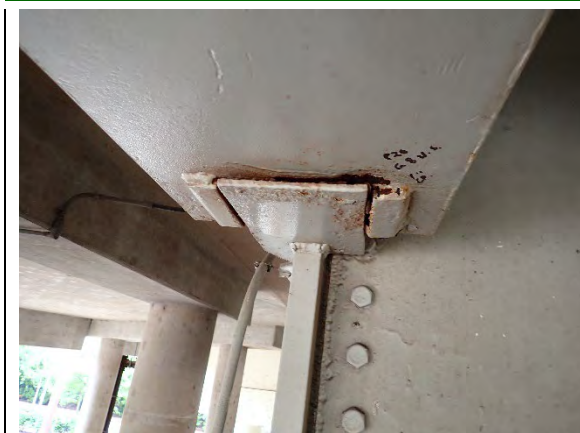
Photograph 23: Perspective View of 1 in. Crack in the Keeper Bar Weld at the North Side of Girder 8, Looking South

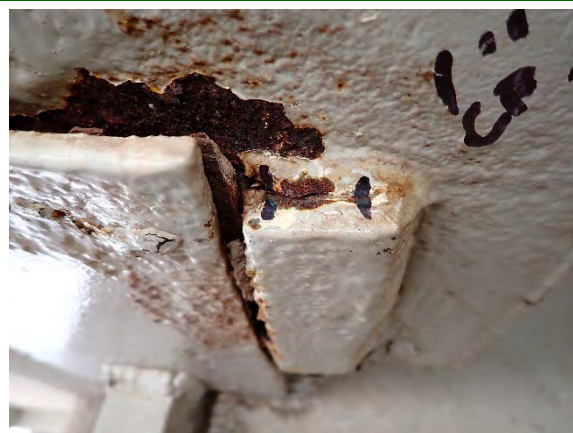
Photograph 24: Close Up View of 1 in. Crack in the Keeper Bar Weld at the North Side of Girder 8, Looking South

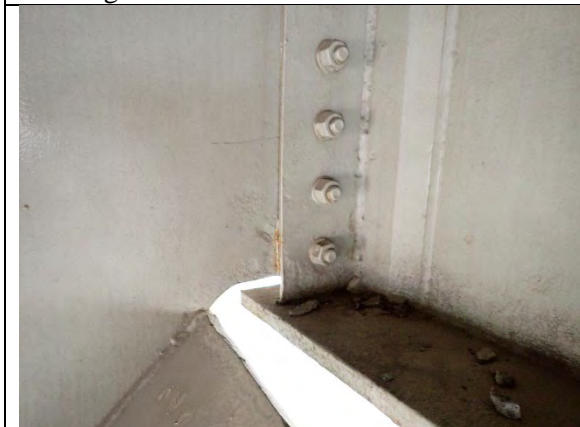
Photograph 25: Typical Example of Painted Over Section Loss at the Interface of the Hanger Bracket and the Pier Cap with No Change.

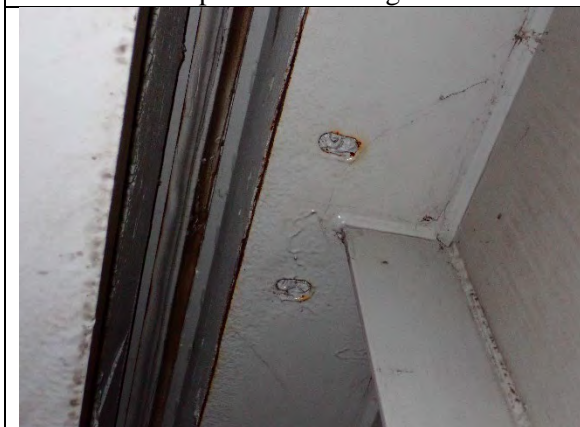
Photograph 27: Typical Example of Sheared/Missing Bolts on the Top Flange of the Pier Cap with No Change.

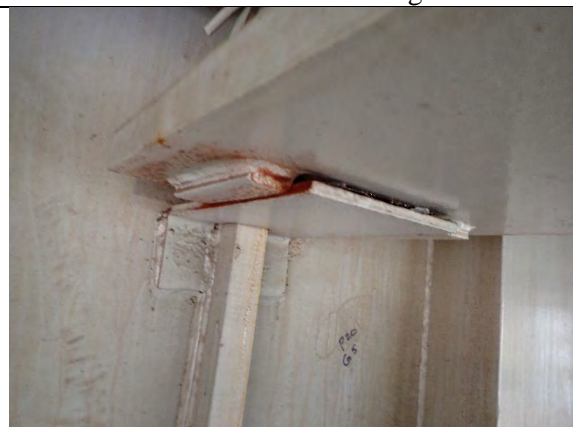
Photograph 28: Typical Example of Girder Bottom Flanges Rubbing Against the Keeper Plates with Up to 1/32 in. Wear on the Keeper Plates and No Change.

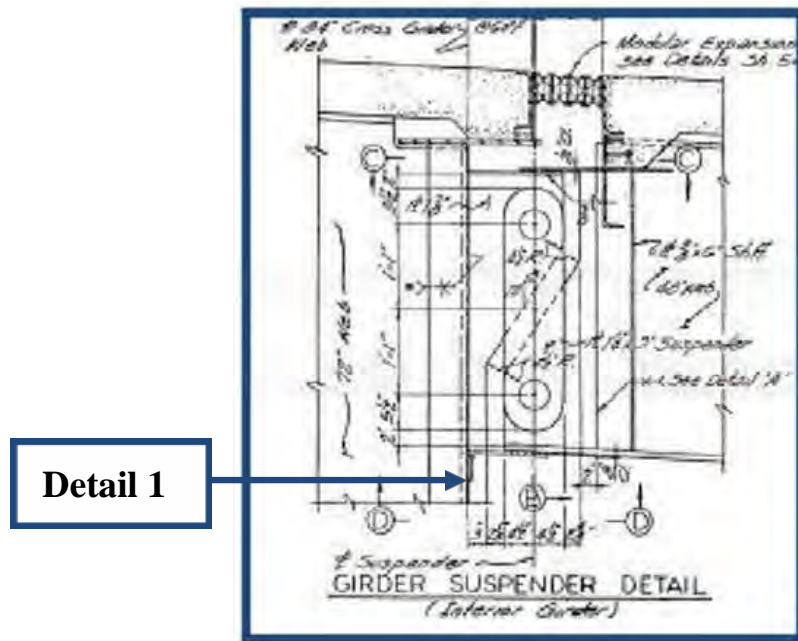
Figure 8: Section of Pier Cap 20

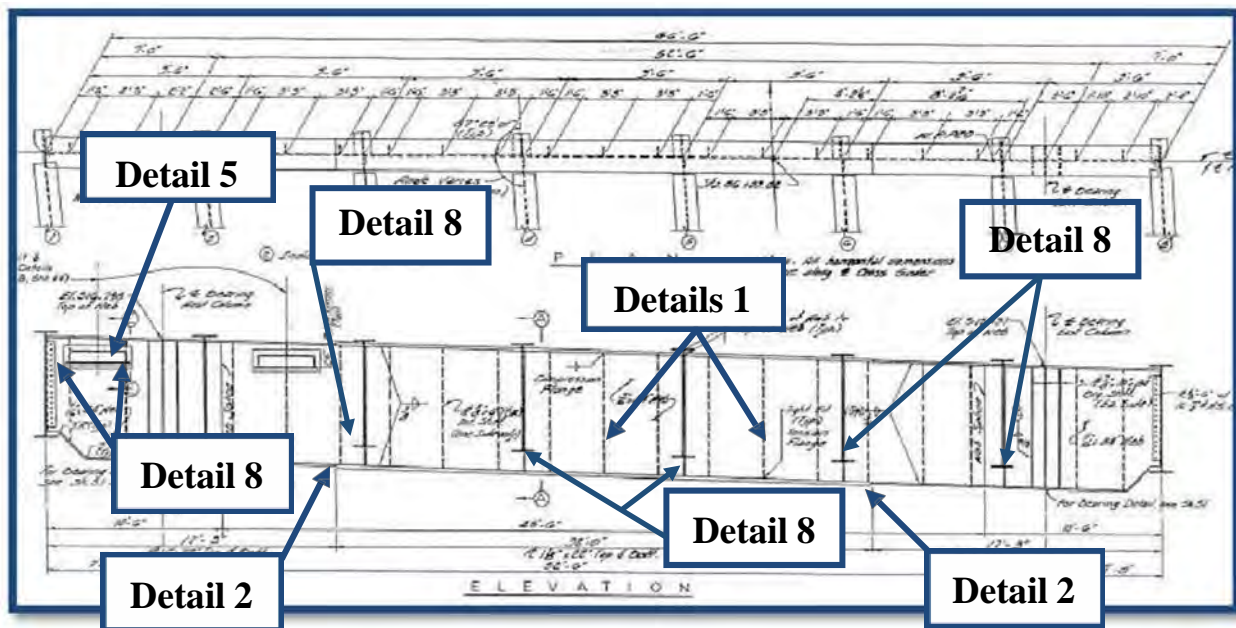
Figure 9: Plan and Elevation of Pier Cap 20

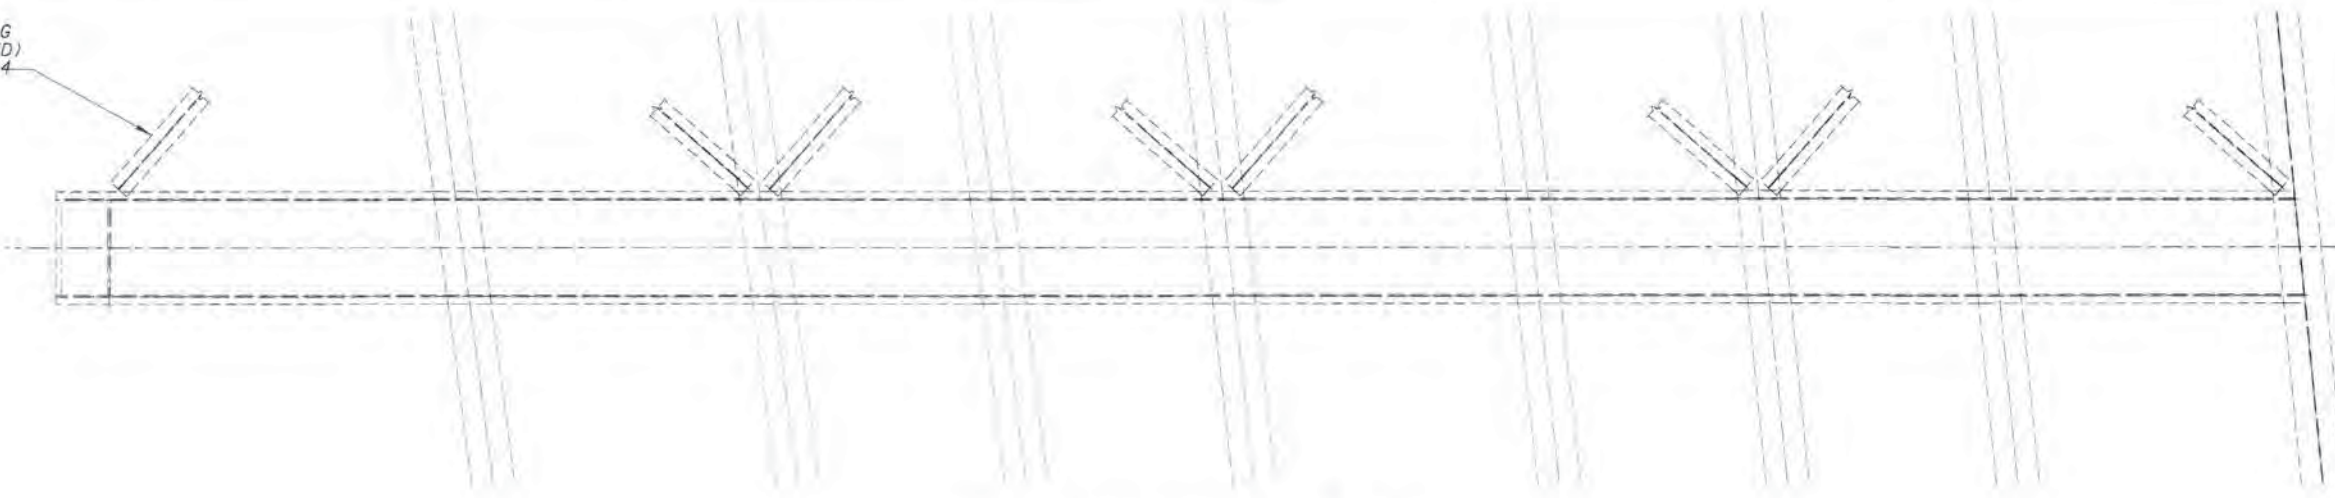
PIER 18 BOX GIRDER CAP PLAN

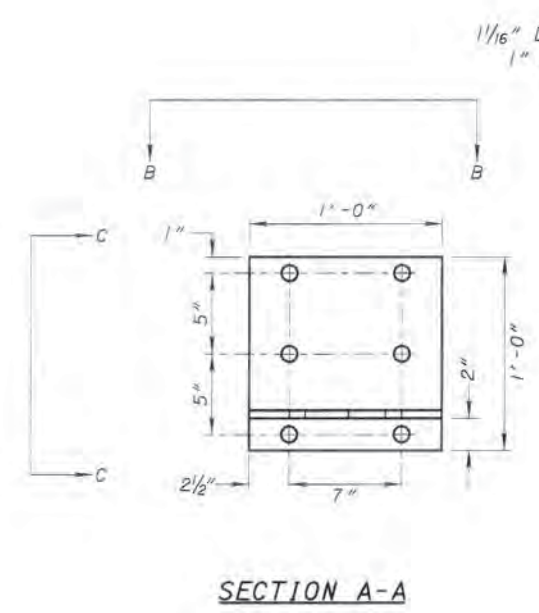
1 1/16" DIA. BOLT HOLE FOR 1" DIA. BOLT (TYP)
