# FRACTURE CRITICAL PIER CAP INSPECTION REPORT

SFN3101215 (HAM-42-0257R)

I-71 NB RAMP OVER US-42 NB (READING RD)

June 2023

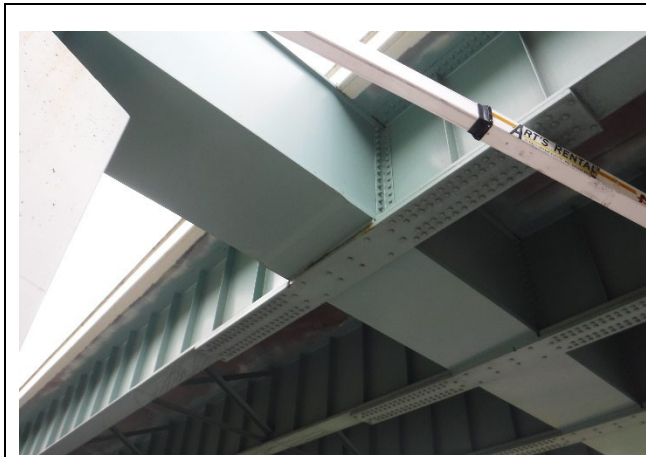
Pier Cap 1 was in Good Condition (7) overall (Photograph 3). Moisture/dew/water droplets are still present along most of the cap. Condensation was present on the top flange inside the cap at all bays (Photograph 4), and water has ponded to the brim of the perforation for the easternmost portion between east column bearing stiffeners (Photograph 5). The ponding water has noticeably increased since the prior inspection. Some has spilled over to the western portion between the east column bearing stiffeners. The paint system under the water appears intact, currently. The condensation on the interior face of the cap was causing freckling corrosion with no section loss along the top and bottom corners of the pier cap web plate. This was noted previously and does not appear to have significantly increased from the prior inspection. The pier cap interior exhibited potential tri-axial welds at locations where the cap web stiffener welds intersection with the pier cap flange plate to web plate welds (both at the top and bottom of the cap). At most locations the requisite 1/4 in. distance between weld intersections was observed (Photograph 6), though prior inspections have identified five locations where tri-axial welds do exist. Several retrofits were performed prior to the 2010 inspection to address fatigue issues relating to this type of connection.

Photograph 3: General Underview of Pier Cap 1. Note Tie Plates, Bolted Clip Angles, and Overall Steel Configuration, Looking Northeast.

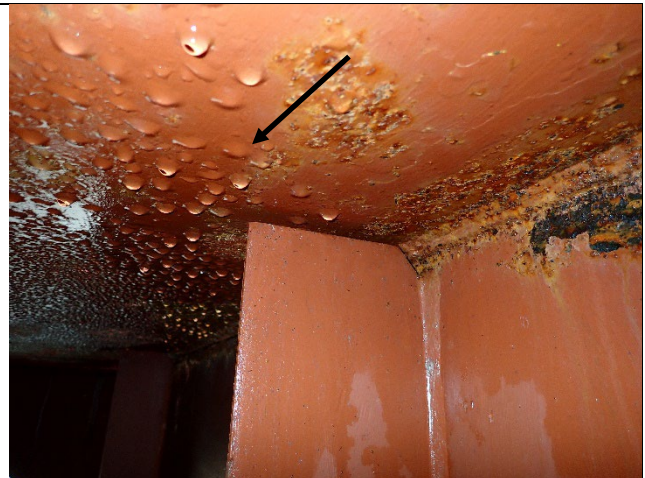
Photograph 4: View of North Web Plate Near West End Between Bearing Stiffeners and Diaphragm A. Note General Example of Condensation Present on Top Plate Due to Humidity, Looking Northwest.

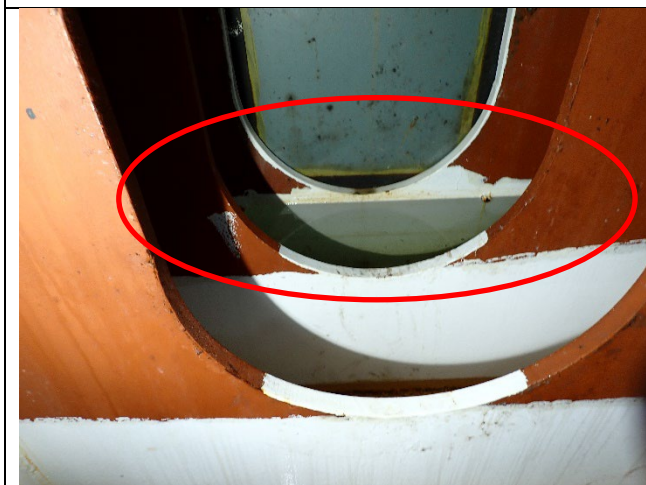
Photograph 5: View of Water Ponding Between the Bearing Stiffeners at the East End. Note The Easternmost Portion Was Completely Filled, Spilling Over to the Portion West of This, Looking East.

- As stated above, the east end of the pier cap exhibited water ponding near the cap door (Photograph 4). At this location the water leaks in from the hatch. For this inspection the two end sections between the end plate and the bearing stiffeners were full, which is a noticeable increase from the prior inspection. Water was spilling into the portion between the bearing stiffener and Diaphragm F.

- Weep holes should be drilled in the underside of the east end of the bottom cap plate to allow water accumulating in these areas to drain.
- Clear out the clogged east end downspout so water can drain effectively.
- Monitor triaxial weld locations for cracks related to excessive restraint.
- Monitor the corrosion on the cap interior for section loss or additional deterioration. Compare future inspections to current conditions to determine any changes.
- Monitor the noted minor defects on the cap exterior for changes. See the bullets in 2.1.1.2 below for specifics and locations.
- Consider replacing the current hatch bolts with new replacements to ease hatch removal.

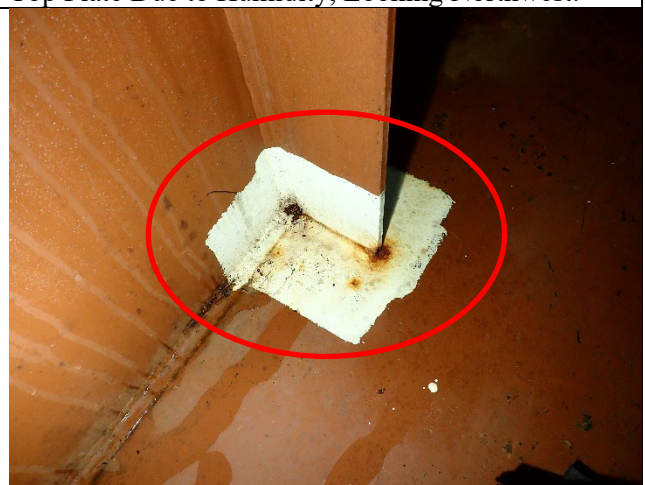
Photograph 6: View of the North Web Plate Between the West Hatch and Diaphragm A at the Base of the Stiffener. Note the Typical Example of Triaxial Weld at Base of Stiffener, Looking Northeast.

- Previous inspections noted five (5) locations of tri-axial welds, where the cap web stiffener welds intersect the cap flange plate to cap web plate weld. At these locations, no weld cracks nor observable changes have occurred since the prior inspection (Photograph 6).

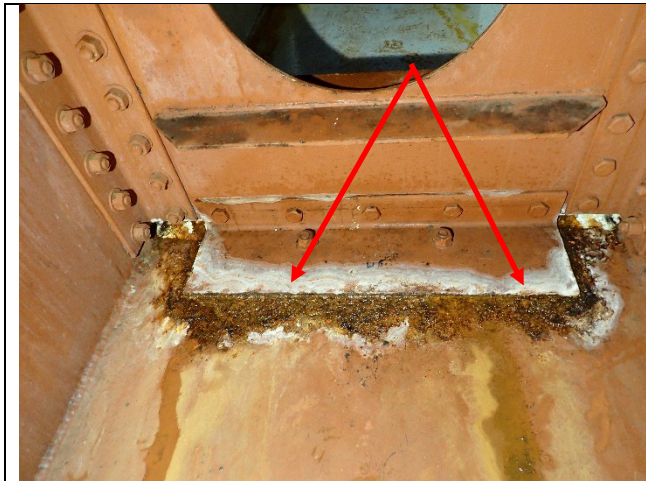
- 
- The connection angle between the bottom of the west face of Diaphragm F and the cap bottom plate exhibits active surface corrosion along the full length (Photograph 7). Steel surface pits are present around this corrosion, but this overall has not noticeably changed since the prior inspection. No pack rust or swelling between the steel plates was observed. This corrosion is atypical compared to other similar locations inside the cap.

Photograph 7 – View of the Connection Angle Between the Bottom of the West Face of Diaphragm F and the Cap Bottom Plate. Note Active Corrosion Developing But No Pack Rust Present, Looking East.

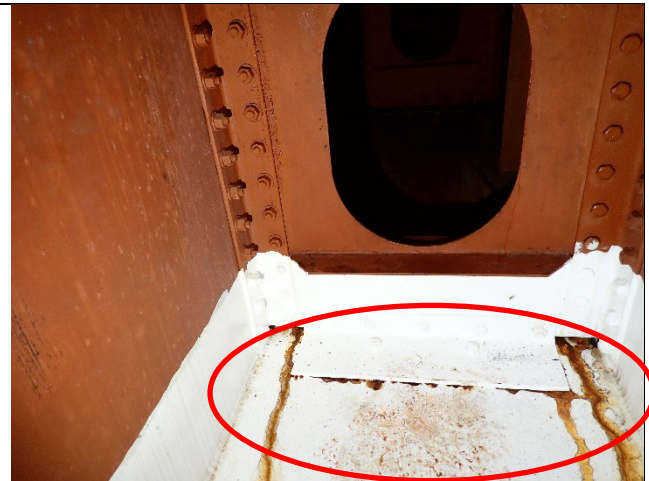
The protective coating system exhibited a consistent amount of light surface corrosion along the top flange and the web plate welds throughout the entire cap; this indicates coating failure along these locations. The lower portion of both ends of the cap were painted during a prior rehabilitation and this white protective layer is protecting the steel as intended, though there is evidence of corrosion reactivating below the protective layer at isolated locations (Photograph 8). Overall, there were no noticeable changes to the paint system on the cap interior.

Photograph 8 – Typical Example of Lower Cap Interior With Recent Painting. Note Blistering Corrosion Developing at Isolated Areas on the Bottom Plate. The East Face of Diaphragm F Shown, Looking West.

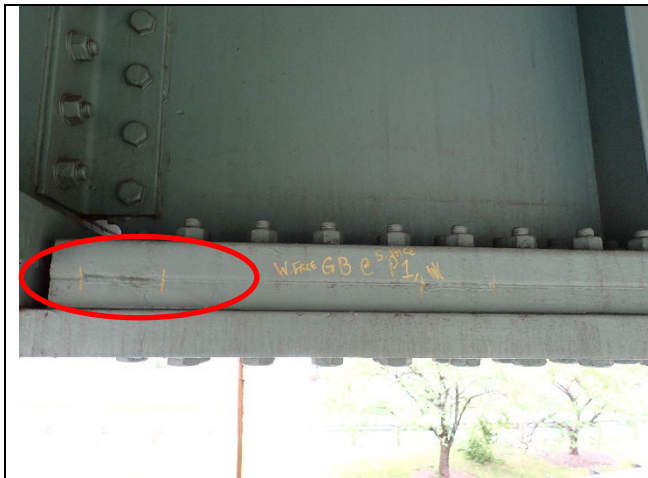
- Tack welds were present between the bottom flange and fill plate for the west face of Girder B on the south face of the pier cap (Photograph 9). This is an old comment and has not changed.

Photograph 9 – View of the West Face of the Bottom Flange of Girder B, South Side of the Pier Cap. Note No Change to the Tack Welds on the Bottom Tie Plate, Looking East.

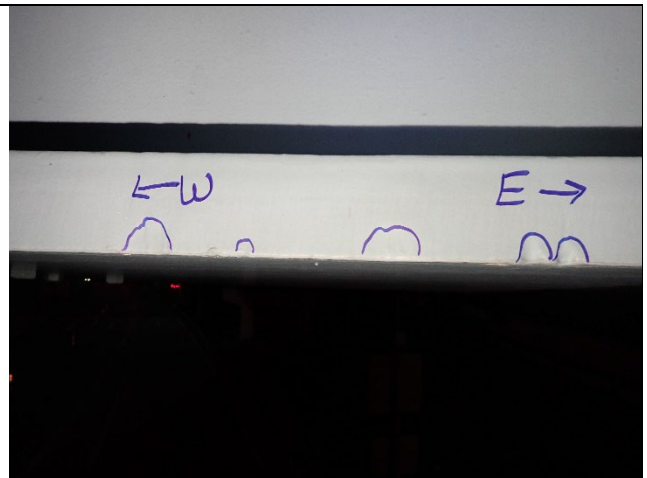
- The south edge of the bottom flange exhibits numerous small impact gouges up to a 1/8 in. deep (Photograph 10). These are likely from fabrication or construction and are not evidence of vehicular impacts. No change from prior inspections.

Photograph 10 – View of the Bottom of the South Plate Over the Right Travel Lane Below the Bridge. Note No Change to Gouges in the Corner of the Bridge, Looking North.

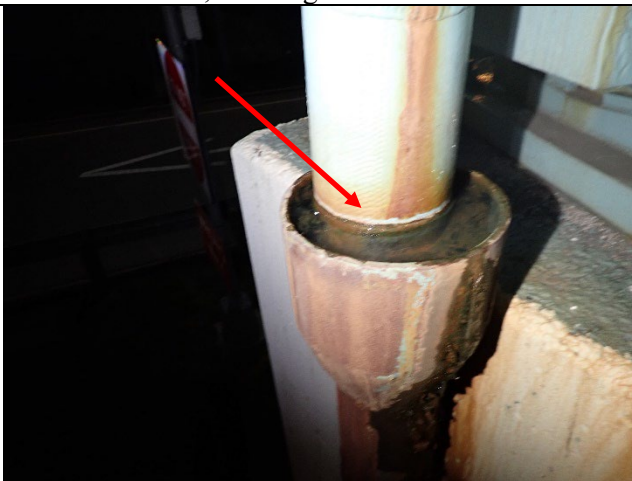
- There was no change to the minor corrosion of the cap bottom flange plate behind Girder D.
- The downspout for the drainage pipe at the east end of the pier cap remains clogged, as noted in prior inspections (Photograph 11). The downspout overflows and has caused active corrosion near the top with rust staining down the downspout. Moss was present, indicating a consistently wet area, but no

Photograph 11 – View of the Downspout on the North Side of the East Column. Note Downspout Was Still Clogged. No Change, Looking Southeast.

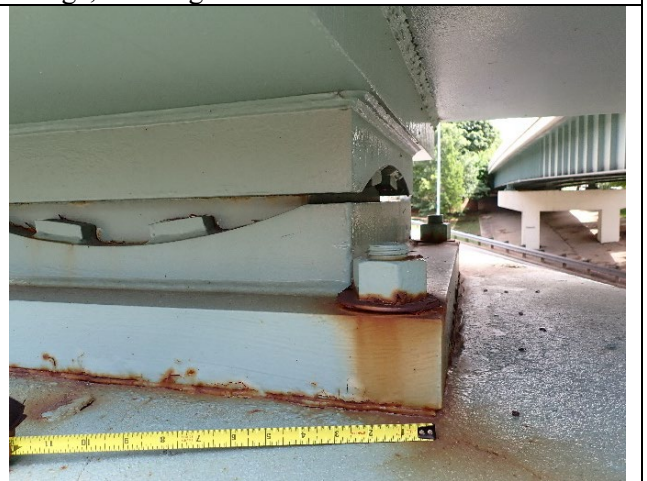
The protective coating system overall was in Good Condition (7). The pier cap bearings were in Good Condition (7), with minor surface corrosion on both bearings and anchor bolts (Photograph 12). This has not changed since the prior inspection.

Photograph 12 – View of the Southeast Corner of the West Bearing. Note Typical Corrosion on the Masonry Plate and Anchor Bolts/Nuts, Looking North.
