FRACTURE CRITICAL PIER CAP INSPECTION REPORT

SFN3101223 (HAM-42-0264R)

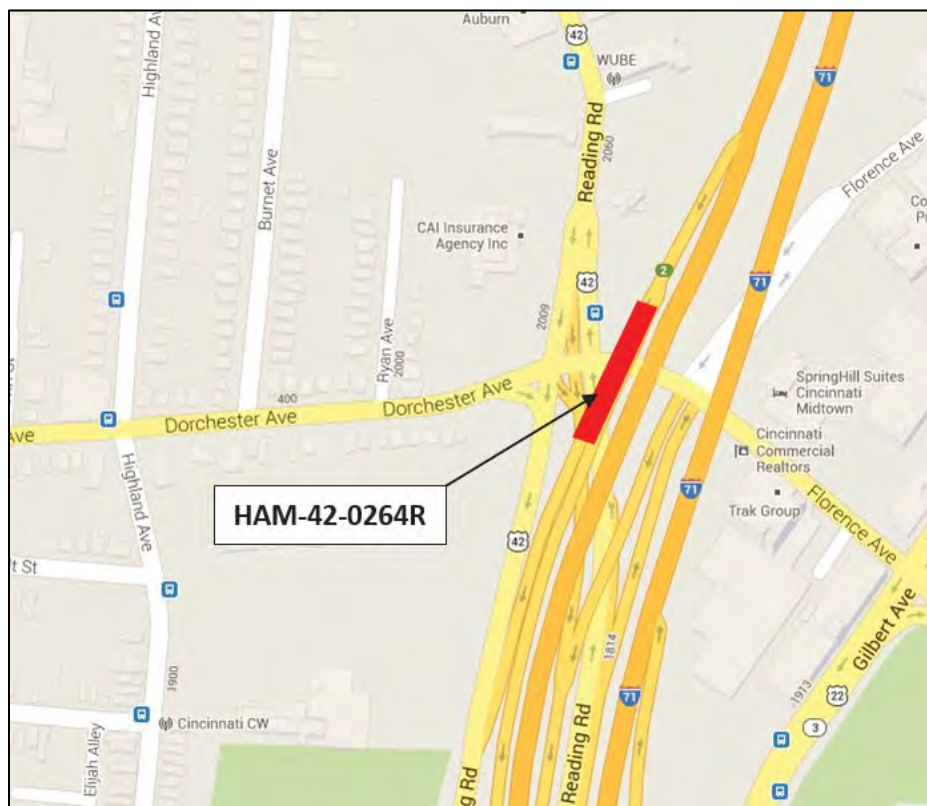
Figure 1: General Bridge Location

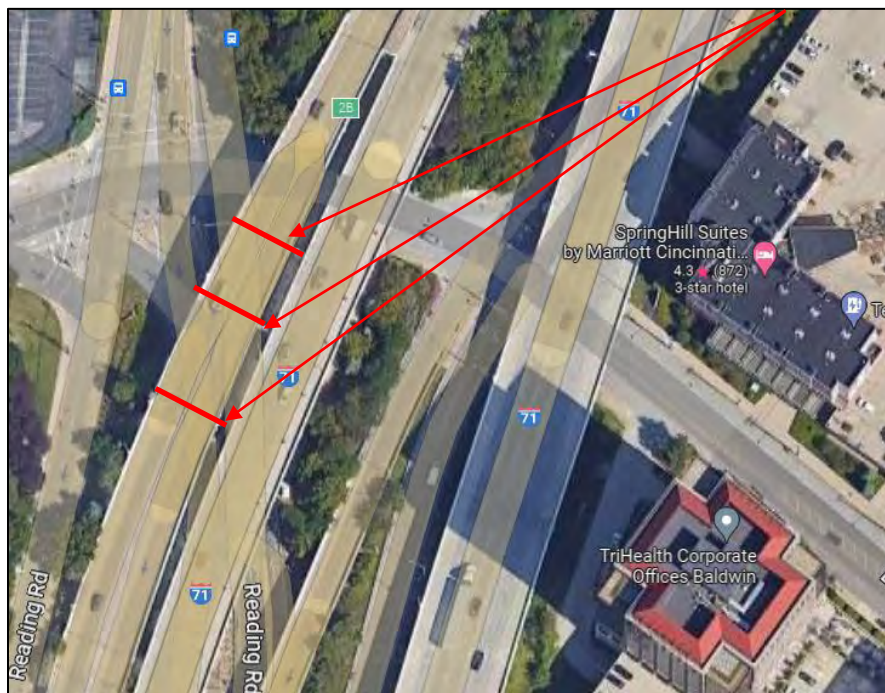
Figure 2: Fracture Critical Pier Cap Location

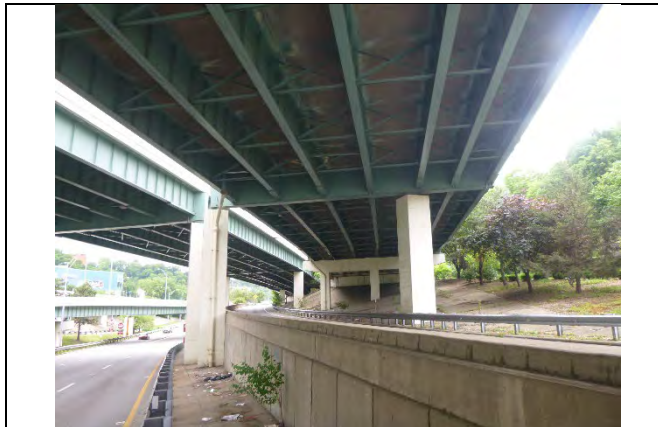
Photograph 3: General Elevation of Pier Cap 2, Looking South.

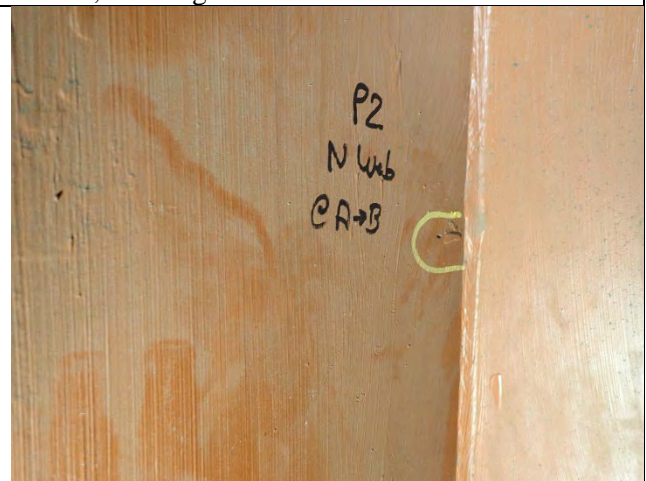
Photograph 7: General Example of Tack Weld Not Removed, North Plate Between Diaphragm A and B Shown, Looking Northeast.

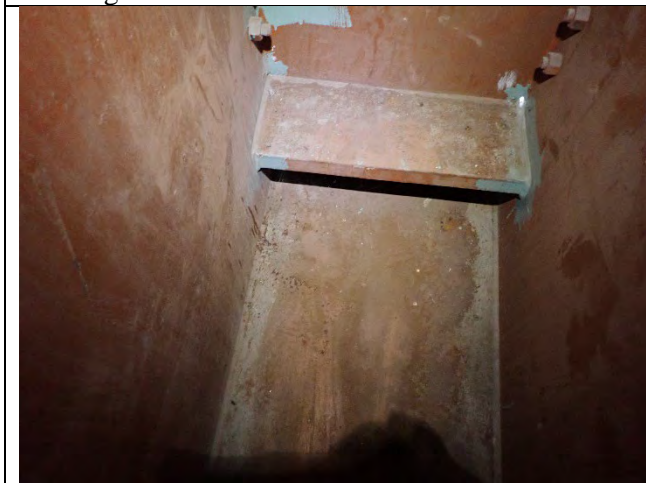
Photograph 10: View of Active Corrosion and Pitting over the West Bearing, Looking West.

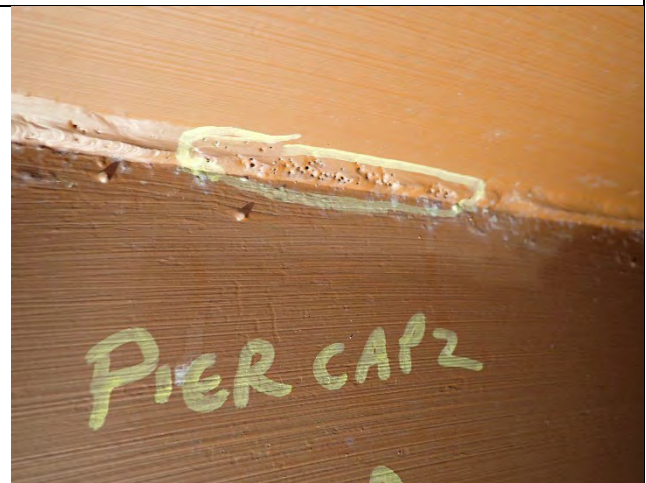
Photograph 11: Porosity Examples For Web Plates, North Cap Plate Top Weld Between Diaphragms E and F Shown, Looking North.

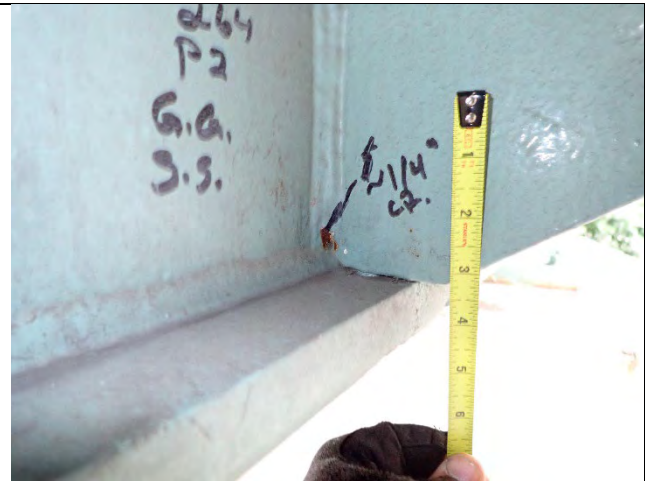
Photograph 13: View of 1/4 in. Crack at East Knee Brace Below Girder G, South Cap Web Plate, Looking Northeast.

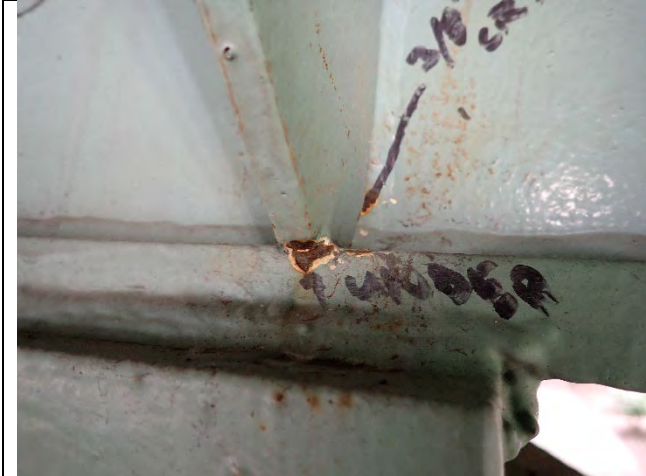
Photograph 14: View of a 3/16 in. Crack at East Knee Brace Below Girder C, North Cap Web Plate, Looking South.

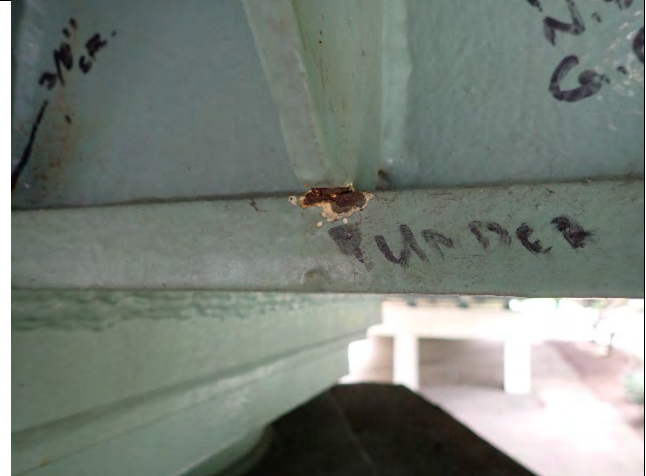
Photograph 15: View of a 1/8 in. Crack at West Knee Brace Below Girder C, North Cap Web Plate, Looking South.

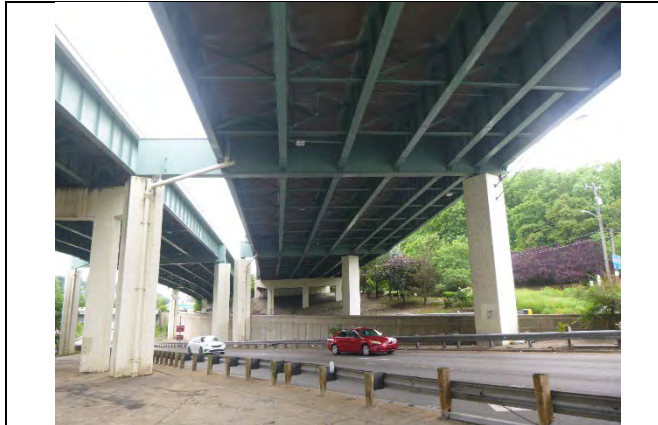
Photograph 18: General Elevation of Pier Cap 3, Looking South.

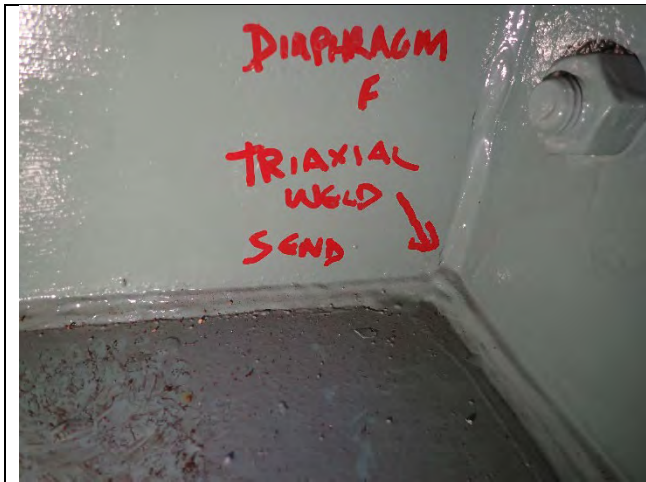
Photograph 19: View of Typical Triaxial Weld on Top of Tie Plate, South Cap Web at West Side of Diaphragm F Shown, Looking Southeast.

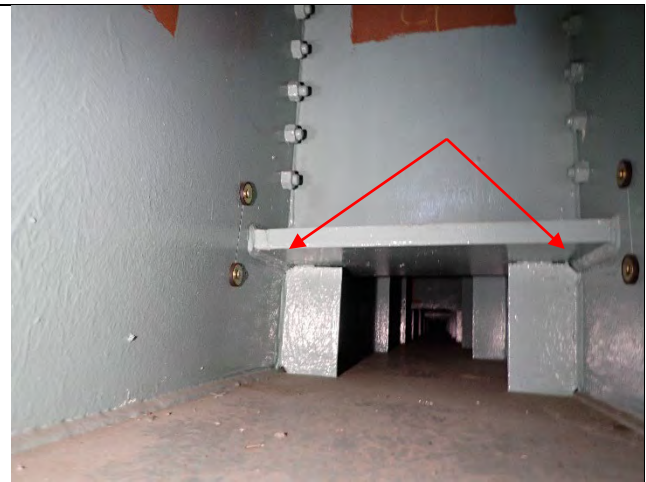
Photograph 20: View of East Face of Diaphragm G at Underside of Girder Tie Plates. Note Coped Corners of Lower Stiffener, Looking West.

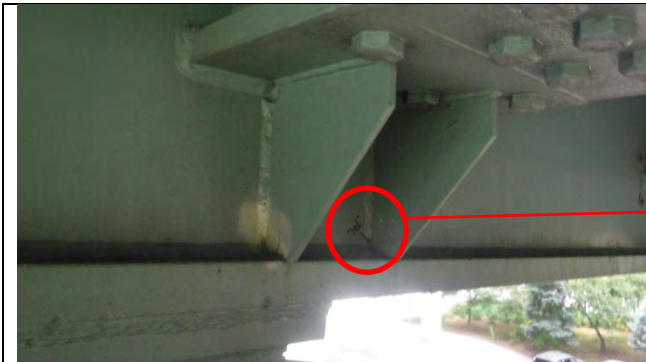
Photograph 25: Perspective View of 3/16 in. Long Crack in Vertical Weld For Knee Brace, Girder B at South Web Plate, Looking Northeast.

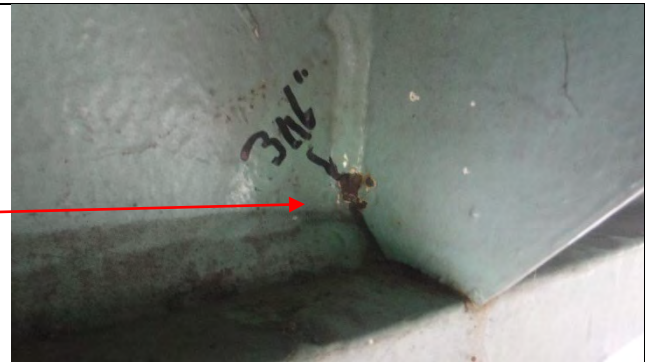
Photograph 26: Close Up View of 3/16 in. Long Crack in Vertical Weld For Knee Brace, Girder B at South Web Plate, Looking Northeast.

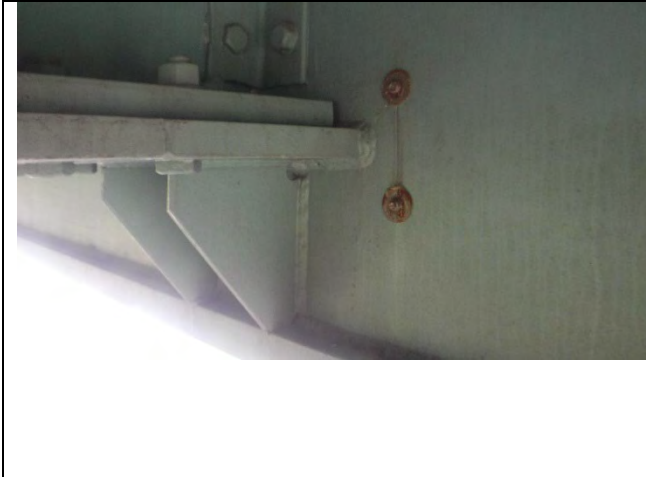
Photograph 27: View of Typical Stress Relief Retrofit. Diaphragm F South Cap Web East Face Shown, Looking Northwest.

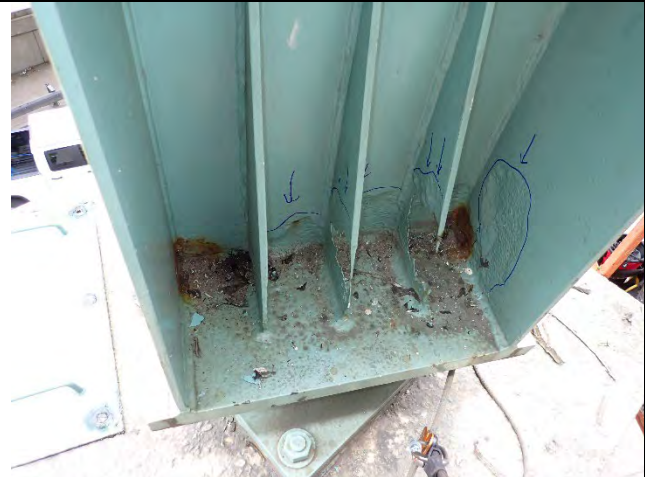
Photograph 28: Overall View of Painted over Pitting and Corrosion Holes at East End of Pier Cap.

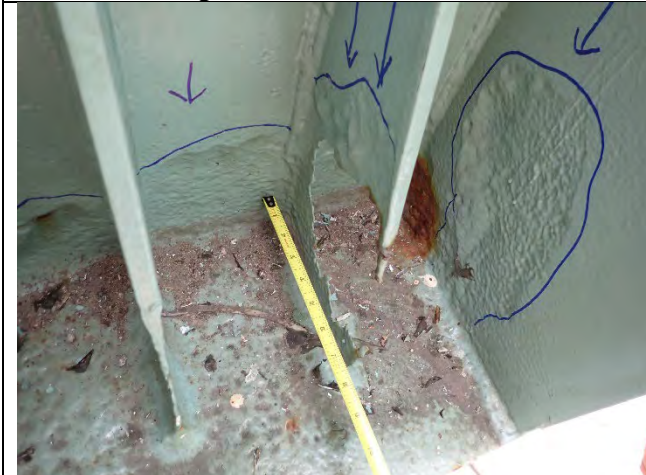
Photograph 29: View of Corrosion Hole at Base of North Knee Brace at East End of Cap, Looking West.

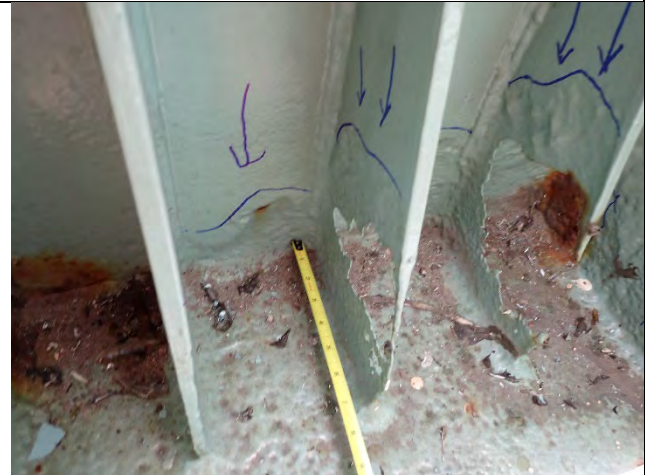
Photograph 30: View of Corrosion Hole at Base of Center Knee Brace at East End of Cap, Looking West.

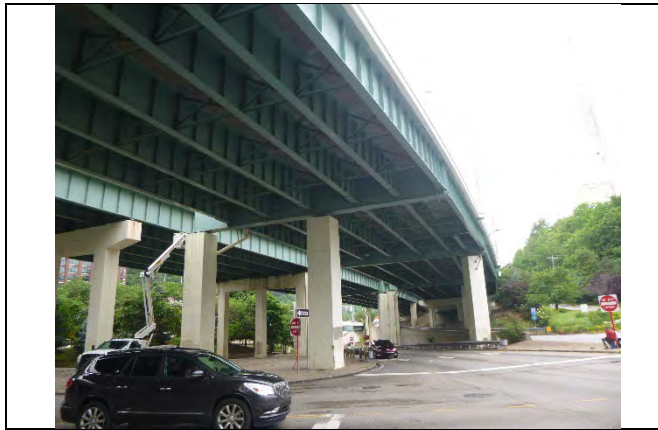
Photograph 31: General Elevation View of Pier Cap 4, Looking South.

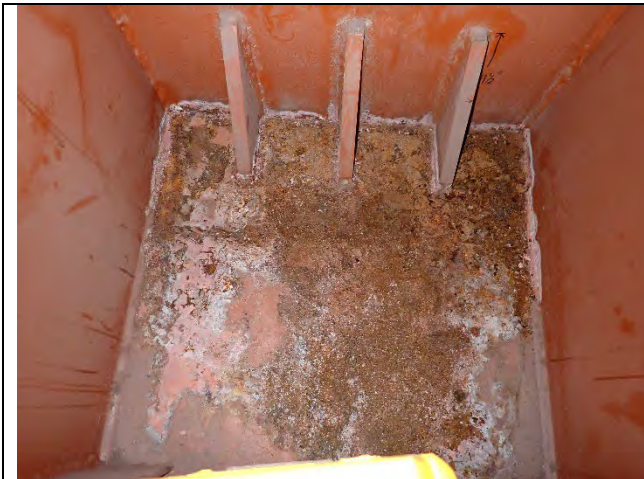
Photograph 32: View of Laminating Corrosion Present Just West of West Bearing on Bottom Plate, Looking West.

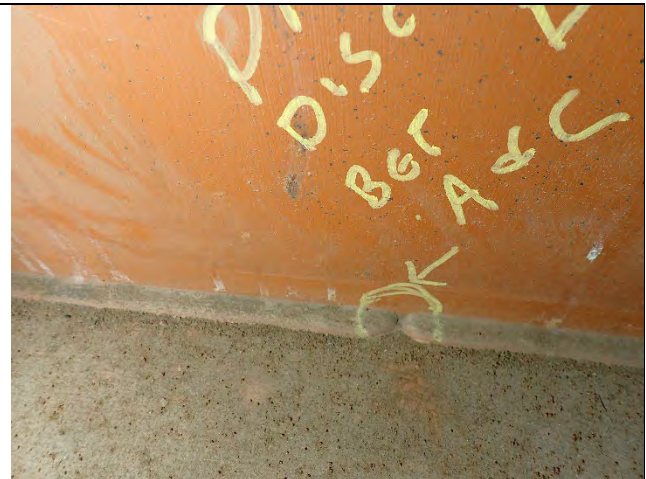
Photograph 33: View of Discontinuity For Fillet Weld Between North Cap Web and Cap Bottom Flange Between the Girders A and C Diaphragm, Looking North.

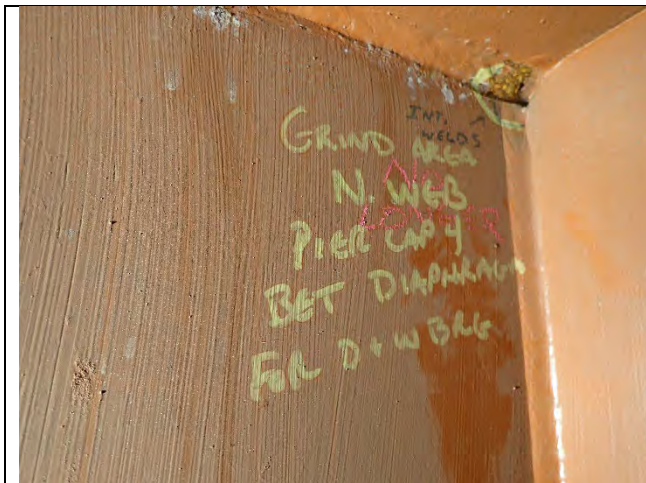
Photograph 34: General Example of Ground Down Fillet Weld Unpainted With Corrosion Activating. Between West Bearing and Diaphragm D Shown, Looking Northeast

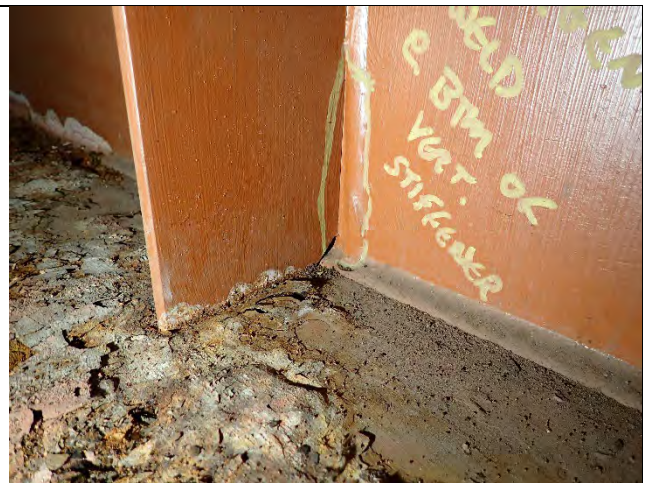
Photograph 35: View of Divergent Weld Located on the South Web Plate, First Stiffener West of West Bearing. Looking Southeast, No Change.

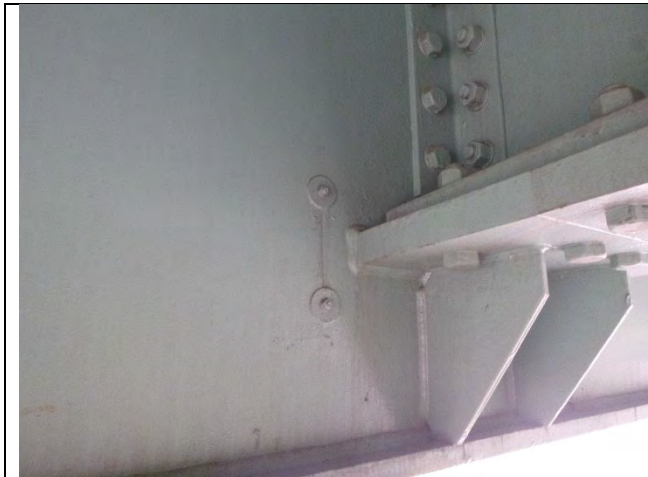
Photograph 37: View of Typical Stress Relief Retrofit. South Web Plate West Face of Girder D Shown, Looking Northeast.

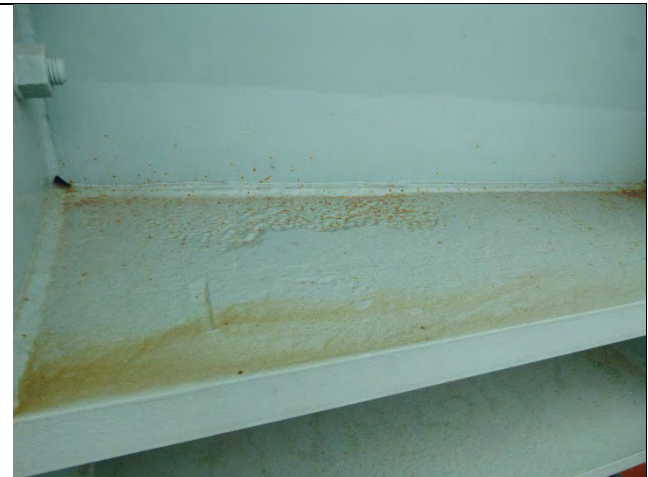
Photograph 38: View of Painted over Pitting To 1/16 in. Deep on Cap Bottom Flange Plate at the West End, Looking East.

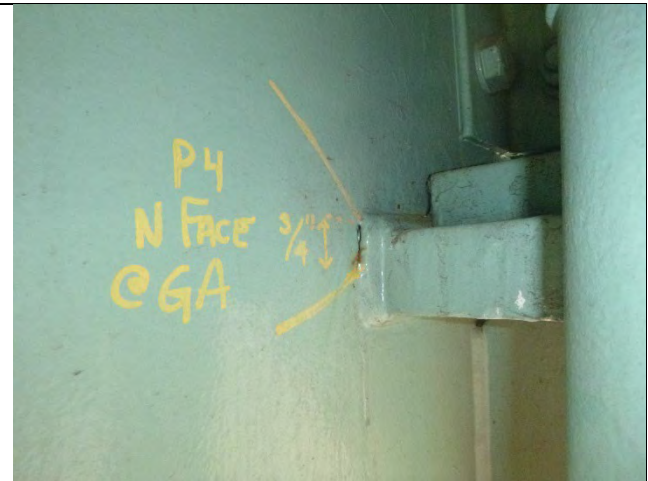
Photograph 40: View of Weld Defect on East Side of Girder A at the North Cap Web Plate. No Change, Looking Southwest.

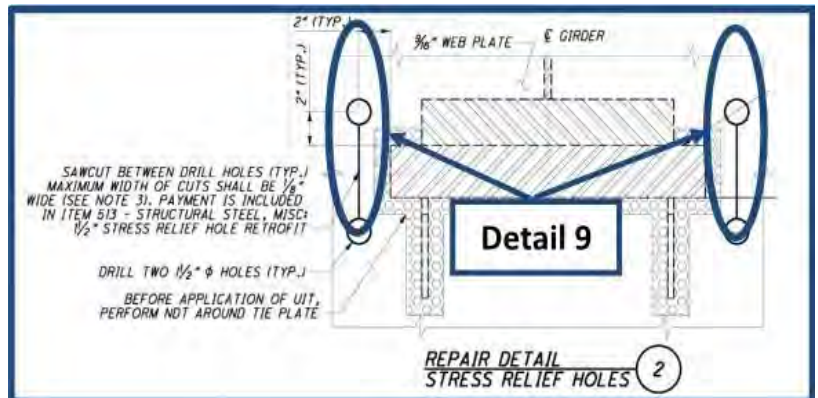
Figure 9: Drilled and Sawcut Stress Relief Retrofits

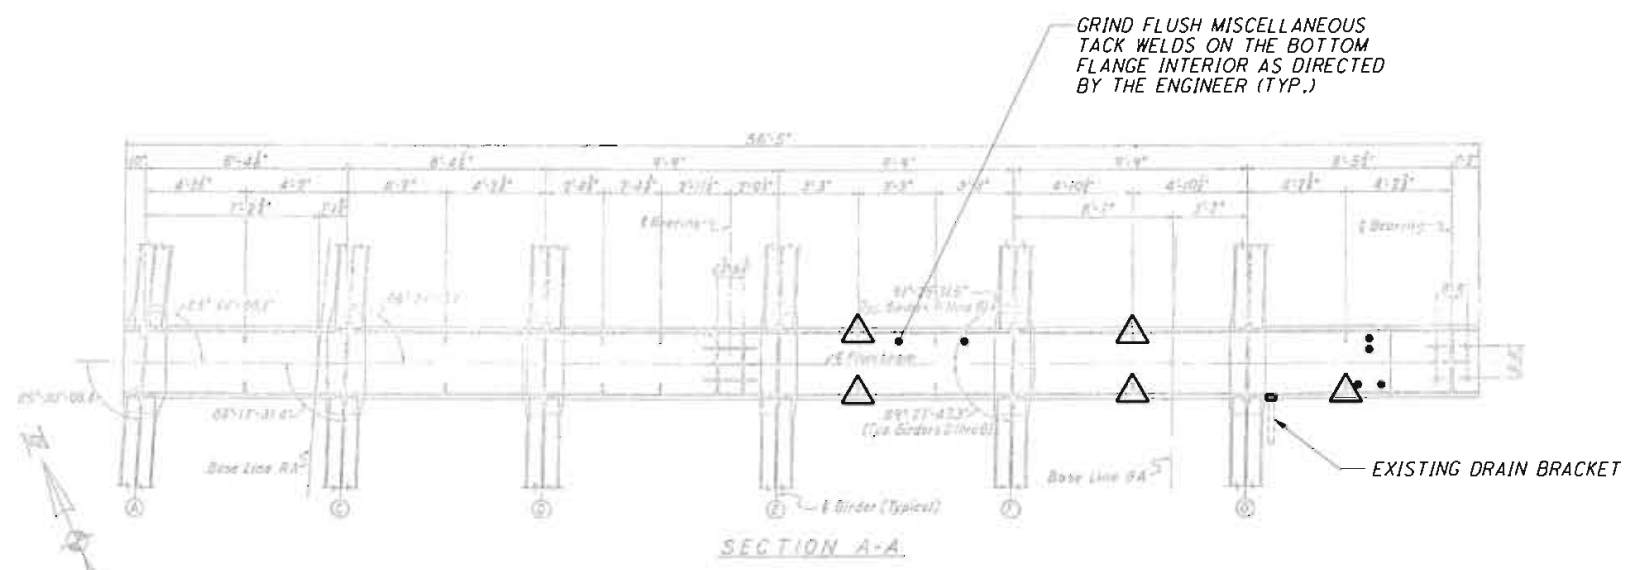
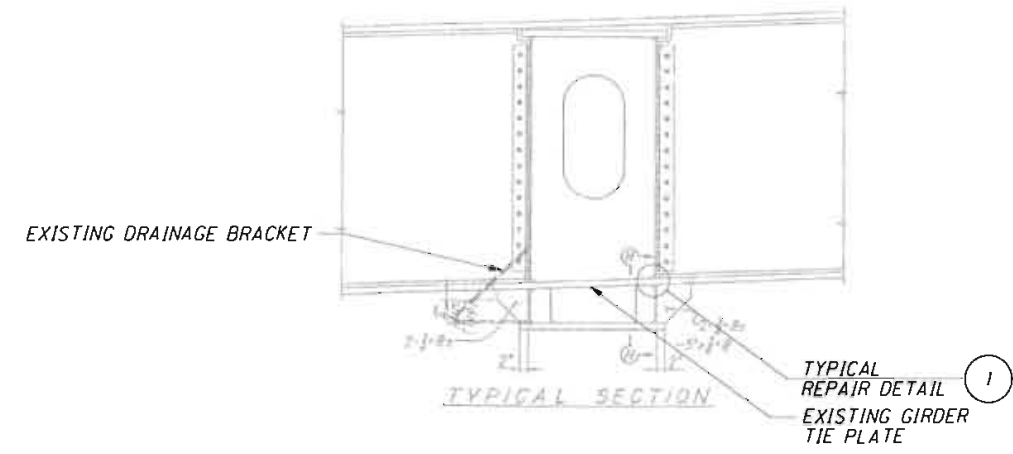
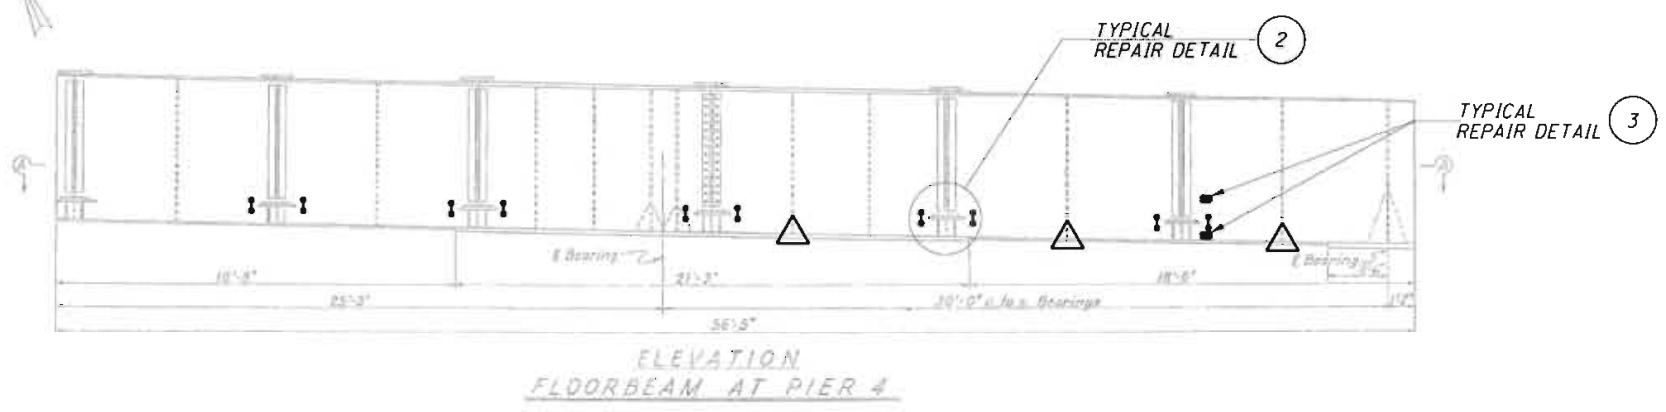
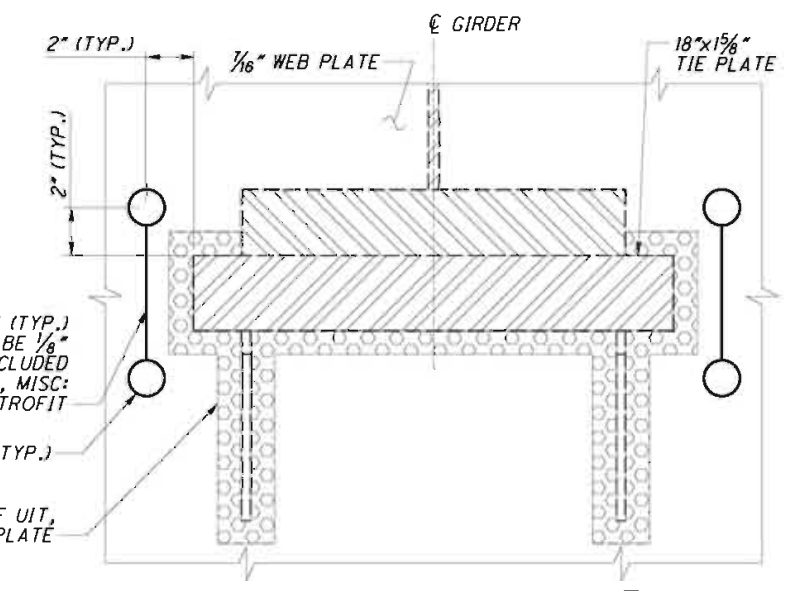
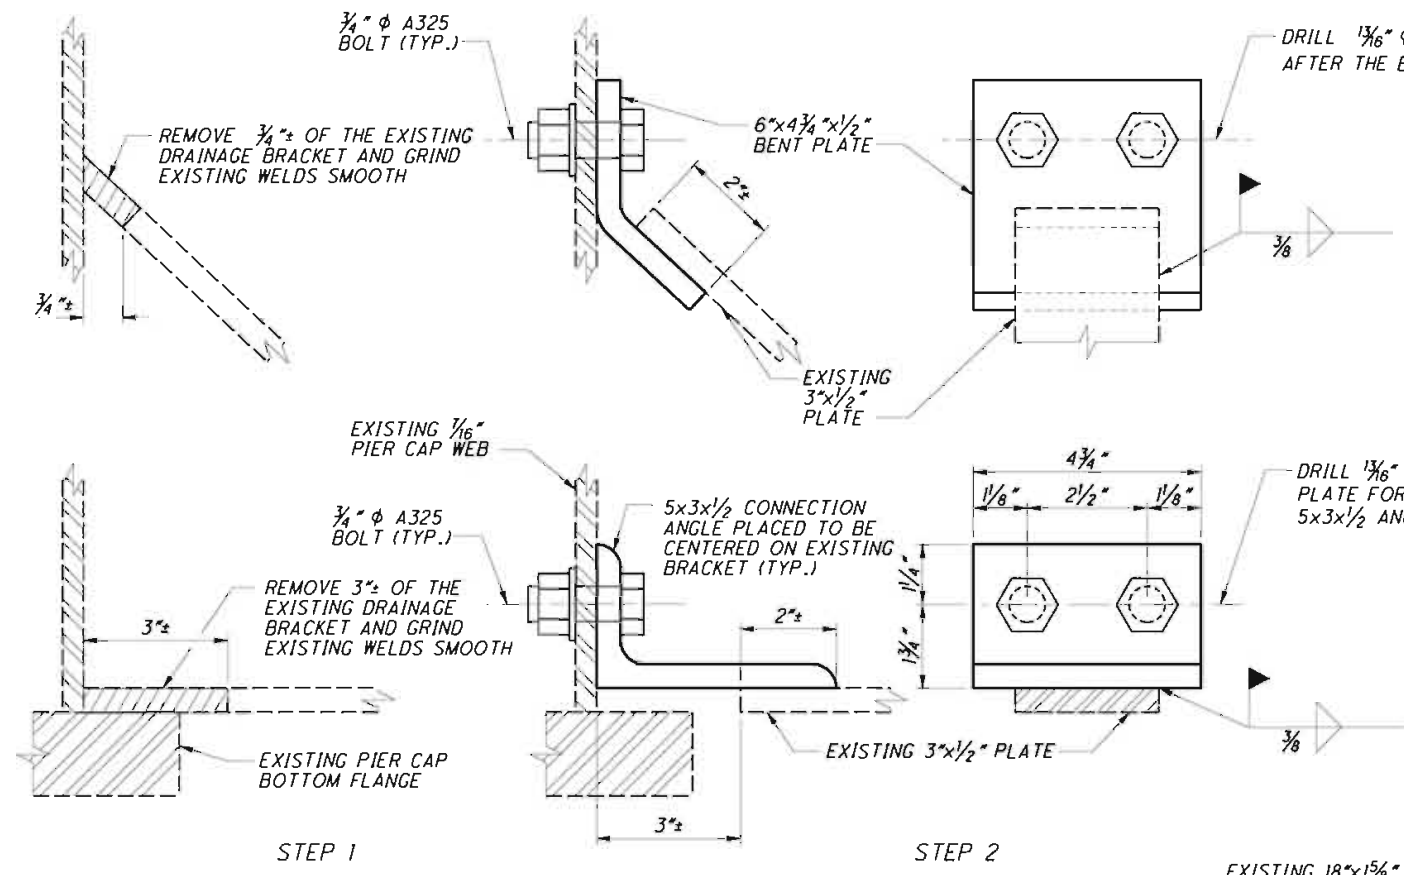
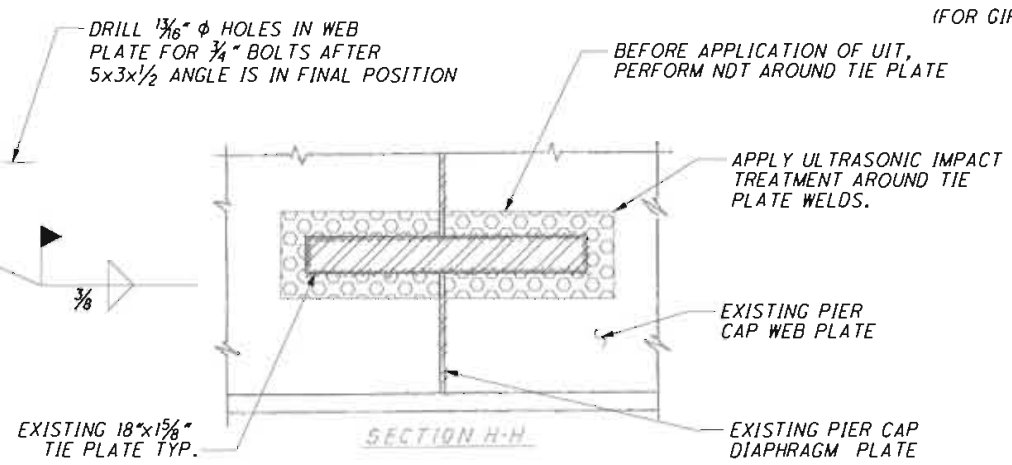
- NOTES:**
1. PIER ELEVATION, SECTIONS A-A AND H-H, AND TYPICAL SECTION ARE TAKEN FROM THE ORIGINAL PLANS.
 2. CLEAN AND PAINT REPAIR AREAS ON INTERIOR OF PIER CAP.
 3. CARE SHALL BE TAKEN NOT TO OVERCUT SAWCUT BEYOND DRILLED HOLES. FLAME CUTTING IS NOT PERMITTED.
- LIMITS OF ULTRASONIC IMPACT TREATMENT
- LOCATION OF INTERSECTING WELD BETWEEN PIER CAP WEB STIFFENER WELD AND PIER CAP FLANGE WELD TO BE REMOVED BY GRINDING

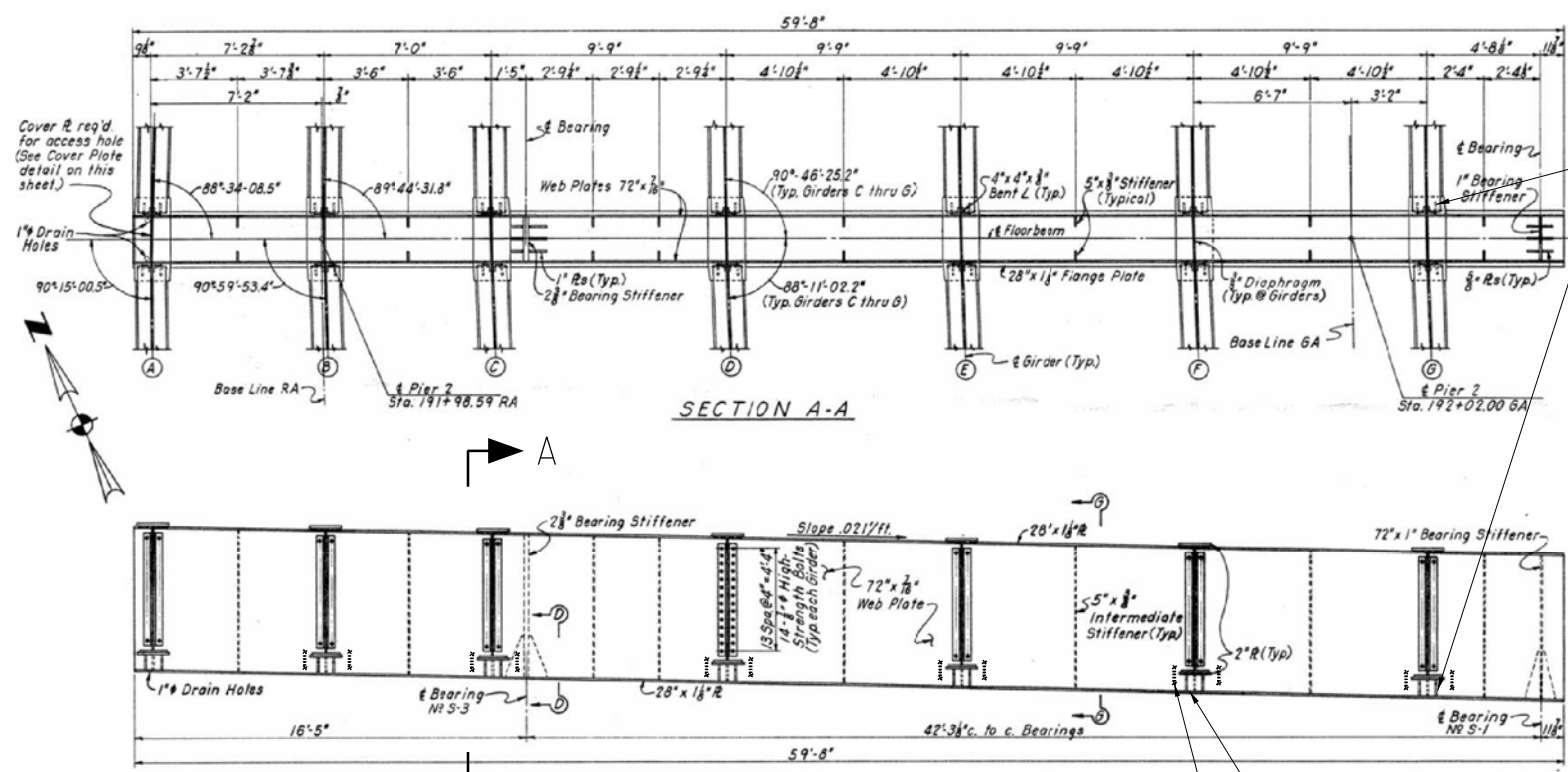
REMOVE AND REPLACE ONE CRACK IN FILLET WELD BETWEEN EAST GIRDER G KNEE BRACE AND NORTH WEB OF PIER CAP 2 PAYMENT SHALL BE INCLUDED WITH ITEM 513-STRUCTURAL STEEL, MISC.: FILLET WELD CRACK RETROFIT. SEE GENERAL NOTES FOR REPAIR PROCEDURE.

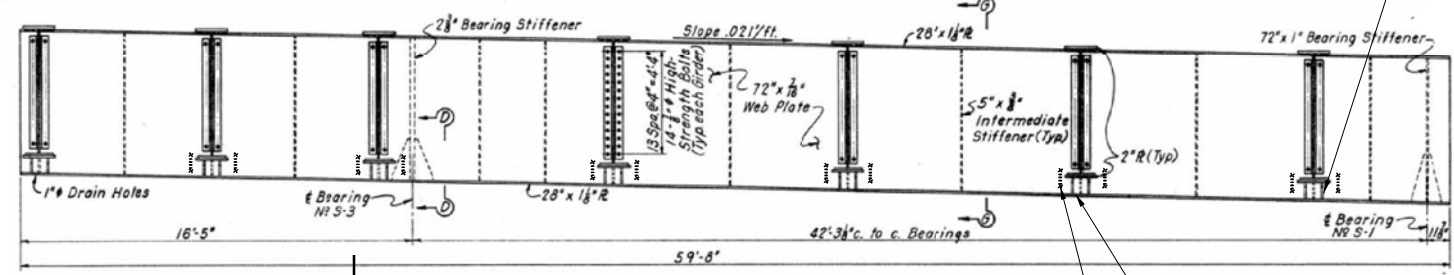
ITEM 513-STRUCTURAL STEEL, MISC.: 2" STRESS RELIEF HOLE RETROFIT TYPICAL AT ALL EXISTING STRESS RELIEF RETROFIT LOCATIONS (DOG-BONE REPAIRS) DONE PREVIOUSLY.

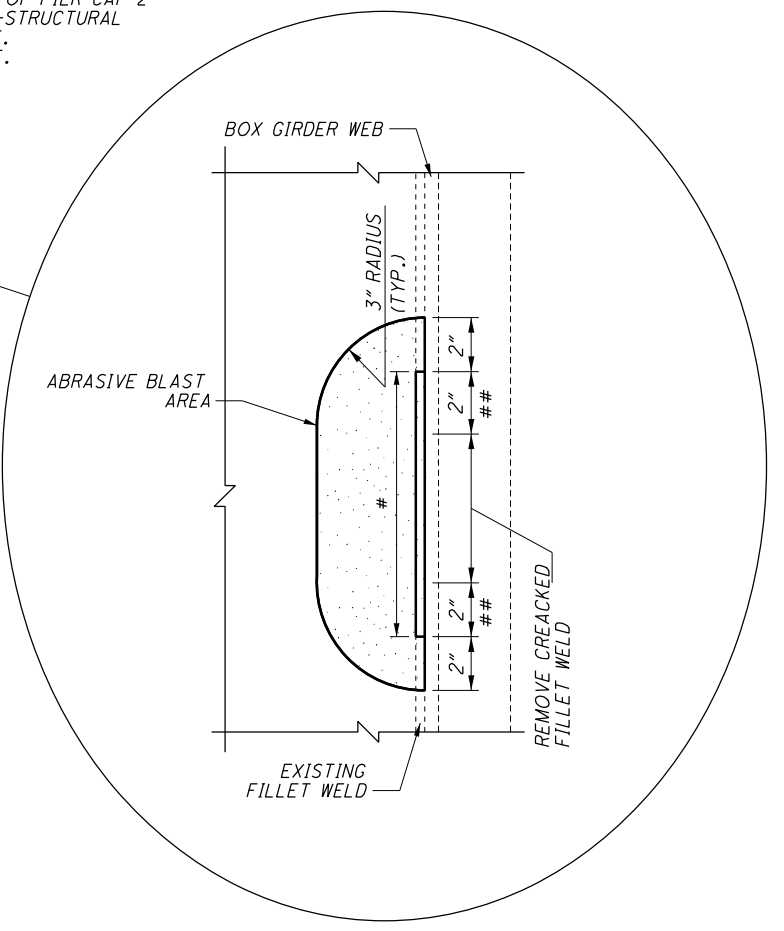
FILLET WELD CRACK RETROFIT DETAILS
(INSIDE ELEVATION)

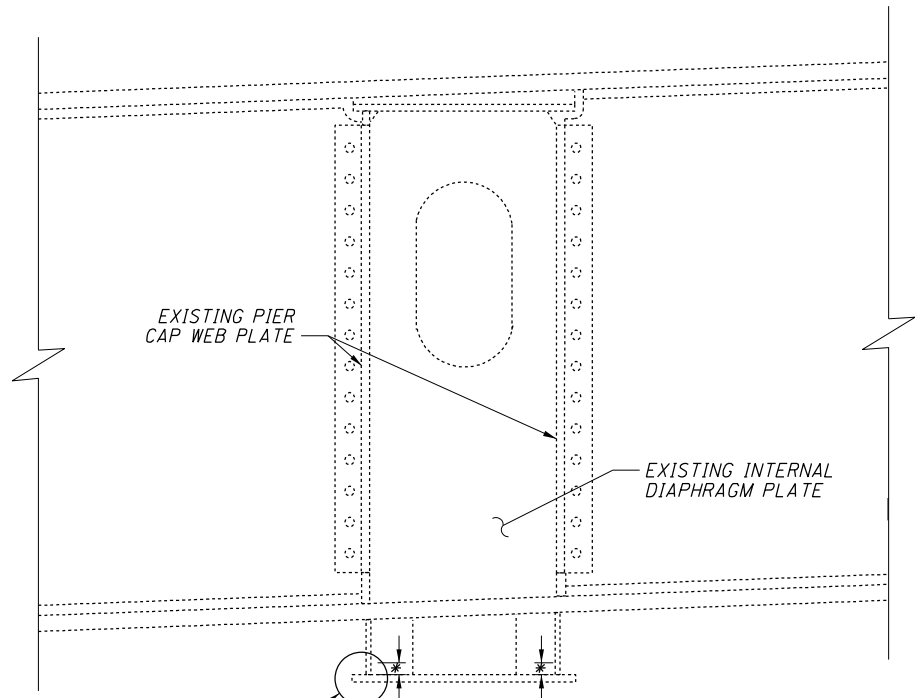
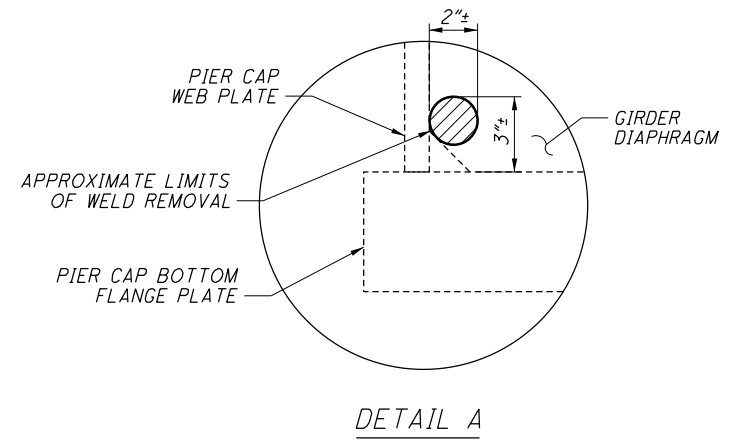
* APPROXIMATE LIMITS OF WEB PLATE WELD REMOVAL. PAYMENT INCLUDED UNDER ITEM 513-STRUCTURAL STEEL, MISC.: 2" STRESS RELIEF HOLE RETROFIT.

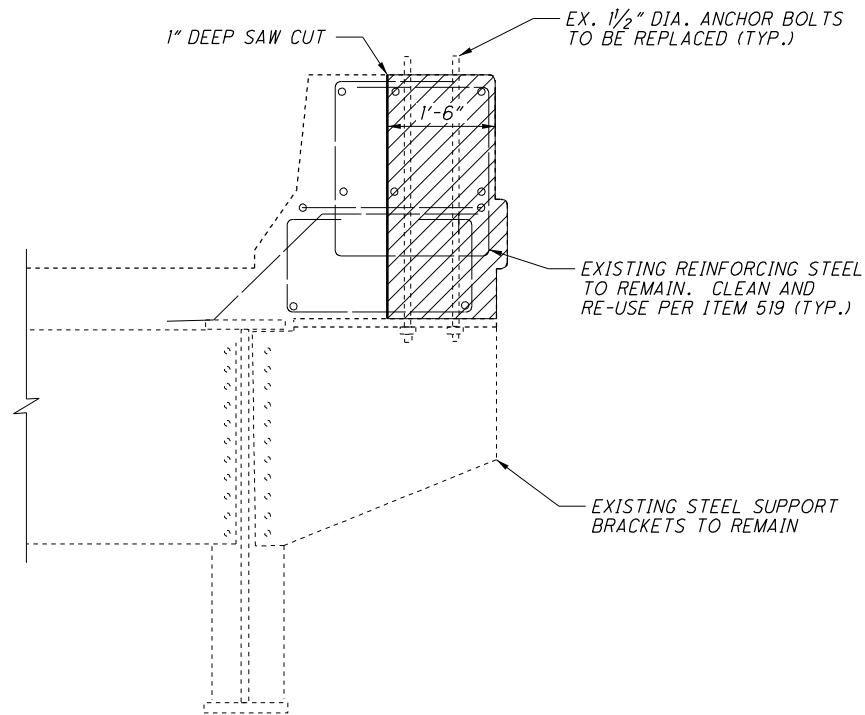
LIMITS OF SEALING CONCRETE SURFACES

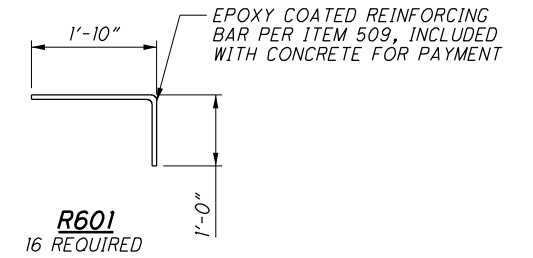
ITEM 511-CONCRETE, MISC.: REPLACE CONCRETE PILASTERS

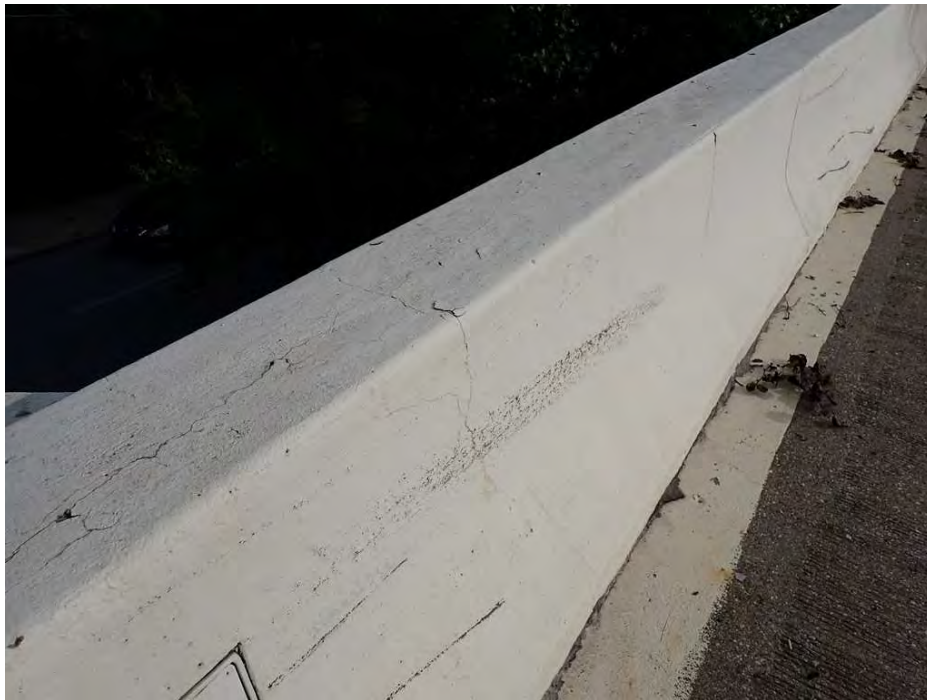
Description Typical deck condition, span 2 shown.

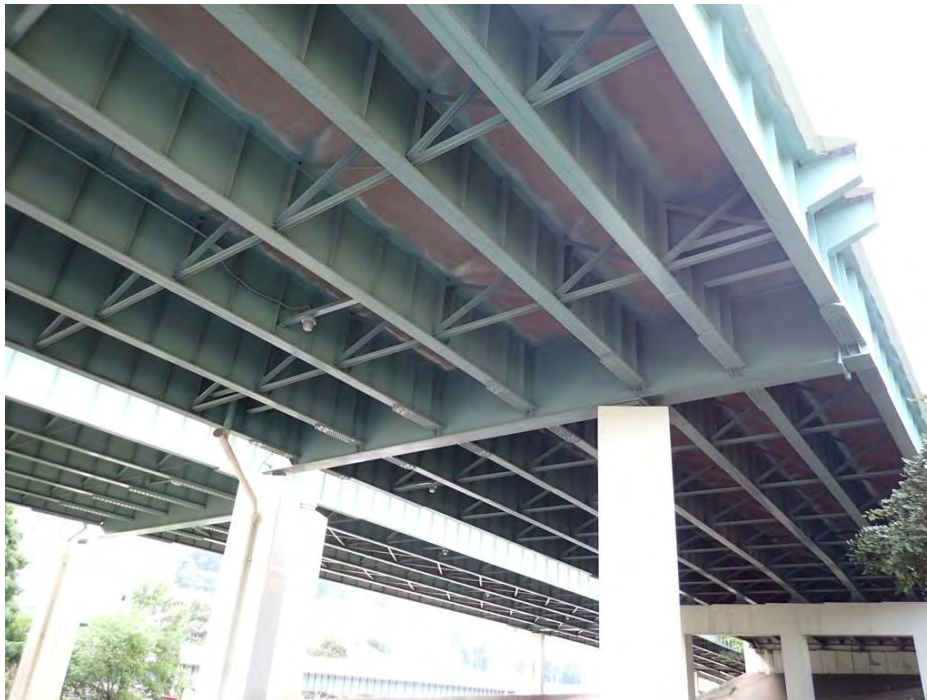
Description Typical girder/superstructure condition. Note no major defects. Span 4 shown looking south.

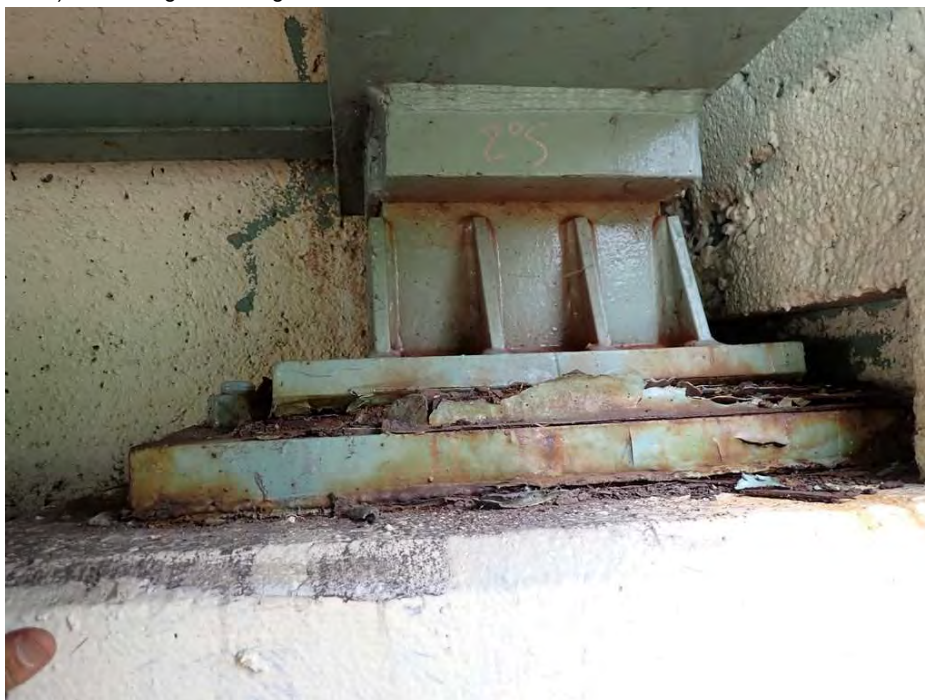
Description View of the bent web stiffener in Span 3, Girder G, just north of the sign supports (13th from Pier 4). No change. Looking west.

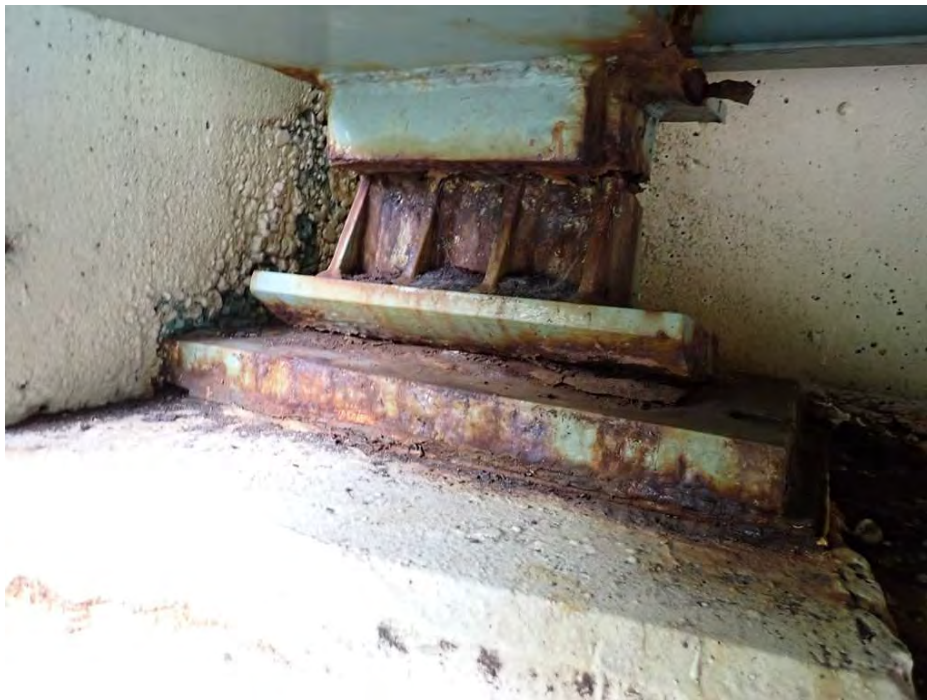
Description Example of heavy corrosion on Abutment 2 bearings, also note bearing rocked far in expansion. Typical at this abutment.

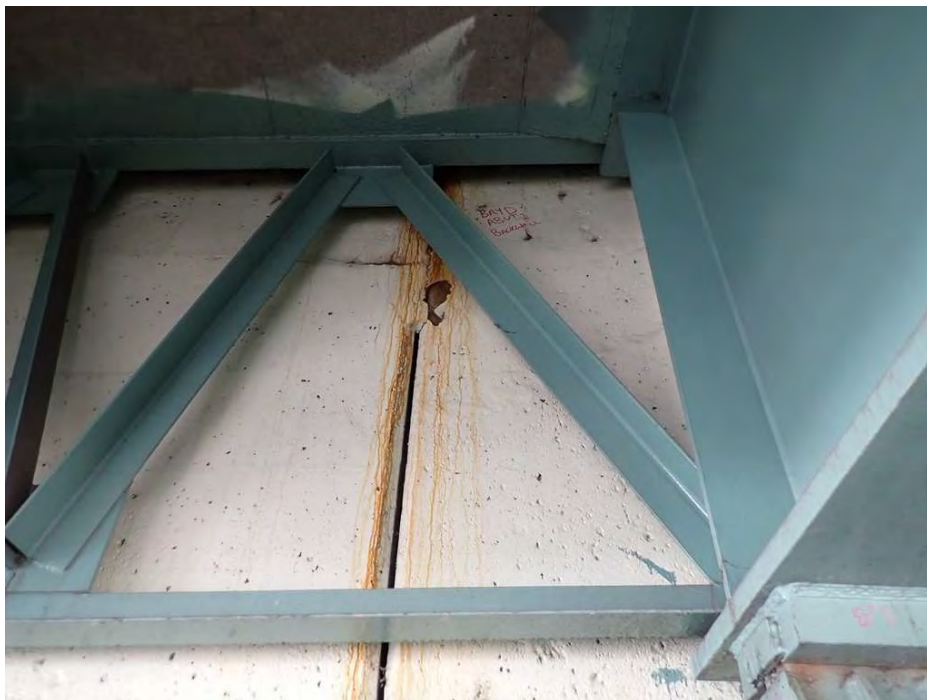
Description Spalls on the northwest corner of the west column at Pier 4. Appear new since last inspection.

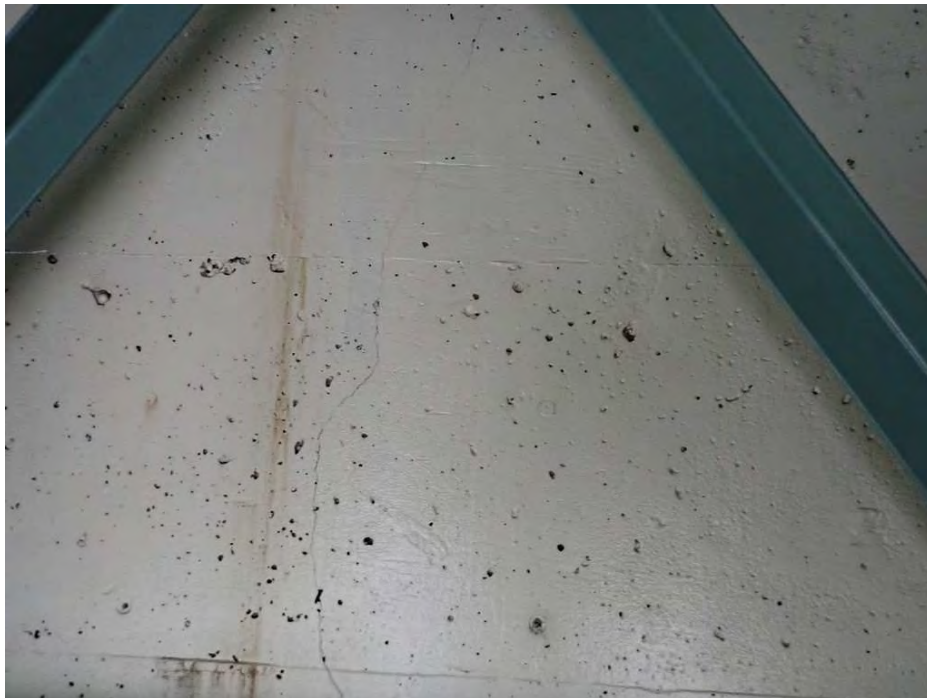
Description General example of rust staining on the Abutment 2 backwall, looking north.

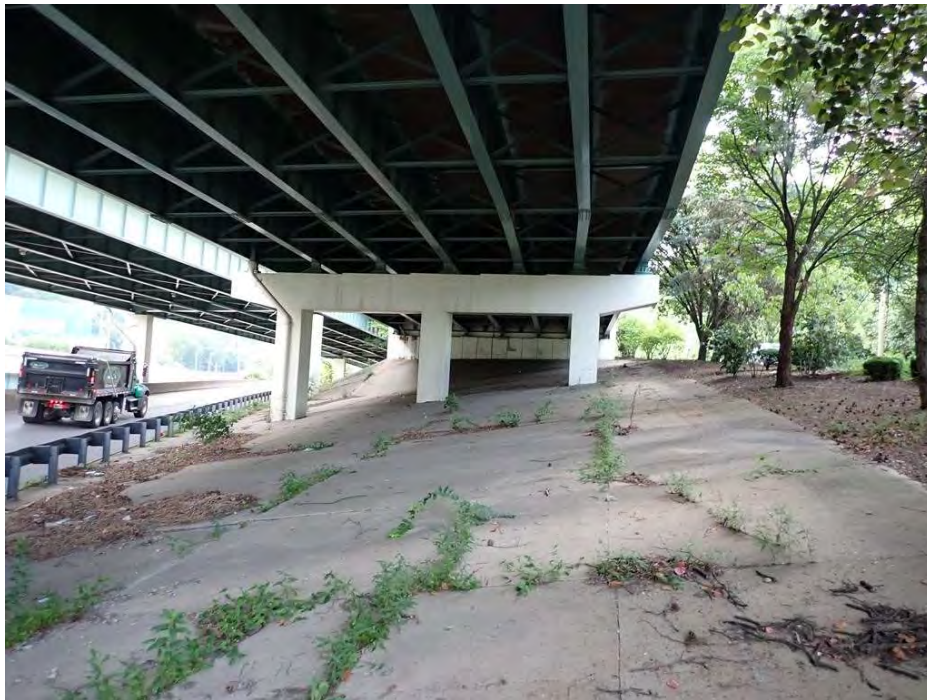
Description Typical example of corrosion holes in corrugate metal drain pipes on the north slope.
