# FRACTURE CRITICAL PIER CAP INSPECTION REPORT

SFN3102807 (HAM-50-1903L)  
US 50 WB OVER MILL CREEK/CSX  
TRANSPORTATION/CENTRAL  
RAILROAD OF INDIANA  
HAMILTON COUNTY, OH  
DISTRICT 8

July 2023

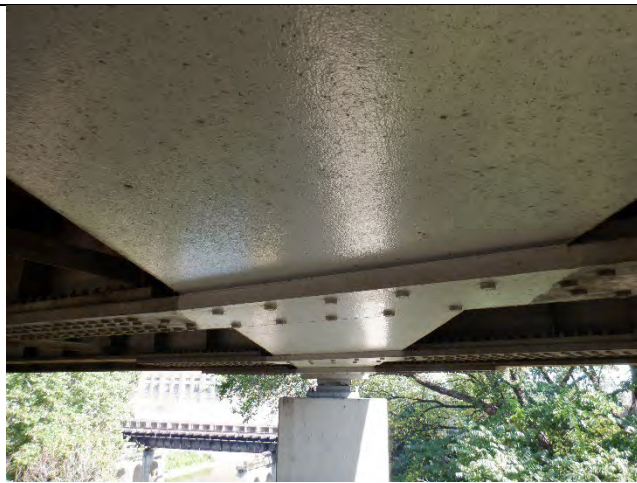
The steel pier cap was in Satisfactory condition [7] (Photograph 1). The pier cap is a built-up steel plate section 6 ft. – 6 in. in height and 4 ft. – 0 in. in width. The bridge girders were attached to the pier cap via bolted tie plates connected to the flanges of both members and bolted angles on the webs. The pier cap was retrofitted in 1992 and 2013, which is detailed in section 1.2 above.

Photograph 1 – View of Pier Cap 5N. Looking north.

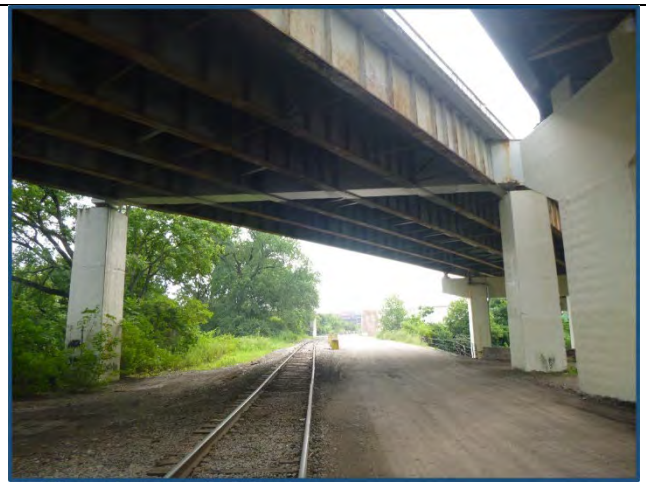
Photograph 2 – Elevation View of Pier Cap 5N. Looking East.

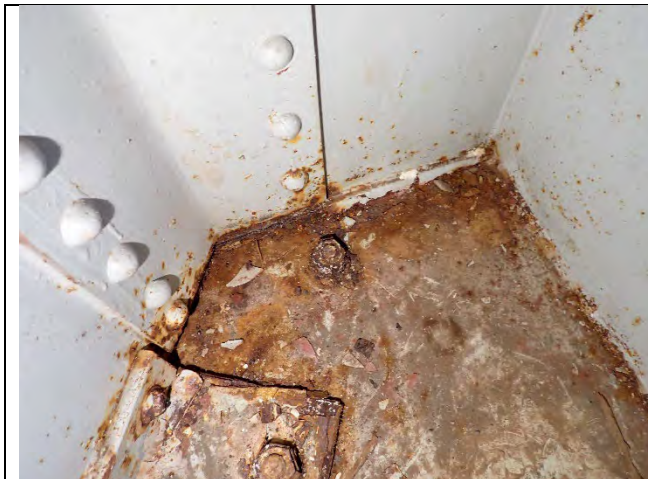
The paint system of the pier cap interior exhibited several areas of light surface corrosion. Active surface corrosion with no loss of section is present inside the cap, predominantly along the bottom plate towards the end of the cap (Photograph 3). This is likely from the humid environment for the interior. This has not changed from the prior inspection. There was evidence of leakage through the bolted connection on the top flange of the pier cap at Girders 1 and 6 (Photograph 4), suggesting that concrete deck cracking above the pier cap is causing water to filter through at the bolt. This continues from the prior inspection.

Photograph 3 – General Example of Active Corrosion On Bottom Plate At End of Cap. South End East Plate Shown. Looking East.

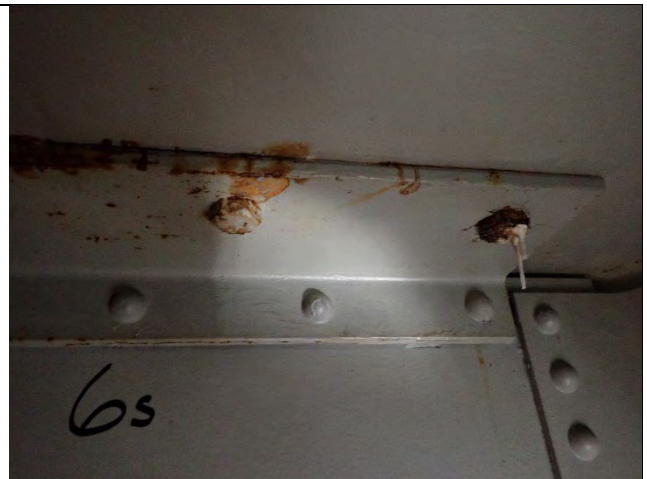
- There is evidence of leakage through bolt holes for the top clip angles at the cap web plates on the interior. Water likely infiltrates cracks in the deck and seeps through these bolt holes. This continues, but has not significantly changed since the prior inspection.

Photograph 4 – Typical Corrosion Through Clip Angle at Cap Top Flange Plate. Diaphragm 6 South Side Shown. Looking North.

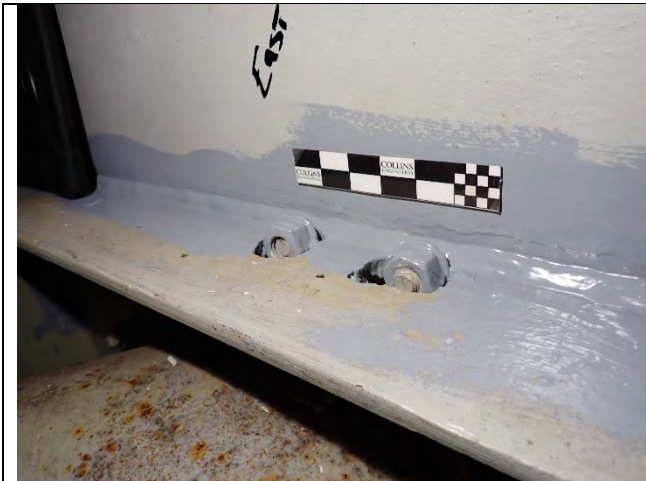
through the fillet welds of the longitudinal web stiffeners surrounding the conduit holes (Photograph 5). This occurs on the top stiffener for both cap web plates, and also to a lesser amount on the bottom east plate. The bottom stiffener west plate has bolts adjacent to the fillet weld, but not through the weld (Photograph 6). Fillet welds with bolt holes through the welds are less wide with less cross-sectional area, which causes a reduced weld capacity and with the copes/section changes can be more susceptible to crack initiation. This situation has not changed since the prior inspection and no weld cracks were observed during this inspection.

Photograph 5 – General Example of Holes Cut Through Fillet Welds of Horizontal Cap Web Stiffeners Above Water Line at Cap Web Plate. Looking West.

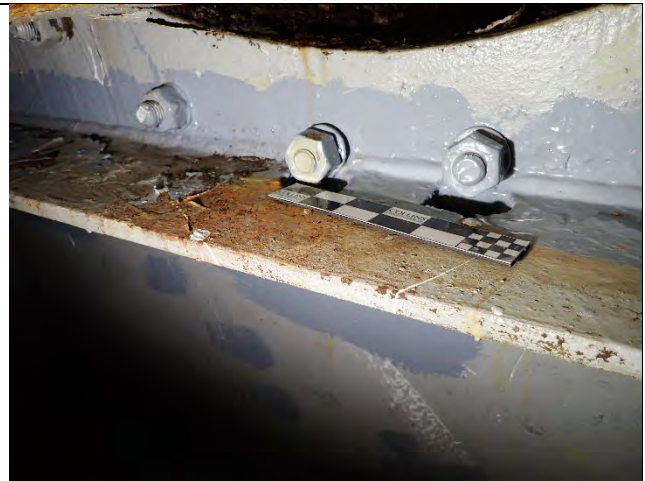
Photograph 6 – General Example of Holes Cut Through Fillet Welds of Horizontal Cap Web Stiffeners Below Water Line at Cap Web Plate. Looking West.

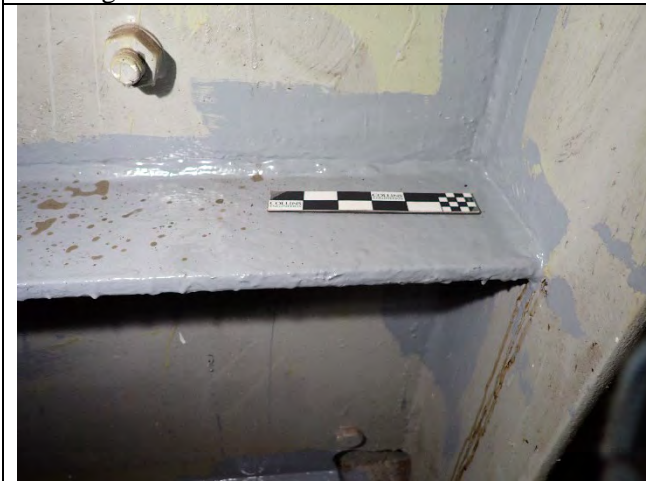
- The fillet welds of the transverse and longitudinal web stiffeners surrounding the water main porthole intersect in tension zones of the web plates (Photograph 7). These locations are closer to the neutral axis than an extreme fiber.

Photograph 7 – General Example of Intersecting Welds For Cap Web Plate Stiffeners Near Water Line. Looking east.

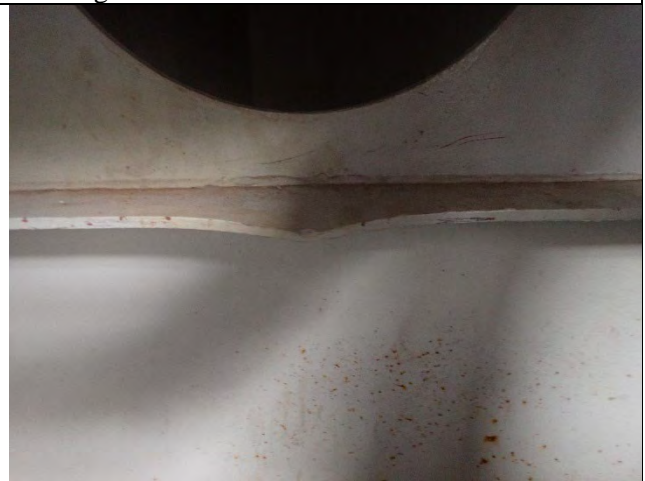
- The horizontal stiffeners below the Girder 6 diaphragm portal were both bent downward slightly (Photograph 8). This is likely construction damage.
- Tack welds are still present at isolated locations inside the cap. These locations include:

Photograph 8 – General Example of Bent Web Stiffener, Girder 6 North Side Shown. No Change. Looking South.

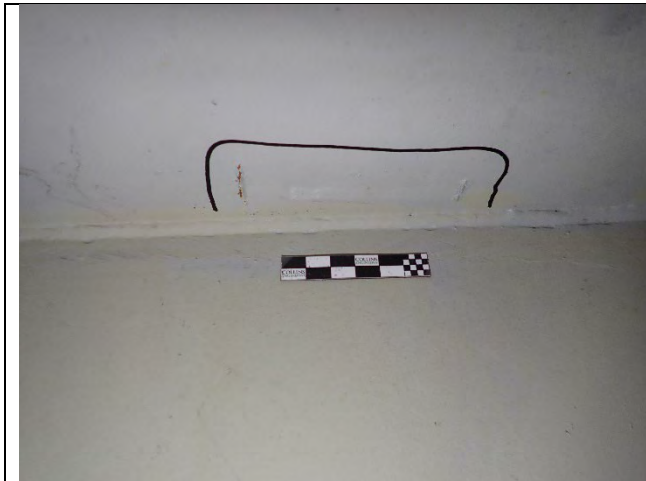
- The two tack welds measuring 1-1/2 in. and 2-1/2 in. on the top flange of the east cap web at the north side of Girder 1 have not changed (Photograph 9).

Photograph 9 – View of 1-1/2 in. and 2-1/2 in. Tack Welds On The Cap Top Flange Plate at the East Cap Web at the North Side of Girder 1. Looking east.

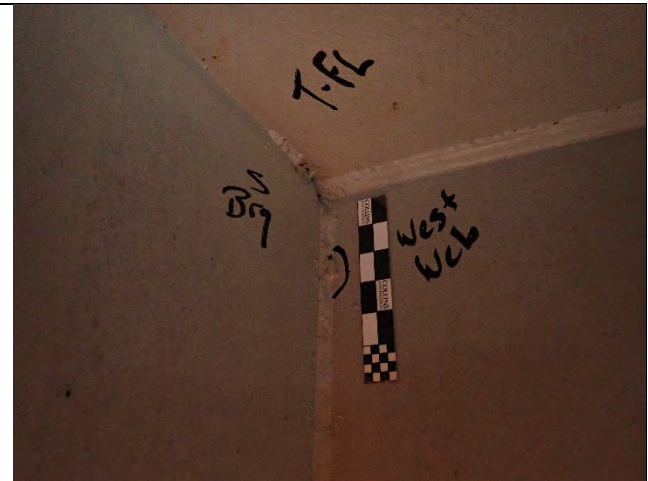
- A tack weld was observed over a fillet weld for the south bearing stiffener on the west cap web plate (Photograph 10). This is an old condition that has not changed.

Photograph 10 – View of Tack Weld Located At the South Bearing Stiffener, West Cap Web Plate. Looking Southwest.

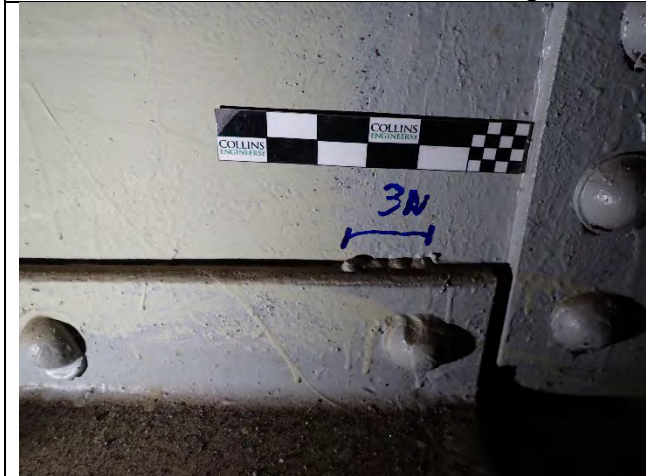
- A tack weld was observed on the lower west corner of the north face of Diaphragm 3, near the clip angle (Photograph 11). This is an old condition that has not changed.

Photograph 11 (left) – General Example of Tack Weld Still Present Between Diaphragm and Clip Angle. North Face of Diaphragm 3 At Lower West Corner Shown. Looking South.

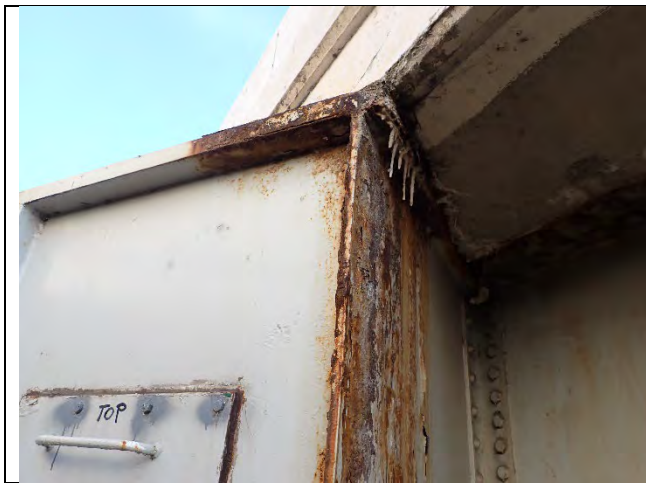
The paint system of the pier cap exterior exhibited active and laminating corrosion around the south end of the cap on both the flange plates and the web plates (Photograph 12). Isolated pits up to 1/8 in. deep were observed (Photograph 13). There is active corrosion with no section loss at several isolated locations along the cap (Photograph 14). In the 2013 rehabilitation project, tack welds were removed from the bottom flange and girder bottom flange tie plates. Three tack welds measuring between 1-3/4 in. and 2-3/4 in. remain on the west side of the bottom flange between Girders 2 and 3 (Photograph 15). This is an old comment that has not changed. Specific items on the exterior to note include:

Photograph 12 – View of Laminating Corrosion on the South End of the Cap, East Side. Looking North.

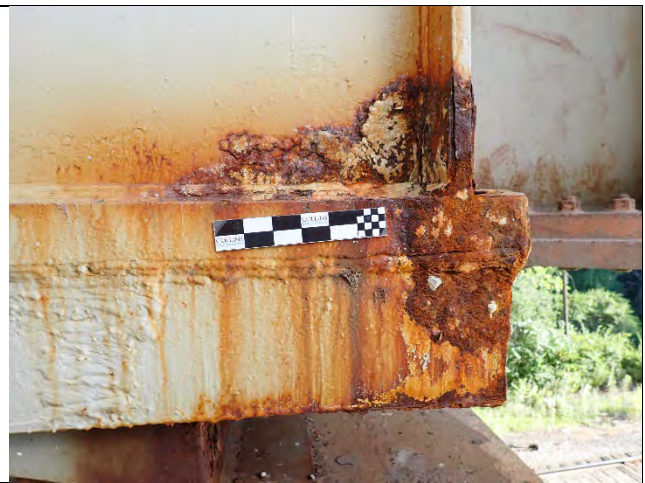
- Active corrosion and laminating corrosion is present on the south end of the pier cap exterior. Localized pits up to 1/8 in. deep are present. This corrosion continues for each inspection cycle.

Photograph 13 – View of Laminating Corrosion on the South End of the Cap, Lower East Corner, With Isolated Pits to 1/8 in. Deep. Looking North.

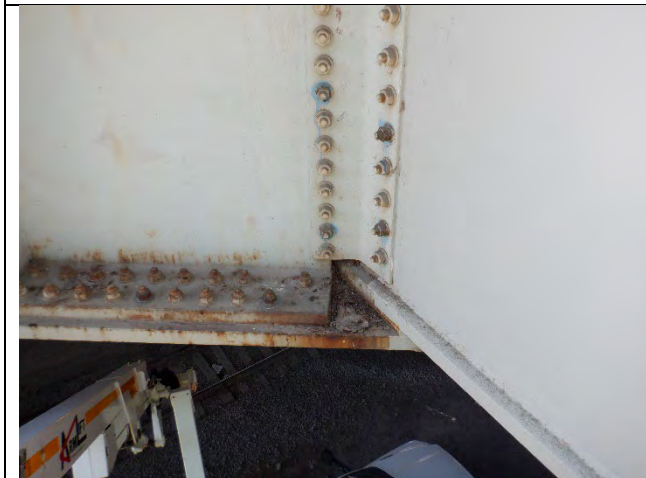
Photograph 14 – General Example of Active Corrosion on Cap With No Section Loss. South End West Face. Looking North.

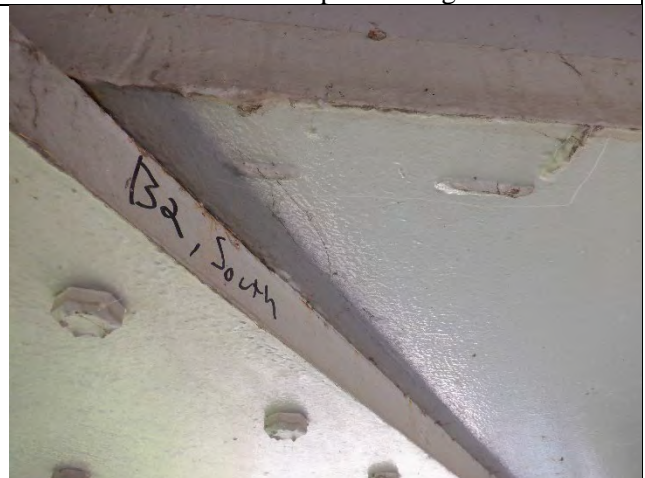
Photograph 15 – View of 3 Tack Welds Present on the West Side of the Cap Bottom Flange Between Girders 2 and 3. Looking East.

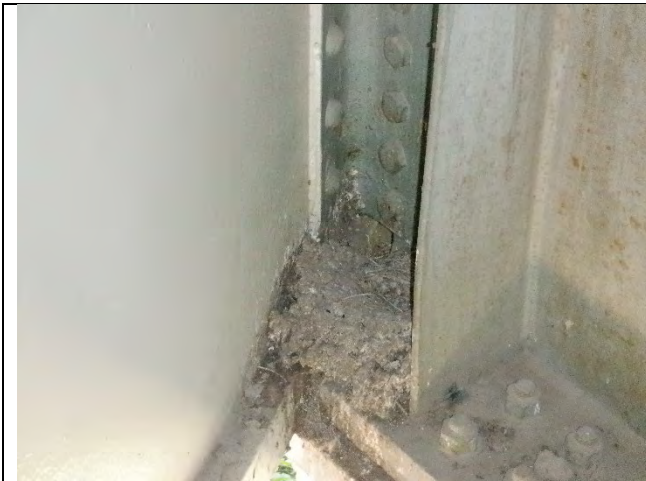
- Heavy bird debris is present at the acute corners for the girder connections at the cap webs. This will retain moisture and promote corrosion (Photograph 16).
- Active pack rust was observed on the structure at the following locations:

Photograph 16 – General Example of Heavy Bird Debris at Girder to Cap Web Plate Connections. West Cap Plate Shown, Looking East.

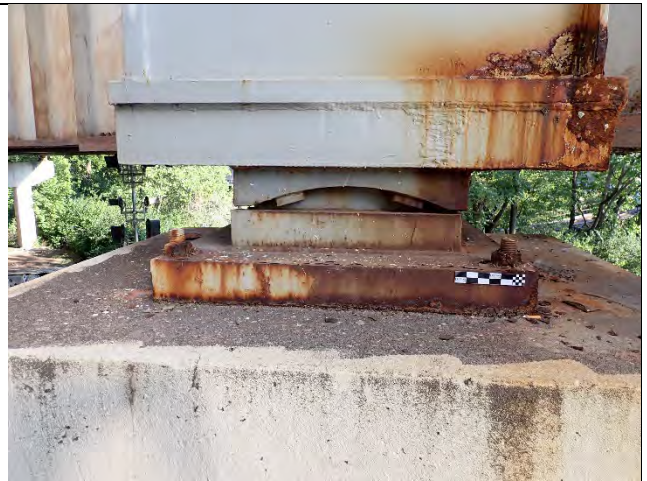
- Active corrosion continues on the south bearing. The anchor bolt nuts still exhibit extensive section loss to the nuts, but the bearings currently function as designed.

Photograph 17 – View of the South Bearing, Note Active Corrosion Continues, Heaviest On Masonry Plate. Looking North.

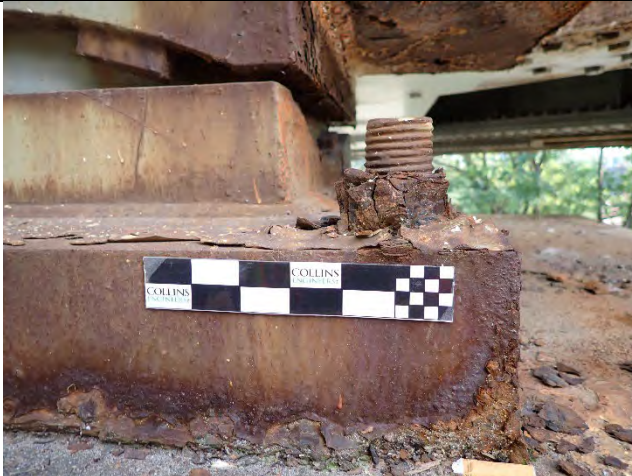
Photograph 18 – General Example of Section Loss to Anchor Bolt Nuts at the South Bearing. Looking North.
