Robert J. Connor and Associates, LLC
5811 Anjolea Way
Lafayette, IN 47905

January 30, 2024

Re: Letter report summarizing findings and recommendations related to diaphragm cracking in the steel cross girder at pier #6 on HAM-562-0147.

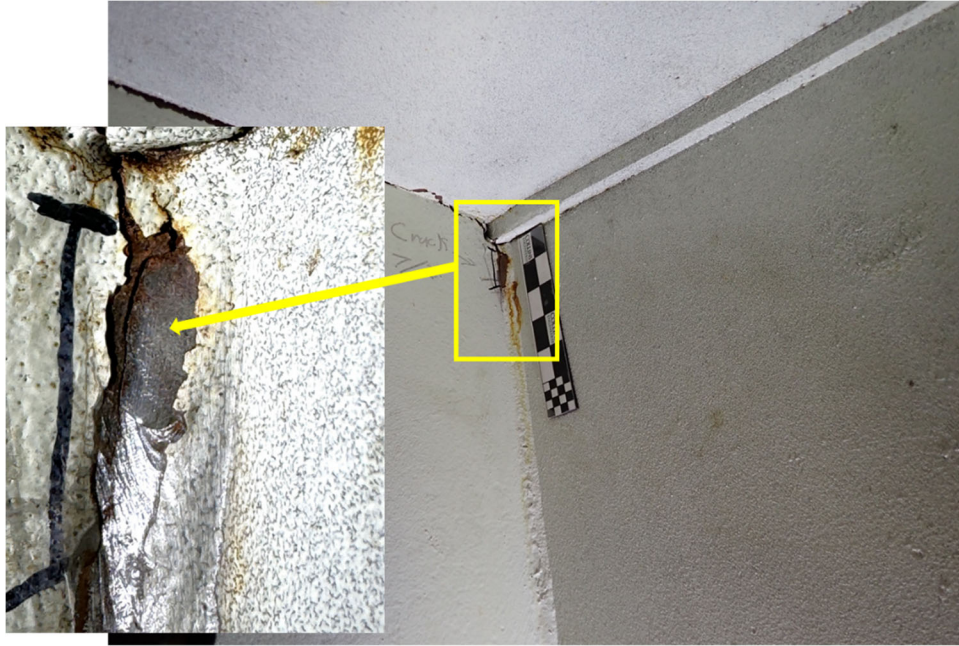
The crack of interest is shown in Figure 1. The crack is present on both fillet welds (i.e., on both sides of the diaphragm). It is also apparent that the diaphragm appears to have been distorted out-of-plane as evidenced by the paint damage where the diaphragm is fit tight to the top flange. As seen in Figure 1, there is no weld between the diaphragm and the top flange. Based on my review of the design drawings, it would seem that the longitudinal girders which frame into the box girder would apply tension forces to this diaphragm due to the negative moments that are generated. However, it is also true that the box girder is flexible in the vertical direction and as such, if one assumed the cross deflected downward, then positive moment would be generated in the longitudinal girders and hence, compression in the diaphragm. However, in the absence of installing strain gages and conduction long-term field measurements, it is not entirely clear if tension or compression from live load is carried through the diaphragm. Similarly, dead load forces could also be in tension or compression depending on fit up and other tolerances that affect locked in forces.

Nevertheless, the cracking is very isolated and I am not convinced that the crack has not actually been present for a number of years. What I could see inside of the crack surface was corroded and I did not see evidence of recent, active movement from live load. Such evidence would be the production of iron oxide that is often observed at displacement induced cracks due to the

rubbing of the crack surfaces. **I think it is impressive that the crack was detected to some degree as these are large box girders and it is an isolated small crack. Thus, it could be that the crack was smaller and has finally reached a size that is more easily detectable, or it was present for many years and the coating has finally failed and hence, it is more detectable.**

Figure 1 – Photograph of crack observed at interior diaphragm of pier 6 cross girder

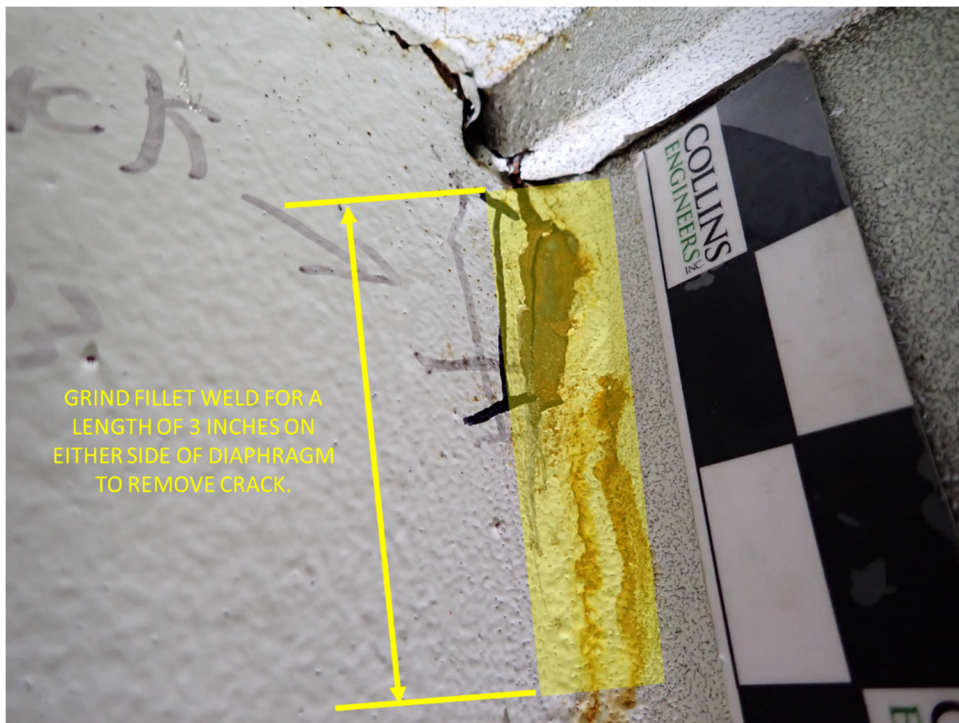
Figure 2 – Photograph of the observed crack illustrating recommended limits of grinding to remove the cracked portion of the fillet weld as well as a portion of the uncracked weld

Since it is an isolated crack that is not in the main member and located in a compression region of the box girder I don't see this to be a very serious matter. As such I would recommend the crack be ground and fillet out for a length of 3 inches to remove it entirely (See Figure 2). I would further recommend MT to ensure the crack was completely removed.

In terms of long-term inspection needs, I would subsequently inspect the repaired detail during normal NSTM inspections and I don't see a need to conduct more frequent inspections of this specific detail. At most, you may wish to examine this detail at 6 or 12 months after the repair is made to make sure no further crack extension is observed. Assuming no changes are observed, simply continue with normal NSTM inspections and note that this is a special detail to be examined by inspectors. Should additional crack growth be detected at this location we can consider the need to conduct a more detailed evaluation as to the cause with the objective of developing a more robust retrofit. Should cracks be detected at other locations (i.e., other interior diaphragms) or become more widespread in the future, the same retrofit could be introduced. However, I would request you reach out to me so that we can make sure the type of cracking is the same.
