# FRACTURE CRITICAL PIER CAP INSPECTION REPORT

SFN3113914 (HAM-562-0147)  
SR-562 OVER ROSS AVENUE AND  
INDIANA & OHIO RAILWAY  
HAMILTON COUNTY, OH  
DISTRICT 8

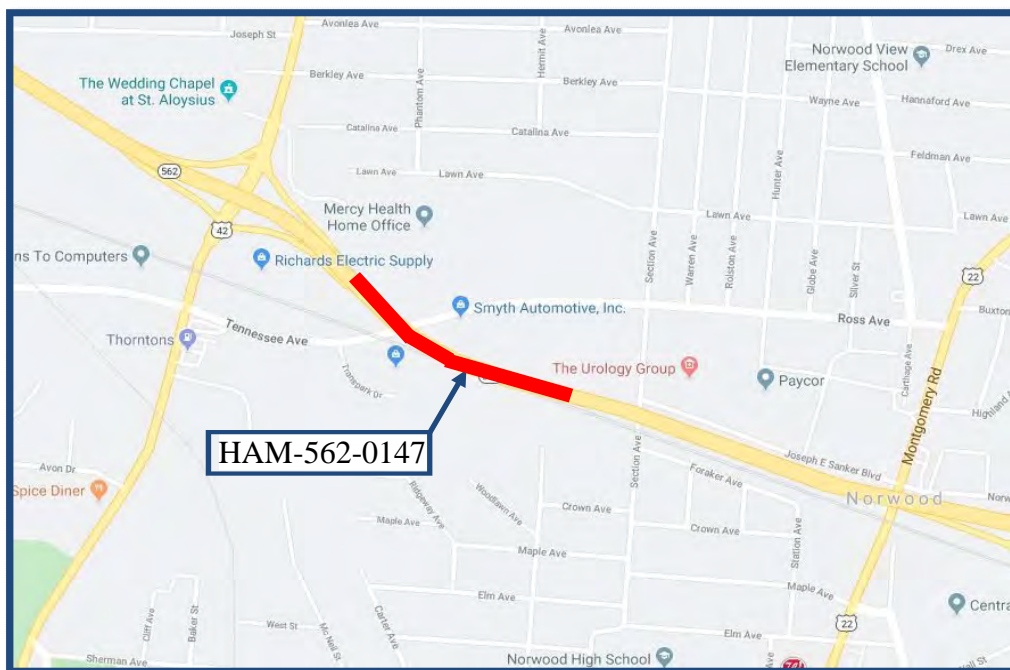
Figure 1: Bridge Location Map

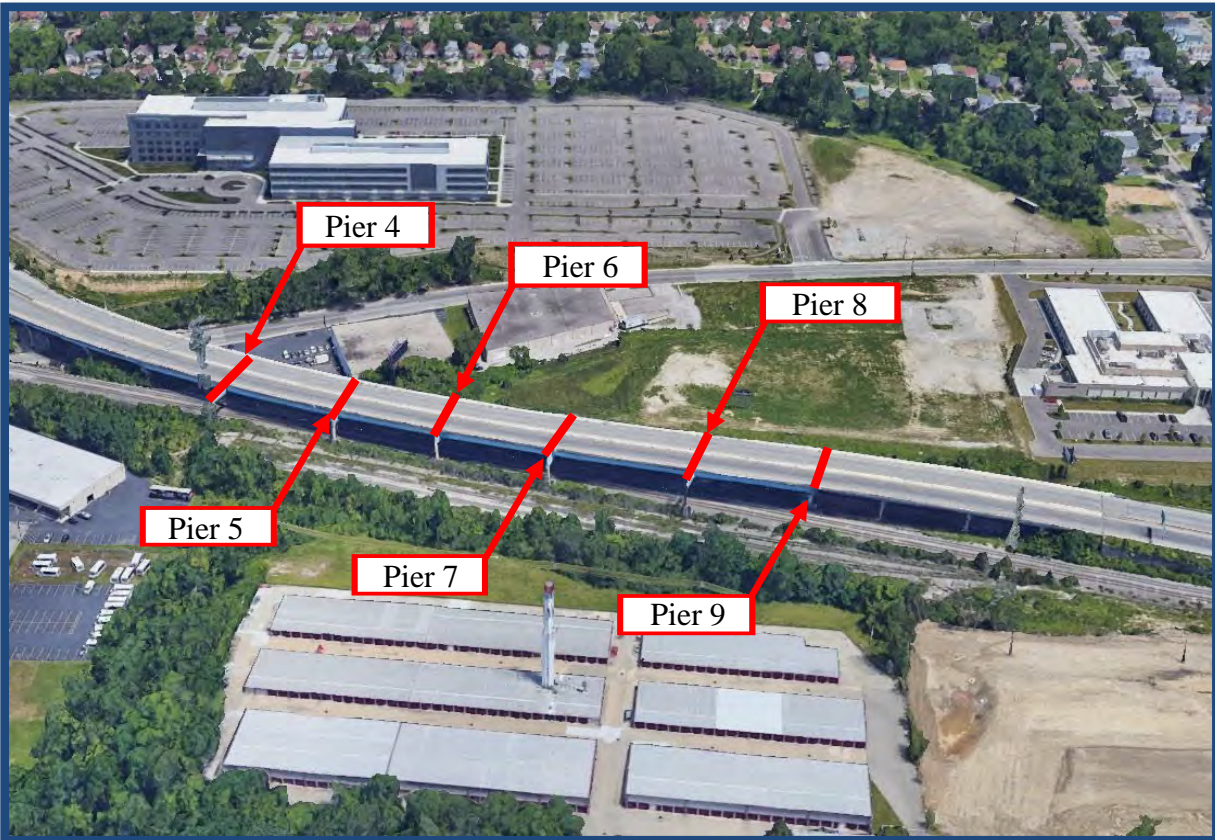
*Figure 2: Fracture Critical Pier Cap Locations*

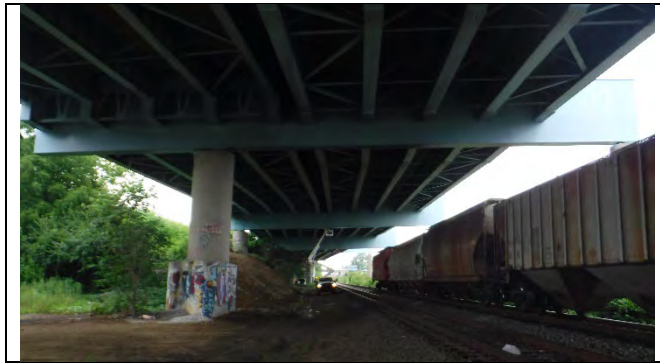
Photograph 1: General Elevation of Pier Cap 4, Looking West.

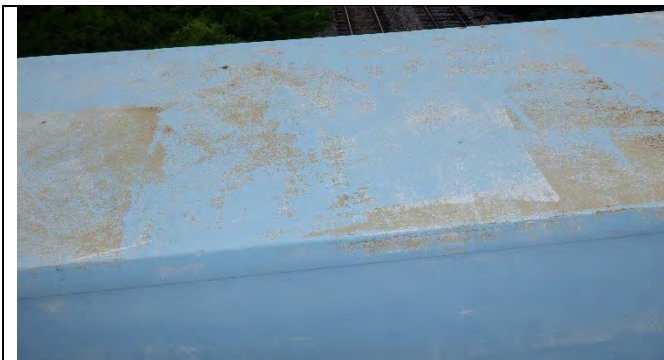
Photograph 8: Typical Fading Paint and Surface Corrosion at the South End of the Pier Cap, Looking West.

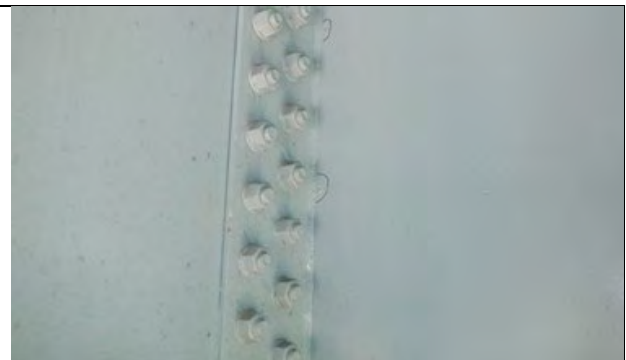
Photograph 9: Five 1 in. Tack Welds on the West Web at the South Face of Girder 9, Looking East.

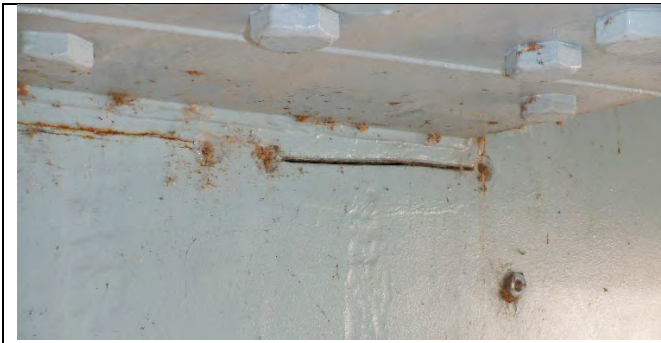
Photograph 10: Rust Staining on the East Web Retrofit at Girder 7, Looking Northwest.

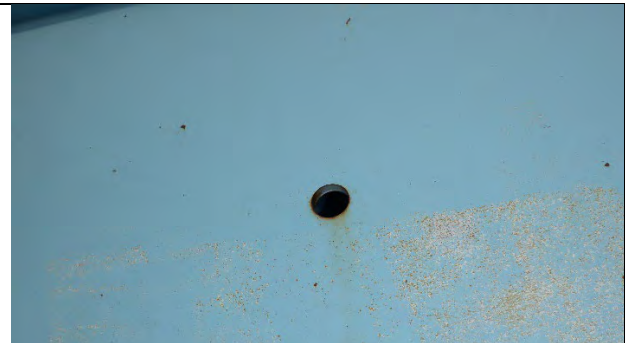
Photograph 11: Missing Expansion Plug in the West Web Retrofit Hole South of Girder 10, Looking East.

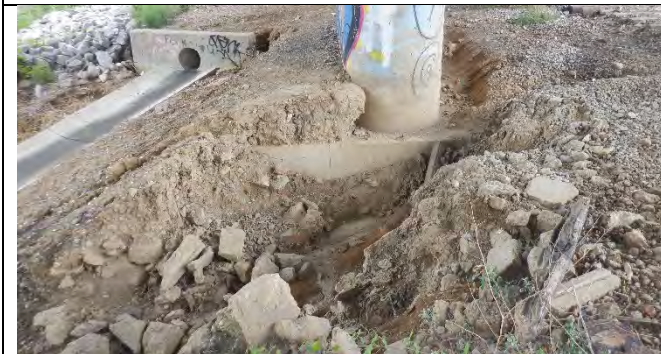
Photograph 12: Erosion at the Base of the East Column, Looking East.

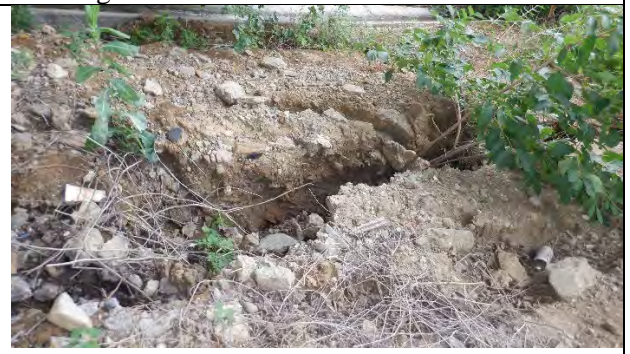
Photograph 13: Erosion at the Base of the North Column, Looking East.

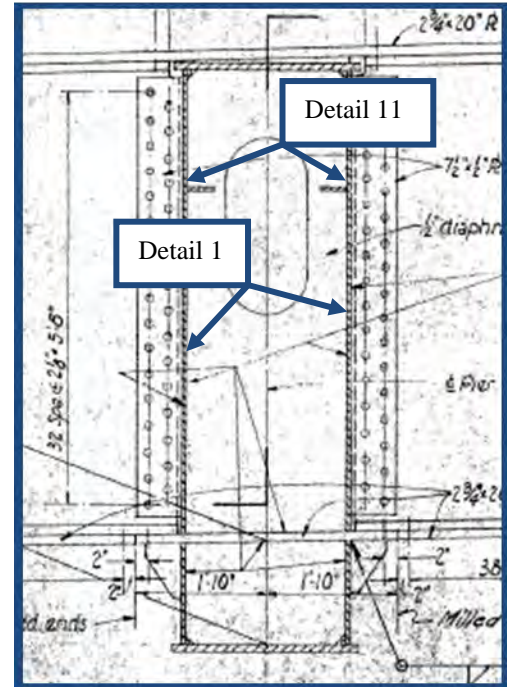
Figure 3: Section of Pier Cap 4

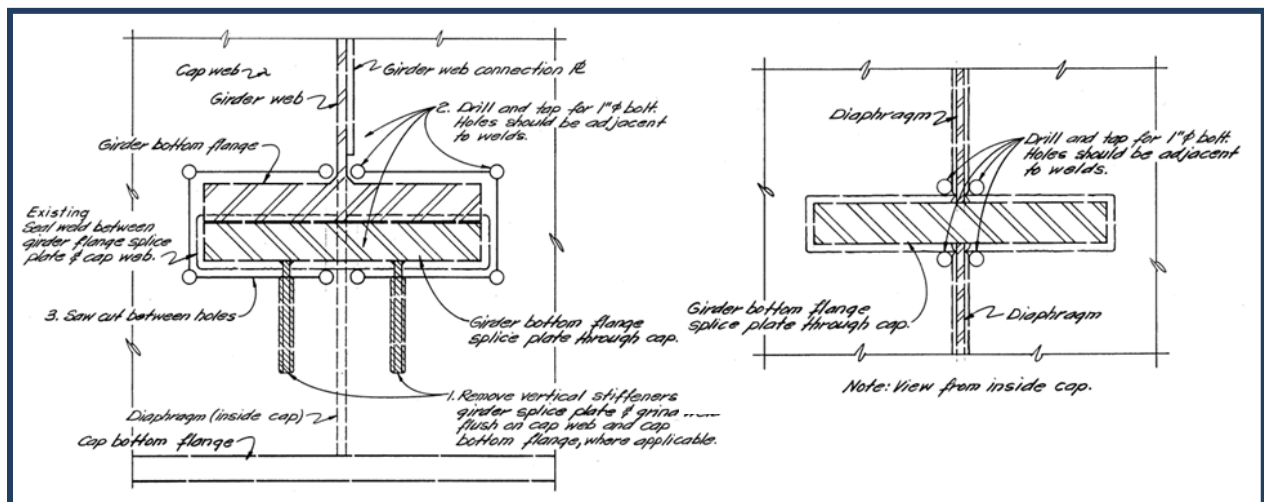
Figure 5: Web plate retrofit details from rehabilitation plans.

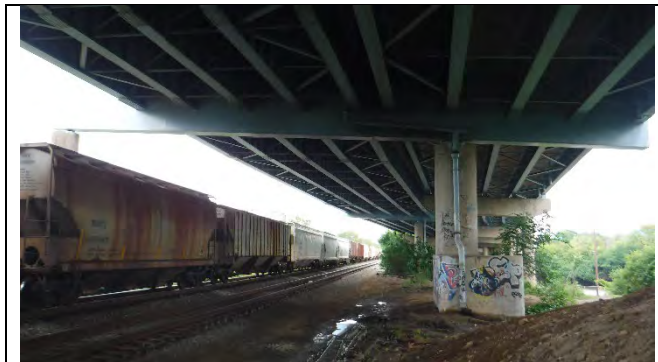
Photograph 14: General Elevation of Pier Cap 5, Looking West.

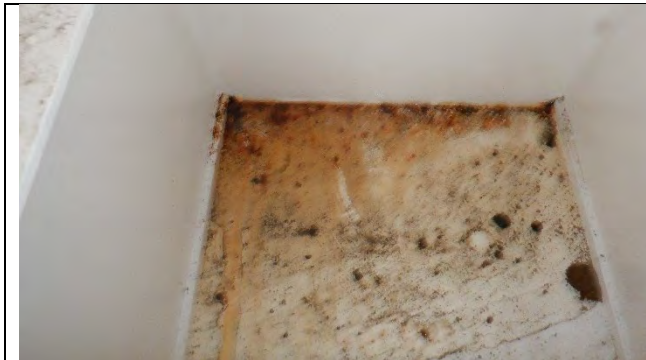
Photograph 15: Evidence of Ponding with Corrosion on the Bottom Flange on the South Side of Girder 5, Looking North.

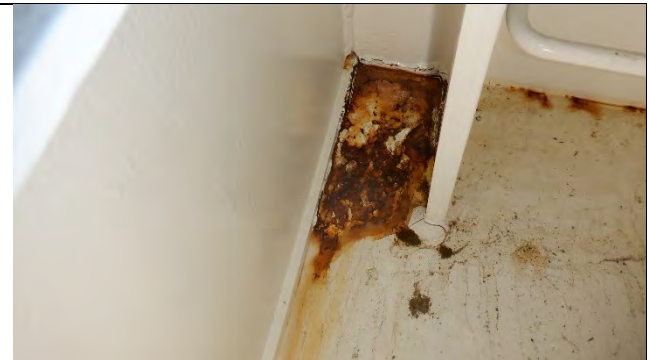
Photograph 16: Typical Corrosion on the South Side at the Bases of the Diaphragm, Looking North.

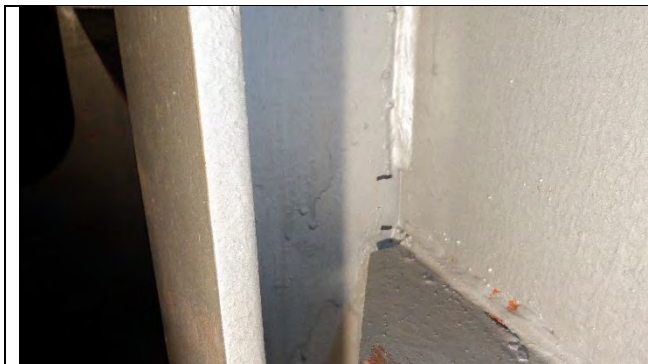
Photograph 17: 1.5 in. Discontinuity in the Weld Between the West Web and a Web Stiffener Between Girders 7 and 8, Looking Southwest

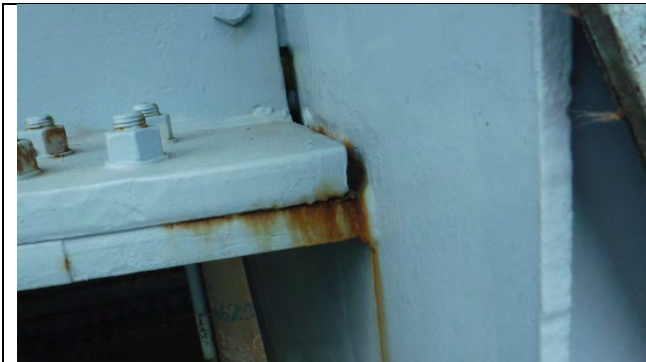
Photograph 23: Reactivated Corrosion at Previously Painted Over Section Loss on the East Web at Girder 1.

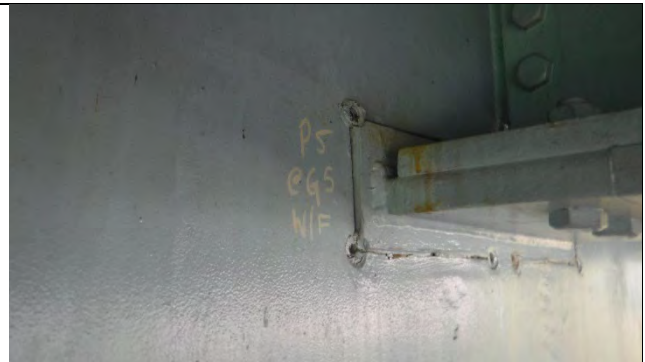
Photograph 24: Typical 1993 Rehabilitation Drill and Saw Cut Retrofits with Web Deflection.

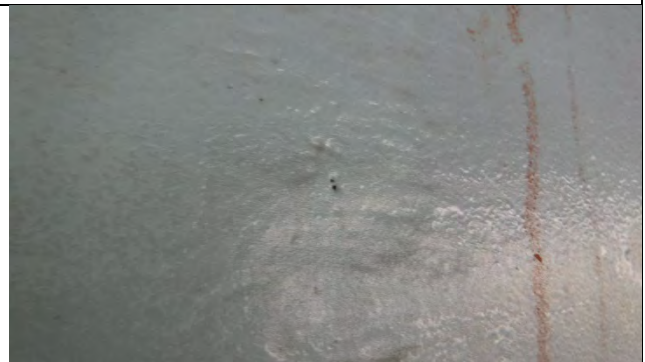
Photograph 26: Minor Porosity in Web Where Knee Braces Were Removed.

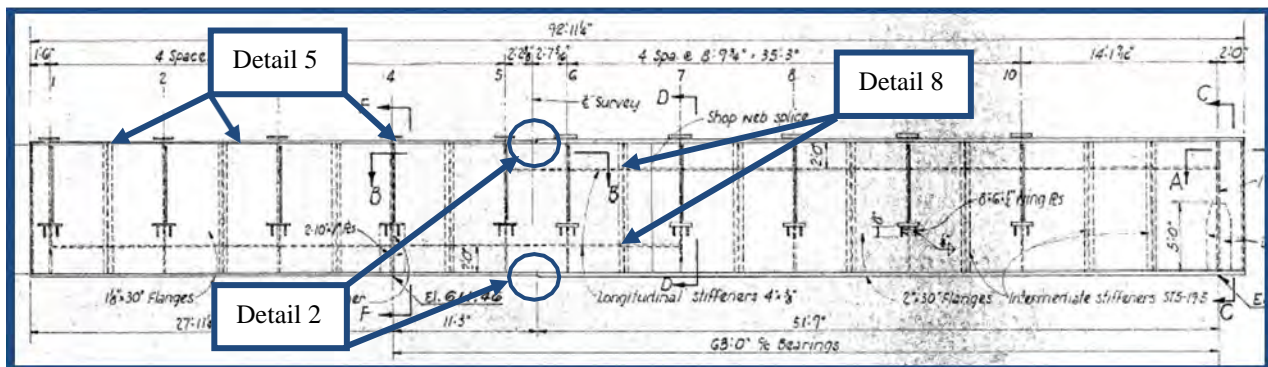
Figure 7: Elevation of Pier Cap 5

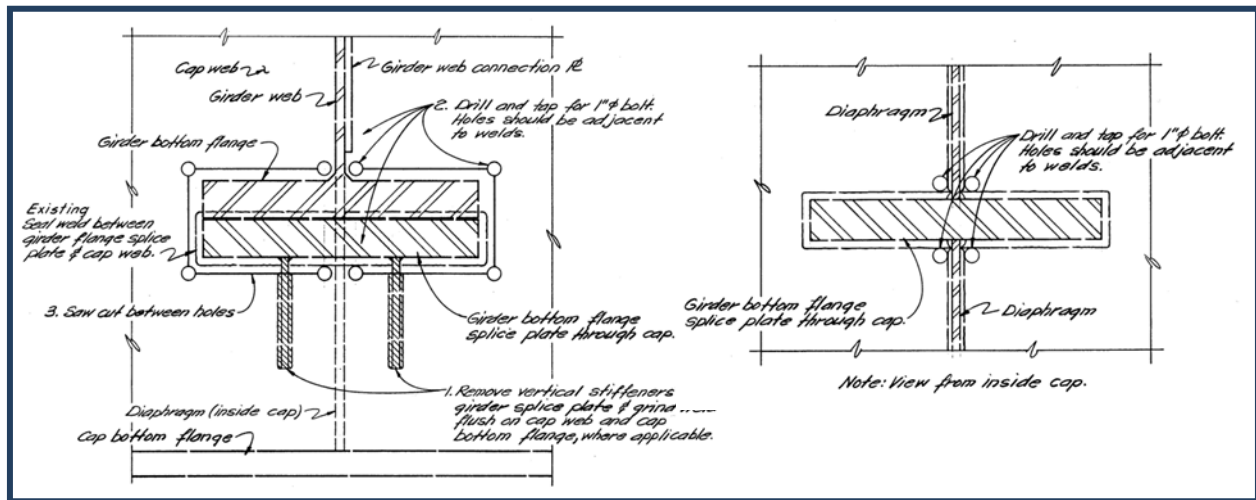
Figure 8: Web plate retrofit details from rehabilitation plans

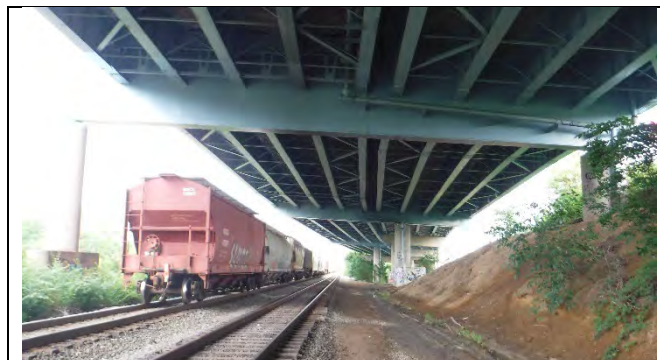
Photograph 27: General Elevation of Pier Cap 6, Looking West.

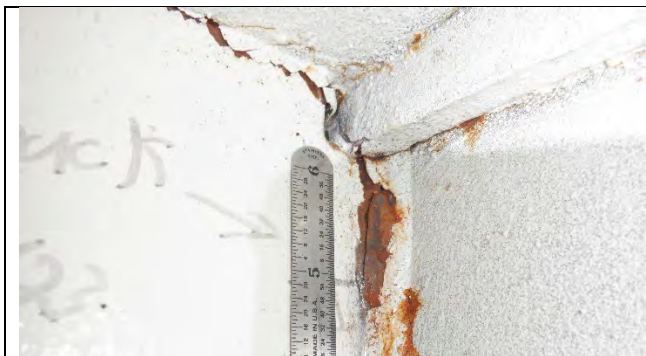
Photograph 28: View of 1.5 in. Weld Crack at the Top of the Fillet Weld for the Diaphragm to West Web Plate at Girder 6, North Side of Diaphragm. Perspective View, Looking South.

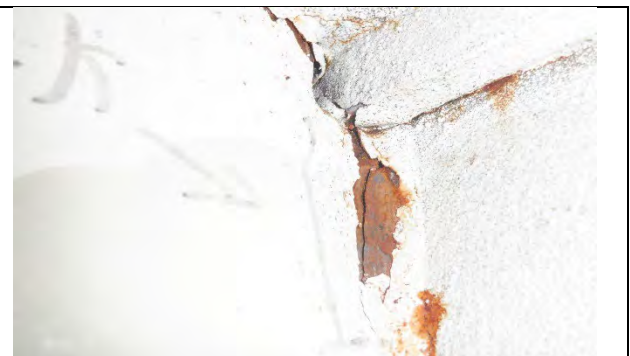
Photograph 29: View of 1.5 in. Weld Crack at the Top of the Fillet Weld for the Diaphragm to West Web Plate at Girder 6, North Side of Diaphragm. Perspective View, Looking South.

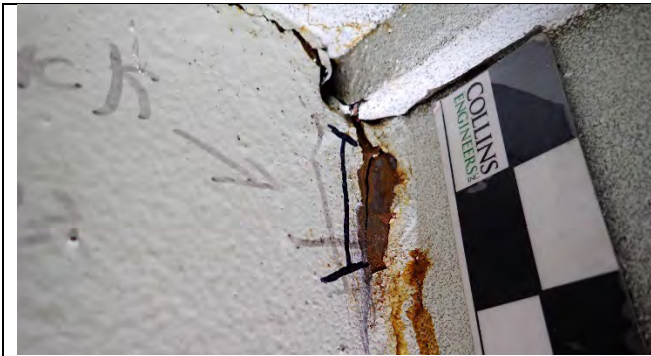
Photograph 30: View of 1.5 in. Weld Crack at the Top of the Fillet Weld for the Diaphragm to West Web Plate at Girder 6, North Side of Diaphragm. Close-Up View, Looking South.

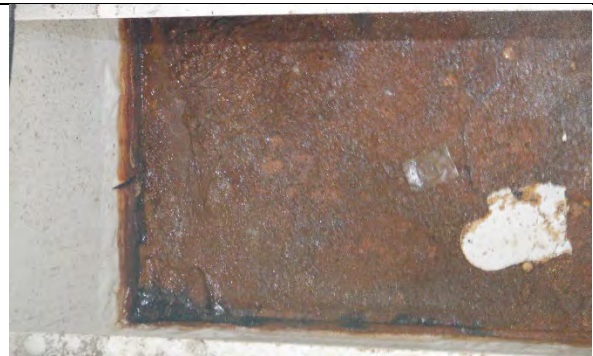
Photograph 31: Typical Ponding Water and Surface Corrosion on Bottom Flange.

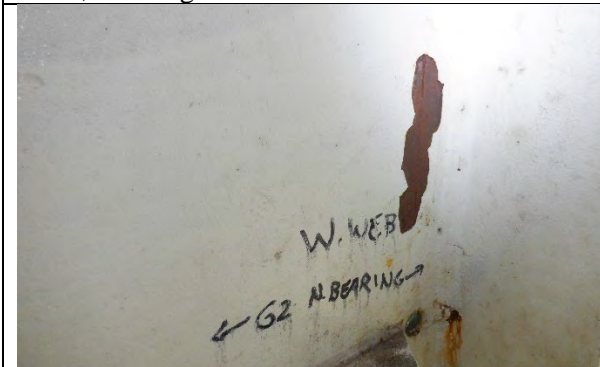
Photograph 32: Typical Paint Defect and Surface Corrosion Due to Missing Epoxy Sealant at Retrofit.

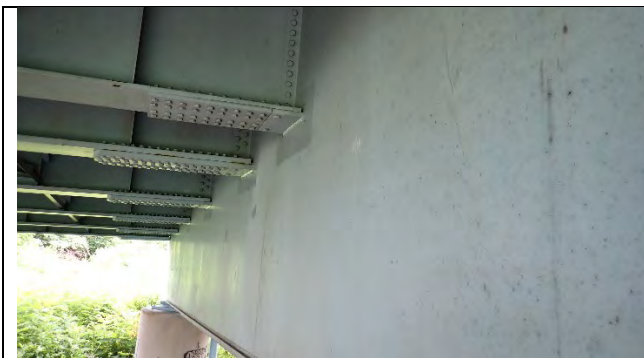
Photograph 33: Typical Condition of the Exterior of Pier 6 at the West Web Plate, Looking North.

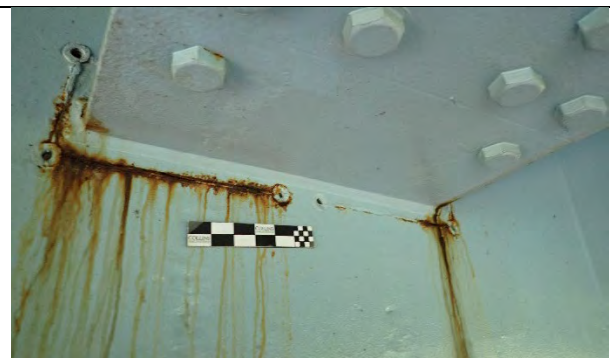
Photograph 34: Corrosion Was Beginning to Reactivate at Previously Painted Over Section Loss at Girder 5 and Pier Cap East Web Plate, Looking West.

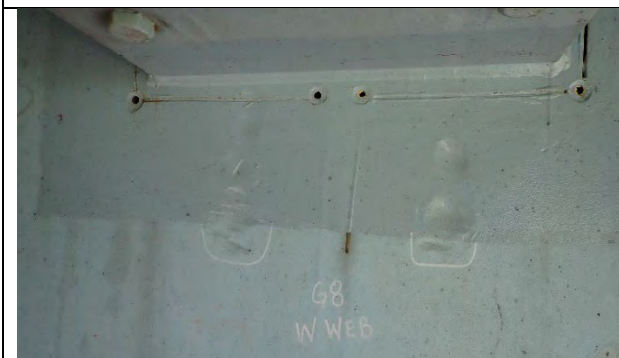
Photograph 35: Heavy Gouging on West Web Plate Below Girder 8 From Girder Knee Brace Removal, Looking East.

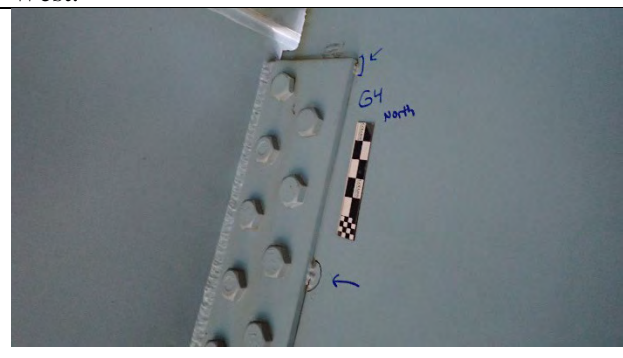
Photograph 36: Cracked Tack Welds on the North Face of Girder 4 and Pier Cap West Web Plate Connection, Looking Southeast.

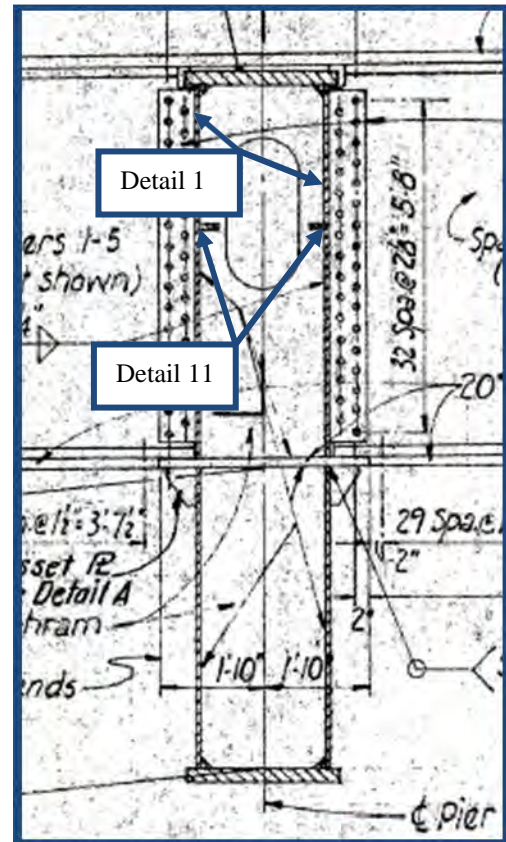
Figure 9: Section of Pier Cap 6

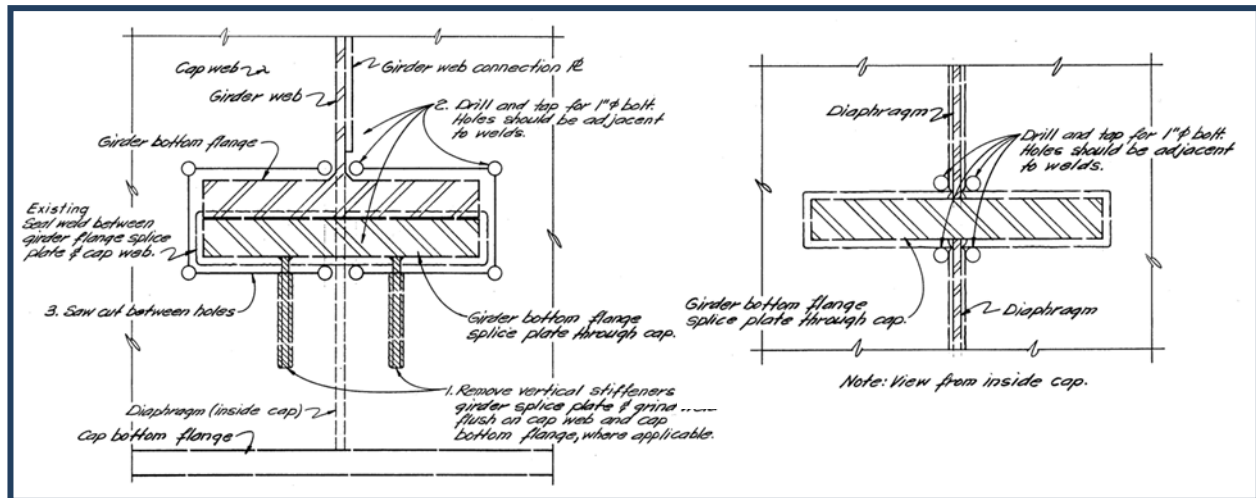
Figure 11: Web plate retrofit details from rehabilitation plans

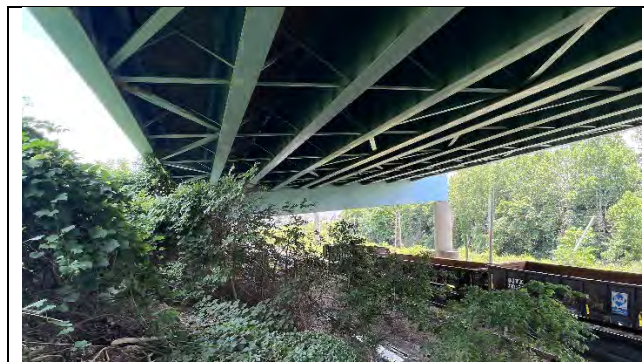
Photograph 37: General Elevation of Pier Cap 7, Looking East.

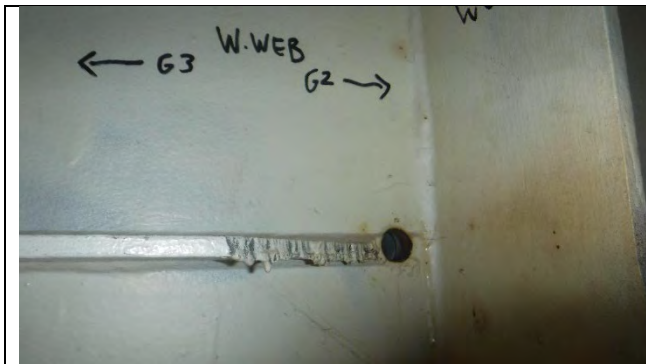
Photograph 38: Typical Longitudinal Stiffener Retrofit Detail.

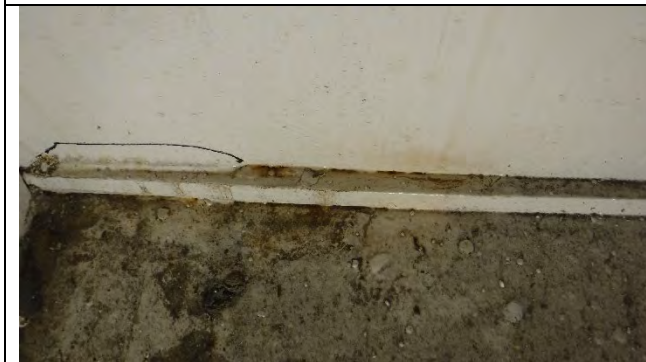
Photograph 40: Corrosion Has Reactivated Between Backer Bar and East Web Near Welds, Looking West.

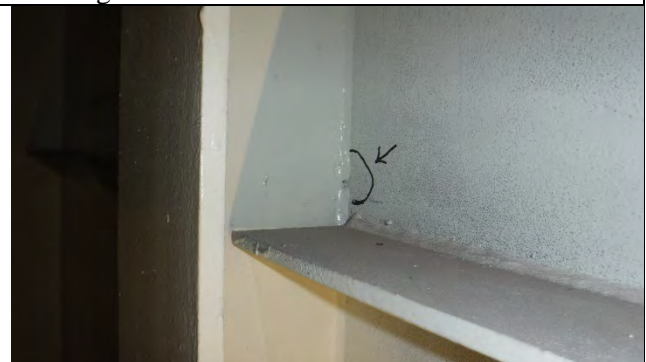
Photograph 41: 1.25 in. Discontinuity in the Transverse Stiffener Weld on West Web Between Girders 7 and 8, Looking East.

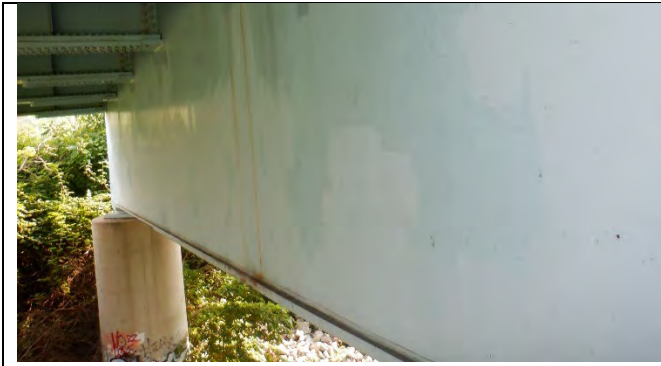
Photograph 42: Typical Pier 7 Paint Condition.

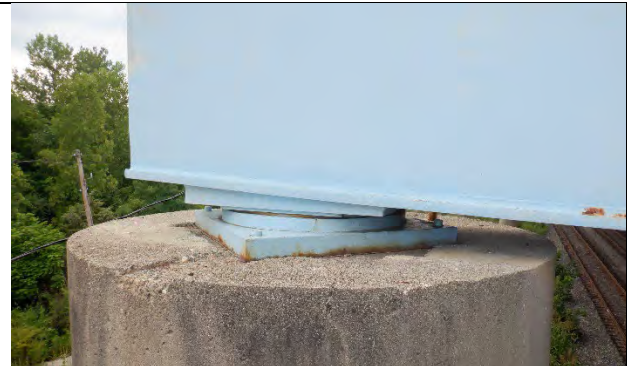
Photograph 43: South Bearing Masonry Plate Corrosion, Looking West.

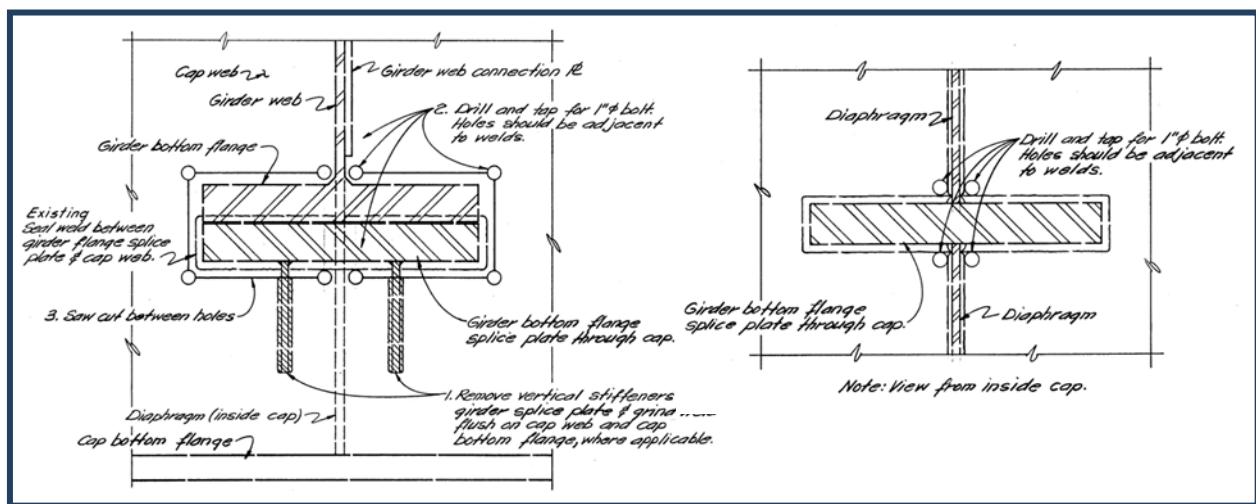
Figure 14: Web plate retrofit details from rehabilitation plans

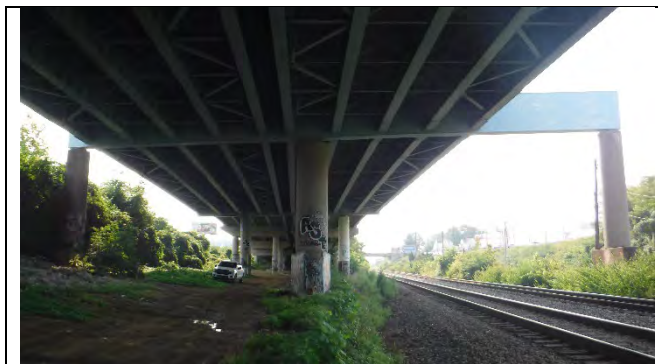
Photograph 44: General Elevation of Pier Cap 8, Looking East.

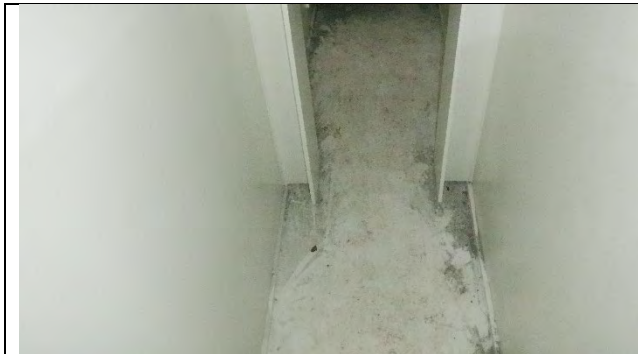
Photograph 45: Typical Bottom Flange Paint Condition.

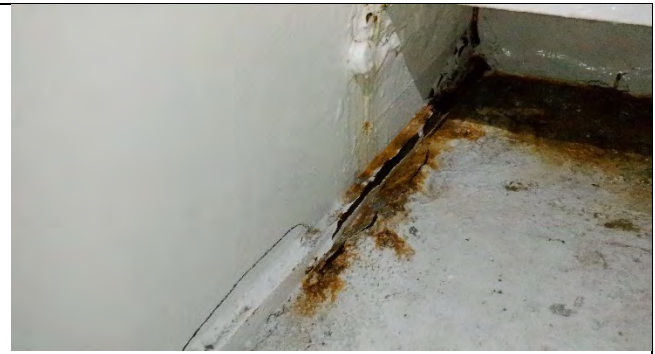
Photograph 46: Rust Staining from Retrofit Holes at Girder 10.

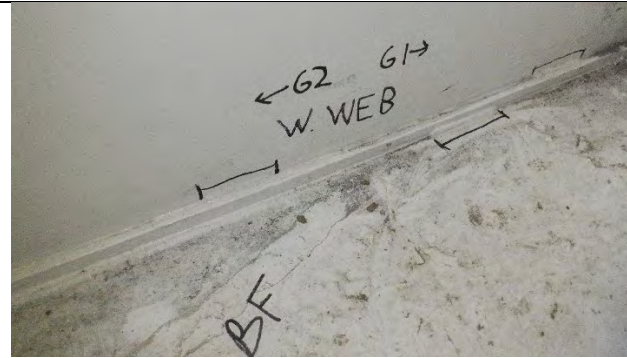
Photograph 48: Tack Welds in the West Web Between Girders 1 and 2, Looking East.

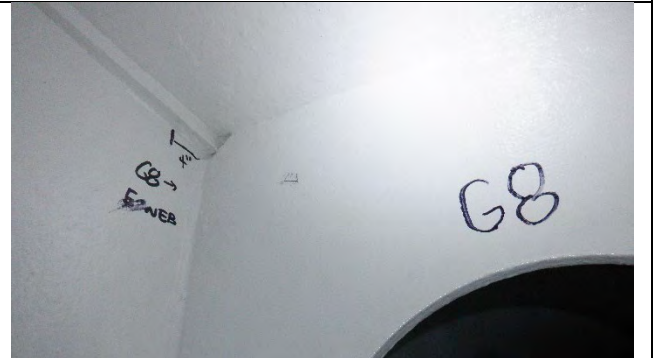
Photograph 49: Weld Extending Through Web Cope at Girder 8, Looking Southeast.

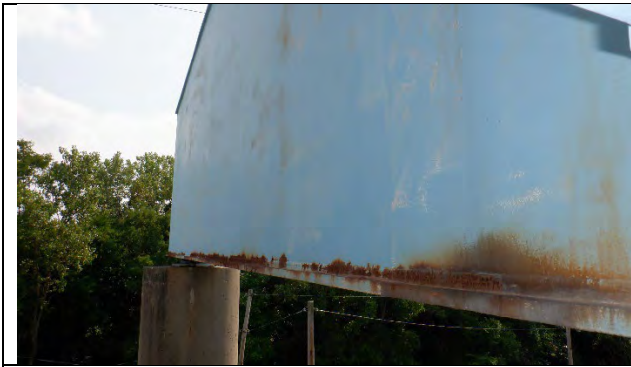
Photograph 49: Surface Corrosion with No Section Loss Along the Lower Corner of the Cap on the East Face, Looking Southwest.

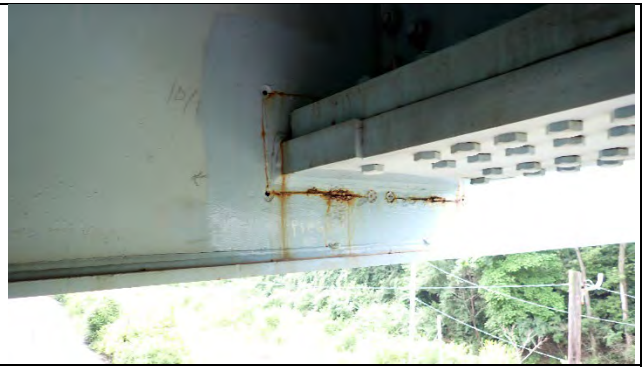
Photograph 50: Reactivated Corrosion at Girder 10, Looking Southeast. No Change Since the Last Inspection.

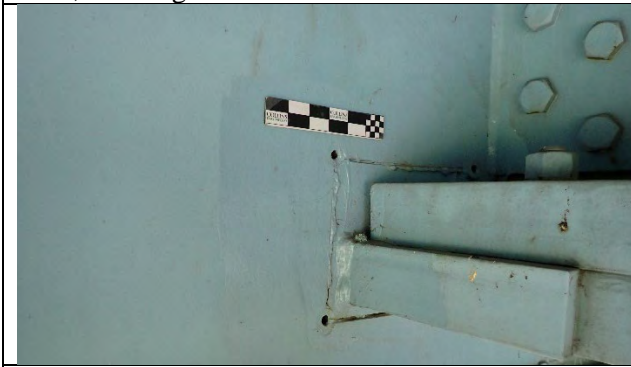
Photograph 51: No Change to 1/16 in. Bow/Indentation Previously Observed, Looking Northwest.

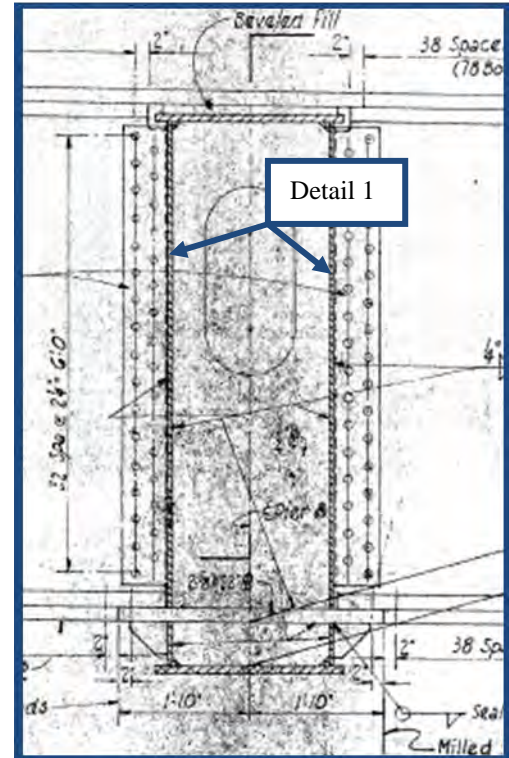
Figure 15: Section of Pier Cap 8

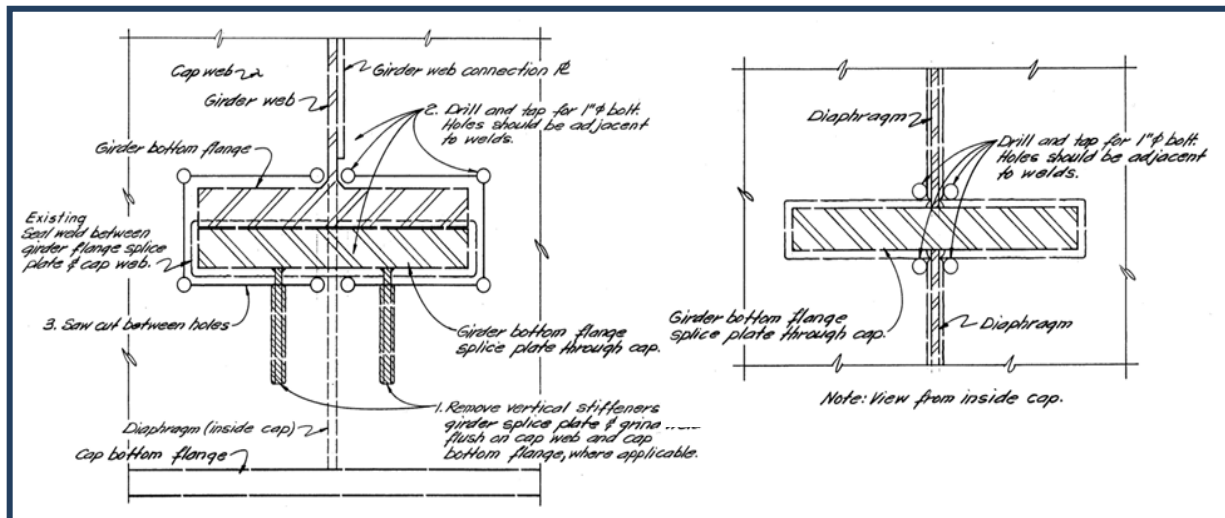
Figure 17: Web plate retrofit details from rehabilitation plans

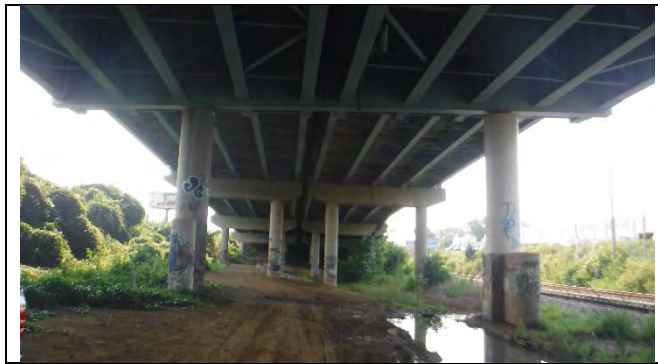
Photograph 52: General Elevation of Pier Cap 9, Looking East.

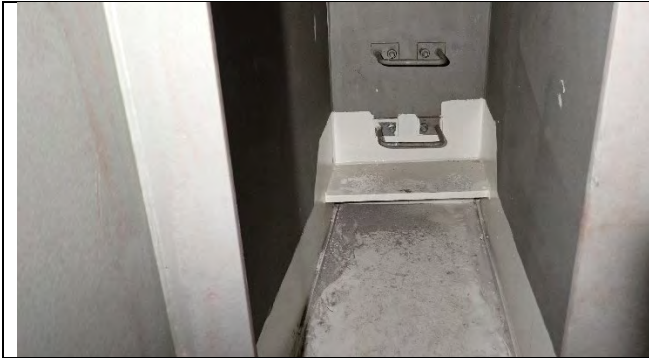
Photograph 53: Typical Interior Condition of Pier Cap 9, Looking South.

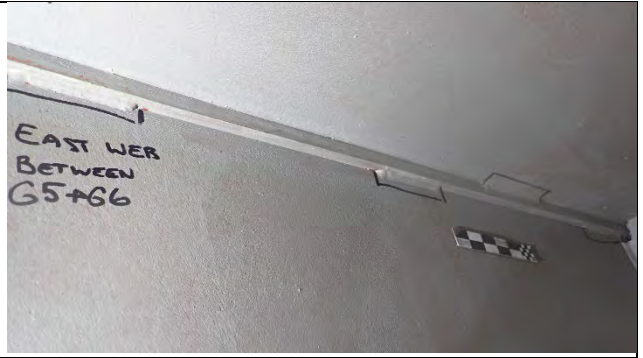
Photograph 54: Typical Fillet Welds Along Backer Bar Between Girders 5 and 6, Looking Southeast.

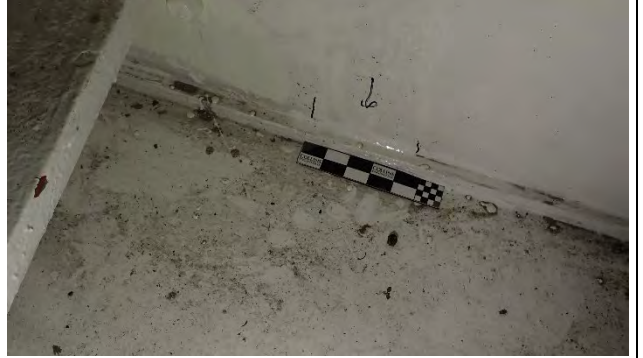
Photograph 56: Newly Observed 4.5 in. Fillet Weld Along the Lower Corner of Diaphragm 6, Looking East.

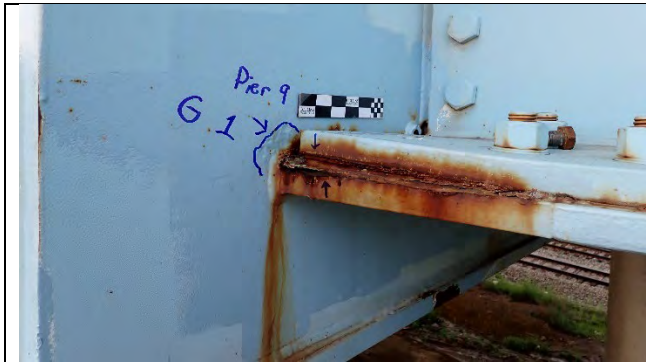
Photograph 57: Pack Rust Up To 1/2 in. Between Girder and Tie Plate and Painted Over Pitting to 1/16 in. on Cap Web, Looking Southeast.

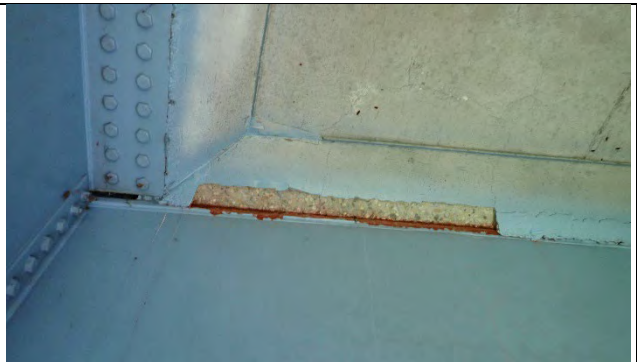
Photograph 58: No Change to Spall Along Haunch, Looking East.

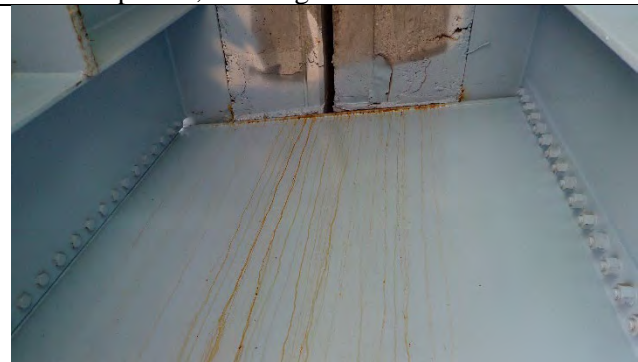
Photograph 59: View of Surface Corrosion on Top Flange Plate Edge and Rust Staining on Cap Web Plate, Looking West.

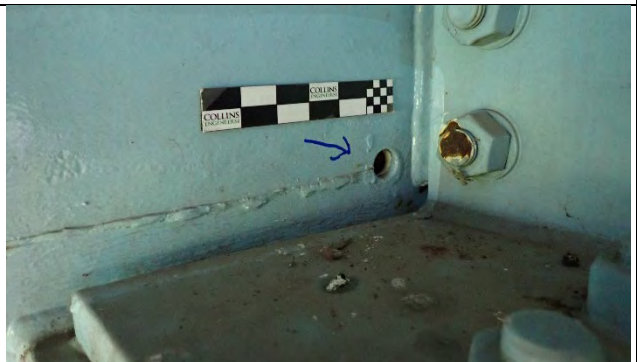
Photograph 60: Typical Example of Missing Expansion Plugs, Looking East.

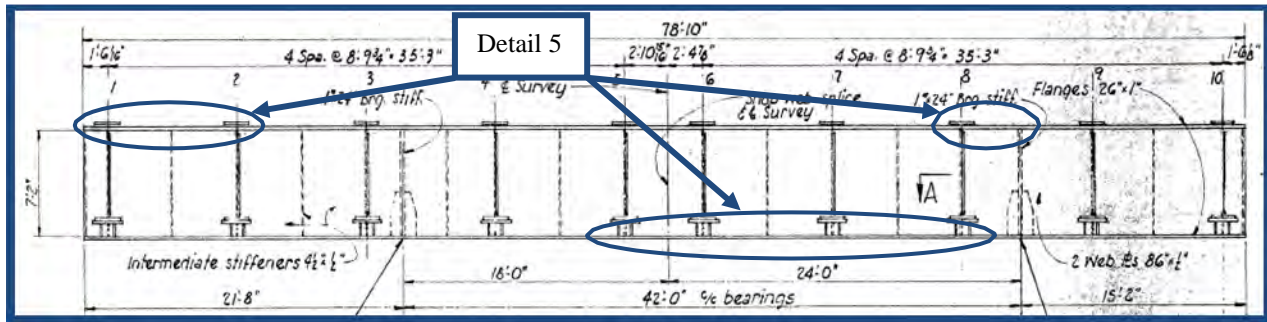
Figure 19: Elevation of Pier Cap 9

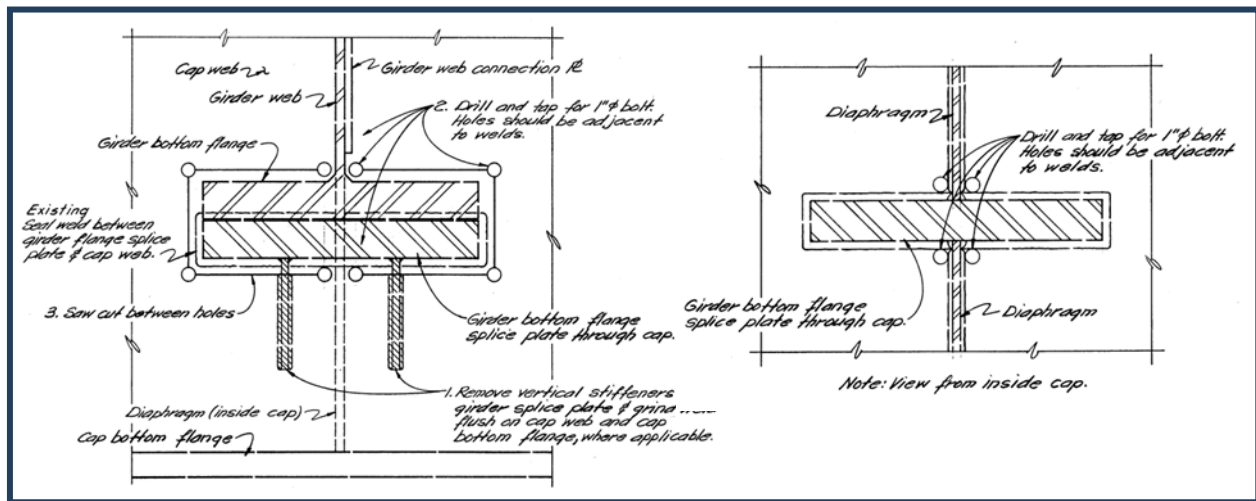
Figure 20: Web plate retrofit details from rehabilitation plans
