# FRACTURE CRITICAL PIER CAP INSPECTION REPORT

SFN3113914 (HAM-562-0147)  
SR-562 OVER ROSS AVENUE AND  
INDIANA & OHIO RAILWAY  
HAMILTON COUNTY, OH  
DISTRICT 8

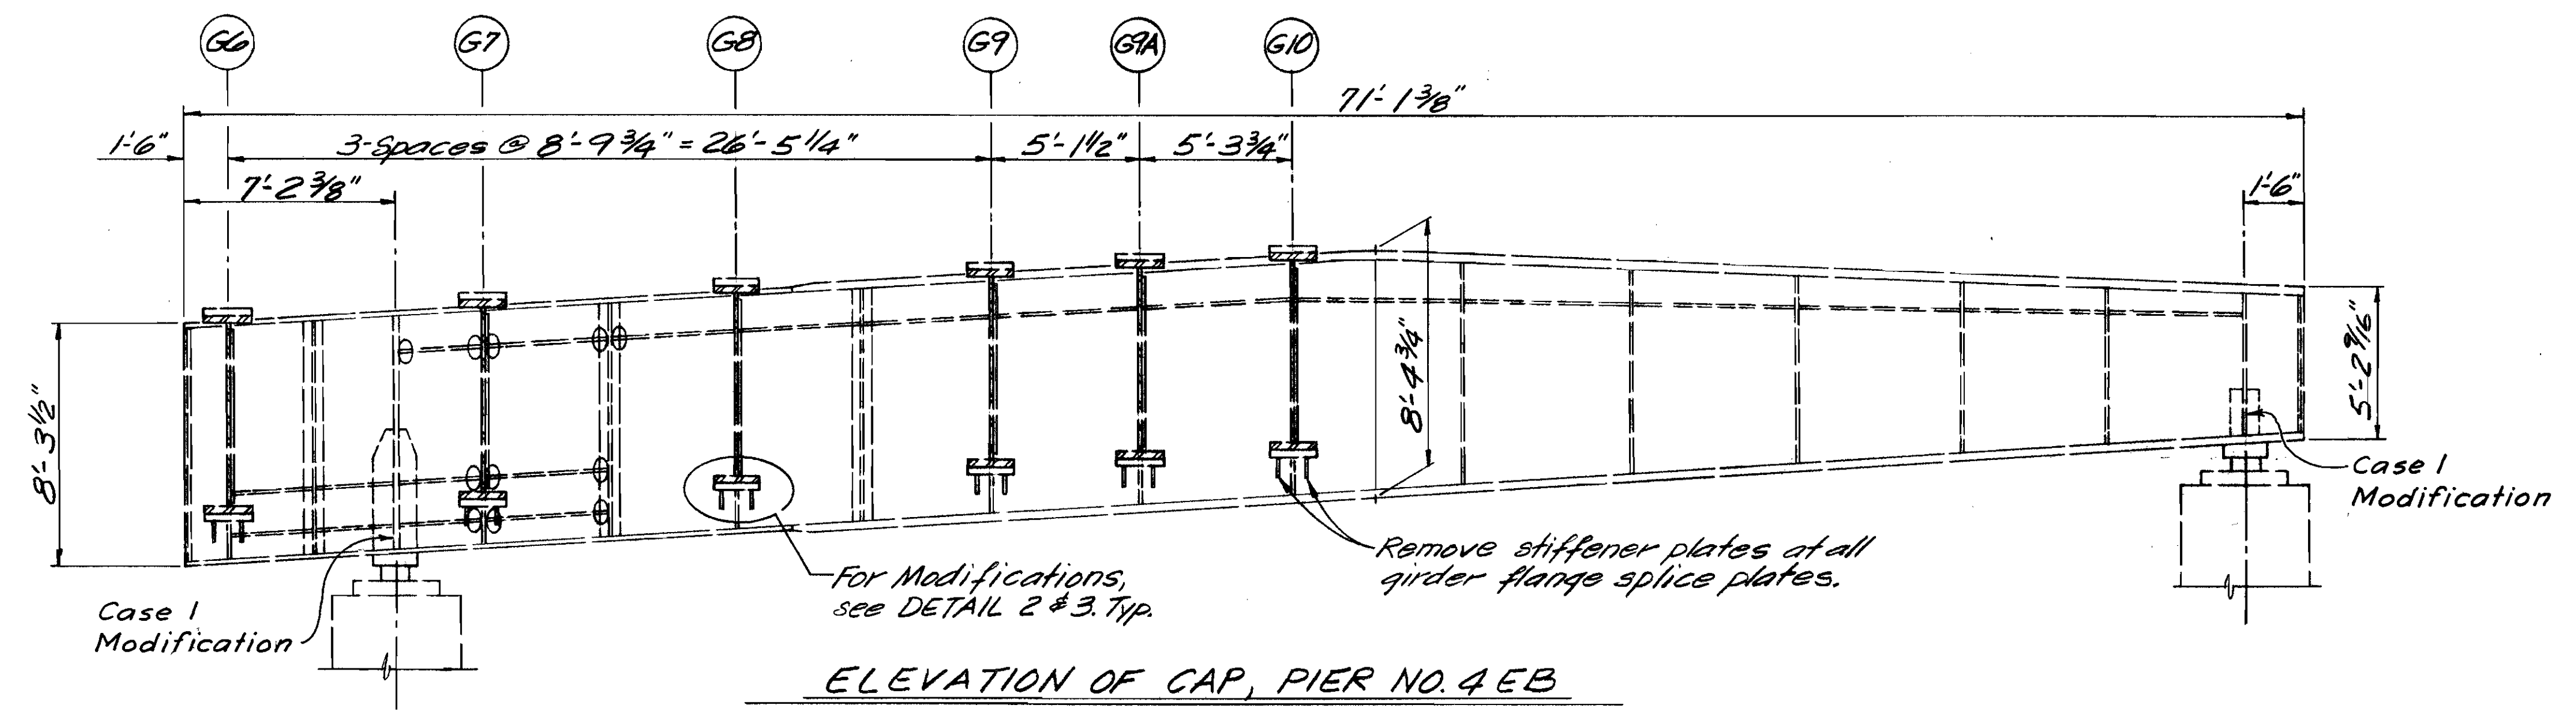
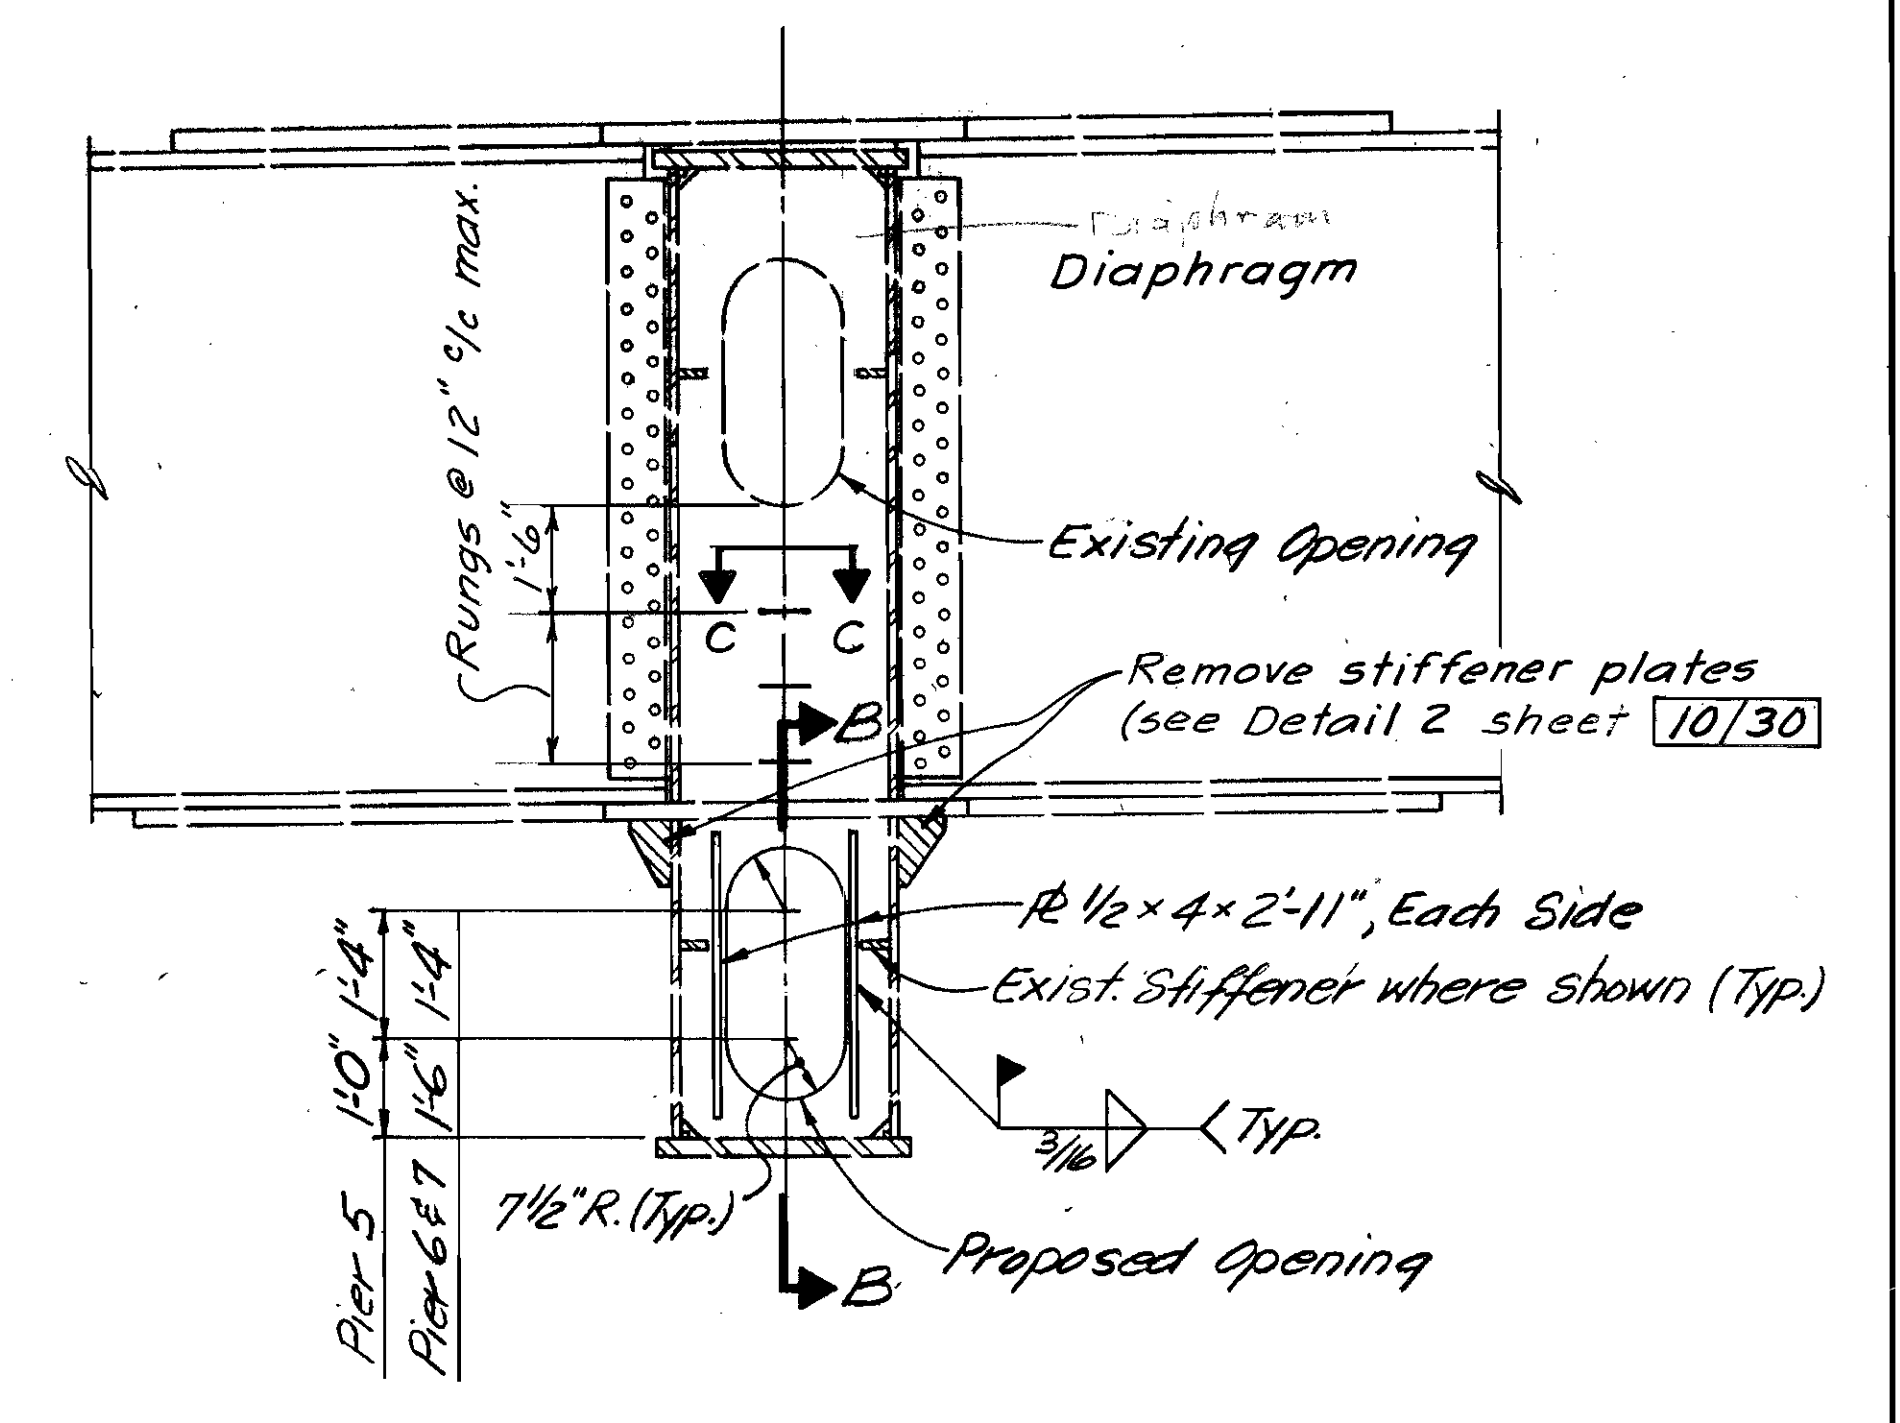
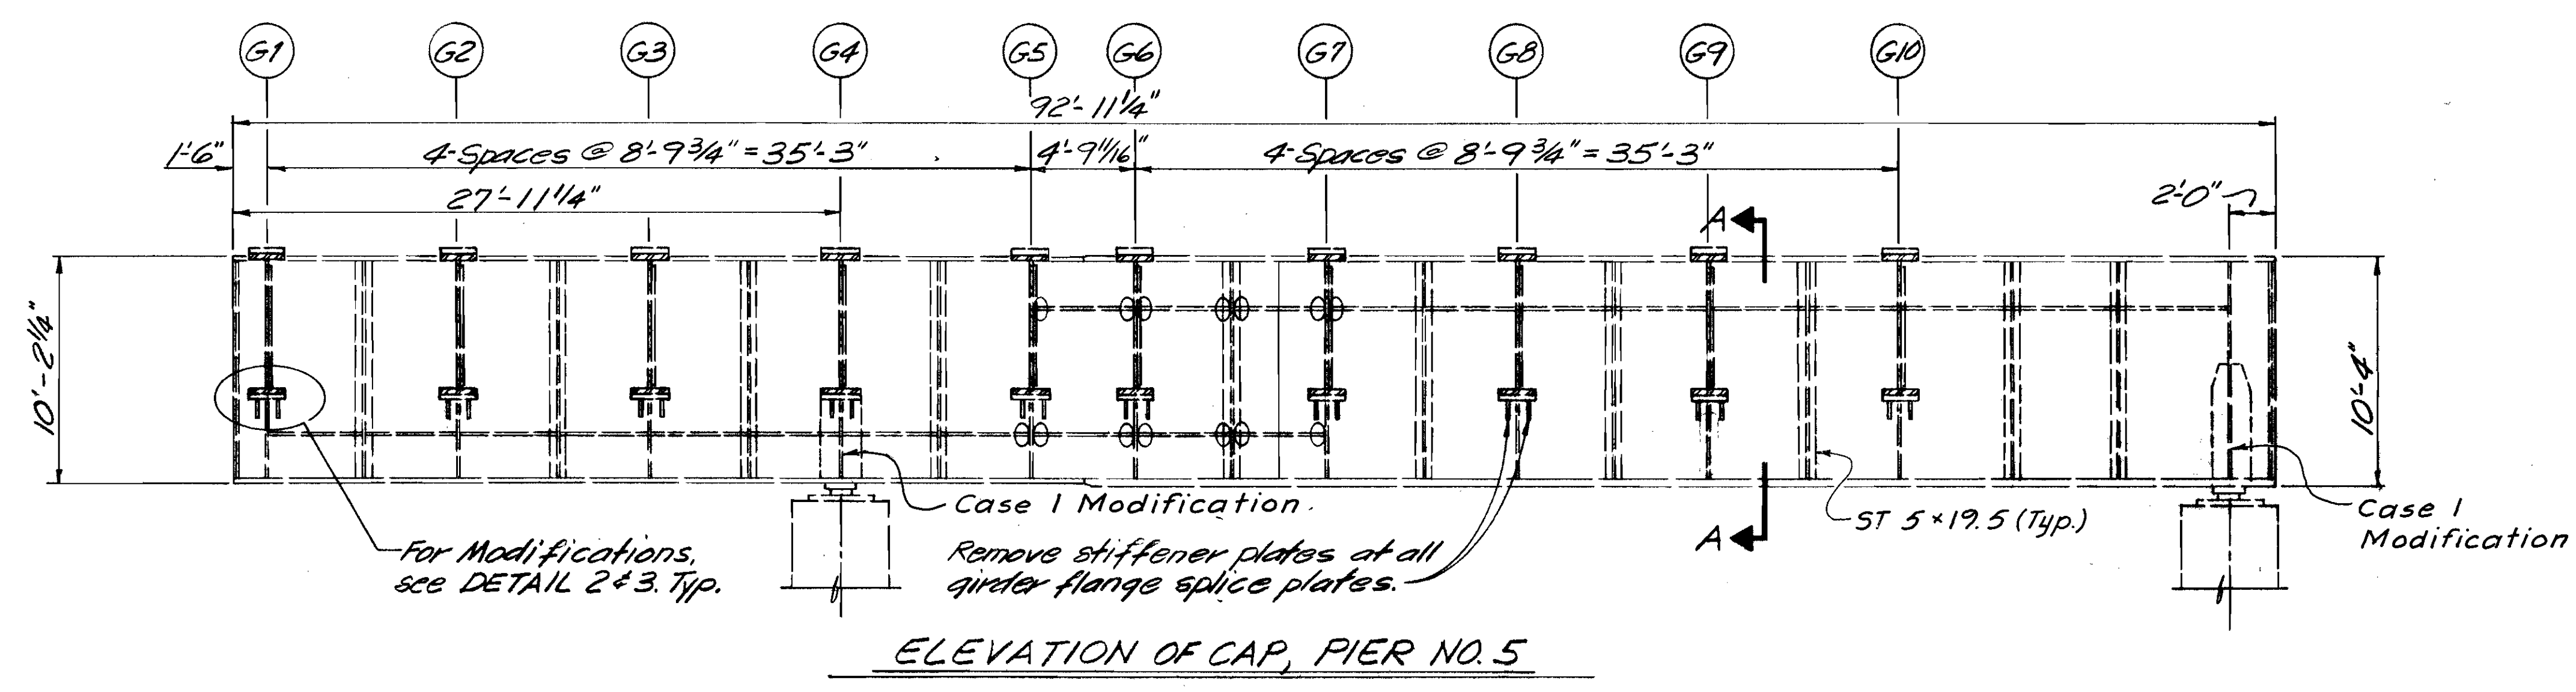
**SECTION A-A**  
TYPICAL AS NOTED  
Pier No. 5: G2, G3, G5 thru G10  
Pier No. 6: G2 thru G10  
Pier No. 7: G2 thru G10

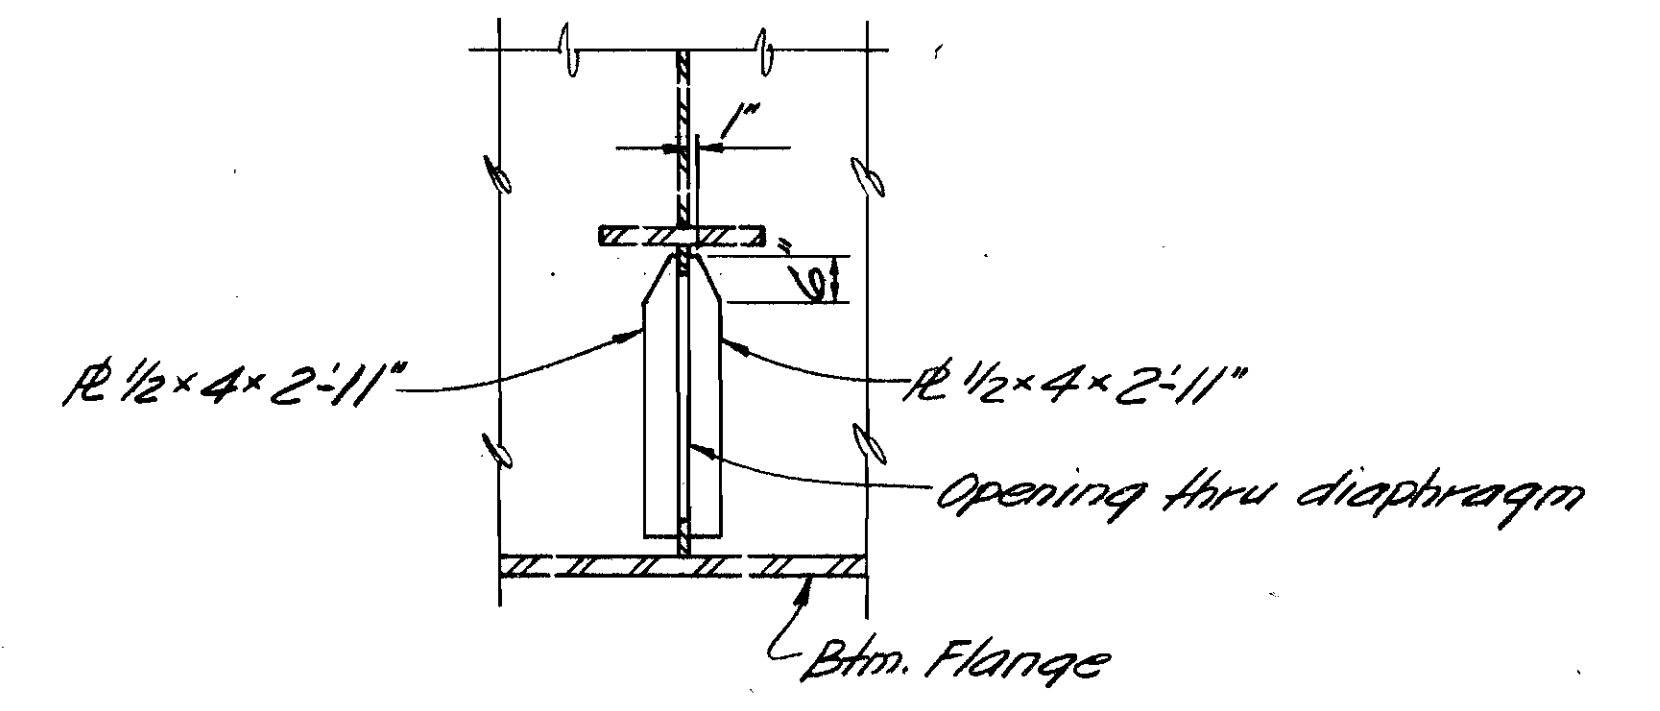
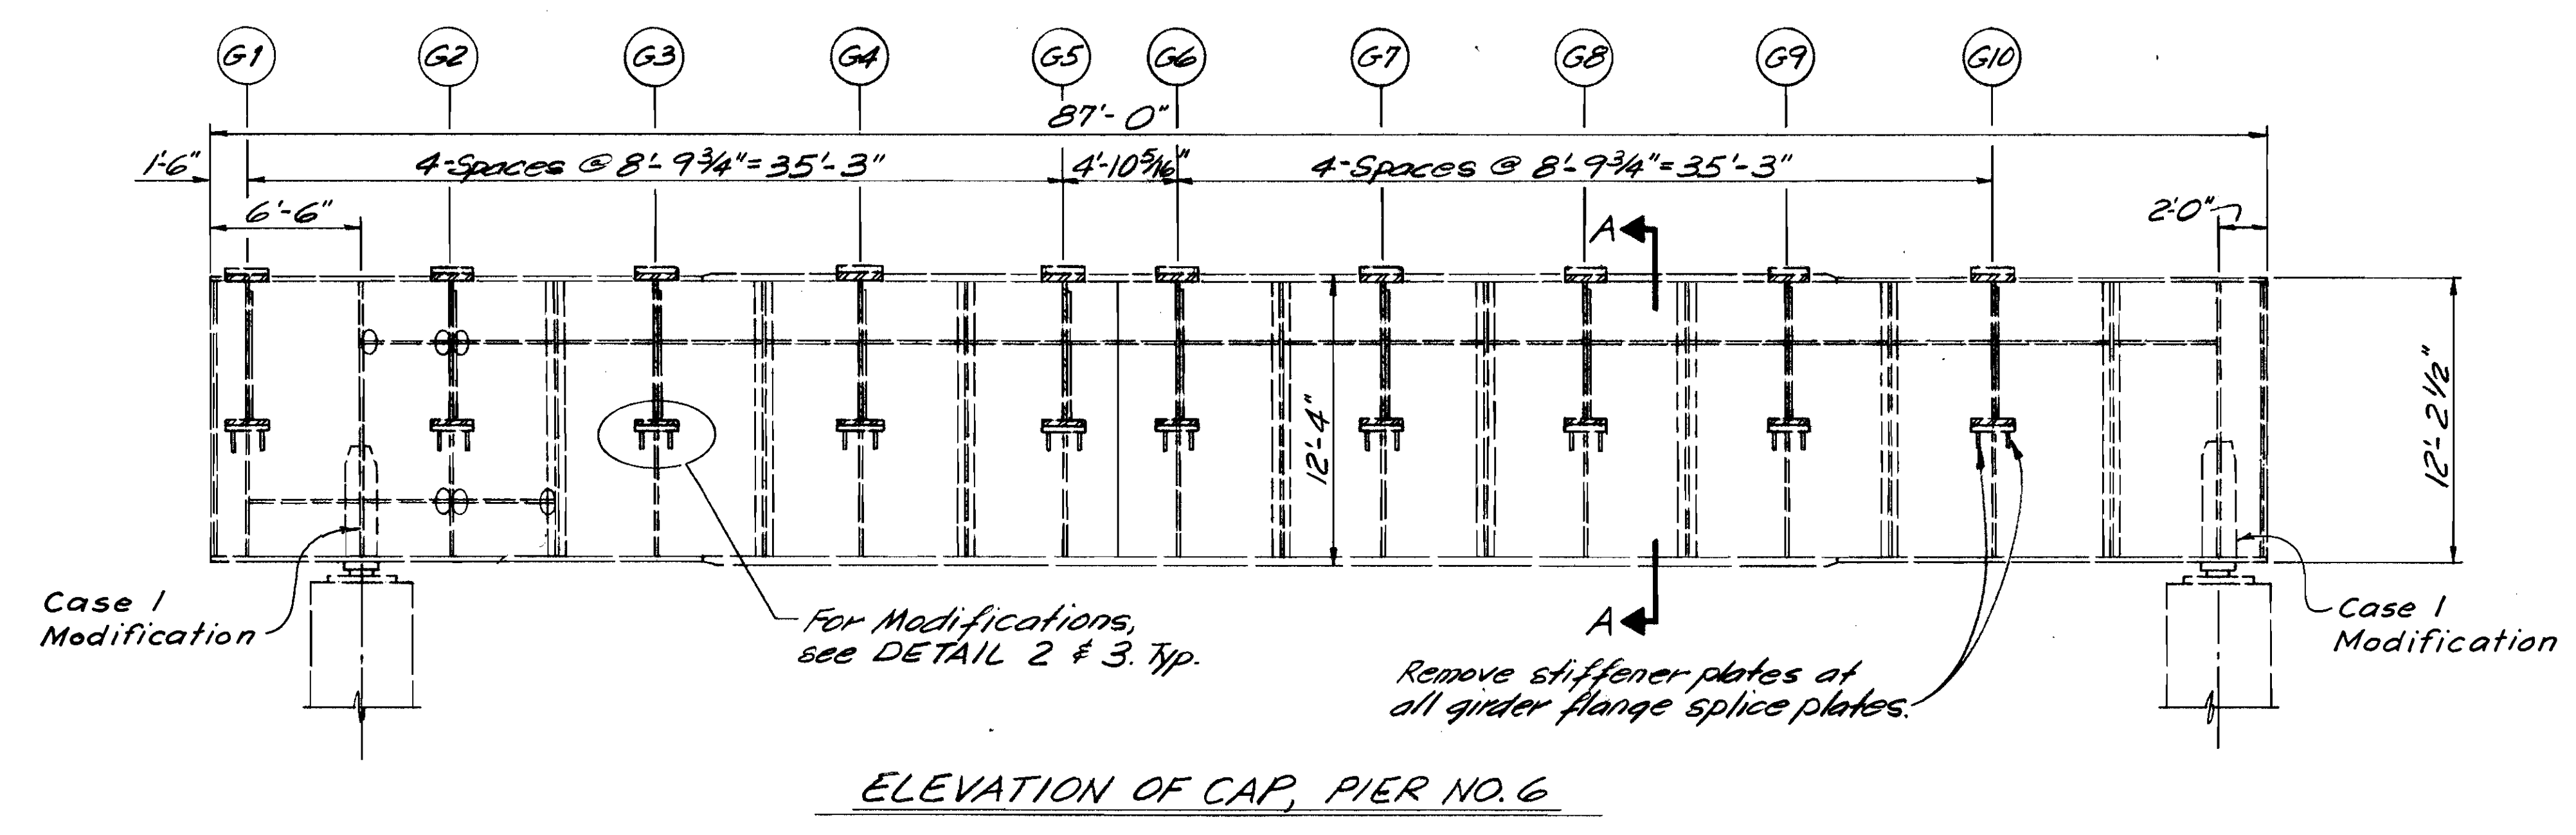
**NOTES:**  
Unless noted otherwise, all diaphragm shall be modified per Case 2 detail as shown on sheet 10/30.  
For Case 1 modification see sht. 10/30.  
O denotes location of longitudinal stiffener retrofits. See DETAIL 1 on Sheet 9/30.  
For DETAIL 2 & 3, see sht. 10/30.  
For SECTION C-C see sht. 10/30.

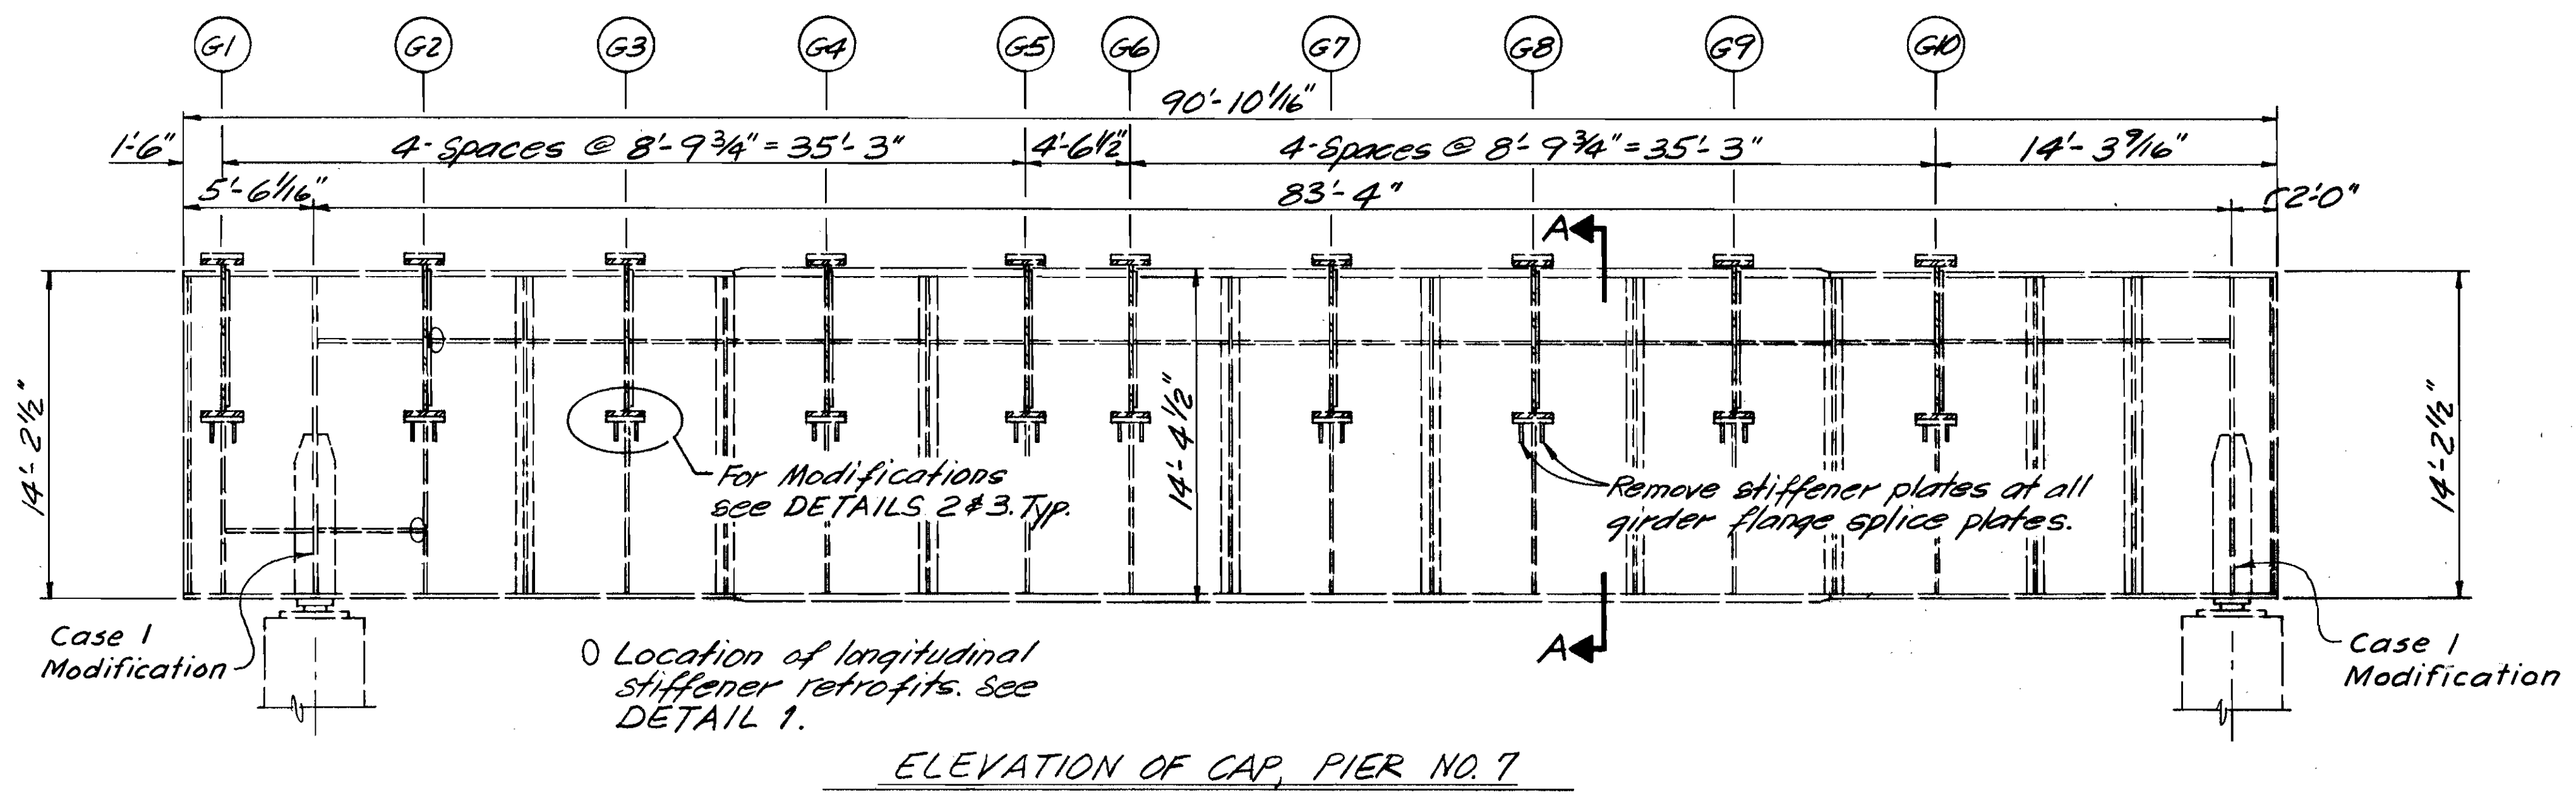
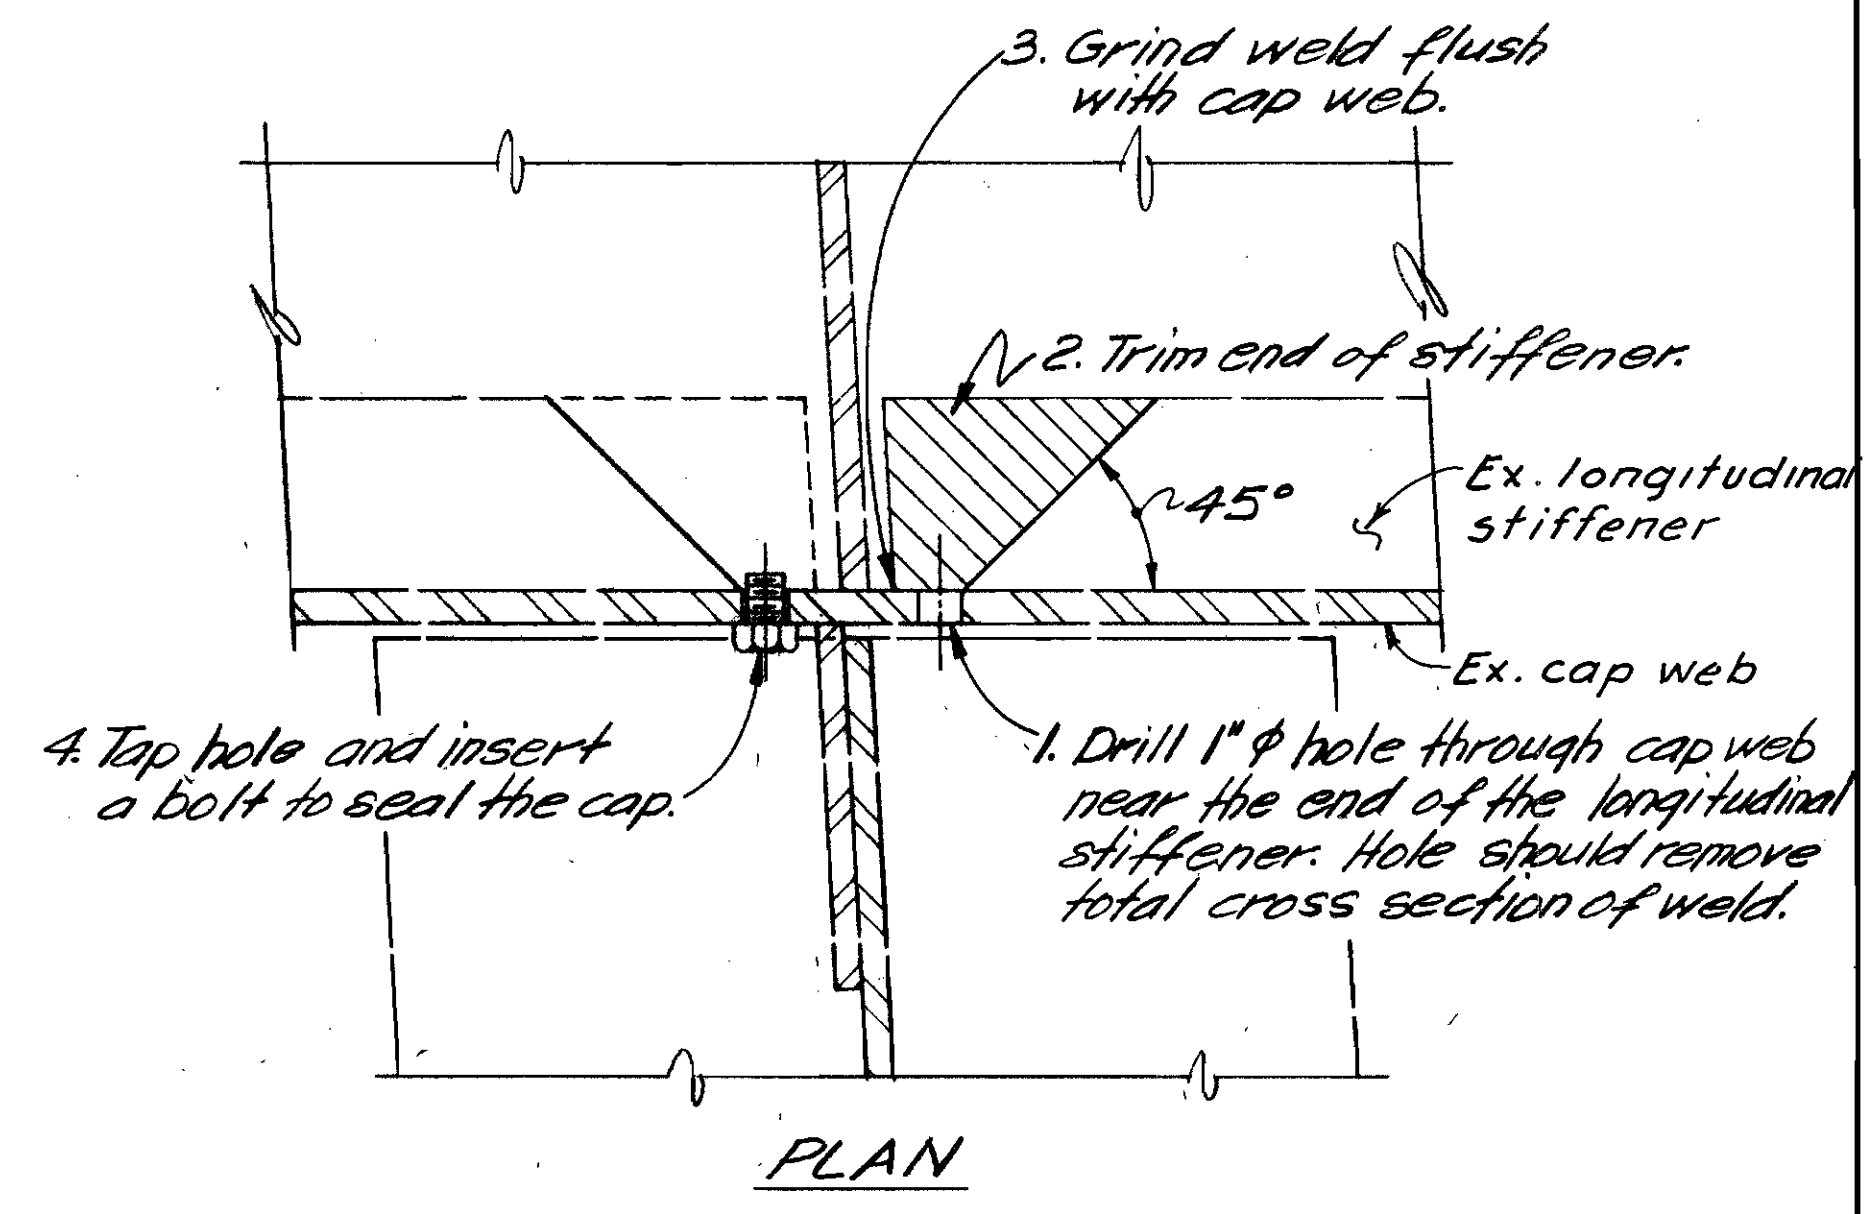
Retrofit detail for termination of longitudinal stiffener in tension zone of cap.

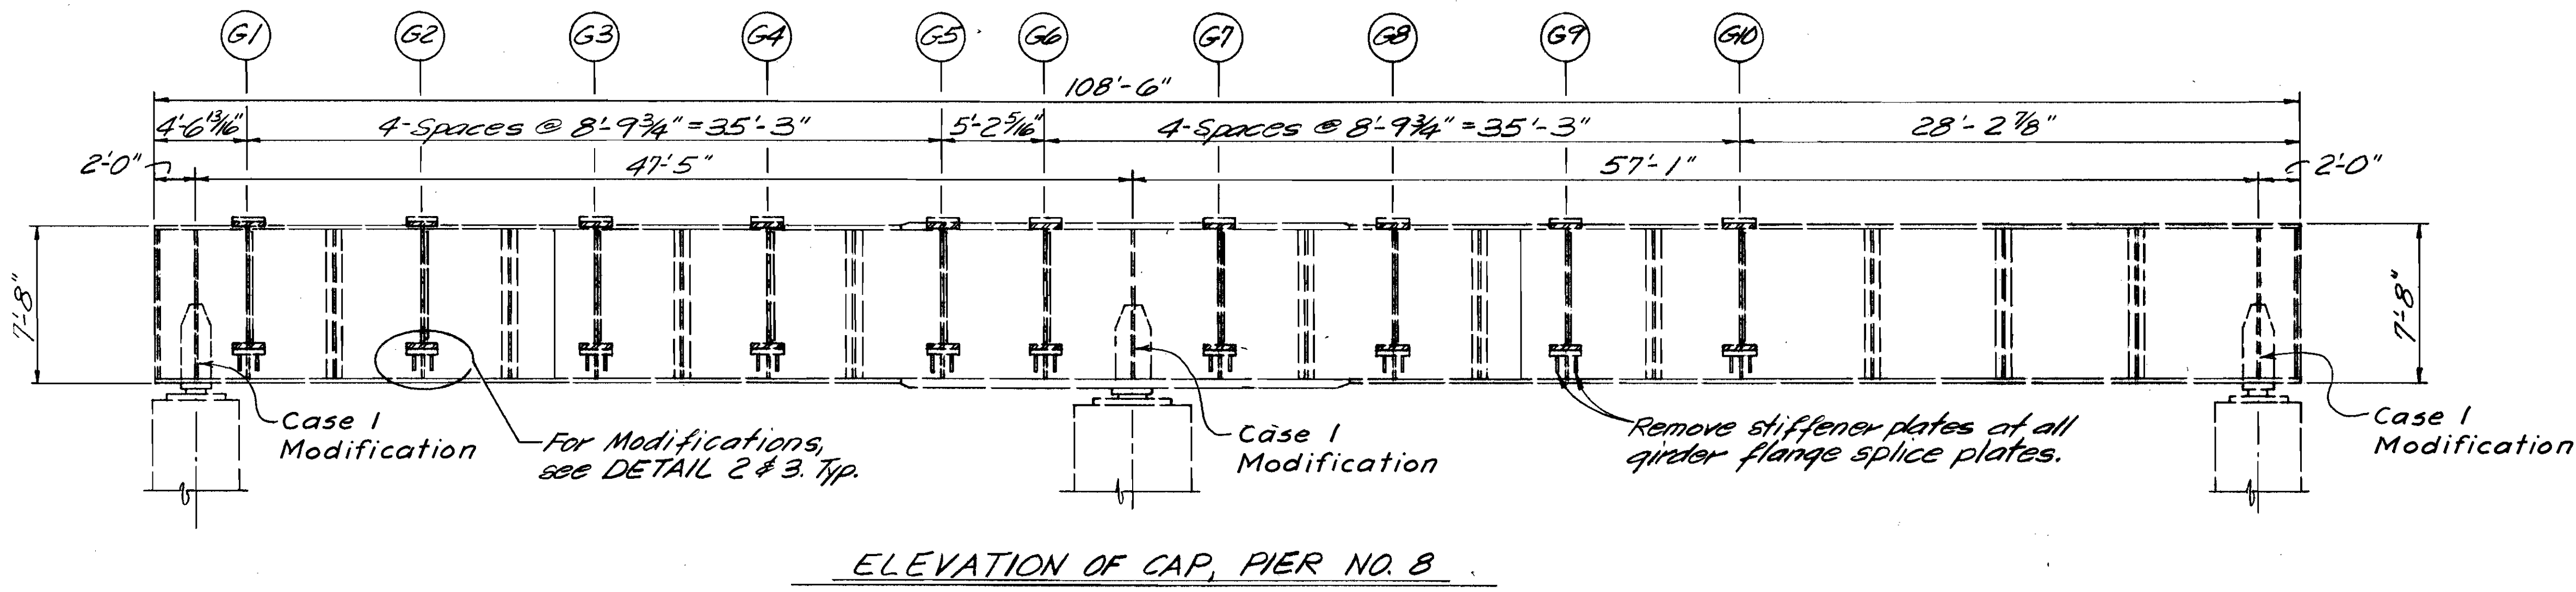
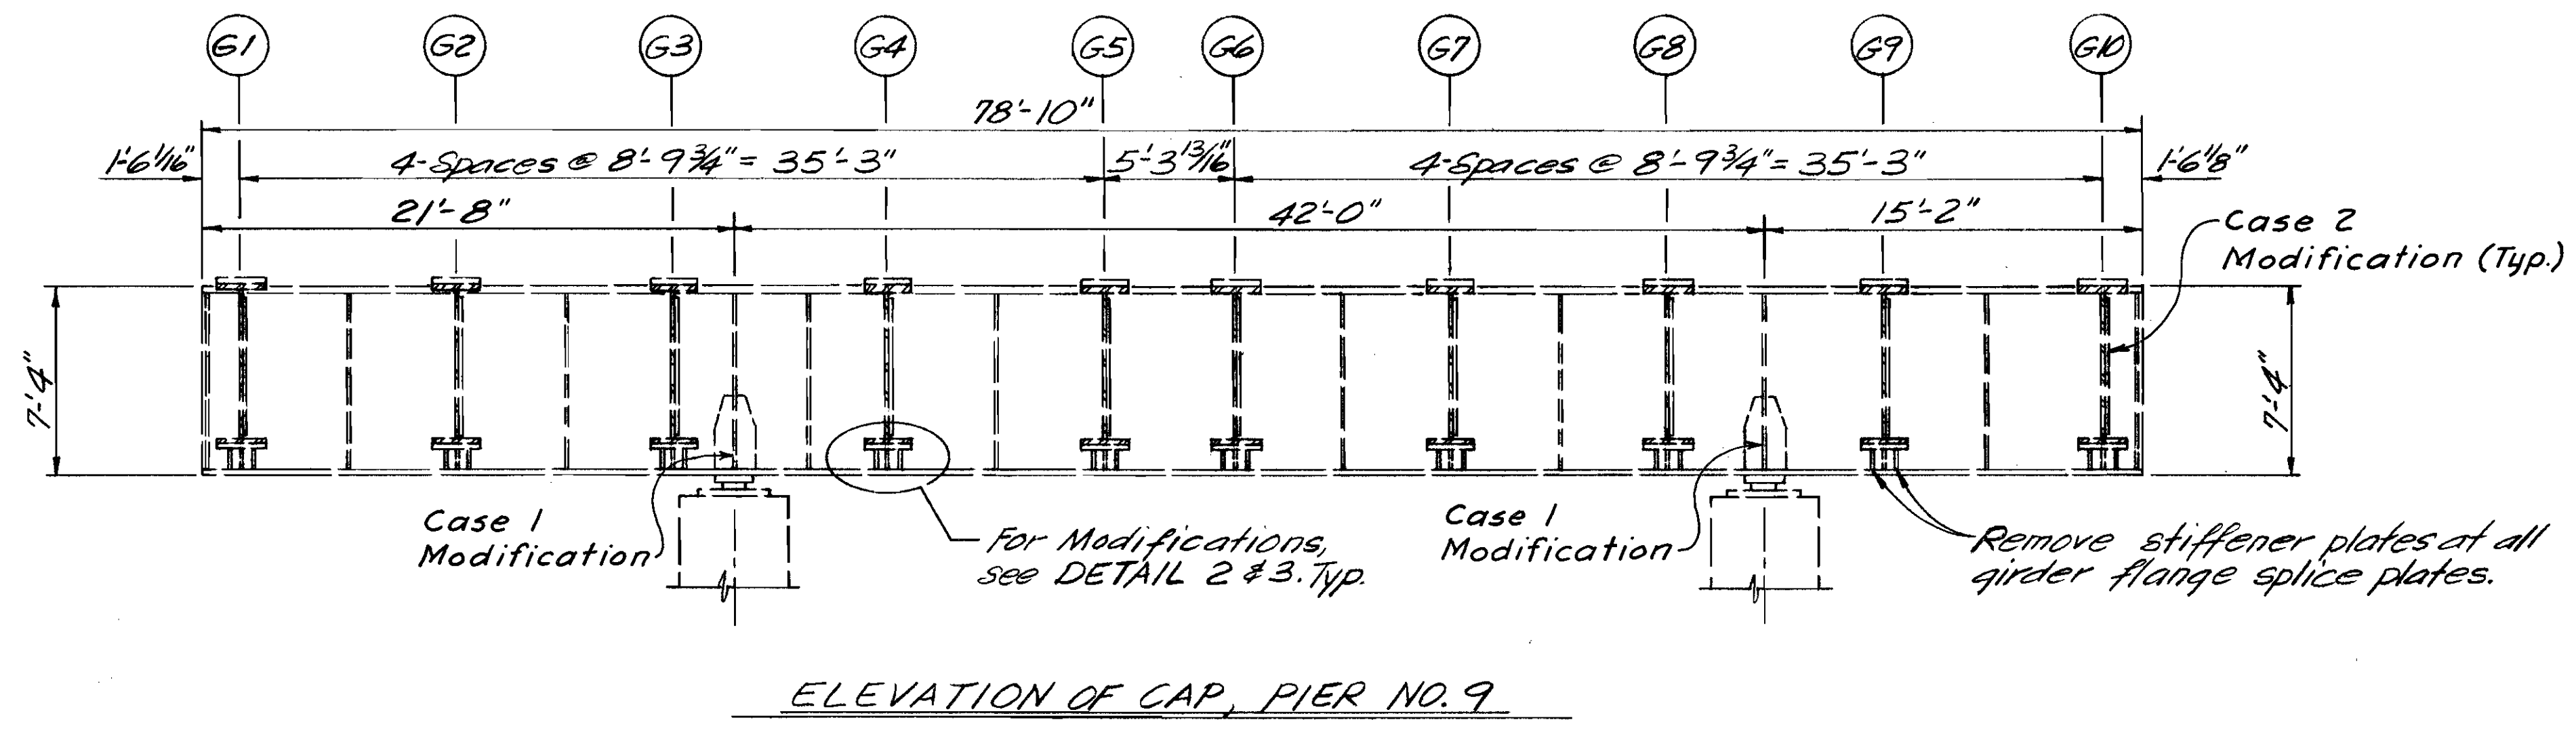
NOTES  
 Unless noted otherwise, all diaphragms shall be modified per Case 2 detail as shown on sheet 10/30  
 For Case 1 modification see sheet 10/30  
 For SECTION A-A see sheet 8/30  
 For DETAIL 2 & 3 see sheet 10/30

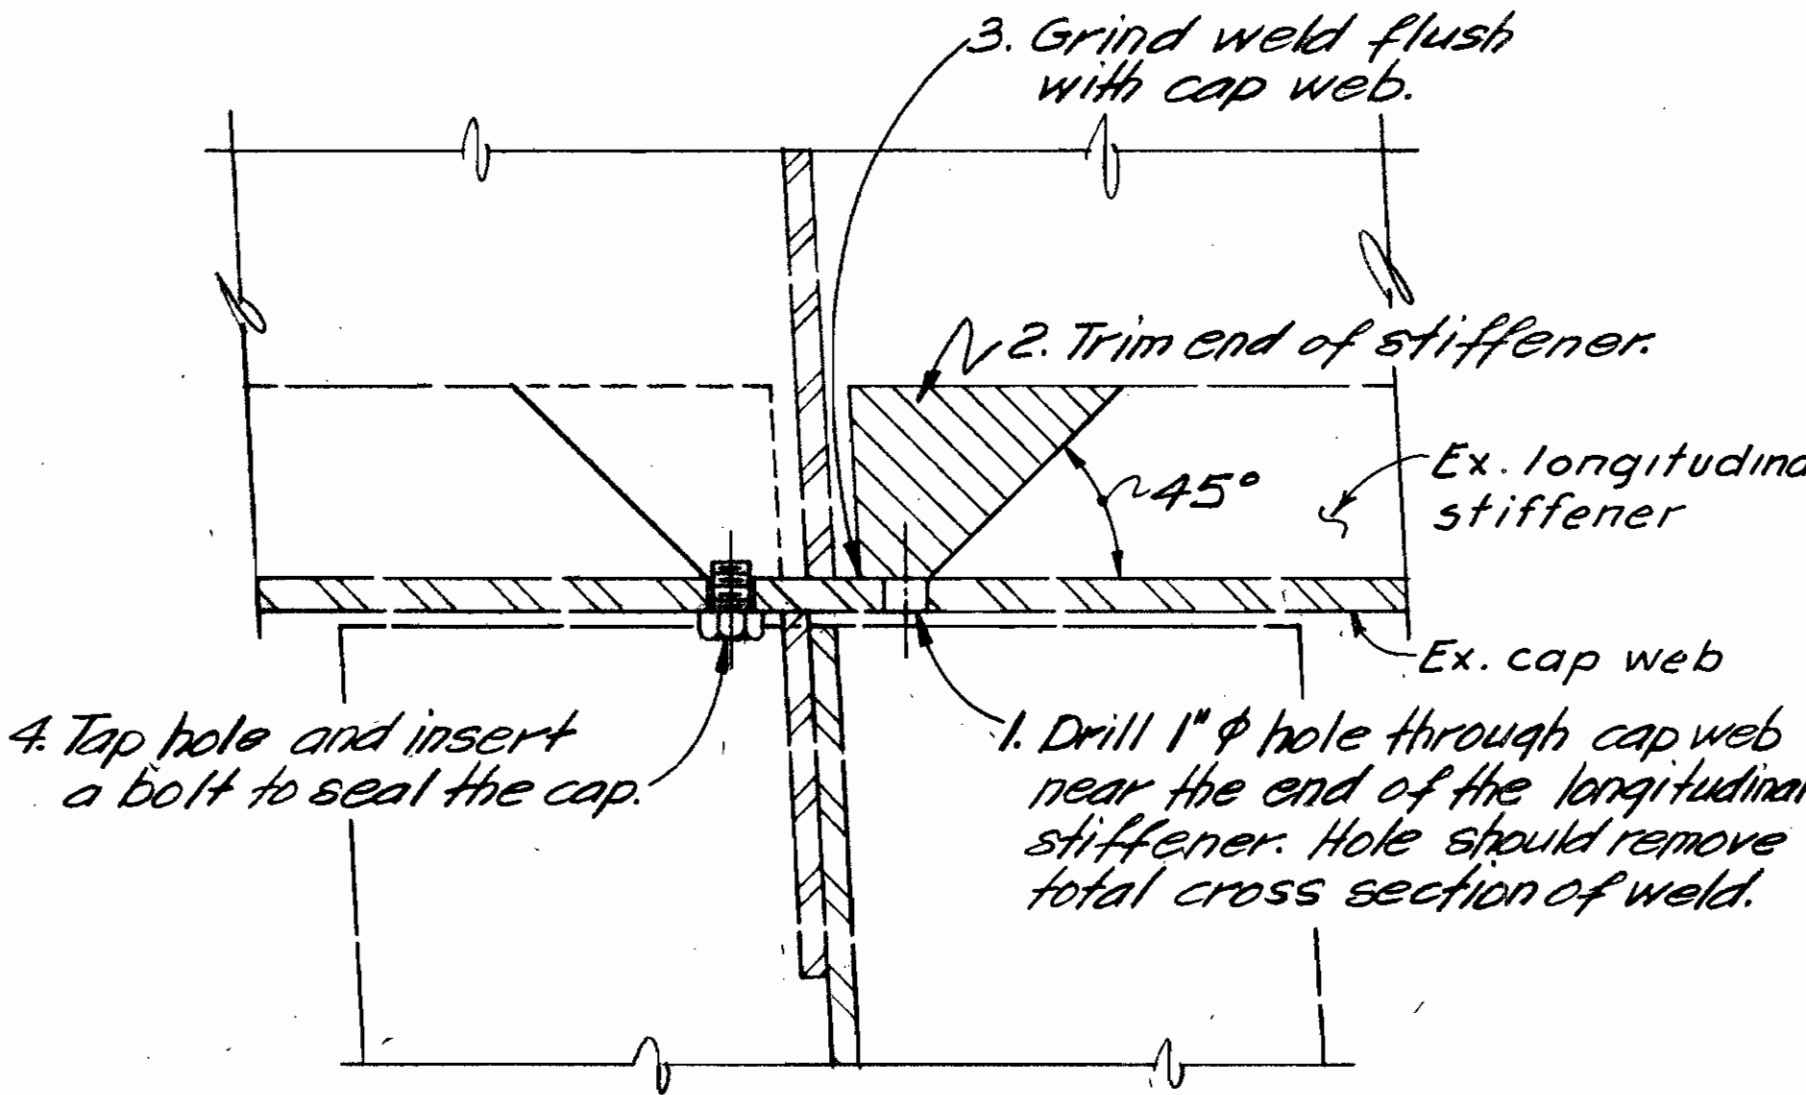
BALKE ENGINEERS					9/30
1848 SUMMIT RD.					
CINCINNATI, OHIO 45237					
PIER CAP DETAILS					
BRIDGE NO. HAM-562-0147					
NORWOOD LATERAL OVER					
ROSS AVE. AND B. & O. R.R.					
DESIGNED	DRAWN	TRACED	CHECKED	REVIEWED DATE	REVISED
MRS	WJH	~	VDG	GRS 3/93
