# FRACTURE CRITICAL PIER CAP INSPECTION REPORT

SFN3113914 (HAM-562-0147)  
SR-562 OVER ROSS AVENUE AND  
INDIANA & OHIO RAILWAY  
HAMILTON COUNTY, OH  
DISTRICT 8

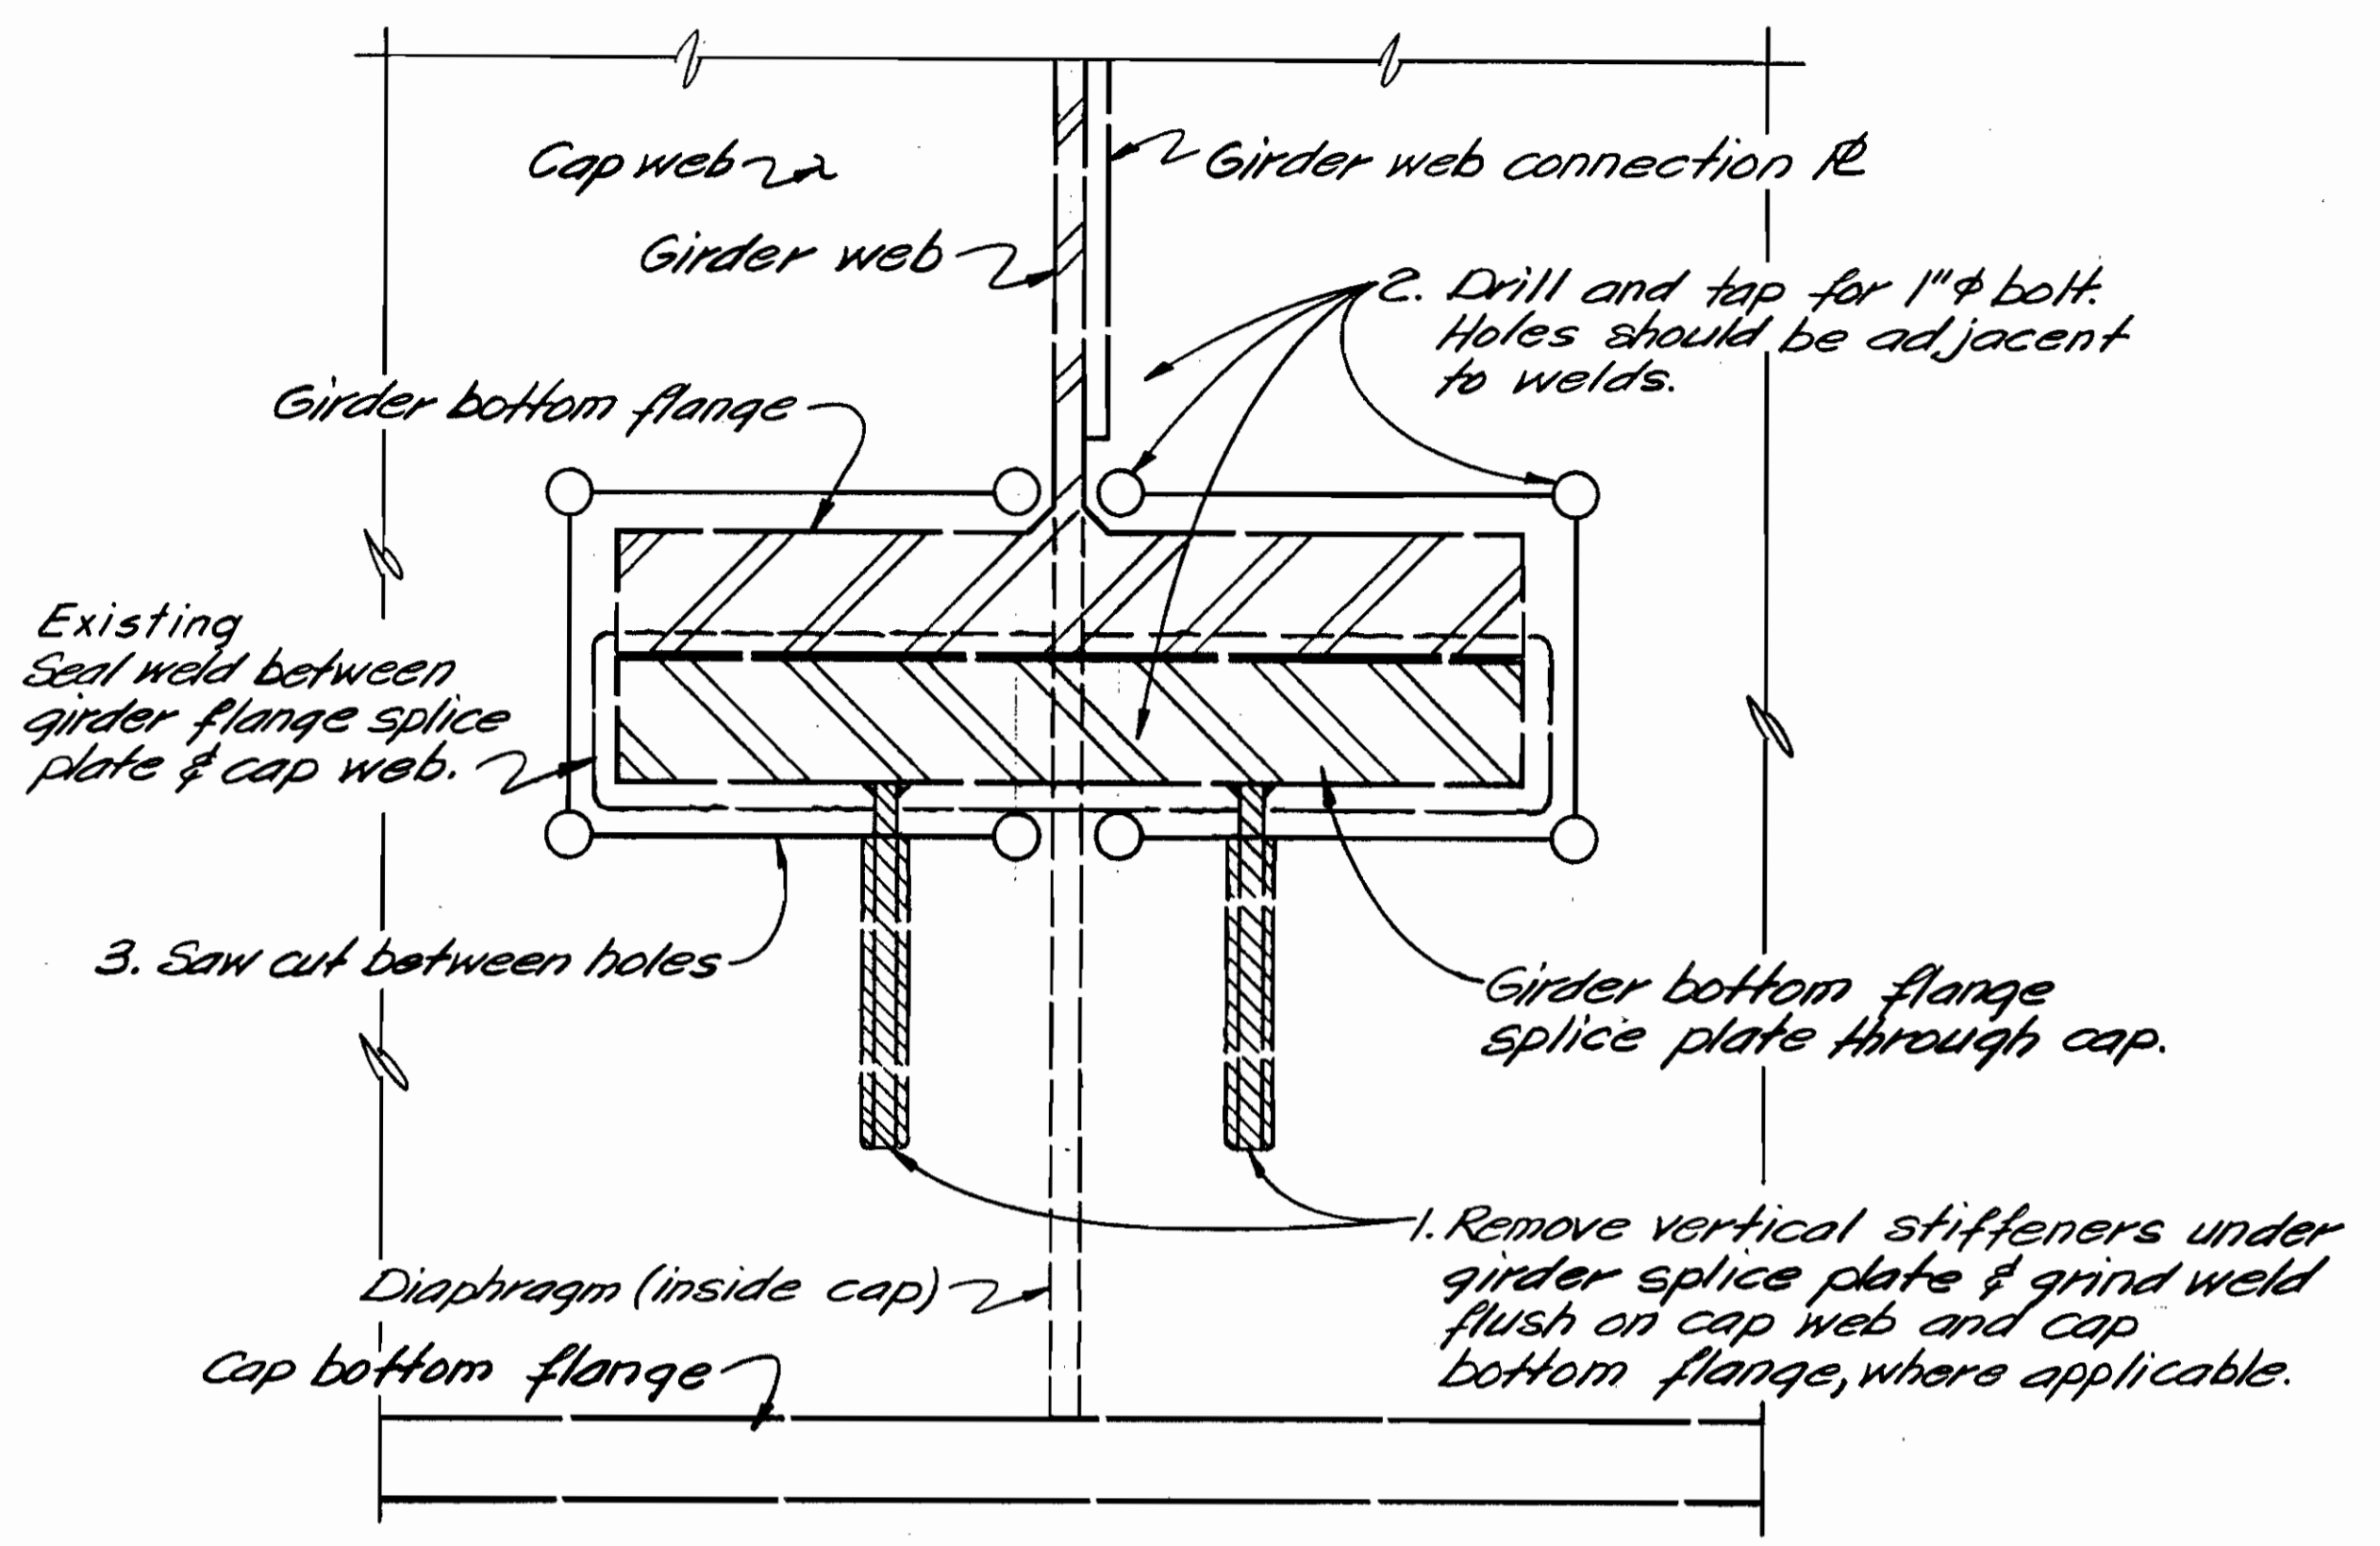
Retrofit detail for termination of longitudinal stiffener in tension zone of cap.

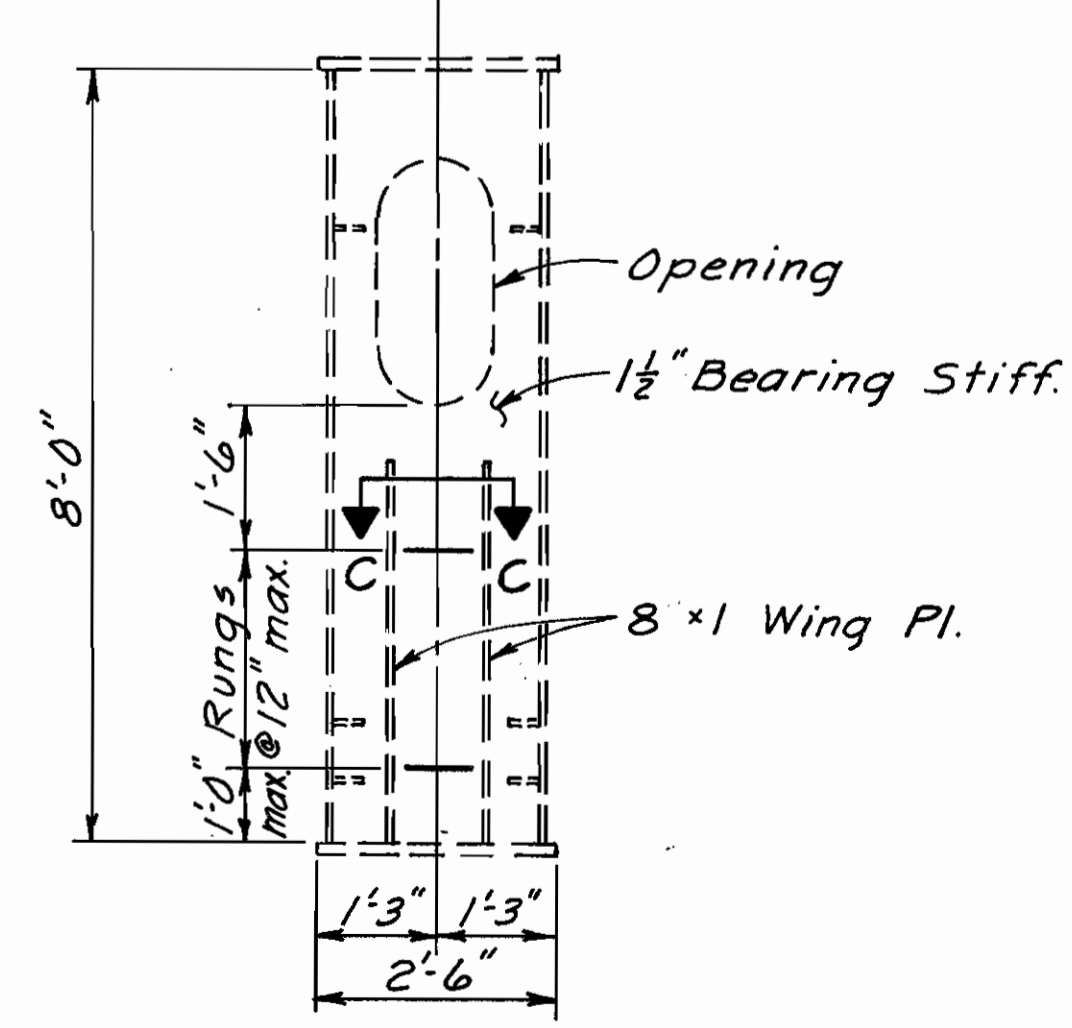
**CASE 1**  
Stiffener Modification

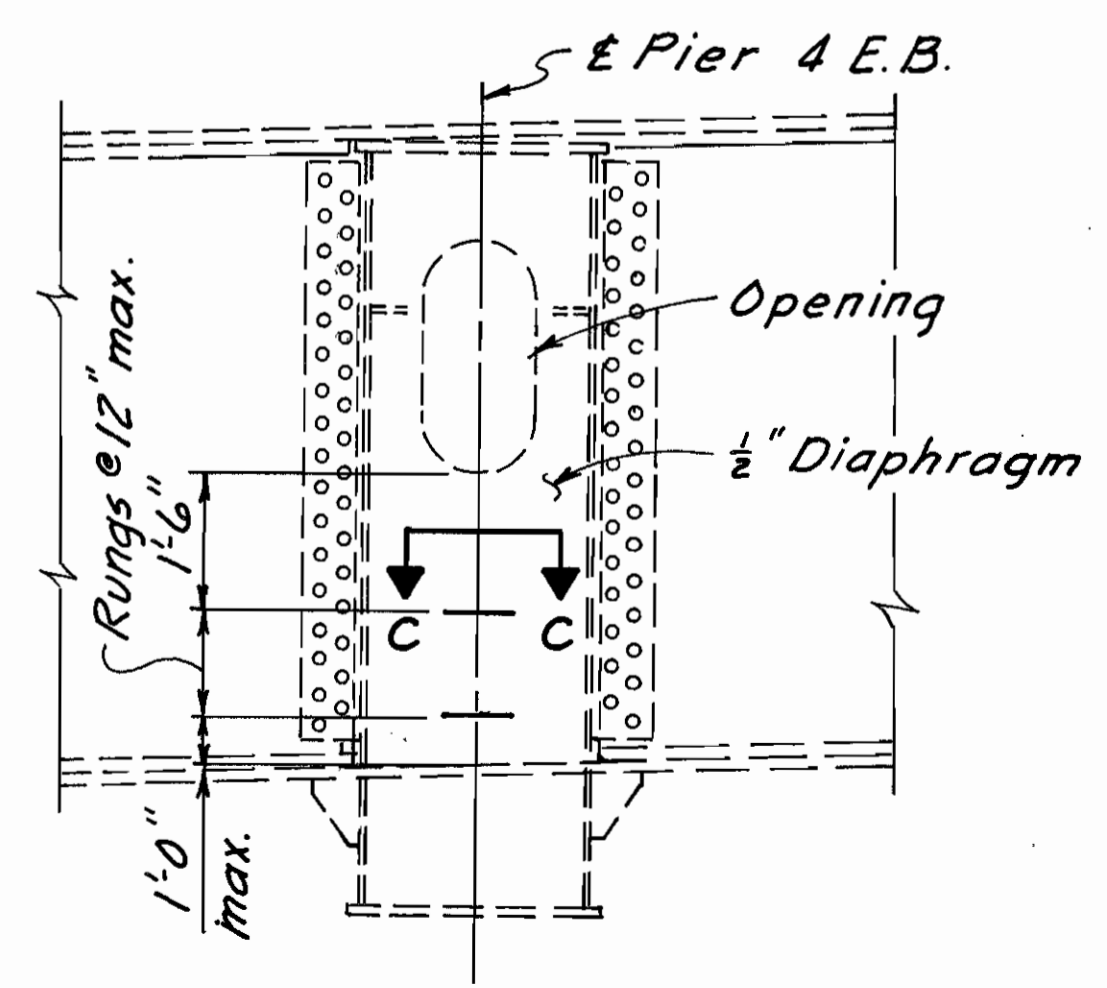
**CASE 2**  
Diaphragm Modification

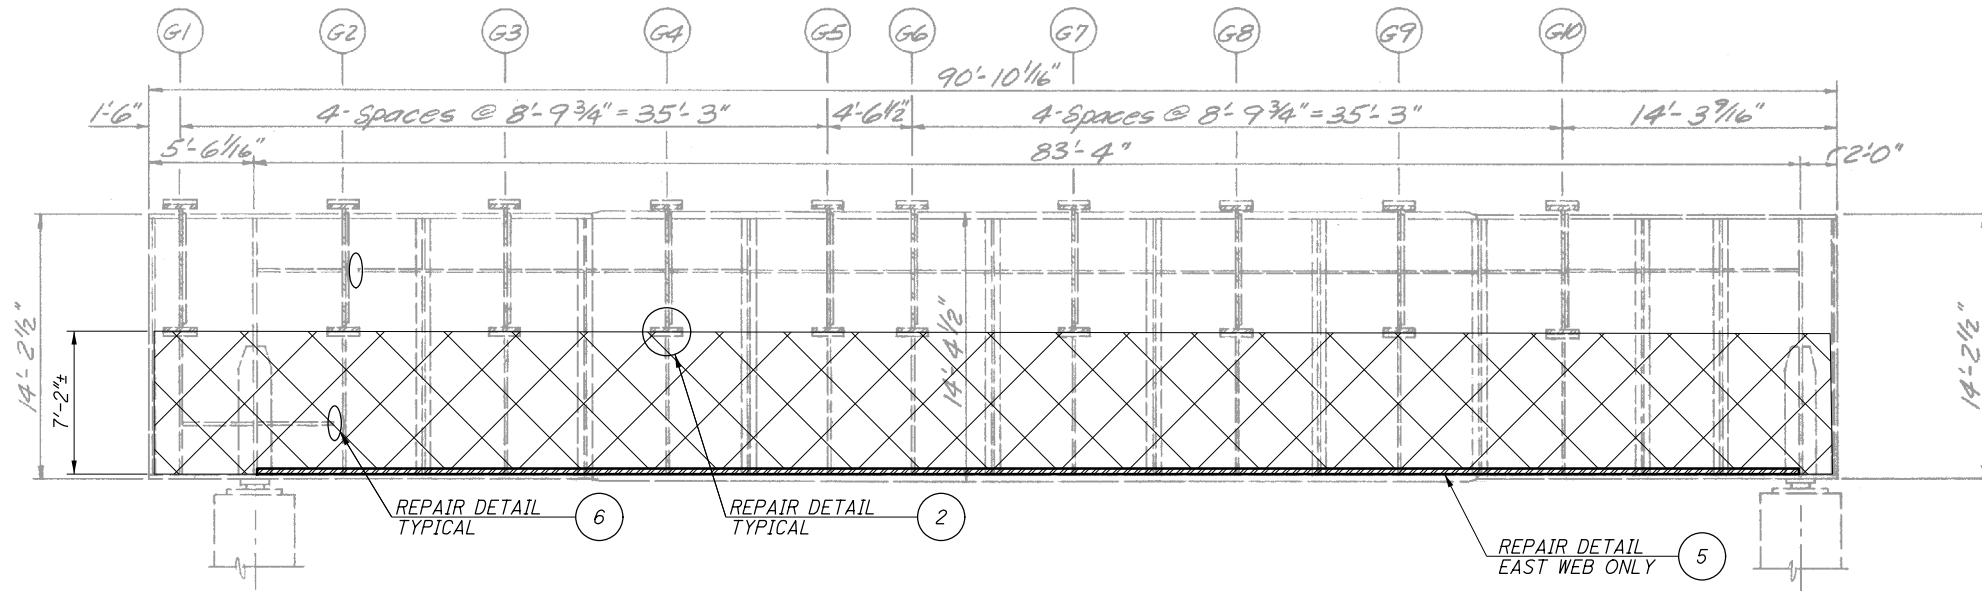
**WEST ELEVATION OF CAP, PIER NO. 7**  
(ELEVATION TAKEN FROM 1991 REHAB. DRAWINGS)

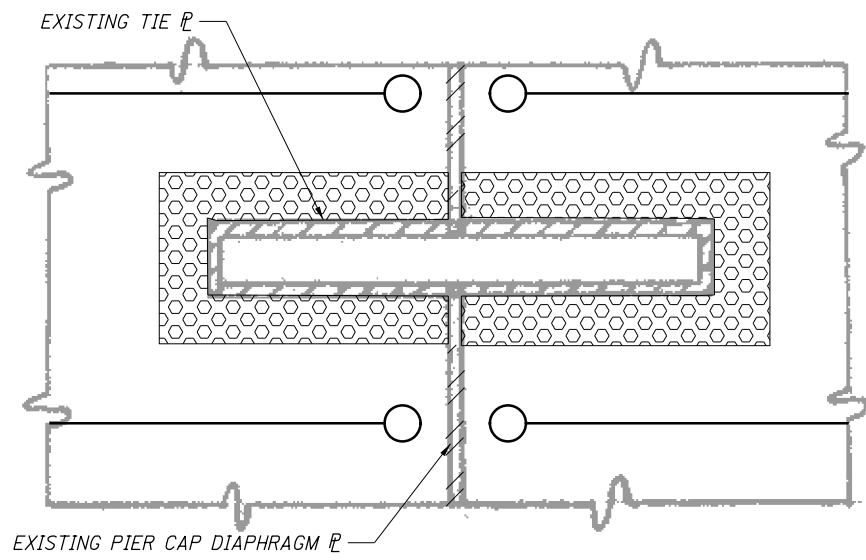
**REPAIR DETAIL**  
**INTERIOR TIE** 1

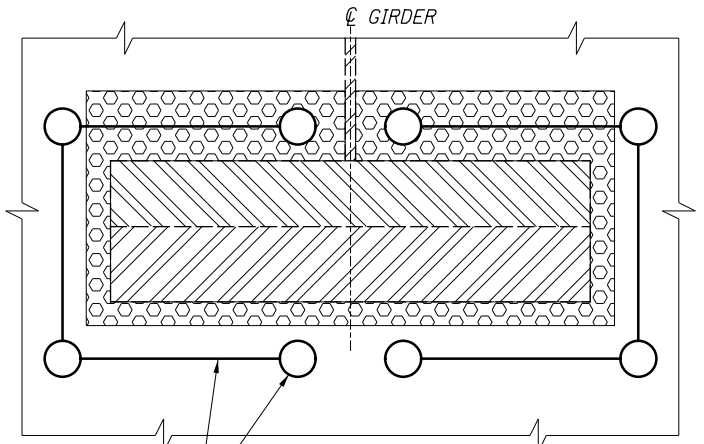
CLEAN AND RECAULK EX. SAW CUTS AND REPLUG THE STRESS HOLES WITH 1" EXPANSION PLUGS (TYP.)

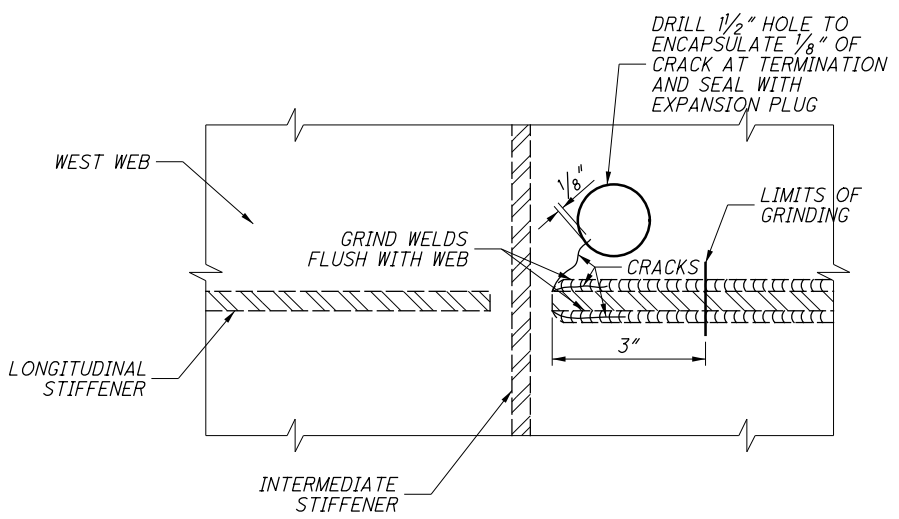
**REPAIR DETAIL**  
**EXTERIOR TIE** 2

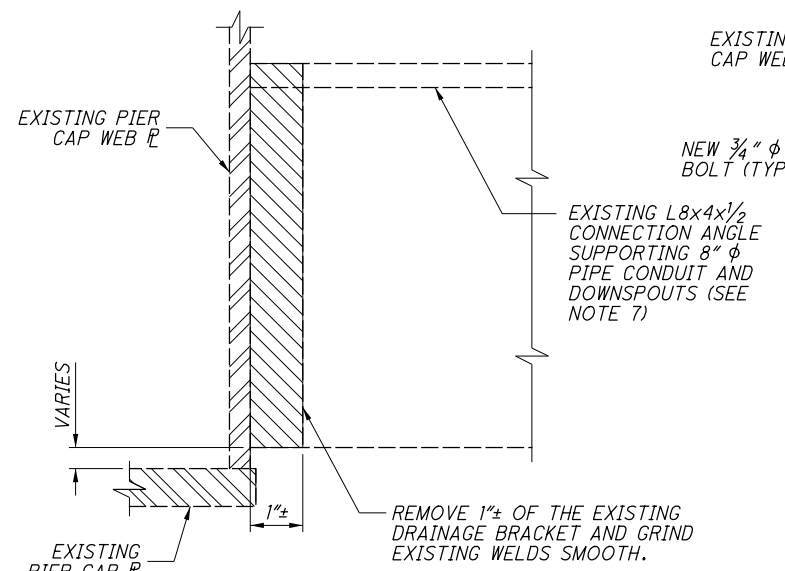
**STEP 1 FOR REPAIR DETAIL 4**

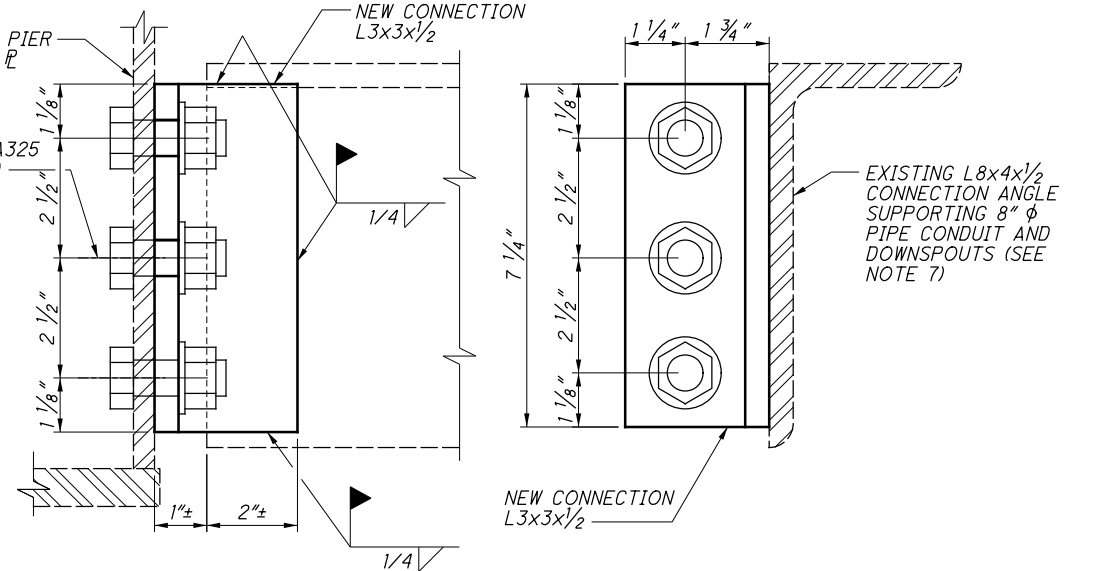
**STEP 2 FOR REPAIR DETAIL 4**

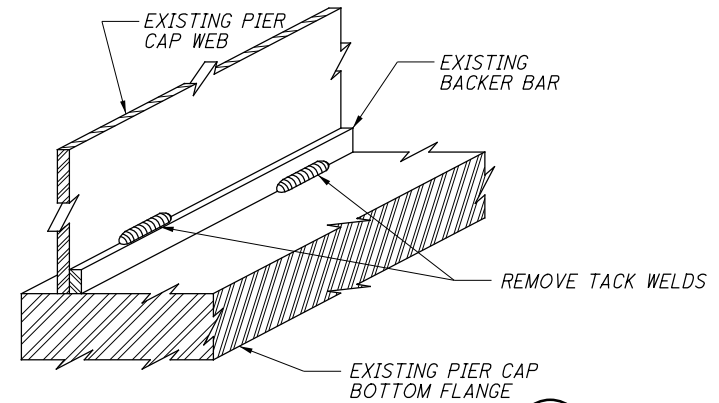
**REPAIR DETAIL**  
**BACKING BAR WELD REMOVAL DETAIL** 5  
(BOTTOM FLANGE SHOWN, TOP FLANGE SIMILAR)

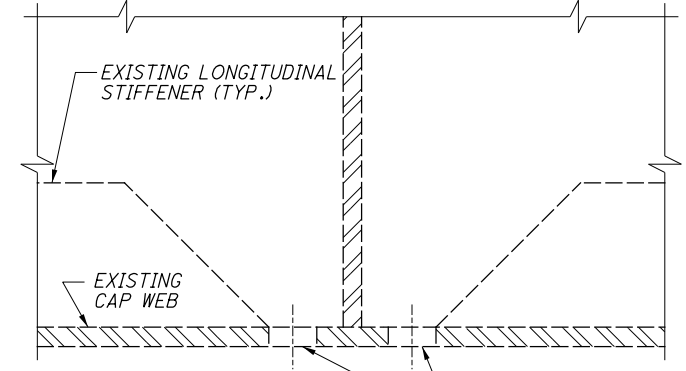
**REPAIR DETAIL**  
**LONGITUDINAL STIFFENERS** 6  
REPLUG AND CAULK THE EXISTING STRESS HOLES WITH NEW 1" EXPANSION PLUGS (TYP.)
