FRACTURE CRITICAL PIER CAP INSPECTION REPORT

SFN3106608 (HAM-71-0159)

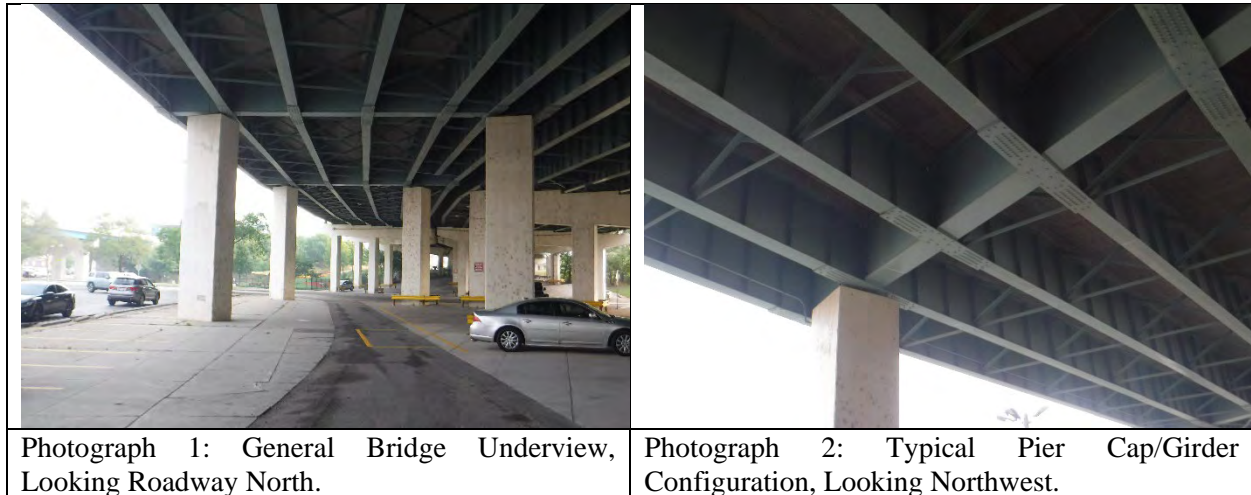
1.3 Method of Investigation

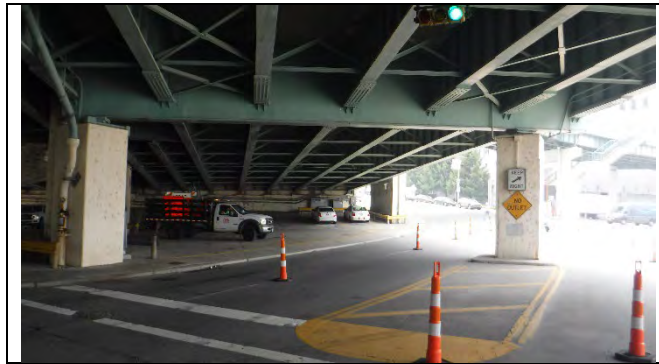
Photograph 3: General Elevation of Pier Cap 1W, Looking Roadway South.

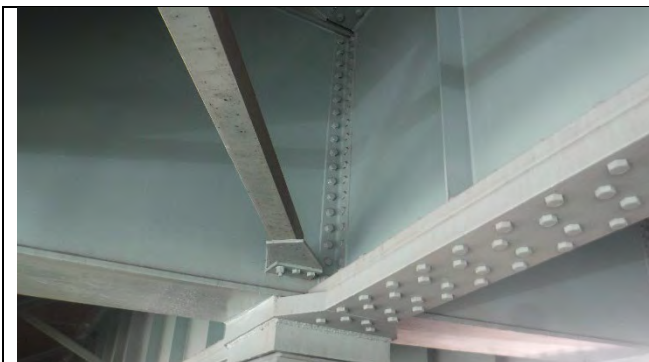
Photograph 8: View of Bolted Lateral Brace Connection Replacing Welded Connection, Looking Southwest.

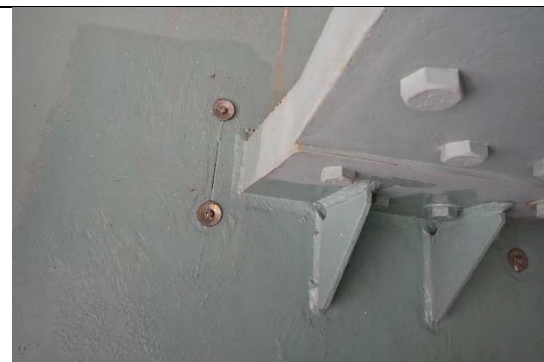
Photograph 9: Typical Example of Drilled Hole Retrofits at Girder Bottom Flanges/Tie Plates.

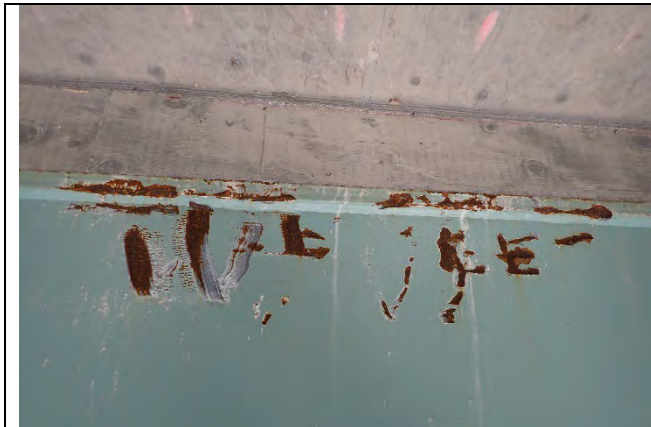
Photograph 10: View of Scrape Damage to North Web Plate Between Girders A and B, Looking South.

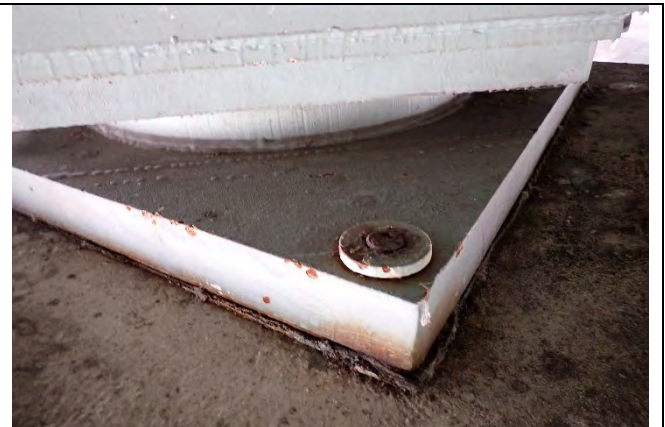
Photograph 11: Sheared Southeast Anchor Bolt at East Bearing, Looking Roadway Northeast.

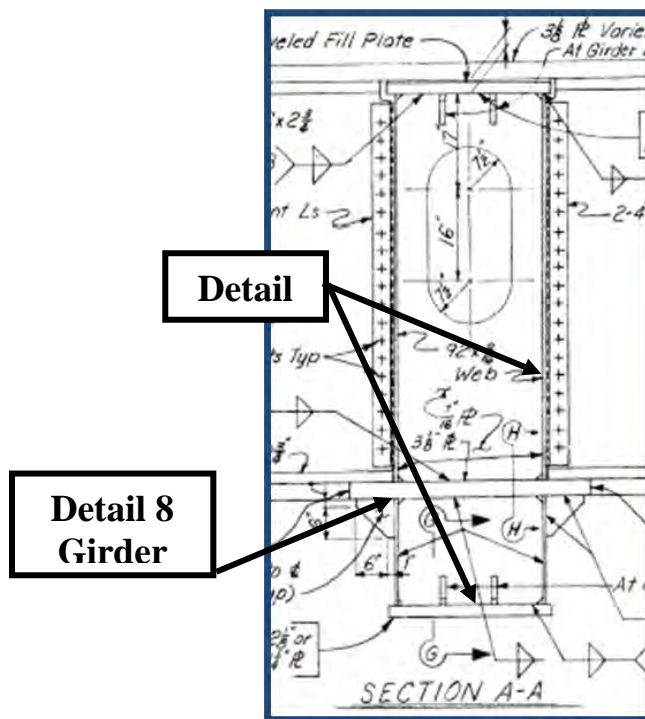
Figure 4: Typical cross section of Pier Cap 1W

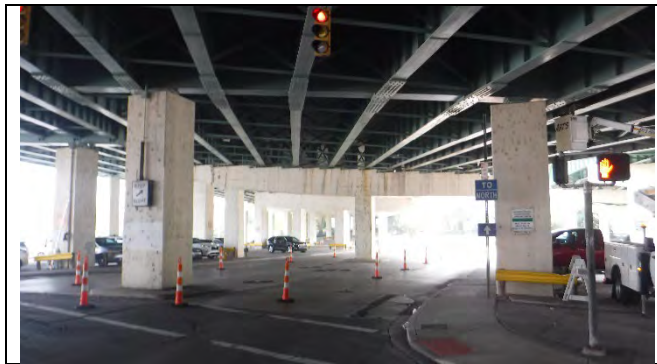
Photograph 12: General Elevation of Pier Cap 2E, Looking Roadway North.

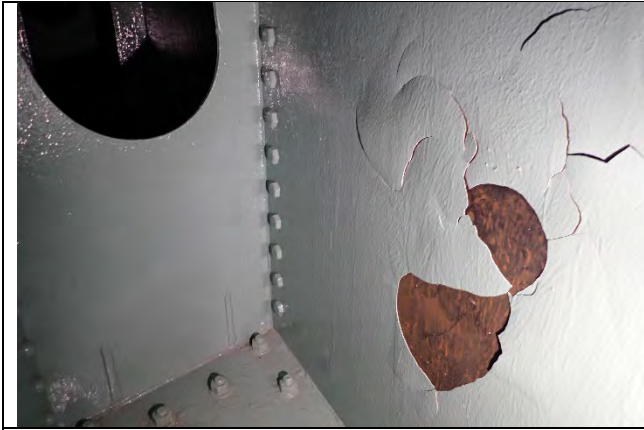
Photograph 13: Failed Paint and Active Corrosion on North Web Plate Between Girders M and N, Looking Northwest.

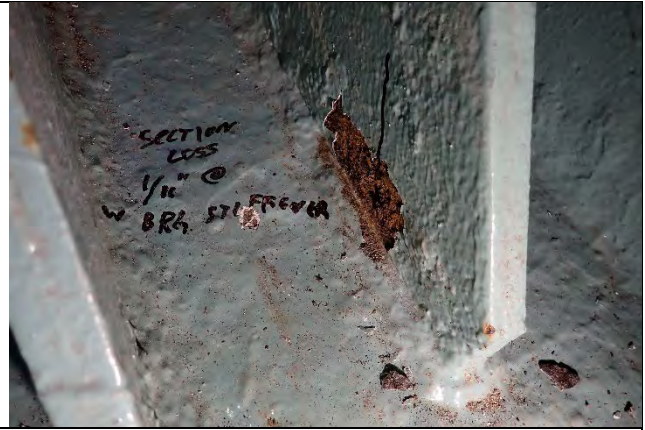
Photograph 14: View of Section Loss to 1/8 in. on Braces Near the East Bearing Stiffener, Looking West.

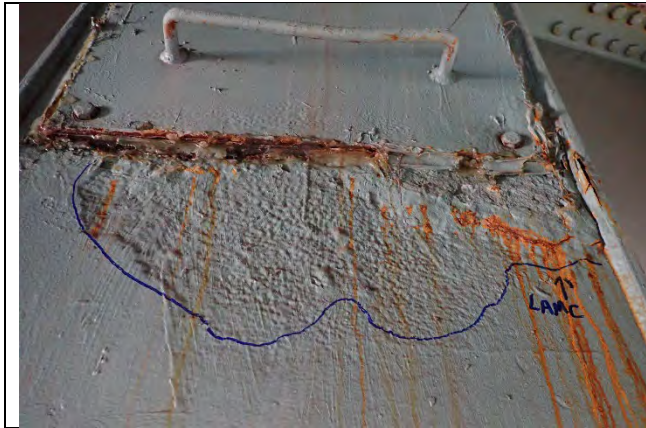
Photograph 17: View of East End Plate Below Hatch. Note Reactivated Corrosion and Section Loss up to 1/8 in. Looking West.

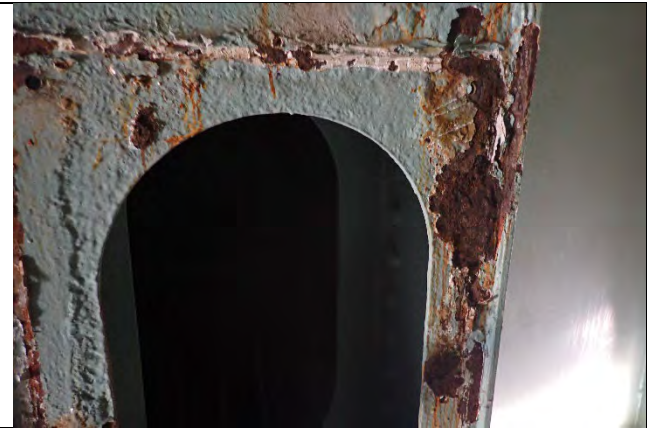
Photograph 18: View of East End Plate At Top of Hatch With Door Removed. Note Corrosion and Section Loss up to 1/8 in. Looking West.

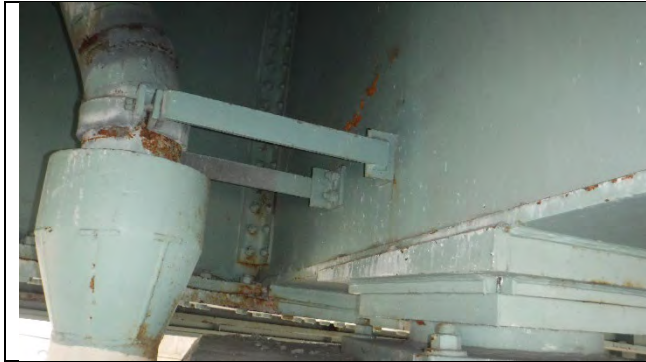
Photograph 19 – View of Bolted Connections that replaced Welded Connections for Drainage System. Looking Southeast.

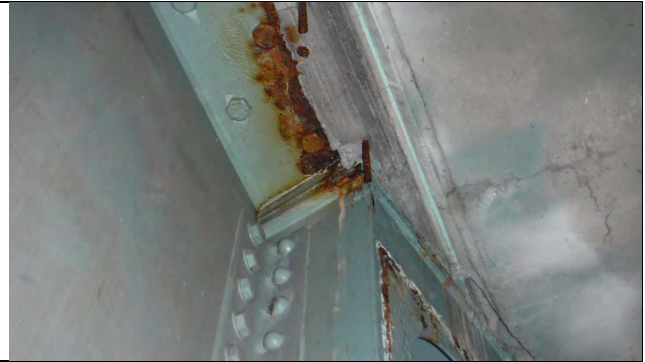
Photograph 20 – View of Active Corrosion on the Girder Top Flange and Cap Top Flange Plate East of Girder N. Looking North.

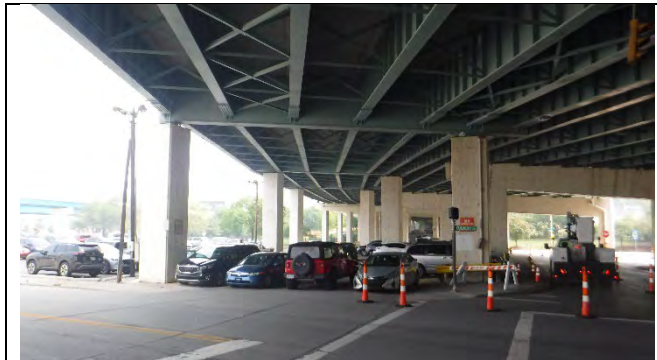
Photograph 21: General Elevation of Pier Cap 2W, Looking Roadway North.

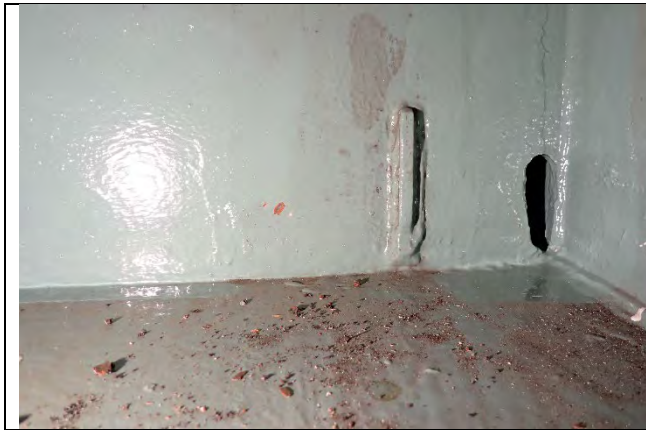
Photograph 22: Typical Example of Remnants of Knee Brace Connections Removed. East Face of Diaphragm E Shown.

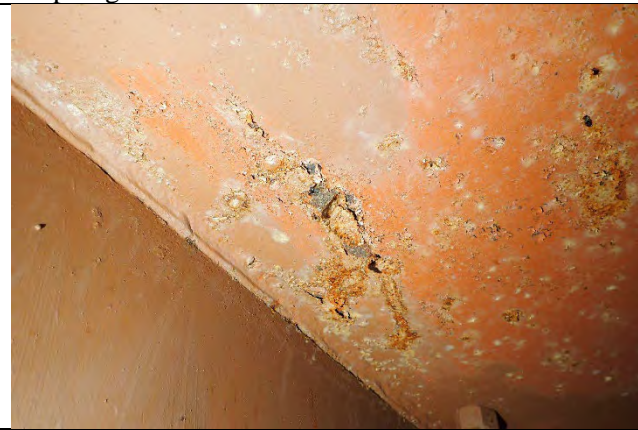
Photograph 24: General Example of Flaking Paint and Active Surface Corrosion along the Top Plate. Occurs Randomly but Consistently along the Plate.

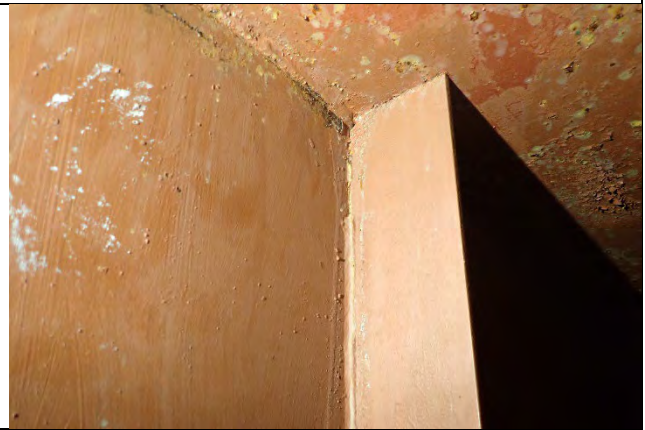
Photograph 25: View of Discontinuous Weld Noted on the North Web Stiffener between Girders A and B.

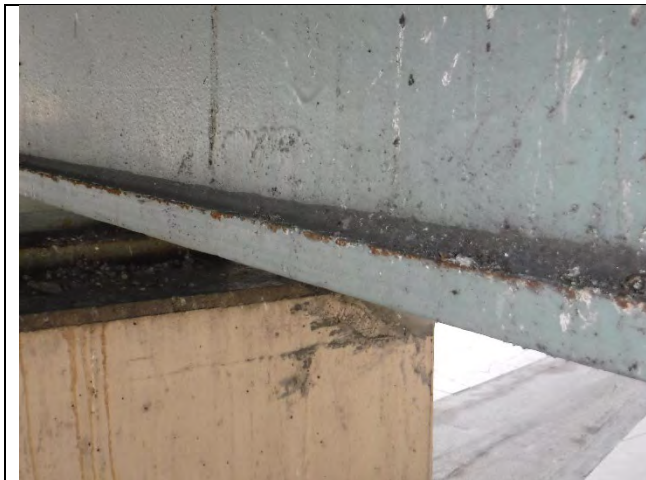
Photograph 26: View of the Minor Surface Corrosion Noted on the Bottom Flange of Pier Cap 2W.

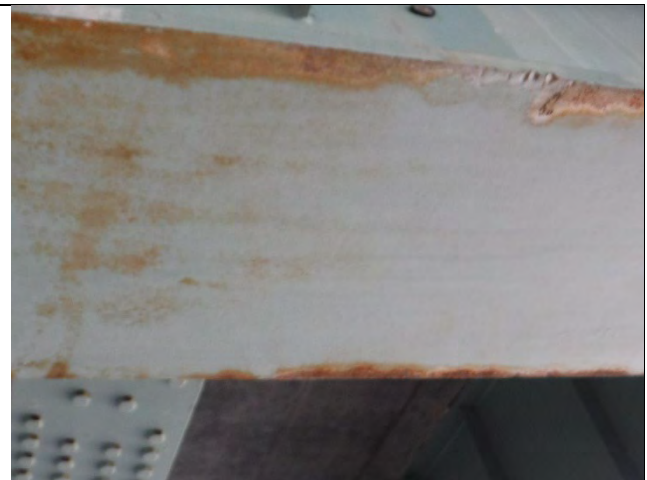
Photograph 27: View of the Minor Surface Corrosion Noted on the Bottom Flange of Pier Cap 2W.

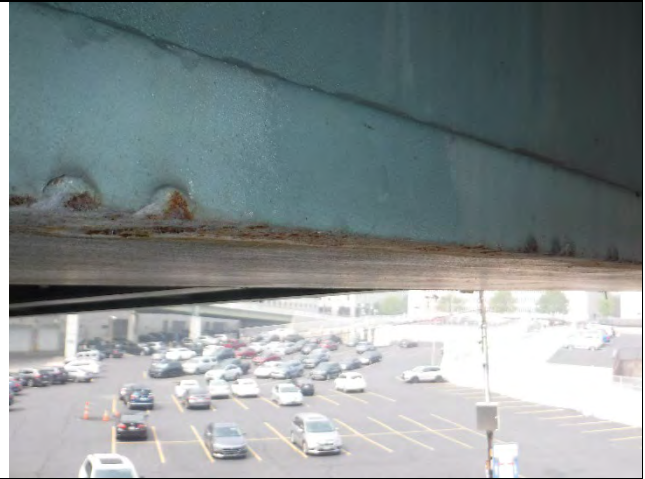
Photograph 31: View of the Gouges at the North Edge of the Bottom Flange over the Length of the Pier Cap, most of which are near Girder D.

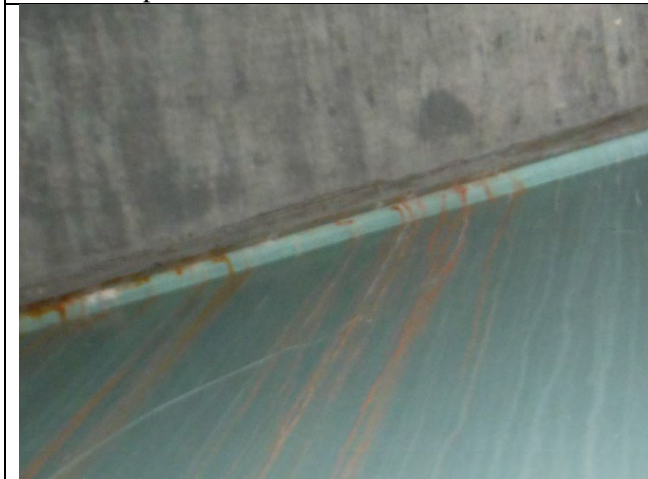
Photograph 34: View of the Moderate to Heavy Fretting Rust on the North and South Faces of the Cap along the Top Flange to Deck Interface Between Girders C and D.

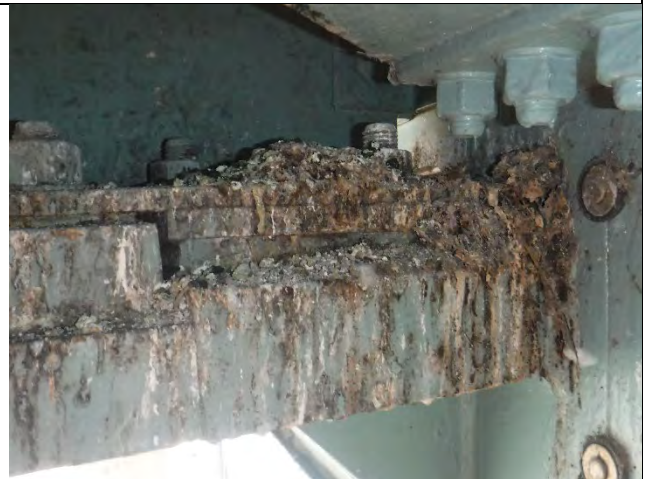
Photograph 35: View of the Pigeon Nests and Construction Debris was Observed on the South Web and Girder Lower Flanges.

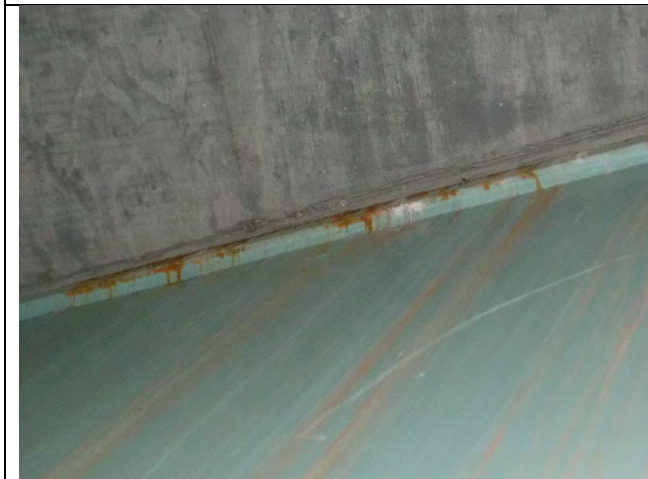
Photograph 36: View of the Typical Rust Staining on the South and North Web of the Cap.

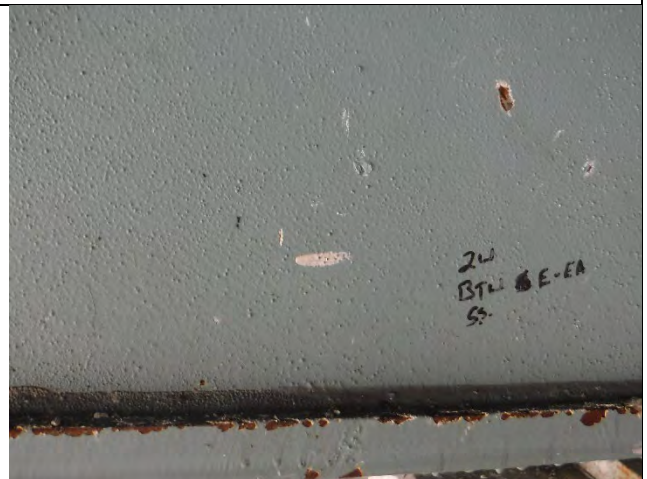
Photograph 37: View of the Typical Protective Coating System Condition.

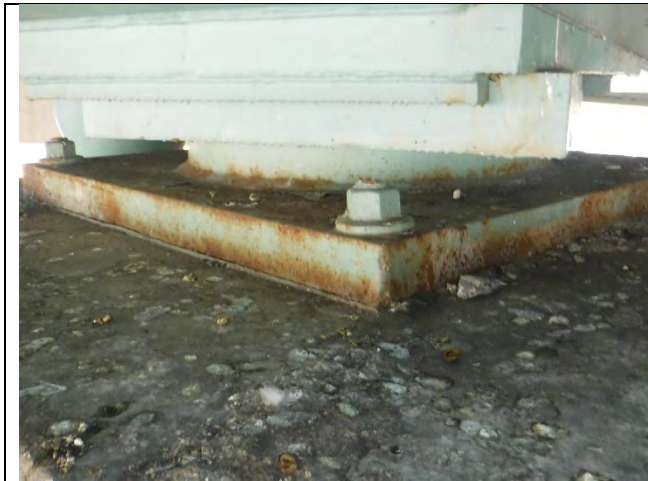
Photograph 38: View of the Typical Bearing Condition.

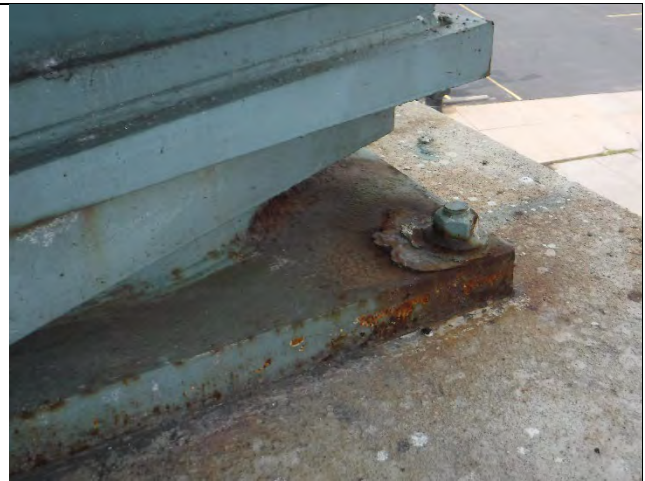
Photograph 39: View of the West Bearing with Moderate Surface Corrosion and Section Loss Around the Northwest Anchor Bolt.

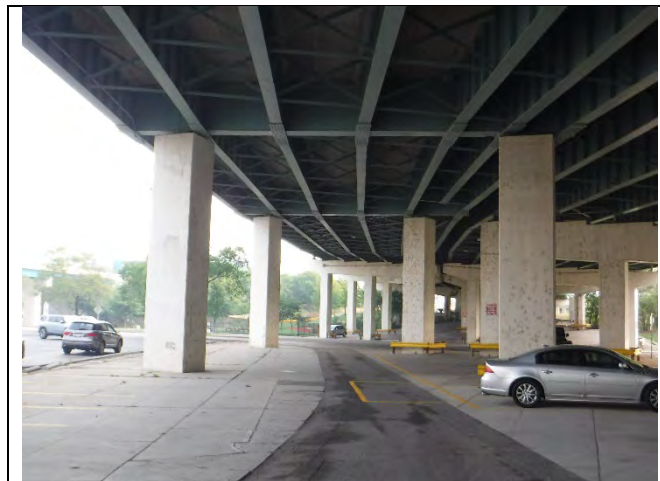
Photograph 40: General Elevation of Pier Cap 3W, Looking North.

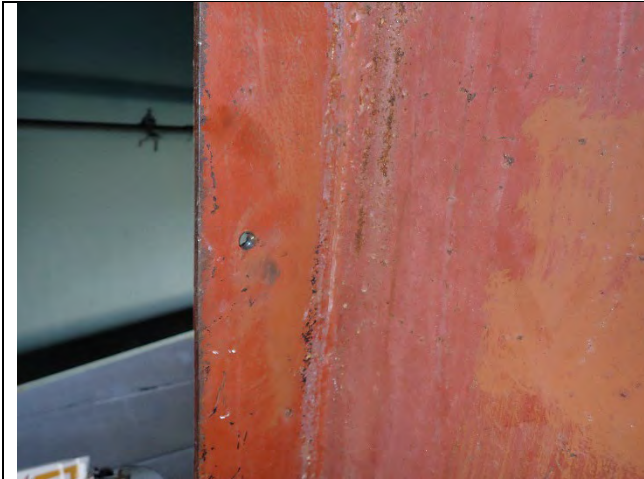
Photograph 41: Isolated Locations of Surface Corrosion Inside the Cap, Mostly at the Ends Near the Hatches.

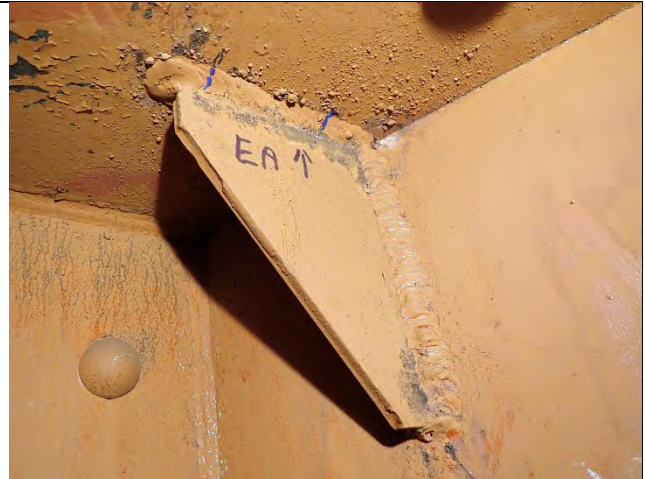
Photograph 42: Visual Crack Indication at Girder EA. Indication was Tested with Magnetic Particle and Determined to Not Be A Crack.

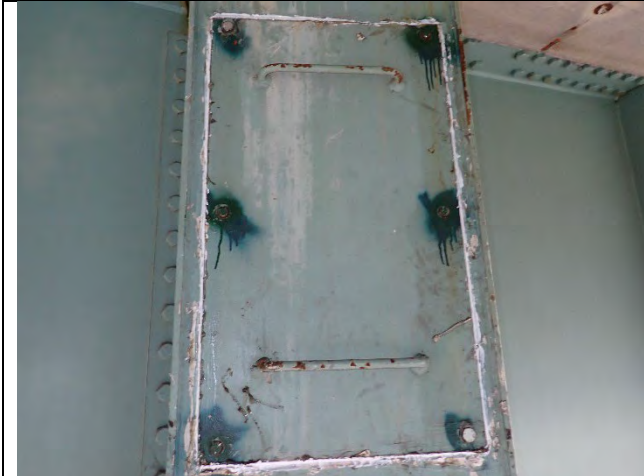
Photograph 43: Two out of six bolts were previously missing on the east access hatch but have been replaced. The open holes were caulked and sealed to prevent moisture infiltration.

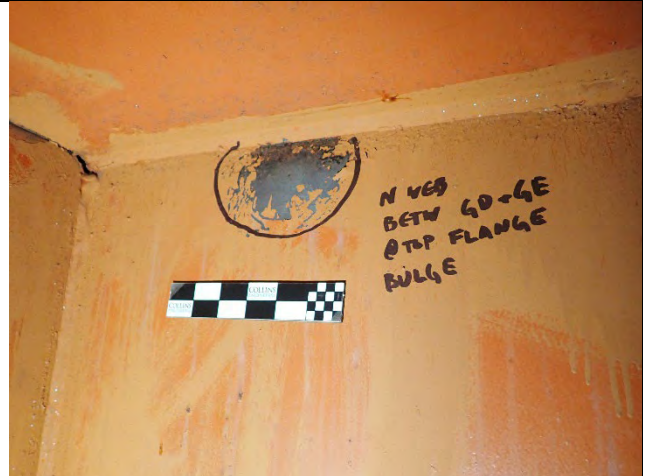
Photograph 44: Two minor bulges on a stiffener in the north web near the top flange between Girders D and E.

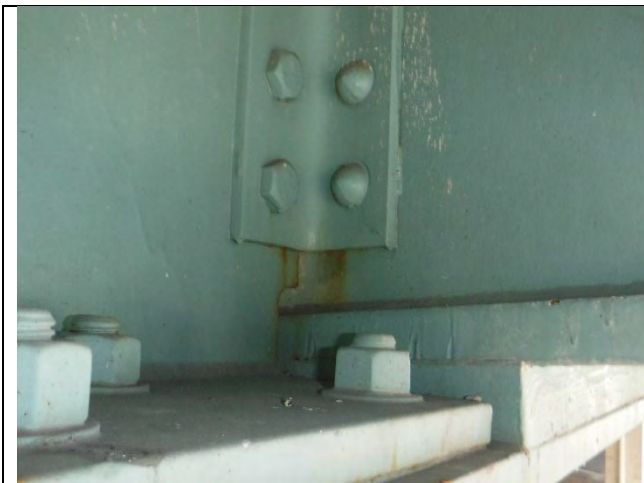
Photograph 49: View of the Remaining Tack Welds on the Bottom Flange at the West Edge of Girder B fill Plate, the West Edge of Girder E, and at the East Edge of the Girder EA Fill Plates.

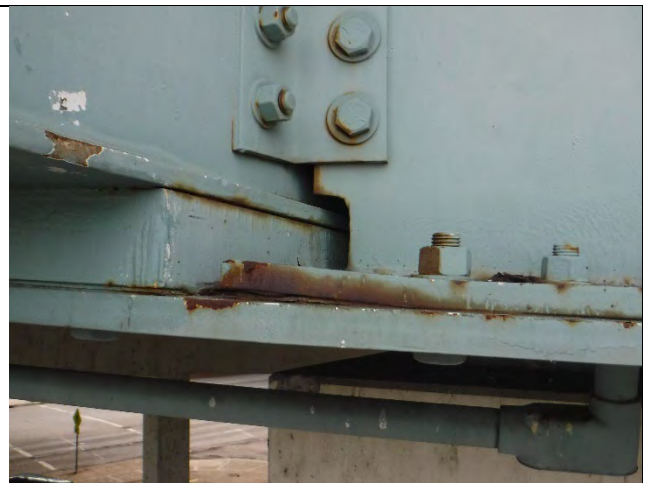
Photograph 50: View of the Pack Rust with Section Loss on the West Side of Girder A Between the Bottom Flange Plate and Tie Plate.

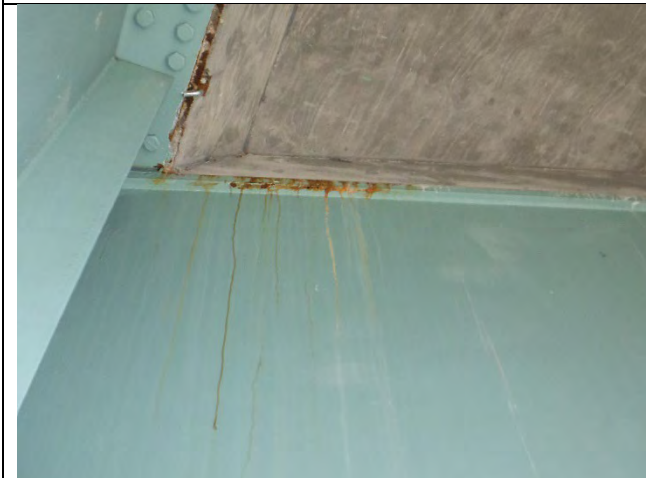
Photograph 53: View of the Corrosion and Rust Staining Observed on the Top Flange on the North Web just West of Girder C.

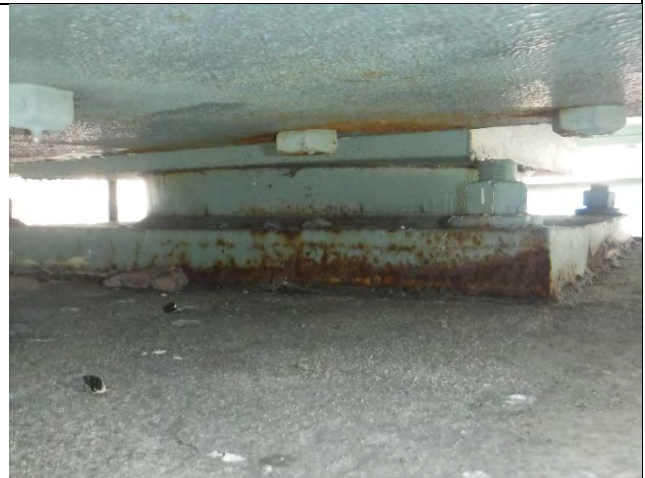
Photograph 54: View of the Typical Bearing Condition.

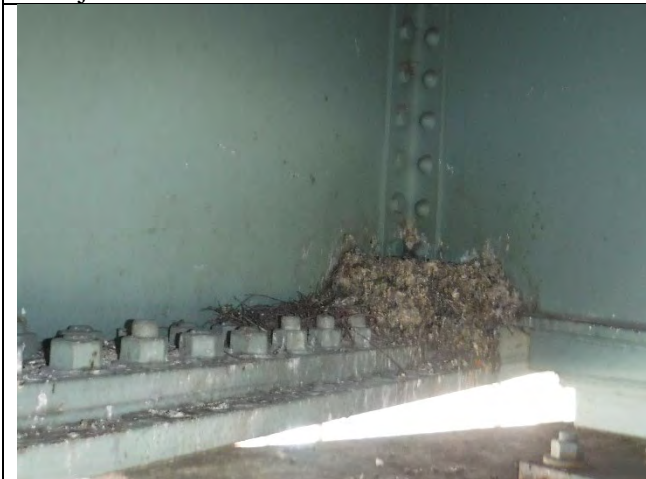
Photograph 55 (left): View of the Bird Nest at Girder EA.

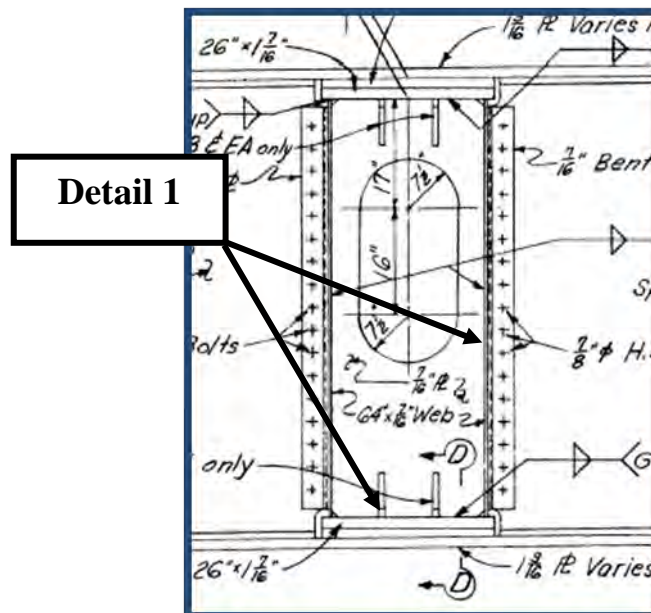
Figure 11: Typical cross section of Pier Cap 3W

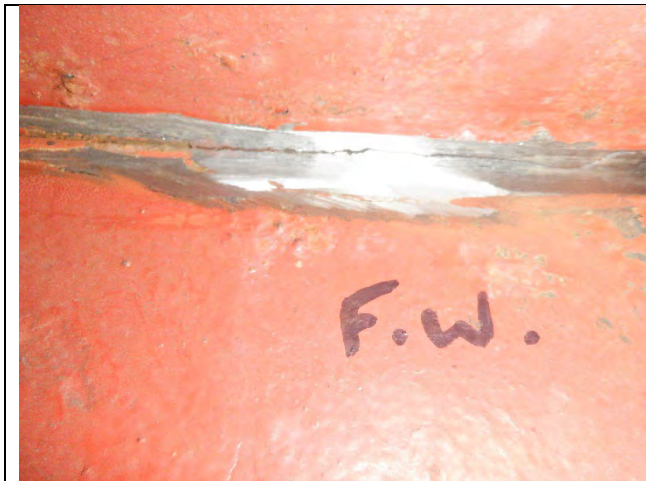
Photograph 56: Example of Ground and Removed Intermittent Tack Welds Between the Top Flange and Bearing Stiffeners at Both West Bearing Stiffeners.

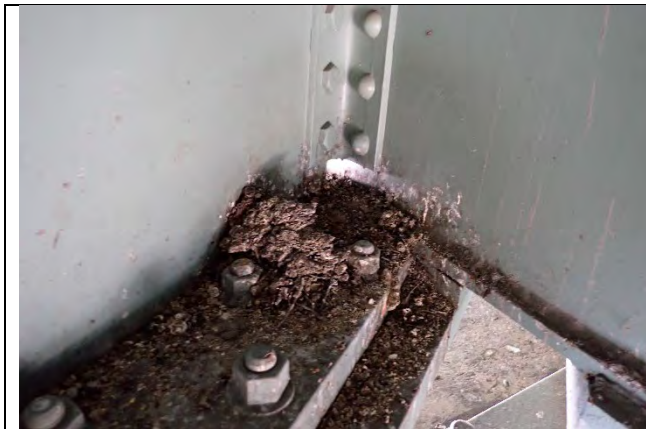
Photograph 58: View of the Typical Pigeon Debris Near End of Girders, East Face of Girder E Shown.

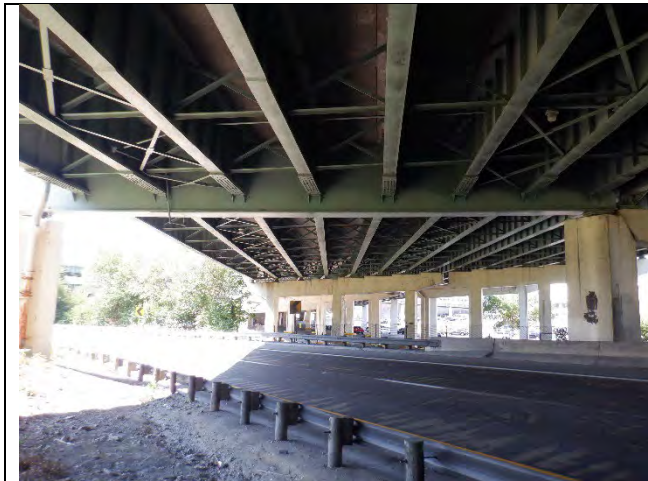
Photograph 60: Overall Cap Elevation, Looking Roadway South.

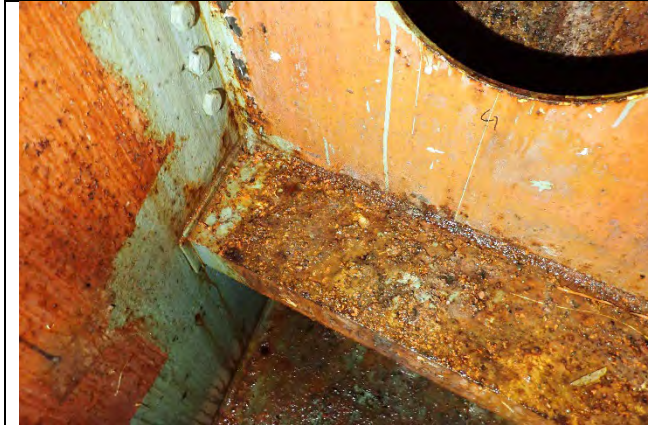
Photograph 62: General Example of Corrosion and Section Loss from Moisture Infiltrating Cap. Near West Bearing Stiffener Shown Looking West.

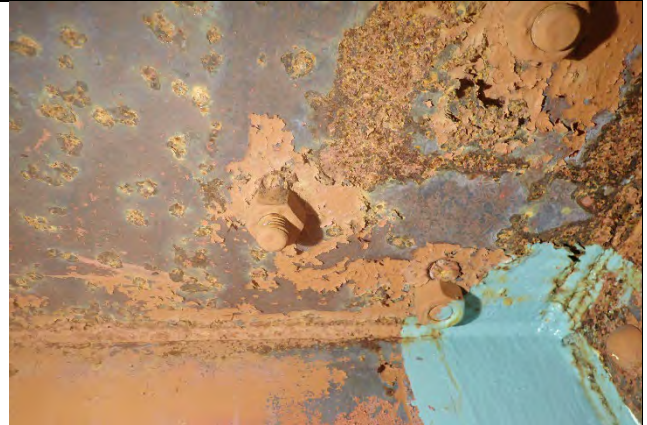
Photograph 63: Typical Example of Oversized Bolt Holes on Cap Top Flange Plate, Diaphragm M East Face Shown.

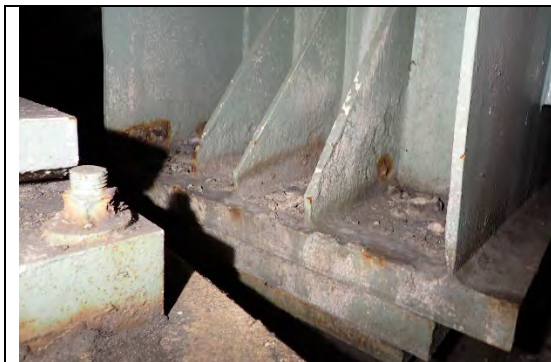
Photograph 65: Example of Painted over Pitting to 1/16 in. Deep on West Bearing Stiffeners.

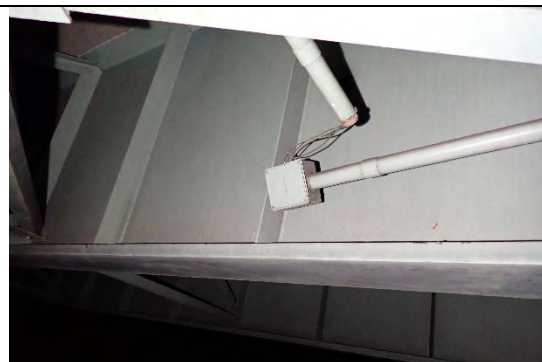
Photograph 66: No Change to Damaged Conduit on West Face of Girder N, North of the Cap.

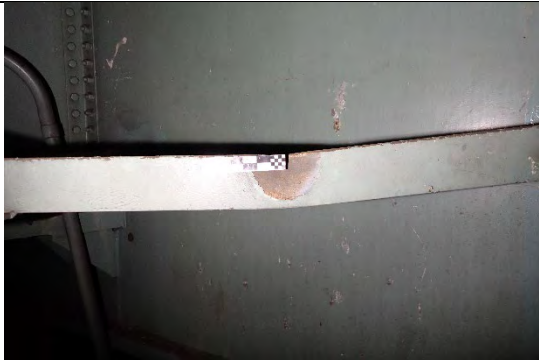
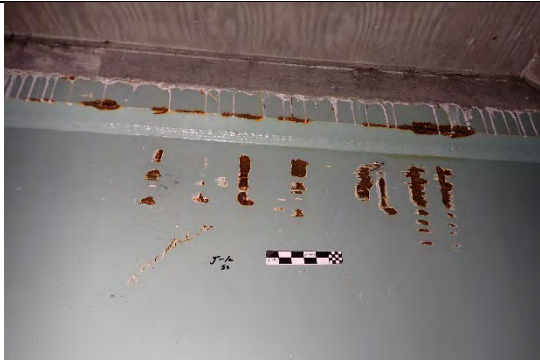
Photograph 67: View of No Change to Impact Damage Between Girders M and N, North Face of Cap. Looking South.	Photograph 68: No Change to Impact Damage to Cap, South Face Between Girders J and K Looking North.

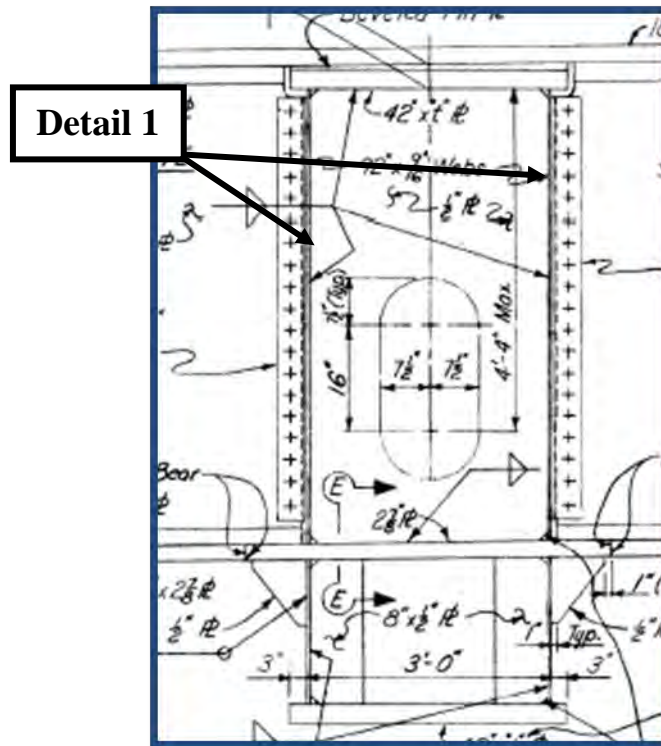
Figure 16: Typical cross section of Pier Cap 7E

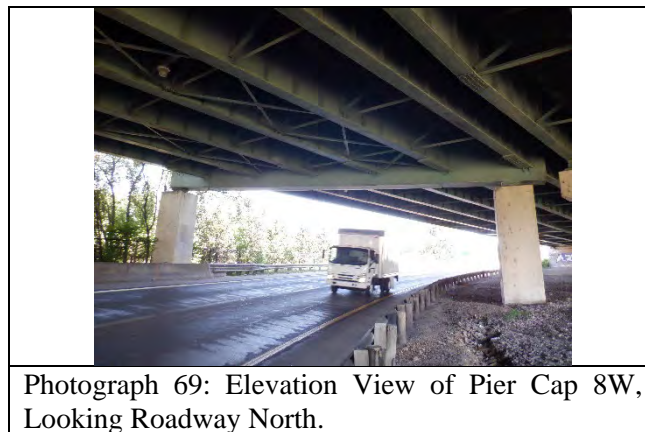
Photograph 69: Elevation View of Pier Cap 8W, Looking Roadway North.

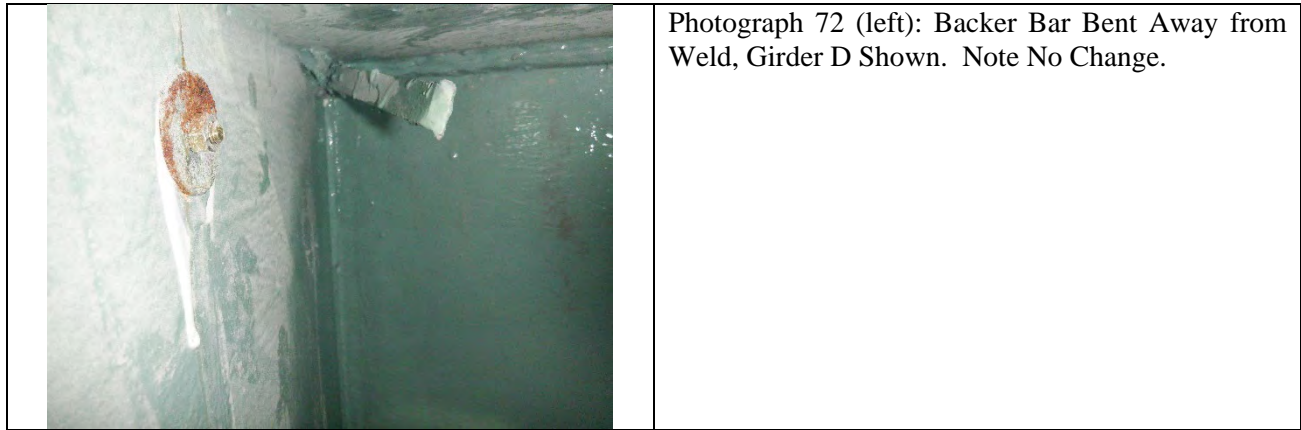
2.1.7.2 Pier Cap 8W Exterior

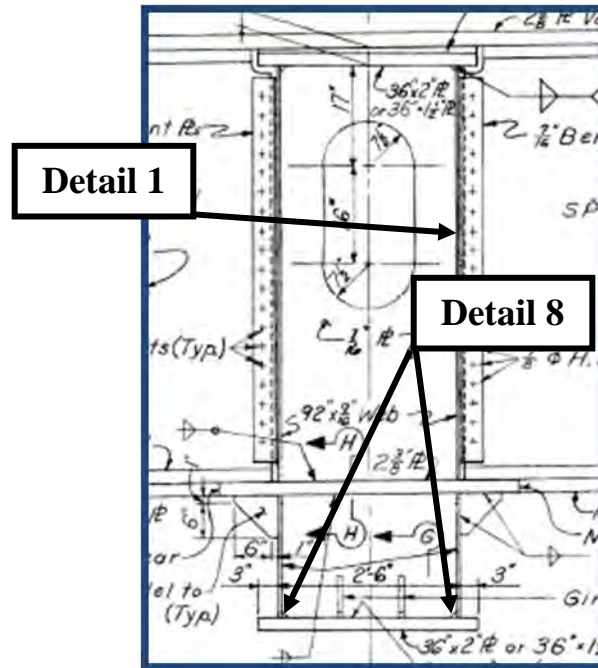
Figure 19: Typical cross section of Pier Cap 8W

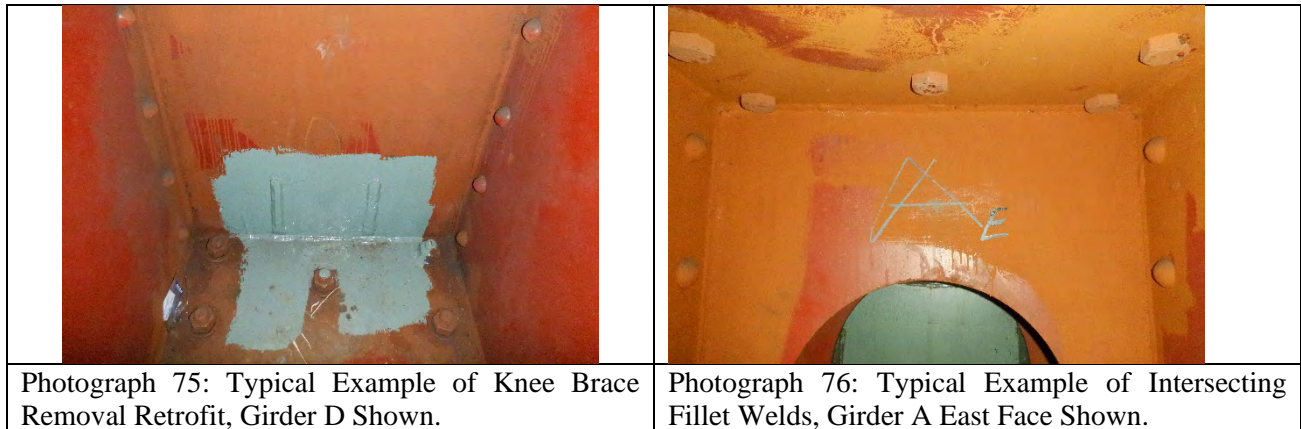
2.1.8.2 Pier Cap 9W Exterior

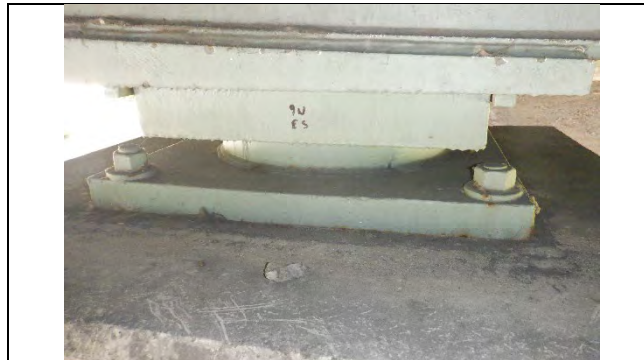
Photograph 77: Typical Bearing Condition, East Bearing Shown.

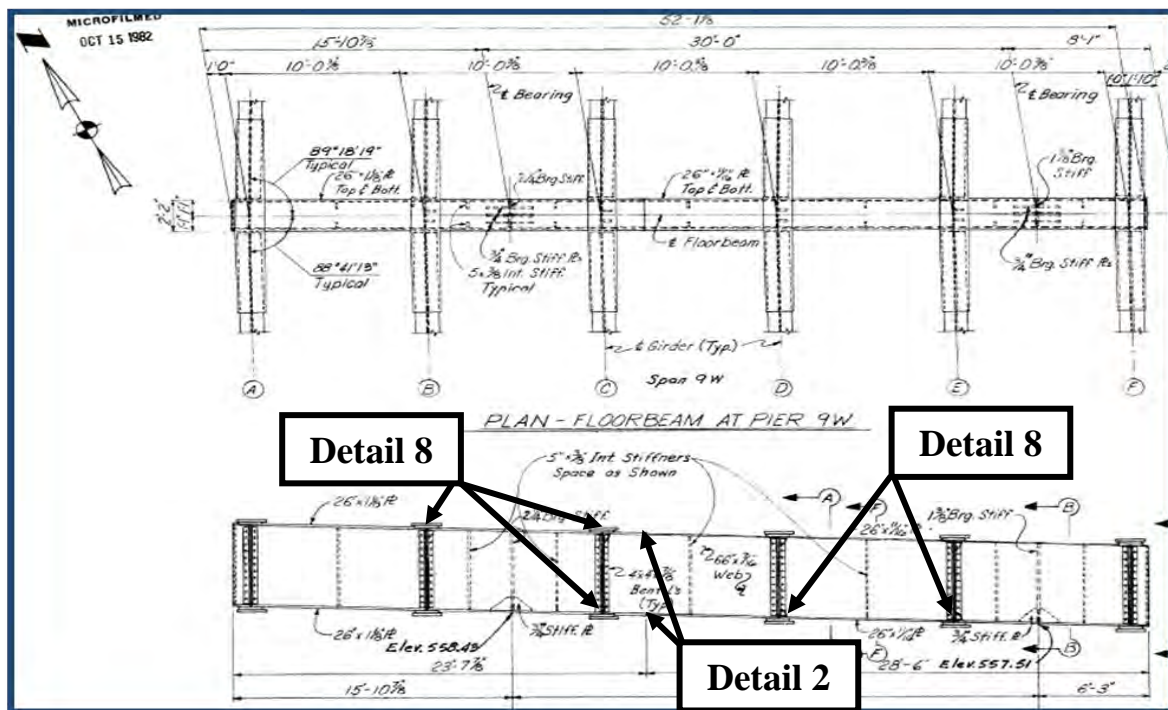
Figure 22: Plan and Elevation of Pier Cap 9W

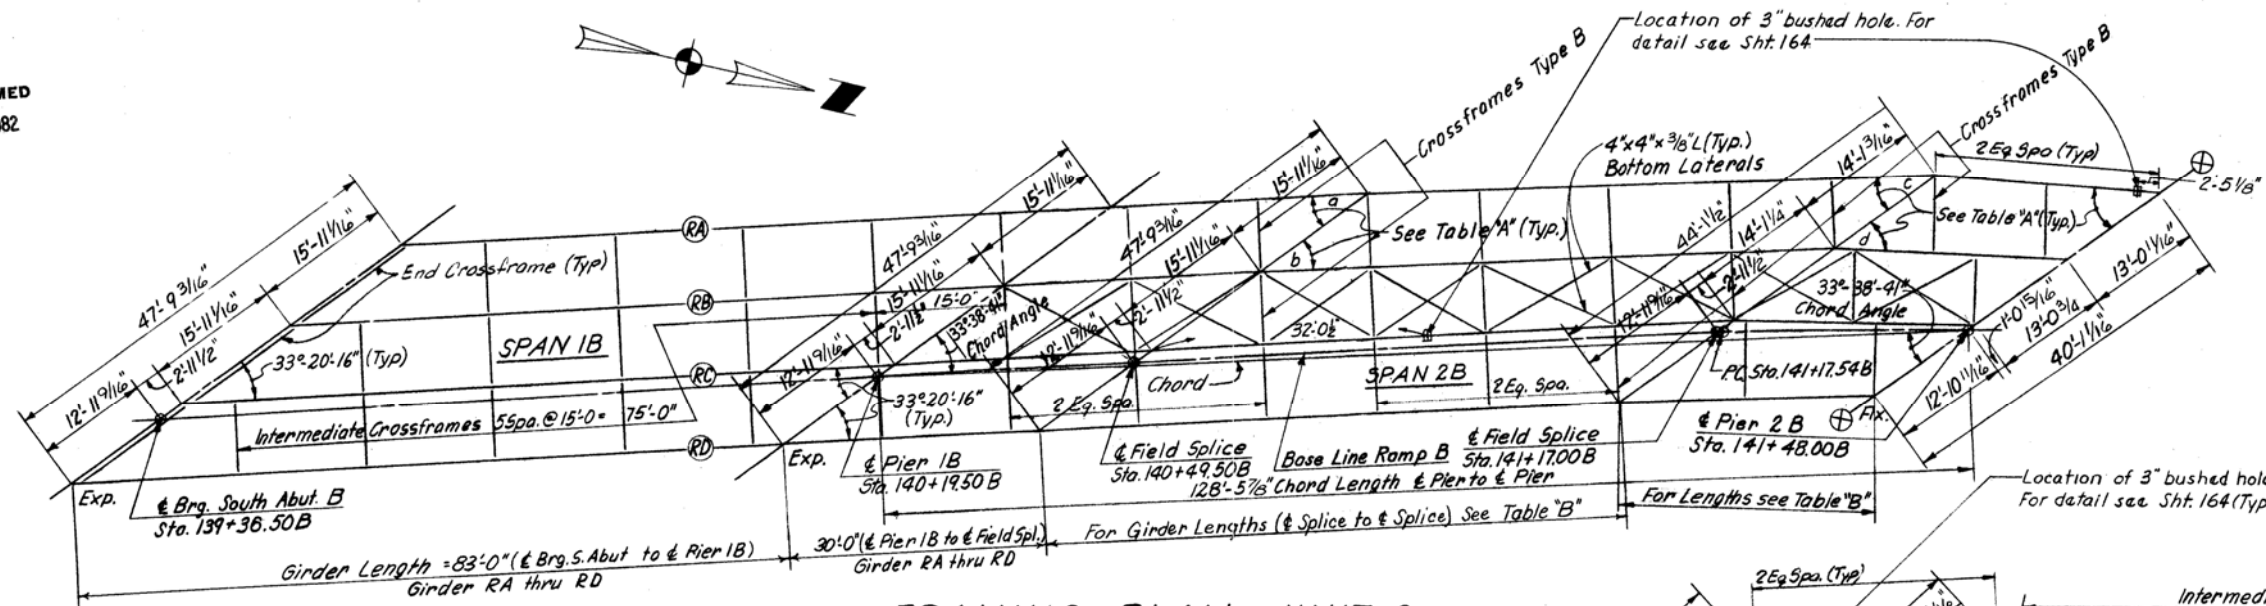
NOTE: All Crossframes are Intermediate Crossframes except those noted otherwise. Maximum Crossframe Spacing = 15'-0"
