FRACTURE CRITICAL PIER CAP INSPECTION REPORT

SFN3106659 (HAM-71-0197W)
TWO SINGLE LANES OF RAMP TOWARD
SB I-471 OVER A RAMP FROM GILBERT
AVENUE TO NB I-71
HAMILTON COUNTY, OH
DISTRICT 8

SB I-471 over a ramp from Gilbert Ave to I-71NB • SFN3106659 (HAM-71-0197W)

Hamilton County, OH • July 2023

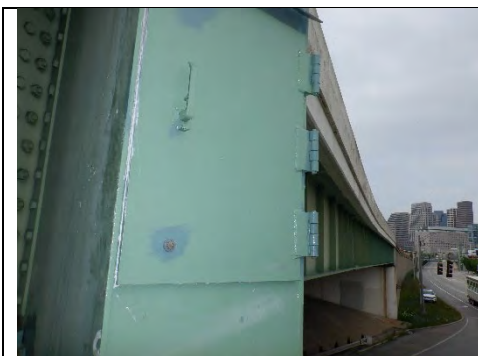
On July 13, 2023, Collins Engineers Inc. performed a fracture critical inspection of the fracture critical pier cap of Bridge SFN3106659 (HAM-71-0197W). A 46 ft bucket truck was used to access the pier cap interior and perform the “arm’s length” exterior inspection. The east (compass south) pier cap hatch cover was removed for the entry, replaced with an impact wrench, and resealed with exterior grade silicone caulk after the inspection. Both hatch covers were recently retrofitted with rain guards, hinges, and door handles (Photograph 1). Note that the door handle mechanisms were installed without interior latches (Photograph 2). Two bolts secure each door.

Photograph 1: View of Hatch Exterior, West Hatch Shown. Looking South.

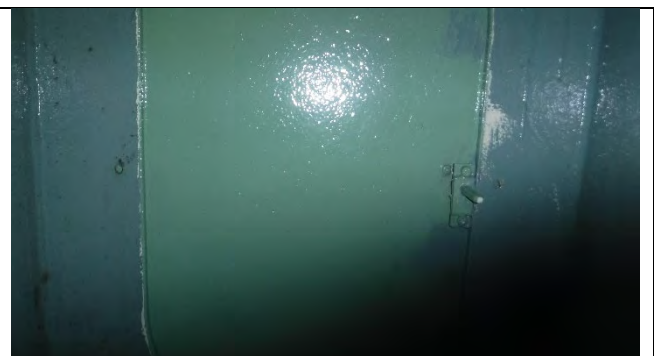
Photograph 2: View of No Interior Latch, West Hatch Shown. Looking West.

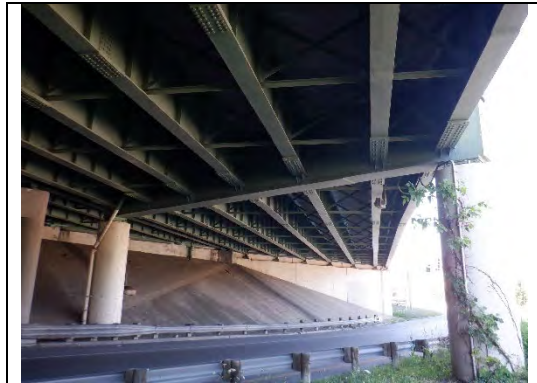
Pier Cap 1 is in Good Condition [7] overall (Photograph 3). No moisture was found inside of the cap at the time of inspection. Surface corrosion with no section loss was present on the bottom of one interior pier diaphragm, on the underside of several flange tie plates, and on the interior bottom flange at one location. Overall no changes from the prior inspection.

Photograph 3: Elevation Photograph of Pier Cap 1 Looking South.

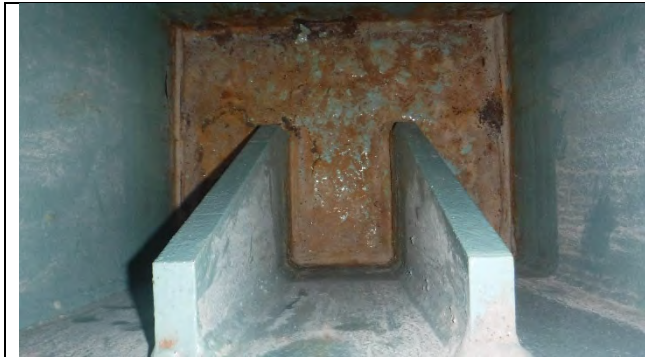
- Prior inspections noted ponding water between the east (compass south) bearing stiffener and the end plate. For this inspection, as with 2021, there was no ponding water present at this location inside the cap (Photograph 4). There was minor surface corrosion with no section loss in this area during this inspection.
- Isolated areas of active surface corrosion with no section loss are present at isolated locations. This included the bottom of the Girder T diaphragm (Photograph 5) and on the bottom flange tie plates of Girders T, U, V, and Z. This has been previously noted and has not changed.
- Intermittent tack welds were removed from the bottom flange backer bars and web plates, but were still present at the cap webs to top flange corners along the cap length (Photograph 6).

Photograph 4: View of Cap Bottom Plate Between the East (Compass South) Bearing Stiffener and End Plate. Note No Ponded Water. Looking Down.

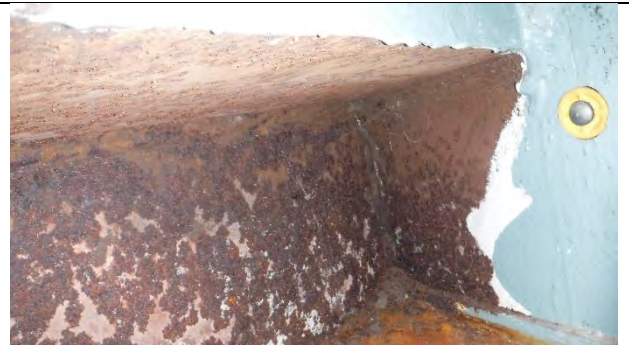
Photograph 5: View of Active Surface Corrosion Located Under Tie Plate on the South (Compass West) Face of Girder T Diaphragm.

- Spot clean and paint the interior, focusing on the underside of the flange tie plates and adjacent areas, and repaint the south end plate.
- Future inspections should monitor the drilled hole retrofits and sawcuts to ensure they continue to function as designed.
- Future inspections should monitor the interior for ponding water or other signs are moisture infiltration. While noted in the past, the cap interior has been dry over the past couple inspection cycles.

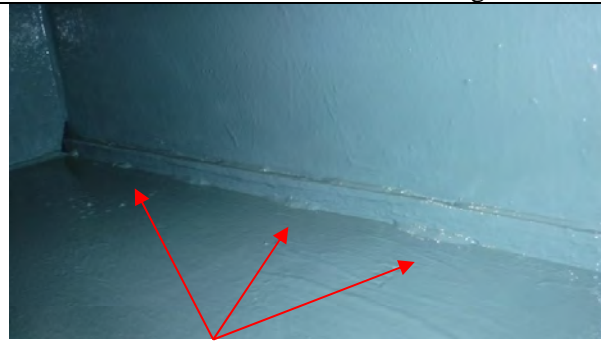
Photograph 6: View of Tack Welds Present Along Cap Top Plate Backer Bars. Cap Web Between Diaphragm U and Diaphragm V Shown.

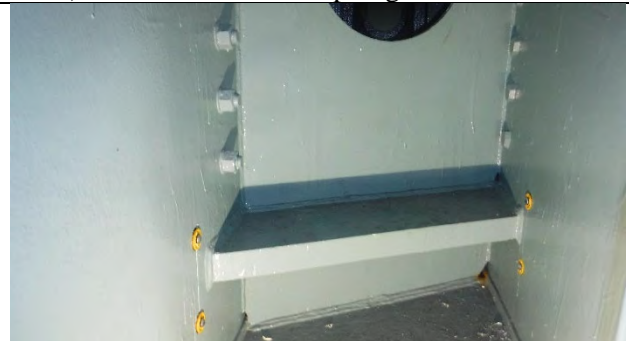
Photograph 7: Typical Example of Interior Diaphragm Condition and Configuration. East (Compass South) Face of Girder U Shown.

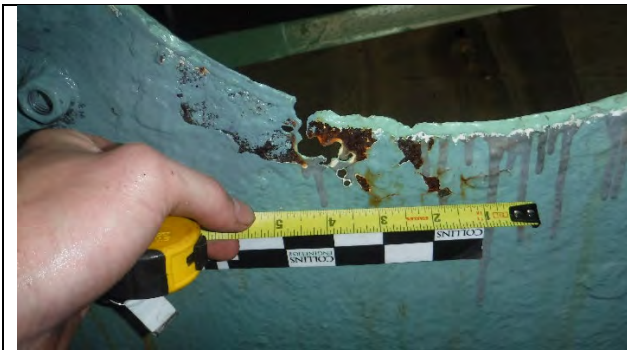
- At the east (compass south) access hatch corrosion has reactivated on the end plate, resulting in slight growth to the small area of 100% section loss. The corrosion hole now measures in total 1-1/2 in. in length x 1/2 in. in height. There is up to 50% section loss for the rest of the width and scattered areas of light pitting around the east hatch as well.
- Areas where ponding typically would build were dry throughout the 2023 inspection. There is active corrosion located on Diaphragm T likely cause from prior water ponding in the past.
- The drilled hole and sawcut retrofits are performing as designed.
- Overall, there were no major changes to the structure from the prior inspection.

The exterior paint is in Good Condition [7] and exhibits small, isolated spots of surface corrosion with no section loss. These overall have not changed since the prior inspection. The east hatch corrosion has reactivated around the hatch perforation. Localized section loss of 100% is present in an area measuring 1-1/2 in. length x 1/2 in. height (Photograph 8). Section loss up to 50% is present around this corrosion hole. This overall has slightly increased since the prior inspection and the corrosion continues. Painted over pitting up to 1/16 in.

maximum is present on small, isolated areas on the end plate at the east hatch. This has not changed since the prior inspection. Other items to note on the exterior include:

Photograph 8: View of 100% Section Loss Measuring 1 1/2 in. in Length at East (Compass South) Hatch Opening. Looking West.

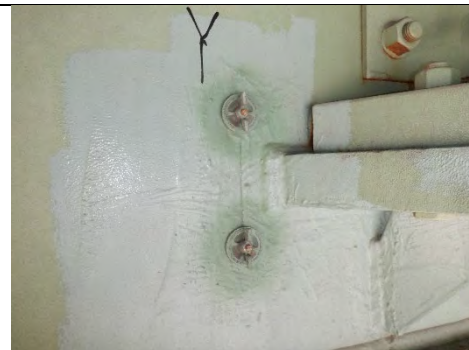
- Previous rehabilitations were performed on these pier caps. Work performed included the cap web plates being retrofit with drilled stress relief holes connected by vertical sawcuts adjacent to the welded connections of the bottom flange tie plates of the interior girders at both webs (Photograph 9), at Girder T at the east (compass south) web, and at Girder Z at the west (compass north) web. Additionally, the drainpipes were rerouted or otherwise reconfigured with the bolted connections of the drainpipe support brackets left in place (Photograph 10). These retrofits function as designed and have not changed since the prior inspection.

Photograph 9: Typical Example of Drilled Hole and Sawcut Retrofit. South Cap Web West Side of Girder Y Shown. Looking North.

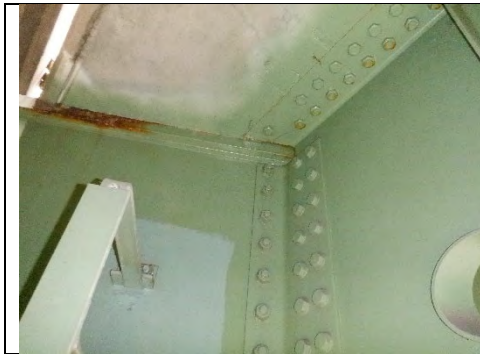
Photograph 10: General View of Bolted Drainpipe Connection in Place With Updated Drain Members and Configuration.

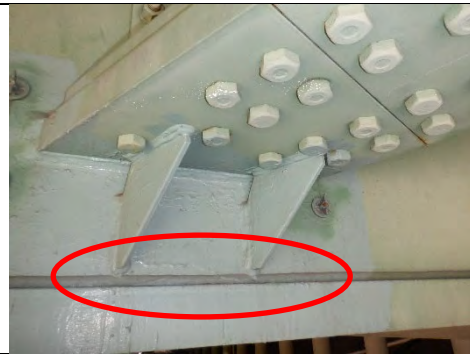
- Fillet welds between the cap north (compass east) web and knee braces below Girders X, Y, and Z intersect the groove weld along the cap web and bottom flange (Photograph 11). This is an old comment that has not changed.

Photograph 11: Typical Example of Girder Knee Brace Welds Intersecting the Cap Web To Cap Bottom Flange Weld. Looking North.
