FRACTURE CRITICAL PIER CAP INSPECTION REPORT

SFN3106780 (HAM-71-0248L)
IR-71 SB OVER EDEN PARK DRIVE AND
READING ROAD (US-42)
HAMILTON COUNTY, OH
DISTRICT 8

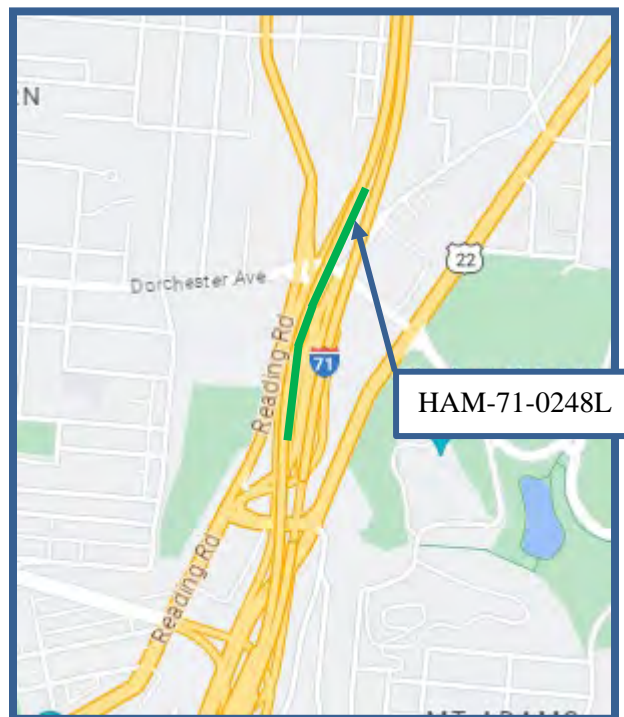
Figure 1: Bridge Location Map

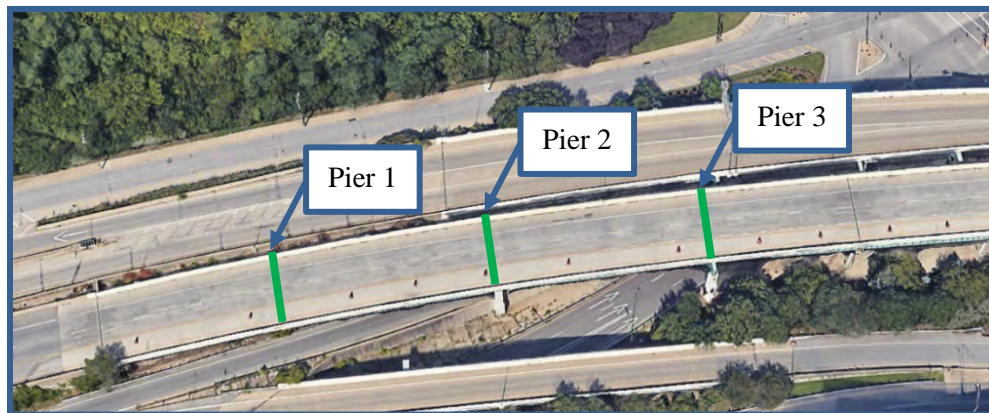
Figure 2: Fracture Critical Pier Cap Locations

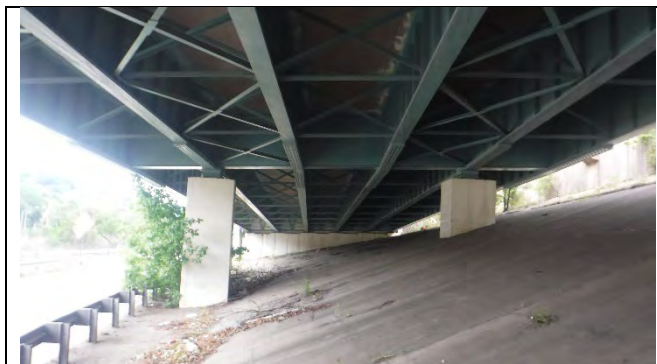
Photograph 3: General Elevation of Pier Cap 1, Looking South.

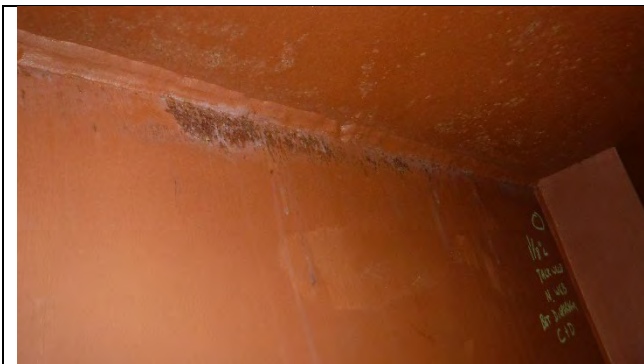
Photograph 4: Typical Example of Corrosion on Web Plates, North Web Between Diaphragms C and D Shown, Looking North.

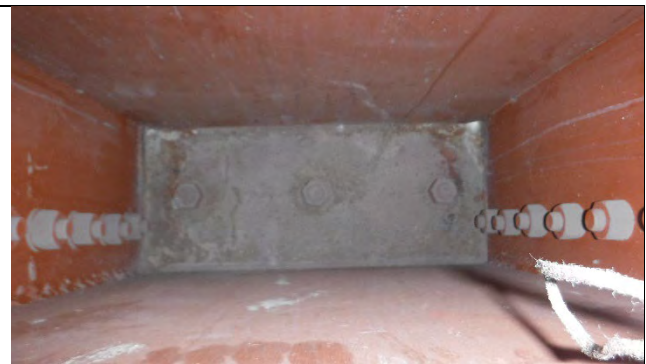
Photograph 5: Typical Steel Pitting at End of Cap, East End Shown.

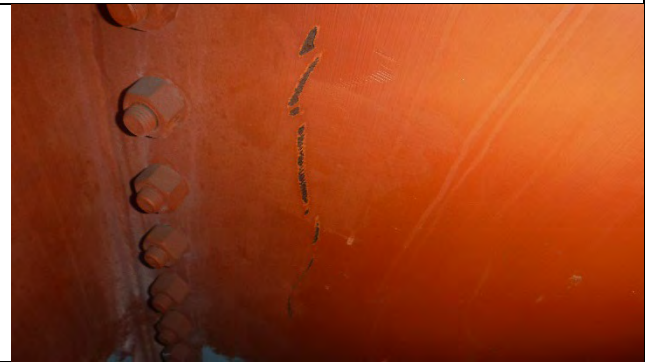
Photograph 9: Minor Grinding Scrape East of Girder D on the North Web.

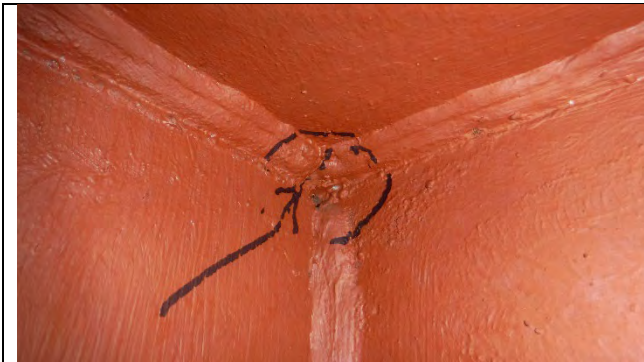
Photograph 10: Weld Porosity Between the Top Flange and the North Web West of Girder F.

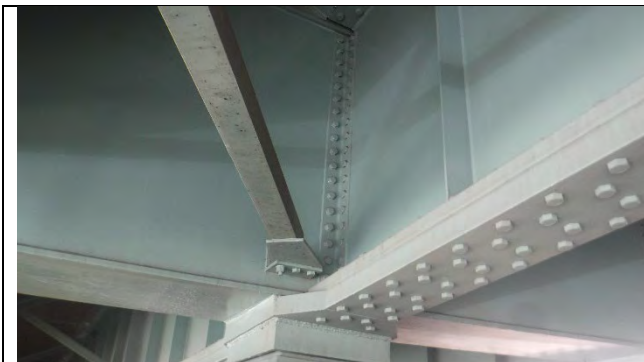
Photograph 12: Bolted connection of Web Plates to Girder A, Looking Southwest.

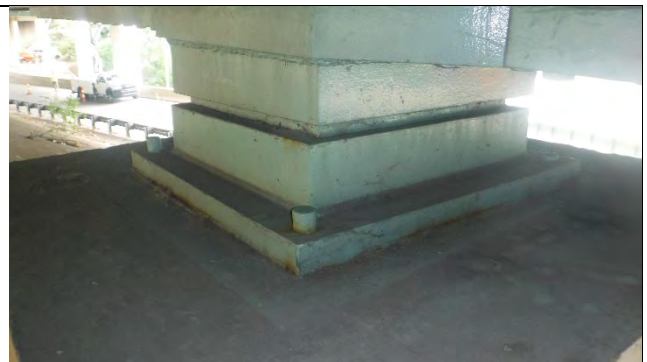
Photograph 13: Typical Example of Missing Nuts at Pier 1, West Bearing, Looking Northeast.

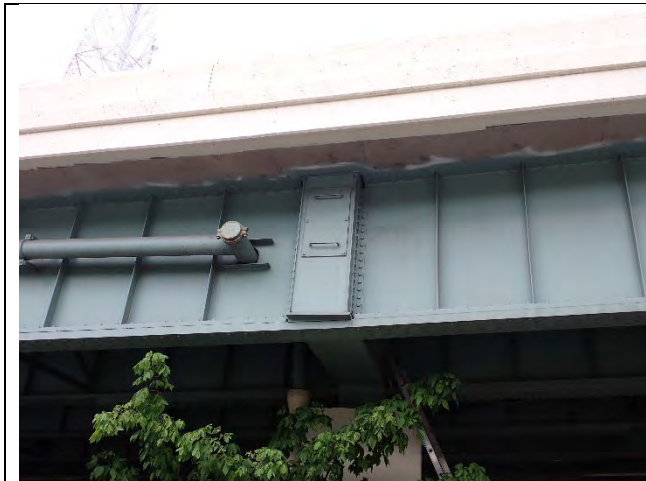
Photograph 14 (left): View of the East End Hatch, Looking West.

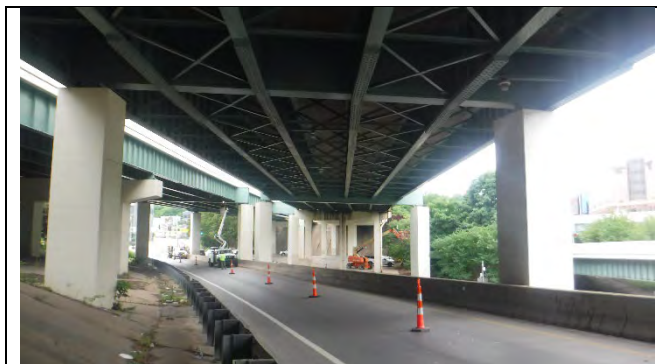
Photograph 15: General Elevation of Pier Cap 2, Looking North.

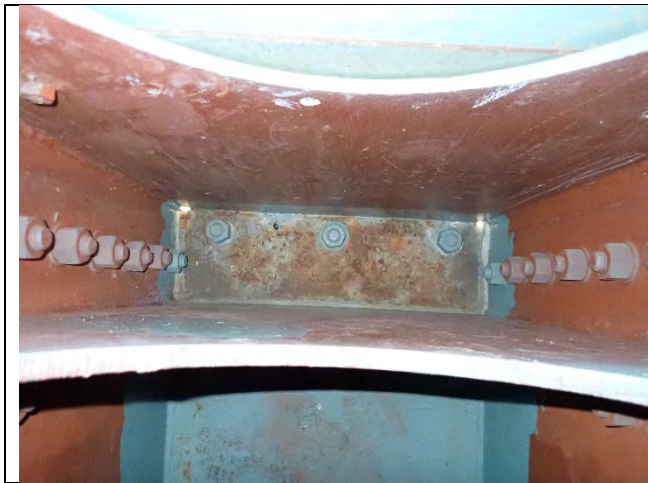
Photograph 16: Example of Corrosion Reactivating on the Bottom Flange Plate, West End Shown.

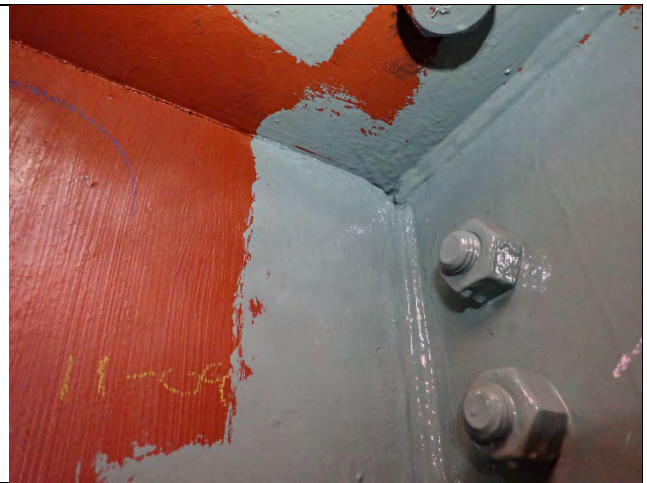
Photograph 17: Typical Example of Tight Cope at Intersecting Welds for Web Plates, Flange Plates, and Diaphragms, Looking East.

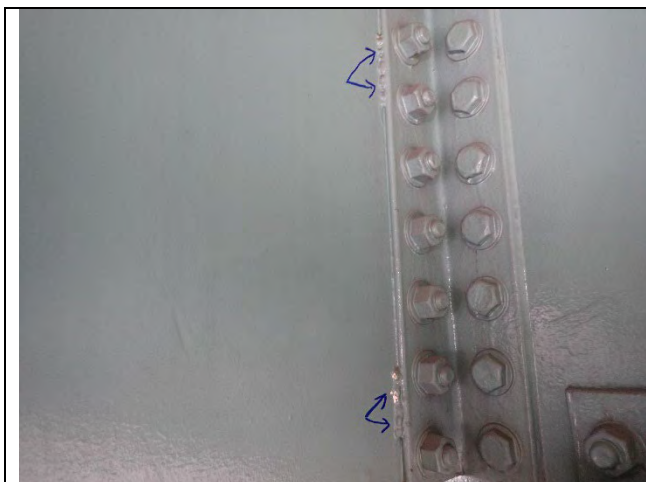
Photograph 20: View of Typical Stitch Welds on Girder to Cap Web Clip Angles., Looking South.

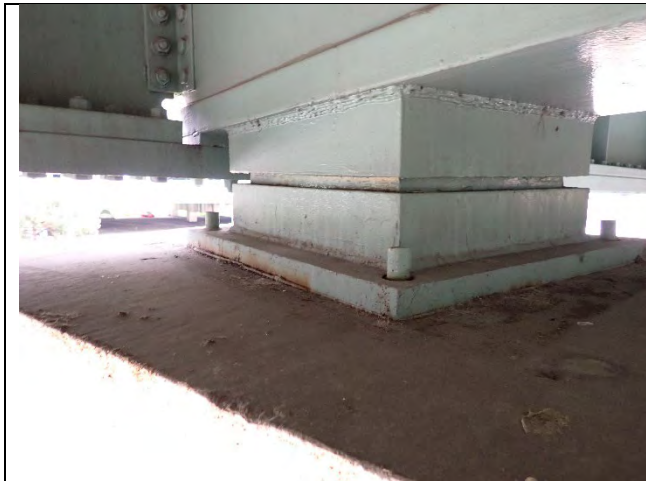
Photograph 22 (left): View of the Typical Missing Nut at the Bearing.

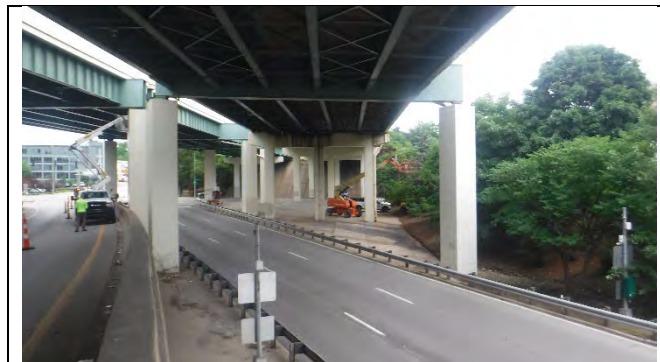
Photograph 23: General Elevation of Pier Cap 3, Looking North.

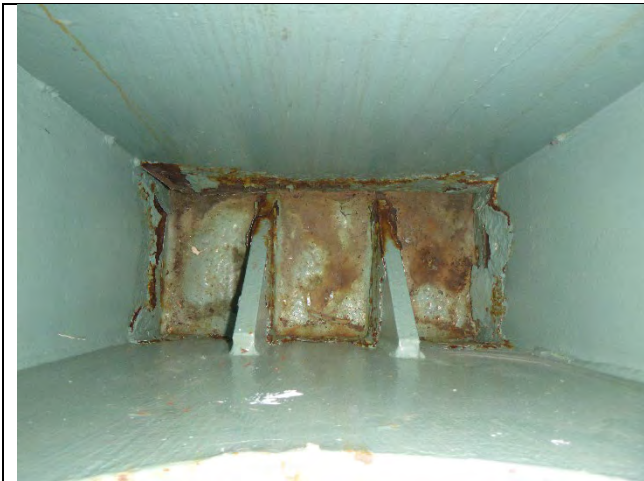
Photograph 24: Laminating Corrosion at the Ends of the Interior of the Pier Cap Has Reactivated.

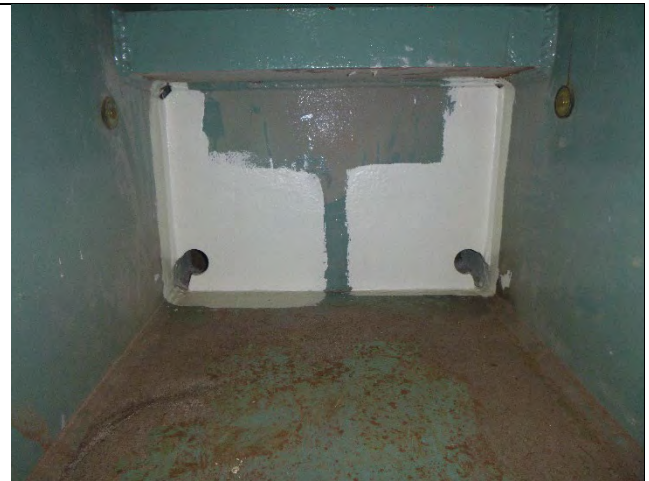
Photograph 25: Typical View of the Coped and Painted Drilled Hole Retrofits at Lower Corners of Diaphragms and Bottom Flange Plate.

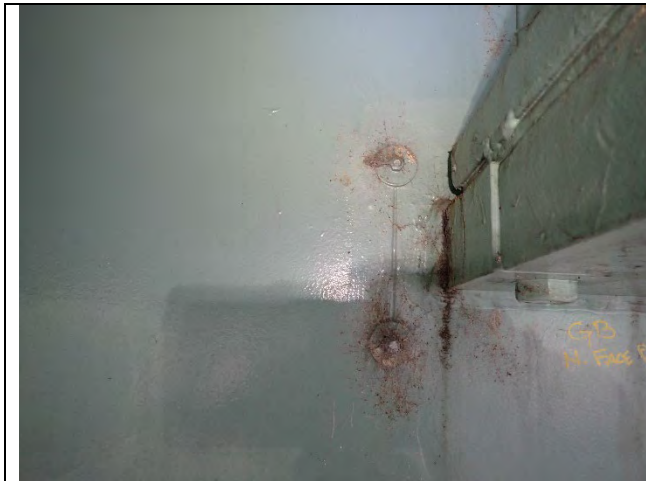
Photograph 26: View of the Typical Drilled Hole Retrofit, North Web Face at Girder B Shown, Looking South.

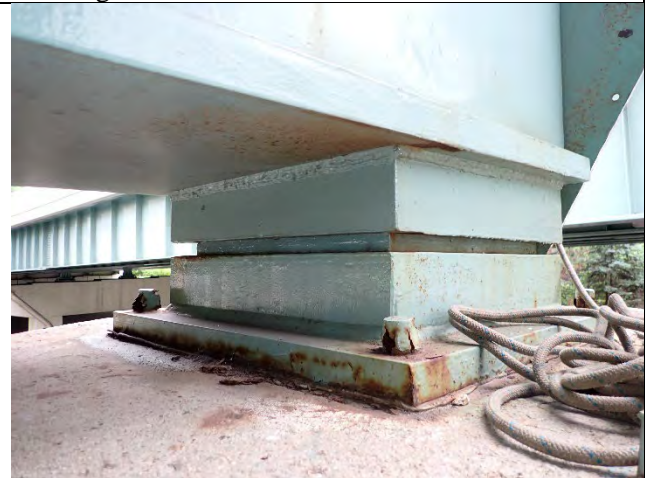
Photograph 29: View of the Typical Bearing Conditions, Looking West.

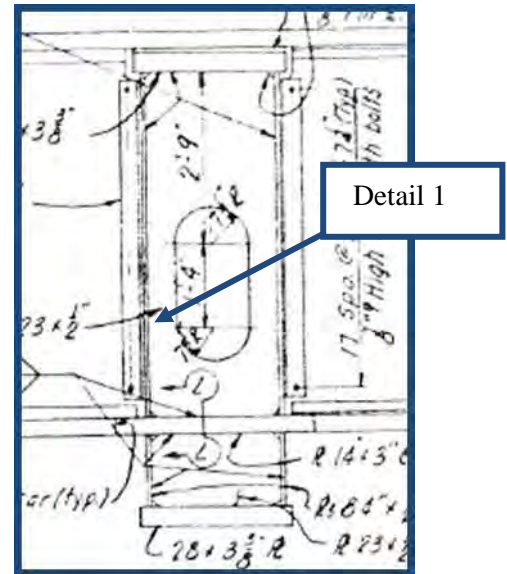
Figure 7: Section of Pier
Cap 3

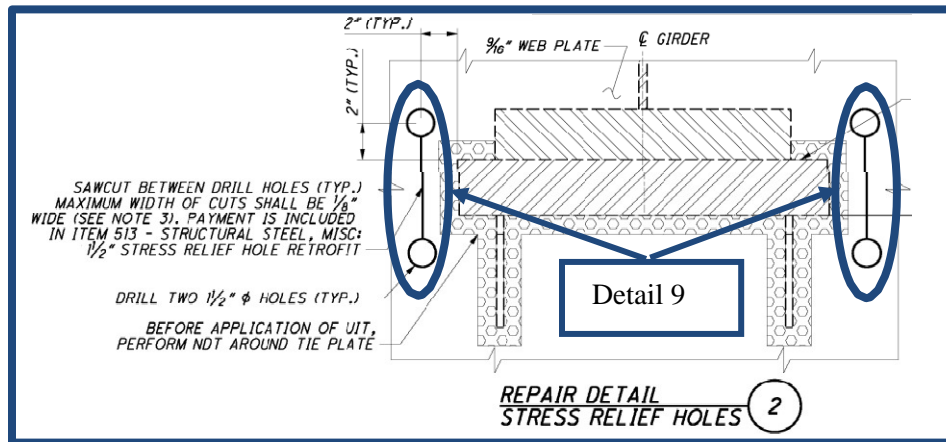
Figure 8: Web Plate Retrofit on Pier Cap 3

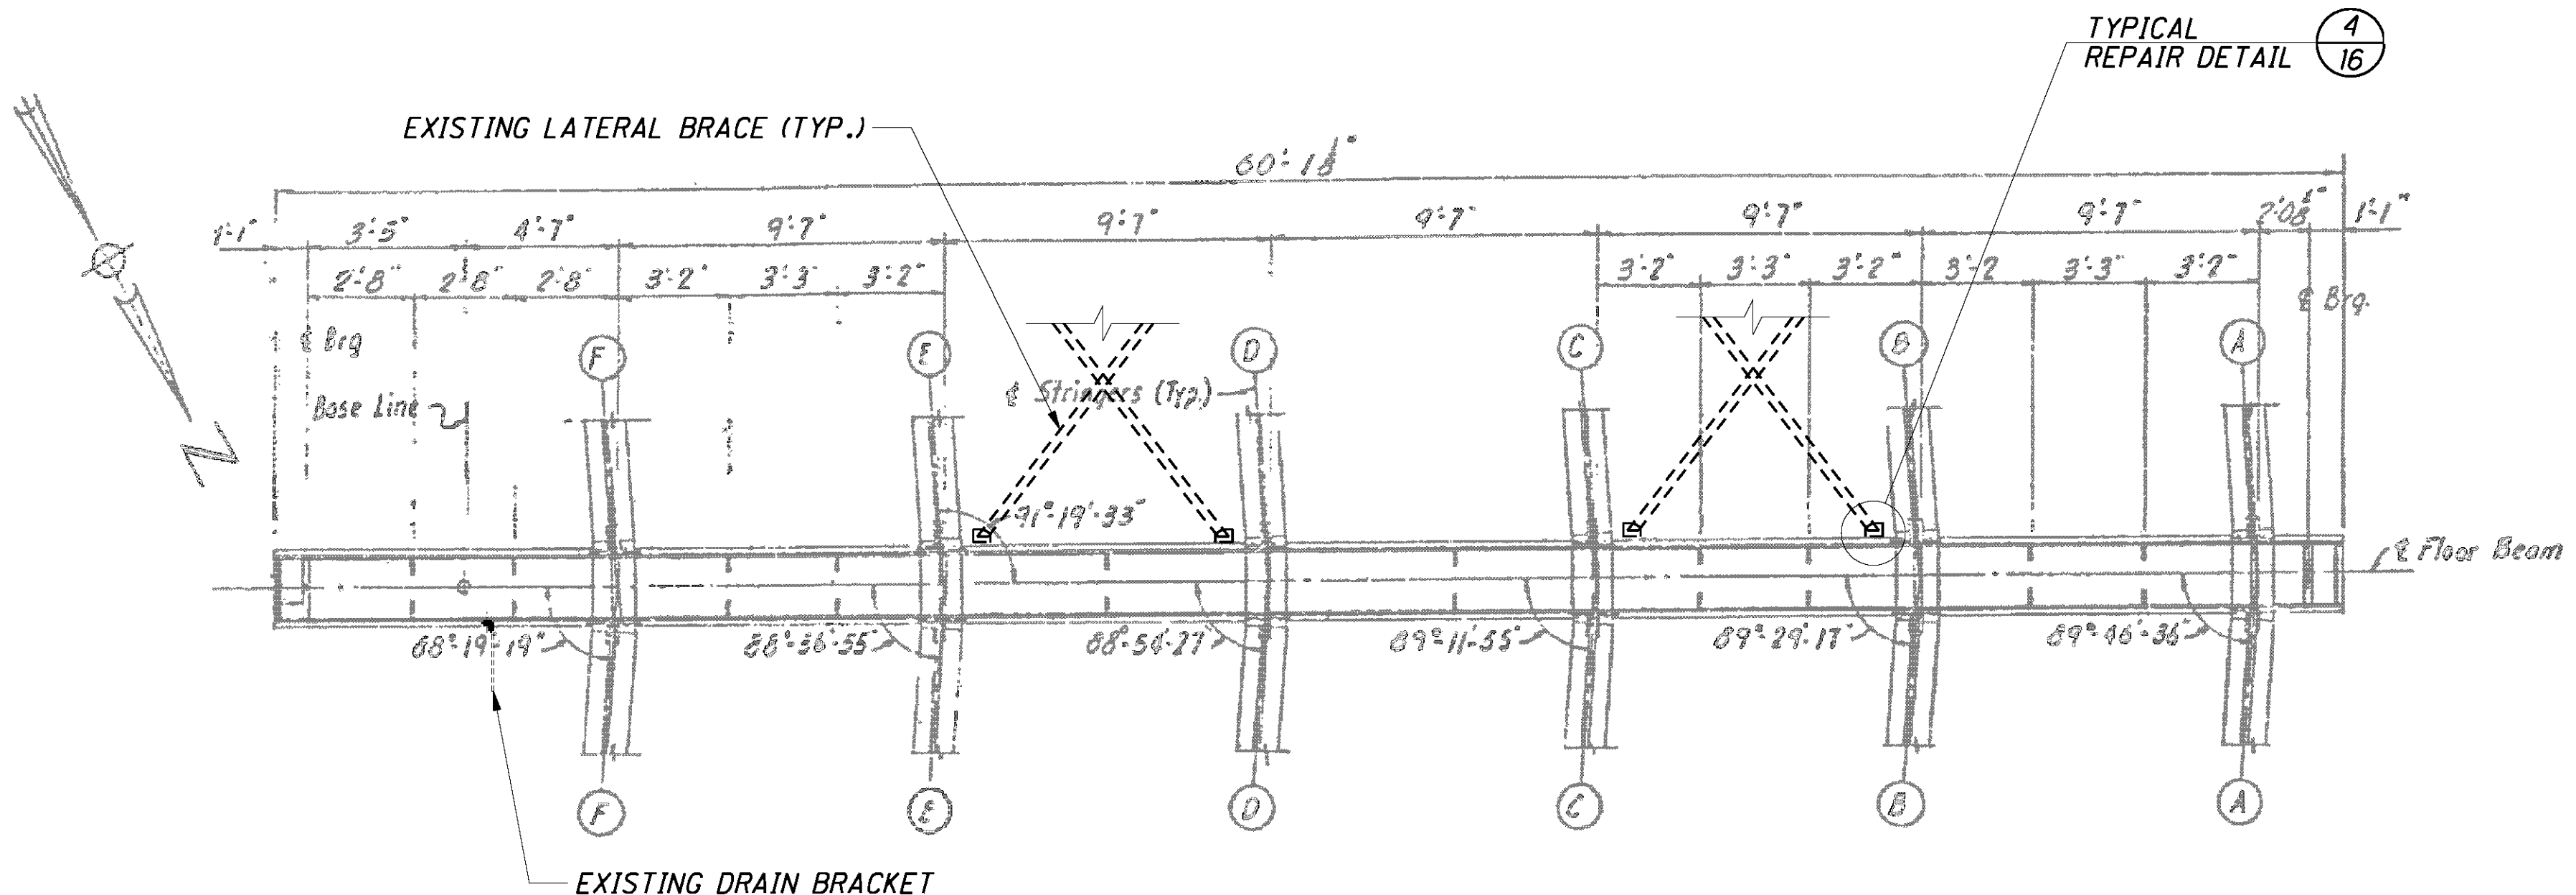
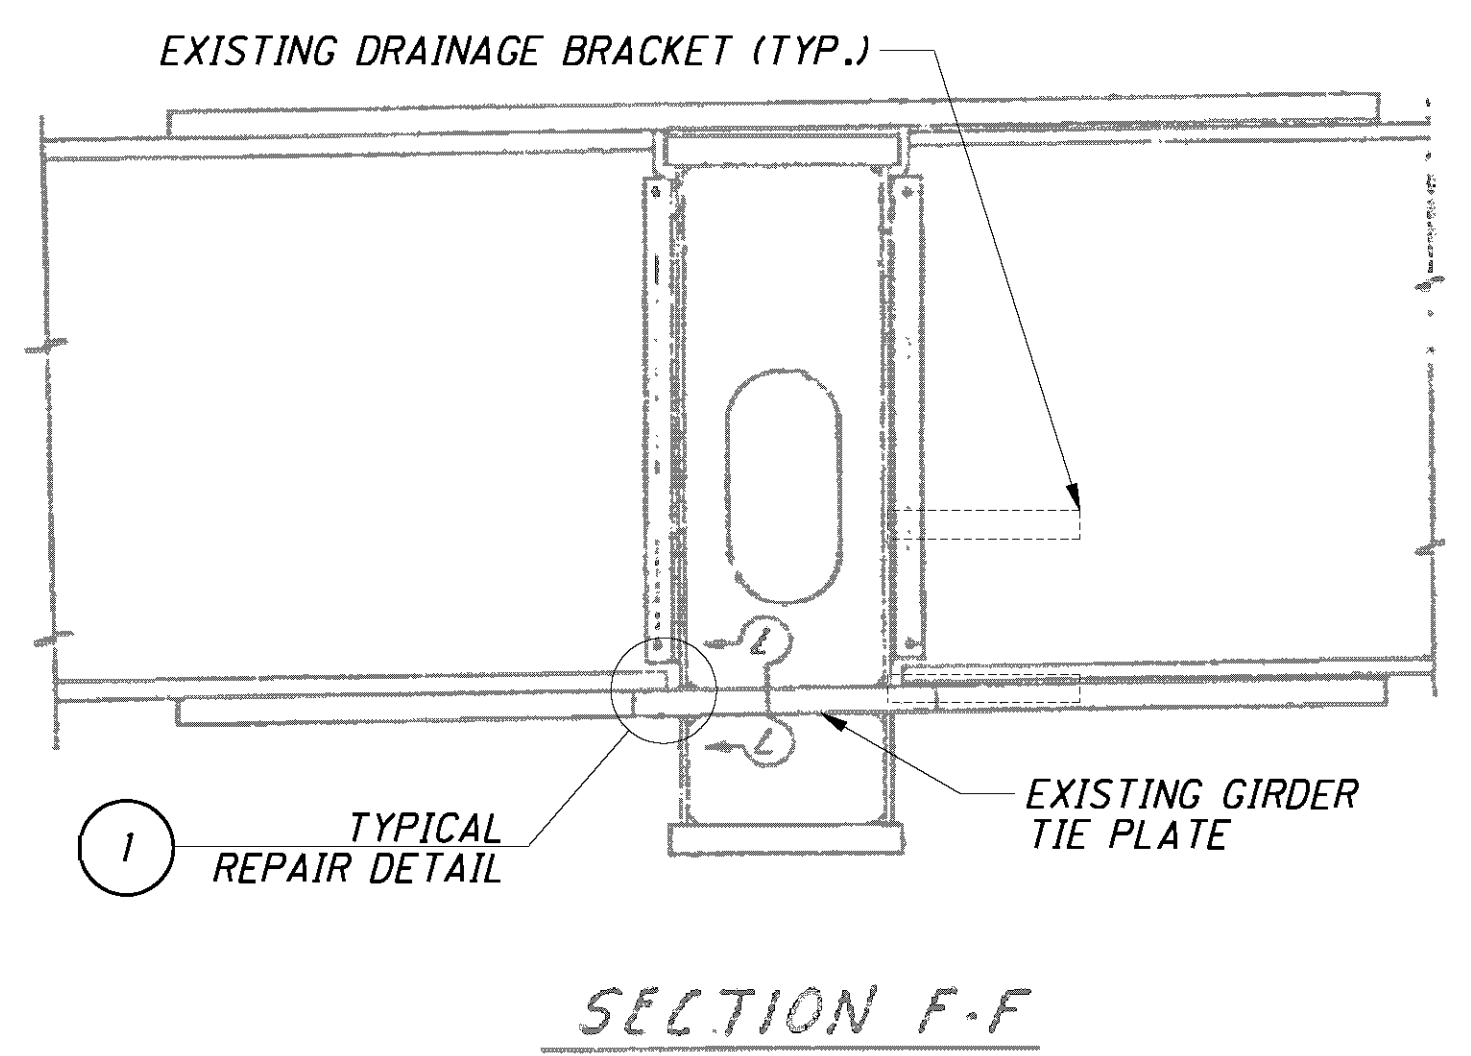
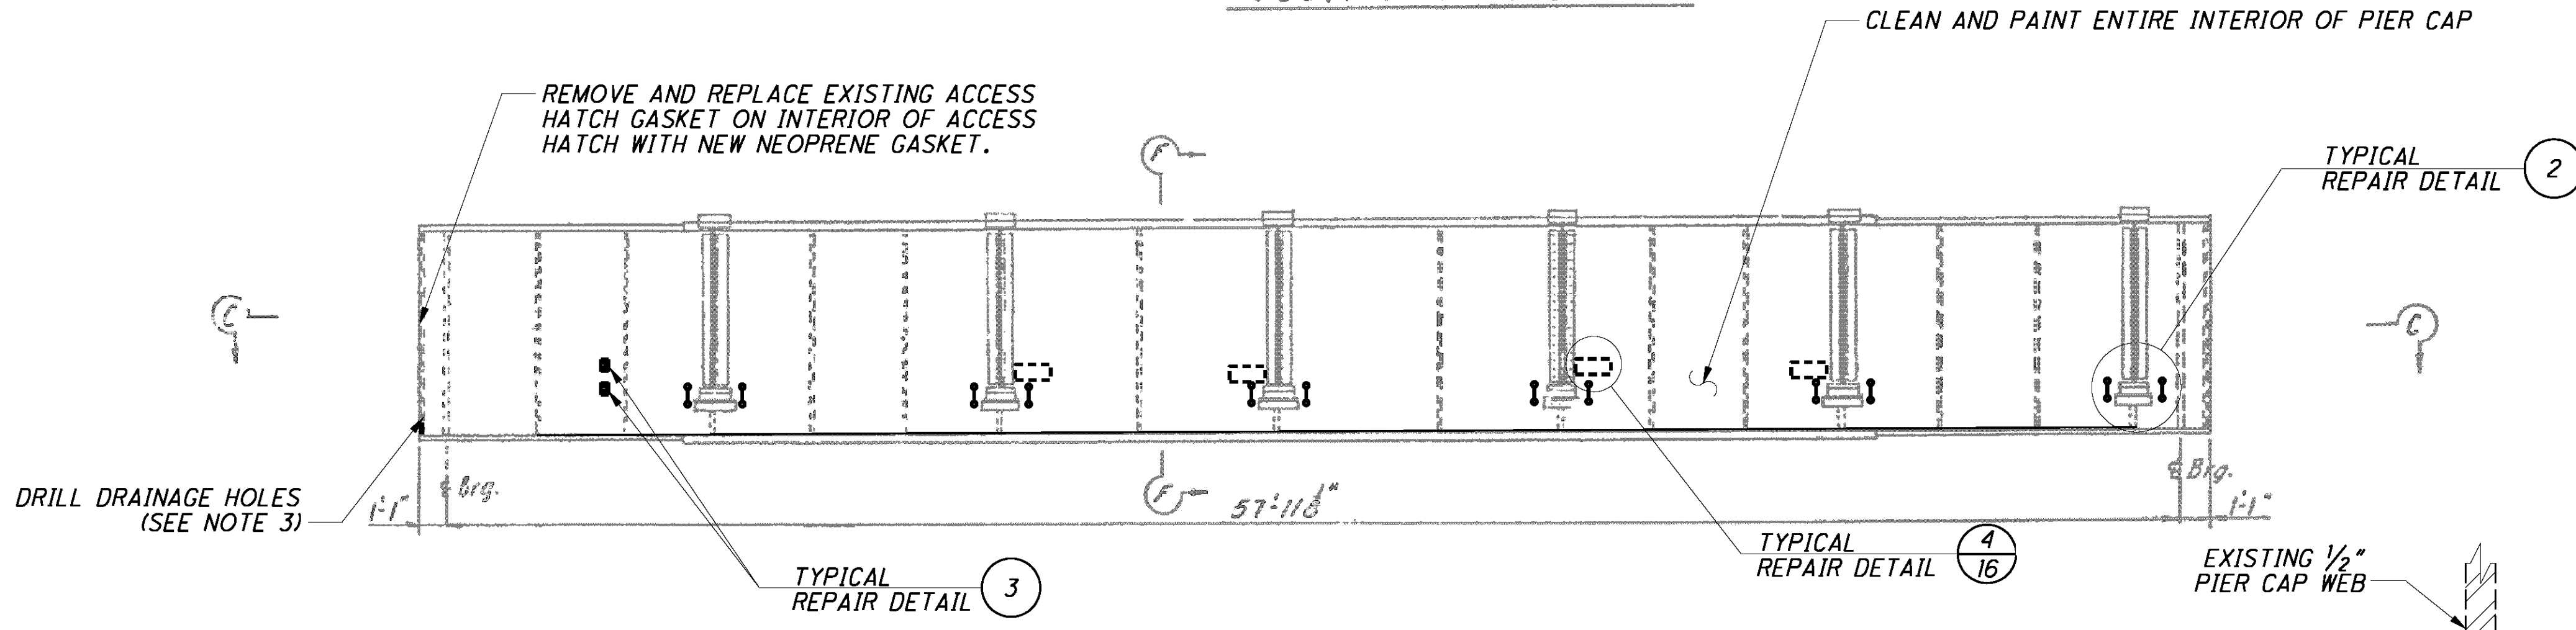
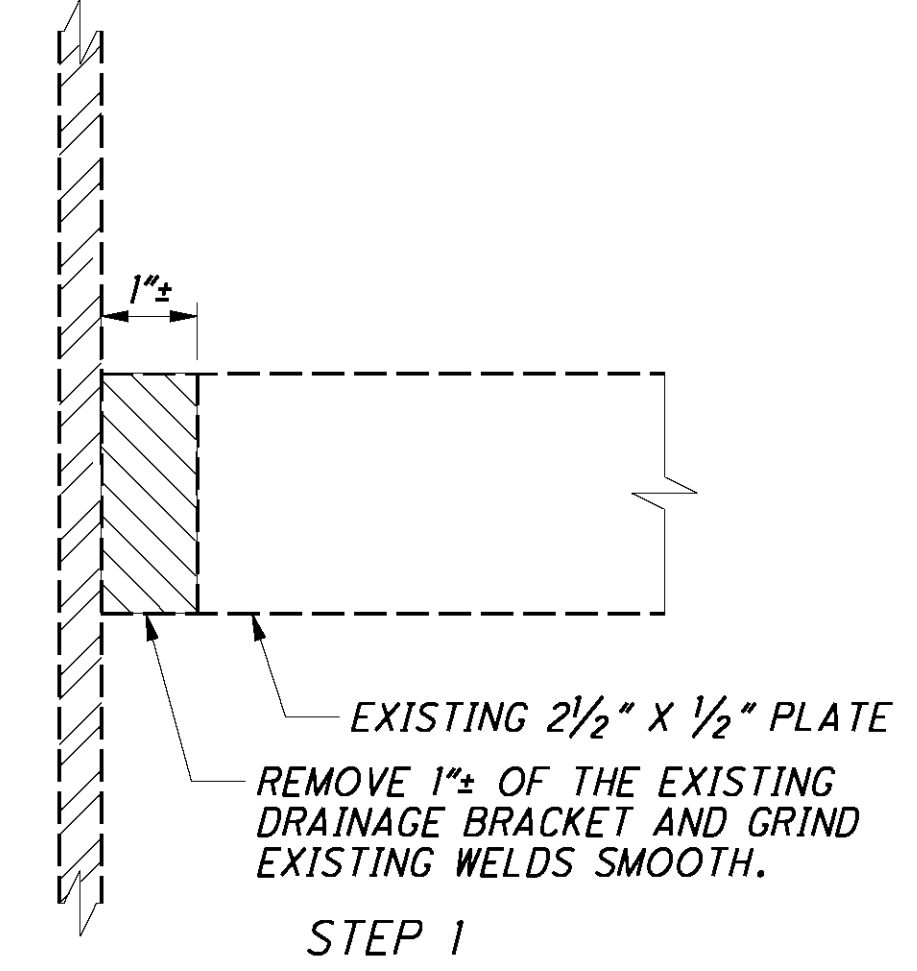
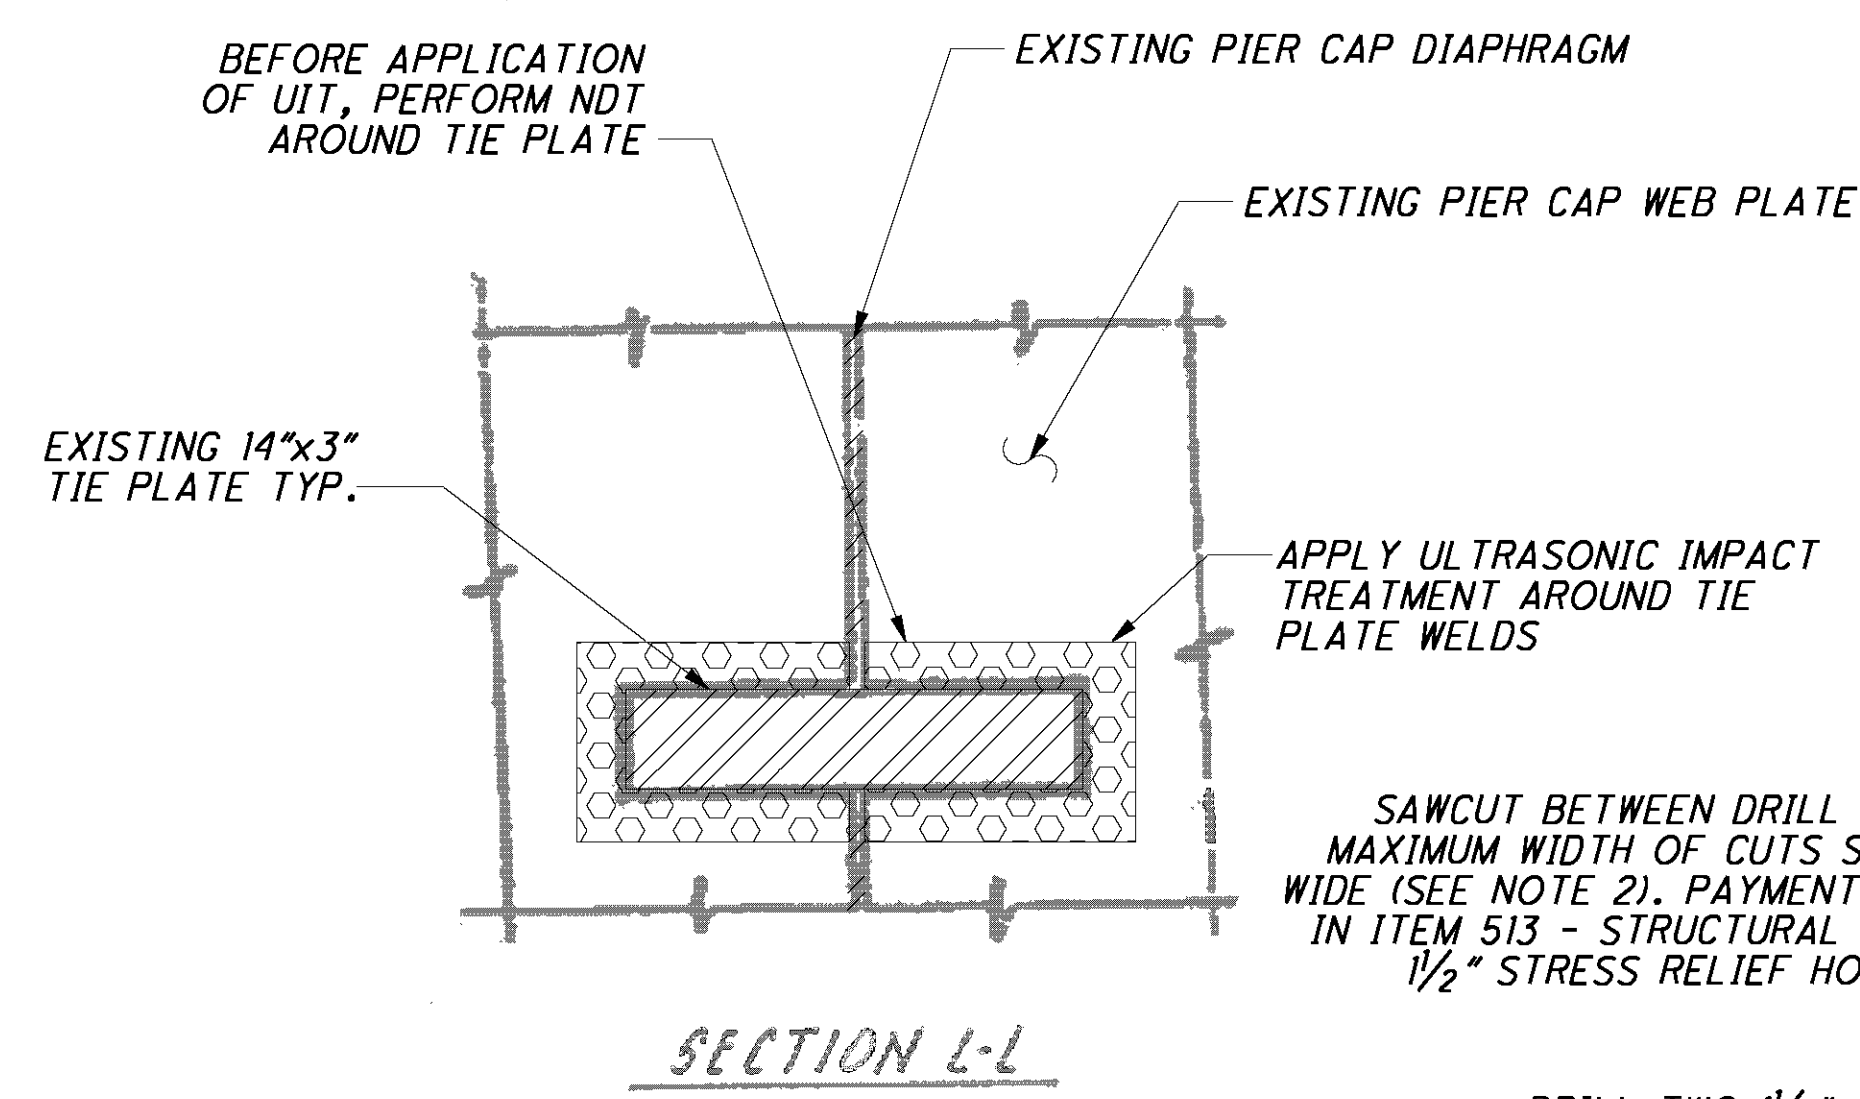
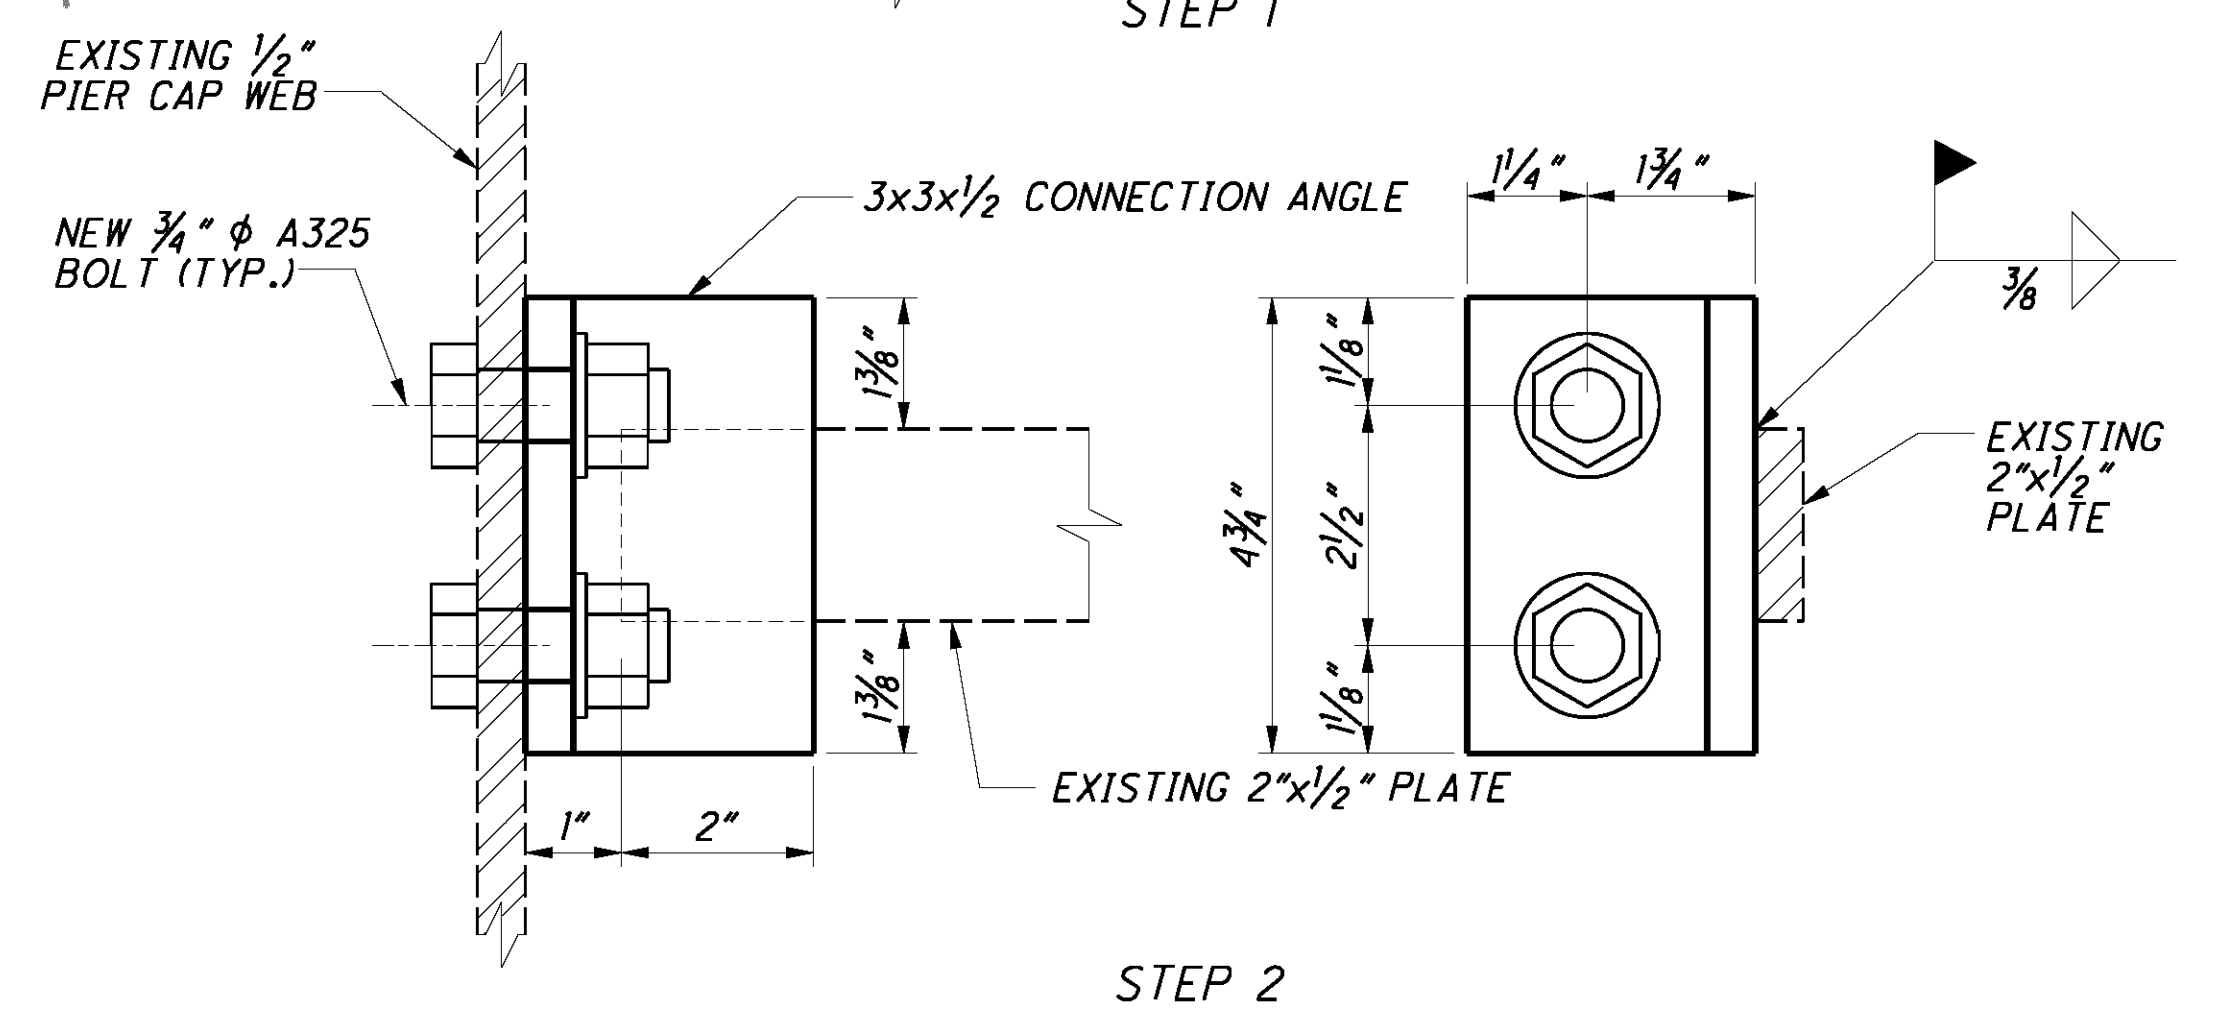
REPAIR DETAIL 1
 INTERIOR TIE PLATE TREATMENT

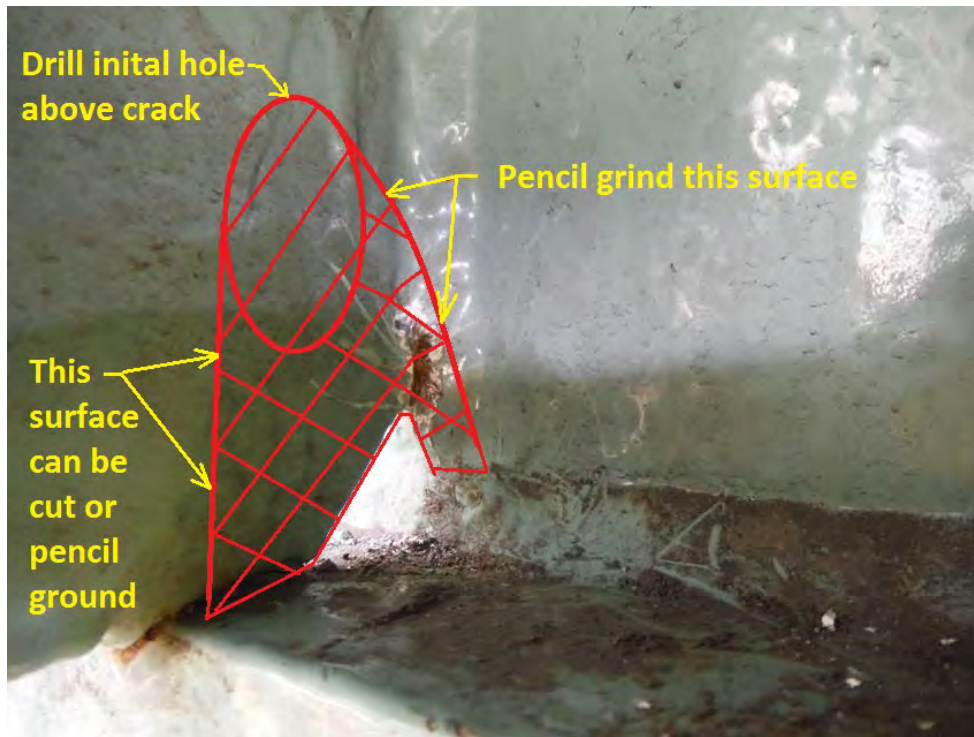
1. ITEM 513 – MISC. 2" STRESS RELIEF HOLE RETROFITS will be non-performed at all three caps since the plates that would be drilled are discontinuous and only welded on the vertical leg.
2. The location of the cracked fillet weld in Pier Cap 2 is shown correctly on sheet 275. A more desirable method of repair is depicted below:

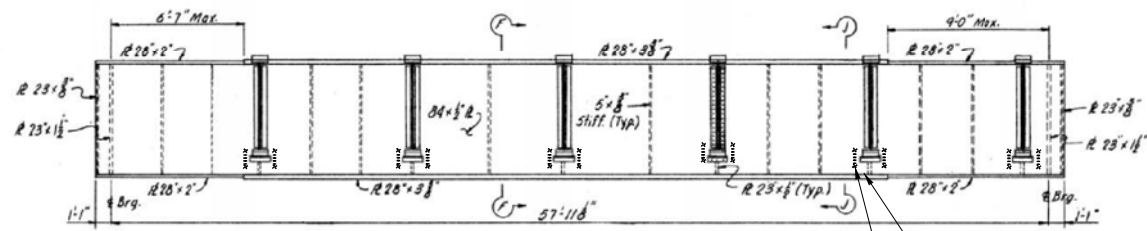
PIER CAP ELEVATION
PIER 3

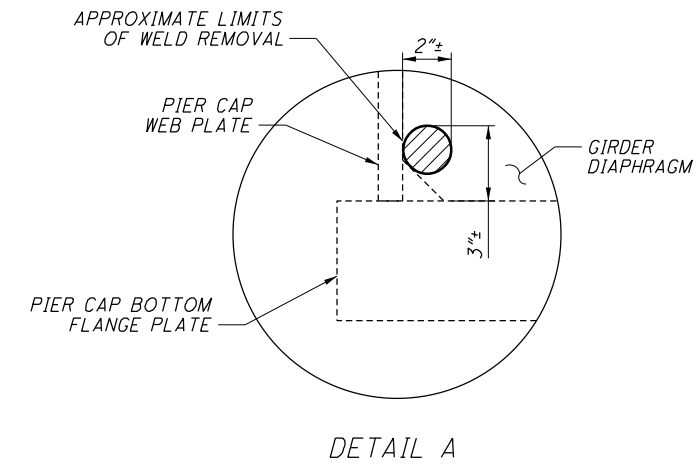
EXISTING STRESS RELIEF RETROFIT LOCATIONS (DOG-BONE REPAIRS) DONE PREVIOUSLY.

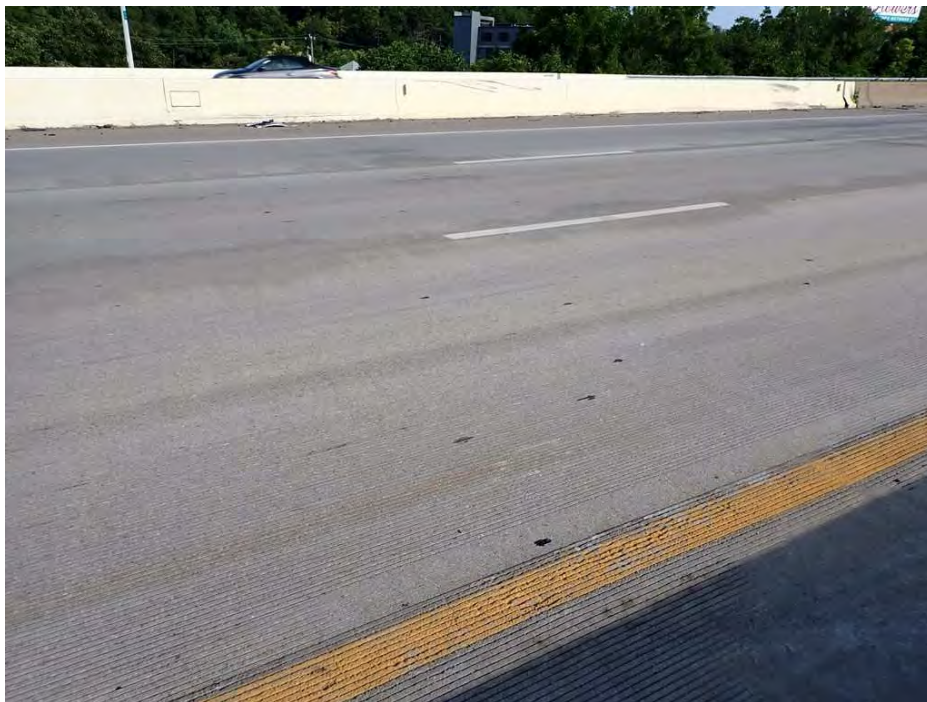
Description Span 5 underview looking north.

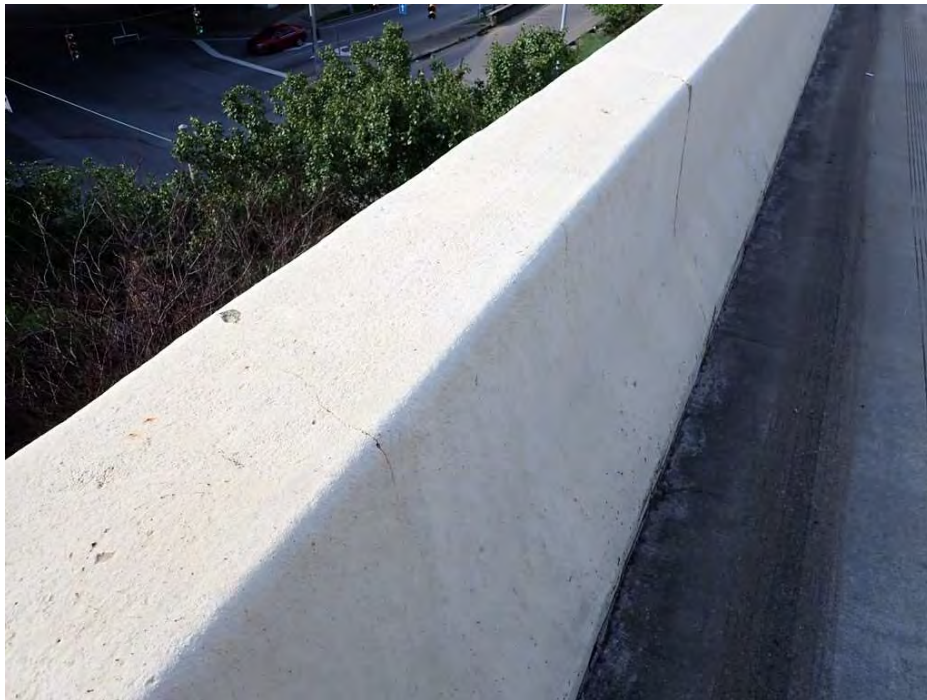
Description View of south joint. Note debris impactation in the joint.

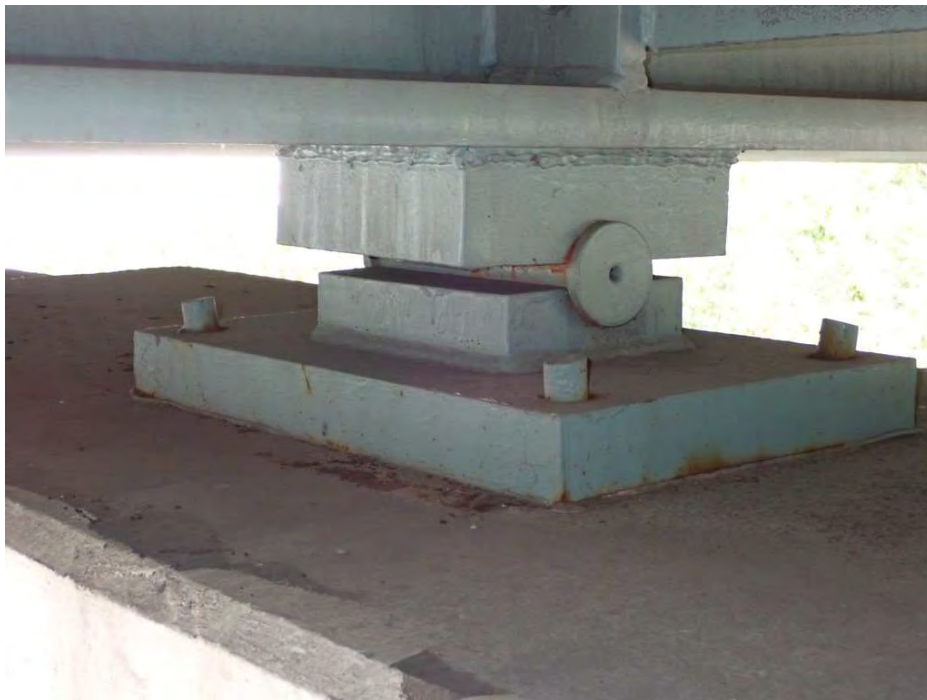
Description View of Span 4, east web of Girder F near Pier 4. Note the painted over 3" diameter corrosion hole in the bottom of the cross-frame bracing angle.
