# FRACTURE CRITICAL PIER CAP INSPECTION REPORT

SFN3106802 (HAM-71-0248R)  
I-71 NB OVER FLORENCE AVENUE AND  
EDEN PARK DRIVE  
HAMILTON COUNTY, OH  
DISTRICT 8

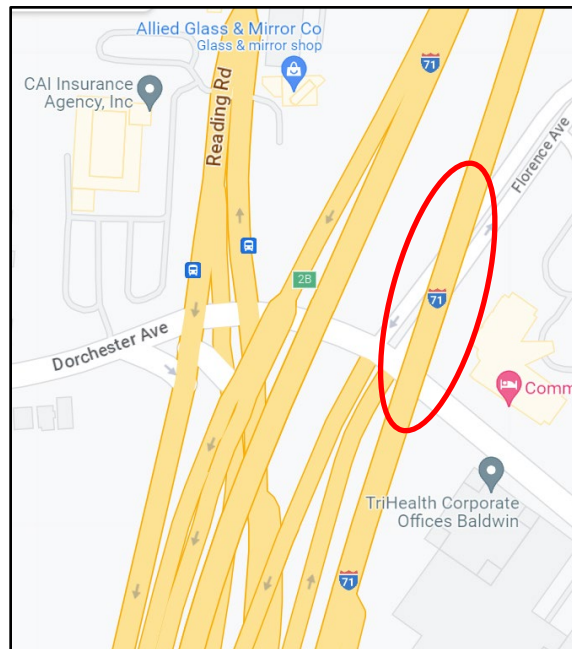
*Figure 1: Bridge Location Map*

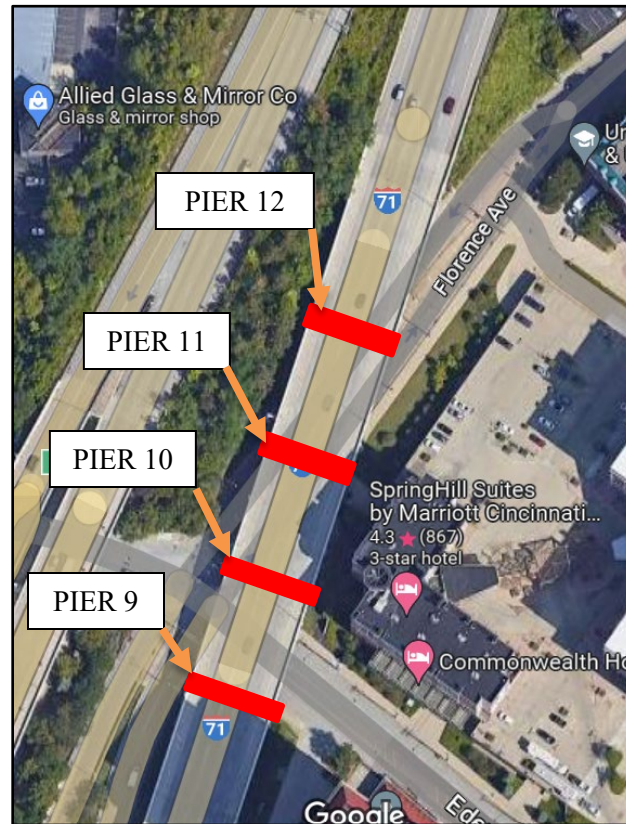
Figure 2: Fracture Critical Pier Caps Locations

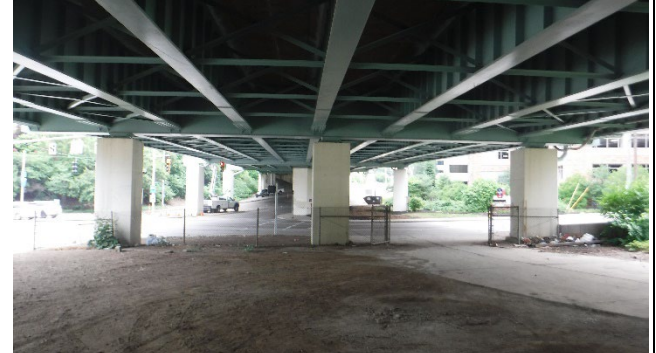
Photograph 2: General View of Superstructure, Looking North From Pier 9.

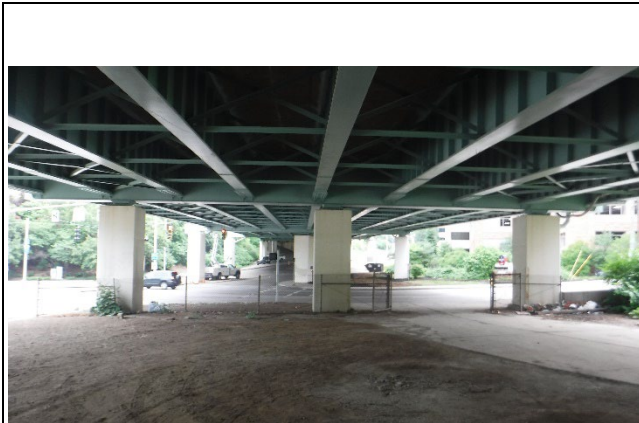
Photograph 3 – Overall View of Pier 9, Looking North

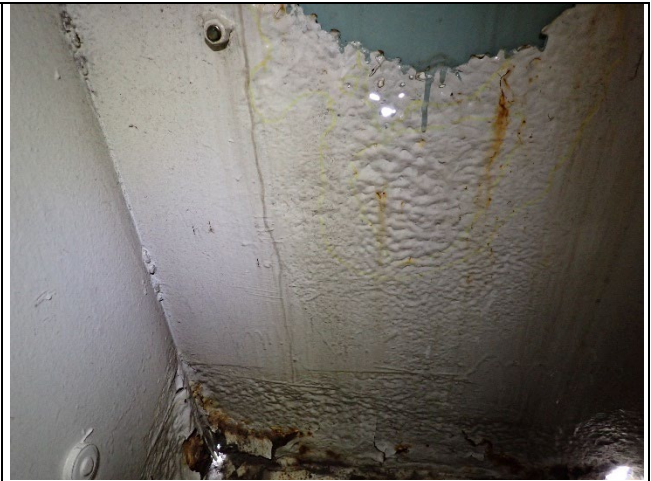
Photograph 4 – View of 3 Corrosion Holes Present at the West end of the Cap Plate.

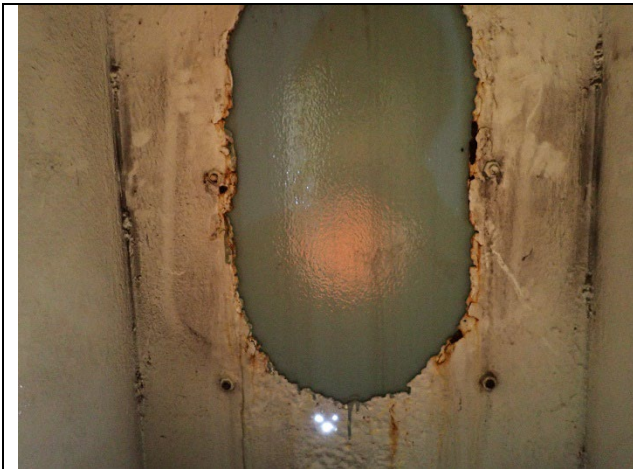
Photograph 5 – View of Knife Edging And Reactivating Laminating Corrosion Around West Hatch

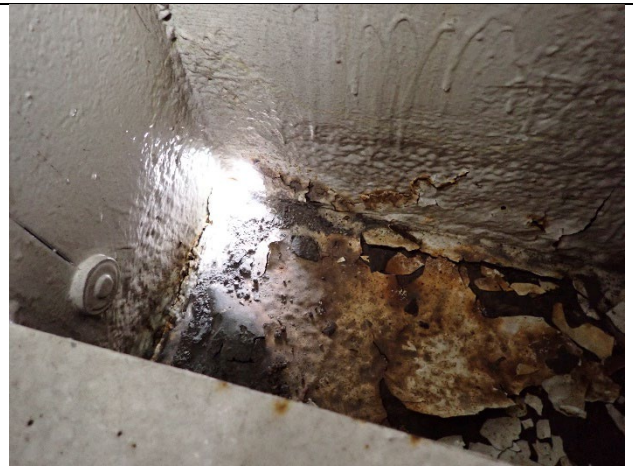
Photograph 6 – View of Laminating Corrosion On The Bottom Plate at the West Hatch

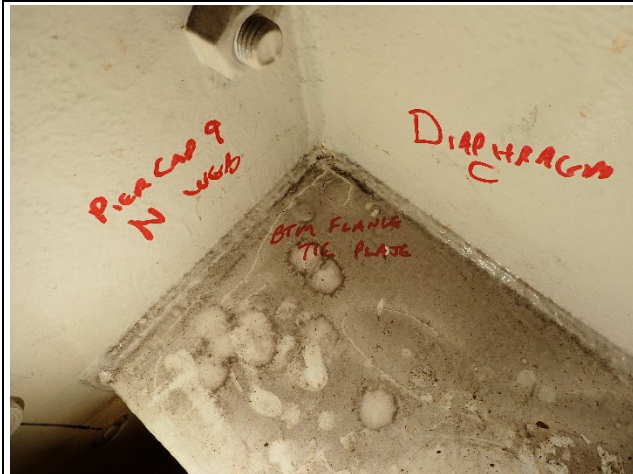
Photograph 7 – General Example of Triaxial Weld Connection. North Cap Web at Diaphragm C, West face shown.

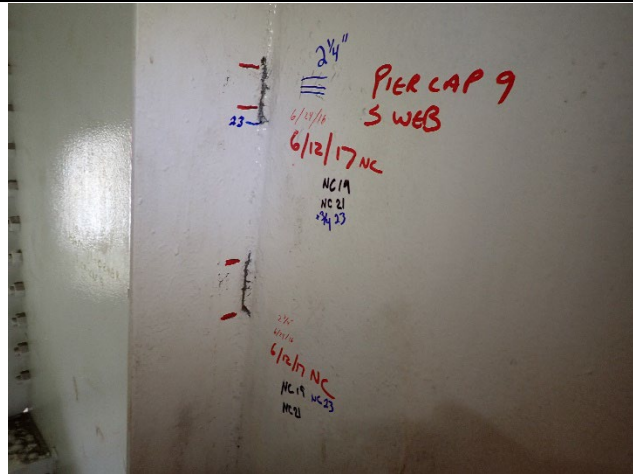
Photograph 8 – Overall View of Two Cracks On South Cap Web Plate Weld to Stiffener, On West Face of Stiffener Between Girder J and East Bearing.

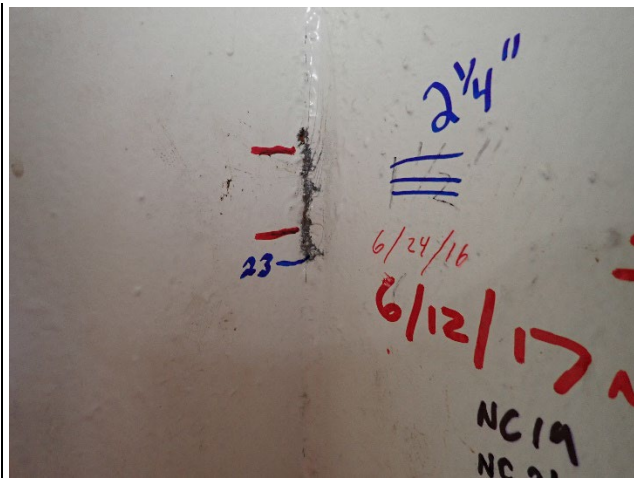
Photograph 9 – Close Up View of Upper Crack For Photograph 8, Note Crack Has Grown 3/4 in.

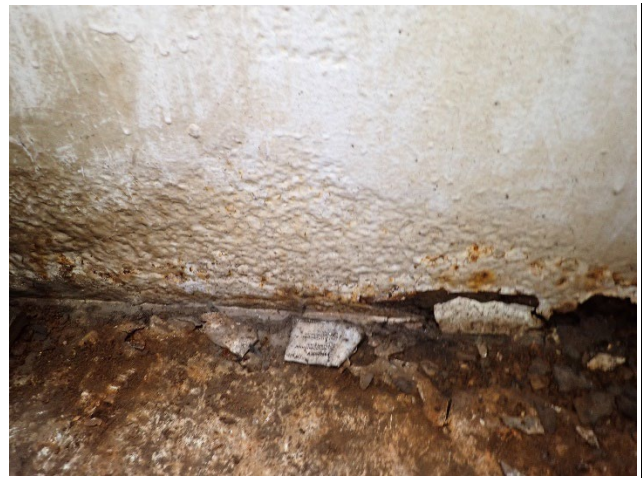
Photograph 10 – View of Painted over Pitting Up To 1/16 in. Deep with Reactivating Laminating Corrosion between the east hatch and Girder J diaphragm.

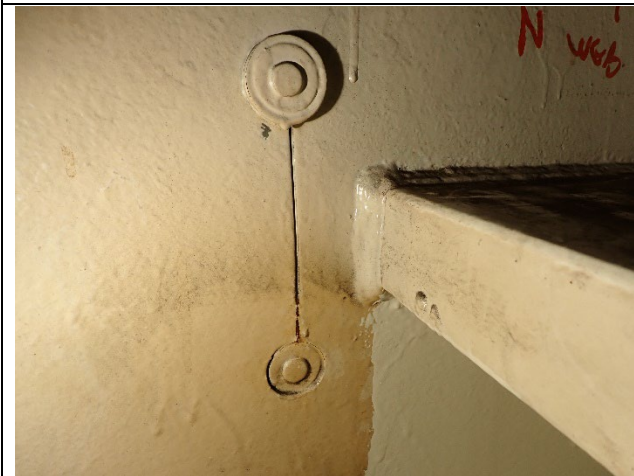
Photograph 11 – View of Missing Gasket On North Cap Plate At West Face of Diaphragm C.

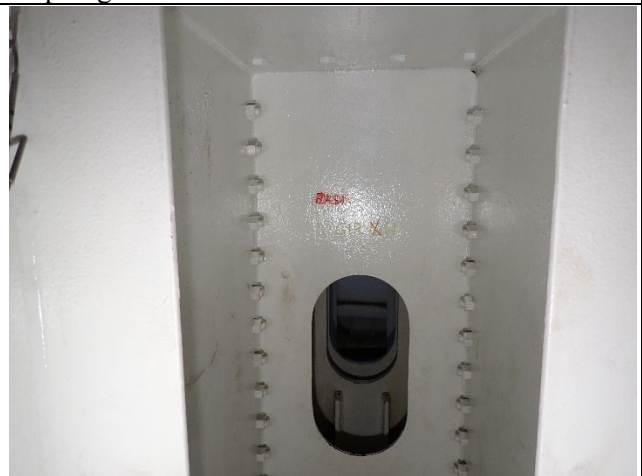
Photograph 12 – Typical Diaphragm Configuration, West Face of Diaphragm H Shown.

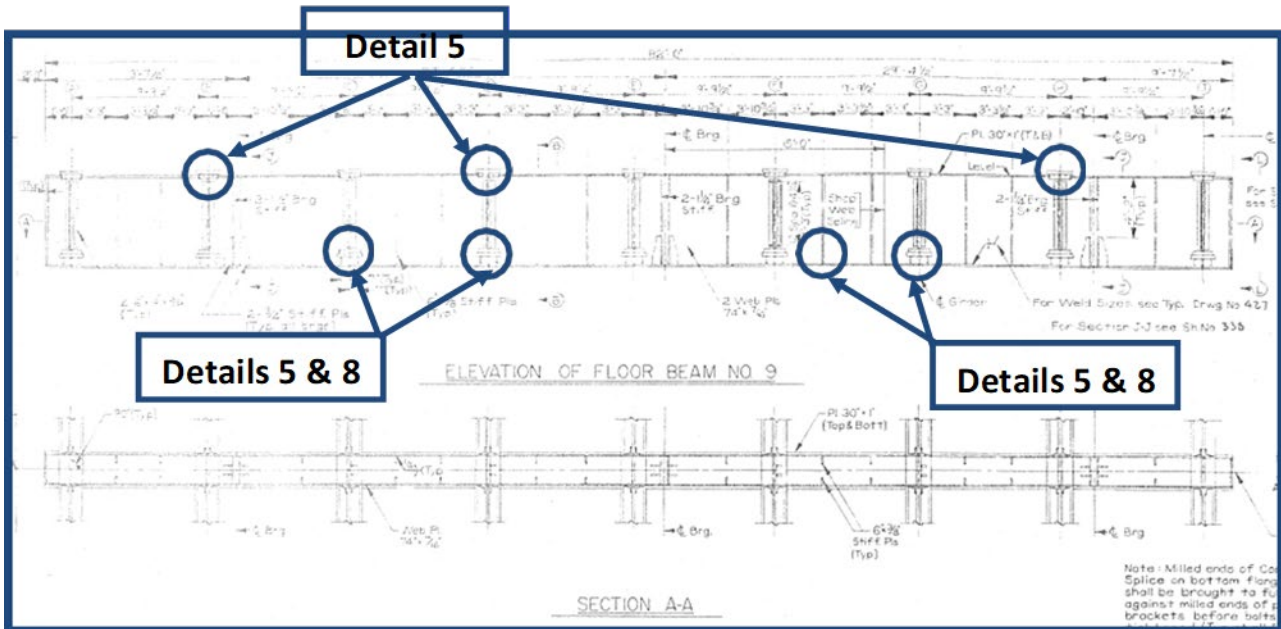
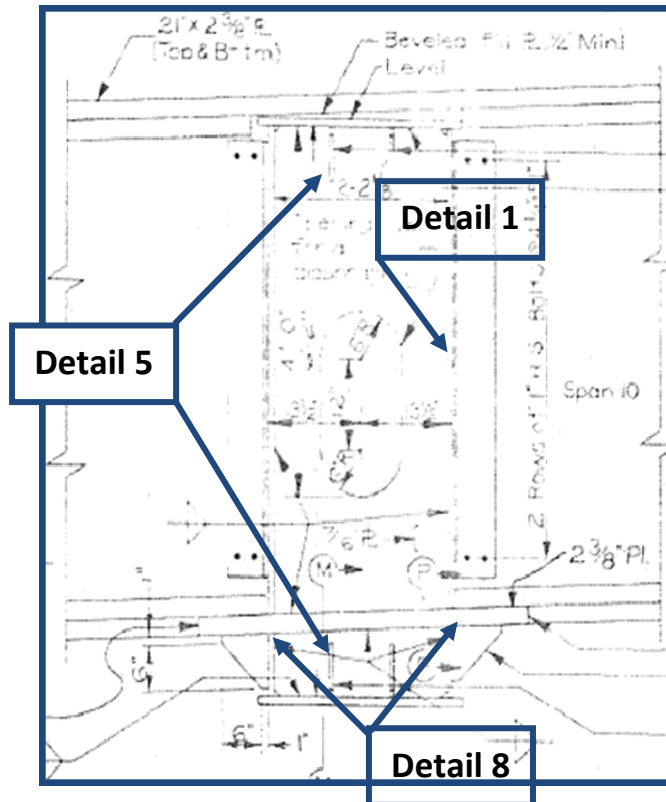
Section of Pier Cap 9

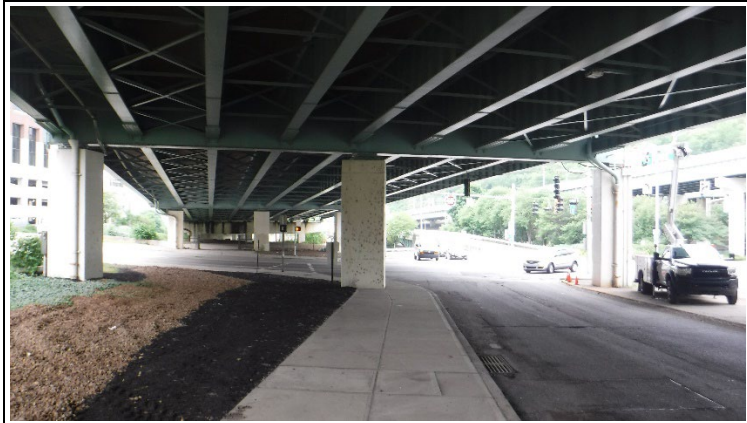
Photograph 21 – Elevation view of Pier Cap 10 looking South

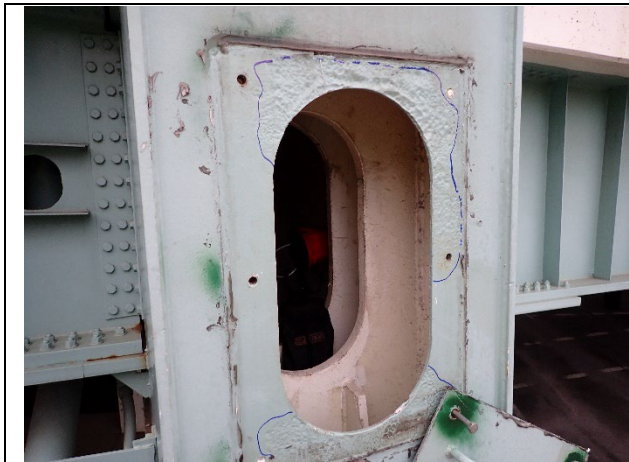
Photograph 22 – View of Painted over Pitting on West End Plate, looking East.

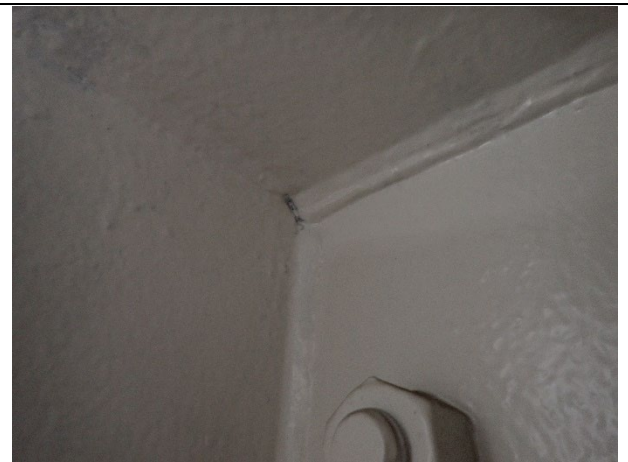
Photograph 23 – View of Top West Corner of Diaphragm D, South Cap Plate. Note Typical Triaxial Weld

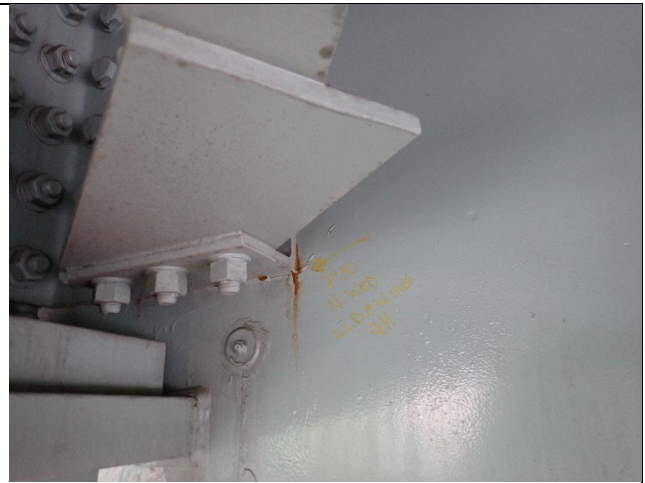
Photograph 29 – View of Minor Fretting Corrosion Between the Bolted Connection on the North Web and Lower lateral Bracing on the East Side Girder G.

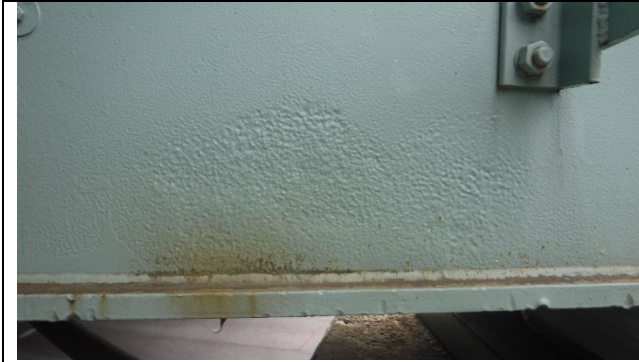
Photograph 30 – View of the 2 ft Wide x 8 in High Area of Surface Corrosion and Painted over Pitting of 1/16in Deep on The South Cap Plate And Edge Between Girder A and the West Bearing.

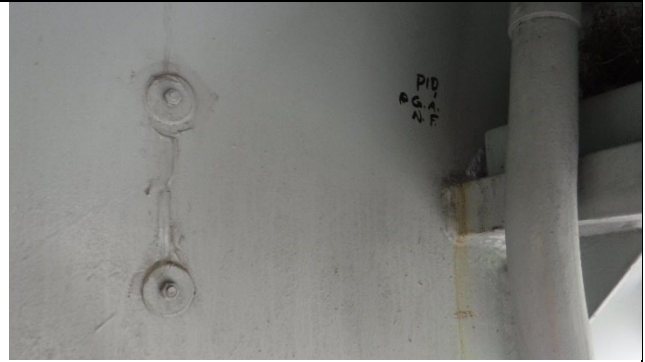
Photograph 31 – View of the Drilled Holes and Sawcut Retrofits Installed 13 in. away from Bottom Flange Tie Plates. Girder A South Side Shown.

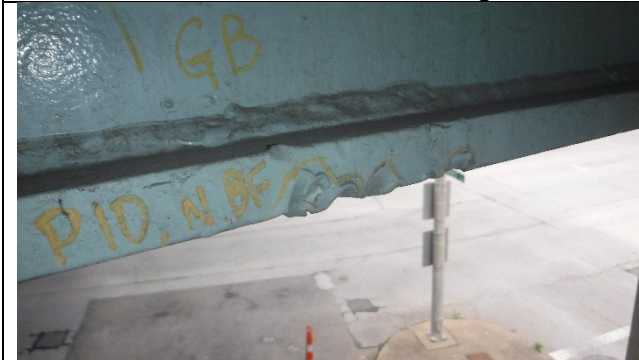
Photograph 32 – View of the 4 in. Long x 1 in Wide Gouge on the Bottom Flange of the North Side of the Pier Below and West of Girder B.

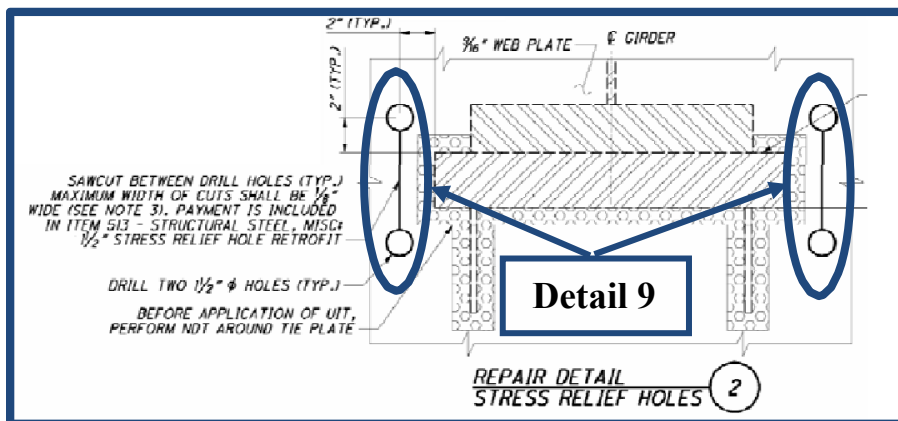
Web Plate Retrofit on Pier Cap 10

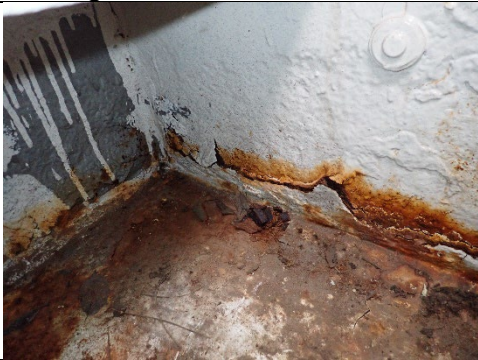
Photograph 45 – View of Reactivating Corrosion and Section Loss on Bottom Cap Plate at West End.

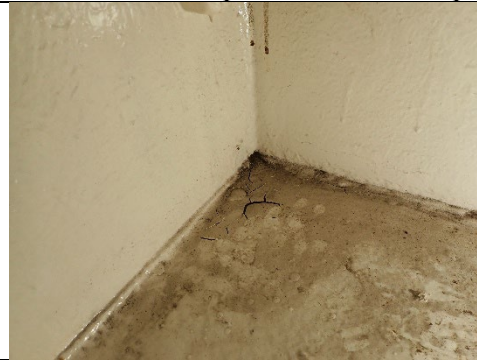
Photograph 46 – General Example of Triaxial Welds at Intersection of Tie Plates, Cap Plates, and Diaphragms. Diaphragm E South Cap Plate, East Side Shown.

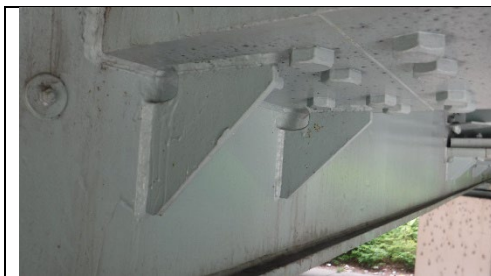
Photograph 51 – General Example of Retrofits to Pier Cap. North Side Girder E Shown.

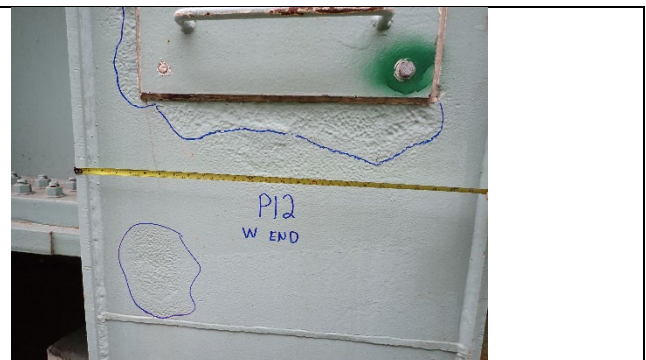
Photograph 52 – View of Painted Over Pitting Below The West Hatch on the End Plate.

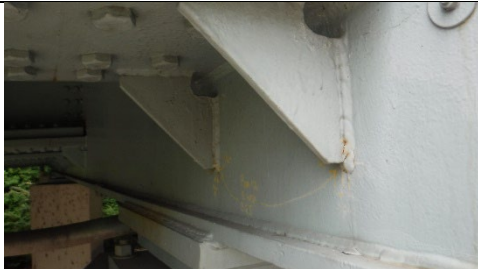
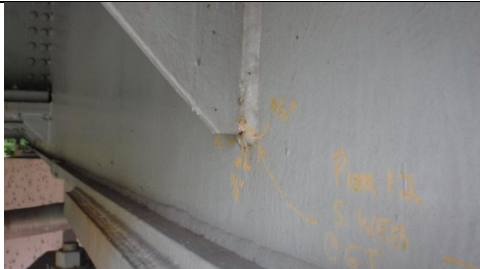
Photograph 53 – View of Cracks To Base of Knee Brace of Girder J, South Cap Plate. Note No Change, Both Legs Shown.	Photograph 54 – View of Cracks To Base of Knee Brace of Girder J, South Cap Plate. Note No Change, West Leg Shown.

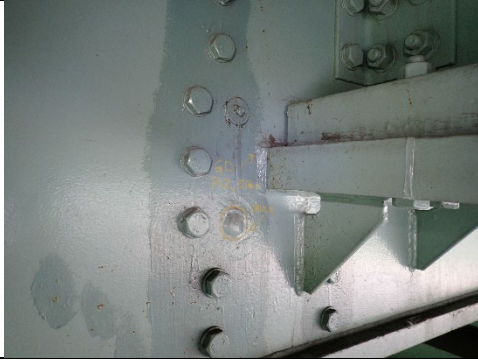
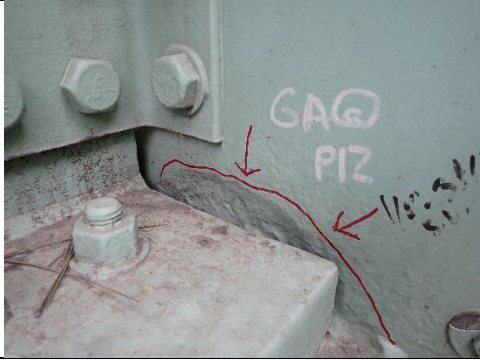
Photograph 55 – View of Bolt Missing and Caulked for Retrofit On South Cap Plate, West of Girder D.	Photograph 56 – View of Painted over Section Loss on the North Cap Plate on the East Side of Girder A Near the Bottom.

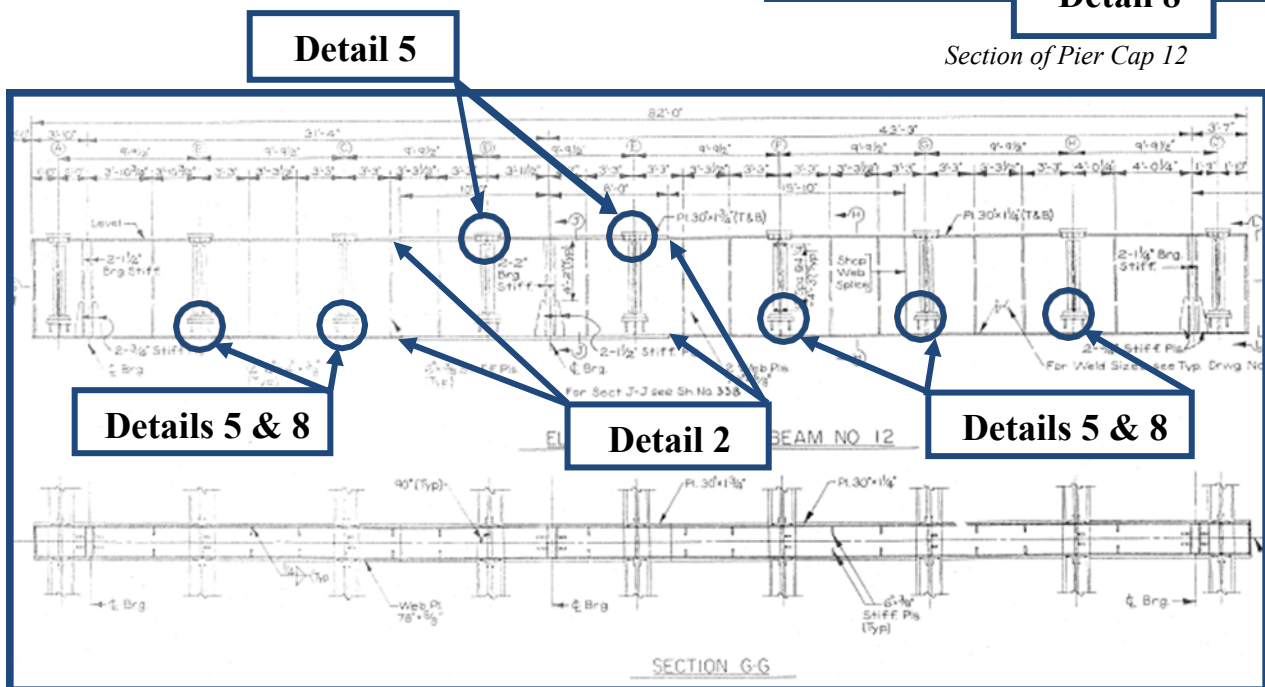
Plan and elevation of Pier Cap 12

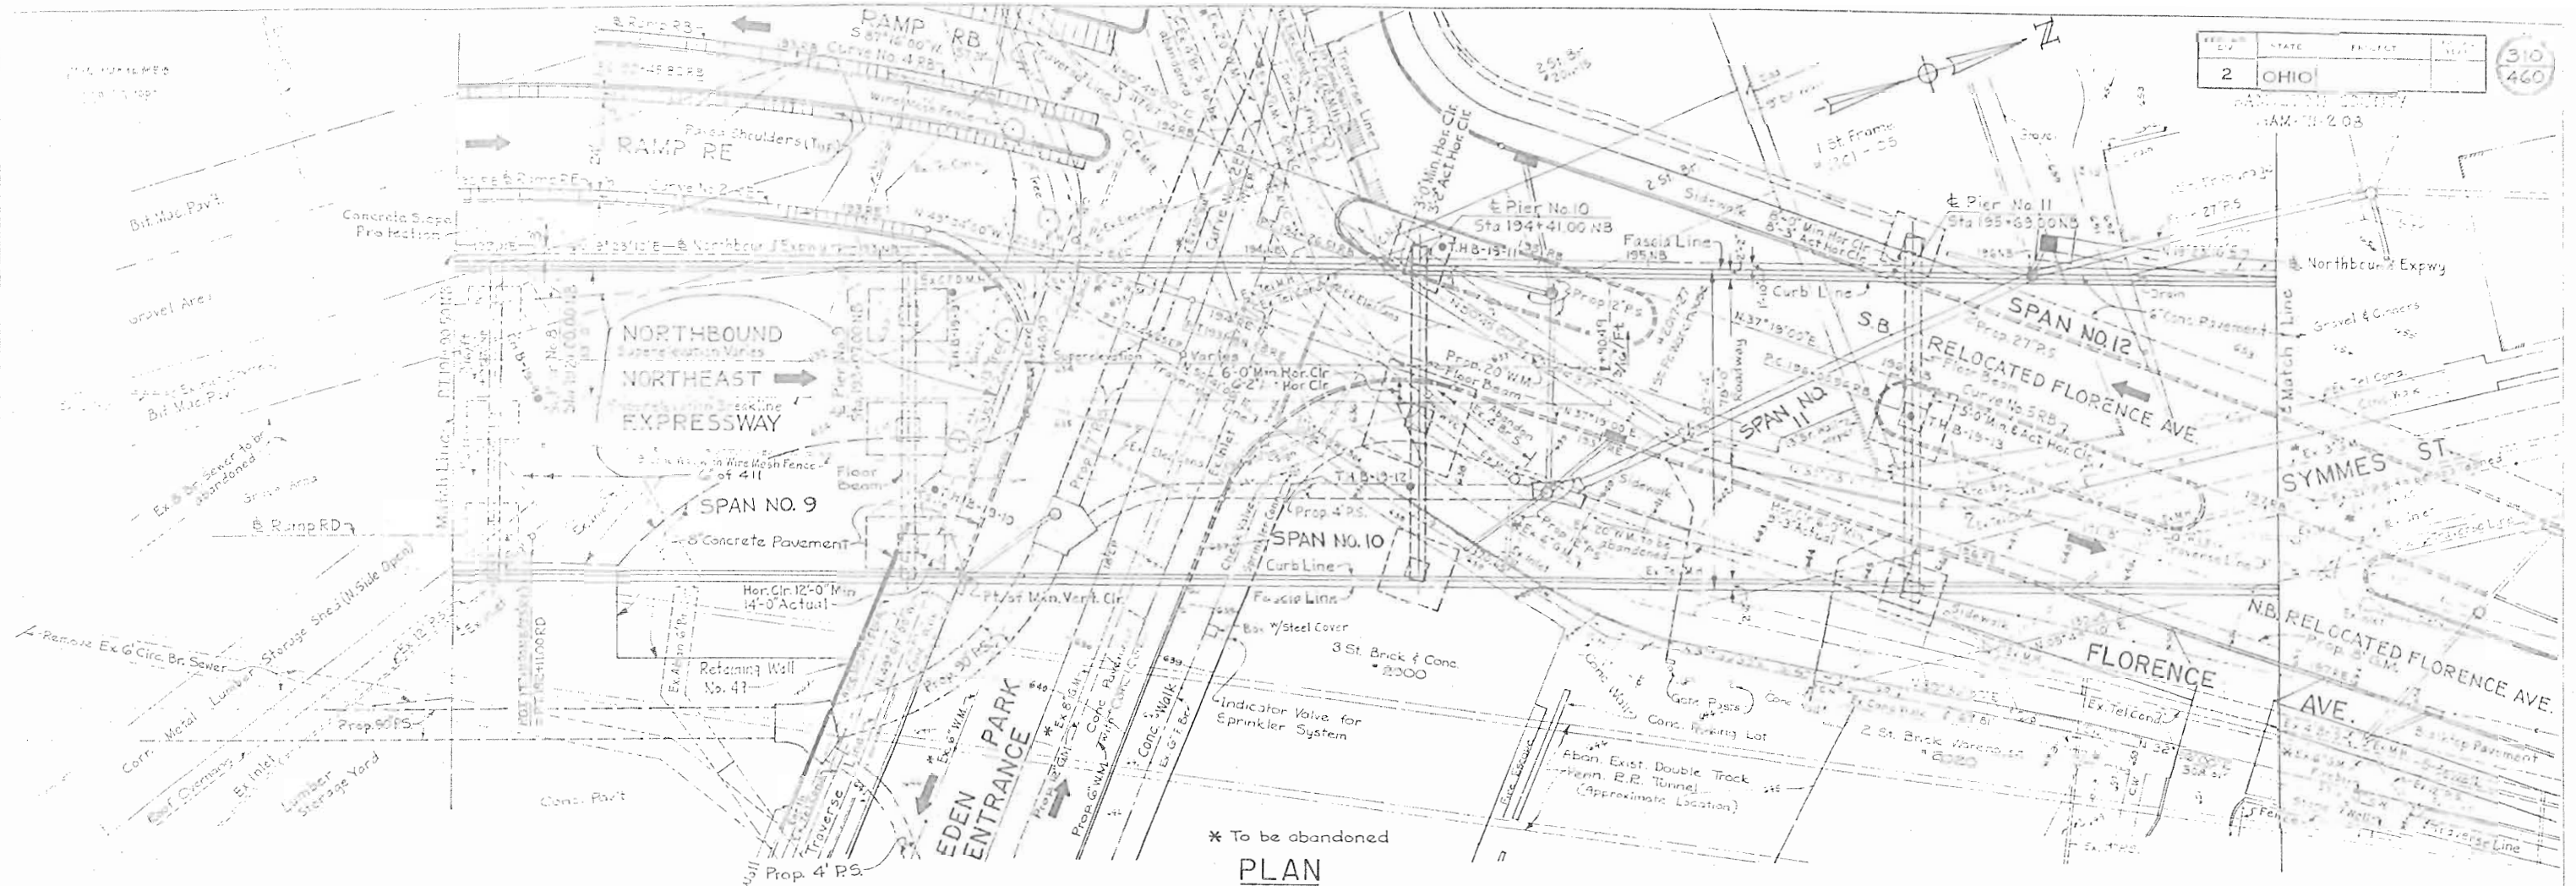
\* To be abandoned  
**PLAN**

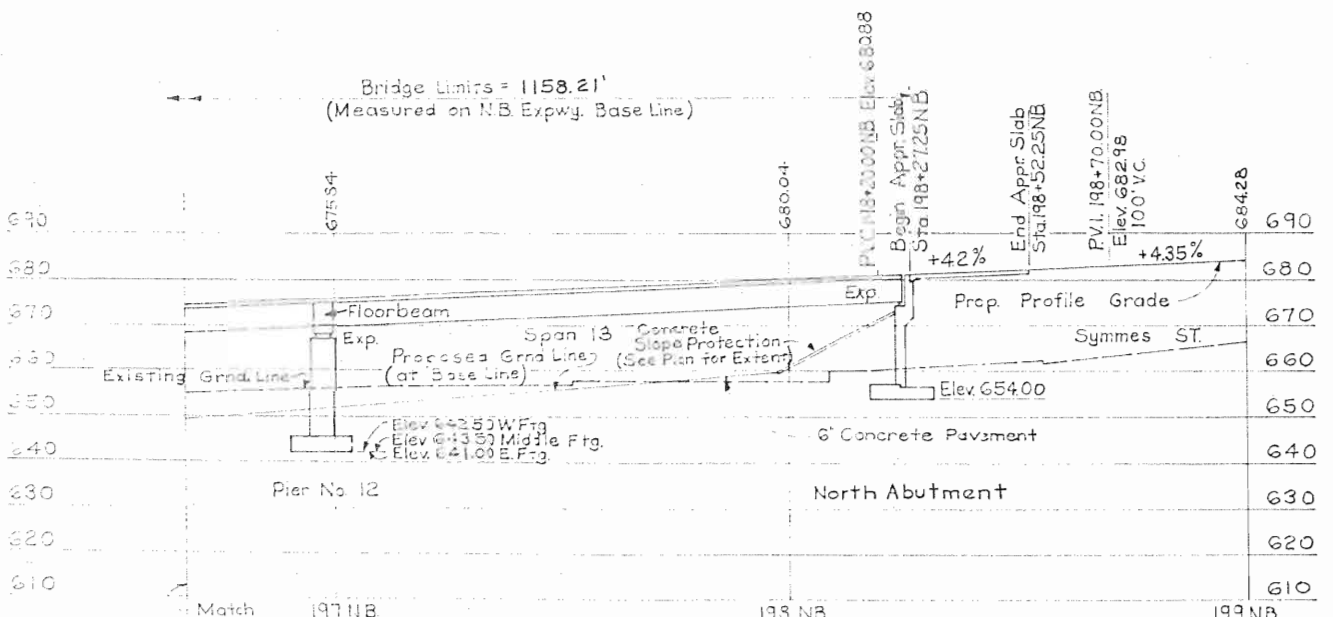
Type: Continuous steel beams (Spans 1 through 8) and continuous plate girders (Spans 9 through 13) with reinforced concrete deck and substructure.  
 Spans: 66'-0" (Spans 1 through 8) 107'-0" (Span 9) 134'-0" (Span 10) & 128'-0" (Spans 11 through 13)  
 Roadway: Varies, see plan; 80 min f/f parapet  
 Skew: 0° (measured from forward tangent)  
 Load Frequency: CF=2000(S7) Adequate for AASHO alternate loading.  
 Wearing Surface: 1" Monolithic Concrete  
 Approach Slab: AS-1-54 (25'-0" Long)  
 Alignment: See plan.  
 Superelevation: Varies, see plan.

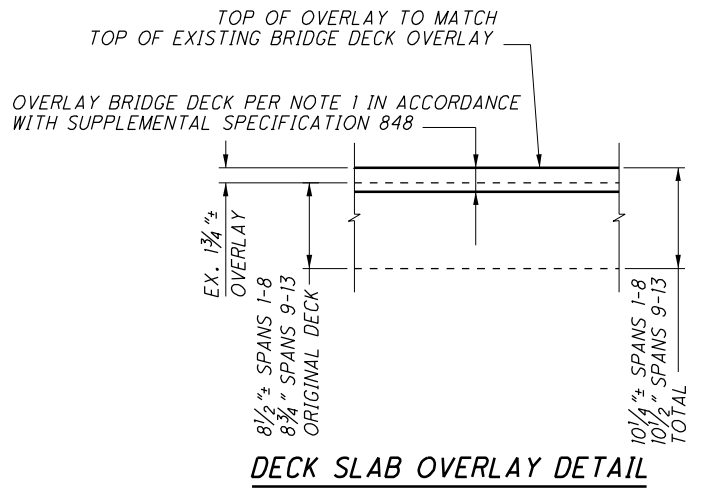
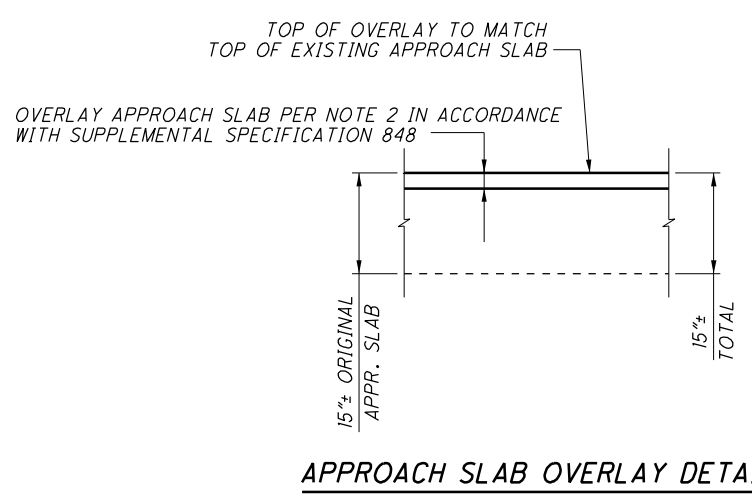
P:\PR54860\HAM\82975\Design\Structures\HAM071\_0248R\Sheets\071\_0248R\_SG002.dgn Sheet 9/8/2016 10:10:22 AM ansim
