FRACTURE CRITICAL PIER CAP INSPECTION REPORT

SFN3110443 (HAM-75-1102R)
I-75 NB OVER WEST FORK MILL
CREEK/GALBRAITH RD
HAMILTON COUNTY, OH
DISTRICT 8

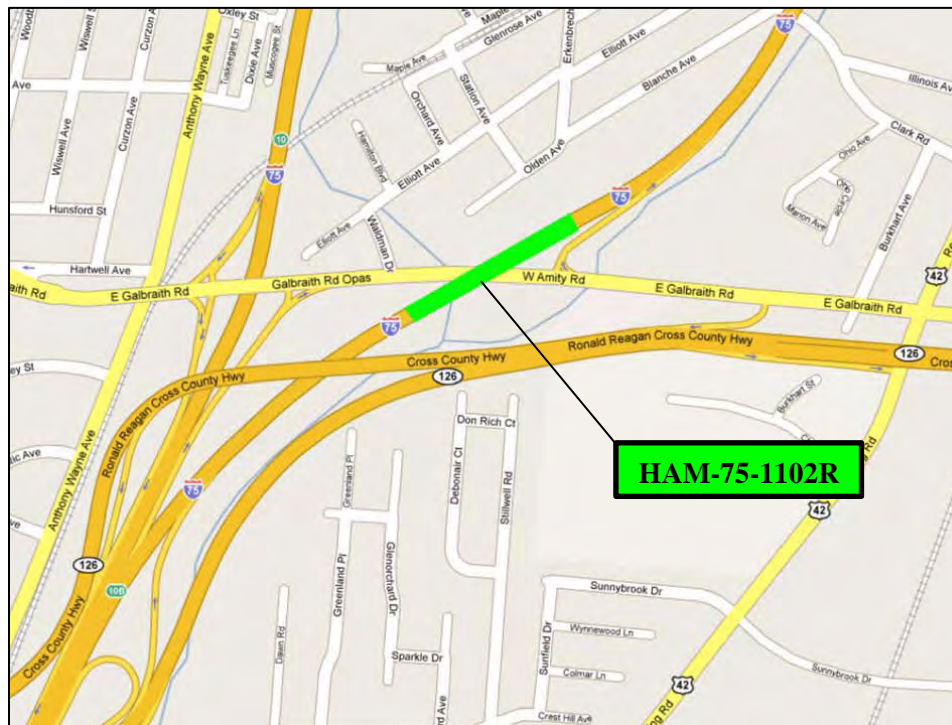
Figure 1: General Bridge Location

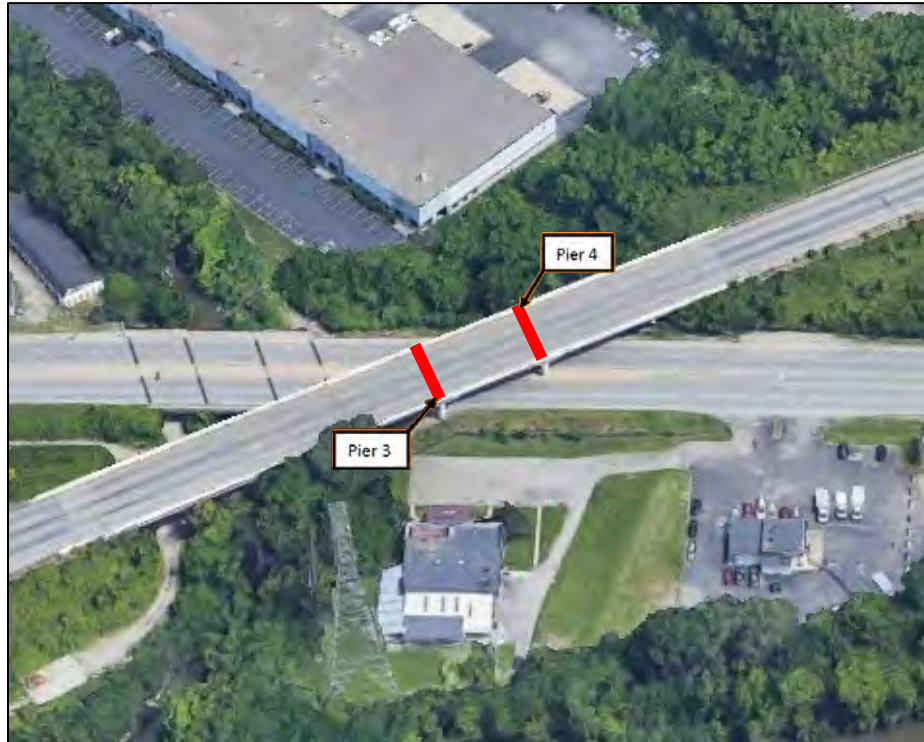
Figure 2: Fracture Critical Pier Cap Location

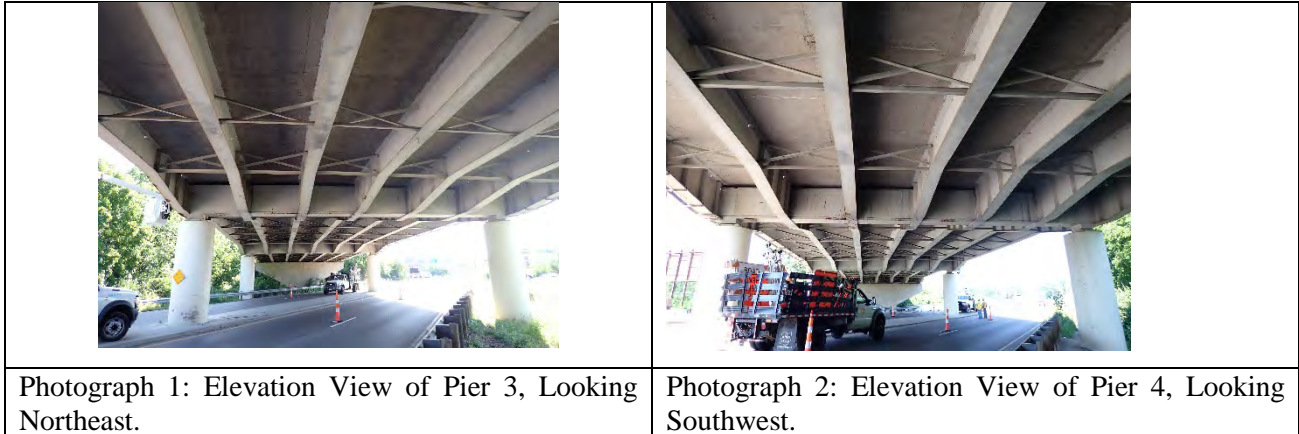
1.3 Method of Investigation

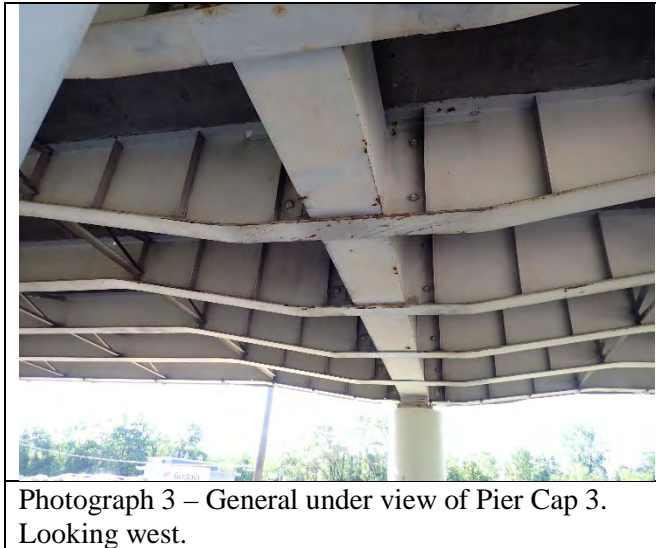
2.1.1.1 *Pier Cap 3 Interior*

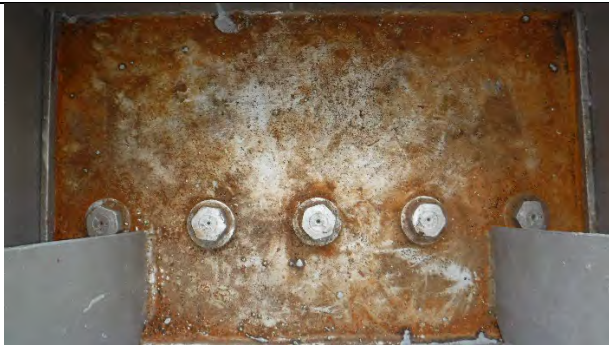
Photograph 4: General Example of Surface Corrosion on the Bottom Flange Adjacent to West Access Hatch. Facing West.

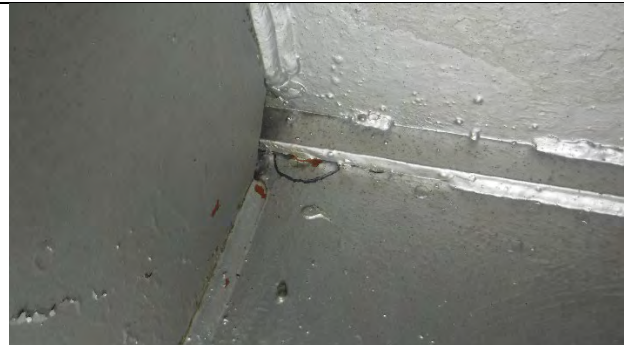
Photograph 5: View of Cracked Tack Weld Between the Top Flange and South Web at Girder 7. Looking South.

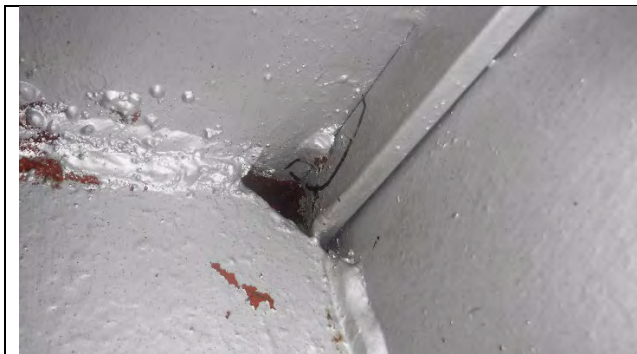
Photograph 6: View of Cracked Tack Weld Between the Top Flange and North Web Between the East Bearing and Girder 7.

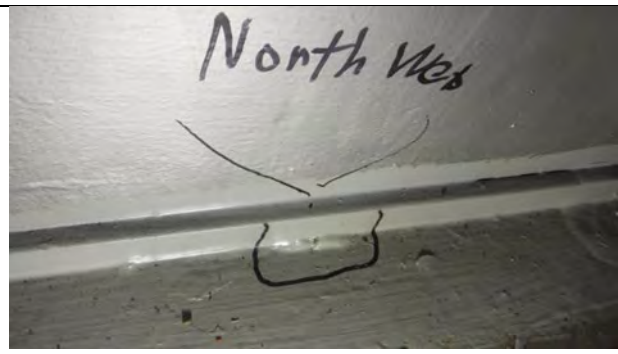
Photograph 7: View of Tack Weld on Cap Bottom Flange at the Cap North Web, East of Girder 3. Looking North.

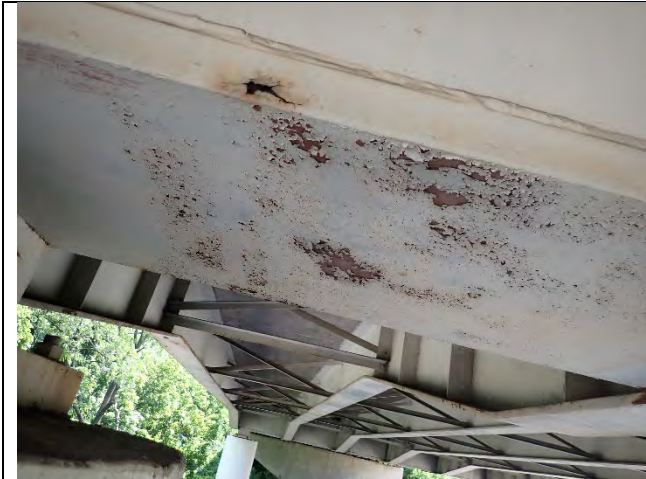
Photograph 12 – General Example of Flaking Paint and Surface Corrosion at Pier 3, Underside Looking Northeast.

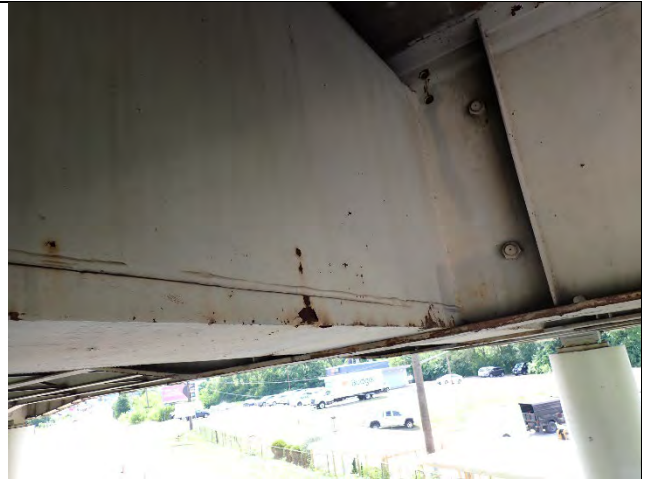
Photograph 13 – General Example of Flaking Paint and Surface Corrosion Along the Pier 3 Cap Edge. Looking Northeast.

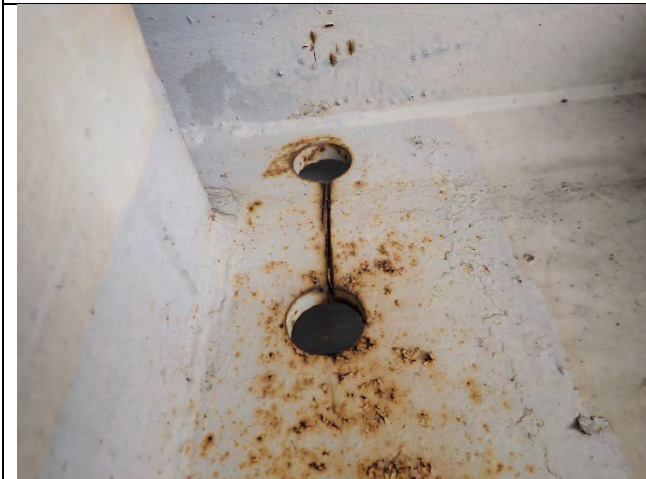
Photograph 14 – View of Two Stress Relief Holes With Errant Sawcuts at the West Face of Girder 2, South Side of Pier. Looking Northeast.

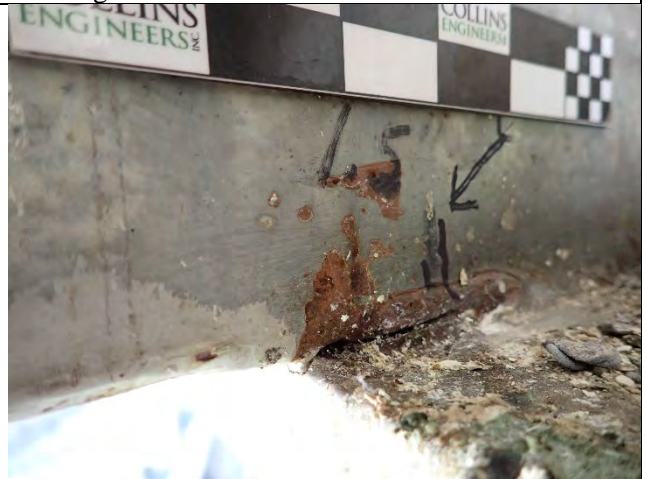
Photograph 15 – Close Up View of a 1-9/16 in. Crack on East Side of Girder 5, North Face of Cap. Note 1/16 in. of Growth. Looking South.

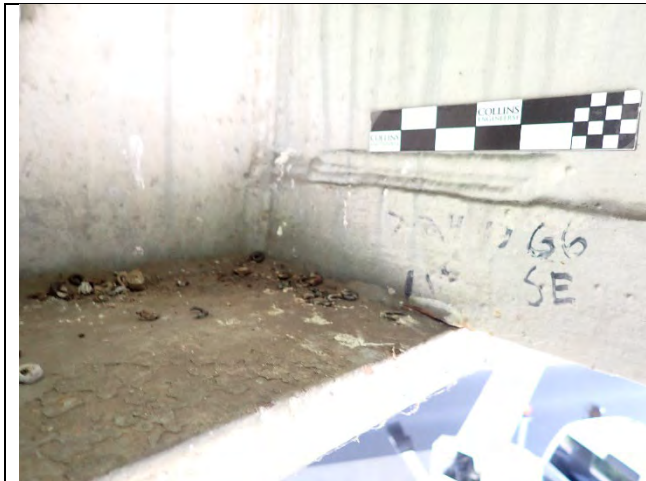
Photograph 16 – Close Up View of a 1-1/2 in. Crack on East Side of Girder 6, South Cap Face. Looking North.

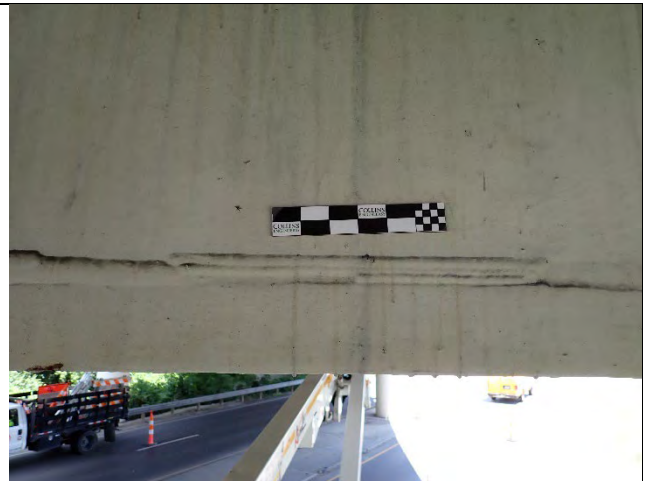
Photograph 17 – General Example of Discontinuous Fillet Welds Not Ground Smooth. Looking North.

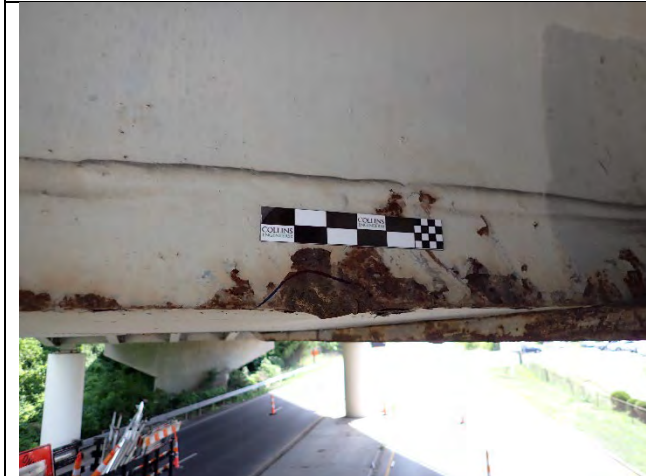
Photograph 18 – Close Up View of 4 in. Long Impact Damage To Cap Bottom Plate, West of Girder 3. Looking Southwest.

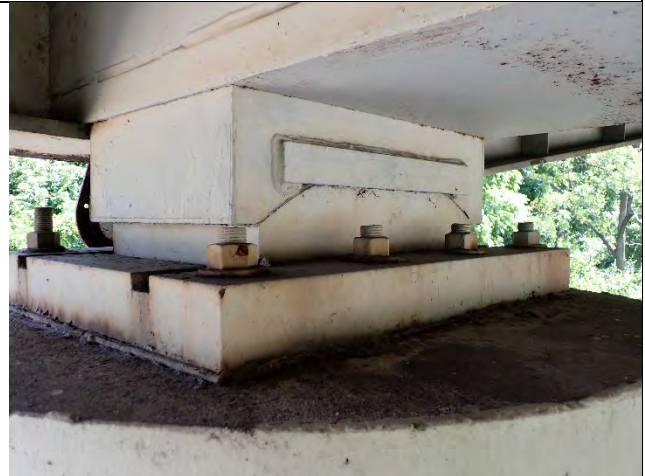
Photograph 19 – View of Typical Bearing Corrosion and Configuration. West Bearing Shown. Looking Northwest.

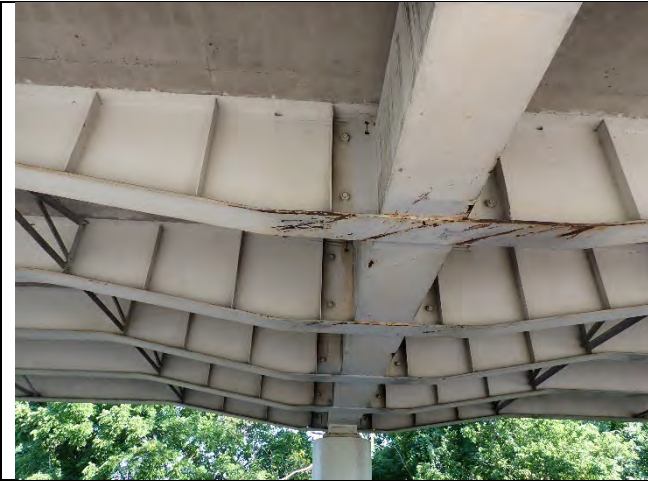
Photograph 19 – General Underview Pier Cap 4.
Looking west.

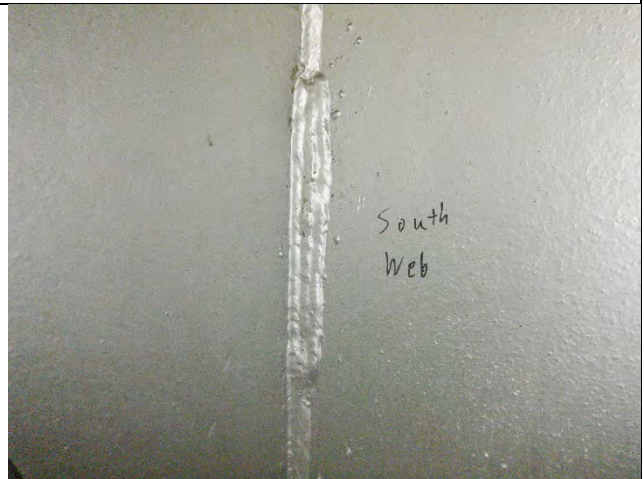
Photograph 23 – General Example of Overlapping Weld for Cap Web Plate to Diaphragm Weld. Looking South.

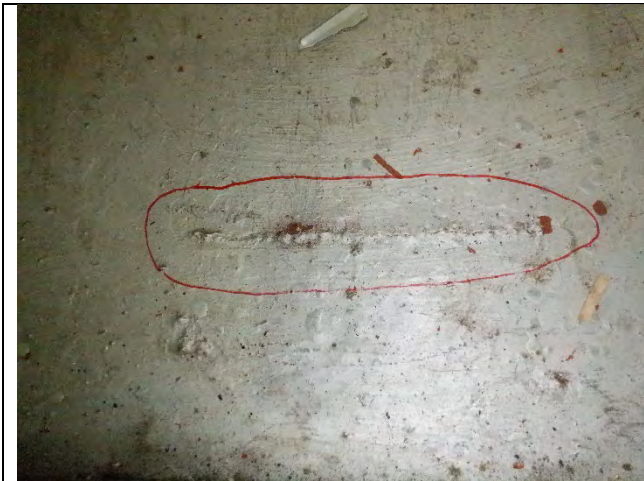
Photograph 24 –View of 7 in. Long Weld on Cap Bottom Flange East of Girder 6 Diaphragm. Looking East.

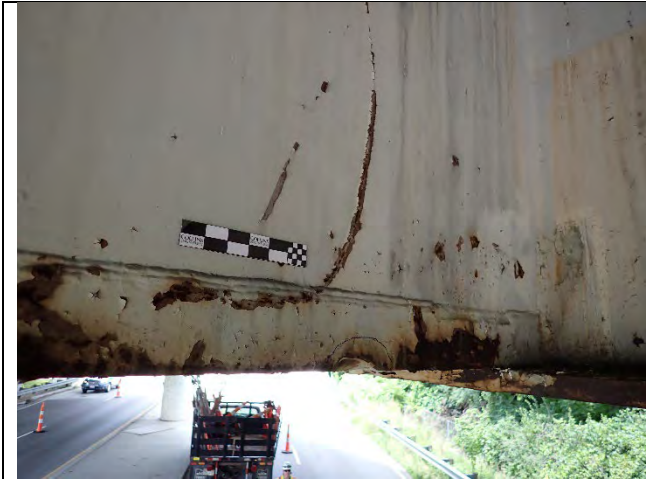
Photograph 26 – View of Impact Gouges and Surface Corrosion On the North Face of the Cap East of Girder 5. Looking Southwest.

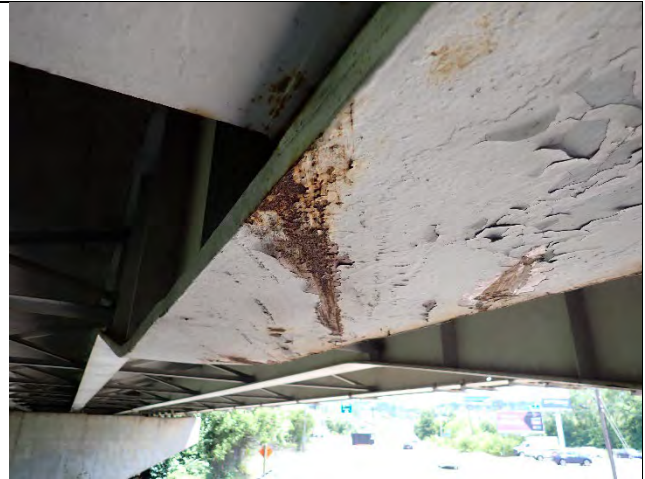
Photograph 27– View of Impact Scrapes and Surface Corrosion On the Underside of the Cap East of Girder 5. Looking Southwest.

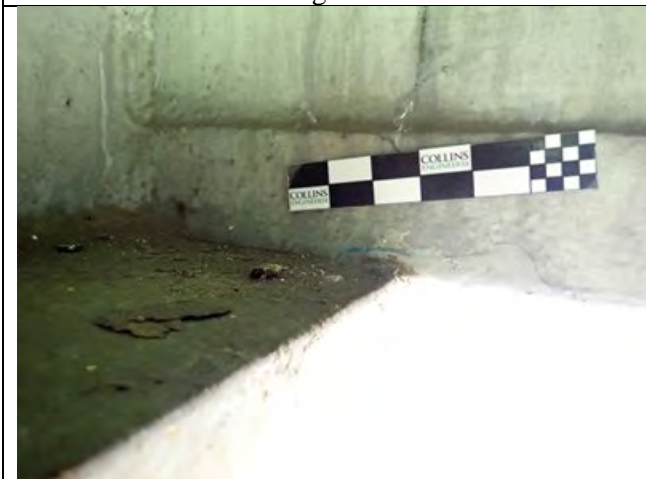
Photograph 28 – View of a 2 in. Tack Weld On West Side of Girder 2, North Face of Pier Cap. Looking Southeast.

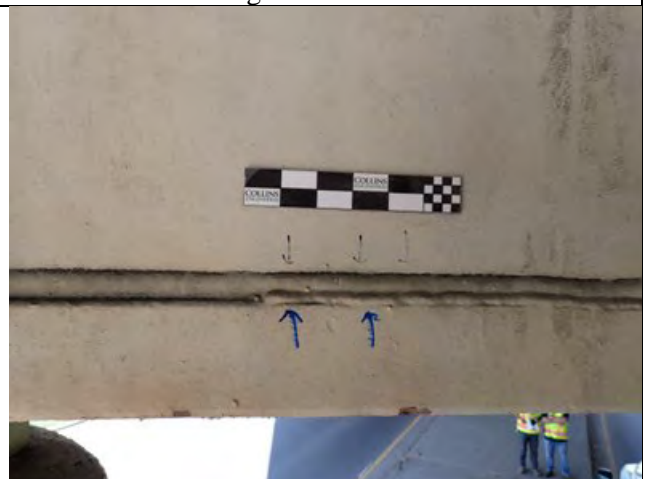
Photograph 29 – General Example of Multipass Welds, North Side Shown. Looking South.

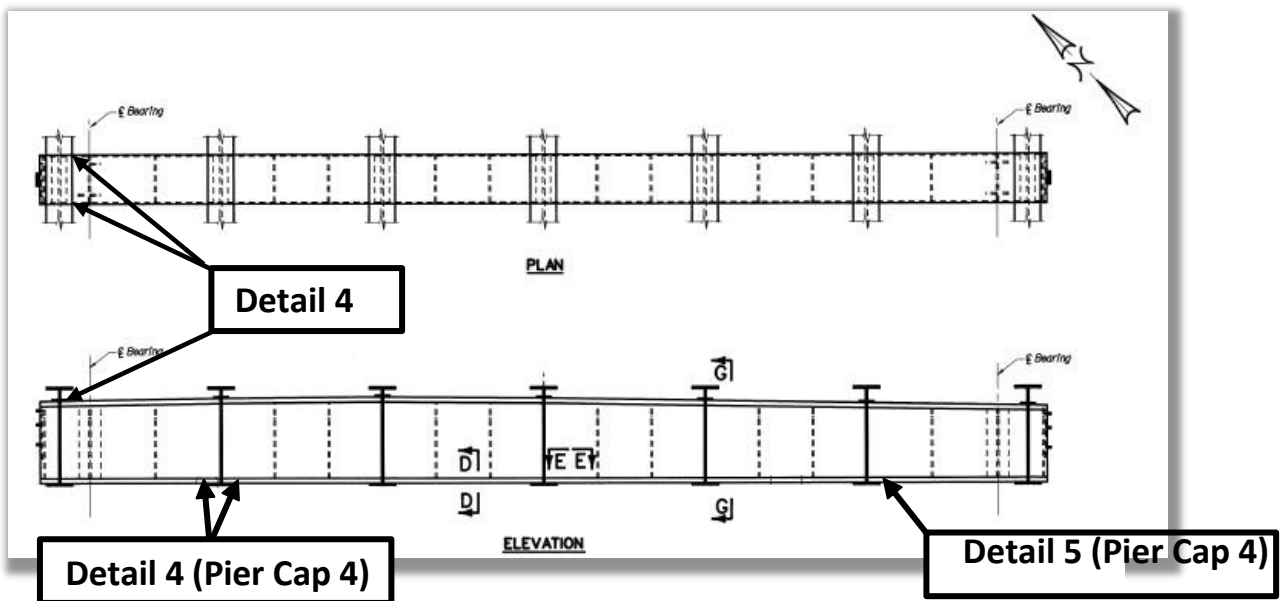
Figure 3: Plan and elevation of Pier Caps 3 & 4 with Fatigue Prone Details

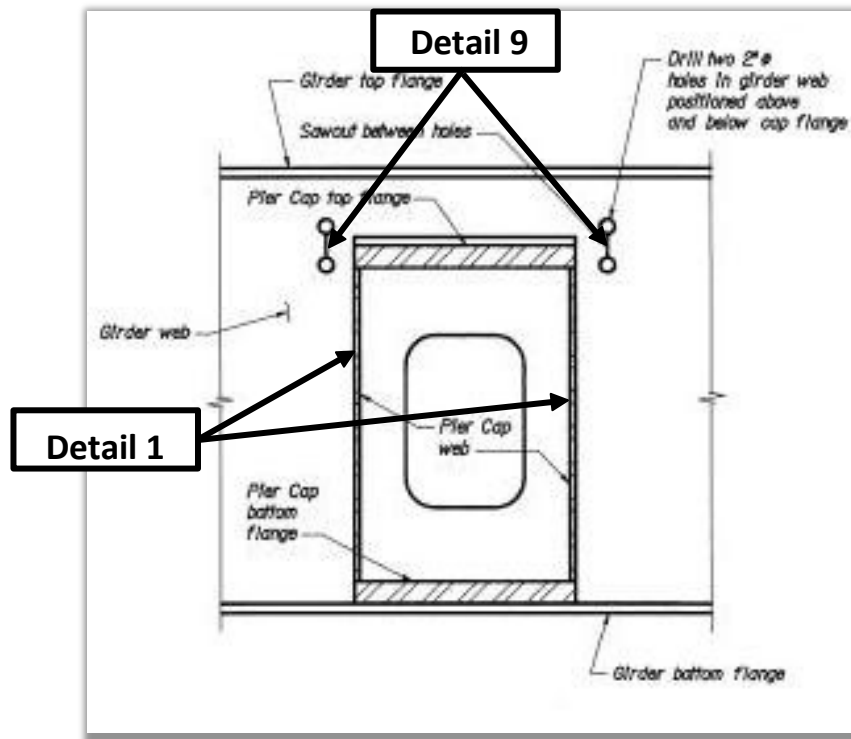
Figure 4: Typical section of Pier Caps 3 & 4.

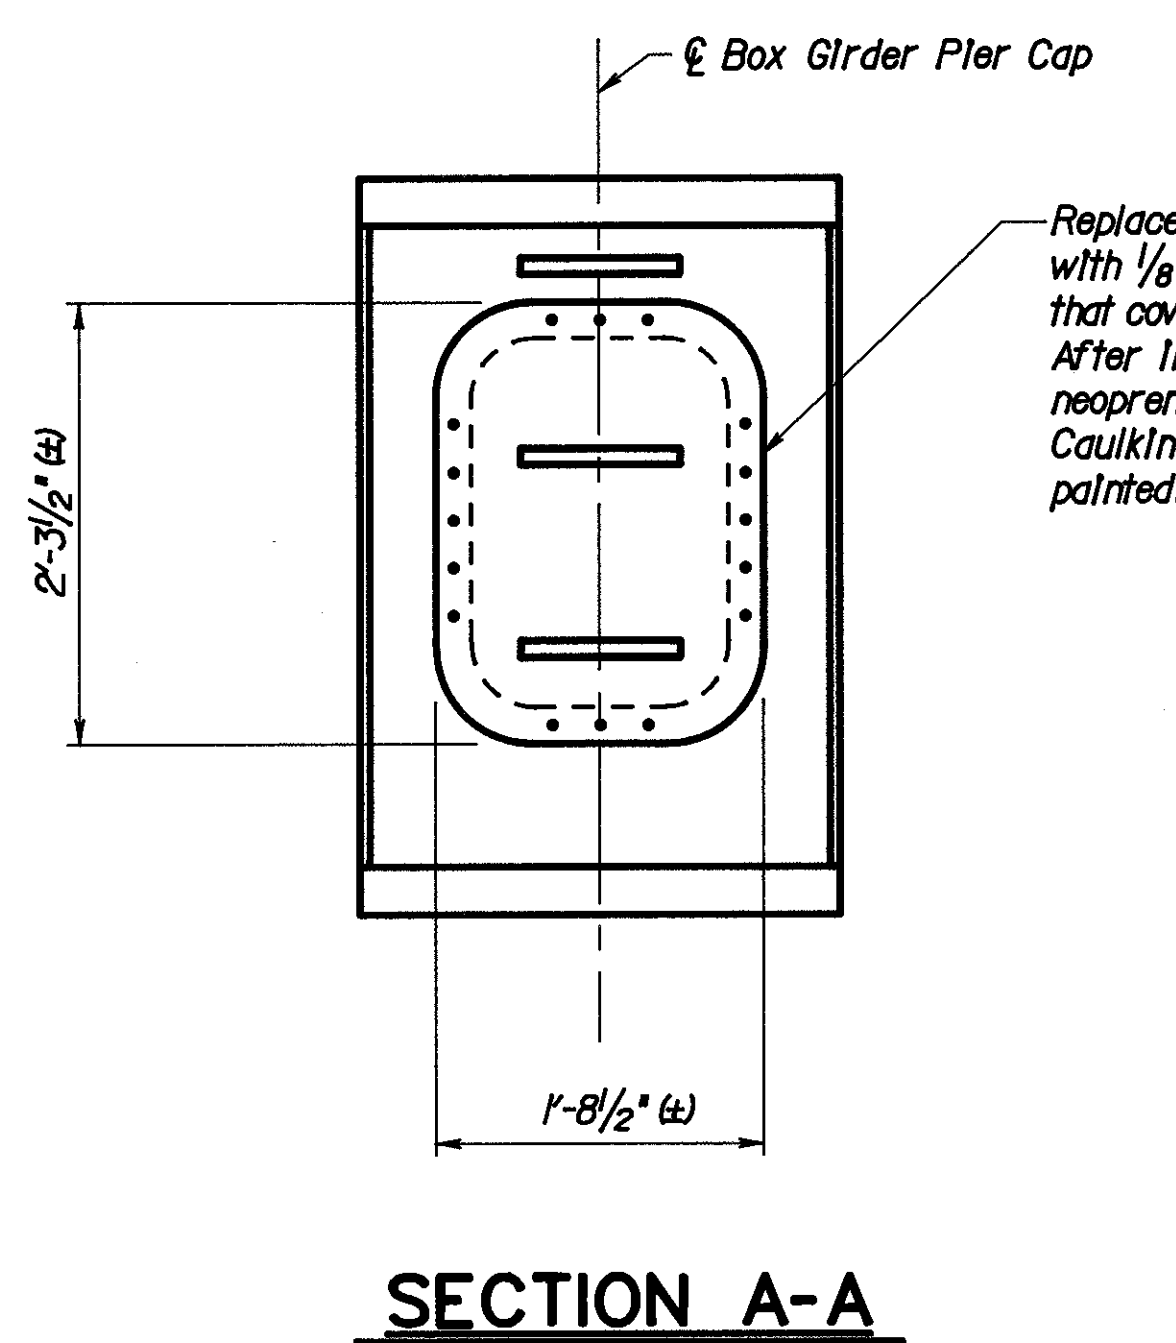
Replace existing asphalt-impregnated gasket with 1/8" thick neoprene closed cell sponge that covers the full face of the hatch cover. After installation of the hatch cover, apply neoprene caulking around access hatch cover. Caulking should be applied to bare steel and painted.

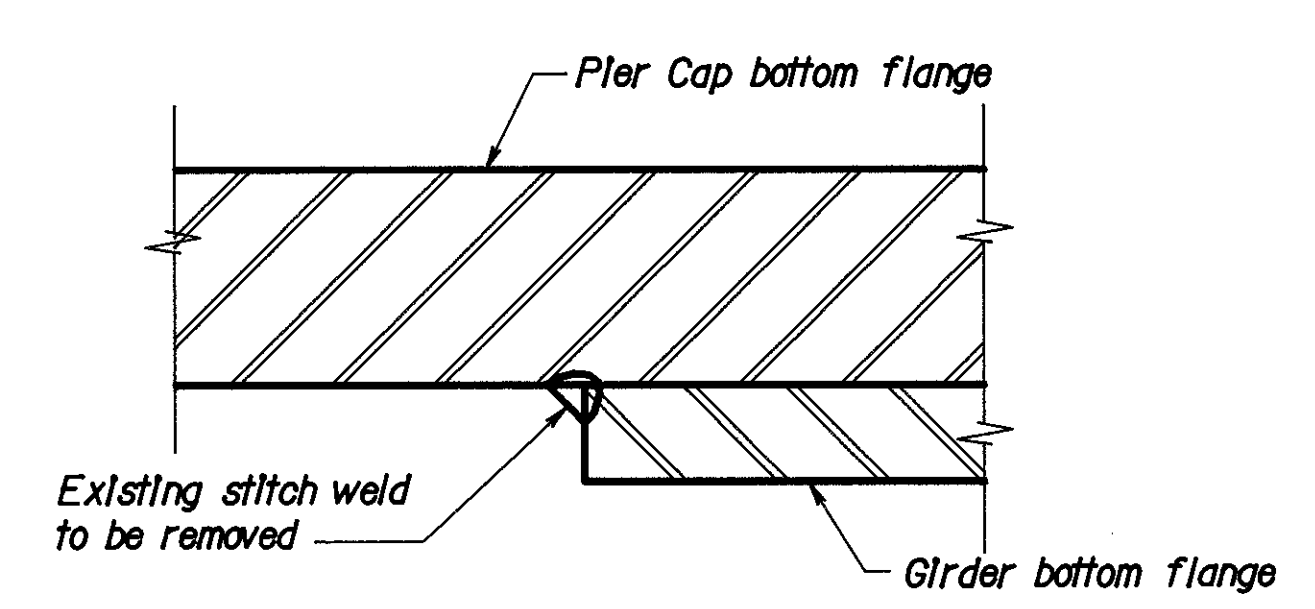
Chip away existing welds being careful not to gouge or remove any of the pier cap bottom flange. Grind away girder bottom flange flush with cap bottom flange until all fused area between cap and girder bottom flange is removed. Grind flush any weld material present on the cap bottom flange. Clean and paint repaired areas.

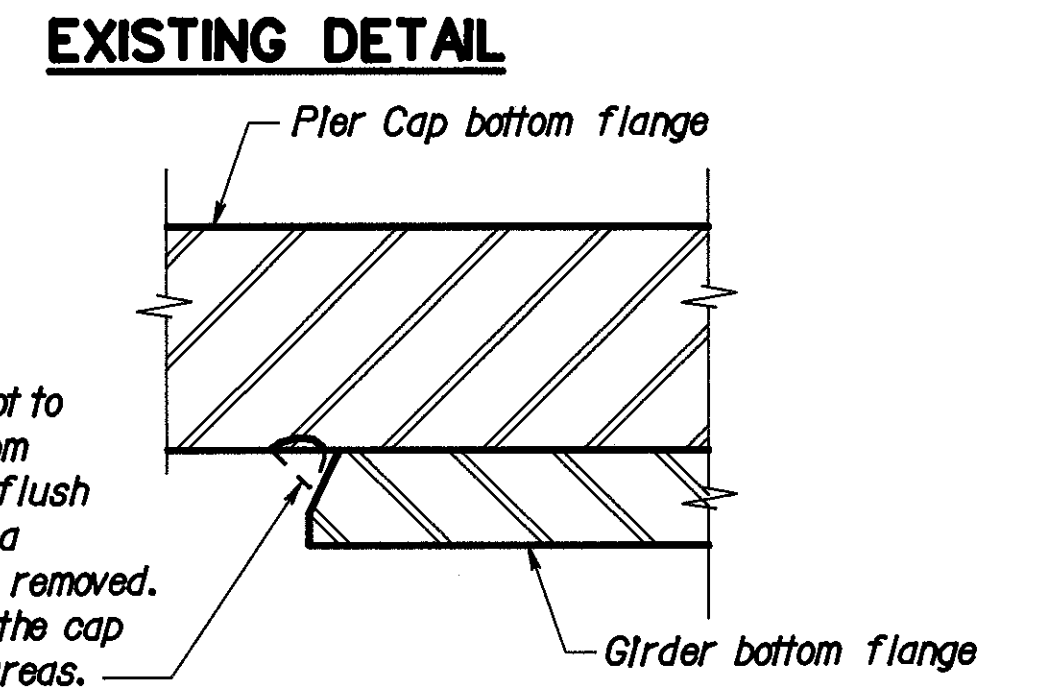
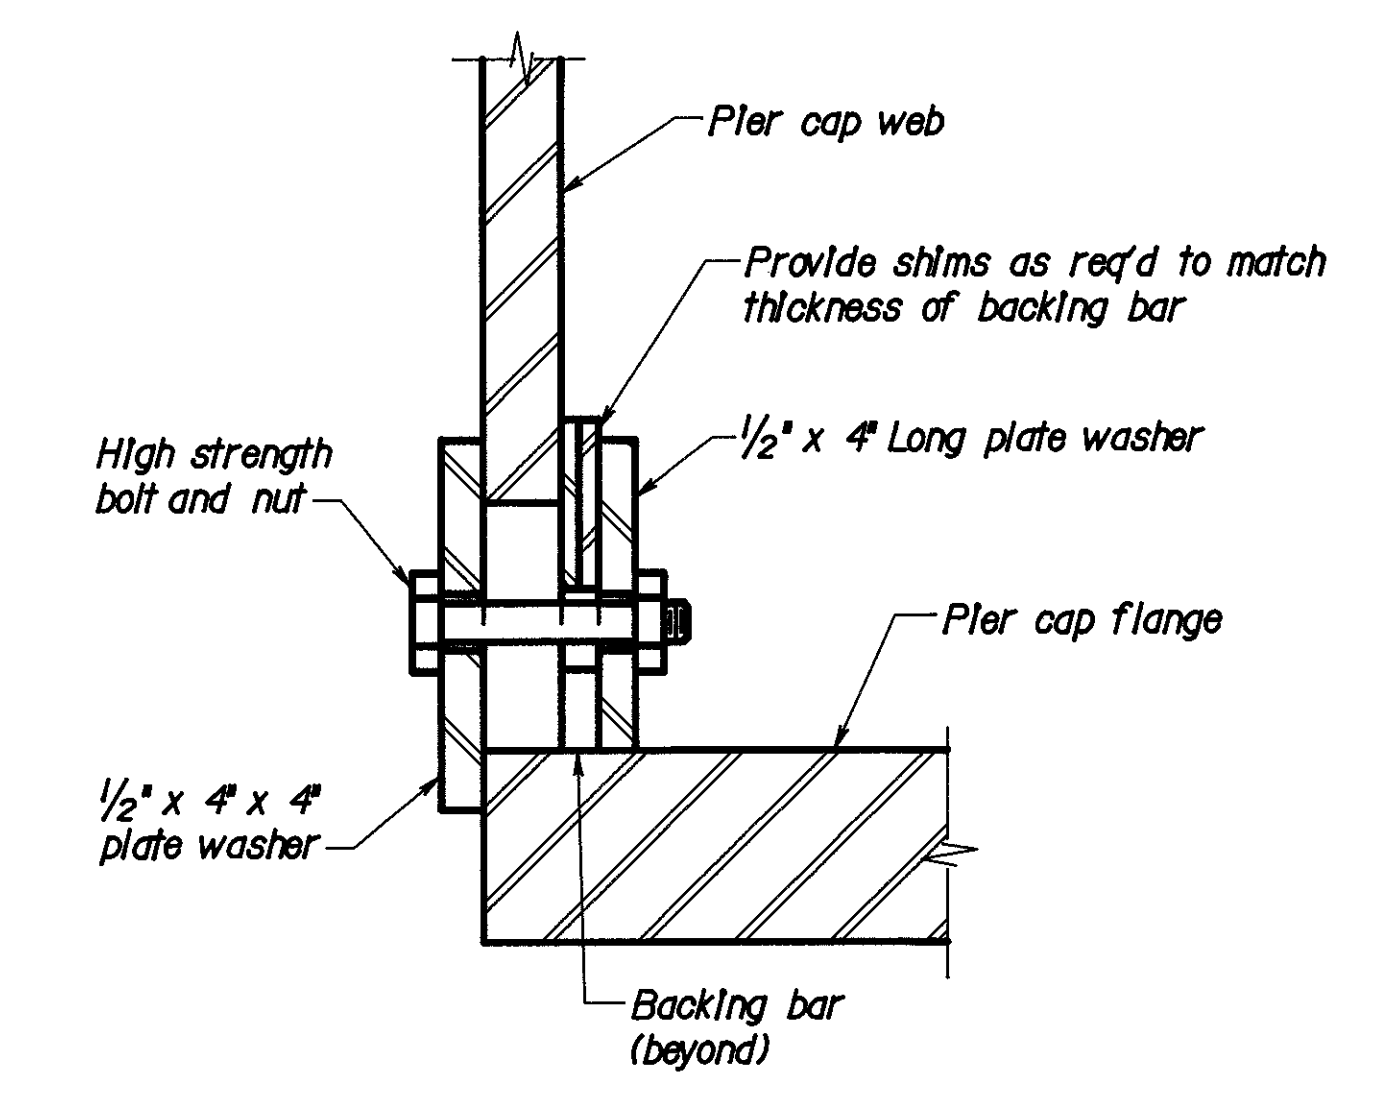
- NOTES**
1. Remove all debris, bird droppings, and nesting material from top of pier caps and bottom flange of girders.
 2. Grind scratches from collision damage on bottom flange of girders in vicinity of pier caps.
 3. Remove soil and debris from inside of cap at pier No. 4. Open hatches to allow moisture to evaporate.
 4. For Sections D-D, E-E and G-G, see sheet 28/105
