FRACTURE CRITICAL PIER CAP INSPECTION REPORT

**SFN3110656 (HAM-75-1192R)
I-75 NB OVER MILL CREEK, BENSON
AVE/SHEPHERD AVE, NS RR
HAMILTON COUNTY, OH
DISTRICT 8**

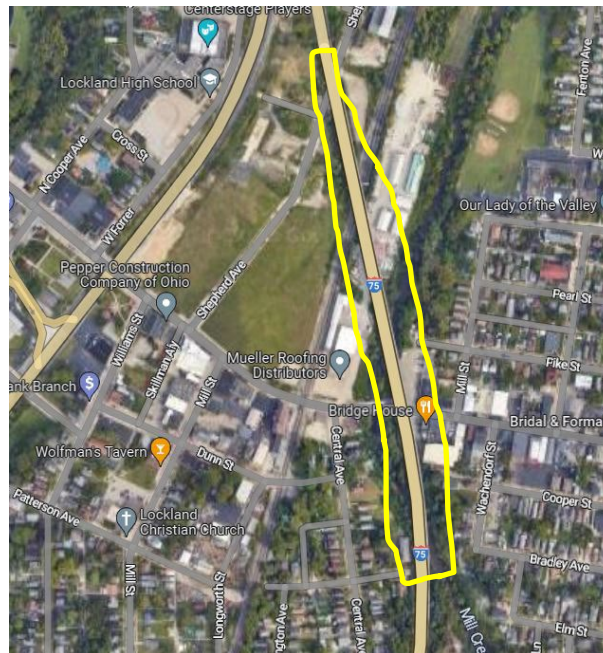
Figure 1: Bridge Location Map

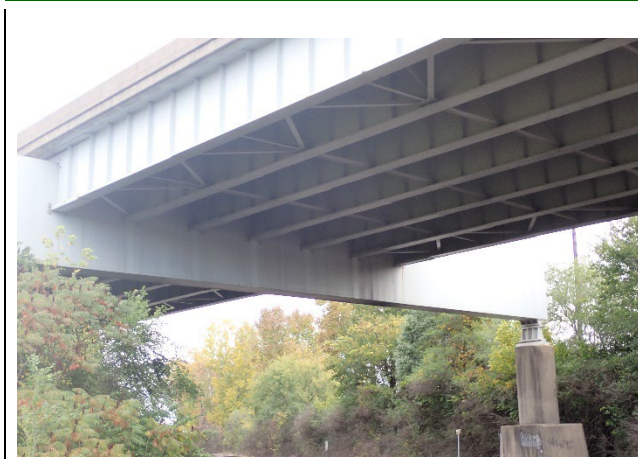
Photograph 1 – Elevation View of Pier 16. Looking Northeast.

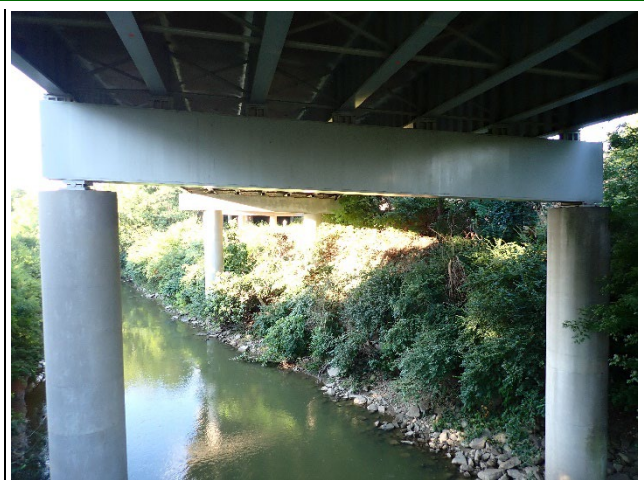
Photograph 2 – Elevation View of Pier 5. Looking South.

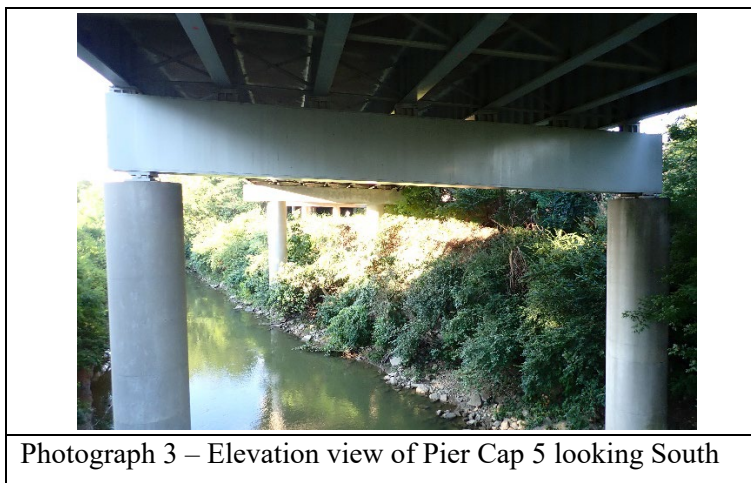
Photograph 3 – Elevation view of Pier Cap 5 looking South

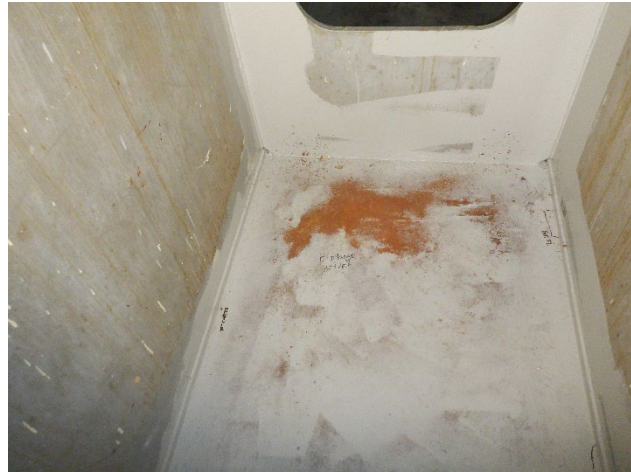
Photograph 4 – View of Typical Surface Corrosion on the Bottom Flange Plate, Between Girders 3 and 4 Shown.

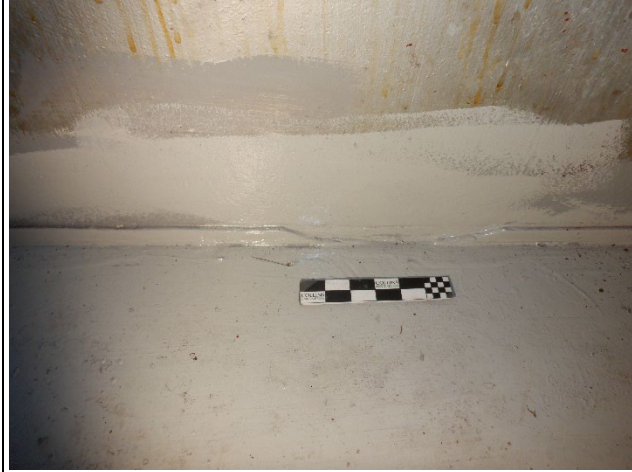
Photograph 5 – View of the Typical Backer Bar Removal, East of Girder 2 Shown.

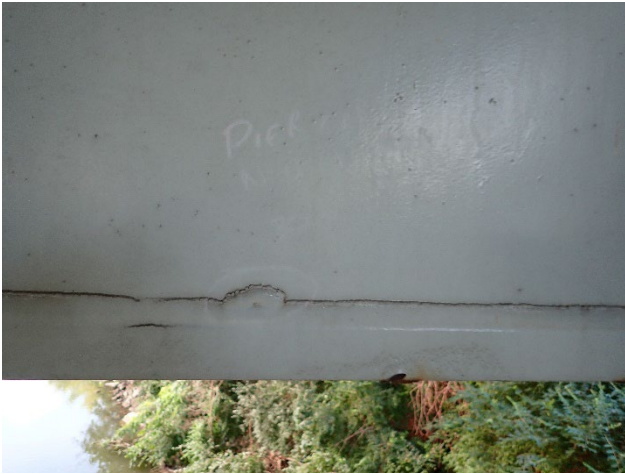
Photograph 8 – View of the Fillet Welds at Groove Weld Between the North Web and the Bottom Flange Weld Between Girder 2 and 3.

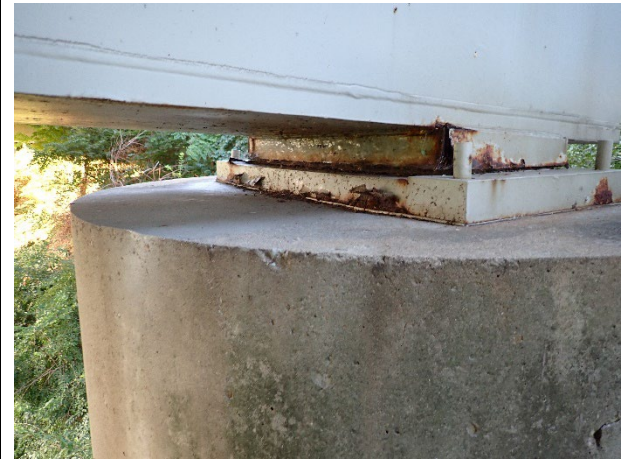
Photograph 11 – View of Bearing at Pier Cap 5.

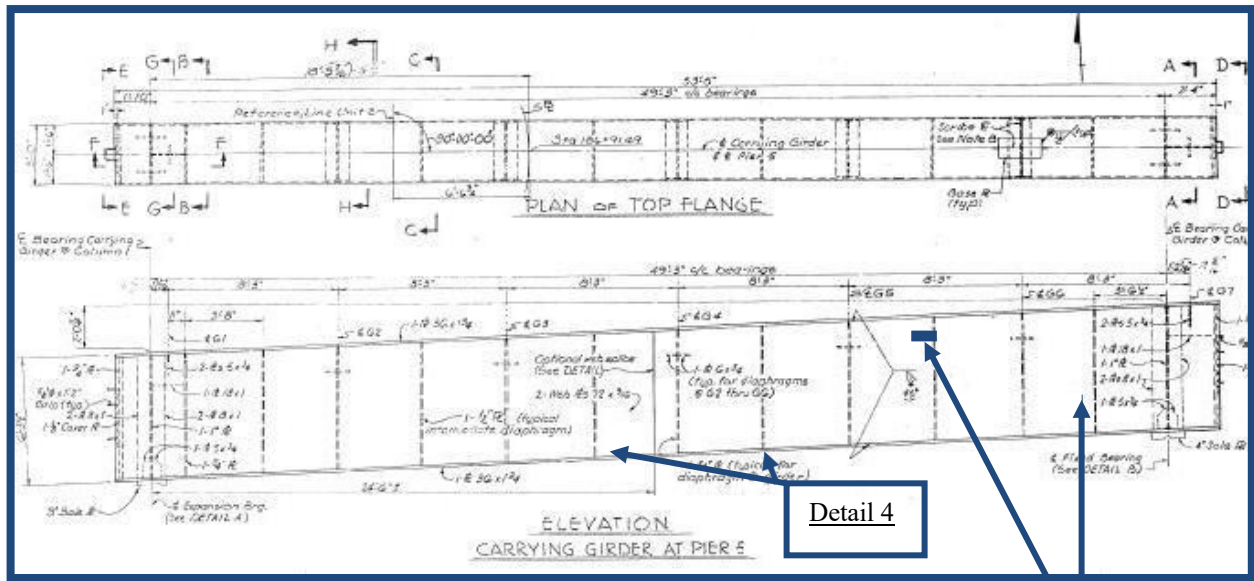
Figure 4: Plan and Elevation of Pier Cap

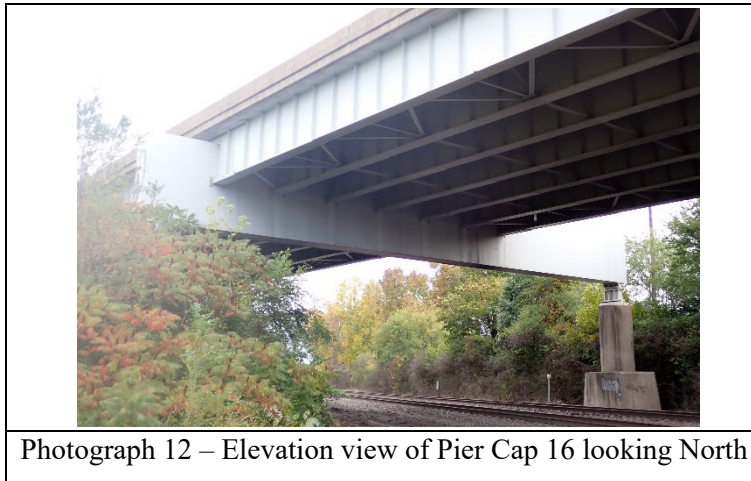
Photograph 12 – Elevation view of Pier Cap 16 looking North

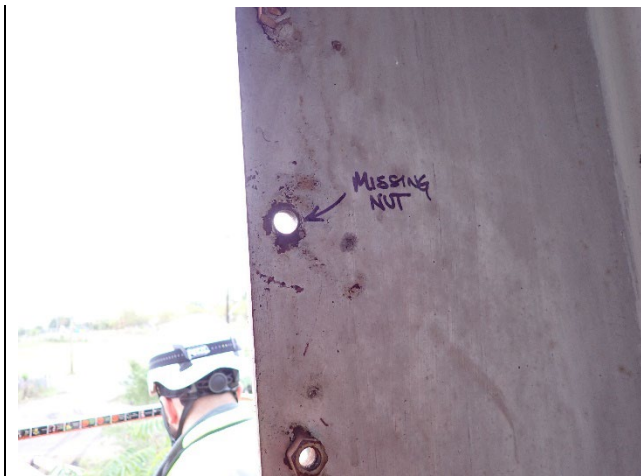
Photograph 13 – View of Missing Hatch Bolt, West Hatch Shown.

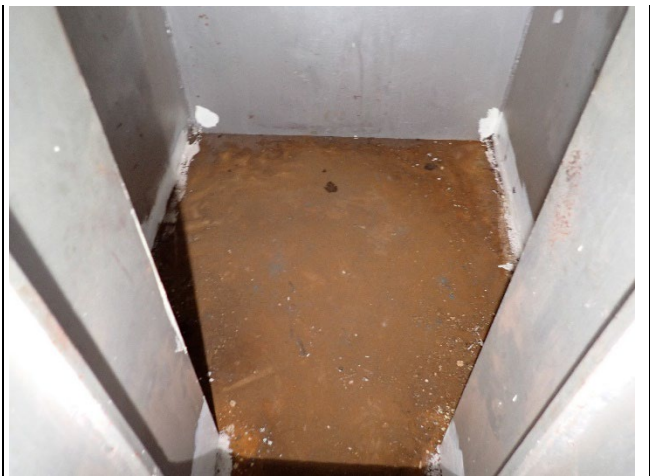
Photograph 14 – View of the Typical Missing Paint and Surface Corrosion, Inside Cap Between Girders 1 and 2 Shown.

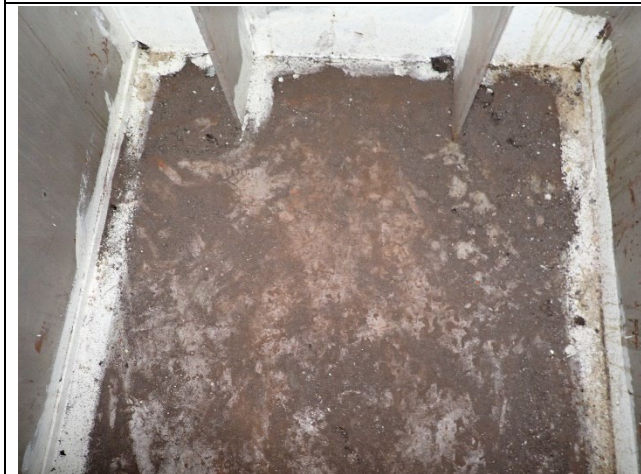
Photograph 15 – View of Accumulation of Steel Filings, Paint Flakes, and Sand Blasting Medium on the Floor.

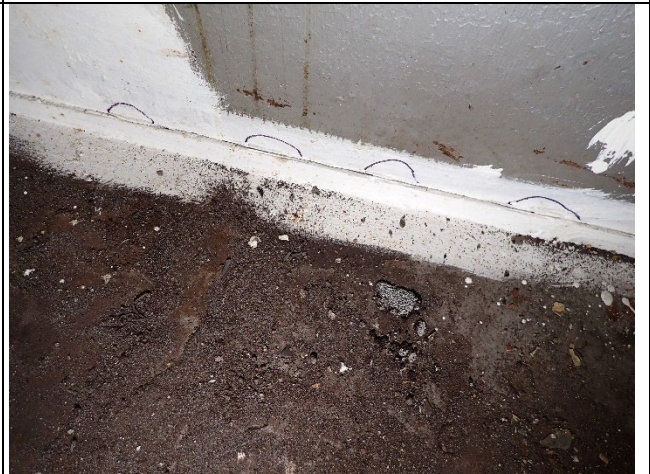
Photo 16 – General Example of the Partially Removed Welds Between the Backer Bar and the Bottom Flange.

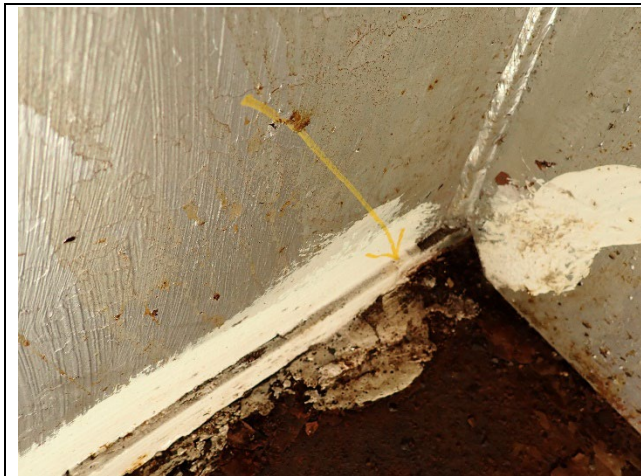
Photograph 17 – View of the Isolated Portions of Backer Bar Removed Along the Length of the Pier Cap to eliminate Butt Joints.

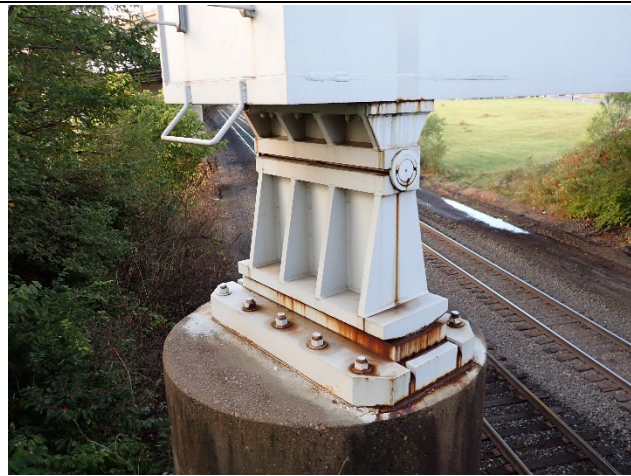
Photograph 22 – View of the Surface Corrosion at the West Bearing.

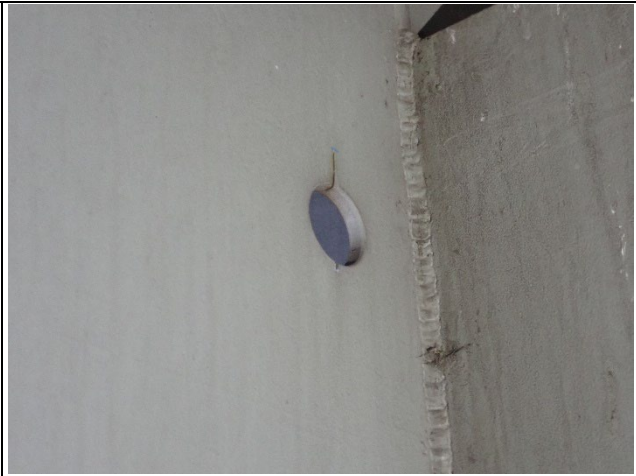
Photograph 23 – View of Typical Drilled Stress Relief Hole with Saw Cuts, North Face of West Side of Girder 4 Shown.

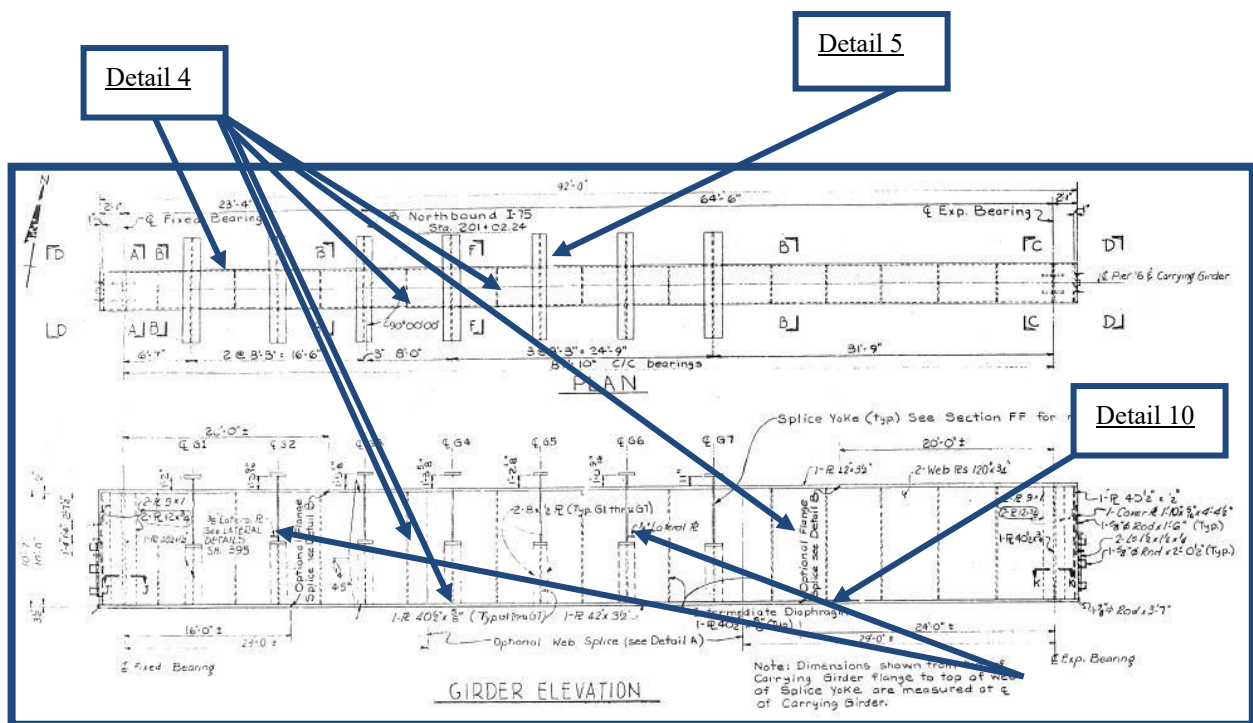
Figure 6: Plan and Elevation of Pier Cap

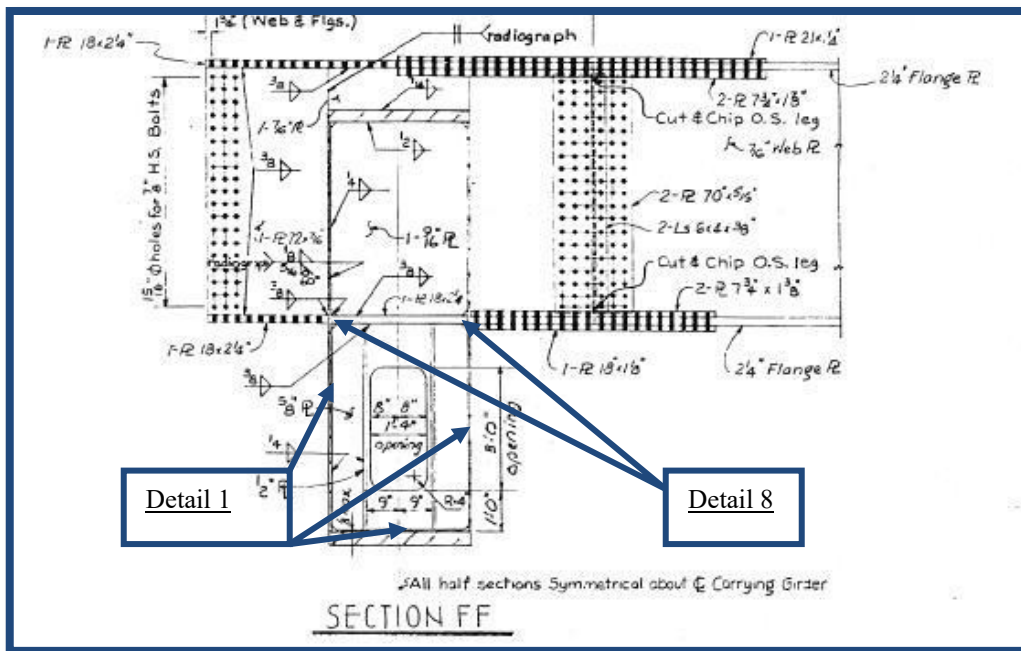
Figure 7: Section of Pier Cap 16

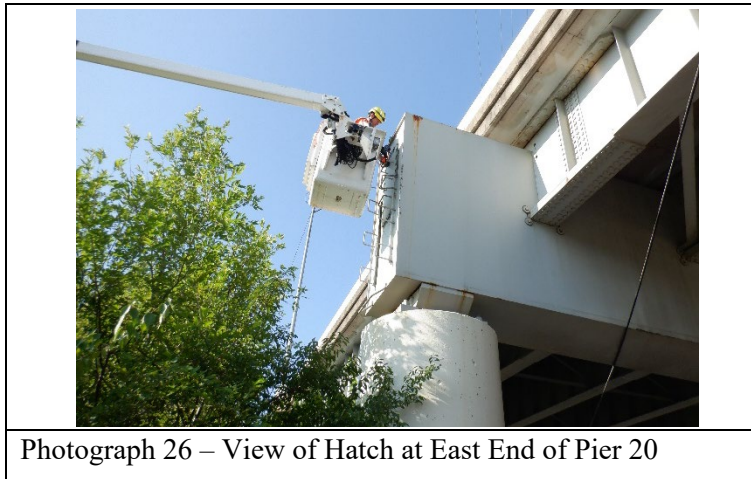
2.1.3.1 Pier Cap 20 Interior

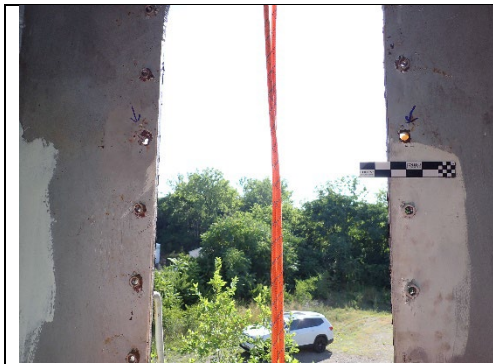
Photograph 27 – Typical Example of Missing Nuts at the East Access Hatch of Pier Cap 20.

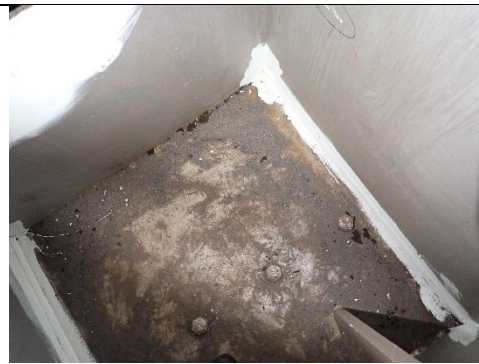
Photograph 28 – View of the Typical Bottom Flange of Pier Cap 20. Note No Major Defects.

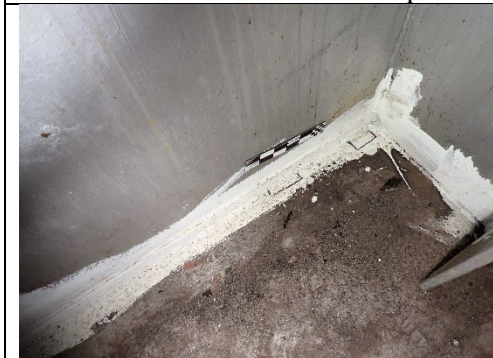
Photograph 29 – General Example of Partially Ground Fillet Welds on Bottom Flange Backer Bar Retrofit.

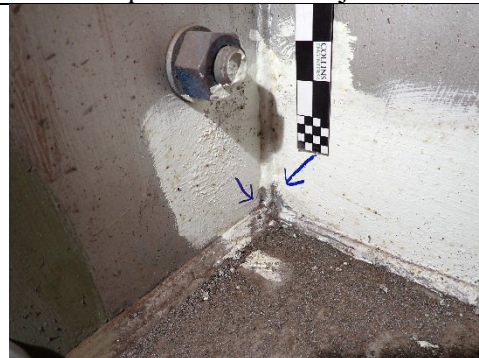
Photograph 30 – General Example of Triaxial Welds at the Intersections of Cap Web Plates, Girder Diaphragms, and Bottom Flange Tie Plates.

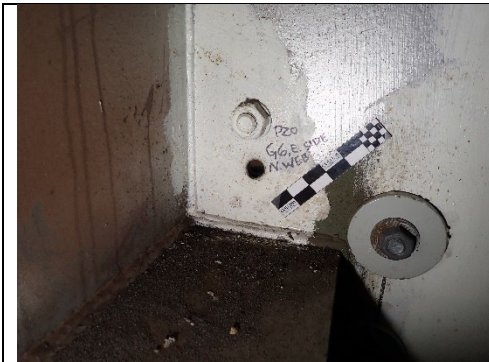
Photograph 31 – View of the Unfilled Stress Relief Hole above the Girder Bottom Flange East of Girder 6 at the North Web.

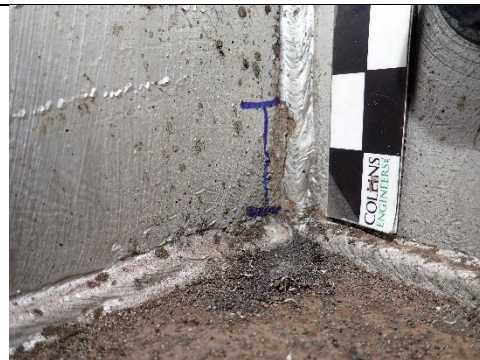
Photograph 34 – View of the 1-5.8 in. Triaxial Weld Crack at the West Face of the Girder 1 Diaphragm at the South Web Plate. Close up view.

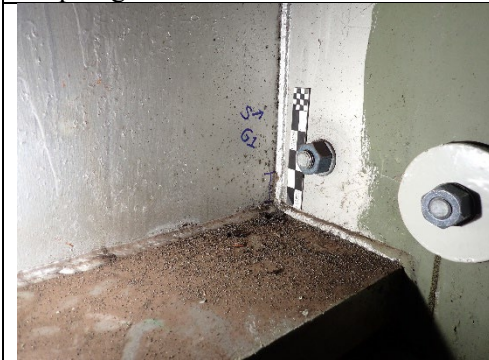
Photograph 35 – View of the 1-5.8 in. Triaxial Weld Crack at the West Face of the Girder 1 Diaphragm at the South Web Plate. Perspective view.

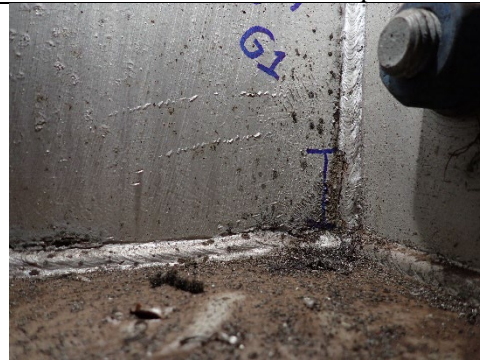
Photograph 36 – View of the 1-5.8 in. Triaxial Weld Crack at the West Face of the Girder 1 Diaphragm at the South Web Plate. Close up view.

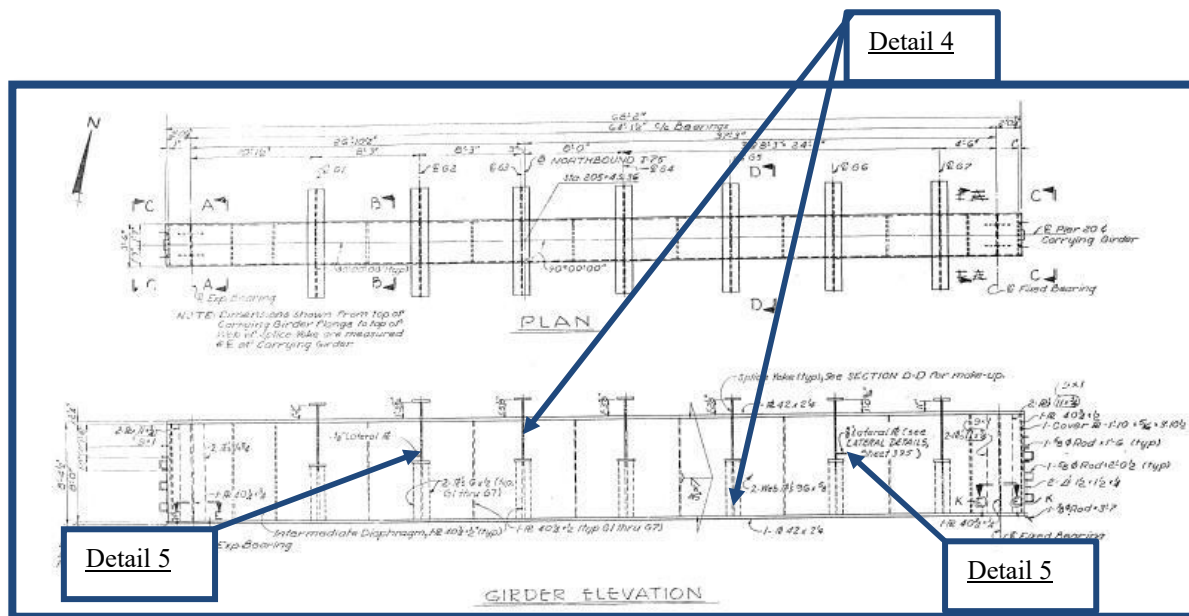
Figure 9: Plan and Elevation of Pier Cap 20

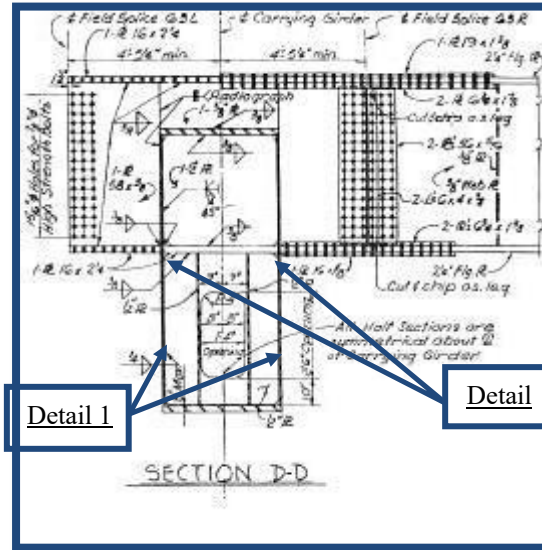
Figure 10: Section of Pier Cap 20

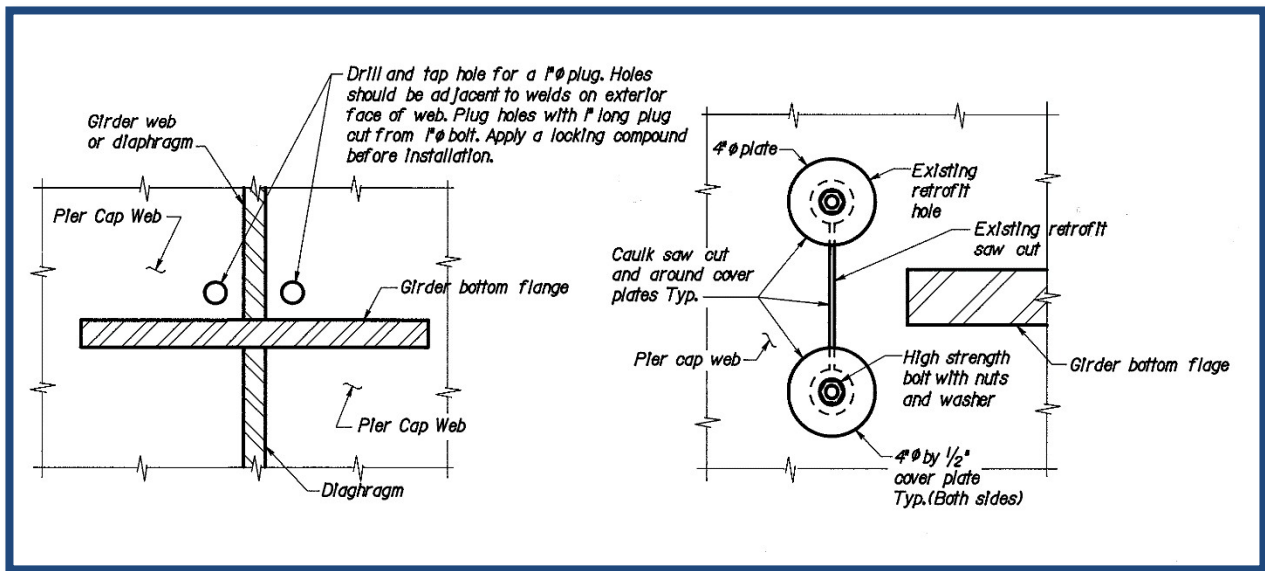
Figure 11: Drilled hole retrofit details from rehabilitation plans

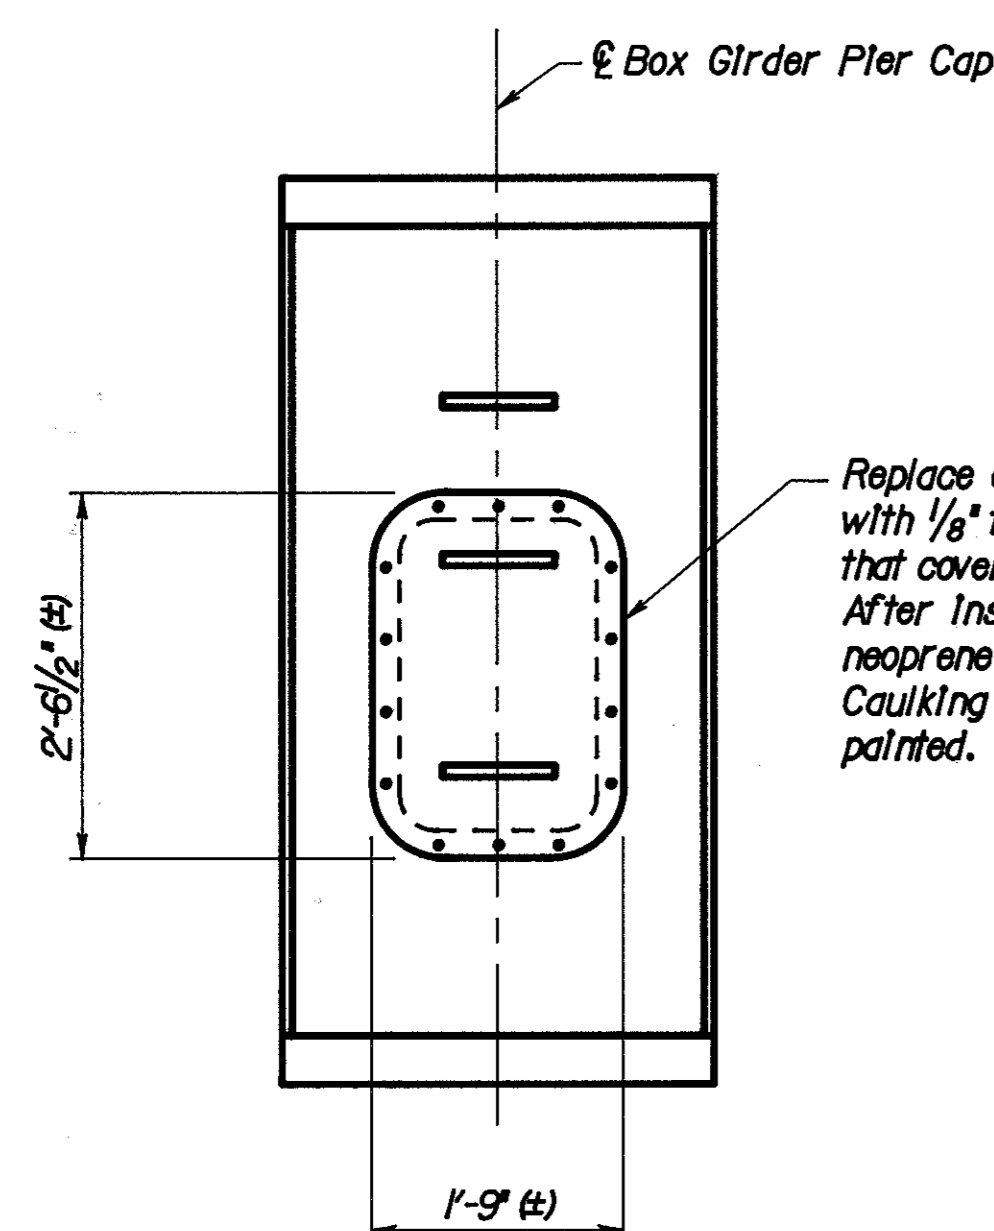
BOTTOM FLANGE SHOWN.
TOP FLANGE SIMILAR.

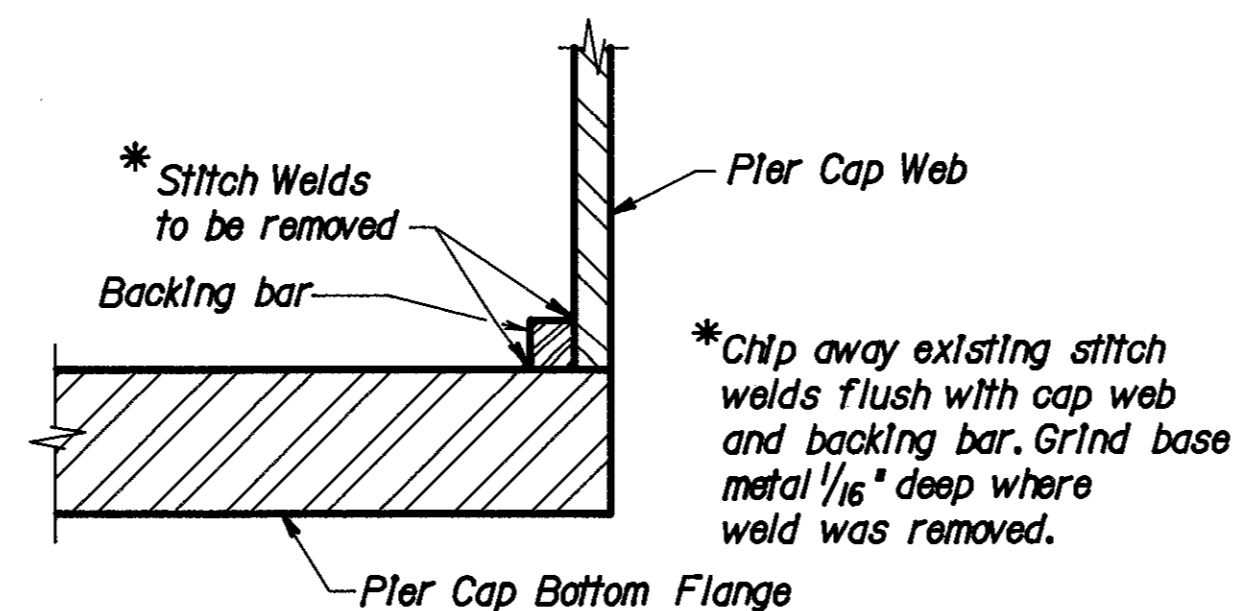
Replace existing asphalt-impregnated gasket with 1/8" thick neoprene closed cell sponge that covers the full face of the hatch cover. After installation of the hatch cover, apply neoprene caulking around access hatch cover. Caulking should be applied to bare steel and painted.

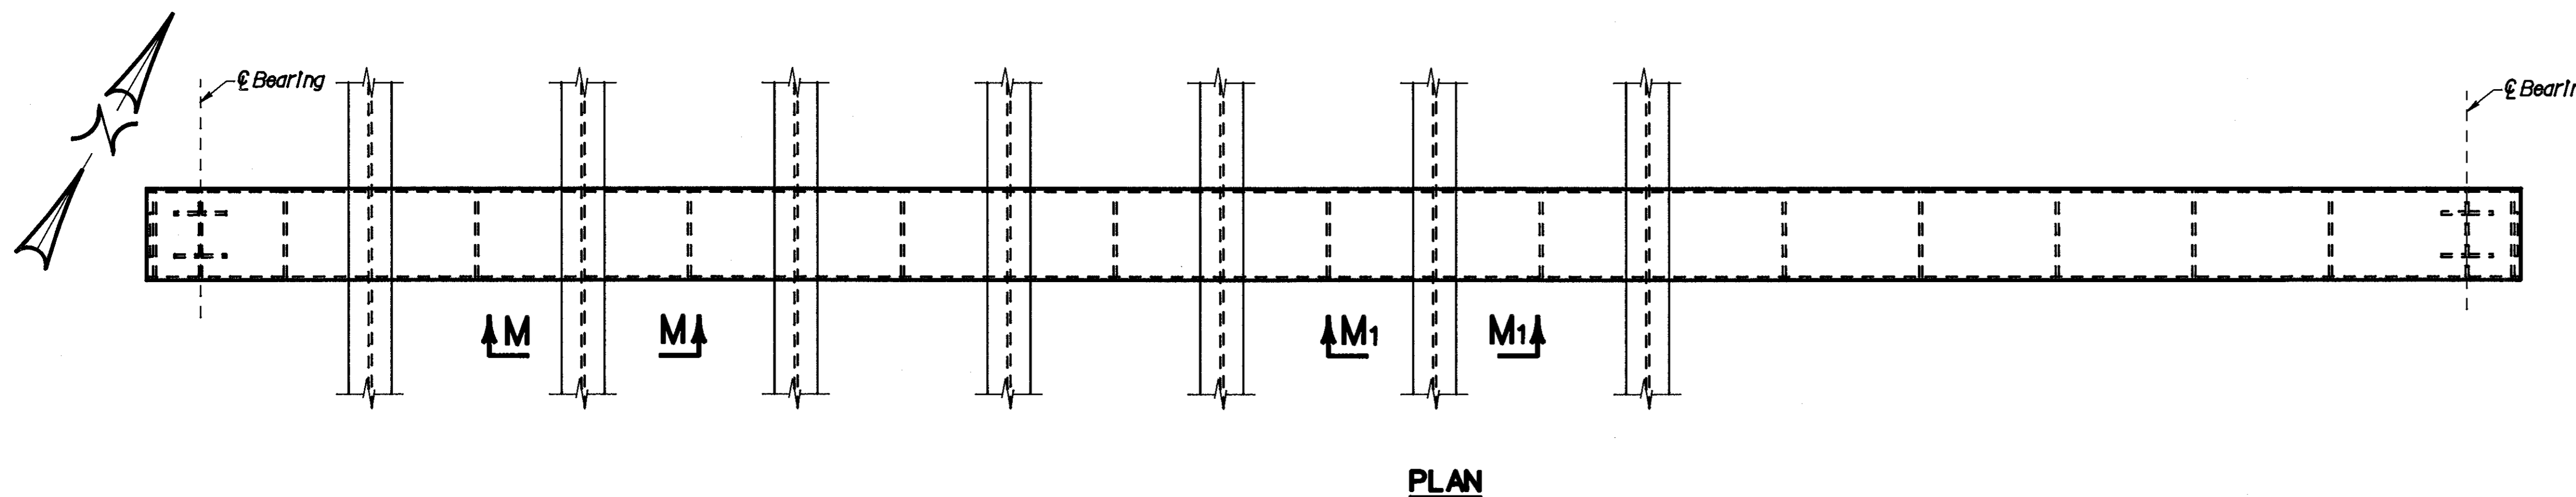
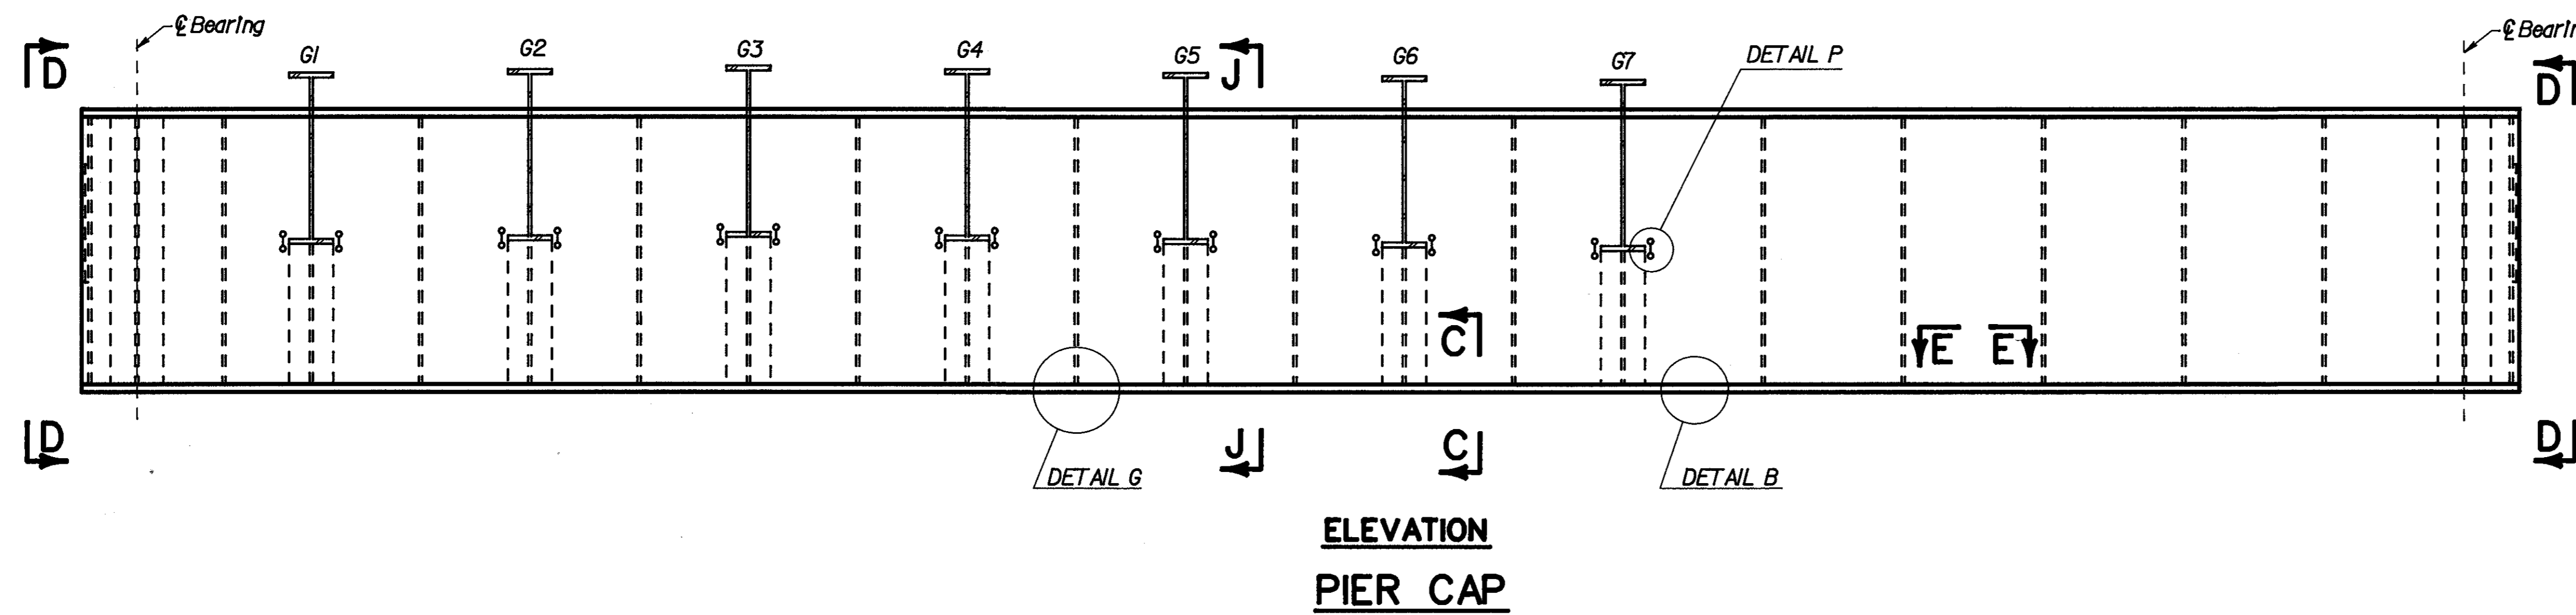
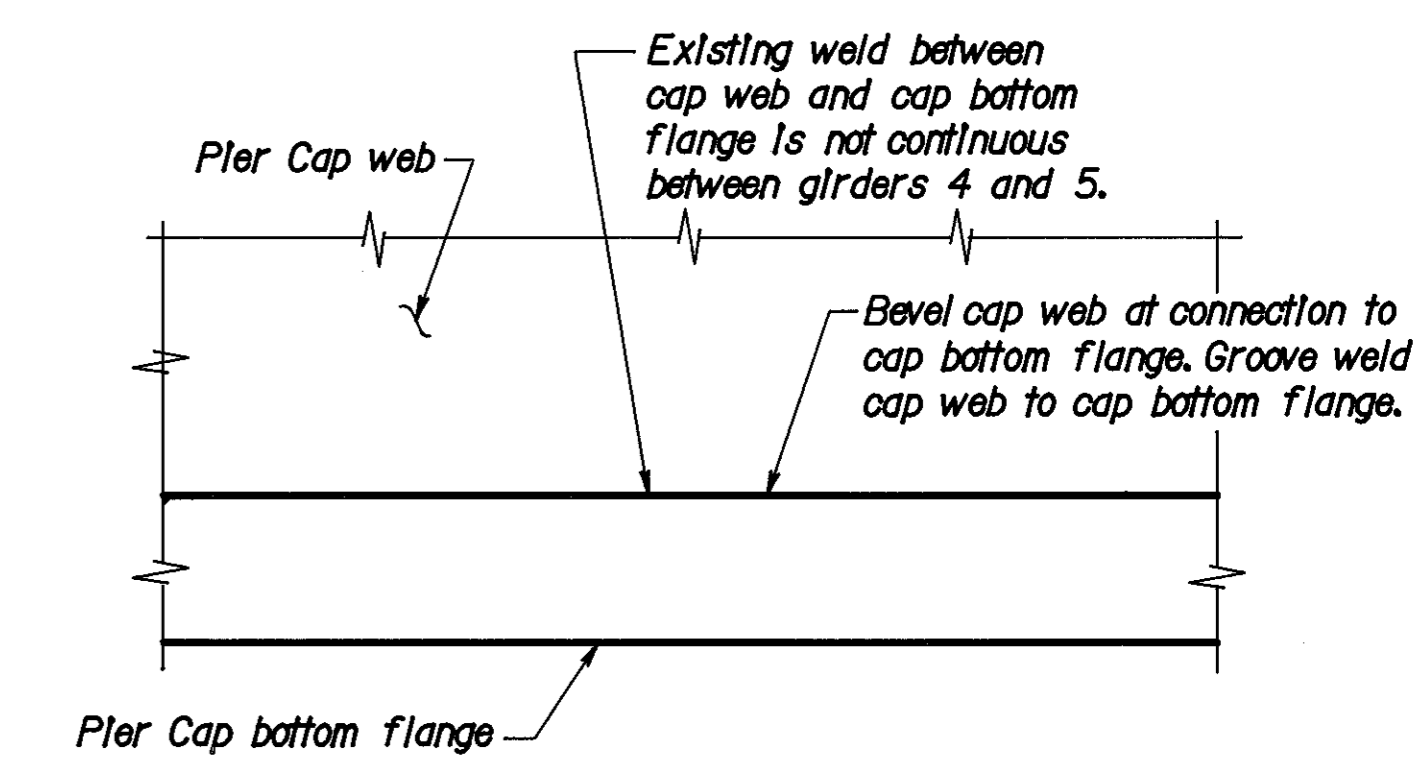
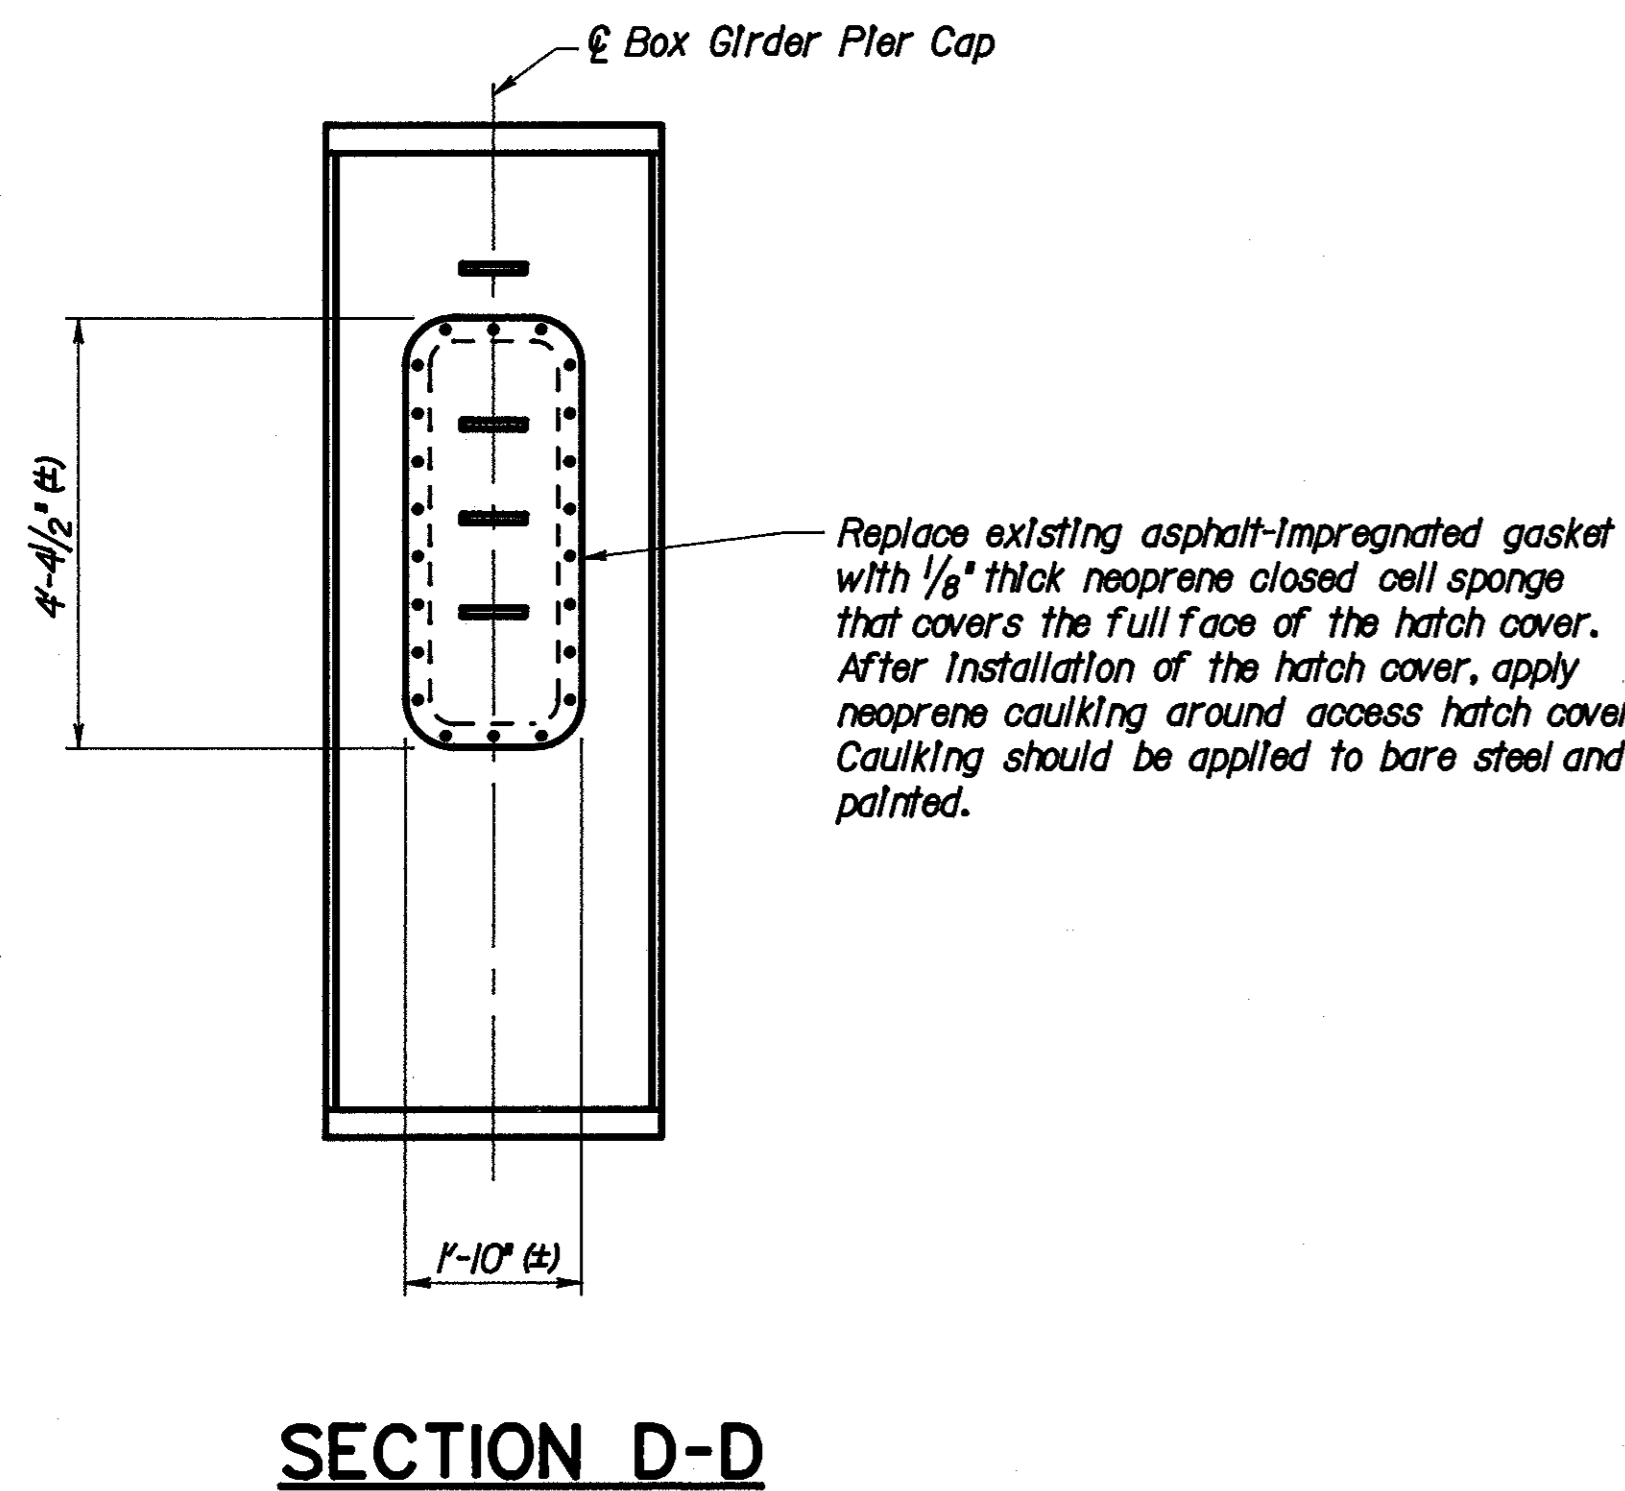
Replace existing asphalt-impregnated gasket with 1/8" thick neoprene closed cell sponge that covers the full face of the hatch cover. After installation of the hatch cover, apply neoprene caulking around access hatch cover. Caulking should be applied to bare steel and painted.
