FRACTURE CRITICAL PIER CAP INSPECTION REPORT

**SFN3110656 (HAM-75-1192R)
I-75 NB OVER MILL CREEK, BENSON
AVE/SHEPHERD AVE, NS RR
HAMILTON COUNTY, OH
DISTRICT 8**

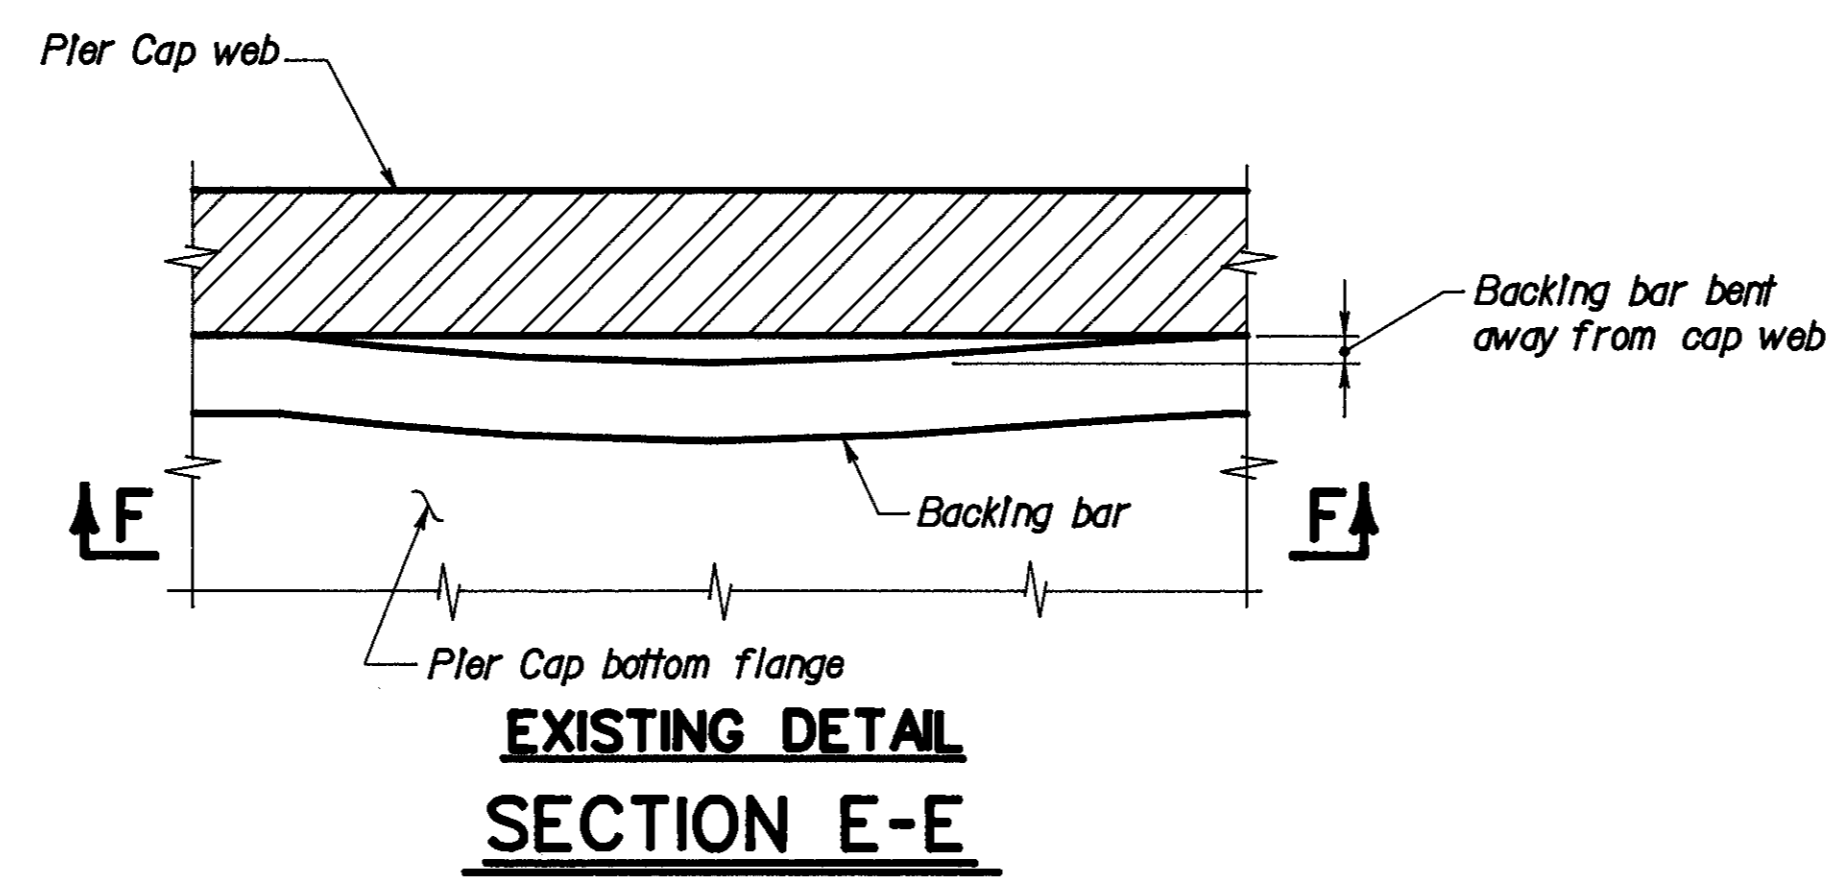
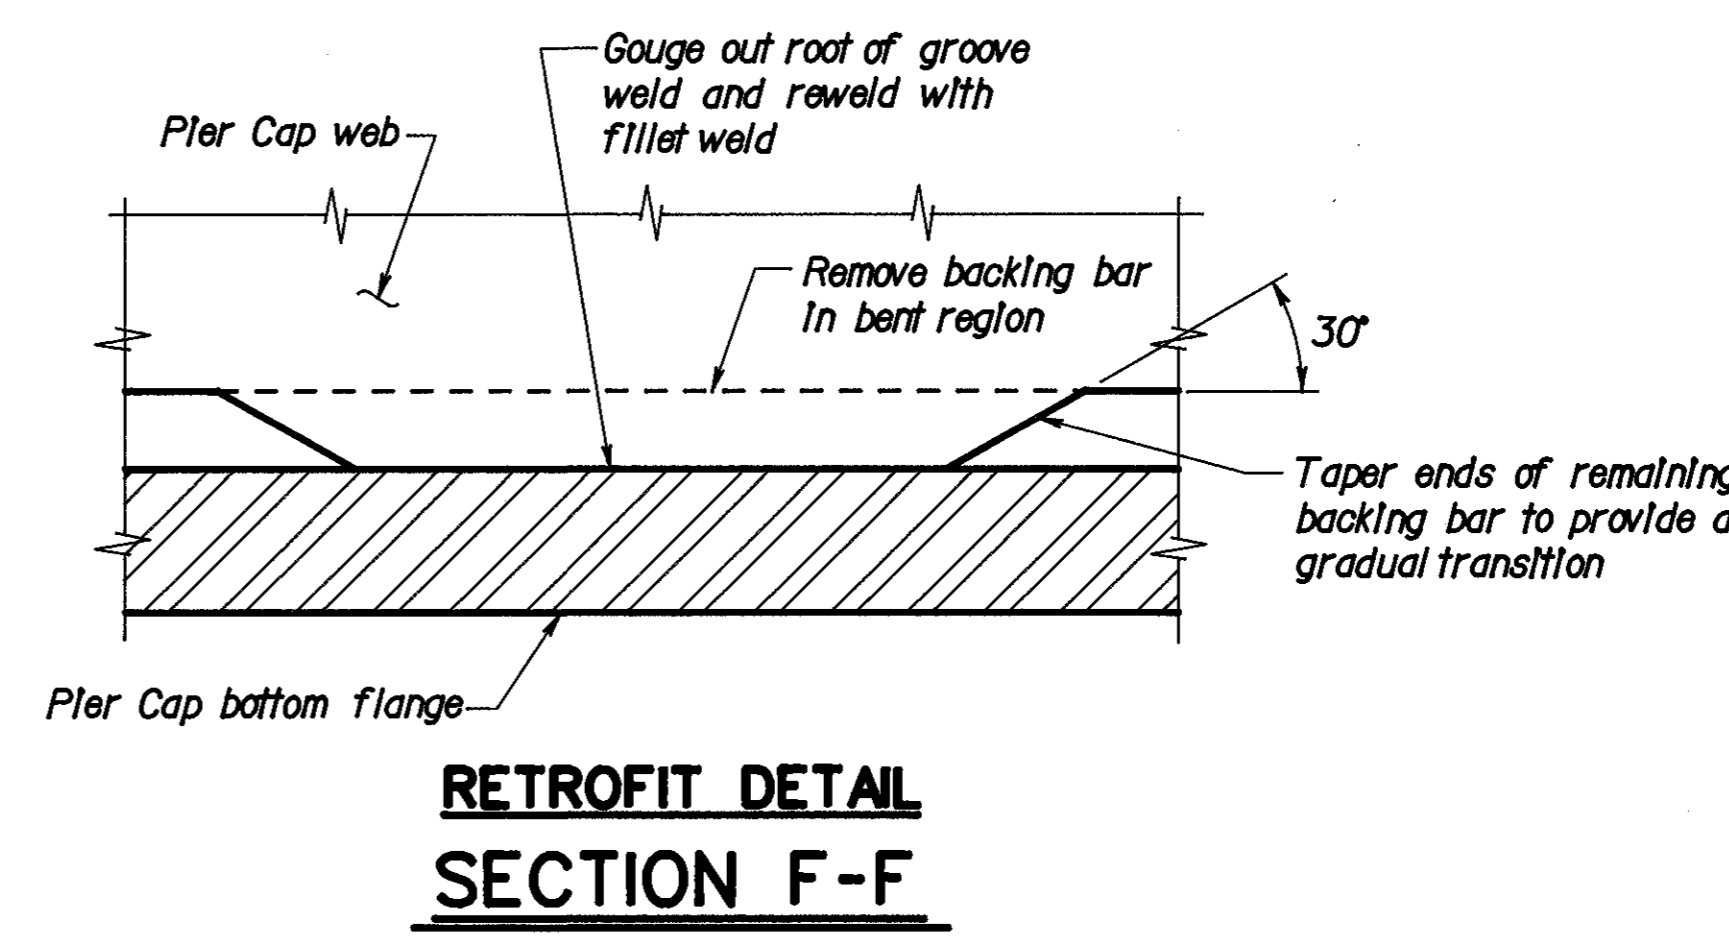
LOCKWOOD, JONES & BEALS CONSULTING ENGINEERS DAYTON, OHIO		55/105
STEEL PIER CAP REPAIR AT PIER 16		
BRIDGE NO. HAM-75-1192R NORTHBOUND I-75 OVER MILL CREEK, BENSON ST., N.Y.C.R.R. & SHEPHERD AVENUE.		
DESIGNED B&N	CHECKED B&N	DRAWN MJZ
CHECKED DFS	REVIEWED DATE HDJ 12/92	REVISED

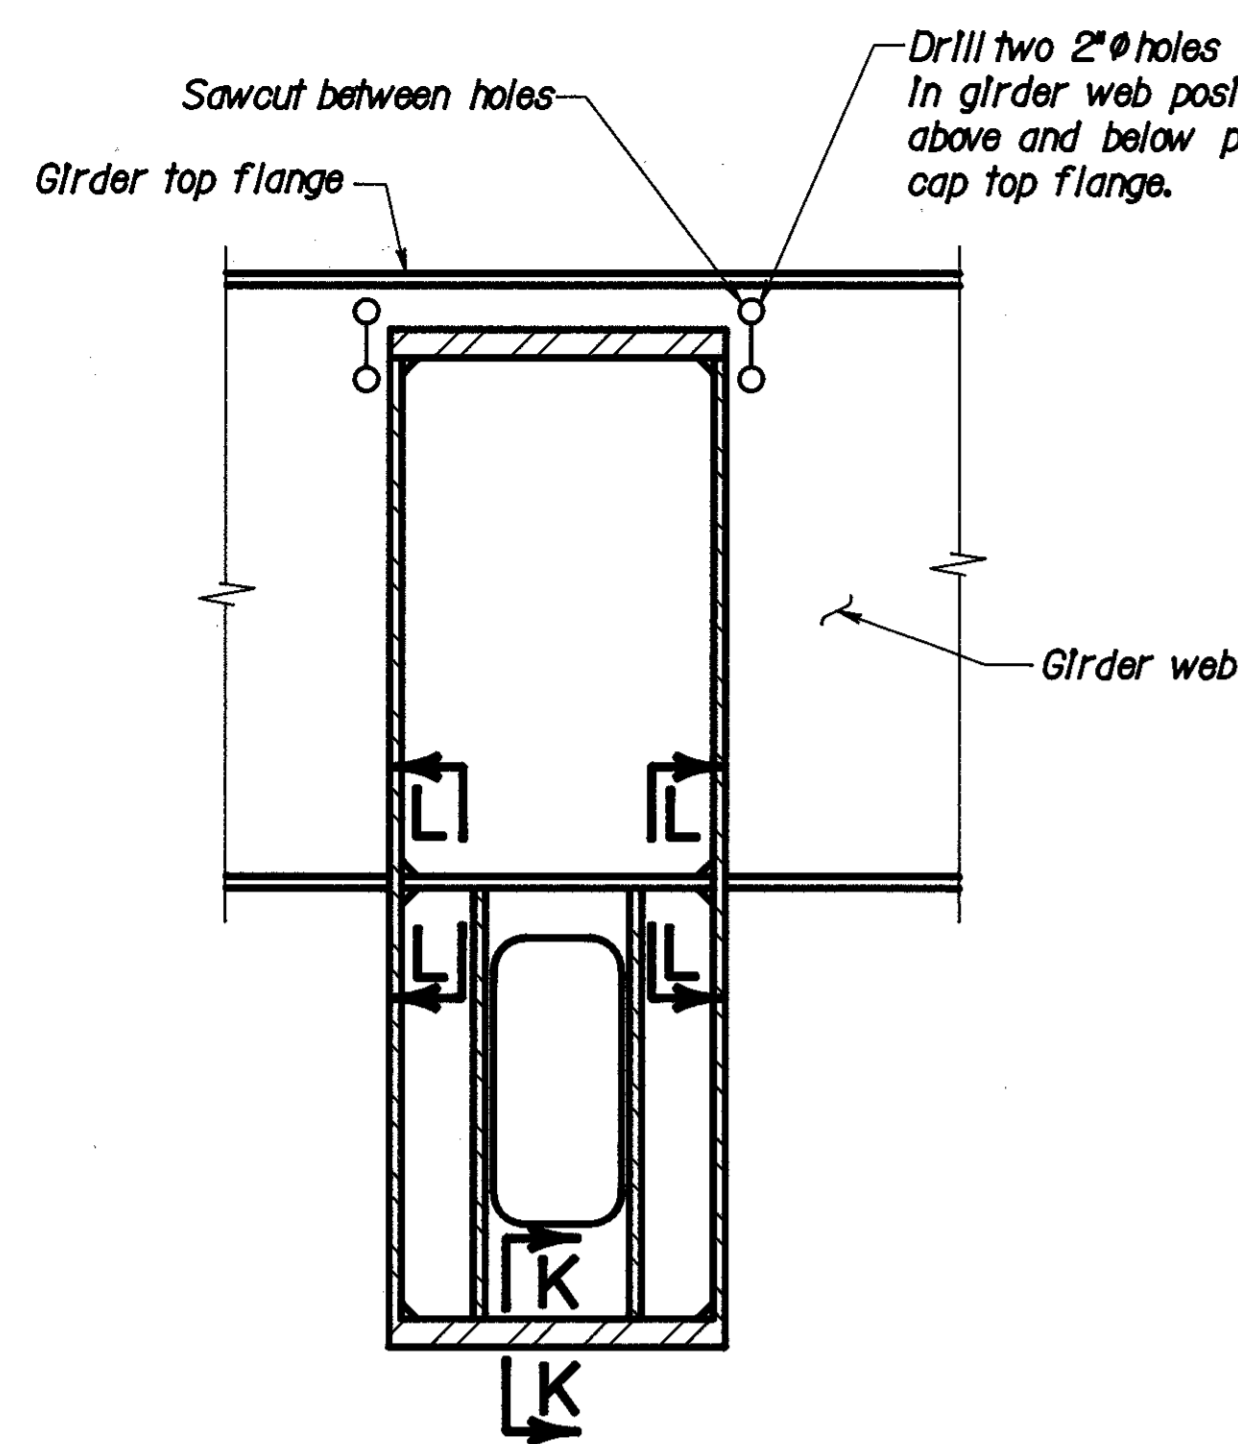
**HAMILTON COUNTY
HAM-75-9.75**

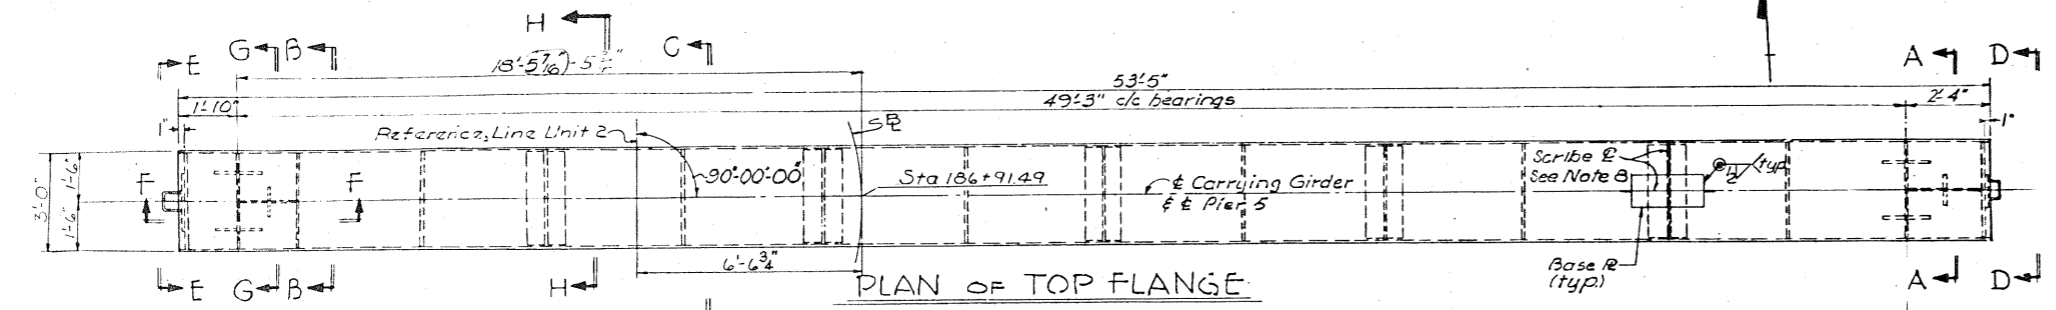
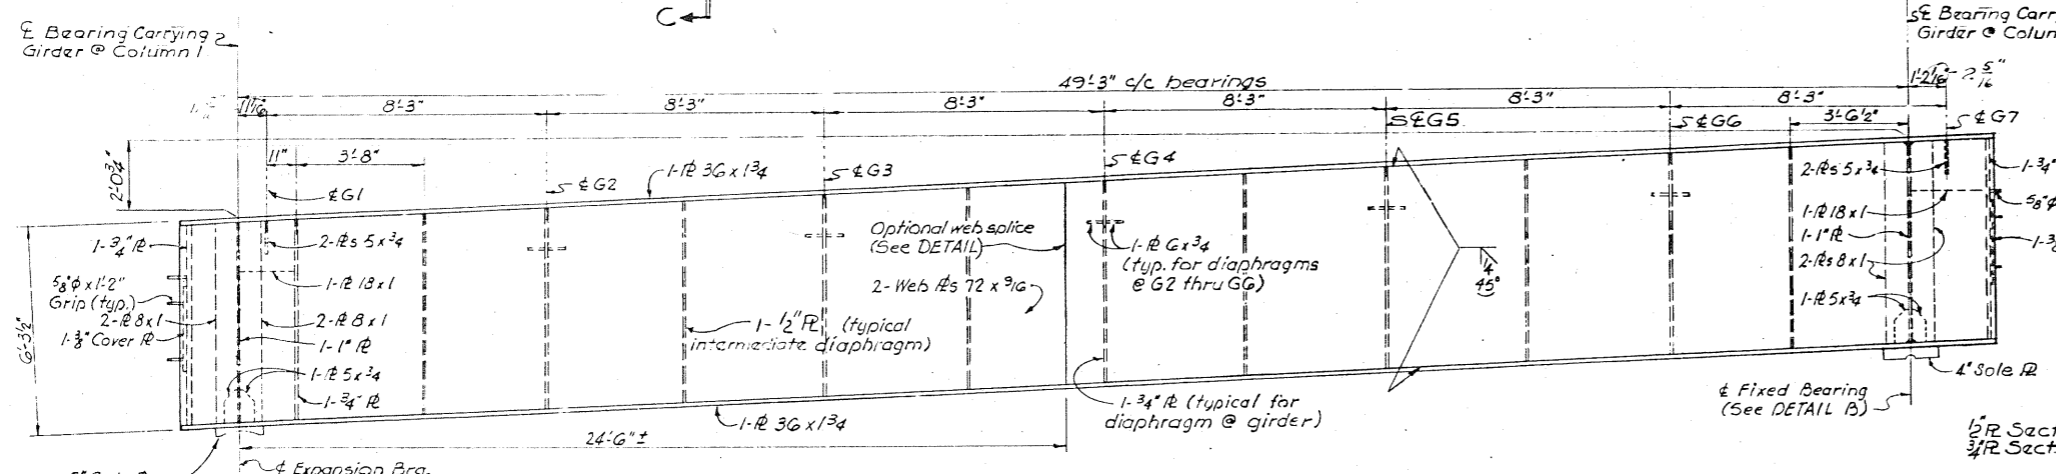
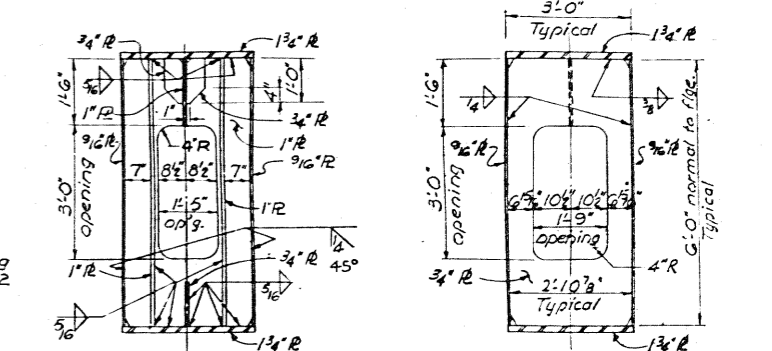
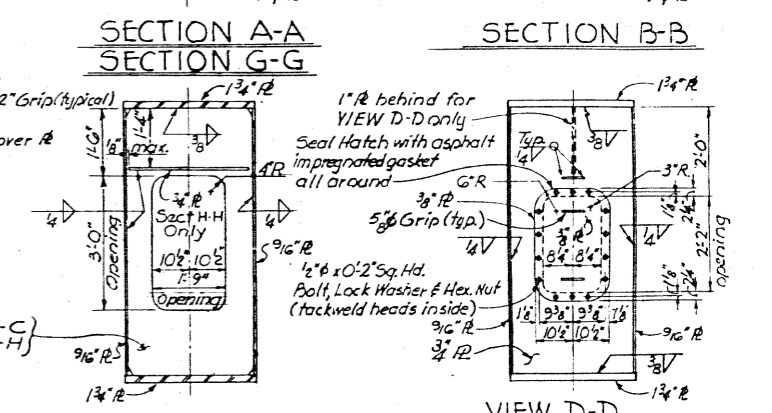
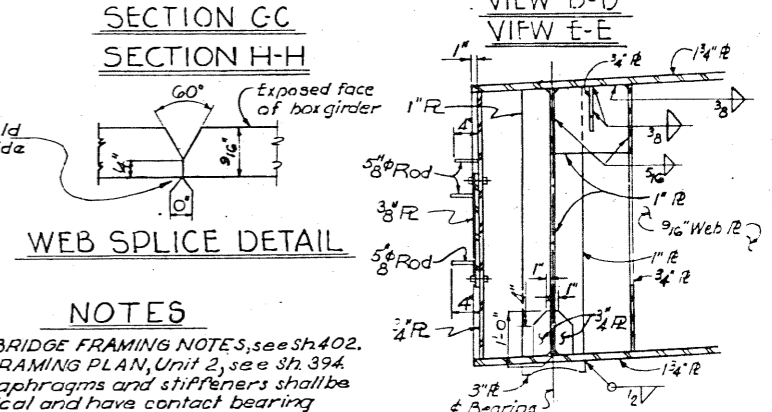
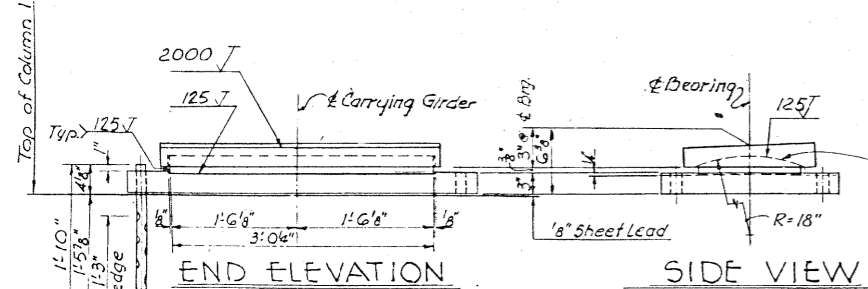
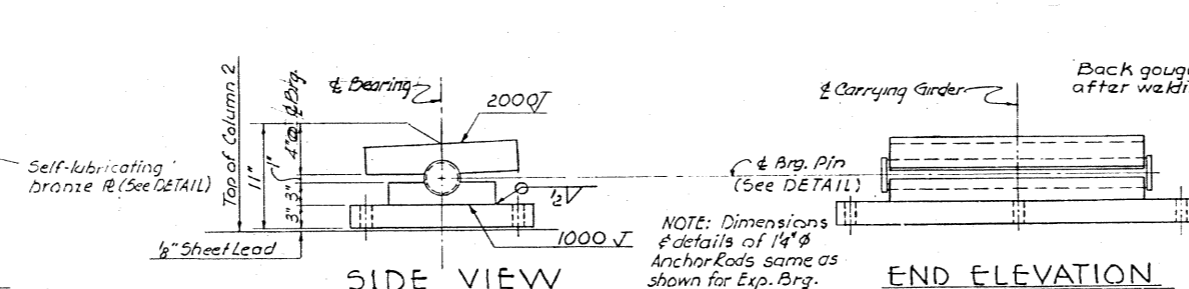
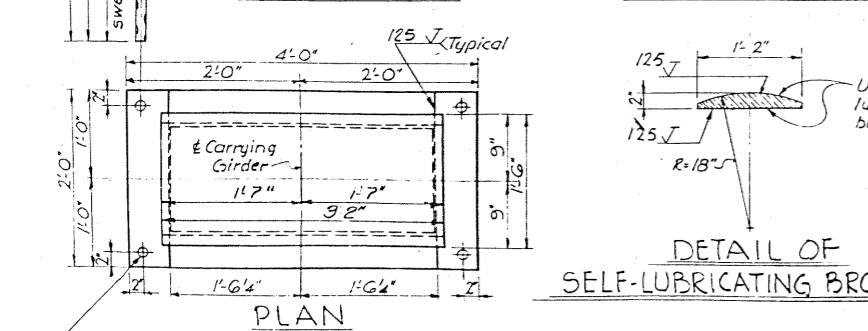
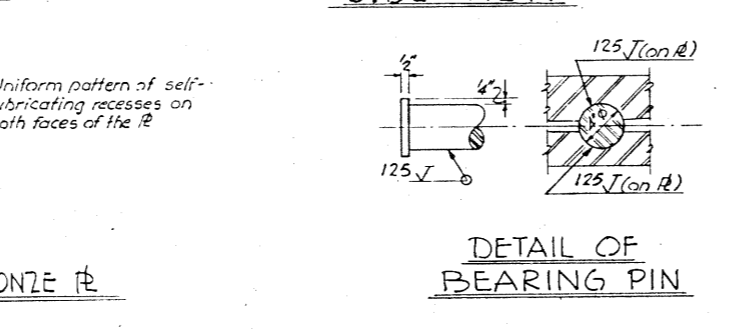
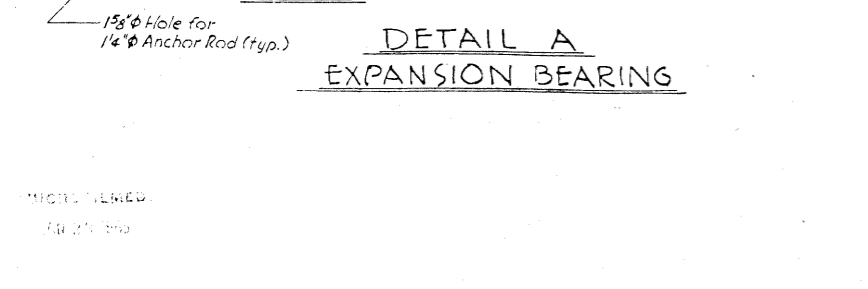
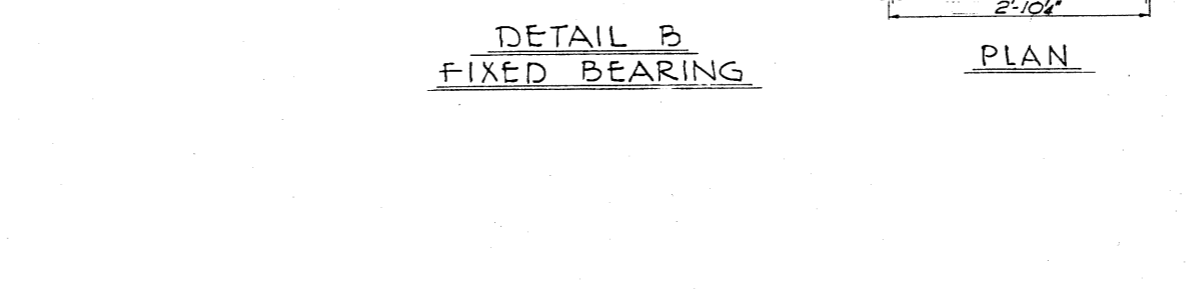
- WEB SPLICE DETAIL
- NOTES
1. For BRIDGE FRAMING NOTES, see Sh. 402.
 2. For FRAMING PLAN, Unit 2, see Sh. 394.
 3. All diaphragms and stiffeners shall be vertical and have contact bearing against the top of flange, unless welding to flange is required.
 4. Sole IRs shipped on girder must be protected against damage in transit.
 5. For Deflection and Camber, see Sh. 395.
 6. Butt welds on girder flange plates shall be ground flush, the finish grinding being parallel to the direction of stress.
 7. Butt welds shall be radiographically examined in accordance with Supplemental Specifications No. S-307, dated 8-23-60.
 8. Scribe center lines of carrying girder and longitudinal girders to extend beyond edges of shoes for control of setting shoes in the field. See Sh. 395.
