# **Lytle Tunnel (HAM-71-0134) Inspection Report Fall 2020**

PID 105470

November, 2020

Ohio Department of  
Transportation  
District 8  
505 South State Route 741  
Lebanon, OH 45036

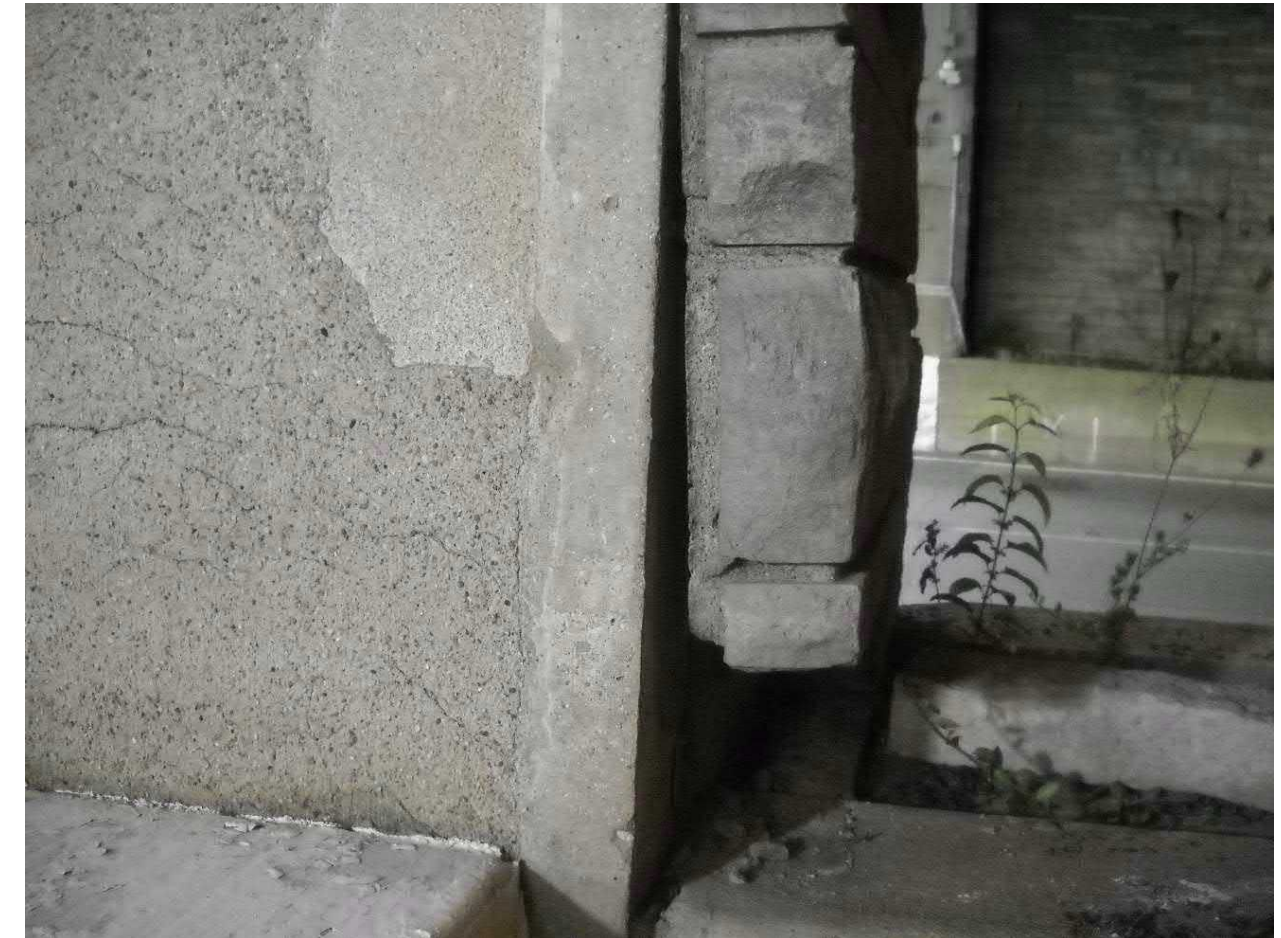
The significant or near-critical findings consist of deteriorating concrete on the South portal of the Southbound tunnel and loose stone masonry façade on the north portal of the Northbound tunnel.

#### 2-1 Loose and Missing Masonry at Portals

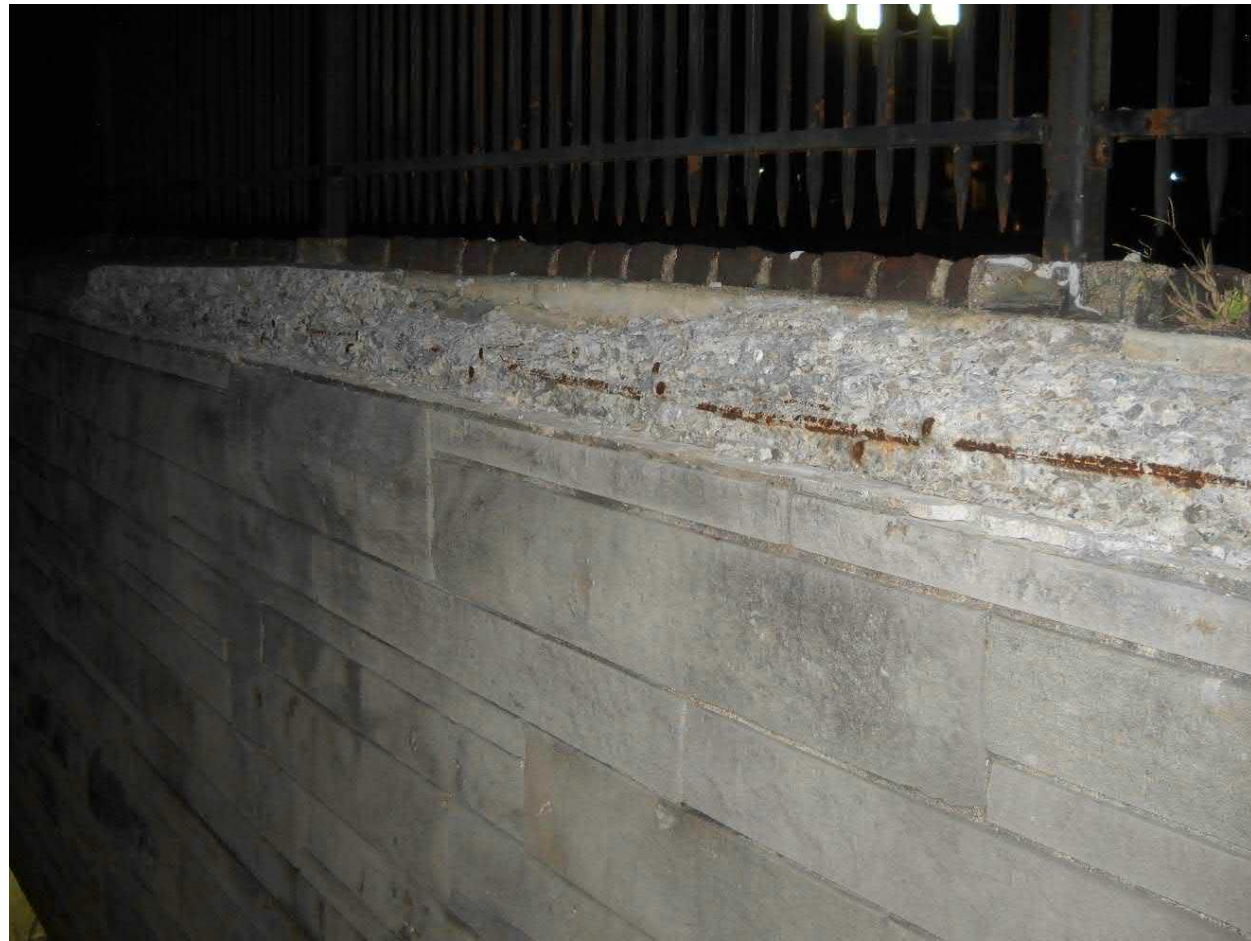
### 2-2 Disintegrated Concrete Cap at Southbound South Portal

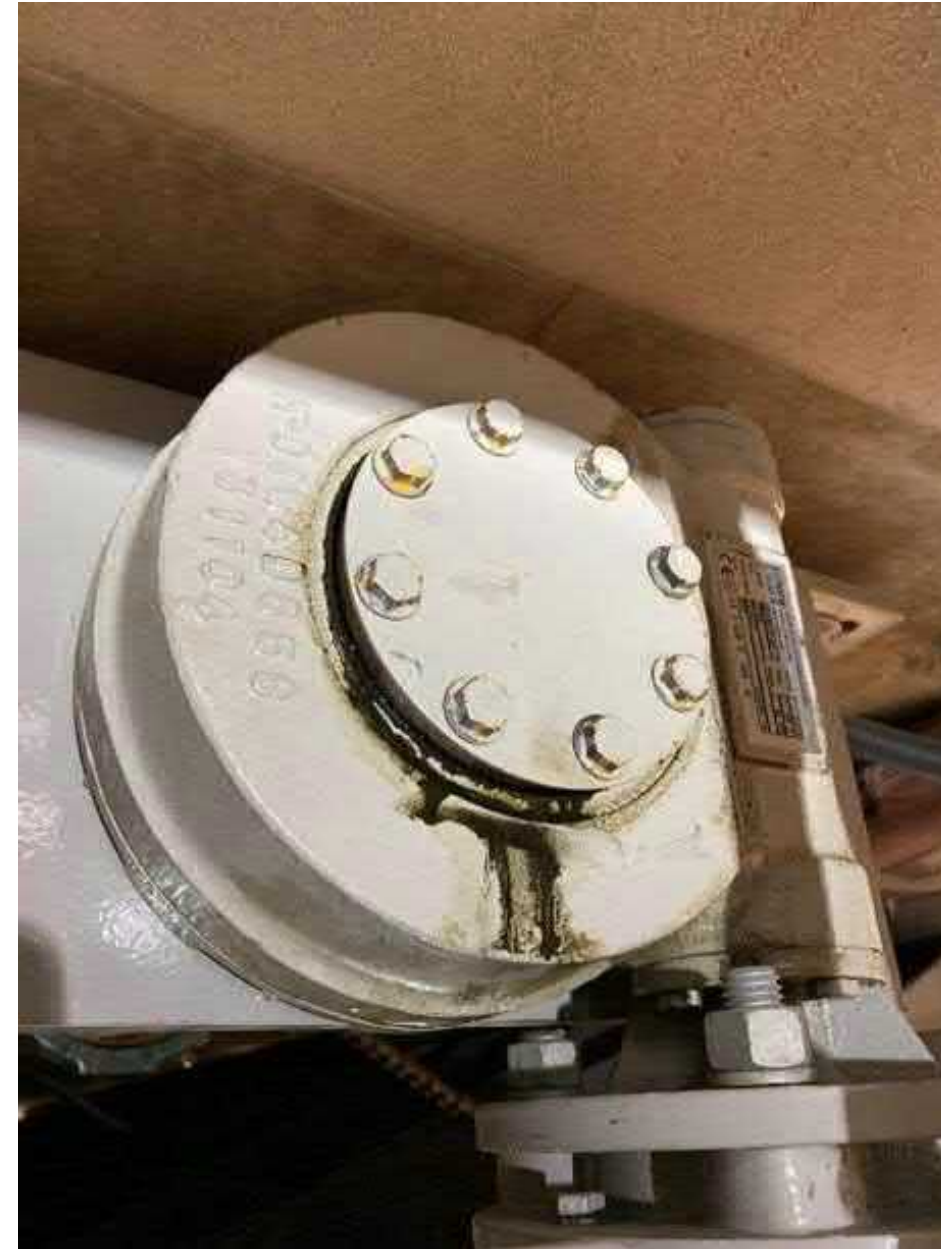
TI-DN Rotork actuator on the left hand side (looking North) leaks at both the hand wheel and the gearbox. Actuator is currently out of warranty. (See Appendix A, page 128.)

3-1 Damper Actuator Oil Leak

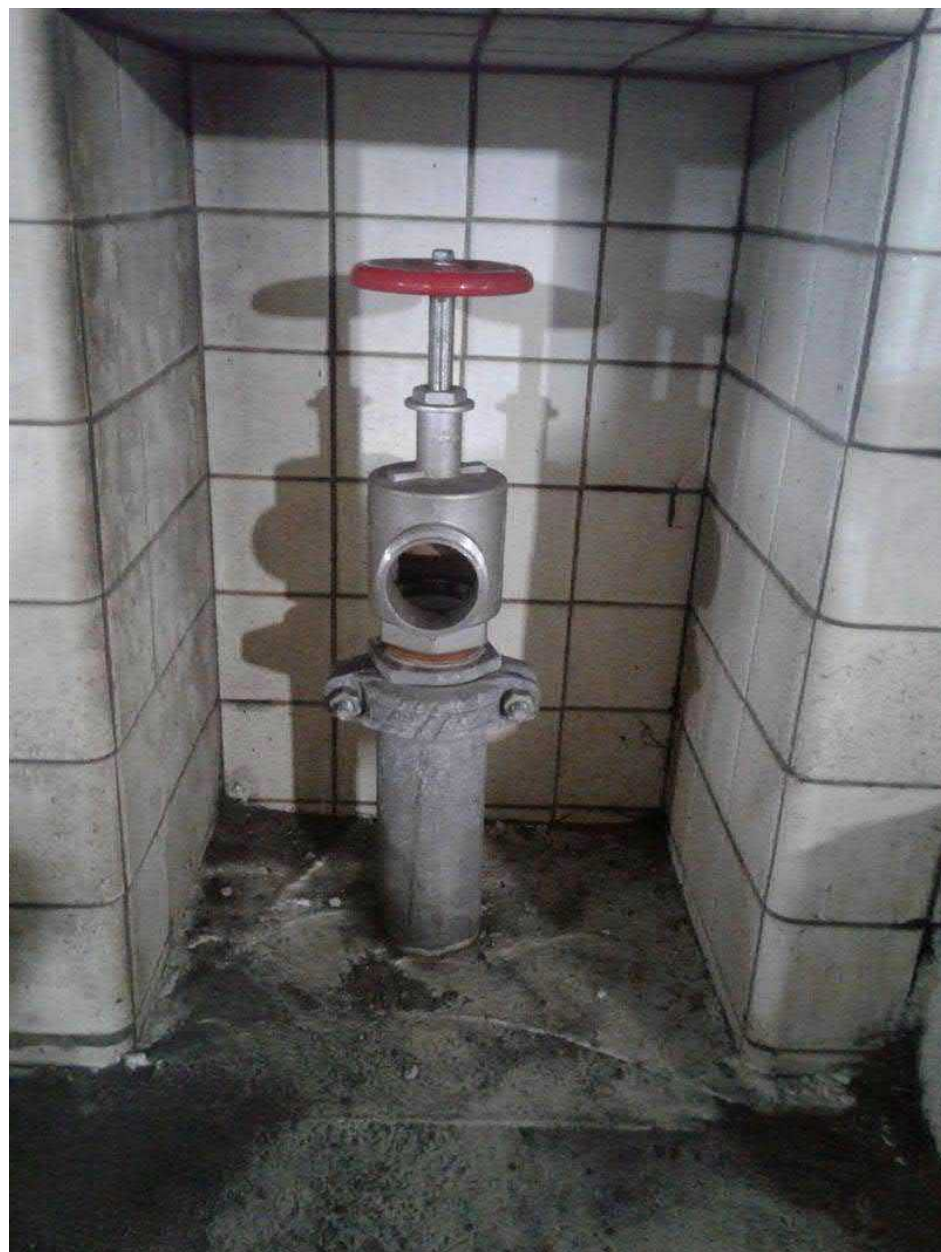
#### 3-2 Missing Standpipe Riser Cap

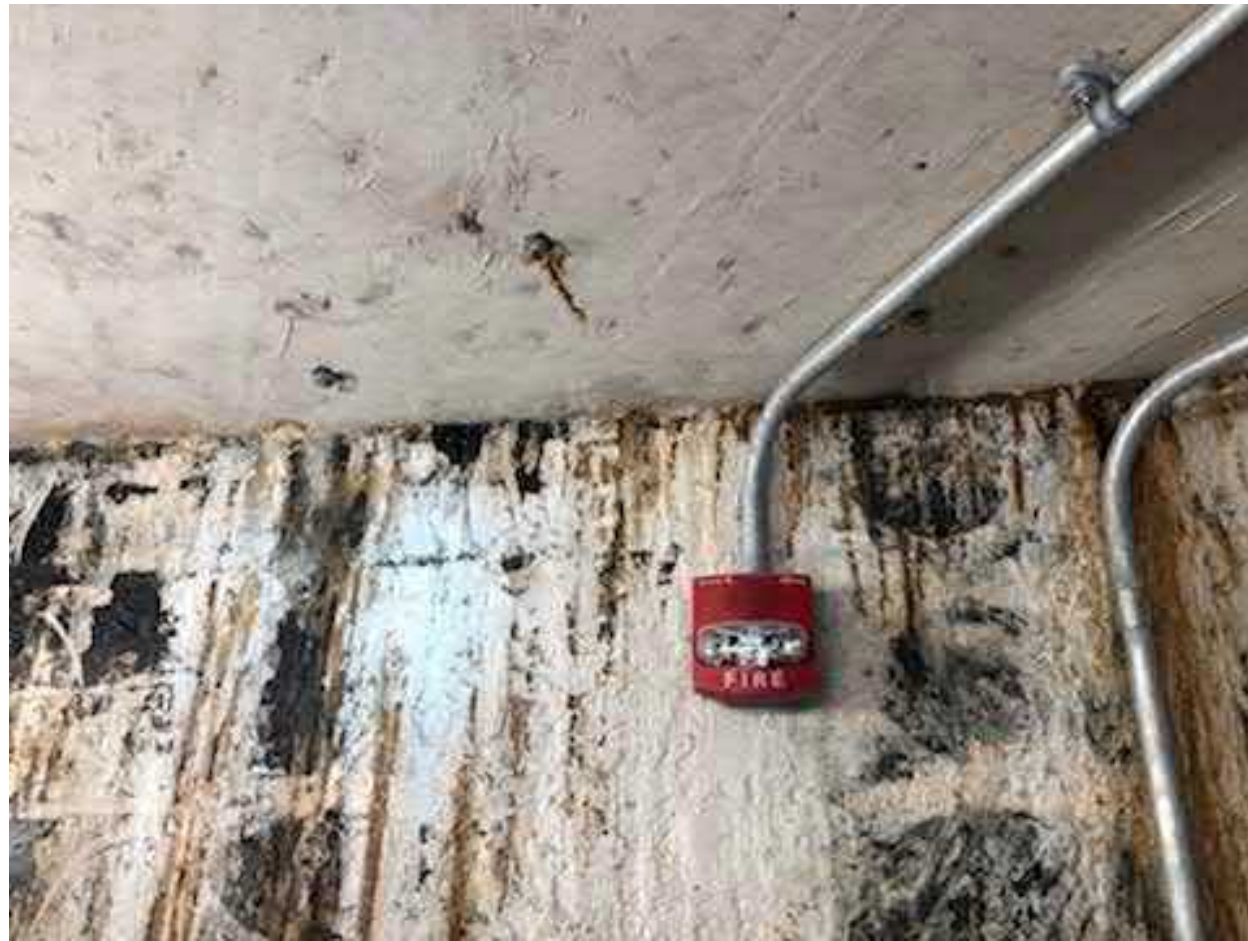
#### 3-5 Evidence of Leakage Along Construction Joint in Stairwell and Injection Ports

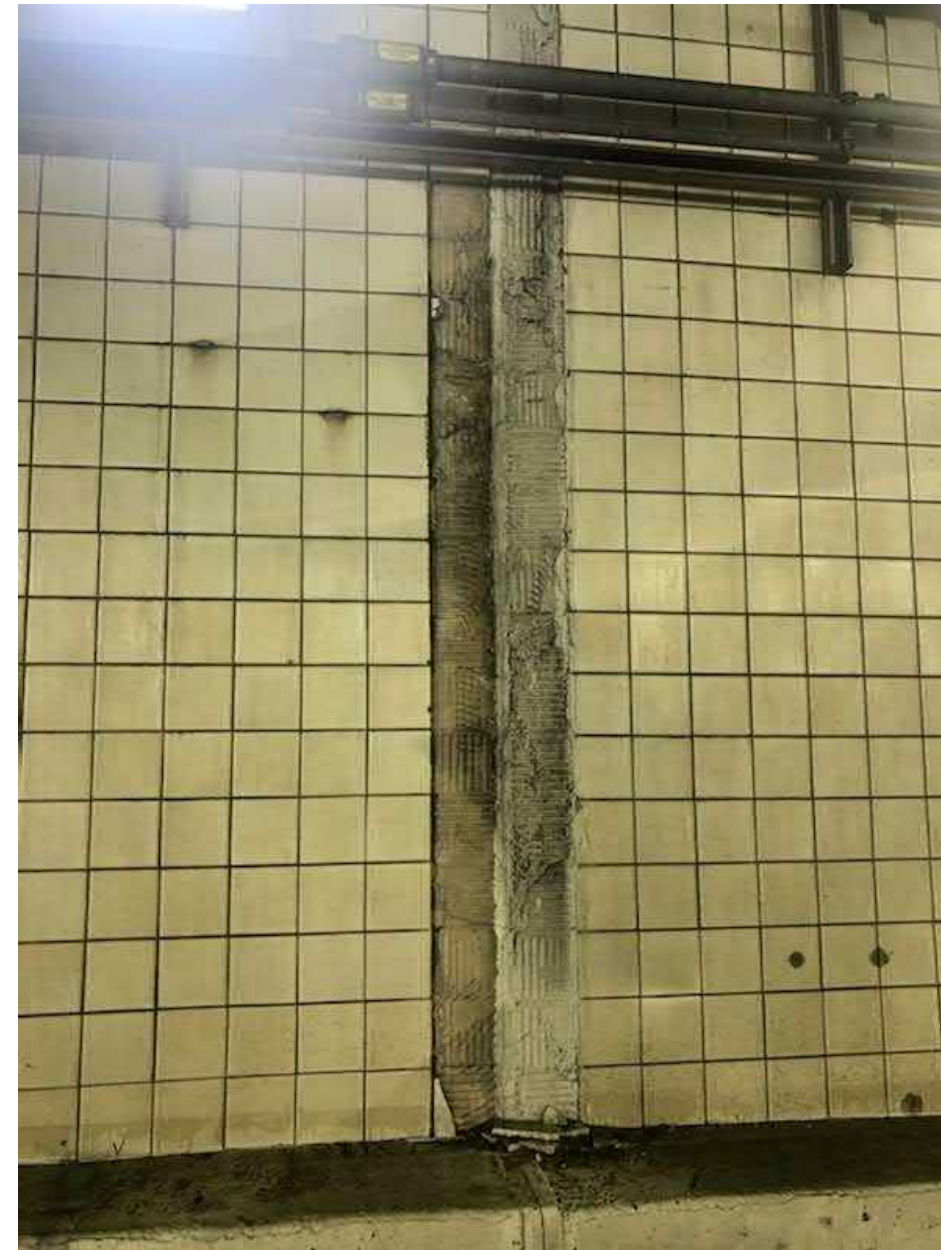
#### 3-6 Loose Tiles at Expansion Joints

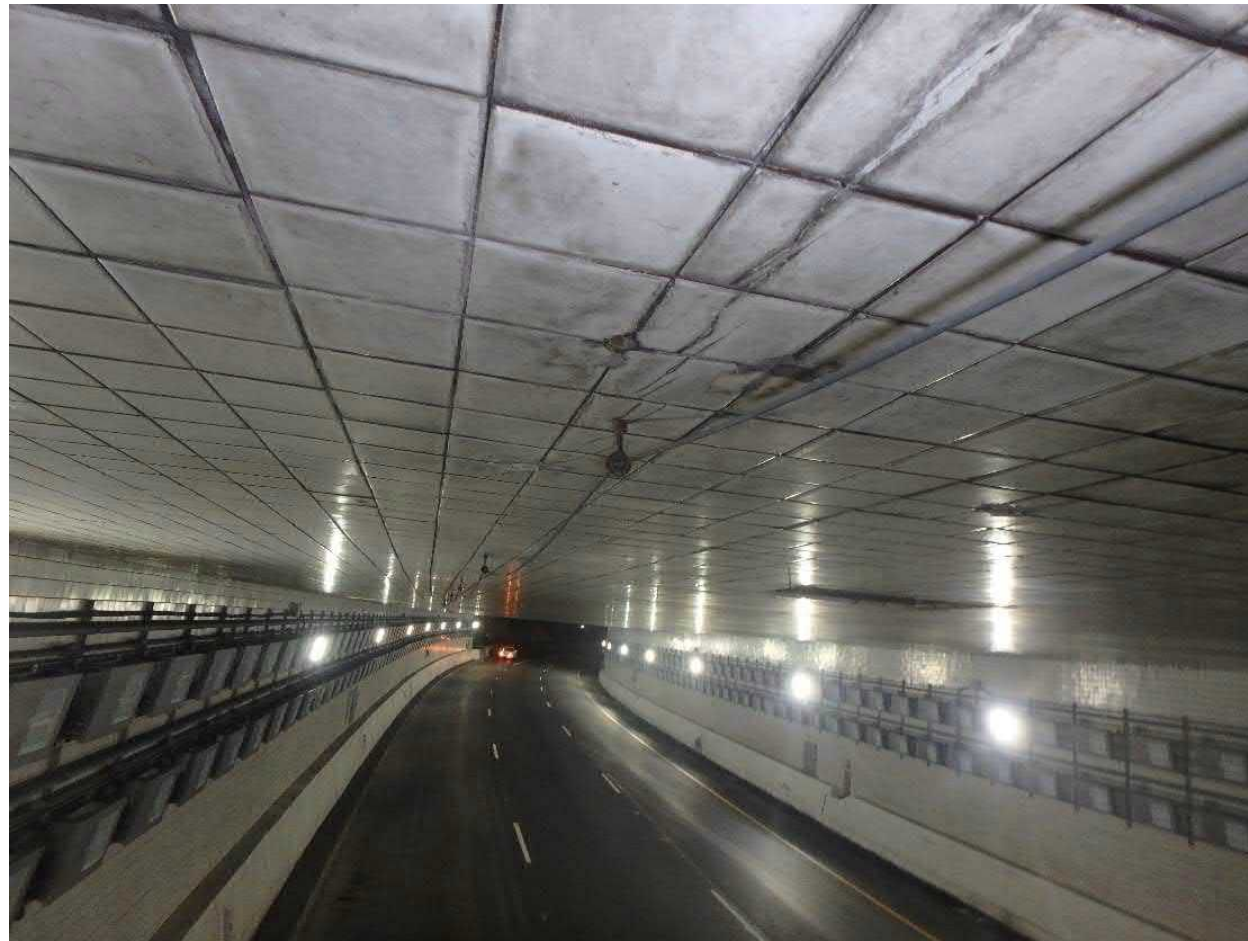
3-7 Typical Hairline Crack in Ceiling Tiles

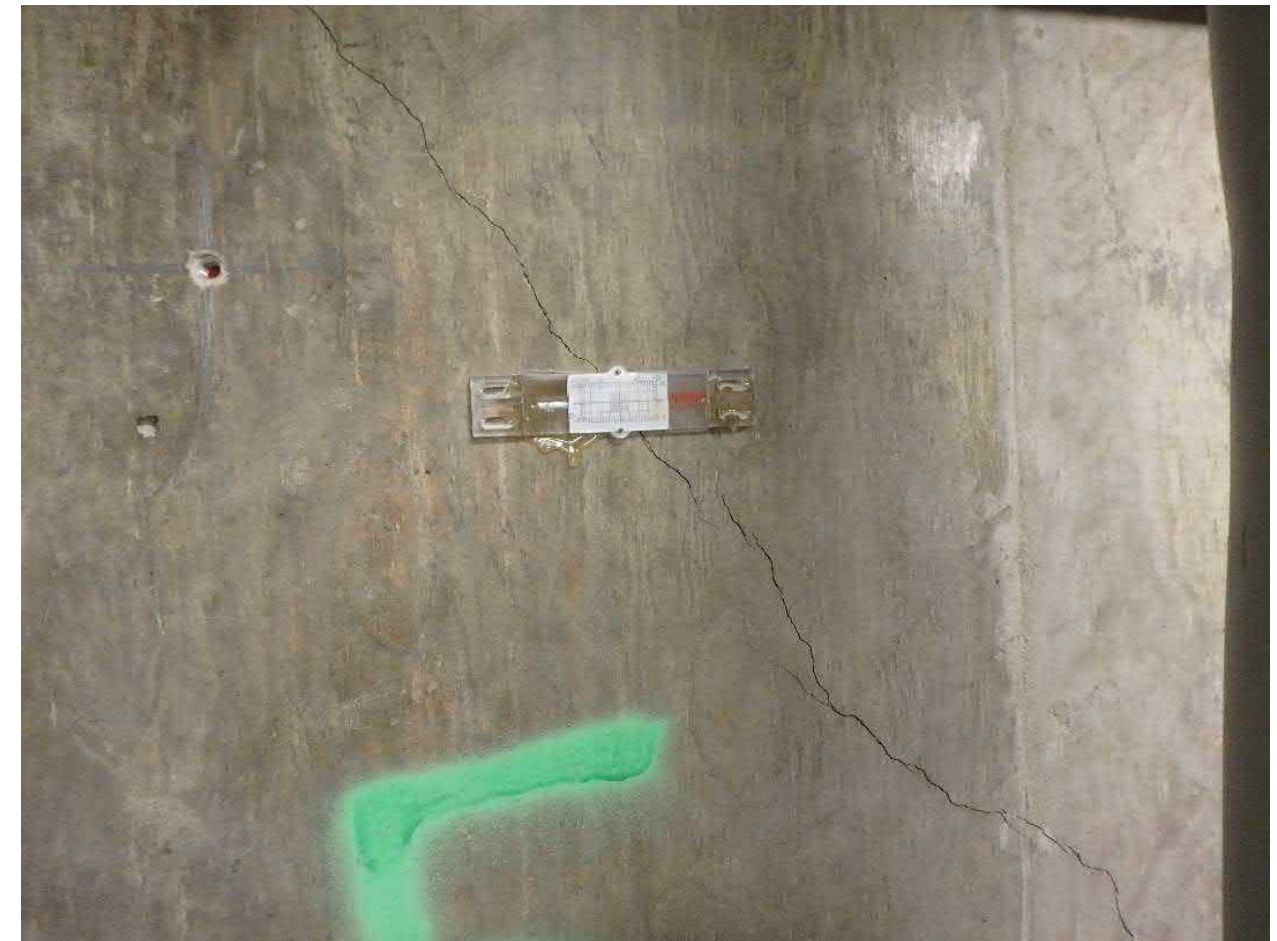
3-8 10 LF Diagonal Hairline Crack with Strain Gauge on Control Room East Wall

There are scattered hairline cracks and multiple isolated small spalls and delamination on the interior walls within the control room and plenum areas. These are tabulated in Appendix C room deficiencies. The interior walls between tunnel walls are typically covered with either ceramic tiles, or fireproofing. Appendix C tabulates the deficiencies found on the interior walls. A large number of vertical hairline cracks in the tiles and hollow or delaminated tiles and fireproofing were encountered throughout the East and West walls of each barrel. The conditions of the tile are indicative of the condition of concrete concealed below. Most joints between units is where hollow sounding tiles were most common. In the Southbound tunnel, along the joint between Units 3 and 4, the entire height of tiles unraveled on the left wall, and a column of tiles on either side of the joint that are hollow sounding on the right wall.

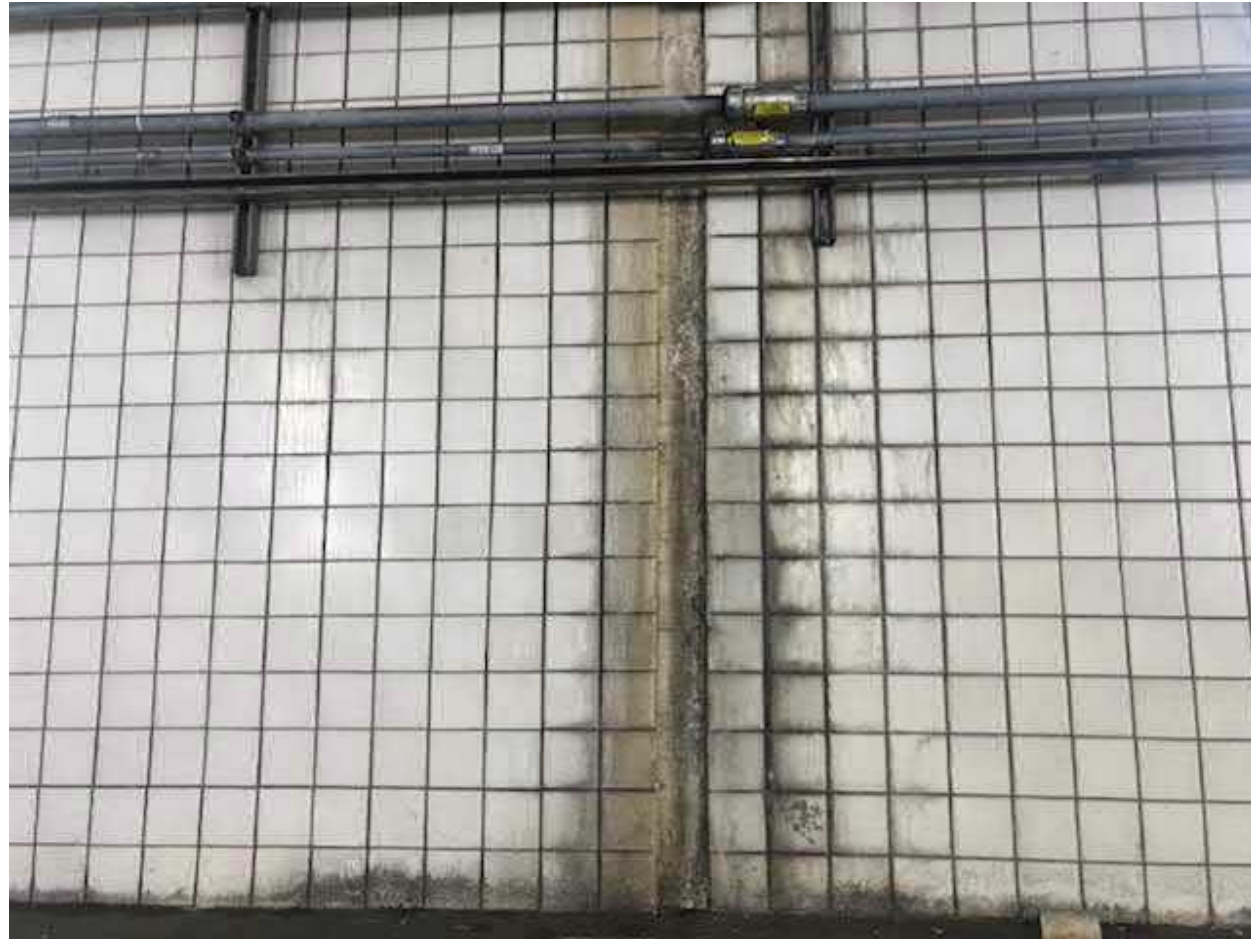
**3-9 Large Area of Efflorescence Present Between Units 16/17 in the Ramp Barrel**

The concrete interior walls are present through all barrels of the tunnel. The concrete interior walls are covered in either tile or fireproof coating and rarely show any deficiencies besides cracking. In this case at the joint between Unit 16 and 17 in the 3<sup>rd</sup> Street exit ramp there is a large area of efflorescence with evidence of moisture. The efflorescence only exists when water is present, meaning there may be a minor leak in this area. Throughout the inspection areas around unit joints exhibit more deficiencies.

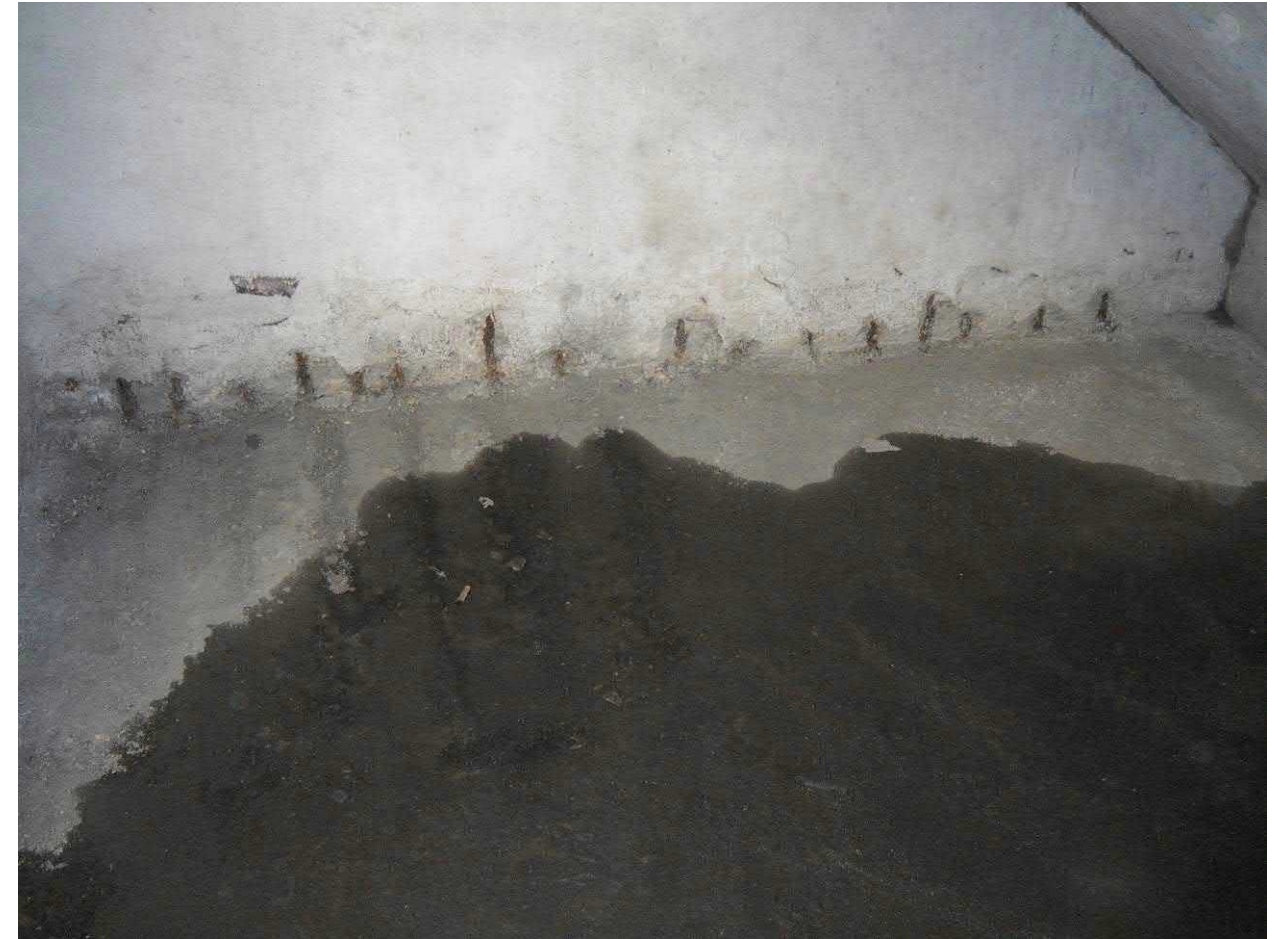
**3-10 Area of Delamination and Spalling with Exposed Rebar in Cross Passageway**

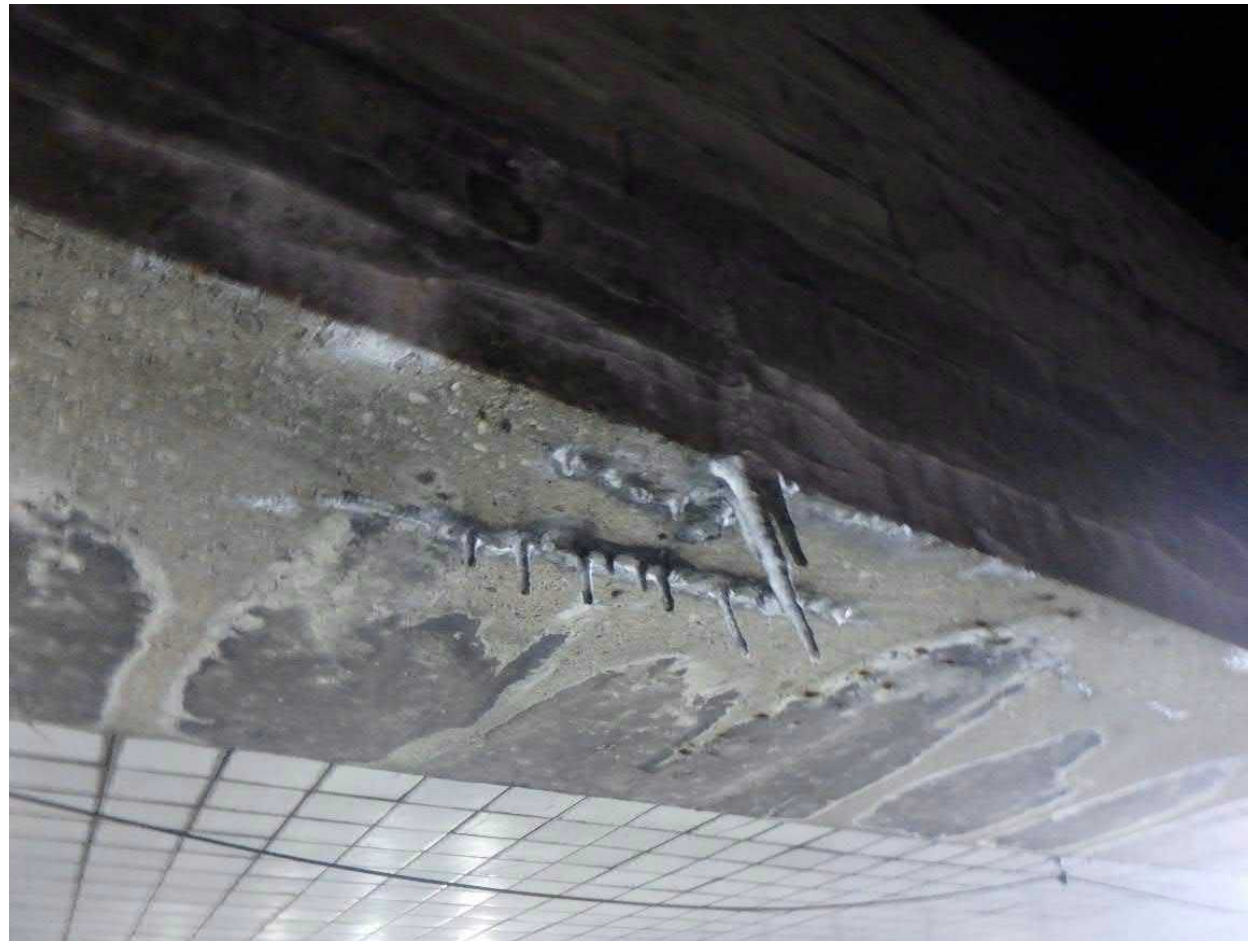
### 3-11 Calcification Cracks and Stalactites at Southbound South Portal Header

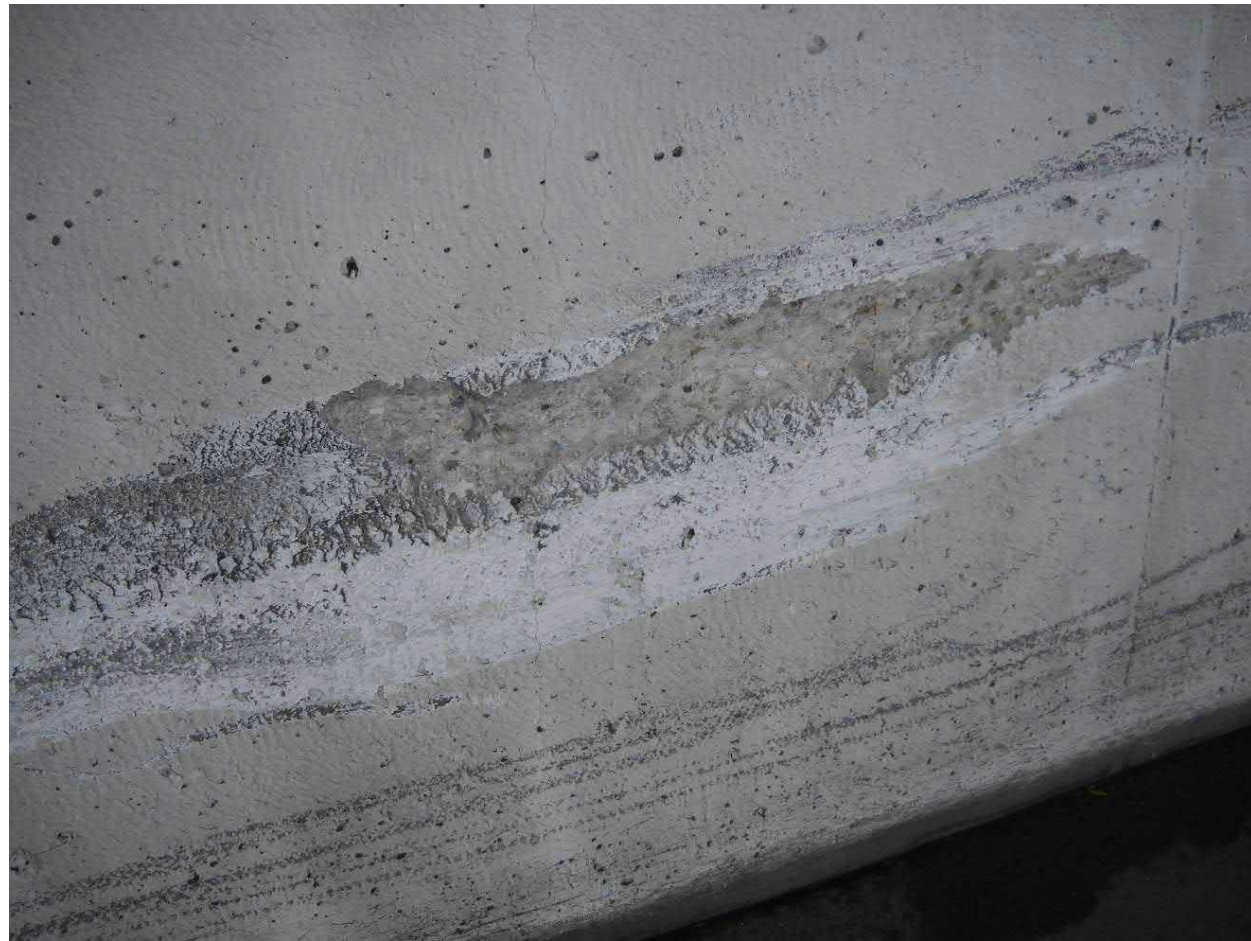
**3-12 Typical Vertical Hairline Crack in Barrier and Collision Scrapes**

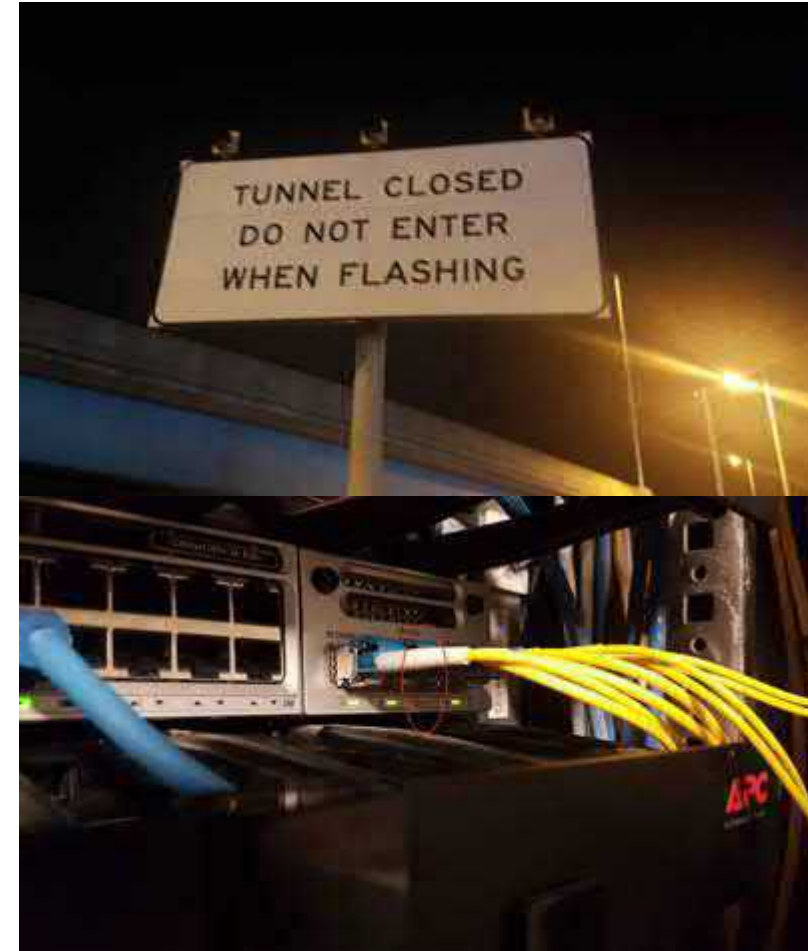
1. The NB "Tunnel Closed" signage located at the South Portal does not operate when in the "ON" position back at the HMI cabinet in the control room. Glenwood tracked the potential problem to the HMI cabinet where some optic fiber ports do not seem to be communicating with comms interfaces at the portal. He said he would contact ODOT as this would be part of their scope to investigate and resolve.

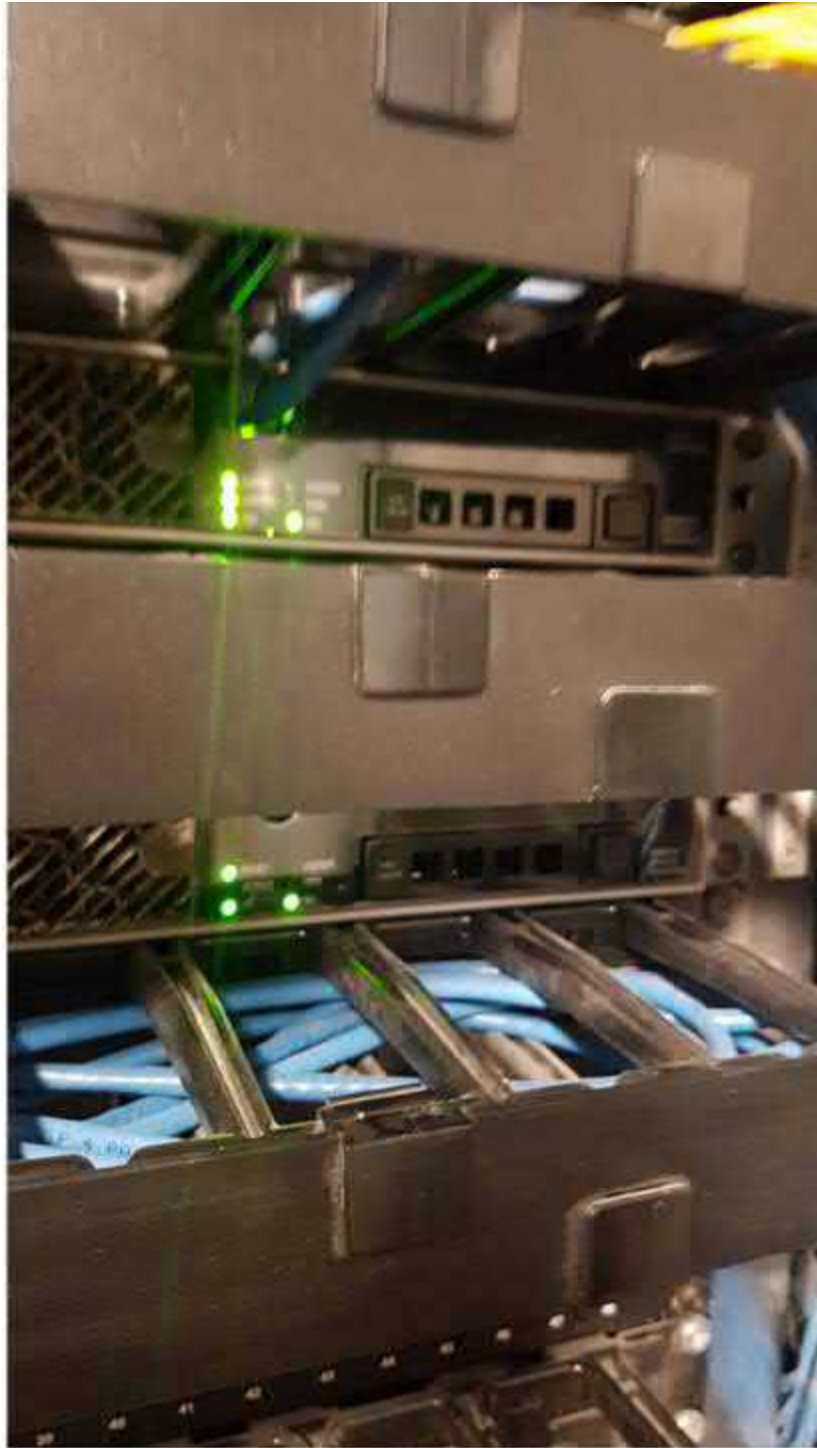
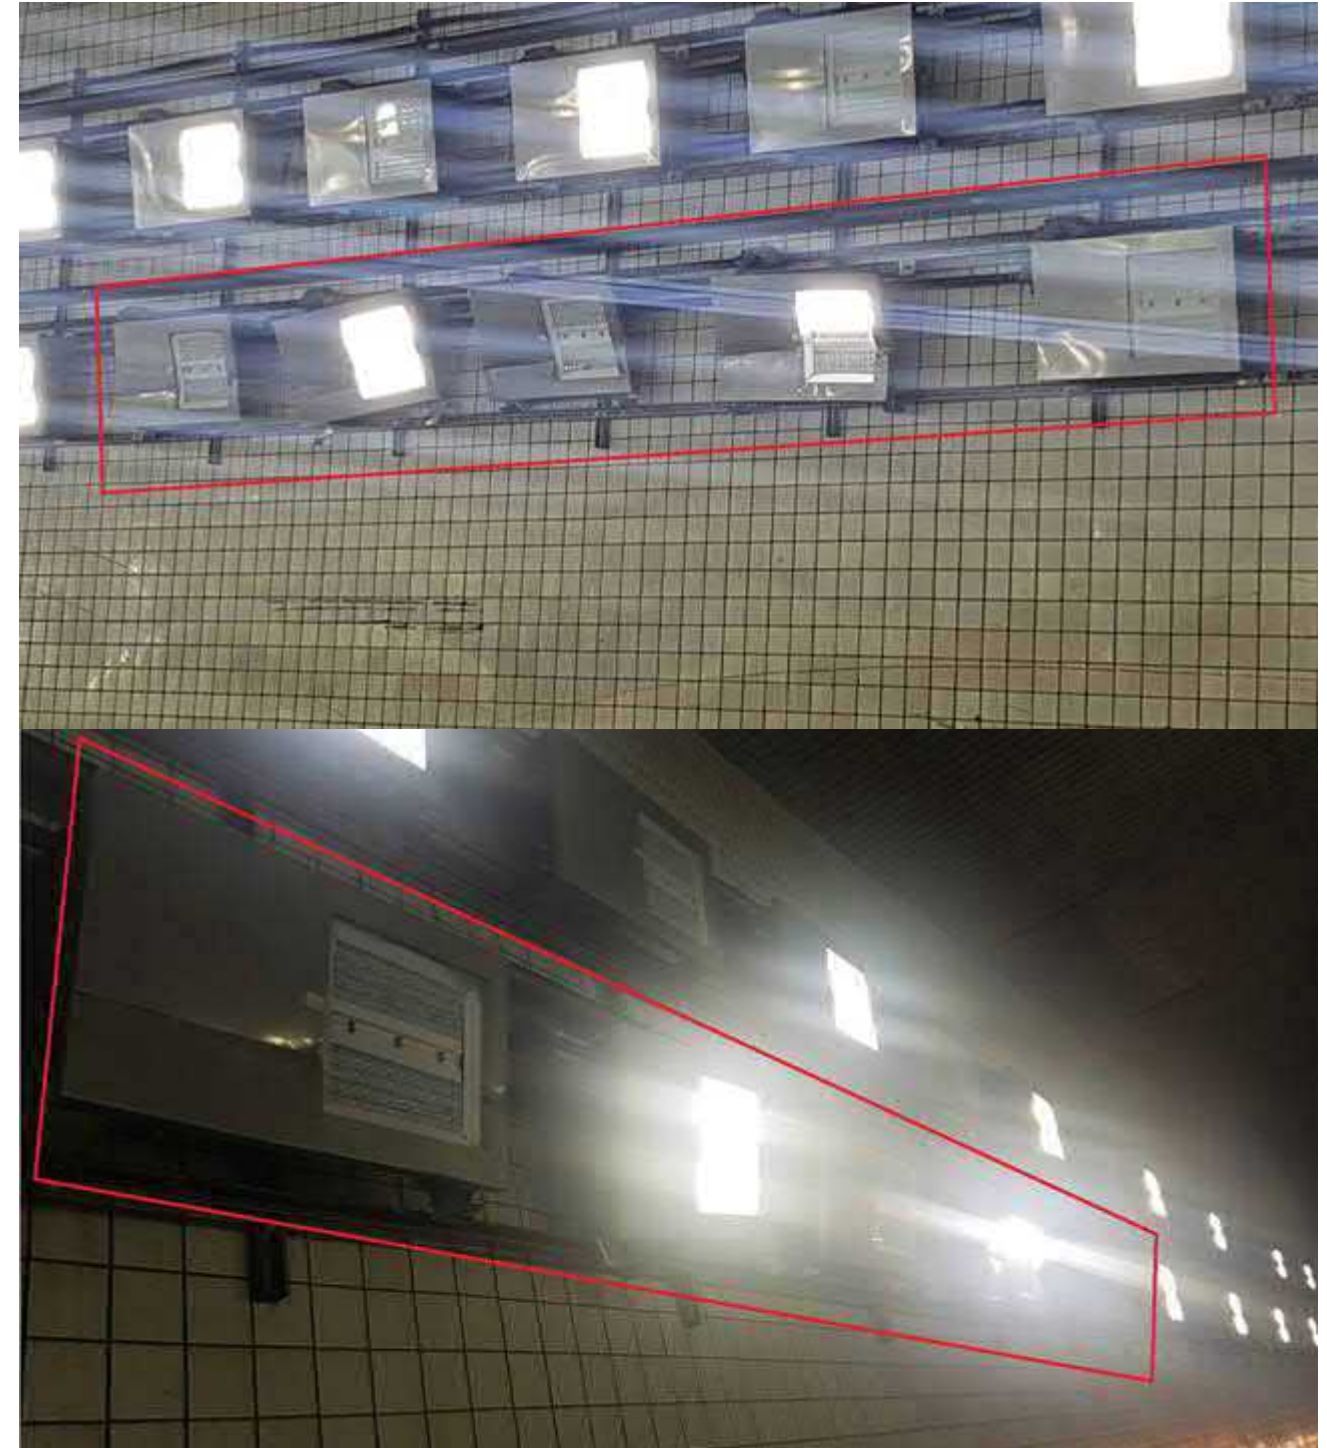
2. North Bound Tunnel Lighting Fixtures #15-19 on the bottom row of the east wall at the south portal have been struck and are badly damaged with one fixture nonoperational and one half – operational. Two fixtures (#16 & #18)) are being held by only 1 bolt, two fixtures (#17 & #19) are being held by only 2 bolts and #15 is being held by 3 bolts. There is no telling when the remaining bolts on #16-#19 are going to fail due to the impact they received after which the only thing that would prevent them from falling onto the roadway are the flexible side entry conduits. I flagged this to an ODOT gentleman on duty (Zack Gillespie I believe) and they addressed the issue temporarily with multiple heavy duty cable ties per loose bracket. It is strongly recommended that ODOT replace these damaged units ASAP, I see they have spares ready to go in the control room – the ODOT gentleman did mention that he thinks these are scheduled for replacement but wasn't 100% sure.
