Inspection Date: 06/24/2025

Facility Carried: SB IR 71

## Ohio Bridge Inspection Summary Report

**HAM-00071-0248L (3106780)**

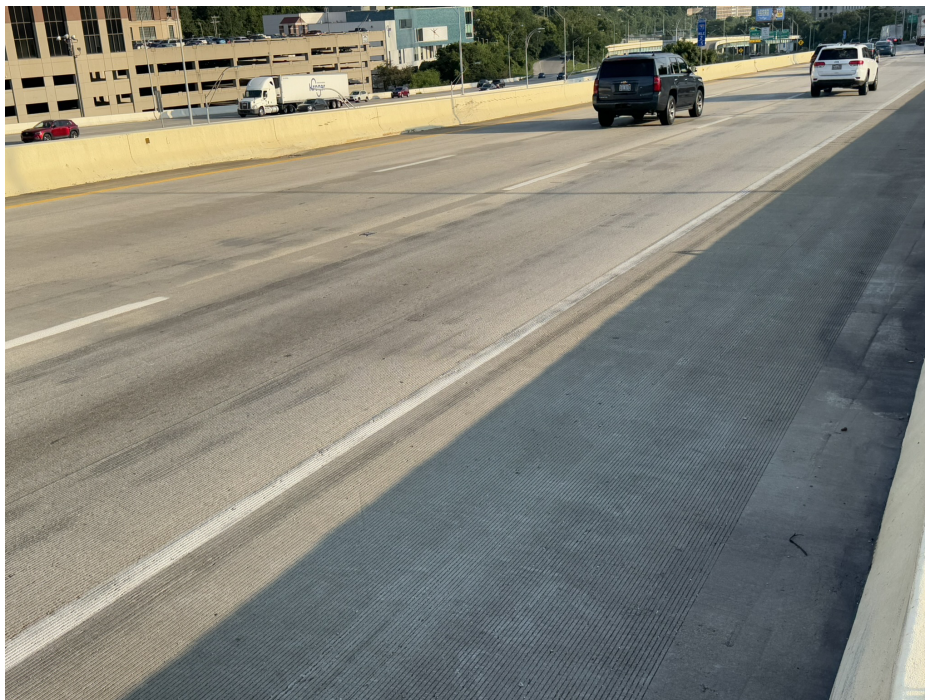
PHOTO 1

Description Typical deck

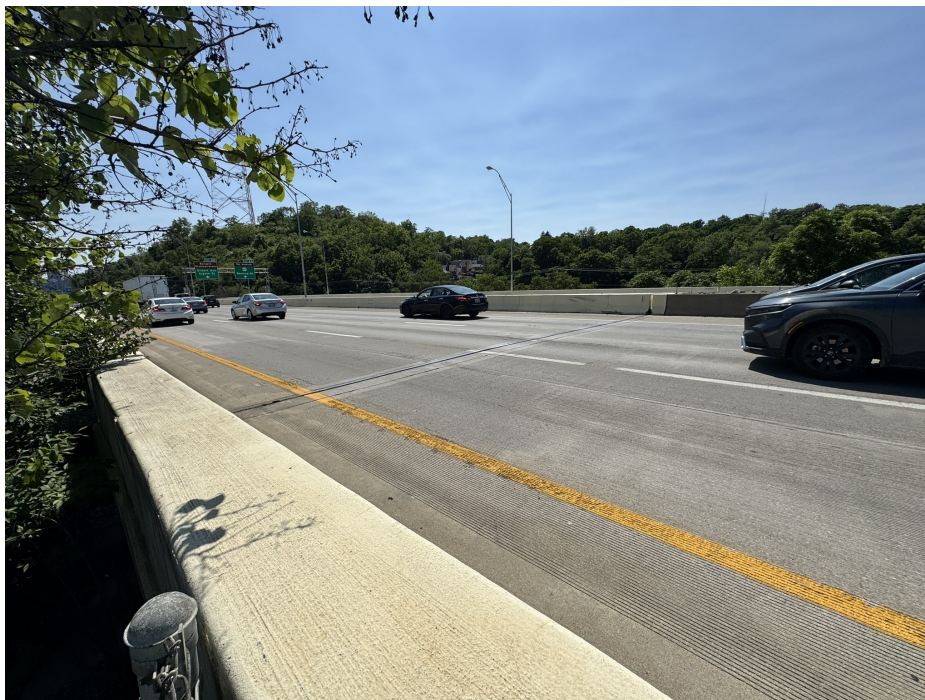
PHOTO 2

Description Typical deck and approach slab

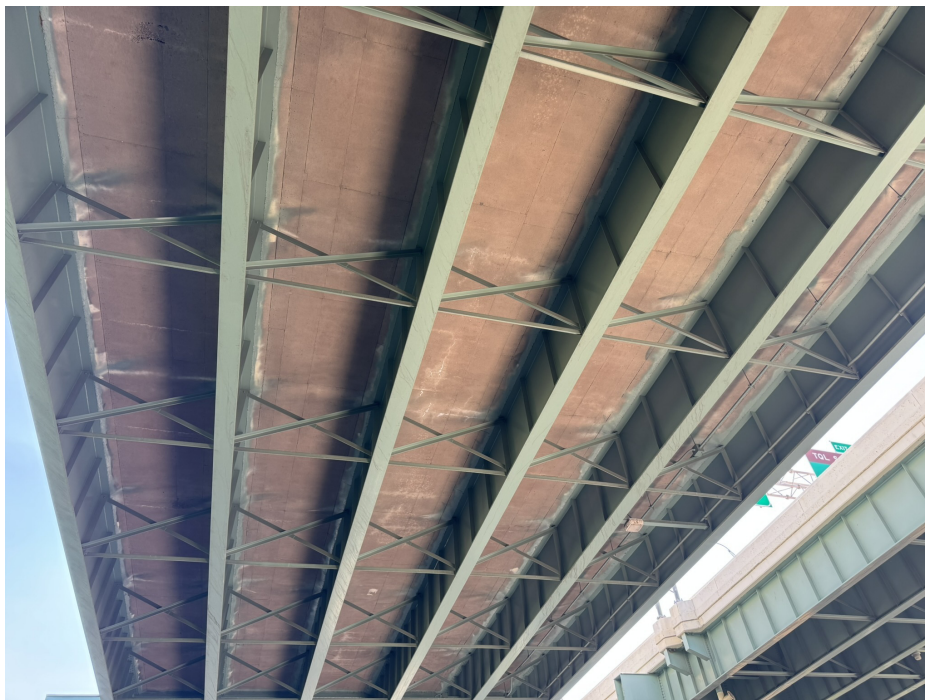
PHOTO 3

Description Typical superstructure and underside of deck

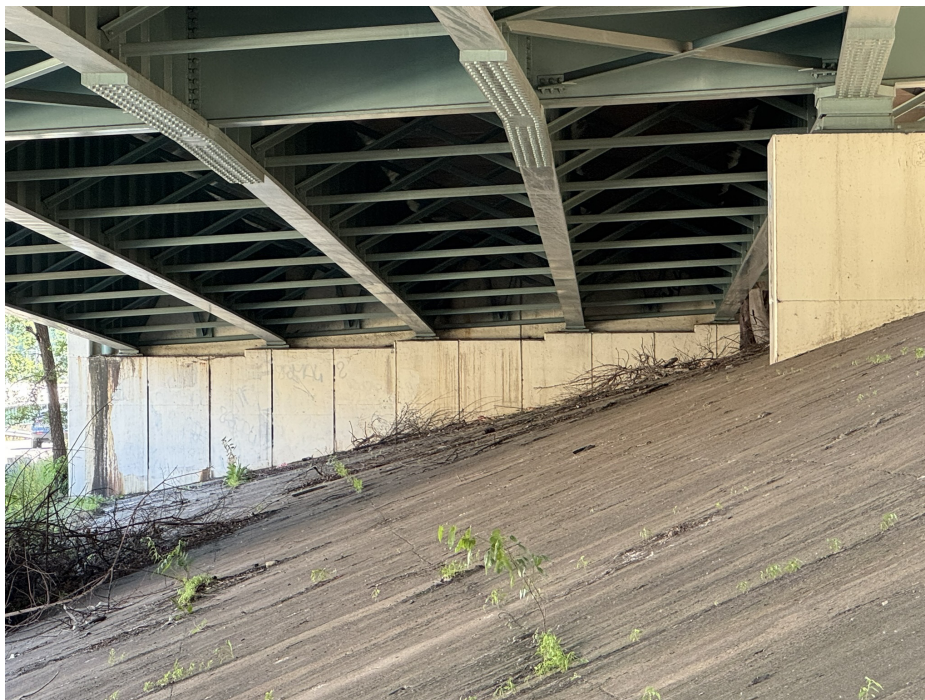
PHOTO 4

Description South abutment

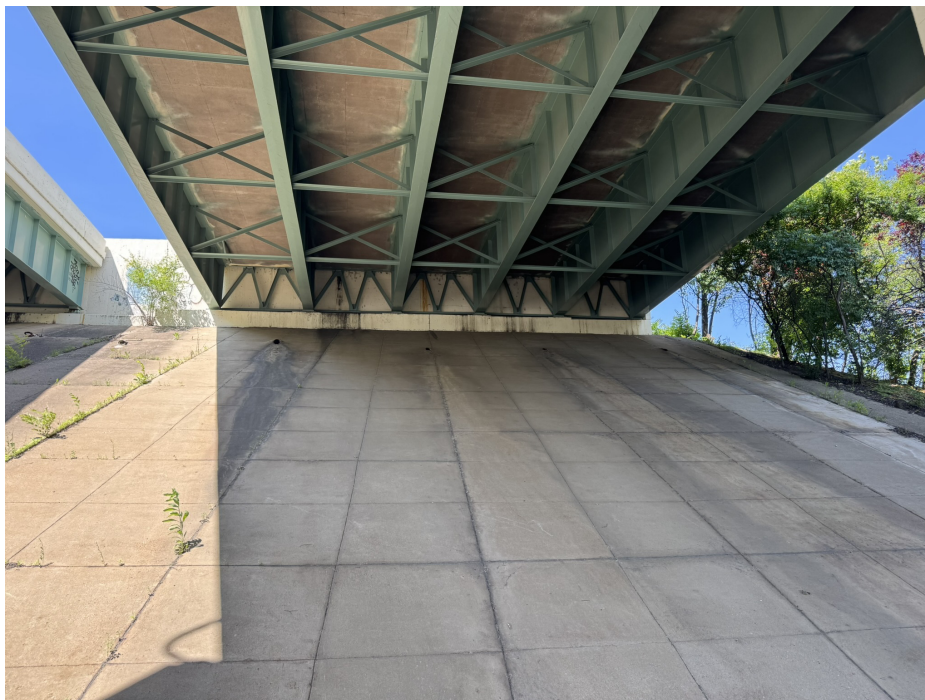
PHOTO 5

Description North abutment

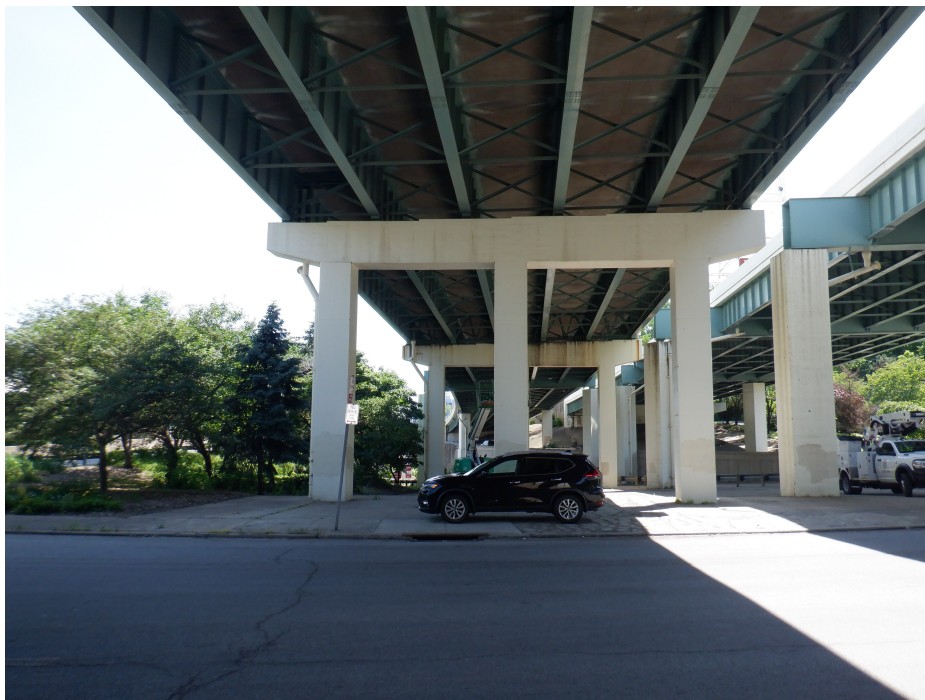
PHOTO 6

Description Typical Pier 5

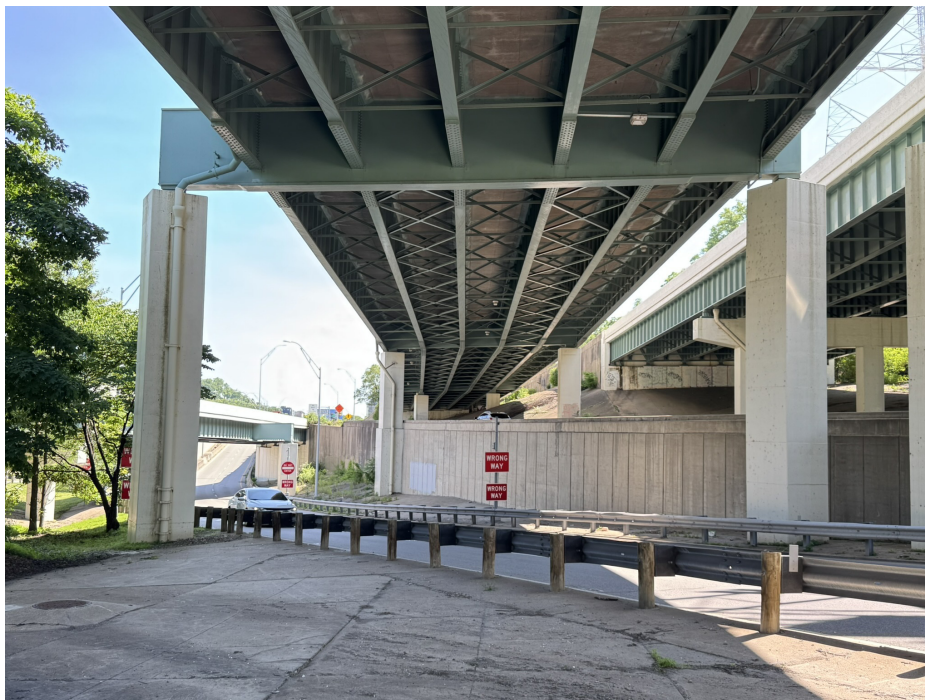
PHOTO 7

The pier caps have been retrofit with stress relief drilled holes connected by vertical saw-cuts adjacent to the welded connections of the girder bottom flange tie plates at all girders, 2017. Retrofits were installed at Pier 3 to remove fatigue prone detail and known cracks,

2019. Floor beams overall are in good condition. See the 2025 NSTM report for specifics.

Description Typical steel pier cap, pier 3

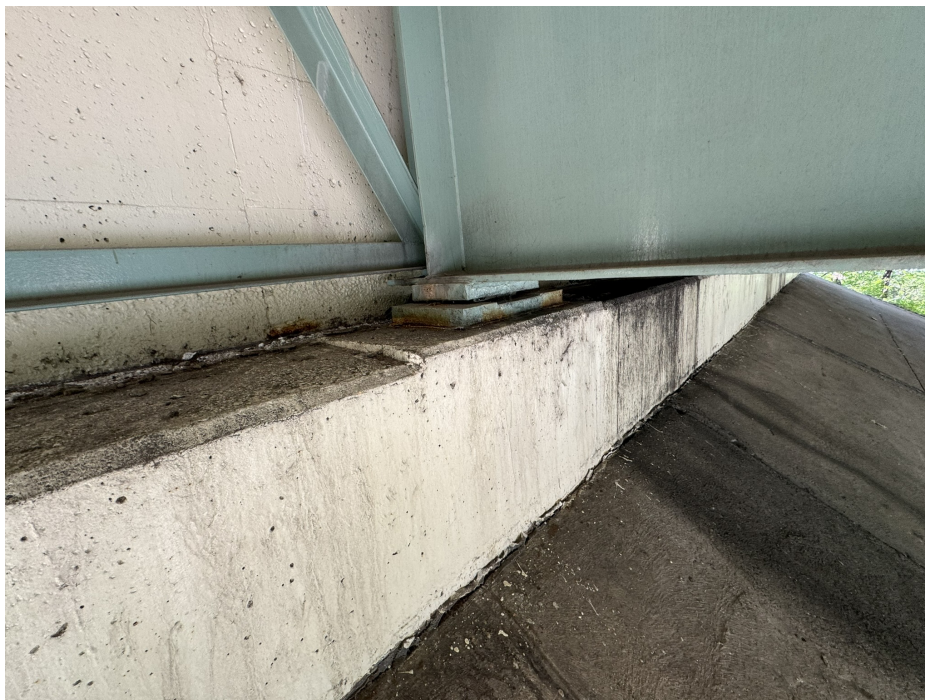
PHOTO 8

Description Typical abutment bearing

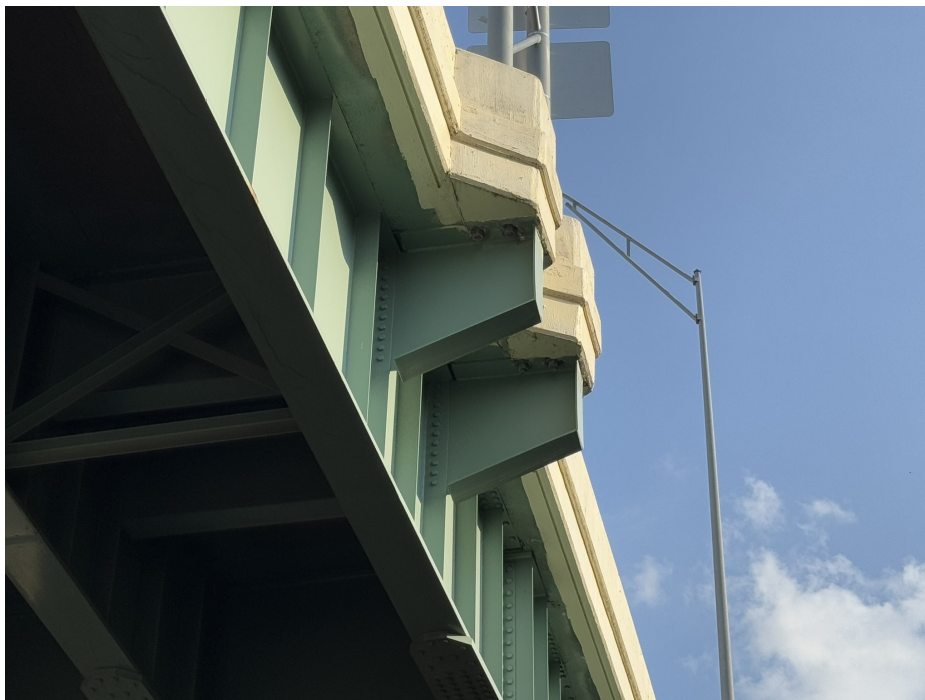
PHOTO 9

Description Typical sign support

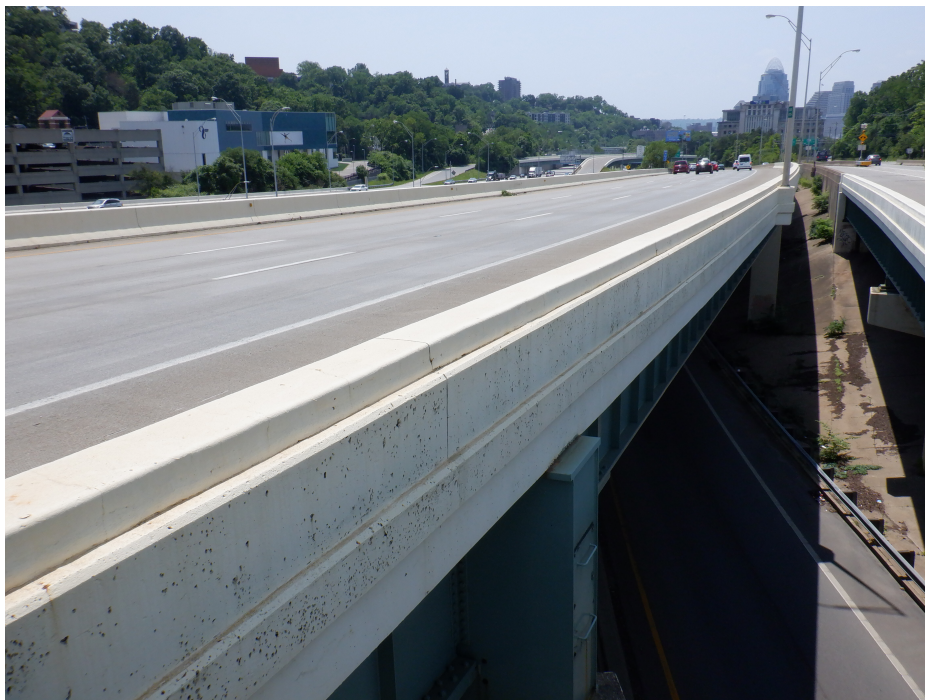
PHOTO 10

Description Bridge elevation, west fascia

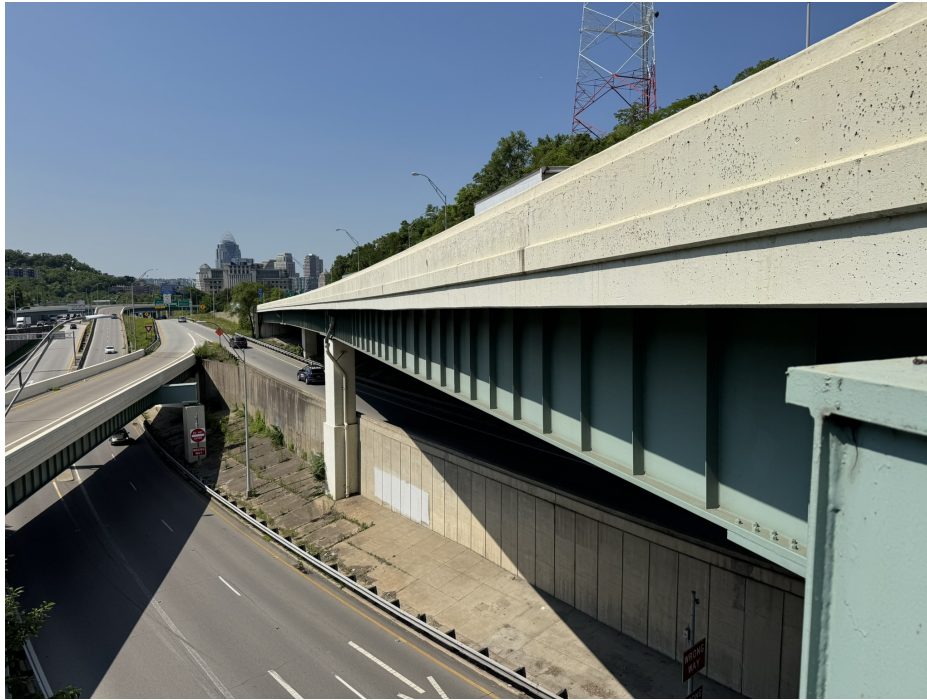
PHOTO 11

Description Bridge elevation, east fascia

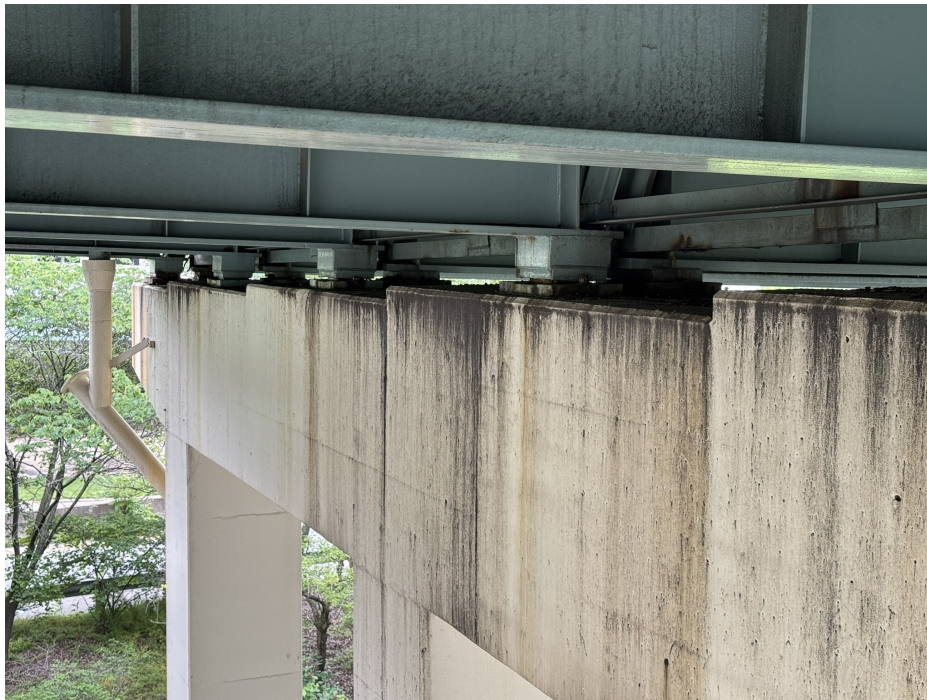
PHOTO 12

Description Pier 4 bearings under joint
