Inspection Date: 08/12/2025

Structure Number: 3110656

Facility Carried: NB IR 75

**Ohio Bridge Inspection Summary Report****HAM-00075-1192R (3110656)**

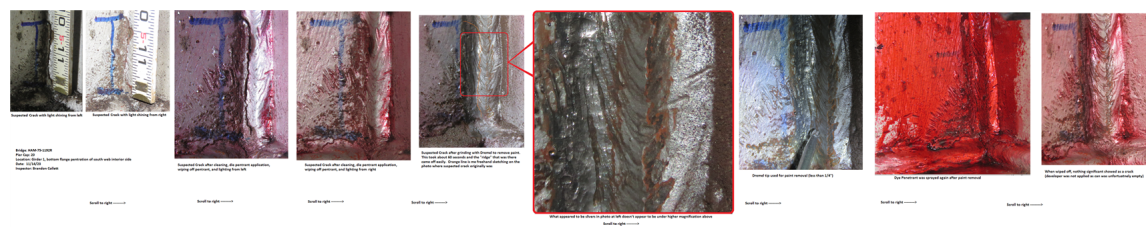
PHOTO 1

2023: Per Fracture Critical inspection performed by Collins Engineers; "For bridge HAM-1192, the crack was found in Pier 20, at the west face of the Girder 1 diaphragm, at the triaxial weld connecting the south plate to the diaphragm. This is the cap over Shepherd Ave. The crack measured 1-5/8" along the vertical weld. We have included a perspective photo showing the detail (MAS3-164) and then 2 photos of close ups of the crack. This is located towards the north end of the pier cap. " 11-14-23 Inspection by Brandon Collett, D-8 bridge engineer, found the suspected crack was just painted over slag. There is no crack (see attached inspection photo).

Description Pier cap 20 Possible crack inspection 11-14-23
