Inspection Date: 06/24/2025

Facility Carried: RMP I71 TO US22/42

## Ohio Bridge Inspection Summary Report

**HAM-00042-0264R (3101223)**

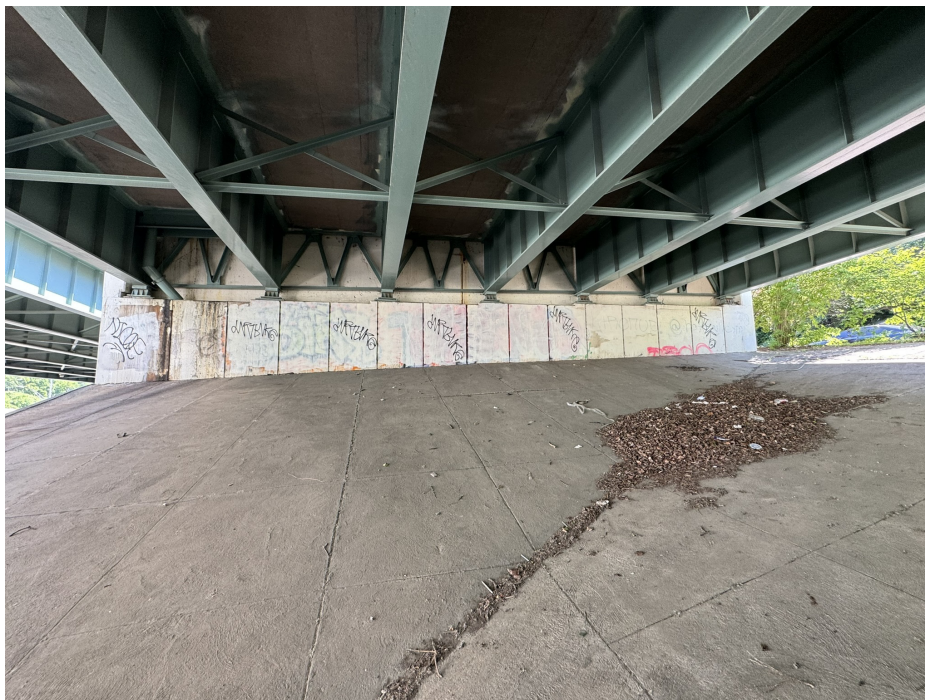
PHOTO 1

Description South abutment

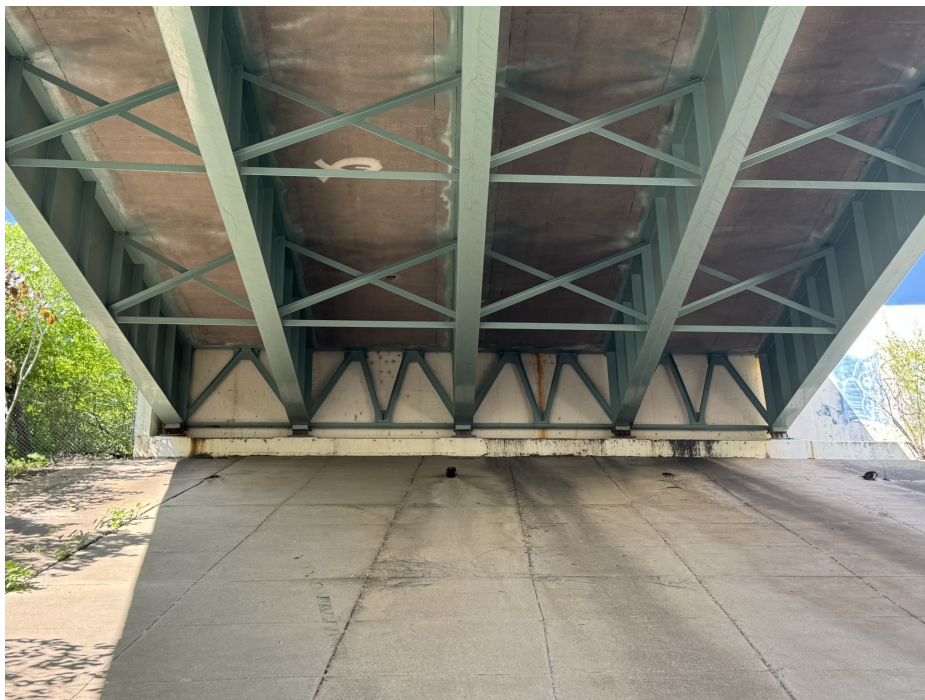
PHOTO 2

Description North abutment

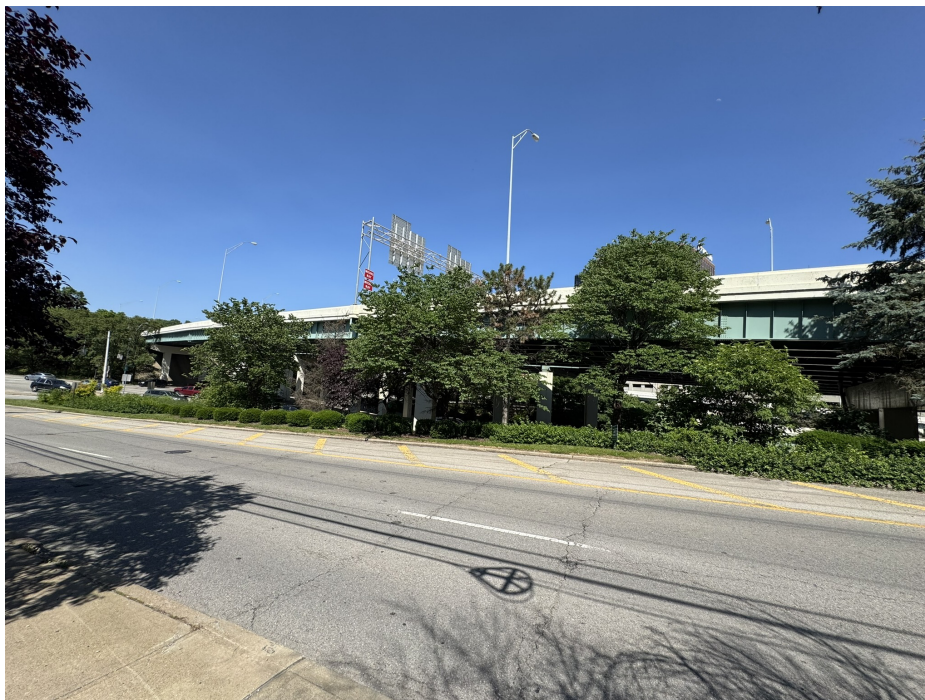
PHOTO 3

Description West bridge elevation

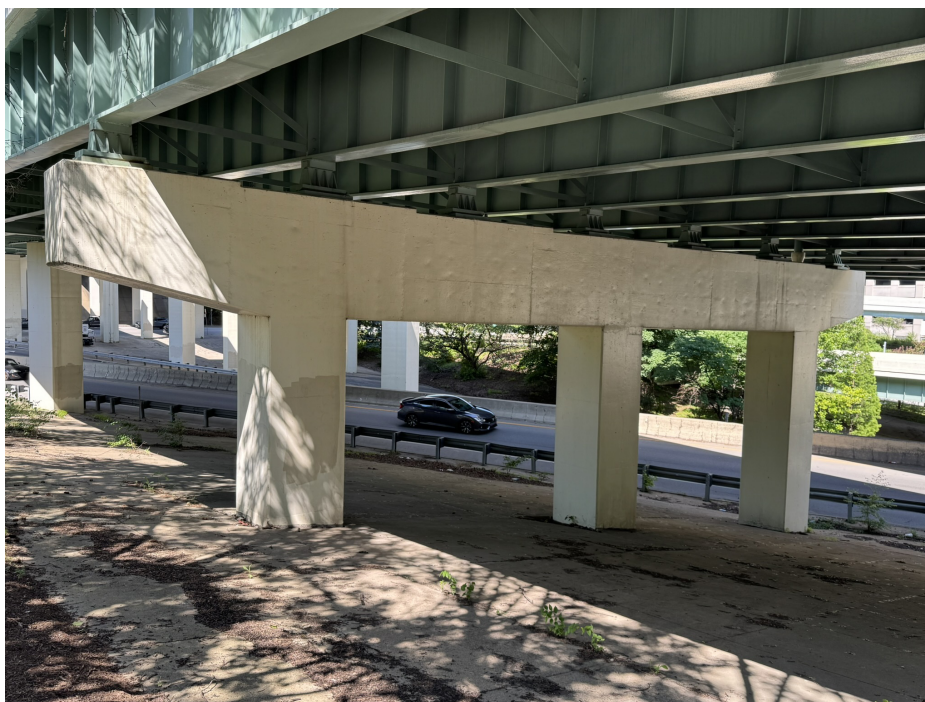
PHOTO 4

Description Typical pier 1

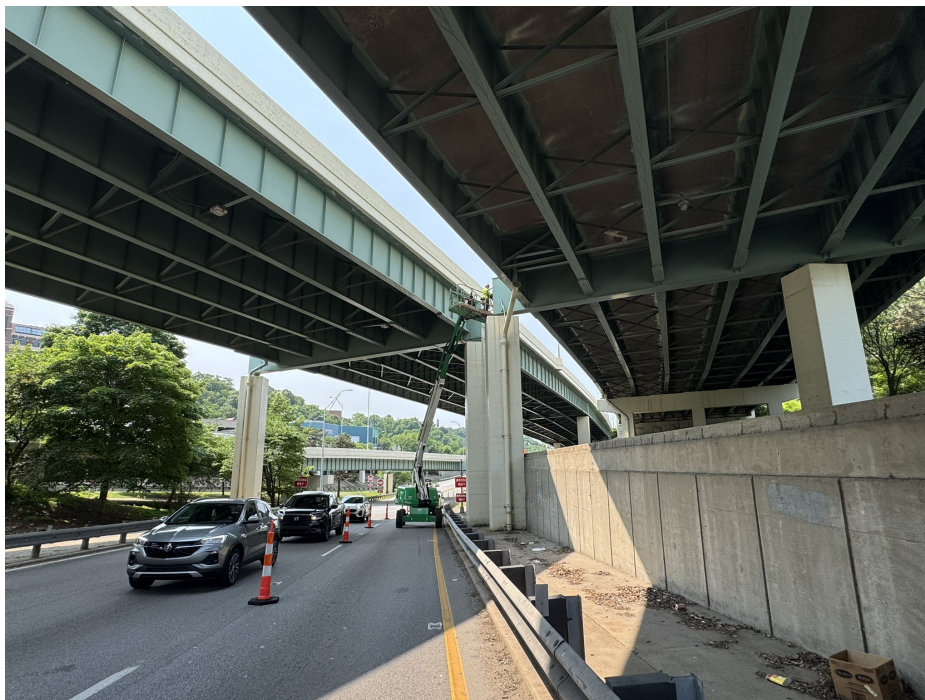
PHOTO 5

Description Pier 2 and typical superstructure

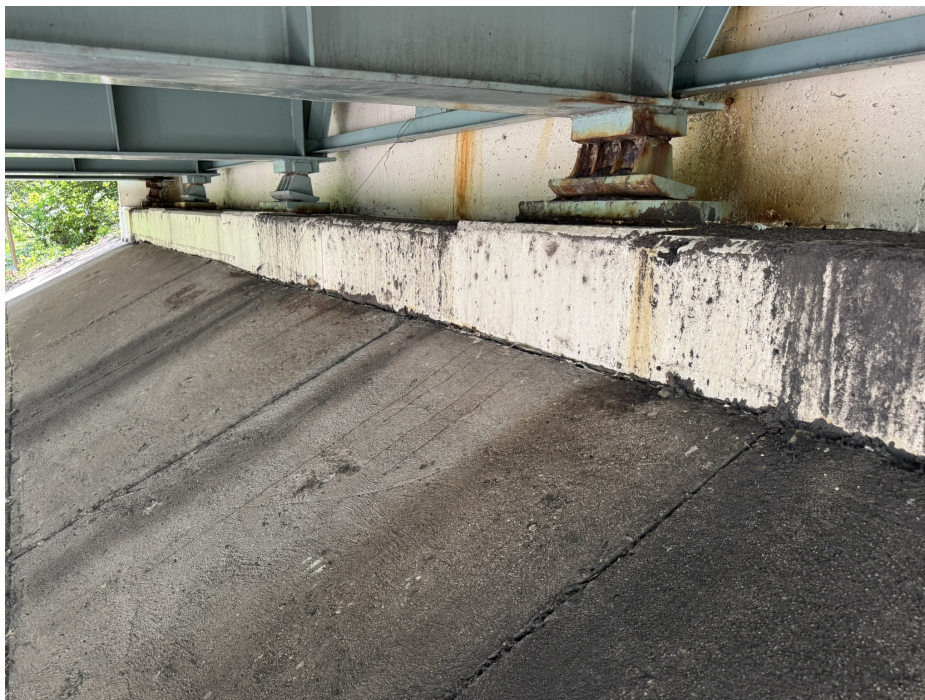
PHOTO 6

| Environment | Total Quantity | Units | Condition State 1 | Condition State 2 | Condition State 3 | Condition State 4 | |
|---|---|---|---|---|---|---|---|
| | CS2: Active laminating surface corrosion is present throughout the bearings, usually on the masonry plate (9). Painted over pitting up to 1/16in. deep is present on the masonry plate at Girder D, Abutment 1. Fascia girder bearings exhibit active corrosion with minor soil and debris present. Steel cap pot bearings are in good condition. The bearings overall function as designed.<br>- The bearings at Abutment 2 have active corrosion and rust staining and debris on the bearing and the masonry plate. The bearings appear to function as intended.<br>- The rocker bearings at Abutment 1 were not uniformly in expansion at the time of the inspection. Girders A and G were expanded less than the others. This appears similar to prior inspections.<br>- The rocker bearings at Abutment 2 are in expansion between 8 and 11 degrees at 70F.<br>- The rocker bearing anchor bolt under Girder B at Pier Cap 5 is not fully seated.<br><br>CS3 - Bearings 1 and 5 at the FWD and bearing 1 at rear have pack rust. | | | | | | |

Description Typical condition of abutment bearings

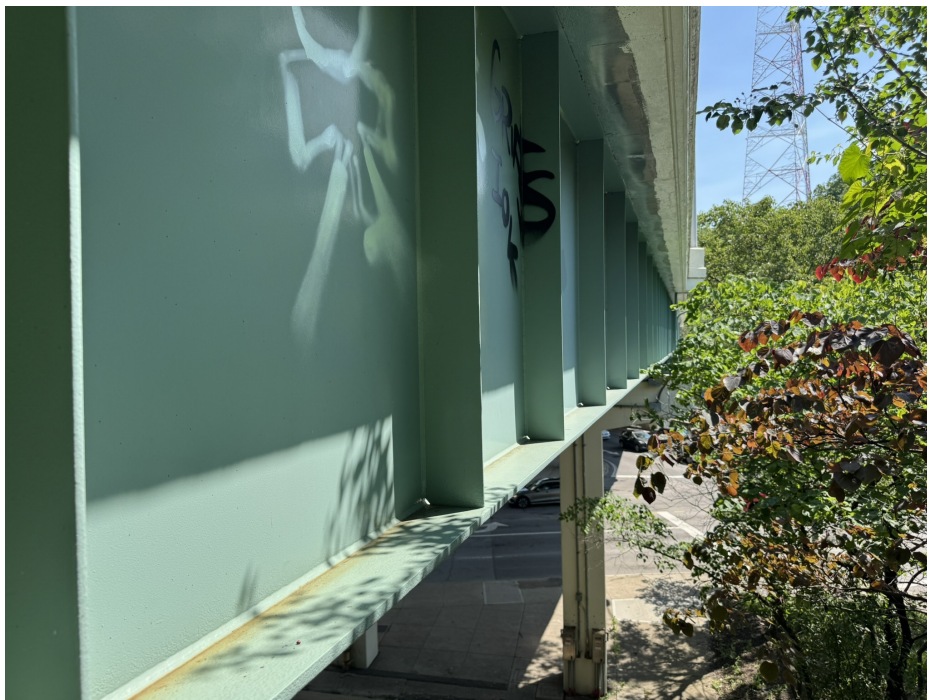
PHOTO 7

Description West fascia girder elevation

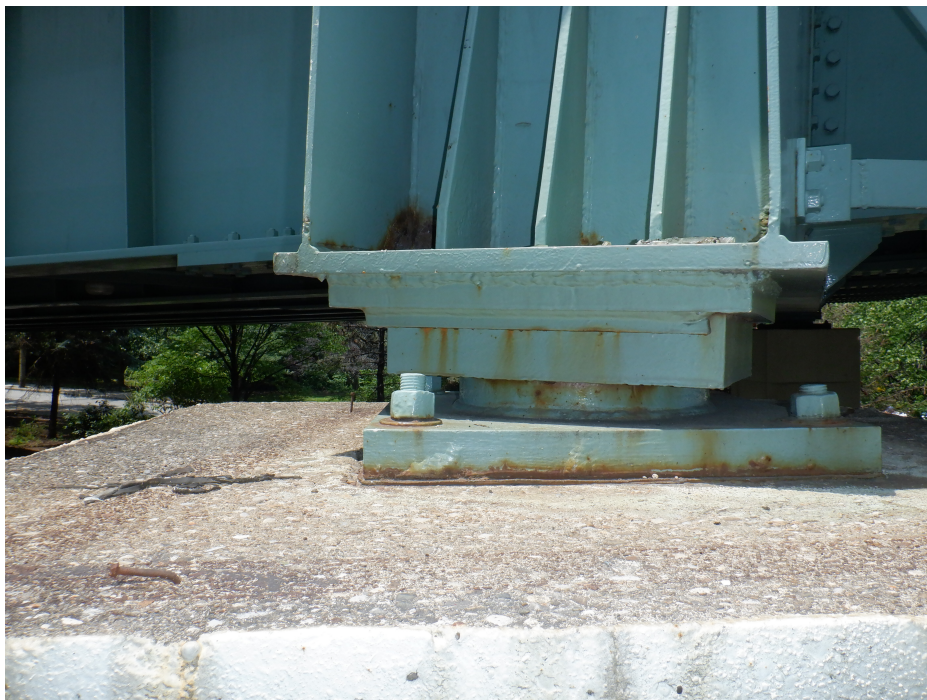
PHOTO 8

Description Typ. steel pier cap bearing

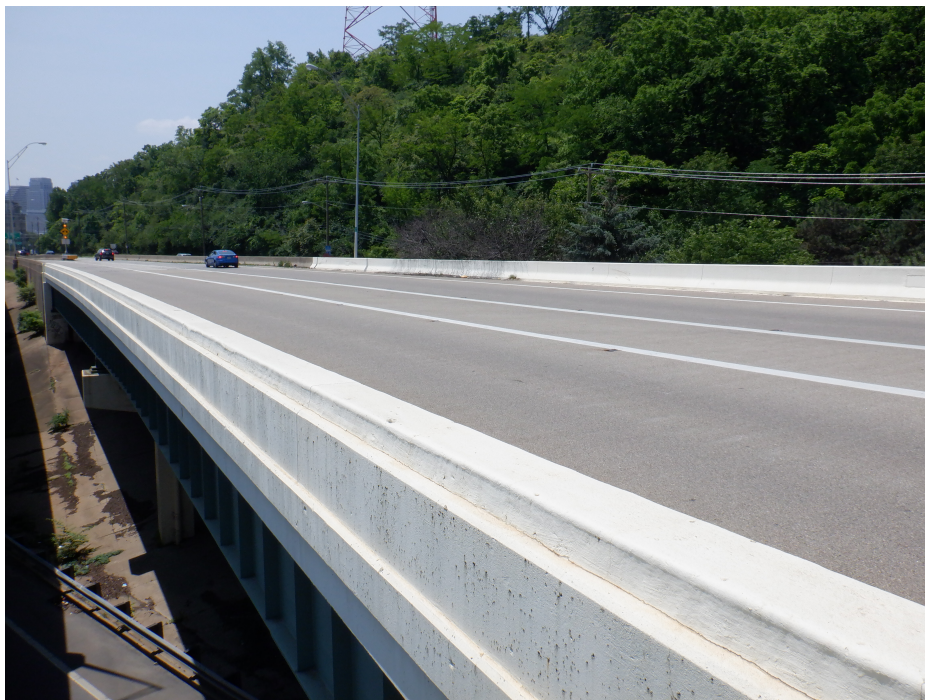
PHOTO 9

Description Typical deck

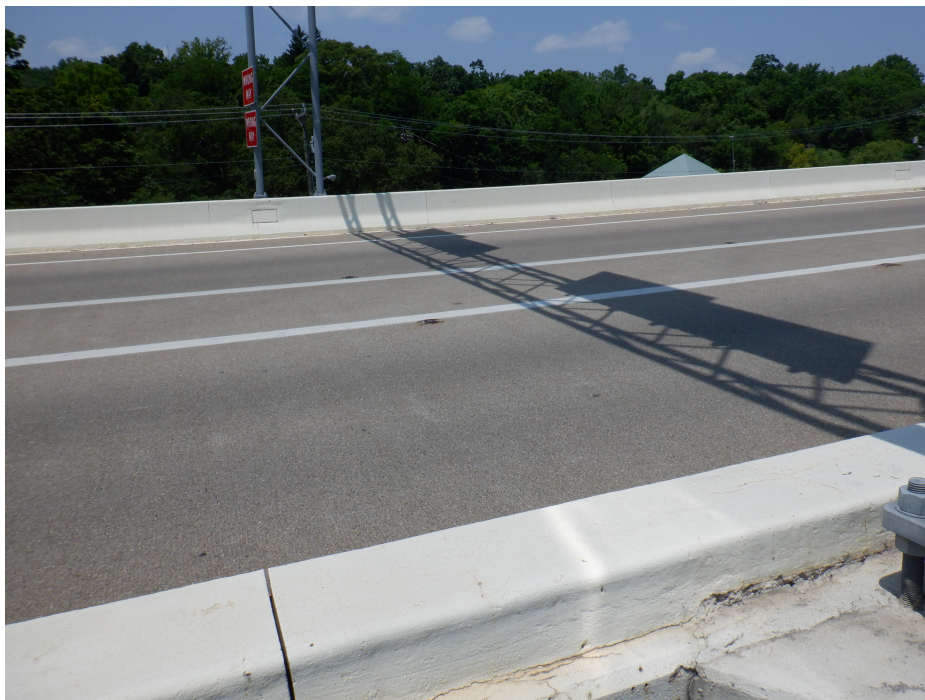
PHOTO 10

Description Typical deck

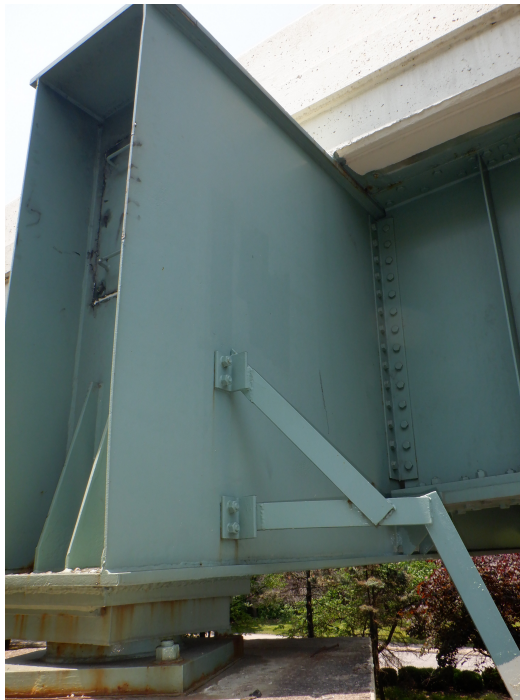
PHOTO 11

| Environment | Total Quantity | Units | Condition State 1 | Condition State 2 | Condition State 3 | Condition State 4 | |
|---|---|---|---|---|---|---|---|
| | - The previously welded brackets to the pier cap webs have been removed as part of past rehabilitation efforts and are now secured via bolted connections.<br>- CS3: The drainage at Abutment 1 is clogged and exhibits rust staining down the abutment wall and section loss/small rust holes at ends of downspout; this is an old comment that has not changed.<br>- CS2: The drainpipes through the slope protection at Abutment 2 have corrosion and section loss up to 1/8in. at the outlets of the pipes.<br>- CS2: Drains and scuppers exhibit signs of being clogged due to debris. | | | | | | |

Description Typical steel pier cap welded drain pipe connections
