# Routine and NSTM Member Inspection Report

## HAM-42-0264R 2025 Routine and NSTM Member Inspection Report (VAR-District 8 Bridge Inspections for Steel Pier Caps)

SFN: 3101223, PID: 109781

August 23, 2025

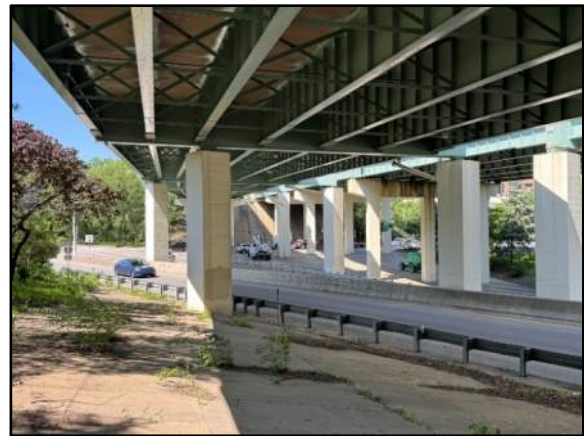
*Photo 1: Pier Cap 2 Elevation*

The pier cap is in overall FAIR condition [5] (Photo 1). The web plates have been retrofit with stress relief drilled holes connected by vertical saw-cuts adjacent to the welded connections of the girder bottom flange tie plates at all girders unless otherwise noted. Additional retrofits noted at the time of inspection were the drilling out of cracks and touch up paint of girder knee plate connections. Round cover plates are utilized to seal the drilled stress relief holes and are held in place by nuts and bolts (Photo 2).

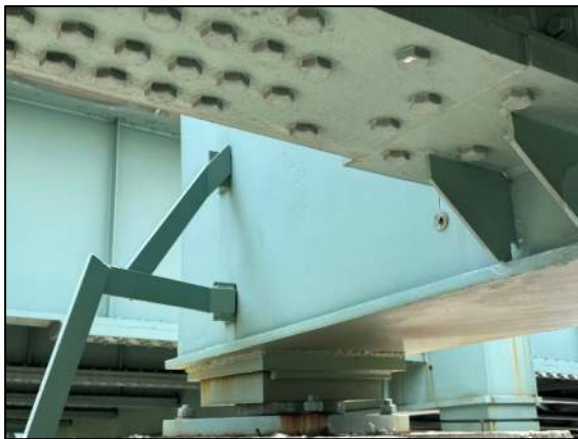
The exterior of the pier cap is in good condition (Photo 7). The welded connection of a drainpipe support bracket on the north web was replaced with a bolted connection (Photo 8). Both cap doors are in place and secure (Photo 9). One bolt is missing on the east access hatch.

*Photo 7: Typical condition of lower flange of steel cap*

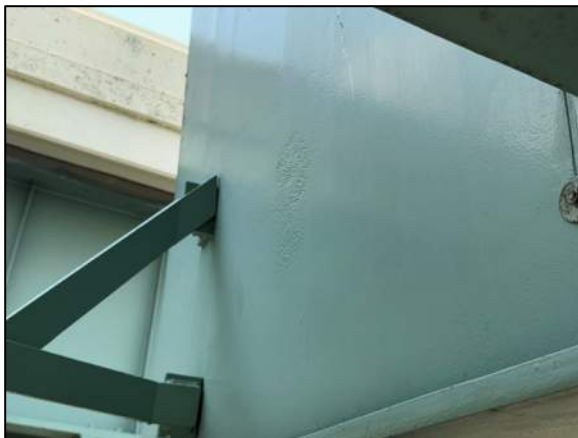
*Photo 8: Bolted Connection Retrofit for Drain Connection*

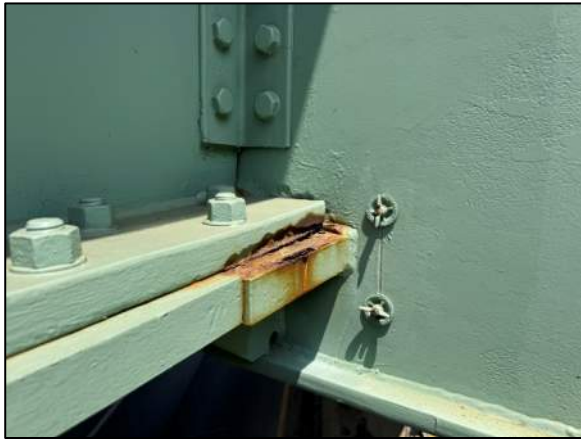
The exterior paint is in GOOD condition [7]. A 7" x 3" area of isolated pitting was found on the south web above the bottom flange tie plate of girder G. There is active rust with minor section loss at Girder G east face (Photo 13). In a previous rehabilitation project, the exterior surfaces of the superstructure were cleaned and painted.

*Photo 13: Active rust at Girder G, east face*

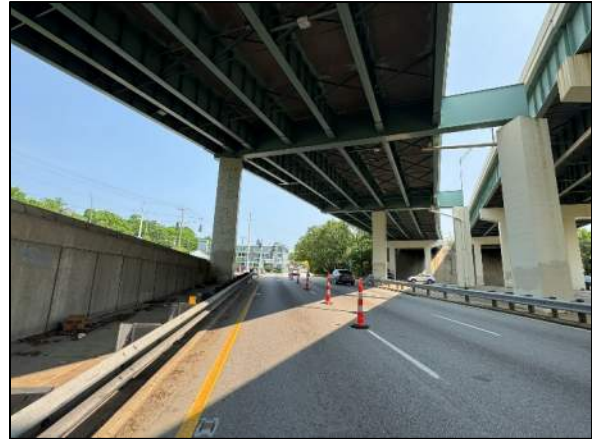
Photo 14: Pier Cap 3 Elevation

Pier Cap 3 is in FAIR condition [5] (Photo 14). At the time of the inspection the pier cap interior was dry.

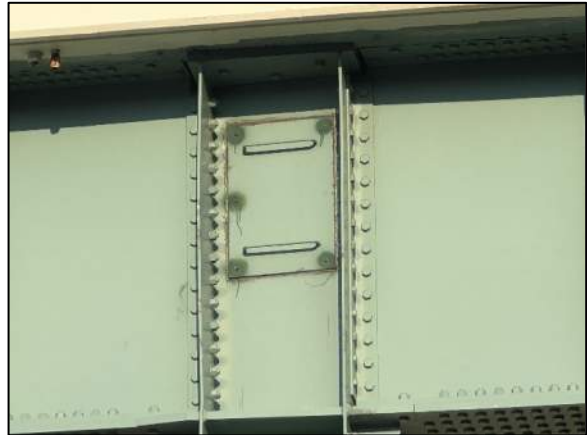
The exterior of the pier cap is in good condition. One bolt is missing from the West access hatch (Photo 22). The middle south bolt is missing at the west access hatch. Missing bolt holes were sealed with caulk to achieve a proper seal.

Photo 22: Missing bolt in West Access Hatch

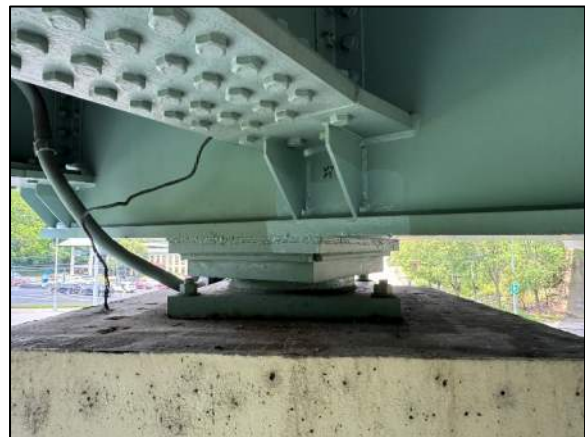
The pot bearings are in good condition and appear to function properly (Photo 23). Painted over section loss was noted on the top of the bottom flange, interior face of the ends of the web plates, and large corrosion holes were noted in the exterior knee braces. The bearing seat at the east column holds water around the masonry plate.

Photo 23: Typical view of West bearing

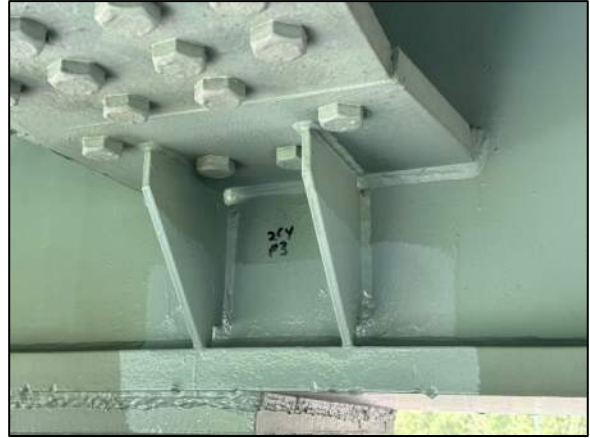
Previously documented cracks at knee brace locations have been drilled out and areas cleaned and painted since the previous inspection. Monitor locations during future inspections (Photo 26).

*Photo 26: Retrofit of drilling out cracks in Fillet Weld Between Knee Brace and South Web Below Girder B*

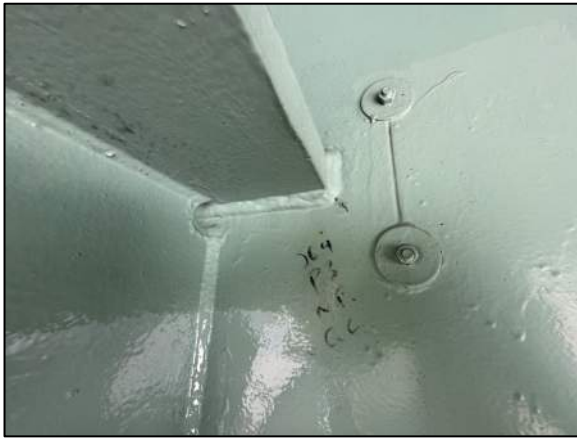
The exterior paint is in GOOD condition [7]. A 7" L x 2" H area of up to 3/16" D painted over pitting exists on the south web of the pier cap above the bottom flange tie plate of Girder G (Photo 24). There is also a 7" L x 2" H area of pitting on the north web of the pier cap above the bottom flange tie plate of Girder A. Active corrosion exists on the fillet weld between the knee brace and north web below Girder G. The crack has not propagated into the base metal. Typical porosity exists in the toe of weld at bottom flange of Girder C and North Web (Photo 25).

*Photo 25: Fillet Weld Porosity at Bottom Flange of Girder C and North Web*

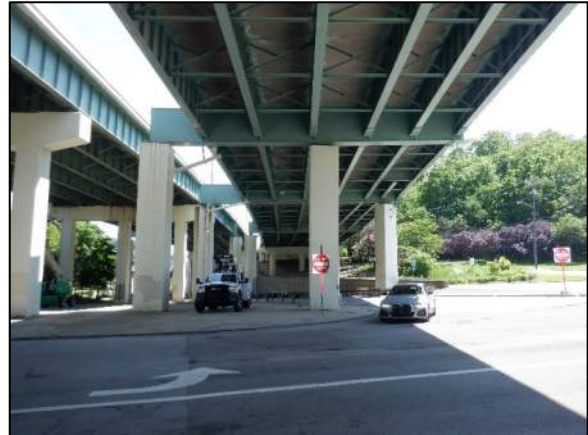
*Photo 27: Pier Cap 4 Elevation*

Pier Cap 4 is in FAIR condition [5] with a few welds of poor quality and scattered areas of light surface rust (Photo 27). At the time of the inspection the pier cap interior was dry.

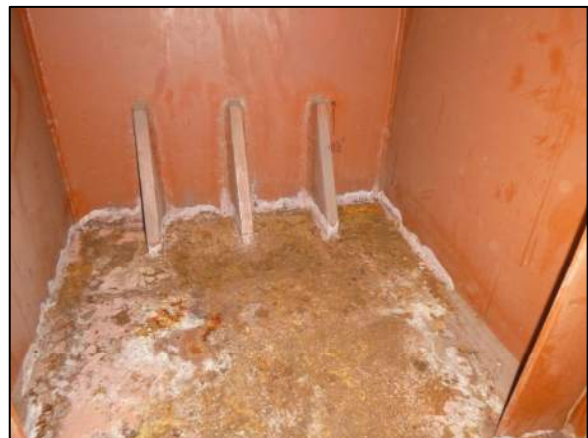
The interior paint is in GOOD condition [7], with minor peeling paint on the top flange throughout the pier cap. Moisture has penetrated the cope holes of the Girder A diaphragm and flowed along the bottom flange to the vertical web stiffeners above the west bearing. There is a 3' L x Full Width area of laminating corrosion on the bottom flange east and west of the diaphragm above the west bearing (Photo 28) and a 3' L x 27" W, L-shaped area of laminating corrosion on the bottom flange west of the Girder D diaphragm (Photos 29).

*Photo 28: Pooling Water Caused Active Corrosion at West End Bottom Flange and Lower Webs*

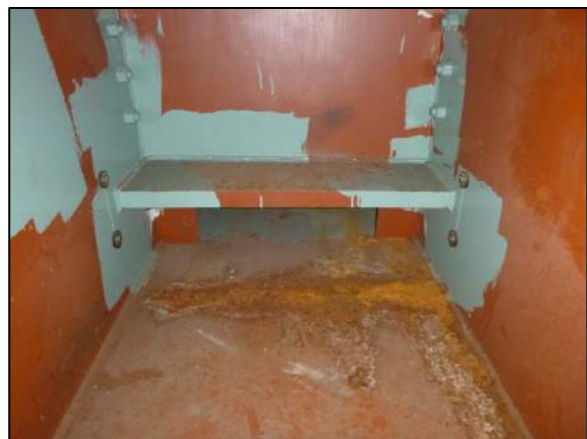
*Photo 29: Bottom Flange, West of Girder D Diaphragm, Active Corrosion*

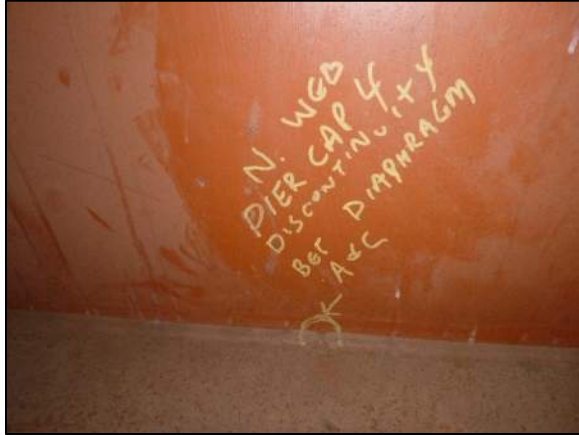
Photo 30: Discontinuity in Fillet Weld Between North Web and Bottom Flange Between Girder A and C Diaphragms

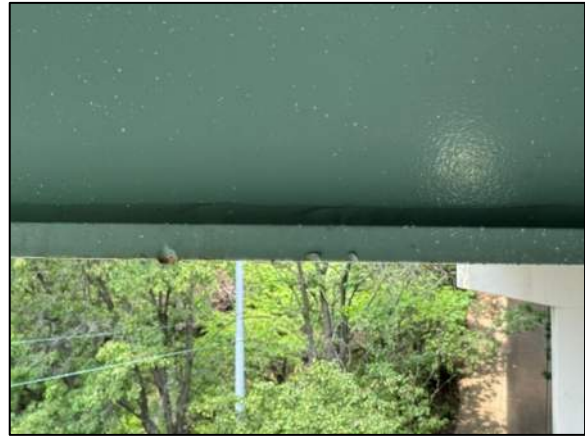
The exterior paint is in GOOD condition [7]. There is no change in the multiple shallow gouges noted along the north edge of the bottom flange of the pier cap at the cantilevered section (Photo 34). Painted over pitting was noted on the bottom of the east end plate and the knee braces at the east end of the pier cap (Photo 36). A 1' L x 4" W area of painted over pitting was observed on top of the bottom flange tie plate for Girder A.

*Photo 34: Shallow Gouges Along North Edge of Bottom Flange at Cantilevered Section*

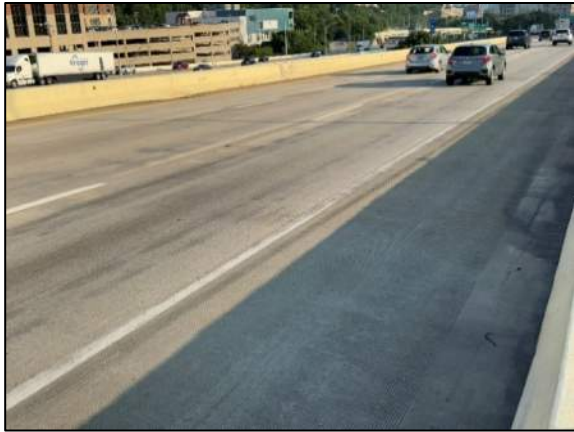
*Photo 38: Typical Deck*

The deck is in satisfactory condition (Photo 38). The top of deck was inspected from the deck corners and from a manlift adjacent to the east deck edge in span 4 during the 2025 routine inspection. Many of the ratings were carried over from the last routine inspection since our team had limited top of deck access.

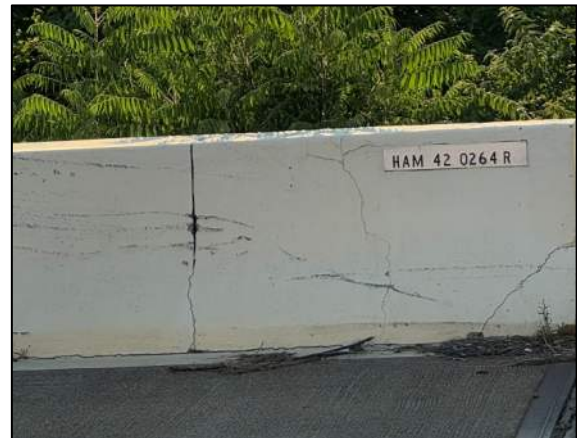
*Photo 39: Typical Cracking and Scrapes on Rail*

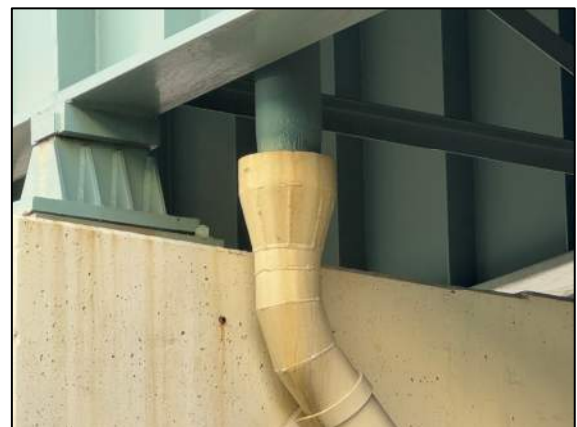
The drainage is in poor condition due to continued active corrosion and not functioning properly due to clogs. Drains and scuppers exhibit signs of being clogged due to debris and rust staining along downspouts. (Photos 40-41). The drainage at Abutment 1 is clogged and exhibits rust staining down the abutment wall. The drainpipes through the slope protection at Abutment 2 have advanced section loss up to 100 (Photos 42-43). The previously welded brackets to the pier cap webs were removed as part of past rehabilitation efforts and are now secured via bolts.

*Photo 40: Down Spout Scupper Connection*

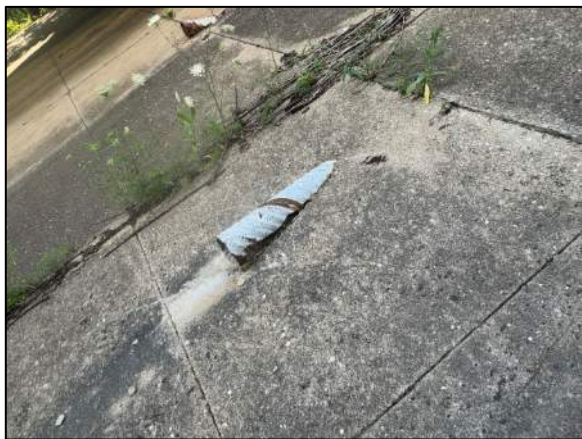
Photo 43: Abutment 2 Slope Protection Drainpipe  
Section Loss

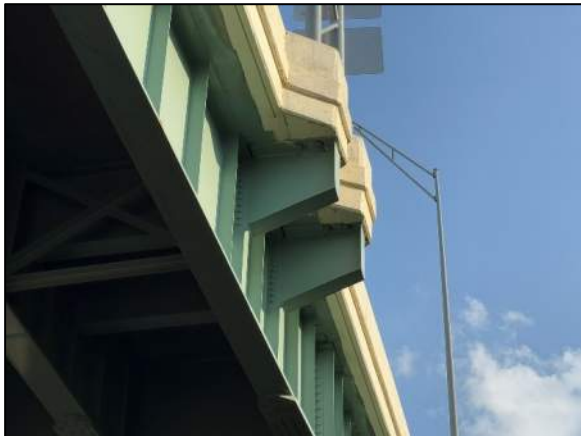
*Photo 44: Sign Support Brackets Connected to Fascia Girder, North of Pier Cap 3*

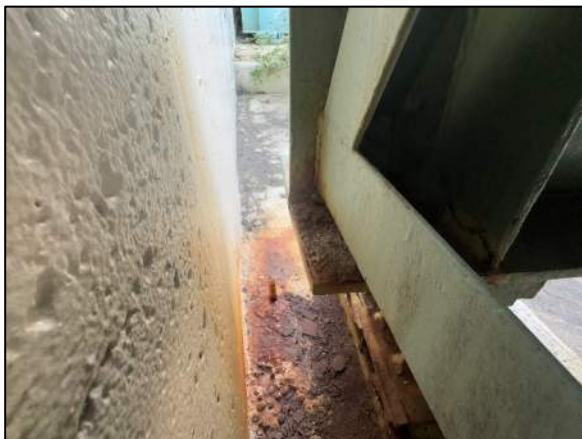
*Photo 46: Section Loss on Girder G Lower Flange and Stiffener Behind Rocker Bearing at Abutment 2*

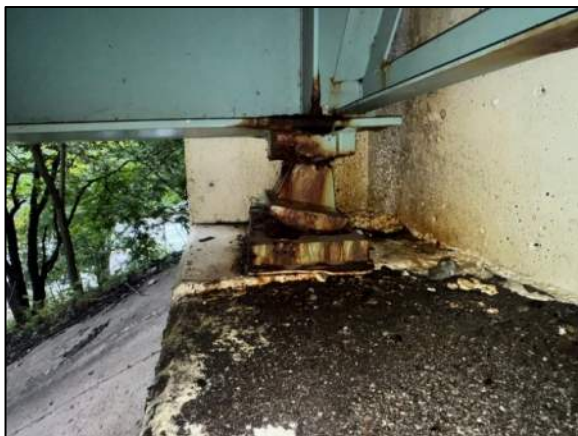
*Photo 47: Corrosion and Staining in Rocker Bearing*

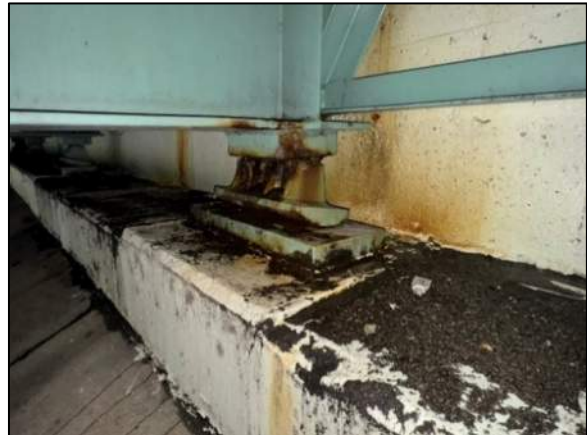
*Photo 48: Debris on the Masonry Plate at Rocker Bearing Below Girder B*

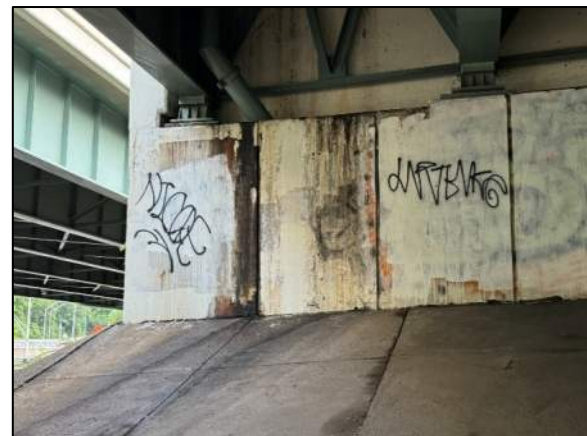
*Photo 50: Rust Staining from Drainage Block Along Abutment 1*

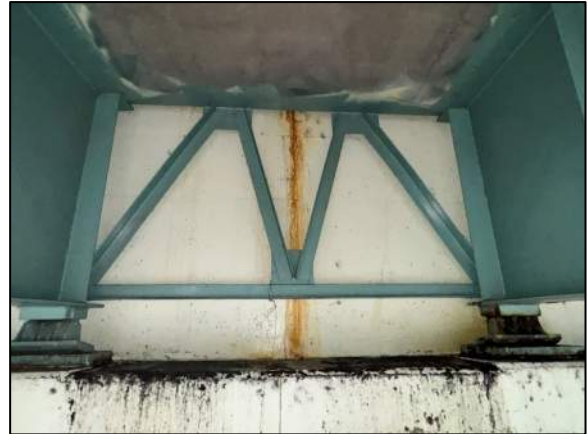
The abutment backwalls are in fair condition. Leakage staining was noted on the Abutment 1 backwall in Bay 4 along the vertical construction joint (Photo 53). Isolated vertical hairline cracking and areas of honeycombing up to 1-1/2" D were noted in the backwall; worst case was noted behind Girder E (Photo 54). Vertical hairline cracks were also noted in the Abutment 2 backwall.

*Photo 53: Leakage Staining on Abutment 2 Backwall*

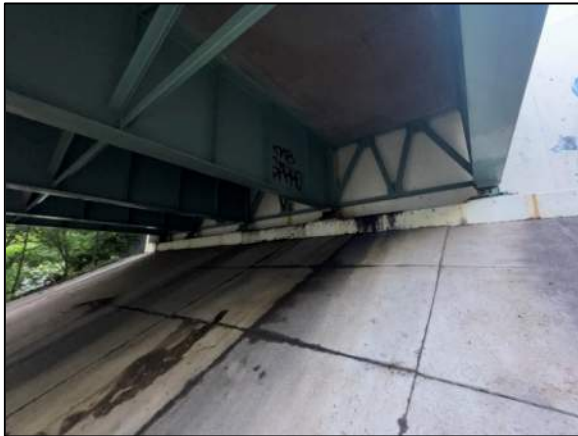
There is staining on the stem and abutment seat due to the deck joint leaking above (Photo 51). Along the top face of the stem, there are 2" diameter spalls due to prior formwork attachments during construction. At the back of the abutment seat, there is poor concrete finish work for the Full-Length x 5" W with exposed vertical reinforcing steel ends that have been sealed when the abutment was sealed (Photo 52).

*Photo 51: Rust Staining on Stem and Abutment Seat Due to Leaking Deck Joint*

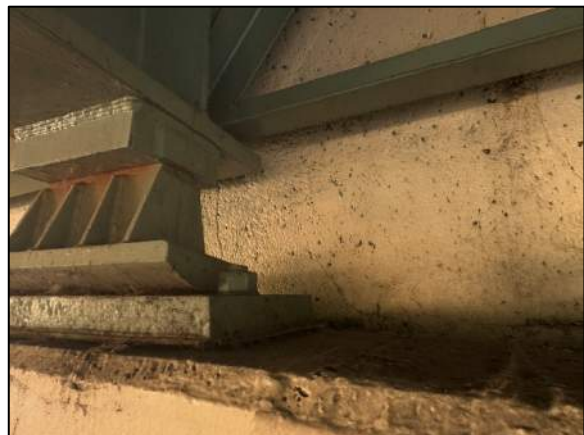
*Photo 54: Abutment 2 Back Wall Vertical Cracking*

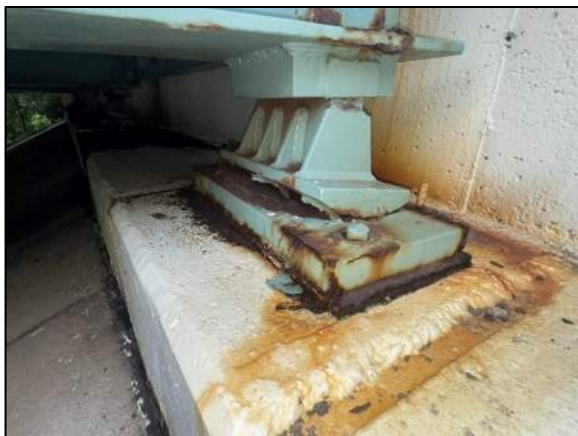
*Photo 52: Poor Concrete Finish Behind Abutment 2 With Exposed Reinforcing Steel*

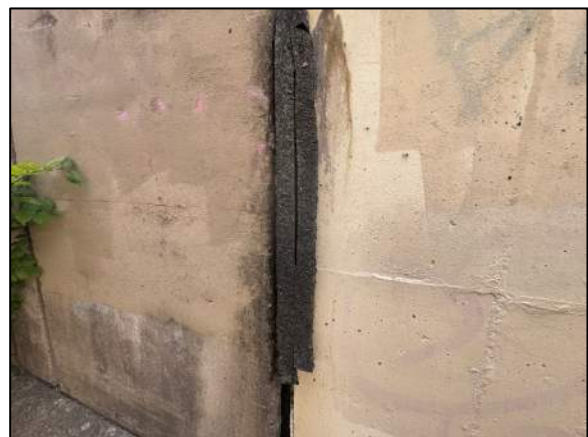
*Photo 55: Abutment 1 SE Wingwall Protruding Joint Filler*

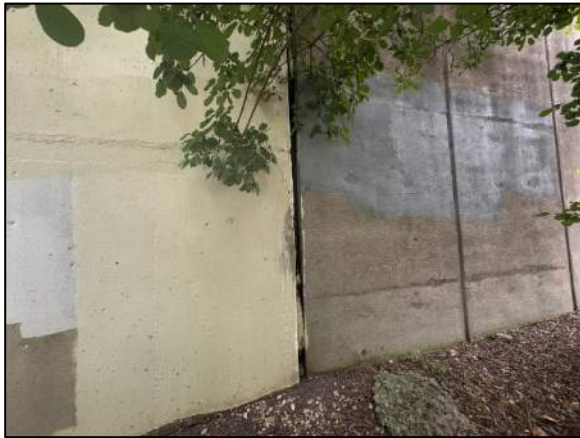
The wingwalls are in fair condition. The southwest wingwall has sealed cracks with efflorescence at the west corner of Abutment 1 (Photo 55). There is a 1.5' H x 6" L x up to 1.5' D spall at the southeast wingwall joint with a 3' L section of missing joint filler (Photo 56). A 5' H x 3" L x 8" D spall at a joint was observed in the southeast wingwall joint approximately 100' south of the abutment (Photo 57). Minor spalls are typical along the wingwalls due to formwork attachments during construction. The northeast wingwall could be considered a continuation of Abutment 2 due to proximity to the adjacent bridge abutment.

*Photo 56: Cracking and Efflorescence in SW Wingwall of Abutment 1*

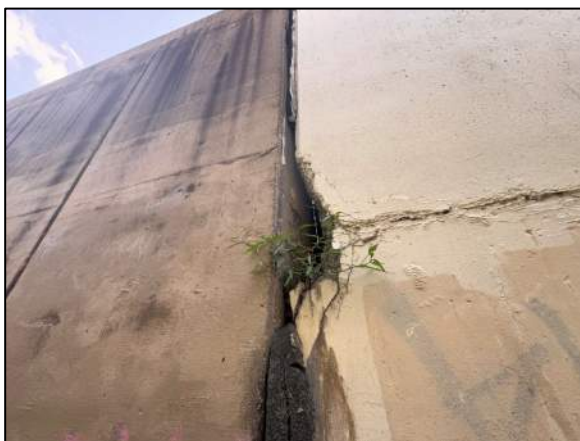
*Photo 57: 5' H x 3" L Spall in SE Wingwall Of Abutment 1*

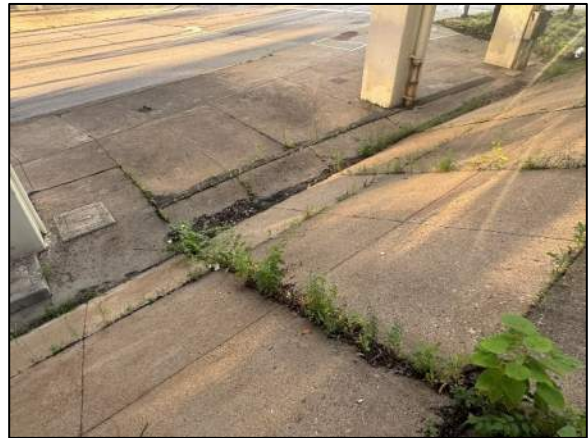
*Photo 58: Vegetation Growing Through Joints at Abutment 2 Slope Protection*

The slope protection is in fair condition. The slope protection near Abutment 1 has light vegetation growth along the joints throughout (Photo 58). Under Pier 1 at Column 3, the slope protection has settled up to 4" (Photo 59). The east side of the concrete slope protection along Abutment 2 also has vegetation growth along the joints (Photo 60). Corrugated metal pipe drains at Abutment 2 are corroded with heavy section loss, see previous photos in the drainage section. There is a full length 2" W x 1" D settlement along one joint of the slope protection under Bay 1. There is a Full height 2" wide 1" deep settlement in the slope protection at Abutment 2 (Photo 61).

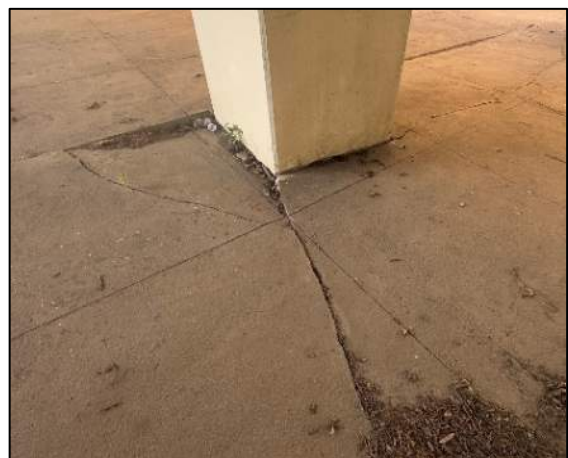
*Photo 59: Settlement of slope protection at Pier 1*

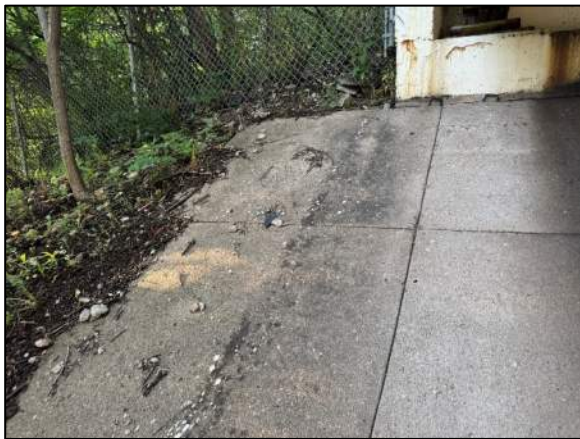
*Photo 61: Settlement of Slope Protection at Abutment 2*
