# NSTM Member Inspection Report

**HAM-50-1903L**

## **2025 NSTM Member Inspection Report (VAR-District 8 Bridge Inspections for Steel Pier Caps)**

**SFN: 3102807, PID: 109781**

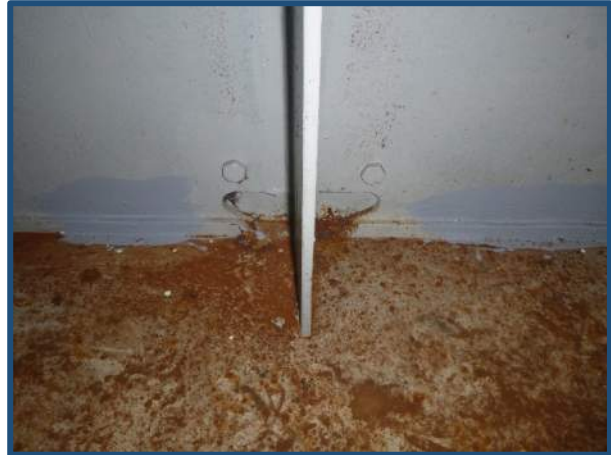
The steel pier cap is in Satisfactory Condition [6]. There were no significant changes observed during the 2025 inspection. The pier cap is a built-up steel plate section 6'-6" in height and 4'-0" in width. The bridge girders are attached to the pier cap via bolted tie plates connected to the flanges of both members and bolted angles on the webs. The pier cap was retrofitted in 1992 and 2013 (Photo 1).

*Photo 1: Typical stiffener retrofit*

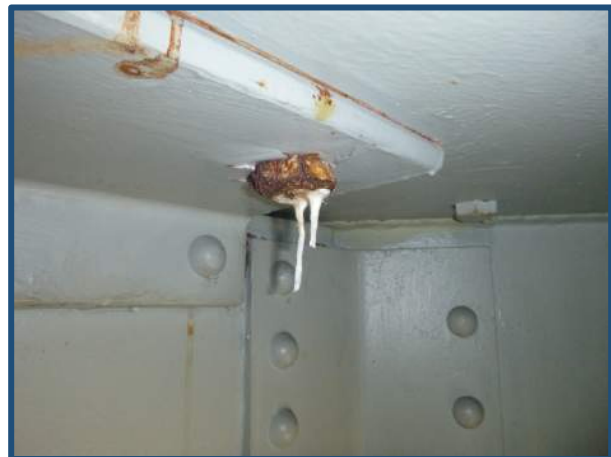
Both access hatches appear to be well sealed. There is evidence of leakage through the bolted connection on the top flange of the pier cap at Girders 1 and 6 (Photo 2), suggesting that there may be cracking in the concrete deck above the pier cap. The paint system of the pier cap interior is in good condition with several areas of light surface corrosion (Photo 3).

*Photo 2: Evidence of leakage through the top flange at Girder 6*

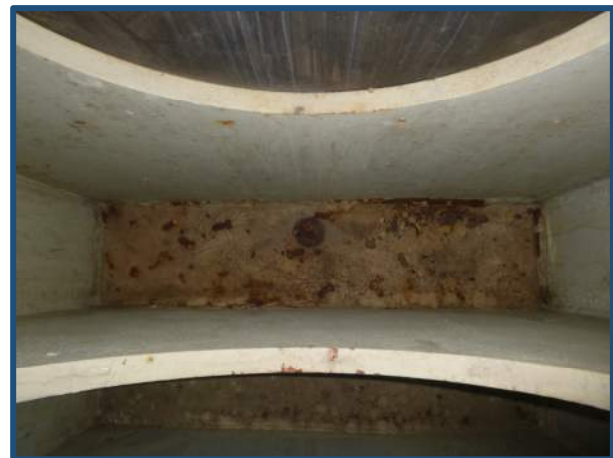
*Photo 3: Surface corrosion on the north end of the Pier Cap bottom flange*

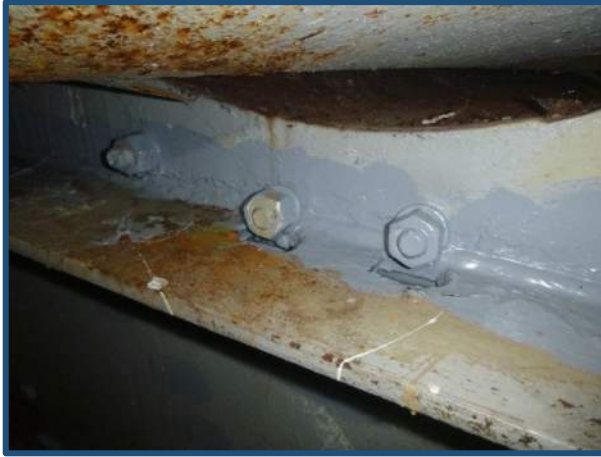
During the rehabilitation project, a bolted sleeve was added to holes that were previously cut into the web plates to allow installation of a 24" water main through the pier cap. Some of the bolts that connect the conduit sleeves to the web plates were cut through the fillet welds of the longitudinal web stiffeners surrounding the conduit holes (Photo 4). The remains of the fillet welds around the bolt holes are thin and vulnerable to crack initiation. During the inspection no signs of distress were found in the welds.

*Photo 4: Thin welds at the water main bolted connection with the Pier Cap web*

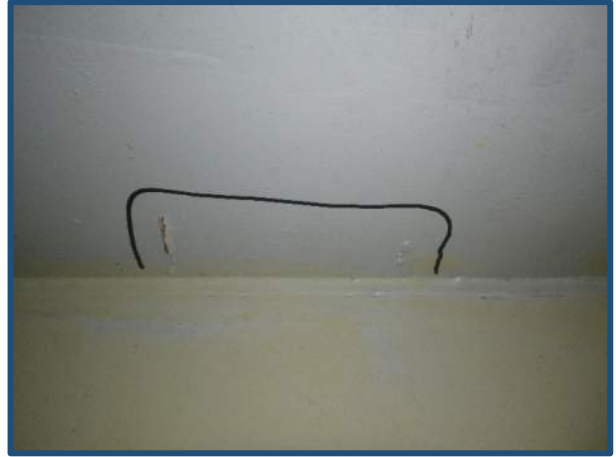
The horizontal stiffeners below the Girder 6 diaphragm portal are both bent downward slightly (Photo 6). There are two tack welds measuring 1-1/2" and 2-1/2" on the top flange of the pier cap at the north side of Girder 1 (Photo 7). There are several locations of un-welded butt joints between the bottom flange backer bar sections (Photo 8).

*Photo 7: Two tack welds on the top flange north of Girder 1*

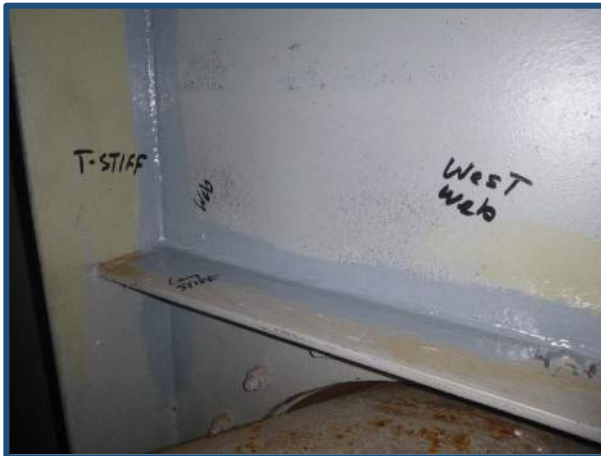
The fillet welds of the transverse and longitudinal web stiffeners surrounding the water main porthole intersect in tension zones of the web plates (Photo 5).

*Photo 5: Triaxial weld between the transverse and longitudinal stiffeners at the water main*

Intersection of fillet welds.

Category: E

Location: Fillet welds of web plates and longitudinal stiffeners intersecting fillet welds of web plates and transverse stiffeners around the water main portholes between Girders 3 and 4.

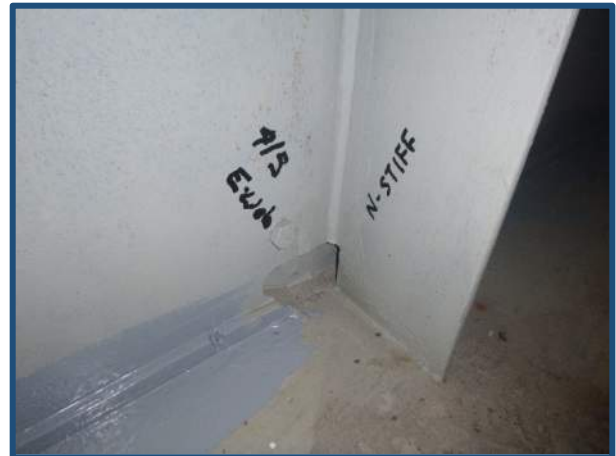
*Photo 8: Un-welded butt joint between backer bar sections on the east web between Girder 4 and Girder 5*

Unwelded butt joint between sections of backer bar.

Category: No fatigue category is defined, but a significant potential exists for crack initiation in the web and flange plates adjacent to the butt joint.

Location: Butt joints between sections of bottom flange backer bars along both webs (5 total).

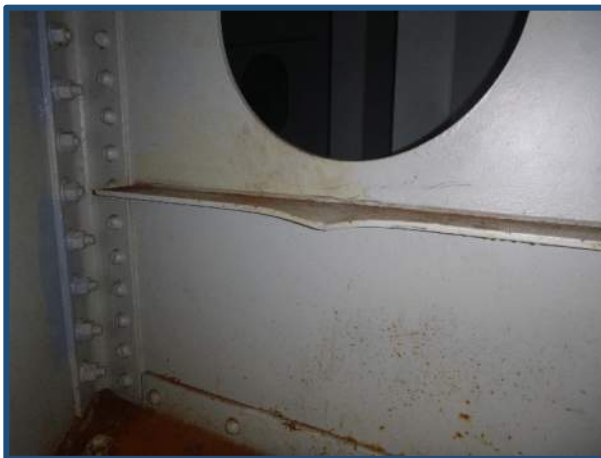
*Photo 6: Bends in both horizontal stiffeners at the Girder 6 diaphragm*

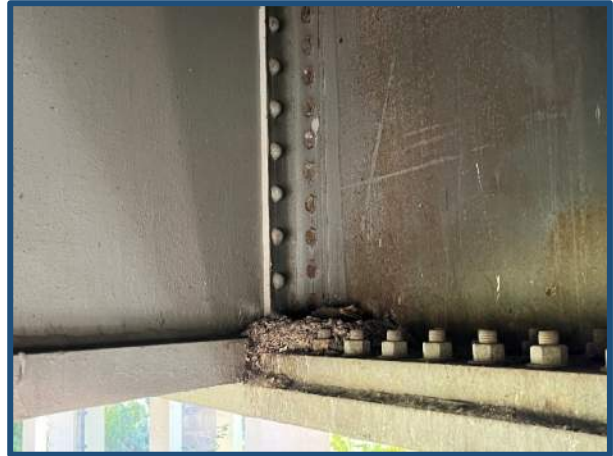
The paint system of the pier cap exterior is in good condition with corrosion present at the south end of the cap and corrosion initiating at several isolated locations. Heavy bird debris at the girder intersections with the pier cap is a typical condition (Photo 9).

*Photo 9: Typical bird debris buildup at the Girder connections with the Pier Cap*

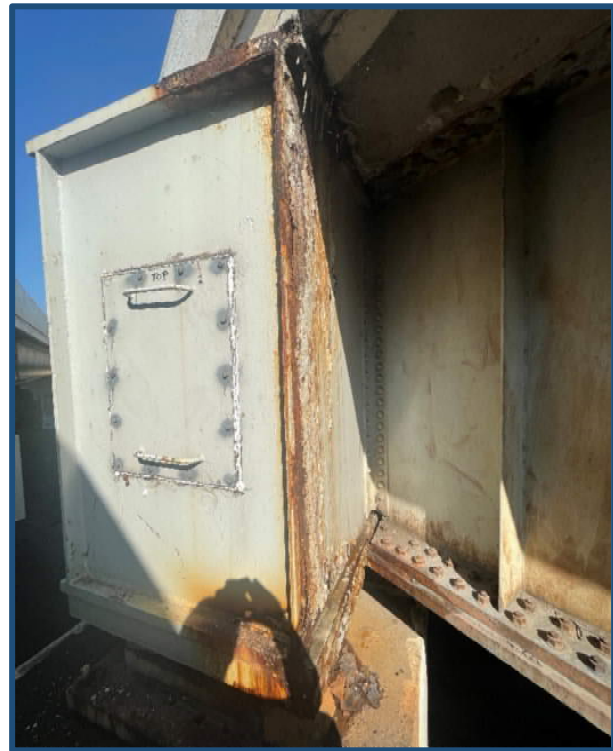
There is moderate surface corrosion on both the pier cap flange plates and web plates at the south end of the pier cap (Photo 10). There is also minor surface corrosion initiating at the edge of the bridge deck on the south end of the top flange of the pier cap (Photo 11). Pack rust was observed between the Girder 6 bottom flange tie plate and both the pier cap filler plate and girder bottom flange (Photo 12). There is also pack rust beginning to impact the bottom flange of the pier cap at the east web on the north side of Girder 1.

*Photo 10: Surface corrosion on the south end of the Pier Cap*

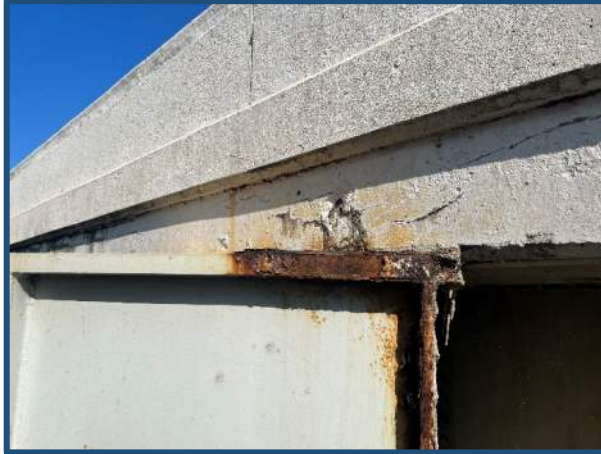
*Photo 11: Minor corrosion on the south end of top flange at the bridge deck edge*

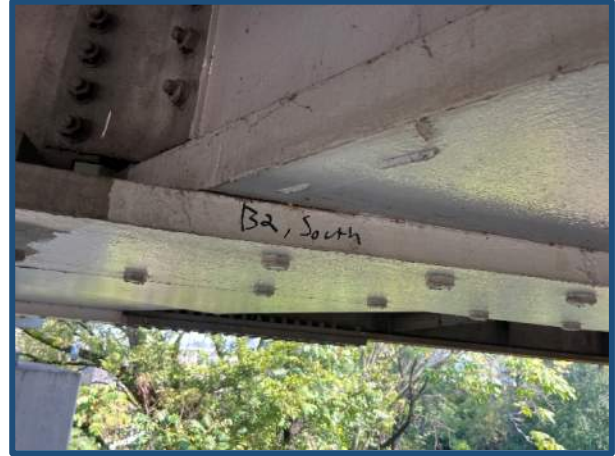
In the 2013 rehabilitation project, tack welds were removed from the bottom flange and girder bottom flange tie plates. Three tack welds measuring between 1-3/4" and 2-3/4" remain on the west side of the bottom flange between Girders 2 and 3 (Photo 13).

*Photo 13: Tack welds on the west side of the bottom flange of the Pier Cap at Girder 2*

Tack welds, less than 2", on flange plate.

Category: C

Location: Two tack welds on exterior of bottom flange at Girder 2.

| <b>Maintenance:</b> | Remove the tack welds on the exterior of the bottom flange at Girder 2. |

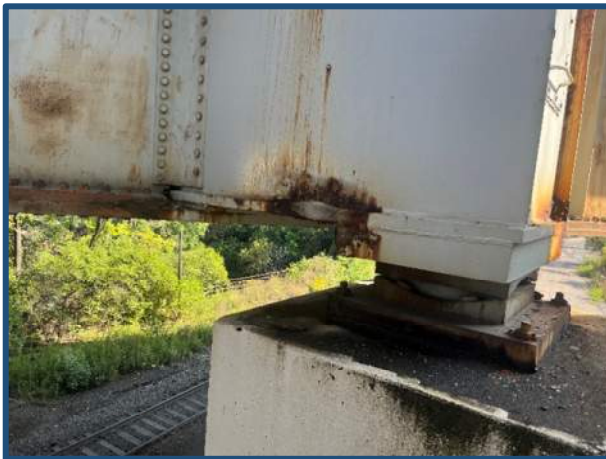
*Photo 12: Pack rust at the west web of the Pier Cap at the Girder 6 connection*

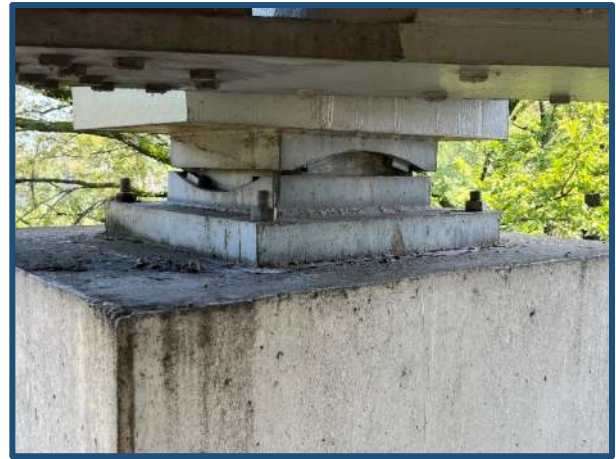
The bearings for the steel pier cap are in good condition. The bearing devices for Pier Cap 5N consist of curved plate bearings. Both the south and north pier cap bearings display minor surface corrosion, especially on the lower portion of the masonry plate (Photo 14) and pack rust around the anchor bolts (Photo 15).

*Photo 14: Typical Peeling Paint and surface corrosion at the east bearing of Pier Cap 5*

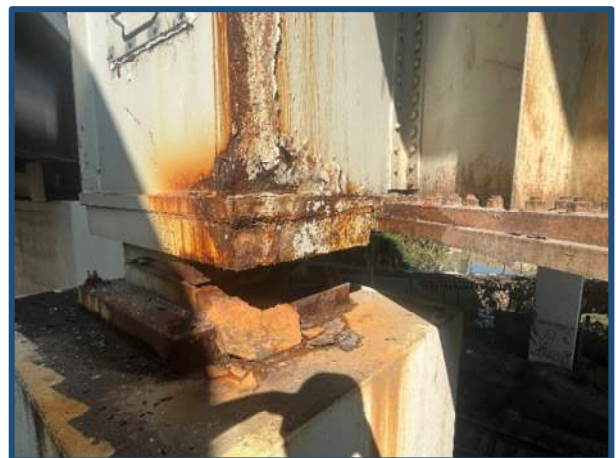
*Photo 15: Surface corrosion and pack rust on the anchor bolts of the south bearing*
