# NSTM Member Inspection Report

## HAM-71-0197W 2025 NSTM Member Inspection Report (VAR-District 8 Bridge Inspections for Steel Pier Caps)

SFN: 3106659, PID: 109781

September 11, 2025

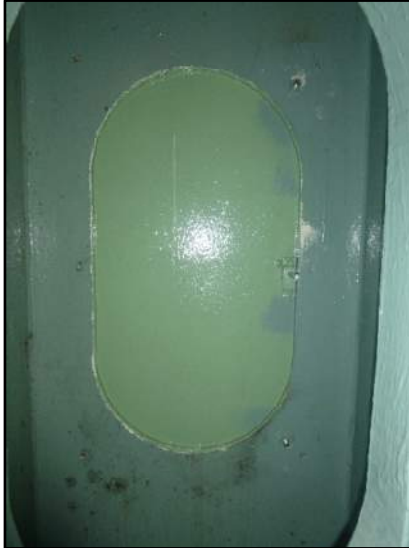
*Figure 3: Interior Photo of North Hatch.  
Note No Interior Latch*

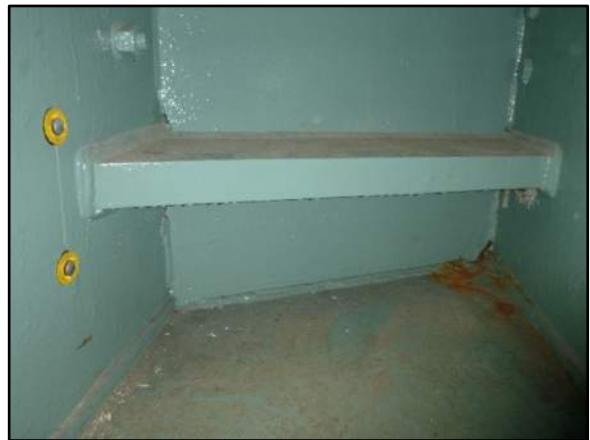
The interior paint is in Good Condition [7] with isolated areas of surface rust, including at the bottom of the Girder T diaphragm (Photo 2) and on the bottom flange tie plates of Girders T, U, V, and Z. The underside of the flange tie plates were not consistently re-painted during a previous rehabilitation. The south face diaphragm at Girder Z appears to have been previously primed but not painted. Intermittent tack welds were removed from the bottom flange backer bars and web plates. Miscellaneous tack welds were also removed from the web plates. Previously observed ponding water on the bottom flange tie plate near Girder T (Photo 3) was not present. No significant changes observed during the 2025 inspection.

*Photo 3: Previously Reported Area of Ponding Water on the Bottom Flange Tie Plate of Girder T Not Present. Dry During 2025 Inspection*

| <b>Maintenance:</b> | Spot clean and paint the interior, focusing on the underside of the flange tie plates and adjacent areas, and repaint the south end plate. |

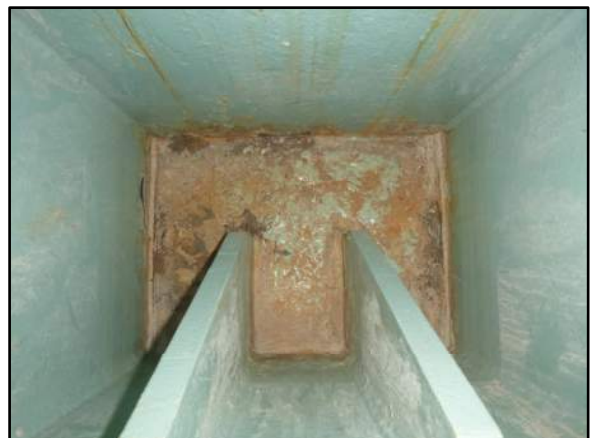
Moderate surface rust was found on the bottom flange and bottom of south end plate between the south bearing stiffener and the end plate. The previously observed 6-8" of standing water (Photo 4) between south bearing stiffener and end plate was not present. Area was dry during 2025 inspection. There were numerous areas of paint cracking from excess paint that is peeling.

*Photo 4: Surface Corrosion on the Bottom Flange Between the South Bearing Stiffener and End Plate.*

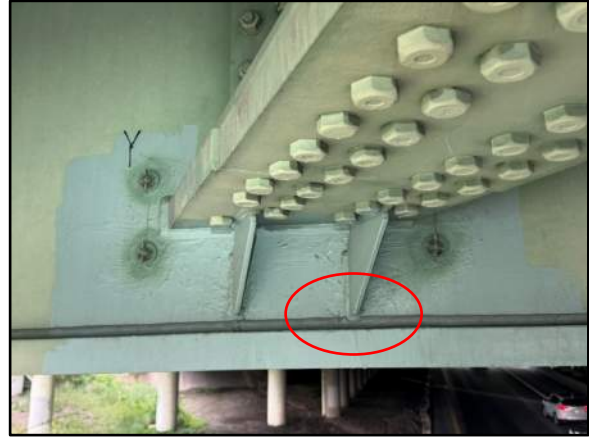
The exterior paint is in Good Condition [7] with small, isolated spots of minor corrosion. During a previous rehabilitation, the bolted connections of the drainpipe support brackets remain, but the drainpipes appear to be rerouted (Photo 5). The web plates were retrofit with stress relief drilled holes connected by vertical saw cuts adjacent to the welded connections of the bottom flange tie plates of the interior girders at both webs, Girder T at the east web, and Girder Z at the west web. Porosity was noticed in the fillet welds around the bottom flange tie plates, but they appear to be sound. Fillet welds between the west web and knee braces below Girders X, Y, and Z intersect the groove weld of the web and bottom flange (Photo 6). There was a small crack indication previously noted above the weld on one bottom flange knee brace on the east face of Girder U connection, but it was verified that the weld was not cracked. Corrosion exists where paint was previously removed.

Photo 6: Typical Fillet Weld of the Girder Knee Brace and West Web Intersecting the Groove Weld Between the Web and Bottom Flange. Dog Bone Retrofit in Cap Web.

Location: Fillet weld between the west web and knee brace below girder Z intersecting the groove weld of the web and bottom flange.

| <b>Rehabilitation/Evaluation:</b> | Consider retrofits of Category E details of intersecting welds. Simple drilled and ground retrofit at intersection recommended. |

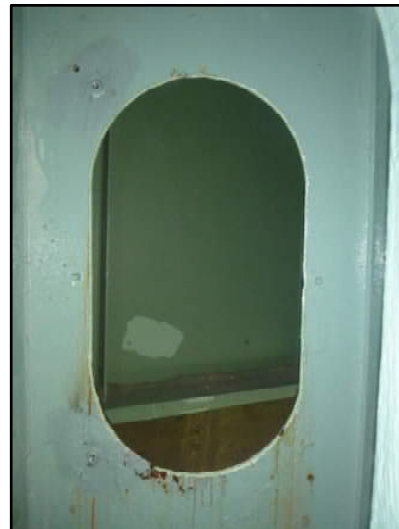
The cover plate on both access hatches have been replaced. The south access hatch has 1-1/2" x 1/2" area of 100% section loss, and up to 50% section loss for the rest of the width (Photo 7). Both access hatches have been retrofitted with bolts to secure closure and rain shields. The north and south pot bearings both have minor surface rust but appear to function appropriately (Photo 8).

Photo 7: 1" of 100% Section Loss at South End Hatch Opening.

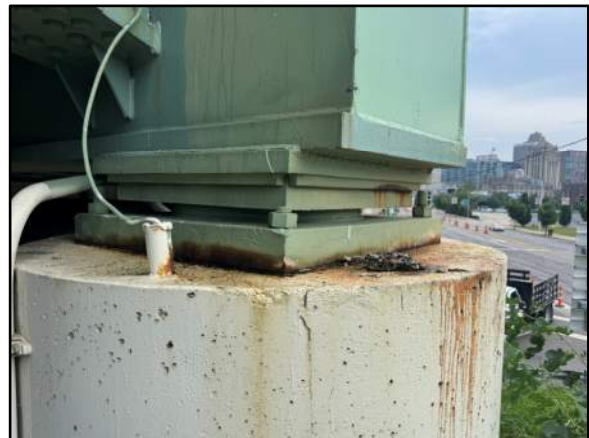
Photo 8: Typical Condition of North Bearing.
