# Routine and NSTM Member Inspection Report

## **HAM-71-0248L** **2025 Routine and NSTM Member Inspection** **Report** **(VAR-District 8 Bridge Inspections for Steel Pier** **Caps)**

**SFN: 3106780, PID: 109781**

August 23, 2025

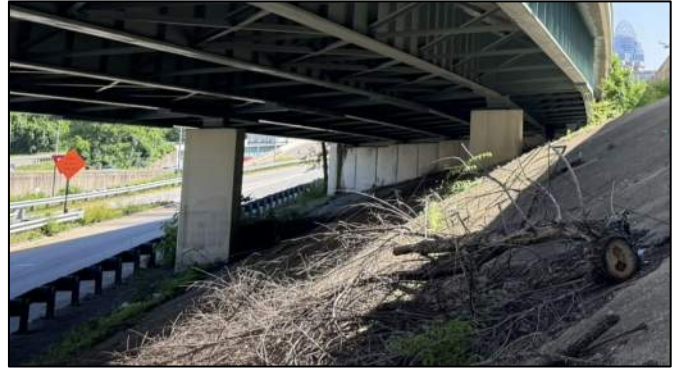
Pier Cap 1 is in Good condition [7] (Photo 1). There are isolated areas of light surface rust on the interior surfaces of the cap. At the time of inspection, the pier cap interior was dry.

*Photo 1: Pier Cap 1 Elevation*

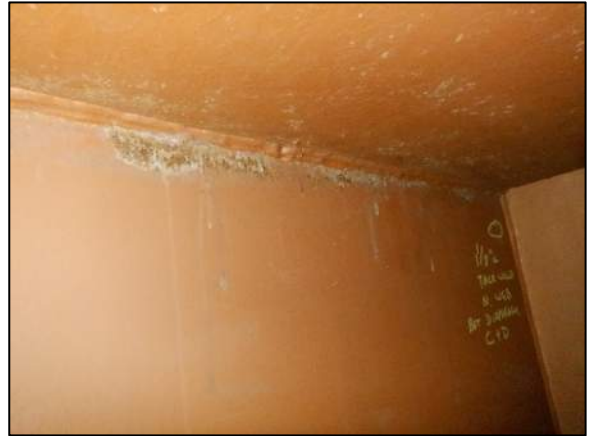
The interior paint is in Good condition [7] with isolated areas of light rust spots on the top flange and at the top of the web plates (Photo 7) and at the bottom flange between diaphragm and end caps (Photo 8). There is a minor gap above Girder E and top flange of steel pier cap.

*Photo 7: Typical Corrosion Along Upper Flange and Top of Webs Near Web Flange Interface*

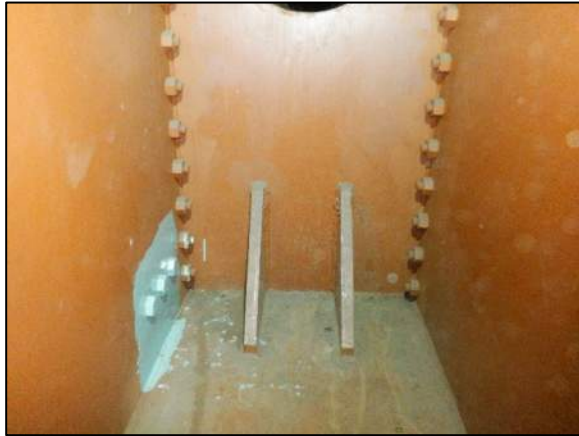
*Photo 5: Typical Diaphragm Bracing*

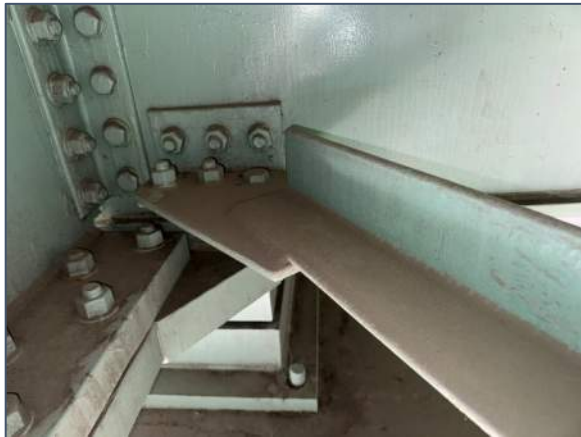
The exterior of the pier cap is in Very Good [8] Condition. During previous rehabilitations, tack welds were removed from the bottom surface of the pier cap bottom flange and the edges of the girder fill plates. Tack welds exist along the edges of the pier cap bottom flange and the girder fill plates. The welded lateral bracing connections were removed from the web plates and replaced with bolted connections (Photo 9).

*Photo 9: Retrofitting with Bolted Connections in Lateral Bracing*

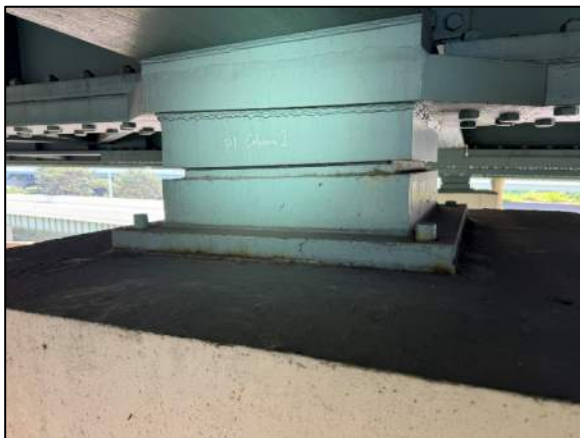
The exterior paint is in Very Good Condition [8]. The nuts are missing from the anchor bolts on all three of the pot bearings (Photo 10). The pot bearings appear to function properly.

*Photo 10: Nuts Missing from Anchor Bolts at Pot Bearings, Typical*

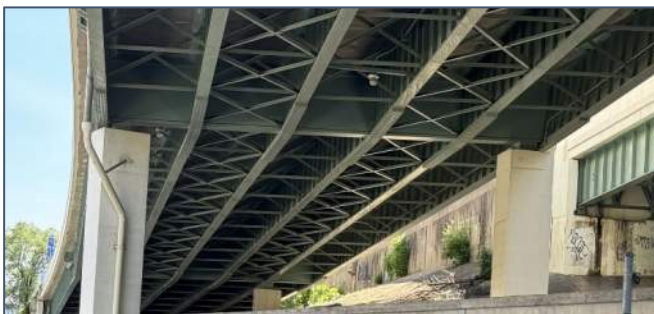
Pier Cap 2 is in Good Condition [7] (Photo 11). At the time of inspection, the pier cap interior was dry.

Photo 11: General Elevation Pier Cap 2

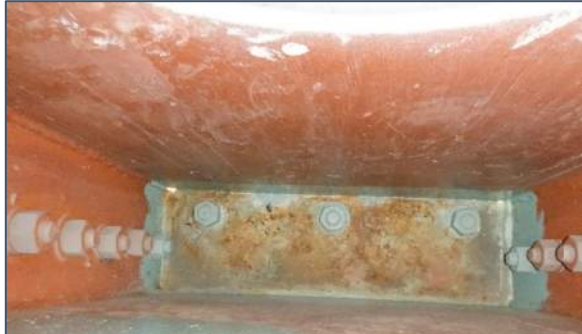
The interior paint is in Very Good Condition [8]. The lower flange and portions of web at the end caps were painted during a previous rehab, however corrosion is reactivating along the lower flange (Photo 15).

*Photo 15: Reactivating Corrosion Along Lower Flange  
at Cap Ends*

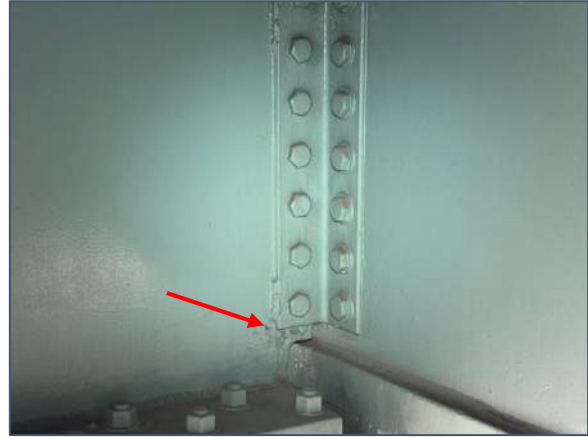
Welds exist between the web and angled mounting brackets of the girders (Photo 16). Tack welds remain along the edges of the pier cap bottom flange and the girder fill plates throughout. Two tack welds, on the interior of the north web plate between the west bearing and Girder B, have been previously ground, but not completely removed (Photo 17). A bolted connection of the lower lateral bracing on the north web has been retrofitted at Girder B. There are drilled stress relief holes connected by saw cuts at all girders throughout Pier Cap 2.

Photo 16: Welds to Bolted Angle Bracket

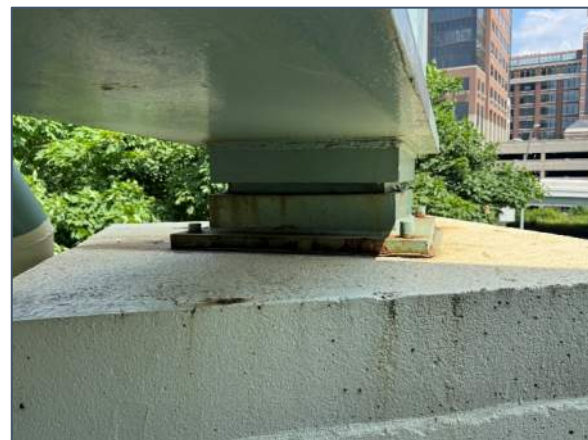
The exterior paint is in Very Good Condition [8]. There is typical cracking in the paint along the lower portions of the web stiffener and the bottom flange. The nuts are missing from the anchor bolts at all bearings (Photo 18); however, the pot bearings appear to function properly.

Photo 18: Typical Pot Bearing; Missing Nuts from Anchor Bolts

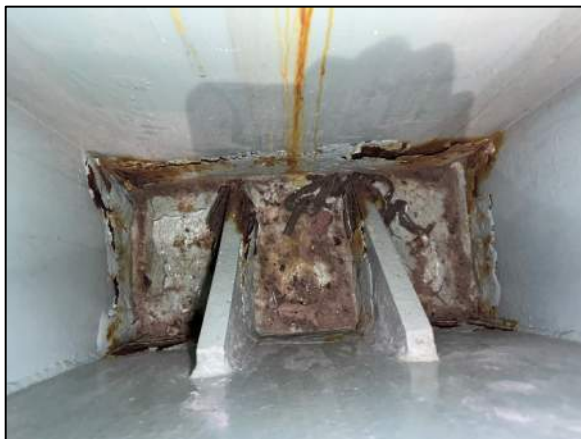
*Photo 20: Active Rust Along Bottom Flange Between East Access Hatch and East Bearing Diaphragm*

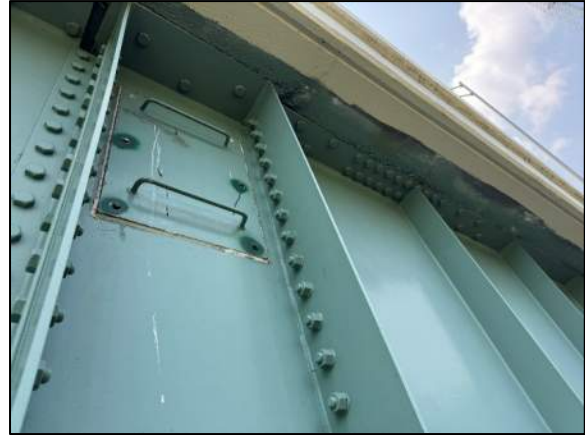
The exterior of the pier cap is in Very Good [8] Condition. The east access hatch cover is missing both middle bolts, bolt holes have been caulked over to seal the hatch. The West hatch door gasket seal is missing.

*Photo 23: West Hatch, Left and Right top bolts have been sealed over*

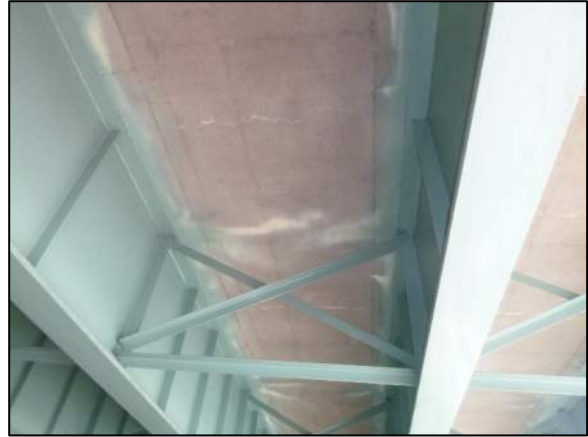
The soffit has longitudinal, transverse and map cracking. Cracks are typically hairline in width, and exhibit efflorescence (Photos 26). Minor efflorescence was observed in Span 3, between Girders C and D, and moderate efflorescence north of Pier 4. Previously noted water infiltration at crack locations was not observed although conditions were dry at the time of inspection. The worst case of efflorescence was noted in Span 5 (Photo 27). Honeycombing was in isolated areas. Isolated areas of spalling were observed, the worst case of spalls along the east side of Girder E at Pier 4, 3' L x full haunch width with 1' of delamination (Photo 28).

*Photo 26: Underside of Deck in Bay 3, Span 2, Near Pier 2, Cracks with Efflorescence*

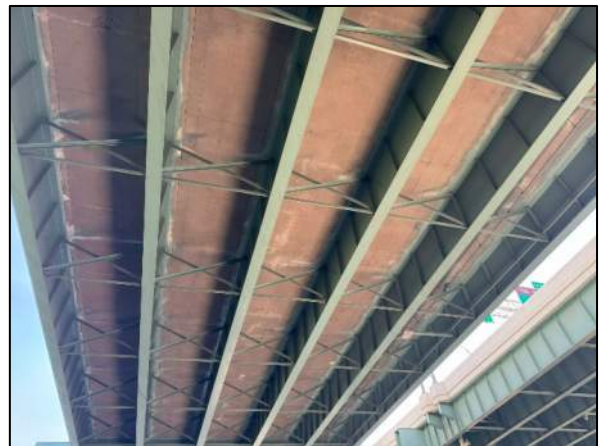
*Photo 27: Efflorescence and Cracking in Span 5*

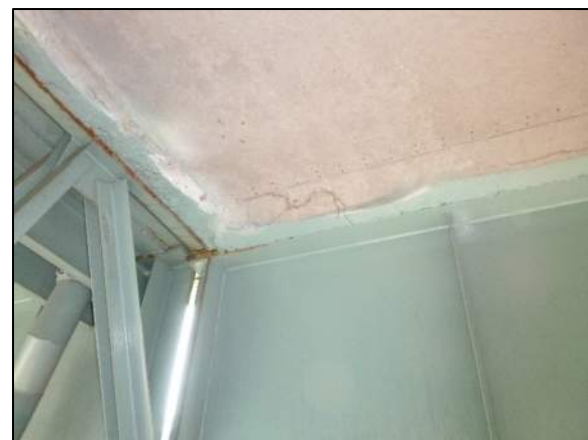
*Photo 28: 3' L X Full Haunch Spall With 1' Delamination*

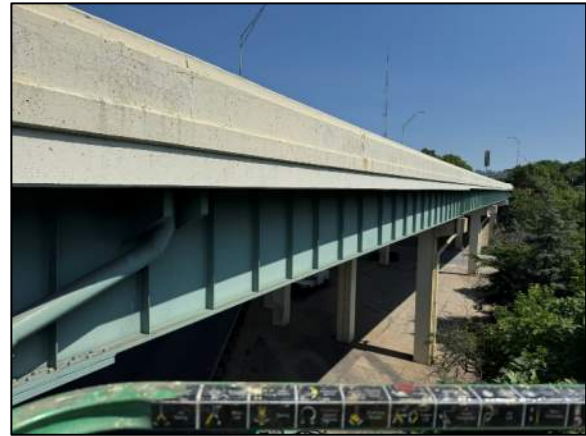
The railing was inspected from the deck corners and from a manlift adjacent to the east deck edge in span 4 during the 2021 routine inspection (Photo 29). The concrete parapet has been sealed and minor staining has occurred throughout due to a porous finish. The parapet also exhibits minor cracking at most joints.

Photo 29: Typical View of Rail Cracking

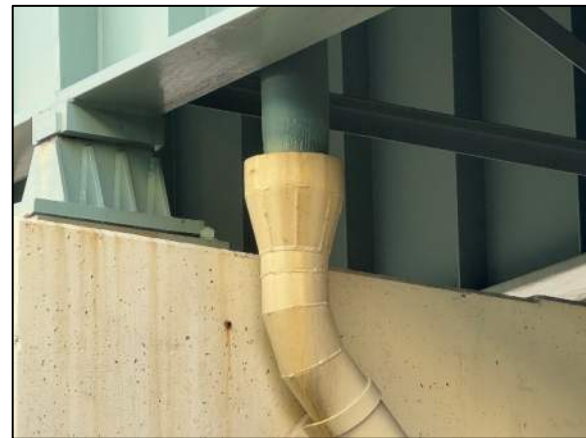
The drainage is in fair condition. Downspouts are mounted to the east columns of the piers. The previously welded brackets to the pier cap webs have been removed as part of past rehabilitation efforts. There are painted over corrosion holes through the bottom edge of the downspouts at the bell connection for the drainpipes but appear to still function as intended, though the corrosion is active (Photo 30).

Photo 30: Typical Condition of Downspout to Bell Connection at Pier 5

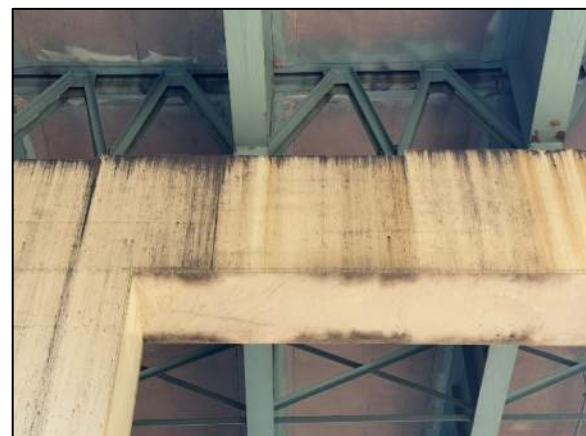
Expansion Joints (Good Condition) The expansion joints are in good condition. The deck joint over Pier 4 appears to have been leaking along the full-length due to the staining along the concrete pier cap underneath (Photo 31). However, this seal was replaced during a rehab in 2017. The joint seal over Abutment 1 was replaced, and the joint seal over Abutment 2 is in good condition. (Photos 32 and 33).

Photo 31: Full Length Staining of Pier 4 Underneath Deck Joint

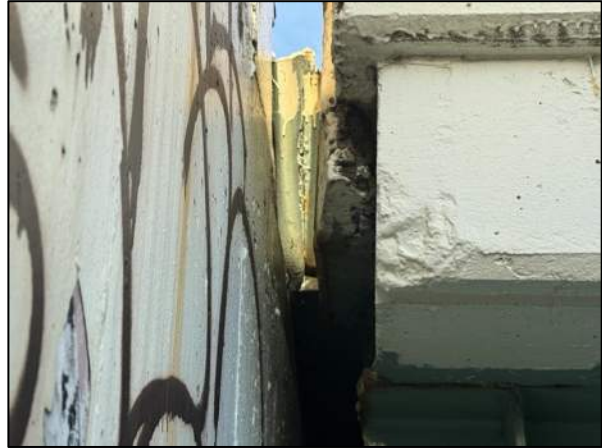
*Photo 32: Typical condition of underside of Abutment 2 Joint*

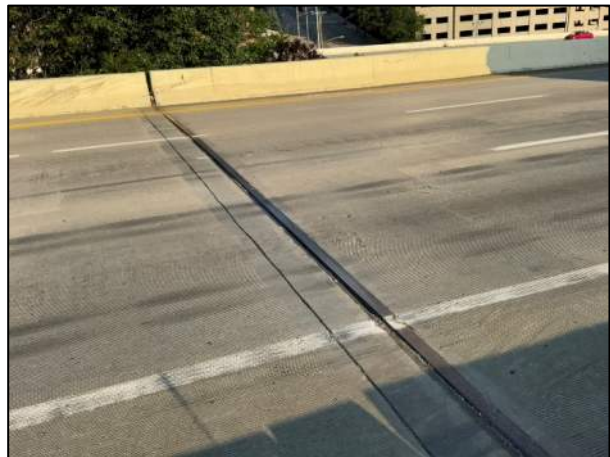
*Photo 33: Abutment 2 Expansion Joint*

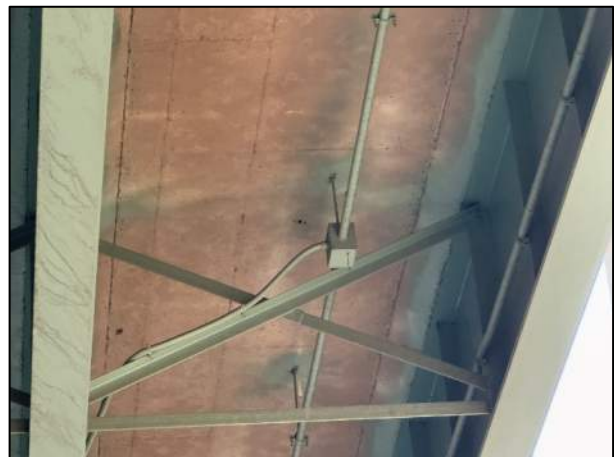
The girders are in fair condition. Areas of previous section loss were noted on the fascia girders and on the girders beneath the deck joints. All these locations have been cleaned and painted (Photos 34 - 35). There is no change in the 6" H x 1.5" W corrosion hole through the end of the Girder C web adjacent to the web stiffener over the bearing at Pier 4 for Span 4. There is also no change in the 1.25" diameter corrosion hole through the web of Girder F over the bearing at Pier 4 for Span 4, adjacent to the bearing web stiffener.

*Photo 34: Typical Condition; East Face Girder A, South of Pier 4*

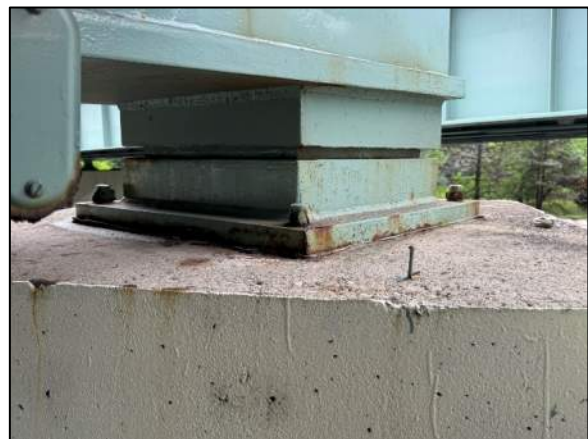
*Photo 37: Minor Pitting and Corrosion on West Column Bearing for Pier 3*

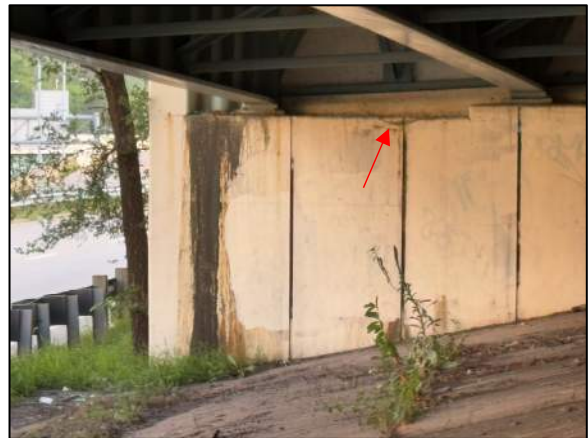
*Photo 40: Abutment 1 Stem in Bay 5; 4' L X 1/4" W  
Crack and Delamination with Rust Staining*

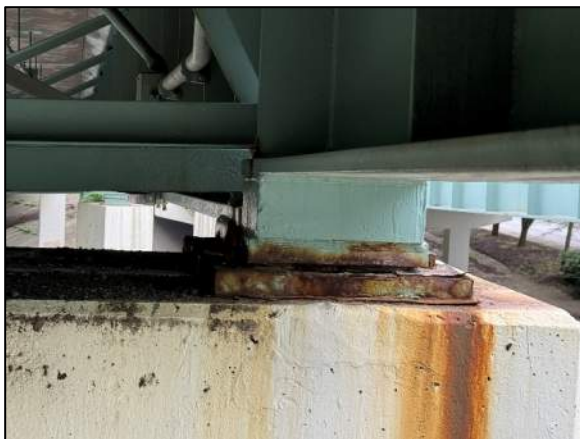
*Photo 38: Peeling Paint and Active Corrosion on  
Sliding Bearings at Pier 4*

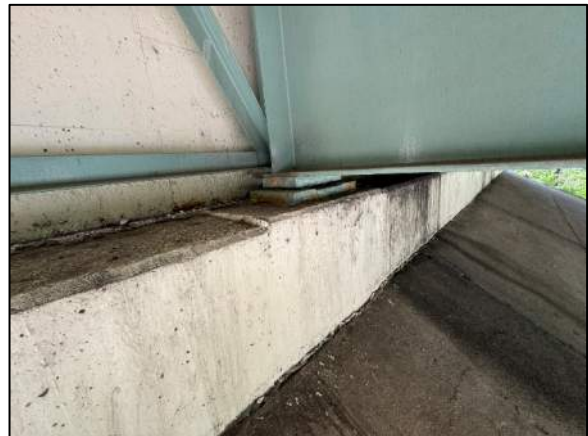
Abutment 2 has staining on the stem just east of Girder B. Poor consolidation is typical along the back of the abutment seat (Photo 41).

*Photo 41: Typical Poor Consolidation Along Back of  
Seat at Abutment 2*

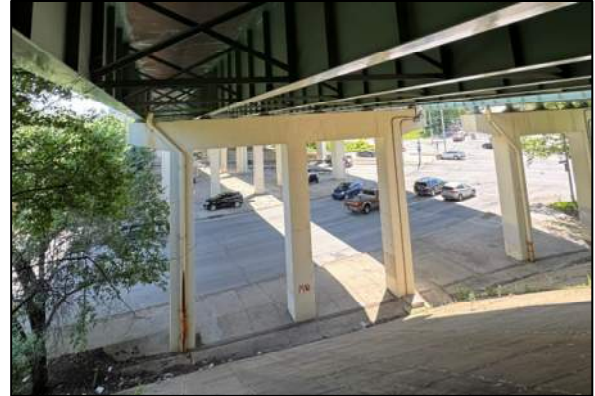
*Photo 43: Minor Staining on Pier 6*

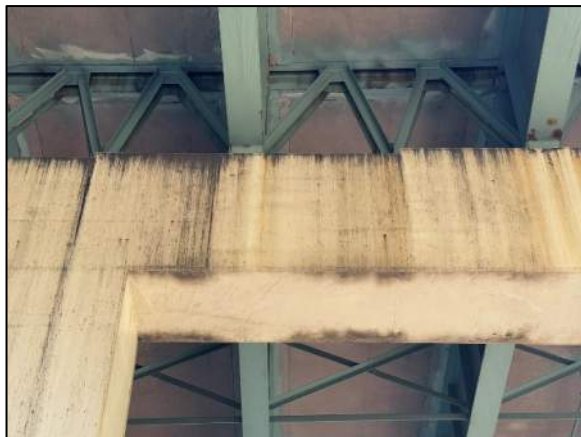
*Photo 42: Moderate Staining Along Pier 4*

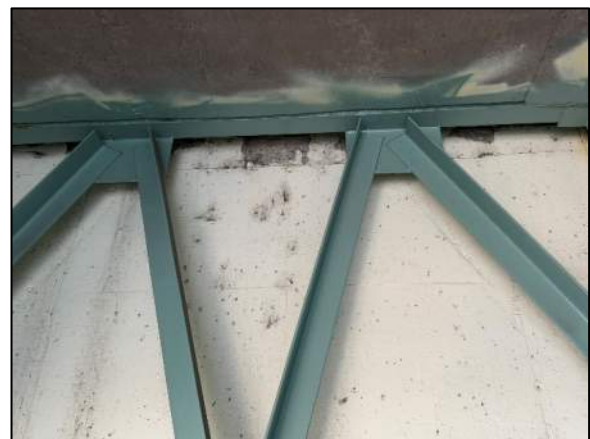
The backwalls are in fair condition. There is poor consolidation with up to 1" D voids throughout the Abutment 1 backwall (Photo 45). The deck joint armor of Abutment 2 is missing a section of concrete 1' H x 1' W at the top east corner of the back wall with a timber plank remaining in place. Hairline vertical cracks are typical throughout all bays in Abutment 2 (Photo 46). Between Girder E and F at Abutment 2, there is one horizontal

*Photo 45: Poor Consolidation and up to 1" D Voids in Abutment 1 Backwall*

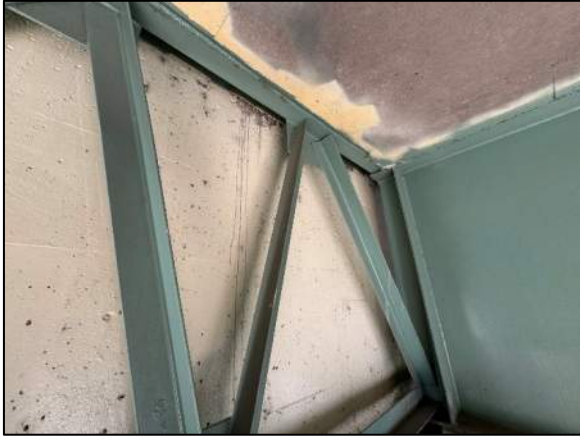
*Photo 46: Typical View of Cracking in Backwall at Abutment 2*

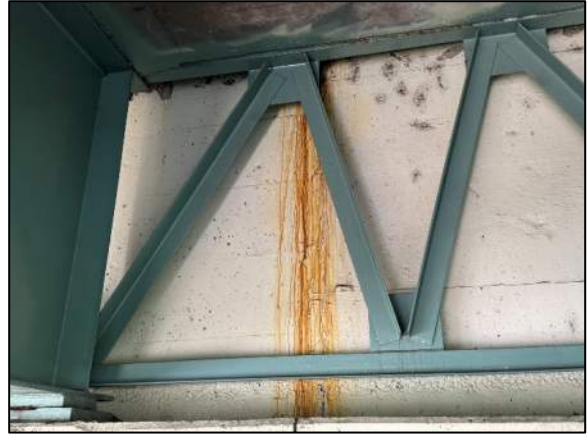
and one diagonal crack. Staining from the leaking deck joint is present on the Abutment 2 backwall at the vertical control joint between Girders C and D (Photo 47).

*Photo 47: Rust Staining on Abutment 2 Backwall between Girder C and D*

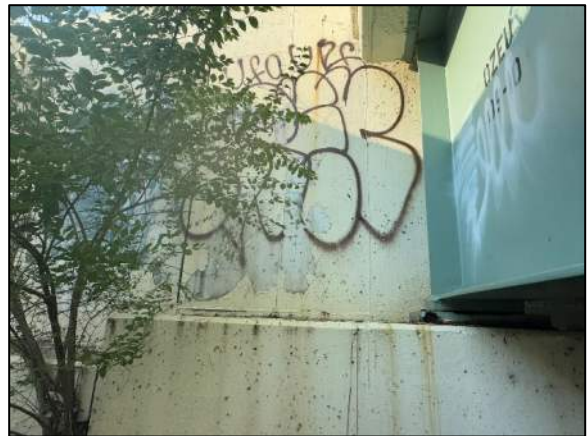
*Photo 48: Missing Sealant and Graffiti on Abutment 2 North West Wingwall*

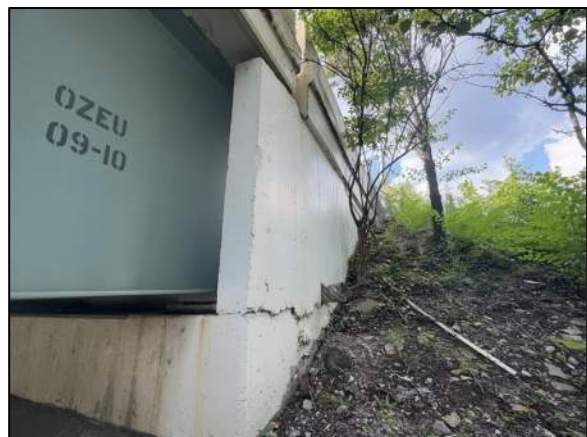
There is a rough and jagged construction joint between Abutment 2 and the cheek wall on the northeast wingwall (Photo 49).

*Photo 49: Abutment 2 NE Wingwall; Rough Transition to Cheek Wall*

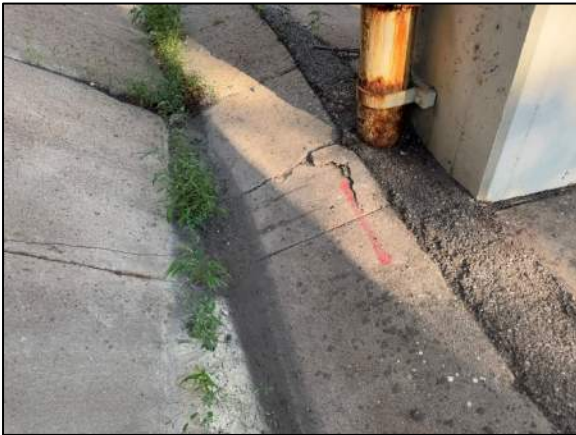
Photo 51: Cracked and Broken Slope Protection at Bottom next to Pier Column

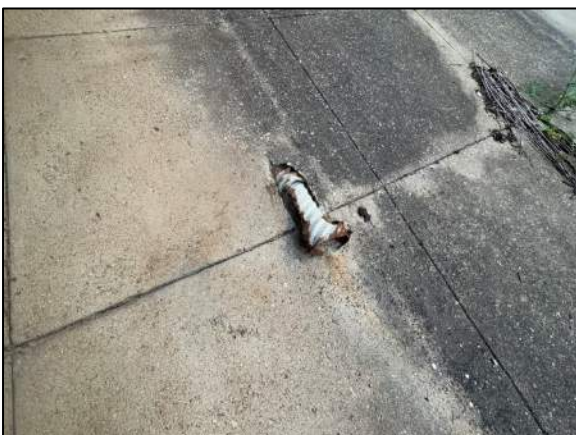
Photo 52: Typical Section Loss in Drainpipes in Slope Protection at Abutment 2.
