# NSTM Member Inspection Report

**HAM-71-0248R**

## 2025 NSTM Member Inspection Report (VAR-District 8 Bridge Inspections for Steel Pier Caps

**SFN: 3106802, PID: 109781**

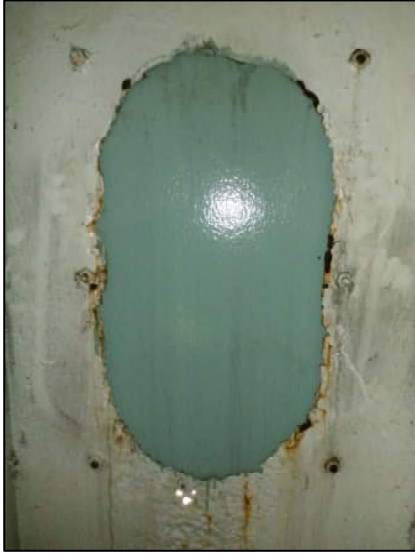
*Photo 1: Pier Cap 9 Elevation*

Pier Cap 9 is in GOOD CONDITION [7] overall (Photo 1). The condition rating has been raised in 2019 due to the designed repairs being constructed in 2017 returning the condition close to the original condition. Previously noted cracks were removed and dog bone crack arrest holes installed as specified in the repair plans in the appendix below. The interior of the cap was dry at the time of inspection. Moderate pitting of steel surfaces was found throughout the interior of the cap. The bottom flange in the interior end caps is heavily corroded.

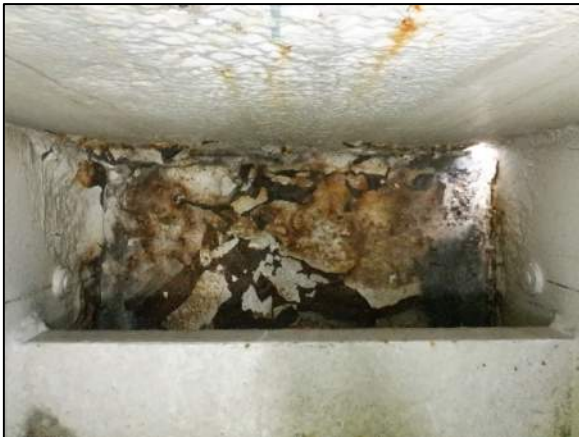
At the west access hatch, there is knife edging along the perforation of the hatch due to corrosion. Seven corrosion holes are present below the bottom of the perforation in the end diaphragm (Photo 2). Reactivating laminating corrosion is present along the bottom flange adjacent to the west hatch (Photo 3). There is painted over pitting and reactivating laminating corrosion on the bottom flange between the east hatch and Girder J diaphragm (Photo 4).

Photo 2: West Access Hatch Opening; Knife Edging and Corrosion Holes Along the Perforation in The End Diaphragm

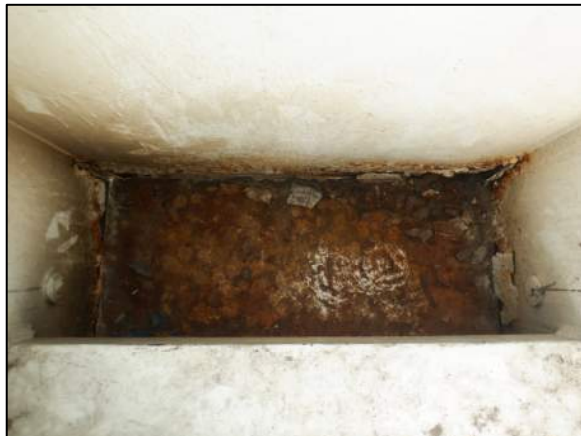
Photo 3: Bottom Flange Adjacent to West End; Painted Over Pitting and Reactivating Laminating Corrosion

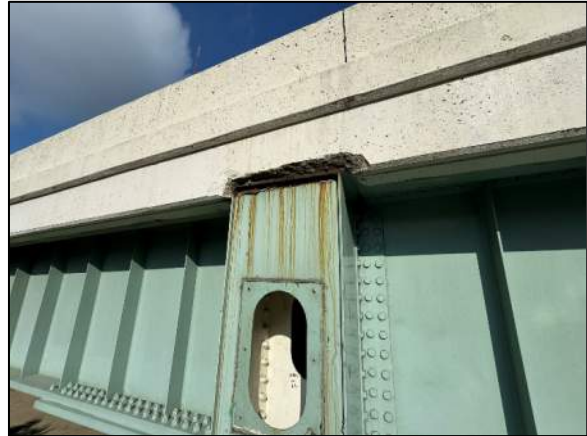
Minor surface corrosion exists along the top flange and both web plates for majority of length. At the west access hatch, two out of six anchor bolts are missing around the perimeter. These bolt holes were caulked over to provide a tight seal. Also, below the bottom edge of the perforation, three painted over pinholes, up to 1/4" diameter, were noted. At the bottom corners of the west end plate, the drain holes exhibit section loss resulting in enlarged holes, up to 1-1/2" Diameter. Active corrosion of the top flange and corrosion staining was noted above the east hatch (Photo 10).

*Photo 10: East End of Pier Cap; Active Corrosion on Top Flange and Corrosion Staining. Spall size unchanged.*

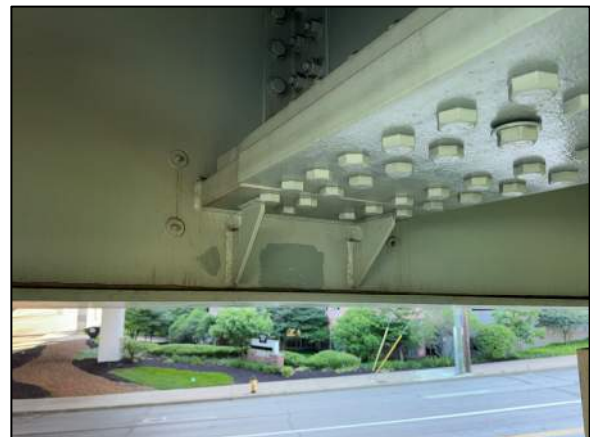
The web plates were retrofitted with drilled stress relief holes connected by saw cuts adjacent to the welded connections of the girder bottom flange tie plates and the knee braces connecting the girder bottom flanges tie plates to the pier cap webs were coped to remove intersecting fillet welds (Photo 11). The welded connections of the drainpipe support brackets and the lower lateral bracing were removed from the web plates and replaced with bolted connections. Due to excessive coping, a 2" diameter x up to 3/16" D gouge on the north pier cap web exists at the Girder B east knee brace (Photo 12) and at the knee brace for Girder E, with minor gouges elsewhere.

*Photo 11: Retrofit Dog Bone Drilled Stress Relief Holes Connected with Saw Cut and Coped Knee Braces*

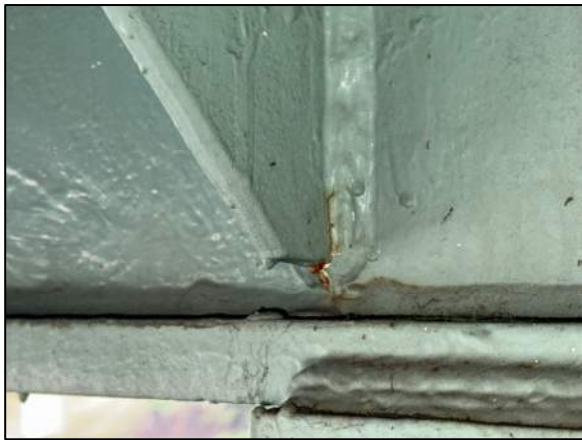
A crack was previously noted on the knee brace below Girder H, however, after further investigation, the crack was determined to only be in the paint (Photo 13).

*Photo 13: Paint Crack Located in Knee Brace Below Girder E*

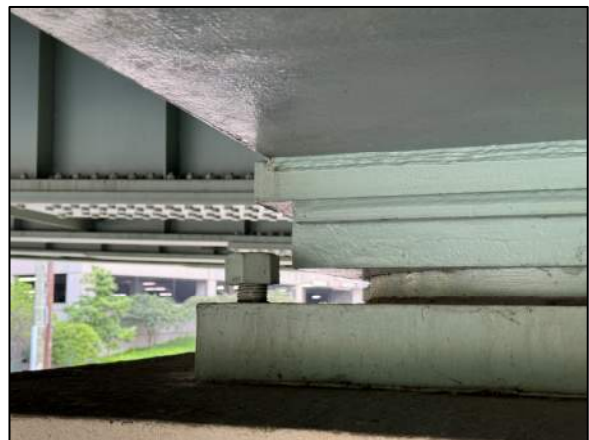
The spherical bearings have minor surface rust but appear to function properly. Anchor nuts on the middle and west bearings are not seated on the base plate (Photo 16).

*Photo 16: West Bearing Unseated Anchor Nut on Center Column*

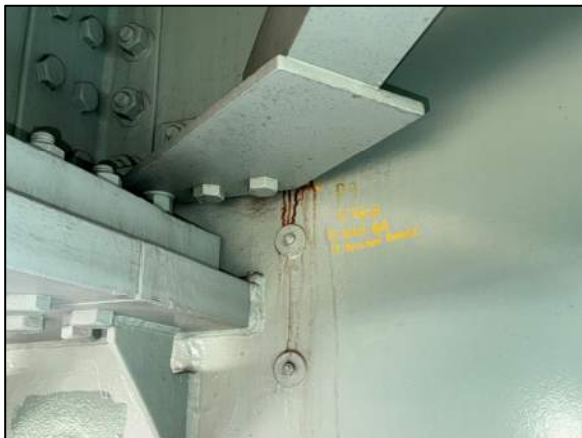
The south web at the west side of Girder C, east side of Girder G, and west side of Girder H exhibits minor corrosion staining from the bolted connection for the lateral bracing due to cracked paint and water infiltration (Photo 14). The north web on both sides of Girder B and Girder C also exhibits similar minor corrosion staining.

*Photo 14: South Web East of Girder G; Corrosion Staining at Bolted Connection for Lower Lateral Bracing*

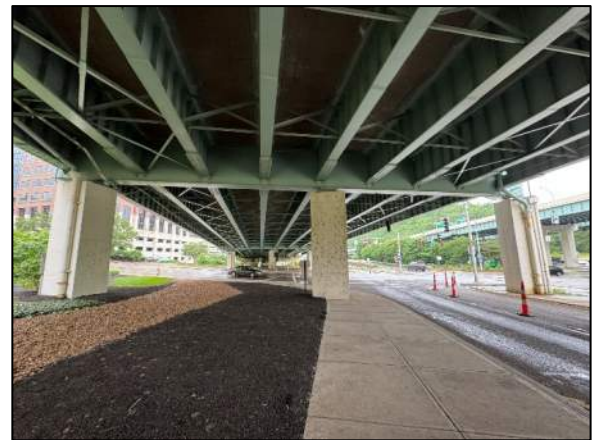
*Photo 17: Pier Cap 10 Elevation*

Pier Cap 10 is in GOOD CONDITION [7] overall (Photo 17). The condition rating was raised in 2019 due to the designed repairs being constructed in 2017 returning the condition close to the original condition. Previously noted cracks were removed and dog bone crack arrest holes installed as specified in the repair plans in the appendix below. The interior of the cap was dry at the time of inspection. Isolated areas of moderate pitting and section loss were found on the bottom flange, end plates and lower portions of the web plates between the fascia girders and access hatches.

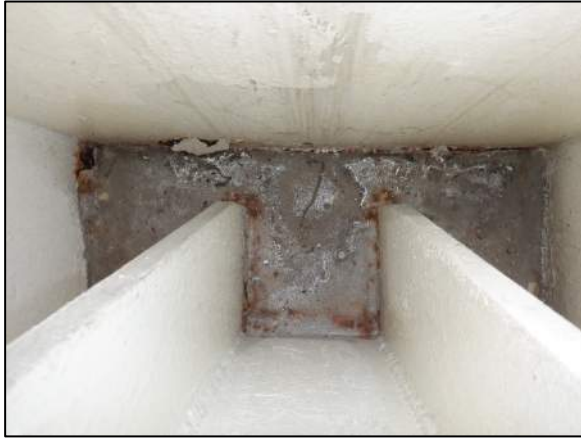
*Photo 24: Active Corrosion and Paint Peeling Along Bottom of Web and Bottom Flange at West End Cap*

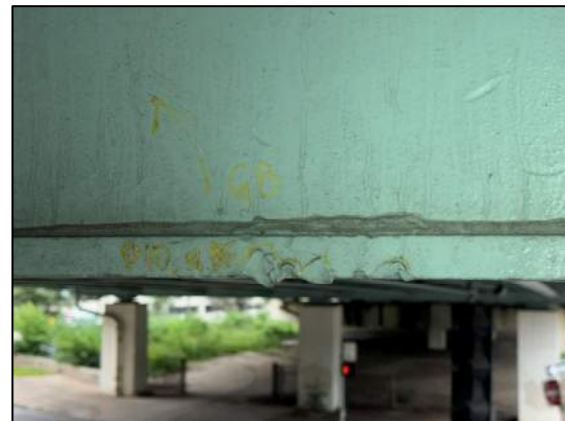
A 4" L x 1" H area of minor gouges on the bottom flange exists on the north side of Pier 10 just below the west side of Girder B (Photo 26). Shallow painted over pitting on the top face of the west end. Minor fretting corrosion was noted between the bolted connection on the north web and lower lateral brace on the west side of Girder H and east side Girder G (Photo 27).

Photo 26: 4" X 1" Minor Impact Damage to North Side of Bottom Flange West of Girder B, no change.

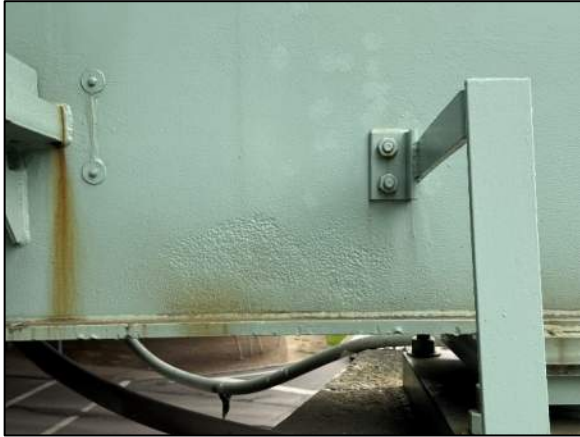
*Photo 27: Minor Fretting Corrosion Between Bolted Connection on North Web and Lower Lateral Brace on West Side of Girder H*

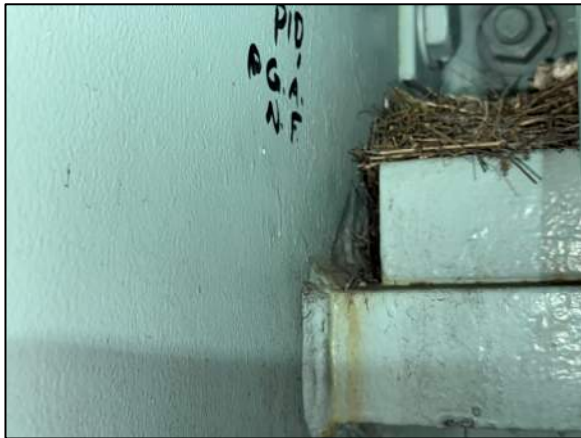
Painted over section loss was noted on the North Web behind the bottom flange of Girder A (Photo 28). Rust Staining left of Girder A coming from the Deck.

*Photo 28: Section Loss on The North Web Behind Girder A. Minor Rust Staining and Bird Debris Present*

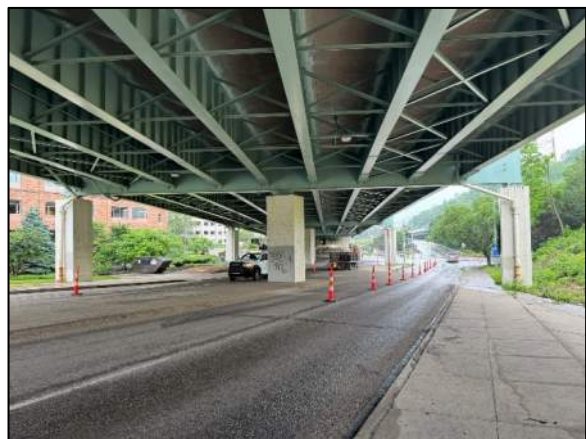
*Photo 29: General Elevation Pier Cap 11*

Pier Cap 11 is in GOOD CONDITION [7] overall (Photo 29). At the time of the inspection the cap was free from moisture.

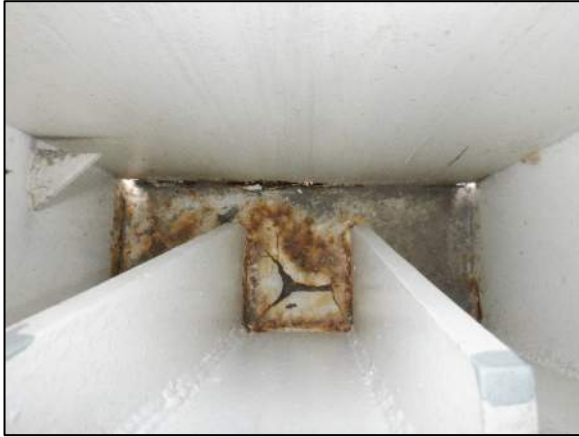
The west access hatch was dry at the time of inspection though localized active corrosion and peeling paint along the bottom flange was observed (Photo 30).

Photo 30: Peeling Paint and Active Corrosion Along Lower Flange Between Diaphragm and East Access Hatch

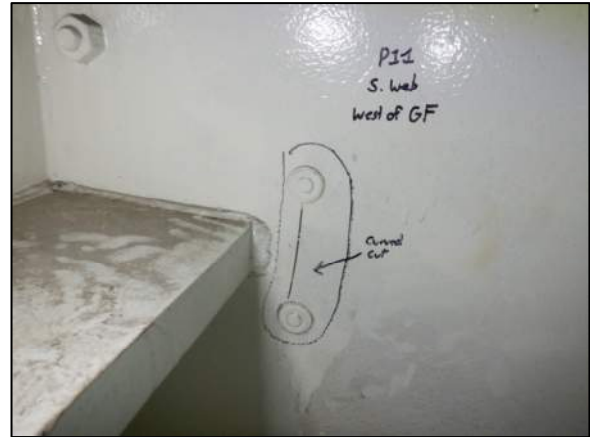
- North Web, west of Girder G
- North Web west of Girder H
- South Web, west of Girder F (Photo 33)
- South Web west of Girder G

Photo 33: Curve in dog bone retrofit cut on South Web, West of Girder F

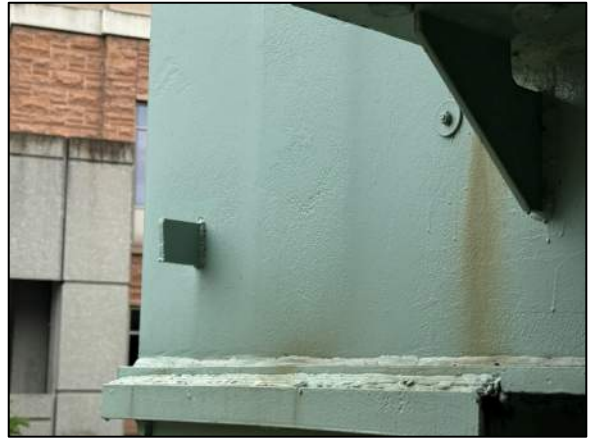
As part of a previous rehabilitation, the knee braces are properly coped, and the stress relief holes are present. On the north web at east side of Girder A, the drilled holes and sawcut was installed 12" away from the bottom flange tie plate rendering it ineffective. It is possible that drilling the holes within 2" of the tie plate was not feasible due to the previous downspout configuration. Also, during the previous rehabilitation, the welded connections of the drainpipe support brackets and the lower lateral bracing were removed from the web plates and replaced with bolted connections. Remnants of the welded drainpipe connection still exist on 3the North Web, east of Girder J (Photo 35).

*Photo 35: Remnants of Welded Drain Pipe Connection and Minor Surface Corrosion on North Web, East of Girder J*

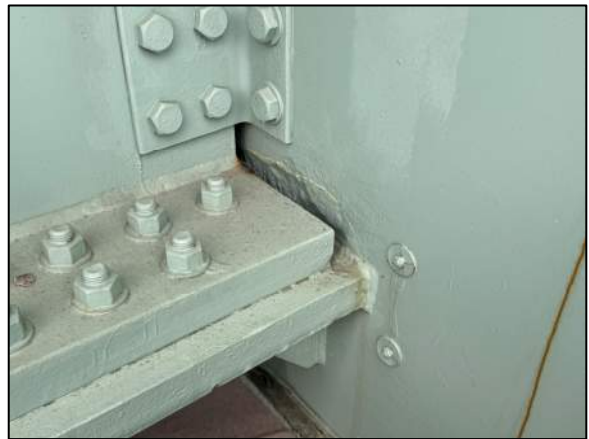
An 18" L x 3" W area of section loss, up to 7/16" D, exists in the north pier cap web just east of the web of Girder A, extending to the west side of Girder A (Photo 36).

*Photo 36: Section Loss in North Web Behind Bottom Flange of Girder A*

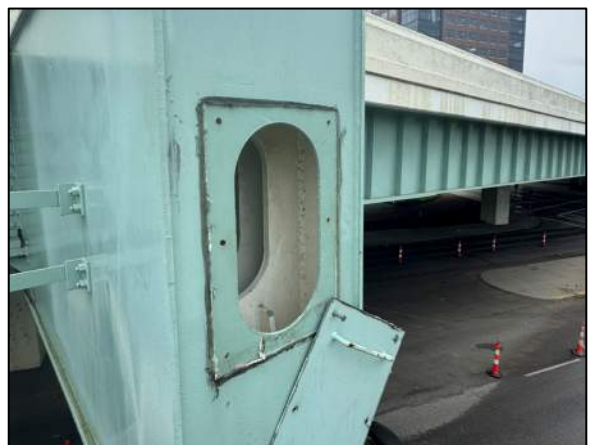
The perimeter of the east access hatch exhibits painted over pitting (Photo 37). Only two of the original six nuts remain on the west hatch. The hatch door was secured and sealed with exterior caulk.

*Photo 37: Painted Over Pitting on East Access Hatch*

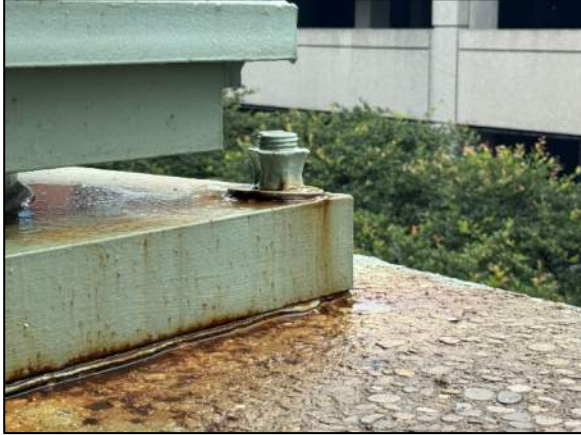
The spherical bearings are in GOOD CONDITION [7] and appear to function properly. Two anchor nuts on the east bearing have suffered approximately 50% section loss (Photos 38 and 39). One anchor nut on the center bearing is not tightly seated on the masonry plate.

*Photo 38: Up to 50% Section Loss of East Column, SE Anchor Nut. Section Loss Has Been Painted Over and Active Minor Surface Corrosion.*

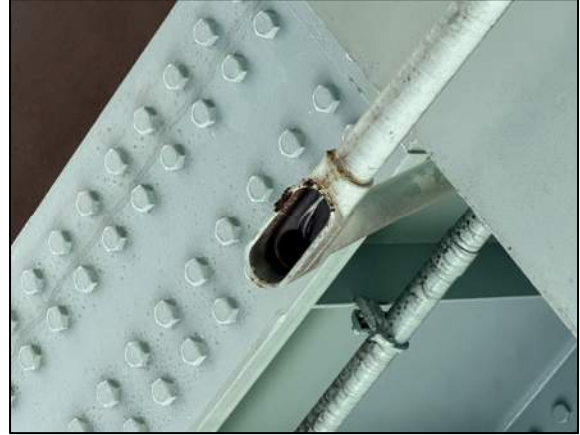
There is a missing conduit cover on the north side, east of Girder E (Photo 40).

*Photo 40: Missing Conduit Cover, North Side, East of Girder E.*

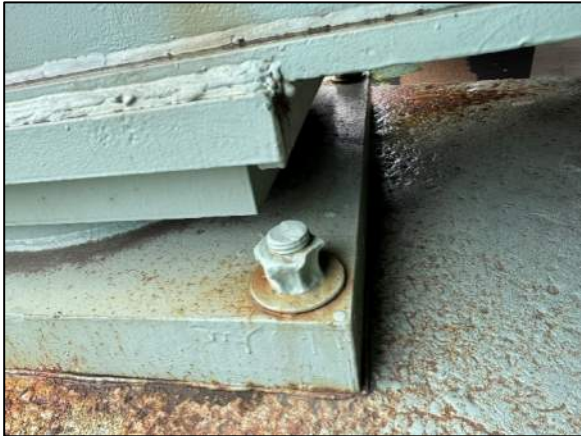
*Photo 39: Up to 50% Section Loss of East Column, NW Anchor Nut. Section Loss Has Been Painted Over and Active Minor Surface Corrosion .*

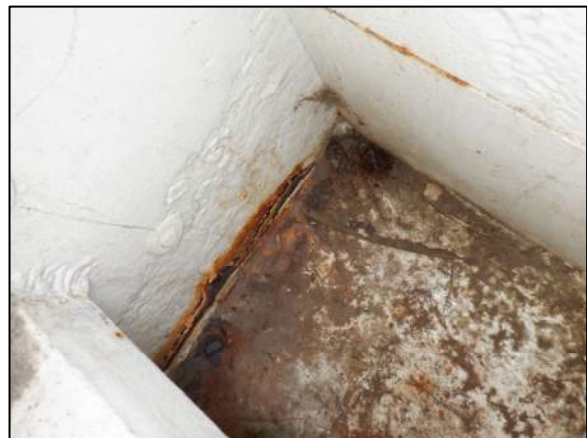
The interior paint is in VERY GOOD CONDITION [8]. Painted over heavy pitting and isolated section loss were found on the bottom flange and along the bottom of the girder diaphragm, web, and end plates between the access hatches and fascia girder diaphragms. During previous rehabilitation, the interior surfaces of the pier cap were cleaned and painted, the lower interfaces between the web and flange at both ends of the cap have reactivating corrosion (Photo 47).

Photo 47: Typical Corrosion and Section Loss in Bottom Flange and Bottom of Web at West End Cap

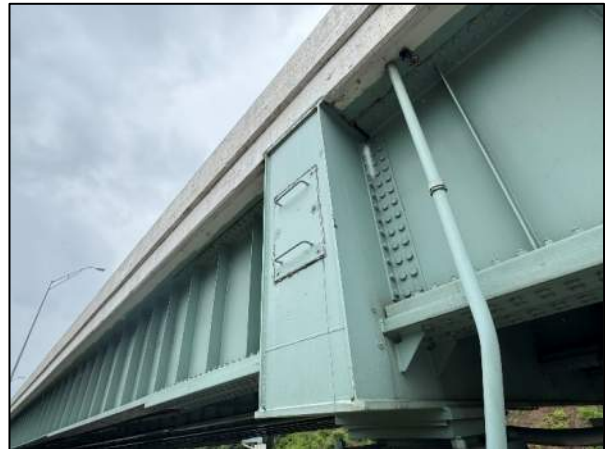
Photo 48: West Access Hatch; Middle Bolt Hole Filled with Caulk

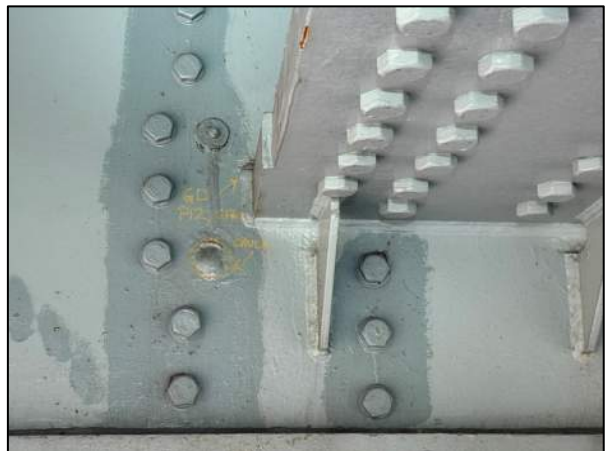
Photo 49: Missing Bolt in South Web, West of Girder D; Hole Filled with Caulk and Painted Over

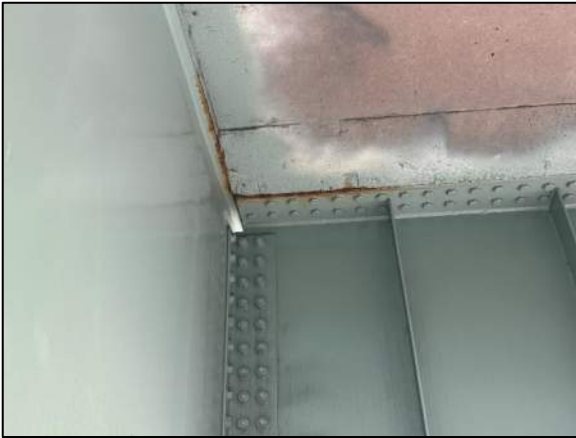
*Photo 50: Rust Staining Along Top Flange of Pier  
Cap at Girder J*

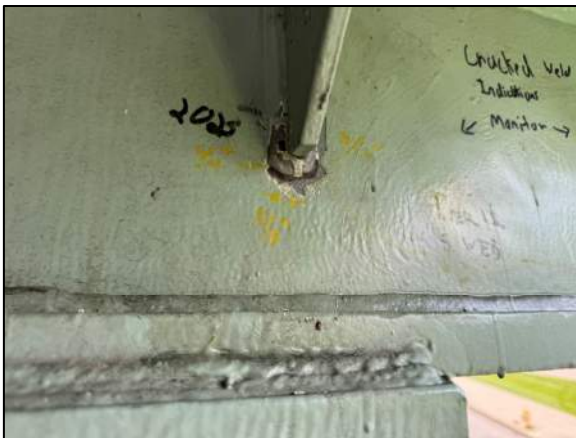
*Photo 51: Cracked Weld Indications on West Knee Brace  
Fillet Weld*

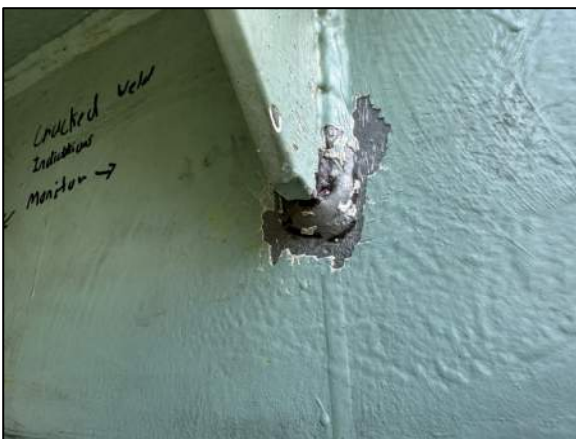
*Photo 52: Cracked Weld Indications on East Knee Brace  
Fillet Weld*
