# NSTM Member Inspection Report

## HAM-75-1102R 2025 NSTM Member Inspection Report (VAR-District 8 Bridge Inspections for Steel Pier Caps)

SFN: 3110443, PID: 109781

September 09, 2025

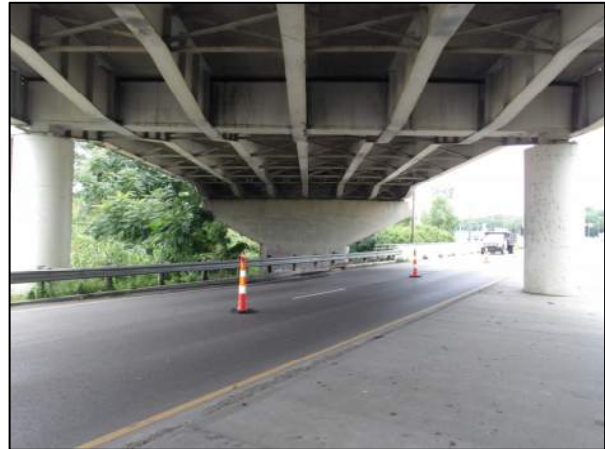
Photo 1: Pier Cap 3 Elevation

Based on the 2021 inspection, Pier Cap 3 is in Satisfactory condition [6] (Photo 1). The pier cap is a built-up steel plate sections of varying thicknesses and heights. As part of the 1993 rehabilitation project, tack welds were removed along the webs and bottom flange and backer bars. Additionally, 2" Diameter stress-relief holes were drilled and connected with a sawcut through the webs of the longitudinal girders on both sides of the pier caps.

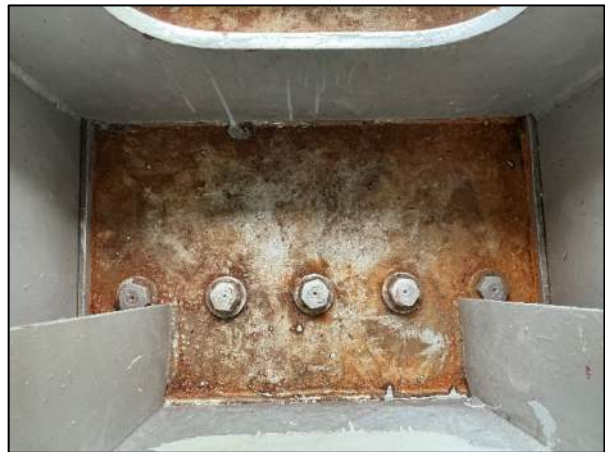
The interior of Pier Cap 3 was dry at the time of inspection. Both access hatches appear to be well sealed. No water staining or leakage was noted inside the pier cap. The paint system of the pier cap interior is in good condition with adequate coverage throughout. There is minor surface corrosion on the bottom flange adjacent to the west access hatch (Photo 2).

Photo 2: Surface corrosion on the bottom flange of Pier Cap 3 adjacent to west access hatch.

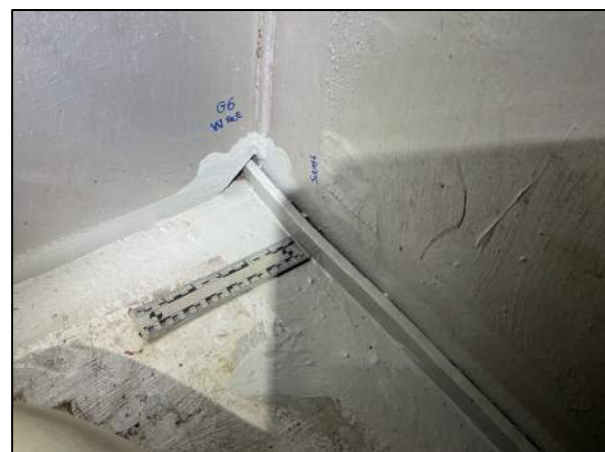
Photo 3: Gap between the backer bar and south web plate west of Girder 6 at Pier Cap 3.

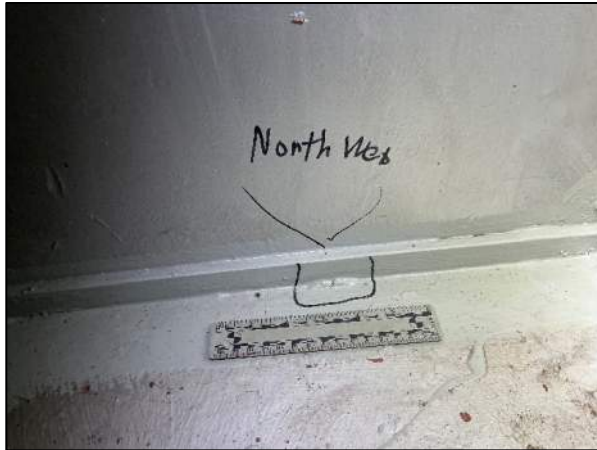
Photo 4: 1-1/2" tack weld on bottom flange at the north web of Pier Cap 3 east of Girder 3.

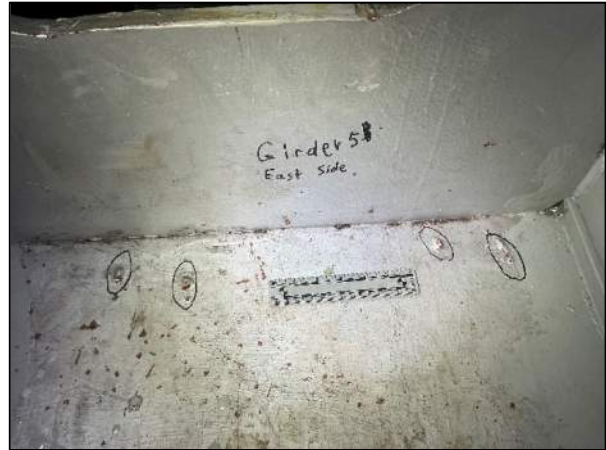
There are seven miscellaneous tack welds on the bottom flange throughout the pier cap: three 1/2" welds between Girder 4 and the east adjacent diaphragm, and three 1/2" and one 1" welds between Girder 5 and the east adjacent diaphragm (Photos 7-8). There are also tack

Photo 7: Four tack welds ranging from 1/2" to 1" on the bottom flange of Pier Cap 3 east of Girder 5.

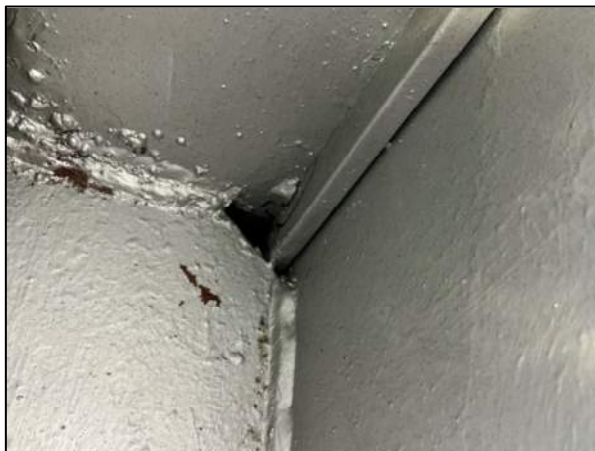
Photo 5: Cracked tack weld between the top flange and north web between the east bearing and Girder 7 at Pier Cap 3.

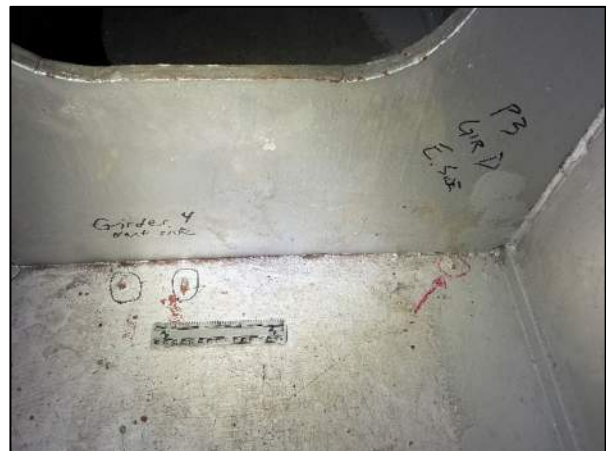
Photo 8: Additional 1/2" tack welds on the bottom flange east of Girder 4.

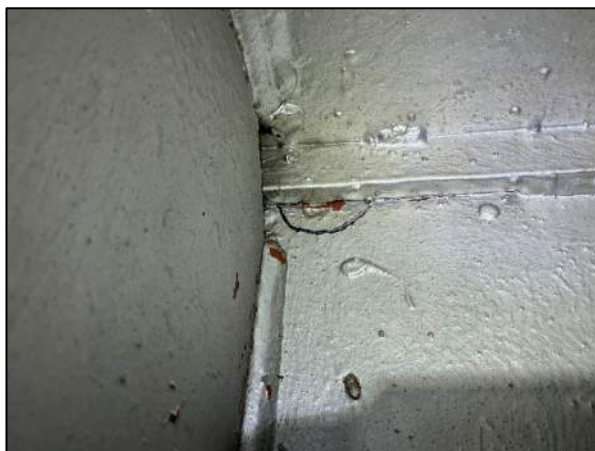
Select portions of the bottom flange backer bars were removed throughout the length of the pier cap where the backer bars were bowing away from the web plate or where two backer bars met without a butt-weld. Some of the remaining backer bars show gaps between them and the web plates (Photo 3). There are two remaining 1-1/2" tack welds between both north and south backer bars and the bottom flange between Girder 3 and the east adjacent diaphragm (Photo 4). The top flange backer bars are connected to the webs and flange with intermittent tack welds, some of which have cracked. There are two cracked welds between the top flange backer bars and both web plates between the east bearing and Girder 7 (Photo 5). There is also a completely cracked tack weld between the top flange backer bar and the south web plate at Girder 7 (Photo 6).

Photo 6: Cracked tack weld between the top flange and south web at Girder 7 at Pier Cap 3.

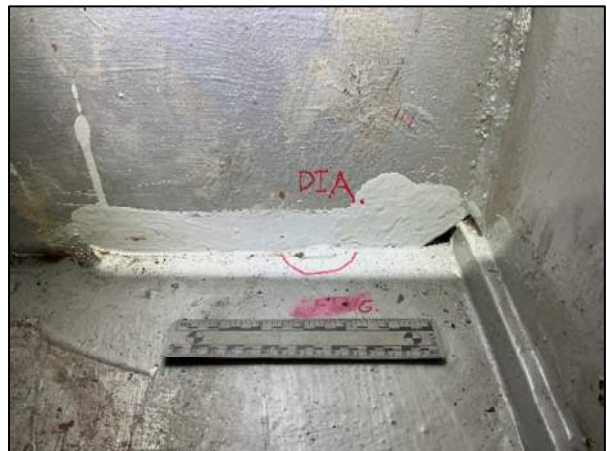
welds between diaphragm east of the west bearing and the bottom flange (Photo 9).

Photo 9: 1" tack weld on the Pier Cap 3 bottom flange at the diaphragm east of the west bearing.

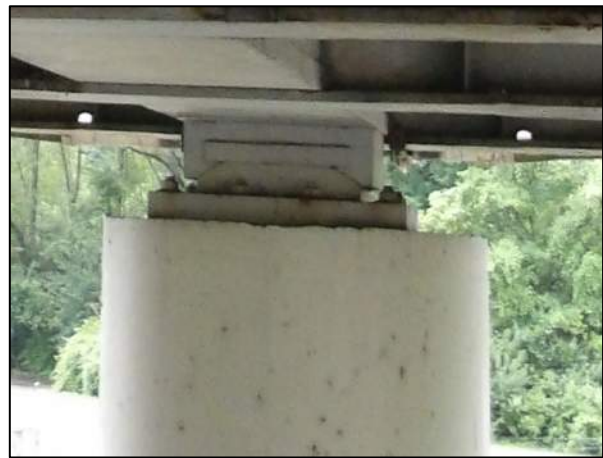
The east pier cap bearing displays minor surface corrosion with some layered corrosion around the anchor bolts (Photo 10). The west bearing exhibits minor surface corrosion on the masonry plate and anchor bolts (Photo 11).

*Photo 10: Typical Peeling Paint and surface corrosion at the east bearing of Pier Cap 3*

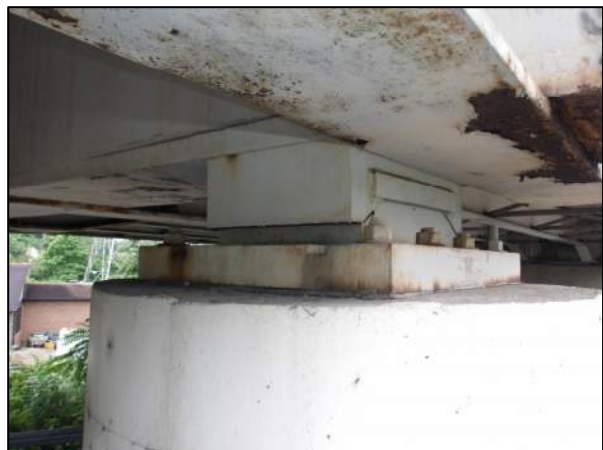
*Photo 11: Minor surface corrosion on the masonry plate and anchor bolts at the Pier Cap 3 west bearings.*

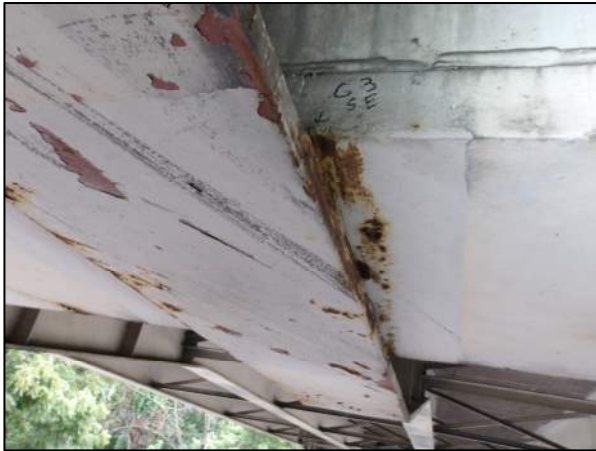
The paint system of the pier cap exterior is in satisfactory condition with widespread areas of chalking. There are several small areas of minor freckling corrosion and peeling paint on the bottom flange near the bearings (Photo 12) and the top flange between the girders. There is moderate surface corrosion on the west end of the pier cap resulting in 5/16" of pack rust between the bottom flange and the pier cap (Photo 13). On the south side of the bottom flange west of Girder 3, there is a 4" long area of impact damage (Photo 14).

*Photo 12: Minor freckling corrosion, peeling paint and vehicle scrapes on bottom flange.*

1. Remove the welds between the edges of the bottom flange and the bottom flange of the girders.
2. Clean and paint the exterior surfaces of the pier cap and girder connections.

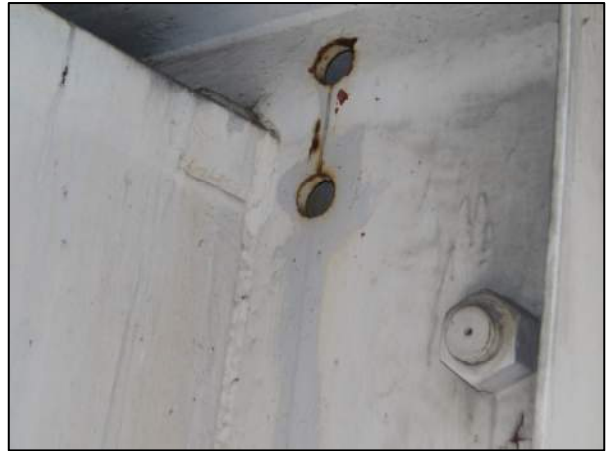
*Photo 15: Typical gouges in the Girder sawcut retrofit.*

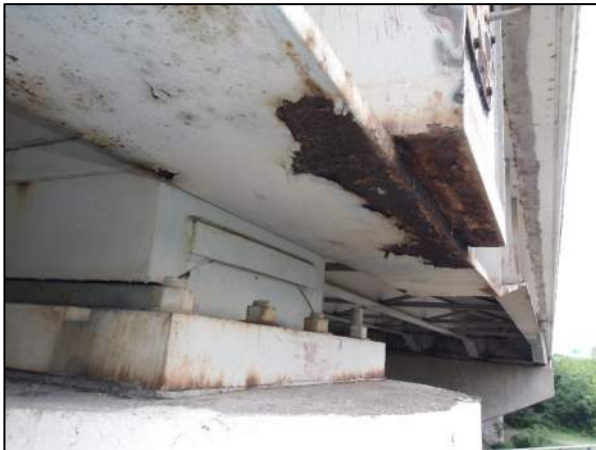
*Photo 13: Up to 5/16" pack rust between the Girder 1 bottom flange and the pier cap at the west end of Pier Cap 3.*

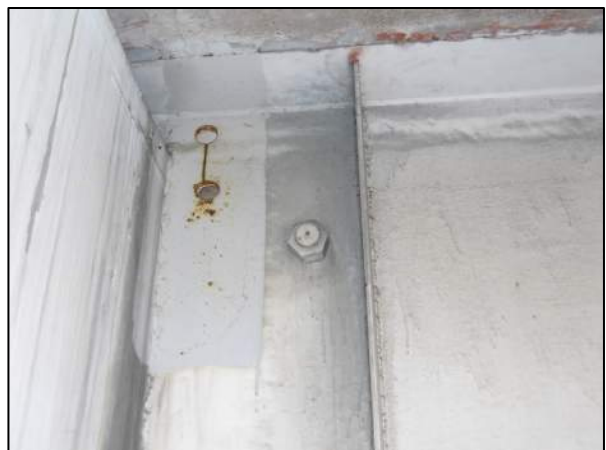
As per the 1993 rehabilitation project, 2" Diameter stress relief holes were drilled through all girder webs adjacent to the pier cap top flange and connected with sawcuts. Some of the retrofits display gouges in the stress relief holes due to mis-drilled holes at Girders 1, 2, 3, and 6 (Photo 15). On the south side of the west face of Girder 2, there are errant sawcuts between two of the stress relief holes (Photo 16).

*Photo 16: Typical view of errant sawcuts on the Girders.*

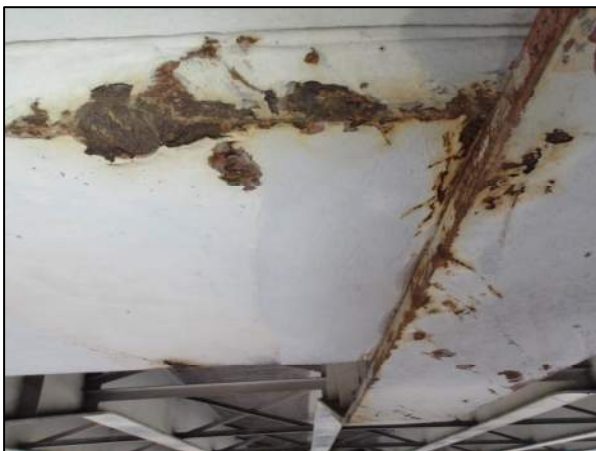
*Photo 14: 4" long area of impact damage on Pier Cap 3 bottom flange west of Girder 3.*

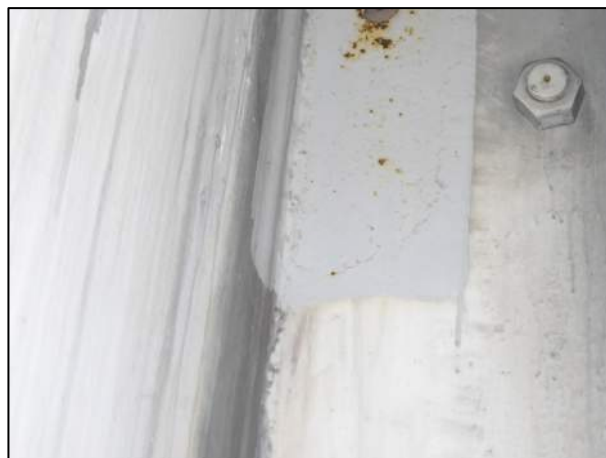
The full penetration groove welds between the flange plates and web plates are overlapped with multiple discontinuous fillet welds that were not ground smooth, but the welds show no signs of distress (Photo 17). Tack welds or fillet welds were typically found between the bottom flange and the bottom flanges of the girders. The welds running transverse to the pier cap flange were removed during the rehabilitation. This caused gouging of the bottom flange (Photo 18), and some gouging of the welds running longitudinally along the pier cap flange (Photo 19). At several locations, this removal has resulted in cracks of the welds longitudinally along the pier cap flange. Locations of this condition include:

*Photo 17: Typical overlapping welds on the Pier Cap 3 web plates.*

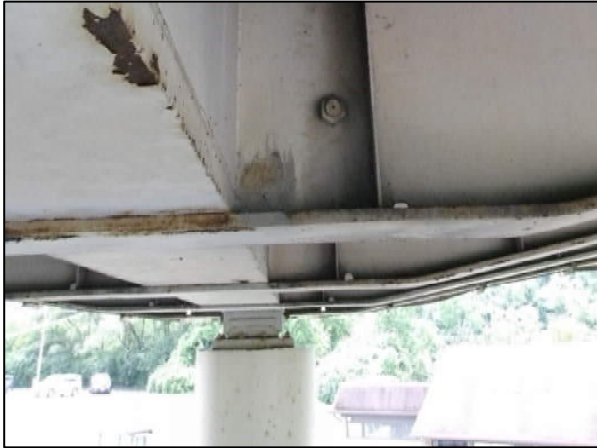
*Photo 18: Gouges of the bottom flange of Pier Cap 3 at the west side of Girder 4 from stitch weld removal.*

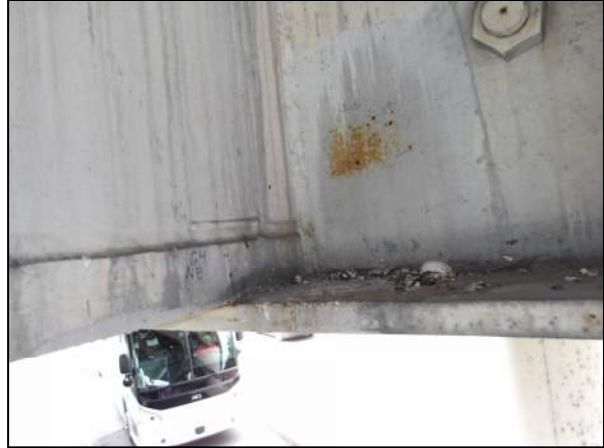
These cracks show no signs of growth since the previous inspection.

*Photo 21: 3/4" sawcut and 1" crack on the northwest corner of Girder 4 at Pier Cap 3.*

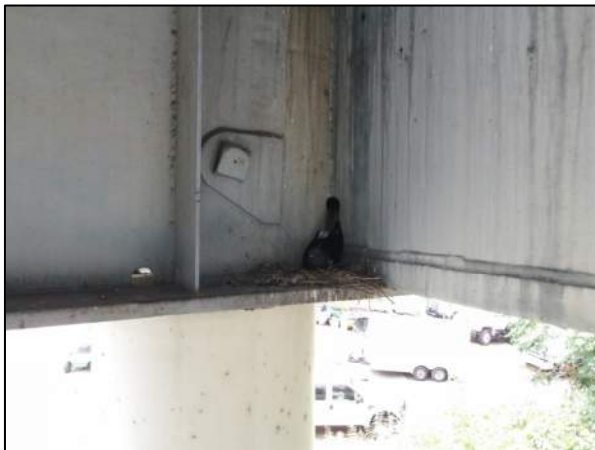
*Photo 19: 1-1/2" sawcut in the weld on the northwest corner of Girder 6 at the north face of Pier Cap (could not access due to pigeon nest).*

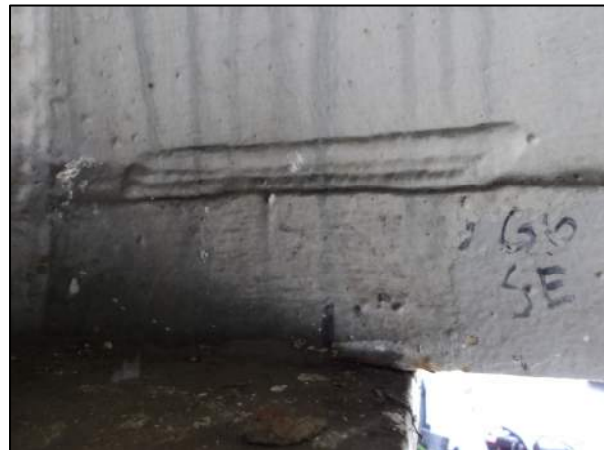
- On the northeast corner of the Girder 5 bottom flange, there is a 1-1/2" sawcut with a 9/16" crack (Photo 20).
- On the northeast corner of the bottom flange of Girder 4, there is a 3/4" sawcut with a 1" crack (Photo 21).
- On the southeast corner of the bottom flange of Girder 6, there 1-1/2" crack (Photo 22).

*Photo 22: 1-1/2" combination sawcut and crack in the weld on the southeast corner of Girder 6 at the south face of Pier Cap 3.*

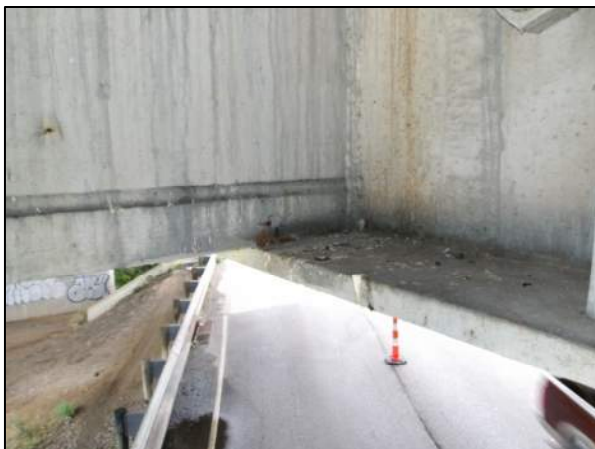
*Photo 20: No change to the 1-1/2" combination sawcut and crack on the northeast corner of Girder 5 at the north face of Pier Cap 3.*

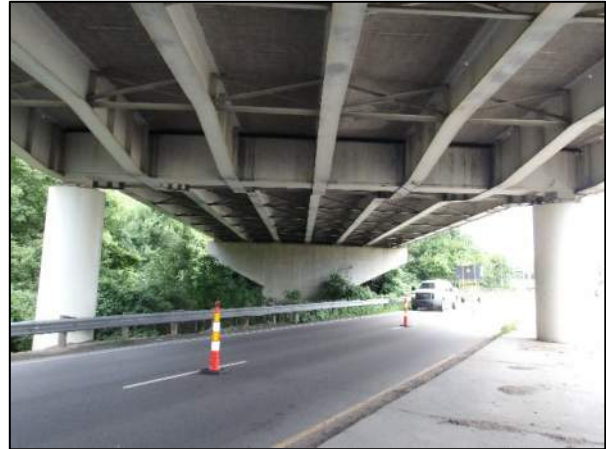
Photo 23: Pier Cap 4 Elevation

Based on the 2021 inspection, Pier Cap 4 is in Good condition [7] (Photo 23). It was dry at the time of the inspection and no moisture was found inside the cap. The paint system on the interior of the pier cap is in good condition while the exterior paint system is in satisfactory condition. The most noticeable deterioration is the result of impact damage to the pier cap and Girder 5 from westbound vehicular traffic on Galbraith Road. Tack welds were noted between both edges of the bottom flange and the bottom flanges of the girders. A few miscellaneous tack welds were identified on the interior and exterior of the bottom flange.

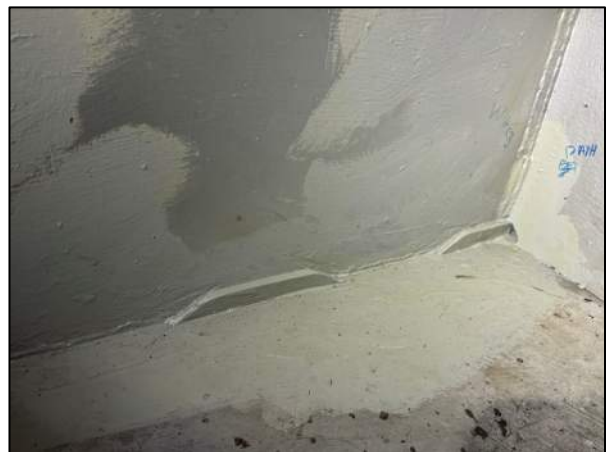
Photo 24: Typical bottom flange backer bar removal from a previous rehabilitation of Pier Cap 4.

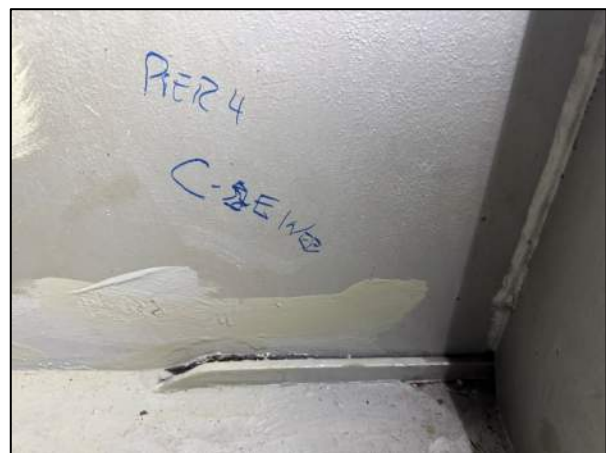
Photo 25: Backer bar pulling 1/2" away from the Pier Cap 4 web plate west of Girder 3.

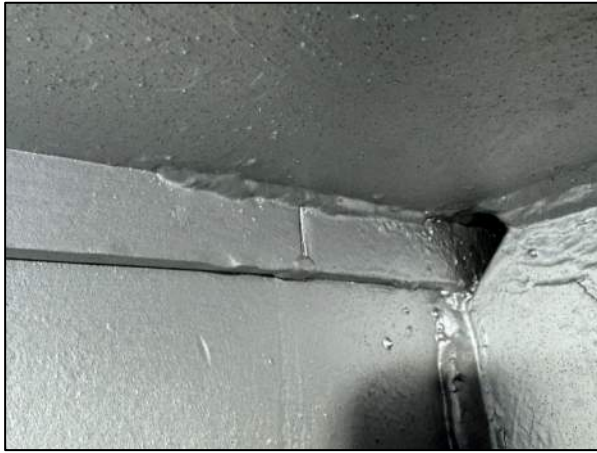
Select portions of the bottom flange backer bars were removed throughout the length of the pier cap where the backer bars were bowing away from the web plate or where two backer bars met without a butt-weld (Photo 24). Some of the remaining backer bars are still bowing away from the web plates (Photo 25). There are discontinuous stitch welds of varying lengths and unwelded butt joints on the top flange backer bars (Photo 26).

*Photo 26: Discontinuous backer bar and varying length stitch welds east of Girder 3 on the top flange of Pier Cap 4.*

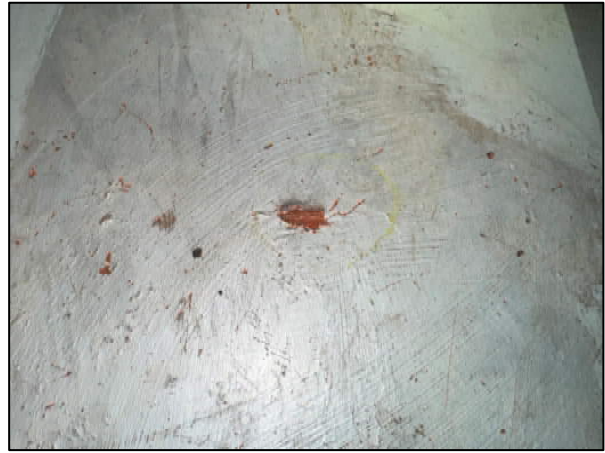
*Photo 29: Partially ground tack weld west of Girder 5 on the bottom flange of Pier Cap 4.*

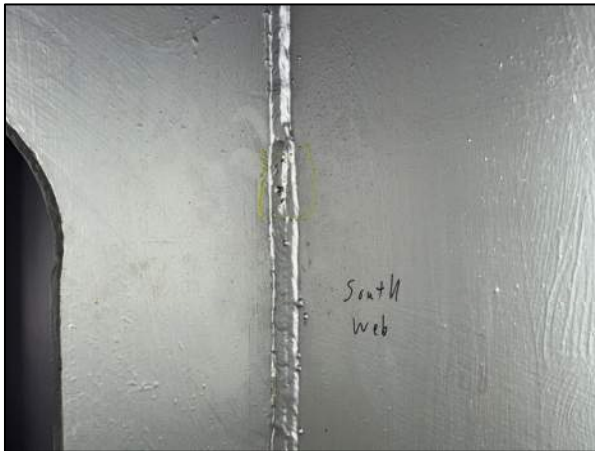
Typically, there are numerous poor-quality welds at the pier cap diaphragms that display overlapping and porosity (Photo 27).

*Photo 27: Poor quality welds displaying overlapping and porosity on the diaphragms of Pier Cap 4.*

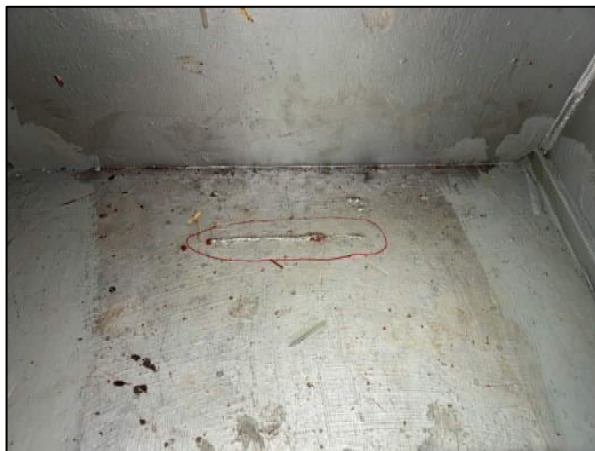
- At the bottom flange east of the Girder 6 diaphragm, there is a 7" long tack weld (Photo 28).
- At the bottom flange west of Girder 5, there is a 1-1/2" partially ground tack weld (Photo 29).
- At the bottom flange east of Girder 2, there is a 2" long tack weld.

*Photo 28: 7" transverse weld east of the Girder 6 diaphragm on the bottom flange of Pier Cap 4.*

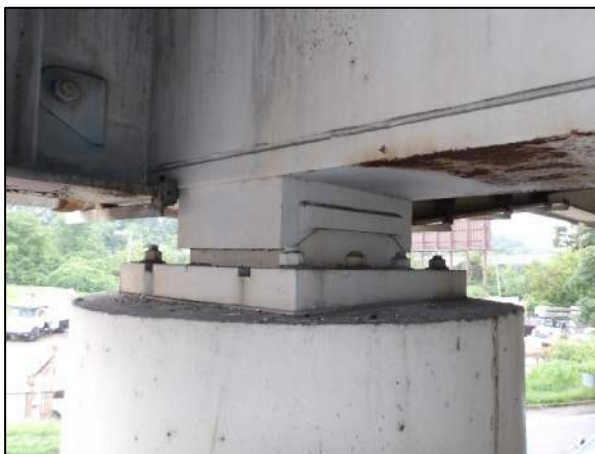
Both bearing devices for Pier Cap 4 exhibit minor corrosion on the masonry plate and anchor bolts (Photo 30).

Photo 30: Minor surface corrosion on the masonry plate and anchor bolts at the Pier Cap 4 east bearing.

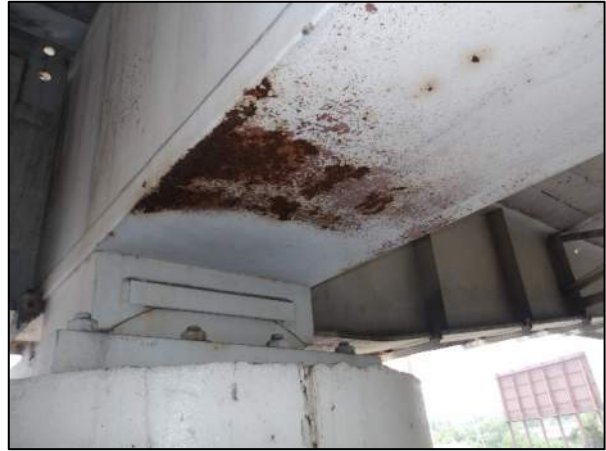
The paint system of the pier cap exterior is in satisfactory condition with widespread areas of chalking. There are isolated areas of peeling paint and surface corrosion with active rust on cap bottom flange (Photo 31). At north face of the pier cap at Girder 5, there are several areas of impact damage with peeling paint and surface corrosion on the bottom flange (Photo 32).

Photo 31: Typical minor surface corrosion on Pier Cap 4

1. Remove the welds between the edges of the bottom flange and the bottom flange of the girders.
2. Clean and paint the exterior surfaces of the pier cap and girder connections.

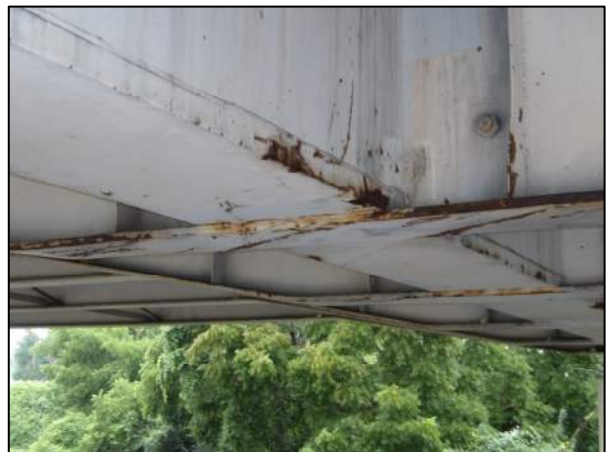
Photo 32: Impact damage with peeling paint and surface corrosion on the bottom flange at the north face of Pier Cap 4 and Girder 5.

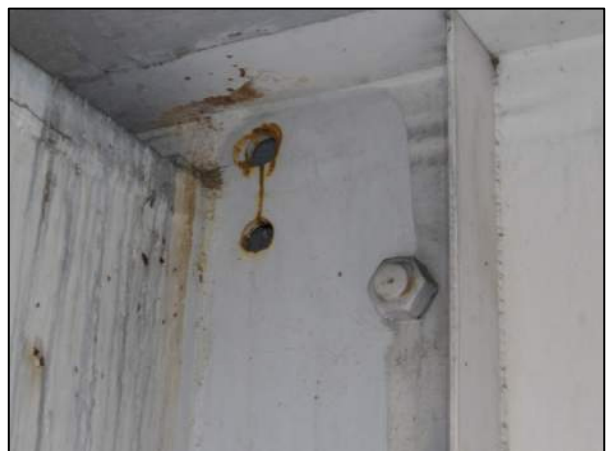
As per the 1993 rehabilitation project, 2" Diameter stress relief holes were drilled through all girder webs adjacent to the pier cap top flange and connected with sawcuts. Some of the retrofits display gouges in the stress relief holes due to mis-drilled holes at Girders 2, 4, and 5 (Photo 33).

Photo 33: Typical gouges in the Girder sawcut retrofit.

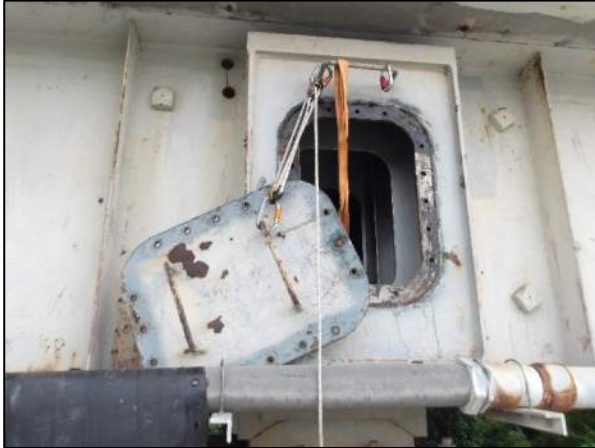
At the northwest corner of Girder 2, there is a 2" tack weld along the bottom flange. Pier Cap doors have minor surface corrosion with active rust (Photo 34). Groove welds typically exhibit multiple passes and overlaps (Photo 35). The removal of tack welds between the pier cap bottom flange and girder bottom flange plates typically produced minor gouges in the pier cap bottom flange (Photo 36).

*Photo 34: Typical condition of Pier Cap Door and Seal, east side.*

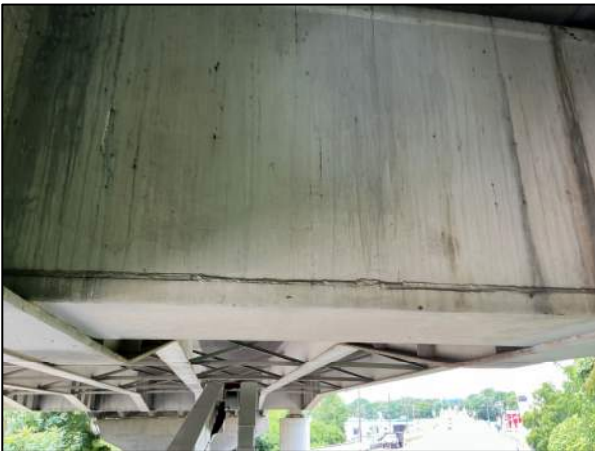
*Photo 35: Typical multiple passes and overlap in the bottom flange groove weld of Pier Cap 4.*

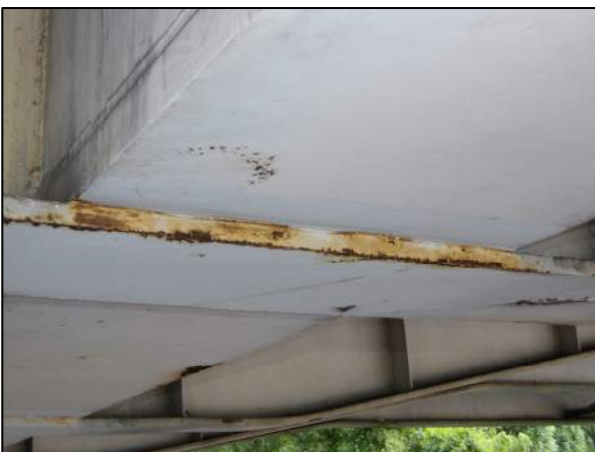
*Photo 36: Typical gouges on the Pier Cap bottom flange from tack weld removal.*
