# NSTM Member Inspection Report

**HAM-562-0147**

## **2025 NSTM Member Inspection Report (VAR-District 8 Bridge Inspections for Steel Pier Caps)**

**SFN: 3113914, PID: 109781**

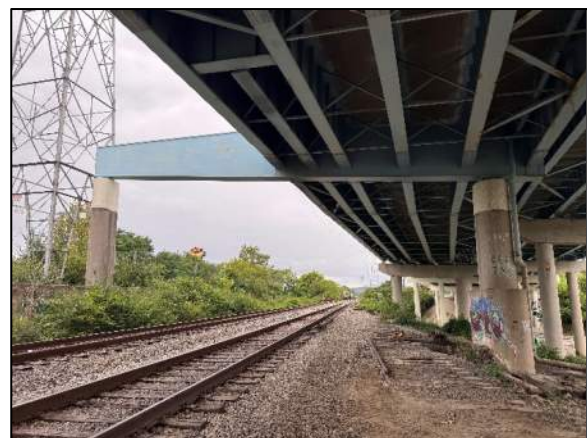
Pier Cap 4 is in Good condition [7] (Photo 1). As part of a 1993 rehabilitation project, retrofits were installed in the webs for the pier cap that consist of drilled holes above and below each girder's bottom flange ends at the webs and are connected with three sawcuts. The welded knee braces were removed from the pier cap web plates below every girder bottom flange tie plate. To remove all welds, the surfaces were ground smooth. In the tension zones of the pier cap webs, the ends of the longitudinal stiffeners were clipped and tapered. The ends of the longitudinal stiffener welds were ground flush with the pier cap webs and stress relief holes were drilled through the web plates near the ends of the stiffeners. As part of the 2015 rehabilitation, welds between the interior backer bars and top flange or web plates were removed. Blasting and painting was performed along the interior and exterior based upon limits noted in the rehabilitation plans. Drilled holes and sawcut locations were also cleaned, resealed, and had expansion plugs installed in the holes.

*Photo 1: Elevation of Pier Cap 4*

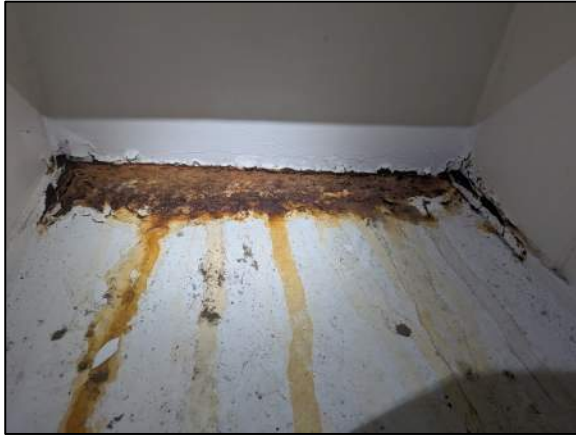
Signs of ponding water and active corrosion with bubbling paint were noted on the bottom flange on the south faces of the stiffener below Girders 1 through 4, 9A, and 10 (Photo 2). Moderate painted over pitting is typical throughout the bottom flange, webs, and stiffeners. The pitting on the lower portion of the web plates between the north end plates and Girder 9 was measured up to 1/16" deep. This pitting increases to 1/8" near the north access hatch. Pitting up to 1/16" was also noted across the top flange between the north end plate and Girder 9A. The corrosion is re-initiating due to leakage through the retrofit holes (Photo 3). Girder 9 on the east web has a 1/8" gap between the web and top flange backer bar.

*Photo 2: Signs of water with active corrosion and bubbling paint on the south side of Girder 9A*

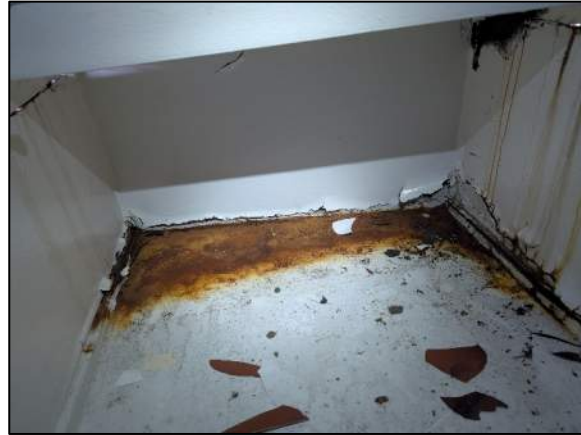
*Photo 5: Peeling paint and active corrosion resulting from leakage through the retrofit on the south side of Girder 10*

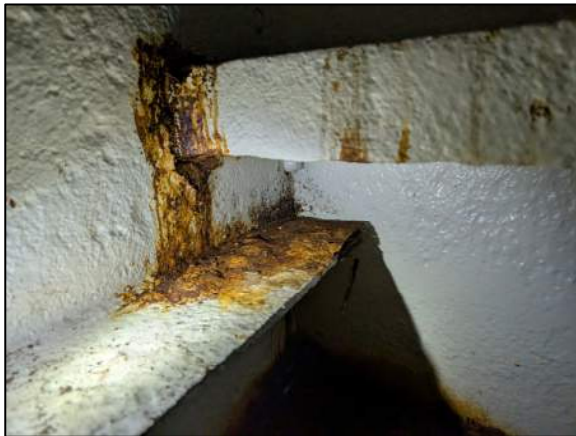
*Photo 3: Painted over pitting on web plate on the south side of Girder 6*

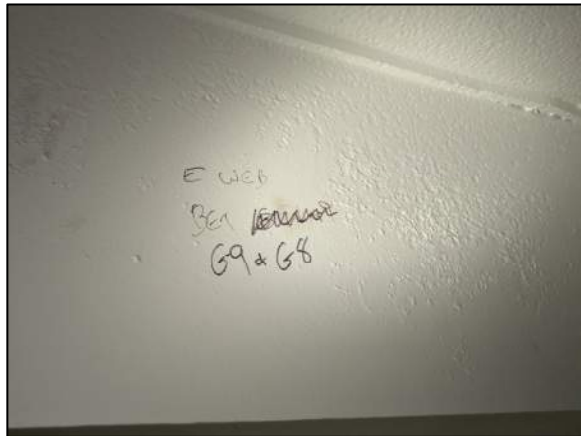
4). There is a section of paint loss on the south face of the Girder 10 diaphragm (Photo 5). There is also an area of failing, bubbling paint on the east web plate between Girders 8 and 9 due to inadequately cleaned surfaces during repainting (Photo 6). Several isolated areas of peeling paint were also noted.

*Photo 6: Inadequate surface preparation leading to bubbling paint on web plate between Girders 8 and 9*

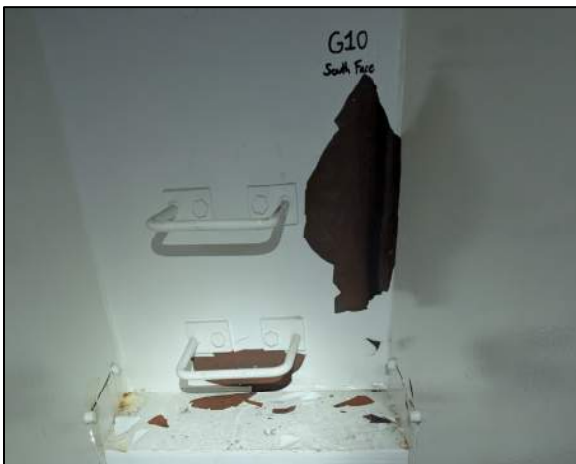
*Photo 4: Paint loss on the south face of the Girder 10 diaphragm*

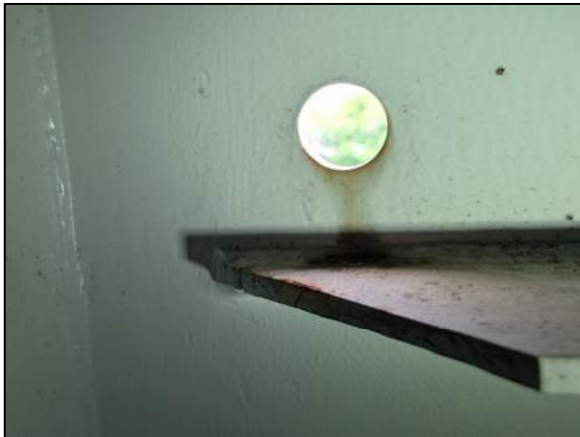
During the 2015 rehabilitation, a 1/4" long crack was removed from the west web at the transverse stiffener on the south side of Girder 10. The crack originated at an intersection of the fillet welds connecting the longitudinal and transverse stiffeners to the west web. The stiffener was clipped, both the weld intersection and the crack were ground from the web plate, and a 1-1/2" diameter crack arrest hole was drilled (Photo 9).

*Photo 9: Crack arrest retrofit on the west web, south of Girder 10*

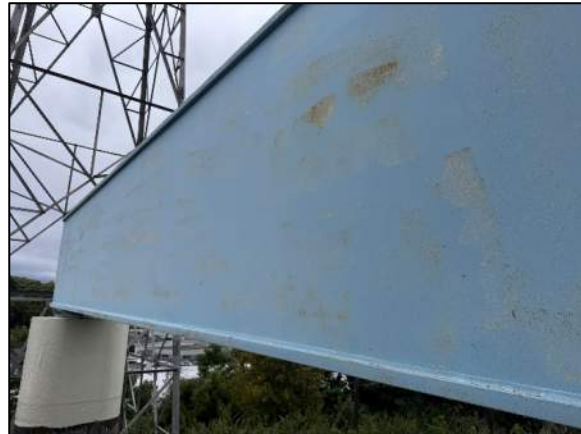
The paint system of the pier cap exterior is in good condition with minor freckling corrosion along the webs and flanges throughout the pier cap and fading paint on the portion of the cap outside the deck (Photo 10).

*Photo 10: Typical fading paint and surface corrosion at the south end of the pier cap*

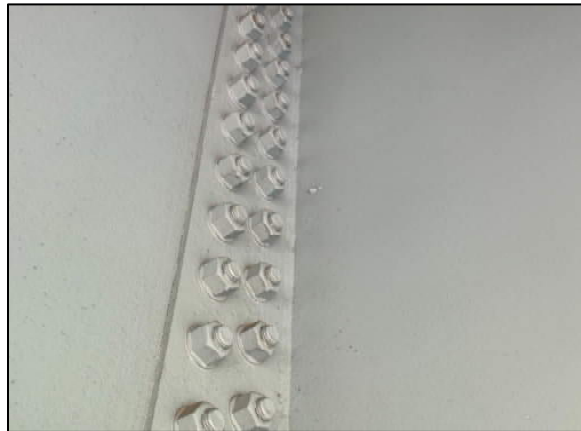
There is a 3/4" tack weld on the west web plate adjacent to the south side of Girder 6 (Photo 11). There are five 1" long tack welds on the west web on the south side of Girder 9 (Photo 12). There is a similar condition with four 1" long tack welds on the west web on the south side of Girder 10.

*Photo 11: 3/4" tack weld on the west web at the south face of Girder 6*

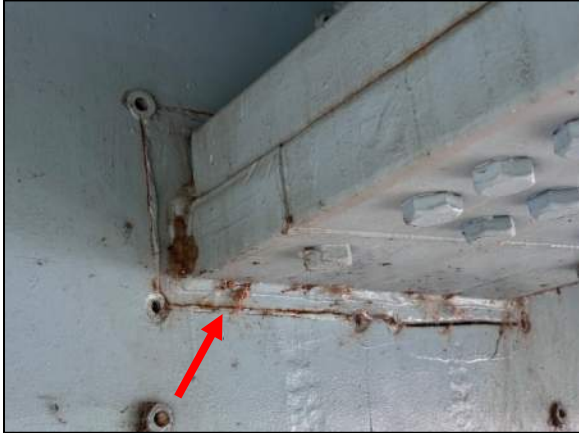
As part of the 1993 rehabilitation, the stress relief hole and sawcut retrofits were performed at Girders 7 through 10 only. Thin cracks have begun to form in the epoxy sealant that also exhibit are showing rust staining (Photo 13). There are also some areas that are missing the epoxy sealer on the east web plate at Girders 7 and 9 (Photo 14). There are also missing retrofit hole expansion plugs on the west web at Girder 10 and between Girders 7 and 8 (Photo 15). These issues are likely the cause of the corrosion issues on the interior of pier cap.

*Photo 13: Thin cracks in epoxy with rust staining on east web retrofit at Girder 7*

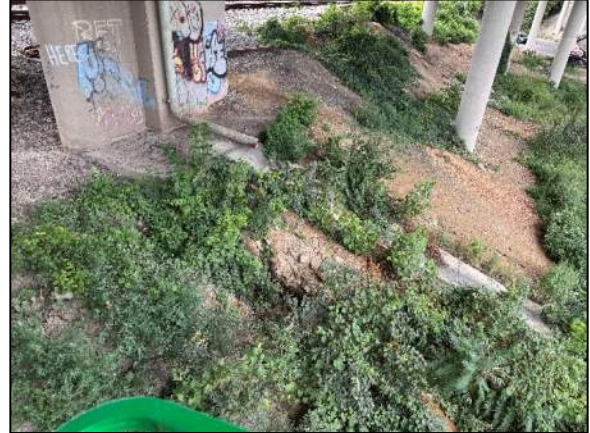
At the base of the north column, runoff has created an erosion hole below the abandoned railroad tracks and around the pier column (Photos 16-17).

*Photo 16: Erosion at the base of the north column*

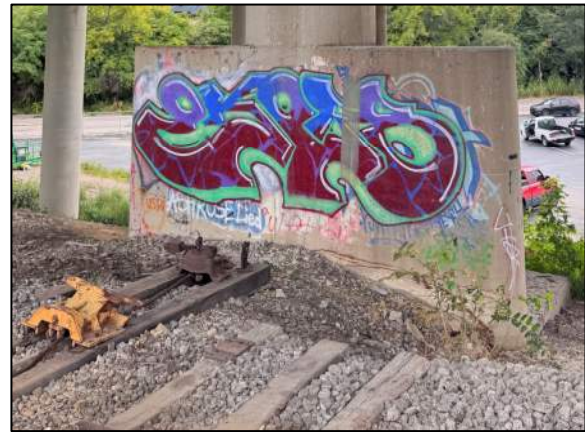
*Photo 17: Erosion at the base of the north column*

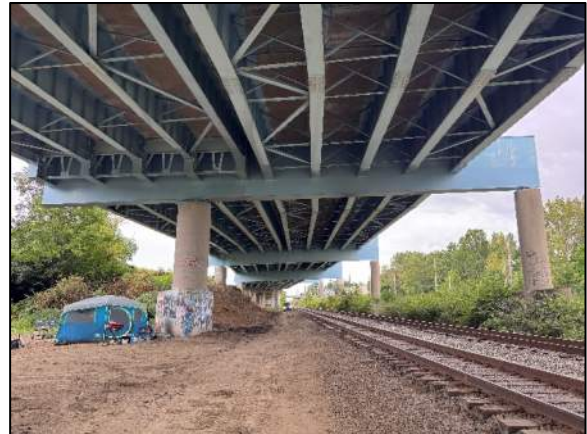
Pier Cap 5 is in Good condition [7] (Photo 18). As part of a 1993 rehabilitation project, retrofits were installed in the webs for the pier cap that consist of drilled holes above and below each girder's bottom flange ends at the webs and are connected with three sawcuts. The welded knee braces were removed from the pier cap web plates below every girder bottom flange tie plate. To remove all welds, the surfaces were ground smooth. In the tension zones of the pier cap webs, the ends of the longitudinal stiffeners were clipped and tapered. The ends of the longitudinal stiffener welds were ground flush with the pier cap webs and stress relief holes were drilled through the web plates near the ends of the stiffeners. As part of the 2015 rehabilitation, welds between the interior backer bars and top flange or web plates were removed. Blasting and painting was performed along the interior and exterior based upon limits noted in the rehabilitation plans. Drilled holes and sawcut locations were also cleaned, resealed, and had expansion plugs installed in the holes. During the 2025 bridge rehab holes were drilled errantly by the contractor within Pier 5 until it was discovered they were in the wrong pier cap. Reference Pier 6 for retrofit details.

*Photo 18: Elevation of Pier Cap 5*

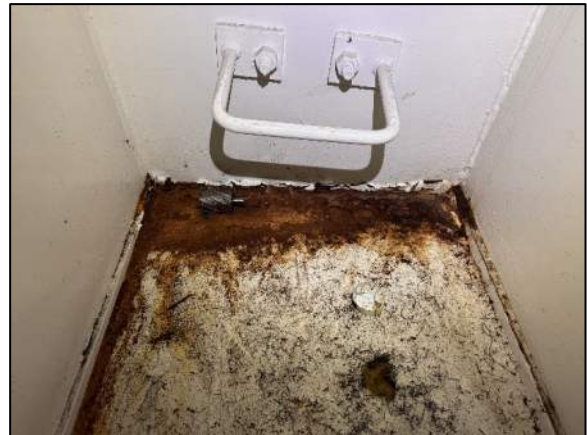
The interior of Pier Cap 5 has evidence of ponding water on the bottom flange, notably on the south sides of Girder 4 and Girder 5 (Photo 19). There is new paint on lower half of pier cap interior throughout. However, there is some corrosion visible on the bottom flange at the north end.

*Photo 19: Evidence of ponding with corrosion on the bottom flange on the south side of Girder 5*

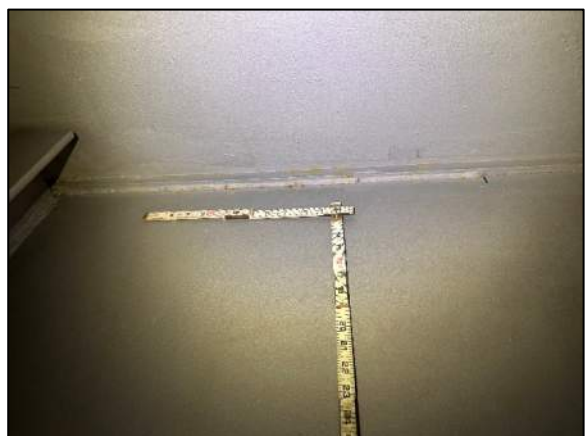
*Photo 20: 33" long fillet weld between the top flange and east web between Girders 1 and 2*

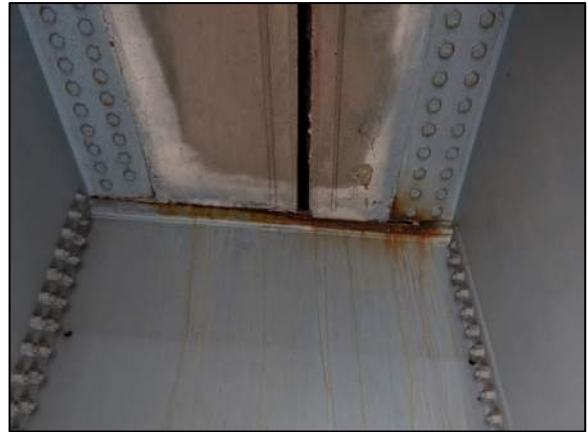
The paint system of the pier cap exterior is in fair condition with corrosion staining and flaking paint on the east web and top flange between Girders 5 and 6 due to leakage through the longitudinal soffit joint (Photo 27). The locations of the cap outside the limits of the deck display fading paint and minor surface corrosion (Photo 28). Previously noted areas of painted over section loss in the web plates above the tie plate for Girders 1 and 5 are in good condition, however the section loss has reactivated at Girder 1 (Photo 29).

*Photo 27: Corrosion and rust staining on top flange and web between Girders 5 and 6.*

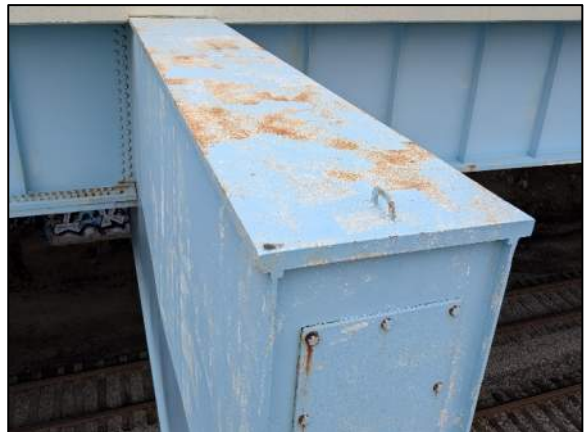
*Photo 28: Fading paint and surface corrosion on the top flange between Girder 10 and the south end of Pier Cap 5*

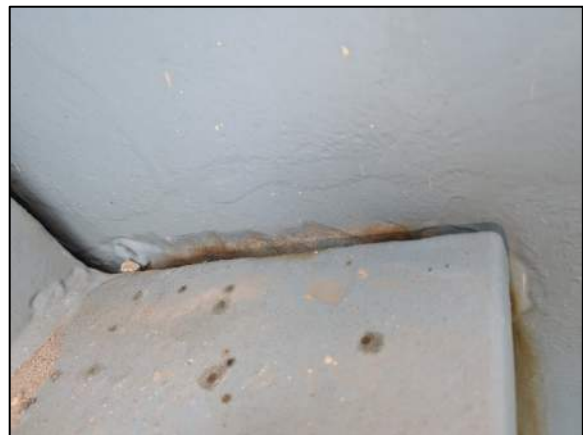
*Photo 29: Reactivating corrosion at previously painted over section loss on east web at Girder 1.*

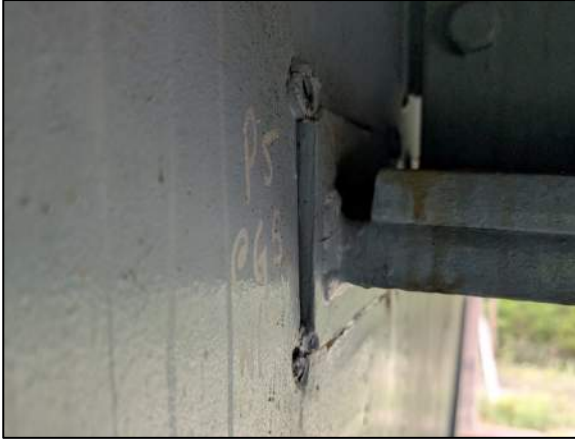
Retrofit at northwest corner of Girder 5 is bowing outward up to 3/8" and opposite bowing inward. Girder 6 has a similar bowing, but not as severe.

*Photo 30: Retrofit in west web deflected up to 3/8"  
at Girder 5*

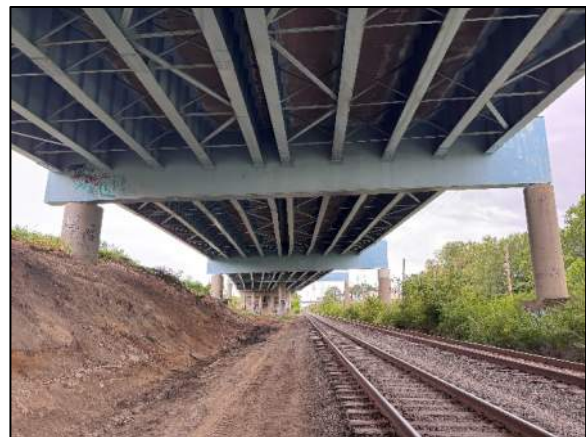
Pier Cap 6 is in Satisfactory condition [6] (Photo 33). As part of a 1993 rehabilitation project, retrofits were installed in the webs for the pier cap that consist of drilled holes above and below each girder's bottom flange ends at the webs and are connected with three sawcuts. The welded knee braces were removed from the pier cap web plates below every girder bottom flange tie plate. To remove all welds, the surfaces were ground smooth. In the tension zones of the pier cap webs, the ends of the longitudinal stiffeners were clipped and tapered. The ends of the longitudinal stiffener welds were ground flush with the pier cap webs and stress relief holes were drilled through the web plates near the ends of the stiffeners. As part of the 2015 rehabilitation, welds between the interior backer bars and top flange or web plates were removed. Blasting and painting was performed along the interior and exterior based upon limits noted in the rehabilitation plans. Drilled holes and sawcut locations were also cleaned, resealed, and had expansion plugs installed in the holes.

Photo 33: Elevation of Pier Cap 6

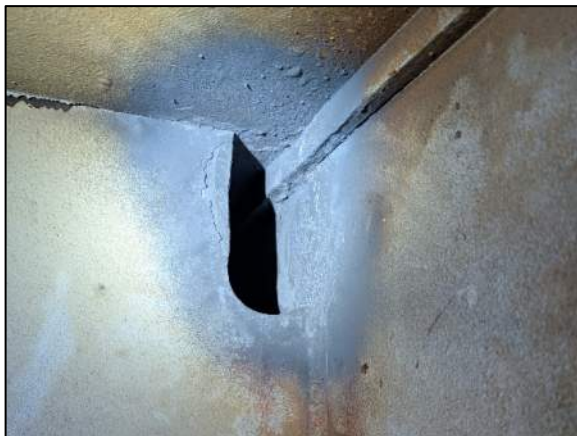
The reported crack during the 2023 inspection was drilled out at Girder 6 and the weld was removed from the bottom of the crack to the top flange by sawcut. Similar repairs were made at the top of Girders 5, 6, and 7 (Photo 34). Holes were also drilled errantly by the contractor within Pier 5 until it was discovered they were in the wrong pier cap.

Photo 34: Typical view of upper corner retrofit between the diaphragms and web at Girder 6

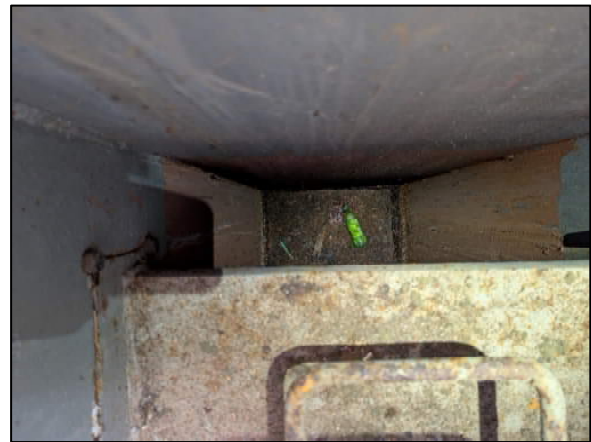
was also noted on the bottom flange between the north end plate and Girder 1 (Photo 36). Measurements were unobtainable due to space constraints between the end plate and the tie plate for Girder 1.

Photo 36: Area of laminating corrosion on bottom flange between Girder 1 and the north end of the cap

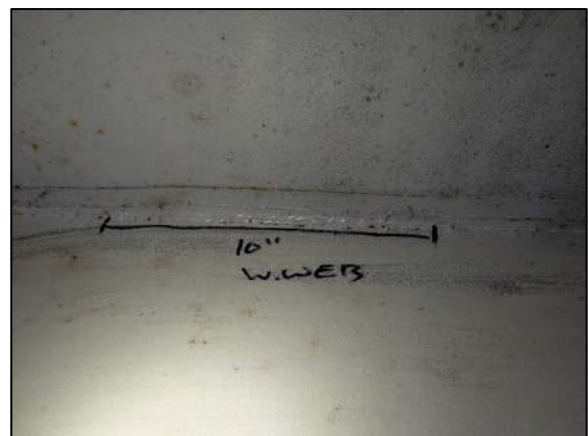
Photo 37: 10" fillet weld between the east web and top flange backer bar south of Girder 2

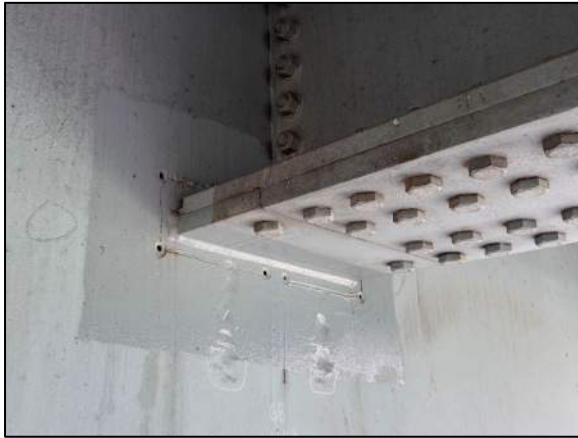
*Photo 44: Heavy gouging on west web plate below Girder 8 from girder knee brace removal*

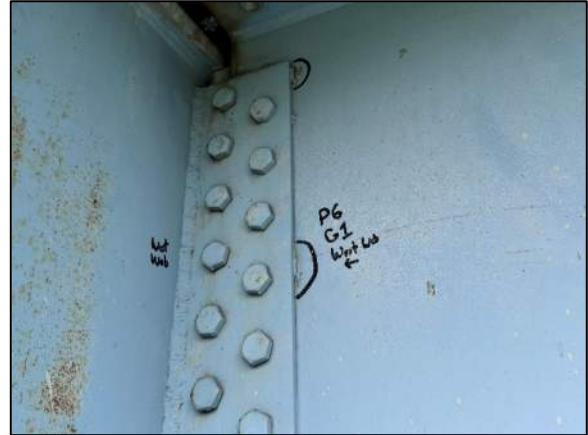
*Photo 47: one cracked tack weld and one poor quality tack weld on the north face of Girder 1 at the girder web and pier cap west web connection plate*

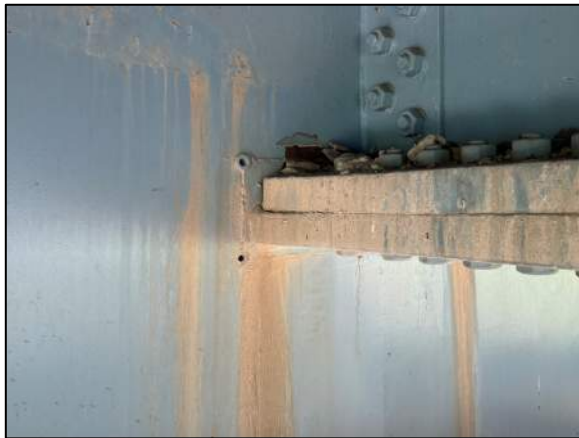
*Photo 45: East web retrofit at Girder 5 bowing inward approximately 1/8"*

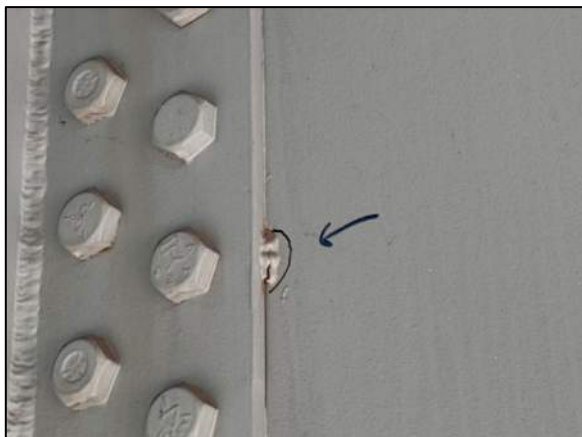
*Photo 46: Cracked tack weld on the Girder 4 and pier cap west web plate connection*

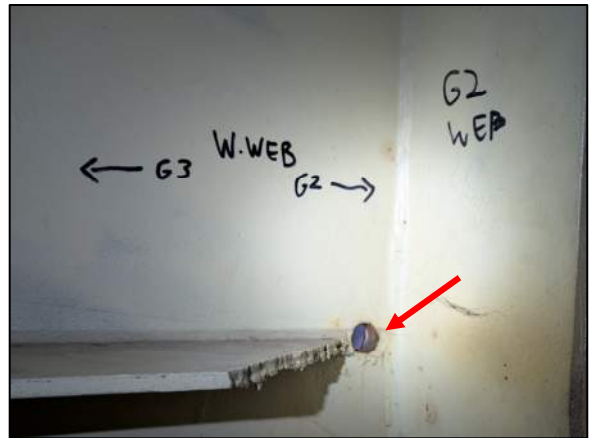
Photo 51: Missing expansion plug at the upper longitudinal stiffener retrofit at Girder 2

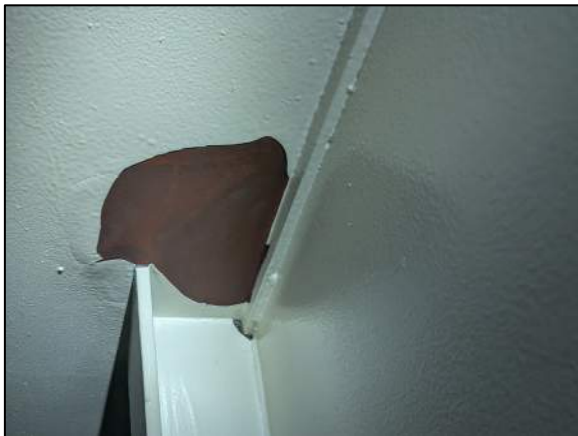
Photo 49: Typical scattered peeling paint throughout the interior of the pier cap

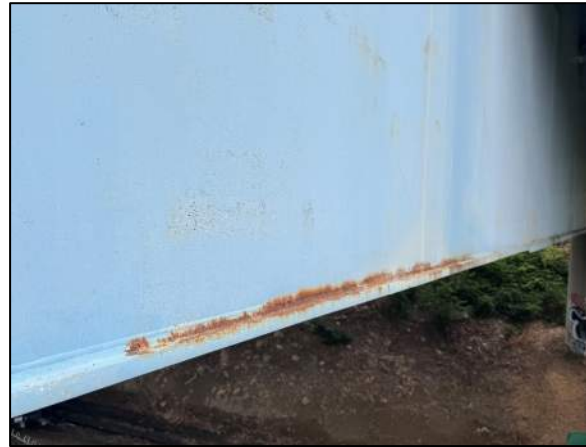
*Photo 54: Typical fading paint and surface corrosion at the south end*

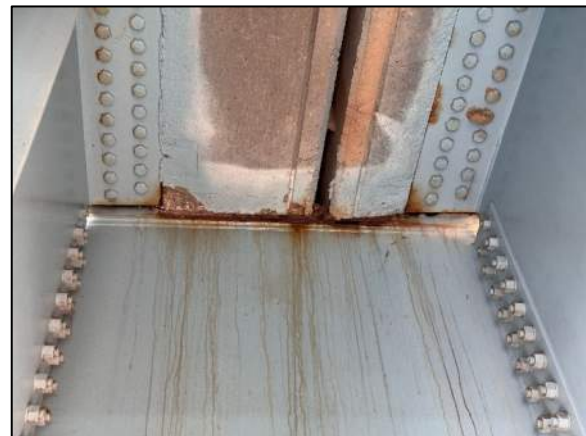
*Photo 55: Layered corrosion on top flange and rust staining of the web plates due to leakage through the deck joint between Girders 5 and 6*

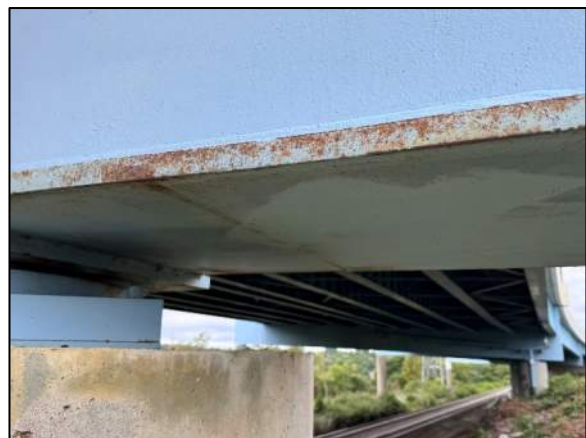
*Photo 56: Surface corrosion along bottom flange*

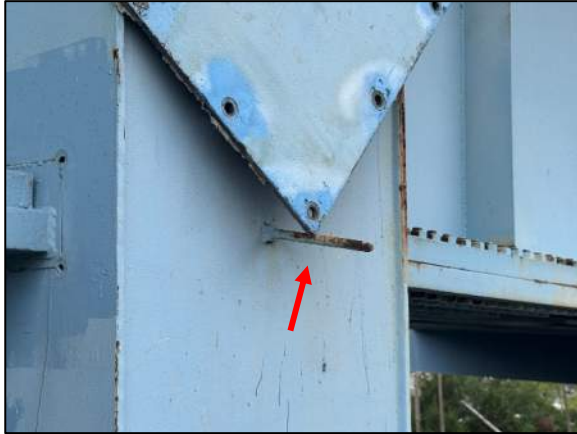
Below north access hatch, there is an 8" long steel rod and nut welded to the pier cap. This might have been used as a step for access into the pier cap during construction or during the rehabilitation projects (Photo 57).

*Photo 57: 8" long steel rod and nut welded to the pier cap below north access hatch*

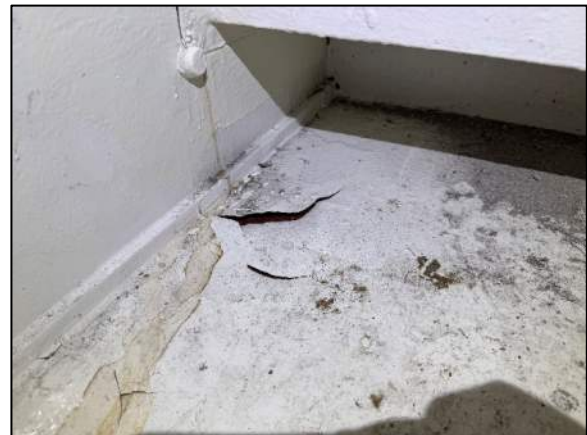
*Photo 60: Typical scattered minor areas of peeling paint on the interior*

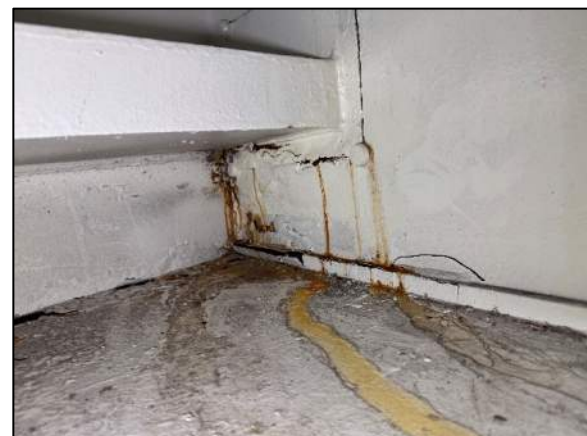
The interior of the pier cap is in overall good condition. After the repainting of the entire interior during the 2015 rehabilitation project, the paint remains in good condition throughout, with only a few minor areas of peeling paint (Photo 60). There is an area of bubbling paint and rust staining on the web plates, bottom flange, and stiffeners on both sides of Girder 10 from seepage through retrofit holes (Photo 61).

*Photo 61: Bubbling paint and rust staining resulting from leakage through the web retrofit at Girder 10*

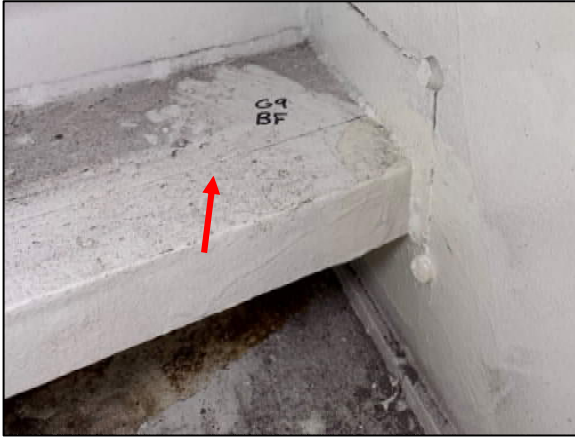
There is a 20" long cut in the girder bottom flange strap plate that is up to 1/16" deep, on the south side of Girder 9 (Photo 62).

Photo 62: 20" long (1/16" deep) cut in the bottom flange strap plate of Girder 9

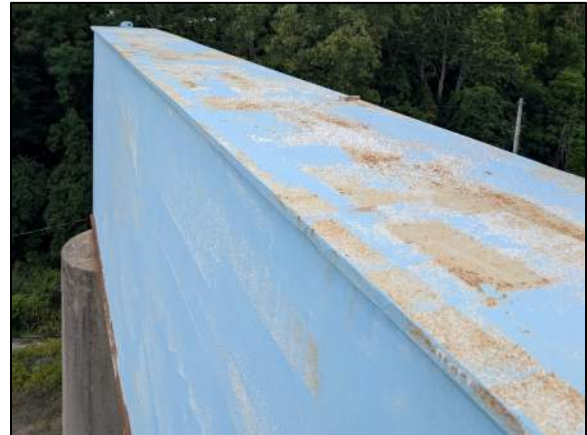
Photo 65: Typical fading paint condition on exterior, exposed southern end of pier cap shown

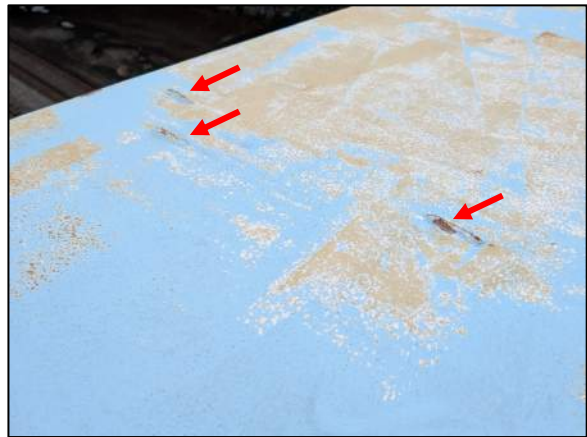
Photo 66: Fillet welds on the top flange at the southern end of the pier cap

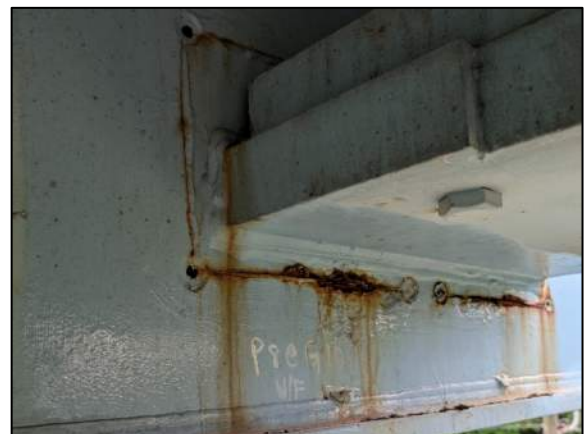
Photo 67: Reactivating surface corrosion on the west web at Girder 10

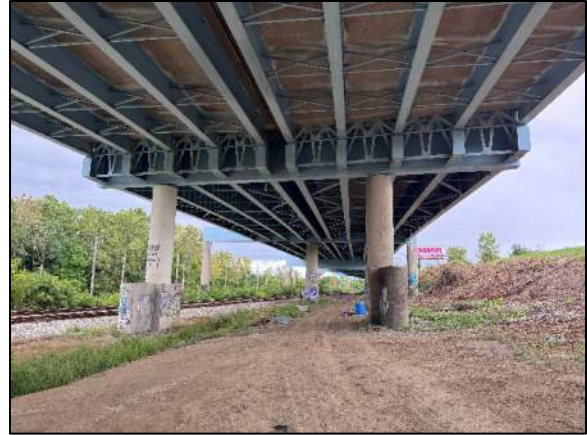
*Photo 71: Elevation of Pier Cap 9*

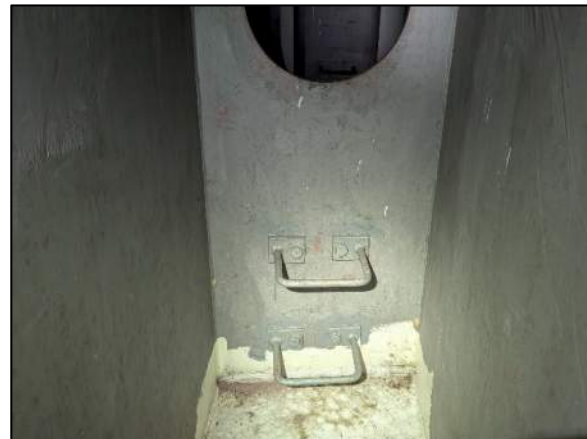
The interior of the pier cap is in overall good condition and was dry at the time of the inspection (Photo 72). The paint, including spot painting performed as part of the 2015 rehabilitation project along the lower portion of the pier cap is also in good condition.

*Photo 72: Typical interior paint condition  
(Girder 5 shown)*

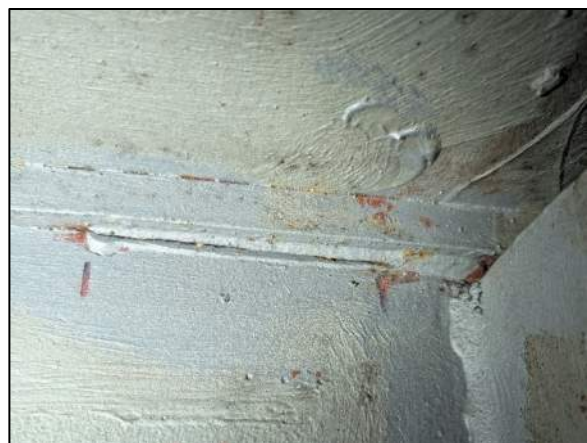
*Photo 73: 2" remaining of a partially ground fillet  
weld between the east web and top flange  
between Girders 2 and 3*

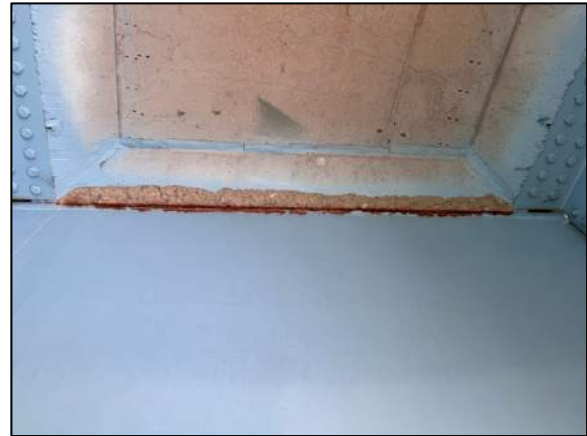
Photo 77: Typical corrosion on top flange between Girders on the east and west web

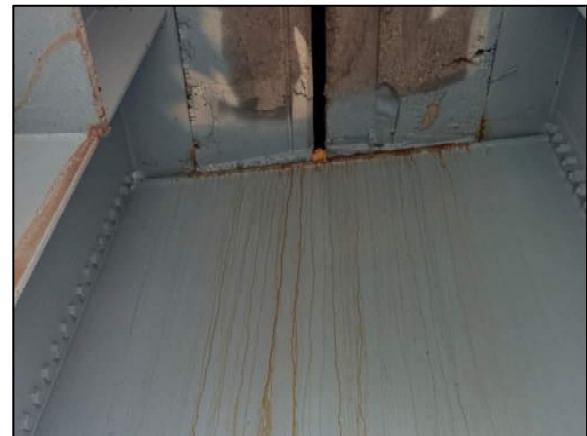
Photo 78: Corrosion and rust staining from leakage through deck joint between Girders 5 and 6

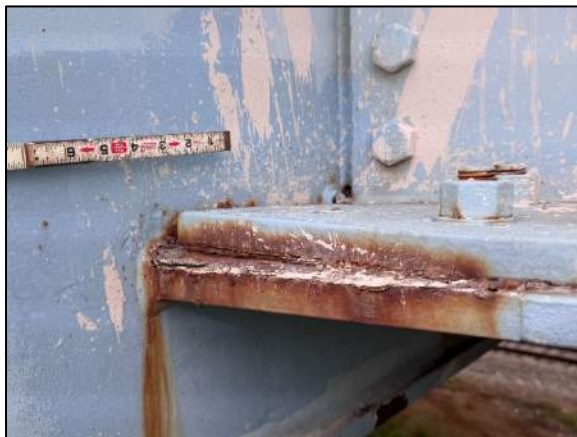
Photo 76: Corrosion reactivating at a location of painted over section loss on west web at Girder 1

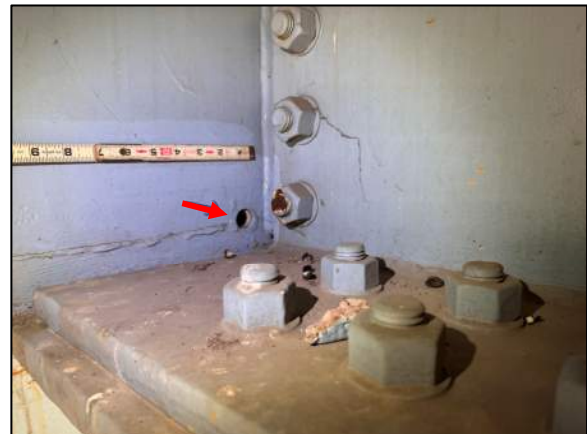
Photo 79: Missing expansion plug on the west web retrofit at Girder 5

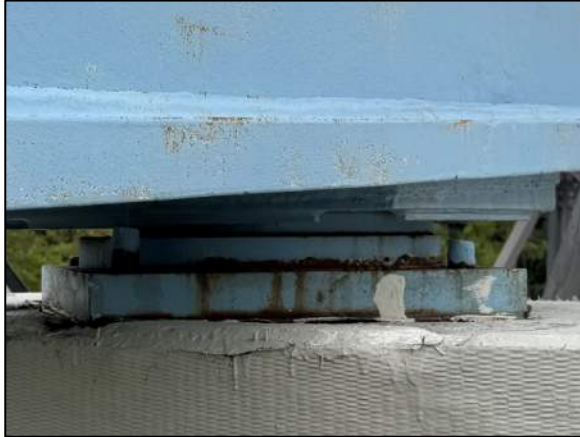
The pot bearings for the steel pier caps are in Fair condition [5] (Photos 80-85).

Surface corrosion is typical along the bottom edges of all masonry plates, and in scattered locations on the sole and bearing plates.

*Photo 80: Pier 4 typical bearing condition  
(south bearing shown)*

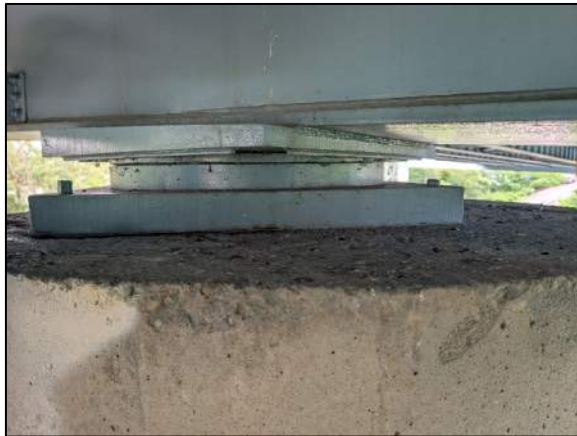
*Photo 81: Pier 5 typical bearing condition  
(north bearing shown)*

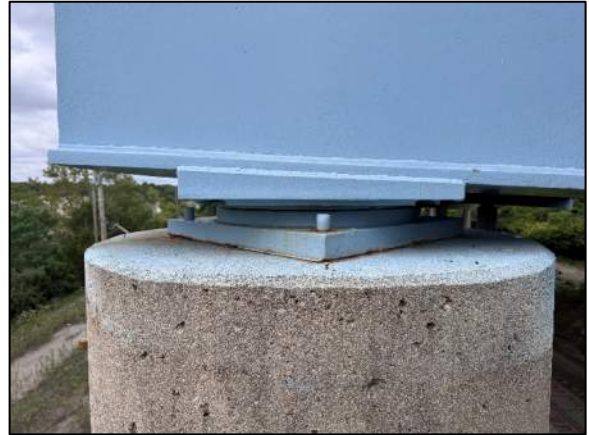
*Photo 82: Pier 6 typical bearing condition  
(south bearing shown)*

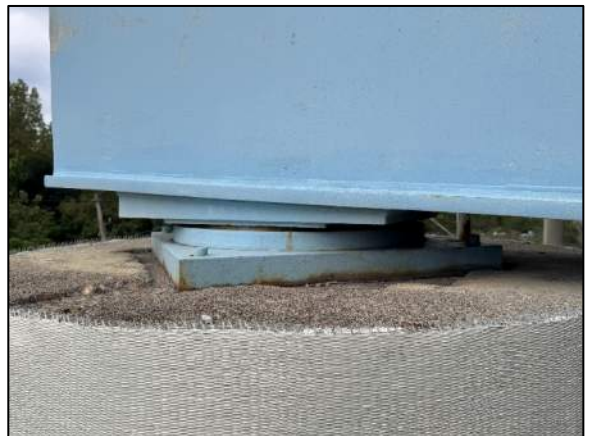
*Photo 83: Pier 7 typical bearing condition  
(south bearing shown)*

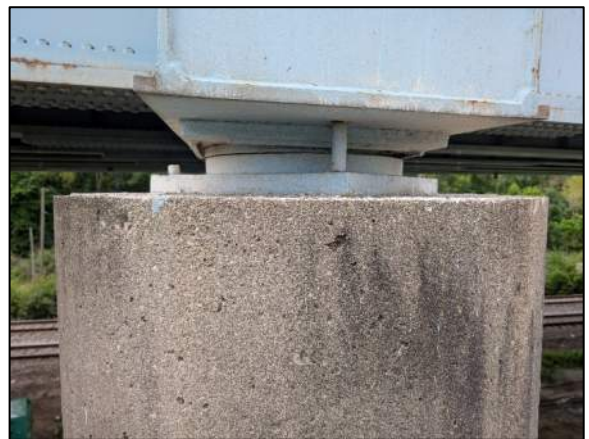
*Photo 84: Pier 8 typical bearing condition  
(north bearing shown)*

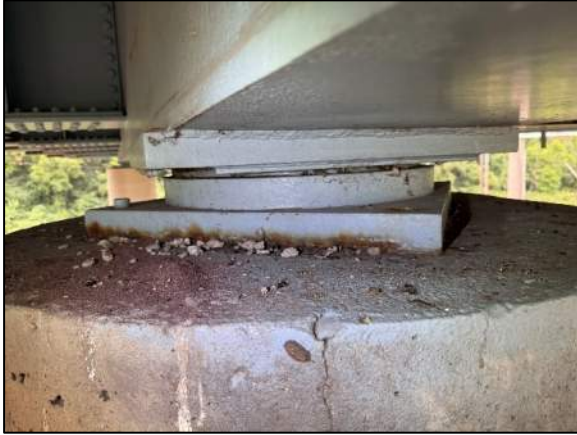
*Photo 85: Pier 9 typical bearing condition  
(north bearing shown)*
