# NSTM Member Inspection Report

## HAM-75-1192R 2025 NSTM Member Inspection Report (VAR-District 8 Bridge Inspections for Steel Caps) SFN: 3110656, PID: 109781

October 2, 2025

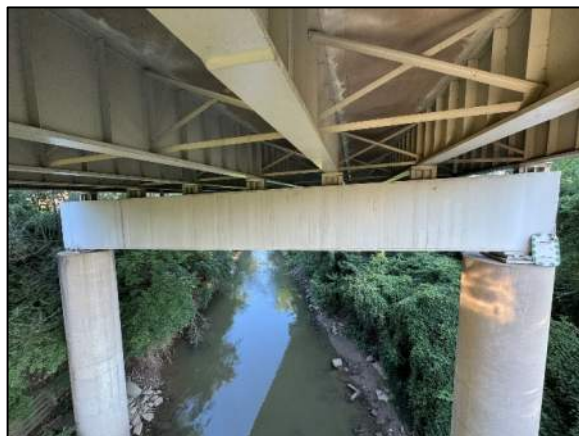
Pier Cap 5 is in Good condition [7] (Photo 1). As part of the 1993 rehabilitation project, tack welds were removed along the webs and bottom flange and backer bars, though many still remain. Additionally, 1" Diameter holes were drilled through the webs of the pier cap on both sides of the girder webs in which bolts were installed.

Photo 1: Elevation of Pier Cap 5

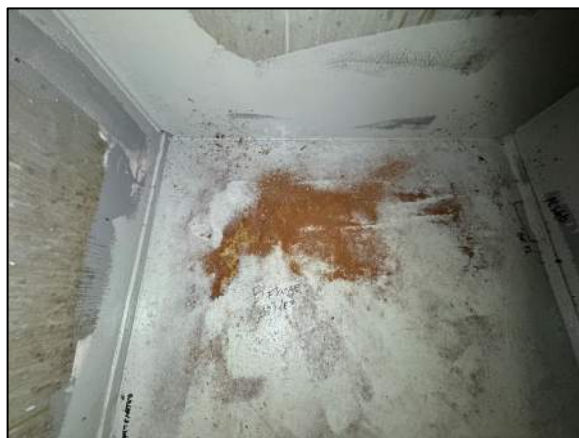
Photo 2: Surface corrosion on the bottom of the flange of Pier Cap 5 between Girders 3 and 4

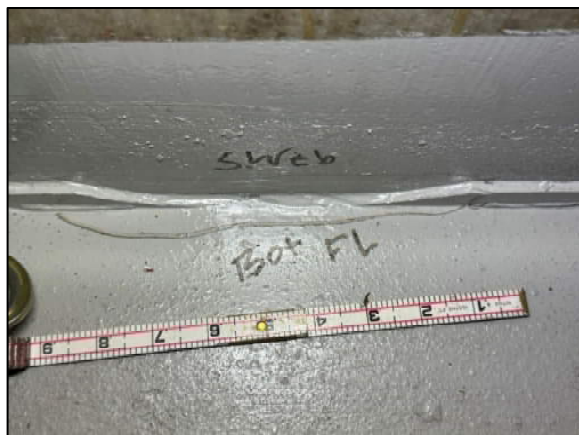
Photo 3: Typical Bottom Flange backer bar retrofit of Pier Cap 5, east of Girder 2

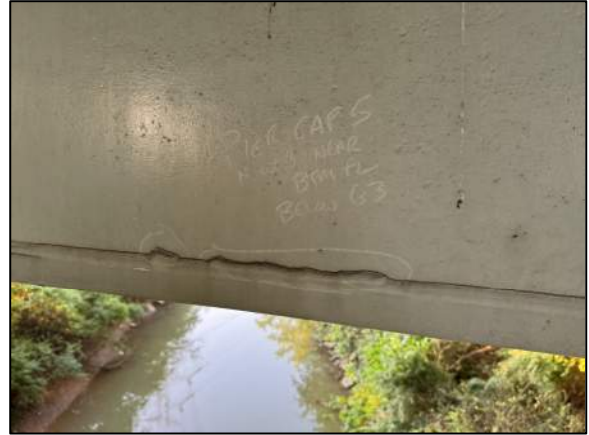
Photo 11: Fillet welds at groove weld between north web and bottom flange of Pier Cap 5, between Girder 2 and 3

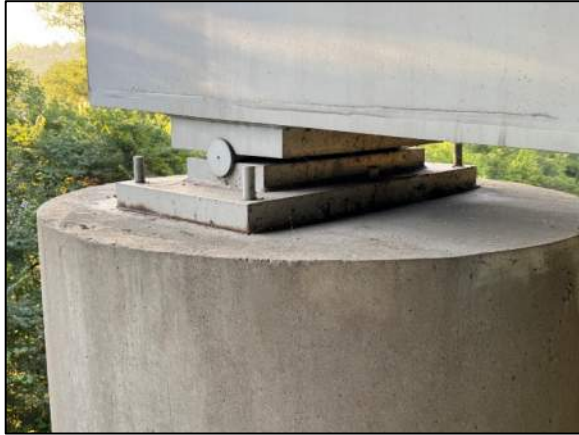
The east pier cap bearing displays isolated peeling paint and surface corrosion at the bottom of the masonry plate (Photo 14). There is peeling paint with areas of surface and laminating corrosion on the west pier cap bearing (Photo 15).

*Photo 14: Typical Peeling Paint and surface corrosion at the east bearing of Pier Cap 5*

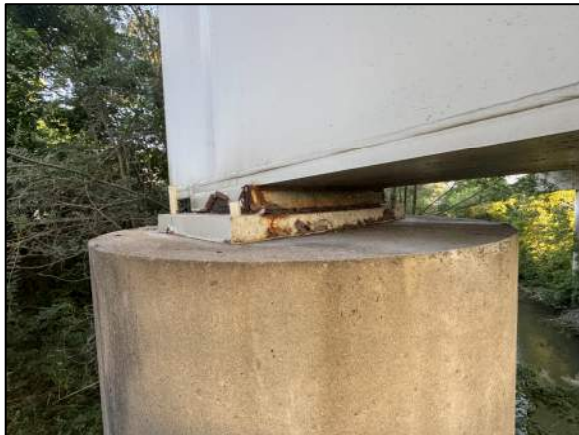
*Photo 15: Typical Peeling Paint and surface corrosion at the west bearing of Pier Cap 5*

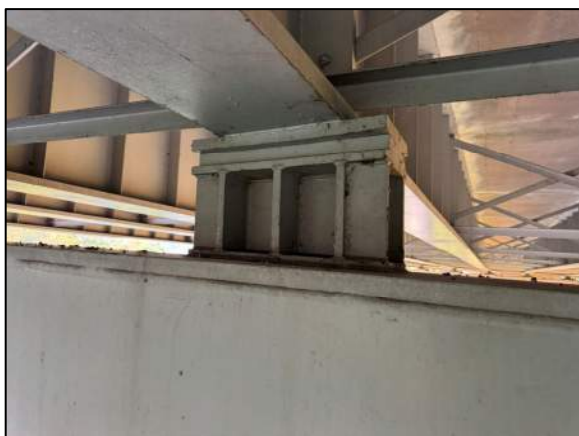
The girder bearings are welded to the top flange of the pier cap and typically exhibit light surface corrosion (Photo 16).

*Photo 16: Surface Corrosion of the girder bearings at Pier Cap 5*

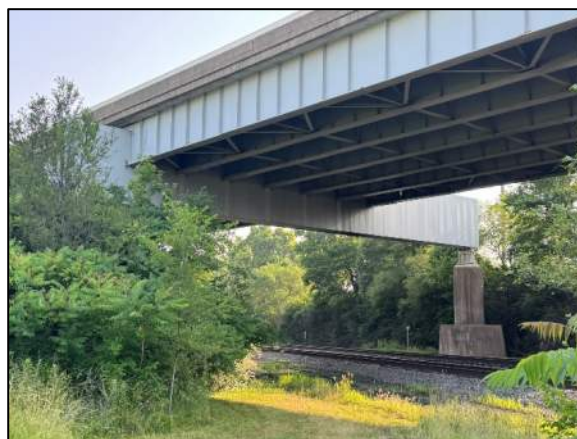
Pier Cap 16 is in Good condition [7] (Photo 17). As part of the 1993 rehabilitation project, tack welds were removed along the webs and bottom flange and backer bars, though many still remain. Additionally, 1" diameter holes were drilled through the webs of the pier cap on both sides of the girder webs in which bolts were installed.

*Photo 17: Elevation of Pier Cap 16*

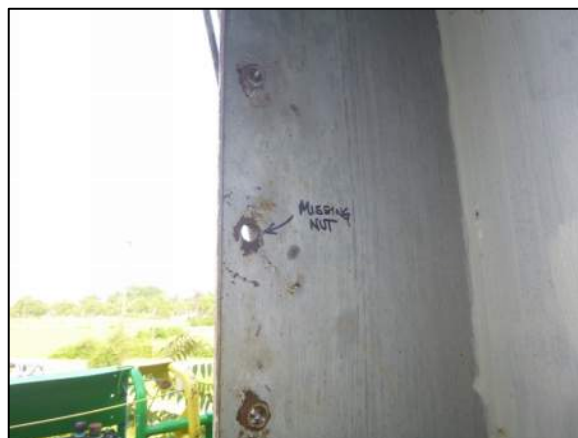
The interior of Pier Cap 16 was dry at the time of inspection. Both access hatches appeared to be properly sealed, however, both hatches are missing a nut (1 per hatch) that secures the hatch covers (Photo 18).

*Photo 18: Missing nut for the west access hatch of Pier Cap 16*

| <b>Maintenance:</b> | Replace the detached anchor nut on the west hatch cover and remove feces at east end of Pier Cap. |

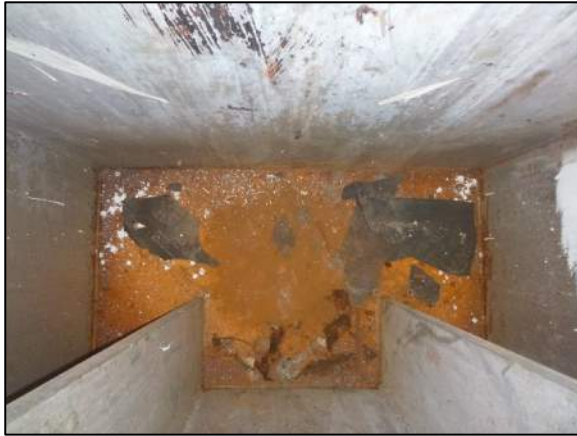
The paint system of the pier cap interior is in fair condition. There are several locations of peeling paint and surface corrosion on the top flange, bottom flange, and web plates throughout (Photo 19). The floor was covered in accumulations of steel filings, paint flakes, and sand blasting medium (Photo 20).

Photo 19: Corrosion on the bottom flange of Pier Cap 16

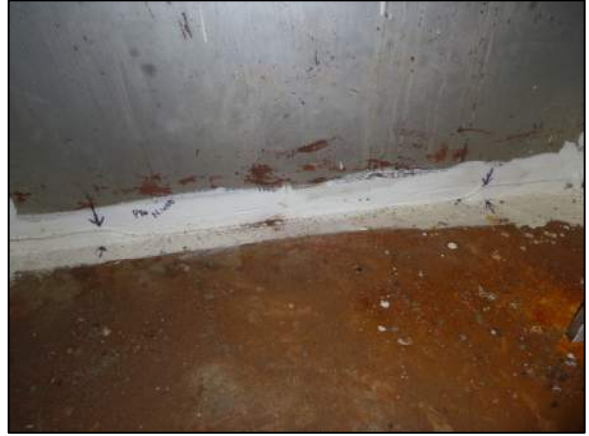
Photo 22: Typical bottom flange backer bar retrofit of Pier Cap 16

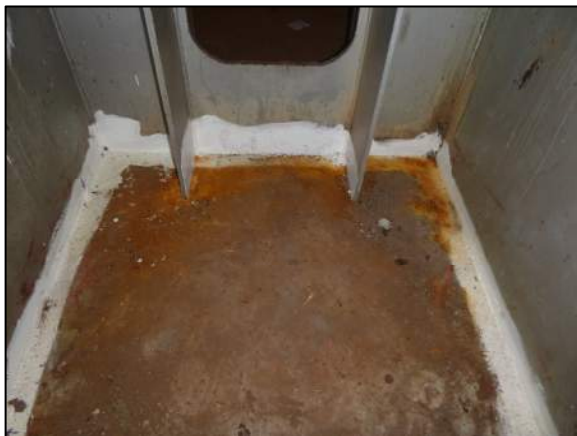
Photo 20: Typical corrosion and blasting media on the bottom of Pier Cap 16

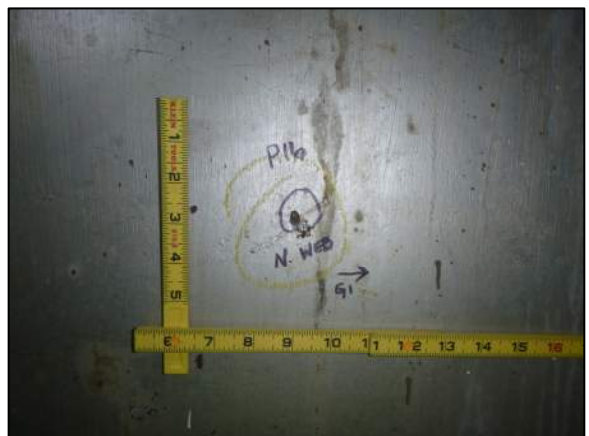
During the 1993 rehabilitation project, tack welds along the bottom flange, webs and backer bars were ground down. A total of 40 partially removed welds were noted between the north web and the backer bars. A total of 36 partially removed welds were noted between the bottom flange and the backer bars (Photo 21). Random tack welds were also observed throughout the pier cap. Select portions of bottom flange backer bar have been removed throughout the length of the pier cap to eliminate butt joints (Photo 22). A random spot weld was also noted on the north web between Girder 1 and the west diaphragm approximately 3' above the bottom flange (Photo 23).

Photo 23: Random spot weld on the north web of Pier Cap 16, west of Girder 1

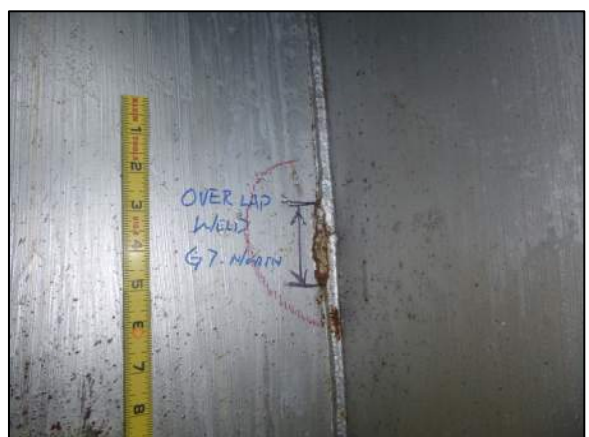
Photo 24: Overlapping weld with minor corrosion above girder tie plate on the north web of Pier Cap 16 at Girder 7.

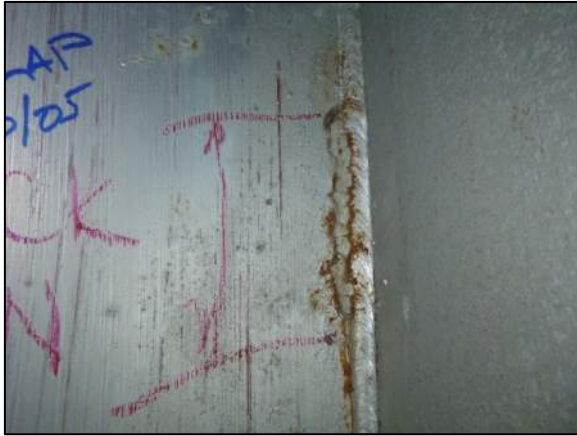
*Photo 25: Typical excess weld bead material breaking off at overlapping welds*

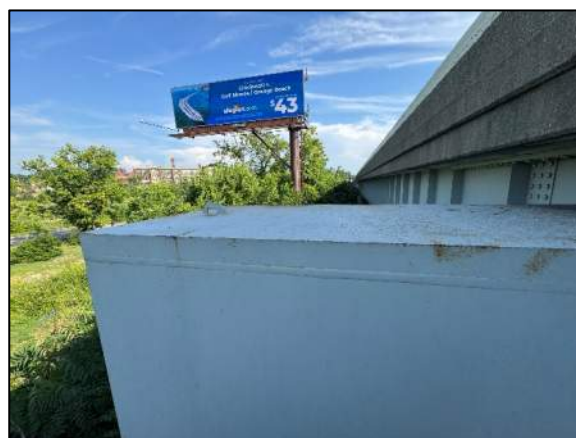
The paint system of the pier cap exterior is in good condition with scattered minor freckling corrosion, mostly on the top flange (Photo 28). The west side of Girder 1 exhibits bubbling paint and corrosion, which is starting to extend onto the south web of the pier cap (Photo 29). The bearing devices for Pier Cap 16 are steel rockers and bolsters. The west bearing exhibits surface corrosion (Photo 30).

*Photo 28: Typical freckling corrosion on the top flange at the west end of Pier Cap 16*

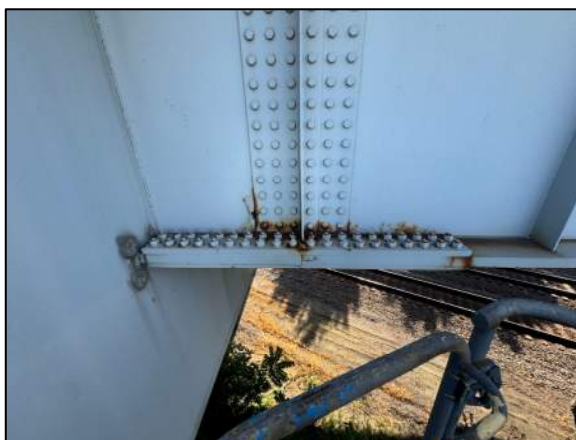
*Photo 29: Bubbling paint and corrosion on the west face of Girder 1 extending onto the south web of Pier Cap 16*

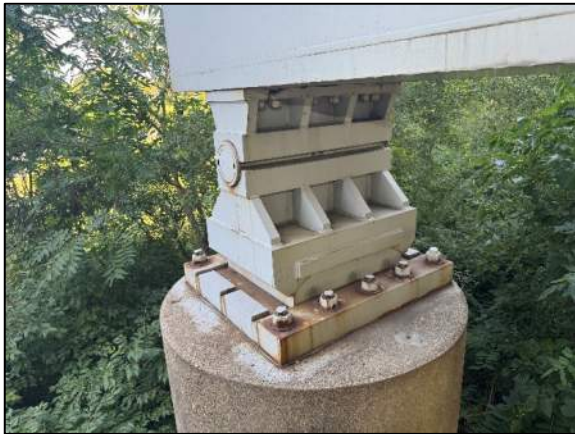
Photo 30: Surface corrosion on west bearing of Pier Cap 16

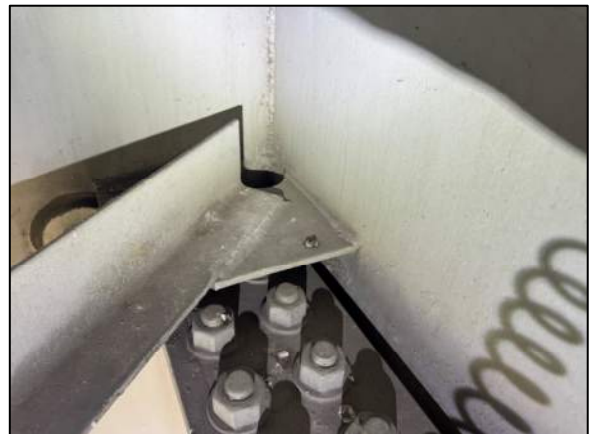
Photo 33: Typical lateral bracing cope detail at Pier Cap 16, fillet welds not completely removed

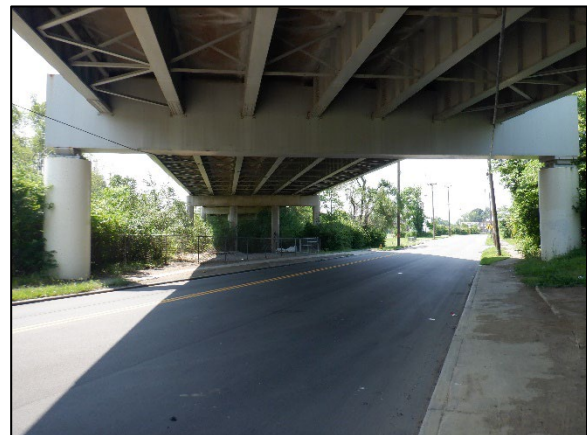
Pier Cap 20 is in Satisfactory condition [6] (Photo 36). As part of the 1993 rehabilitation project, tack welds were removed along the webs and bottom flange and backer bars, though many still remain. Additionally, 1" diameter holes were drilled through the webs of the pier cap on both sides of the girder webs in which bolts were installed.

Photo 36: Elevation of Pier Cap 20

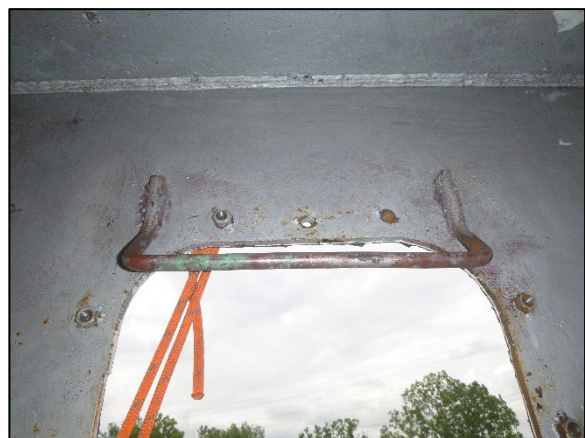
The interior of Pier Cap 20 was dry at the time of inspection. Both access hatches appeared to be properly sealed, however, the west hatch is missing the top middle nut and the top south nut and the east hatch is missing two nuts in the top row and one in each side row (Photo 37). The paint system of the pier cap interior is in fair condition. A few areas of light surface corrosion and accumulations of steel filings, paint flakes, and blasting medium exist throughout the bottom flange (Photo 38).

Photo 37: Two of the four missing nuts at the east access hatch of Pier Cap 20

| <b>Maintenance:</b> | Replace the detached anchor nuts (6 total) at both the east and west access hatches and ensure that the hatch cover plates can be removed. |

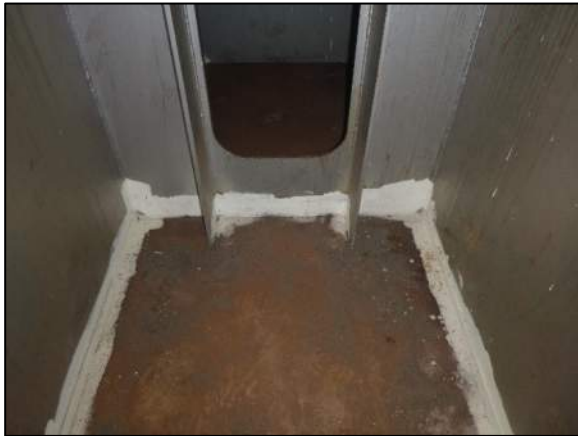
*Photo 38: Typical light corrosion on the bottom flange of Pier Cap 20*

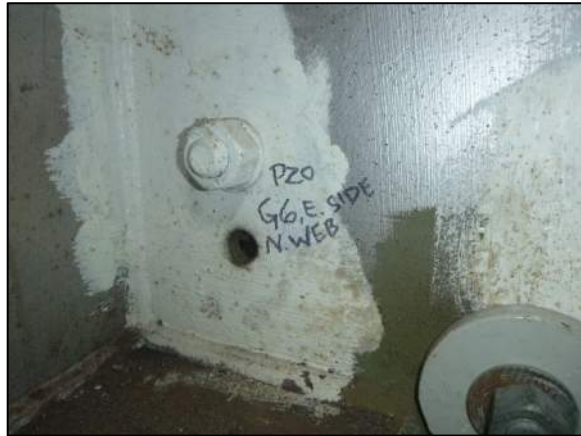
*Photo 41: Unfilled stress relief hole above girder bottom flange east of Girder 6 at the north web*

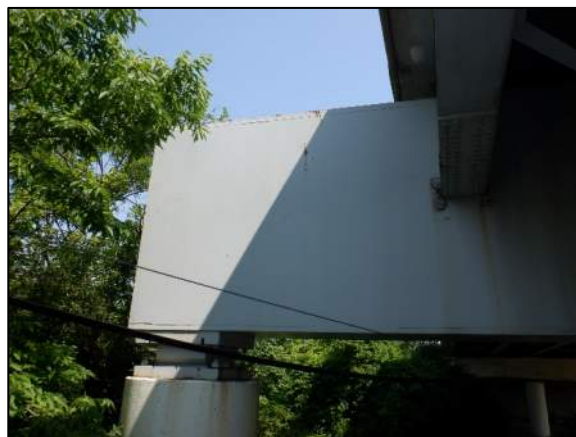
Bubbling and peeling paint with surface corrosion is a typical condition on the top flange and on the pier cap webs at some of the girder connections (Photo 46).

*Photo 46: Bubbling paint and corrosion on the east face of Girder 7 extending onto the north web*

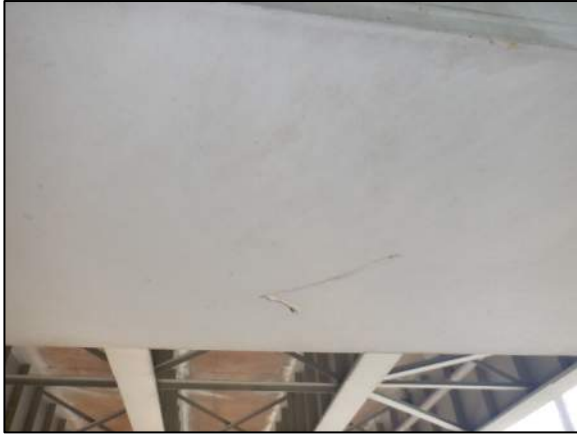
The steel cable supporting the utility lines under the pier cap is rubbing against the bottom flange and has worn through the paint between Girders 6 and 7. On the underside of the bottom flange between Girders 5 and 6, there is a 14" long paint scrape due to impact (Photo 47). Impact damage to bottom flange below Girder 5 on south side.

*Photo 47: 14" Paint scrape due to impact on the bottom flange of Pier Cap 20 below Girders 5 and 6*
