# FRACTURE CRITICAL PIER CAP INSPECTION REPORT

SFN3102807 (HAM-50-1903L)  
US 50 WB OVER MILL CREEK/CSX  
TRANSPORTATION/CENTRAL  
RAILROAD OF INDIANA  
HAMILTON COUNTY, OH  
DISTRICT 8

July 2023

US 50 WB over MILL CREEK/CSX TRANSPORTATION/CENTRAL RAILROAD OF INDIANA •  
SFN3102807 (HAM-50-1903L) • Hamilton County, OH • July 2023

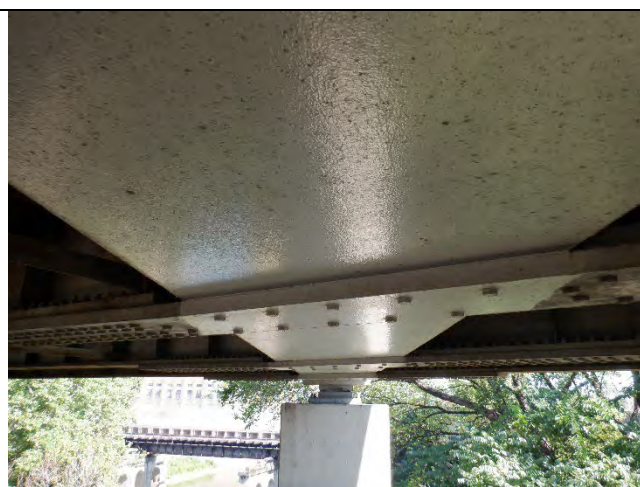
The steel pier cap was in Satisfactory condition [7] (Photograph 1). The pier cap is a built-up steel plate section 6 ft. – 6 in. in height and 4 ft. – 0 in. in width. The bridge girders were attached to the pier cap via bolted tie plates connected to the flanges of both members and bolted angles on the webs. The pier cap was retrofitted in 1992 and 2013, which is detailed in section 1.2 above.

Photograph 1 – View of Pier Cap 5N. Looking north.

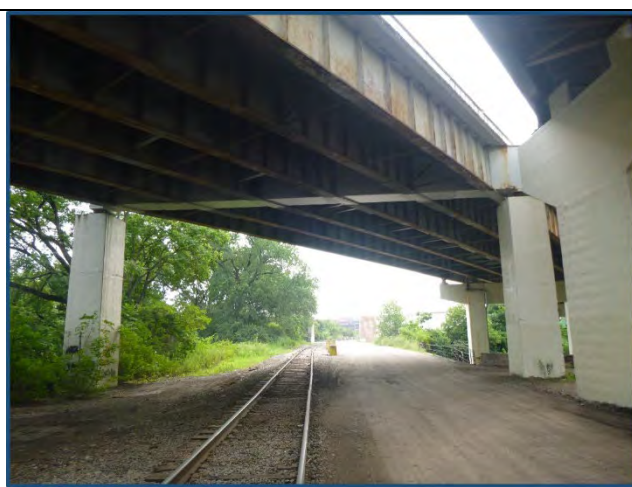
Photograph 2 – Elevation View of Pier Cap 5N. Looking East.

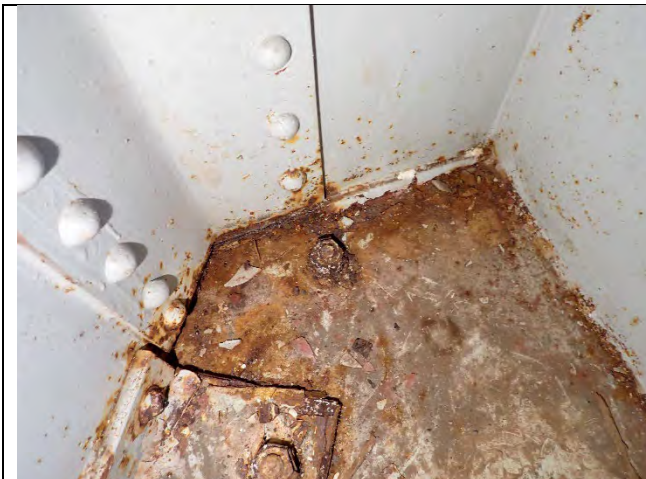
The paint system of the pier cap interior exhibited several areas of light surface corrosion. Active surface corrosion with no loss of section is present inside the cap, predominantly along the bottom plate towards the end of the cap (Photograph 3). This is likely from the humid environment for the interior. This has not changed from the prior inspection. There was evidence of leakage through the bolted connection on the top flange of the pier cap at Girders 1 and 6 (Photograph 4), suggesting that concrete deck cracking above the pier cap is causing water to filter through at the bolt. This continues from the prior inspection.

Photograph 3 – General Example of Active Corrosion On Bottom Plate At End of Cap. South End East Plate Shown. Looking East.

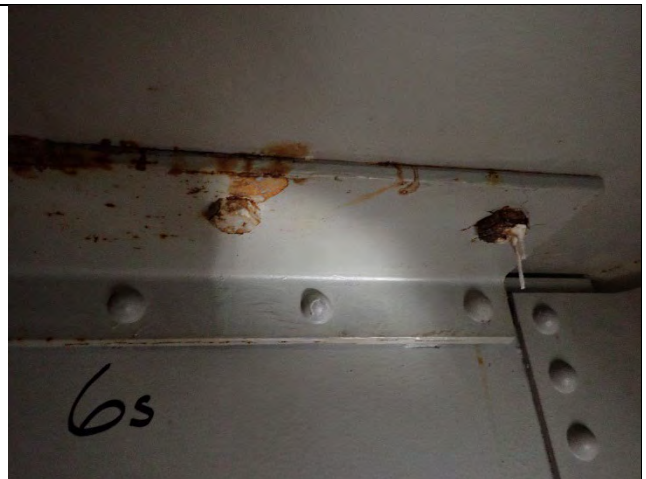
Photograph 4 – Example of Active Corrosion Through Bolted Clip Angle at Cap Top Flange

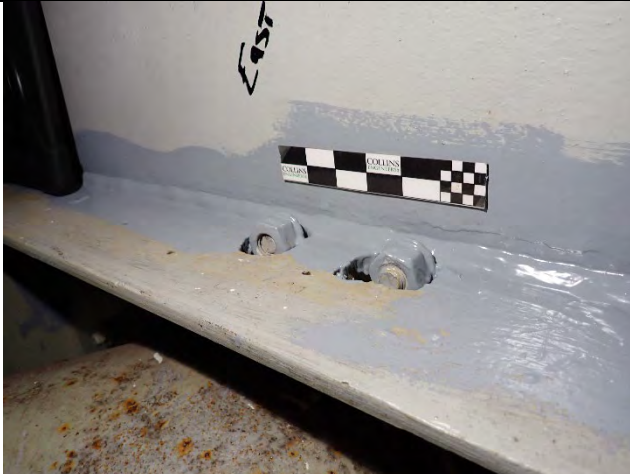
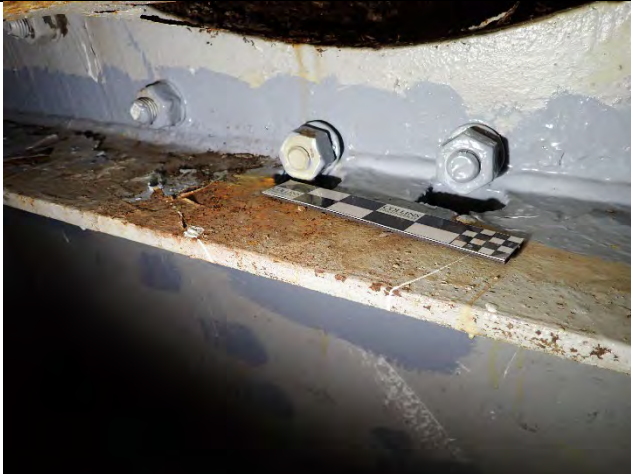
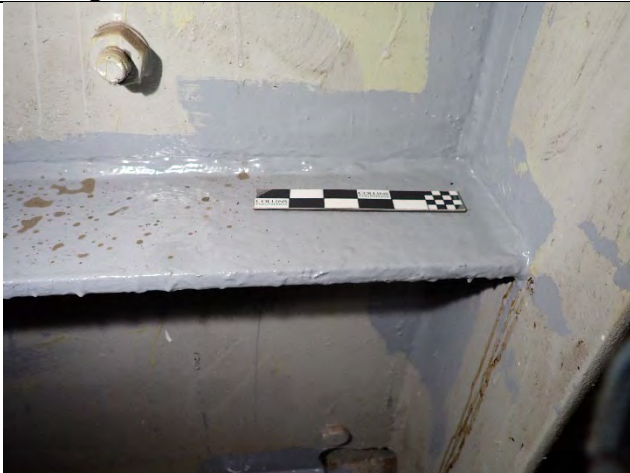
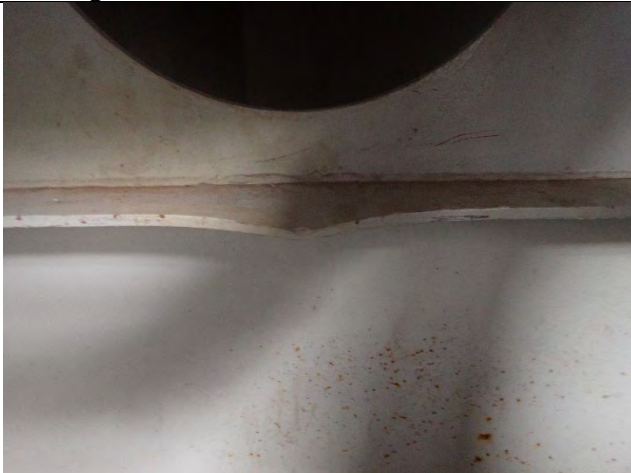
through the fillet welds of the longitudinal web stiffeners surrounding the conduit holes (Photograph 5). This occurs on the top stiffener for both cap web plates, and also to a lesser amount on the bottom east plate. The bottom stiffener west plate has bolts adjacent to the fillet weld, but not through the weld (Photograph 6). Locations with bolt holes through the fillet welds are therefore less wide and less cross section area, which lessens the weld capacity and may enable fatigue crack initiation. During the inspection no signs of distress or crack initiation were found in the welds (no change from prior inspection).

- The fillet welds of the transverse and longitudinal web stiffeners surrounding the water main porthole intersect in tension zones of the web plates (Photograph 7). These locations are closer to the neutral axis than an extreme fiber.

- The horizontal stiffeners below the Girder 6 diaphragm portal were both bent downward slightly (Photograph 8). This is likely construction damage.
- Tack welds are still present at isolated locations inside the cap. These locations include:

| <p>Photograph 5 – General Example of Holes Cut Through Fillet Welds of Horizontal Cap Web Stiffeners Above Water Line at Cap Web Plate. Looking West.</p> A close-up photograph of a horizontal metal plate with a circular hole. A black and white checkered scale bar is placed below the hole. The metal surface is painted light blue and shows some rust. | <p>Photograph 6 – General Example of Holes Cut Through Fillet Welds of Horizontal Cap Web Stiffeners Below Water Line at Cap Web Plate. Looking West.</p> A close-up photograph of a horizontal metal plate with a circular hole. A black and white checkered scale bar is placed below the hole. The metal surface is painted light blue and shows some rust. |
| <p>Photograph 7 – General Example of Intersecting Welds For Cap Web Plate Stiffeners Near Water Line. Looking east.</p> | <p>Photograph 8 – General Example of Bent Web Stiffener, Girder 6 North Side Shown. No Change. Looking South.</p> |

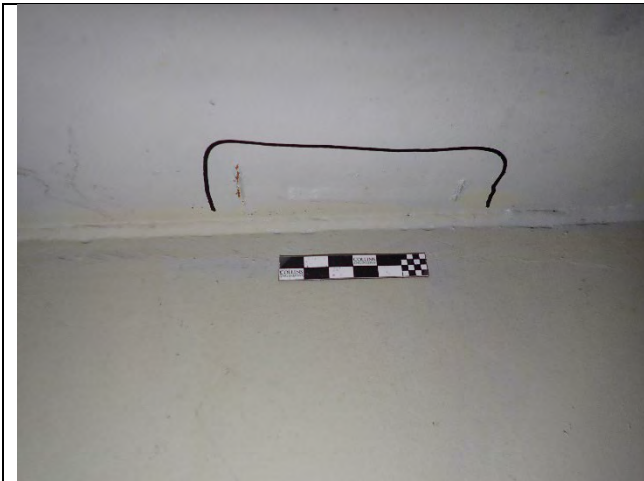
- The two tack welds measuring 1-1/2 in. and 2-1/2 in. on the top flange of the east cap web at the north side of Girder 1 have not changed (Photograph 9).

Photograph 9 – View of 1-1/2 in. and 2-1/2 in. Tack Welds On The Cap Top Flange Plate at the East Cap Web at the North Side of Girder 1. Looking east.

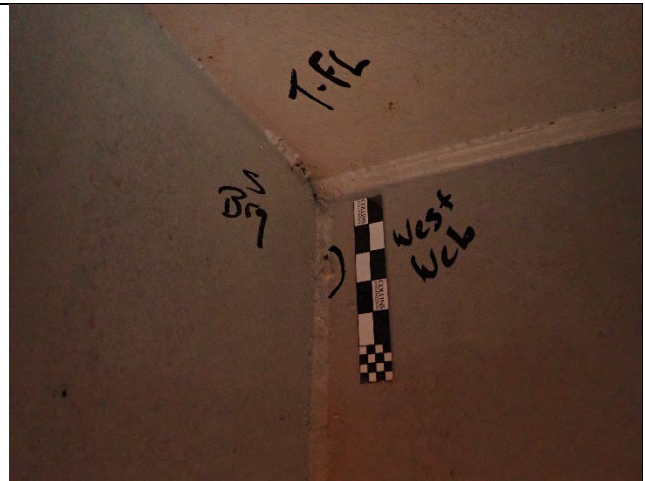
- A tack weld was observed over a fillet weld for the south bearing stiffener on the west cap web plate (Photograph 10). This is an old condition that has not changed.

Photograph 10 – View of Tack Weld Located At the South Bearing Stiffener, West Cap Web Plate. Looking Southwest.

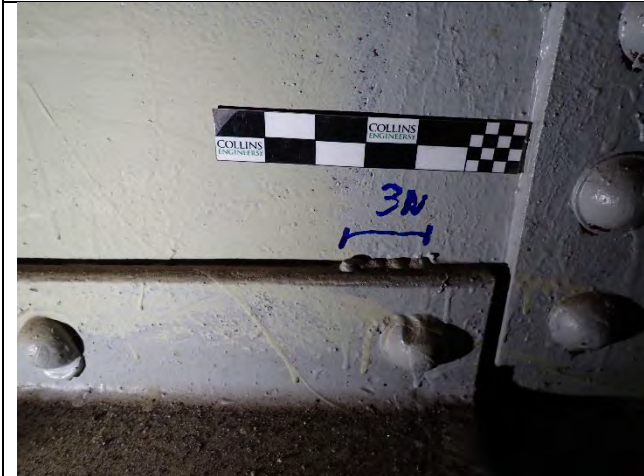
- A tack weld was observed on the lower west corner of the north face of Diaphragm 3, near the clip angle (Photograph 11). This is an old condition that has not changed.

Photograph 11 (left) – General Example of Tack Weld Still Present Between Diaphragm and Clip Angle. North Face of Diaphragm 3 At Lower West Corner Shown. Looking South.

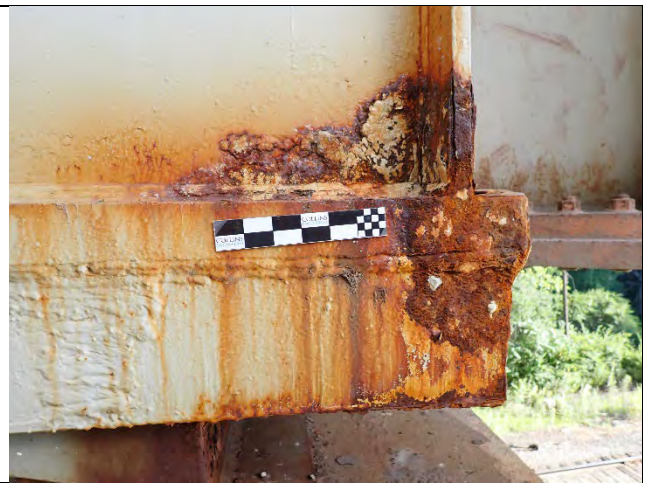
The paint system of the pier cap exterior exhibited active and laminating corrosion around the south end of the cap on both the flange plates and the web plates (Photograph 12). Isolated pits up to 1/8 in. deep were observed (Photograph 13). There is active corrosion with no section loss at several isolated locations along the cap (Photograph 14). In the 2013 rehabilitation project, tack welds were removed from the bottom flange and girder bottom flange tie plates. Three tack welds measuring between 1-3/4 in. and 2-3/4 in. remain on the west side of the bottom flange between Girders 2 and 3 (Photograph 15). This is an old comment that has not changed. Specific items on the exterior to note include:

Photograph 13 – View of Laminating Corrosion on the South End of the Cap, Lower East Corner, With Isolated Pits to 1/8 in. Deep. Looking North.

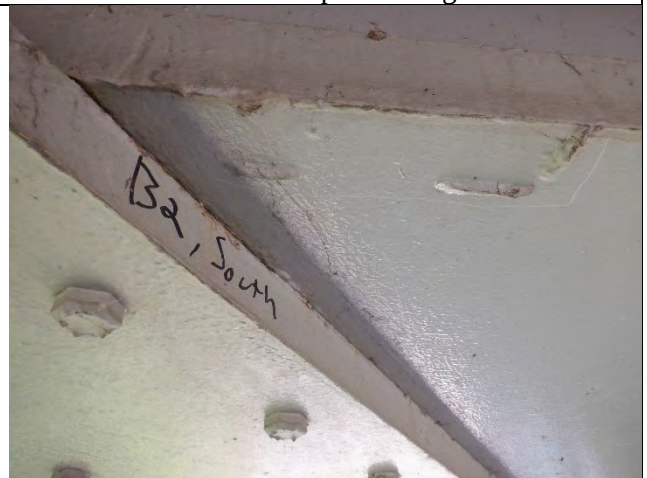
Photograph 15 – View of 3 Tack Welds Present on the West Side of the Cap Bottom Flange Between Girders 2 and 3. Looking East.

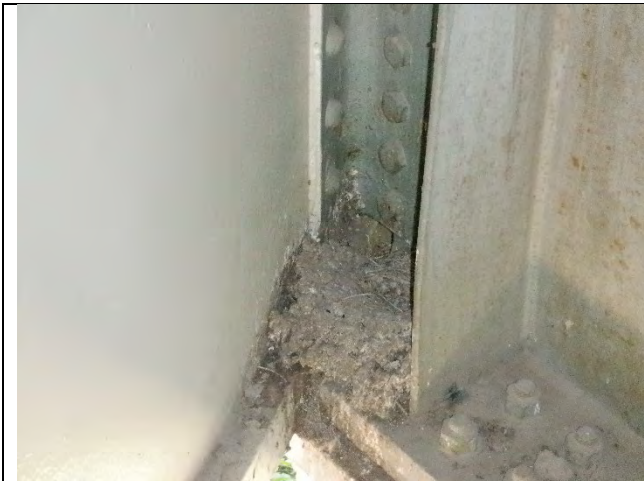
- Bird debris has accumulated at most of the acute corners of the girder to cap connections. This has not significantly changed since the prior inspection. This retains moisture and can promote corrosion.

- Heavy bird debris is present at the acute corners for the girder connections at the cap webs. This will retain moisture and promote corrosion (Photograph 16).
- Active pack rust was observed on the structure at the following locations:

Photograph 16 – General Example of Heavy Bird Debris at Girder to Cap Web Plate Connections. West Cap Plate Shown, Looking East.

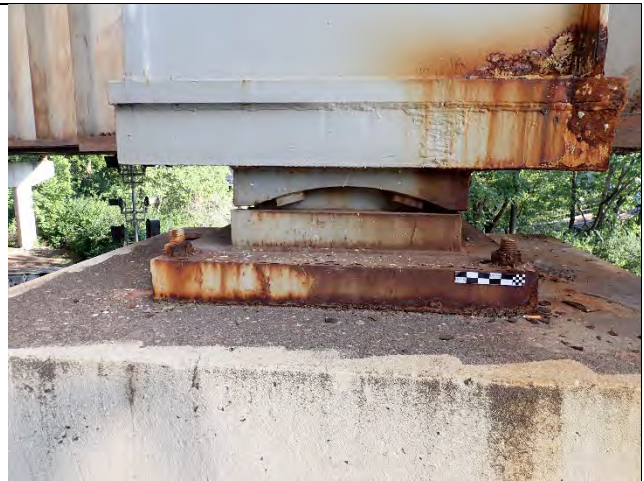
- Active corrosion continues on the south bearing. The anchor bolt nuts still exhibit extensive section loss to the nuts, but the bearings currently function as designed.

Photograph 17 –View of the South Bearing, Note Active Corrosion Continues, Heaviest On Masonry Plate. Looking North.

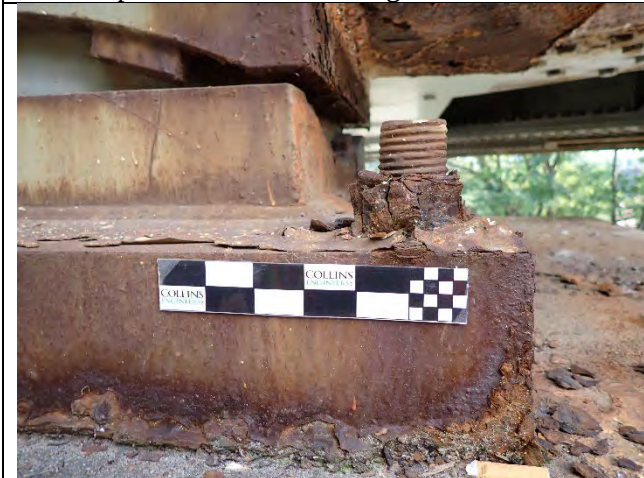
Photograph 18 – General Example of Section Loss to Anchor Bolt Nuts at the South Bearing. Looking North.
