# FRACTURE CRITICAL PIER CAP INSPECTION REPORT

SFN3103811 (HAM-50-2910)

US-50 OVER NORFOLK SOUTHERN,  
INDIANA AND OHIO RAILROAD, DUCK  
CREEK, AND RED BANK ROAD  
HAMILTON COUNTY, OH  
DISTRICT 8

March 2024

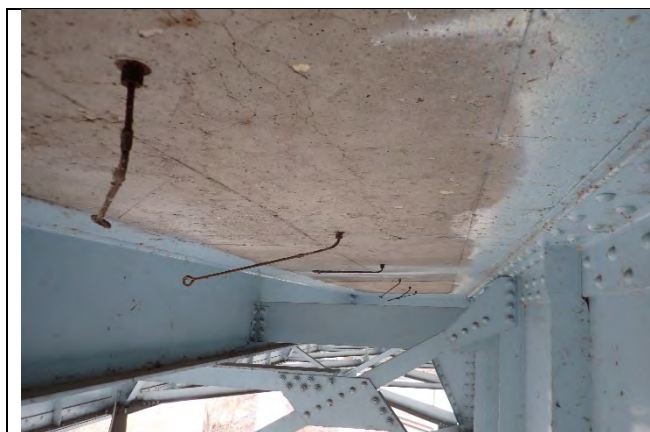
Transverse cracks spaced from 5 ft to over 20 ft with scattered efflorescence were present on the soffit for the full length of the bridge. Hairline to medium cracking was present along the soffit. Saturation was

Photograph 3: Typical Span 2 soffit, looking west.

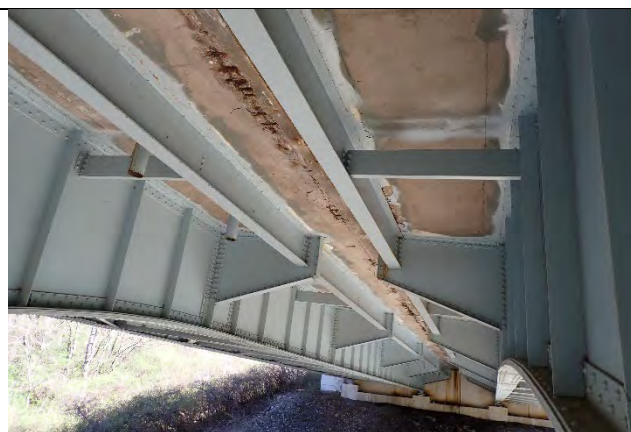
observed around the scupper drains and the centerline joint. Saturation measuring 3 ft wide was observed along the entire length of the center joint.

Photograph 4: Typical condition and configuration of the soffit between the two bridges from Pier 2, looking northeast.

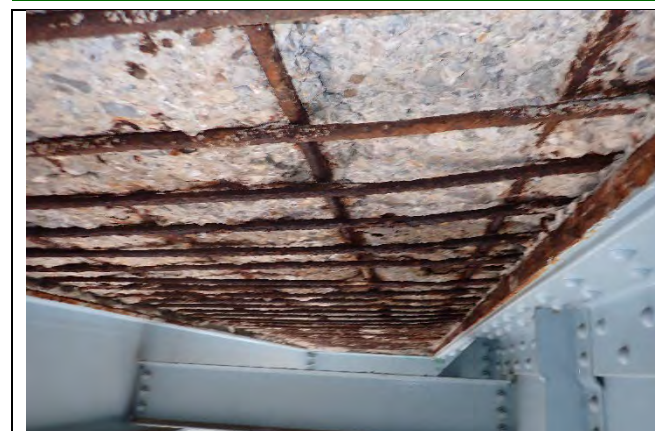
Extensive full depth repairs were present along the centerline and in various areas throughout spans. Formwork from deck repairs was observed left in place along the right edge of Span 3. Small shallow spalls generally 2 to 4 square feet were observed along the girders and stringers of Spans 2 and 3. Span 3 typically exhibited the delamination and spalls along Stringer 2. Heavy delamination and spalls with exposed reinforcing steel with rust and section loss visible were observed between the girders and along the median area. Numerous areas of wide delamination were observed randomly throughout all spans, predominately under the westbound lanes. Large areas of unsound concrete were removed by the contractor over Redbank Rd. in 2020. All transverse reinforcing bars in this area were not engaged with the soffit, and the reinforcing bars exhibited section loss with one bar fully severed. This condition was similar between Stringers 2 and 3 of Span 3.

Photograph 5: Span 3 soffit near Girder 1 south side between Floor Beams 2 and 3, looking west. Note: all transverse reinforcing bars were not engaged with the soffit, and section loss was observed on each with 1 bar fully severed.

As noted above, the concrete deck will be replaced soon after this inspection and the deteriorated deck and deficient exposed reinforcing steel will not be present during the next inspection.

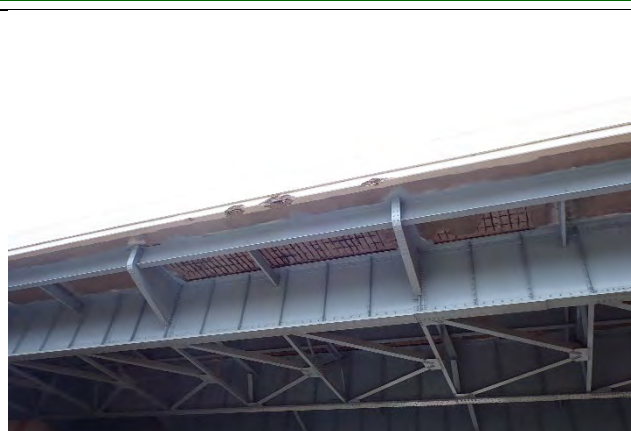
Photograph 6: Typical exterior deck condition, looking south.

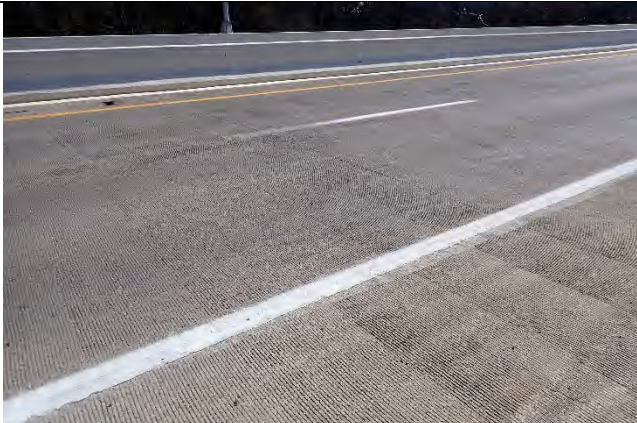
Random longitudinal cracking spaced 2 ft to 8 ft was observed throughout the wearing surface of the eastbound and westbound lanes. Transverse cracks were present along the bridge and were spaced at an average 8 to 10 ft throughout both the eastbound and westbound wearing surface. No changes were observed since the last inspection. Saturation, cracking, rust stains, and unsound areas were observed on the westbound lanes along the median parapet. There were two areas in Span 2 and four areas in Span 1 with extensive localized deterioration at the top up to a few square feet in shape. Spalls were observed throughout the eastbound wearing surface along a crack 2 ft from the south parapet wall running longitudinally for the full length of the bridge. The spalls were most severe at the scuppers in the eastbound wearing surface. Delamination was observed along the shoulder area at the rail in eastbound lanes with spalls up to 18 in. diameter by 2 in. deep with exposed reinforcing steel around scupper drains. The eastbound left lane exhibited two 2 square ft asphalt patches. Approximately 62 square ft of deteriorated patched areas were observed in the westbound right lane. The Span 1 westbound right lane exhibited a patch coming undone. The pavement exhibited deterioration and heaving approximately 30 ft from the west end of the bridge at the westbound west approach.

| Photograph 7: Typical wearing surface condition (westbound Span 3 shown), looking southwest. | Photograph 8: Cracks and popouts along longitudinal crack 2 ft from eastbound parapet, looking west. |

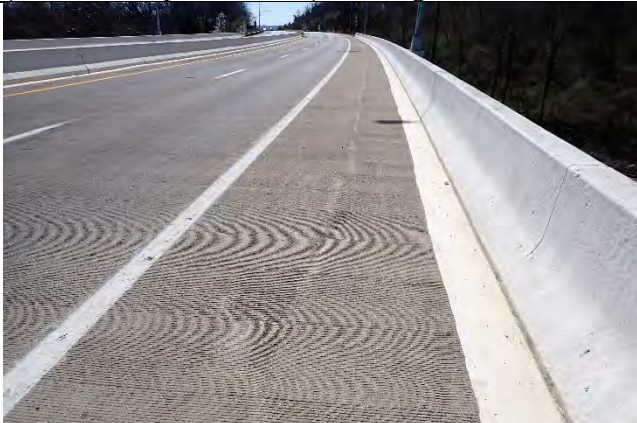
| Photograph 9: Longitudinal crack along cantilevered portion, Span 2 WB shown, looking west. | Photograph 10: General example of patch on deck, westbound Span 2 right lane shown, looking southwest. |

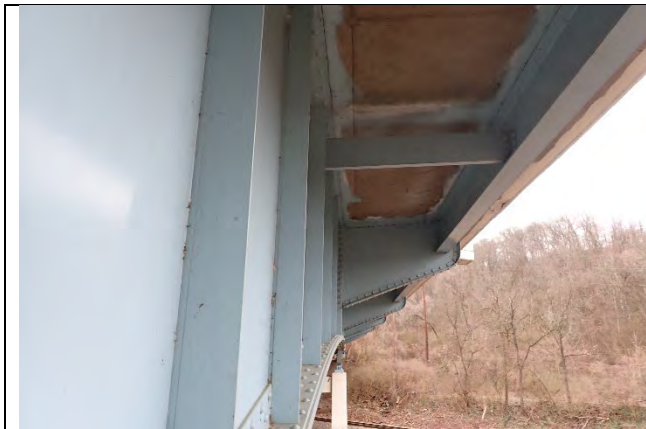
Photograph 11: Typical exterior floor beam cantilever configuration and condition (Span 2 north exterior shown), looking west.

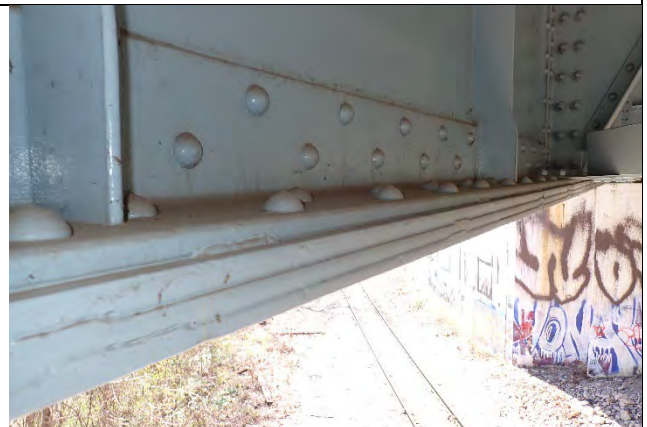
The center of the Span 1 built-up straight girder bottom flange plates has edges tack welded together on 2 ft spacing. Spans 2 and 3 do not have these tack welds. No tack weld cracks were observed during this inspection. Most of the C-channel diaphragm connecting angles are tack welded to girder webs and outside stringer webs (not riveted).

Photograph 14: Typical example of tack welds between bottom flanges and plates, looking south.

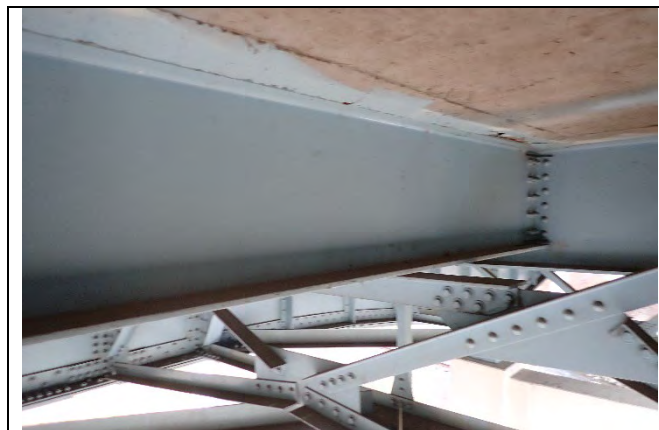
Corrosion was observed at the top flanges of the stringers along the median joint. Several stringers located at downspouts exhibited painted over loss of section up to 1/16 in. deep to the bottom flange and lower web due to drainage splash. This is an old comment and has not changed. Small areas of pack rust were observed between stringer top flanges and the deck due to deck leakage. No “pumping” was observed, but gaps and edge spalling along the stringer top flange was present.

Photograph 17: Typical stringer condition (Span 3 near Floor Beam 1 shown), looking southwest.

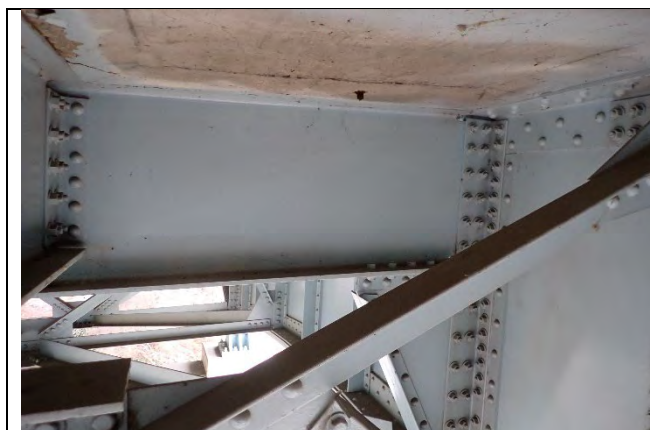
Painted over pitting up to 1/16 in. deep was observed on the girders under the abutment joints (past the bearings) due to past joint leakage. Floor beam connections exhibited painted over pitting up to 1/16 in. deep with no active corrosion.

Photograph 18: Typical floor beam and floor beam connection condition in Span 3 near Floor Beam 1 shown, looking west. Note: no major defects.

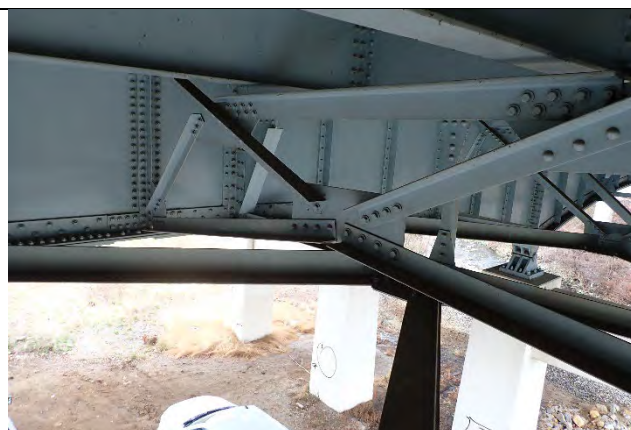
Photograph 19: Typical floor system steel and paint condition (Span 3 near Floor Beam 1 shown), looking southwest. Note: no major defects.

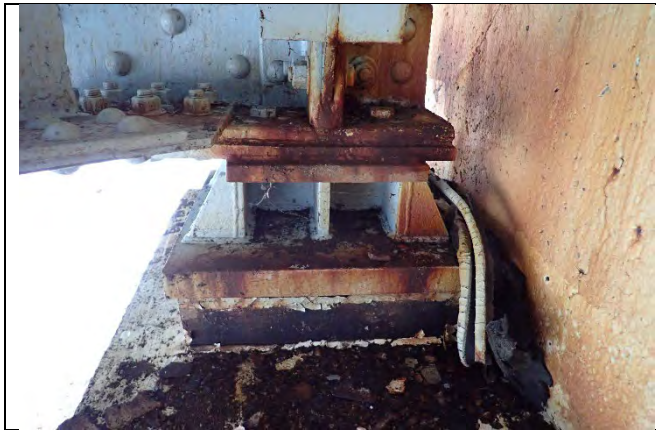
The superstructure was painted in 2013 and remains in good condition overall. Active corrosion and rust staining is present under the abutment joints due to the leaking joint. Light rust was visible on girder ends at the abutments, floor beams, and stringers due to deck leakage. Minor corrosion was observed at the top flanges of stringers at the median joint, with some pack rust on the top flanges in small, random areas. This is not structurally significant at this time.

Photograph 20: Girder 2 Rear Abutment bearing with typical example of rust staining on beam and bearing, looking south.

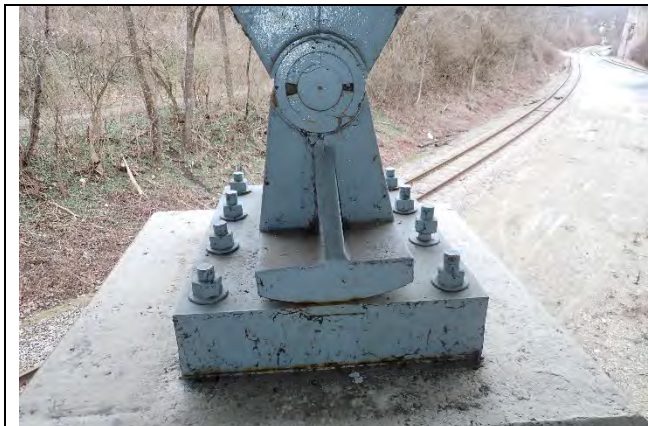
The piers supported steel rocker bearings, and the abutments supported elastomeric bearings. Surface corrosion with no section loss was present at small, localized locations on the masonry plates on the backside of the Rear Abutment bearings due to leaking joints. The east side of Pier 1 Girder 1 bearing, there was an anchor nut that was not fully seated. There has been no change from 2013. The Pier 2 Column 4 bearing exhibited one loose nut at the masonry plate.

Photograph 21: Girder 1 bearing at Pier 1 with an improperly seated anchor nut, looking north.

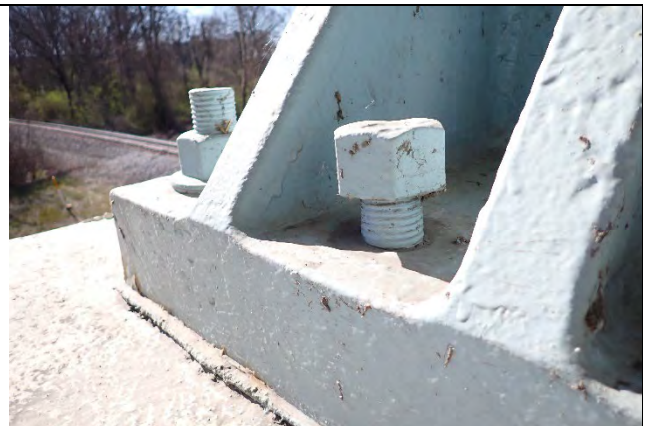
Photograph 22: Loose nut at the Girder 4 bearing at Pier 2, looking south.

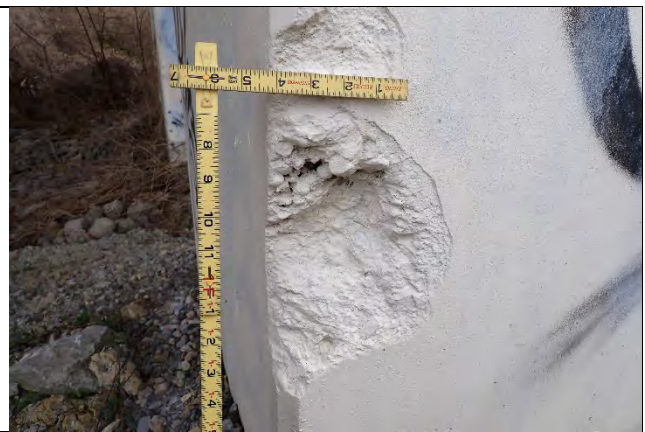
Column 1 of Pier 1 exhibited two shallow spalls measuring 5 in. diameter by up to 1.5 in. deep located 2 ft above the ground. Columns 1 and 3 of Pier 1 exhibited small spalls; Column 3 exhibited 3 small spalls with exposed reinforcing steel due to lack of cover for the horizontal bars. Column 2 of Pier 2 exhibited four shallow spalls measuring 5 in. diameter by up to 1.5 in. deep located 2 ft above the ground. Column 4 of Pier 2 exhibited a spall located at the left edge of the bearing seat 4 ft long by 10 in. vertical by 3 in. deep with one exposed horizontal reinforcing bar and seven exposed vertical reinforcing bars with approximately 20% section loss.

Photograph 24: Pier 1 Column 1 shallow spall, looking south.

- Patch the spalls and delamination in the substructure units to cover/protect exposed reinforcing steel.

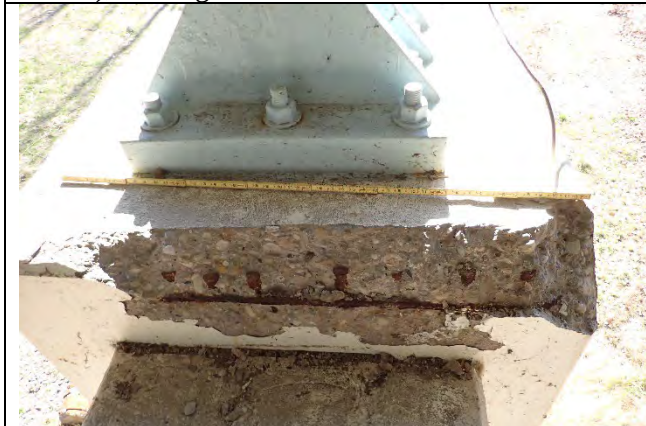
Photograph 25: Pier 2 Column 4 spall near the bearing seat, looking south.

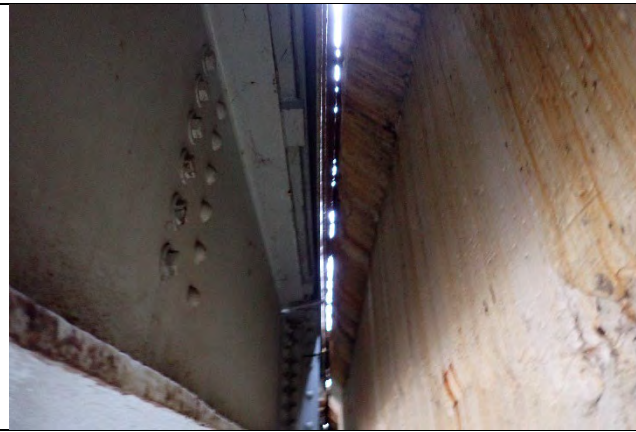
The Rear Abutment joint was failed through 20% of its length. The Forward Abutment joint failed through 90% of its length, and adjacent deck headers exhibited spalls and delamination up to 3 in. deep over the full length of the header. The bottom of the joints exhibited section loss with a few gouges from impact.

Photograph 28: Forward Abutment deck header spalling and joint failure, looking east.

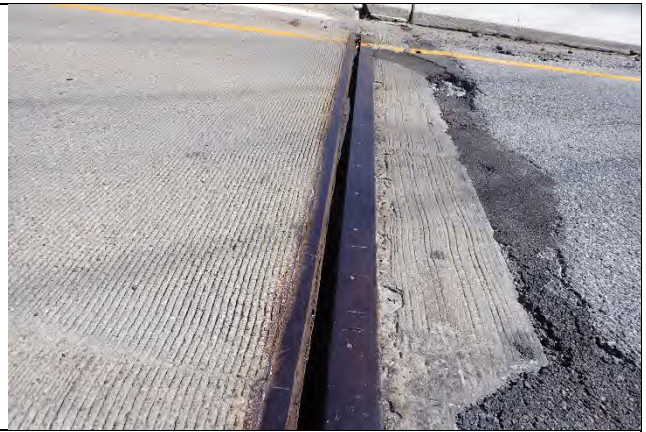
Photograph 29: Failed westbound left lane joint seal at the Rear Abutment, looking south.

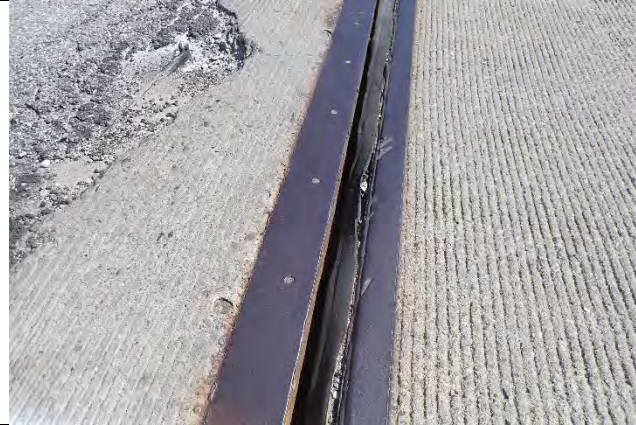
Photograph 30: Close up view of torn and fallen joint seal (Forward Abutment westbound right lane shown), looking south.

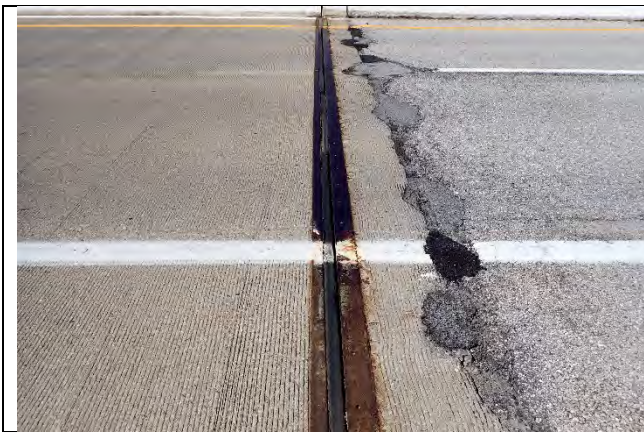
The eastbound right lane exhibited a pothole around an unsound patch 24 in. diameter by up to 2 in. deep, and the asphalt overlay exhibited raveling at the eastbound pothole. A few potholes and areas of failing asphalt patches were observed along header joints in the rear and forward slabs. Patches in the header joints in the eastbound lanes appeared sound. Overall, there were no major changes from the previous inspection.

Photograph 35: Eastbound east joint with potholes, looking north.

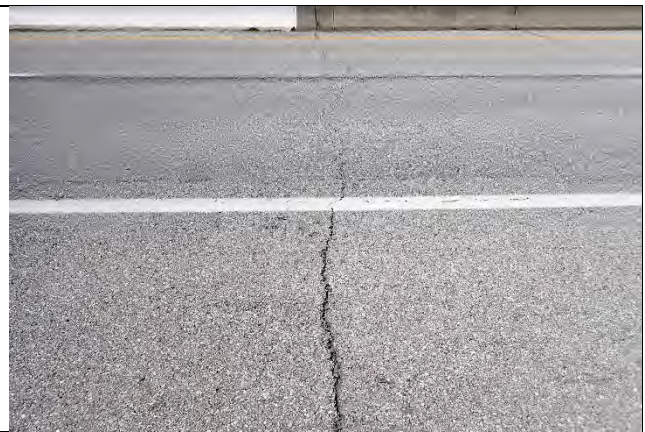
Photograph 36: Typical approach crack (eastbound shown), looking north.

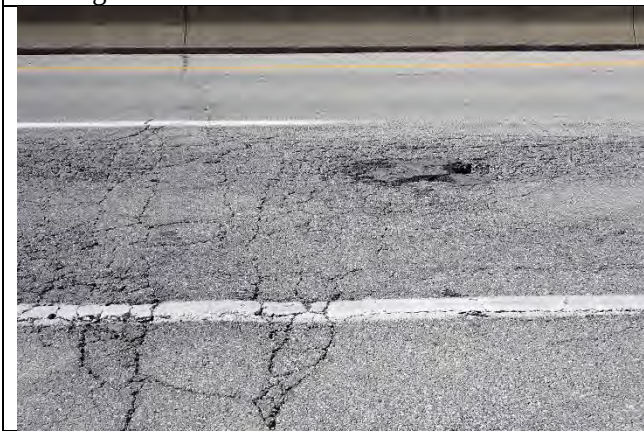
Photograph 37: Approach cracks and potholes (westbound shown), looking north.

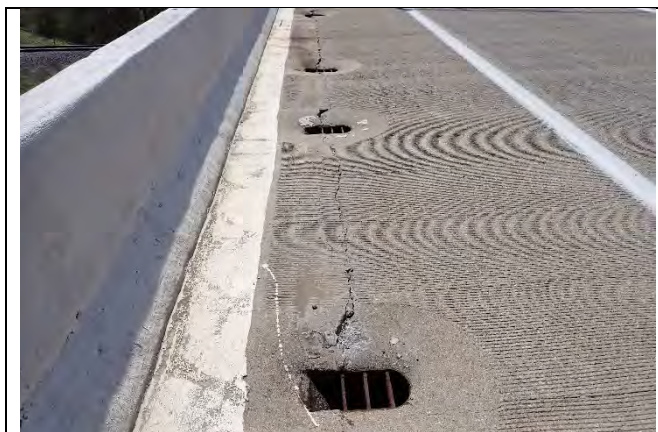
Areas around a few scuppers exhibited delaminations, spalls, and cracks. The drains were clear overall.

Photograph 38: Typical scupper, looking west.

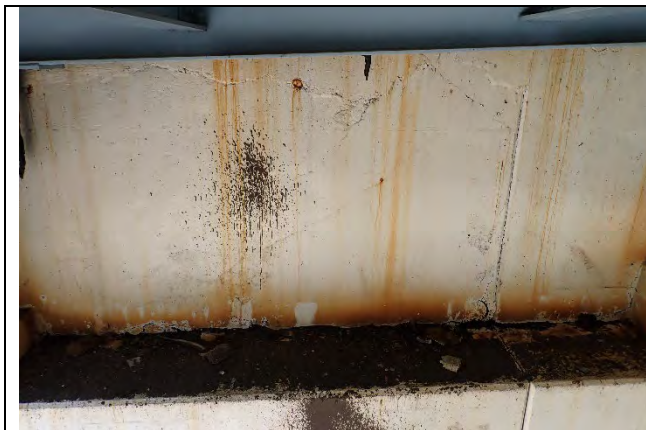
The backwalls exhibited vertical, diagonal, and random cracks with minor efflorescence. Both abutments have had a sealant installed and prior spalls patched. The south Rear Abutment backwall exhibited a spall 6 ft vertical by 18 in. wide by up to 2.5 in. deep with 1 exposed vertical reinforcing bar. The Rear Abutment backwall exhibited spalls up to 3.5 ft vertical by 3 ft wide on the south end of the backwall with two reinforcing bars exposed located at the wingwall spall. The Forward Abutment exhibited a spall at the center and the north end. Shallow but wider spalls were observed along the top of the breastwall under the joint armor. Overall, there were no major changes since the previous inspection.

Photograph 39: Rear Abutment backwall, typical, looking west.

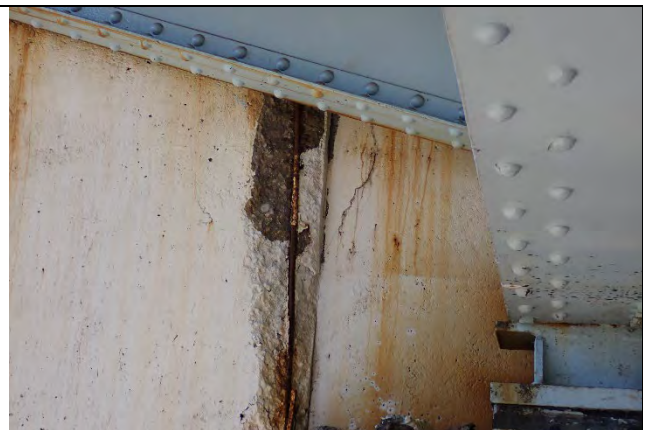
- The right rear abutment backwall exhibited a spall 6 ft vertical by 18 in. wide by up to 2.5 in. deep with 1 exposed vertical reinforcing bar.
  - Scattered cracks with efflorescence were observed throughout the concrete substructure units.

Photograph 40: Spall in Rear Abutment backwall, looking west.

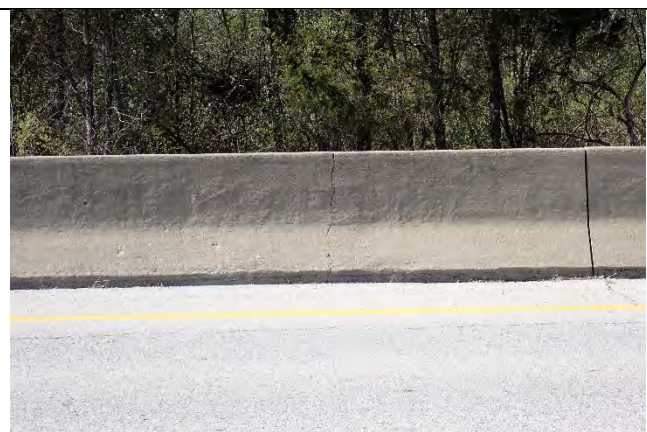
Photograph 42: West approach median parapet cracking, looking north.

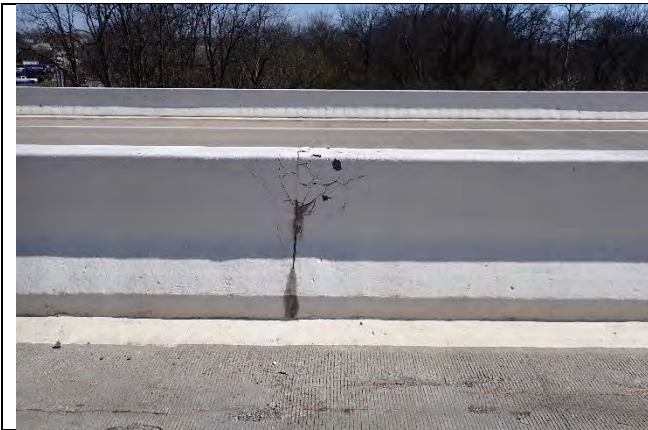
Photograph 43: General example of map/random cracking and deterioration of median (Span 1 westbound shown), looking south.

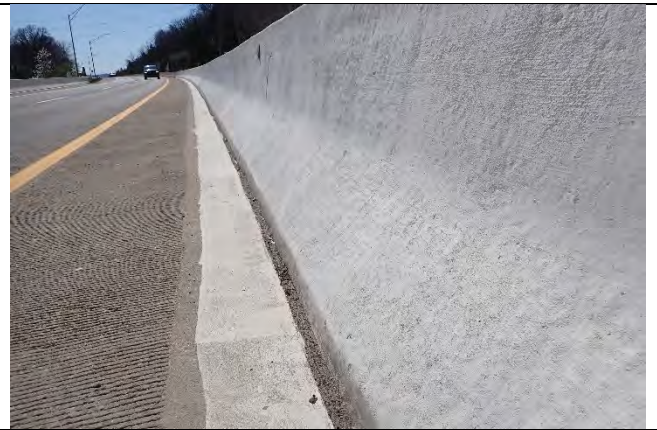
Photograph 44: View of joint along median for eastbound bridge, looking west. This is where the leakage between the bridges is coming through.

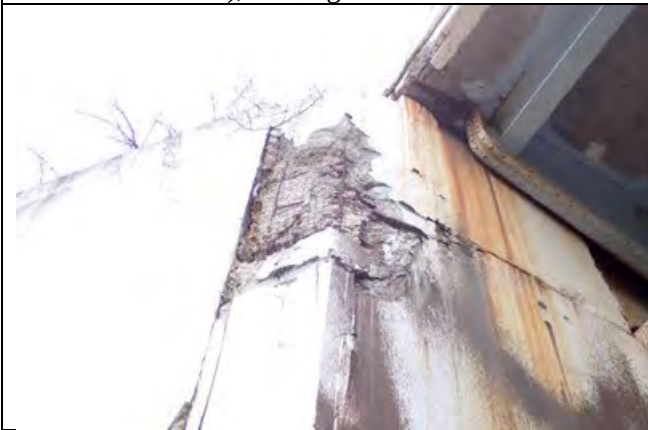
Photograph 45: Spalled area at top corner of southwest wingwall at the abutment with exposed rebars and wire mesh, looking northwest.
