# BRENT SPENCE APPROACH BRIDGE

HAM-71-0000L

SFN: 3105946

## 2025 In-Depth/NSTM Inspection Report

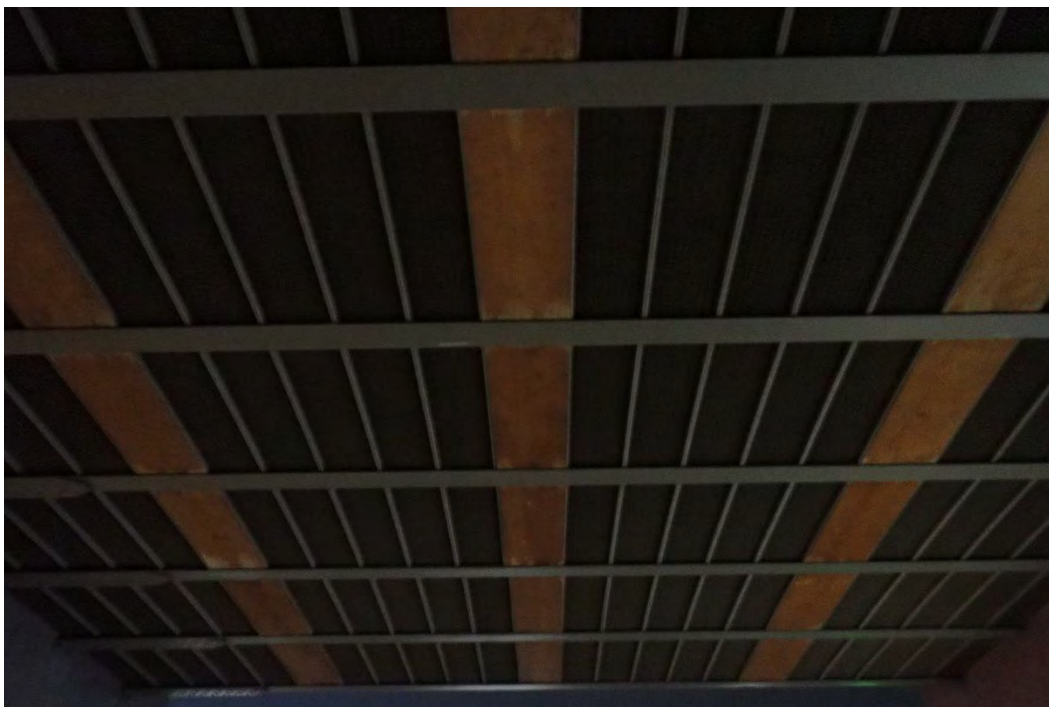
*Photo 4 - Typical Deck underside with debris grating at Span 1A looking south.*

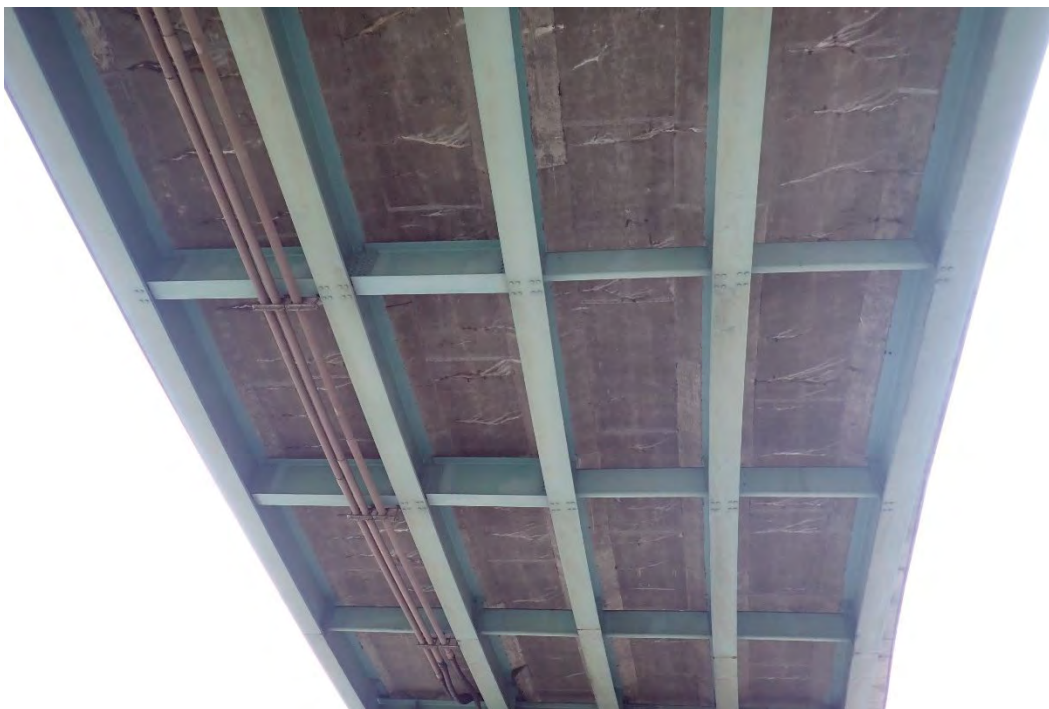
*Photo 6 - Typical transverse cracking with efflorescence on deck underside at Span 29B, looking northeast.*

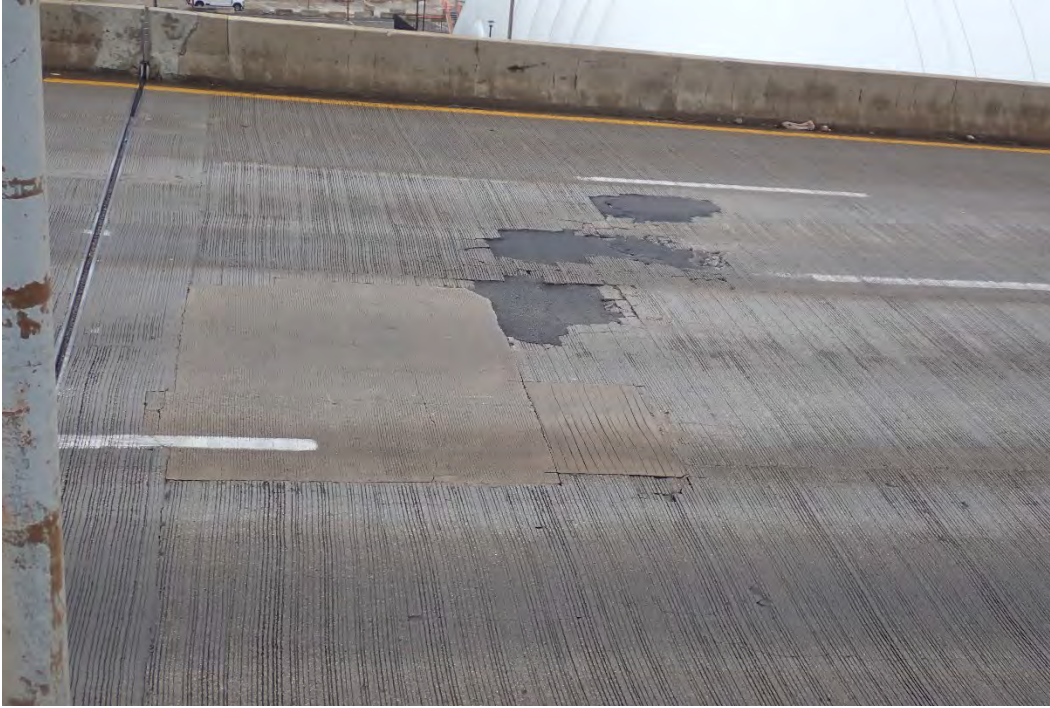
*Photo 7 - Pothole in top of deck with temporary asphalt fill/patch at Span 8A, looking east. Note: previous deck repair.*

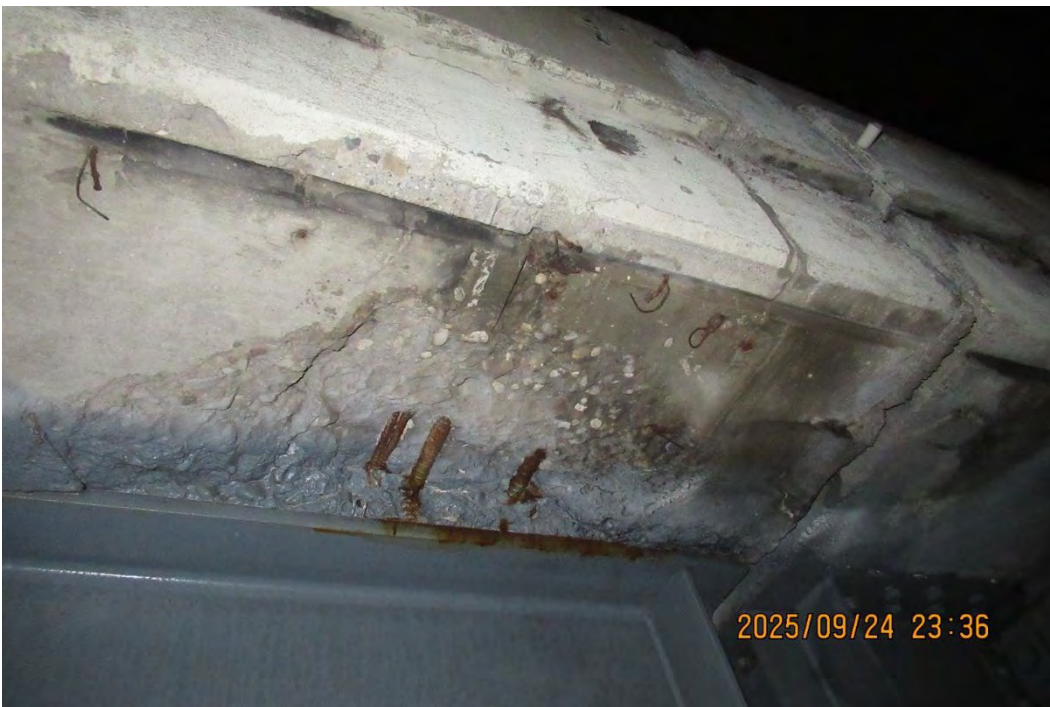
Photo 10 - 5' long by 20" wide by 5" deep spall with exposed rebar in the east overhang, both near midspan of Span 8A.

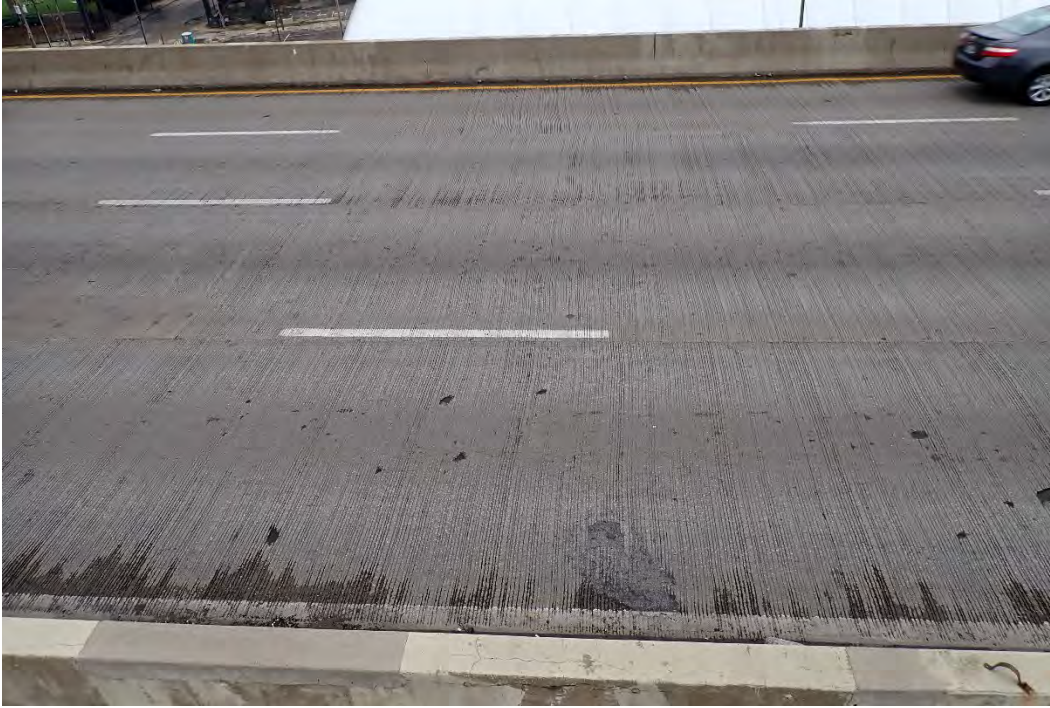
*Photo 12 - Typical high-friction deck top at Span 5A, looking east. Note: Minor concrete popouts/ spalls in far west travel lane.*

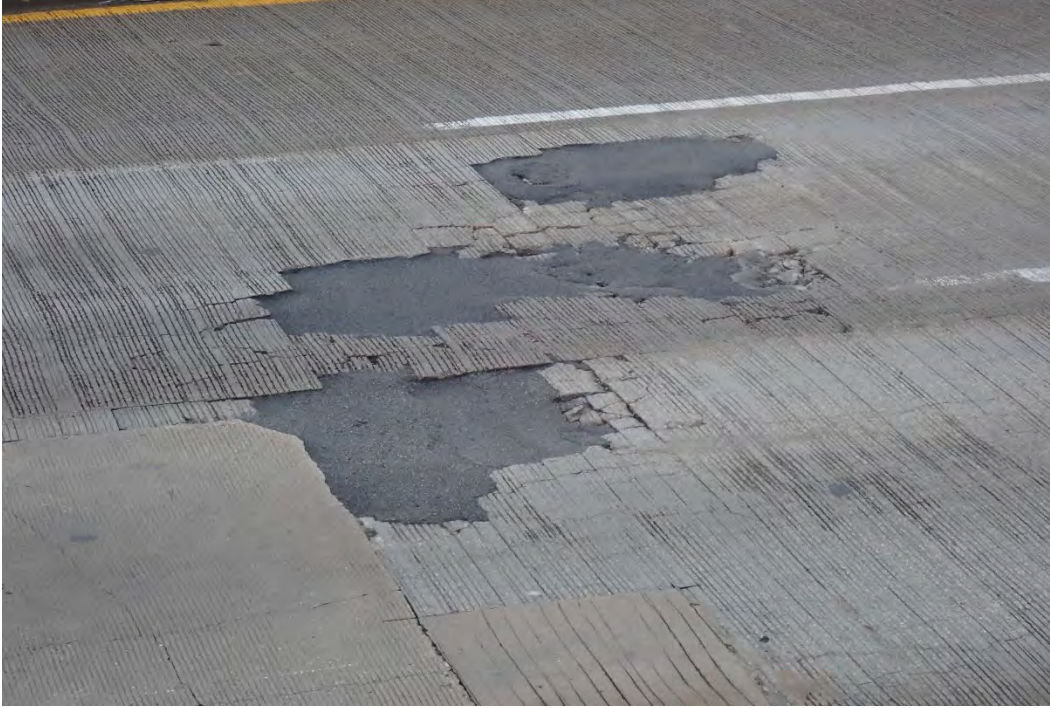
*Photo 14 - Typical asphalt patching of pothole in deck at Span 8A, looking east.*

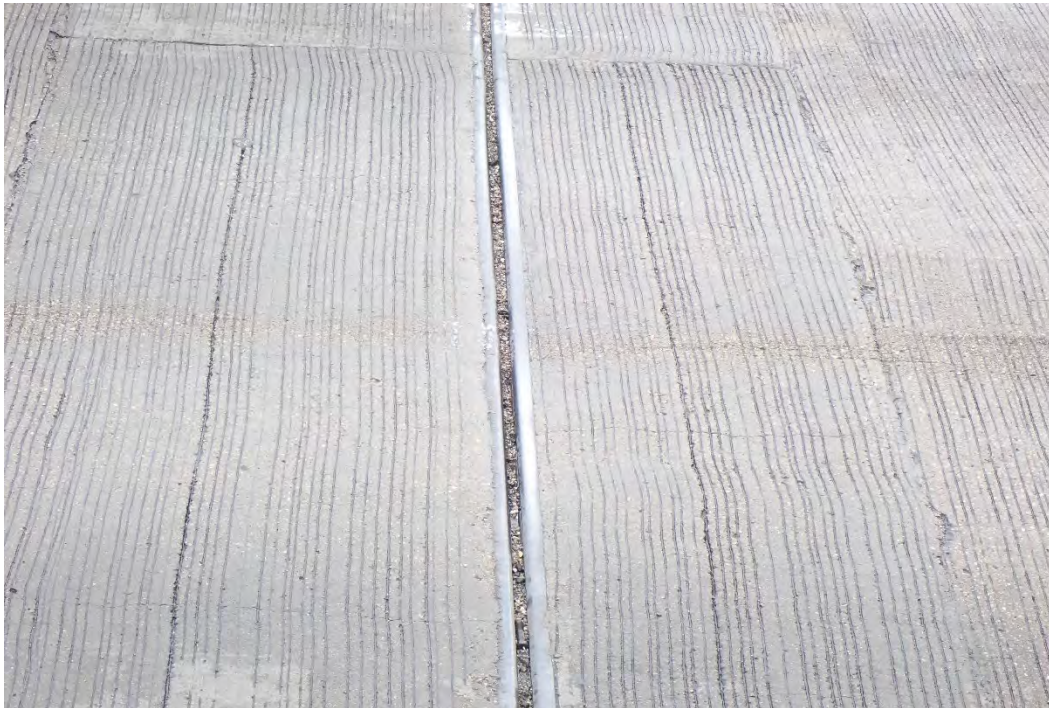
*Photo 15 - Typical debris accumulation in expansion joint at Pier 4A, looking east.*

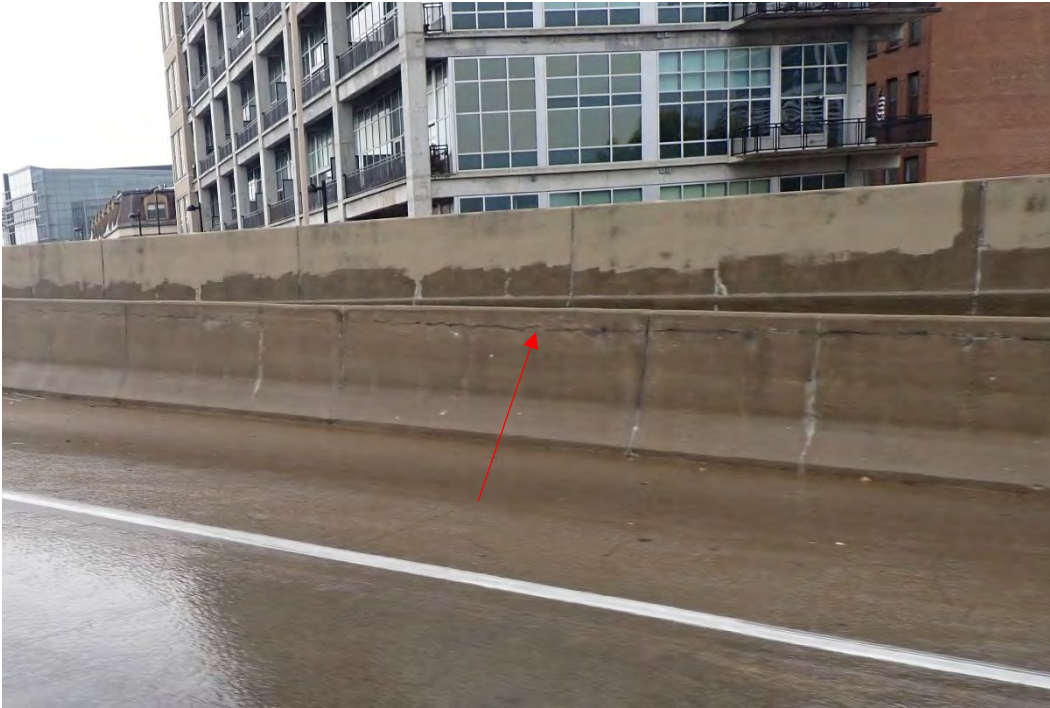
*Photo 18 - Typical longitudinal cracking along top of concrete bridge railing.*

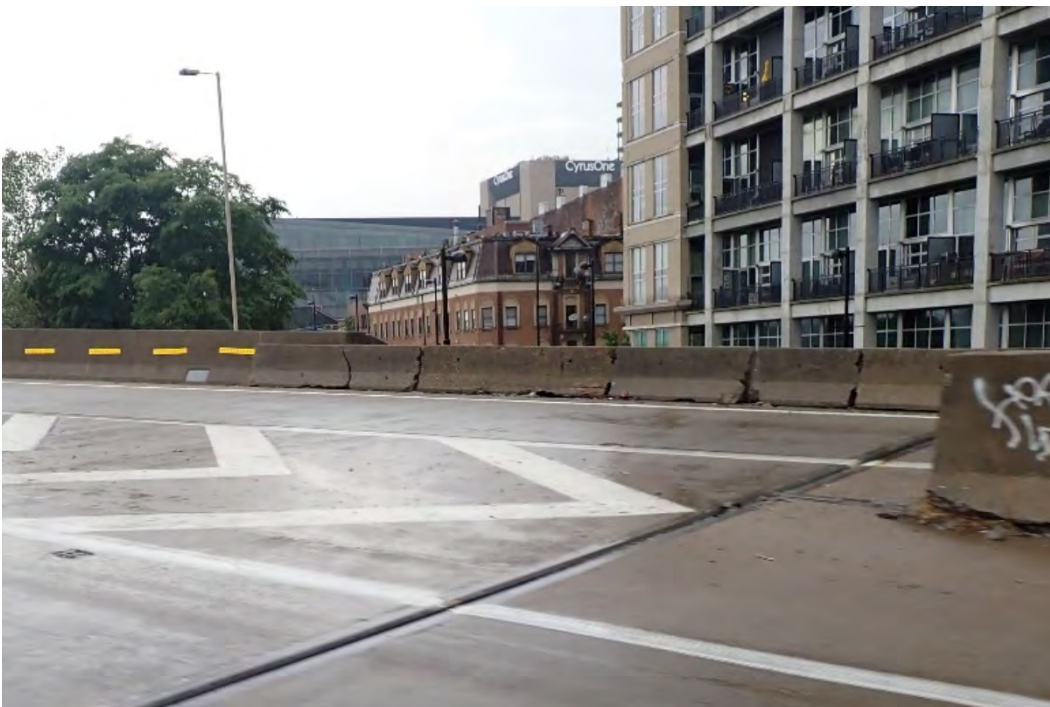
*Photo 19 - Wide vertical cracks in concrete railing on west railing or Span 5.*

- Repair spalls and seal cracks in the wearing surface.
- Repair spalls, delaminations, and seal cracks in concrete railings throughout structure.
- Spot paint areas of corrosion in pier box cap interiors.
- Clean and apply protective coating on Spans 15A to 28B.
- Repair isolated spalls and delaminations on concrete substructure units throughout the structure.

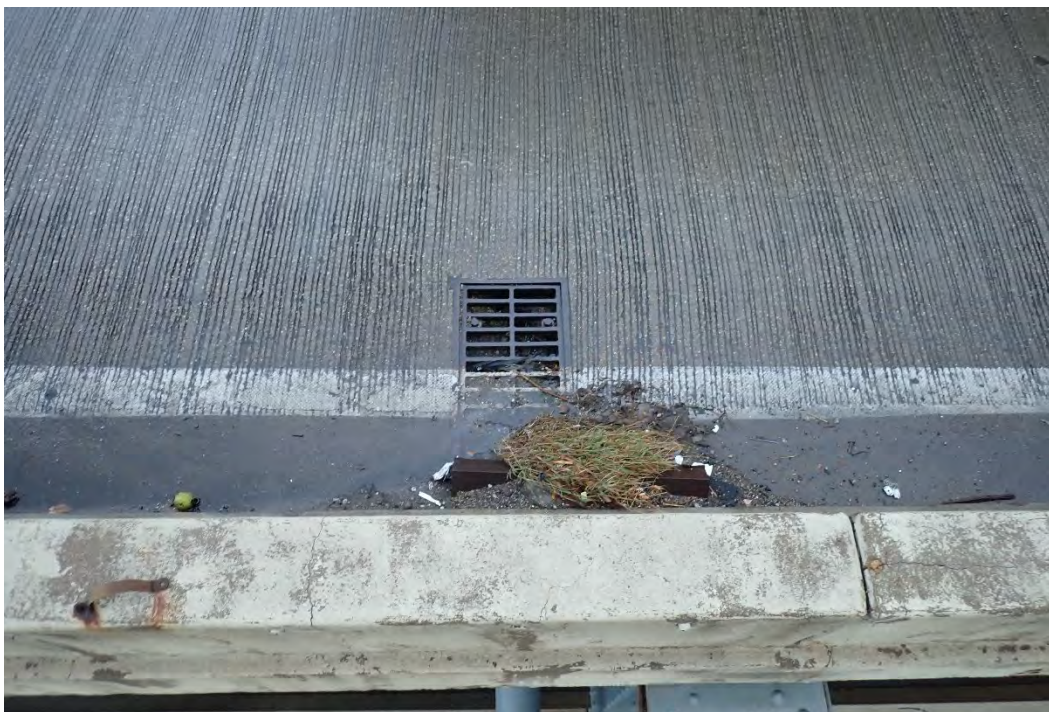
*Photo 23 - Debris impacted deck drain with vegetation growth at pier 6A, looking east.*

- Remove debris/ clean clogged deck drains, scuppers, and clogged drainpipes.
- Repair broken/ missing/ disconnected/ drainpipes and bulging boots throughout.

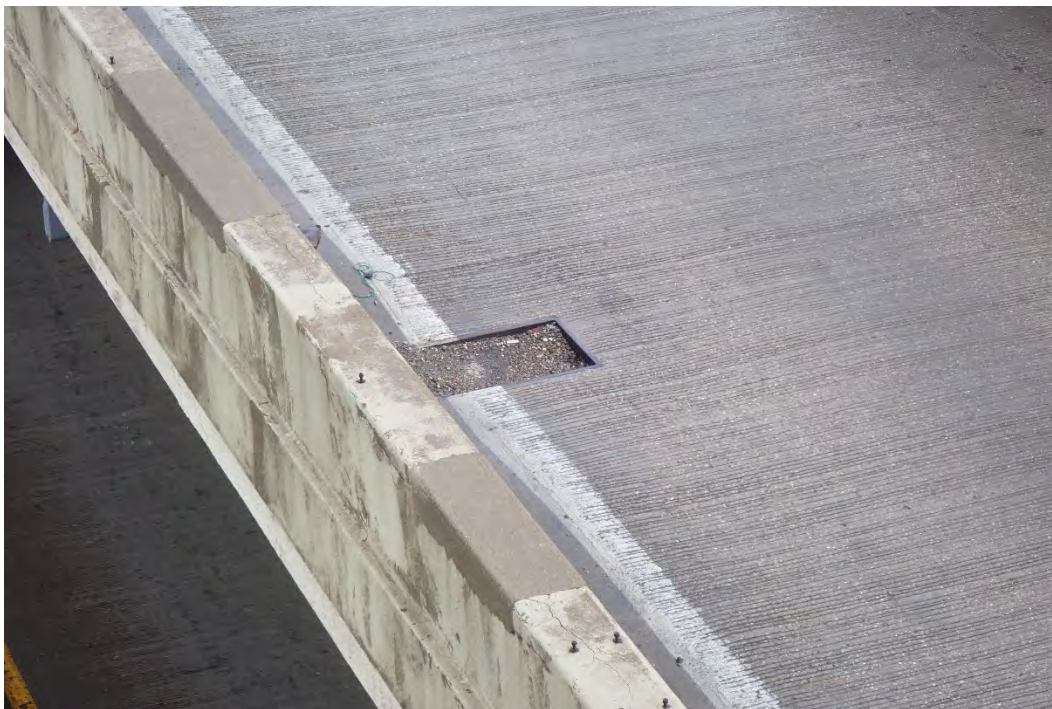
*Photo 25 - Missing deck drain grate with debris accumulation at Span 2A, looking northeast.*

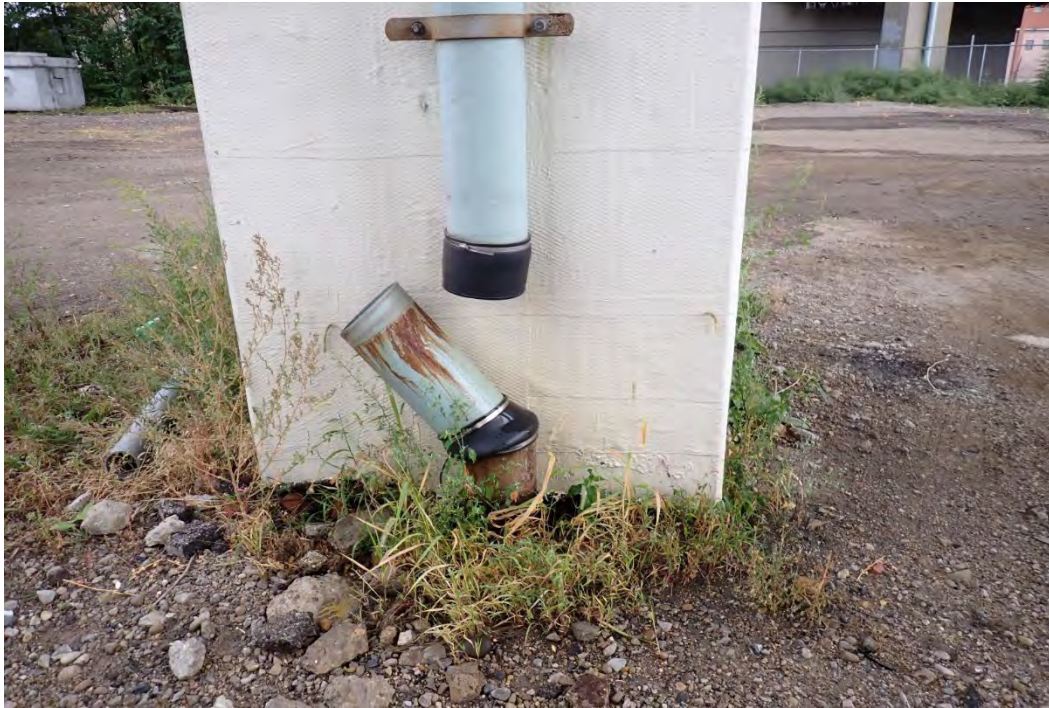
*Photo 26 - Typical disconnected drainpipe at pier column base at Pier 19A, looking south.*

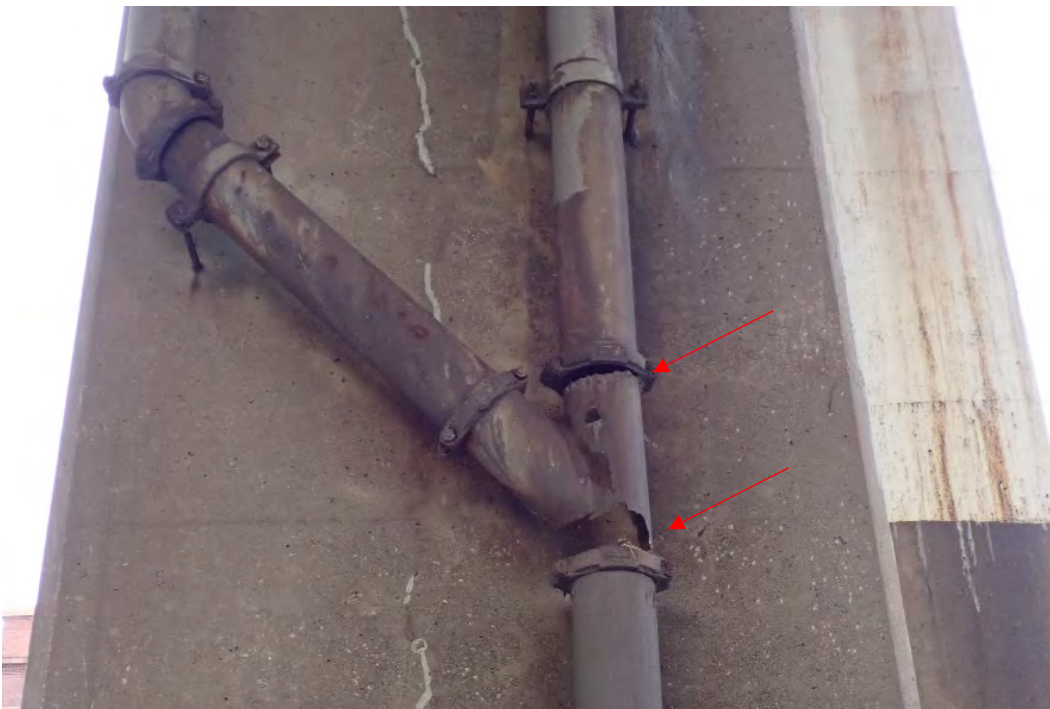
*Photo 29 - Corroded drainpipe, with holes and disconnections at joints at River Pier west column, looking west.*

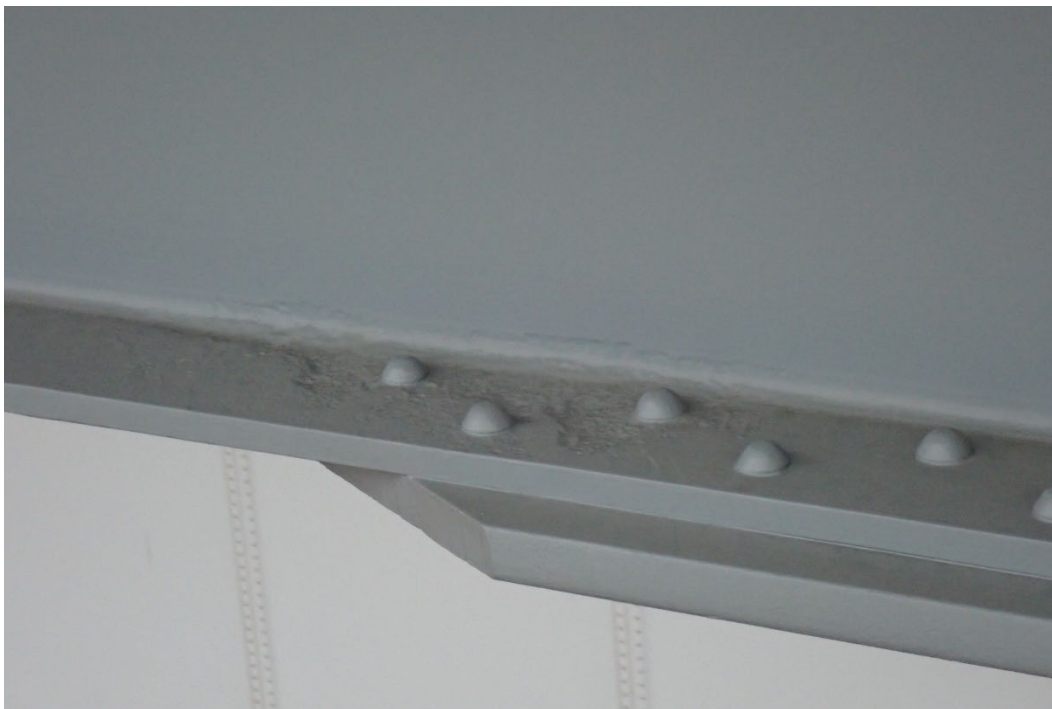
*Photo 31 - Typical Painted over minor section loss from previous corrosion on bottom flange at Pier 7A, looking east.*

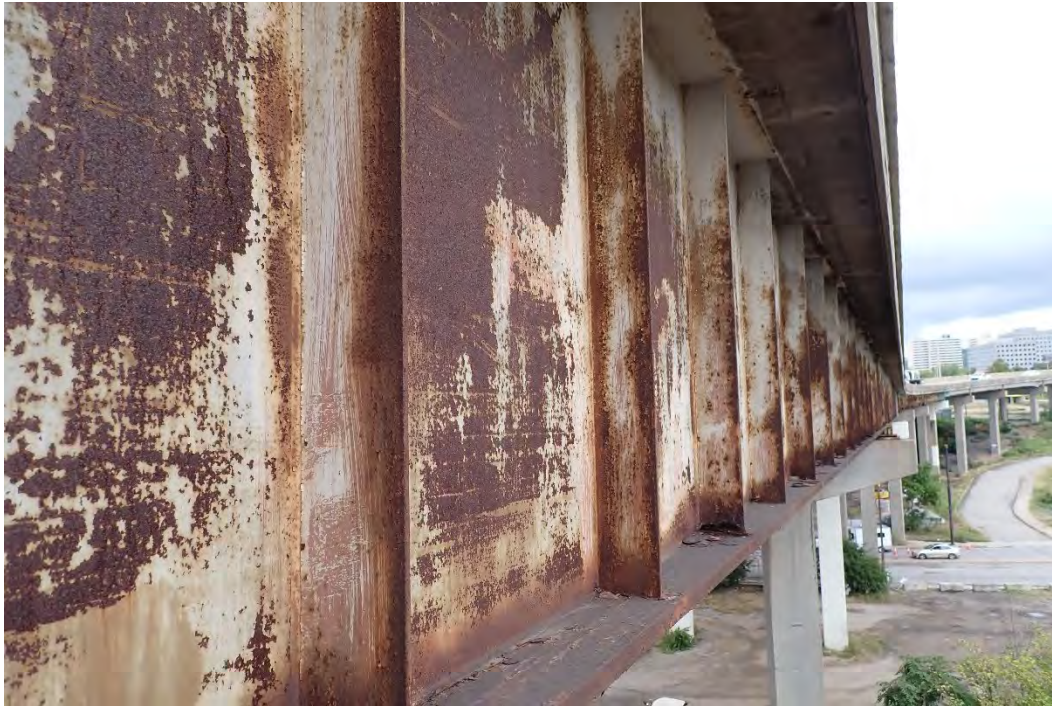
*Photo 36 - Typical surface corrosion and pack rust in webs and bottom flange of girders at Span 18A east facia girder looking north.*

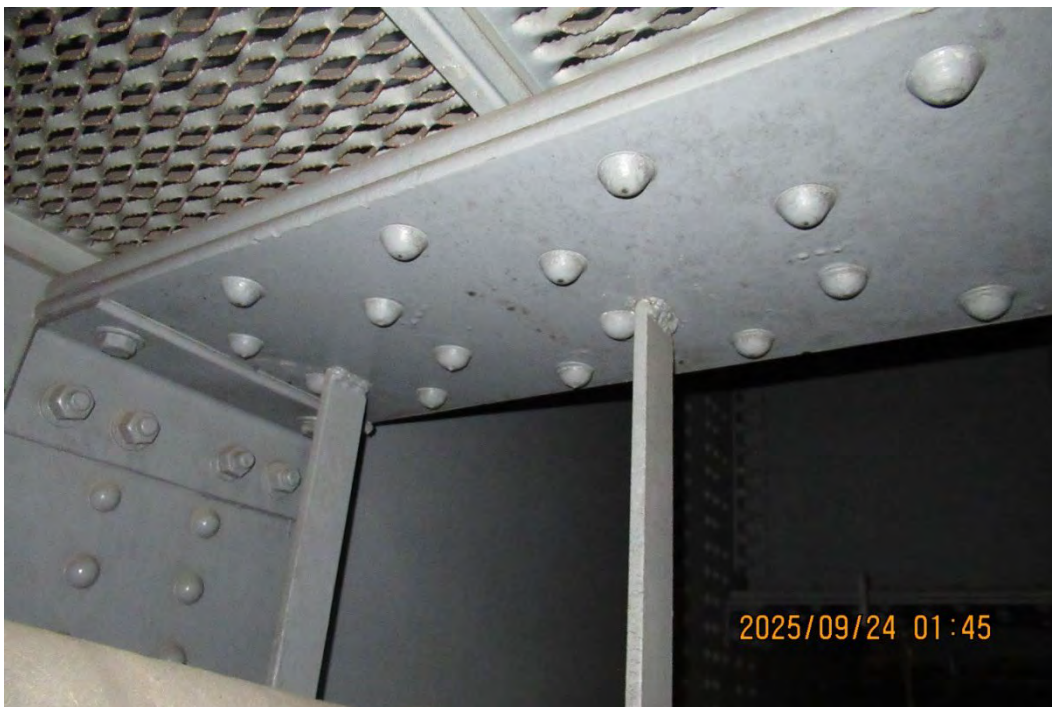
*Photo 37 - Drain pipe hangers welded to the bottom flange of Girder E at Pier 12A, looking southeast.*

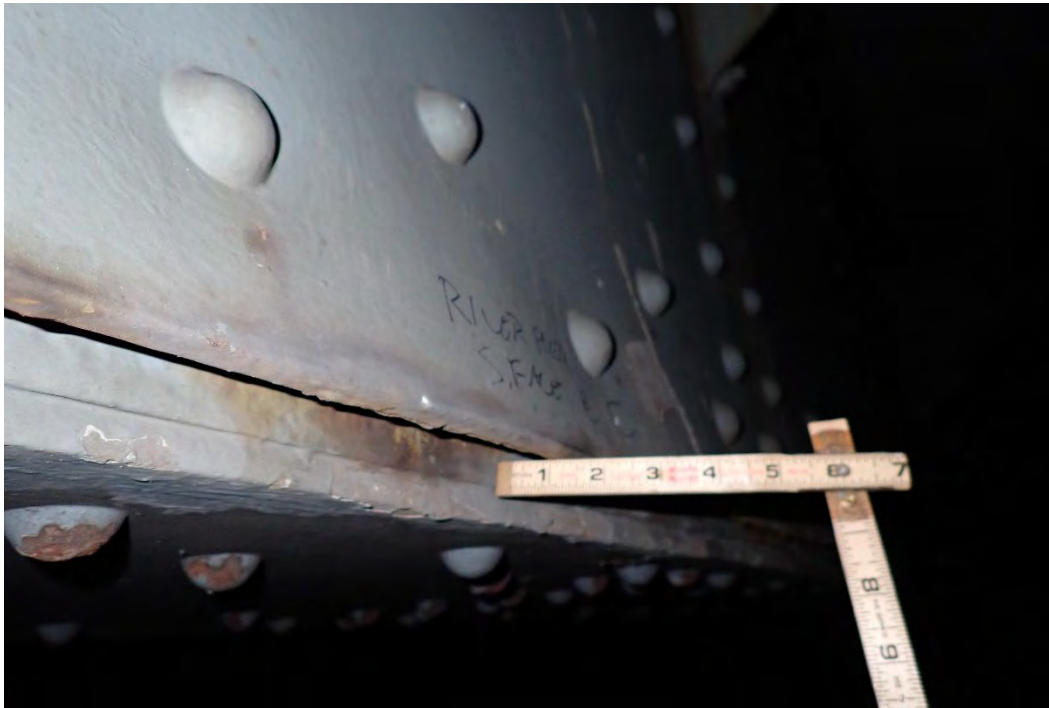
Photo 44 - Typical pack rust between box cap web and internal bottom flange angles at River Pier Girder C, looking east.

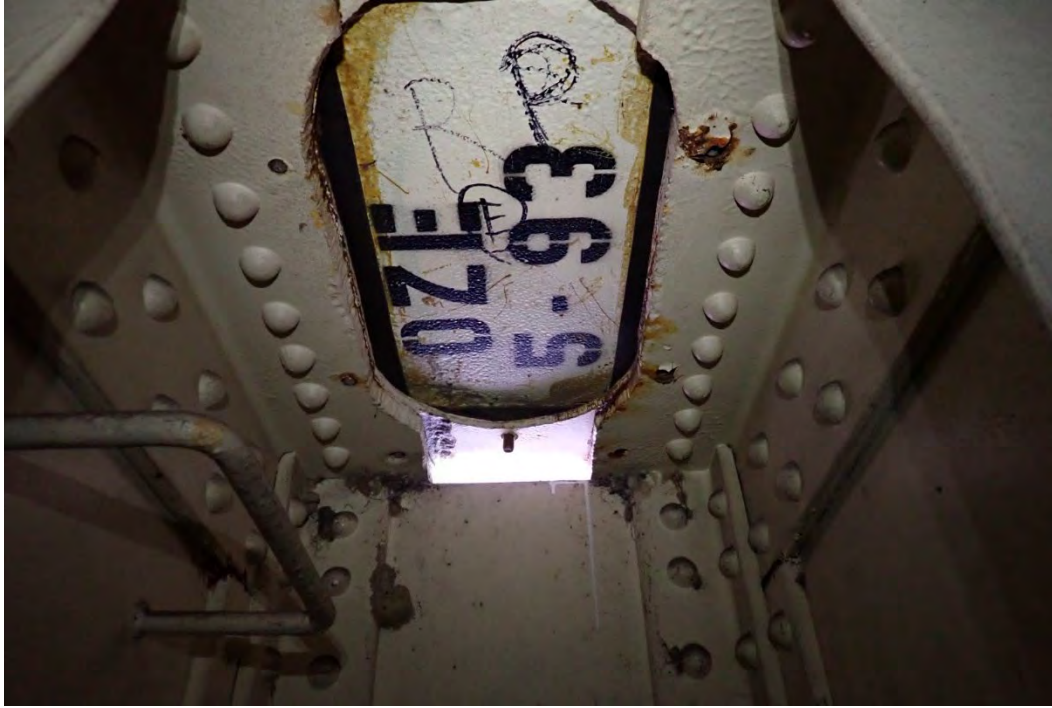
*Photo 47 - Minor areas of freckled rust around top hatch at east end of box cap at River Pier, looking east.*

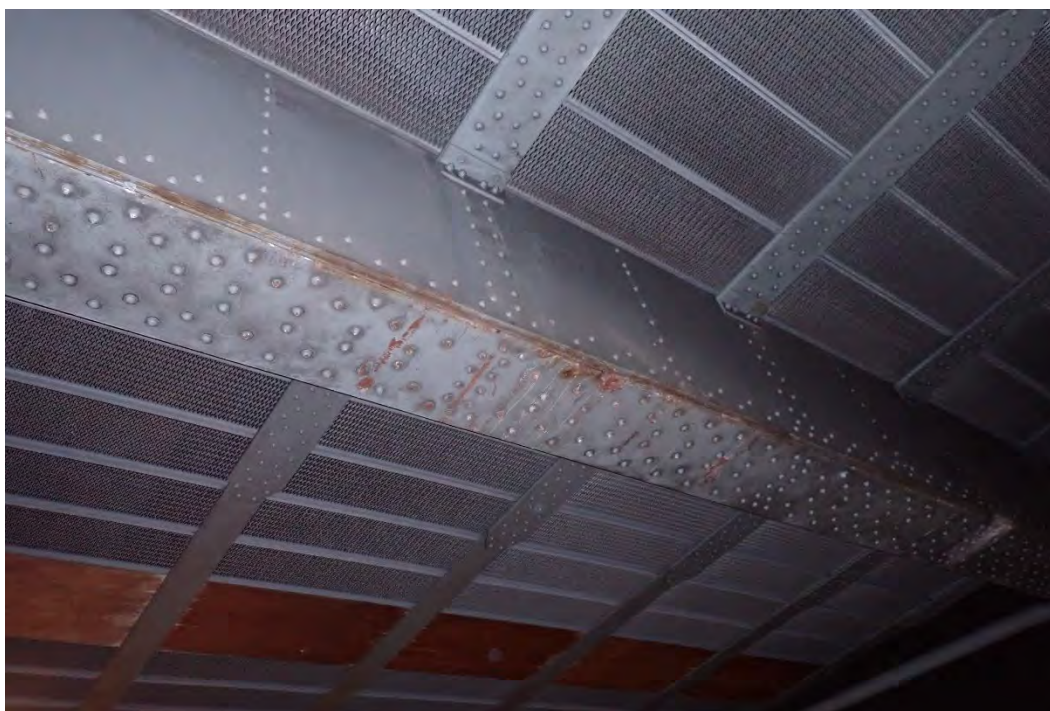
*Photo 48 - Typical surface corrosion and impact damage on bottom flange of box cap at Pier 1A, looking northeast.*

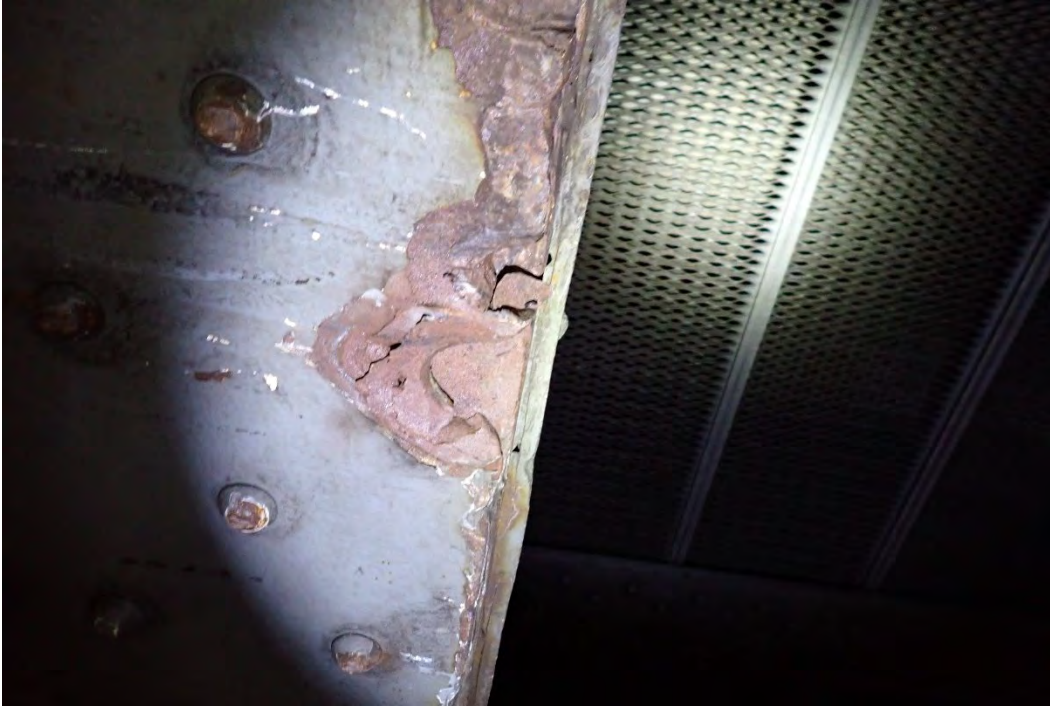
Photo 49 – Impact damage and corrosion with minor section loss, with missing rivet from bottom flange over center lanes on Pier 1A, looking northeast.

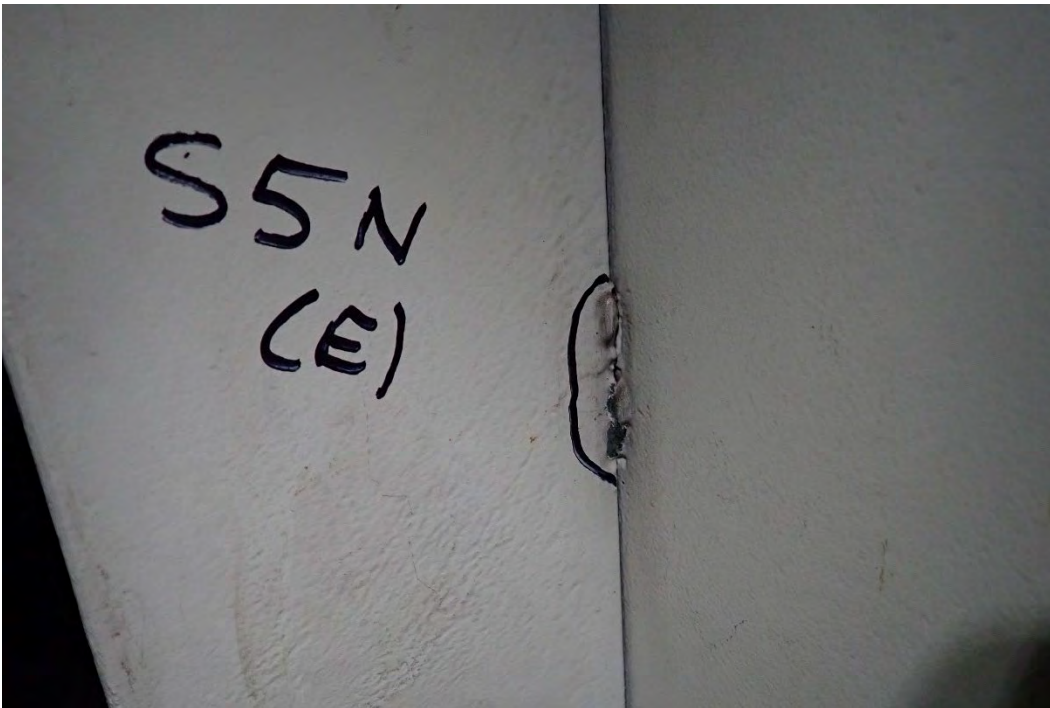
\*According to the most recent version of the AASHTO LRFD Bridge Design Specifications, tack welds do not have a defined fatigue category but are considered problematic details. Therefore, each type of tack weld was assigned an equivalent Fatigue Category based on size, orientation, and location.

Photo 50 - Typical tack weld between box cap web and interior stiffeners at Pier 1A, looking west.

- Continue to monitor the lateral movement of the girder ends in Span 24B.
- Continue to monitor the fatigue-prone details of the Non-Redundant Steel Tension Member members, especially cracked tack welds.
- Monitor erosion around Pier 18A.

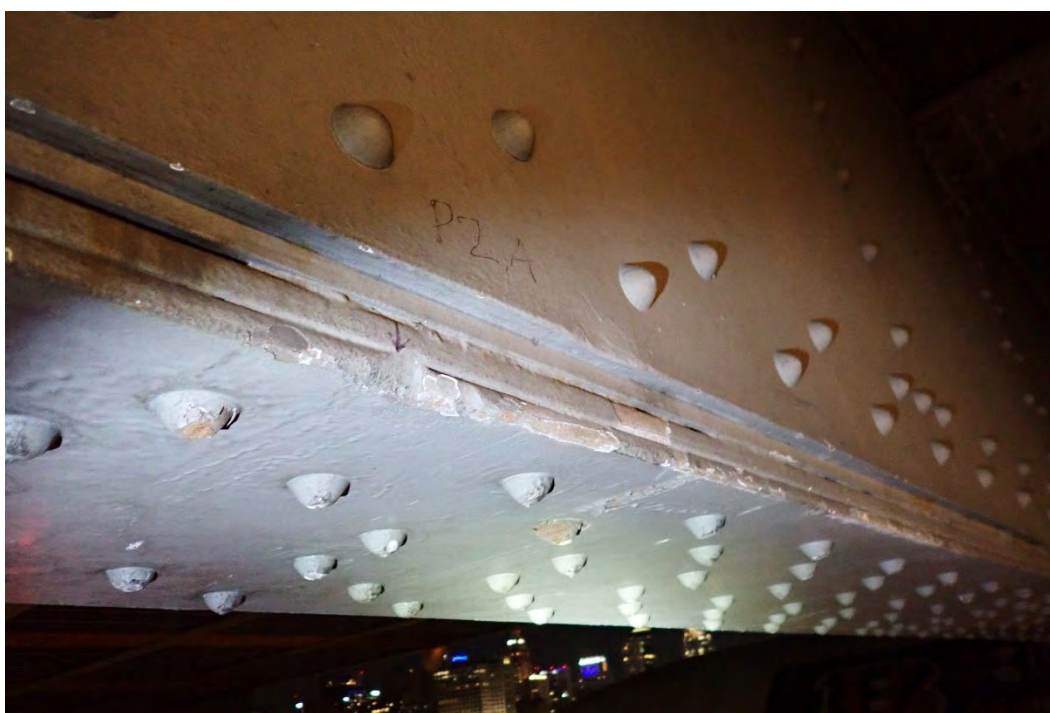
*Photo 51 - Minor impact damage and scrapes along bottom flange of box cap at Pier 2A, looking northeast.*

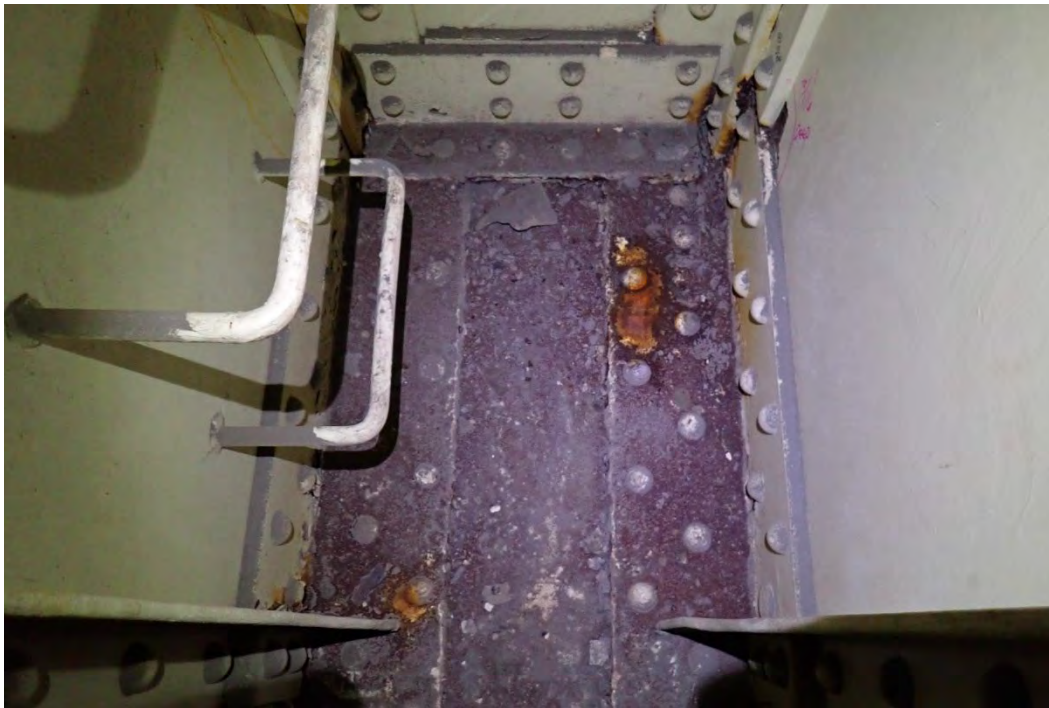
*Photo 53 - Typical interior corrosion with pitting of bottom flange in box cap at Pier 3A, looking east.*

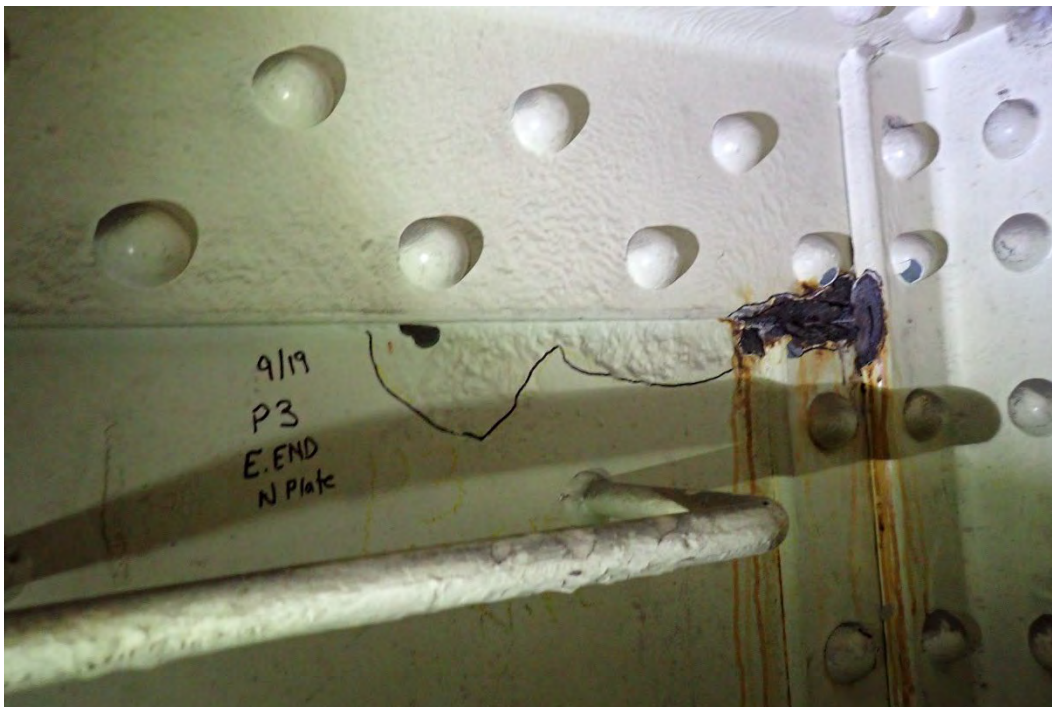
Photo 55 – Painted-over pitting and active corrosion at the east end on Pier 3A, looking north.

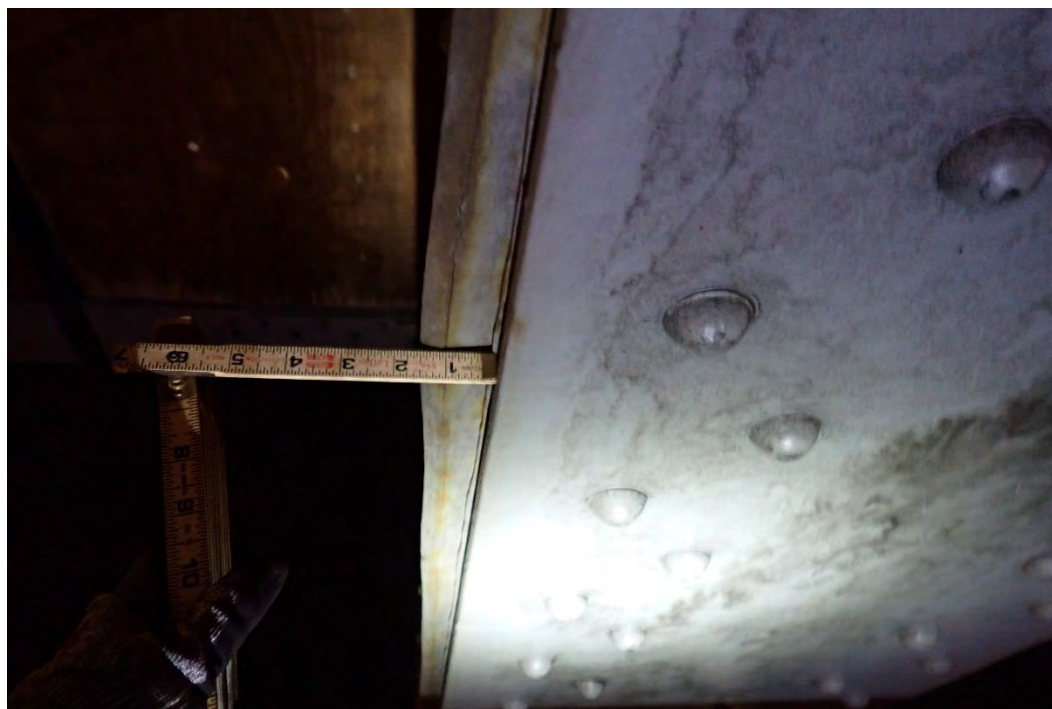
*Photo 56 - 1" thick pack rust below the bottom row of rivets, between the web plates and the internal bottom flange connection angles at Pier 4A.*

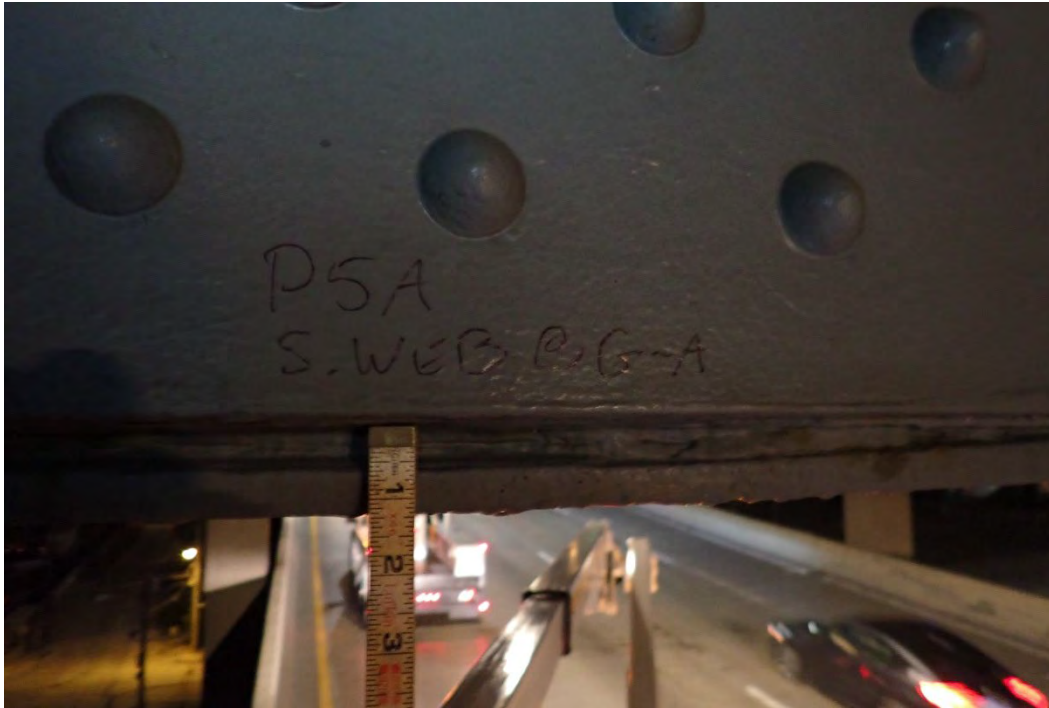
Photo 59 - 5/8" thick pack rust below the bottom row of rivets, between the web plates and the internal bottom flange connection angle at Girder A of Pier 5A.

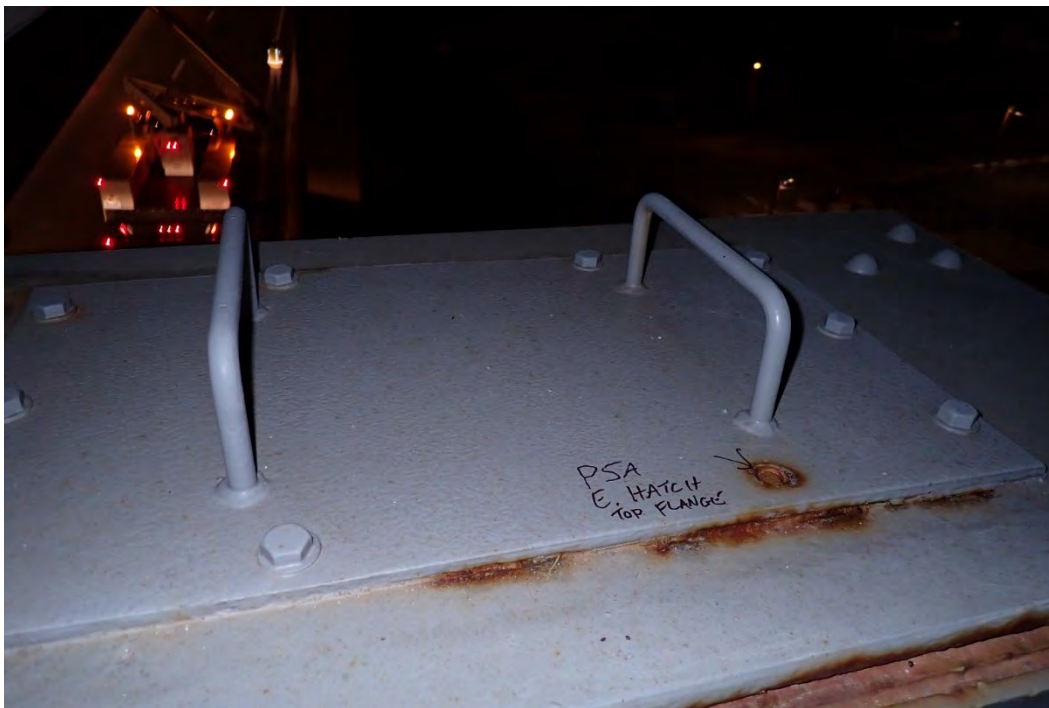
Photo 60 - Typical top hatch access to box cap interior, with missing bolt at Pier 5A, looking north.

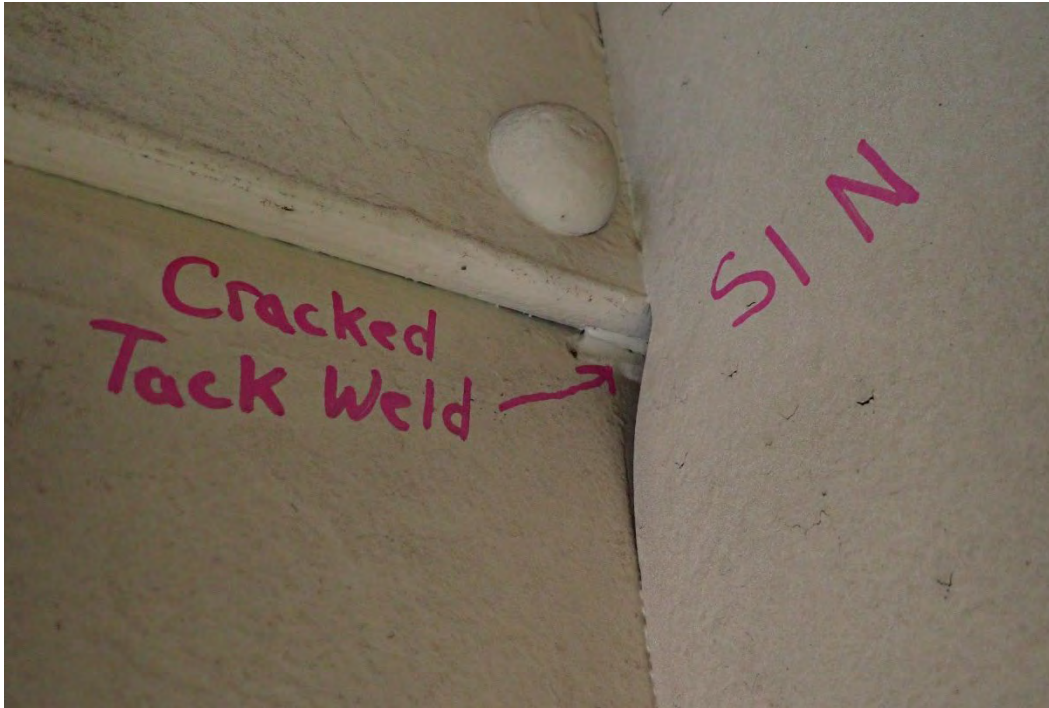
Photo 61 - Typical cracked tack welds between the top flange connection angles and web plates at Stiffener 1 of Pier 5A.

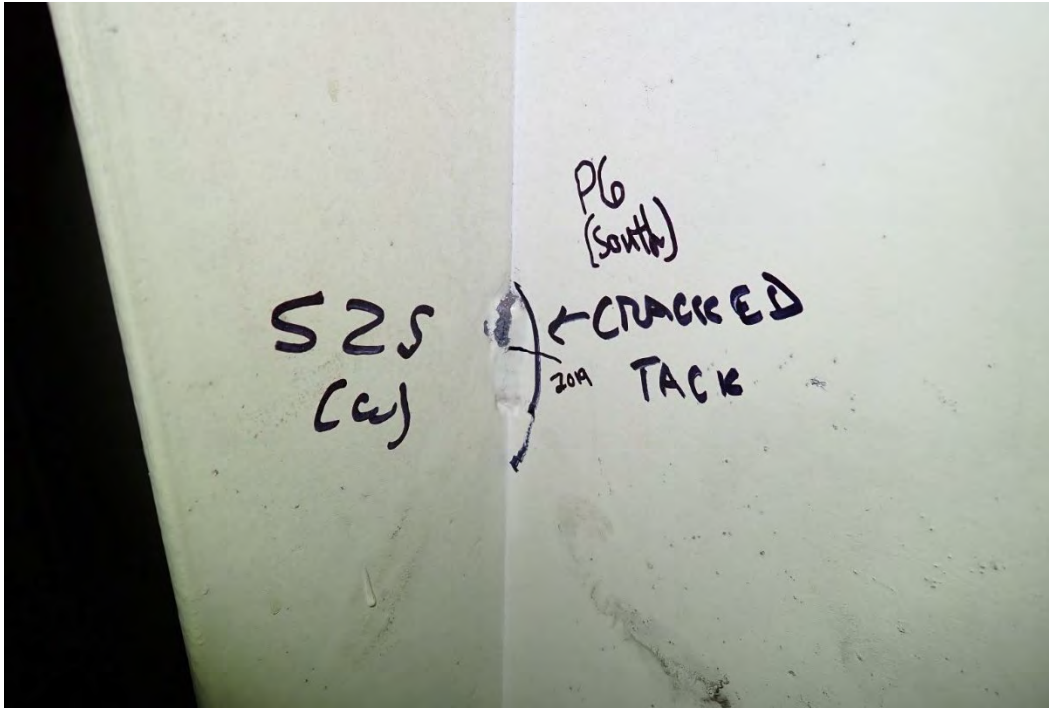
Photo 65 - Typical cracked tack weld in box cap interior at Pier 6A, looking southeast.
