# BRENT SPENCE APPROACH BRIDGE

HAM-71-0000L

SFN: 3105946

## 2025 In-Depth/NSTM Inspection Report

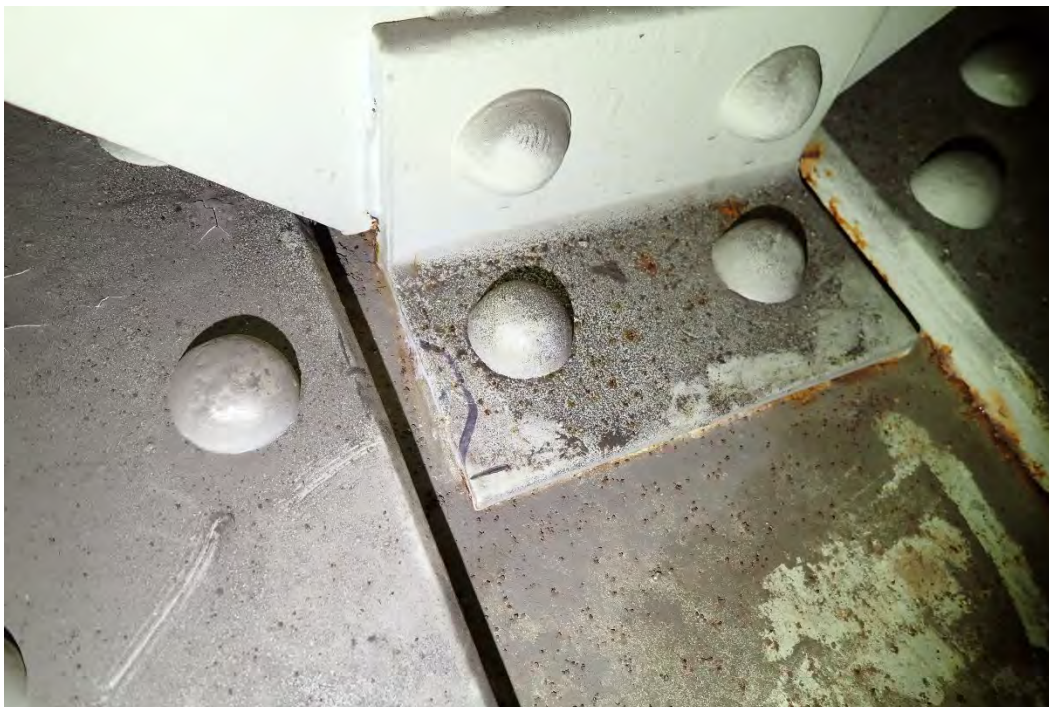
Photo 66 - Typical freckled rust on the surface of the bottom flange plates and bottom flange angles in box cap of Pier 6A.

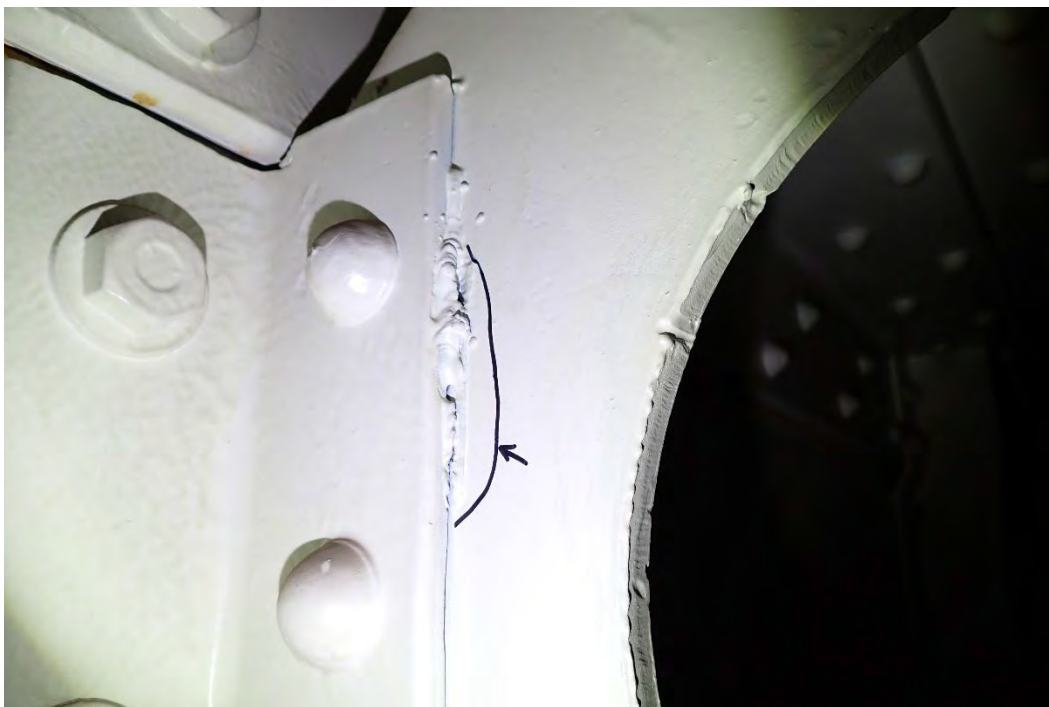
Photo 68 - Typical cracked weld between interior connection bottom angle and the diaphragm plate at Pier 7A, looking northeast.

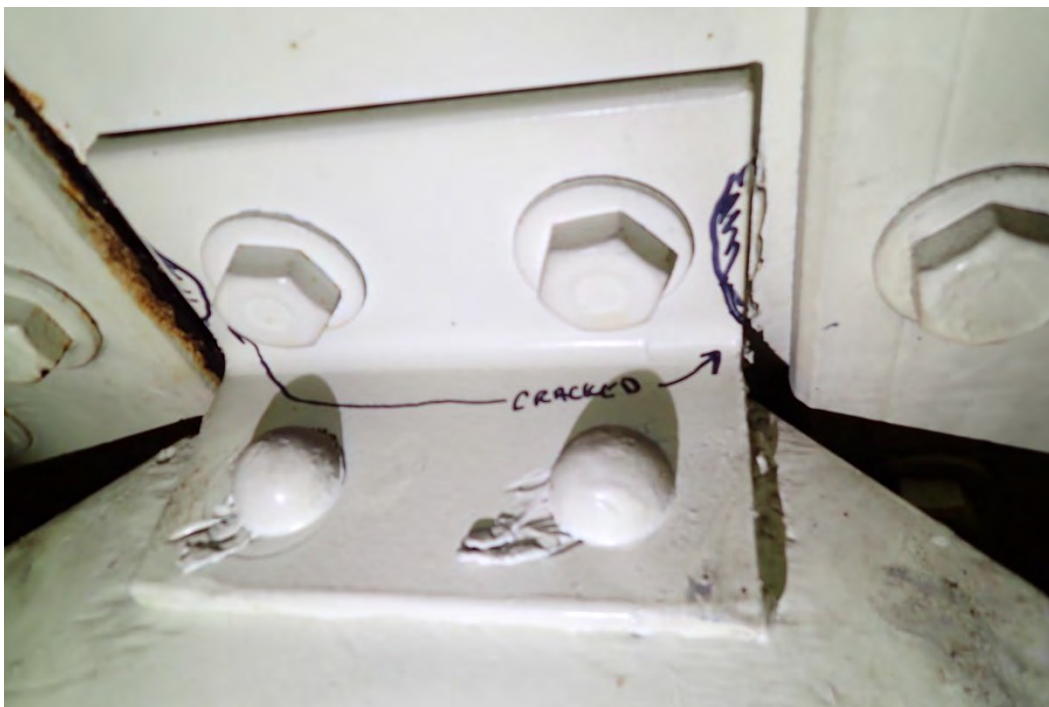
Photo 70 - Cracked welds between the top flange and the top clip angle of the interior diaphragm of Pier 8A, looking west.

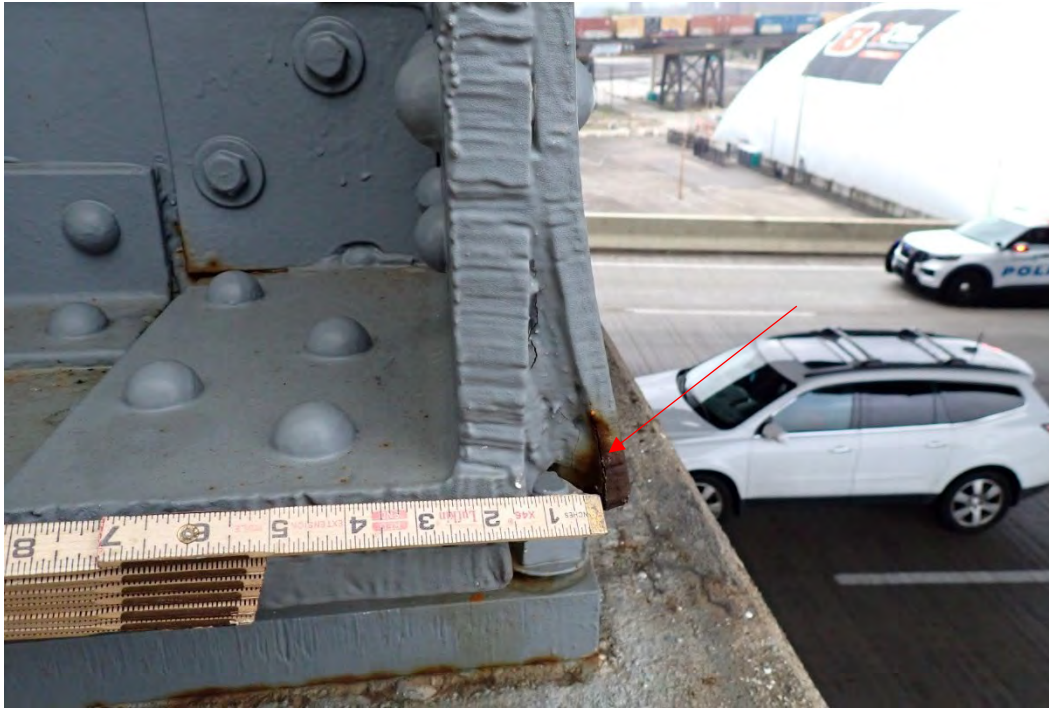
Photo 71 - 1/8" pack rust at the west end of Pier 9A's box cap, looking east.

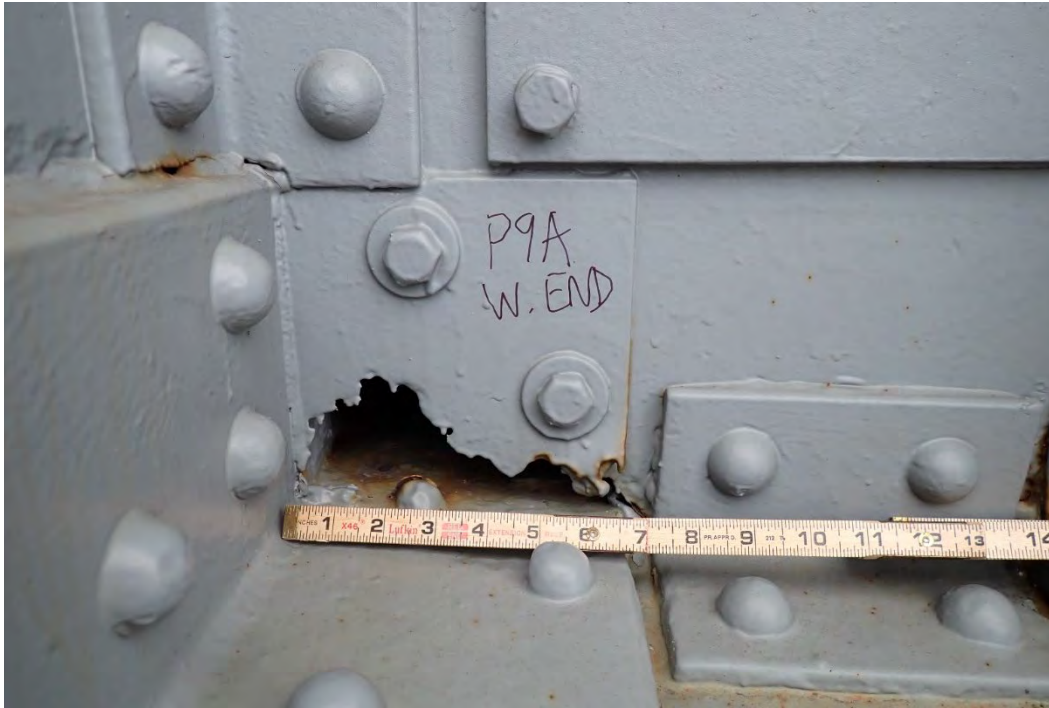
Photo 73 - 100% section loss of a bolted and welded keeper plate approximately 6.5" x 3" at the west end of Pier 9A's box cap, looking east.

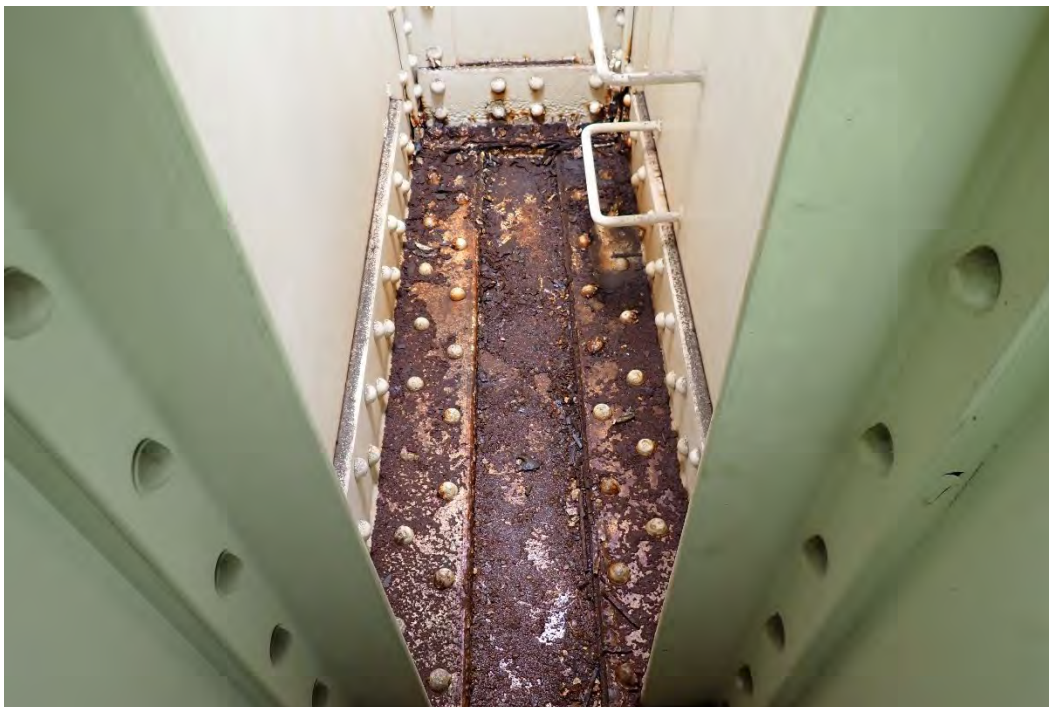
Photo 74 - Bottom surface of box cap covered by up to 1/2" of granular debris and dust that is rusting from moisture.

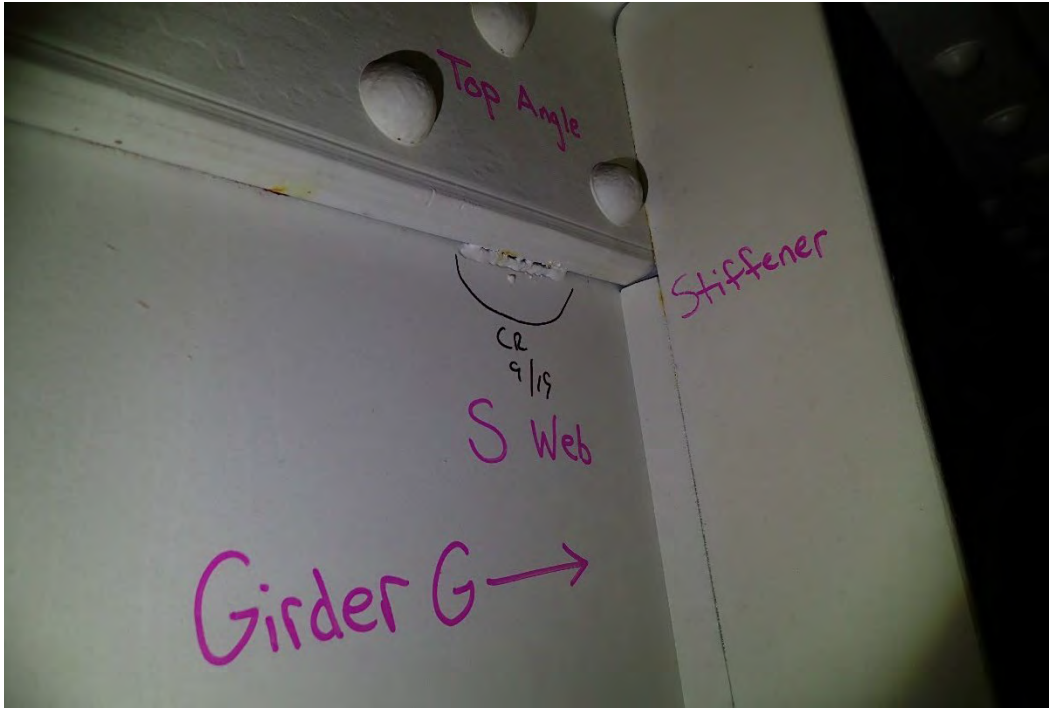
Photo 75 – Cracked tack weld at the south web and top flange angle at the first stiffener east of Girder G.

- Continue to monitor the lateral movement of the girder ends in Span 24B.
- Continue to monitor the fatigue-prone details of the Non-Redundant Steel Tension Member members, especially cracked tack welds.
- Monitor erosion around Pier 18A.

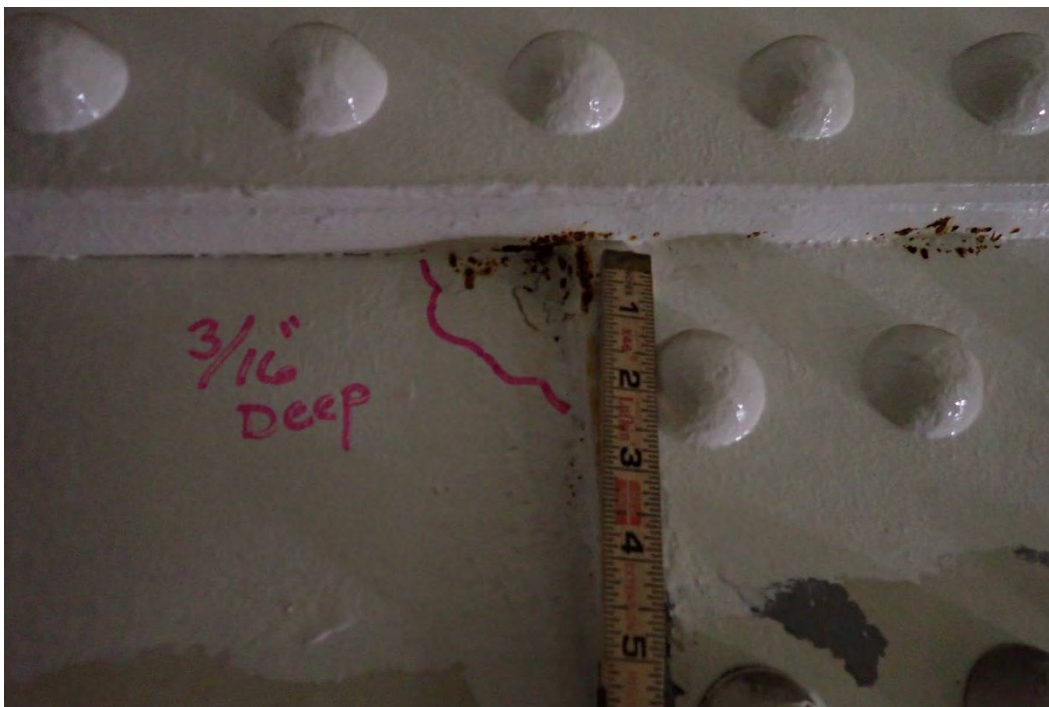
*Photo 81 - 1" diameter area of up to 3/16" deep pitting on south web at splice plate.*

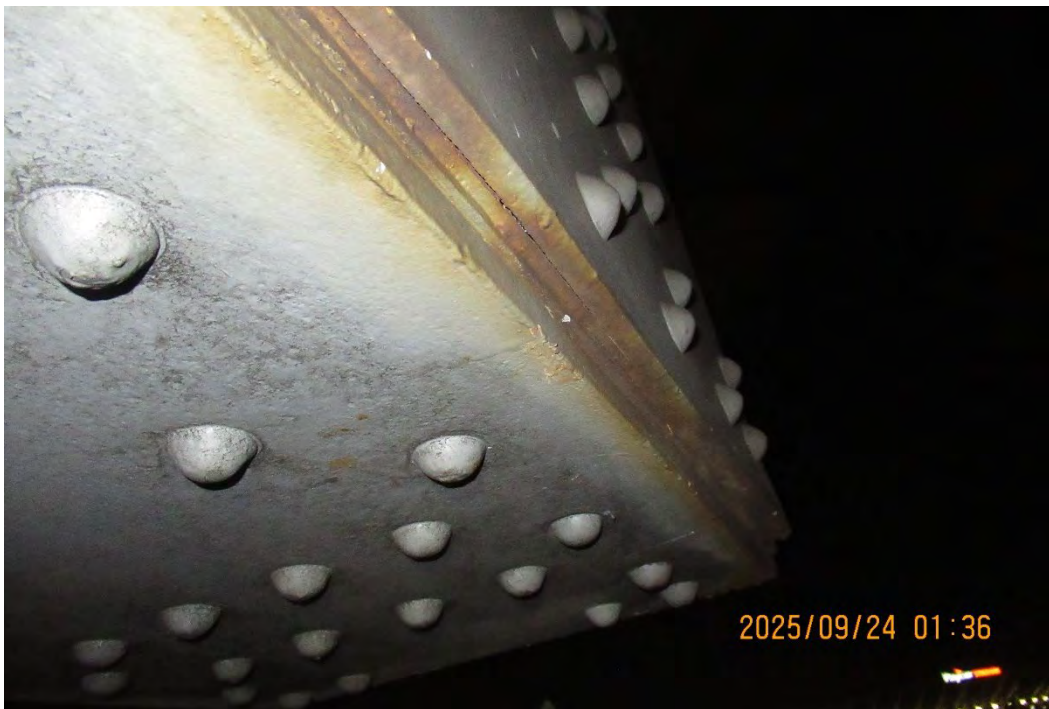
*Photo 82 - 3/8" thick pack rust between both web plates and bottom flange angles that has been previously caulked and painted.*

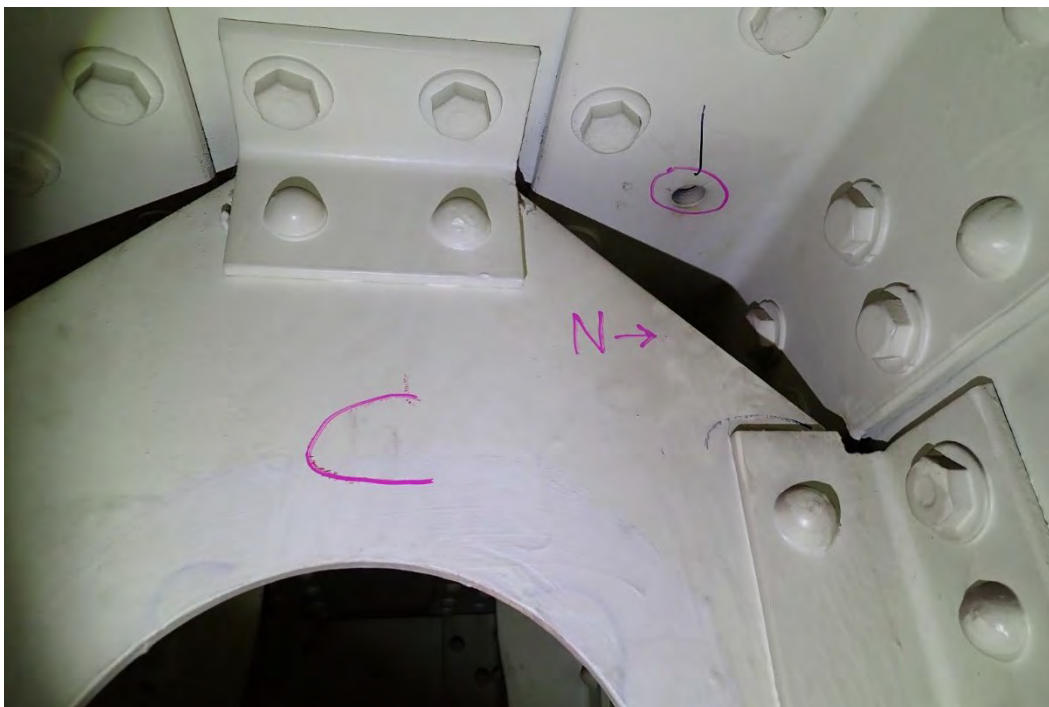
Photo 85 - Top flange angle at Girder C in box cap has a blank hole at Pier 13A, looking west.

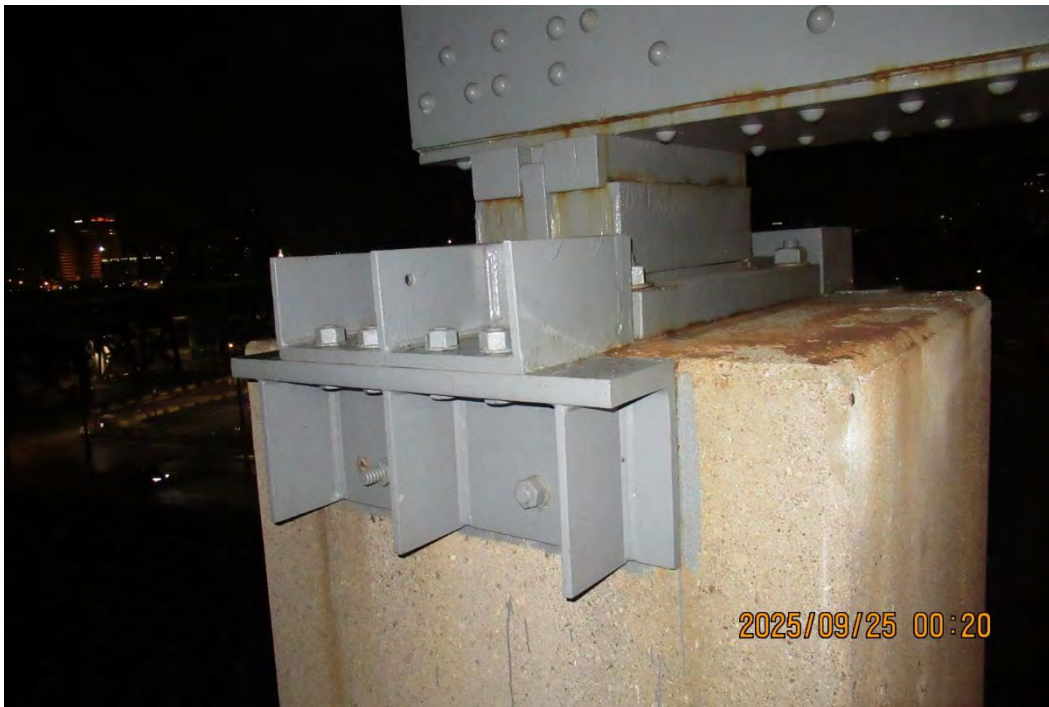
The east bearing of Pier Cap 11A has a retrofit to the bearing plate (Photo 94) and the south keeper lug of the rocker plate is misaligned and sitting on top of the masonry plate (Photo 95). There are loose anchor nuts at the west bearing of Pier Cap 8A, the east bearing of Pier Cap 12A, and the east bearing of Pier Cap 13A (Photo 96).

*Photo 94 - Retrofit to east bearing sole plate of Pier 11A, looking east.*

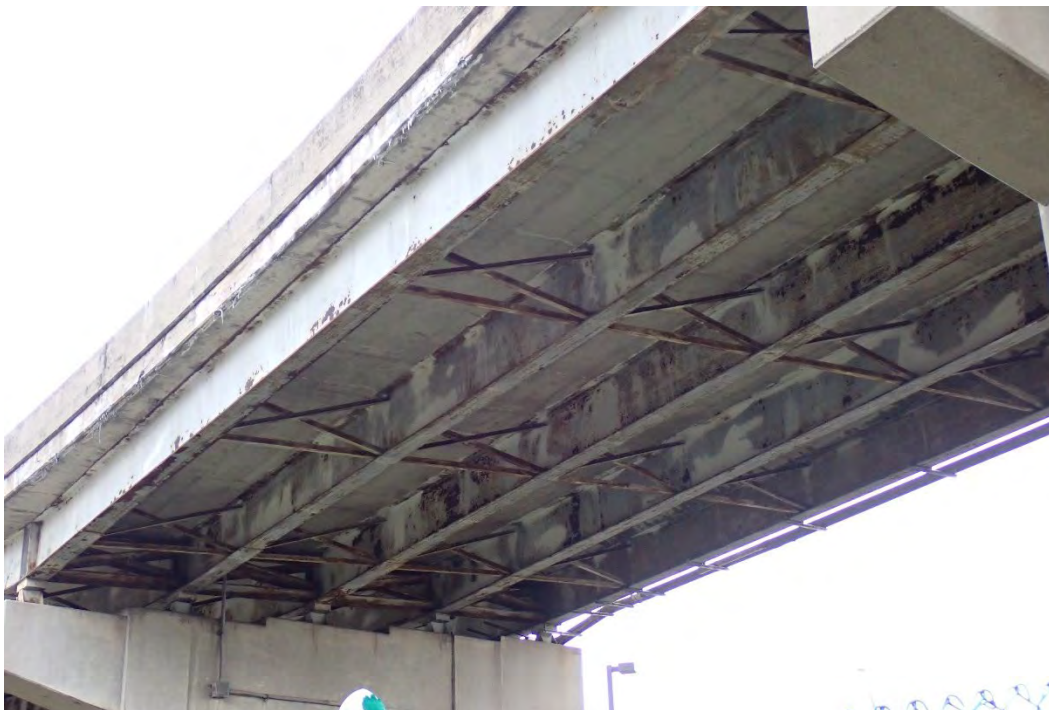
*Photo 99 - Span 27B exhibits typical paint failure on girders with chalking, dulling, flaking, and peeling, looking south.*

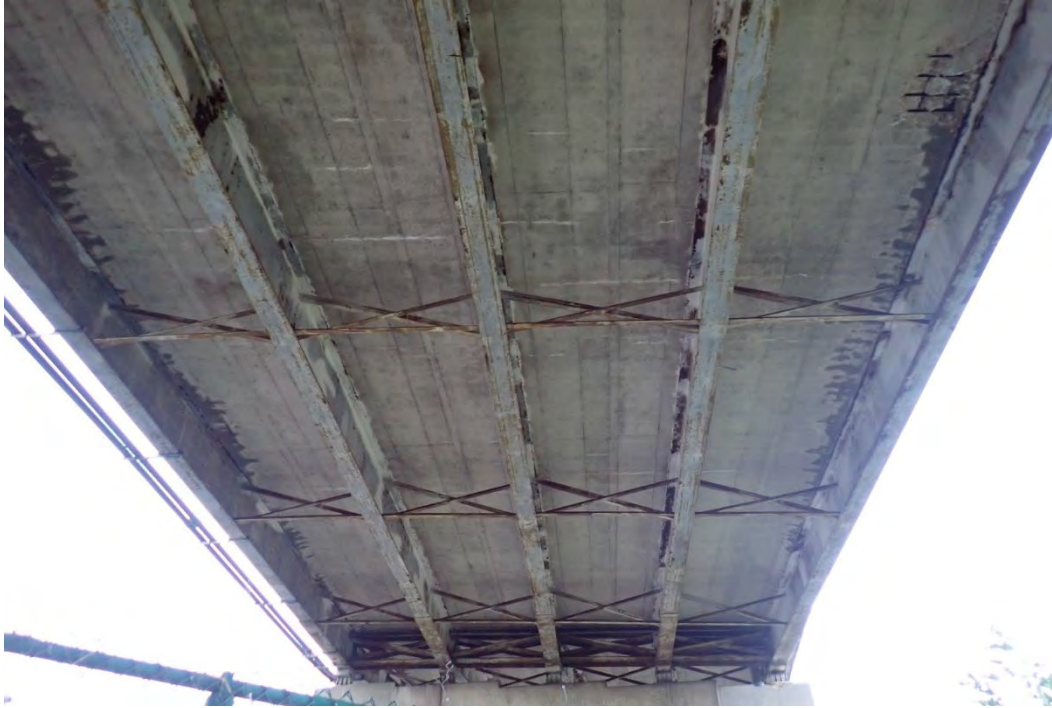
*Photo 102 - Typical protective coating failure, with minor surface corrosion, and chalking from Pier 15A to Pier 28B. Photo of Span 27B, looking north.*

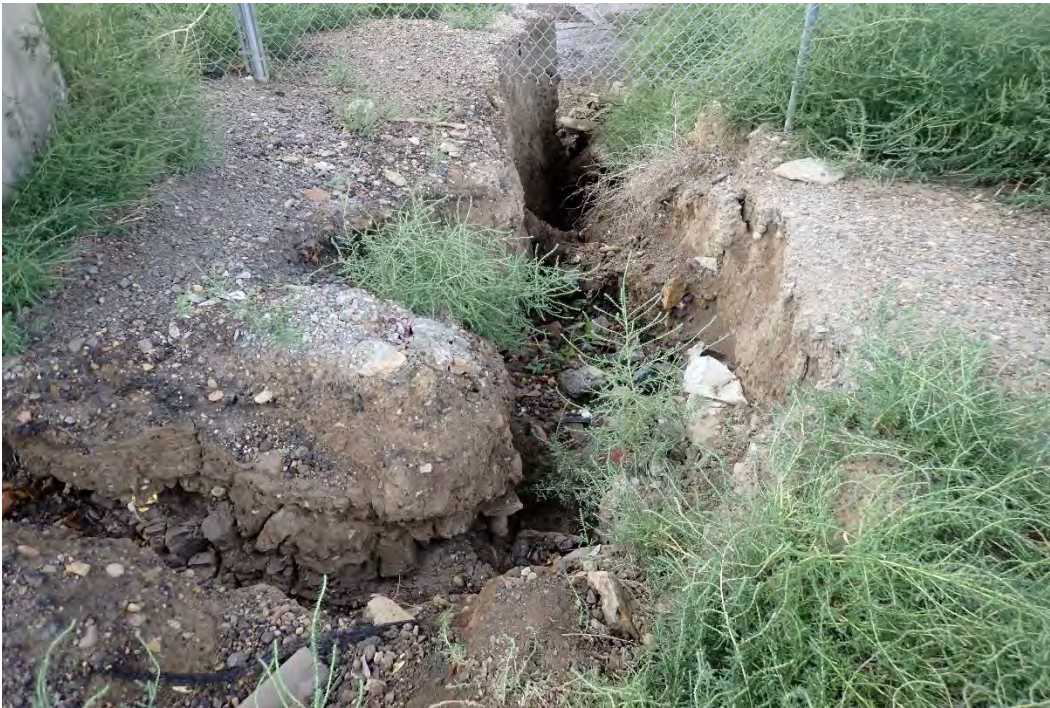
*Photo 114 - Up to 24" of erosion at the east column base of Pier 18A, looking south. Note: Erosion starts at the discharge of the pier drain pipe.*

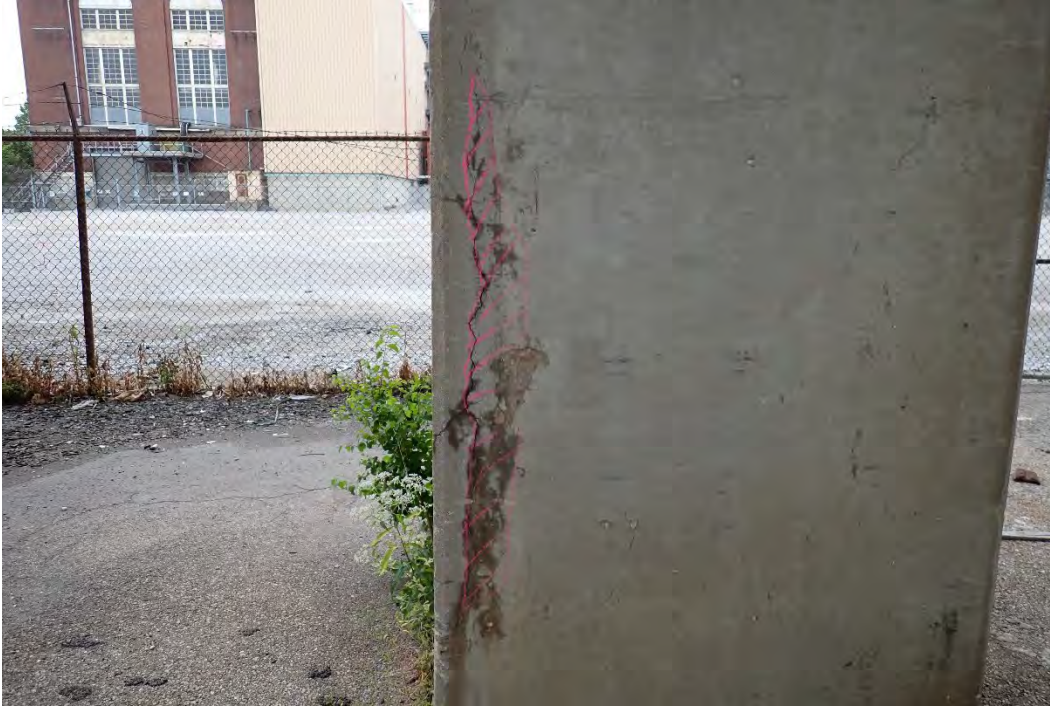
*Photo 115 - Minor spalling and delamination on west column of Pier 1A, looking west.*

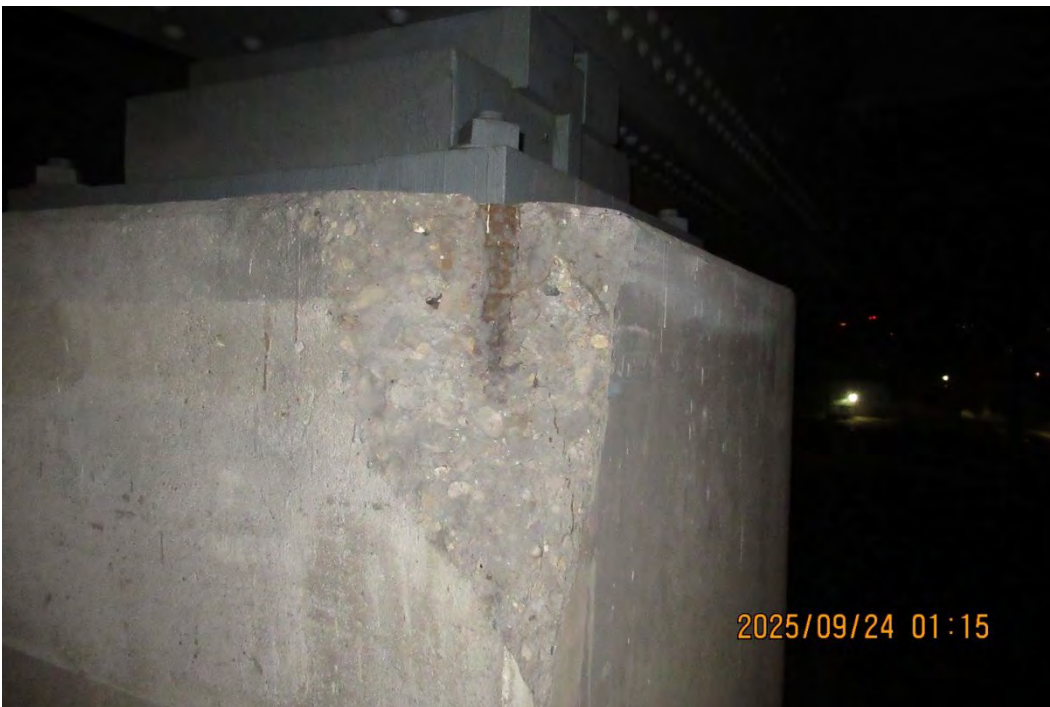
*Photo 116 - 12" x 12" x 3" corner spall with exposed rebar at Pier 11A, looking southwest.*

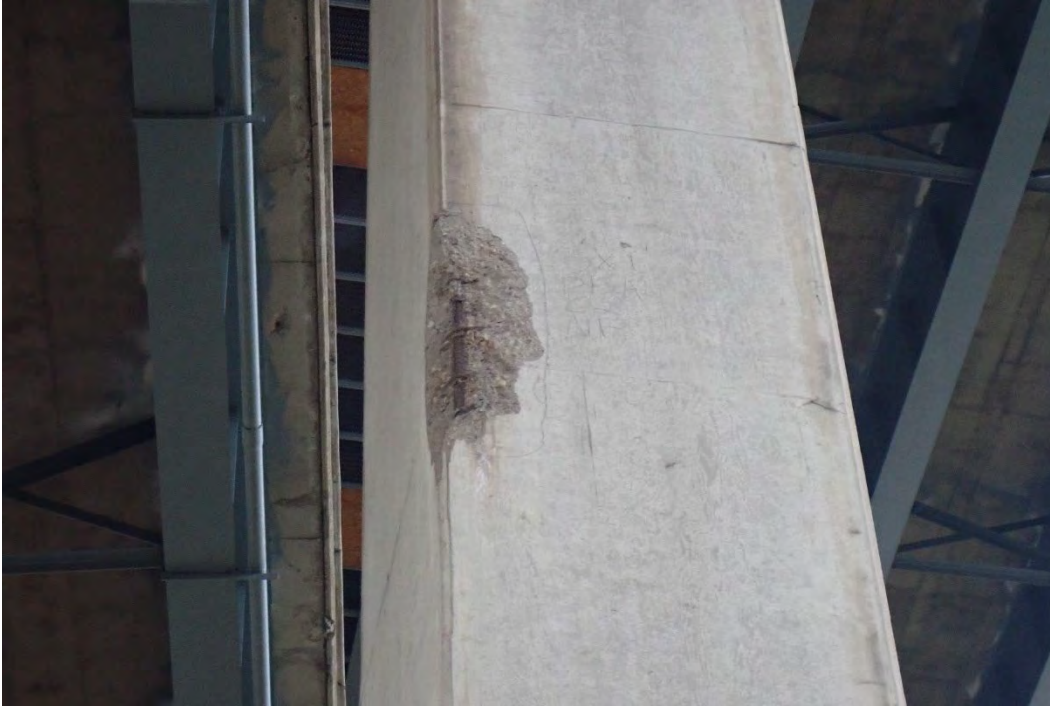
*Photo 117 - Large corner spall with rebar on the east column of Pier 13A, looking south.*

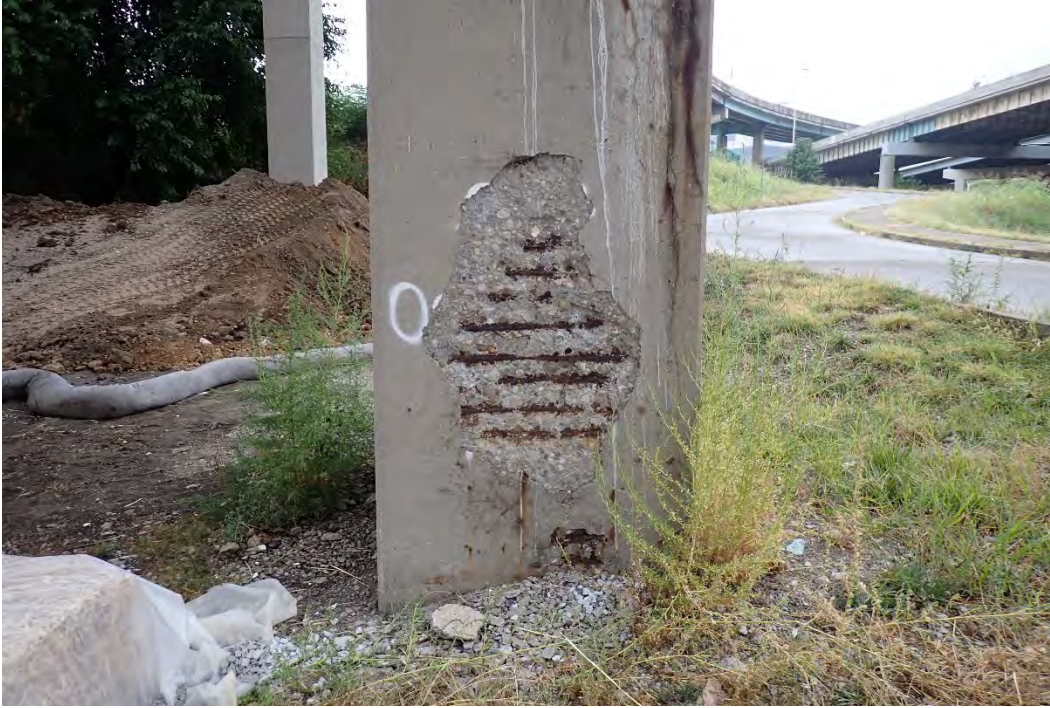
*Photo 119 - Large spall with rebar on east column of Pier 23B, looking northwest.*

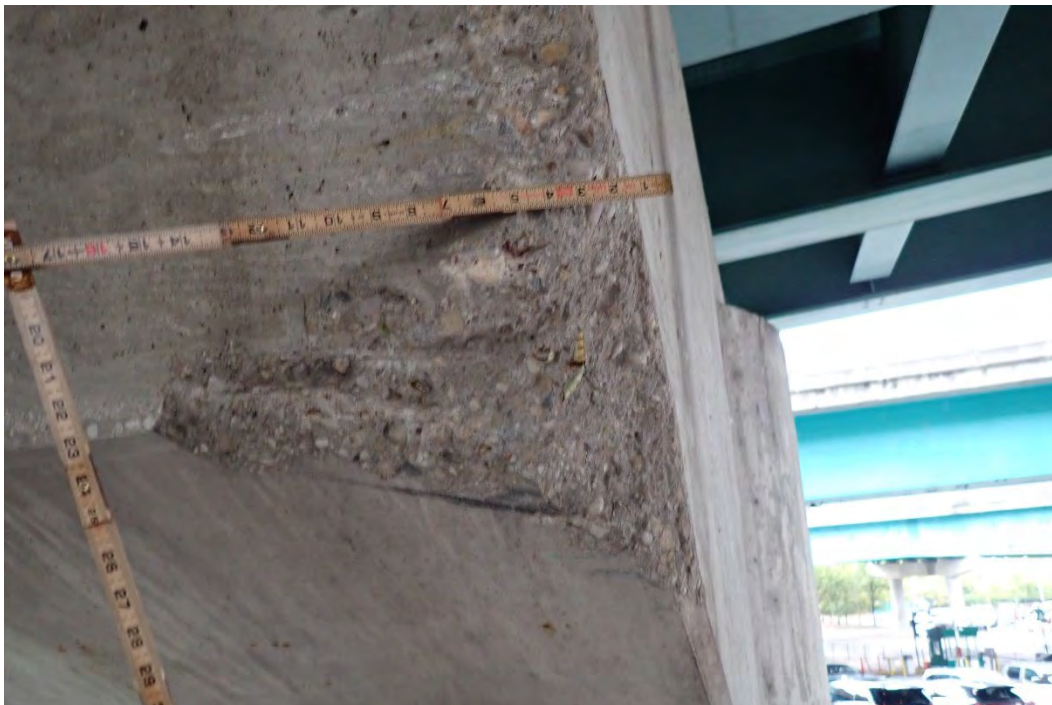
*Photo 122 - 24" wide by 24" high by 4" deep corner spall with exposed reinforcement at Pier 2 (FWW).*

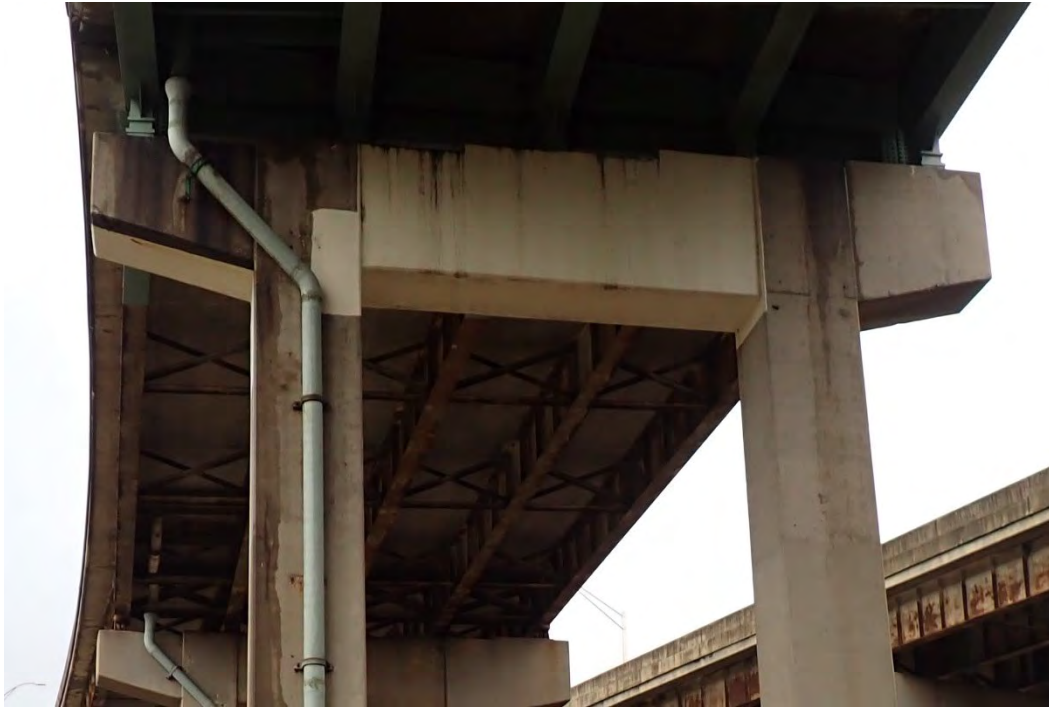
*Photo 123 - Failing/peeling protective coating at Pier 23B, looking south.*
