# BRENT SPENCE APPROACH BRIDGE

HAM-71-0000R

## 2025 In-Depth Inspection Report

Inspection Date: September 22-26, 2025

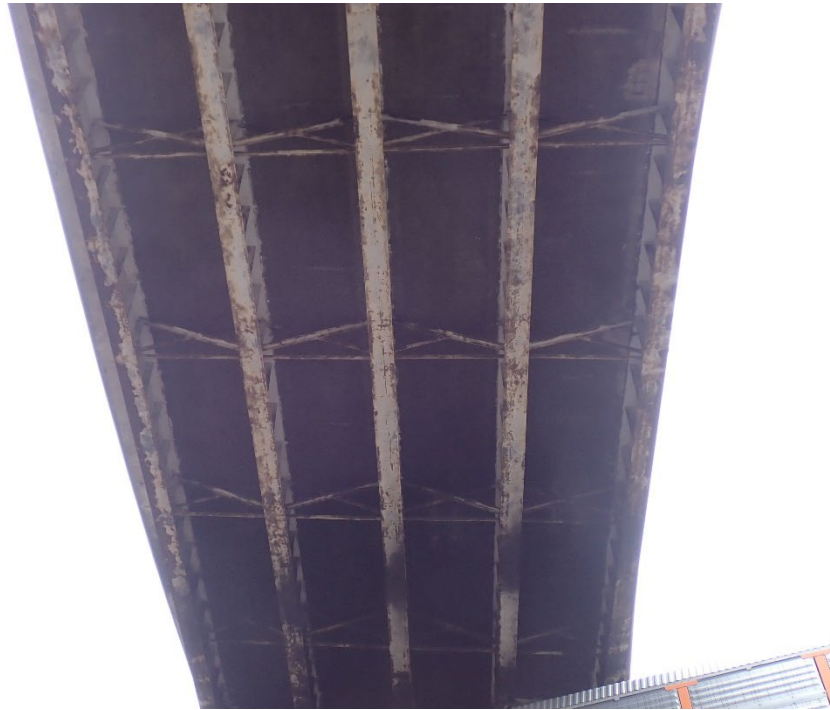
*Photo 1 - Soot staining the underside of Span 17D, looking north.*

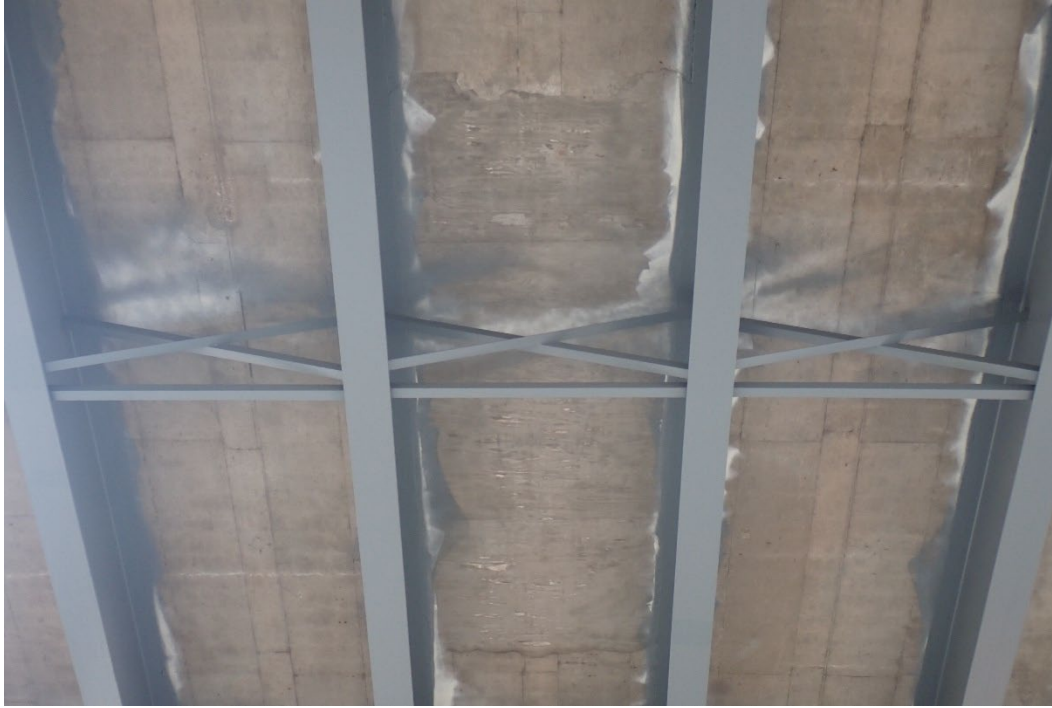
*Photo 2 - Typical full bay width patch at Span 2A Bay 3.*

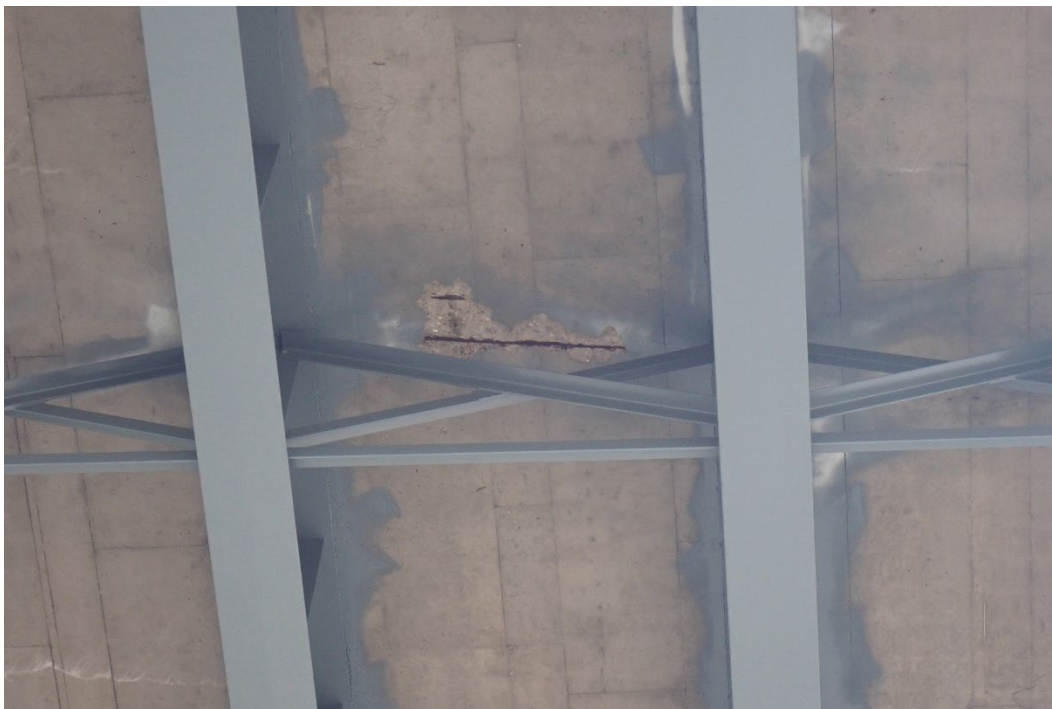
| Deck Defects | |
|---|---|
| Span 10A | 2' long x 1' wide deep spall with exposed rebar in Bay 6 at midspan ( <b>Photo 3</b> ). |

*Photo 3 – 2' long x 1' wide deep spall with exposed rebar in Bay 6 of Span 10A, looking south.*

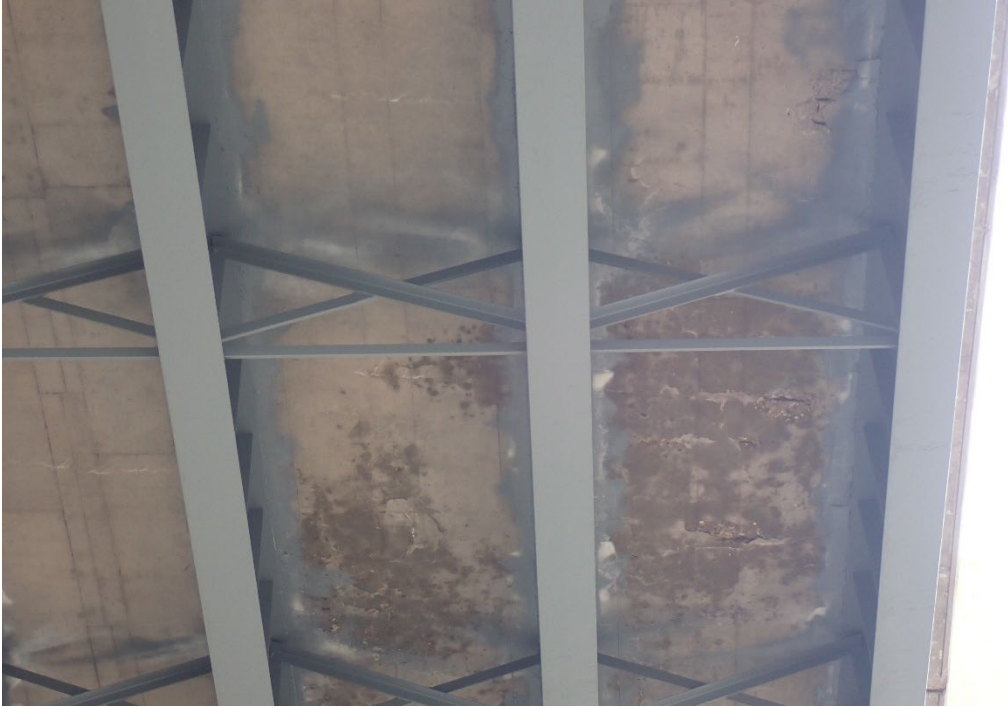
*Photo 4 - Minor spalls with exposed rebar in Bay 7 of Span 10A, looking south.*

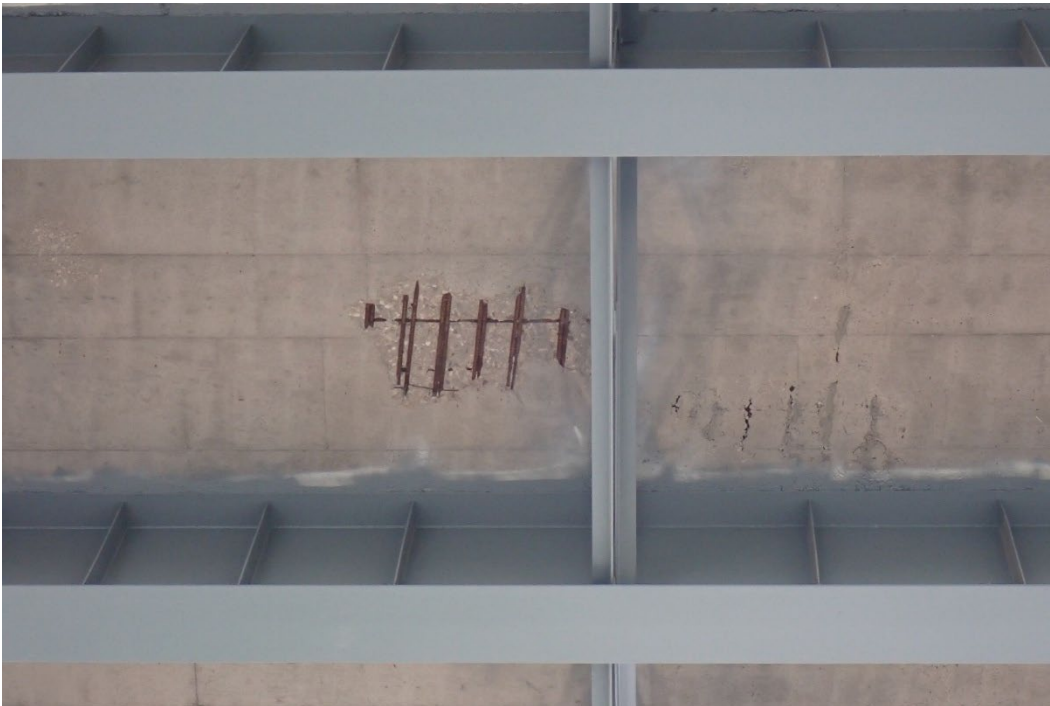
*Photo 5 - Deck spall with exposed rebar at Span 11A in Bay 4.*

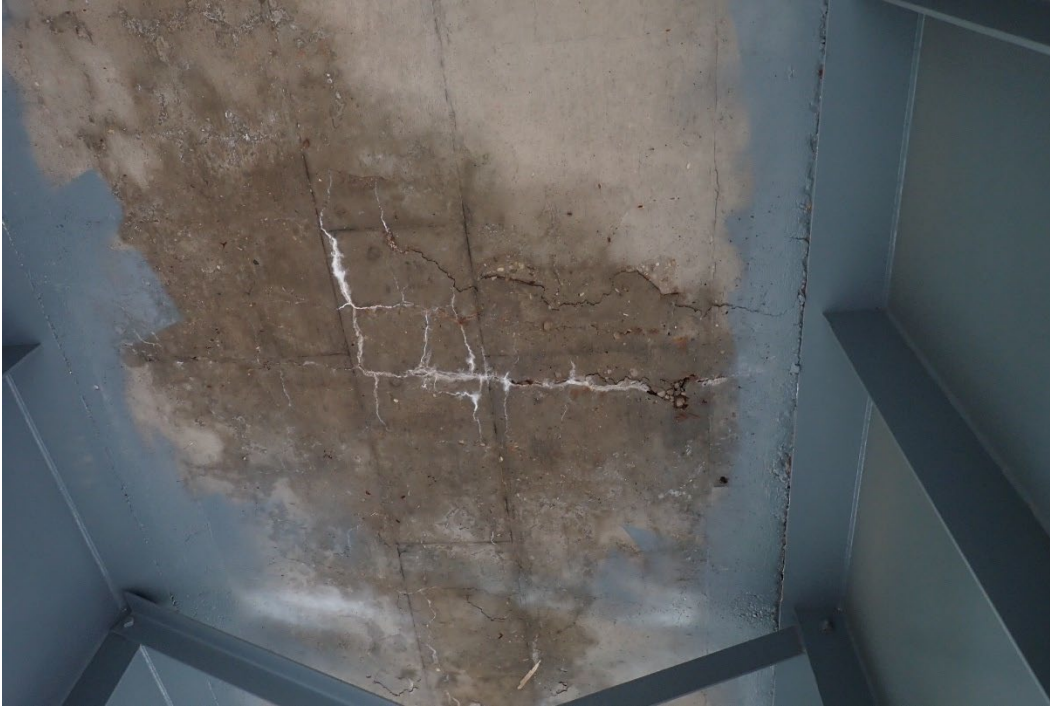
*Photo 6 - Delaminated and cracked area with efflorescence, at Span 12A, looking north.*

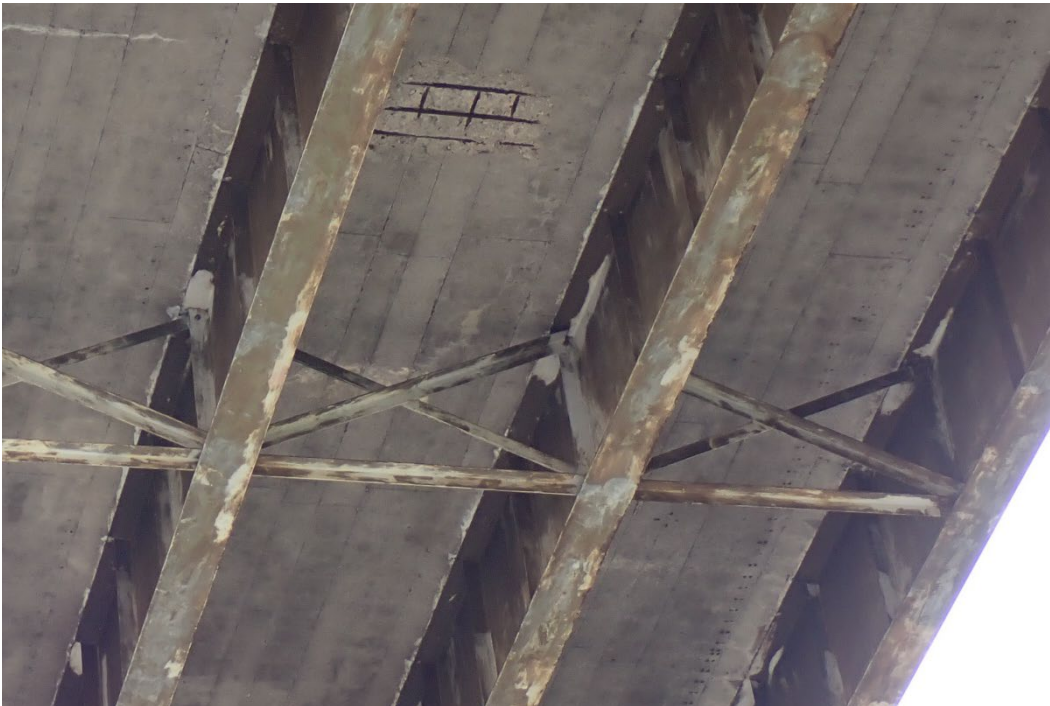
*Photo 7 – 36" x 48" x 2 1/2" spall with exposed rebar in Bay 2 of Span 18D.*

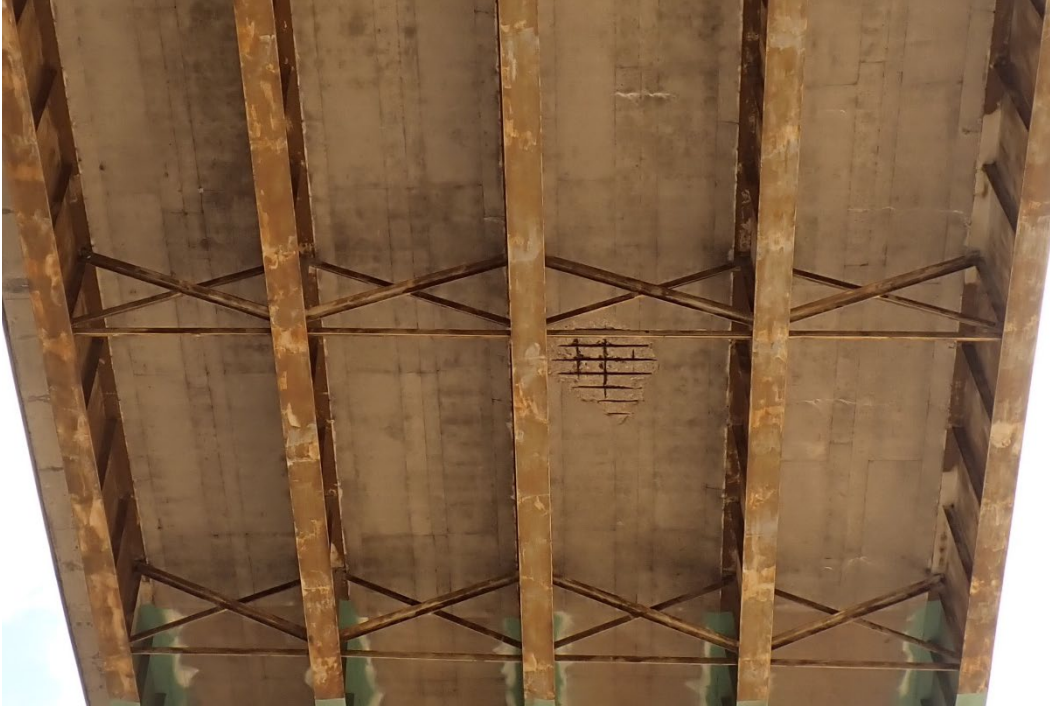
*Photo 8 – 64" x 52" x 2 1/2" with exposed rebars in Bay 3 of Span 20D, looking east.*

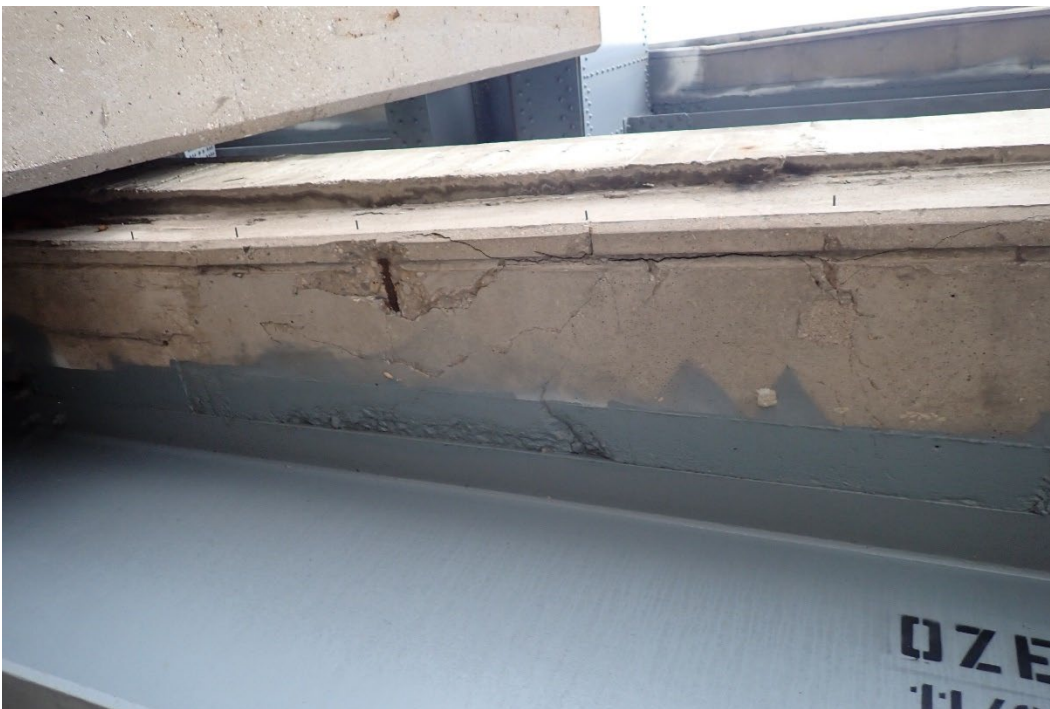
*Photo 9 - Spall with exposed rebar under parapet in Span 1A.*

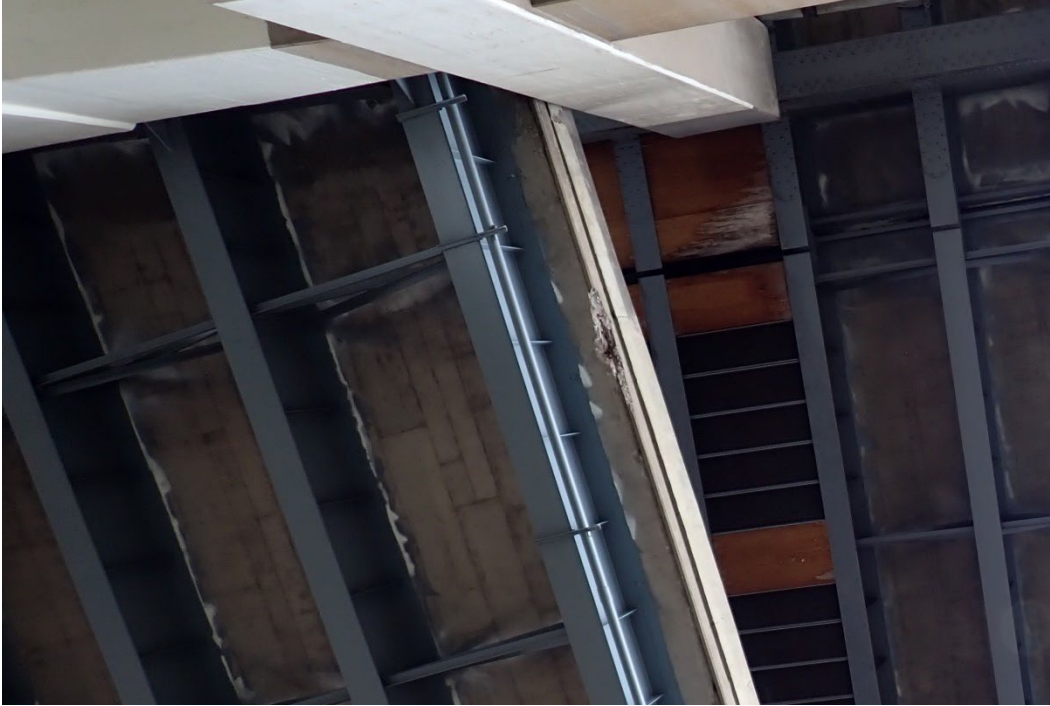
There is a concrete spall 10' x 3' x 3" with exposed rebar on the East overhang over the full-depth concrete repair at Pier 12C expansion joint, West overhang has a 4' long spall with exposed rebar in Span 12C (Photo 10).

*Photo 10 – 4' long spall with exposed rebar on west overhang in Span 12C.*

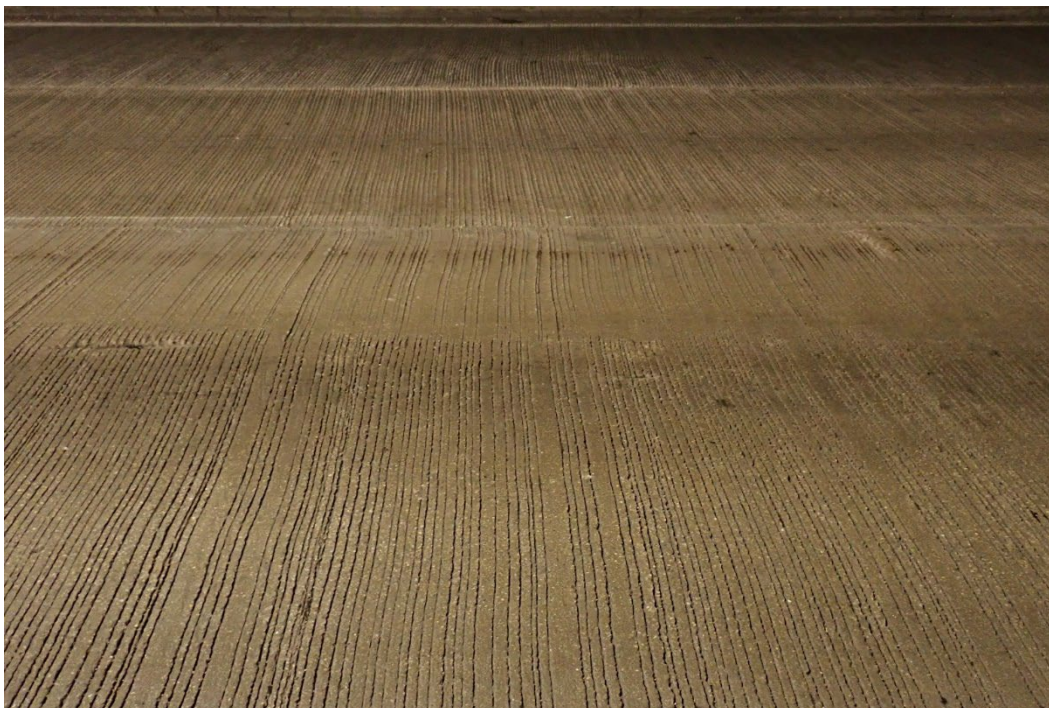
Photo 11 - Typical wearing surface with small spalls and gouges, in Span 6A.

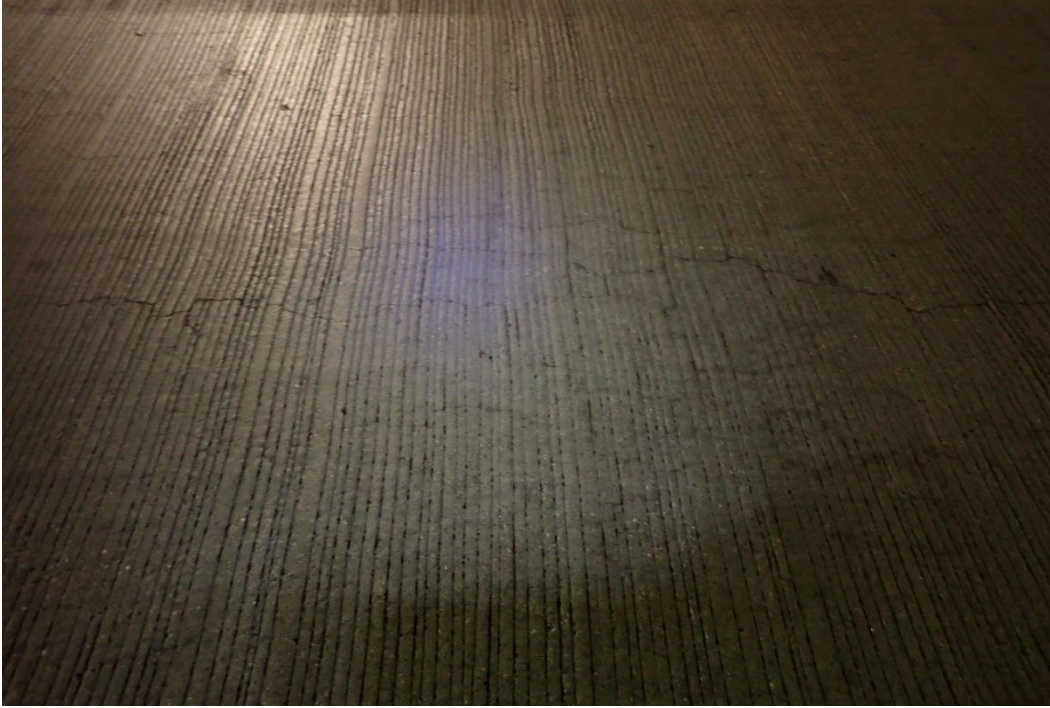
*Photo 12 - Typical isolated longitudinal cracking in wearing surface at Span 10A.*

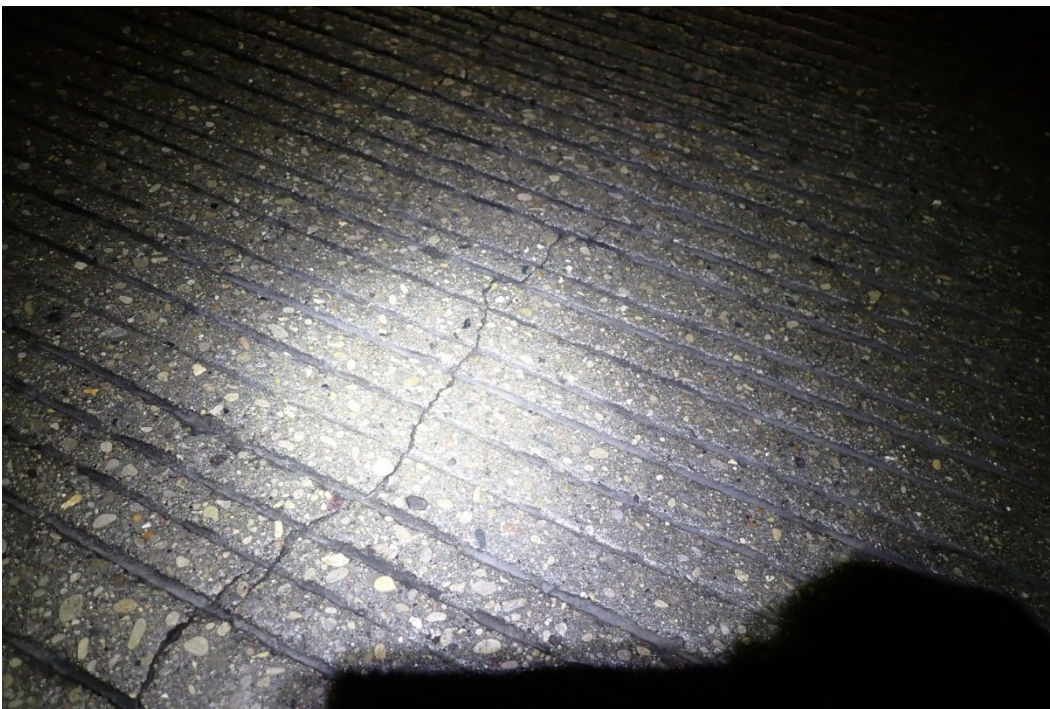
*Photo 13 – Typical 1' to 3' longitudinal cracking in wearing surface in Span 1A midspan, looking south.*

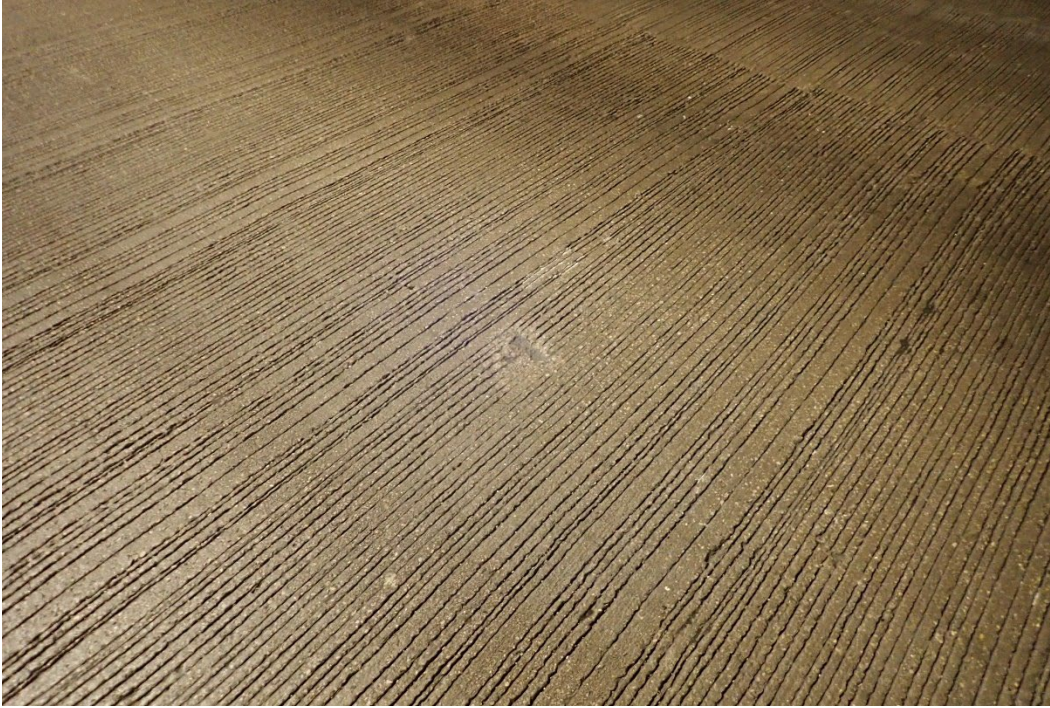
*Photo 14 - Typical 6" diameter x 1/2" deep surface spall in Span 9A.*

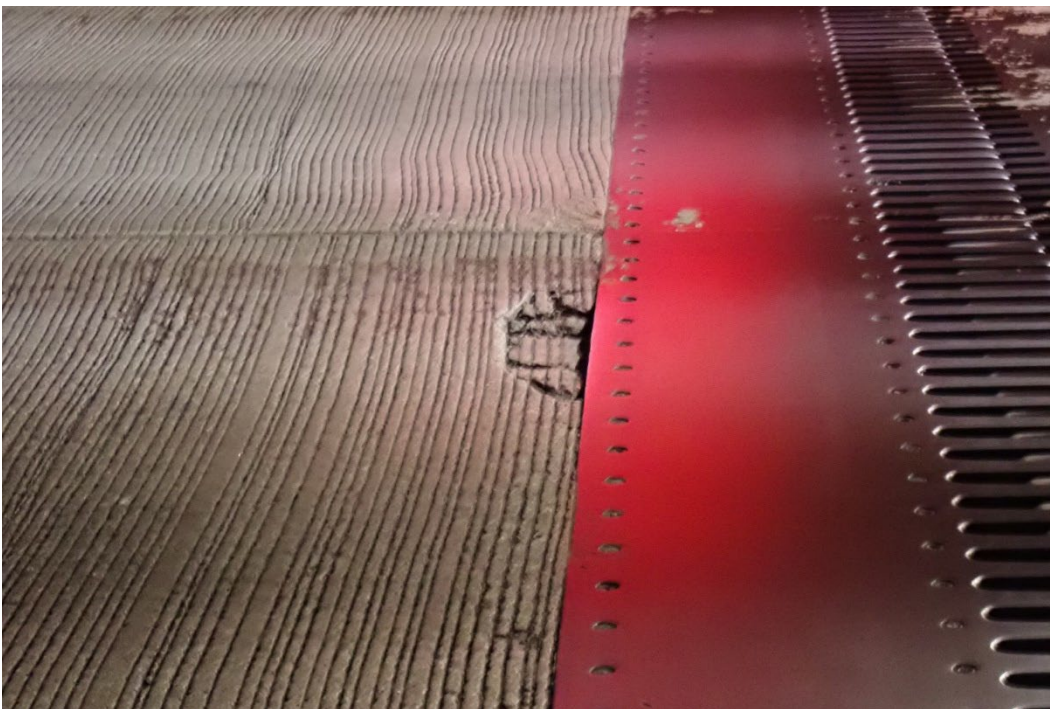
*Photo 15 – 12" x 6" spall in wearing surface at joint with main span, at River Pier looking east.*

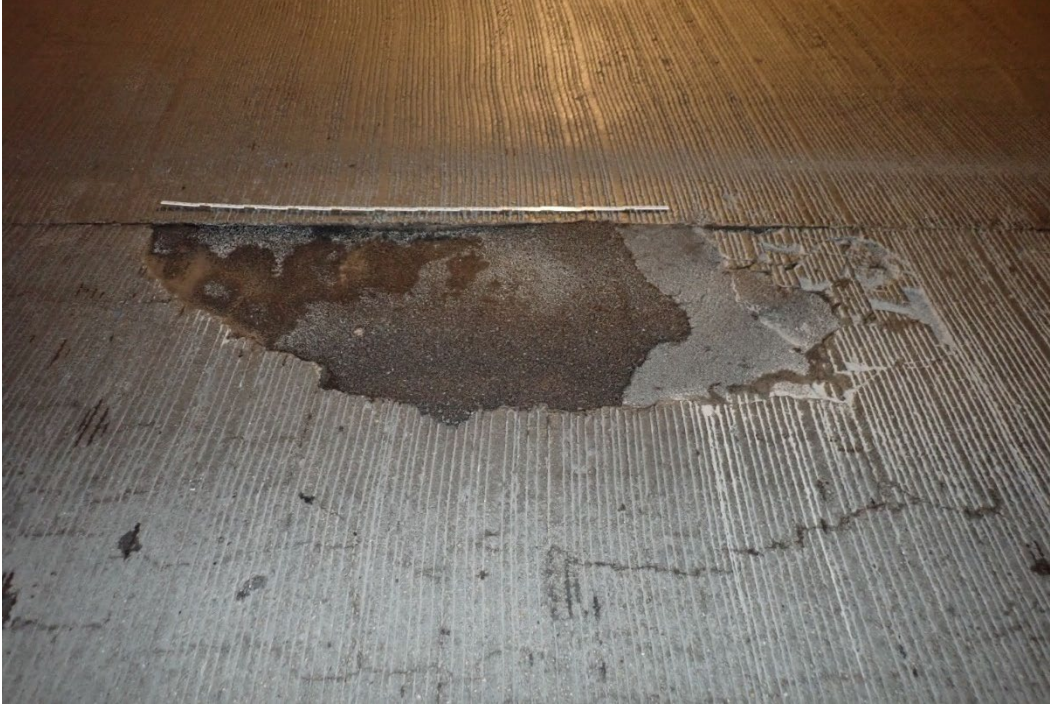
*Photo 16 - 10'x 4' asphalt filled pothole in Span 9A near Pier 8A.*

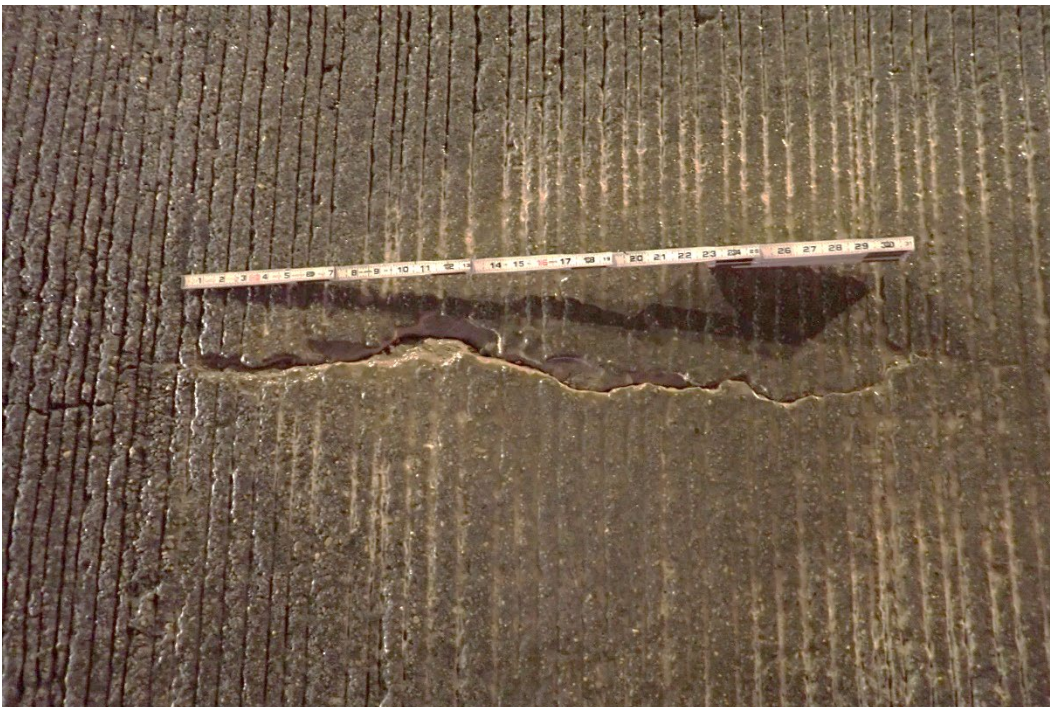
| Wearing Surface Defects | |
|---|---|
| Span 10A | 3' long x up to 3" wide crack in deck near Pier 10A (Photo 17). |

*Photo 17 - Moderate crack to deck in Span 10A near Pier 10A.*

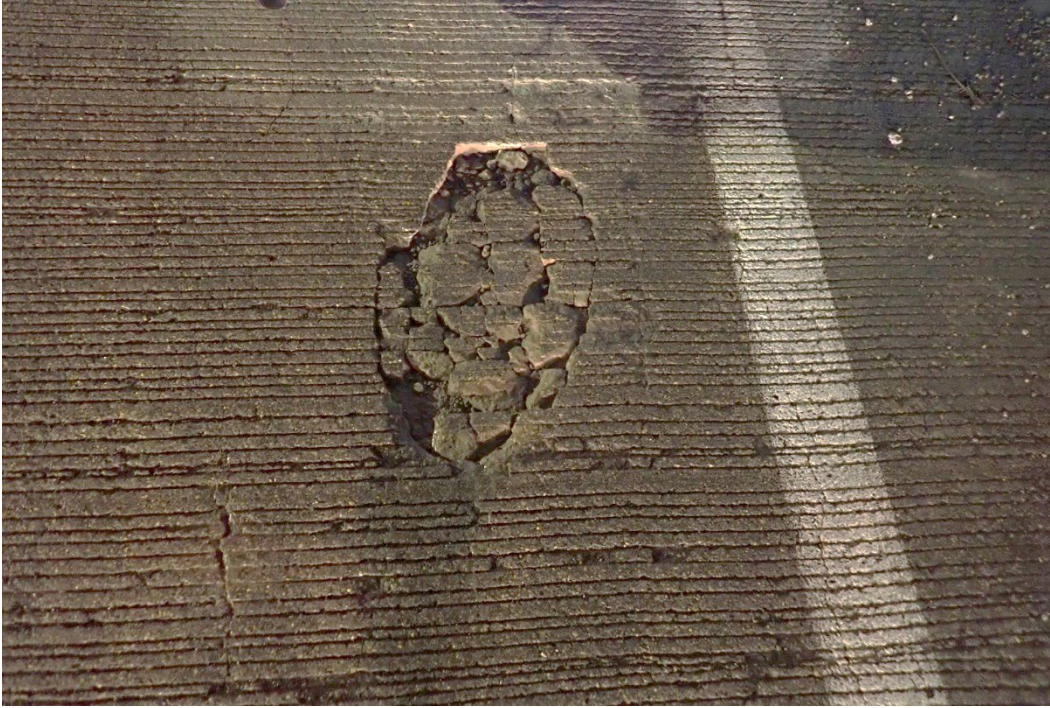
| Wearing Surface Defects | |
|---|---|
| Span 11A | 24" long x 12" wide spall forming pothole near Pier 10A (Photo 18). |

*Photo 18 - Pot hole in deck at Span 11A near Pier 10A.*

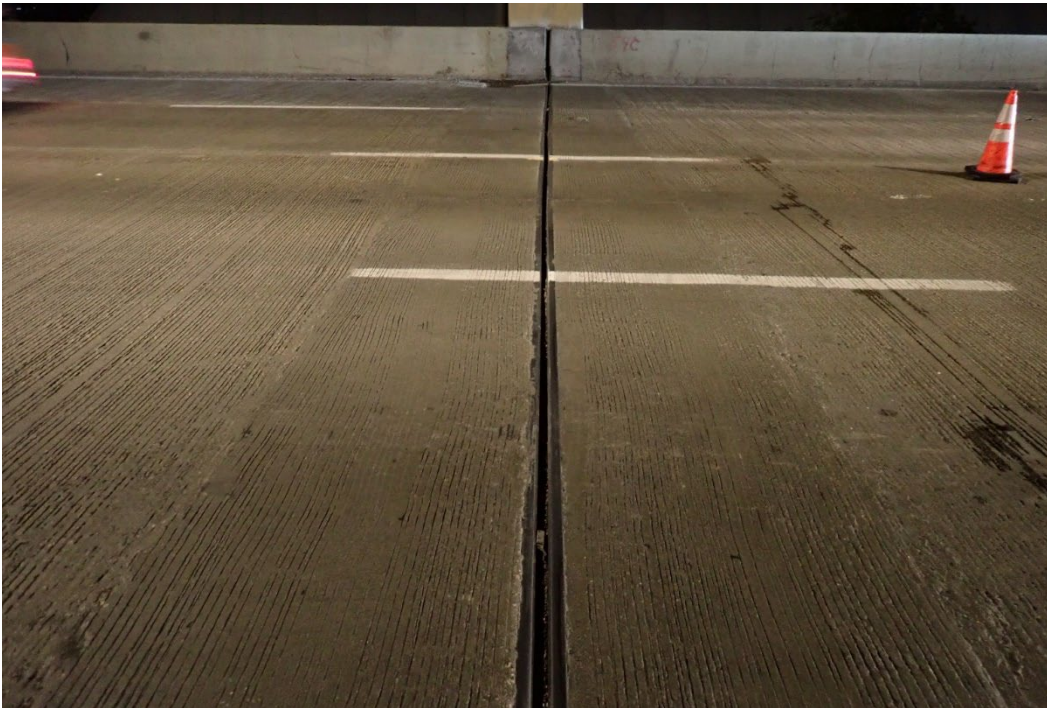
The expansion joints are in FAIR CONDITION [NBIS-5] overall with minor to heavy debris accumulation, deterioration, and isolated areas of leakage. Expansion joints are located at Piers 4A, 8A, 12C, 15C, 17C, 20D, and 5 (Photo 19). There is loosely packed debris in expansion joints on the deck (Photo 20). There is a tear on Pier 5 allowing free-flow water through the joint. Leakage onto pier caps is evident, as well as active corrosion on the girders and bearings below these joints.

*Photo 19 - Typical strip seal expansion joint at Pier 4, looking west.*

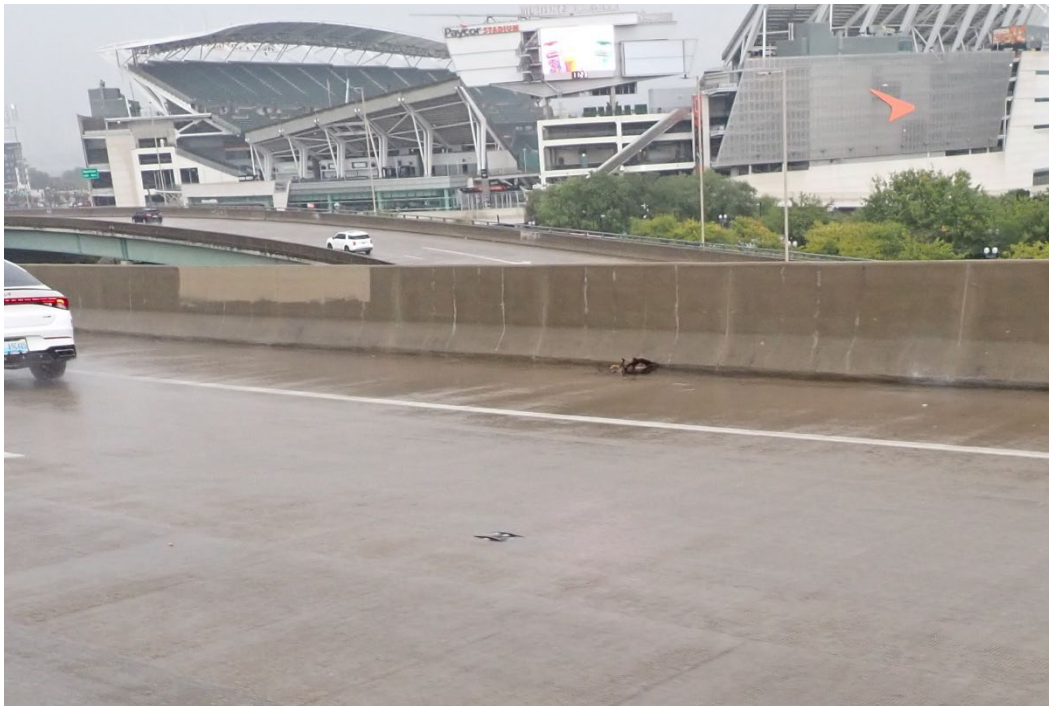
*Photo 21 - Hairline vertical cracking with efflorescence spaced approximately 1' to 3' along concrete bridge railing. Note: concrete patch repair to top of railing, looking south.*

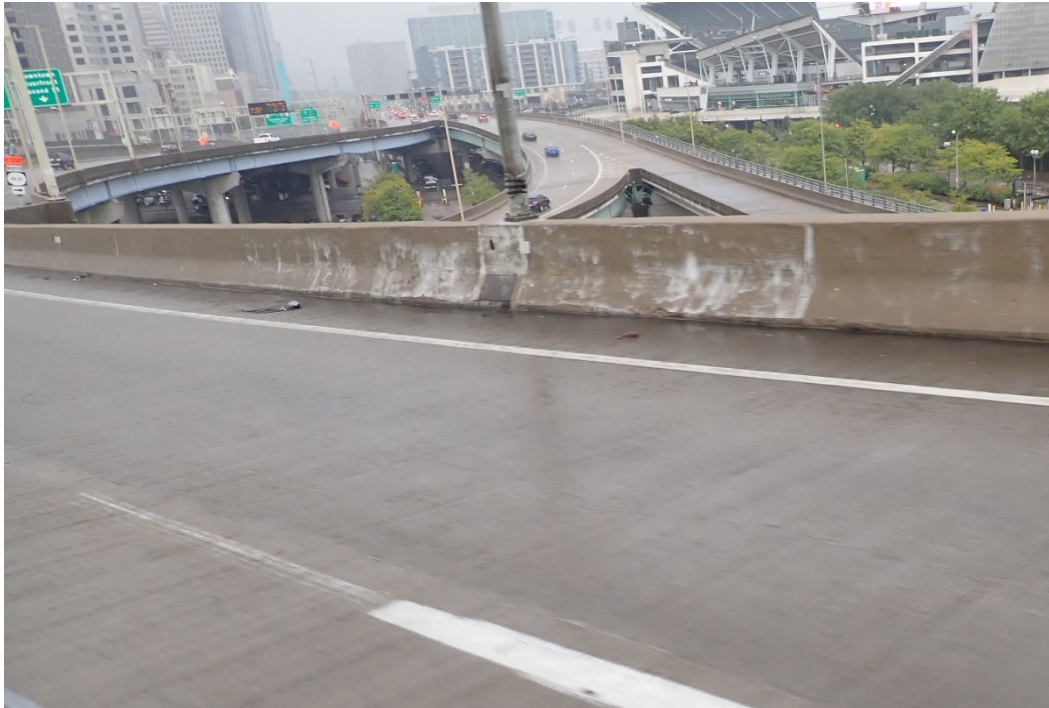
*Photo 22 - Hairline longitudinal cracks with efflorescence in concrete railing, looking east.*

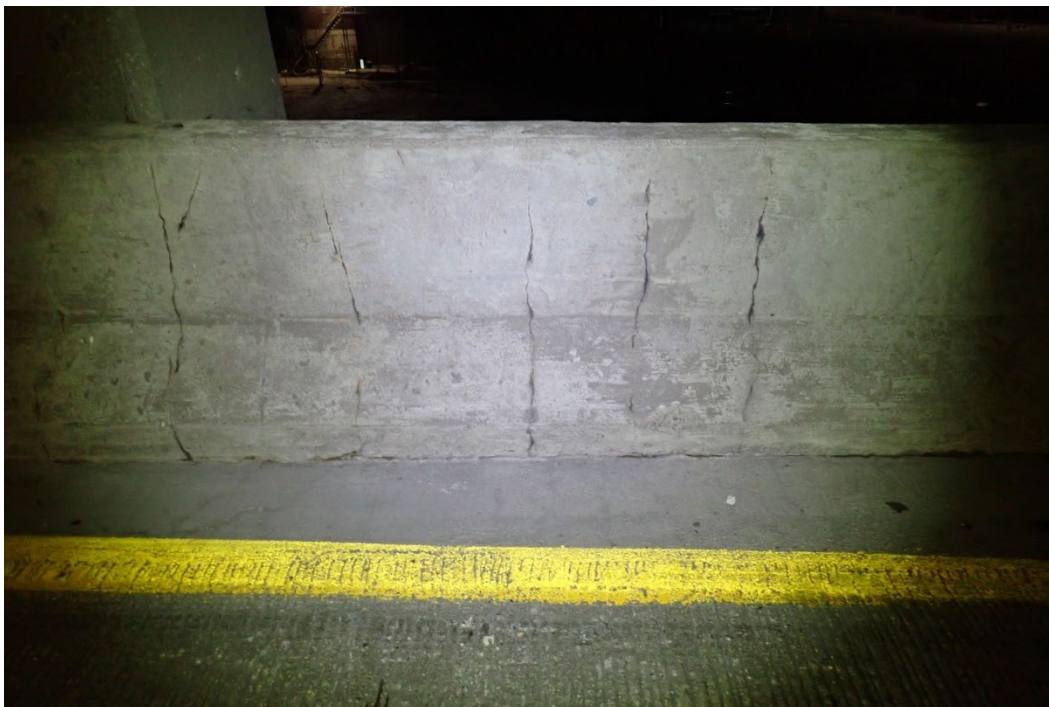
*Photo 23 - Typical hairline vertical cracking on bridge railing at west railing at River Pier, looking west.*

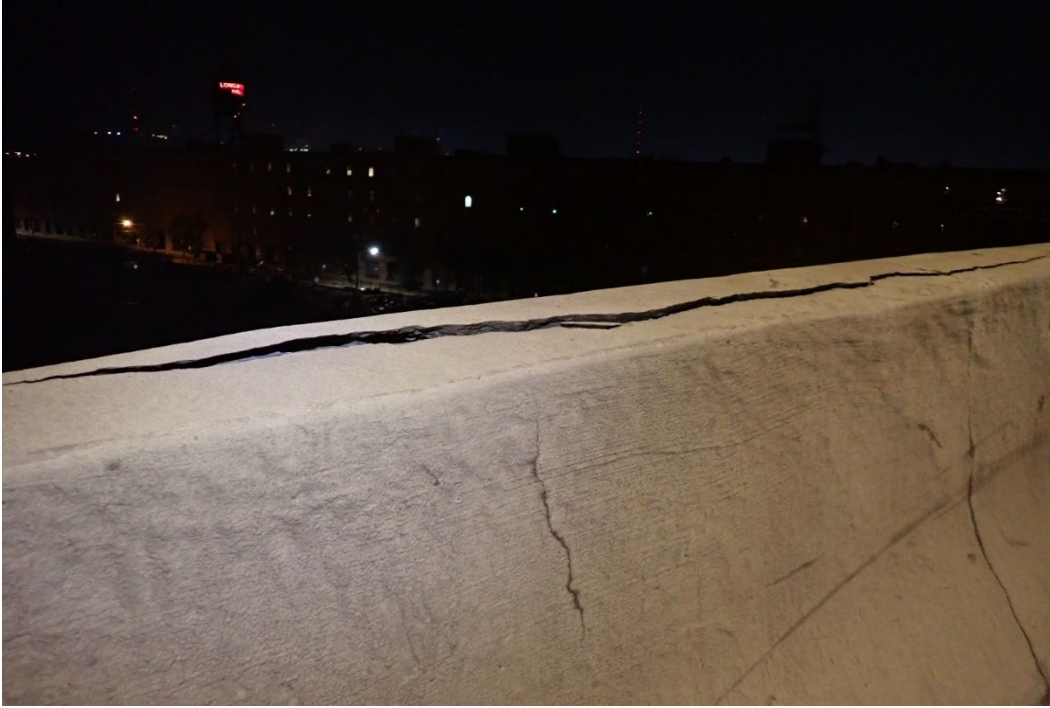
There is a 6' long corner spall with delamination on top edge of concrete railing and longitudinal cracking, with delamination on outside at Span 11A (**Photo 24** & **Photo 25**). There is a 24" x 3" x 1" spall in the inside corner of the west railing in Span 6 (**Photo 26**).

*Photo 24 – 6' long corner spalling with delamination on top edge of concrete railing at Span 11A, looking east.*

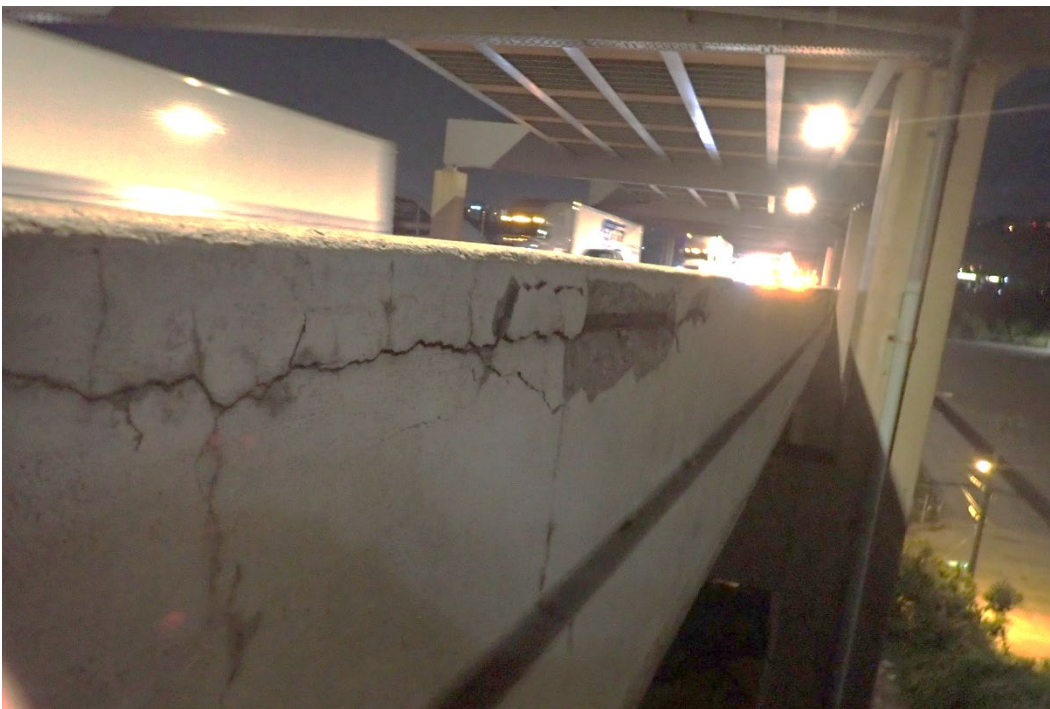
*Photo 25 - Longitudinal cracking, with delamination on outside of concrete railing at Span 11A, looking north.*

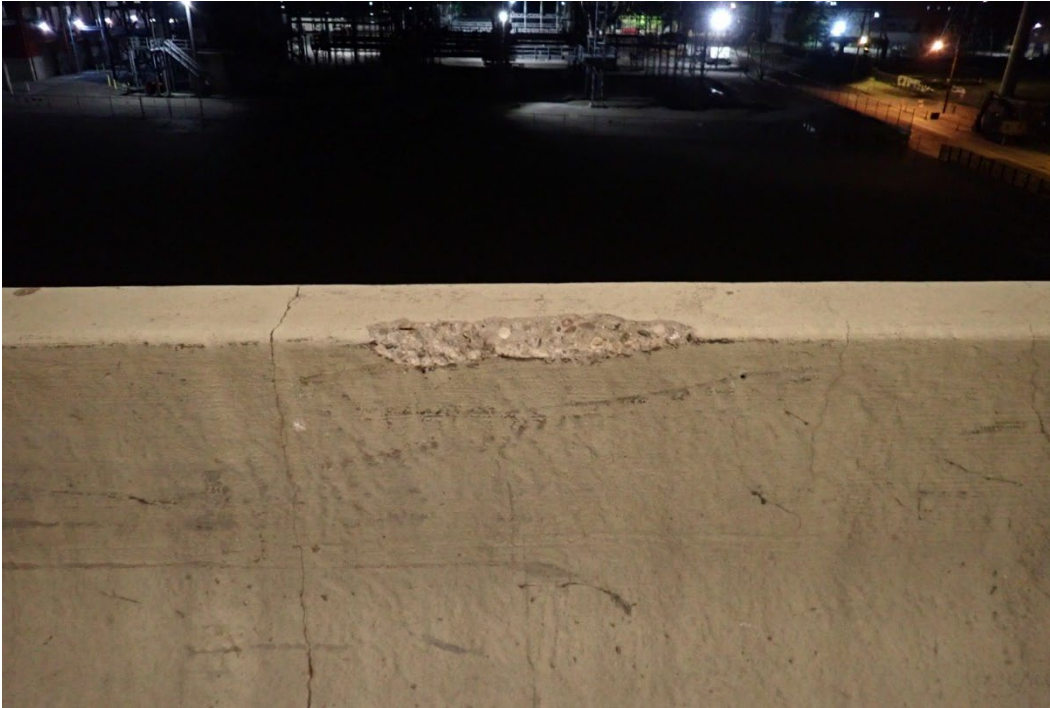
*Photo 26 - Minor edge spall on top of west railing a Span 6 mid span looking west.*

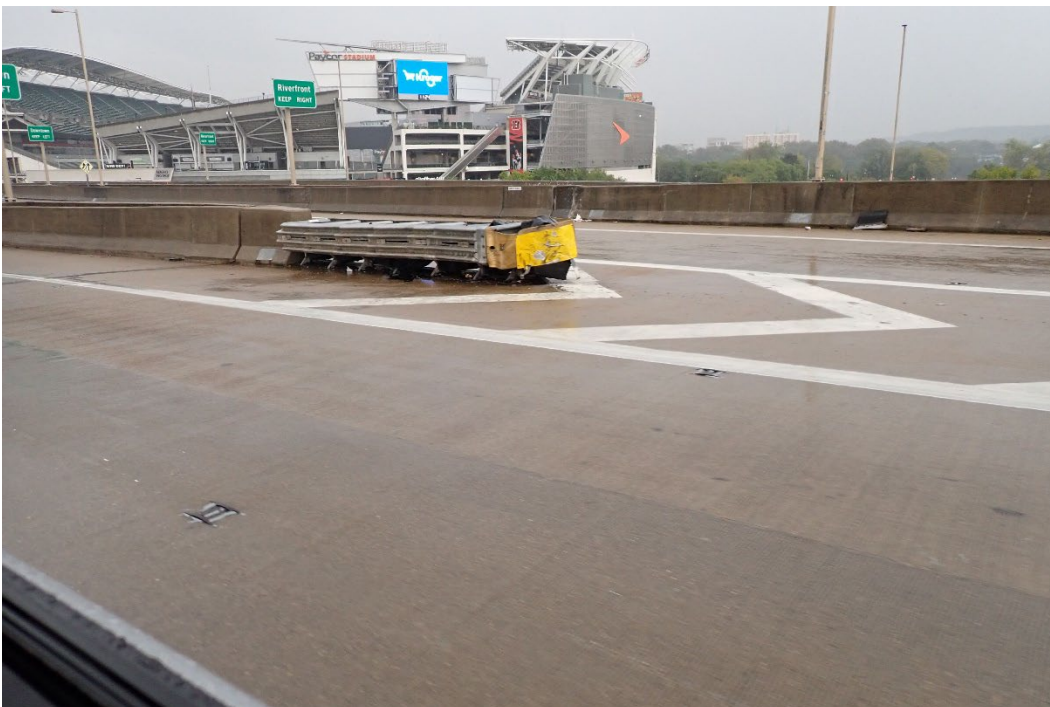
Minor damage to impact attenuators at the I-71 & I-75 split and the I-71 & Second Street split was observed, but did not appear to affect the operation of the unit (**Photo 27**).

*Photo 27 - Minor damage to impact attenuator at I-71 & 2nd street split, looking south.*

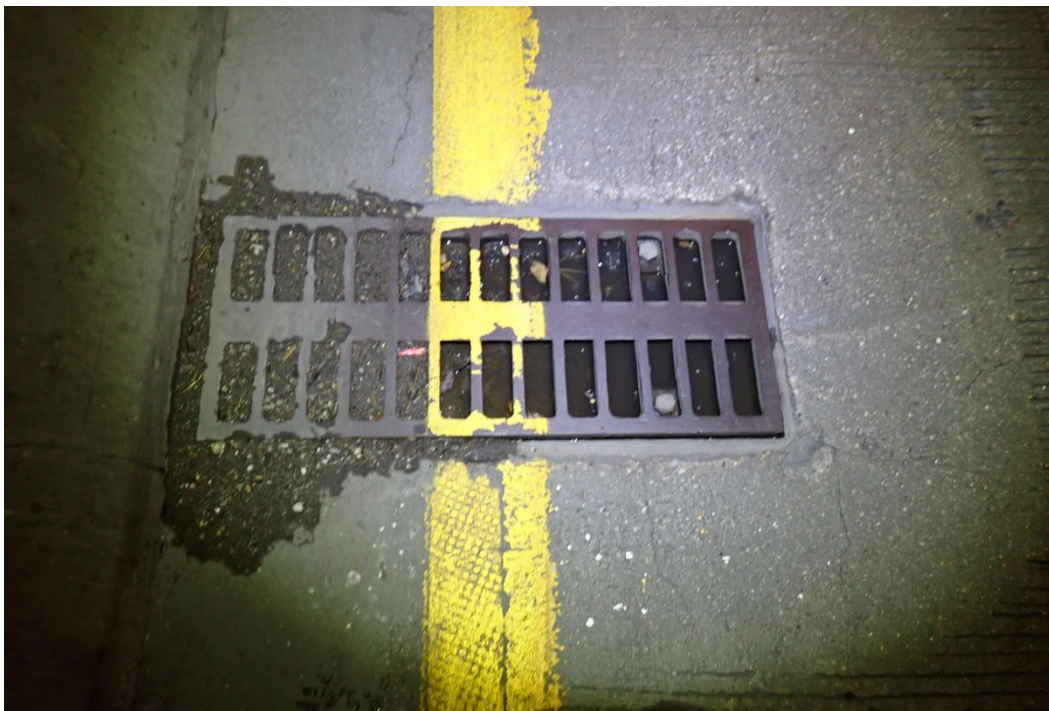
The drainage system is in POOR CONDITION [4-NBIS] due to multiple drainpipes being completely or partially clogged at the deck level scupper locations (Photo 28) and at the ground level (Photo 29), causing water ponding on the deck. The drain grate in Span 2A is missing (Photo 30). There are several disconnected and misaligned drain boots at column bases. The exposed drainage bells are typically fully clogged with debris (Photo 31 & Photo 32).

*Photo 28 – Typical clogged deck drain at Pier 1, looking north.*

- Shim movable bearings that have gaps between rocker and sole plate.
- Remove debris/ clean clogged deck drains, scuppers, and clogged drainpipes.
- Repair broken/ missing/ disconnected/ drainpipes and bulging boots throughout.
- Repair broken weld on cross frame at Girder G in Span 9A over Pier 8A.

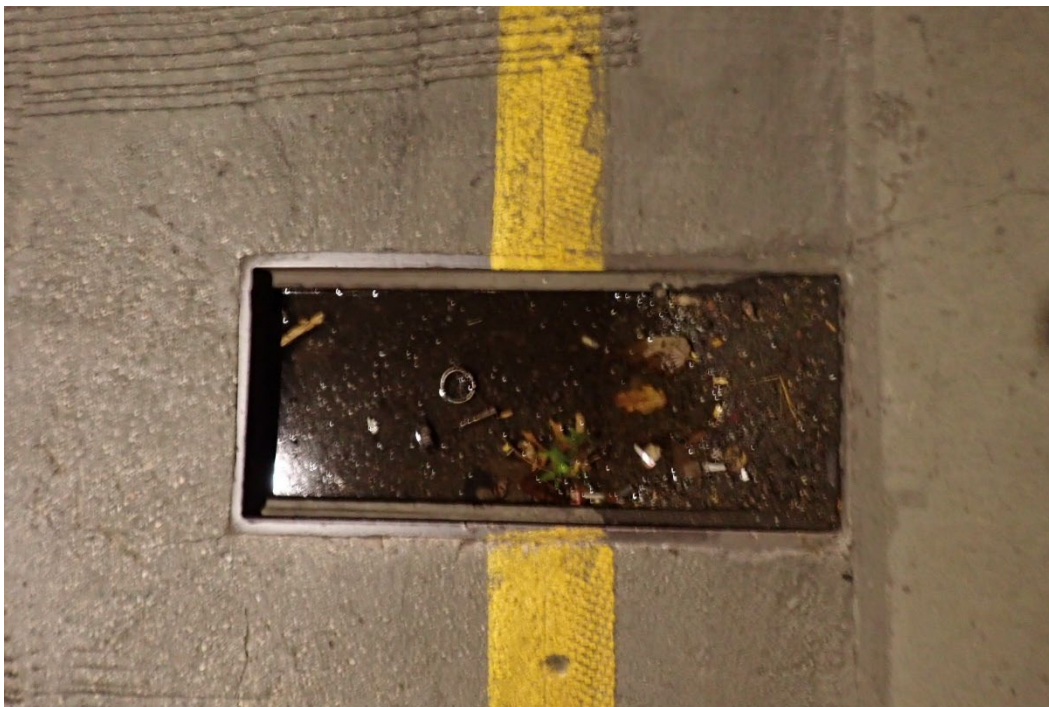
*Photo 30 - Missing deck drain grate with debris accumulation, at Span 2A midspan, looking south.*

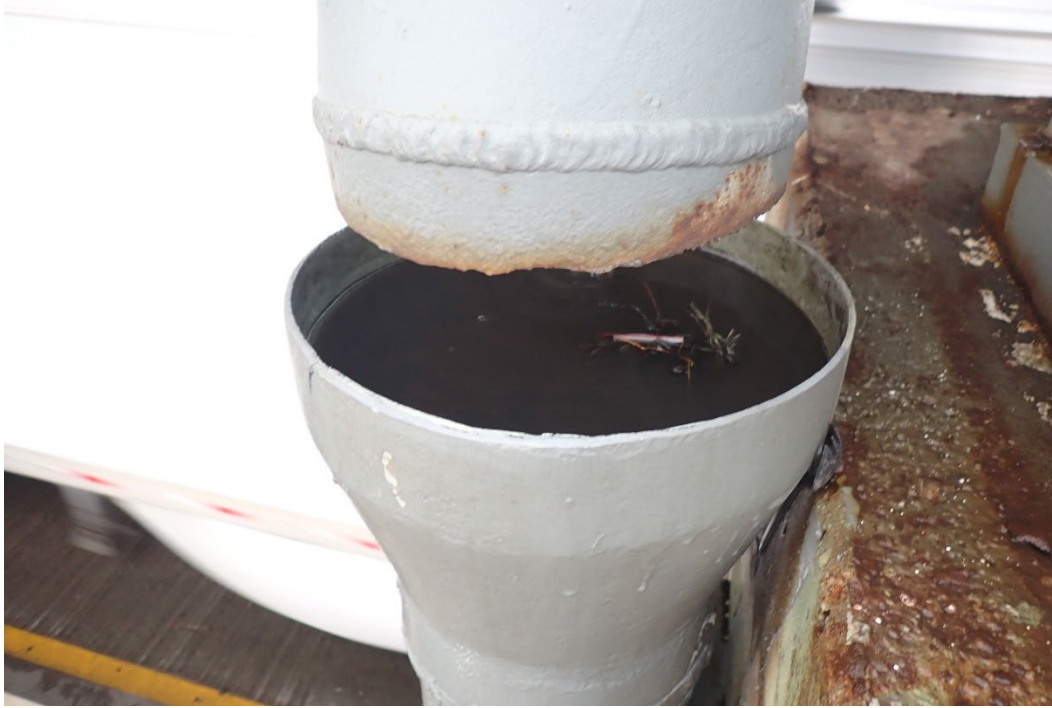
*Photo 31 - Typical clogged drainpipe at Pier 8A, looking east.*
