# BRENT SPENCE APPROACH BRIDGE

HAM-71-0000R

## 2025 In-Depth Inspection Report

Inspection Date: September 22-26, 2025

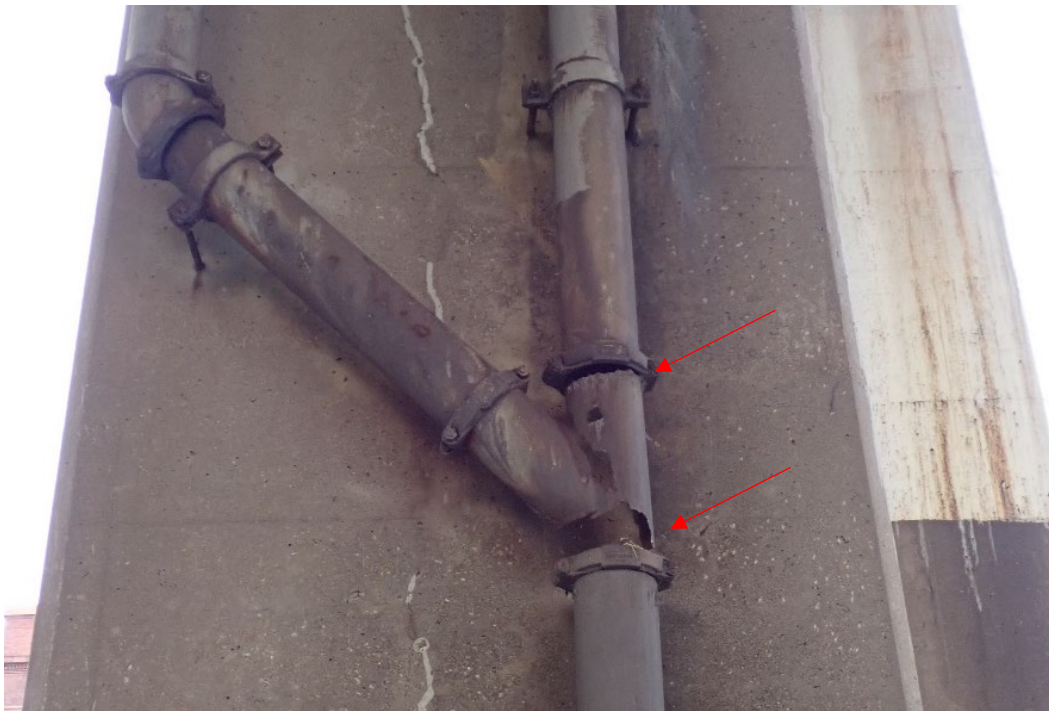
The drainpipe T-joint is disconnected on the north face of Column 1 at Pier 12A, and the pipe is cracked, but this condition has not changed from the 2024 inspection. Most downspouts are partially or completely disconnected at the ground termination of Column 2 at Pier 4A. Various locations throughout are also disconnected from the underground drainage termination, but do not show signs of erosion. Several drainpipes are cracked with corrosion holes through the pipe wall throughout the structure (Photo 33).

*Photo 33 - Corroded drainpipe, with holes and disconnections at joints at River Pier west column, looking west.*

- Shim movable bearings that have gaps between rocker and sole plate.
- Remove debris/ clean clogged deck drains, scuppers, and clogged drainpipes.
- Repair broken/ missing/ disconnected/ drainpipes and bulging boots throughout.
- Repair broken weld on cross frame at Girder G in Span 9A over Pier 8A.

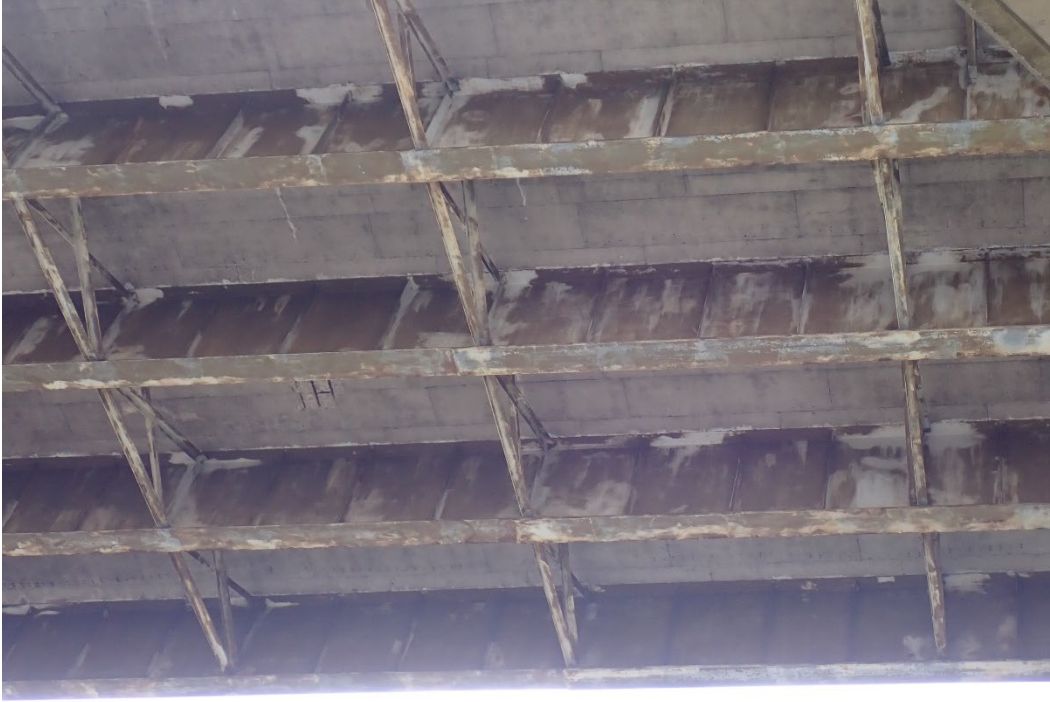
Photo 34 - Typical girder condition for Spans 15C to 20D, at Span 18D, looking north.

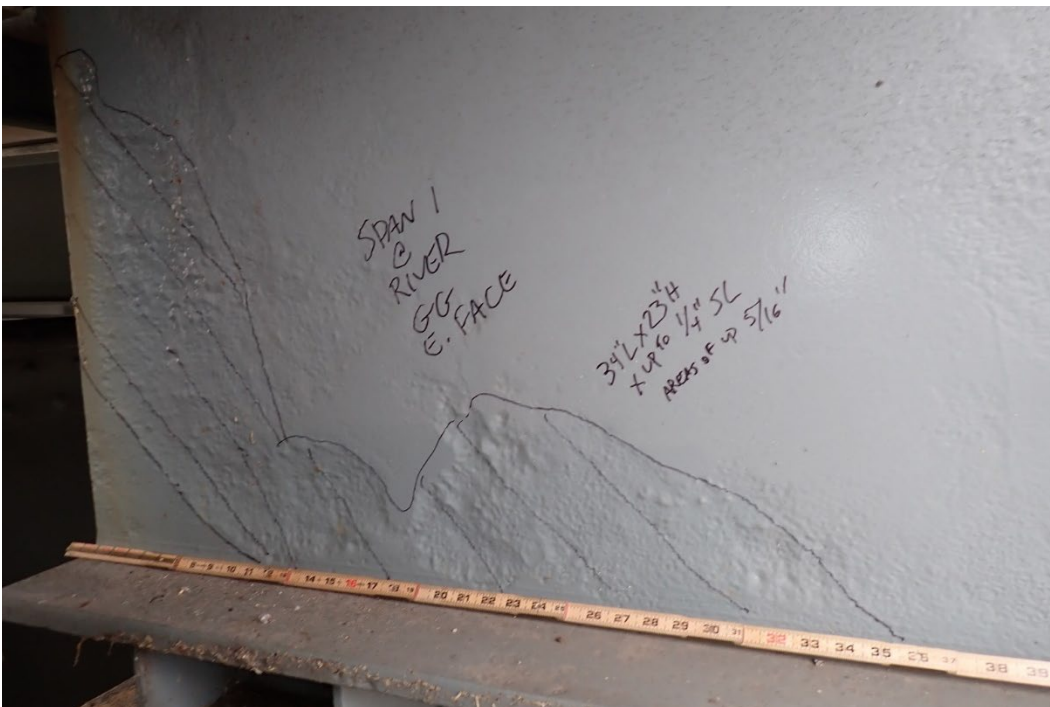
Photo 35 - 34" x 23" x up to 5/16" section loss in web and bottom flange of Girder G at River Pier, looking east.

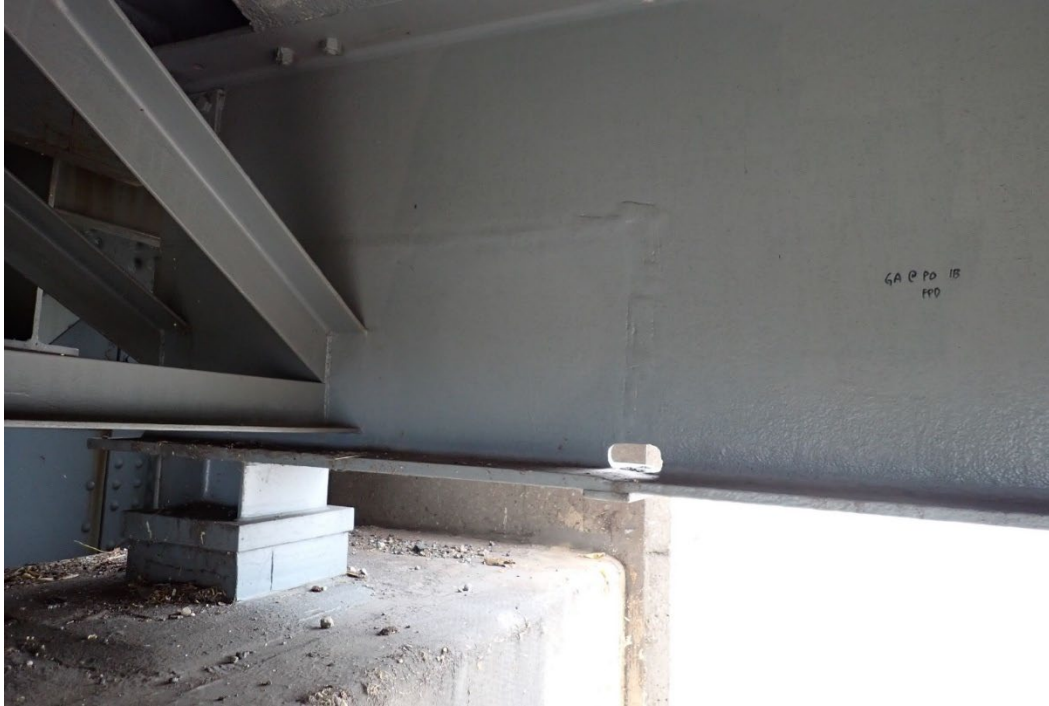
Photo 36 - Welded retrofit web and bottom flange replacement on Girder A over the River Pier, looking west.

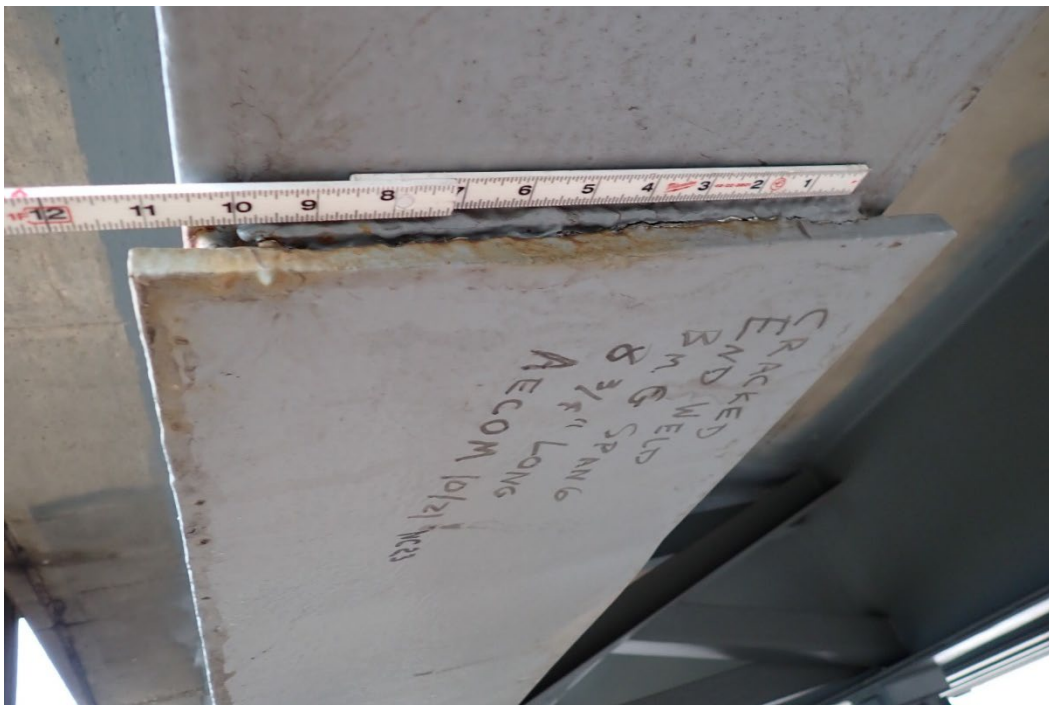
Photo 37 - Cracked cover plate on Girder G in Span 6, looking south.

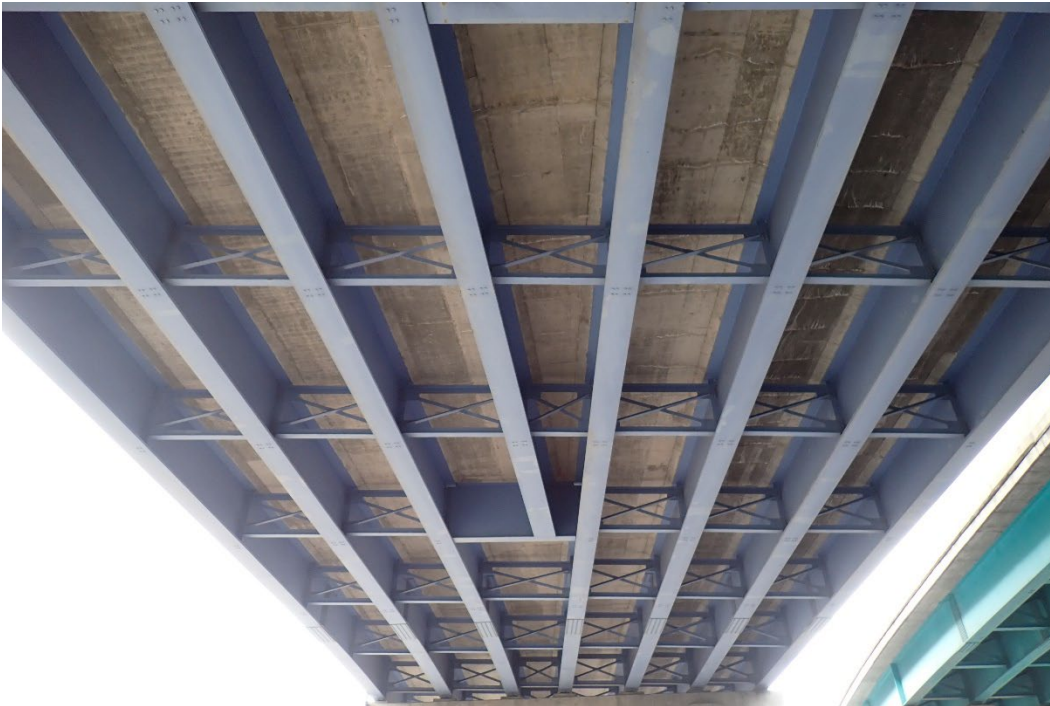
The girders on the reconfigured spans are in good condition. No significant signs of corrosion or section loss were noted during the inspection (Photo 39).

*Photo 39 - Typical reconfigured span in good condition at Span 5, looking east.*

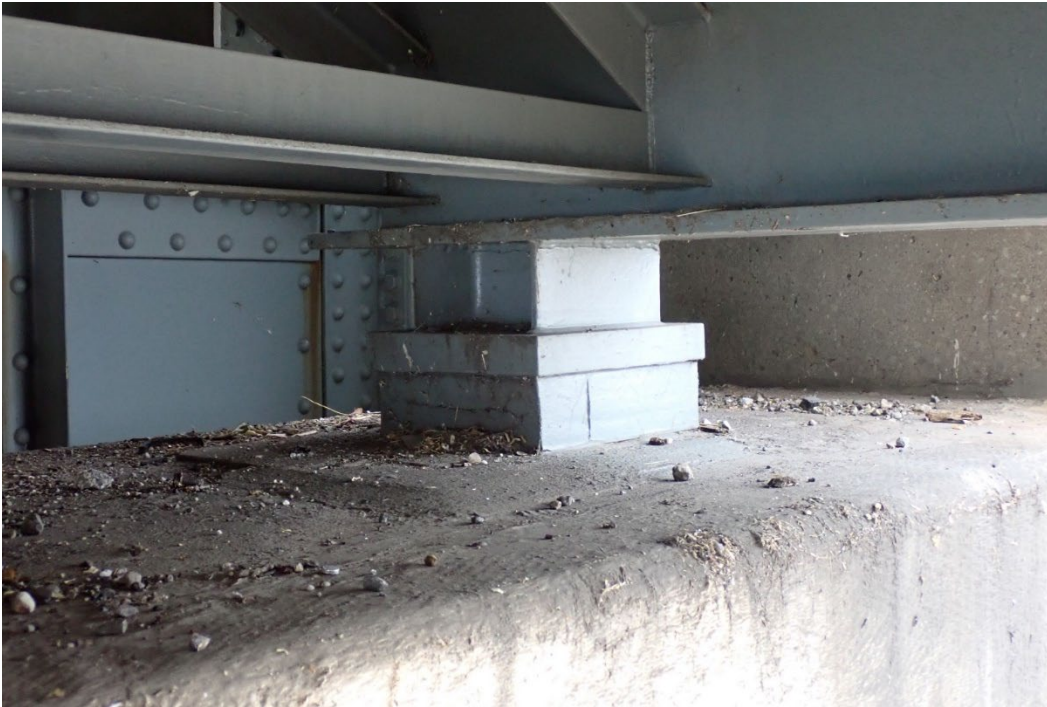
The Elastomeric Bearings are in GOOD CONDITION [NBIS-7] overall (Photo 40 & Photo 41). There are elastomeric bearings at the River Pier, Piers 12C, 15C, and 17D. The bearings typically have minor surface corrosion and isolated paint failure. The bearings exhibited few signs of expansion and were in a neutral position.

*Photo 40 - Typical elastomeric bearing at River Pier, looking west.*

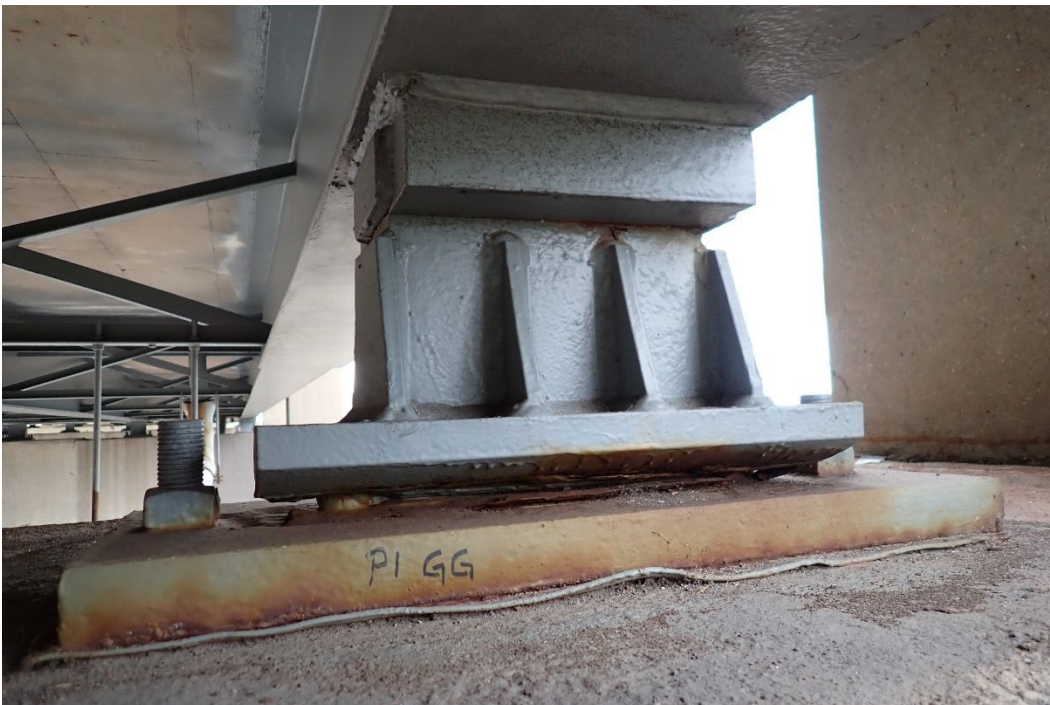
*Photo 43 - Rocker bearing with minor surface corrosion at Girder G at Pier 1A, looking north. Note: gap between rocker and sole plate.*

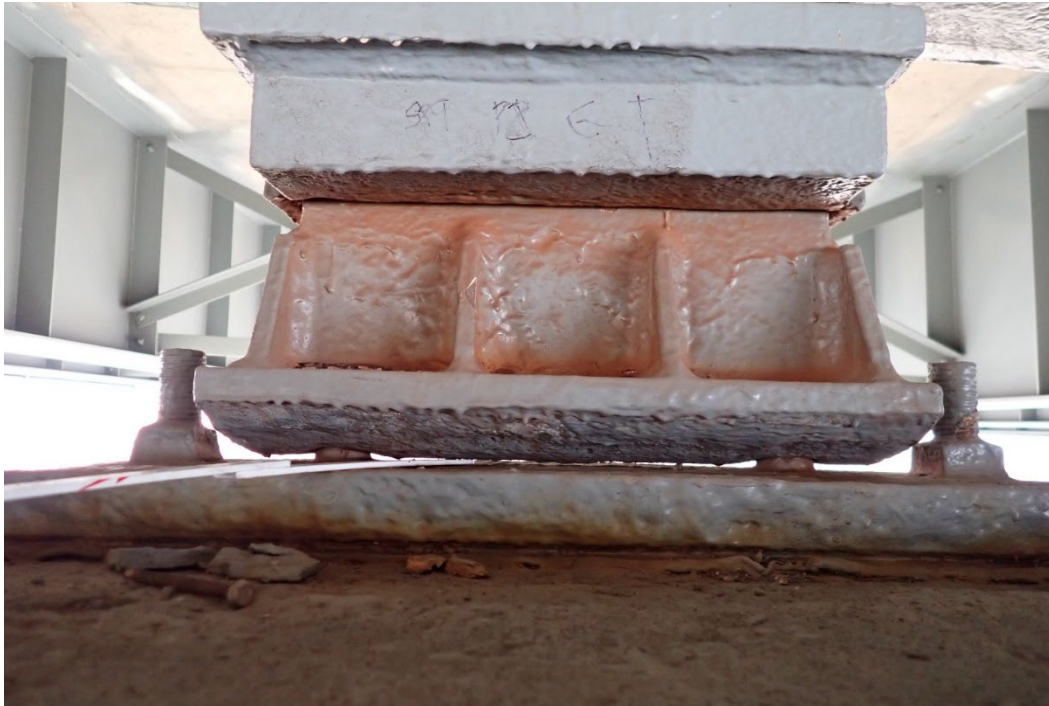
Photo 44 - Rocker bearing with gap up to 1/4" wide with rust fretting at Pier 8A Girder D, looking north.

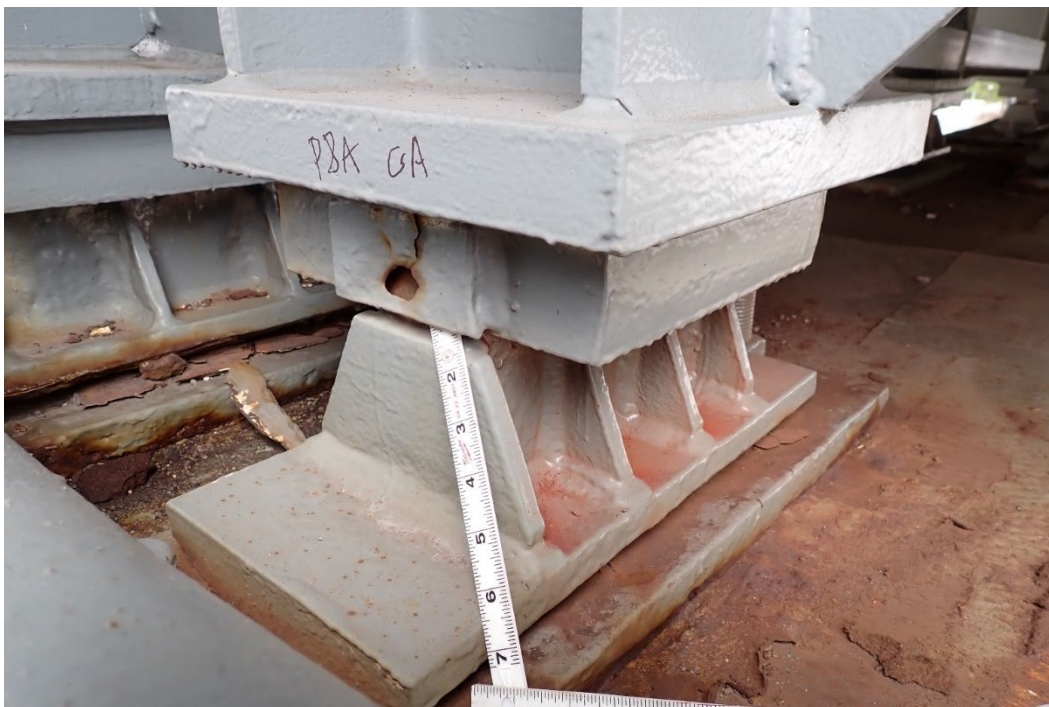
Photo 45 - Hole in bearing keep plate at Girder A of Pier 8A, looking northeast. Corrosion hole in bearing keeper plate at Girder A of Pier 8A, looking northeast.

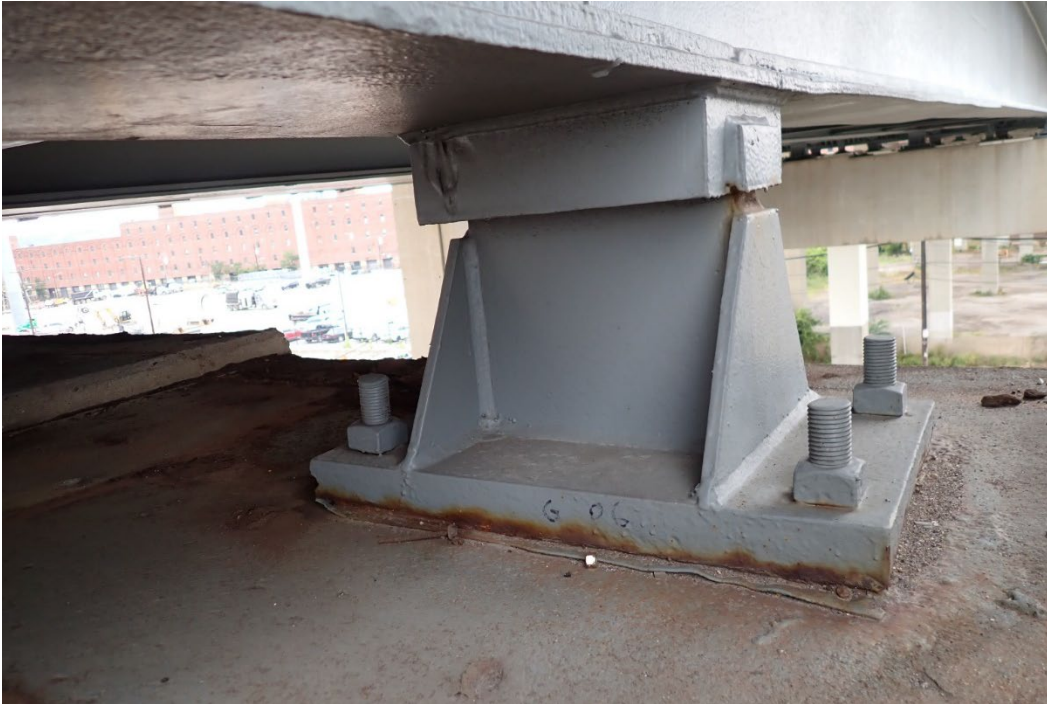
The Fixed Bearings are in SATISFACTORY CONDITION [6-NBIS] overall and typically exhibit minor paint failure and minor surface corrosion (**Photo 46** & **Photo 47**). The fixed bearings at Pier 13C for Girders C, D, and E have loose anchor nuts. Girder G, fixed bearing at Pier 6A in Span 7A, has pitting on the masonry plate, and Girder D has loose anchor nuts.

*Photo 46 - Typical fixed bearing with minor freckled rust at base, Girder G of Pier 6A, looking north.*

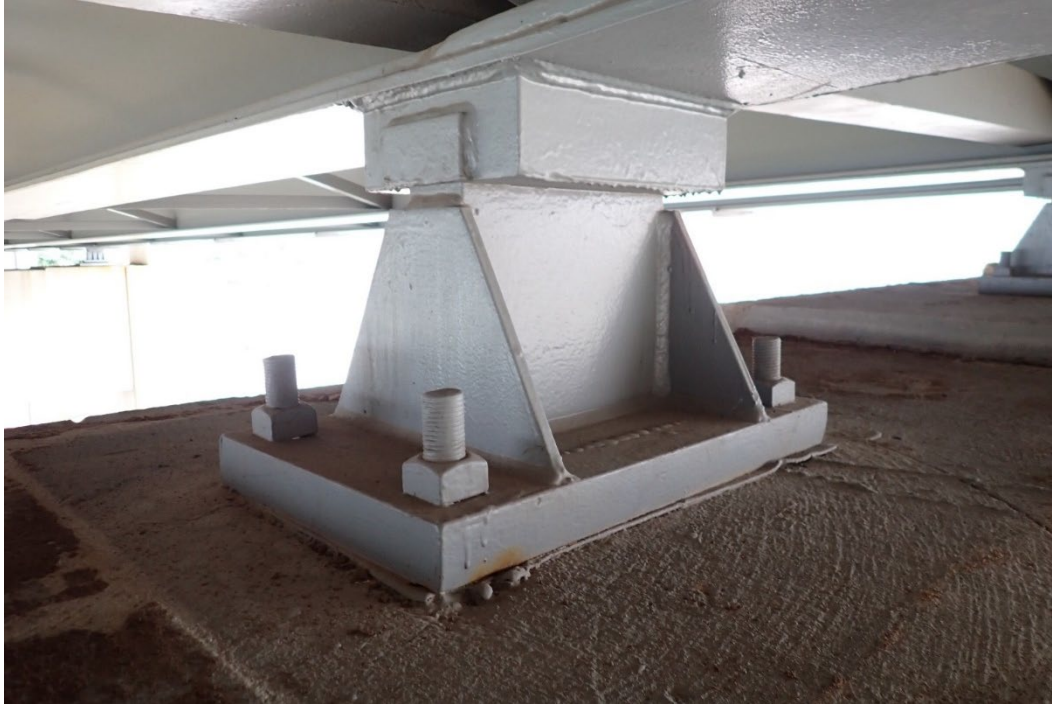
*Photo 47 - Typical fixed bearing at Girder C of Pier 6A, looking southwest.*

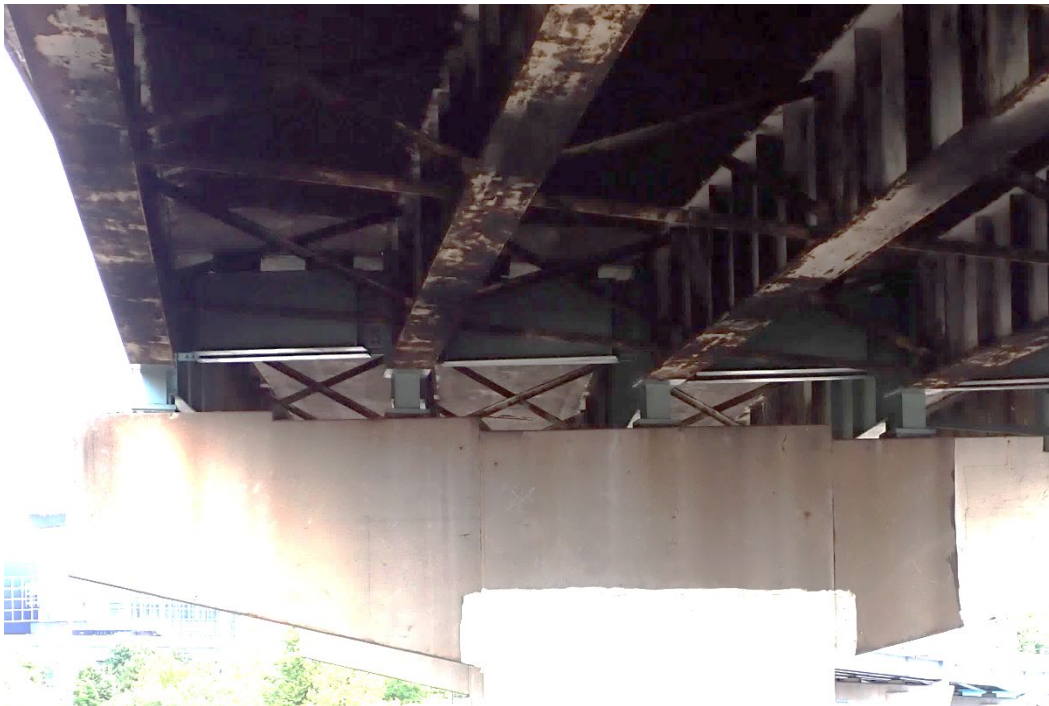
*Photo 48 - Typical coating condition for Spans 15C to 20D, at Span 17D, looking east. Note: failed coating system with chalking, dulling, flaking, peeling, and surface corrosion.*

- Repair spalls and seal cracks in the wearing surface.
- Repair spalls, delaminations, and seal cracks in concrete railings throughout the structure.
- Clean and apply protective coating to the girders and bearings on Spans 15C to 20D.
- Repair isolated spalls and delaminations on concrete substructure units throughout the structure.

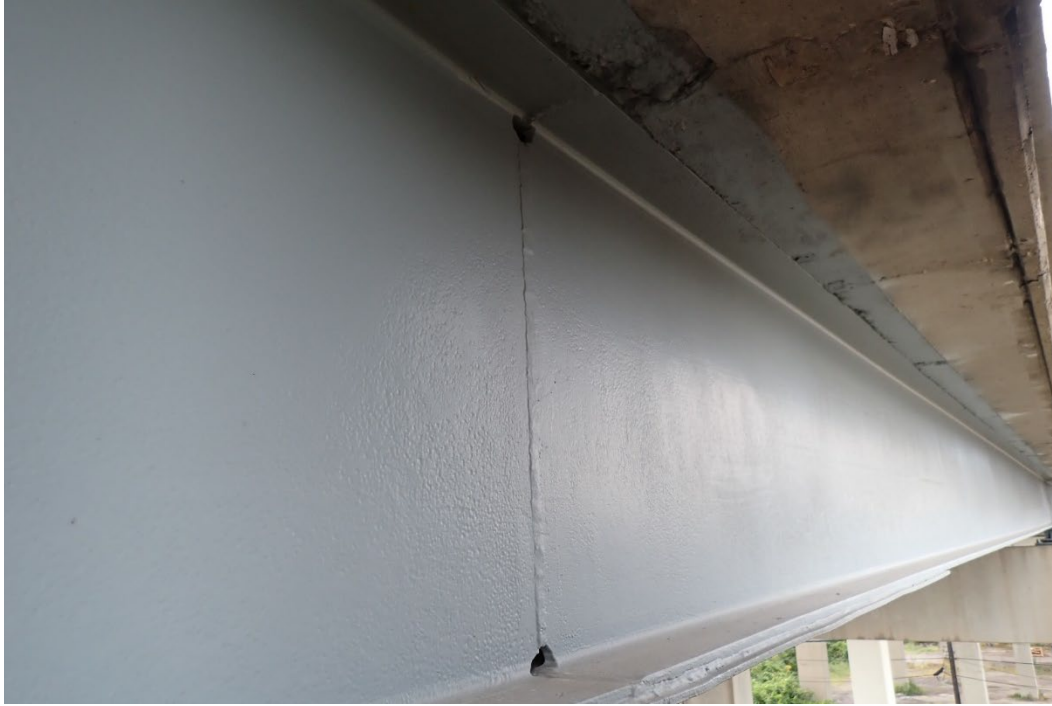
Spans 1A to 14C are in good condition, having been recently recoated (**Photo 49**), along with members below the expansion joints at Piers 4A, 8A, 12C, 15C, and 20D were cleaned and painted (**Photo 50**).

*Photo 49 - Typical paint condition for Spans 1A to 13A at fascia Girder G of Pier 6A, looking north.*

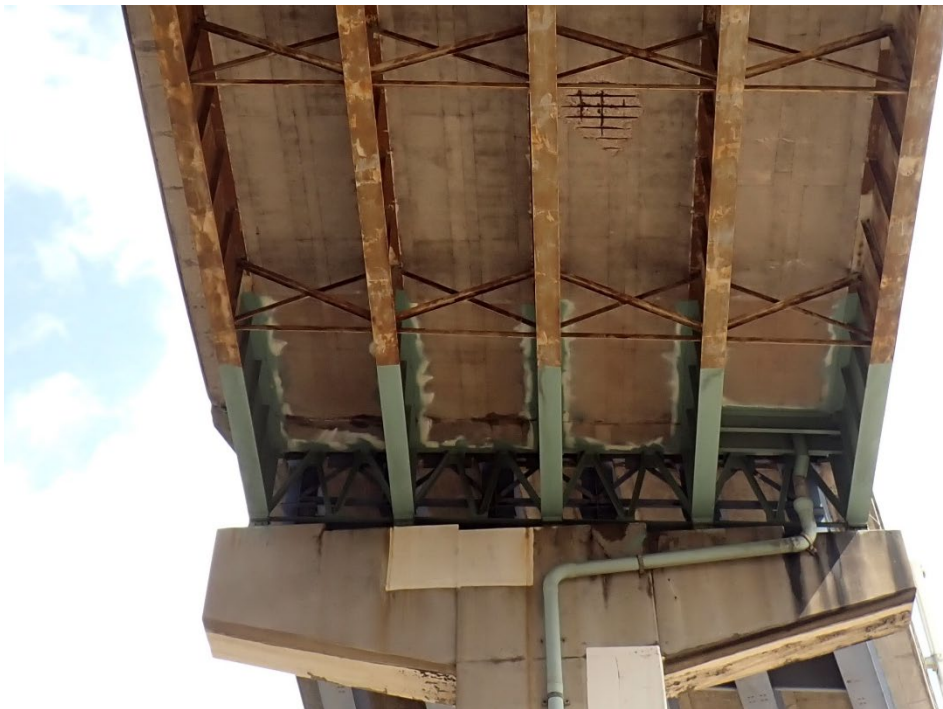
*Photo 50 - Typical deck joint location where the superstructure steel was recently painted, at Pier 20D, looking east.*

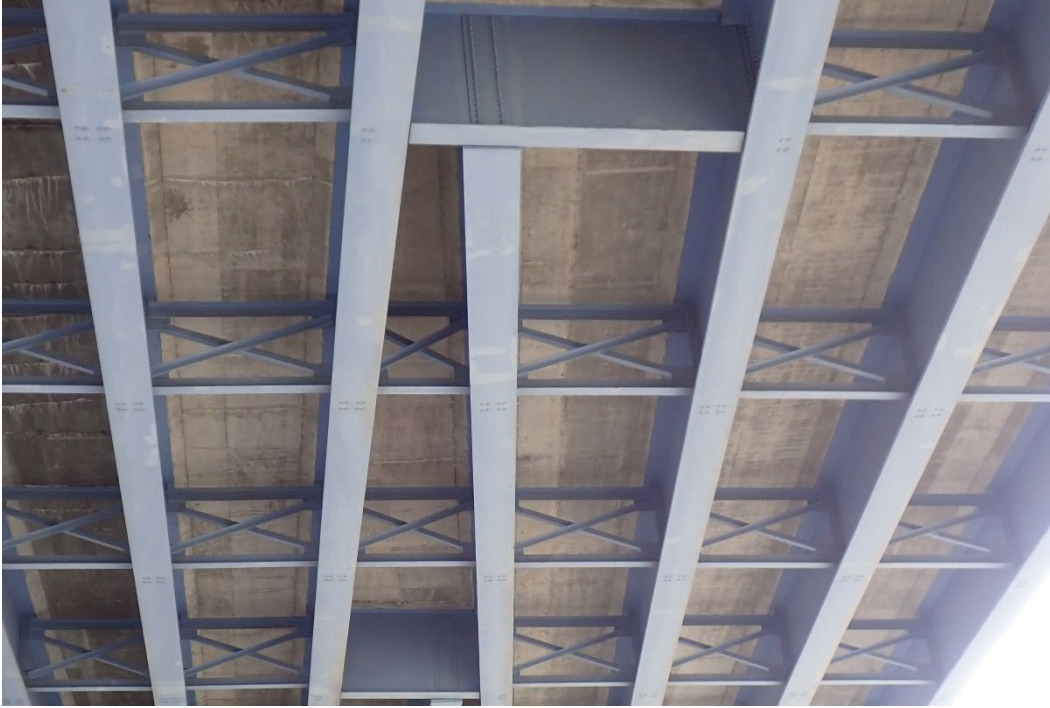
The paint on the reconfigured spans, Spans 1 to 5, is in satisfactory condition with small areas of surface rust, and moderate corrosion concentrated to joint locations (**Photo 51**).

*Photo 51 - Typical coating condition for Spans 1 to 5 is in good condition at Span 5, looking east.*

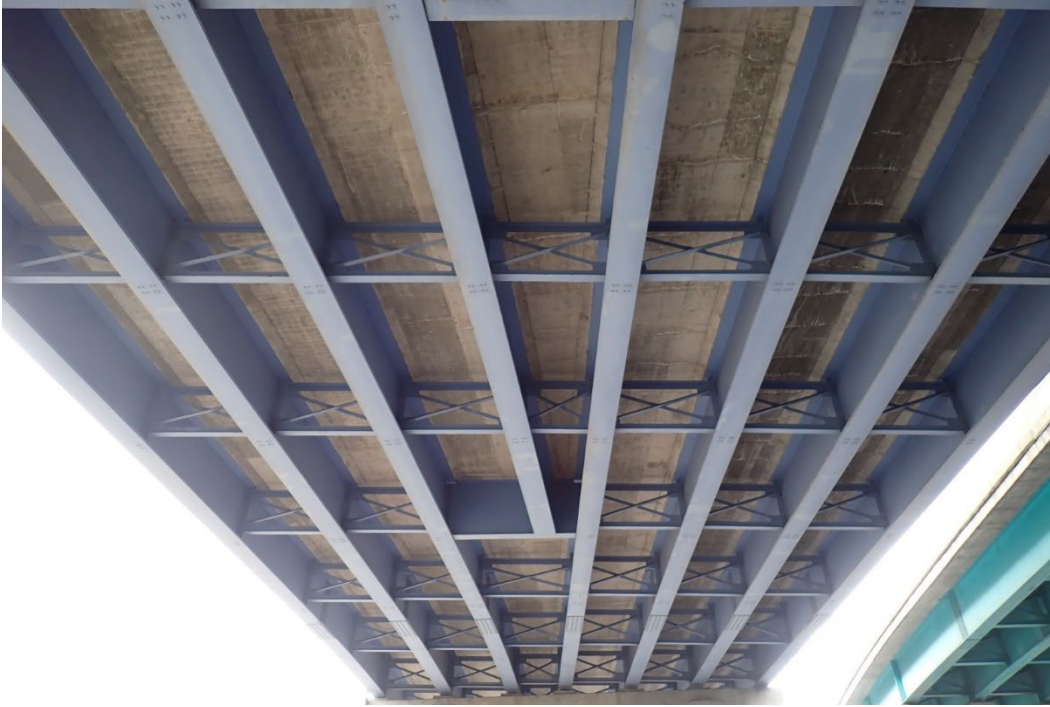
The Steel cross-frames and diaphragms were in GOOD CONDITION [NBIS-7] during the inspection, and no significant changes to defects were noted (Photo 52). There was paint failure on the non-painted spans (Photo 53). Cross frame #5 on Span 14 is bent out of plane. A broken weld at end of cross frame of Girder G in Span 9A was observed (Photo 54).

*Photo 52 - Typical cross frame and diaphragm layout on the underside of Span 5, looking west.*

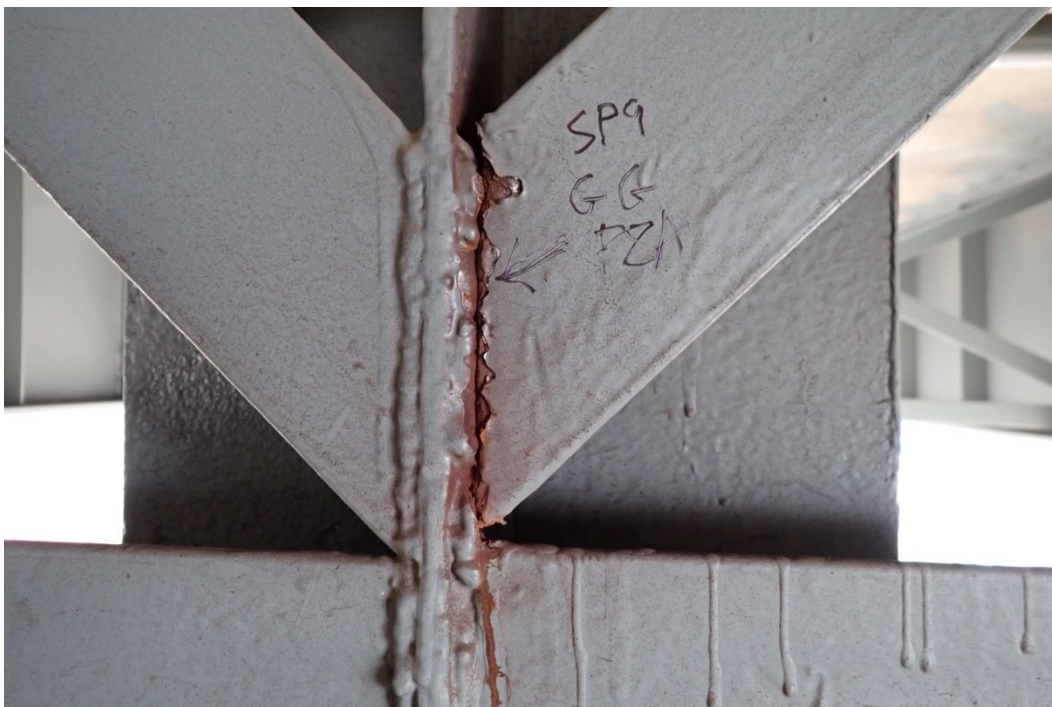
*Photo 54 - Broken weld at end of cross frame of Girder G in Span 9A, looking north.*

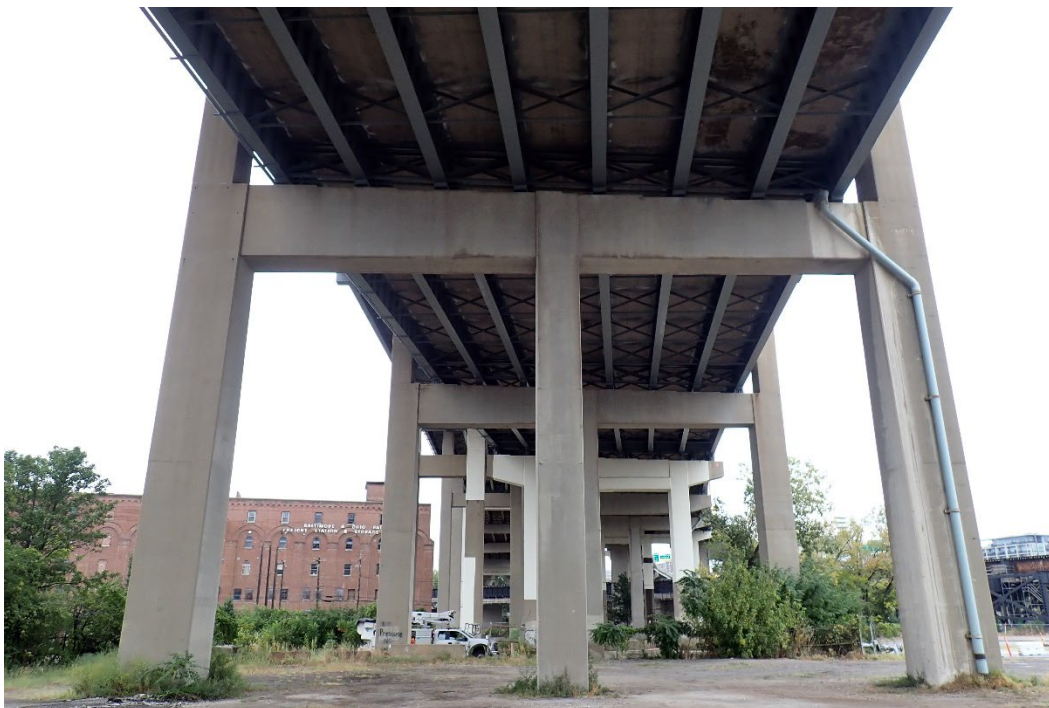
The Pier Columns/bents are in GOOD CONDITION [NBIS-7] overall (Photo 55 & Photo 56), isolated small spalls, exposed rebar, and hairline cracking were observed on columns (Photo 57 & Photo 58). Typically, the round columns in the reconfiguration portion of the bridge are in better condition than the older rectangular columns (Photo 59).

Photo 55 - Typical three-column Pier at Pier 10A, looking north.

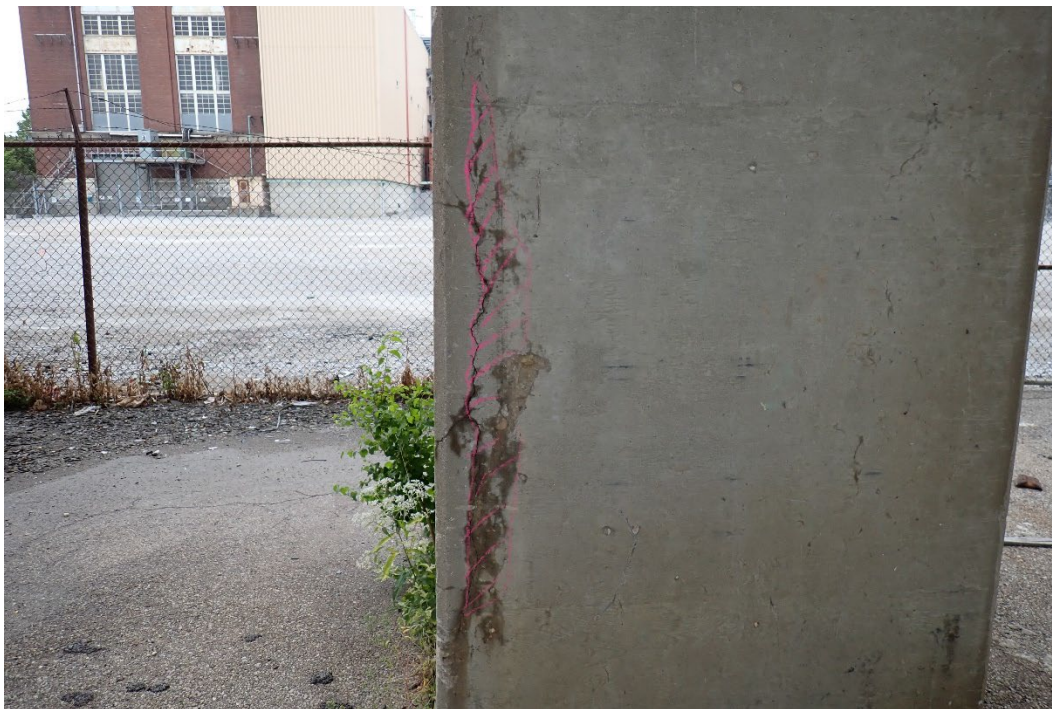
*Photo 57 - Minor spalling and delamination on west column of Pier 1A, looking west.*

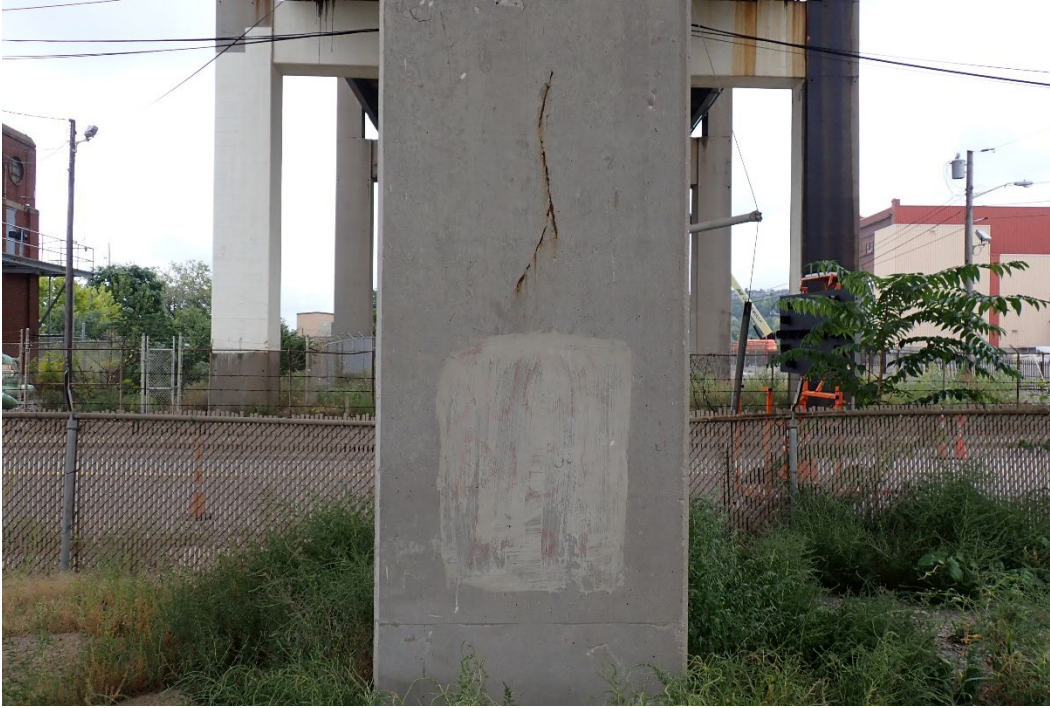
*Photo 58 - Minor spall with exposed rebar on middle column of Pier 9A, looking south.*

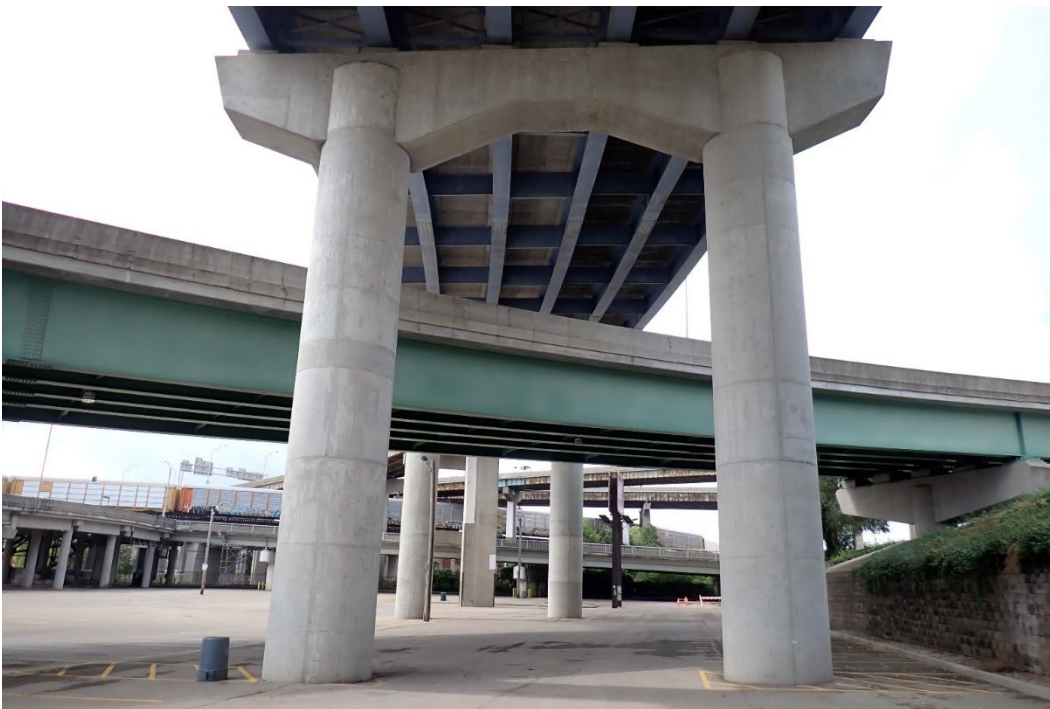
*Photo 59 - Typical concrete pier elevation at Pier 2, looking west.*

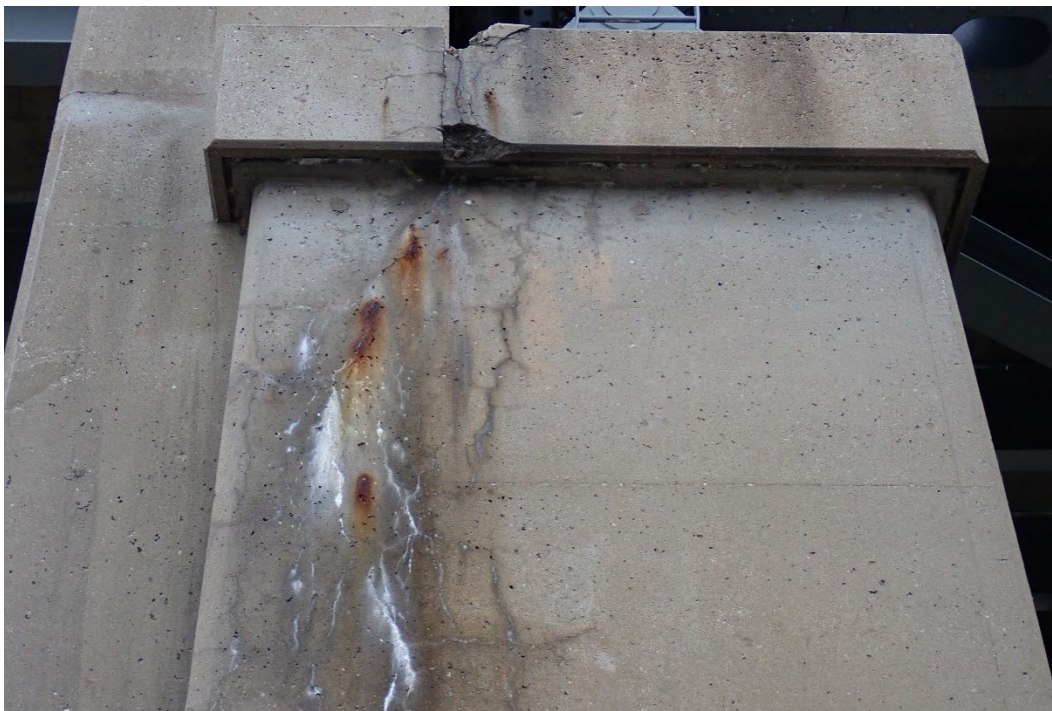
Concrete patching was observed on several columns and FRP wrapping on the River Pier, Piers 4A, 5A, 7A, 8A, 12C, and 15C (Photo 60). Patches are typically sound, and the FRP wrapping is in good condition with only isolated areas of peeling/failing protective coating. There are isolated small spalls without any exposed reinforcing, mainly on the corners, including Piers River, 1A, 5A, 6A, and 19D (Photo 61).

*Photo 61 - Map cracking with delamination, efflorescence, and rust staining on west side of River Pier, looking east.*

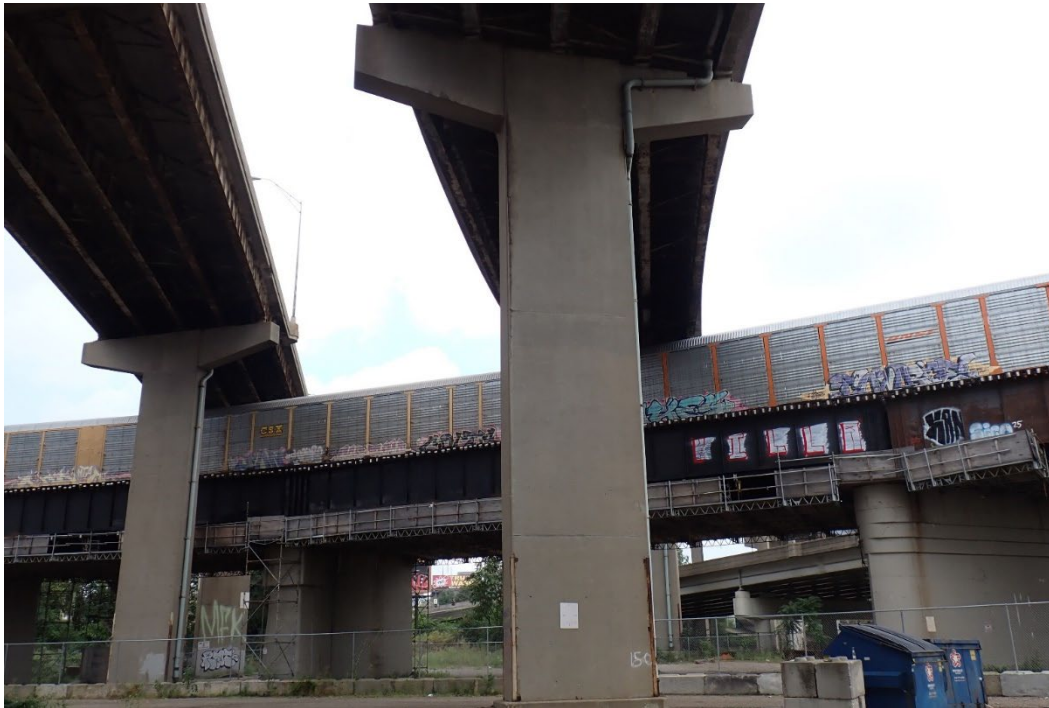
The Reinforced Concrete Pier Walls are in GOOD CONDITION [NBIS-7] overall (Photo 62) and are present at hammerhead Piers 16D, 17D, 19D, and 20D. These piers exhibit isolated hairline cracking. Spalls with exposed rebar were observed at the base of Piers 16D and 20D, where protective corner guards are (Photo 63). Pier 20D has been patched with FRP wrap, and there is rust staining coming through near the cap and alligator scaling of the FRP (Photo 64).

Photo 62 - Typical Elevation View of hammerhead pier at Pier 16D, looking north.

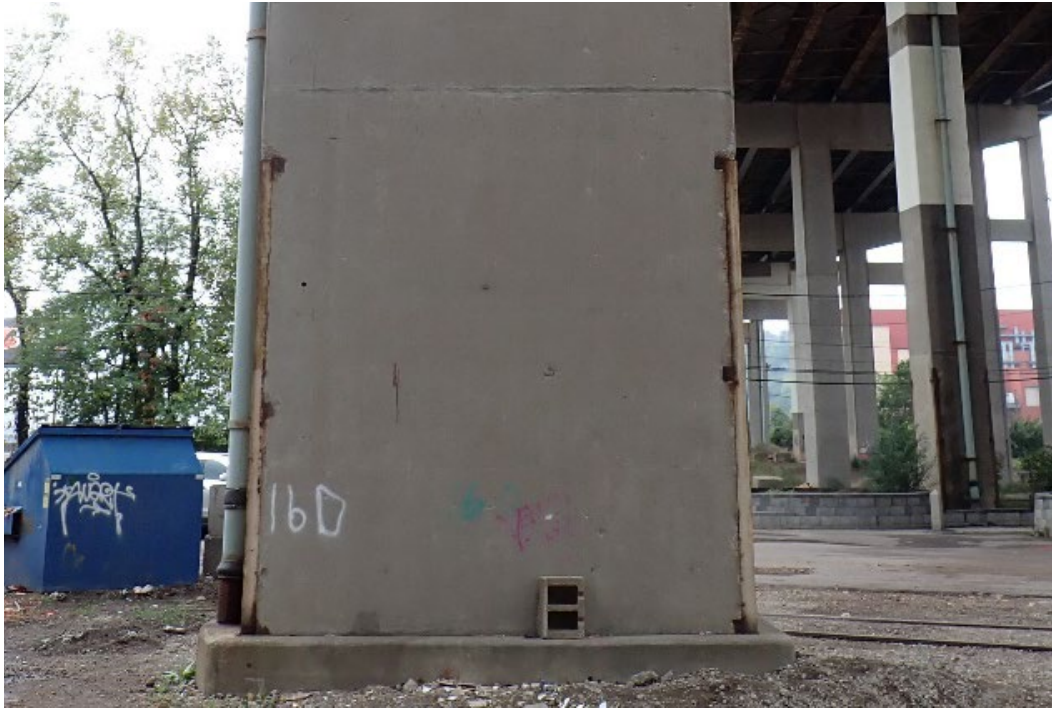
Photo 63 - Minor spalling at corner protection of pier wall at 16D, looking south.

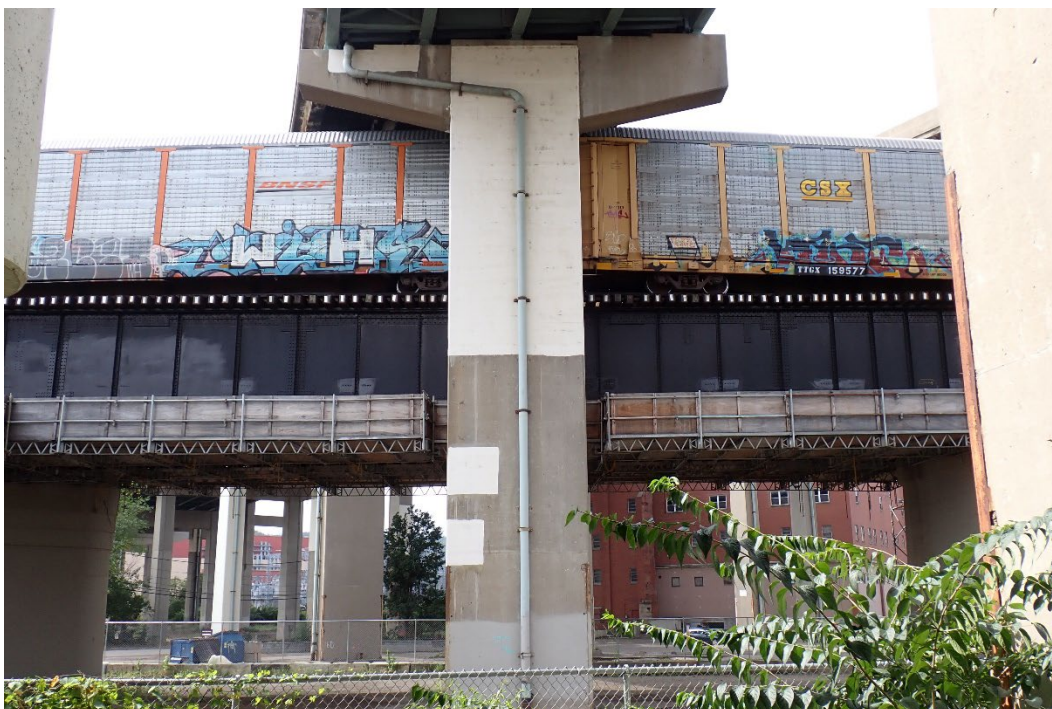
Photo 64 - Typical FRP wrap on pier wall at Pier 17D, looking south.

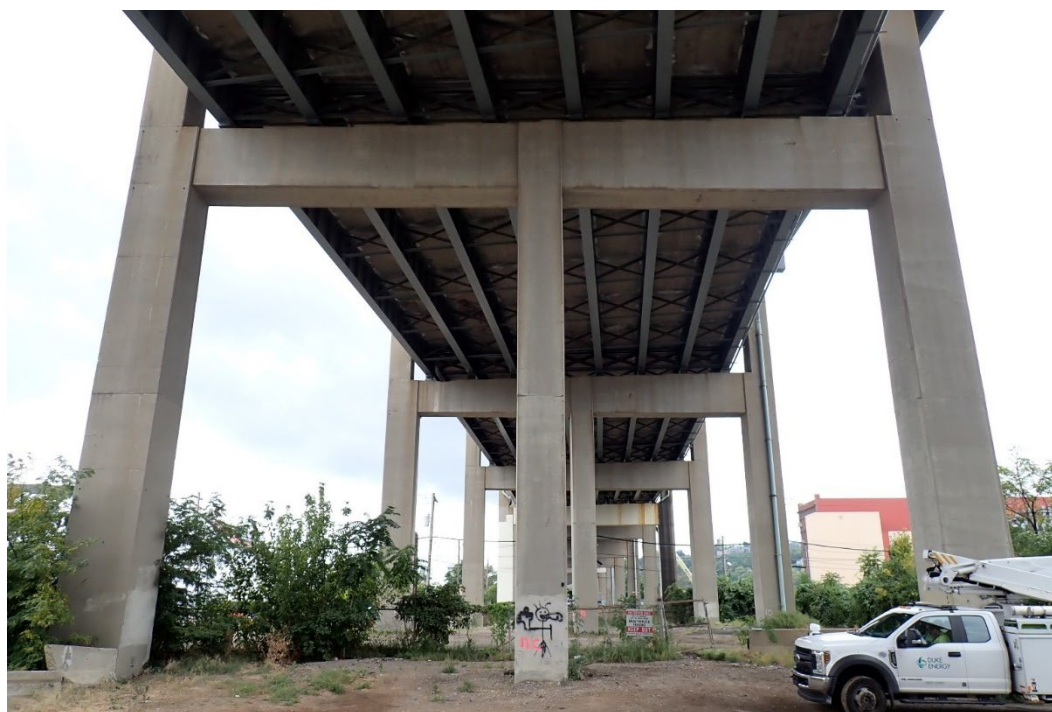
Photo 65 - Pier 11A looking south.

| Pier Cap Surface Defects | |
|---|---|
| Pier 11A | Two 12" x 6" x 1" spalls with exposed reinforcing on the north face and underside of pier cap. |

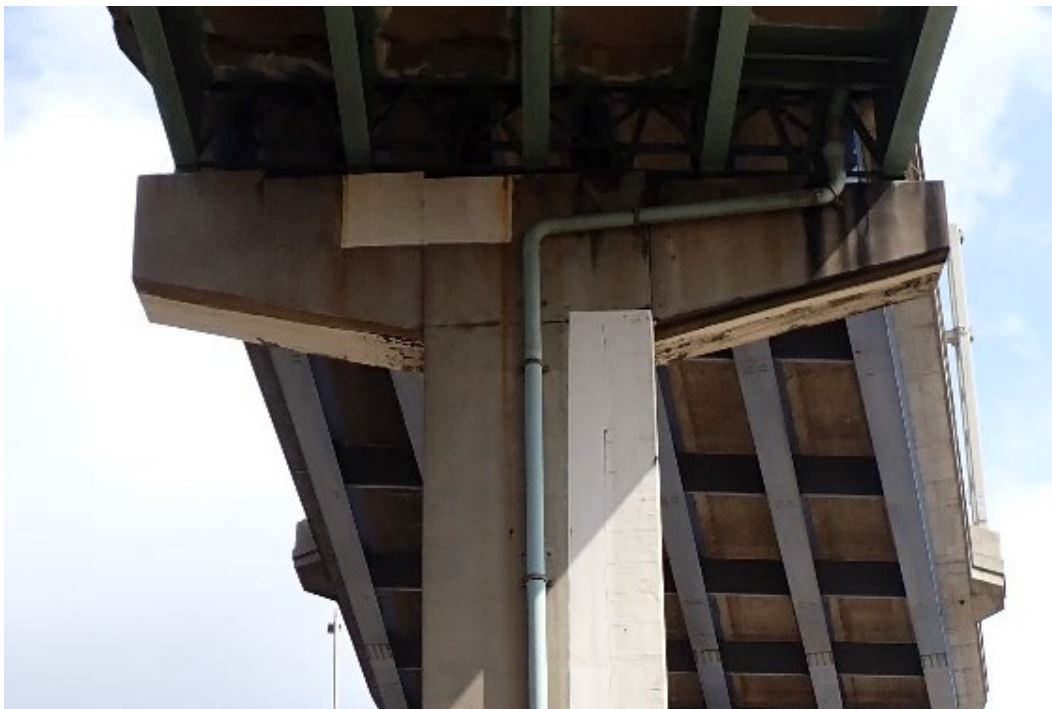
*Photo 69 - Minor cracking on the pier cap overhangs on Pier 20D, looking east.*
