# BRENT SPENCE APPROACH BRIDGE

HAM-71-0000R

## 2025 In-Depth Inspection Report

Inspection Date: September 22-26, 2025

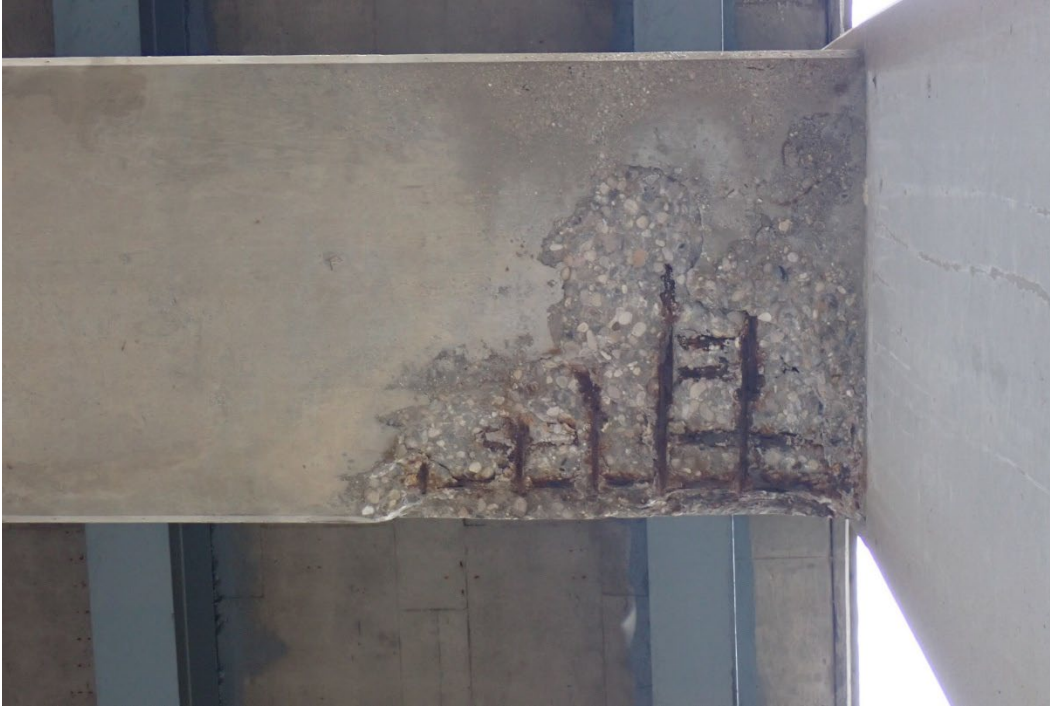
*Photo 70 - Large spall with exposed rebar, and delaminated concrete on underside of pier cap at Pier 5A, looking north.*

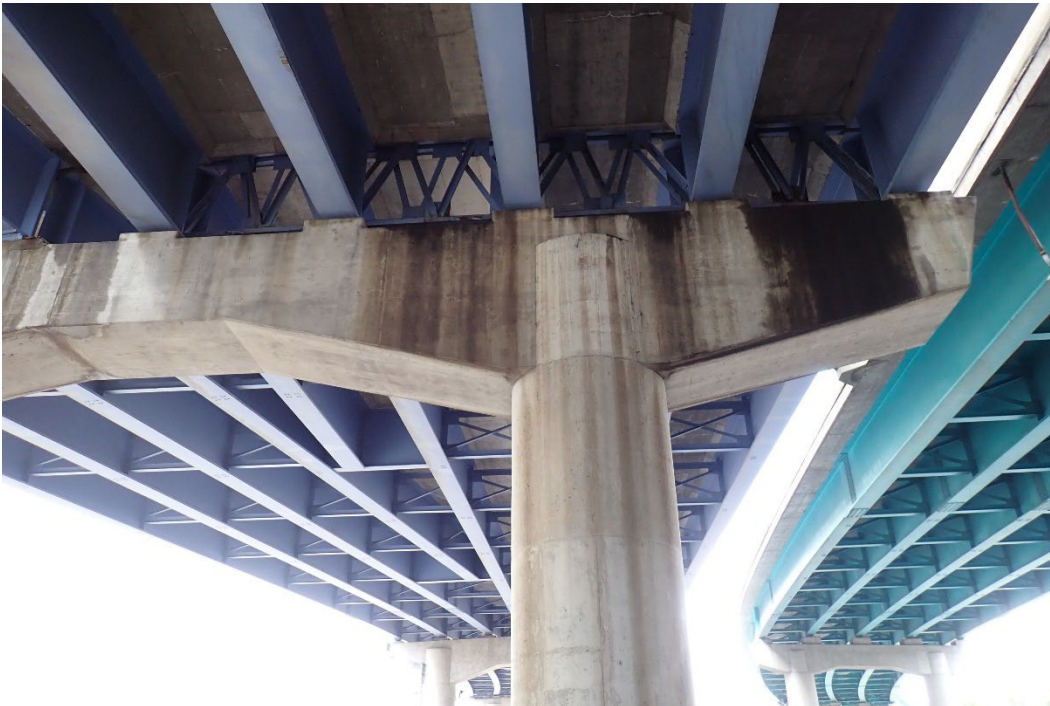
*Photo 71 - Joint leaking onto pier cap with staining at Pier 5, looking west.*

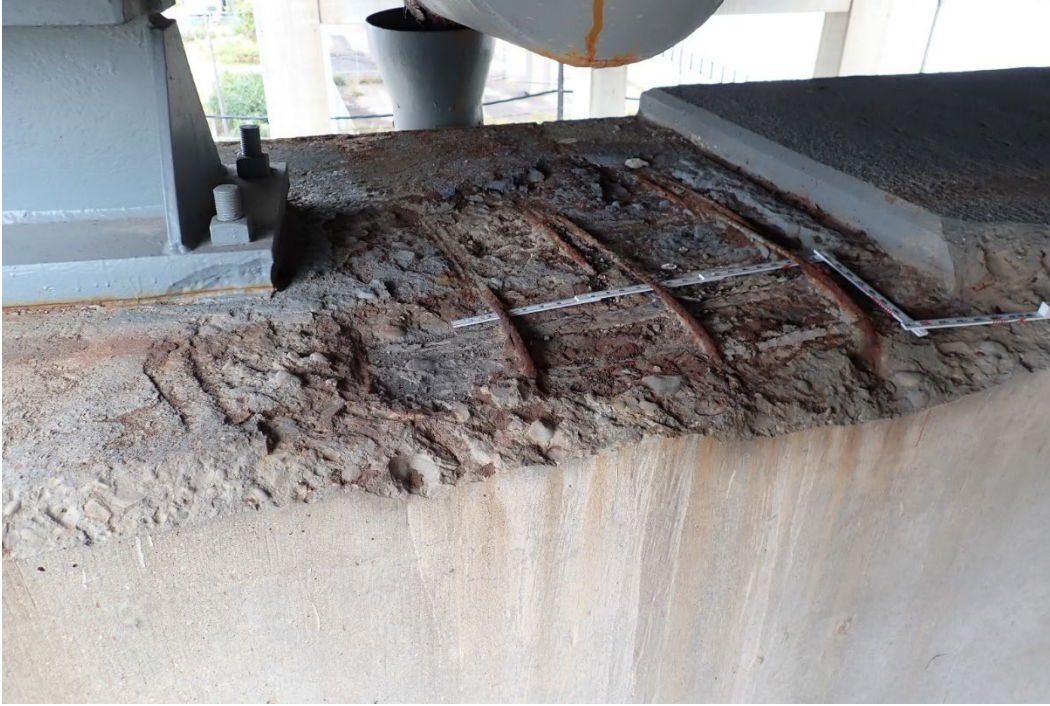
| Pier Cap Surface Defects | |
|---|---|
| Pier 10A | Spall with exposed rebar between Girders G and H on the top of the cap (Photo 72). |

*Photo 72 – Large spall with exposed rebar on pier cap Pier 10A, looking south.*

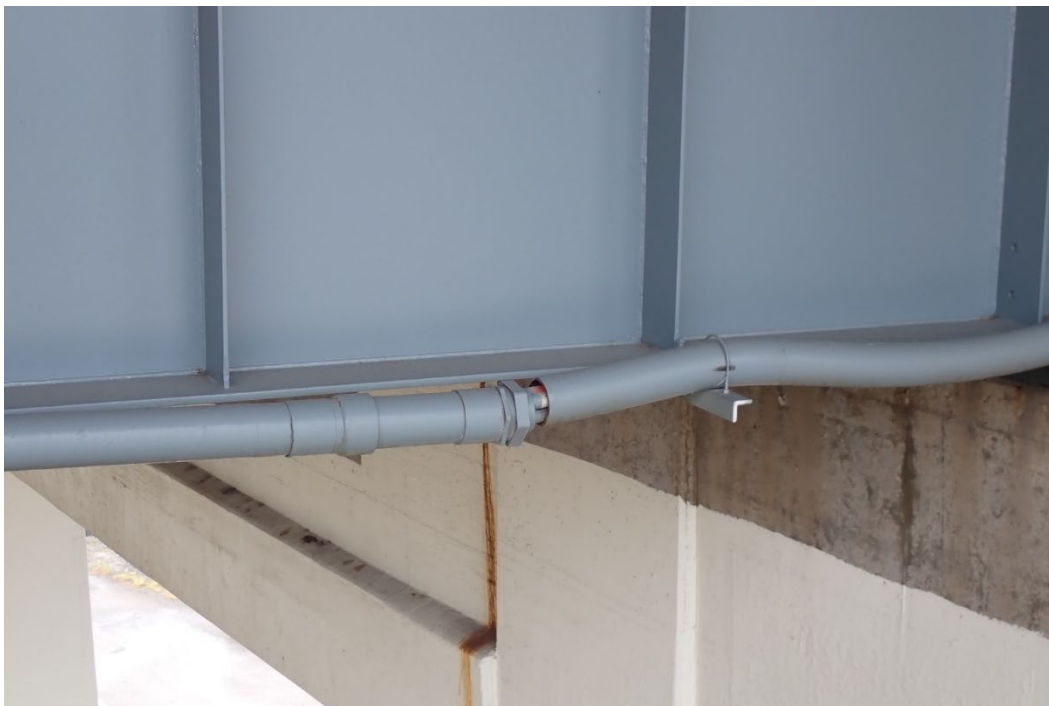
The steel conduit near Pier 12C and in Span 7A has a separated expansion joint exposing the cabling within (Photo 73). There is light surface rust on the electrical junction box and the bracket that is attached to Girder A at Pier 13C.

*Photo 73 - Separated conduit expansion connection, at Span 7A, near Pier 6A, looking south.*
