# 2025 IN-DEPTH INSPECTION REPORT

BRIDGE NO. HAM-75-0022L

SFN: 3108791

Cincinnati, Ohio

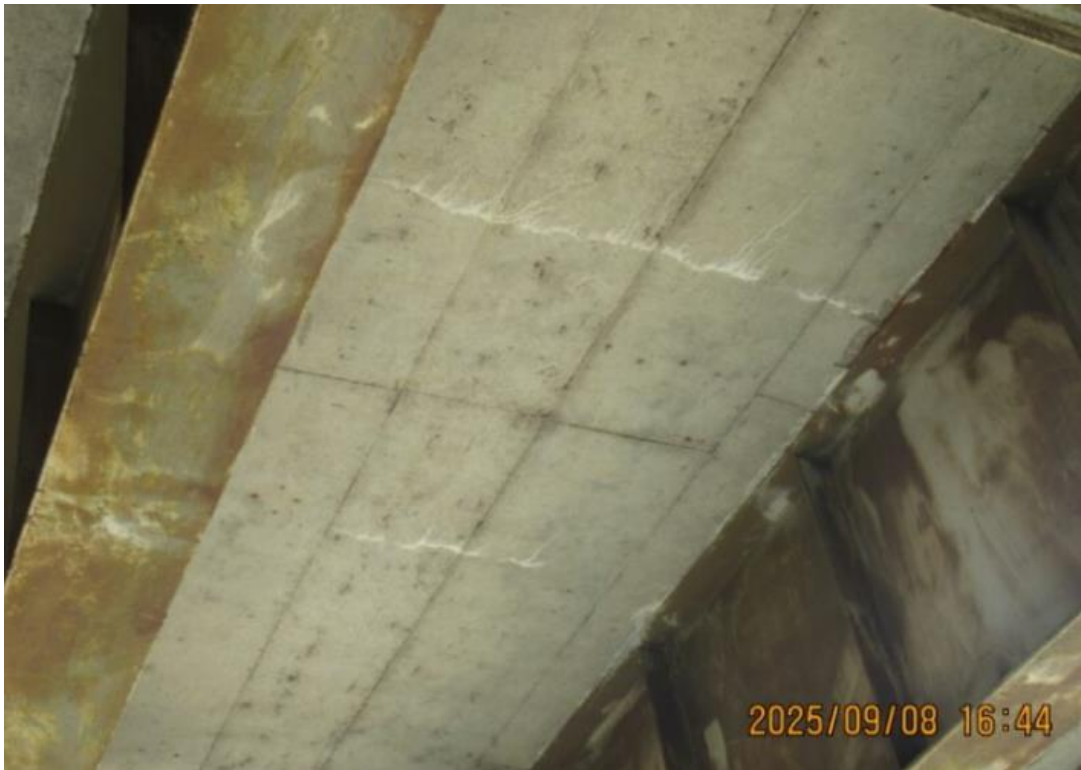
The reinforced concrete deck is in **SATISFACTORY CONDITION (6)** with isolated spalls and exposed reinforcement, isolated minor delaminations, and typical hairline transverse cracks with efflorescence in the underside of the deck (Photo 1). The transverse cracks are typically spaced 4'-6' apart in all spans but were predominantly noted in the interior bays. Numerous isolated spalls are present throughout the deck underside. Minimal section loss of less than 1/16" is typical to the exposed reinforcement at all spall locations. The top of the deck is covered by a microsilica overlay.

*Photo 1: Typical transverse crack with efflorescence (Span 20A shown)*

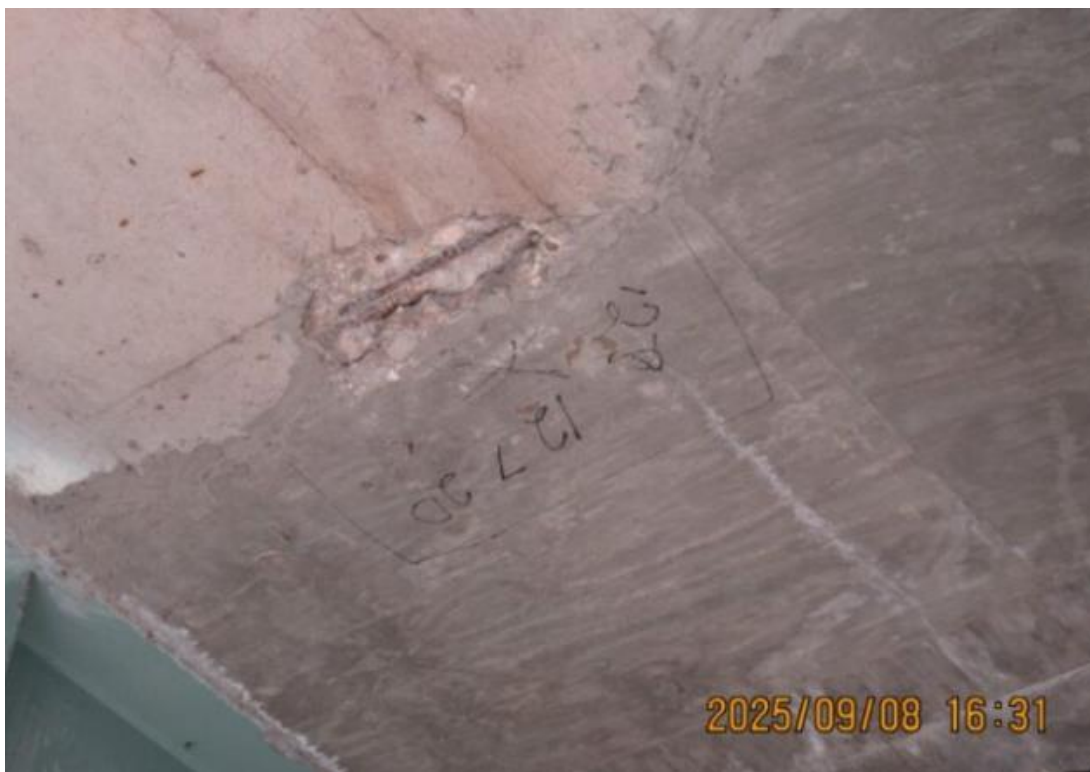
- A 1' long x 6" wide x 2" deep spall with exposed rebar near Pier 19A of Span 20A (Photo 2).
- A 1' diameter x 2" deep spall with exposed rebar in Bay 2 of Span 21A.

*Photo 2: 1'L x 6"W x 2" deep spall with exposed rebar near Pier 19A (Span 20A)*

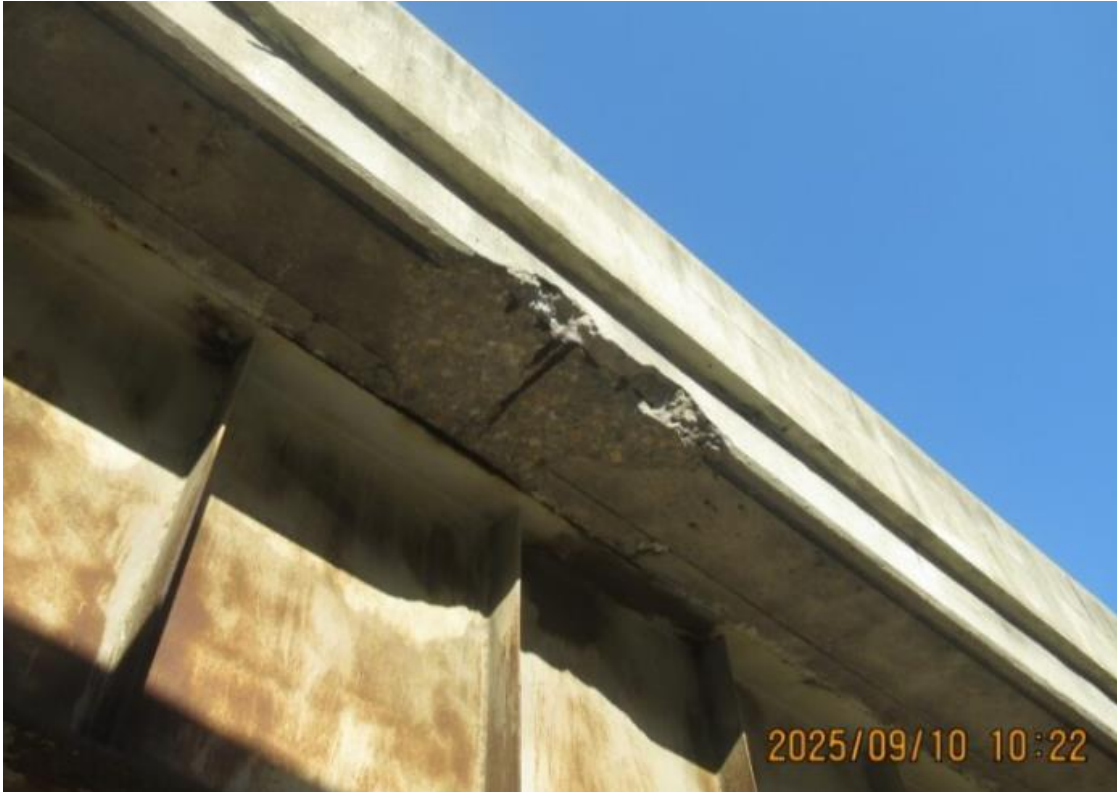
- A 1' diameter x 2" deep spall with exposed rebar in the west overhang of Span 22A.
- A 3' long x 2' wide x up to 4" deep spall with one longitudinal and five transverse reinforcing bars exposed in the east overhang underside of Span 22A near the first crossframe from Pier 21A (Photo 3).

*Photo 3: 3'L x 2'W x 4" deep spall with exposed rebar in east overhang (Span 22A)*

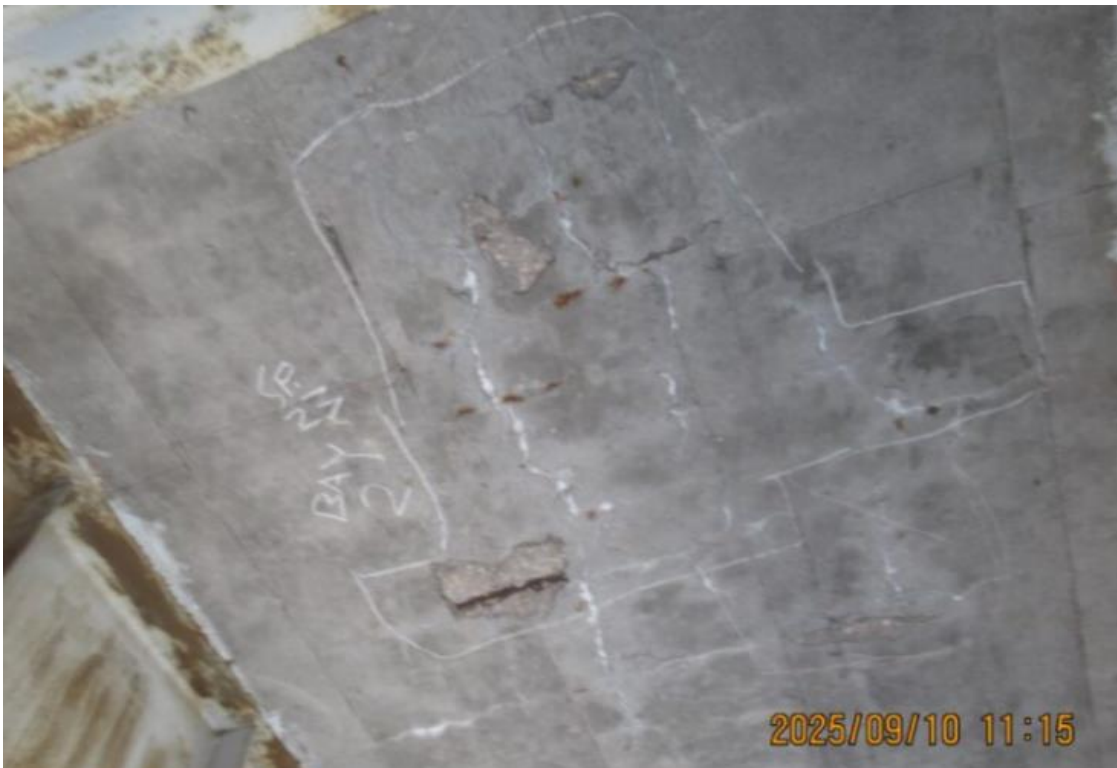
- A 3' long x 1' wide x 3" deep spall with exposed rebar in Bay 1 of Span 22A.
- An 8' wide x 8' long x up to 1" deep area of spalling and delamination is present in Bay 2 of Span 23A. One transverse reinforcing bar is exposed and has minimal section loss (Photo 4).

*Photo 4: 8'L x 8'W x 1" deep area of spalling and delamination (Span 22A)*

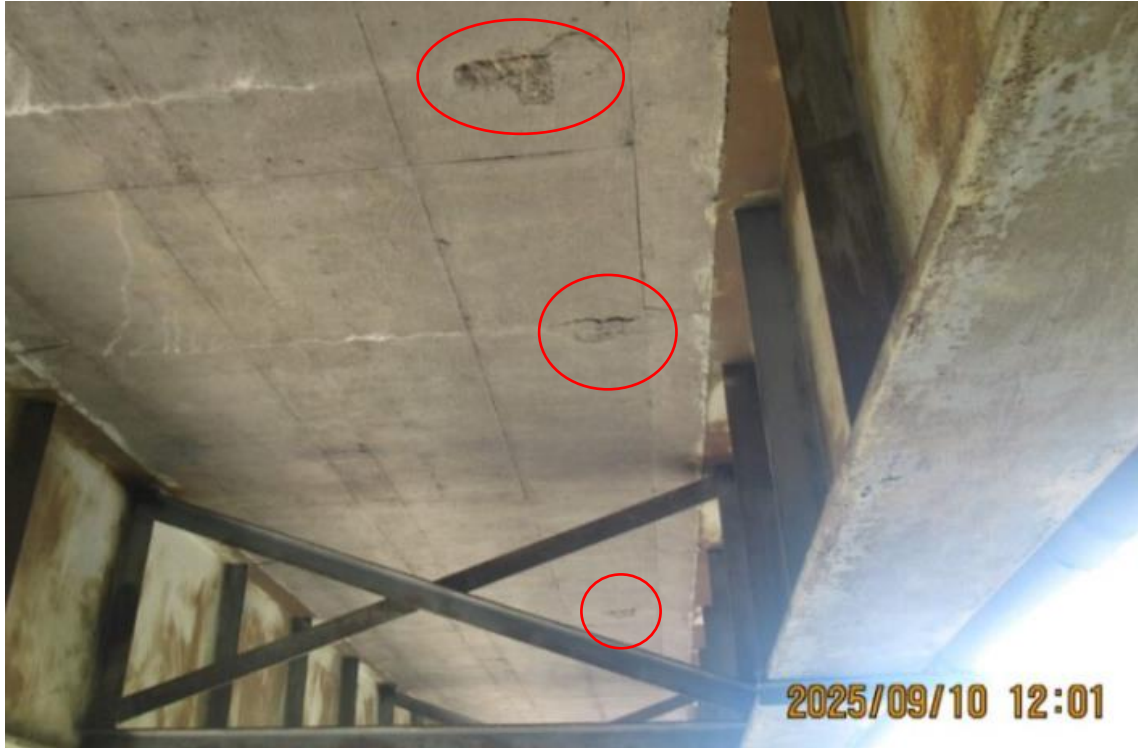
- A 1' diameter spall with exposed rebar in Bay 1 of Span 23A.
- Multiple spalls up to 1' diameter x 1" deep in Bay 1 and the west overhang of Span 24A (Photo 5).

*Photo 5: 3 spalls 1' dia. x 1" deep in Bay 1 (Span 24A)*

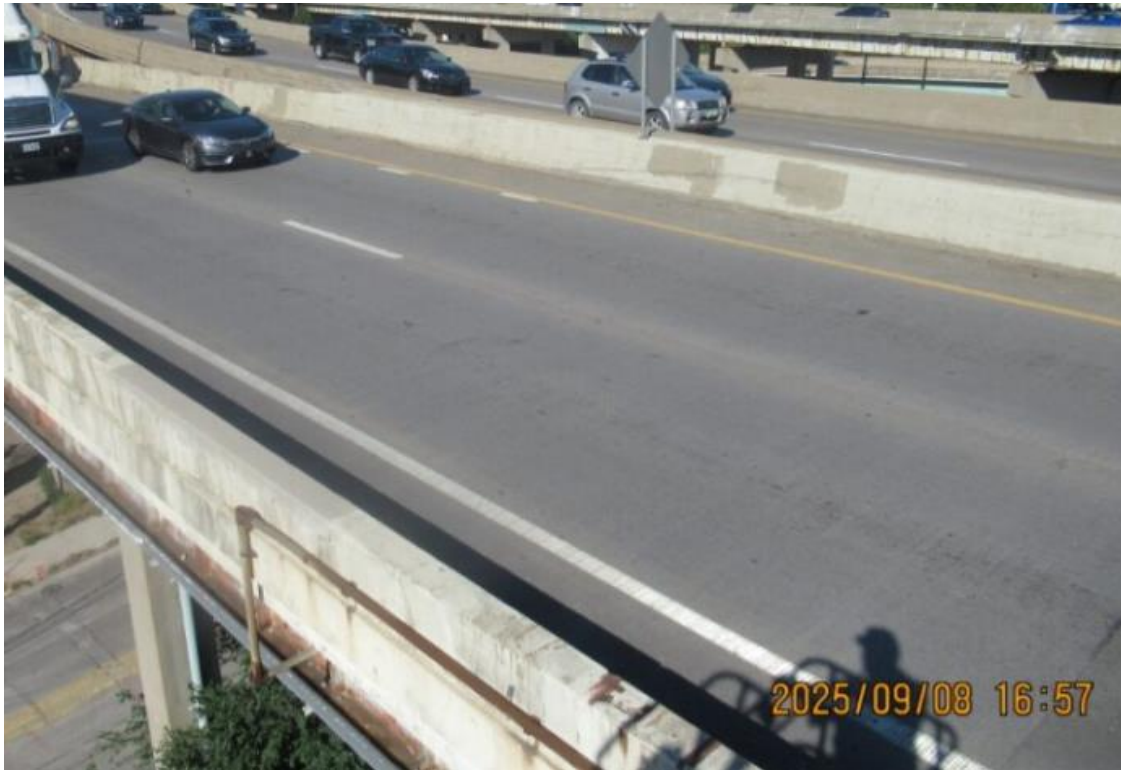
The integral concrete deck wearing surface is in **SATISFACTORY CONDITION (6)** overall with isolated delaminations, minor spalls, and hairline longitudinal and transverse cracks throughout (Photo 6). There is a 6" diameter spall in the right lane of Span 22A near Pier 21A and a 1' x 1' spall previously patched in the right lane of Span 22A near midspan. There is a 1' long x 6" wide x 1" deep spall in the west shoulder of Span 23A (Photo 7). There are four shallow spalls up to 4" in diameter in the west lane of Span 24A (Photo 8). There are six minor areas of delamination based on the 2020 ODOT Concrete Wearing Surface Delamination Report (available from the District).

*Photo 6: Wearing Surface Typical Condition (Span 20A shown)*

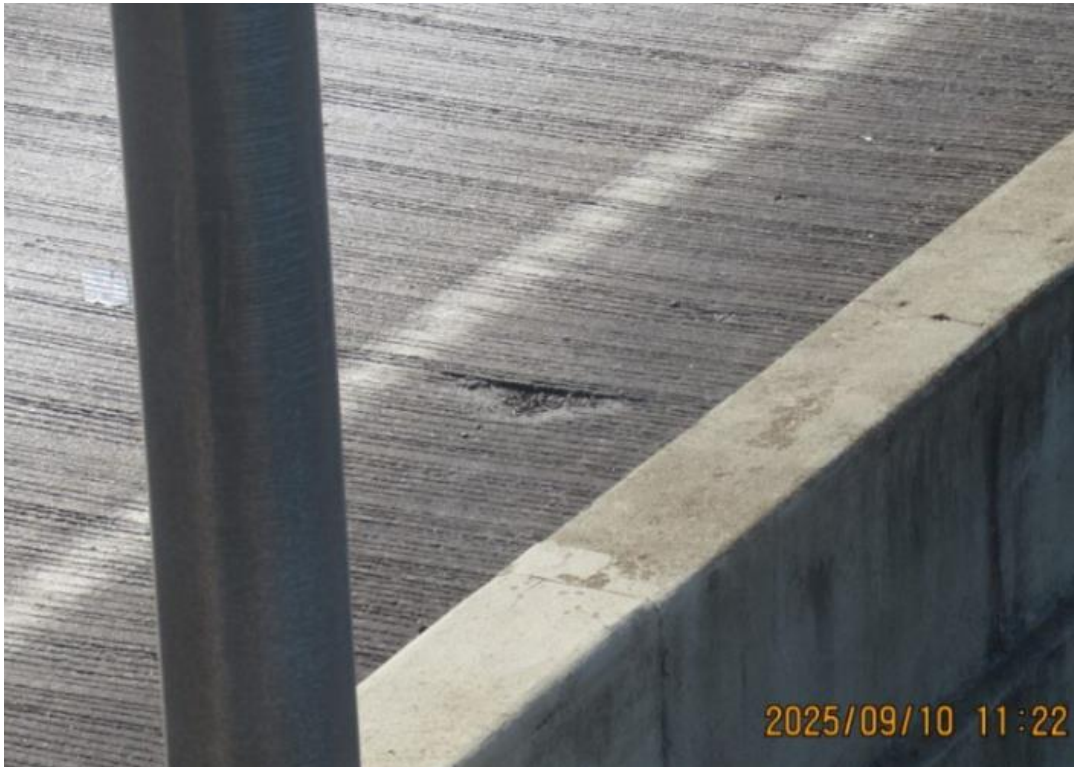
*Photo 7: 1'L x 6"W x 1" deep spall in west shoulder (Span 23A)*

- Clean debris from clogged drainage scuppers.
- Patch spalls/potholes in the concrete wearing surface.

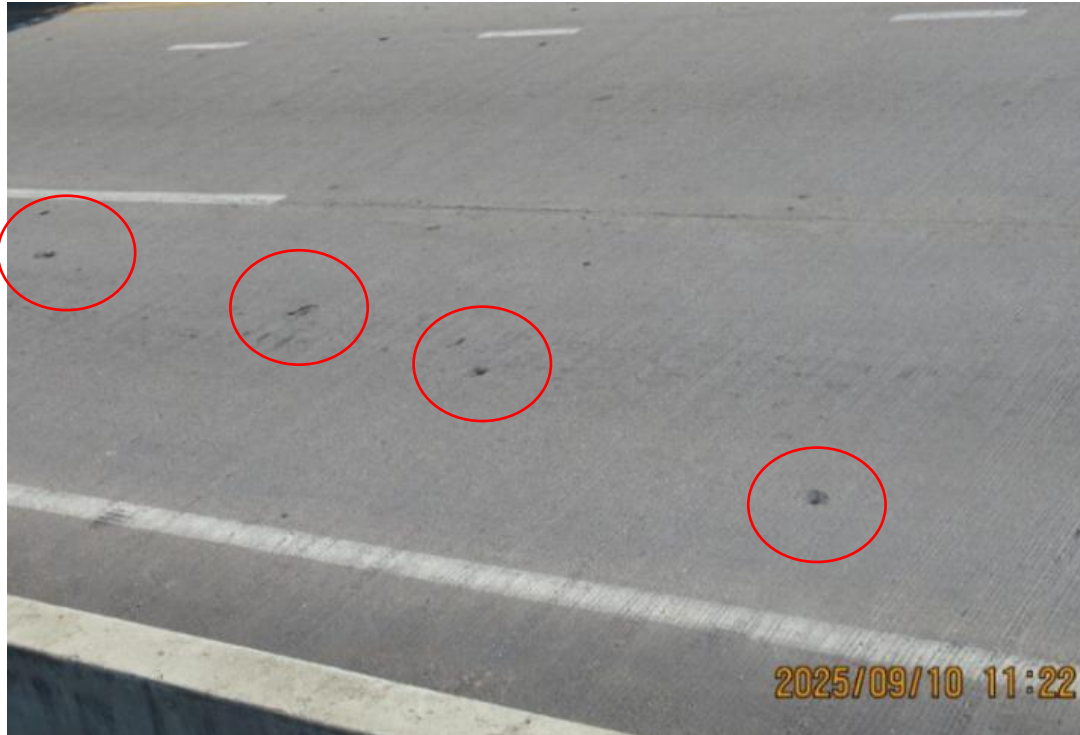
*Photo 8: Four shallow spalls up to 4" in dia. in west lane (Span 24A)*

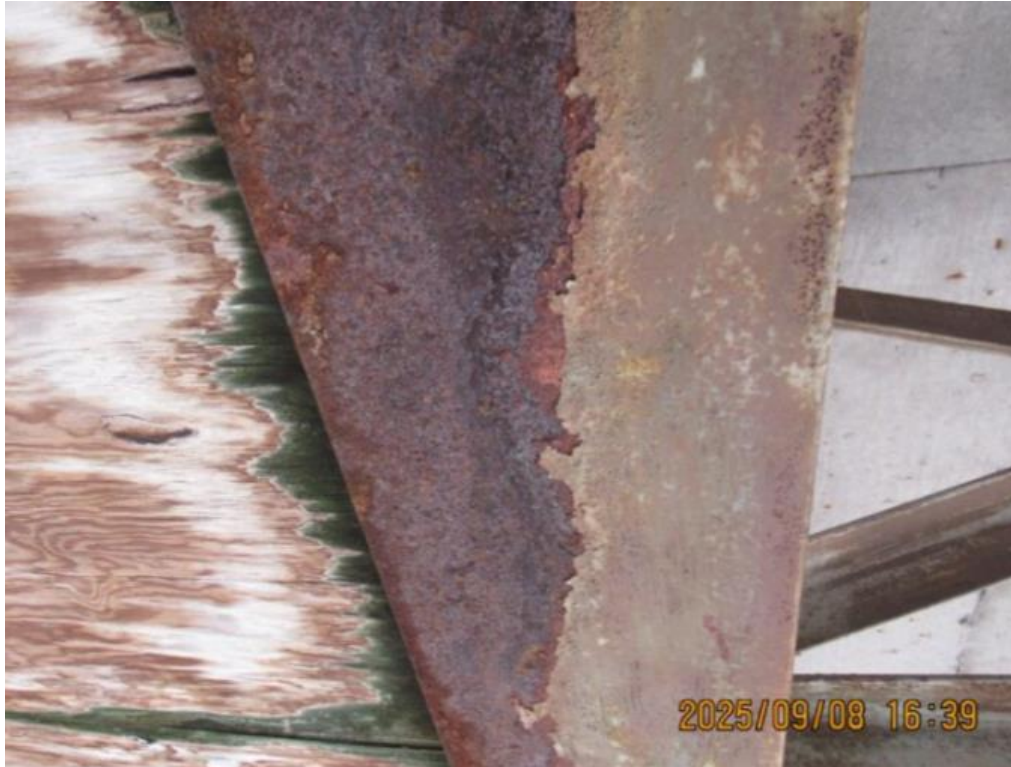
The steel plate girders are in **SATISFACTORY CONDITION (6)**. There is typical freckling and minor surface corrosion throughout the girder webs and flanges, particularly noted the most significant at the fascia girders. Laminate corrosion is present on the bottom flange of the exterior girders and the bottom flange of Girder E adjacent to the timber falsework between HAM-75-0022L and HAM-71-0000L. While most instances of laminate corrosion only exhibit minor section loss, there is an isolated area of up to 1/8" deep section loss on the west edge of the bottom flange of Girder E in Span 20A (Photo 9). Inspectors attempted to remove the timber falsework in order to gain access to the east face transverse stiffeners of Girder E in Span 20A, however it could not be removed at the time of inspection. Therefore, the previously noted corrosion holes at this location were not accessible and not verified. There are cracks in the web of Girder C in Spans 23A-25A that have been previously repaired with arrest holes. These cracks and arrest holes are present at the weld between the web and transverse stiffener near the top flange at the midspan crossframe locations (Photo 10). There were no indications of crack propagation beyond the arrest holes at the time of inspection.

*Photo 9: 1/8" deep section loss on west edge of bottom flange of Girder E (Span 20A)*

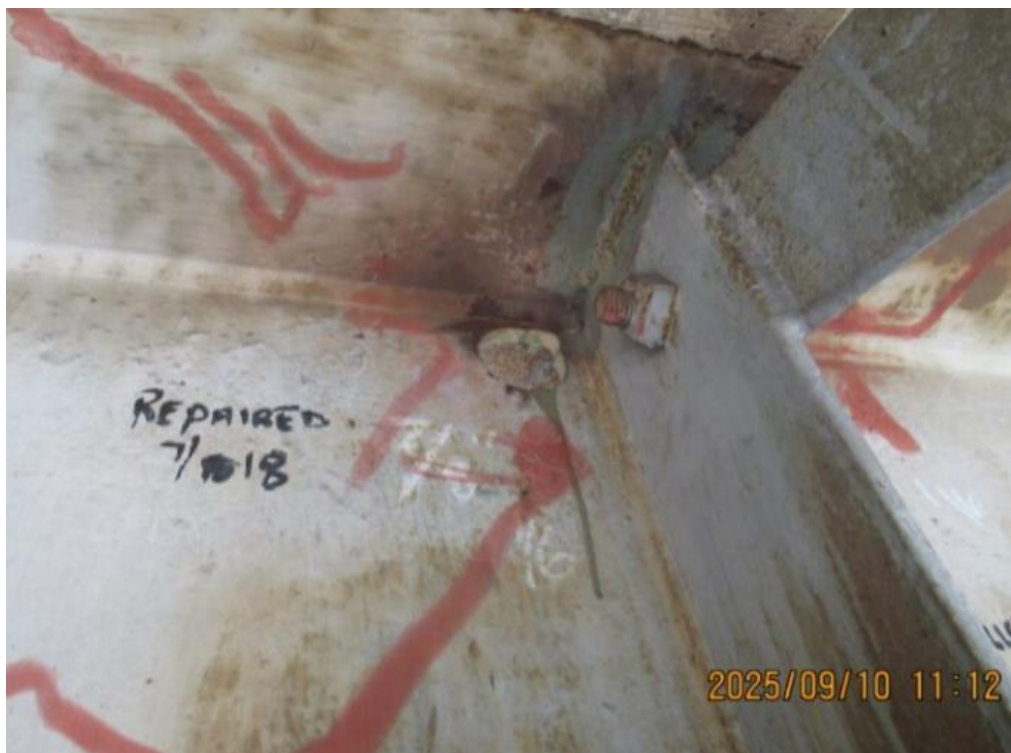
*Photo 10: Crack arrest hole in Girder C (Span 23A)*

The fatigue details of the bridge are in good condition overall. The cracks in the weld between the web and transverse stiffeners of Girder C in Spans 23A-25A were previously repaired with arrest holes and there are no signs of crack propagation beyond the repairs at any location.

- Continue to monitor the crack arrest hole repairs in the web of Girder C in Spans 23A-25A.

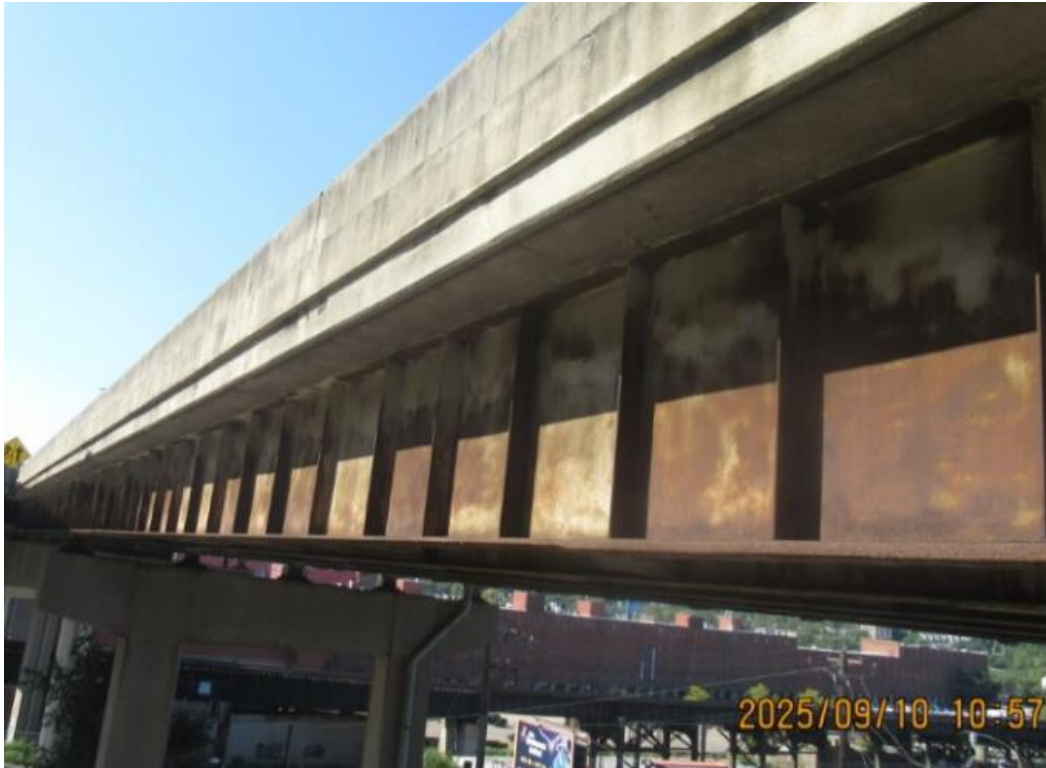
The steel protective coating is in **SERIOUS CONDITION (3)**. As part of the 2017 expansion joint replacement at Pier 19A and Abutment A, the end 10' of the existing girders were cleaned and painted. The protective coating at these locations is in good condition overall. Otherwise, the protective coating system is ineffective or has completely failed throughout all steel members. Chalking, peeling, and cracking paint is typically widespread throughout the interior bearings, crossframes, and girders. The system has failed notably on the fascia girders, exhibiting completely exposed steel and areas of minor surface corrosion (Photo 11).

*Photo 11: Typical paint condition on fascia girders (Span 22A shown)*

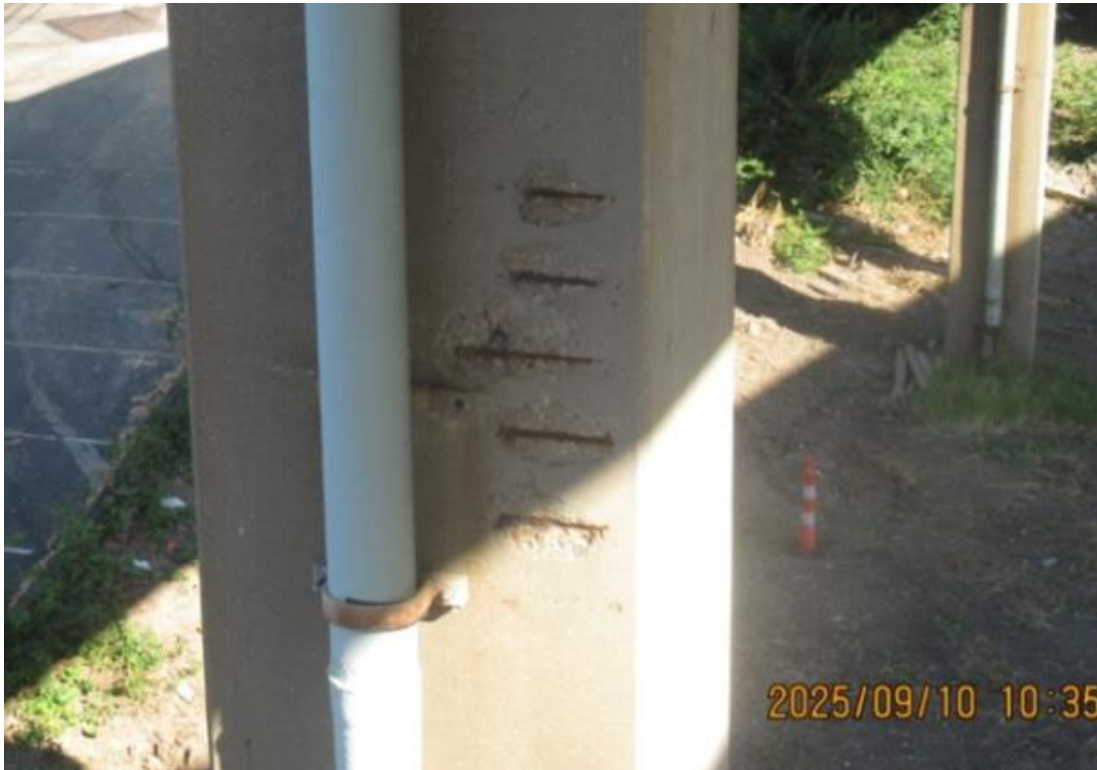
- Pier 22A, Column 1: Multiple spalls up to 3' wide x 16" tall x 1" deep with five exposed reinforcing bars with minor section loss typical on the south face about 12' below the pier cap (Photo 12).
- Pier 23A, Column 1: 6" diameter x 1" deep spall near the drainage support bracket on the south face of Column 1 about 15' above the ground line.

*Photo 12: Multiple spalls up to 1" deep with exposed rebar on the south face of Column 1 (Pier 22A)*

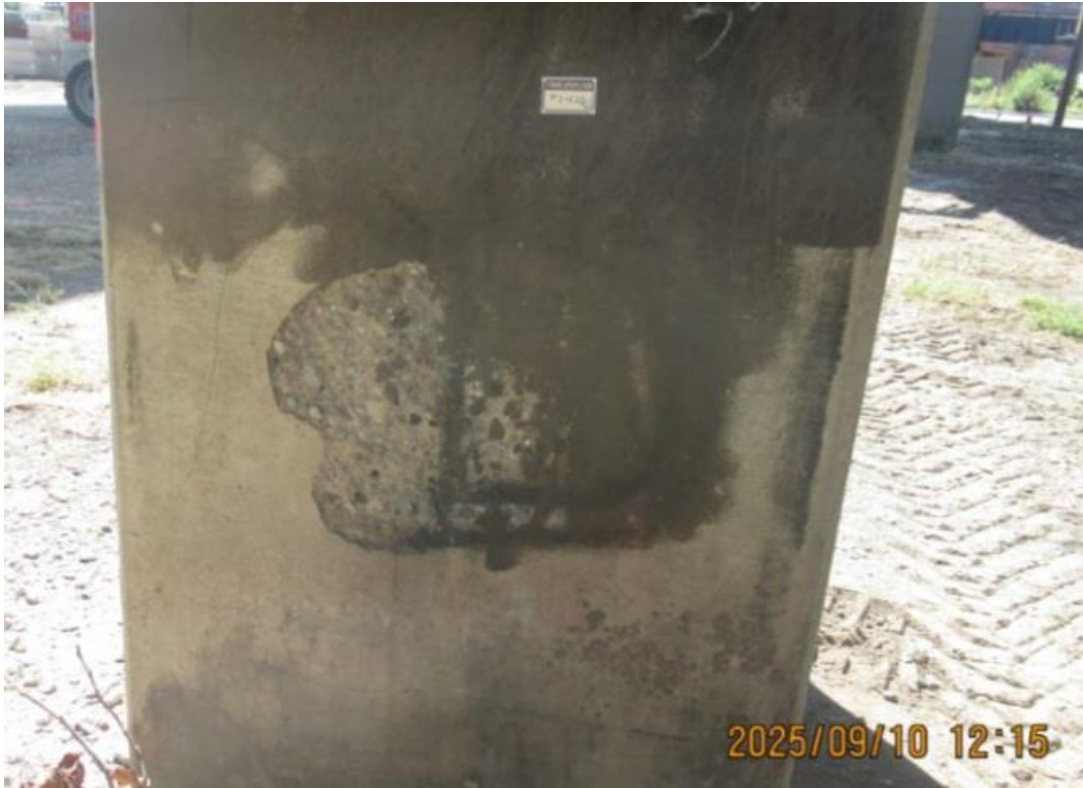
- Pier 23A, Column 2: 20" diameter x 1" deep spall on the north face of Column 2 about 3' above ground line (Photo 13).

*Photo 13: 20" dia. x 1" deep spall on the north face of Column 2 (Pier 23A)*

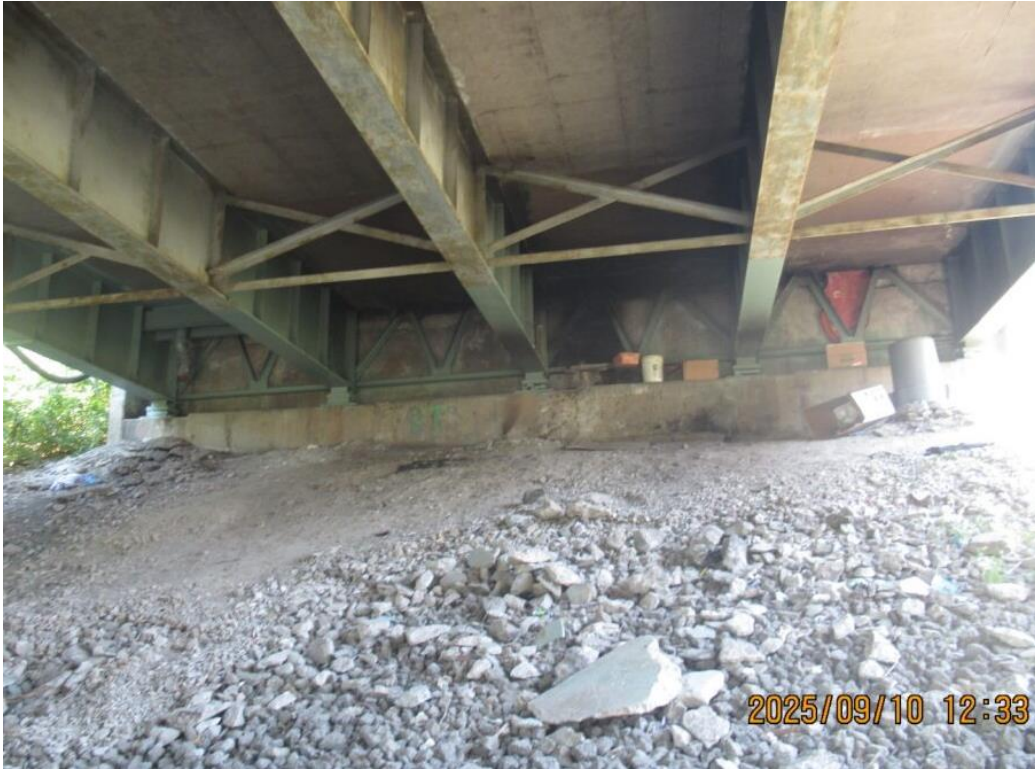
*Photo 14: General Photo (Abutment A)*

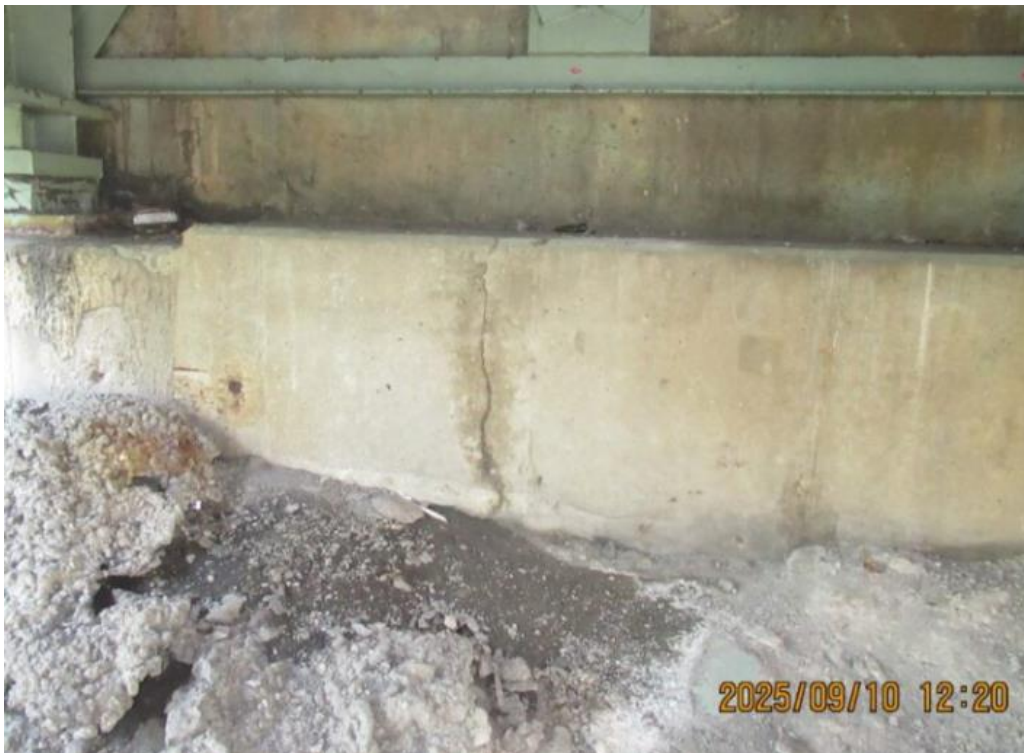
The reinforced concrete abutment is in **FAIR CONDITION (5)** with spalls, delaminations, and hairline to moderate cracking throughout. Concrete patches between Girders A and B and Girders D and E are delaminated and isolated hairline vertical cracks are typical throughout. There are shallow spalls up to 6" in diameter below Bearing A. There is a 12" long by 6" wide by 1" deep spall below the bearing of Girder C and a 4" long by 2" wide by 1" deep spall and hairline crack below the bearing of Girder D. There were no instances of loss of bearing area or exposed reinforcement noted at any of the spall locations. There is discoloration in the backwall between Girders C and D caused by a suspected fire at this location. There is moderate-width vertical cracking in Bays 1 and 3 (Photo 15).

*Photo 15: Full height vertical crack between Bearings A and B (Bay 1, Abutment A)*

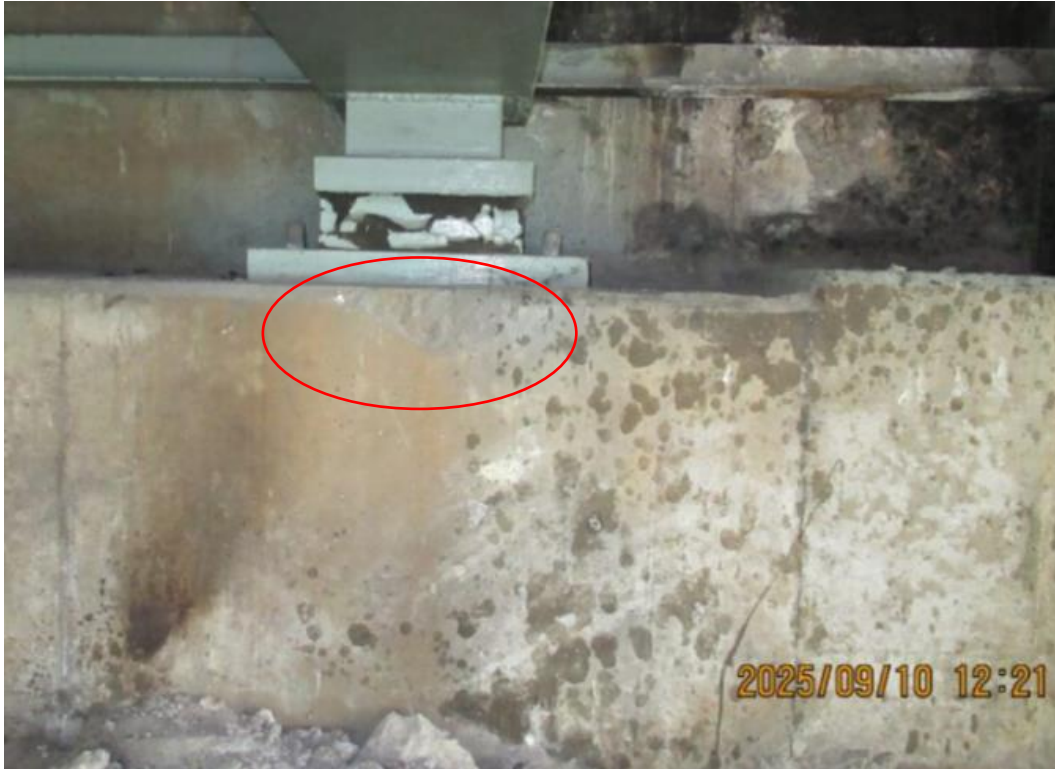
*Photo 16: Typical spalling/delamination under bearings (Abutment A)*

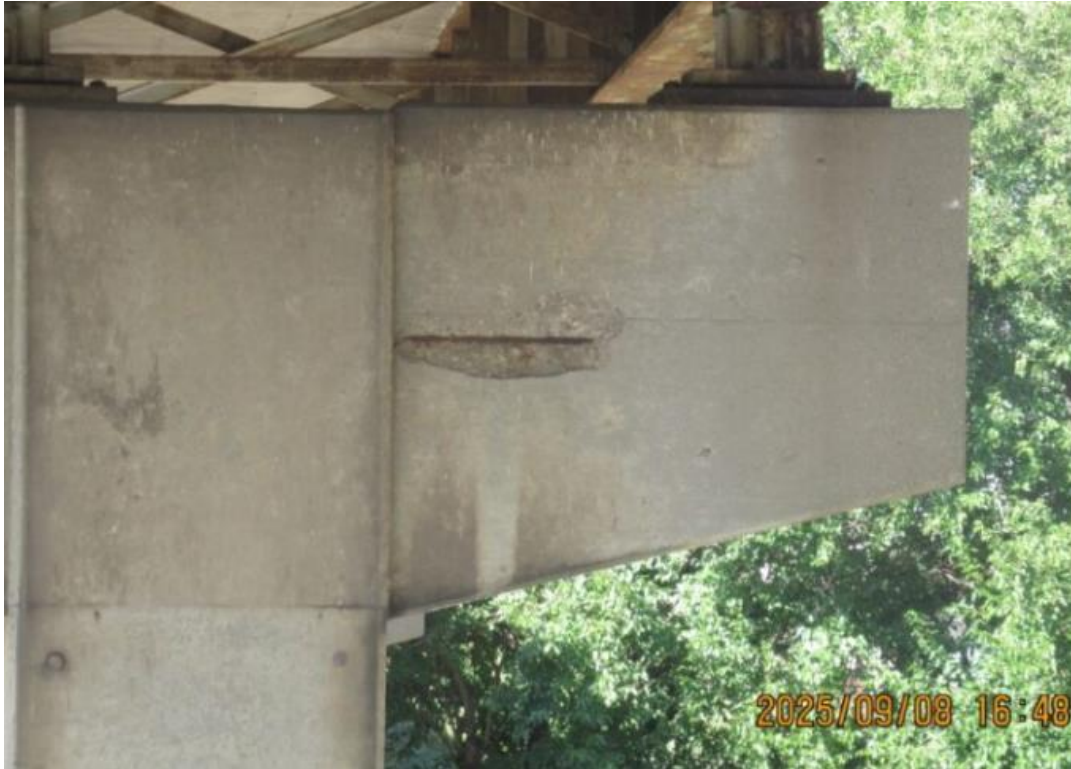
*Photo 17: 1'H x 2'W x 2" deep spall (Pier Cap 21A)*

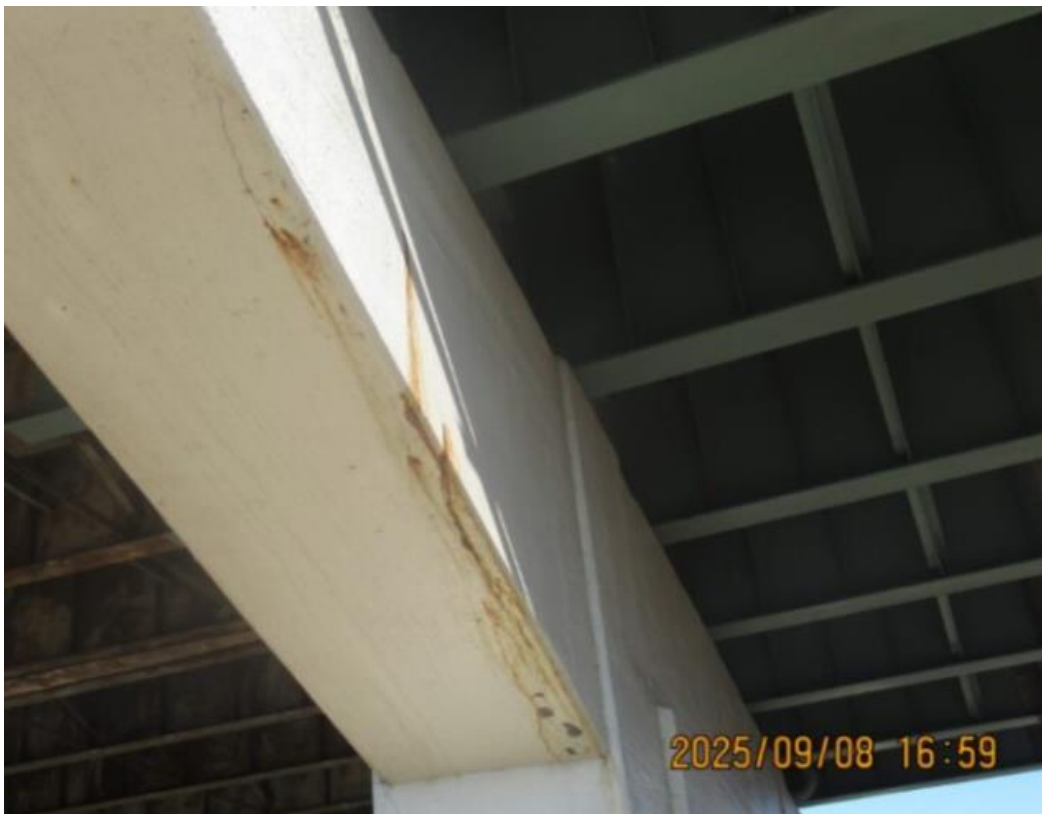
The reinforced concrete pier caps are in **SATISFACTORY CONDITION (6)** with isolated spalls and hairline horizontal and vertical cracks throughout. The horizontal hairline cracks are typically located near the top portion of the caps with isolated vertical cracks beginning to develop. The south face of Pier Cap 21A exhibits a 1' high x 2' wide x 2" deep spall with one exposed reinforcing bar between Girders D and E (Photo 17). There is a 10' wide x 1' long area of delamination, cracking, and rust staining on the underside of the Pier 19A cap between Girders A and B (Photo 18).

*Photo 18: 10'W x 1'L delamination with cracking and rust staining (Pier Cap 19A)*

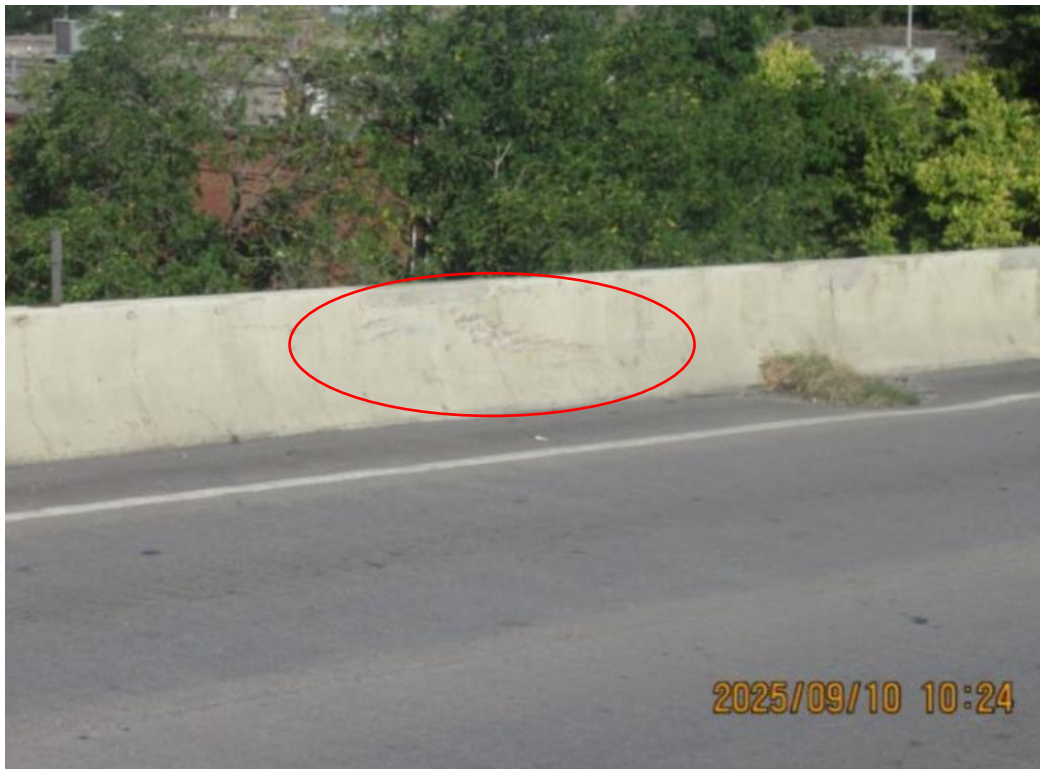
*Photo 19: 5'L x 1'H x 1" deep spall due to impact damage railing (Span 22A shown)*

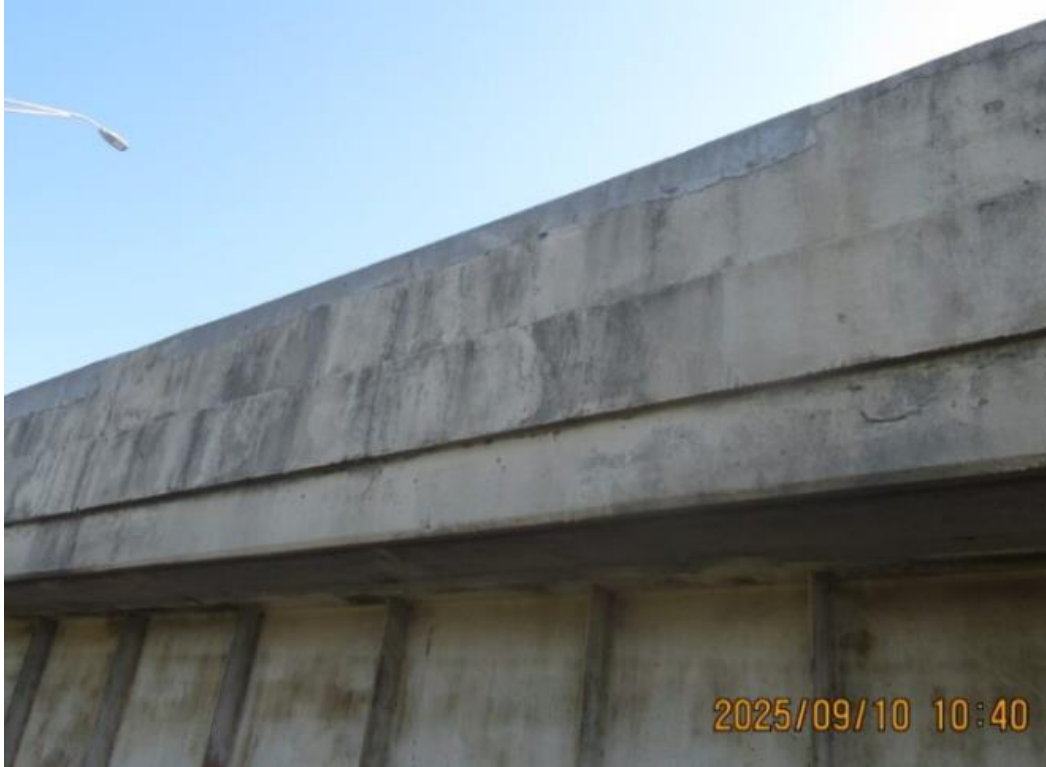
The reinforced concrete bridge railings are in **SATISFACTORY CONDITION (6)** overall with isolated minor spalls, isolated minor delaminations, and full height hairline vertical and transverse cracks throughout. There is a 5' long x 1' high x 1" deep spall due to impact damage on the left railing near midspan of Span 22A (Photo 19). Both railings have concrete patches near Pier 19A and Abutment A as well as at isolated locations throughout. The concrete patches are in good condition overall (Photo 20).

*Photo 20: Typical concrete patch in west railing (Span 23A shown)*

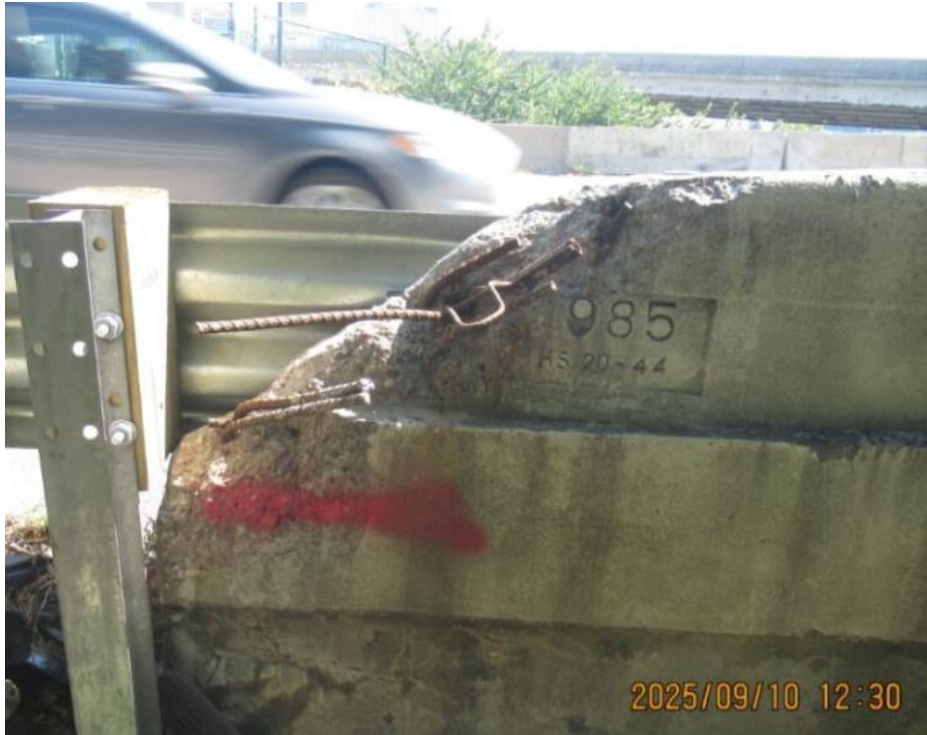
The approach guardrail is in **SATISFACTORY CONDITION (6)**. The approach guardrail in the vicinity of the bridge has been replaced since the previous inspection. There is a full width x full height x 3' long spall with exposed and deformed reinforcement on the end of concrete barrier; this area is behind the metal approach guardrail (Photo 21).

*Photo 21: Full width x full height x 3' long spall with exposed and deformed reinforcement*

A 36" long by 24" high by full width spall with exposed rebar is present on the west approach parapet where the old guardrail was previously connected. Metal approach guardrail in the vicinity of the bridge has been replaced since the previous inspection.

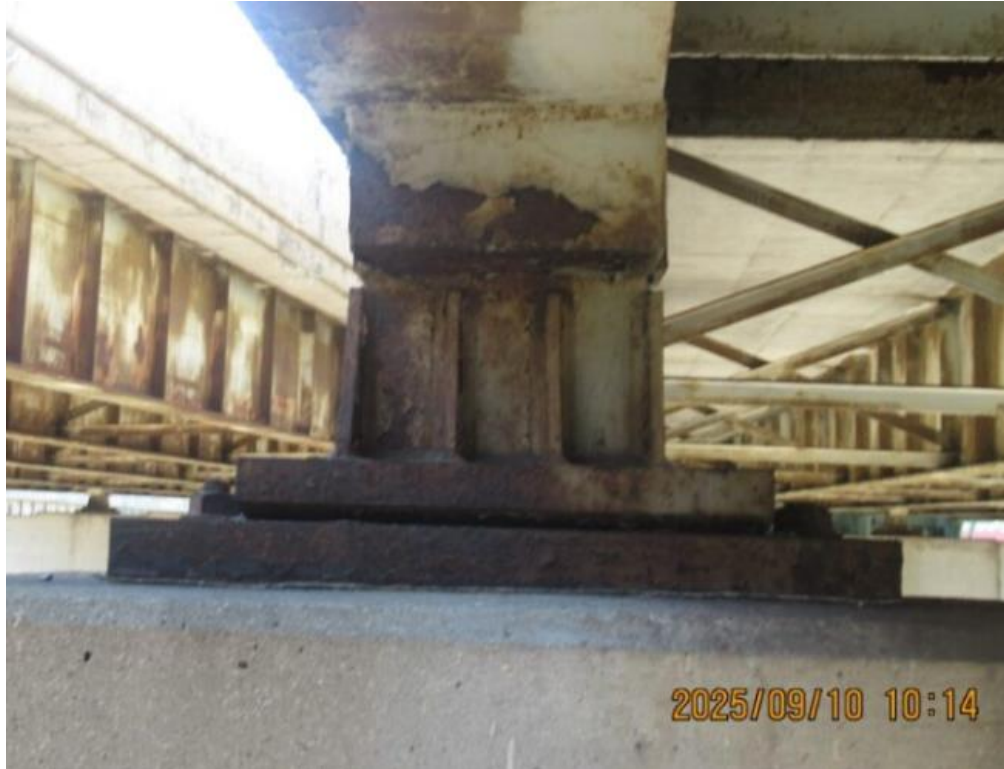
The rocker bearings are in **FAIR CONDITION (5)** with surface corrosion (Photo 22) and isolated locations of pack rust between the rockers and masonry plates. Areas of surface corrosion are most prominent at the fascia bearings. There is up to 1/4" thick pack rust between the rocker and the northeast corner of the masonry plate at Girder E, Pier 20A. Pack rust was also noted at Bearing E at Pier 23A (Photo 23) and at Bearings A and E at Pier 24A. The pack rust does not appear to be restricting the movement or performance of the bearings. There is a missing nut at the Girder B bearing at Pier 21A.

*Photo 22: Typical surface corrosion on bearings (Bearing E, Pier 21A)*

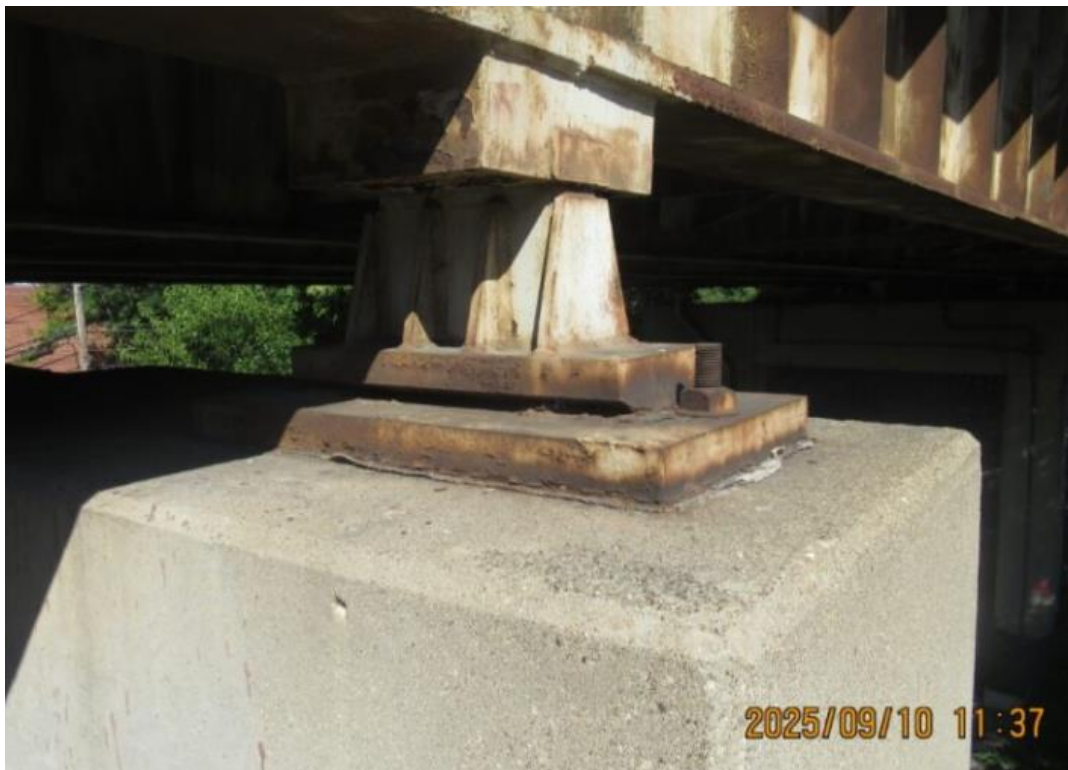
*Photo 23: Pack rust under Bearing E (Pier 23A)*

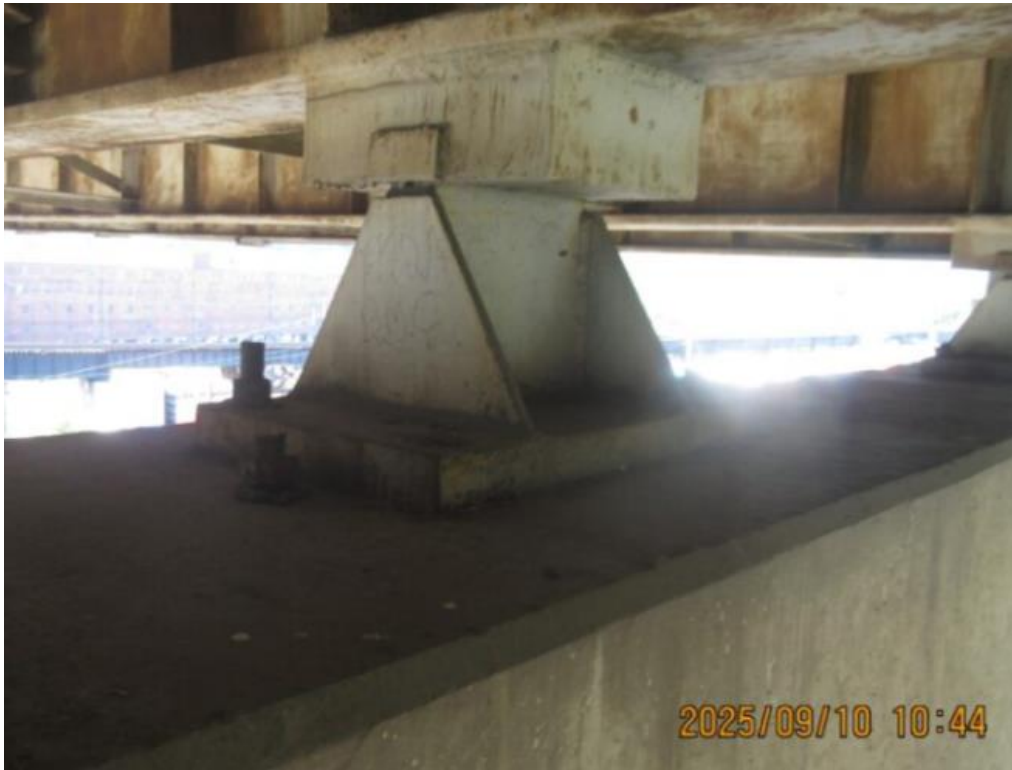
The fixed bearings at Pier 22A are in **SATISFACTORY CONDITION (6)** with surface corrosion on all bearings with no measurable section loss. The northeast anchor bolt at the Girder C bearing at Pier 22A is broken (Photo 24).

*Photo 24: Broken anchor bolt (Girder C, Pier 22A)*
