# 2025 IN-DEPTH INSPECTION REPORT

BRIDGE NO. HAM-75-0022L

SFN: 3108791

Cincinnati, Ohio

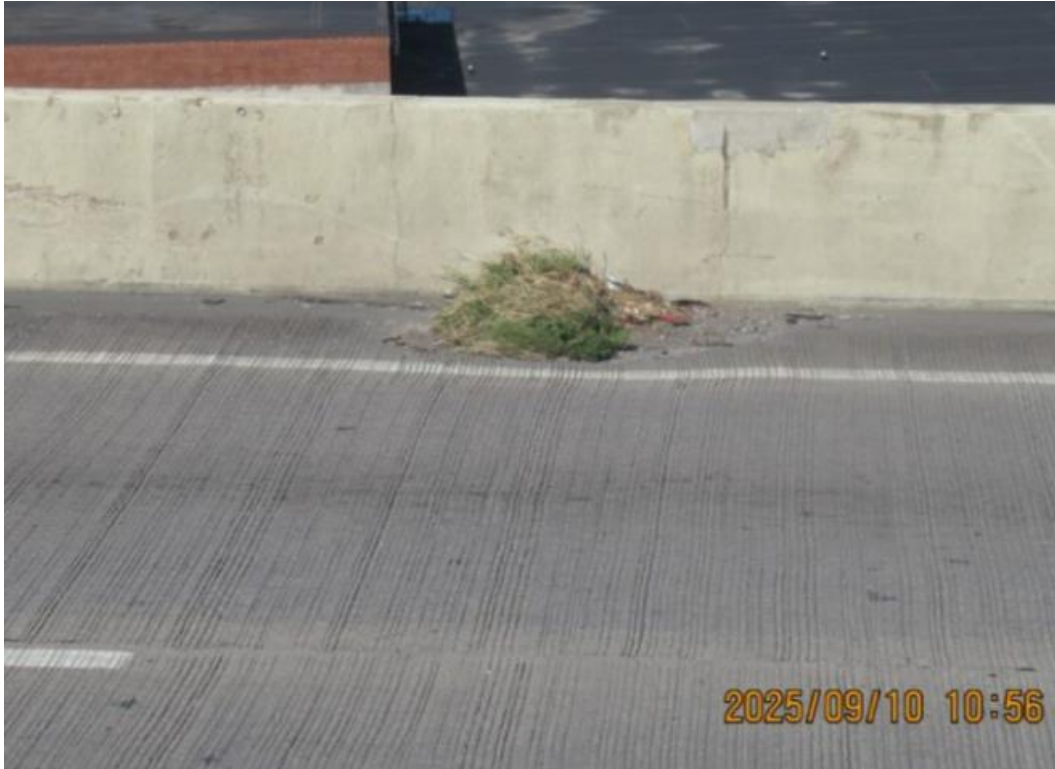
The bridge deck drainage is in fair condition. The deck level scuppers were noted to be 100% clogged with debris accumulated over top (Photo 25). The gaskets for the drainage downspout on Column 1 of Pier 23A are bulging and/or completely cracked causing leakage at the base. The drainpipe seal is torn at Column 1 and the drainpipe at Column 2 is disconnected at Pier 19A (Photo 26). There is a cracked drainpipe at Pier 23A, Column 1 (Photo 27). There is minor corrosion at the end of the drainage downspout at Abutment A between Girders A and B.

*Photo 25: Typical clogged scupper with debris accumulated over top (Span 23A)*

- Clean debris from clogged drainage scuppers.
- Patch spalls/potholes in the concrete wearing surface.

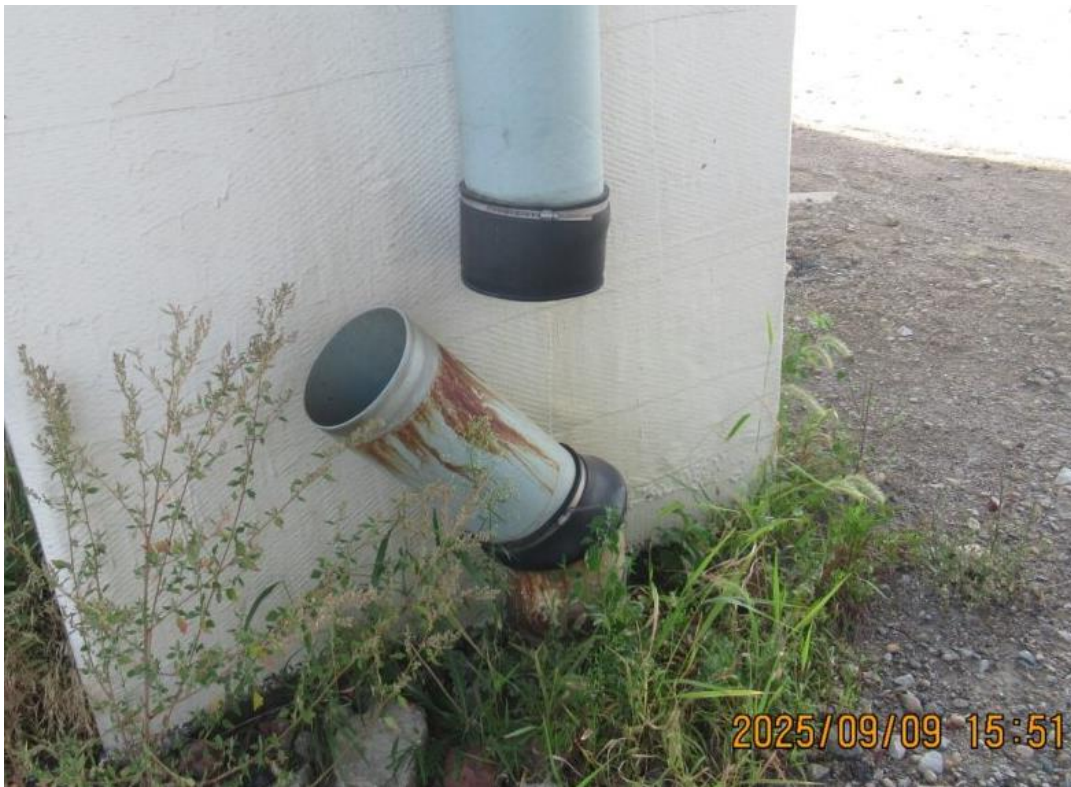
*Photo 26: Disconnected drainpipe at Column 2 (Pier 19A)*

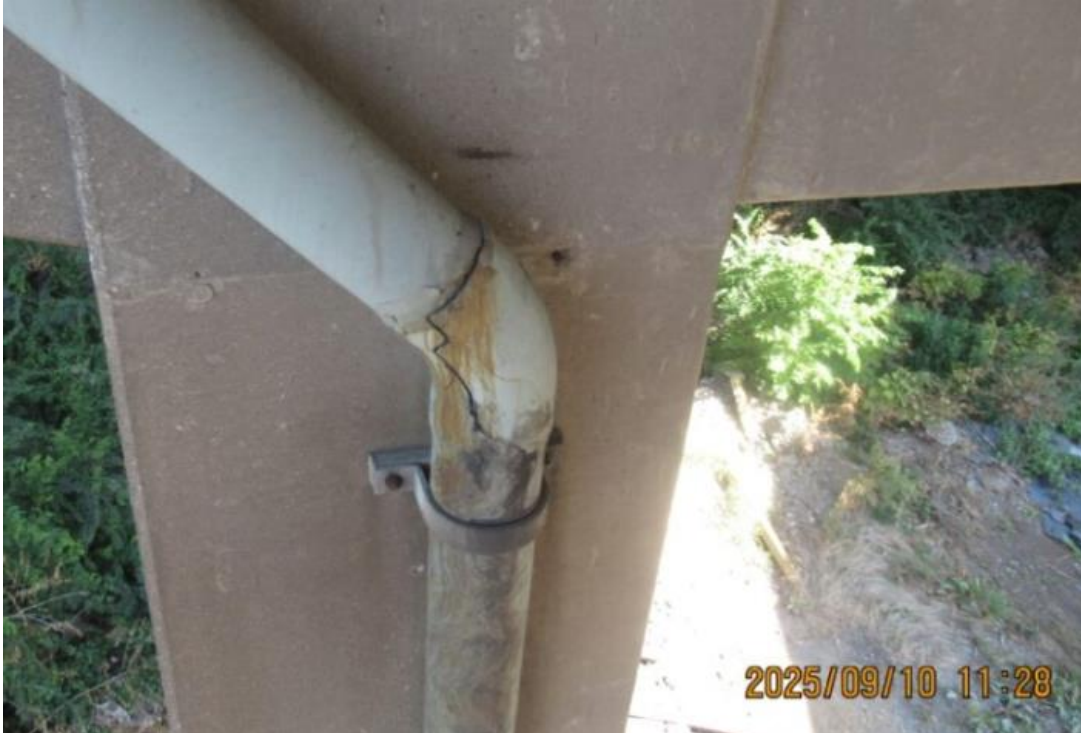
*Photo 27: Cracked drainpipe at Column 1 (Pier 23A)*

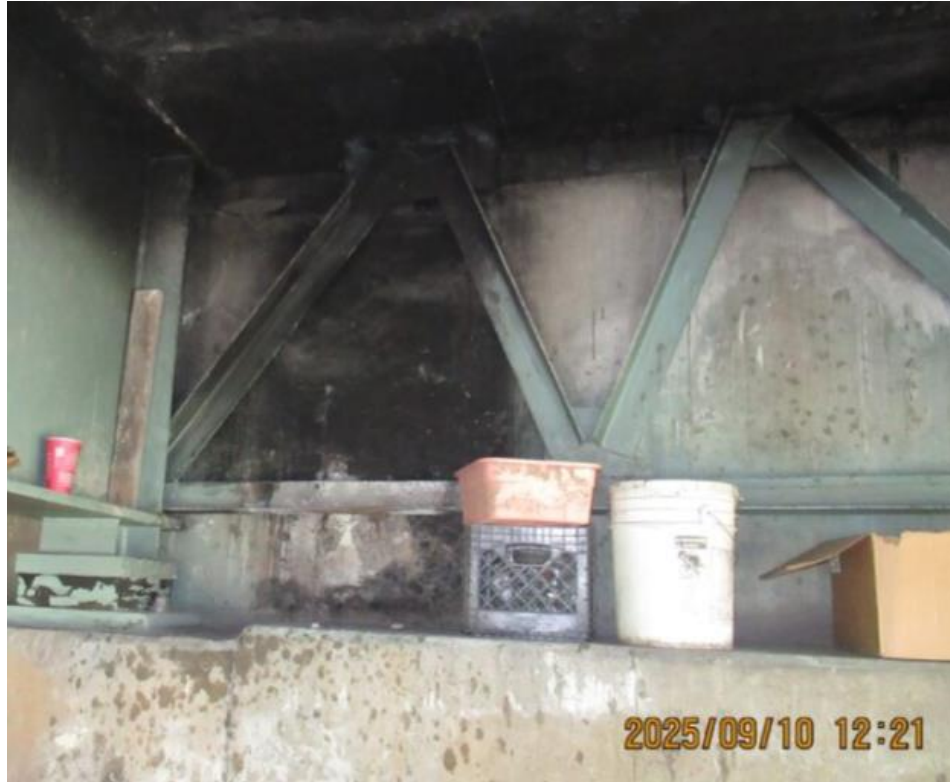
*Photo 28: 3' long area of damage along the bottom horizontal member (Abutment A)*

Paint failure and minor surface rusting is typical throughout. Crossframes at Pier 19A have been replaced with jacking frames, and crossframes at Abutment A have been repainted. There is an isolated 3' long area of fire damage along the bottom horizontal member of the crossframe between Girders C and D at Abutment A. There are missing crossframe bolts at Girder E near Pier 21A.

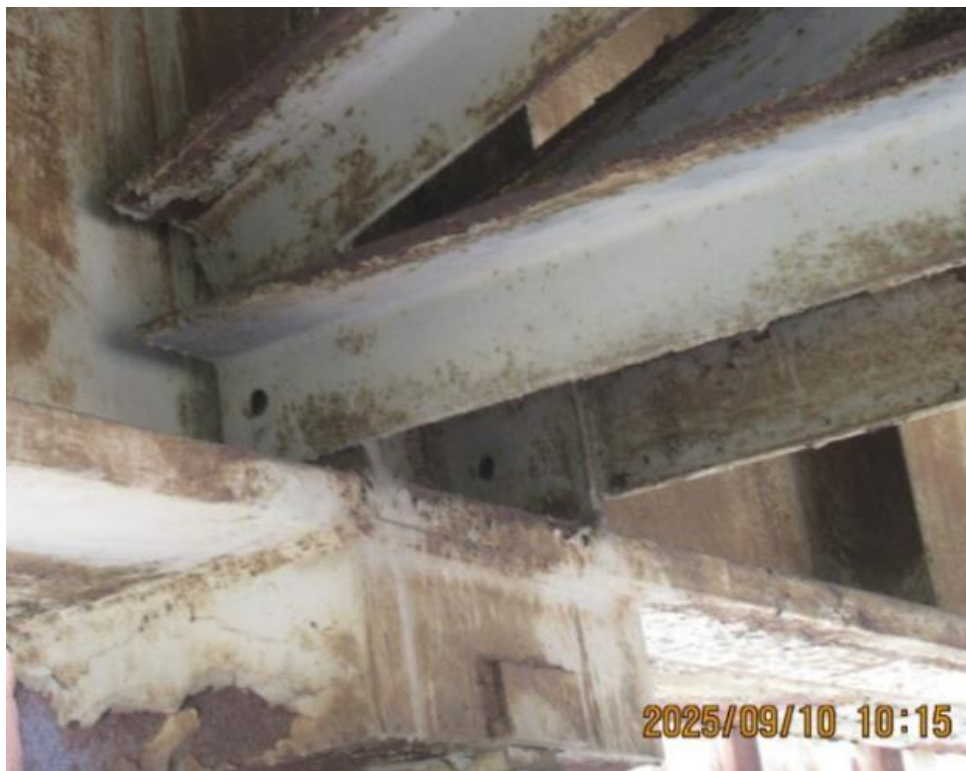
The diaphragms and crossframes are in satisfactory condition overall. There is minor surface corrosion and paint failure throughout. The end crossframes at Pier 19A were replaced with jacking diaphragms and the end crossframes at Abutment A were cleaned and painted when the joints were replaced in 2017. There is a isolated 3' long area of damage along the bottom horizontal member of the end crossframe between Girders C and D at Abutment A. The damage appears to have been caused by a fire set on the abutment seat (Photo 28). Missing crossframe bolts were noticed at Girder E, Pier 21A (Photo 29).

*Photo 29: Missing crossframe bolts at Girder E (Pier 21A)*
