# 2025 IN-DEPTH AND NSTM INSPECTION REPORT

BRIDGE NO. HAM-75-0022R

SFN: 3108805

Submitted to ODOT, District 8  
November 17, 2025

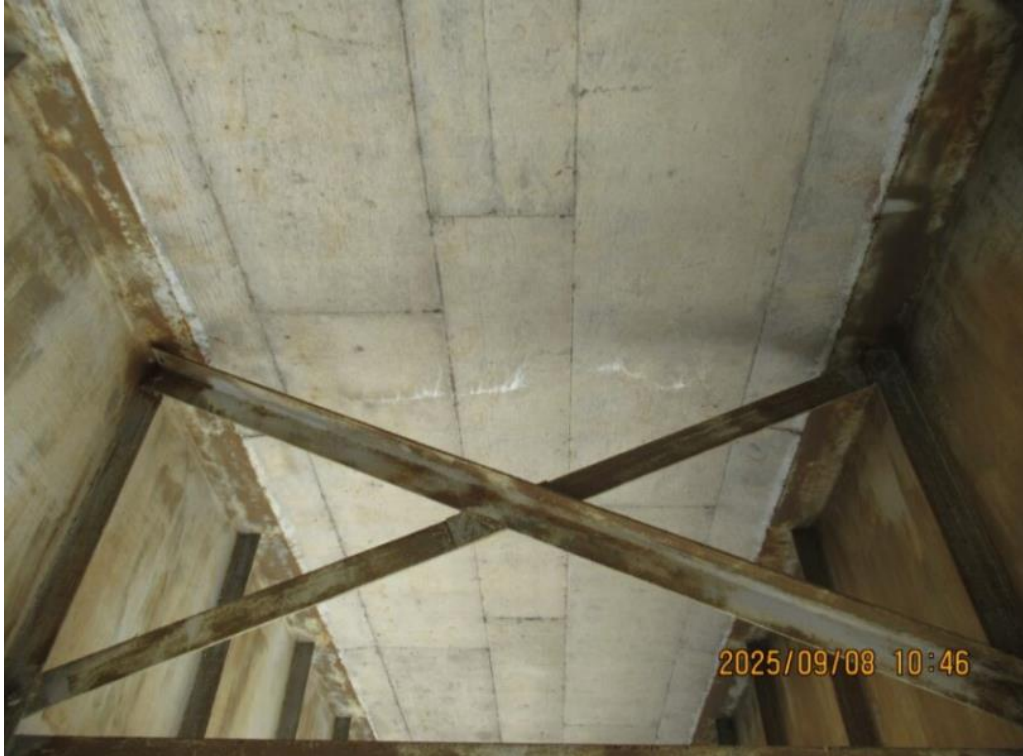
The reinforced concrete deck is in **SATISFACTORY CONDITION (6)**. In all spans, the underside of the deck typically exhibits transverse hairline and moderate-width cracks with efflorescence spaced about 3' apart (Photo 1) and numerous isolated spalls with exposed rebar. The top of the deck is covered by a Super Plasticized Dense Concrete overlay.

*Photo 1: Typical transverse crack with efflorescence (Span 16C shown)*

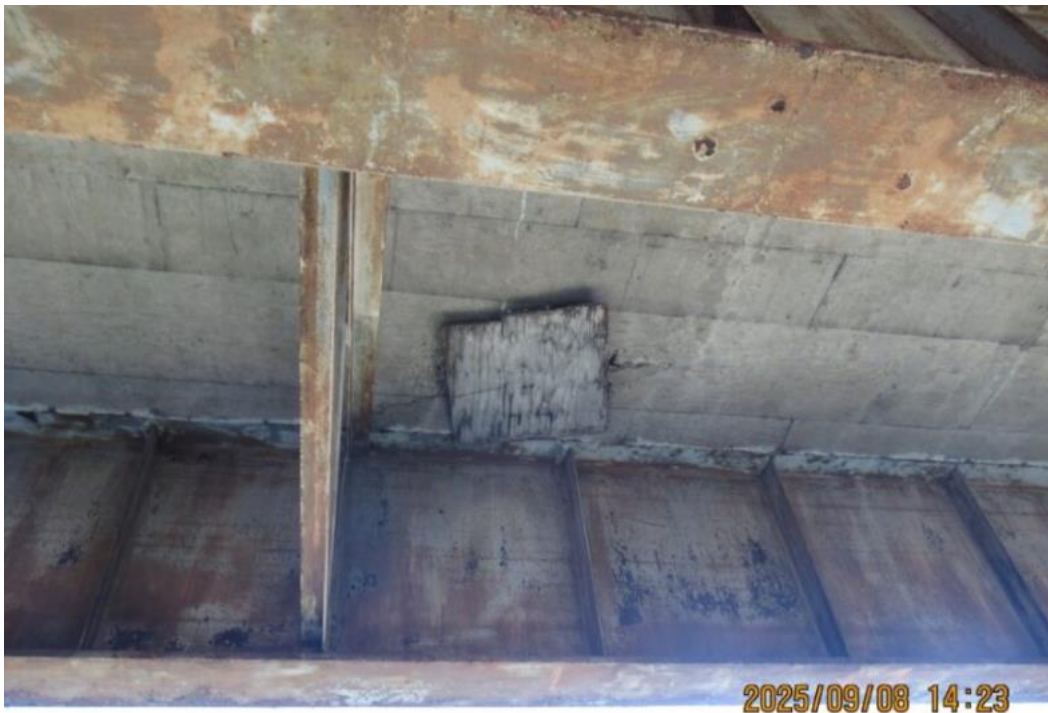
*Photo 2: Typical concrete patch in deck covered with plywood in Bay 4 (Span 19C)*

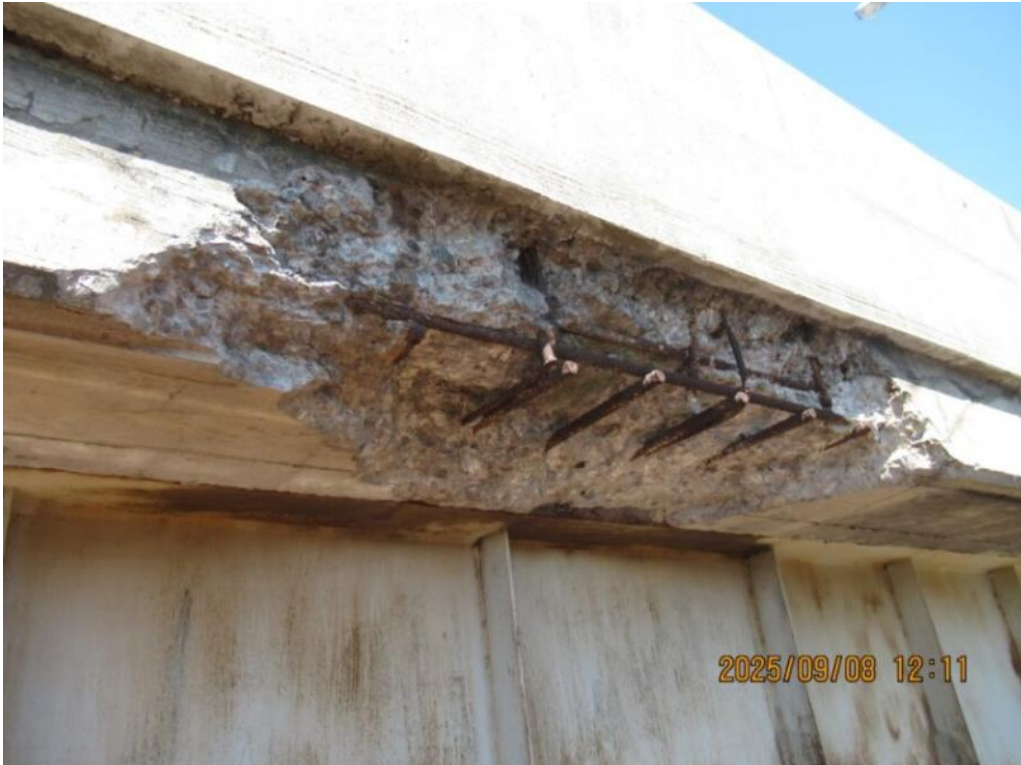
- A 6'L x 2'W x 5" deep spall with exposed rebar at the east overhang on Span 17C (Photo 3).
- A continuous set of spalls up to 1" deep are present in the east overhang of Span 19C (Photo 4).

*Photo 3: 6'L x 2'W x 5" deep spall with exposed rebar in east overhang (Span 17C)*

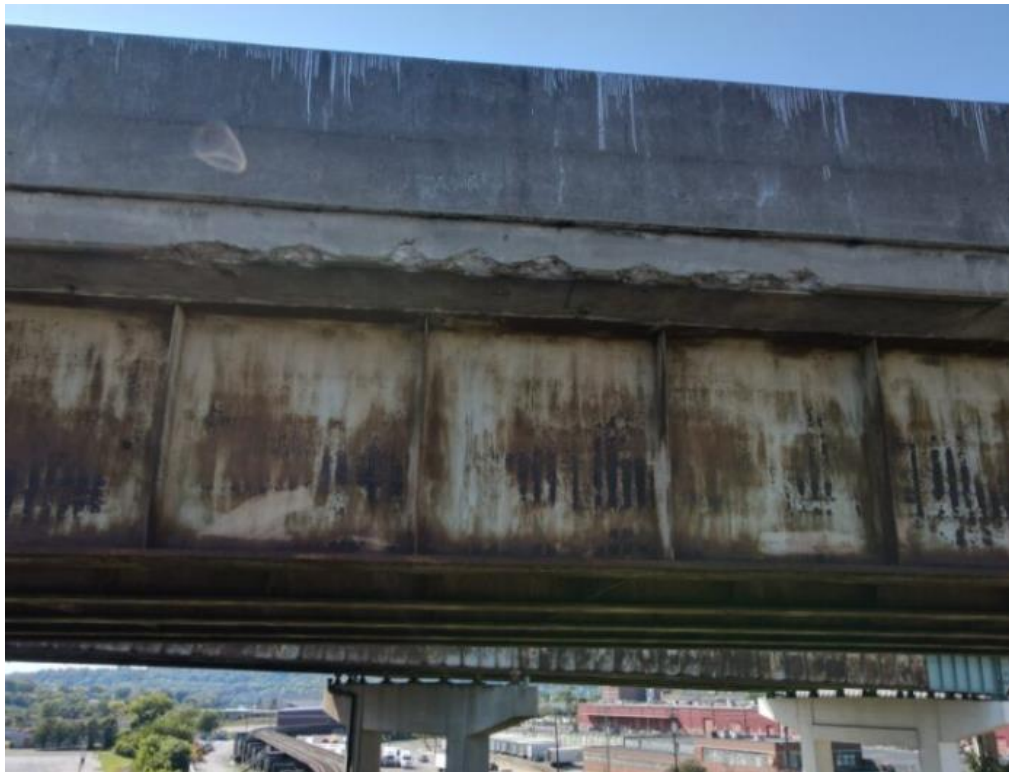
*Photo 4: Continuous set of spalls up to 1" deep in the east overhang (Span 19C)*

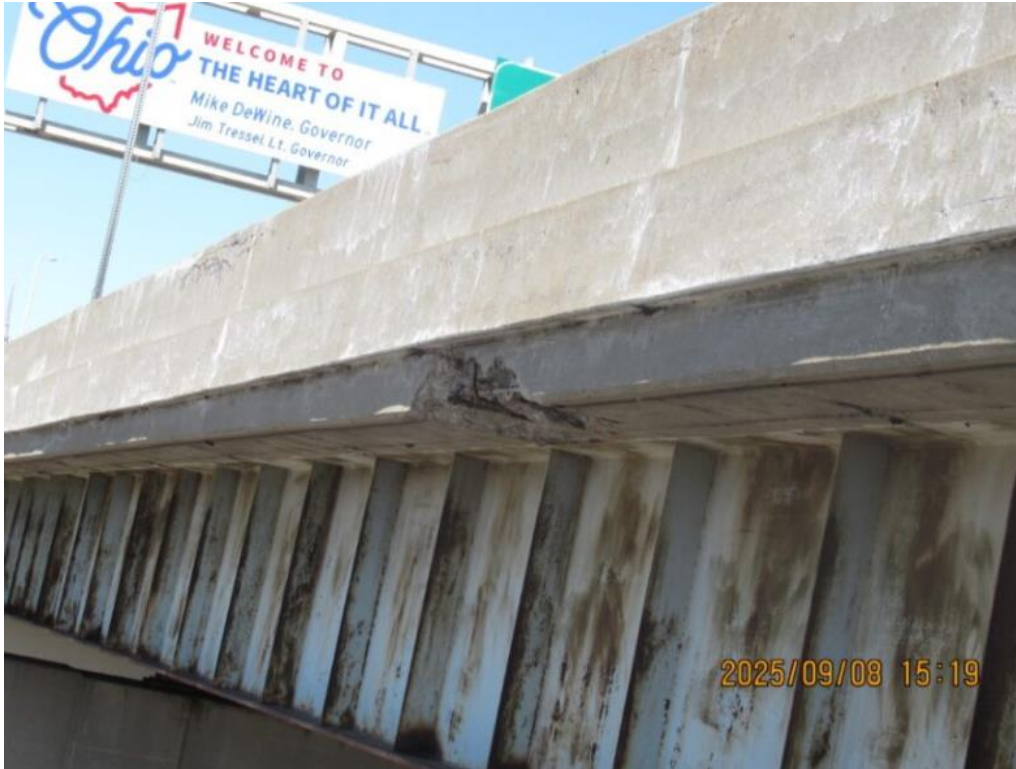
- A 1' x 6" x 3" deep spall in the west overhang of Span 22C.
- A 3' x 2' x 4" deep spall in the west overhang of Span 22C (Photo 5).
- A 1' x 6" x 2" deep spall in the west overhang of Span 23C.

*Photo 5: 3' x 2' x 4" deep spall with exposed rebar in west overhang (Span 22C)*

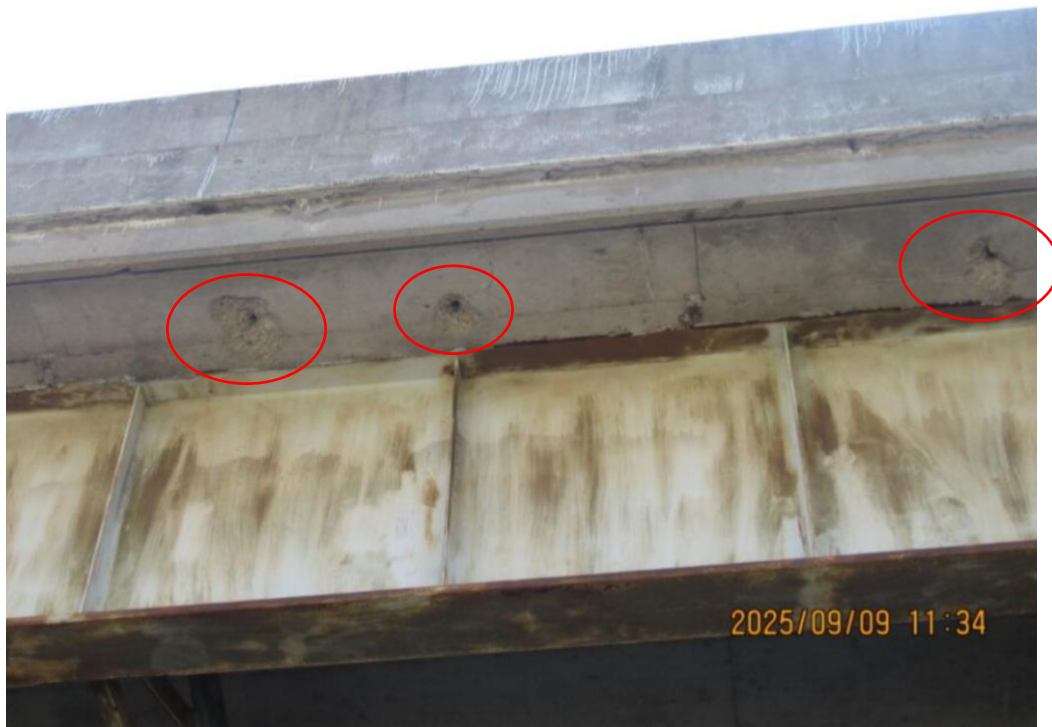
- A 1'L x 2'W x 3" deep spall in west overhang of Span 26C near Pier 25C.
- Three spalls up to 1' diameter x 2" deep in the west overhang of Span 26C (Photo 6).

*Photo 6: 3 spalls up to 1' dia. x 2" deep in west overhang (Span 26C)*

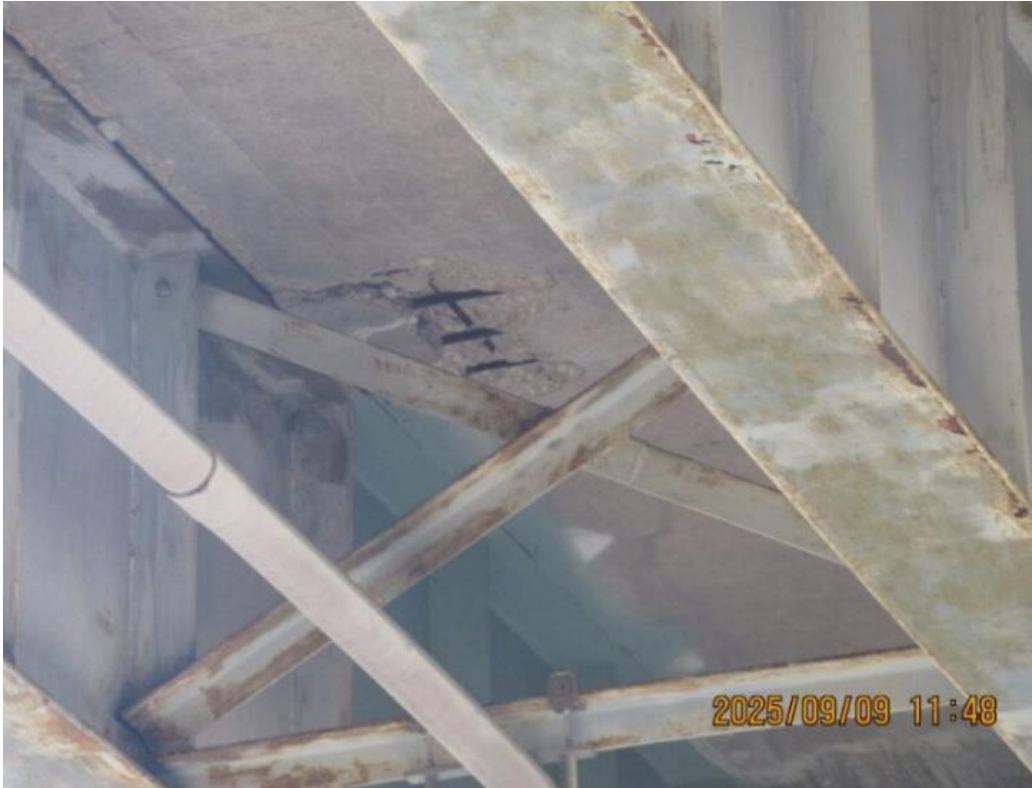
- A 1' diameter spall in the east overhang at the joint at Pier 26C/J.
- A 2' x 1' x 2" deep spall with exposed rebar in Span 27C, Bay 5 .
- Two spalls up to 2' diameter x 2" deep in the west overhang of Span 27C (Photo 7).

*Photo 7: 3 square foot spall with exposed rebar in Bay 5 (Span 27C)*

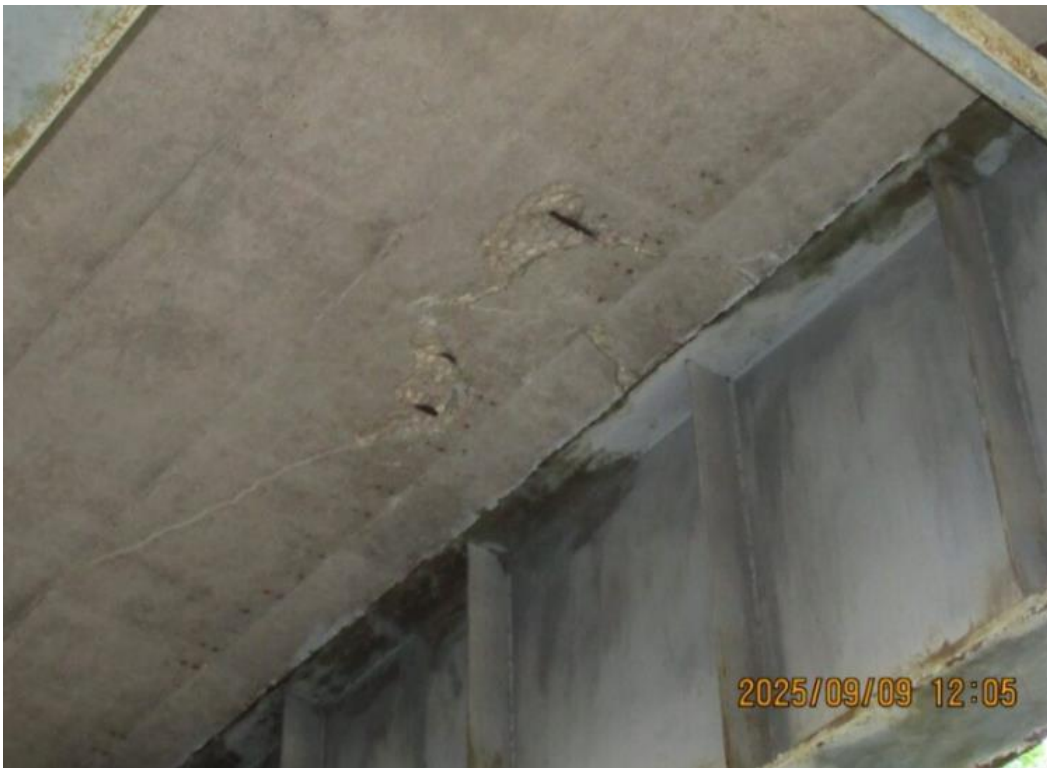
- Four spalls up to 2" deep with exposed rebar, totaling 16SF in Span 29C (Photo 8).

*Photo 8: 2'L x 1'W x 2" deep spall with exposed rebar in Bay 5 (Span 29C)*

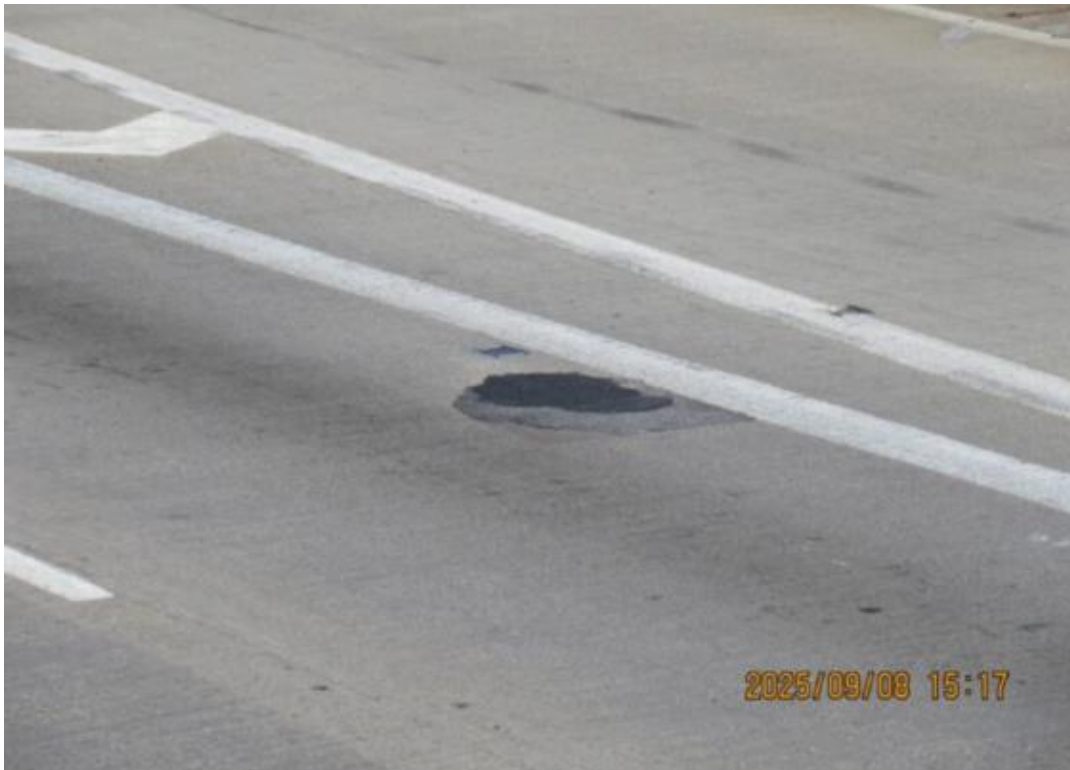
*Photo 9: Typical asphalt patch (Span 22C shown)*

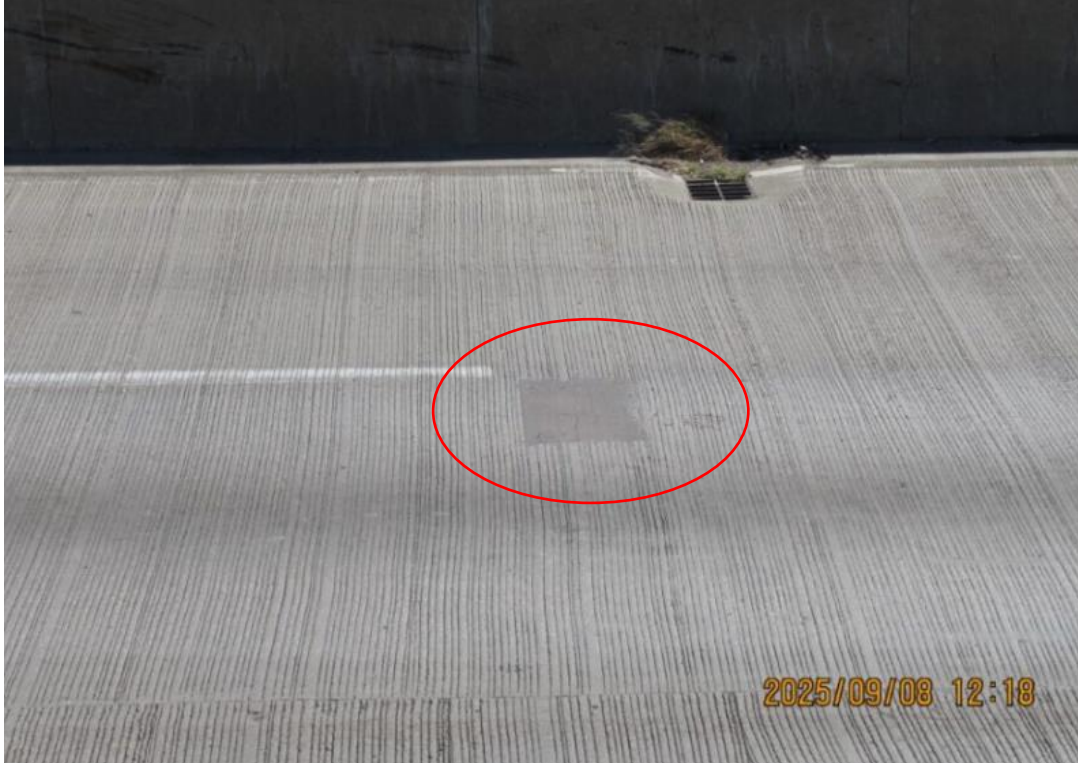
*Photo 10: Typical concrete patch in good condition (Span 17C shown)*

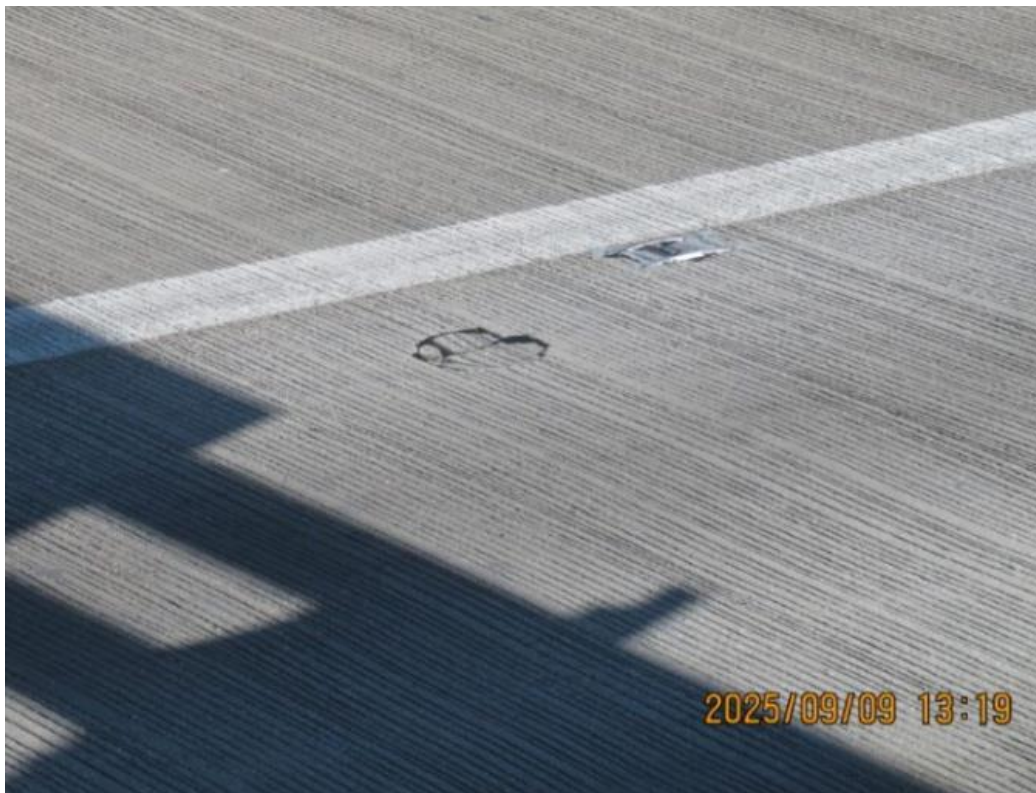
*Photo 11: 6" diameter spall forming in the center lane (Span 22C)*

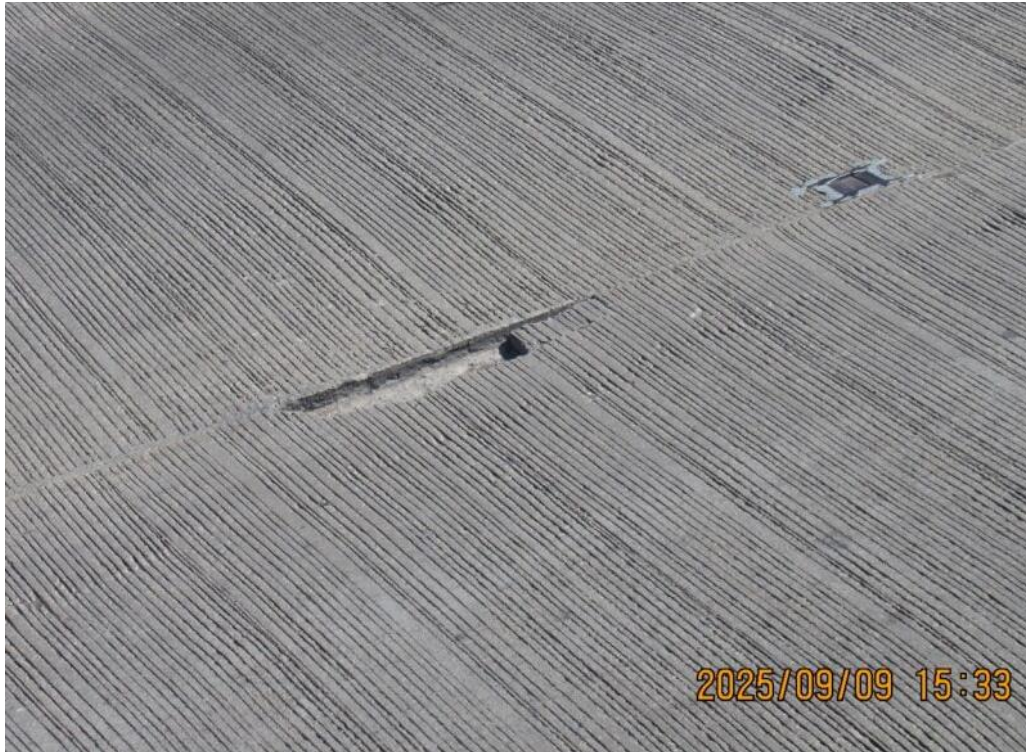
*Photo 12: 1' x 6" x 2" deep spall in center lane (Span 25C)*

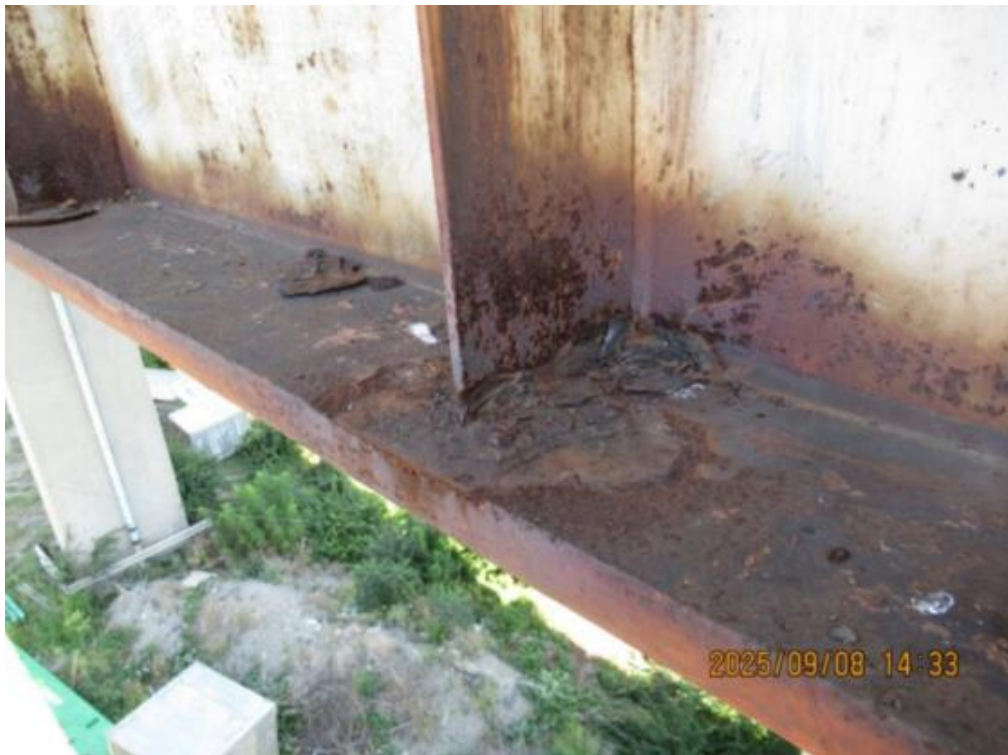
*Photo 14: Laminating corrosion on bottom flange with section loss up to 9"L x 4"W x 3/16" deep (Girder A, Span 20C)*

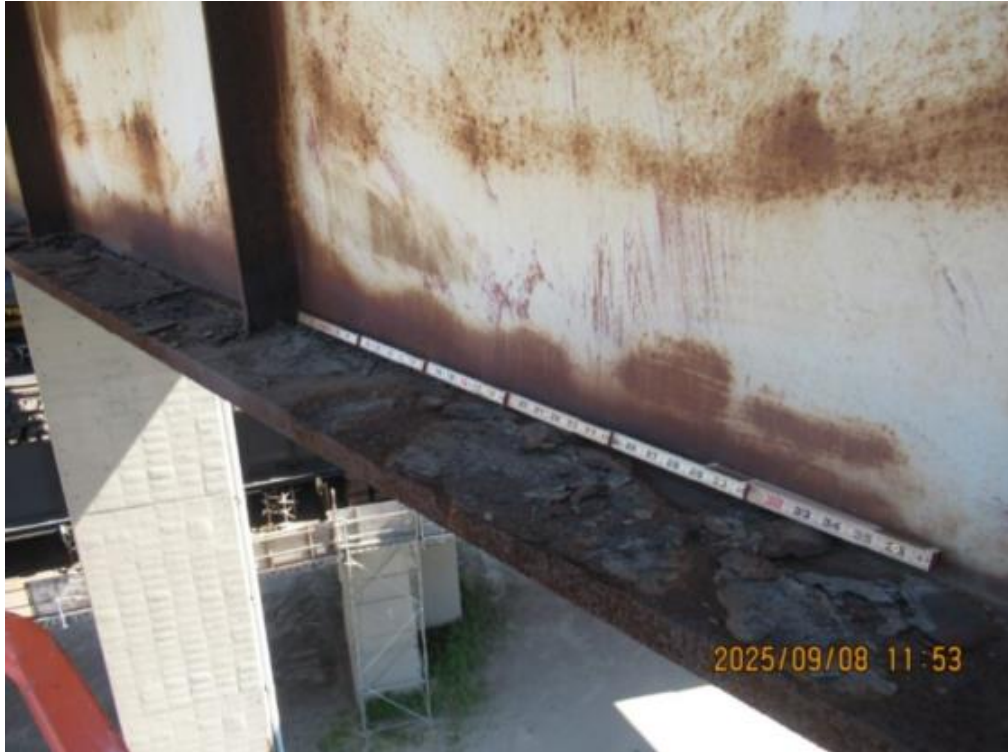
**Photo 15:** Laminating corrosion with section loss up to 8"W x 1/4" deep near midspan (Girder A, Span 17C)

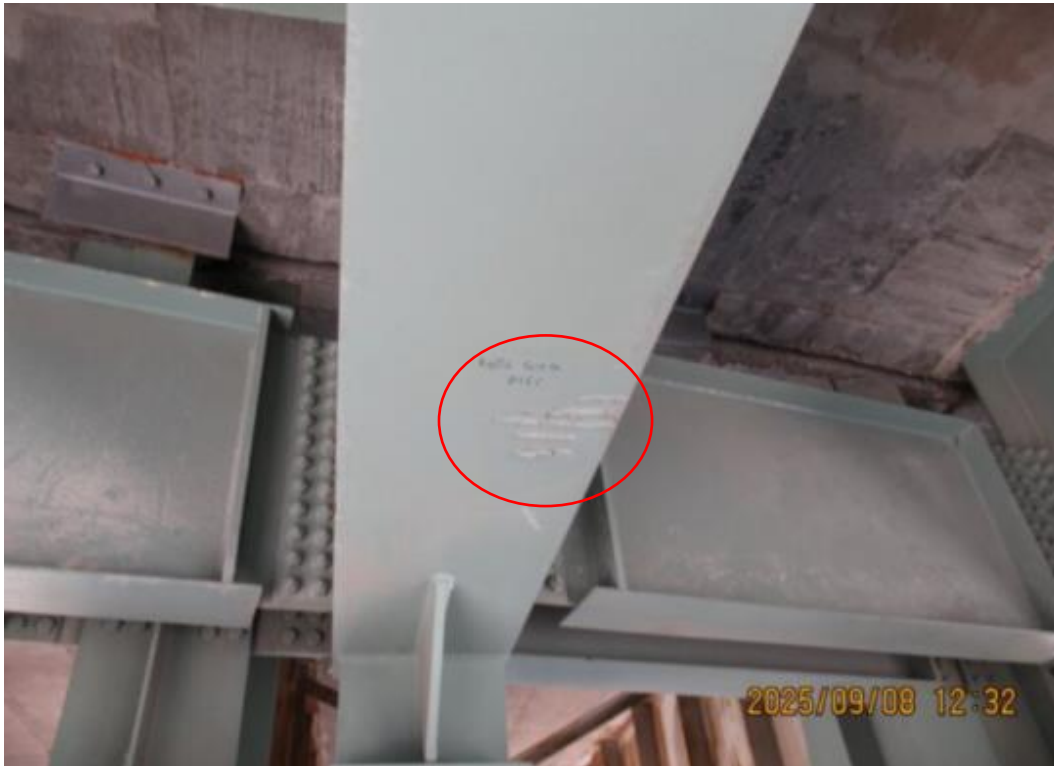
**Photo 16:** Gouges up to 5" long and 1/8" deep on bottom flange (Girder D, Span 16C)

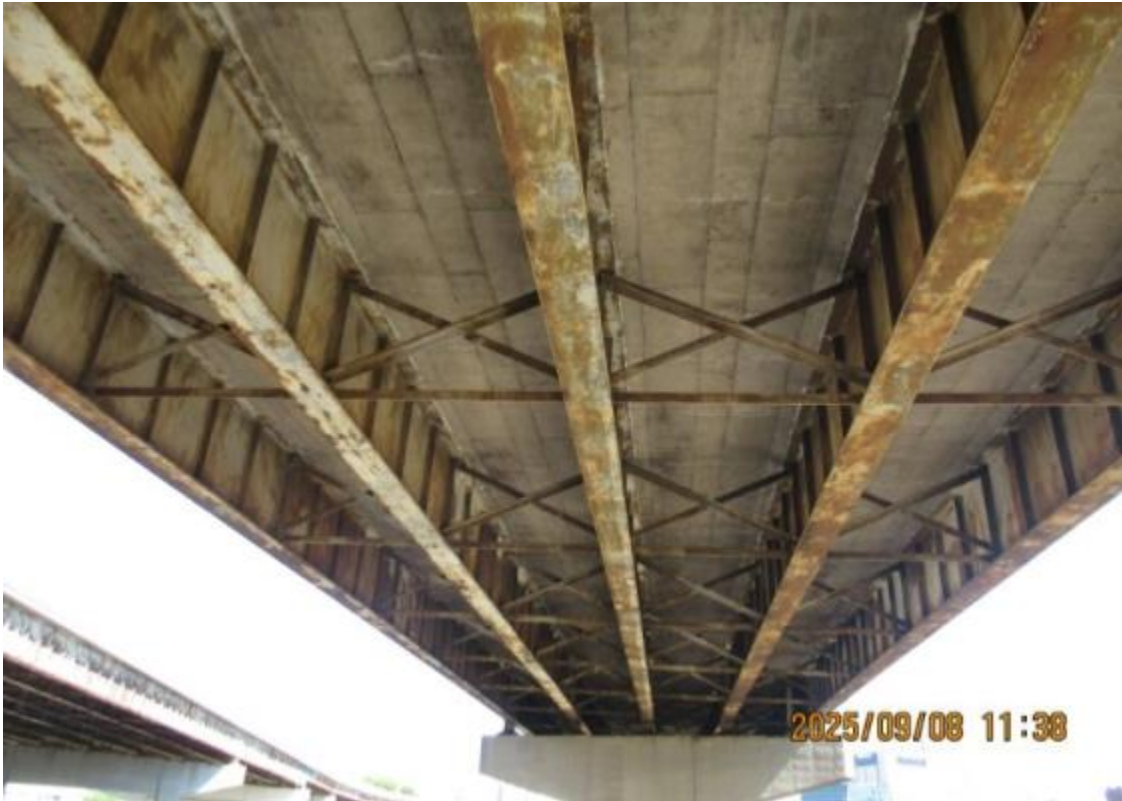
The steel protective coating system is paint and is in **SERIOUS CONDITION (3)** overall. The paint on the retrofit beams is in good condition, with isolated areas of freckling and minor surface corrosion. The ends of the original girders near the expansion joints at Piers 15C, 18C, 23C and 26C were cleaned and painted in 2018; the paint in these areas is in good condition. Elsewhere, the paint on the original girders has failed or is of limited effectiveness (Photo 17). Exposed steel with surface corrosion is widespread throughout the structure, most significantly on the bottom flange and lower web of the fascia girders. Where the paint has not failed, there is widespread chalking with complete loss of pigment, dulling, peeling and flaking. Paint failures with surface corrosion are typical throughout the original steel bearings and are present in isolated areas on the retrofit bearings at Piers 22J-26J. There is evidence of fire and paint damage to the beams in Span 29, Bay 3.

*Photo 17: Typical original girder paint condition (Span 17C shown)*

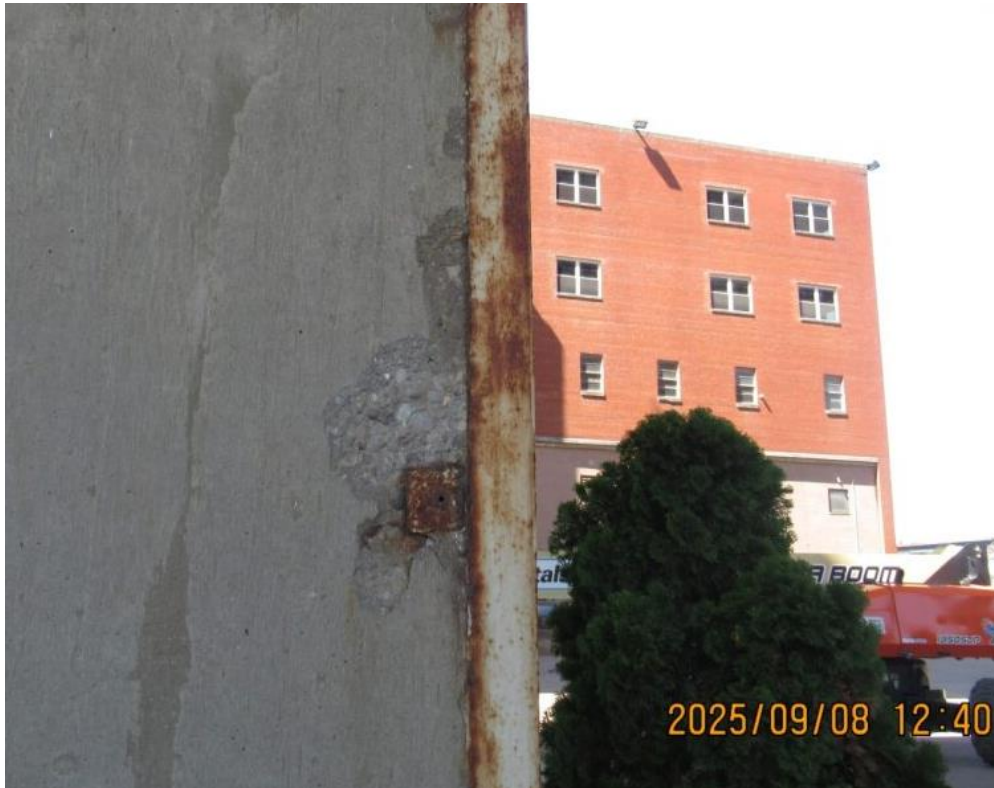
**Photo 18:** Typical spalling around corner armor (Pier 15C)

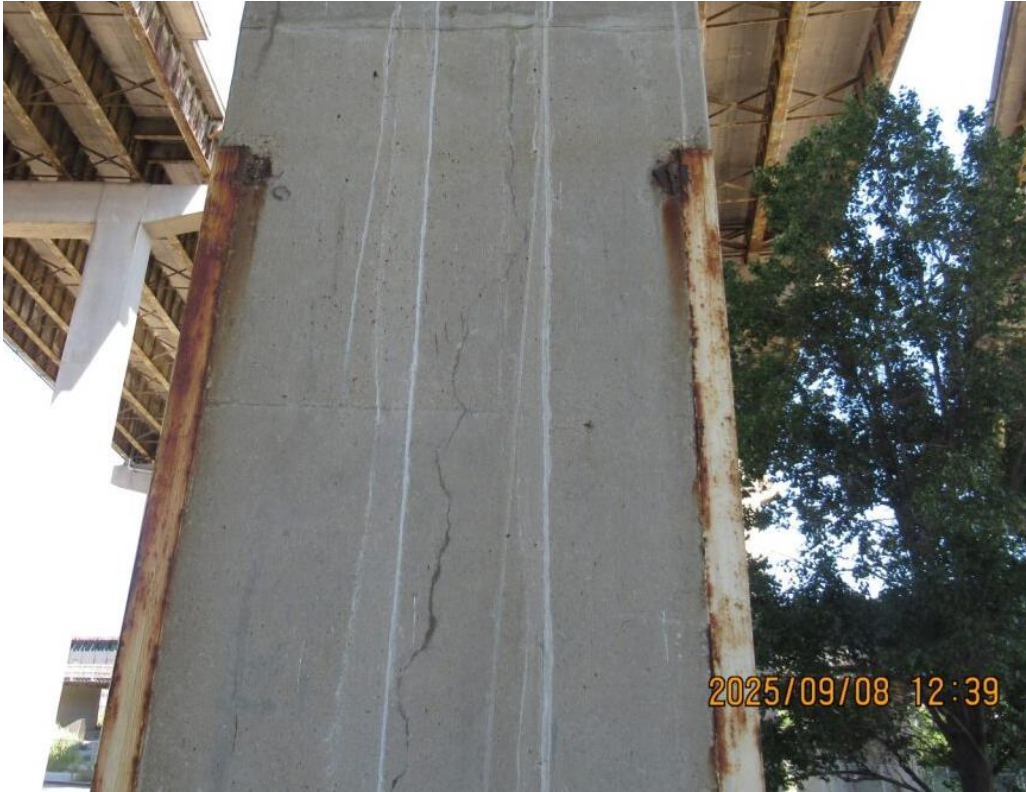
*Photo 19: Moderate-width vertical crack on Column 1 (Pier 15C)*

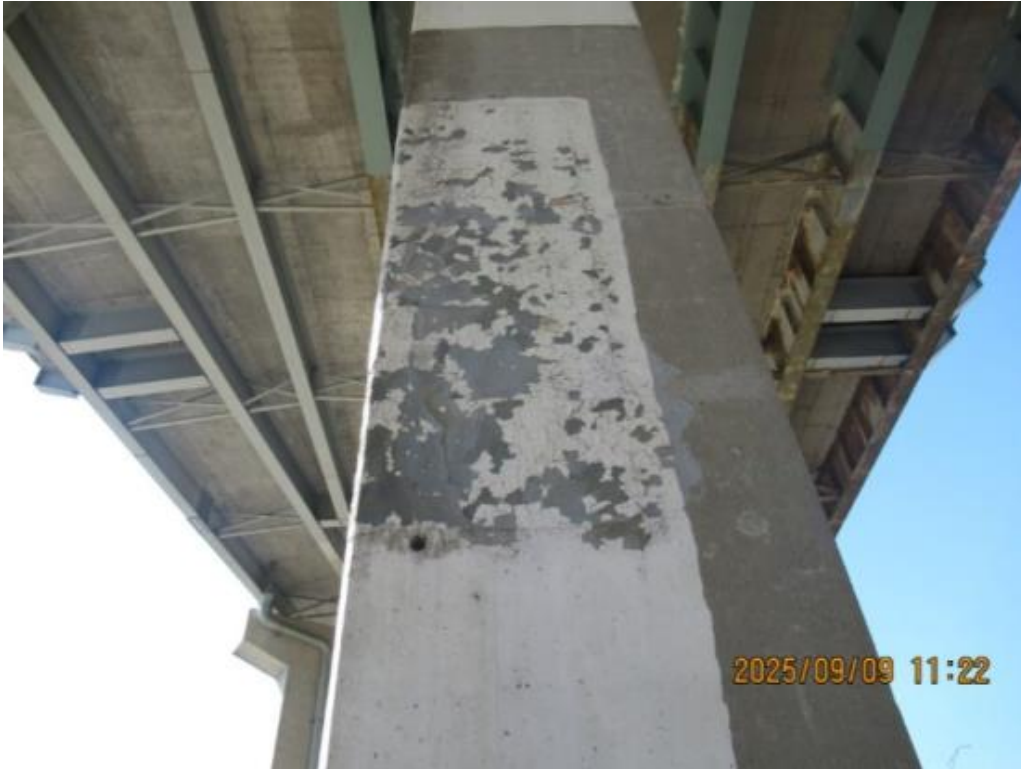
*Photo 21: Cracking and peeling FRP protective coating on Column 2 (Pier 23C)*

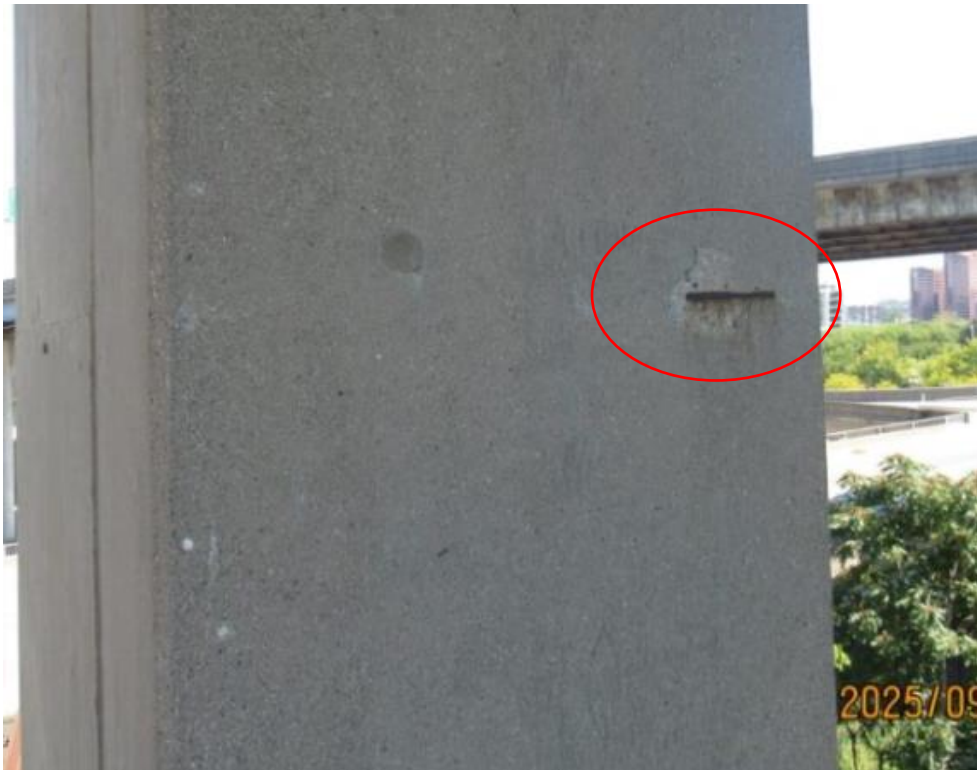
The reinforced concrete pier walls are in **SATISFACTORY CONDITION (6)** with hairline map cracking typical throughout. A shallow spall around the corner armor is present at the base of Pier 16C. Vertical hairline cracks are present on Pier 18C. Concrete patching and FRP wrap were applied to Pier Wall 18C as part of the 2017 rehabilitation. There is a 10" W x 4"H section of FRP that is peeling and cracking on the south face of Pier 18C. Several shallow spalls with exposed reinforcing bars are present on the south and west faces of Pier 19C due to shallow cover (Photo 23).

*Photo 23: Exposed rebar due to shallow cover (Pier 19C)*

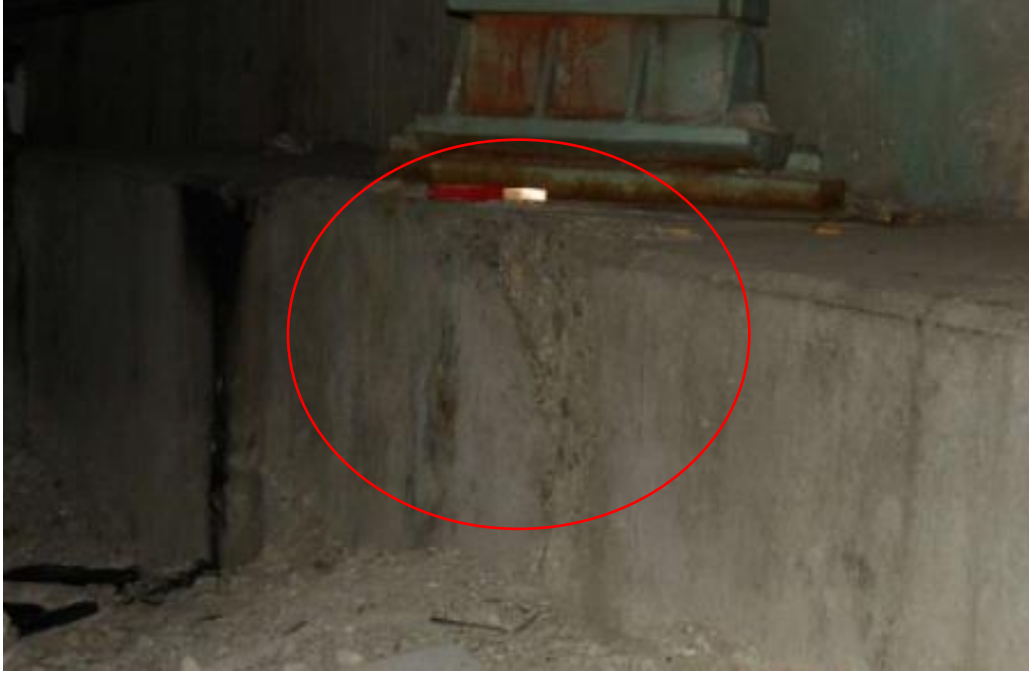
The reinforced concrete abutment wall is in **SATISFACTORY CONDITION (6)** with isolated vertical cracks. There is a 20"W x 24"H X 1" deep spall and delamination below Bearing E (Photo 24). Debris build up has occurred almost fully covering Bearing A. Use caution during future inspections, as several hypodermic needles were found near Abutment C.

*Photo 24: Spall and delamination below Bearing E (Abutment C)*

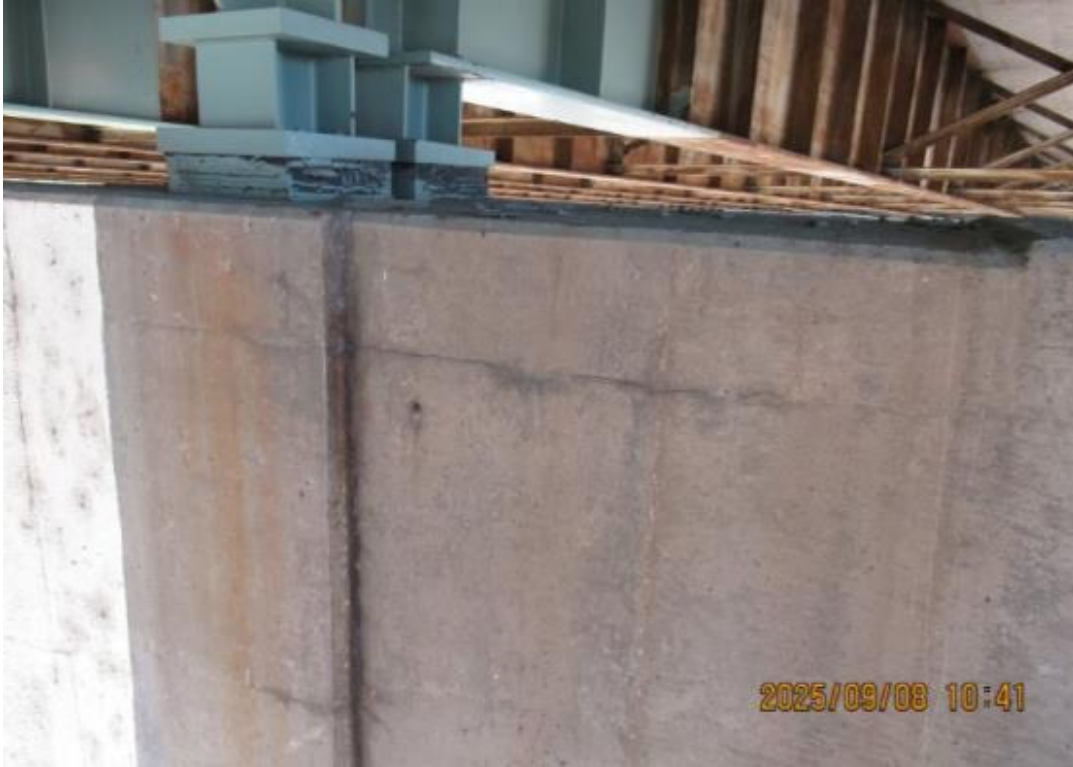
*Photo 25: Typical moderate width horizontal crack near top of pier cap (Pier 15C)*

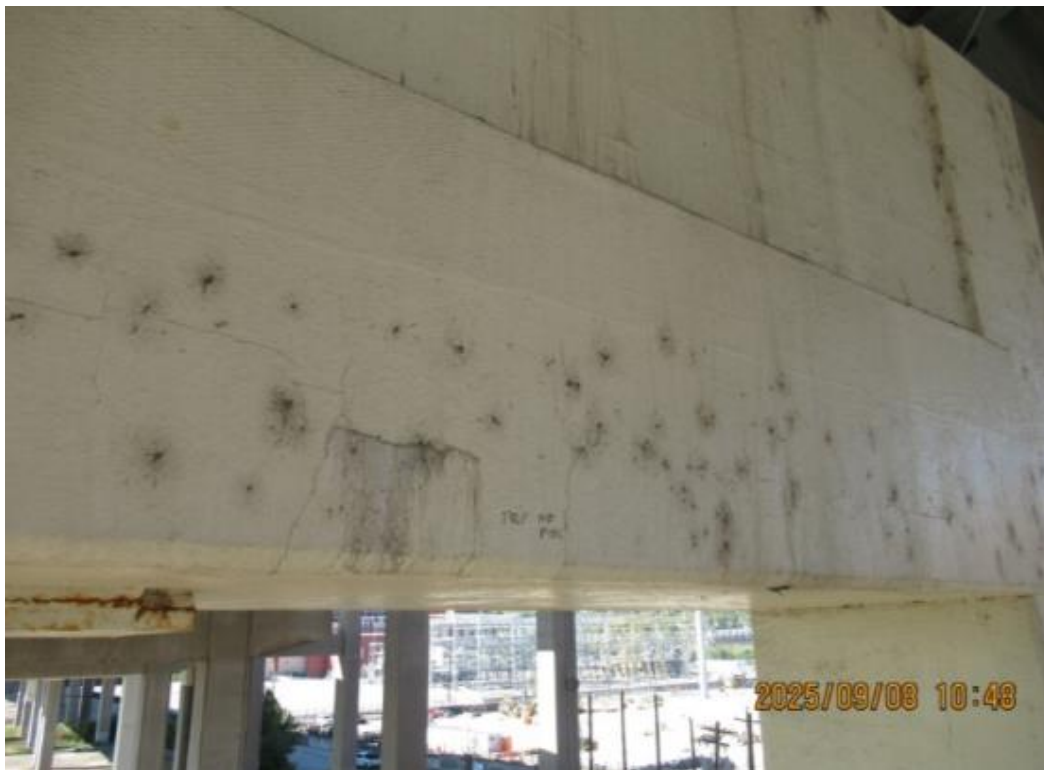
*Photo 26: Moderate width vertical cracks and map cracking (Pier 15C)*

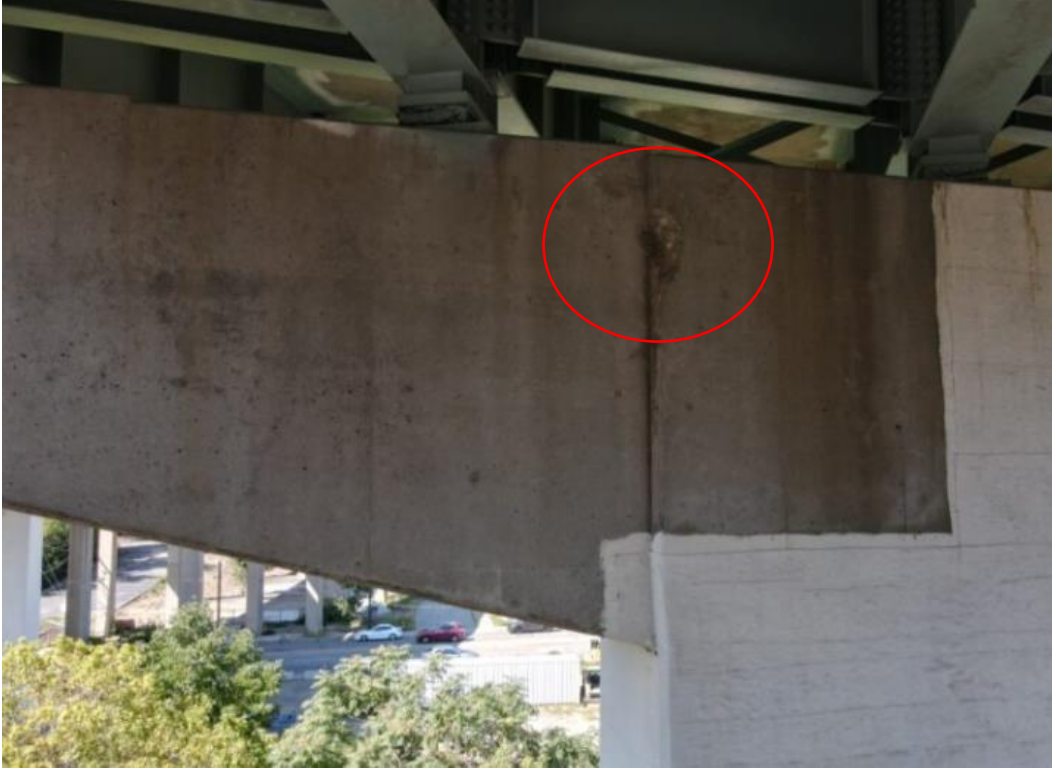
*Photo 27: 16"H x 6"W x 1 1/2" deep spall on the south face (Pier Cap 18C)*

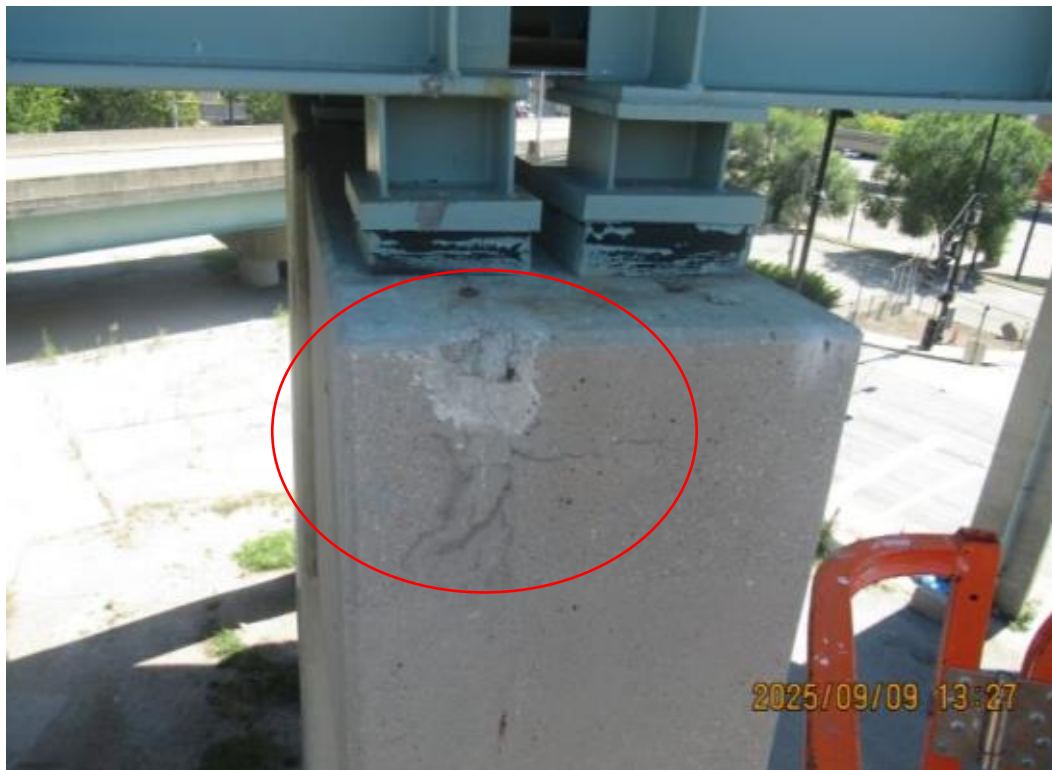
*Photo 28: Map cracking with spall on west face (Pier Cap 23C)*

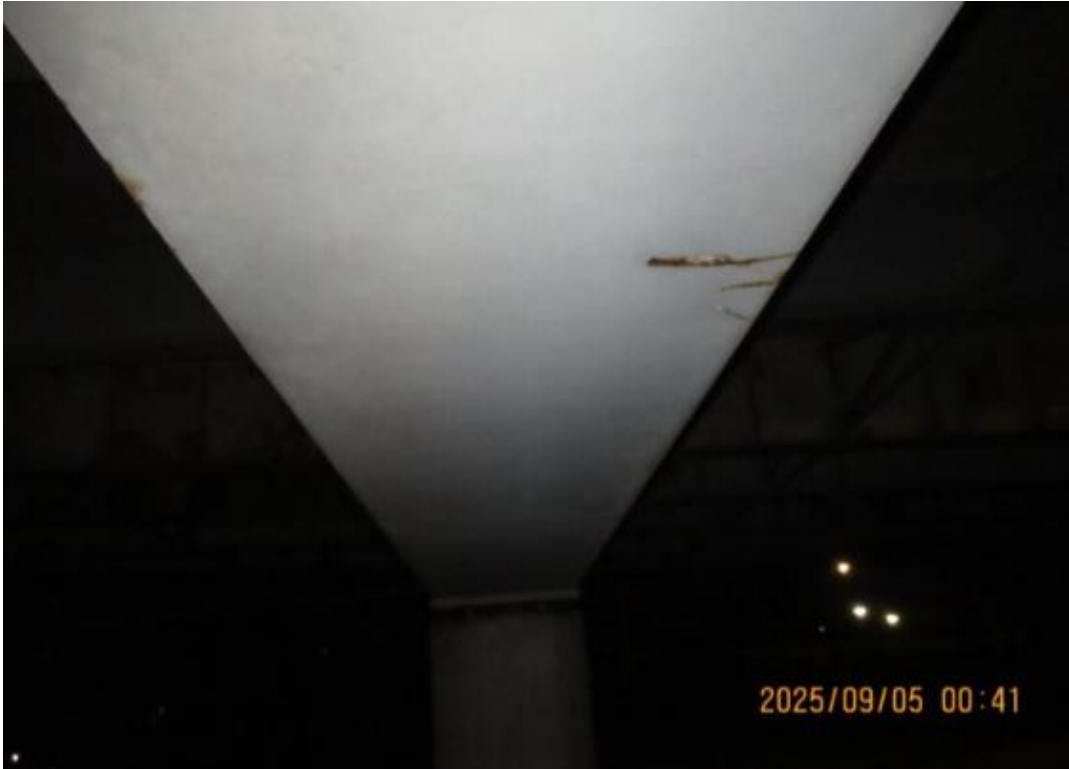
*Photo 30: Scrapes with minor surface corrosion (Pier Cap 25J)*

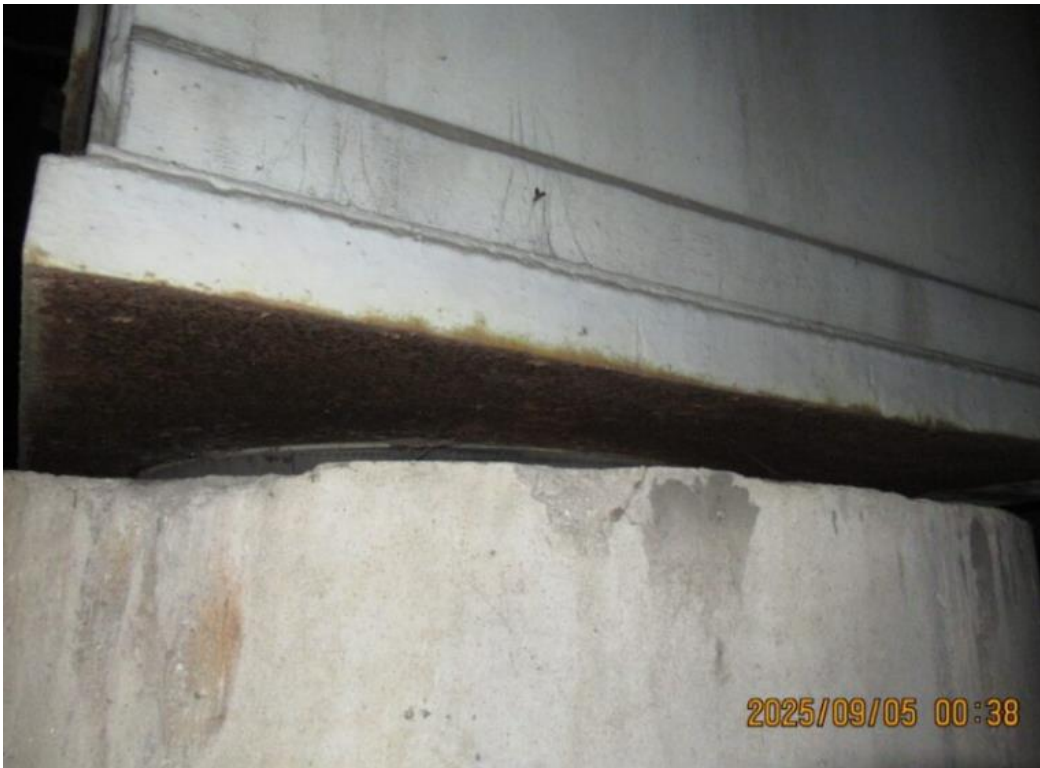
The pier cap exterior is in **GOOD CONDITION (7)**. There are areas of surface corrosion scattered throughout the pier cap exterior, particularly on the top flange at the east end and along the edges of both flanges. There are minor scrapes with surface corrosion in the bottom flange (Photo 30) over the U.S. 50 ramp to 2<sup>nd</sup> Street. The bottom flange bearing plates at both columns exhibit minor surface corrosion (Photo 31).

*Photo 31: Surface corrosion on the underside of the west bearing (east bearing similar, Pier Cap 25J)*
