# 2025 IN-DEPTH AND NSTM INSPECTION REPORT

BRIDGE NO. HAM-75-0022R

SFN: 3108805

Submitted to ODOT, District 8  
November 17, 2025

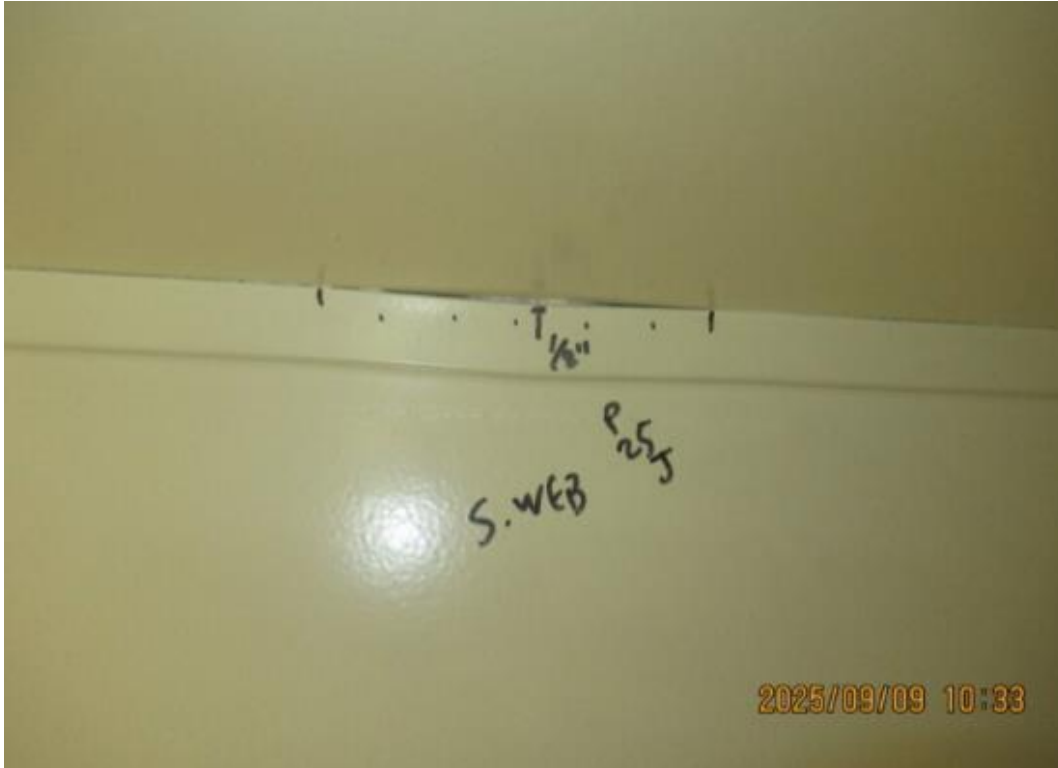
*Photo 32: Top flange backer bar deflected 1/8" at east end (South Web, Pier Cap 25J)*

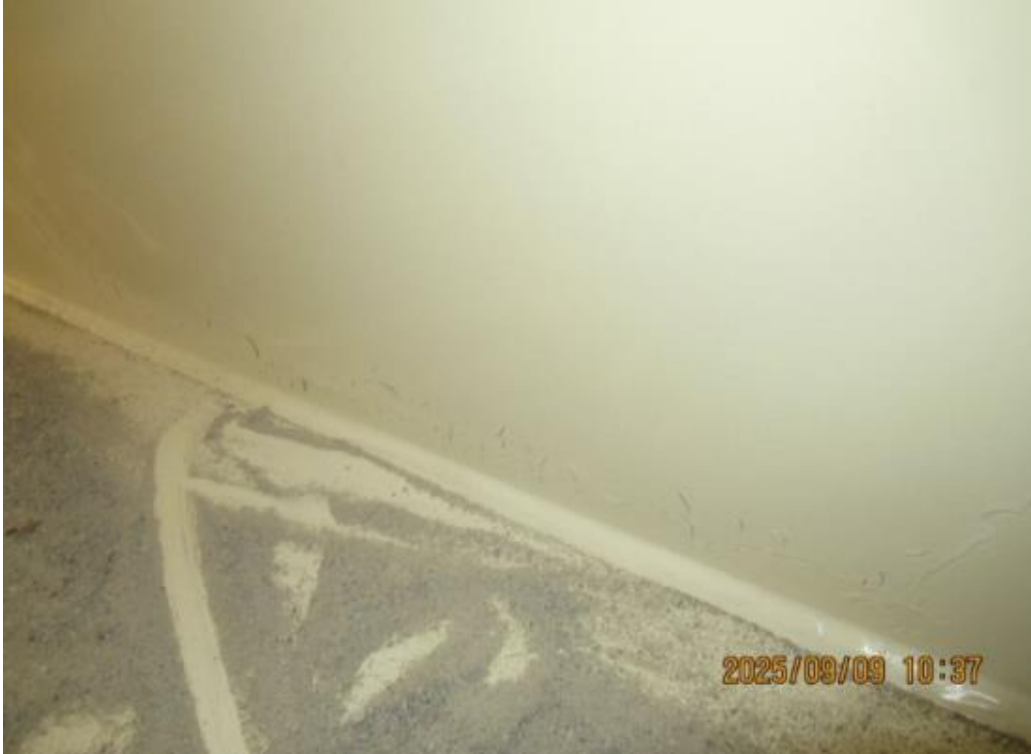
*Photo 33: Typical cracking paint (Pier 25J)*

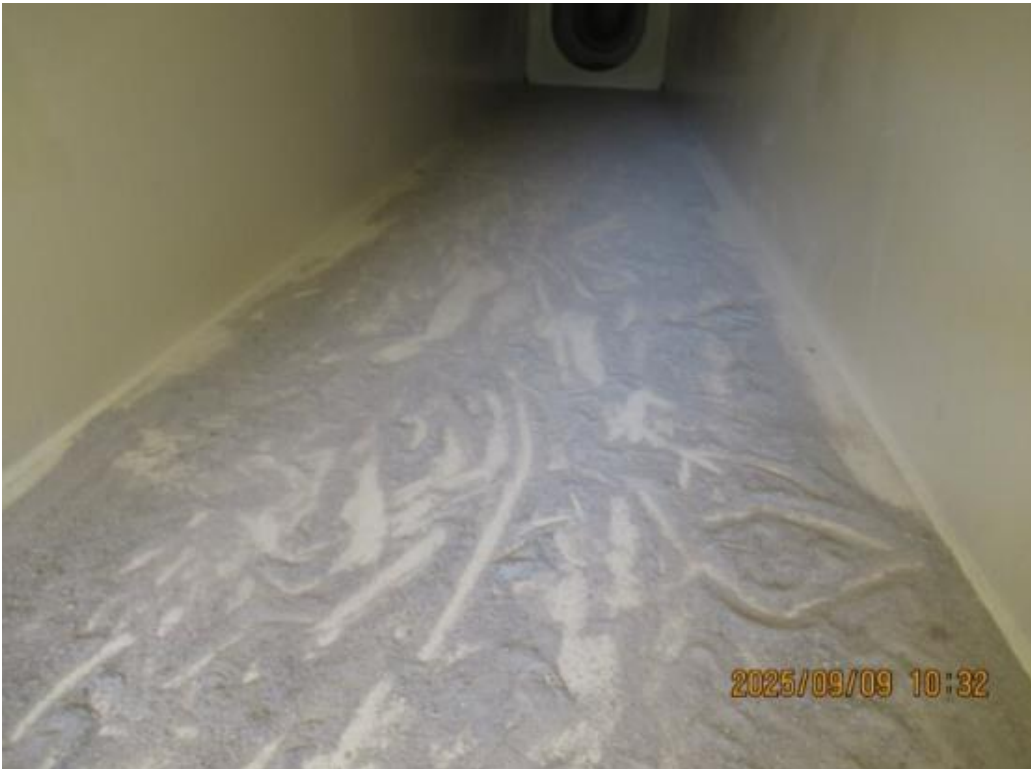
*Photo 34: Debris inside pier cap (Pier Cap 25J)*

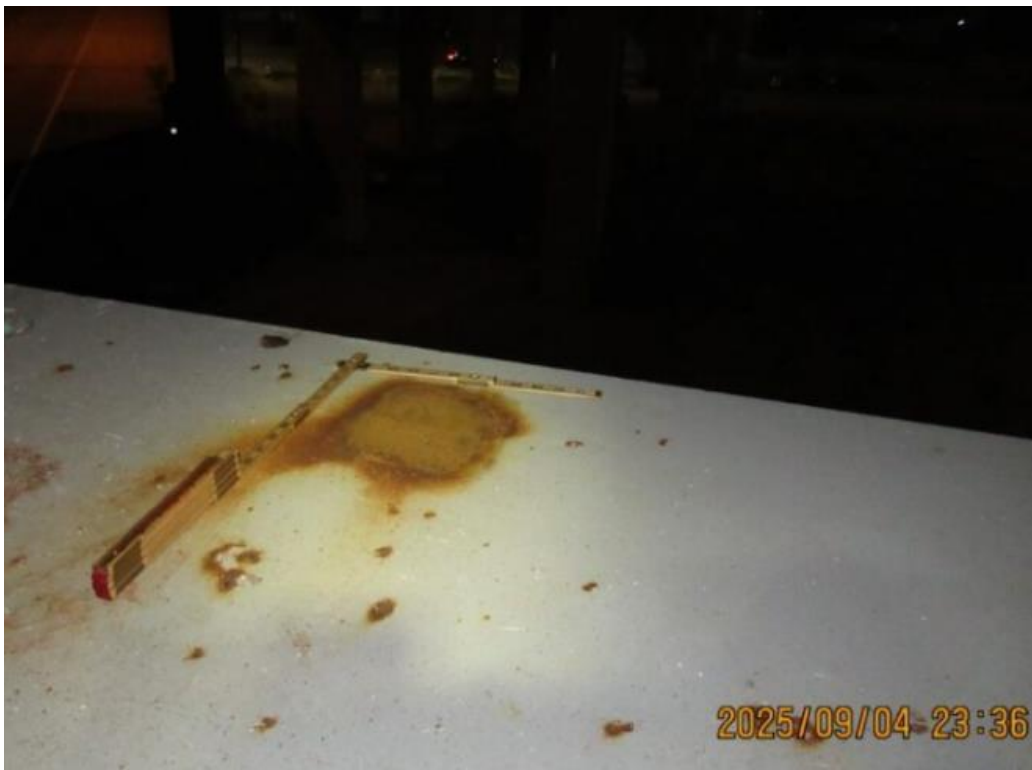
*Photo 37: 6" x 6" x 3/16" deep section loss in top flange at west end (Pier Cap 26C/J)*

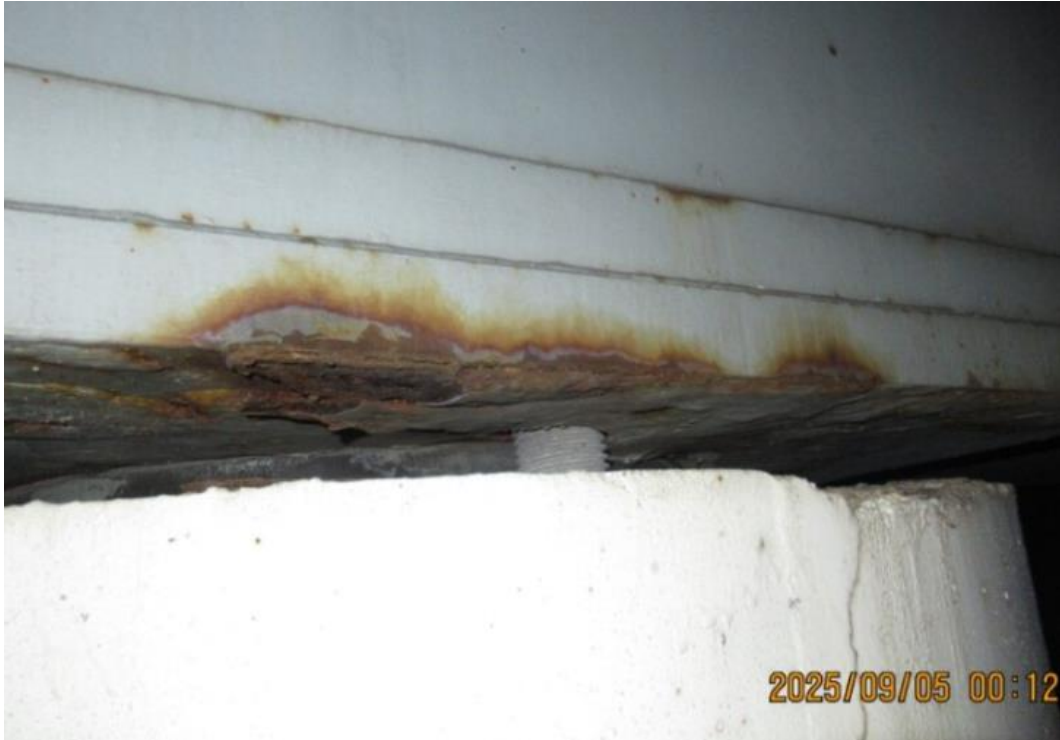
*Photo 38: Laminating corrosion on bearing plate at Column 2 (Pier Cap 26C/J)*

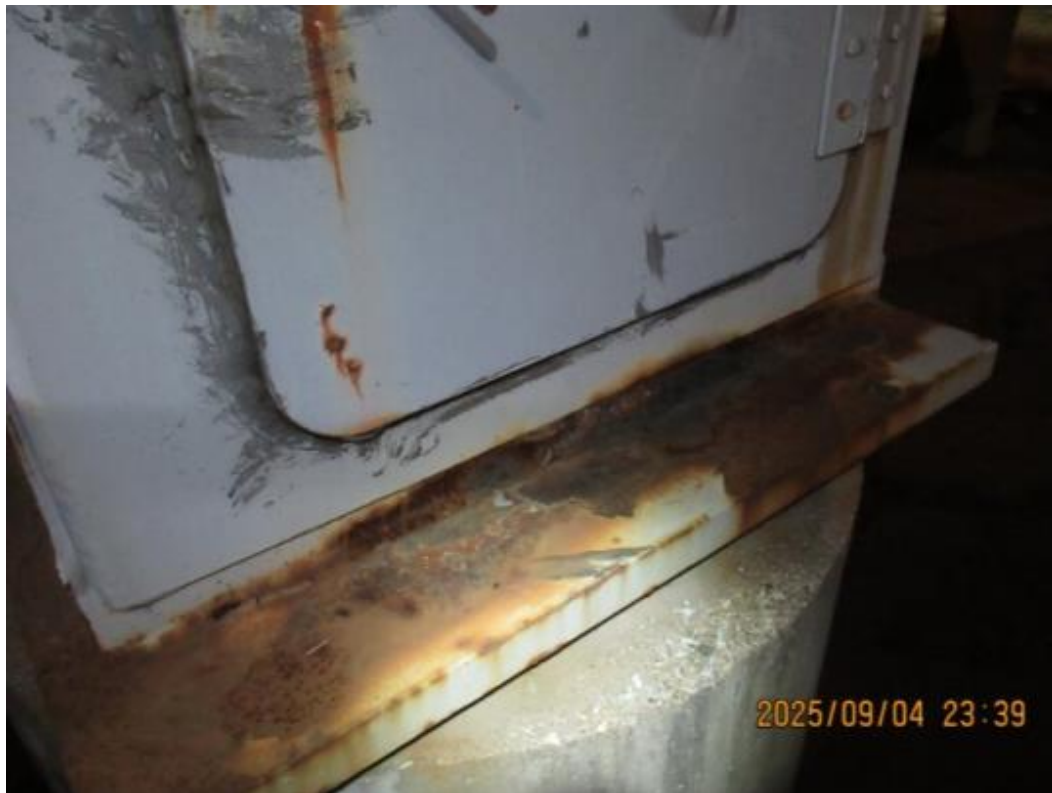
The exterior of steel pier cap 26C/J is in **SATISFACTORY CONDITION (6)**. There is minor surface corrosion throughout the exterior of the pier cap, particularly on the top flange at the ends, and along the edges of both flanges. There is 6" x 6" x 3/16" deep section loss in top flange at west end (Photo 37). There is laminating corrosion with section loss less than 1/16" deep on the undersides of the bearing plates at all columns (Photo 38). On the bottom flange at the openings there is section loss up to 1/16" (Photo 39).

*Photo 39: 1/16" deep section loss in bottom flange at west opening (Pier Cap 26C/J)*

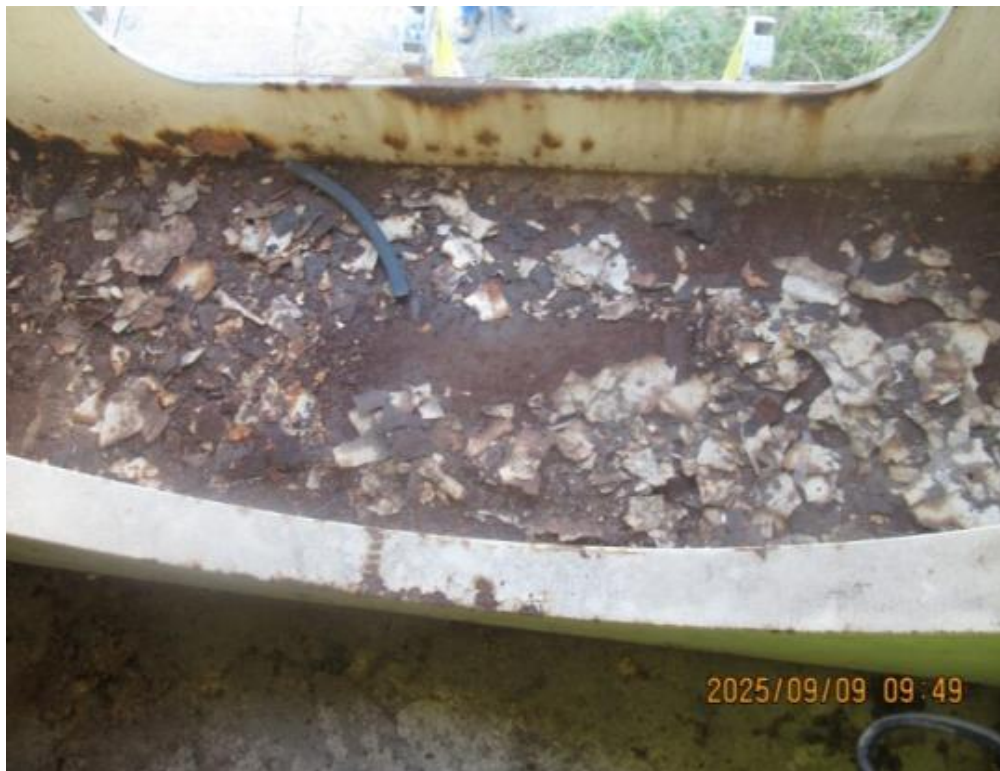
| Location | Defect | Stress Region |
|---|---|---|
| Between West Hatch and Diaphragm 1 | Bottom flange, lower 3" of webs and diaphragm: Surface corrosion, pitting less than 1/16" deep | N/A (outside bearing) |

*Photo 40: Surface corrosion with pitting less than 1/16" deep at west end (Pier Cap 26C/J)*

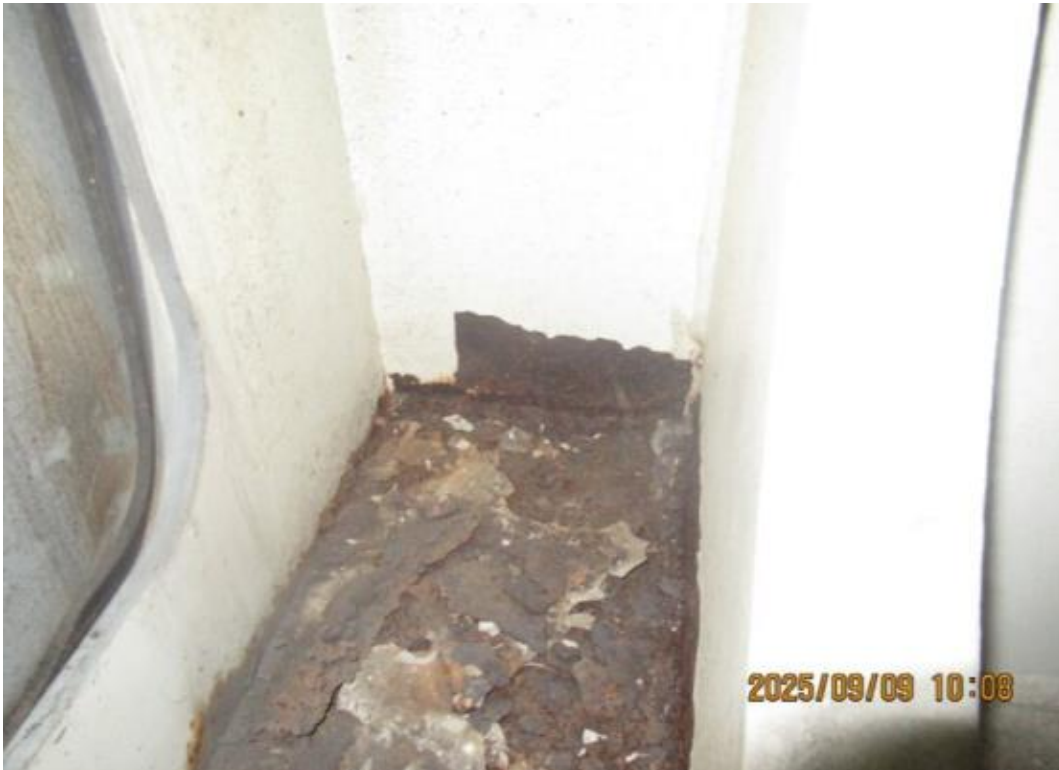
| Location | Defect | Stress Region |
|---|---|---|
| Between East Hatch and Diaphragm 18 | Bottom flange, lower 3" of webs and diaphragm: Laminating corrosion with section loss up to 1/8" deep | N/A (outside bearing) |

**Photo 41:** Laminating corrosion with section loss up to 1/8" deep at east end (Pier Cap 26C/J)

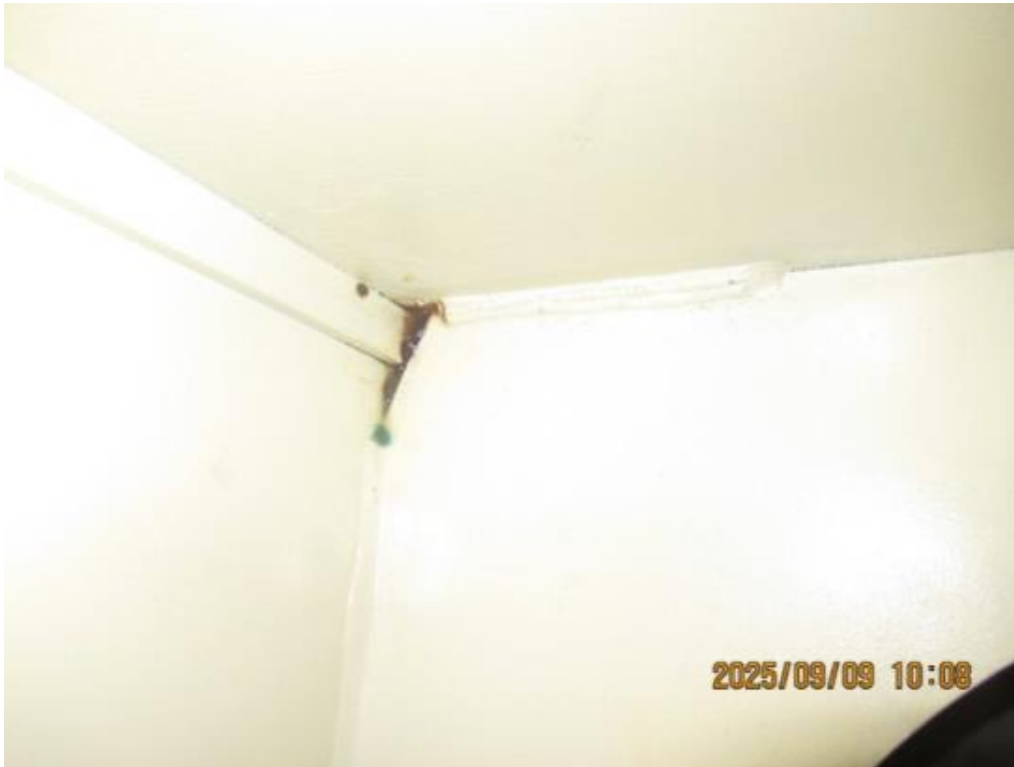
**Photo 42:** Minor surface corrosion at top corners of Diaphragm 17 sealed with silicone (Pier Cap 26C/J)

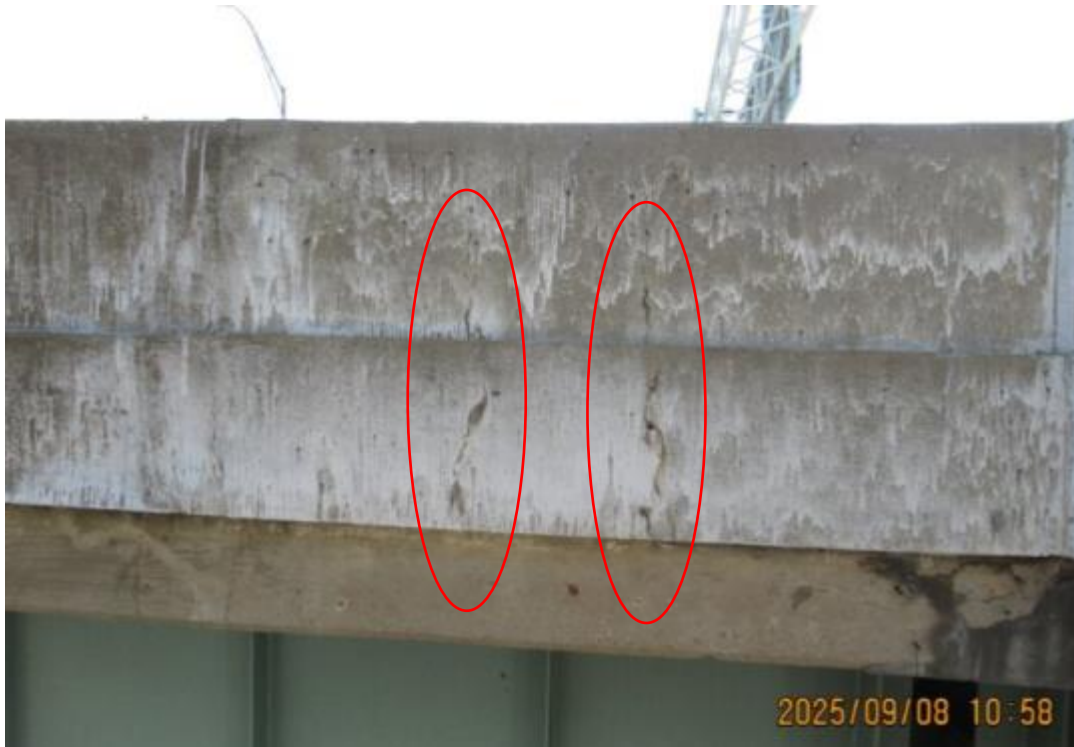
*Photo 44: Typical vertical cracks in west railing (Span 16C shown)*

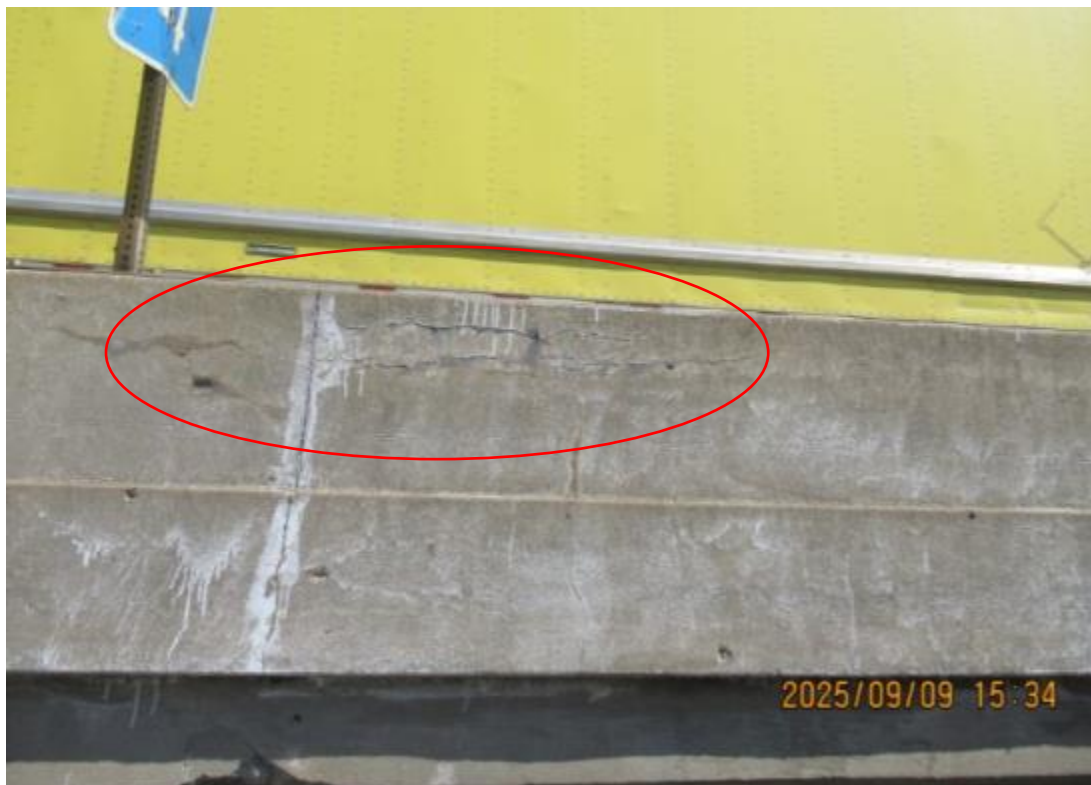
*Photo 45: Map cracking in west rail above Pier 25C*

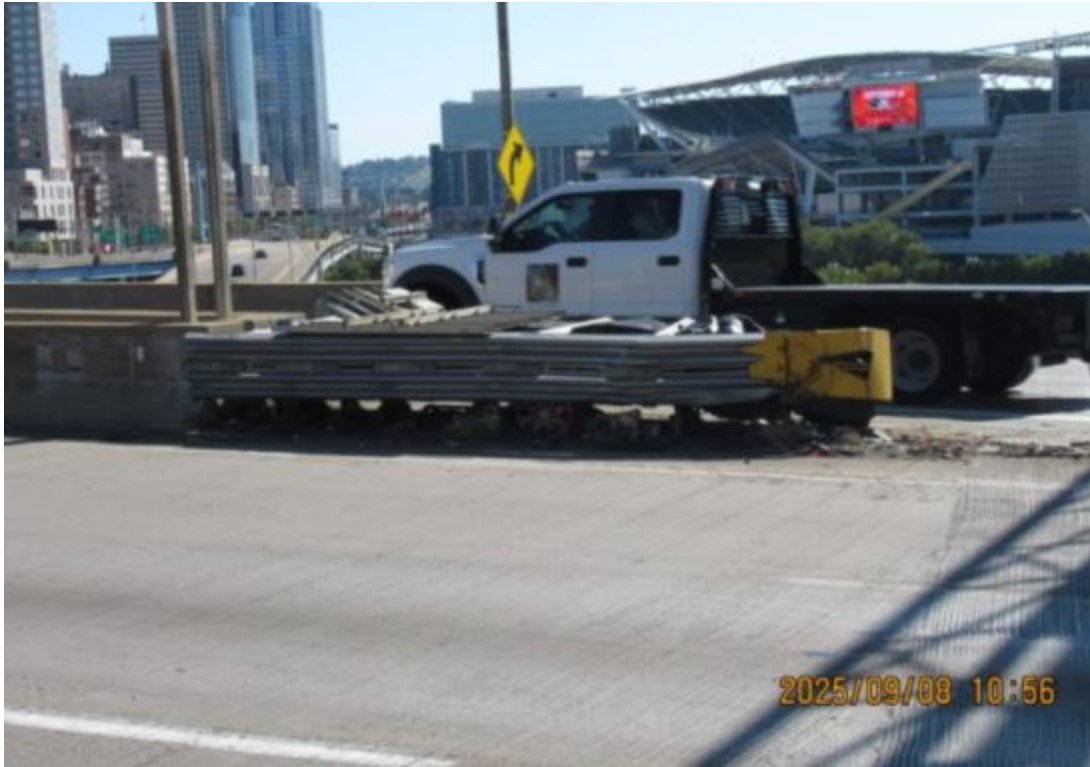
The reinforced concrete bridge railings are in **SATISFACTORY CONDITION (6)** overall. Vertical and transverse hairline cracks with efflorescence as well as isolated small spalls are typical throughout the railings (Photo 44). A horizontal crack is present in the east railing near the light post in Span 20C. There is a map cracking in the top of the west railing near Piers 23C and 25C (Photo 45). There is impact damage to the attenuator at Span 16C (Photo 46).

*Photo 46: Impact damage to attenuator (Span 16C)*

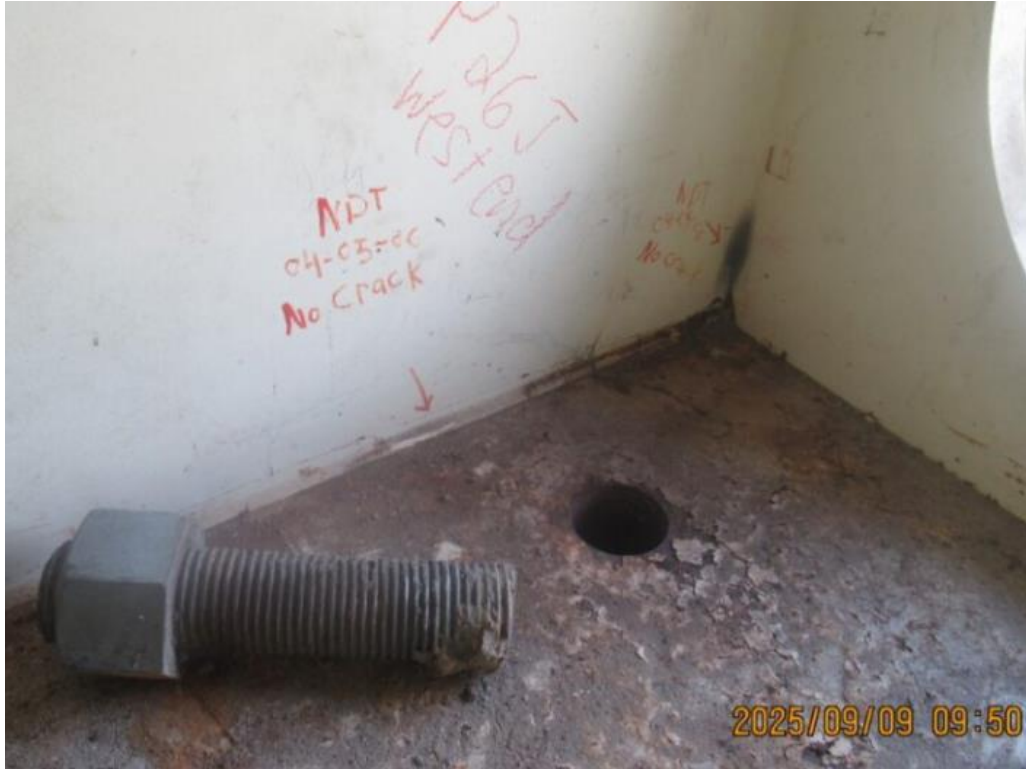
- The south anchor bolt at the west column bearing is broken; no issues were noted with the remaining anchor bolts (Photo 47).
- The cap appears stable with no excessive or unanticipated movements under live load.

*Photo 47: Broken south anchor bolt at the west column bearing (Pier 26C/J)*

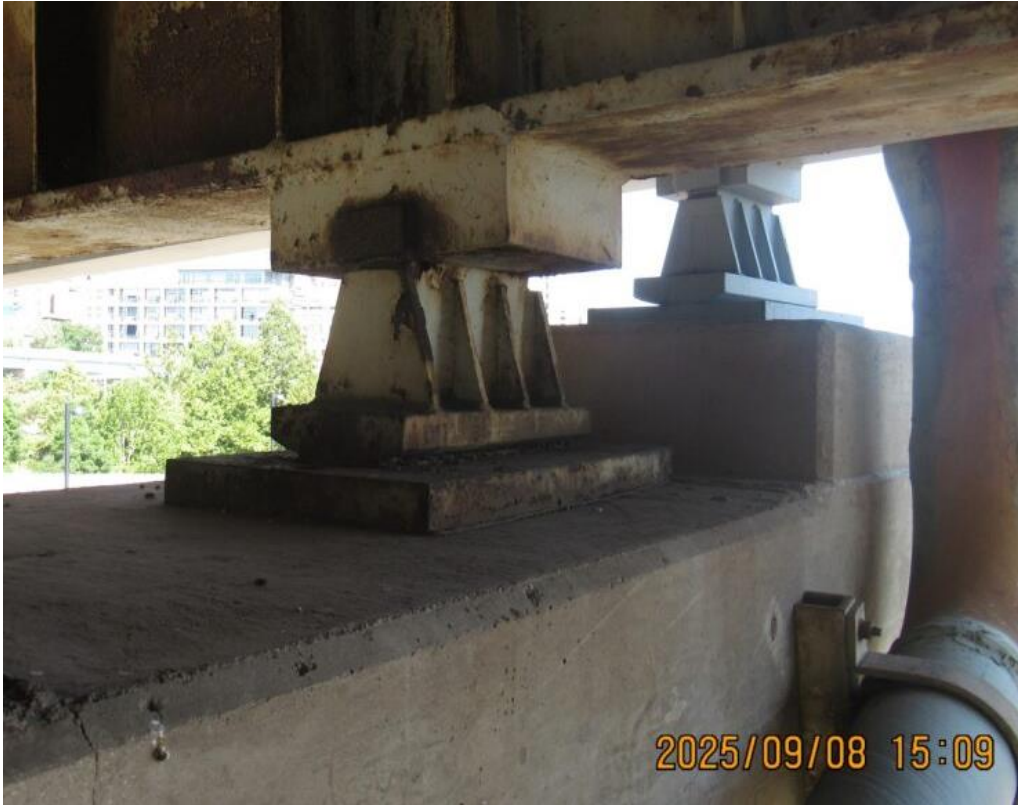
*Photo 48: Pack rust under Bearing E (Pier 21C)*

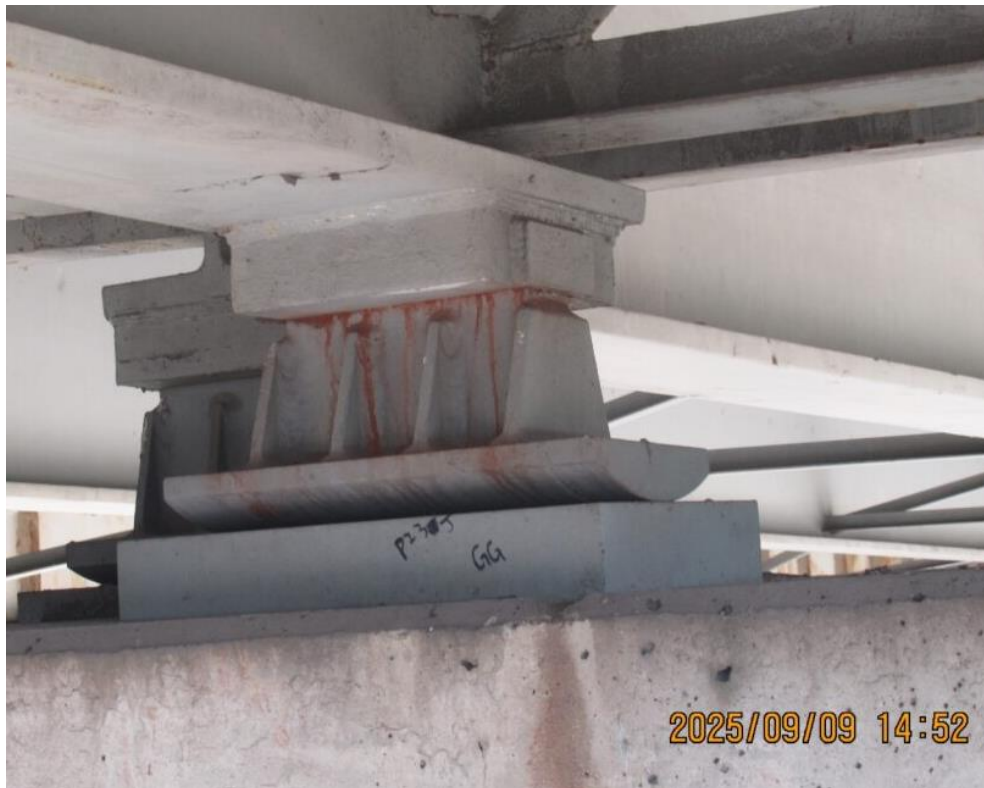
*Photo 49: Minor fretting corrosion on Bearing G (Pier 23J)*

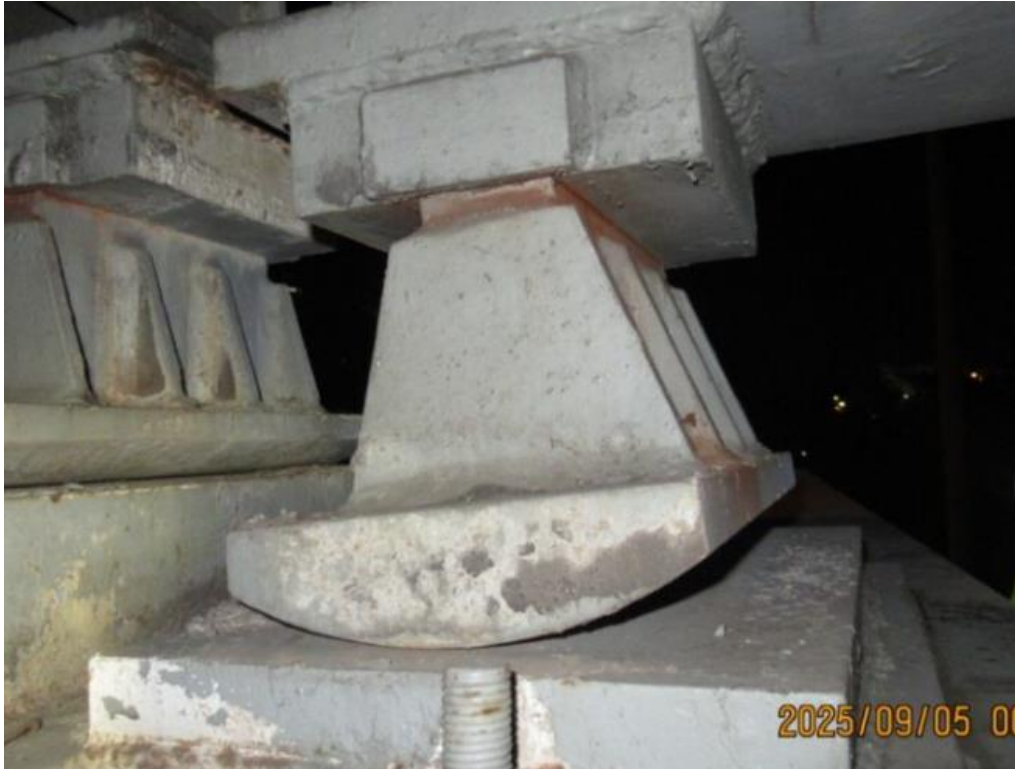
*Photo 50: Bearing G expanded 6° at 55°F (Pier 26C/J)*

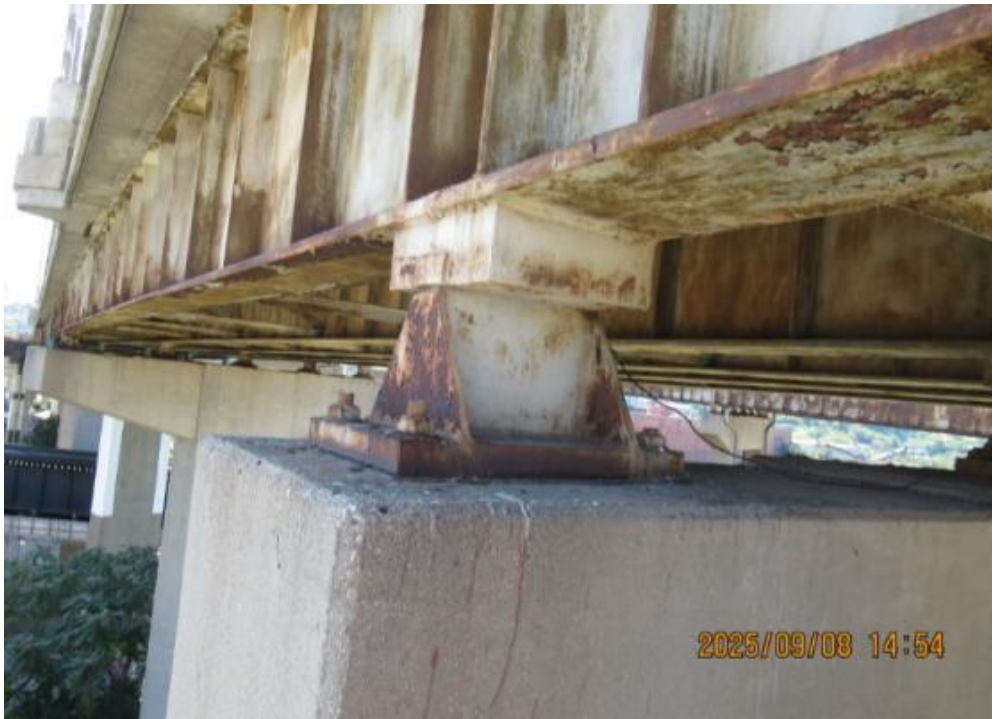
The fixed bearings are in **SATISFACTORY CONDITION (6)** overall. The fixed bearings exhibit surface corrosion with no measurable section loss, with the corrosion more prominent on the fascia bearings (Photo 51).

*Photo 51: Typical surface corrosion on fascia bearing (Pier 20C)*

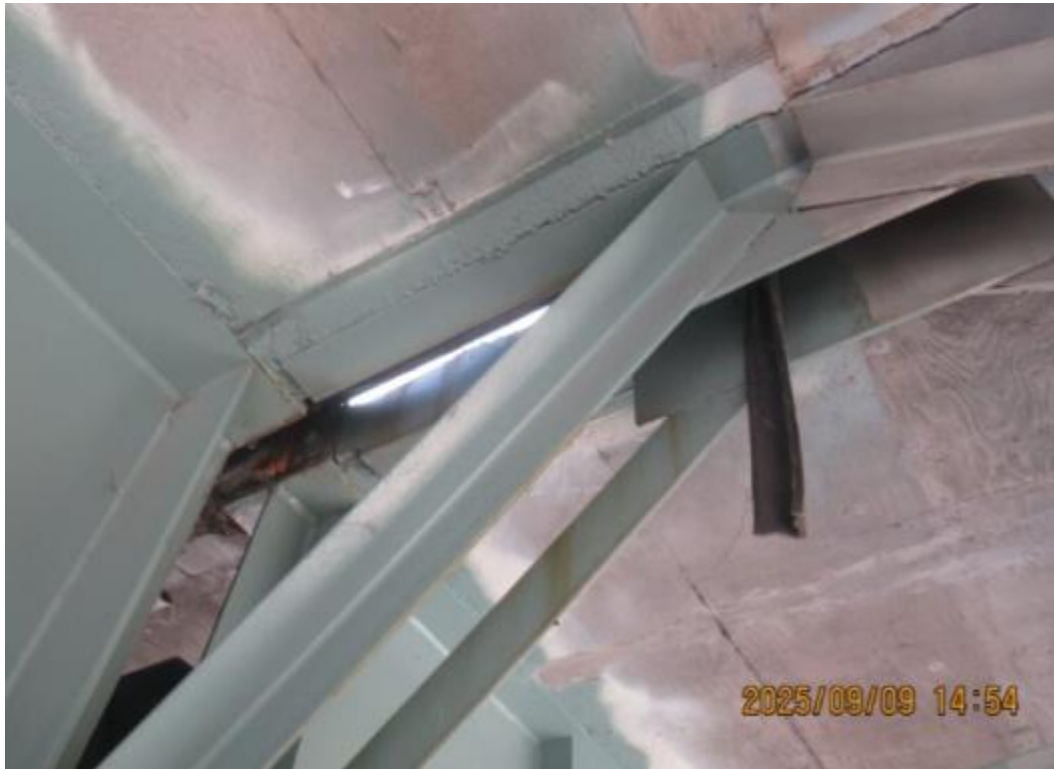
The expansion joints are in **POOR CONDITION (4)** overall. Expansion joints are located at Piers 15C, 18C, 23C, 26C and Abutment C. The expansion joints were visibly inspected from the boom lift. Loosely-packed debris was noted in the expansion joint at Piers 18C and 26C. A 6' long section of the joint seal has pulled out between Beams E and B3 at Pier 23C and water free flows on to the pier at this location (Photo 52).

*Photo 52: Failed joint seal (Pier 23C)*

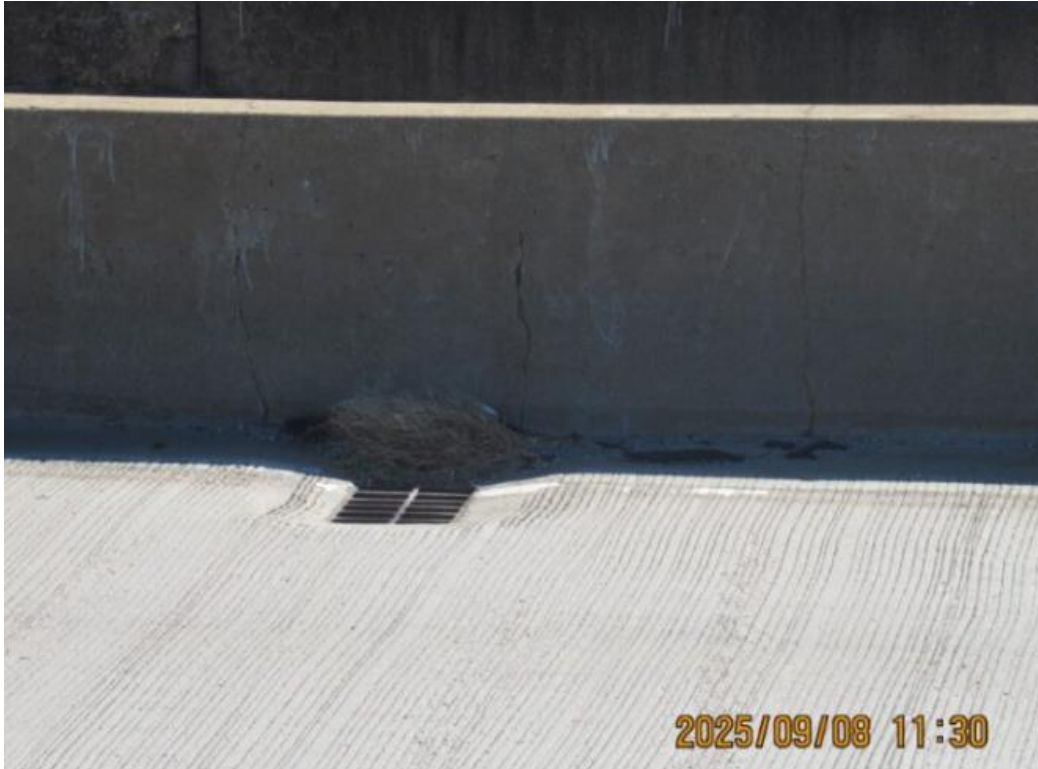
The bridge deck drainage is in satisfactory condition. At the deck level, scuppers were visibly inspected from the boom lift. Vegetation/debris accumulation was observed in a scupper in Span 16C (Photo 53). The drain at Pier 16C was noted to be leaking onto the substructure during a previous inspection.

*Photo 53: Vegetation/debris accumulation in a scupper (Span 16C)*
