ODOT District 8  
2024 In-Depth & NSTM Inspection Report

Bridge No. HAM-50-2180N  
SFN: 3103390

**2024 IN-DEPTH & NONREDUNDANT STEEL  
TENSION MEMBER (NSTM) INSPECTION REPORT**

**BRIDGE NO. HAM-50-2180N**

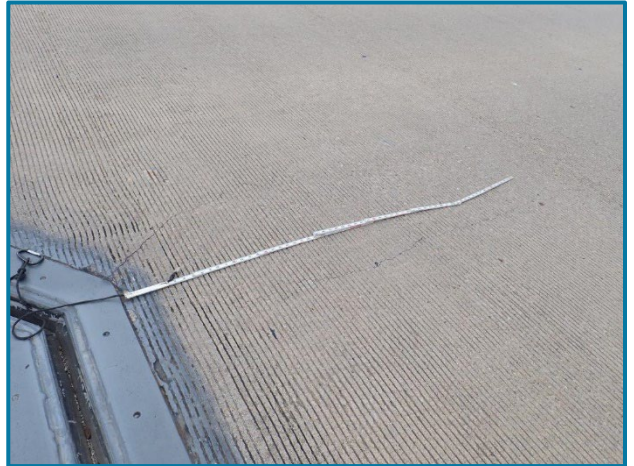
Photo 6 – Moderate to wide cracks near where the expansion joint armor bends (near Pier 10).

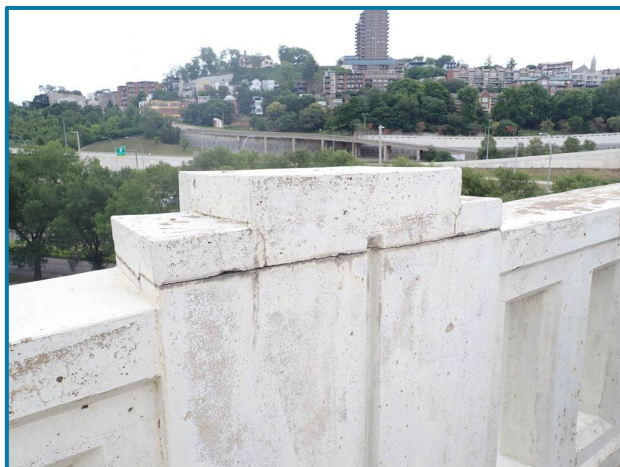
Photo 8 – Crack with delamination at the decorative post cap (looking southwest).

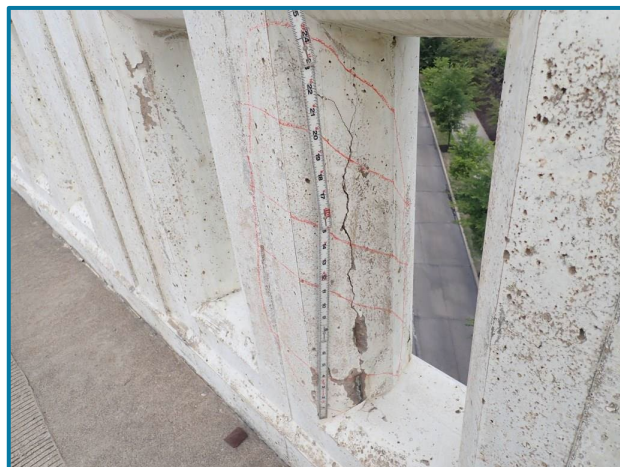
The reinforced concrete bridge railings run the full length of both sides of the bridge and along the north side of the sidewalk. They are in satisfactory condition. Between Pier 5 and Pier 6 of the north railing, the decorative extension to the post is cracked and fully delaminated (see [Photo 8](#)). Between Pier 6 and Pier 7 of the north railing, there is a 2' H x 1' W delamination at the stem (see [Photo 9](#)).

Photo 9 – 2' H x 1' W delamination with a crack in the north railing stem (looking southeast).

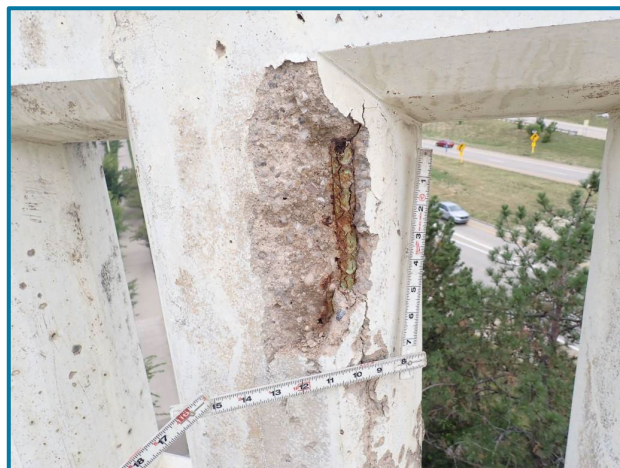
Throughout the length of the railing, there are several locations of various sizes of spalls up to 5" W x 1' H, some with exposed and corroded rebar (see Photo 10). Two locations were noted as having map cracking with efflorescence, but there are indications (tight spiderweb style cracking with thin leakage along the cracking) that these areas may have alkali-silica reaction (ASR) (see Photo 11). The two areas are at posts and are located on the south railing between Piers 7-8 and between Piers 17-18. The protective coating system is faded and is chipping off throughout.

Photo 10 – Spall with exposed rebar in the railing stem (looking northwest at north railing).

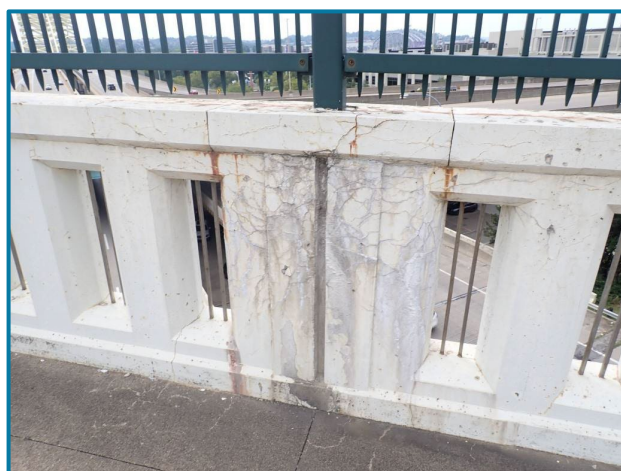
Photo 11 – Map cracking with efflorescence (possible ASR) in the concrete railing (looking south at the south railing).

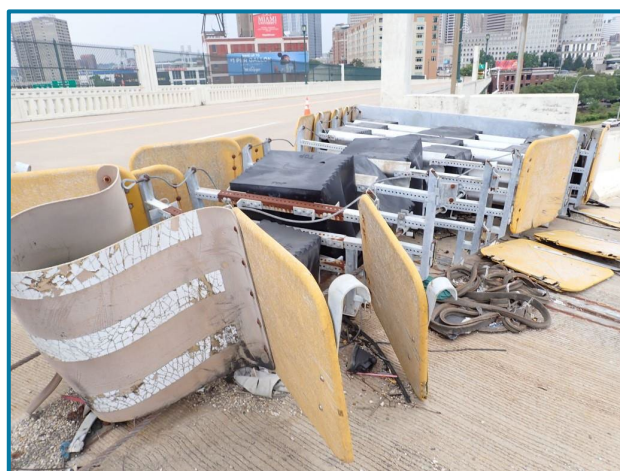
In the westbound lane just east of I-471, there is a crash attenuator at the exit ramp for Sixth St Downtown. The crash attenuator has been damaged and has panels hanging loose, deployed cushions, and loose cables (see Photo 12).

Photo 12 – Damaged crash attenuator with hanging panels, deployed cushions, and loose cables (looking west).

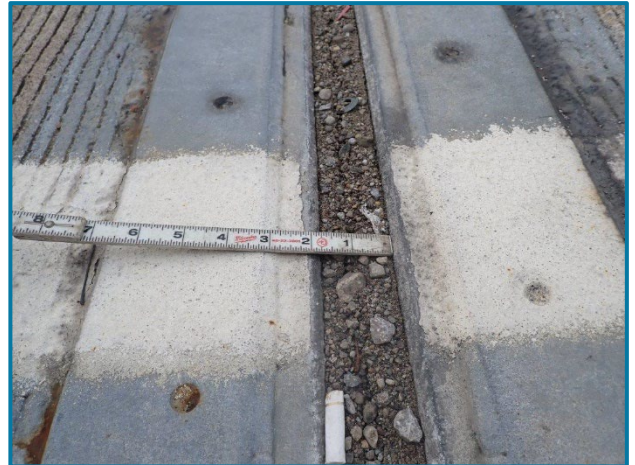
Photo 13 – Debris accumulation in the deck joint (Pier 4 shown, looking south).

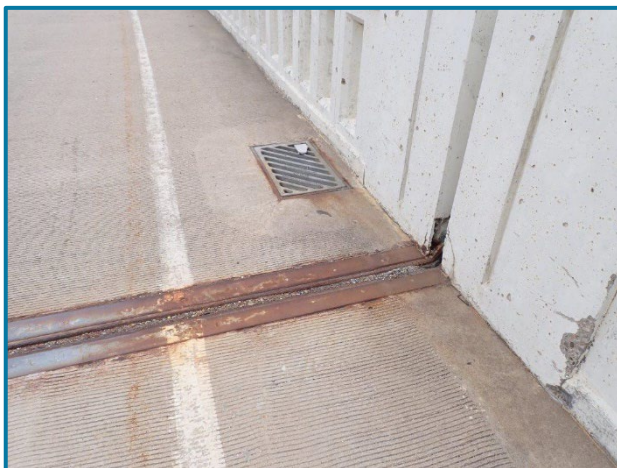
Photo 14 – Surface corrosion to the deck joint armour in the shoulder (Pier 16 shown, looking east).

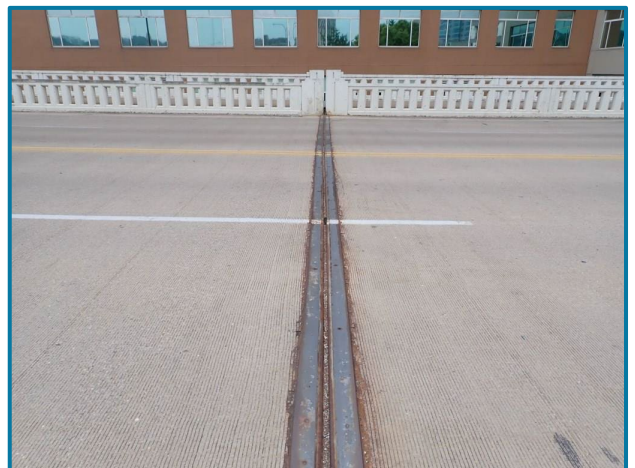
Photo 15 – Surface corrosion to the full length of the deck joint armor (Pier 2 shown, looking south).

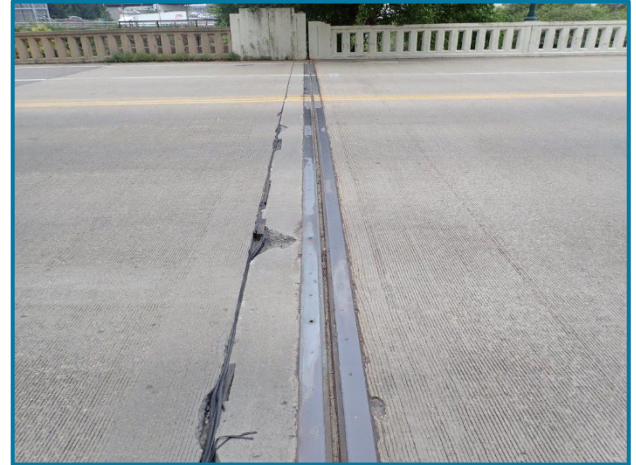
approach side. At Abutment 18 (Forward Abutment), the header has isolated shallow edge spalls and hairline transverse cracks, but at Abutment 1 (Rear Abutment), the spalling is larger in size and the adjacent construction joint is detaching and being pulled away (see Photo 17).

Photo 17 – Spalls in the joint header with damaged construction joint material (Abutment 1 shown, looking north).

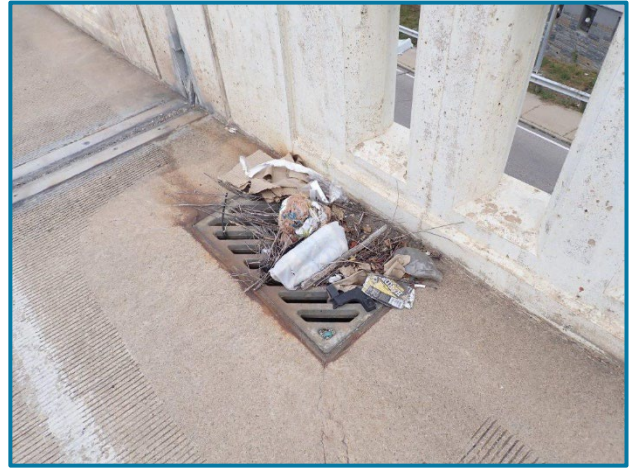
Photo 18 – Debris/Trash build-up at isolated deck scuppers (Pier 17 shown, looking north).

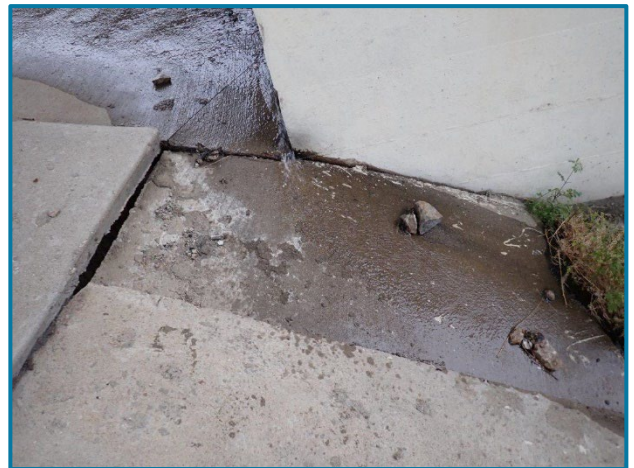
Photo 20 – Slope protection is broken and undermined (Pier 11 shown, looking south).

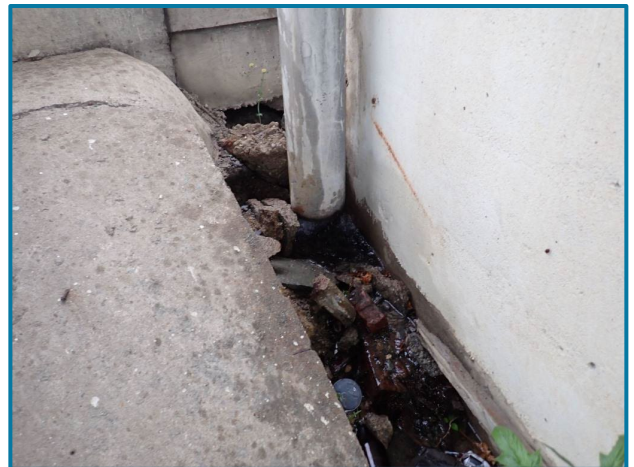
Photo 22 – Slope protection and adjacent approach slab are undermined (Pier 13 shown, looking west).

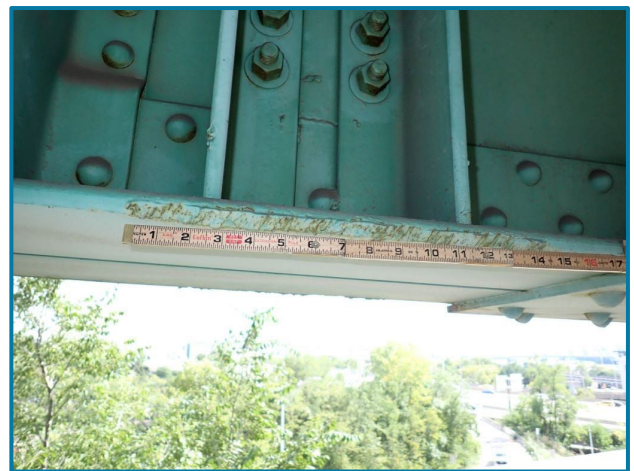
Photo 26 – 1'-2" torch cut bottom flange (Span 14 shown, looking south).

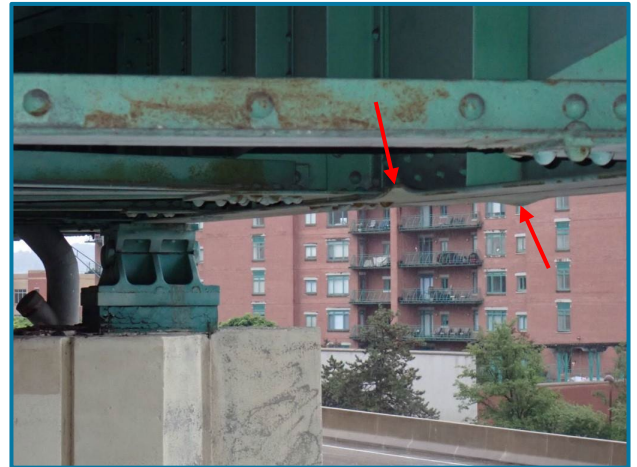
Photo 27 – Bent bottom flange (Span 12 shown, looking southeast).

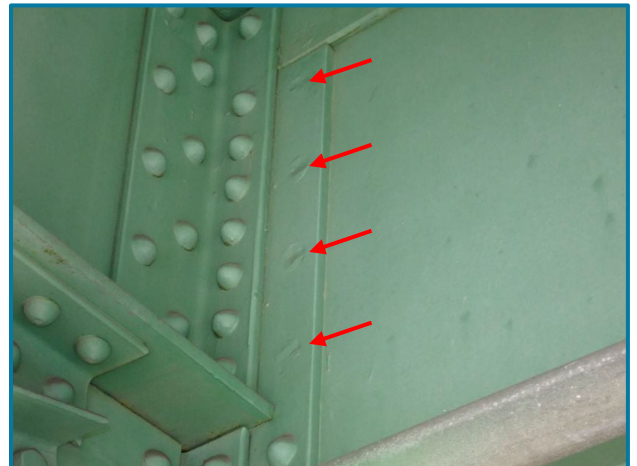
Photo 29 – South Girder near FB 6 has 4 plug welds (Span 16 shown, looking southeast).

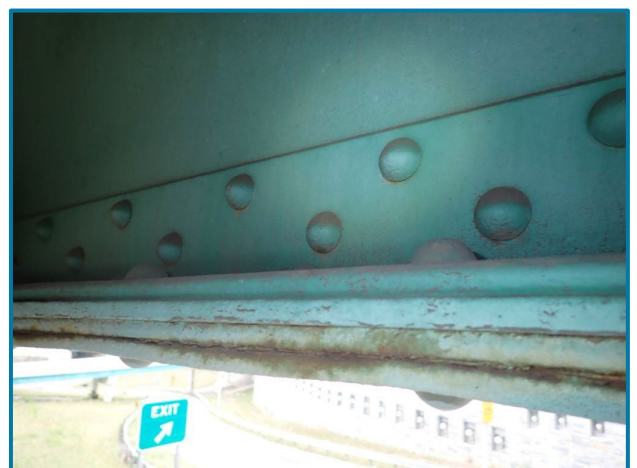
Photo 31 – 1/16" pack rust between the bottom flange cover plates (Span 16 shown, looking northwest).

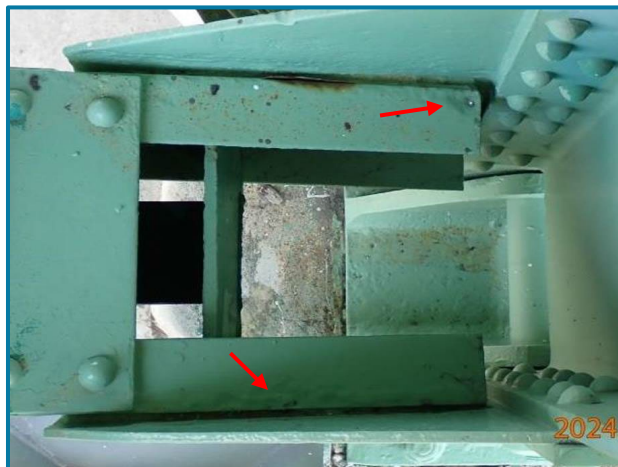
Photo 38 – 3/16" deep section loss to the top flange (L19L20 of the South Truss, Span 6).

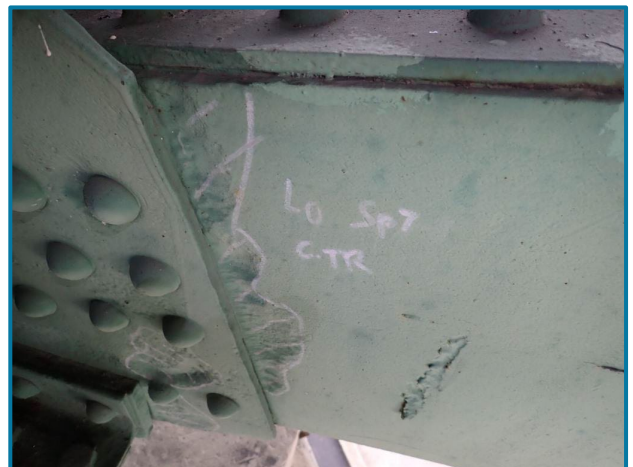
Photo 39 – 3/16" deep section loss to the lower chord adjacent to the gusset plate (L0L1 of the Center Truss, Span 7).

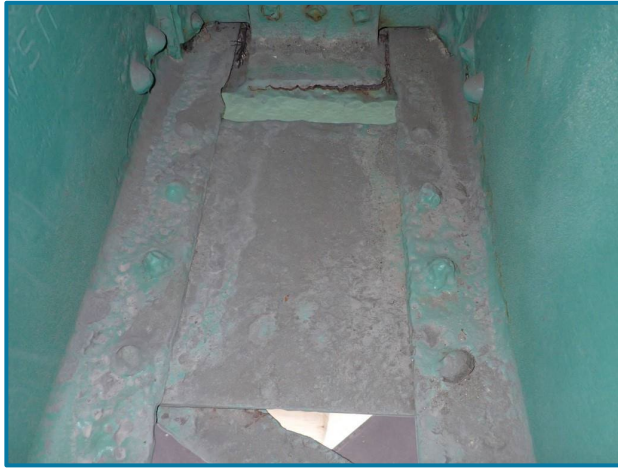
Photo 40 – Up to 50% section loss to the rivet heads inside the lower chord (L0L1 of the Center Truss, Span 7).

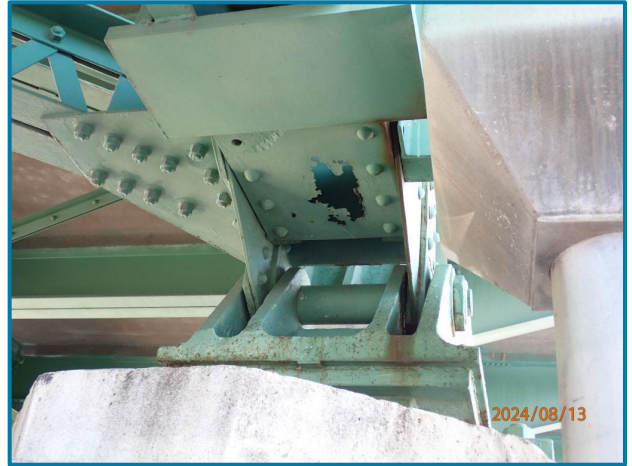
Photo 41 – 10" H x 6" W corrosion hole in the lower batten plate at the bearing (L0 of the North Truss, Span 5).

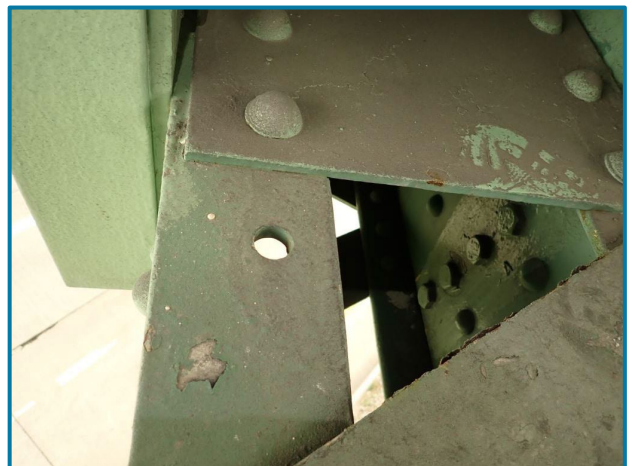
Photo 42 – Blind hole in the lower chord top flange near (L27L28 of the Center Truss, Span 8).

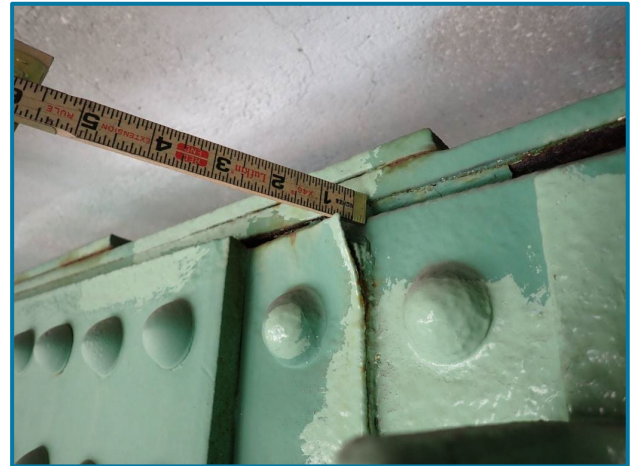
Photo 45 – Pack rust at the top splice plate and distortion at the fill plate (U12U13 of the Center Truss, Span 6).

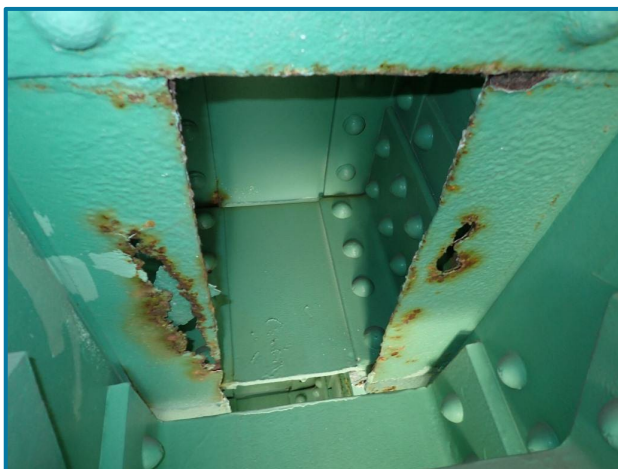
Photo 46 – Corrosion holes, pitting, and active corrosion to the bottom flanges (U0 of the Center Truss, Span 10).

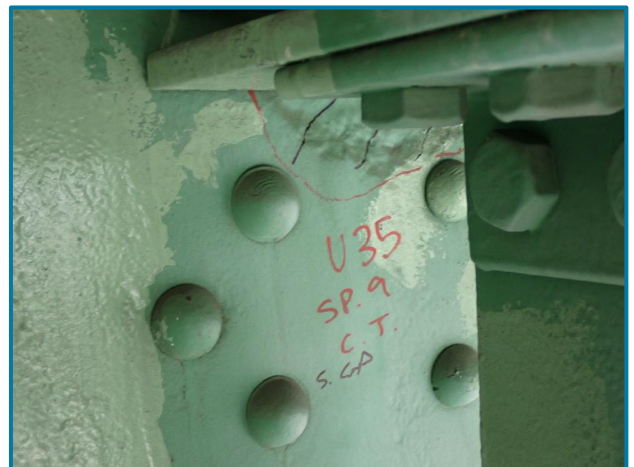
Photo 47 – 6" L x 2" H x 1/8" D pitting underneath the floorbeam connection (U35 of the Center Truss, Span 9).

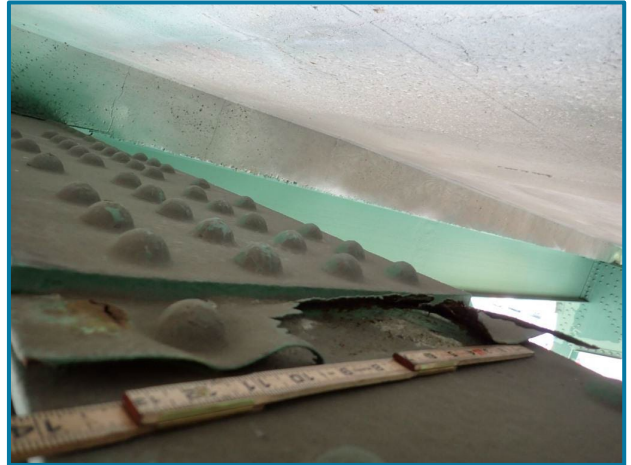
Photo 48 – 8" L x 2" W area of 100% section loss to the fill plate (U9U10 of the Center Truss, Span 6).

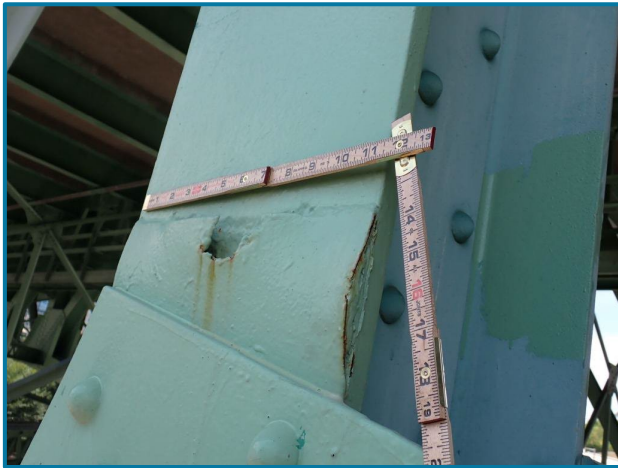
Photo 51 – 9/16” pack rust at the fill plate causing distortion to the plate (U13L13 of the South Truss, Span 7).

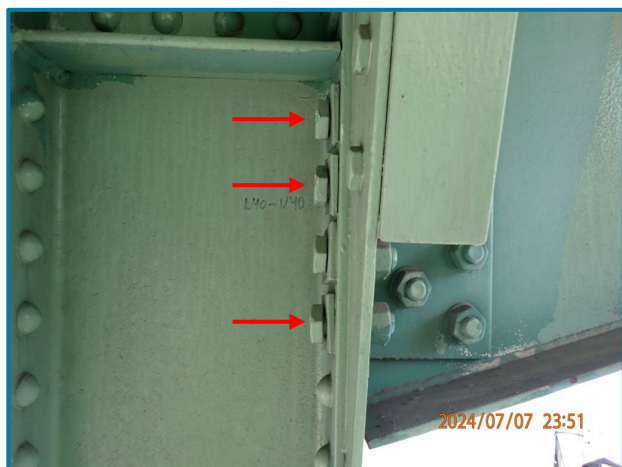
At U40 of the North Truss, Span 9, there are gaps at three bolted connections. The bolts are not loose to the touch, but they have not been properly tightened ([see Photo 55](#)). At U11 of the Center Truss, Span 7, there are three plug welds near the top end of the vertical. No deficiencies are noted in this area. Two rivet heads have been torch cut off at U20 of the North Truss, Span 11 ([see Photo 56](#)).

Photo 55 – Three bolts not properly snug (U40 of the North Truss, Span 9).

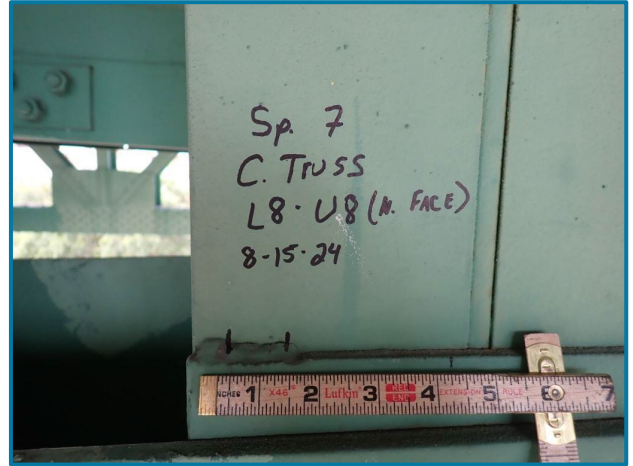
Photo 58 – 1" crack in the fill plate weld to the vertical (U8L8 of the Center Truss, Span 7).

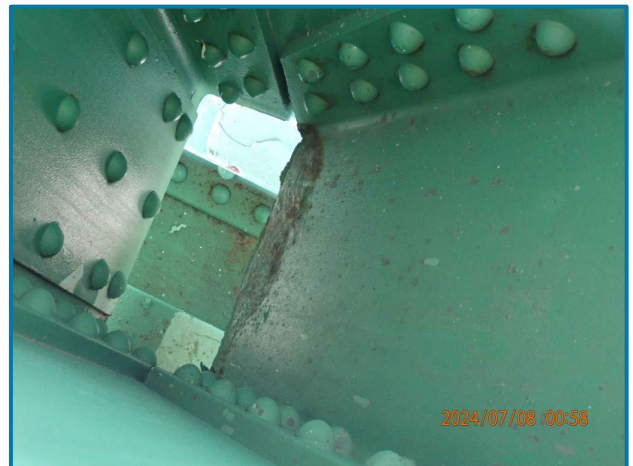
Photo 60 – Surface corrosion at the diagonal end with pack rust forming (U32L33 of the North Truss, Span 9).

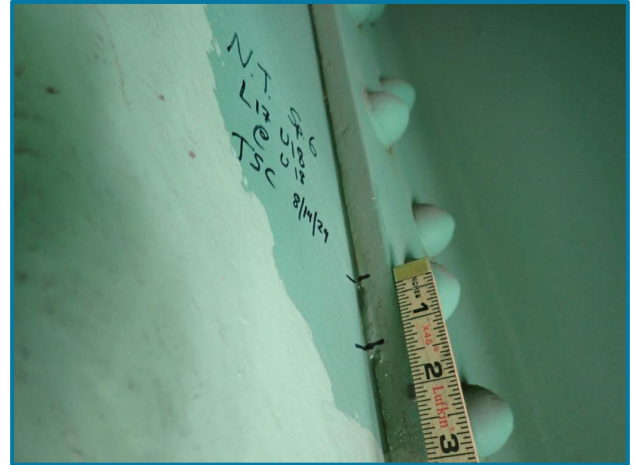
At U18 of L17U18, North Truss, Span 6, there is a 1-1/2" long cracked tack weld between the diagonal and the north gusset plate (see [Photo 61](#)).

Photo 61 – 1-1/2" long cracked tack weld (L17U18 of the North Truss, Span 6).

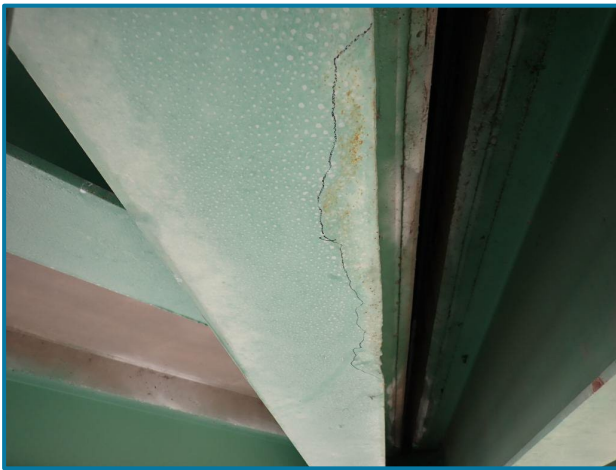
Photo 62 – 2' L x 3" W area of light surface corrosion to the bottom flange (Span 6 over Pier 7).

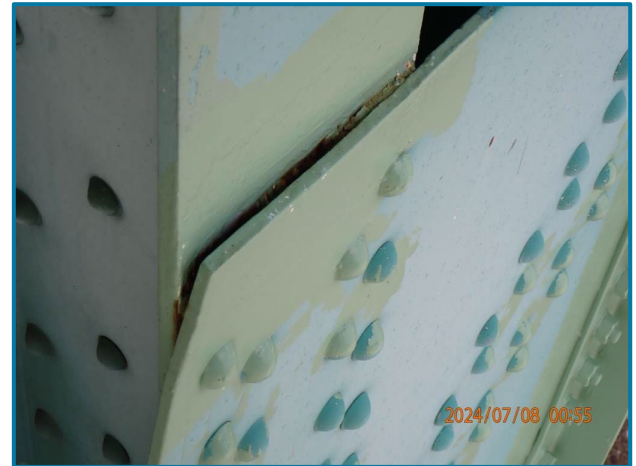
Photo 67 – Typical pack rust at the gusset plate causing distortion (L33, North Truss, Span 9).

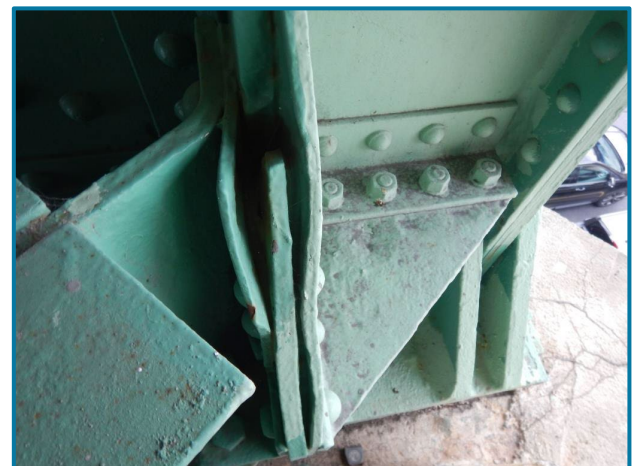
Photo 68 – 1" pack rust between the lower lateral bracing fill plate and the gusset plate (L0, South Truss, Span 5).

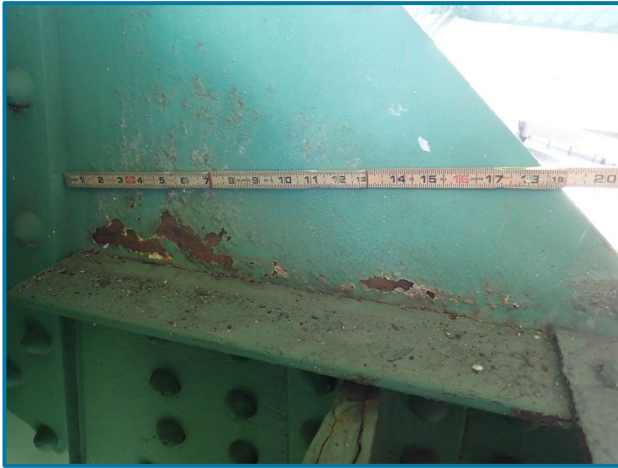
Photo 69 – Failed protective coating system with surface corrosion (L44, Center Truss, Span 9).

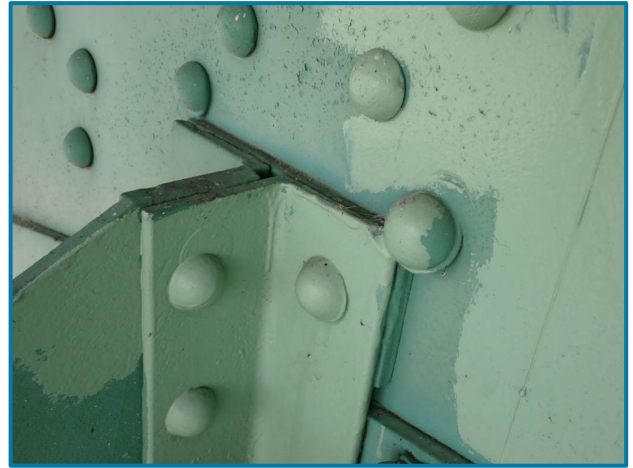
Photo 70 – Rivet deformation due to conflict with the sway bracing connection (L28, Center Truss, Span 8).

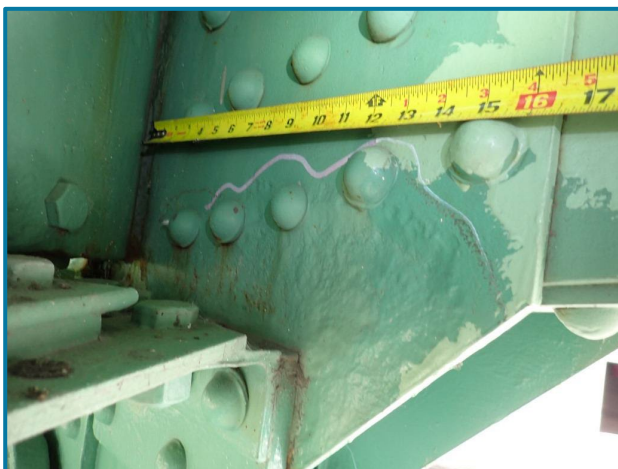
Photo 71 – 2'-4" L x 6" H x 3/16" D painted over pitting adjacent to the bearing (L20, South Truss, Span 6).

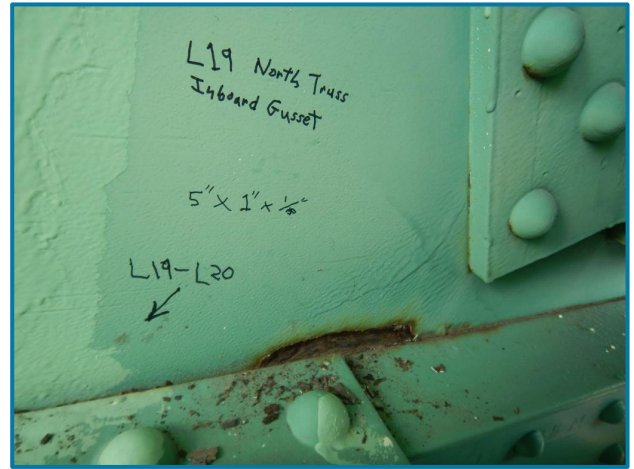
Photo 74 – 1/8" pitting with active corrosion (L19, North Truss, Span 6).

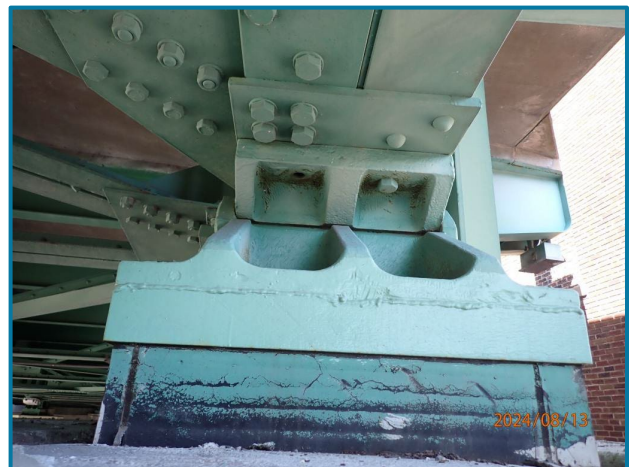
Photo 76 – Missing bolt attaching the sole plate to the girder (North Girder, Floorbeam 0, Span 4, looking west).

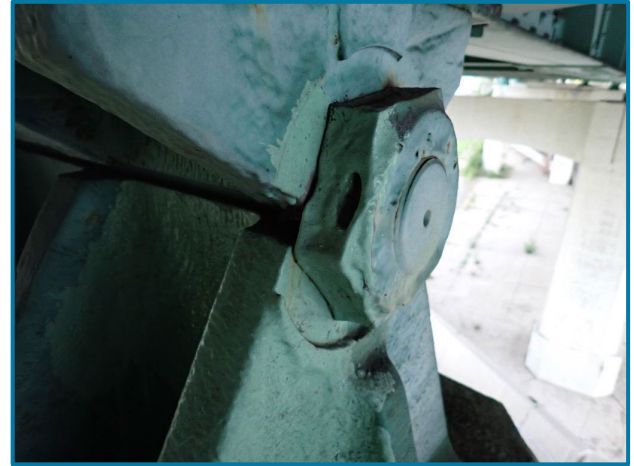
Photo 77 – Gouge in the pin nut with painted over pitting (Pier 12, Center Girder, Span 12, looking southwest).

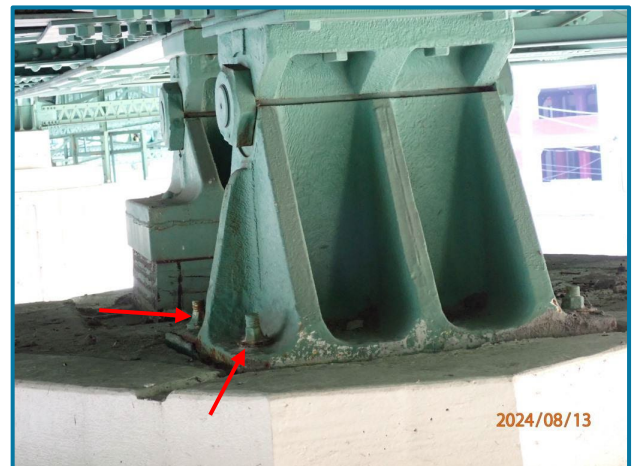
Photo 79 – Up to 40% section loss to the anchor nuts (Pier 4, Center Girder, Span 3, looking southeast).

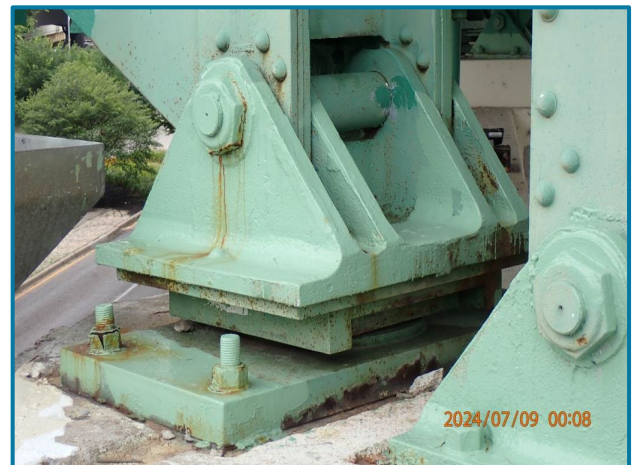
Photo 80 – Surface corrosion and rust staining to the bearing (L14, North Truss, Pier 8, looking southeast).

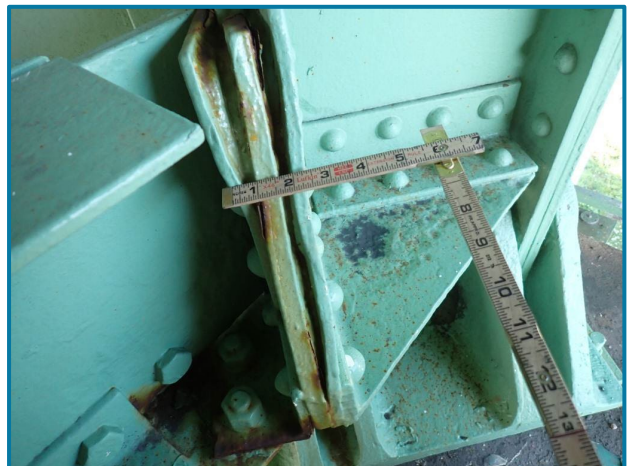
Photo 85 – Up to 1" pack rust at the connection to the truss (L20, North Truss, Span 11, looking northwest).

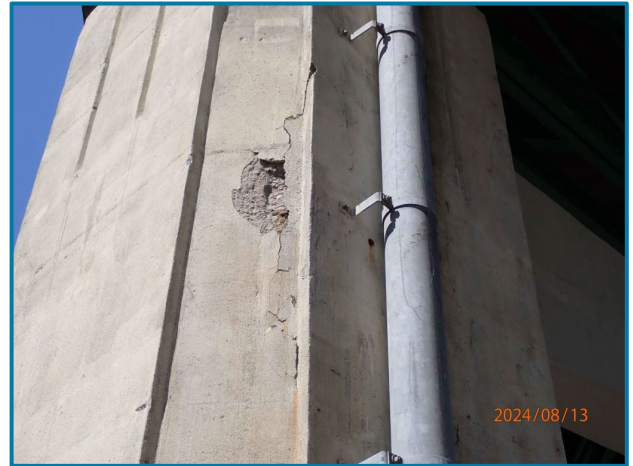
Photo 88 – 2' L x 5' H delamination with 1 SF x 1" spall (Pier 7, South Column, SE Corner, looking northwest).

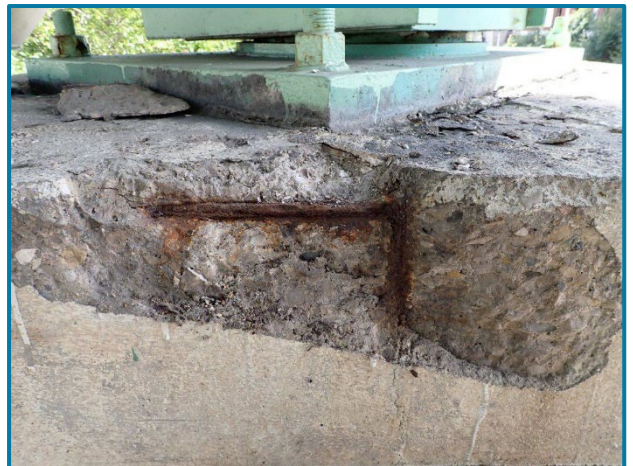
Photo 90 – 1'-9" L x 8" H x 2" D spall with exposed rebar (Pier 8, South Column, North Face, looking south).

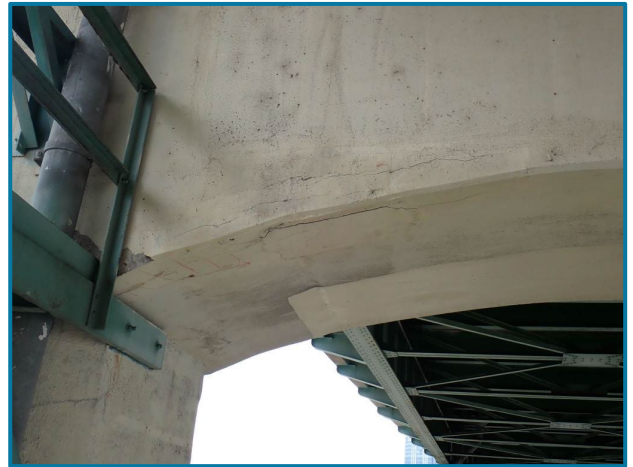
Photo 100 – 10' L section of cracked repair patch that extends 1' underneath (Pier 15, East Face, looking west).

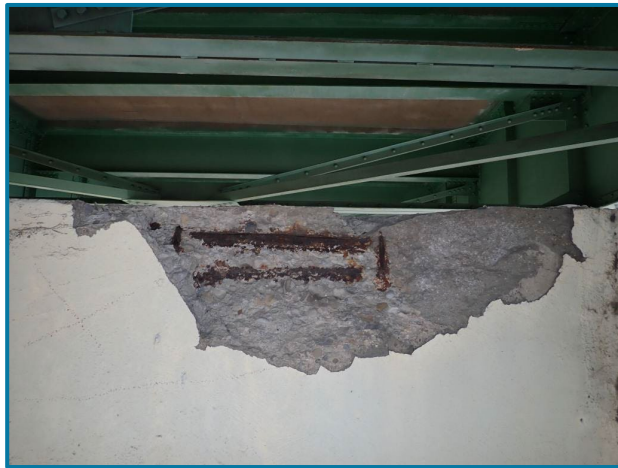
Photo 101 – 3'-8" L x 1'-1" H x 3" D spall with exposed rebar (Pier 16, East Face, looking west).

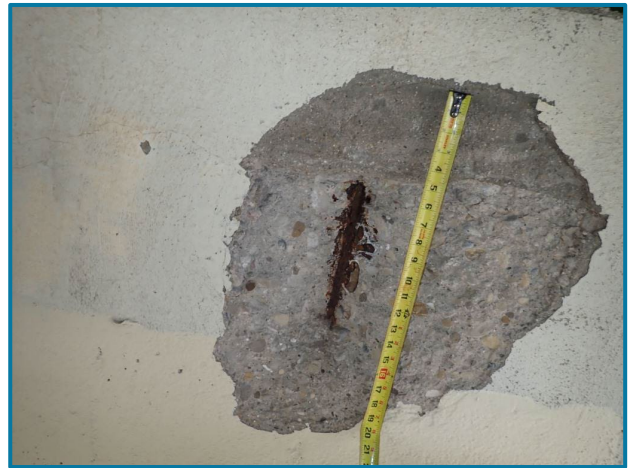
Photo 102 – 1'-8" diameter x 2" D spall with exposed rebar (Pier 16, West Face, looking east).

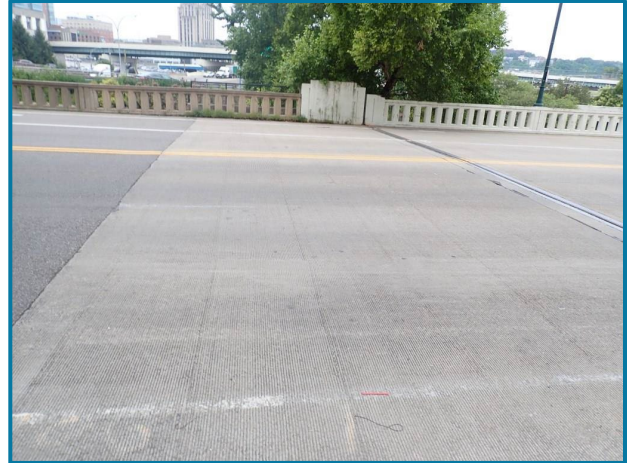
Photo 103 – Wear in the wheel lines of the approach slab (West Approach Slab, looking north).
