ODOT District 8  
2024 In-Depth & NSTM Inspection Report

Bridge No. HAM-50-2181N  
SFN: 3103404

**2024 IN-DEPTH & NONREDUNDANT STEEL  
TENSION MEMBER (NSTM) INSPECTION REPORT**

**BRIDGE NO. HAM-50-2181N  
SFN: 3103404**

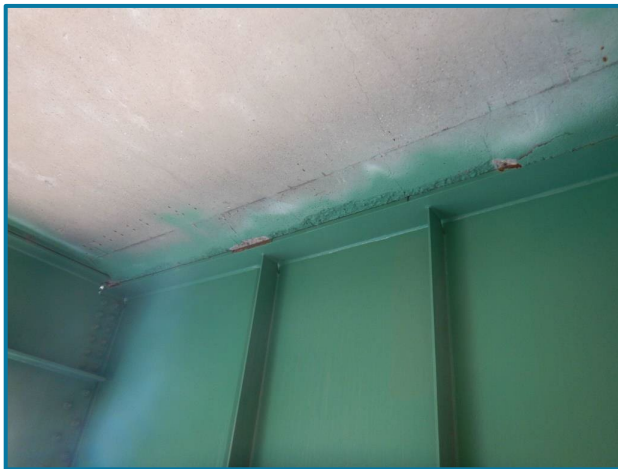
The reinforced concrete deck is in satisfactory condition with isolated haunch spalls (see Photo 1) and hairline cracks, some with light efflorescence. In Span 2, along Girder A, there is an 8' L shallow haunch spall (see Photo 2). At Pier 1, the east soffit, outboard of Girder A, has a 1'-6" L x 1' W x 6" D spall with exposed steel (see Photo 3).

Photo 2 – 8' L shallow haunch spall in the deck (Girder A, Span 2, looking northeast).

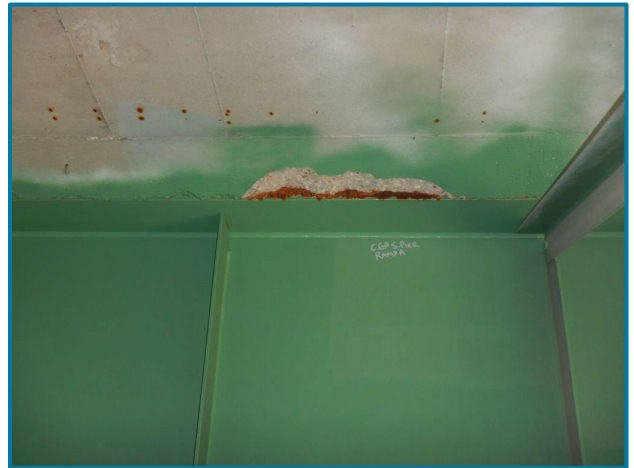
Photo 1 – 2' L haunch spall in the deck (Girder B, Span 2, looking southwest).

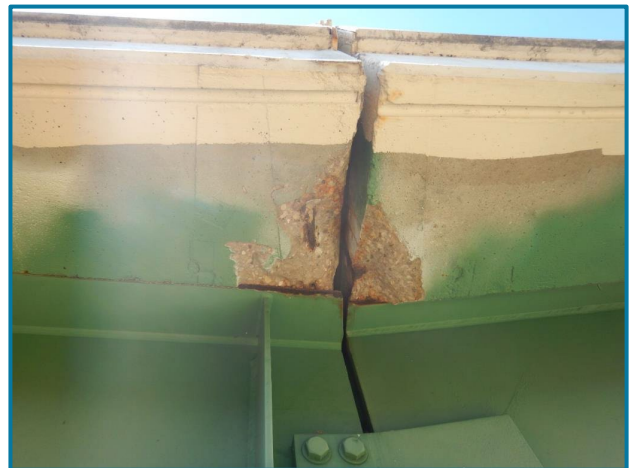
Photo 3 – 1'-6" L x 1' W x 6" D spall in the deck overhang (Girder A, Spans 1-2, looking west).

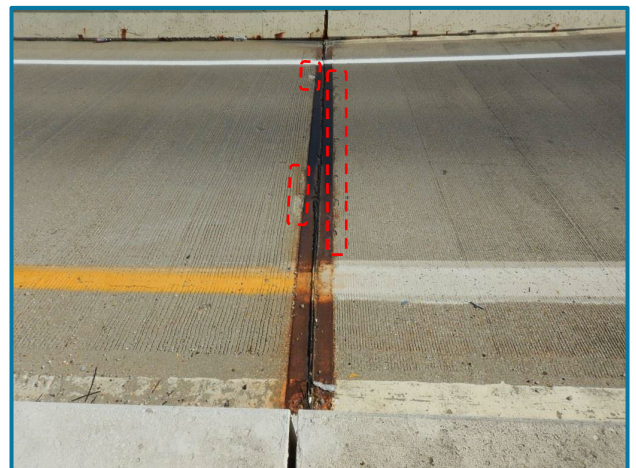
The monolithic concrete wearing surface is in good condition overall with some hairline transverse cracks, isolated shallow spalls along the joint near Pier 1 (see Photo 4), and hairline map cracking near the east end of the bridge.

Photo 4 – Shallow spalls along the joint at Pier 1 and missing/deteriorated compression seals (Pier 1, Spans 1-2, looking east).

The compression seal expansion joints located at the Rear Abutment, Pier 1, and Pier 2 are in fair condition overall. The joint material is deteriorated with tears and portions missing (see Photo 4). The joint armor has surface corrosion over the entire length.

1. Replace the expansion joint material at Pier 1.

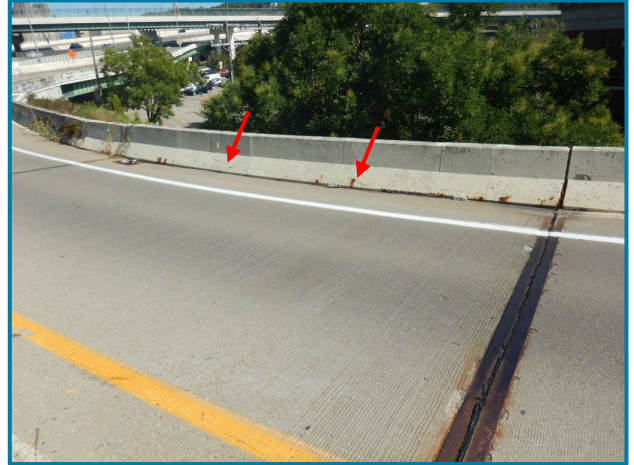
The reinforced concrete bridge railings run the full length of both sides of the ramp and are the New Jersey barrier style. The railing has locations of longitudinal cracking with rust staining along the lower portion (see Photo 5).

Photo 5 – Bridge railing with longitudinal cracking with rust stains (looking east).

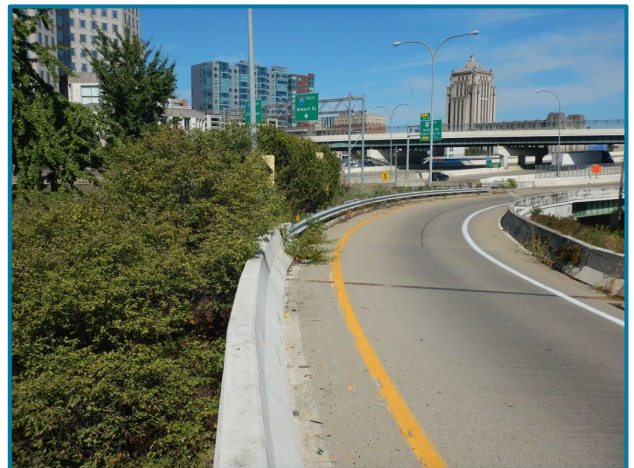
Photo 6 – Transition at the north end. Vegetation in the shoulder (North Approach, looking north).

The reinforced concrete approach slab is in good condition. There is vegetation growing in the shoulders (see Photo 6).

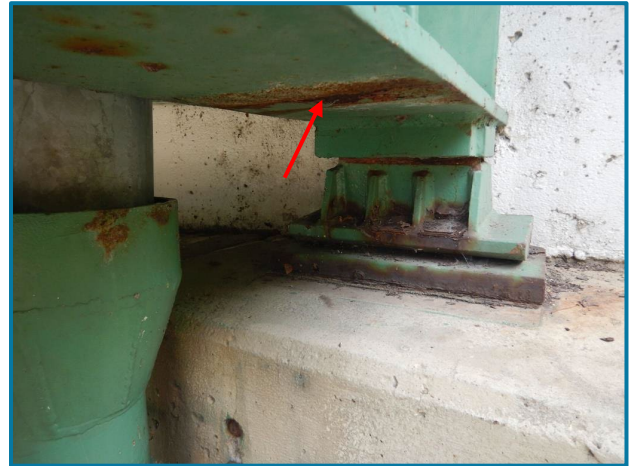
The steel built-up plate girders are in good condition. There are no significant deficiencies noted. There is surface corrosion to the underside of the bottom flanges at the ends near the Rear Abutment (see Photo 7).

Photo 7 – Surface corrosion to the girder bottom flange (Girder A, Span 1, looking north).

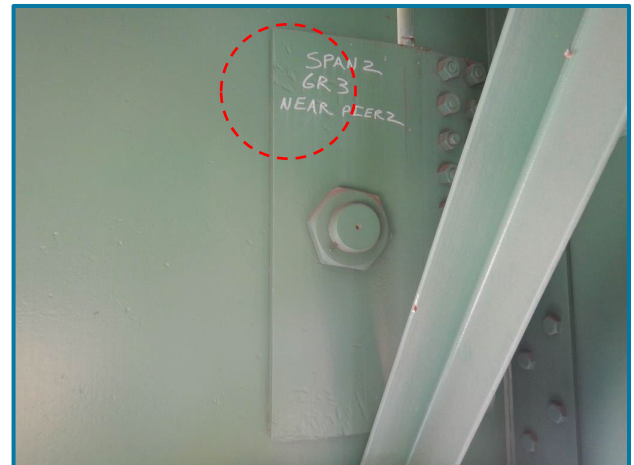
At Pier 1, there are hinges at all three girders made up of a pin with a plate on each side. The pins are in very good condition with no significant deficiencies noted. The plate on the interior face of Girder A has 1/32" gouges in it near the top (see Photo 8).

Photo 8 – Gouges in the plate at the hinge over Pier 1 (Pier 1, Girder A, looking east). The markings on the bridge as shown in the photo are incorrect.

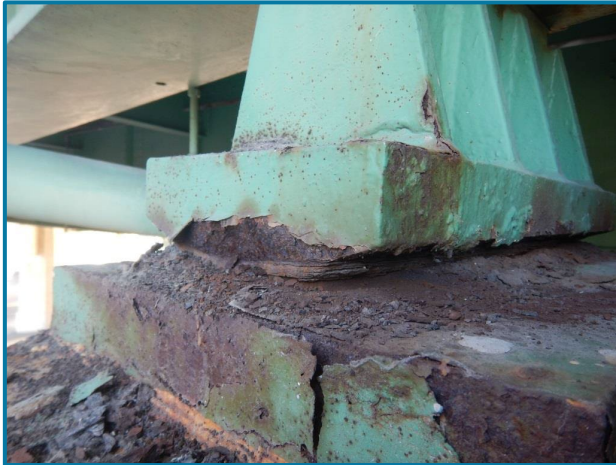
The rocker bearing devices are in satisfactory condition overall with up to 1/2" pack rust between the rocker and the masonry plate at Pier 2 (see Photo 9). The masonry plates at the rocker bearings have both surface corrosion and laminar corrosion. The rockers also have laminar corrosion on them at this location. Girder A is contacting the backwall at the Rear Abutment (see Photo 10).

Photo 9 – 1/2" pack rust between the rocker and the masonry plate (Girder A, Pier 2, Span 3, looking south).

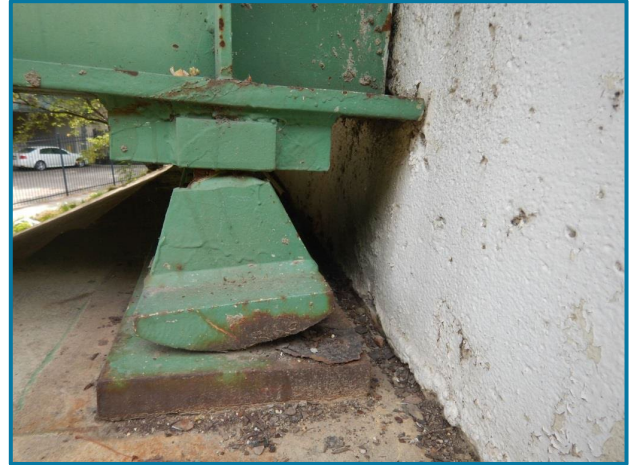
Photo 10 – Corrosion to the bearing and Girder A contacting the backwall (Girder A, Rear Abutment, 4, looking west).

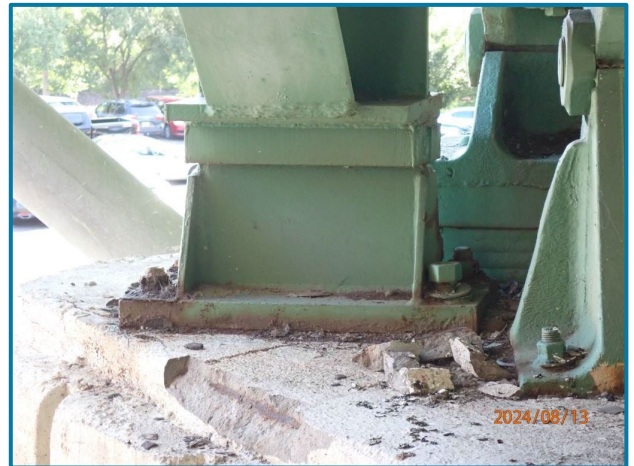
The fixed bearing devices are in satisfactory condition overall. The bearing at Pier 4 of HAM-50-2180N has a loose anchor bolt nut and two anchor nuts that have up to 30% section loss (see Photo 11). The masonry plate has minor laminar corrosion.

Photo 11 – Loose anchor nut and section loss (Girder A, Pier 4 (HAM-50-2180N), Span 3, looking east).

3. Monitor the corrosion and section loss.

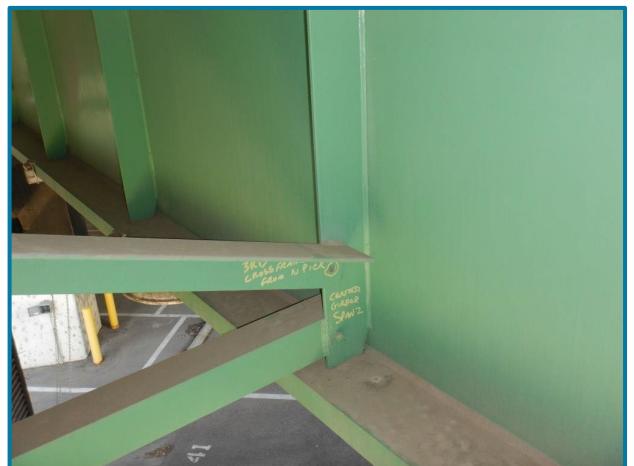
The crossframes are in good condition. In Span 2, the 3<sup>rd</sup> crossframe south of Pier 1 has insufficient weld length and there are no connection bolts at the top east connection and the bottom west connection between Girders A and B (see Photo 12).

Photo 12 – Insufficient weld length and missing connection (Girder A, Span 2, looking north).

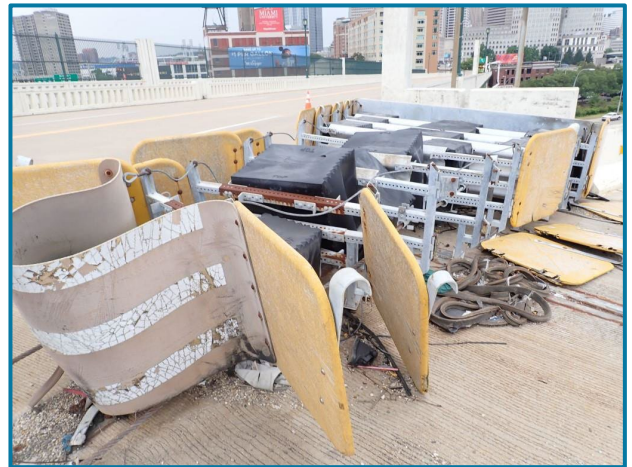
The approach guardrail is in poor condition due to the condition of the crash attenuator at the southwest corner. It has impact damage with loose panels, loose cables, and deployed cushions (see Photo 13). See the report for HAM-50-2080N for details on the crash attenuator. The guardrail near the Rear Abutment is a W-beam rail with no noted deficiencies.

Photo 13 – Impact damage to the crash attenuator at the exit (South Approach, looking west).

2. Replace the crash attenuator at the Sixth St. Downtown exit ramp.
