**PHYSICAL CONDITION REPORT
FOR THE 2022 ROUTINE ELEMENT LEVEL AND FRACTURE CRITICAL INSPECTION**

SR 7 OVER SYMMES CREEK

BR#: LAW-7-02.40

**Inspected: September 27 through September 29, 2022
Report: December 19, 2022**

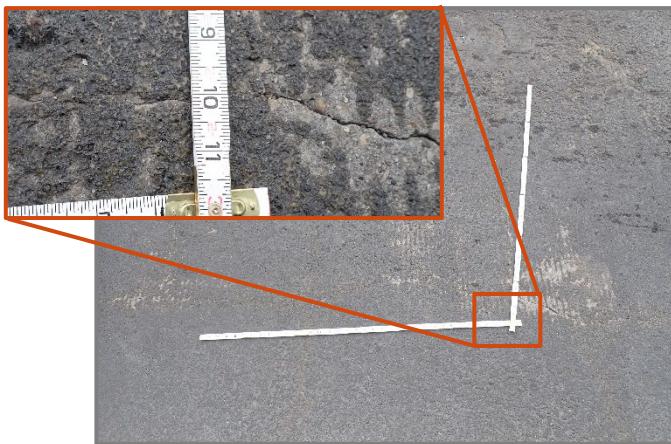
Photo 2 – Map cracking up to 1/32" wide spaced at 2' in top surface of the deck in the westbound lane in Span 1, looking south.

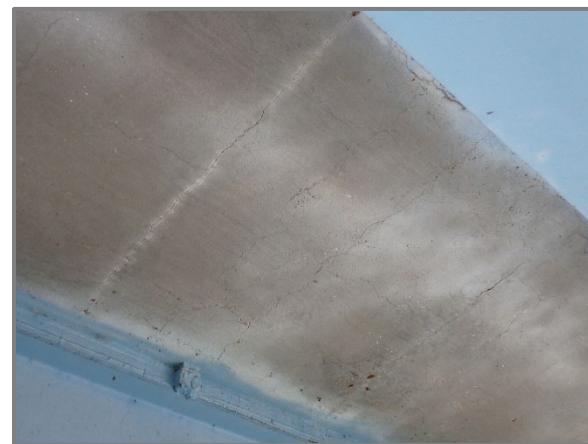
Photo 3 – Hairline to 1/32" wide map cracking spaced at 12" and transverse crack with minor efflorescence in the underside of deck between Stringers 3 and 4 in Bay 3 of Span 2, looking northeast.

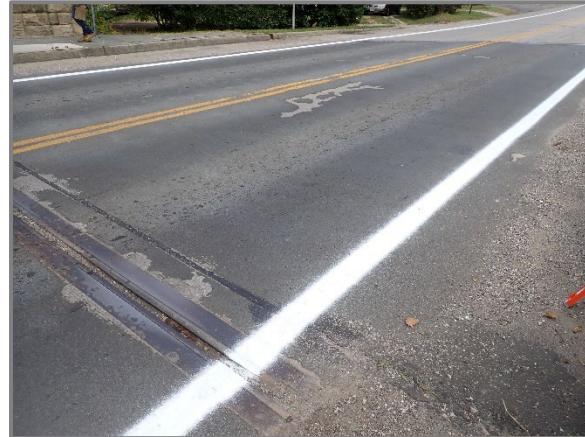
The 1/4" thick epoxy overlay on the concrete deck has moderate to heavy wear in the wheel lines. There are isolated locations throughout the bridge where the overlay is completely worn away exposing the concrete deck top surface. This condition is worst in the eastbound lane of Span 4 where there are large areas of completely worn wearing surface up to 6' long by 2' wide (See Photo 4).

Photo 4 – Up to 6' long by 2' wide area of completely worn wearing surface in the eastbound lane of Span 4, looking northeast.

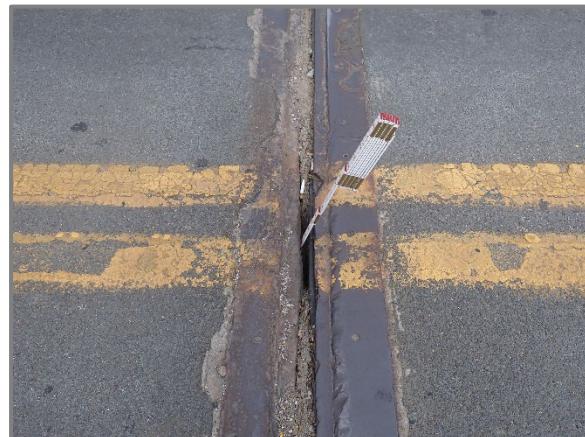
There is an approximately 1' long section of missing joint seal at the roadway centerline of the joint over Pier 2 and two areas up to 4" long of bulging/debonded joint seal in the eastbound lane over the Forward Abutment (See Photo 5).

Photo 5 – Expansion joint over Pier 2 with heavy debris accumulation, laminate corrosion, plow damage, and approximately 1' long section of missing joint seal at roadway centerline, looking north.

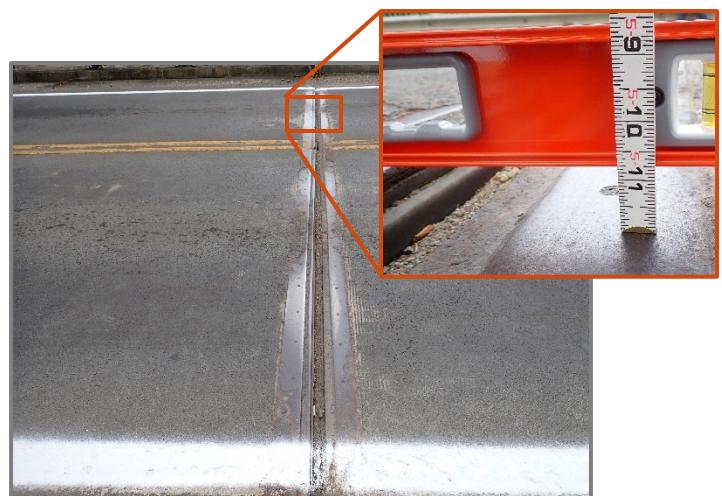
Photo 6 – Up to 1 1/4" vertical misalignment between joint sections on either side of the Pier 2 joint in the westbound lane, looking south. Note forward side of joint is higher.

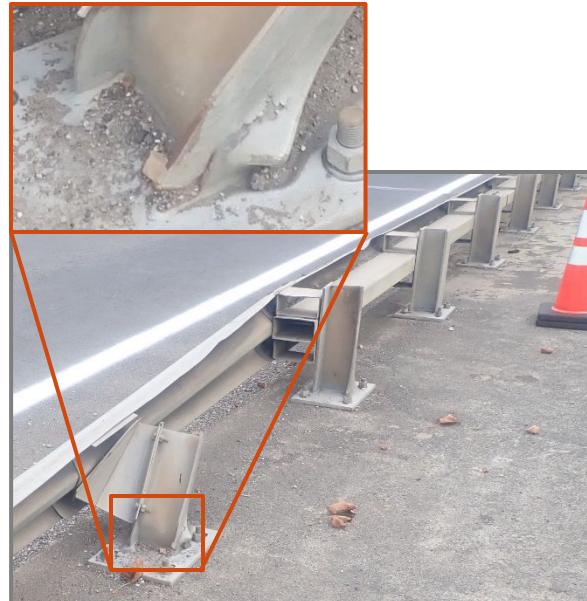
The roadway railing on the bridge consists of a post- and truss-mounted W-beam with steel tubular backup. At the rear end of the right bridge rail in Span 1, the first two posts have significant collision damage (**See Photo 7**). The first post has a 3" long tear in the weld between the southwest flange and base plate and is rotated to the east approximately 45°. The second post has a 3" long tear in the weld between the southwest flange and base plate and is slightly twisted. Additionally, at the forward end on the left rail, the first post is rotated to the west approximately 45° due to collision and the northwest flange is partially torn and the top blockout on the second post is partially torn. Minor dents and impact scrapes are present throughout both bridge rails.

Photo 7 – Collision damage to first two posts of the right bridge rail at the rear end in Span 1, looking northeast. Note posts with tears at bases and rotated/twisted.

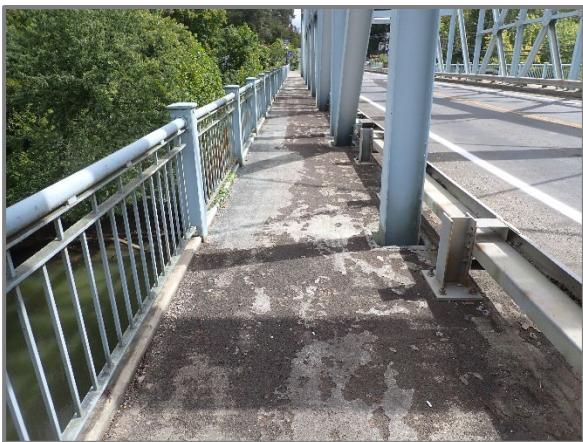
Photo 8 – Typical failing epoxy overlay on the left sidewalk in Span 2, looking east. Note areas of paint loss and minor corrosion on steel pedestrian railing.

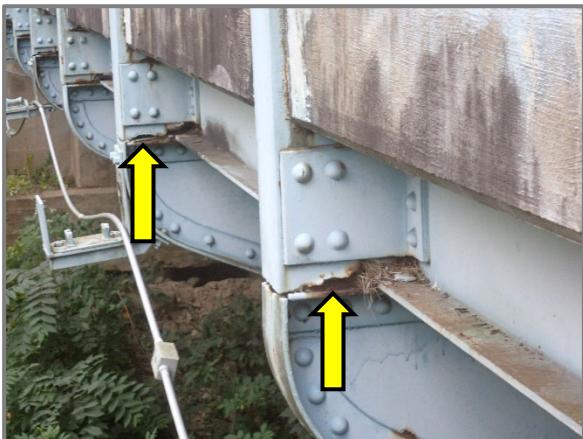
Photo 9 – Corrosion holes at the bases of the right pedestrian railing posts in Span 1, looking northwest.

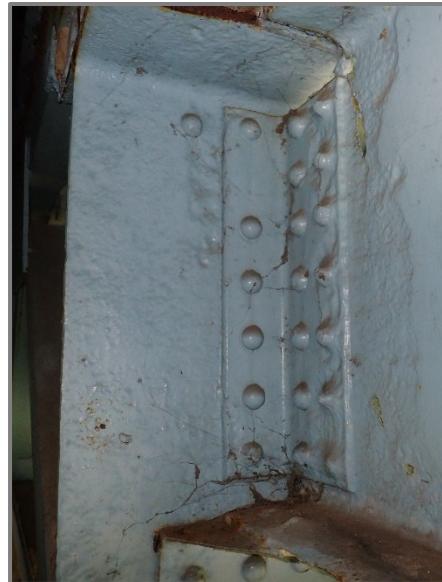
Photo 11 – End 12" of Beam 7 in Span 3 at Pier 2 with 1/8" deep cleaned and painted pitting to both faces of the web and 1/16" deep cleaned and painted pitting to top flange, looking north. Note advanced section loss and corrosion hole in adjacent diaphragm.

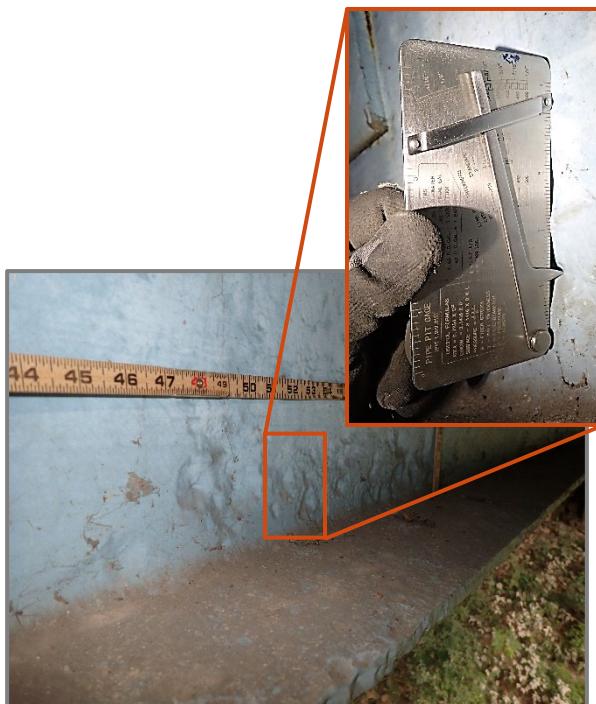
Photo 12 – Cleaned and painting pitting up to 1/4" deep on the bottom 5" of the south web of Beam 7 in Span 3 adjacent to Pier 2, looking northeast.

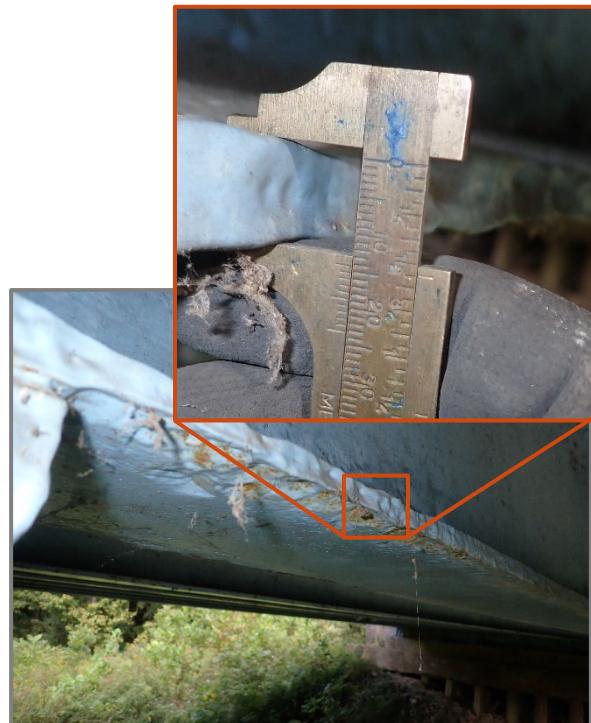
Photo 13 – Bottom flange of Beam 7 in Span 3 adjacent to Pier 2 with 1/2" remaining for 2" width on both edges, looking northeast.

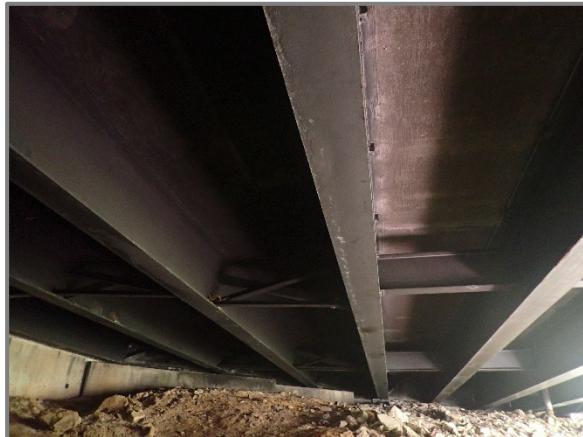
Beams 1 through 5 in Span 4 have extensive soot staining due to a fire event under the bridge since the previous inspection (See Photos 14 and 15). The remaining beams in Span 4 have light to moderate soot staining. No obvious signs of distress were noted in the beams and the paint system appeared to still be fully intact. The beam ends in Span 4 at Pier 3 have widespread active laminate corrosion with negligible section loss. There is a previously noted broken weld between the north face of the Beam 4 web in Span 4 and the crossframe bottom strut at the Forward Abutment (See Photo 15).

Photo 14 – Heavy soot staining on Beams 1 through 5 in Span 4 due to fire event, looking east.

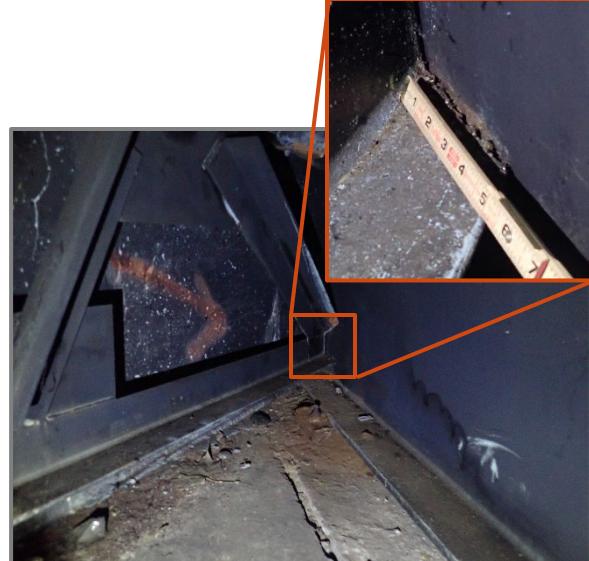
Photo 15 – Broken weld between the north face of the Beam 4 web in Span 4 and the crossframe bottom strut at the Forward Abutment, looking east. Note heavy soot staining on members.

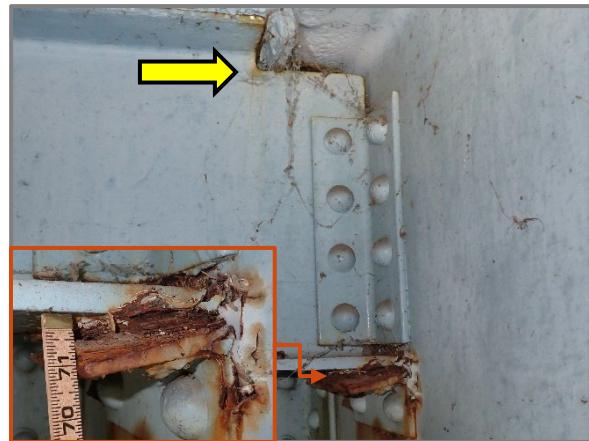
Photo 16 – Up to 1" thick pack rust between Stringer 1 bottom flange and seat angle at the connection to Floorbeam 9 in Span 2, looking north. Note cleaned and painted pitting up to 1/8" at stringer web cope and failing paint with minor surface corrosion on the stringer top flange.

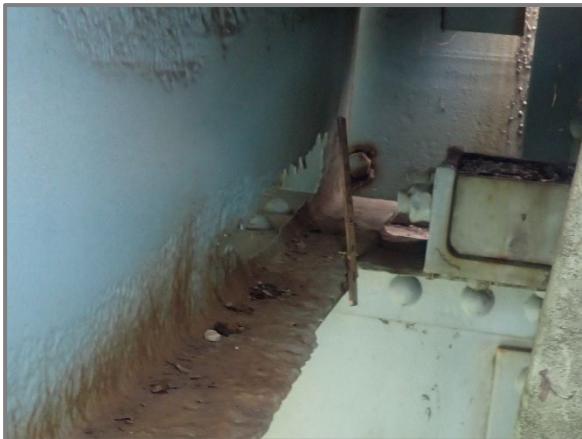
There are four sidewalk stringers each in Spans 1 through 3 consisting of Sidewalk Stringers 1 through 4. Sidewalk Stringers 1 and 4 in Span 2 typically have active advanced section loss at the ends at the connections to the floorbeam brackets with corrosion holes in the webs up to 9" long by 2" high in the web and up to 8" long by 2" wide in the outboard bottom flange (**See Photos 17 and 18**). The rivets connecting the sidewalk stringer bottom flanges to the sidewalk bracket top flanges regularly have over 80% loss to the rivet heads. Sidewalk Stringers 2 and 3 have corrosion holes in the webs up to 24" long by 4 1/2" high and knife edging of the bottom flange isolated to the beam ends at the connections to the end floorbeams (**See Photo 19**).

Photo 19 – Advanced section loss to Sidewalk Stringer 3 at Floorbeam 0 in Span 2 with 24" long by 4 1/2" high corrosion hole in web and knife edging to bottom flange, looking west.

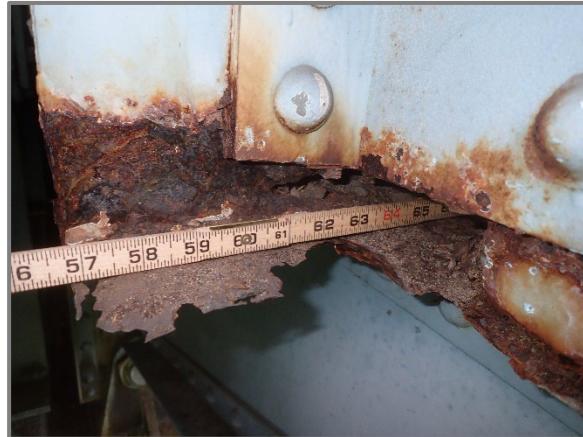
Photo 17 – Advanced section loss to Sidewalk Stringer 1 at Floorbeam 9 in Span 2 with 6" long by 2" wide corrosion hole in bottom flange and 10" long by 1" high corrosion hole in web, looking southeast.

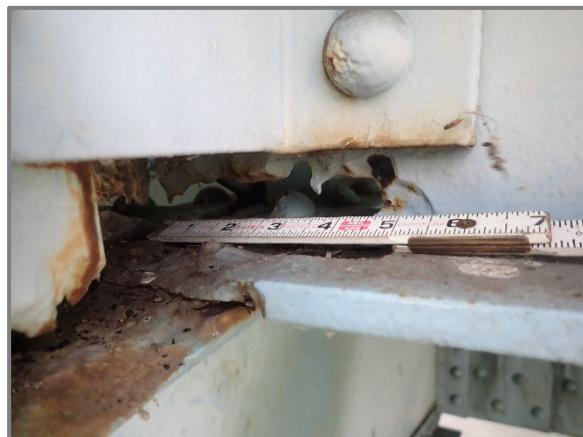
Photo 18 – Advanced section loss to Sidewalk Stringer 4 at Floorbeam 3 in Span 2 with 5" long by 1" high corrosion hole in the web and 80% loss to rivet head on bottom flange, looking north.

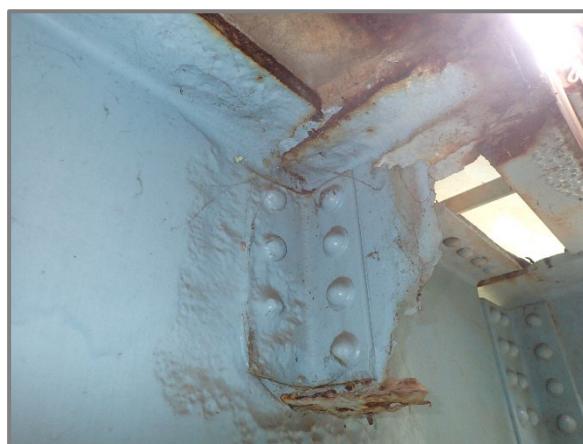
In Spans 1 and 3, Sidewalk Stringers 1 and 4 have similar advanced section loss at the beam ends over Piers 1 and 2 with up to 10" long by 1" high corrosion holes in the webs and up to 2" wide by 1" long corrosion holes in the bottom flanges. The Sidewalk Stringer 2 and 3 stub beam cantilevers at Piers 1 and 2 have advanced section loss and corrosion holes throughout (**See Photo 20**).

Photo 20 – Advanced section loss and corrosion holes throughout Sidewalk Stringer 3 stub cantilever in Span 3 at Pier 2, looking northeast.

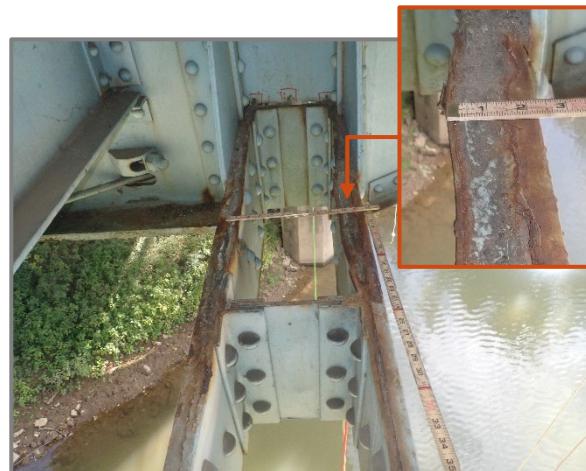
Photo 22 – Up to 1 1/8" thick pack rust between interior and exterior flange plates along top edge on L6-L7 of the Right Truss near L7, looking east.

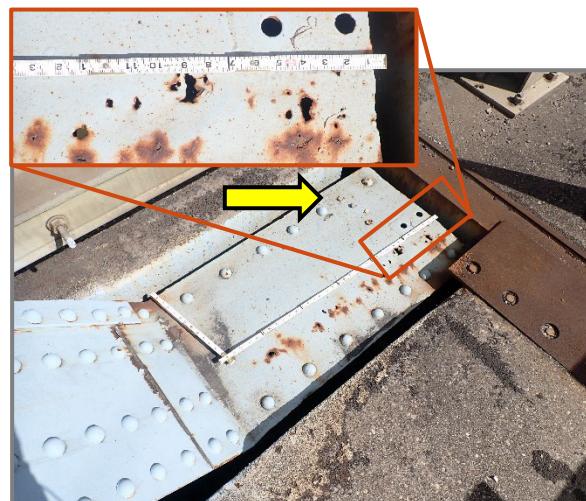
Photo 23 – U8-L9 end post horizontal plate at L9 of Right Truss with up to 2" diameter corrosion holes that are beginning to reactivate and a broken rivet head, looking northeast.

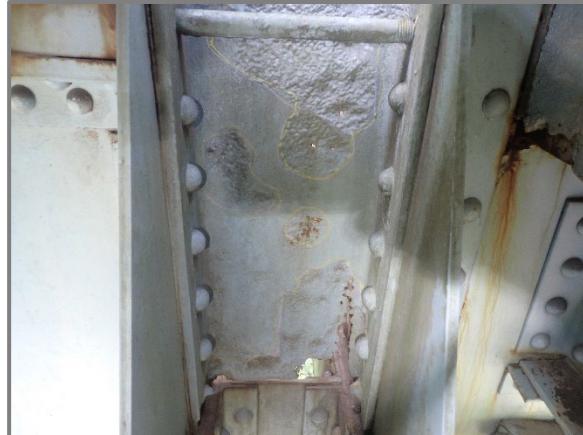
The truss verticals typically have moderate to advanced section loss within the bounds of the lower chord gusset plates. The worst case was noted at L2 on the Right Truss, where the L2-U2 vertical has 1/4" deep typical pitting with 5/8" deep pockets in the web that extends onto the flanges and isolated corrosion holes (**See Photo 24**). There is up to 1/4" deep cleaned and painted pitting to the vertical webs and flanges at the sidewalk interfaces and to the exterior of the inboard flange at previous guardrail connections (**See Photo 25**). Pack rust up to 1/2" thick was noted between the verticals and the thin fill plates at the lower chord gusset plates with up to 100% section loss to fill plates.

Photo 24 – Advanced section loss to L2-U2 web and flanges on the interior of L2 on Right Truss with isolated corrosion holes in web, looking west.

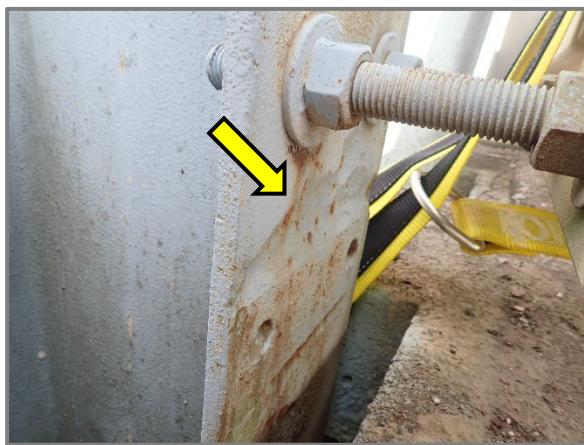
Photo 25 – Up to 1/4" deep pitting to the exterior of the inboard flange of L4-U4 on the Left Truss at previous guardrail connection, looking northeast.

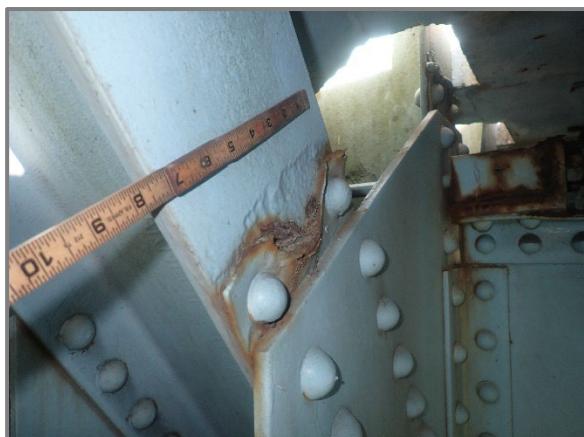
Photo 26 – Up to 3/16" deep pitting to the exterior of the inboard flange of U2-L3 on the Right Truss at the interface with the L3 gusset plate and 100% section loss to the thin fill plate, looking northeast.

At deck level, the truss diagonals have up to 7/32" deep cleaned and painted pitting at the interface where the members go through the deck. There is up to 3" high by full width by 3/16" deep pitting to the exterior of the flanges of the truss diagonals along the lower chord gusset plate interfaces (**See Photo 26**). Pack rust up to 1/4" thick was noted between the diagonals and lower chord gusset plates and up to 1/2" thick between the thin fill plates and diagonals at the lower chord gusset plates with up to 100% section loss to fill plates (**See Photo 26**).

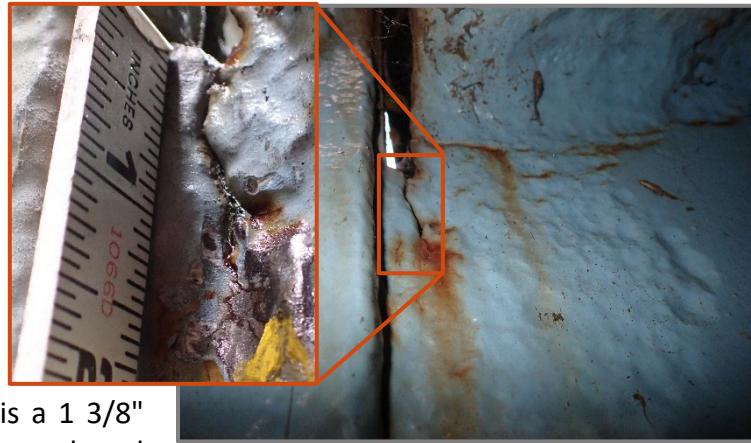
There are cracks emanating from the copes in the webs at both end floorbeams. The locations of cracks were ground with a handheld grinder to remove paint and then magnetic particle testing was performed to determine the crack lengths. At the Floorbeam 0 connection to the Left Truss, there is a 1 3/8" long horizontal crack on the top of the web and a 1 3/4" long vertical crack below with a 1/4" long overcut between them (See Photo 27). These cracks were previously noted to be "1 1/2" long maximum" in the prior inspection report; therefore, the lower diagonal crack has propagated 1/4" since the previous inspection. At Floorbeam 9, there are cracks at both truss connections. At the Floorbeam 9 connection to the Left Truss, there is a 1" long horizontal crack on the top of the web and a 1 3/8" long diagonal crack below with a 1/4" long overcut between them (See Photo 28). These cracks were previously noted to be "1 1/4" long maximum" in the prior inspection report; therefore, the lower diagonal crack has propagated 1/8" since the previous inspection. At the Floorbeam 9 connection to the Right Truss, there are three diagonal cracks in the web. The top and middle diagonal cracks are 1" and 1/4" long, respectively, and the bottom crack, which emanates from a 1/2" overcut in the web, is 5/8" long (See Photo 29). These cracks were previously noted to be "1 1/2" maximum" in the prior inspection report; the change in lengths can be attributed to the inclusion of the overcut in the crack length. Previously noted crack locations at other floorbeams were determined to be overcuts (Floorbeam 3 at the Right Truss) or paint cracks (Floorbeams 3 and 5). See Appendix D for additional photos of the crack locations. The copes on Floorbeams 1 through 8 are of poor quality due to insufficient cope radius and overcuts in the web up to 9/16" long.

Photo 27 – 1 3/4" long vertical crack in the web cope of Floorbeam 0 in Span 2 at Left Truss with 1/4" propagation since previous inspection, looking east.

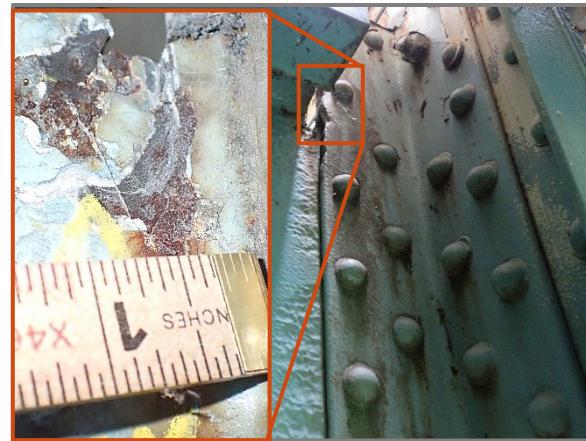
Photo 28 – 1 3/8" long diagonal crack in the web cope of Floorbeam 9 in Span 2 at Left Truss with 1/8" propagation since previous inspection, looking west.

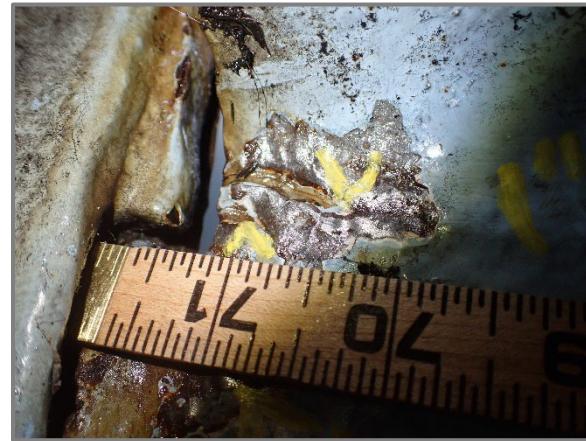
Photo 29 – 1" long and 1/4" long cracks in the web cope of Floorbeam 9 in Span 2 at Right Truss, looking west.

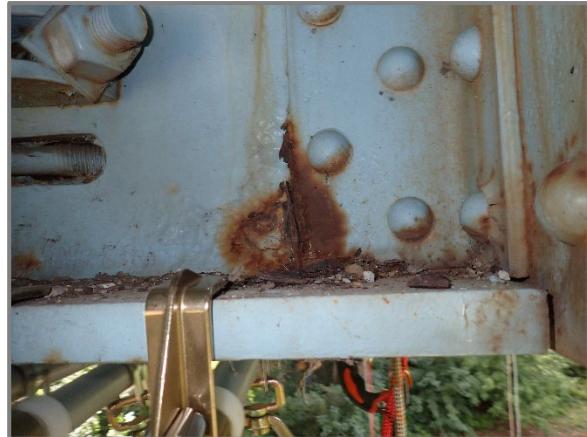
Photo 30 – Up to 3/16" deep pitting over 5" high by 3" wide area of the Floorbeam 4 in Span 2 forward web along bottom flange at the Left Truss that is beginning to reactivate, looking west.

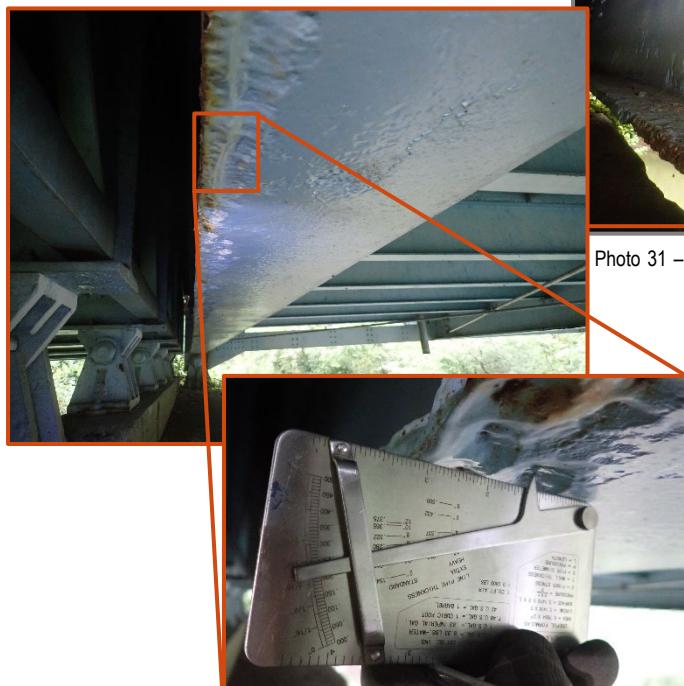
Photo 31 – Up to 1/4" deep pitting over 12' long by 6" high area on Floorbeam 0 in Span 2 rear web near Right Truss with up to 1/4" deep pitting over 2" width on the flange underside, looking northeast.

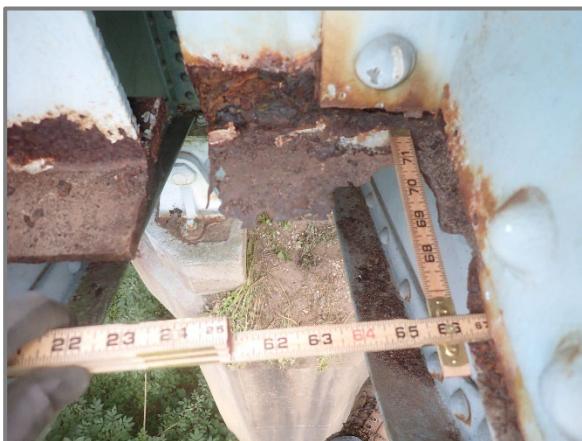
The floorbeam cantilevers that are outboard of the truss lines in Span 2 supporting the sidewalk stringers have advanced section loss to the top flanges at the sidewalk stringer connections with typical 1/8" deep pitting for the full flange width and isolated knife edging and corrosion holes up to 1" wide by 4" long (See Photo 32). The top flange tie rods have advanced section loss at isolated locations of heavy debris accumulation, with the worst location noted on the Floorbeam 8 cantilever at the Left Truss where the west tension bolt has up to 95% section loss to the diameter (the east bolt has minimal loss) (See Photo 33).

Photo 32 – Advanced section loss to Floorbeam 9 north sidewalk cantilever in Span 2 with 4" long by 1" wide corrosion hole in forward bottom flange, looking south.

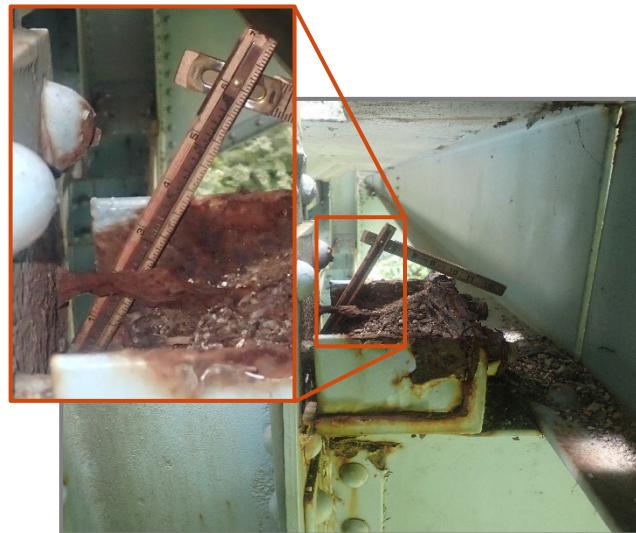
Photo 33 – Up to 95% section loss to the west tie bolt on the Floorbeam 8 cantilever connection to the Left Truss, looking west. Note heavy debris accumulation on top flange of cantilever.

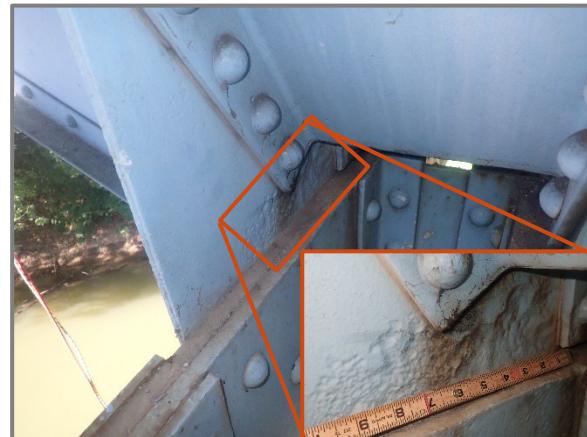
The lower gusset plates in Span 2 have pitting up to 3/16" deep (1/16" to 1/8" deep typical) on the interior faces along the interfaces with the lower chord and web members (See Photo 34), with isolated locations on the exterior of the plates. The pitting is typically cleaned and painted; however, it is reactivating on the exteriors of the outboard plates at the sidewalk cantilevers. Additionally, there is paint failure with minor active corrosion along the edges of the gusset plates and along the interfaces with the truss members. Pack rust up to 1/4" thick was noted between the lower gusset plates and truss members at isolated locations causing minor bows to the plate free edges.

Photo 34 – Cleaned and painted pitting up to 3/16" deep over 10" long by 4" high area on interior of L5 outboard gusset plate along L5-L6 on the Right Truss, looking southwest.

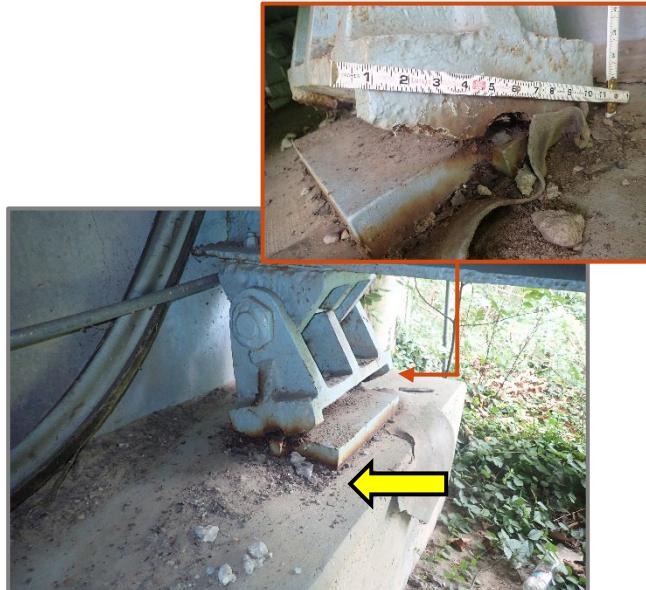
Photo 35 – Excessive expansion tilt of rocker bearing of Beam 1 in Span 1 at Rear Abutment, looking northwest. Note displaced lead sheet between masonry plate and cap.

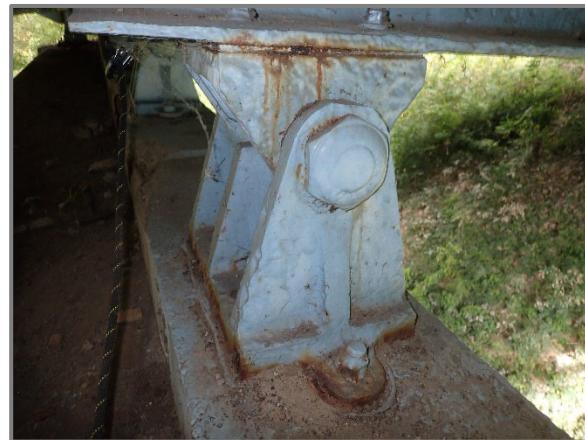
Photo 36 – Freckled pitting up to 1/8" deep throughout the fixed bearing of Beam 7 in Span 3 at Pier 2, looking northeast. Note active corrosion at the base of the casting.

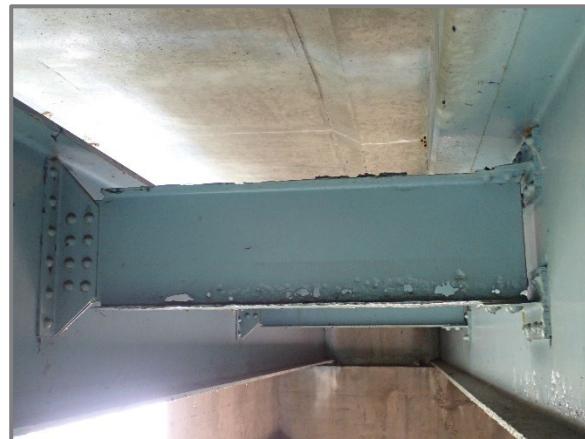
Photo 37 – Advanced section loss and corrosion holes in the diaphragm between Beams 7 and 8 in Span 4 near midspan, looking west.

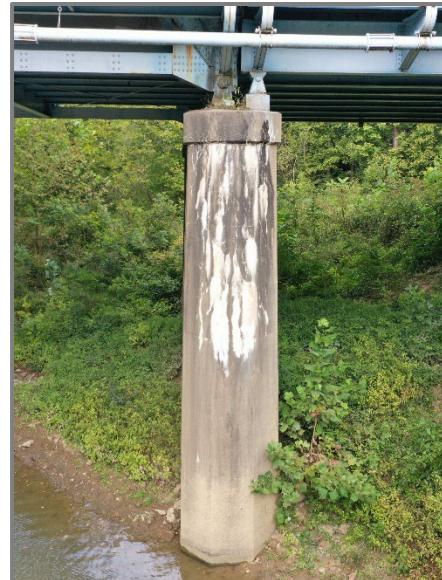
Photo 38 – Hairline cracks with heavy efflorescence on the south face of the south column of Pier 2, looking north.

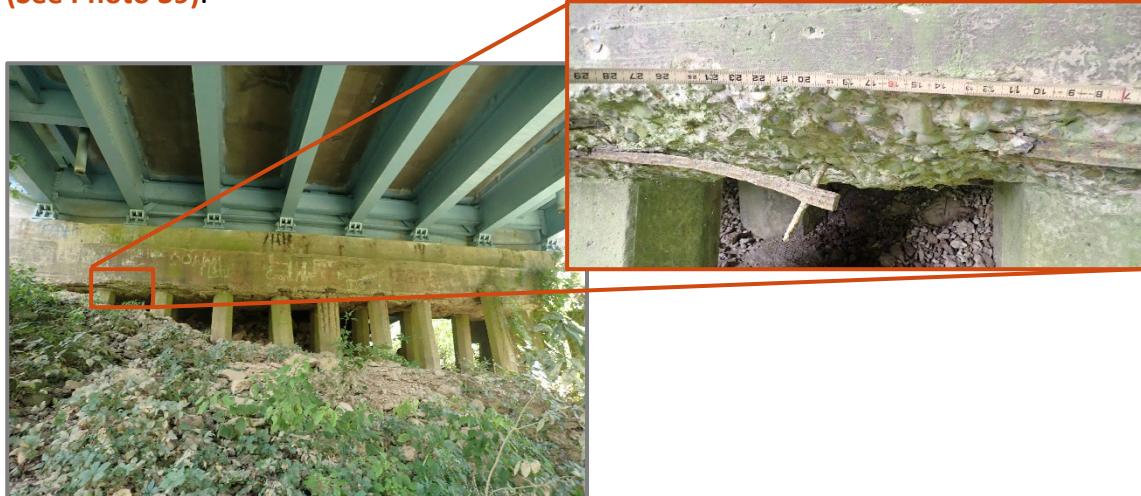
Photo 39 – Pier 3 pile cap with exposed reinforcement on the bottom rear edge due to shallow spalls and lack of cover, looking east. Note broken bar near north end of pile cap.

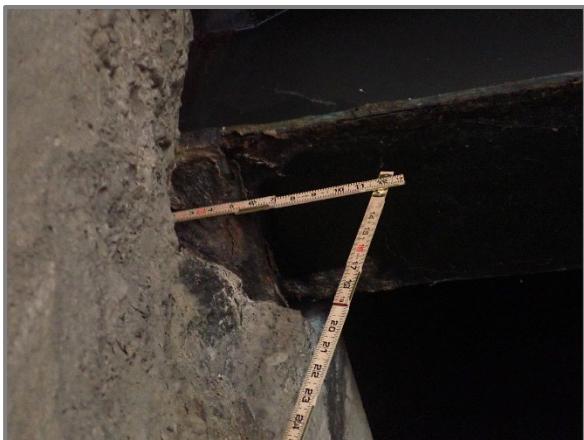
Photo 40 – Spall 15" high by 24" wide by 6 1/2" deep in the forward beam seat below Beam 4 in Span 4 that has undermined the bearing up to 5 1/2", looking northwest.

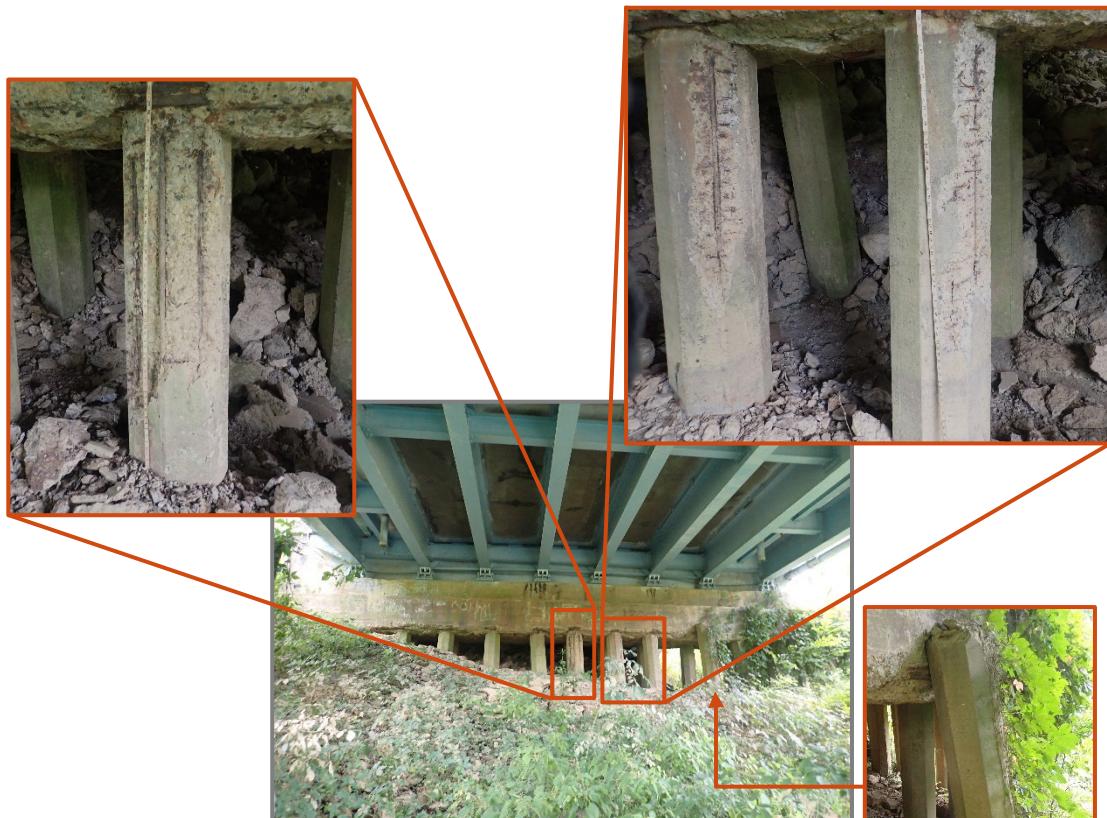
Photo 41 – Pier 3 with one pile with a full height by full width by 2" deep spall with exposed reinforcing on the west face, two piles have full height by 12" wide by 2" deep spalls with exposed reinforcing on the west faces, and one incorrectly constructed pile, looking east.

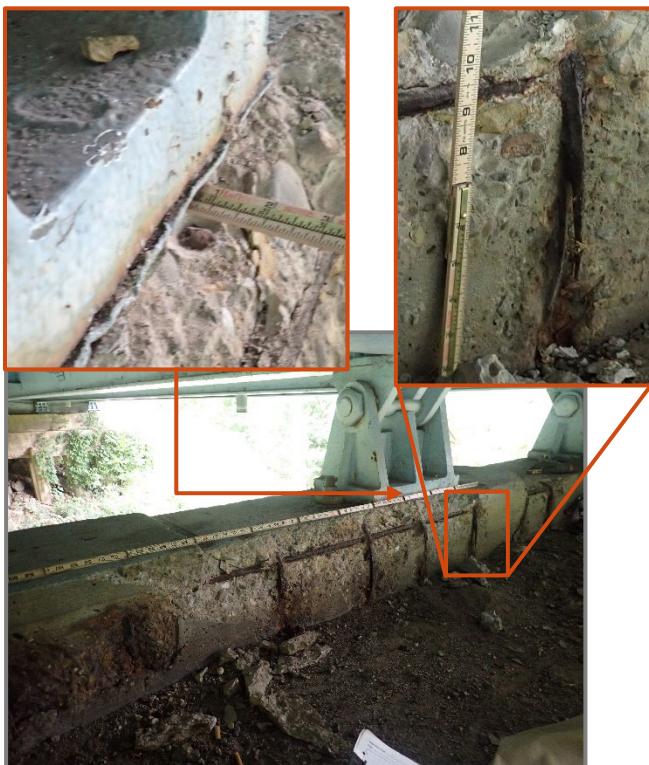
Photo 42 – Spall 68" long by 12" high by 3 3/4" deep with exposed reinforcement and one broken vertical bar between Beams 5 and 6 in Span 2 in Pier 2 beam seat, looking southeast. Note spall undermines Beam 6 bearing up to 3/4".

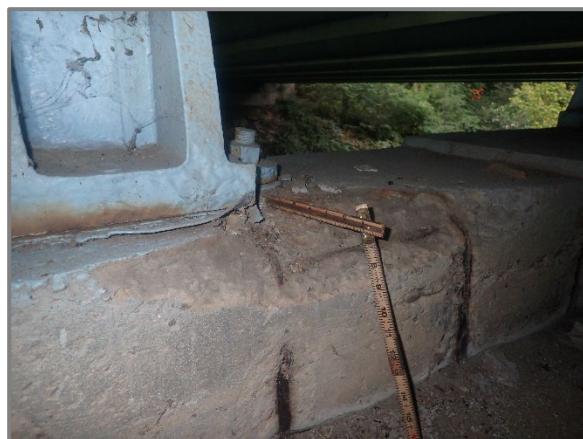
Photo 43 – Corner spall 24" wide by 3" high by 7" deep between Beams 7 and 8 on the forward face of the beam seat of the Pier 1 cap that undermines the Beam 7 bearing up to 1", looking northwest.

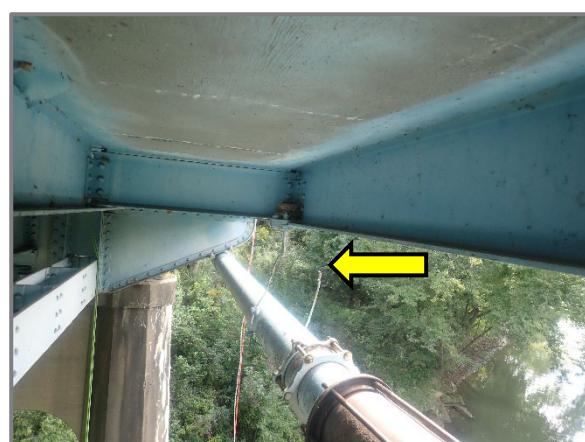
Photo 46 – Broken wire hanger for water main between Panel Points 7 and 8 on the right side of the truss, looking east.

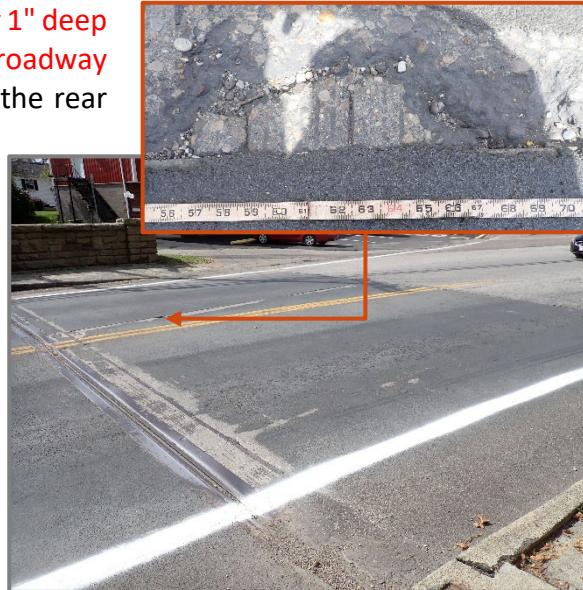
Photo 47 – Spall 17" long by 4" wide by 1" deep in the eastbound lane of the rear approach slab, looking southwest. Note moderate to heavy wear of epoxy overlay and areas where overlay is completely worn away.

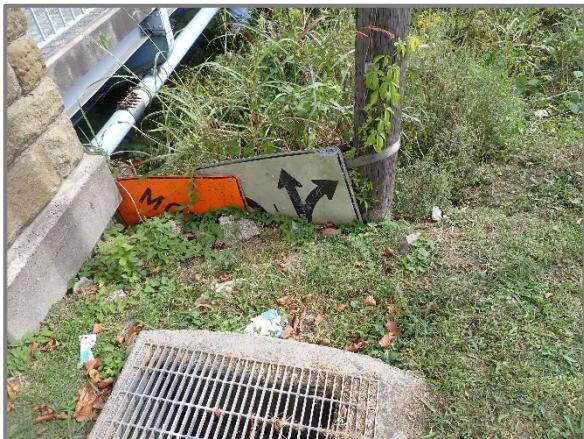
Photo 48 – Makeshift retaining wall consisting of roadway signs and ratchet straps at the southwest corner of bridge, looking east.

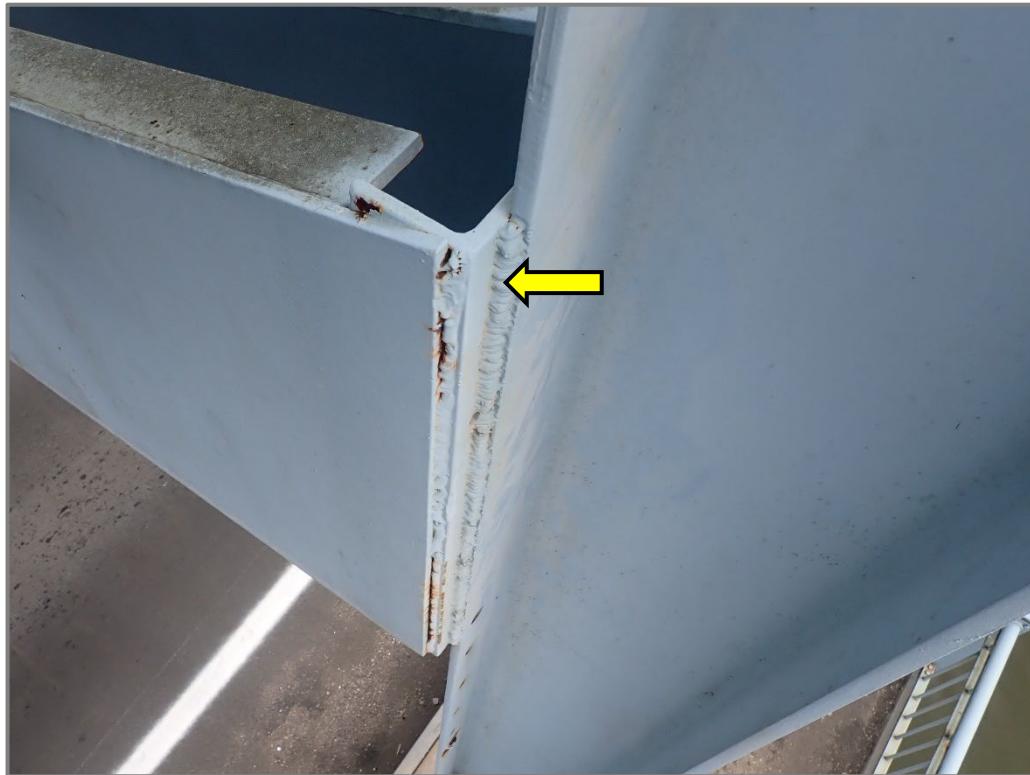
Photo 1 – Sway bracing connection angle attached by fillet welds with no transition radius (Category E). U6-L6 of the Right Truss is shown (looking northeast).

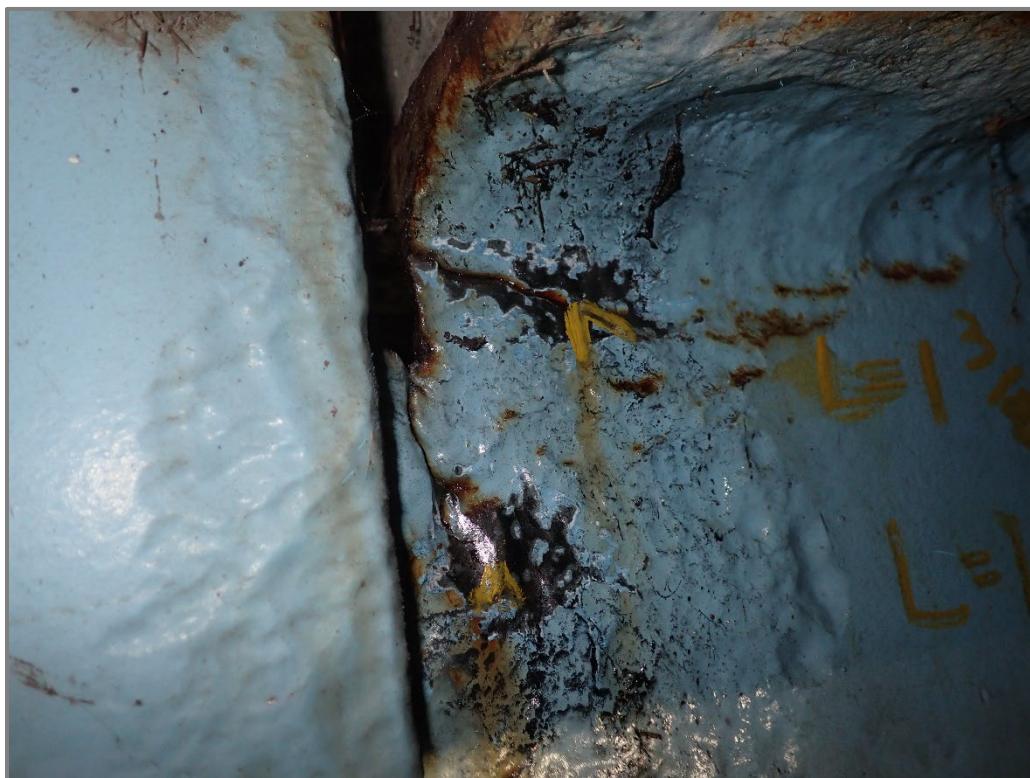
Photo 2 – Cracking in the web of a floorbeam at the upper cope (looking east at Floorbeam 0 in Span 2 adjacent to the Left Truss).

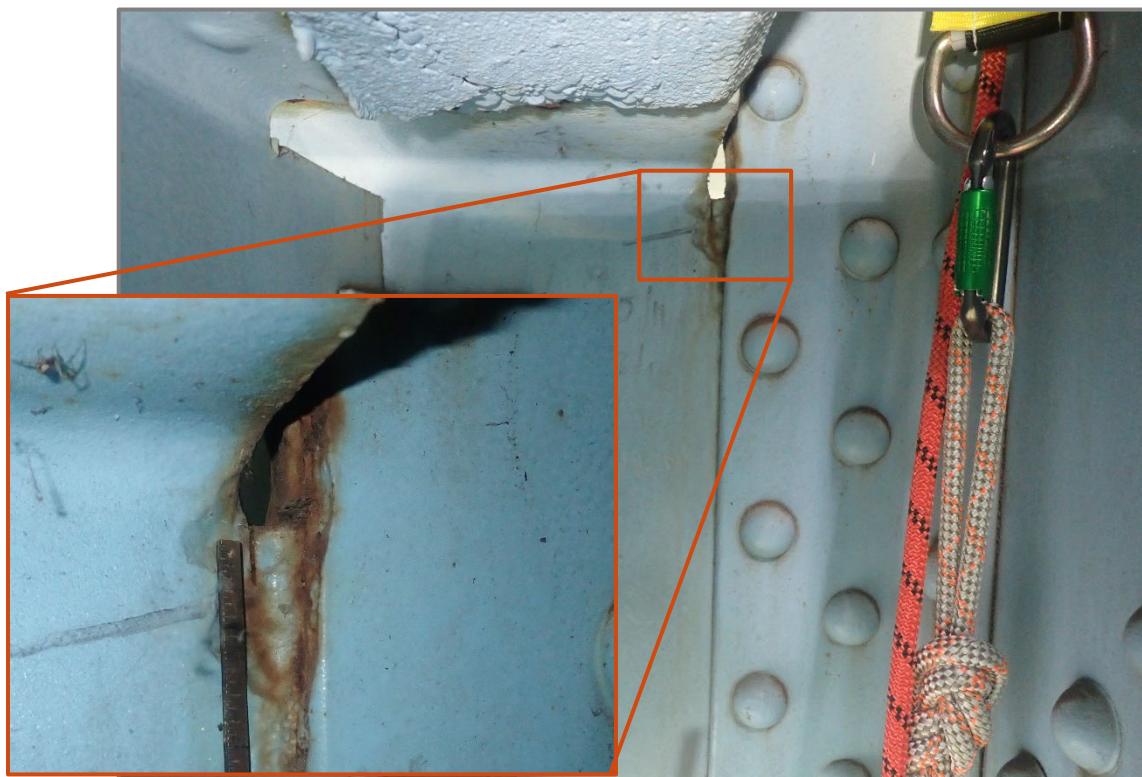
Photo 3 – Overcut in a floorbeam web at the upper cope at the connection to the truss
(looking east at Floorbeam 3 adjacent to the Right Truss).

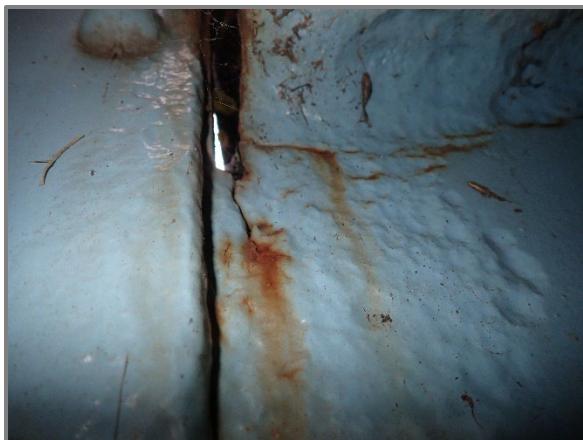
Photo D1 – Floorbeam 0 in Span 2 cracks in the rear top web cope at the Left Truss prior to grinding.

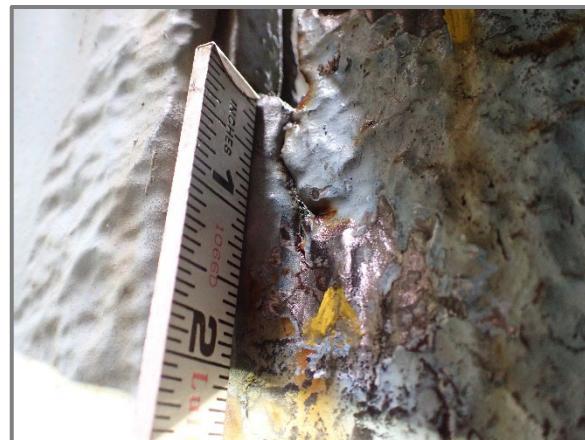
Photo D2 – Floorbeam 0 in Span 2 bottom 1 3/4" long crack in the rear top web cope at the Left Truss after grinding and magnetic particle testing. Note crack has propagated 1/4" since previous inspection.

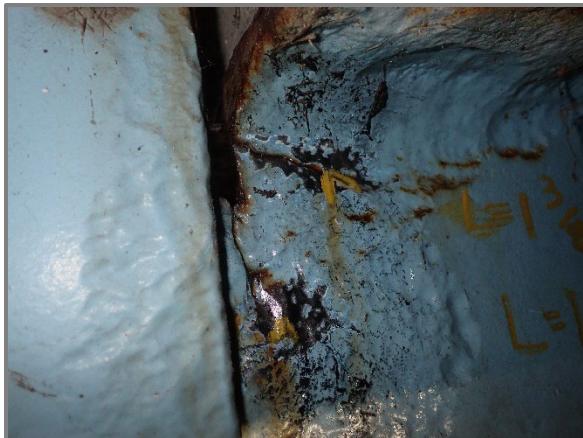
Photo D3 – Floorbeam 0 in Span 2 top 1 3/8" long crack in the rear top web cope at the Left Truss after grinding and magnetic particle testing.

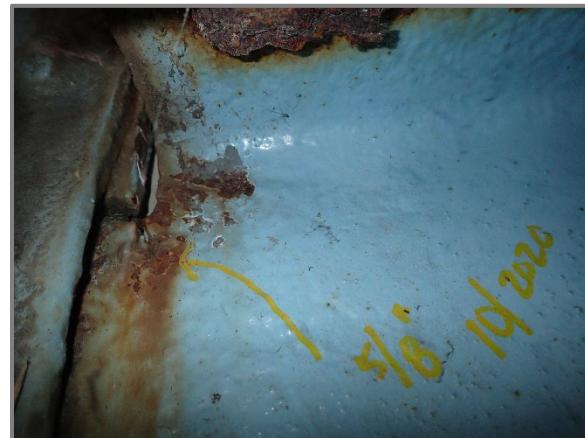
Photo D4 – Floorbeam 9 in Span 2 cracks in the forward top web cope at the Right Truss prior to grinding.

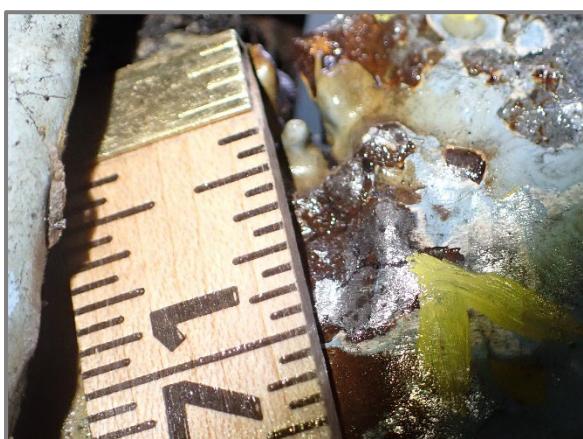
Photo D5 – Floorbeam 9 in Span 2 bottom 5/8" long crack in the forward top web cope at the Right Truss after grinding and magnetic particle testing.

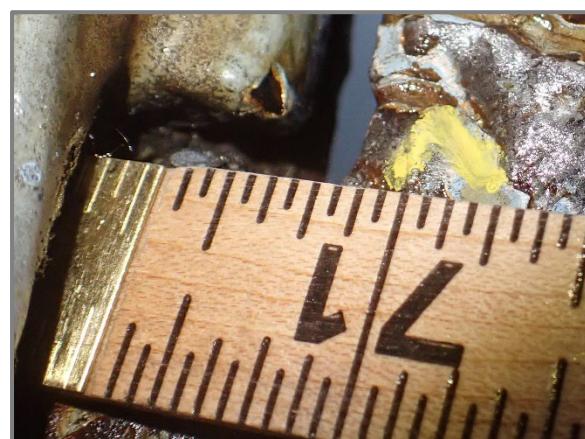
Photo D6 – Floorbeam 9 in Span 2 middle 1/4" long crack in the forward top web cope at the Right Truss after grinding and magnetic particle testing.

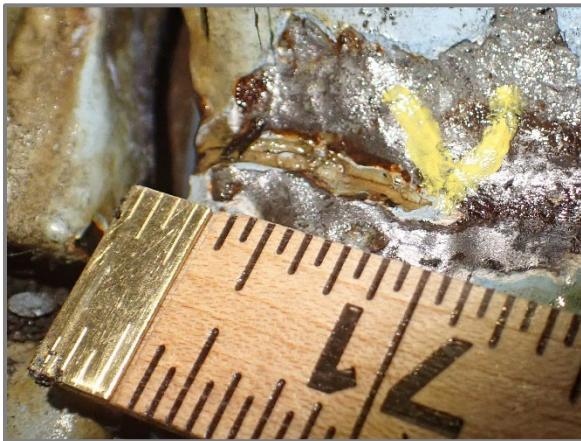
Photo D7 – Floorbeam 9 in Span 2 top 1" long crack in the rear top web cope at the Left Truss after grinding and magnetic particle testing.

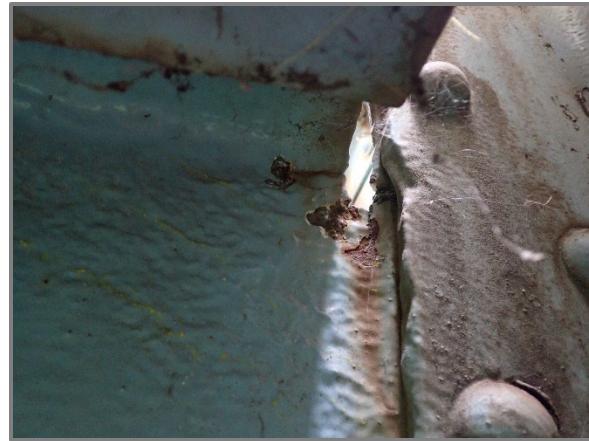
Photo D8 – Floorbeam 9 in Span 2 cracks in forward top web cope at the Left Truss prior to grinding.
