**PHYSICAL CONDITION REPORT
FOR THE 2022 ROUTINE ELEMENT LEVEL AND FRACTURE CRITICAL INSPECTION**

SR 7 OVER SYMMES CREEK

BR#: LAW-7-02.40

**Inspected: September 27 through September 29, 2022
Report: December 19, 2022**

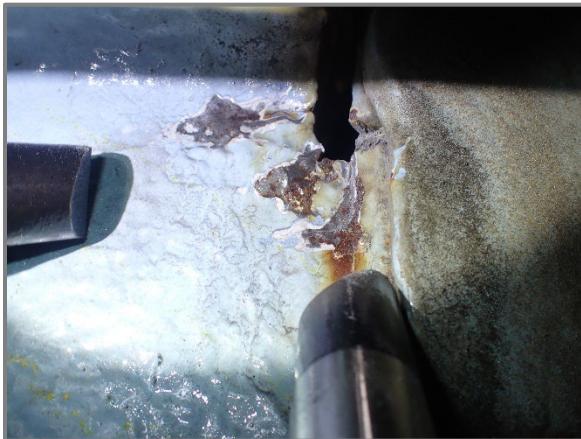
Photo D9 – Floorbeam 9 in Span 2 cracks in the forward top web cope at the Left Truss after griding and magnetic particle testing.

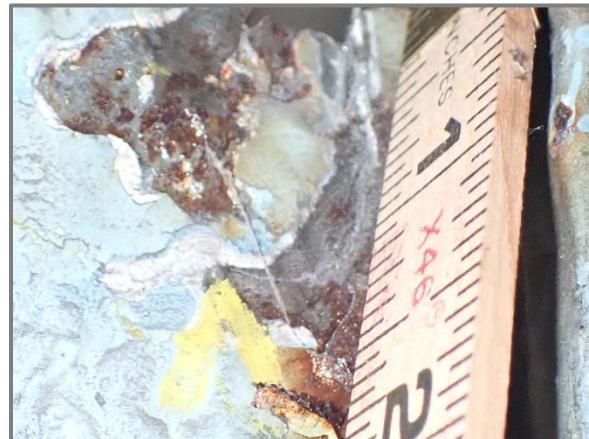
Photo D10 – Floorbeam 9 in Span 2 bottom 1 3/8" long crack in the rear top web cope at the Left Truss after grinding and magnetic particle testing. Note crack has propagated 3/8" since previous inspection.

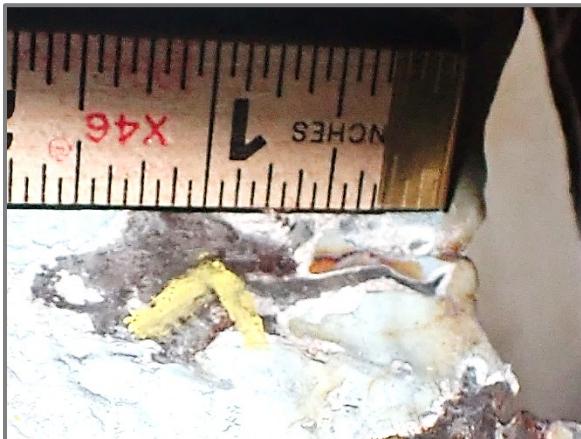
Photo D11 – Floorbeam 9 in Span 2 top 1" long crack in the rear top web cope at the Left Truss after grinding and magnetic particle testing.
