Structure Number: 0700312

Facility Carried: SR 7

Ohio Bridge Inspection Summary Report

BEL-00007-1187 (0700312)

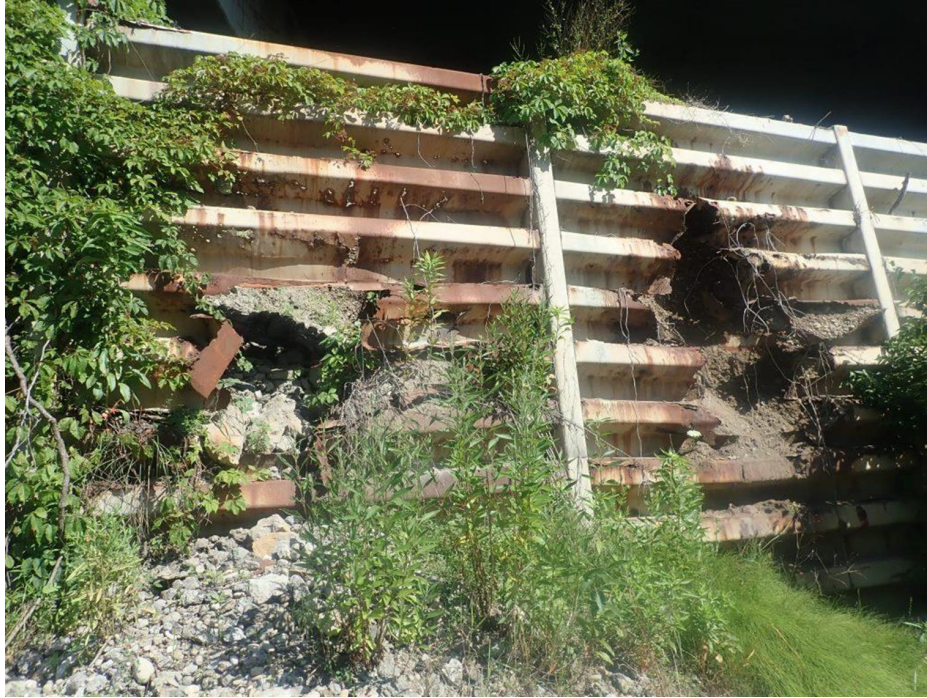
PHOTO 2

Advanced corrosion with up to 7' diameter corrosion holes in the rear right retaining wall has resulted in a large void (10' L x 6' W x 8' D) in the backfill with backfill material ~8' high beginning to encroach on the railroad tracks.

Description Advanced corrosion with 7' diameter corrosion holes in the right rear retaining wall (looking west)

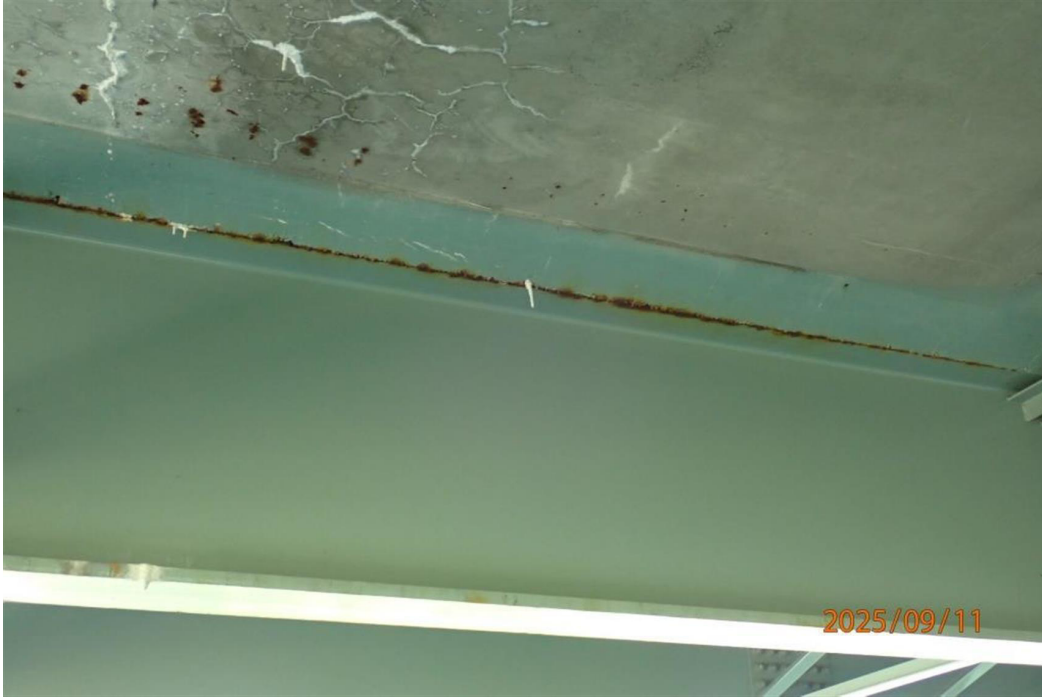
PHOTO 3

515-Steel Protective Coating		54375	sq. ft.	54037	0	338	0
	CS3: - Failing protective coating with minor surface corrosion at the beam top flanges (338 SF).						
205-Reinforced Concrete Column	3 - Mod.	4	each	3	1	0	0
	CS2: - Pier 5, Column 1 has a 1' W x 5' H x 1/2" D area of shallow spalls (1 EA).						
210-Reinforced Concrete Pier Wall	3 - Mod.	104	ft.	104	0	0	0
215-Reinforced Concrete Abutment	3 - Mod.	150	ft.	102	48	0	0
	CS2: - Medium width vertical cracks throughout both abutments. Minor saturation and rust staining are present with light efflorescence (48 LF total).						
231-Steel Pier Cap	3 - Mod.	375	ft.	354	18	3	0

Description Failing protective coating with surface corrosion at the beam top flanges, Span 7 shown (looking west)

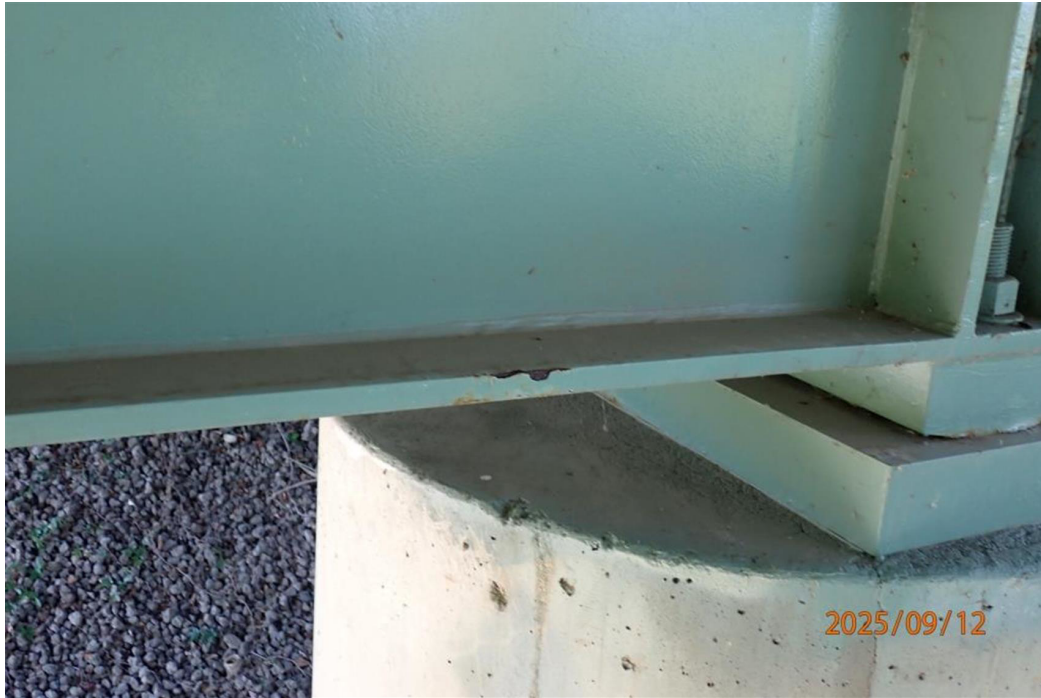
PHOTO 5

Description 1' of surface corrosion on the north bottom flange of Pier 2, just east of Column 1 (looking south)

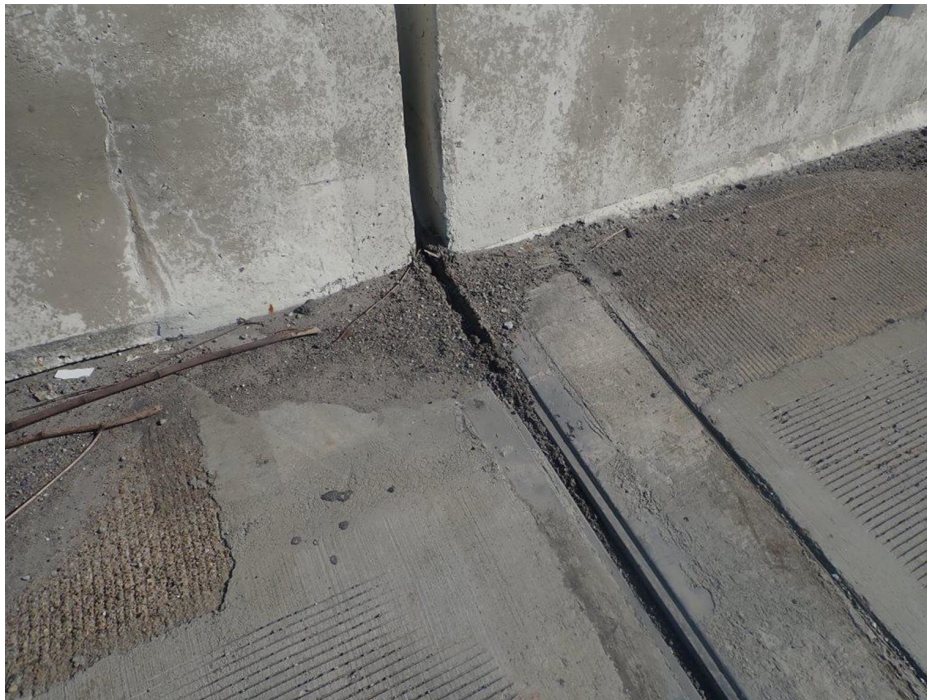
PHOTO 6

Description Moderate buildup of loose dirt and gravel at the Forward Abutment joint, left side of the southbound lanes (looking northwest)

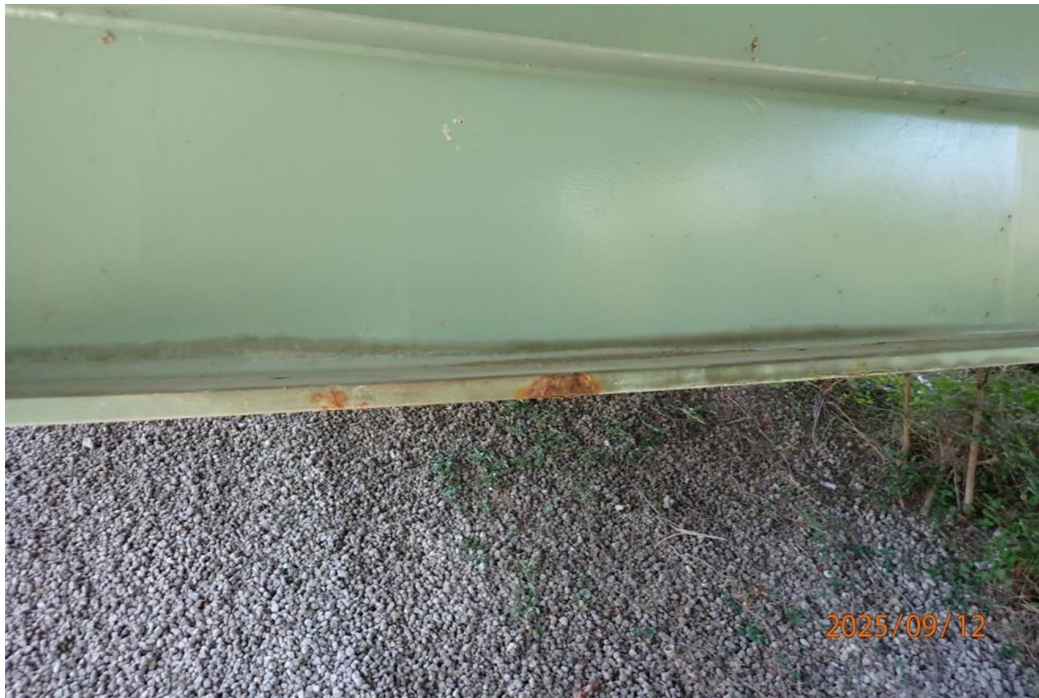
PHOTO 6

Description 1' of surface corrosion with 5' of staining on the north bottom flange of Pier 2 at midspan (looking south)

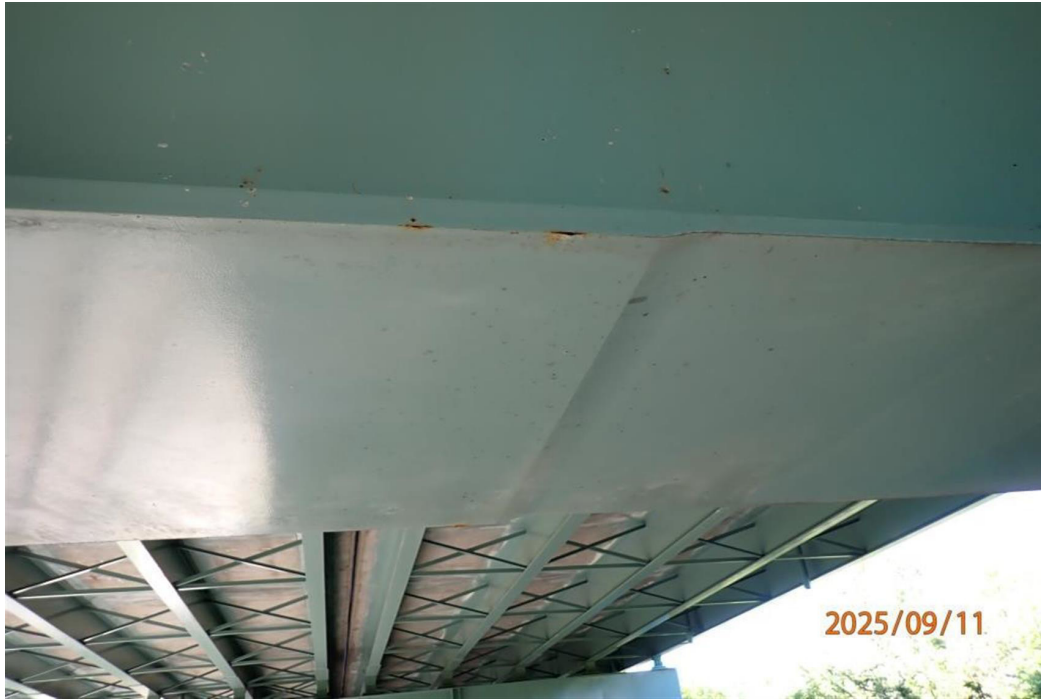
PHOTO 8

Description 1' of surface corrosion to the bottom flange of Pier 3 where the flange thickness changes from the west (looking south)

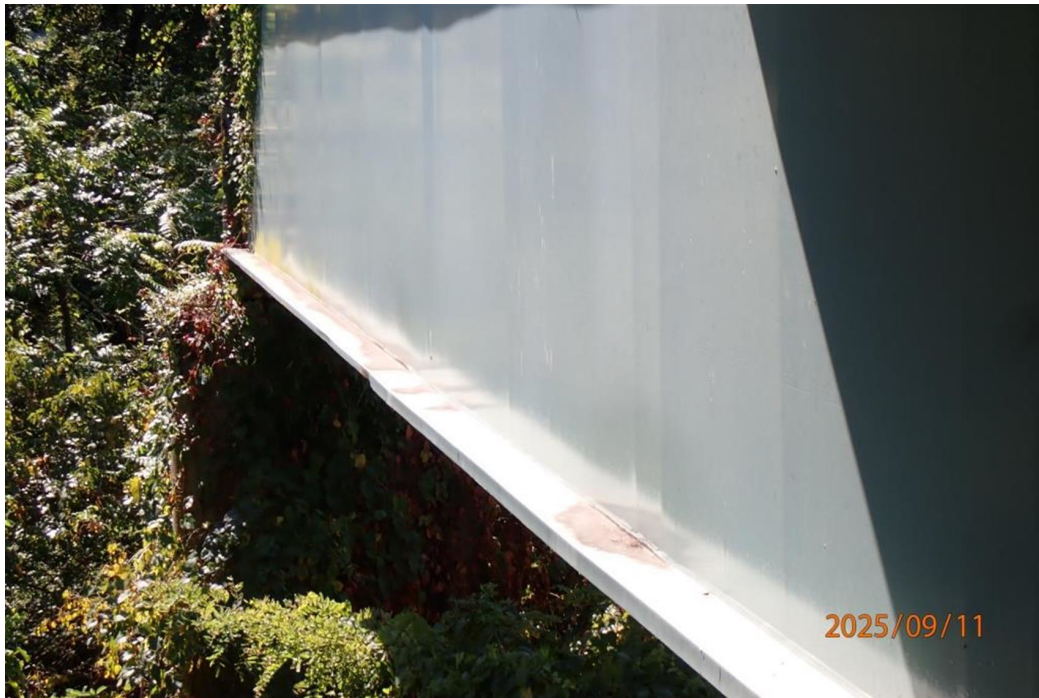
PHOTO 9

Description Staining on the north bottom flange of Pier 3 over 25' at the east end (looking east)

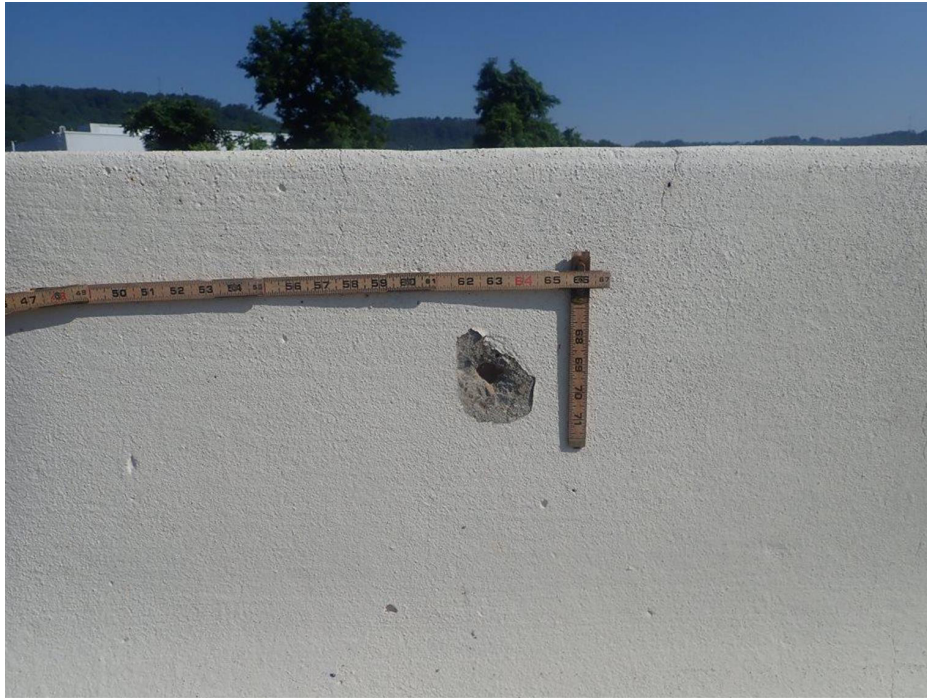
PHOTO 11

Description Popout spall in the left railing at the rear end of Span 6, southbound lanes (looking west)

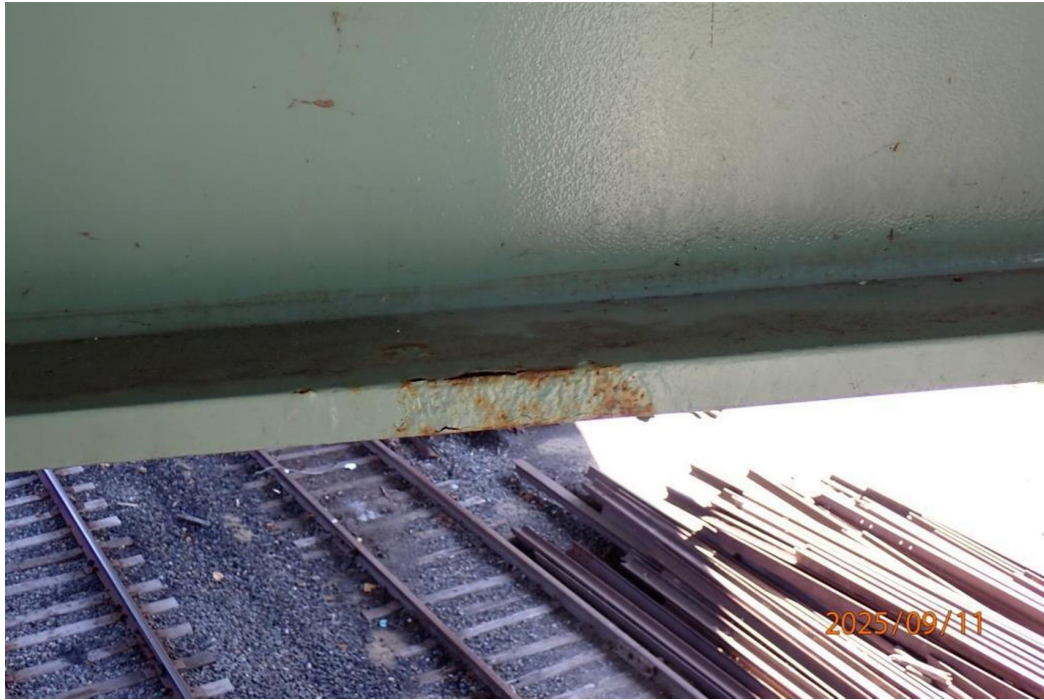
PHOTO 12

Description 1' of surface corrosion to the south bottom flange of Pier 3 at 4' west of where the flange thickness changes (looking north)

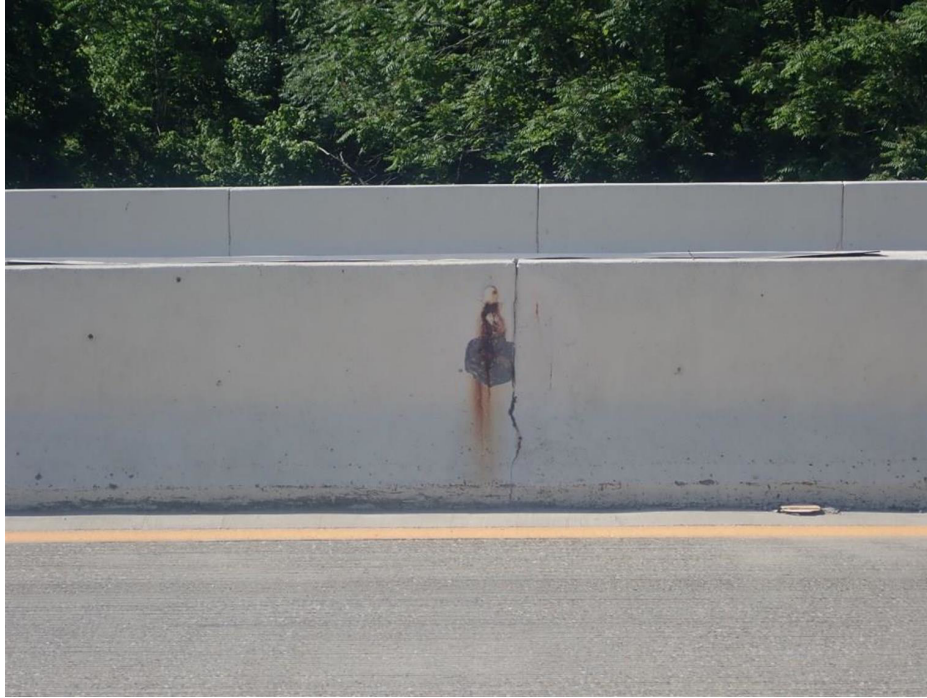
PHOTO 13

Description Spall in the bridge median at Pier 2, southbound lanes (looking east)

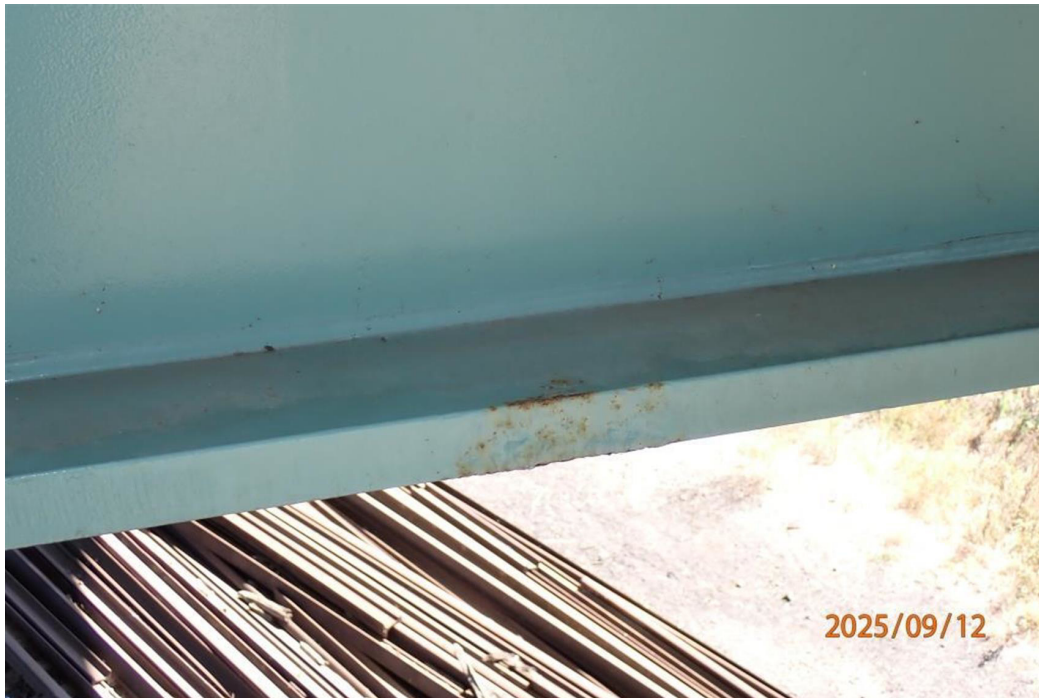
PHOTO 13

Description 1' of surface corrosion to the south bottom flange of Pier 3 at midspan (looking north)

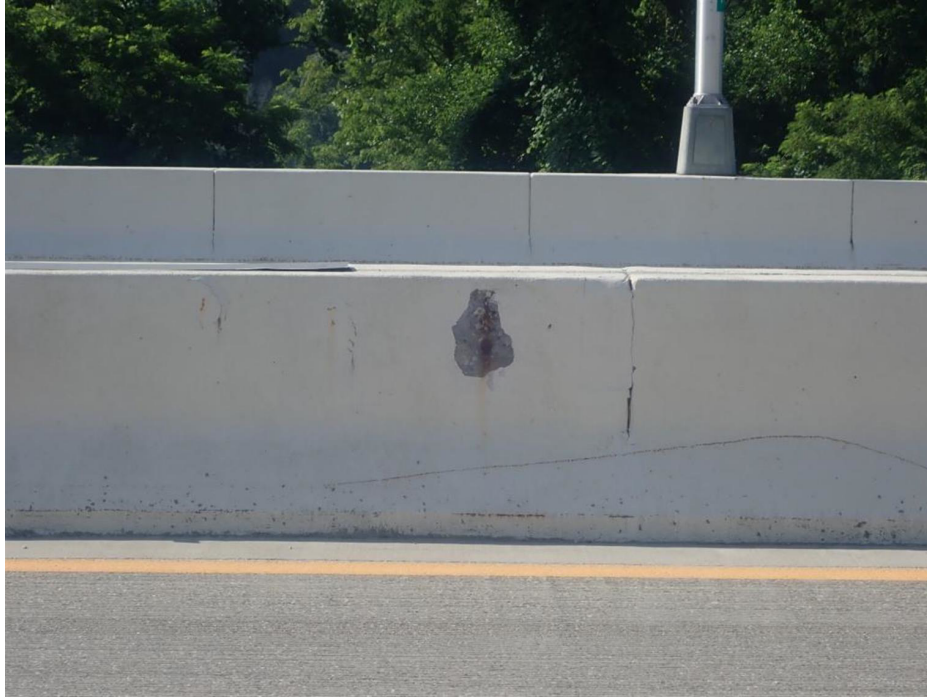
PHOTO 14

Description Spall in the bridge median at Pier 3, southbound lanes (looking east)

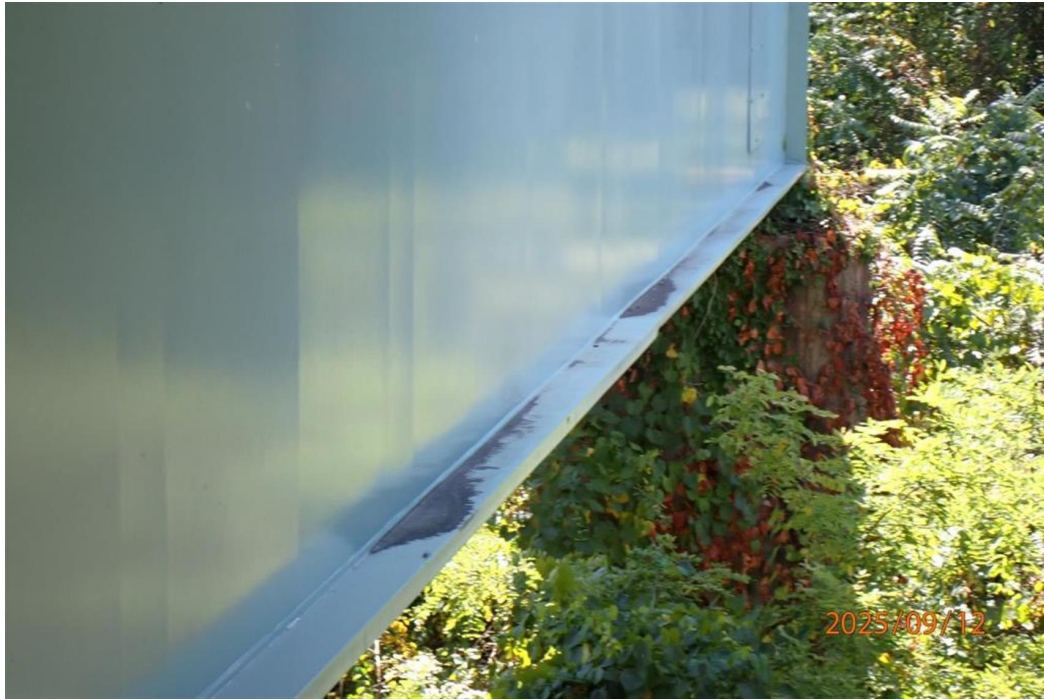
PHOTO 14

Description Staining on the south bottom flange of Pier 3 along 20' of the east end (looking east)

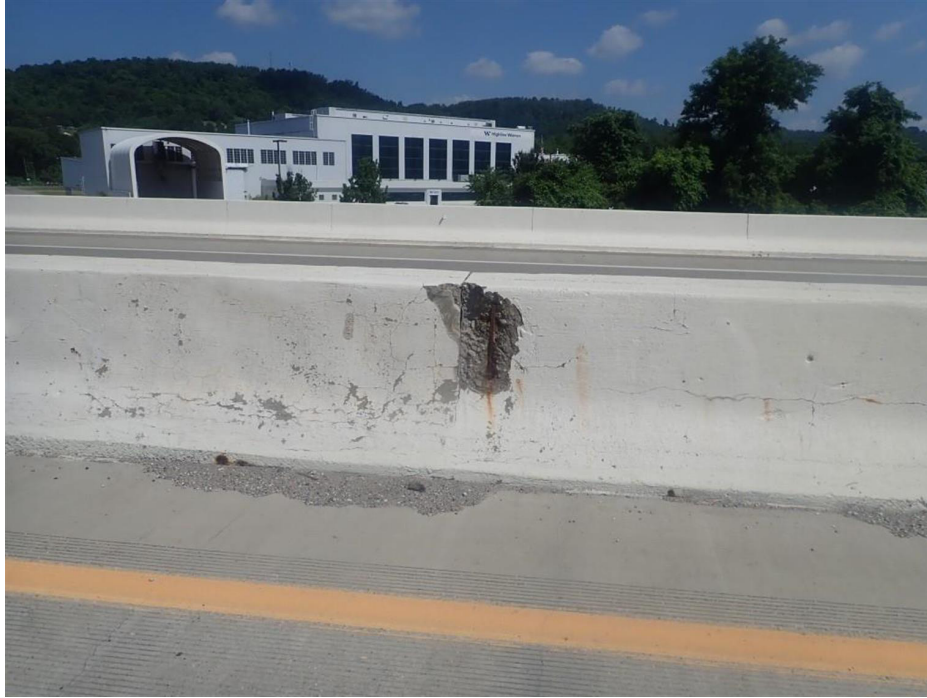
PHOTO 15

Description 1' L x 1'-6" H x 2" D spall with exposed rebar in the bridge median at midspan of Span 6, northbound lanes (looking west)

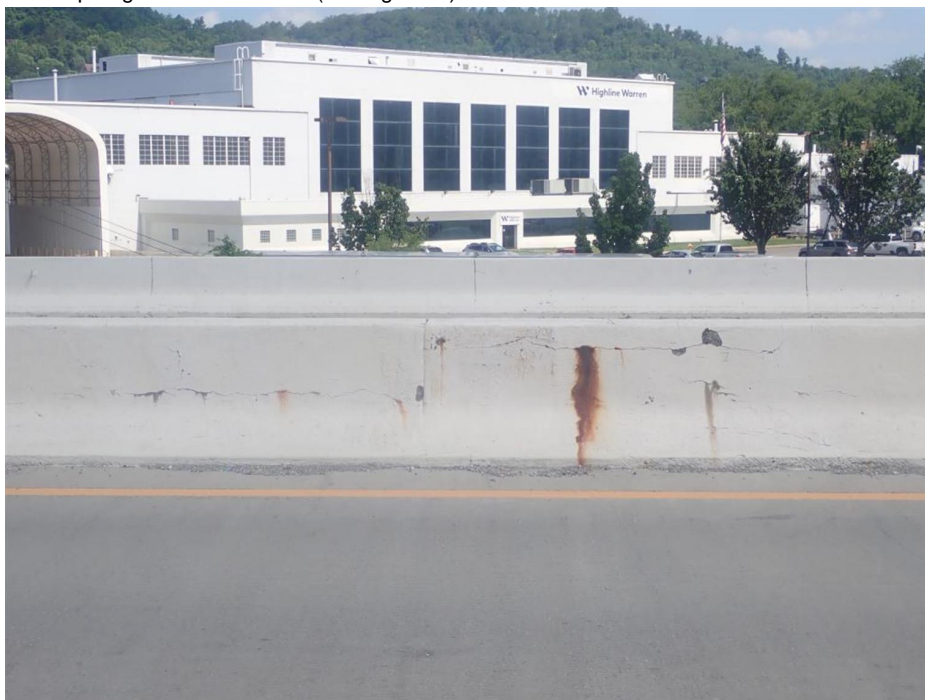
PHOTO 16

Description Isolated rust staining along the median bridge rail at midspan of Span 5 (looking west)

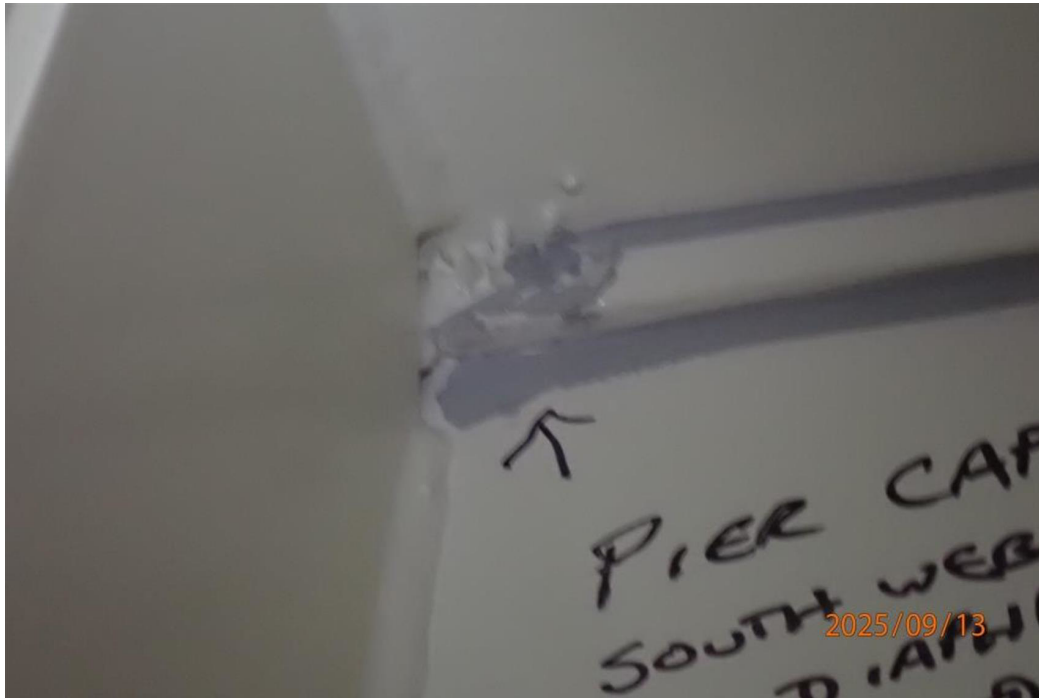
PHOTO 18

Description Discontinuous weld for the backing bar at the top flange/south web interface between Diaphragms 17-18 (looking south)

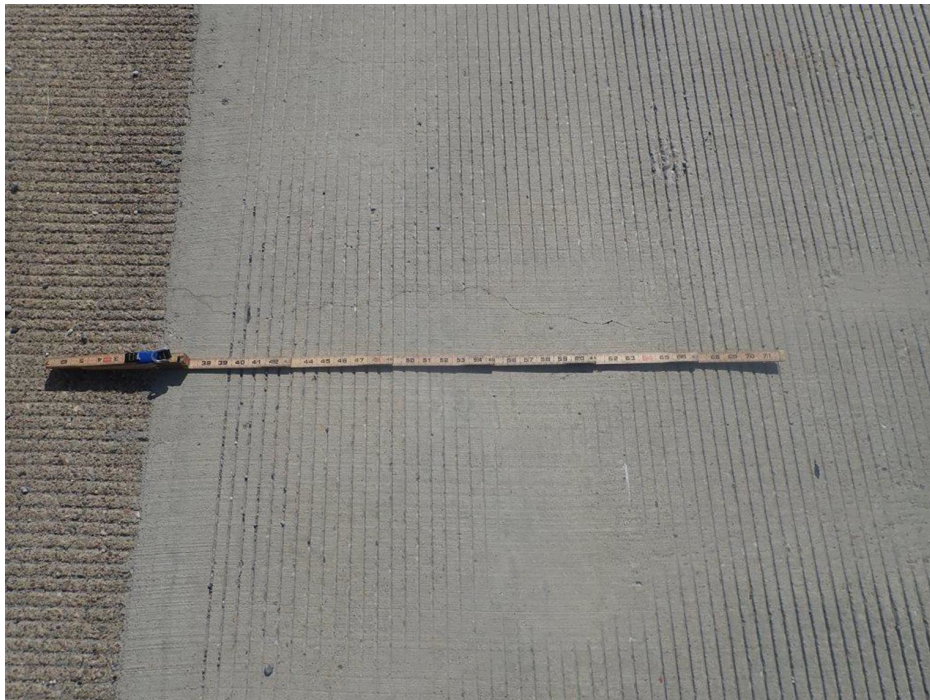
PHOTO 22

Description Isolated transverse cracks throughout the left side, forward end of the Span 5 southbound lanes shown (looking north)

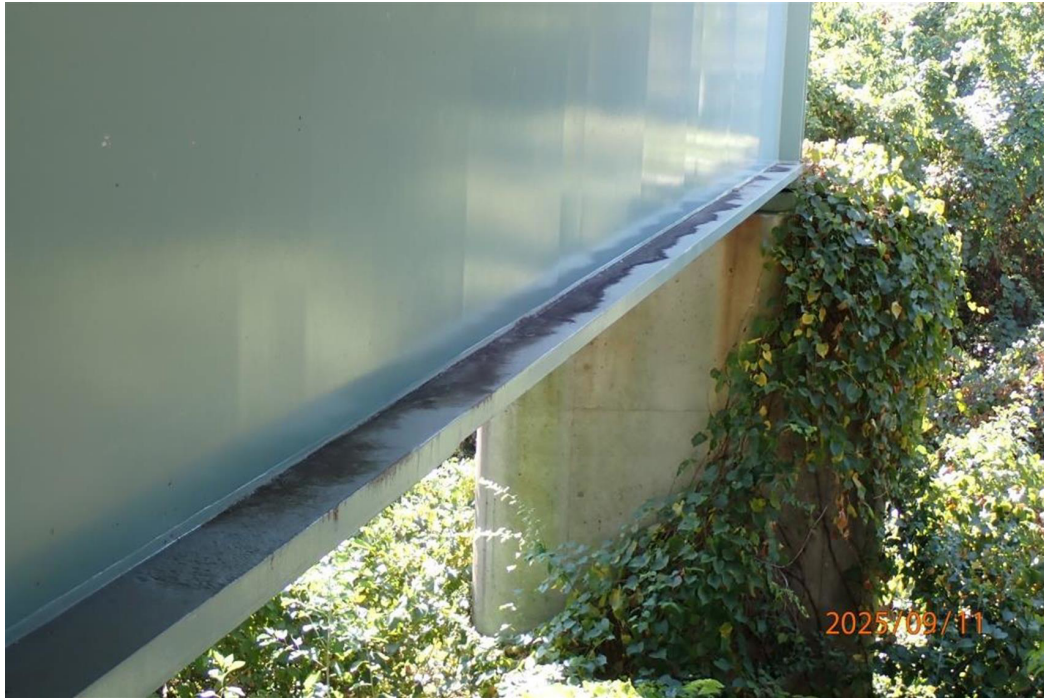
PHOTO 22

Description Staining on the south bottom flange of Pier 4 over the right 30' (looking northeast)

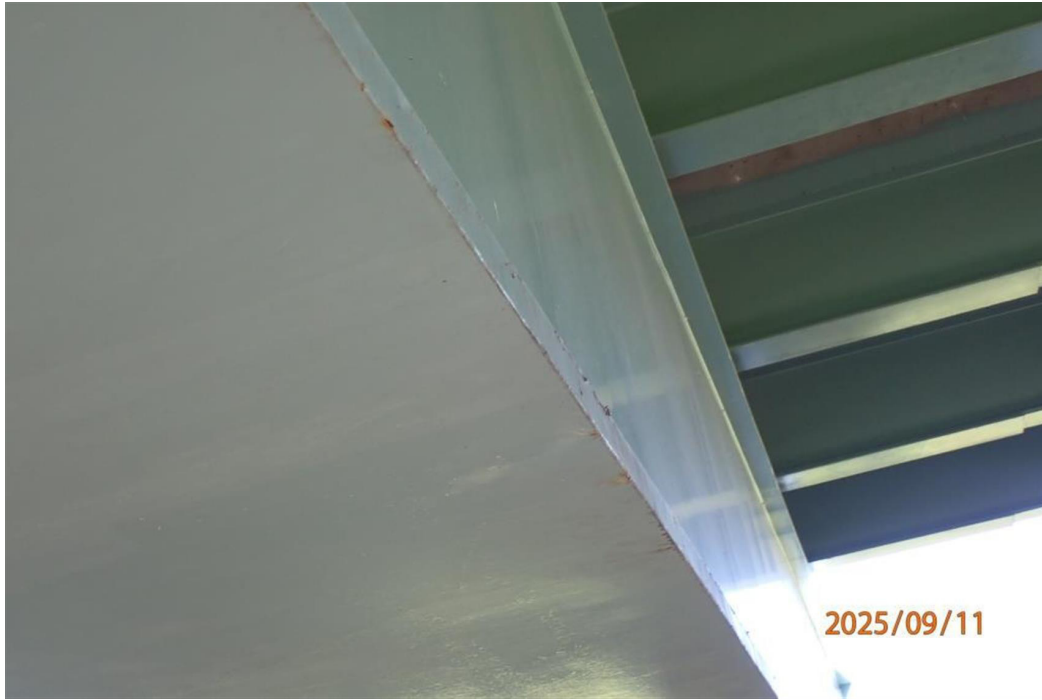
PHOTO 23

Description 5' of surface corrosion on the north bottom flange of Pier 4 near midspan (looking southwest)

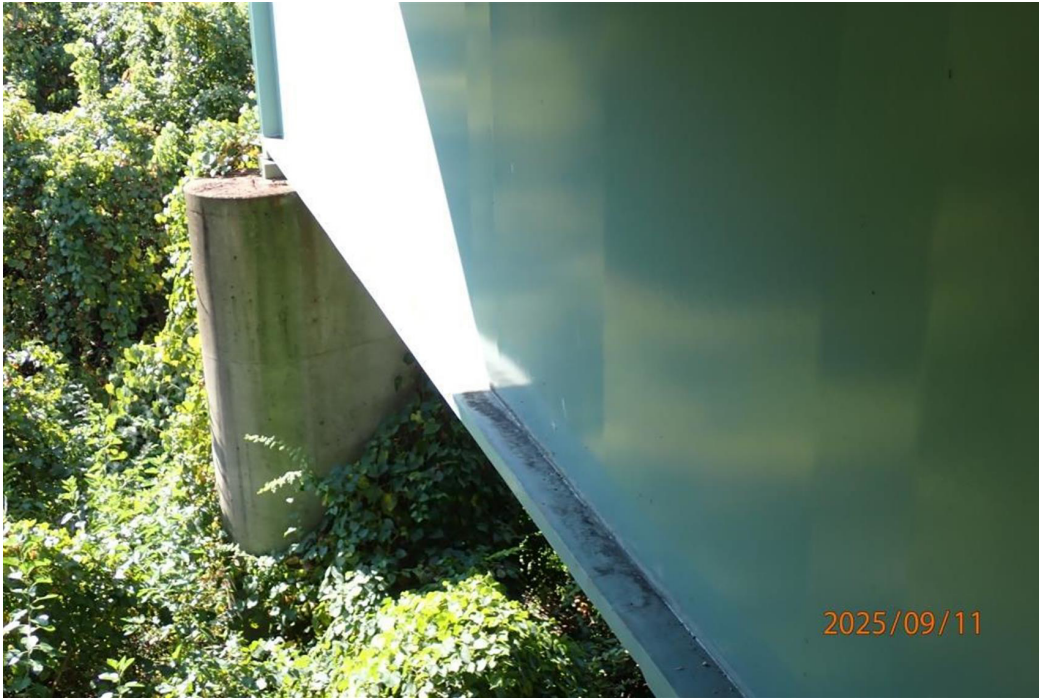
PHOTO 24

Description Staining over 25' of the north bottom flange of Pier 4, east end (looking east)

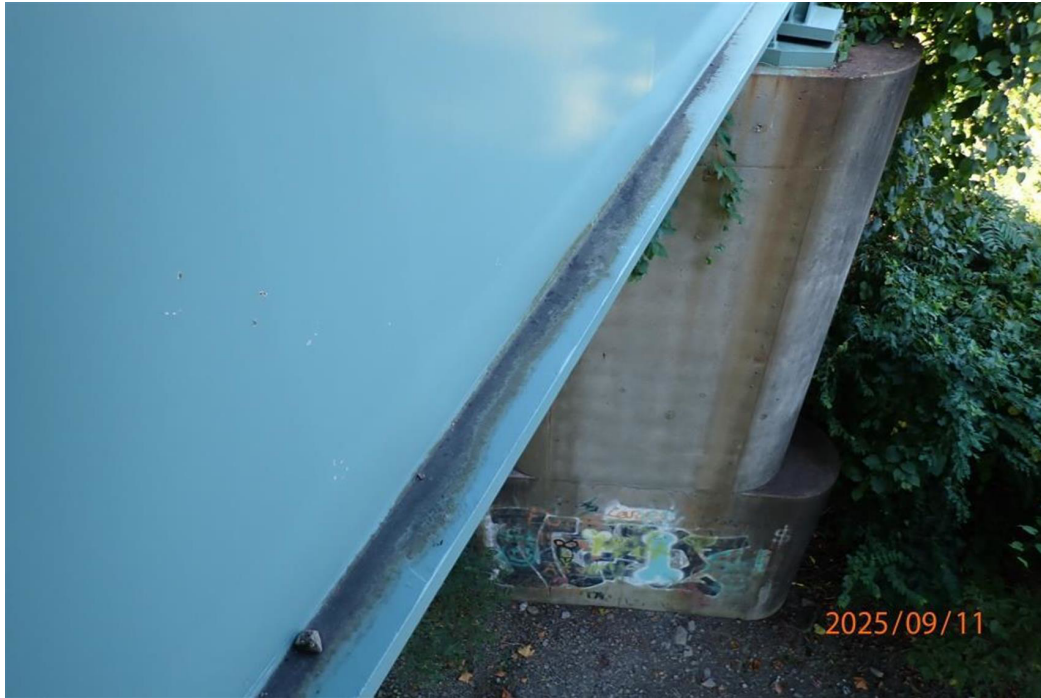
PHOTO 25

Description Staining on the north bottom flange of Pier 4, west end (looking west)

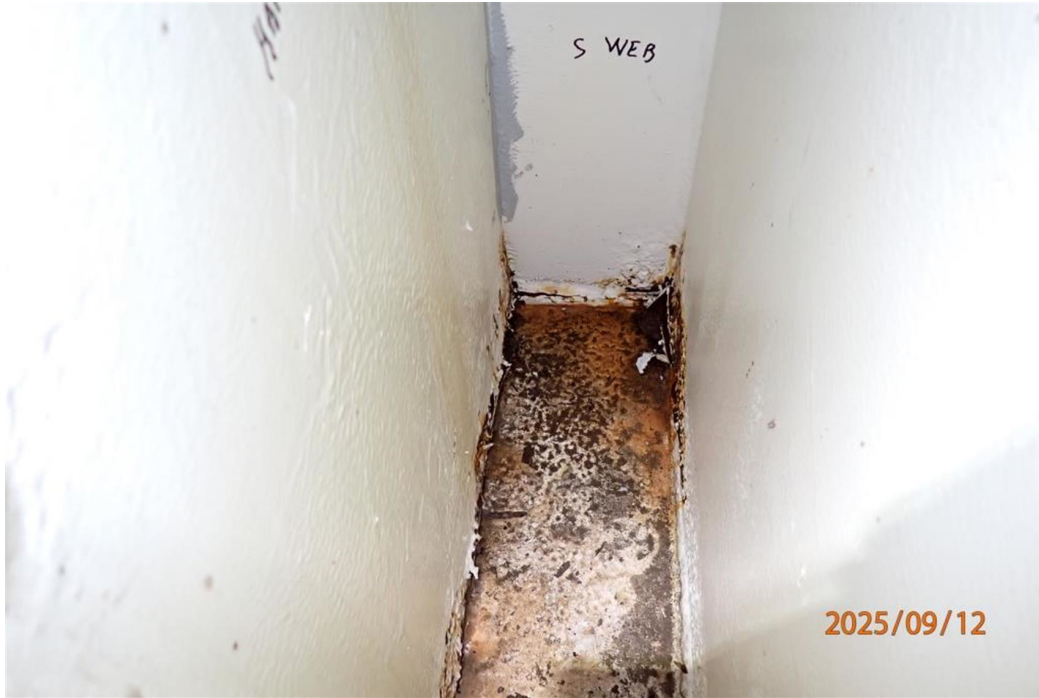
PHOTO 27

Description 1' of 1/8" deep painted over pitting and reactivated laminar corrosion in the last bay between the east end plate and Diaphragm 25 (looking south)

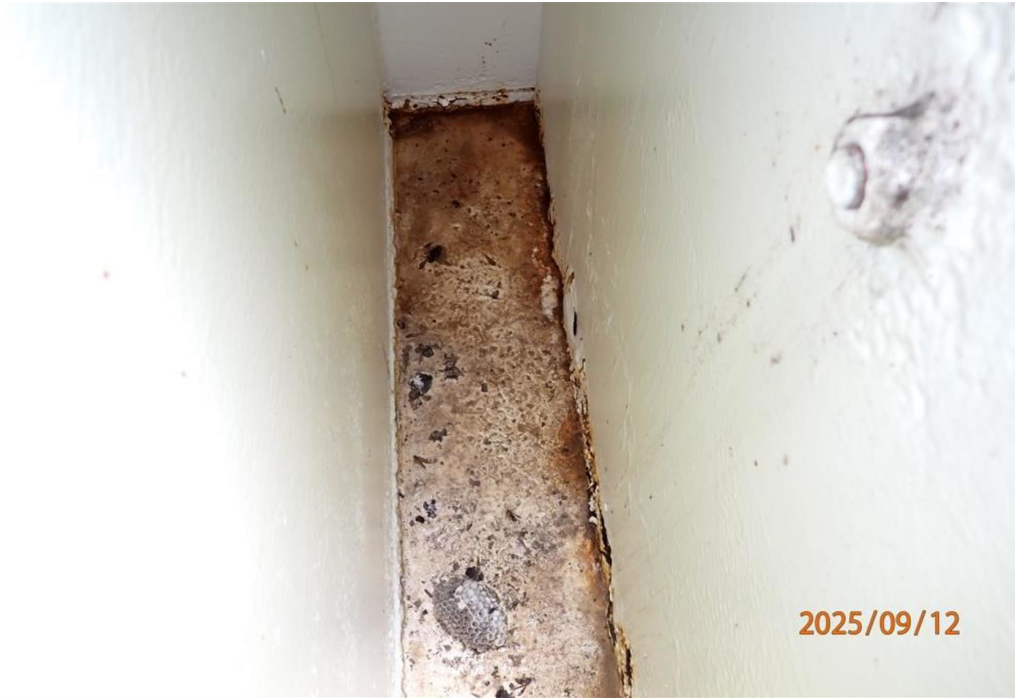
PHOTO 28

Description 1' of 1/8" deep painted over pitting and reactivated laminar corrosion in the last bay between the east end plate and Diaphragm 25 (looking north)

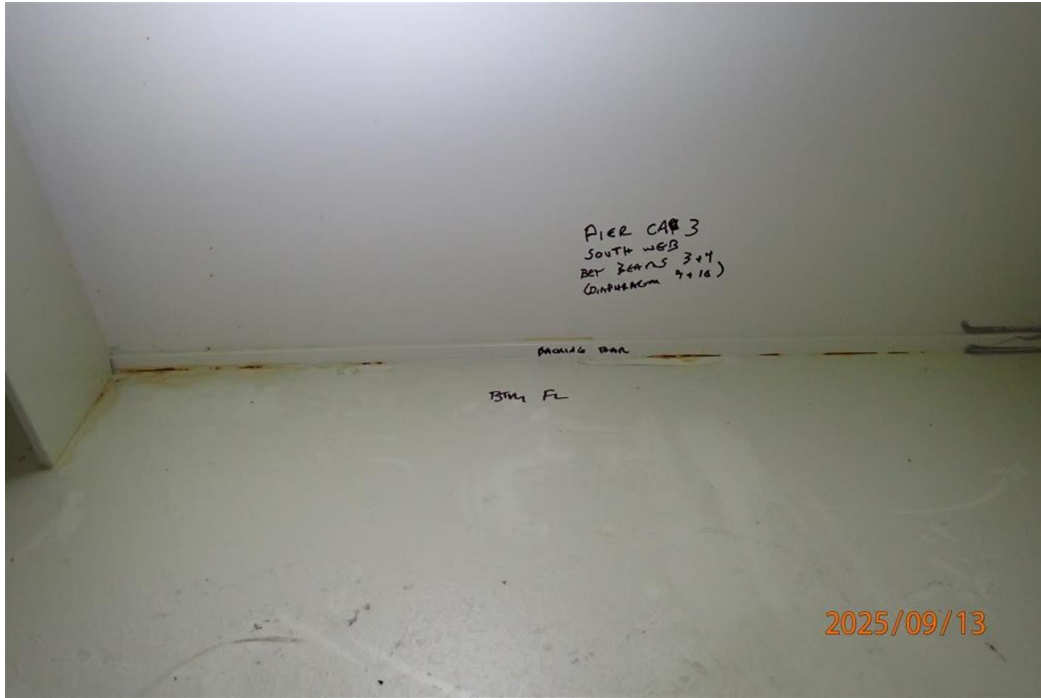
PHOTO 29

Description 3' of localized corrosion initiation at the bottom flange backing bar/bottom flange interface of Pier 4 (looking south)

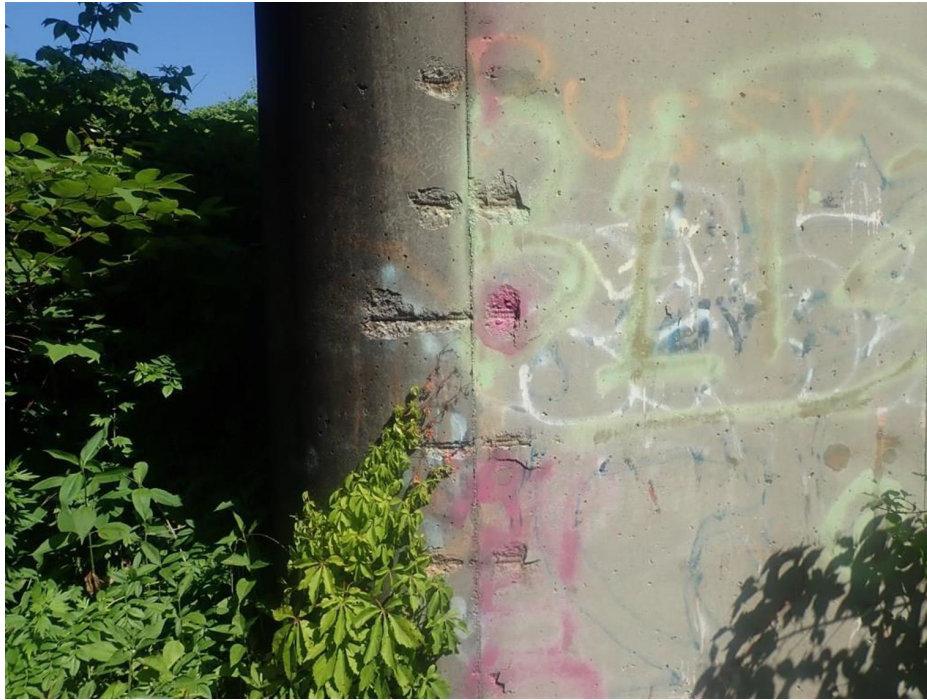
PHOTO 31

Description 1' W x 5' H x 1/2" D spalls in Column 1, Pier 5 (looking west)

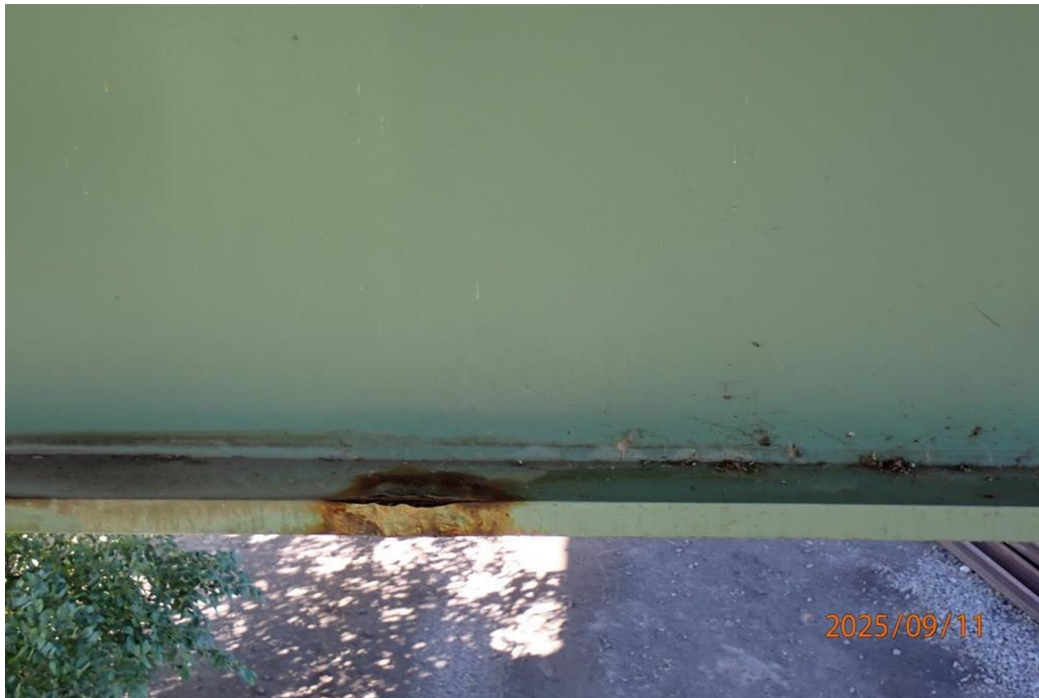
PHOTO 32

Description 1' of surface corrosion on the north bottom flange of Pier 5 near Column 2 (looking south)

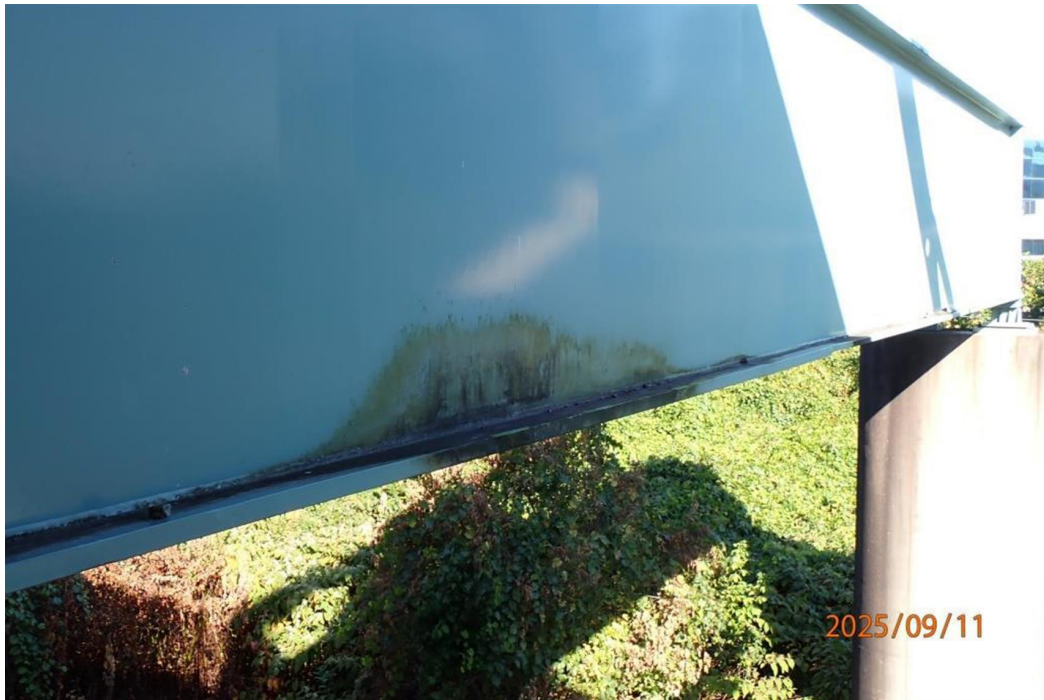
PHOTO 34

Description Algae and staining on the north face of Pier 5 over the tracks (looking southwest)

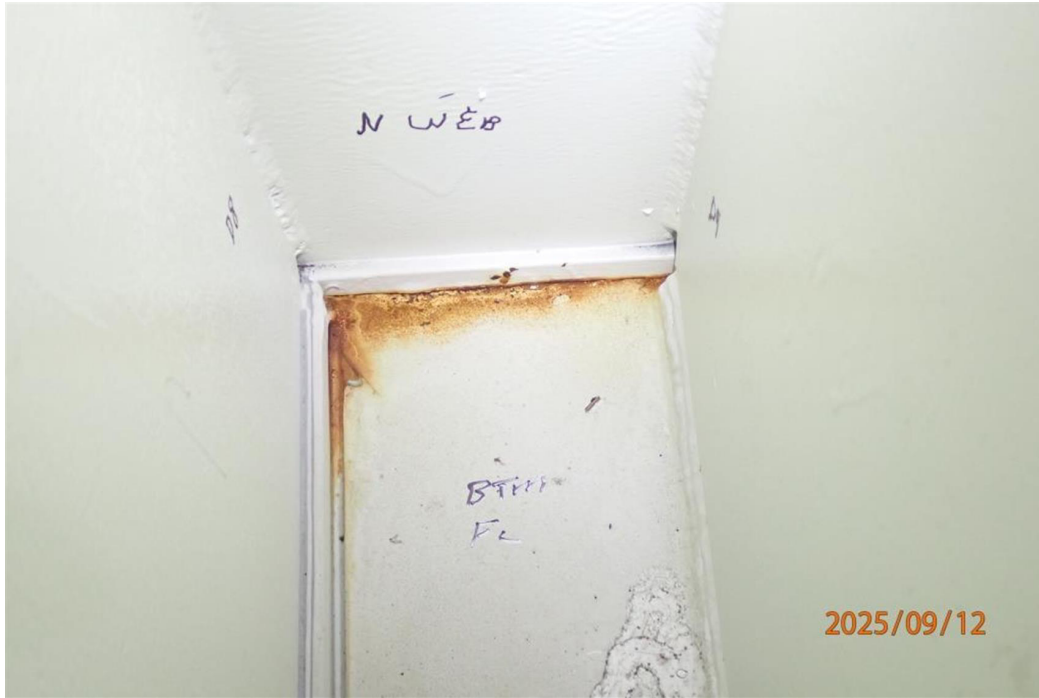
PHOTO 37

Description Rust staining along the north web/bottom flange interface between Diaphragms 7-8 inside Pier Cap 6; similar between Diaphragms 8-9 (looking north)

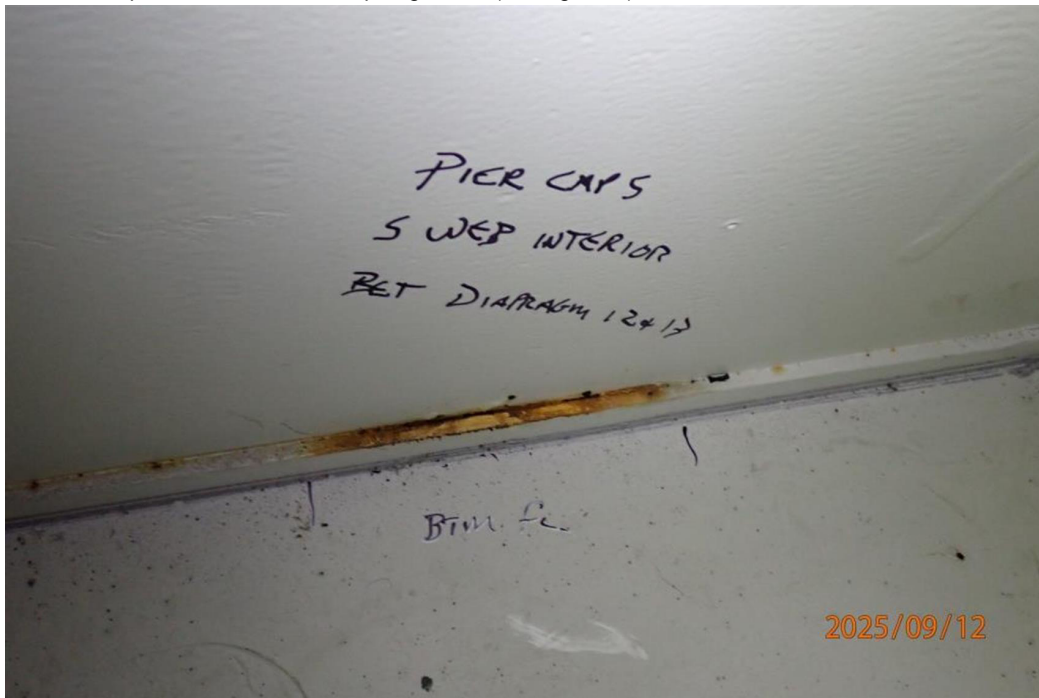
PHOTO 38

Description Rust staining on top of the bottom flange backing bar for the south web between Diaphragms 12-13 inside Pier Cap 6; similar between Diaphragms 8-9 (looking south)
