Ohio Bridge Inspection Summary Report

COL-00518-0099 (1505408)

7: Facility On SR 518
6: Feature Ints WILLARD RUN (BRUSH CR)
9: Location 0.99 MI E OF SR 644
Lat, Lon 40.7016028 , -80.866564

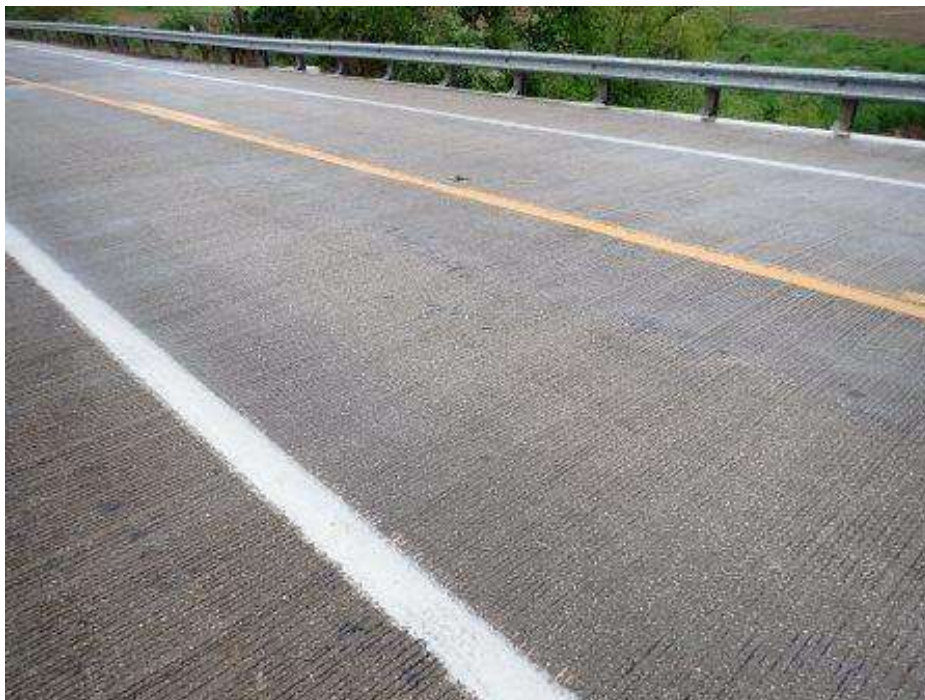
PHOTO 1

Description Looking northwest at the deck wearing surface.

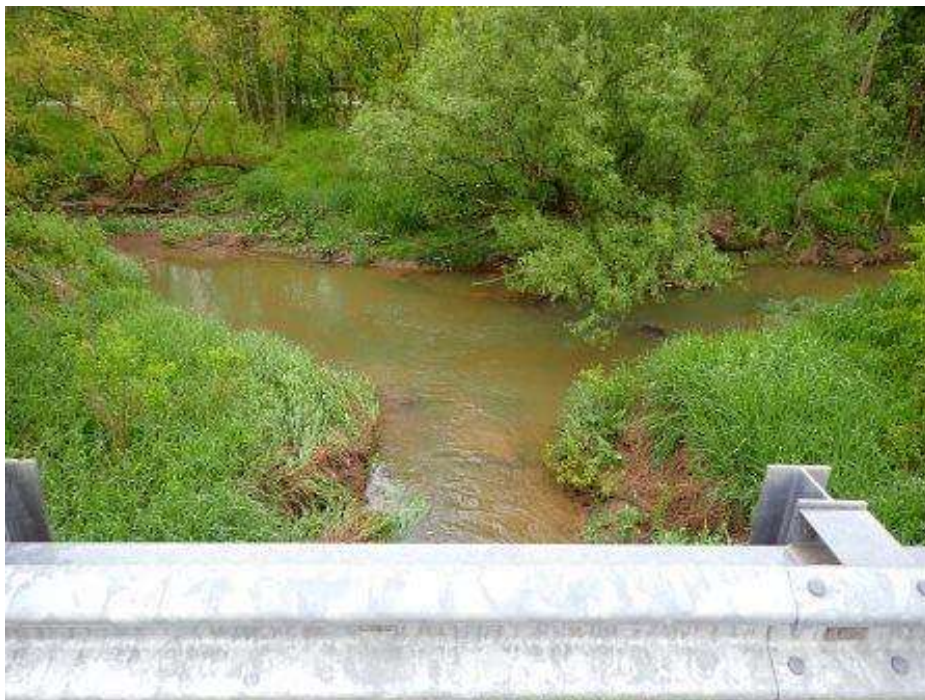
PHOTO 1

Description Looking south at the downstream channel.

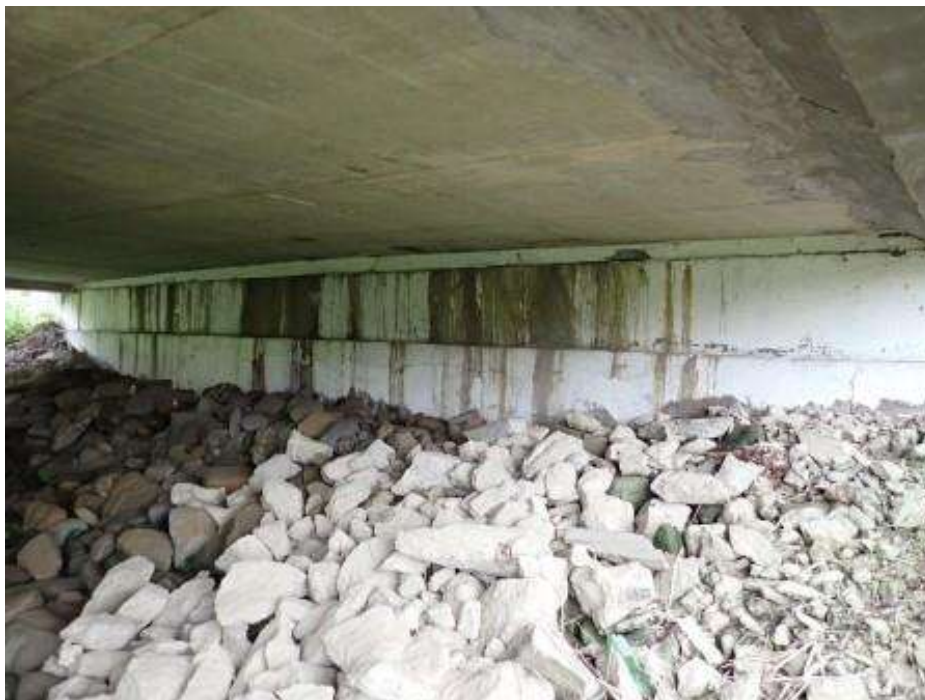
PHOTO 1

Description Looking southwest at the rear abutment.

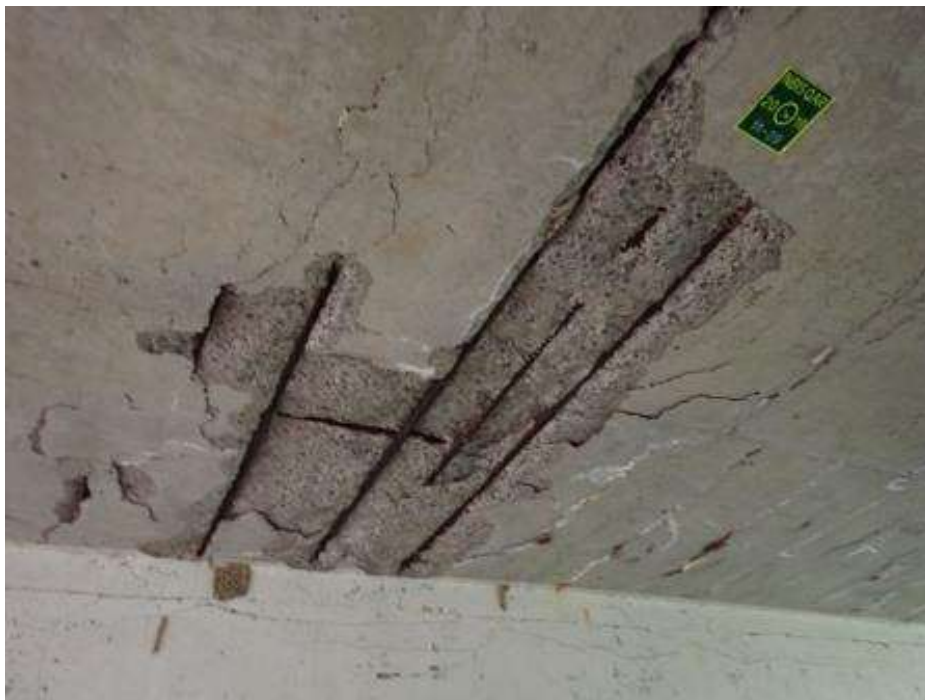
PHOTO 1

SPAN 1: CS4- 24 SF SPALL NEAR PIER 1 WITH 360 DEGREE REBAR EXPOSURE. **CS3-** 184 SF OF AREAS THAT ARE SPALLED WITH REBAR EXPOSED AND AREAS CRACKED AND DELAMINATED WITH RUST STAINS.

Description Looking southeast at the span 1 slab underside. Note: large area of cracking, spalling with exposed and corroded reinforcement and adjacent delaminations.

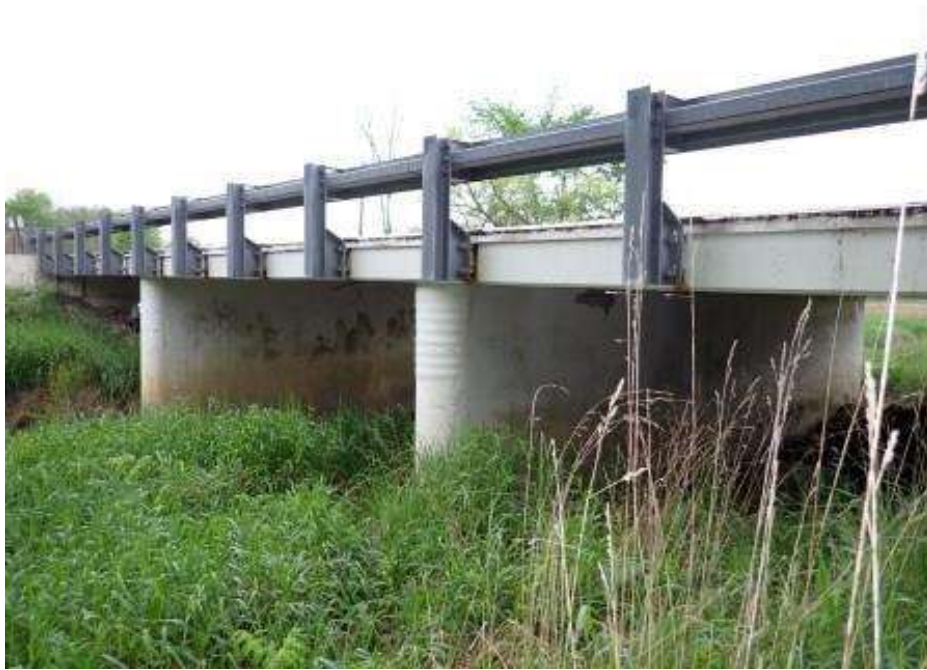
PHOTO 1

Description Looking northwest at the south fascia.

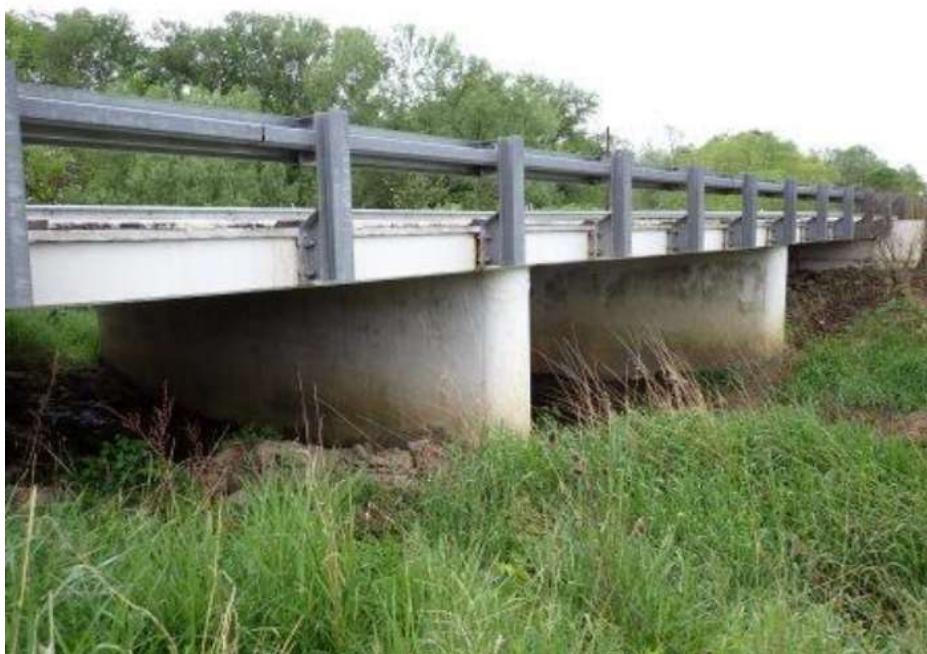
PHOTO 2

Description Looking southwest at the north fascia.

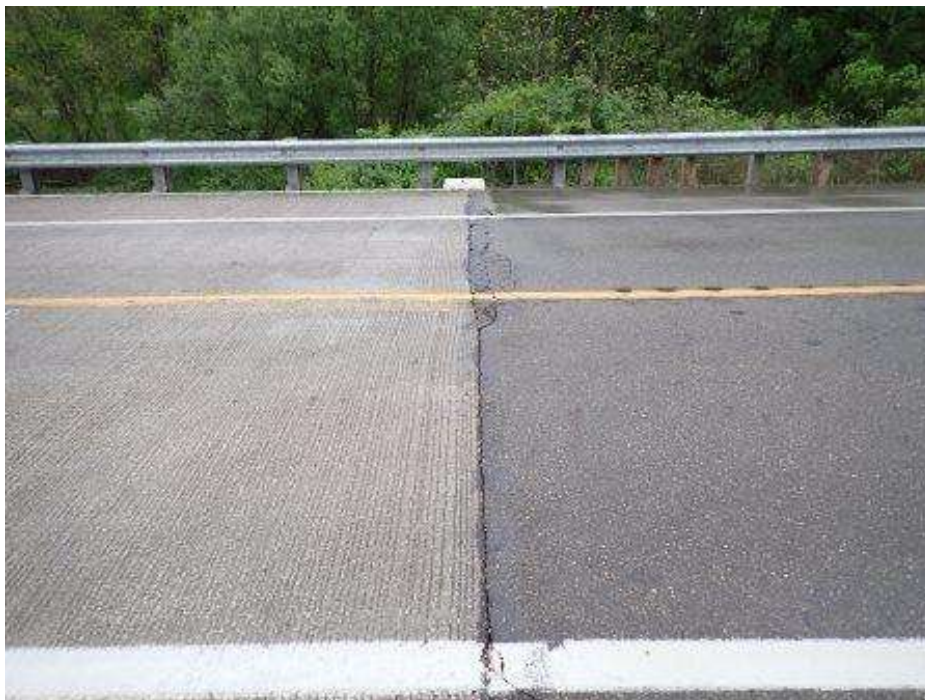
PHOTO 2

Environment	Total Quantity	Units	Condition State 1	Condition State 2	Condition State 3	Condition State 4
330-Metal Bridge Railing	3 - Mod.	146	ft.	146	0	0	0
815-Drainage	3 - Mod.	2	each	2	0	0	0
840-Approach Slab: Termination or Joint	3 - Mod.	72	ft.	0	72	0	0
2024: Full width, transverse cracking at both joints.

Description Looking south at the transition over the rear abutment. Note: cracking in the approach roadway along the transition.

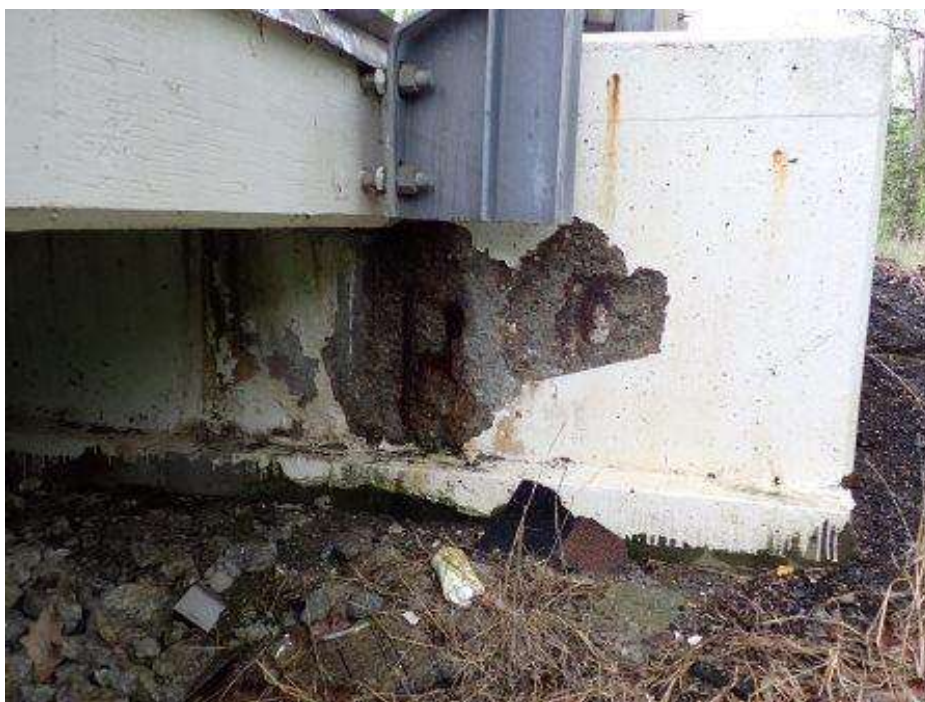
PHOTO 2

2024: Right end of FWD abutment has spall with exposed, corroding rebar.

Description Looking east at the forward abutment wall on the right side. Note: spall with exposed and corroded reinforcement.

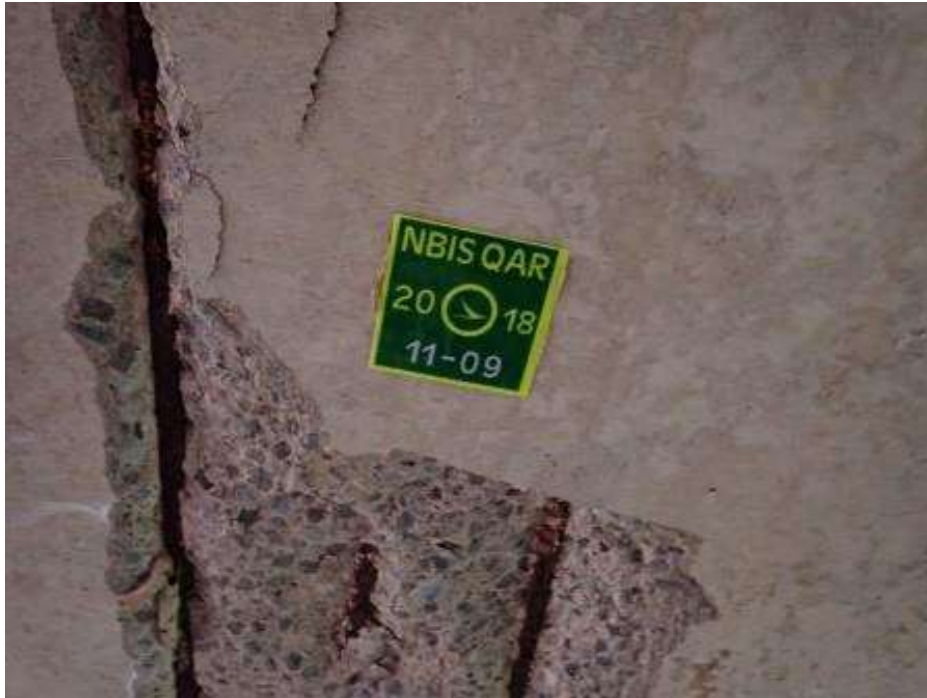
PHOTO 2

SPAN 7' FROM REAR PIER CENTER. NBIS QAR 2018 11-09 FOUND IN REAR SPAN 7' FROM REAR PIER CENTER.

Description NBIS QAR

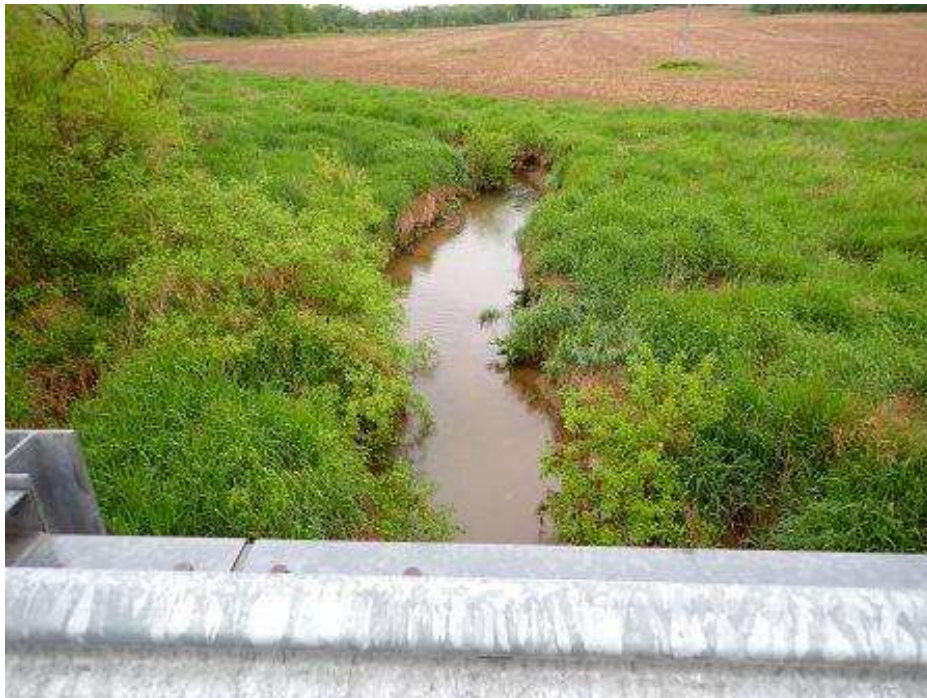
PHOTO 2

Description Looking north at the upstream channel.

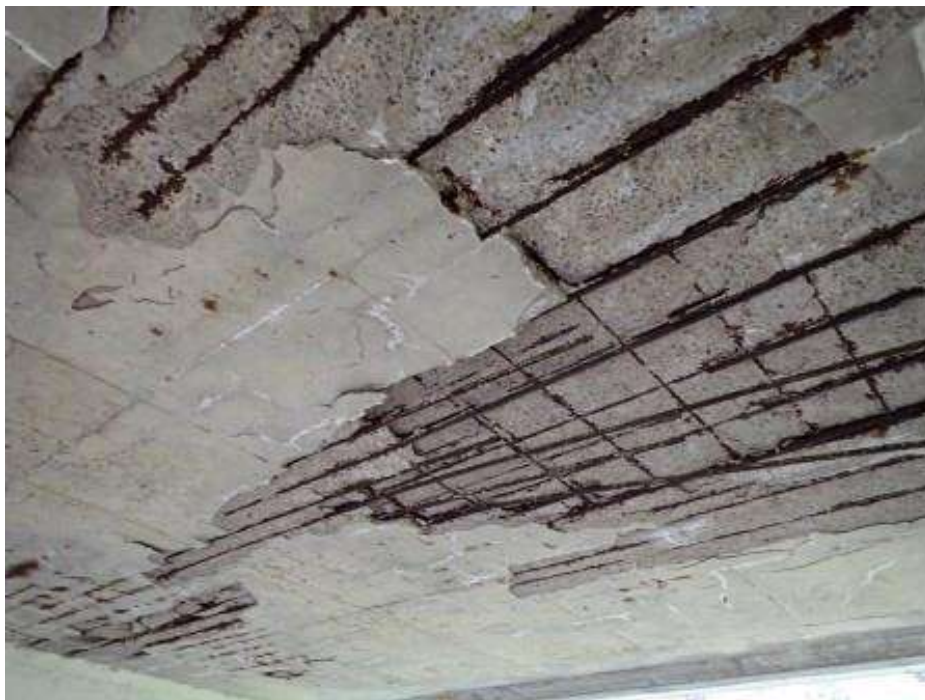
PHOTO 3

SPAN 2: CS4- 256 SF OF SPALLS WITH 360 DEGREE REBAR EXPOSURE OR SEVERE SECTION LOSS TO STEEL. **CS3-** 68 SF OF SPALL WITH REBAR EXPOSED. FEW REBARS ARE HANGING.

2024: Few rebars are hanging in span 2 near CL of bridge.

Description Looking southeast at the span 2 slab underside mostly on the right half. Note: large area of cracking, spalling with exposed and corroded reinforcement and adjacent delaminations. Multiple reinforcement bars are hanging down from the slab.

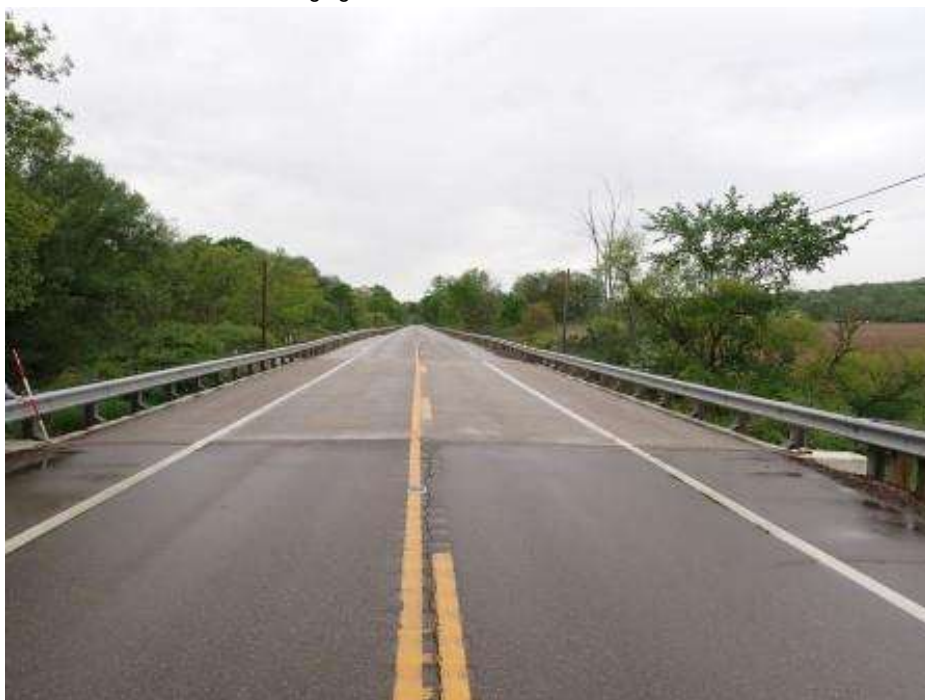
PHOTO 3

Description Looking west at the bridge end view.

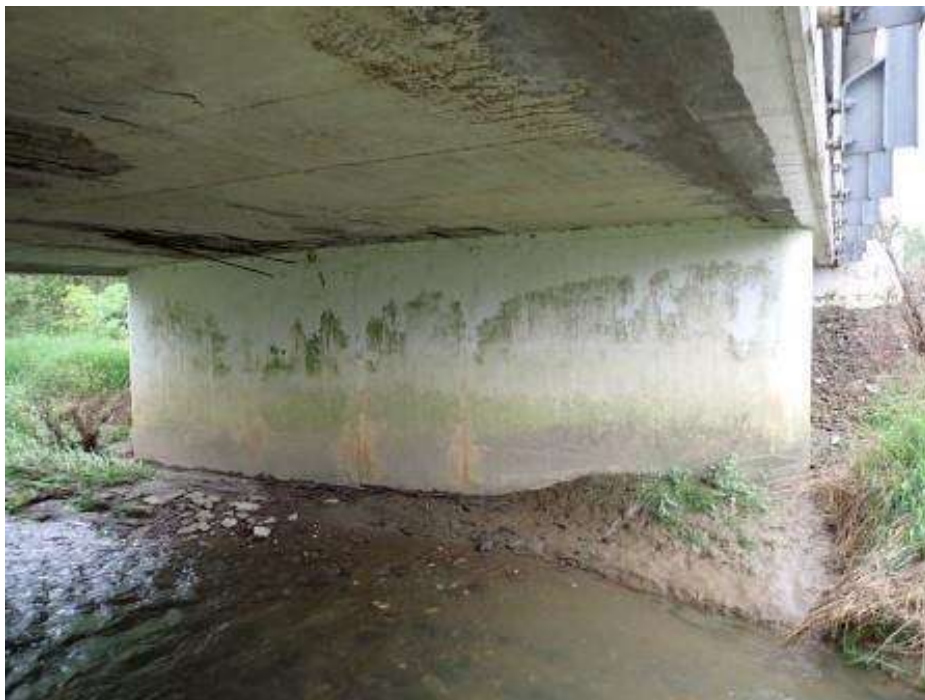
PHOTO 3

Description Looking west at pier 1.

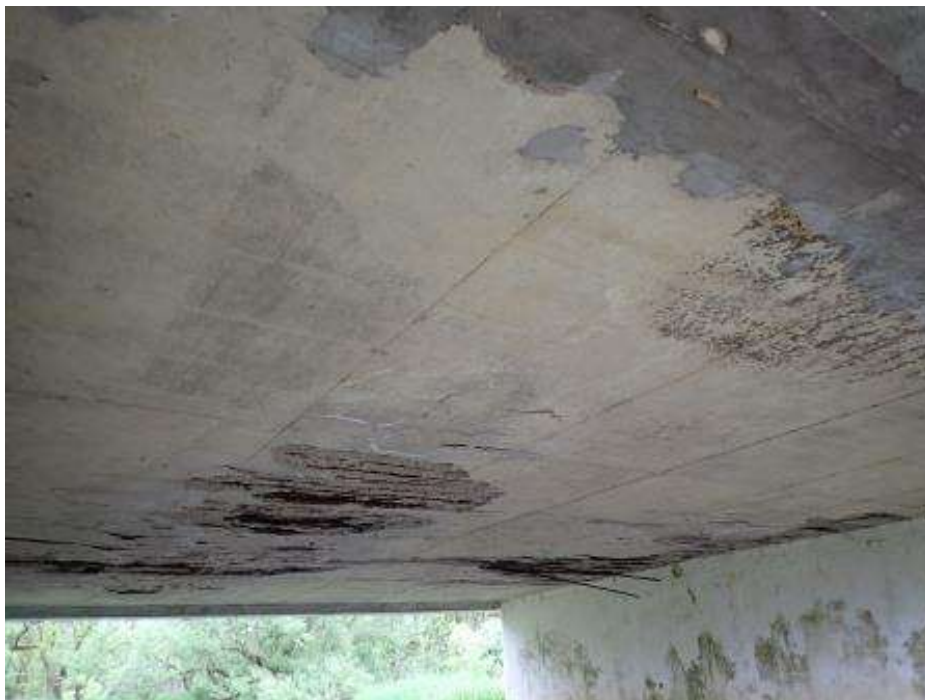
PHOTO 4

Description Looking southwest at the underside in span 2.

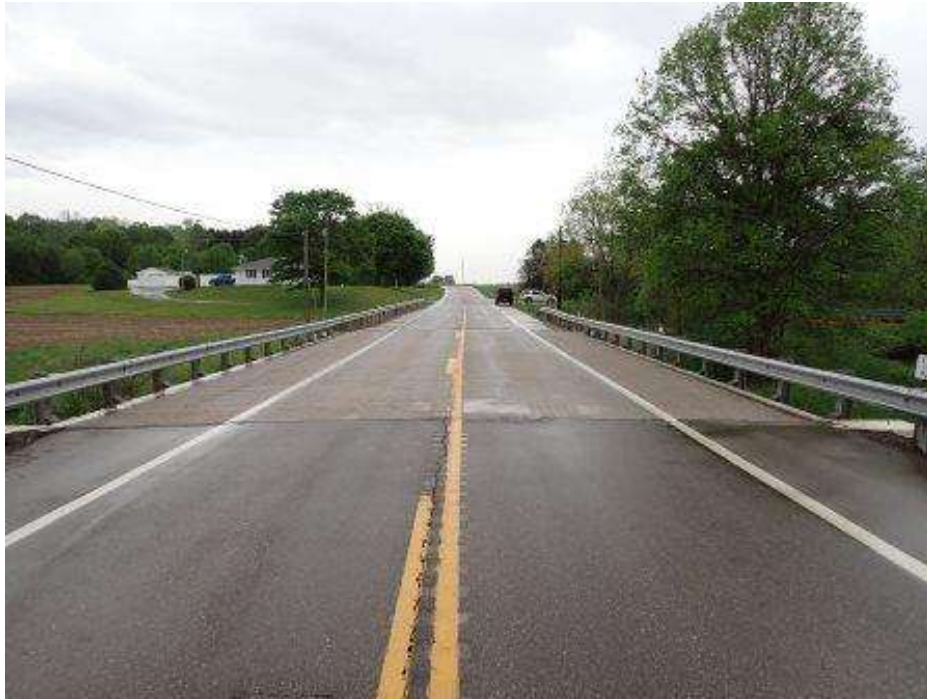
PHOTO 4

Description Looking east at the bridge end view.
