2000 PHYSICAL CONDITION REPORT

VETERANS' MEMORIAL BRIDGE OVER CUYAHOGA RIVER VALLEY

BRIDGE NO. CUY-6-1499
CUYAHOGA COUNTY, OHIO

**Ohio Department of Transportation
District 12**

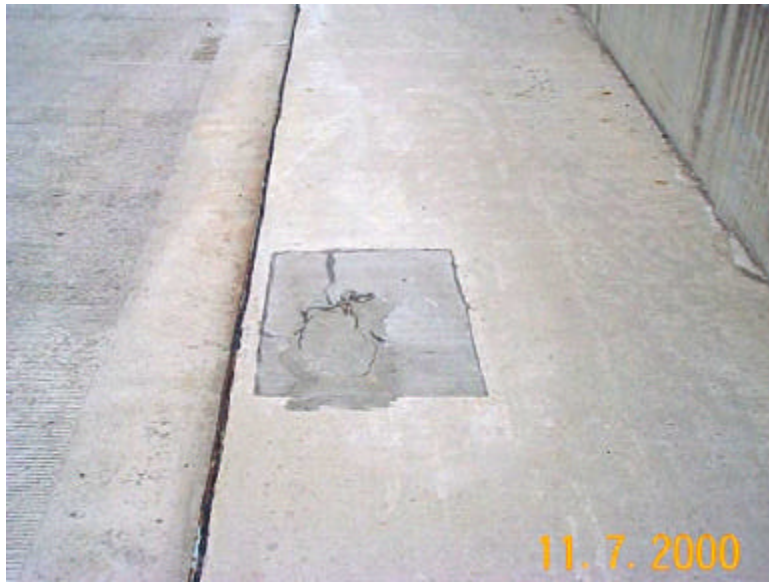
The upper level concrete deck, including the sidewalks, wearing surface and parapets, are in good condition. Two delaminated and cracked sidewalk patches (patched in 1997) in the main span were noted (Photo 3). Minor map cracking is prevalent throughout the structure. Horizontal cracks were common to the bottom of the concrete rail. Vertical cracks, at approximately 5-ft spacing, were noted, but no delaminations or efflorescence was observed (Photos 4). No deficiencies were noted to the aluminum fence.

Photo 3 – Delaminated and cracked sidewalk patch, North sidewalk near panel point 3

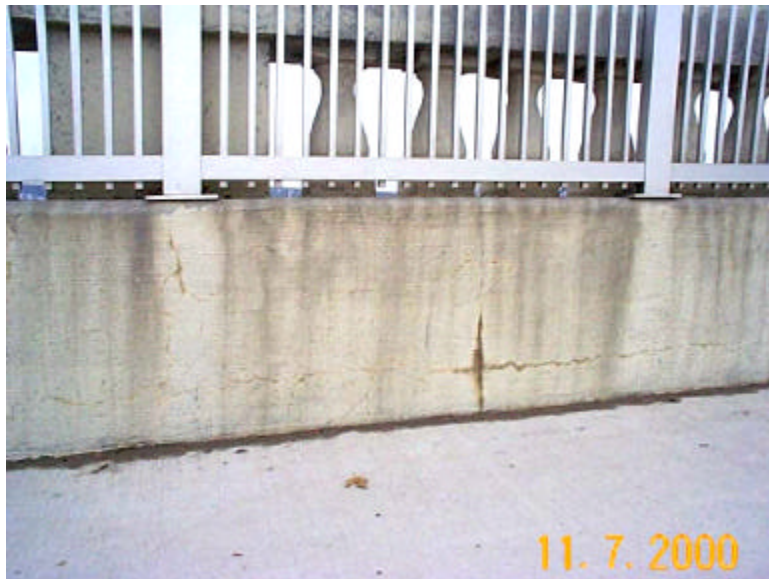
Photo 4 – Cracks and staining to railing

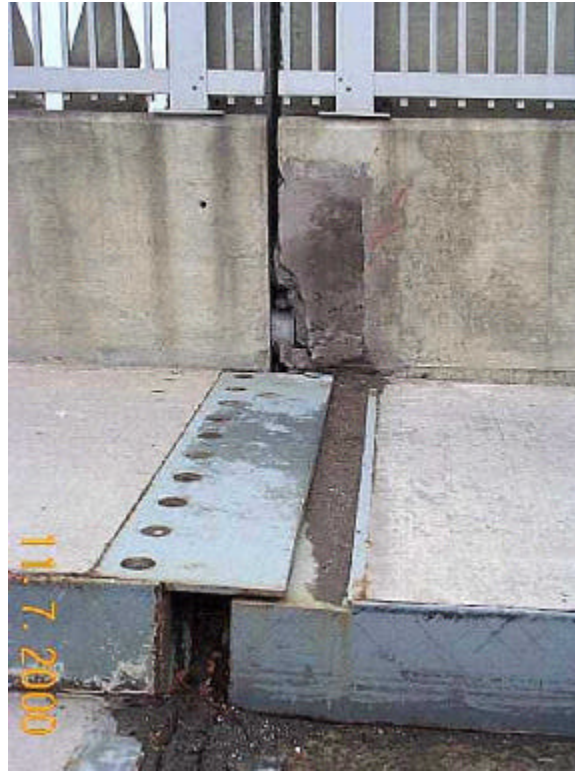
There is a spalled and cracked patch to the north rail at the expansion joint at panel point 0' (Photo 5). The concrete sealer on the upper deck railing is also showing signs of wear and flaking as well as staining from the aluminum fence above. There is active rust on the 8" curb plate.

Photo 5 – Spalled patch to north rail at panel point 0'

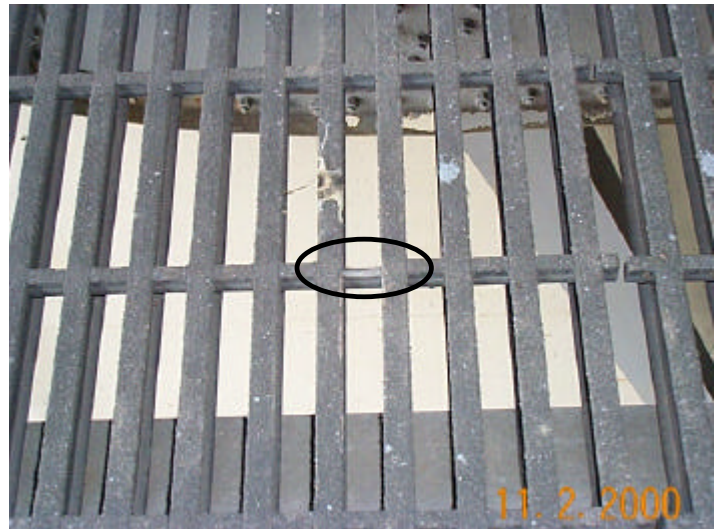
The fiberglass grating walkways are in good condition with two deficiencies noted. Minor damage to the walkway grating to the north walkway at panel point 0' was observed (Photo 6). Second, vertical displacement between adjacent grid panels was observed in the north walkway near panel point 3' (Photo 7).

Photo 6 – Damage to Fiberglass grating, North walkway near Panel Point 0'

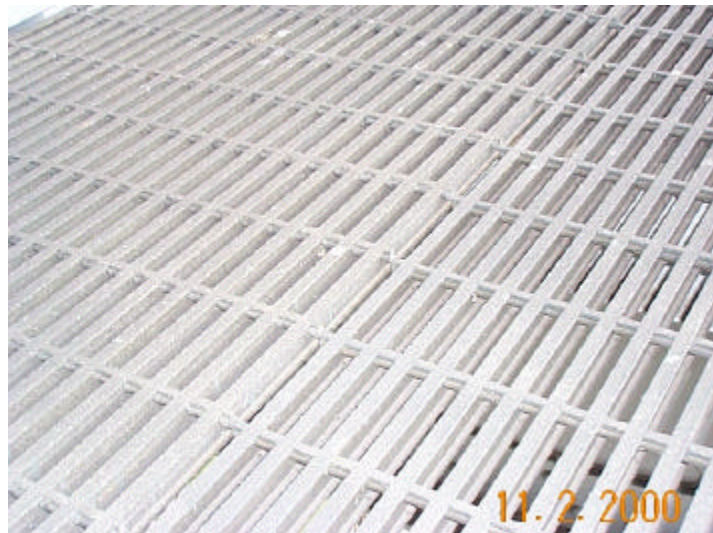
Photo 7 – Vertical Displacement between grating, North walkway near Panel Point 3'

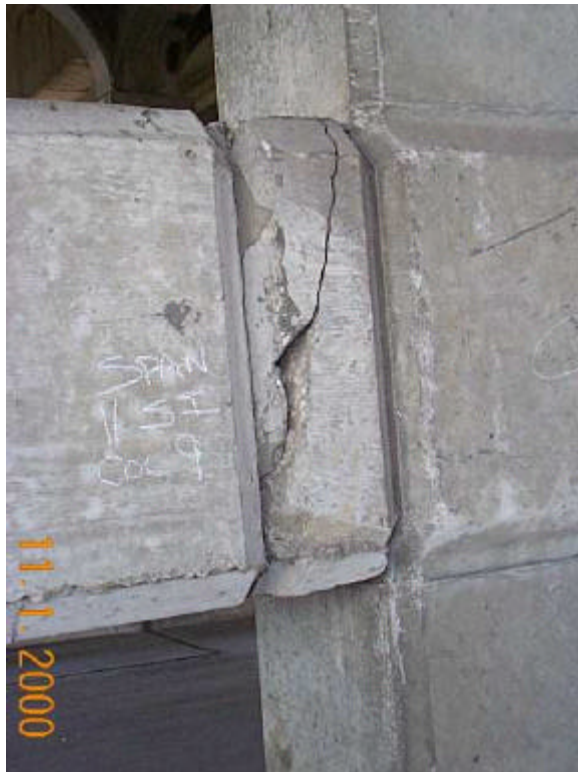
The lower deck railing is in fair to good condition. The exterior concrete rails in the concrete approach spans are in good condition with few, sporadic areas of small spalls and areas of delamination recorded. No deficiencies were noted to the metal pipe rails to the north bay walkway. Several of the center bay rails had areas of delamination, cracks or spalls (Photos 8 & 9). The spalls and delaminations present were not repaired during the last rehabilitation.

Photo 8 – Crack to center bay railing
dcp00111.jpg

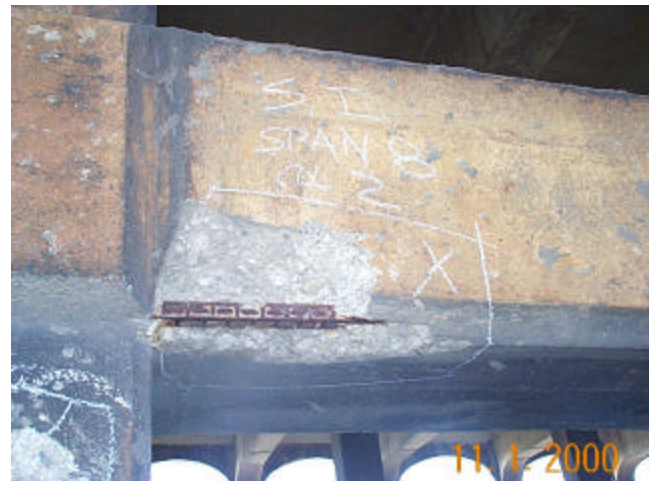
Photo 9 – Spall with exposed reinforcing to center bay railing
dcp00112.jpg

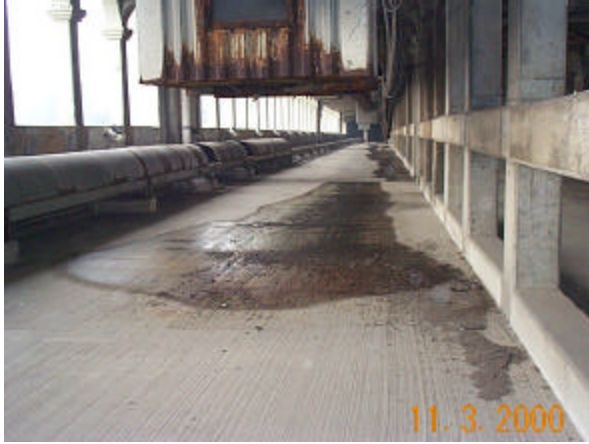
Photo 10 – Lower Deck, South Bay
dcp143.jpg

The compression joints are in good condition. Water leaking from the utility chambers (Photo 10) is collected and pooling in the compression joints (Photo 11). No leaking under the deck was observed.

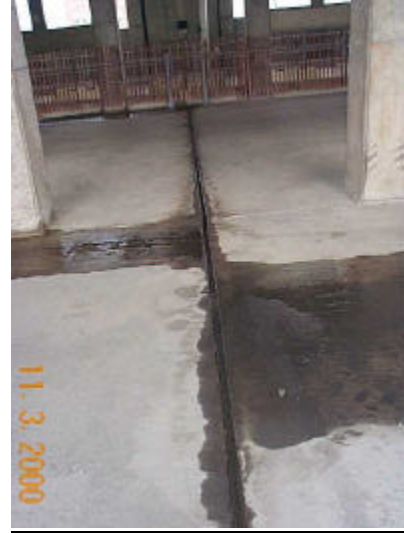
Photo 11 – Lower Deck Compression Joints
dcp00146.jpg

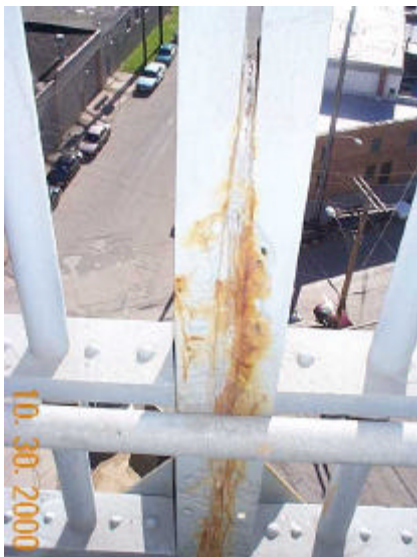
Several deficiencies were observed to the exterior railing in the main span. Packrust up to 2 inches between post channels was common (Photo 12). Holes through the vertical tubular rails were noted to the north rail near panel point 5 (Photo 13).

Photo 12 – Packrust to main span exterior railing posts
dcp00071.jpg

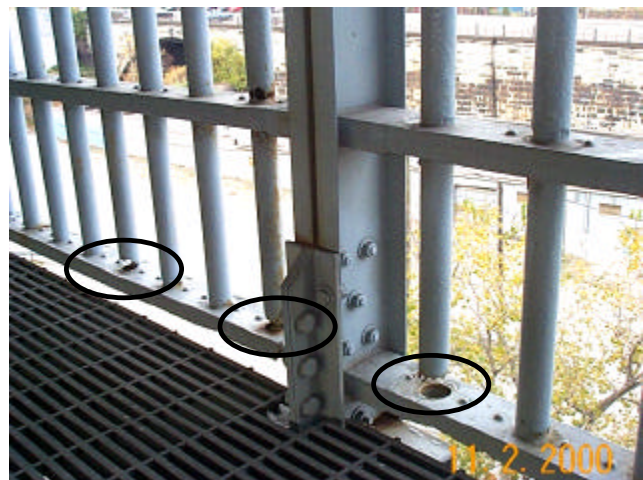
Photo 13 – Holed through vertical tubular rails
dcp00123.jpg

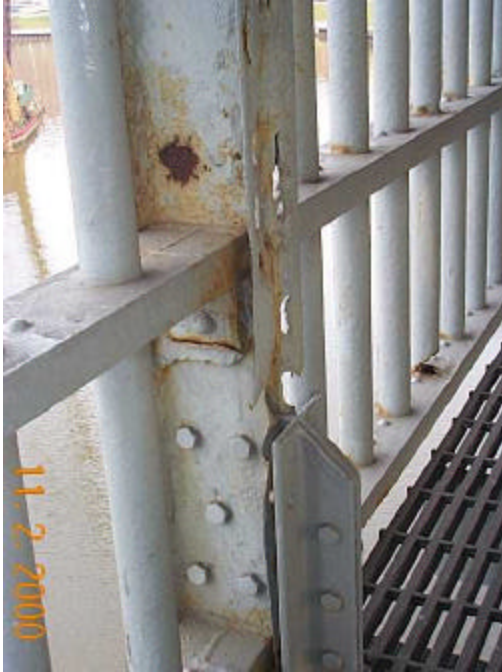
Holes and loss of section were also noted to numerous post channels throughout the span (Photo 14), as well as packrust (Photo 15) and missing bolts (Photo 16) between the end of the lower deck floorbeam and the vertical channel posts.

Photo 14 – Holed through exterior railing posts
dcp00125.jpg

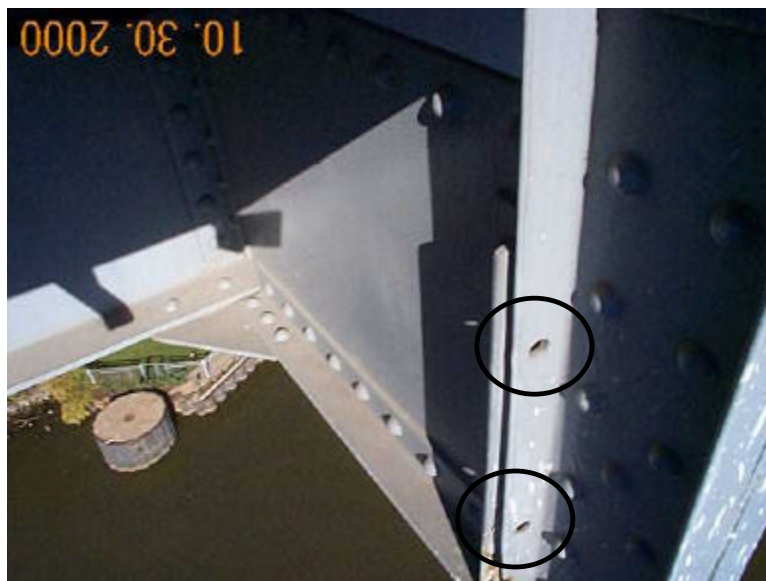
Photo 16 – Missing bolts between lower deck floorbeam and railing
dcp00072.jpg

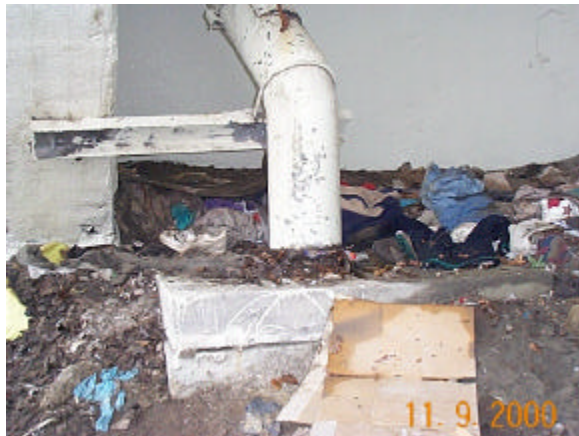
Photo 17 – West Abutment

The drainage is in fair condition. Catch basins in the upper deck slab are clear. Downspouts appear to be clear, except at the bottom of the West Abutment and Pier 1 where debris accumulation is evident (Photos 17).

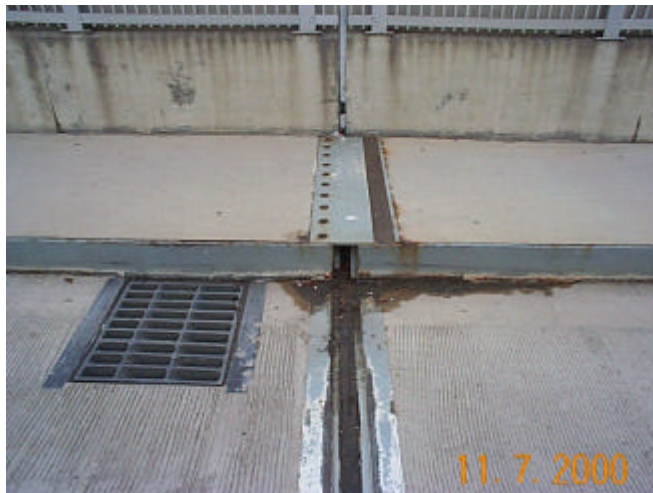
Photo 19 – Debris Accumulation at Gutter
at Expansion Joint
dcp00186.jpg

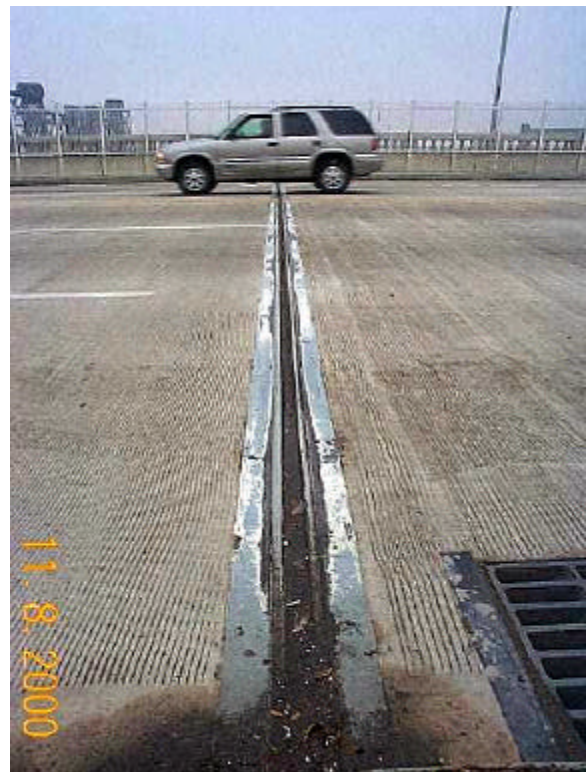
The expansion joints are in good condition. No damage, tears or cracks to the upper deck strip seals were noted. The lower deck compression seals are in excellent condition. Minor debris and ponding water is collecting at the curbs, especially at the expansion joints (Photo 19). There is minor wear and loss of paint to the expansion joint armor (Photo 20).

Photo 20 – Expansion Joint
dcp00202.jpg

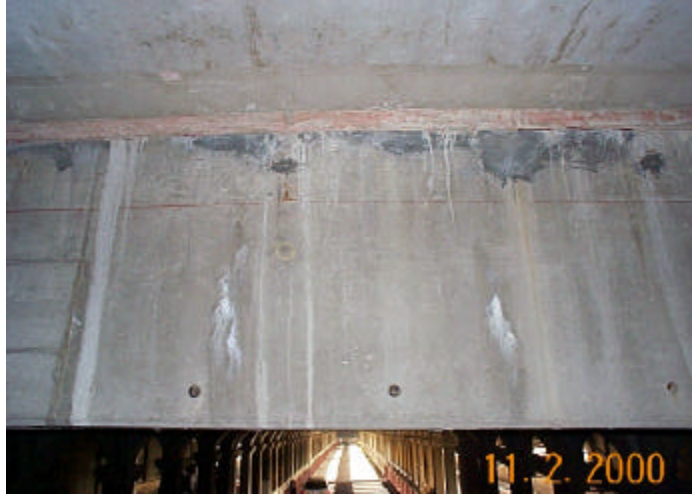
Photo 25 - Span 1A, Floorbeam 4, Center Bay
dcp00113.jpg

Exceptions to this were in span 1A south bay (26 s.f.), span 1 north bay (55 s.f.), span 2 south bay (23 s.f., Photo 3D), span 11 north bay (13 s.f.) and span 12 north and south bays (28 s.f. and 29 s.f., respectively). Spalls with exposed reinforcing were noted in span 2 south bay, span 12 north bay and span 13 north bay. Minor flexural cracks were also noted, but not significant. Sporadic cracks with efflorescence were observed to isolated floorbeams (Photo 25). The epoxy-injected cracks appear to be functioning properly.

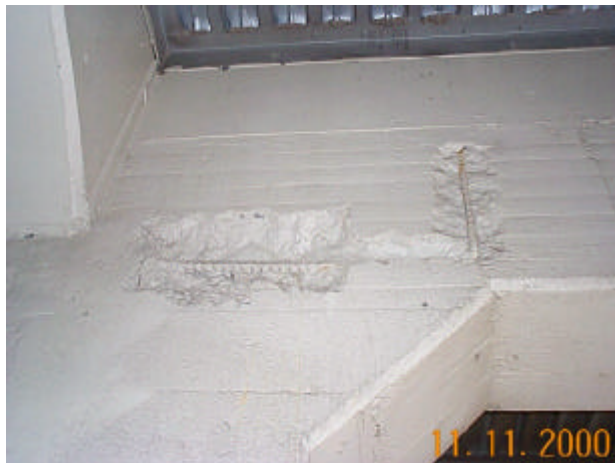
Photo 26 – Span 5, Floorbeam 2, South Bay
dcp00226.jpg

The lower deck floorbeams are in good condition. Generally, areas of delaminated concrete were noted to isolated, random floorbeams, while several other lower deck floorbeams have spalls with exposed reinforcing (Photo 26). While all the spalls have been sealed, bleeding and rust staining due to active corrosion is present at some locations (Photo 27). Minor hairline flexural and map cracks were noted but are not significant at this time.

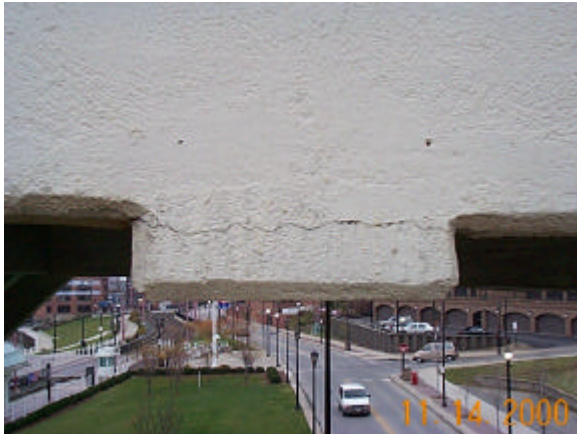
Photo 28 – Span 12, Floorbeam 5, South Face
dcp00248jpg

In Span 12, spalls, cracks and crumbling concrete patches were noted. There are horizontal cracks at the south end of floorbeams 5 and 6 (Photo 28). A crumbling patch over Robert Lockwood Jr. Drive was noted on the east face of floorbeam 4 in the south bay (Photo 29). Similarly, a second poor patch with voids is located on the east face of floorbeam 6 in the center bay (Photo 30).

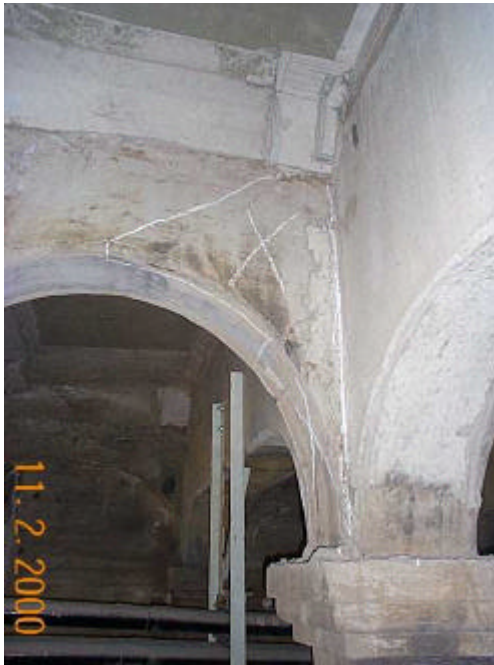
The upper deck jack arches are in good condition. Sporadic areas of voids, cracking and delamination (Photo 31) were noted, mainly in spans 1A and 1B and the north interior column line in span 2. There are two spalls with exposed reinforcing in span 1A at the north interior jack arch between floorbeam 5 and 6 and floorbeams 6 and 7 (Photo 32).

Photo 31 – Span 1A, South Interior
Jack Arch between FB 8 & 9

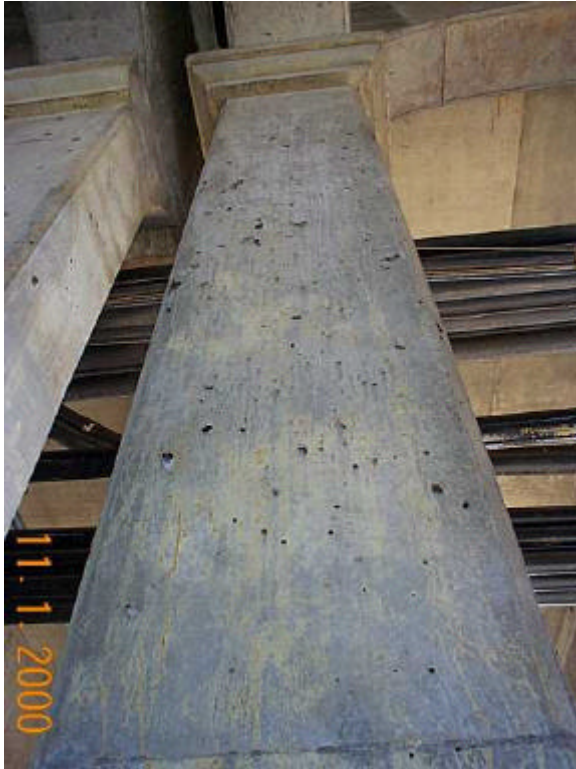
Photo 33 – Span 3, South Int. Column 18
dcp00099.jpg

The upper deck columns are in generally good condition. Voids to columns replaced during the 1994 rehabilitation are common (Photo 33), as well as deterioration and peeling to the textured surface on original columns (Photo 34).

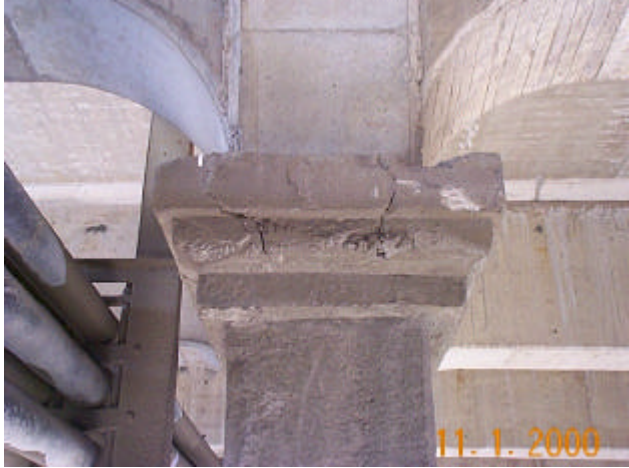
Photo 35 – Span 1 South Interior Column 7
dcp00091.jpg

Cracks, delamination and spalls to the corbel detail were noted throughout the concrete spans (Photo 35). Additionally, three columns in span 3 were replaced without the corbel detail (Photo 36). Minor spalls with exposed reinforcing were observed in spans 1A and 1B, typically near the corbel detail (Photo 37).

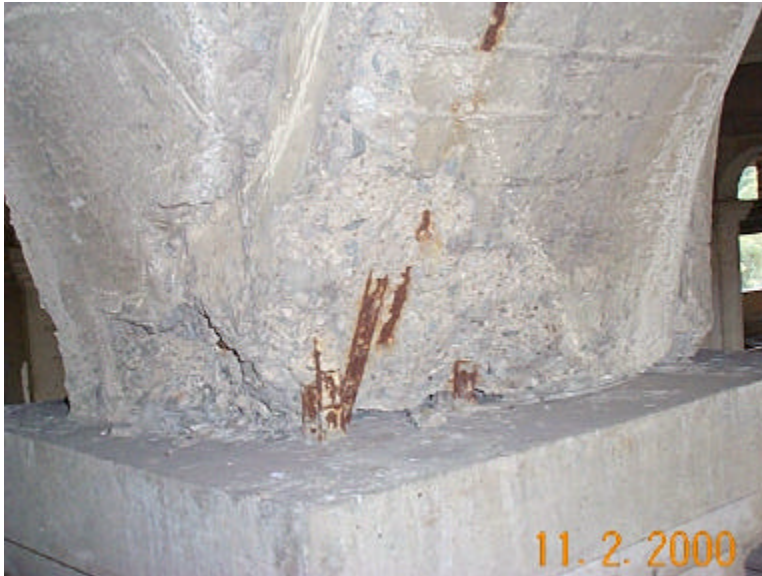
Photo 38 – Span 2, North
Exterior Column 4
dcp00139.jpg

Several columns also had spalls and/or voids to the column core above the corbel detail (Photos 38 and 39).

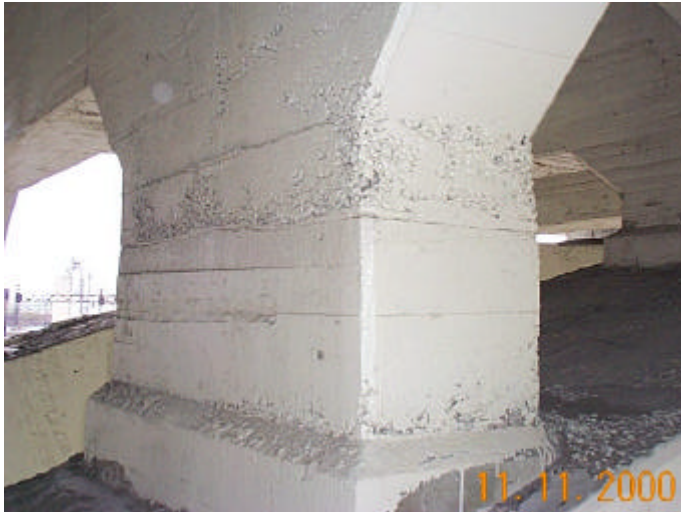
Photo 40 – Span 5, South Interior Column 11

The lower deck columns are in good condition. Localized areas of voids, honeycombing and cracking from original construction were noted to several lower deck columns (Photo 40). An example of this is at South Interior Column 11 in Span 5.

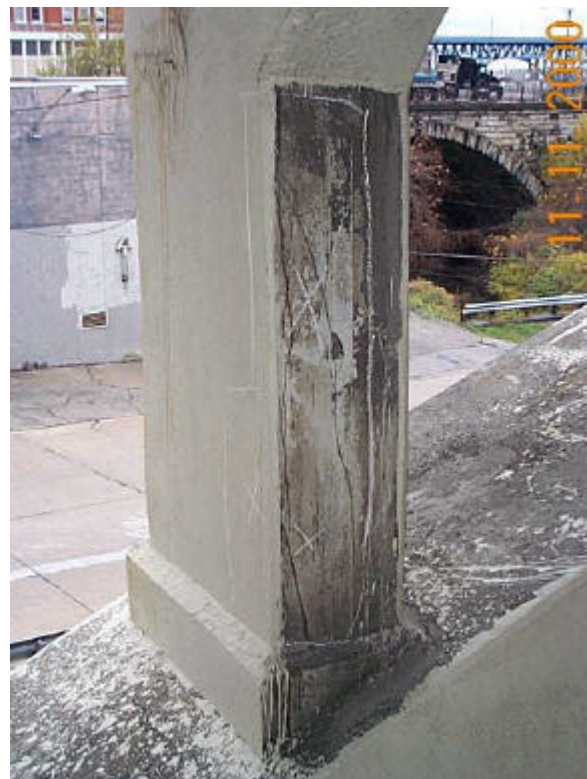
Photo 41 – North Exterior Column 4, Span 2

Several columns also have cracks and/or delaminations, including 4 s.f. to the North Exterior Column 1 and 20 s.f. to the North Exterior Column 4 in Span 2 (Photo 41); 5 s.f. to the North Exterior Column 3 and 4 s.f. to the North Exterior Column 16 in Span 3; and 9 s.f. to the South Exterior Column 1, 10 s.f. to the North Interior Column 10 and 11 s.f. to the North Interior Column 12 in Span 10.

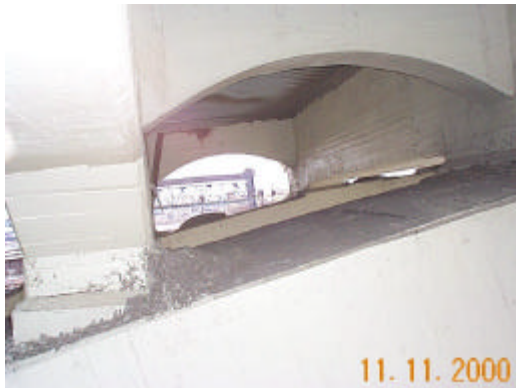
A typical condition that was noted is the presence of debris on top of the arch ribs. This debris included mainly excess concrete waste material. An example of this is shown in photo 42, located at the South Interior arch between columns 9 and 10 in Span 5.

Photo 42 - Debris on top of concrete arches

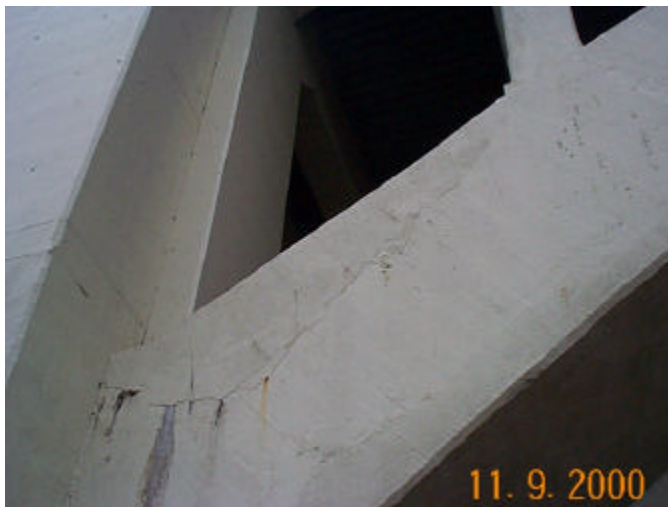
Several other locations have areas that are cracked, delaminated, and/or have seepage, particularly in the north exterior line and the south exterior line. Near the West Abutment, the outside of the South Exterior arch shows this typical condition (Photo 43).

Photo 43 - Cracked exterior arch face, Span 1 South Face at West Abutment

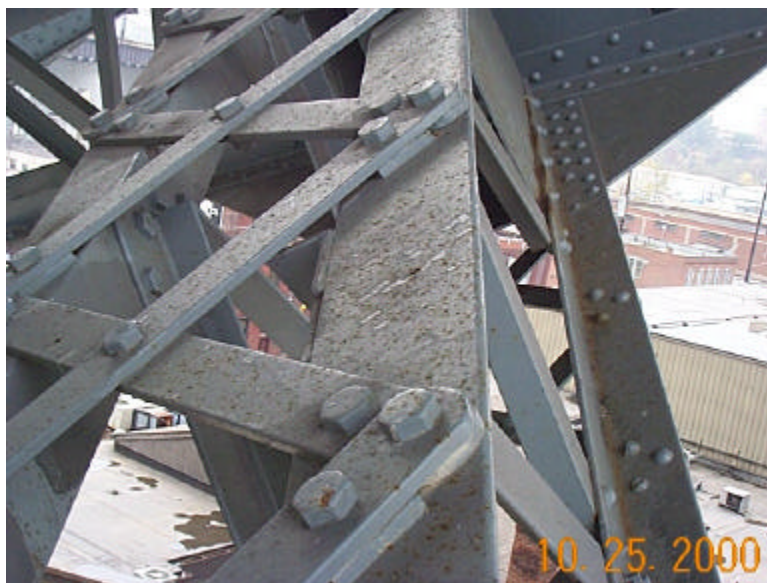
Debris and most noticeably sand blasting material from the recent rehabilitation are present at random locations throughout the steel span. Some of the material has been painted over (Photo 44). The amounts of accumulation of debris ranges from minor to moderate (Photo 45).

Photo 44 – Debris under paint

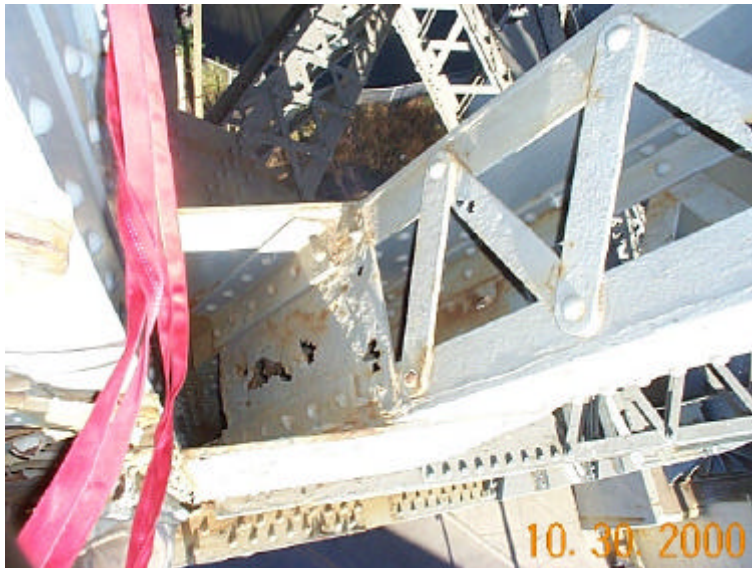
Photo 46 - South Arch at panel point L2

The truss members above the upper deck are in good condition. Below the upper deck, however, a significant number of deficiencies were noted. Although numerous repairs and a total repainting was performed during the previous rehabilitation, areas of paint are beginning to deteriorate leading to minor corrosion and staining. Heavy staining, paint deterioration and flake rusting to the verticals at U2'-L2' and U3'-L3' and the diagonal between U1' and L2' below the upper deck (Photo 46 and 47).

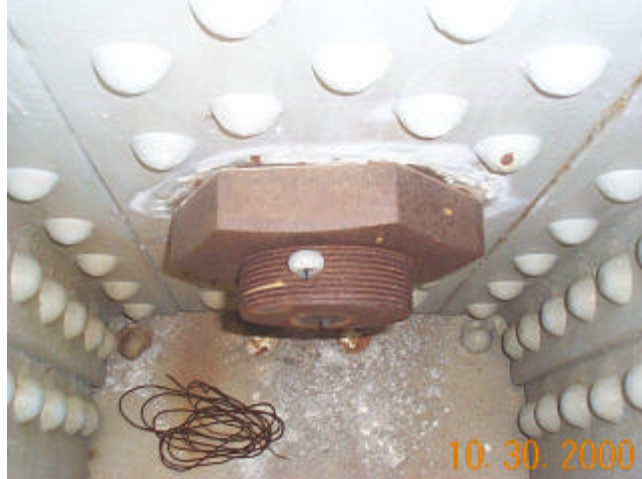
Photo 48 - North Arch Bottom Chord L11'

Minor paint deterioration was commonly noted, especially at hanger locations below the upper deck. Rust staining is prevalent below the upper deck and flake rust is beginning to form at some locations. The lower chord pins and nuts at L11' and L6' are unpainted (Photo 48).

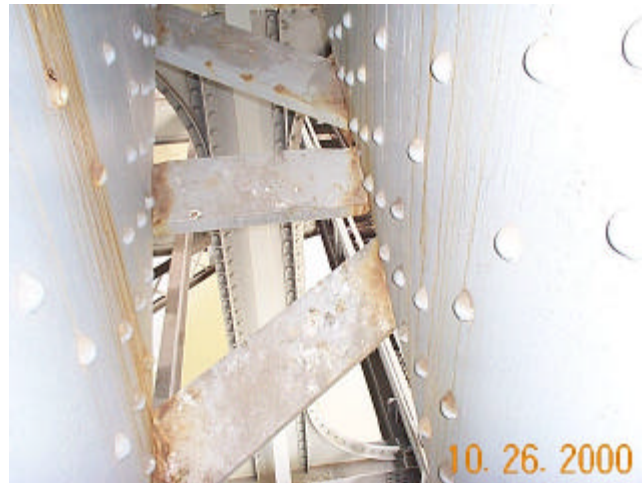
Photo 49 - South Arch L4-L5

Random lacing bars and channels throughout the steel span have been holed through by rust and section loss throughout the steel arch span (Photo 49). In all instances, those areas were cleaned and painted during the last rehabilitation. Active rust staining and corrosion is occurring at numerous locations. At panel point L2' of the north arch, broken lacing bars were noted.

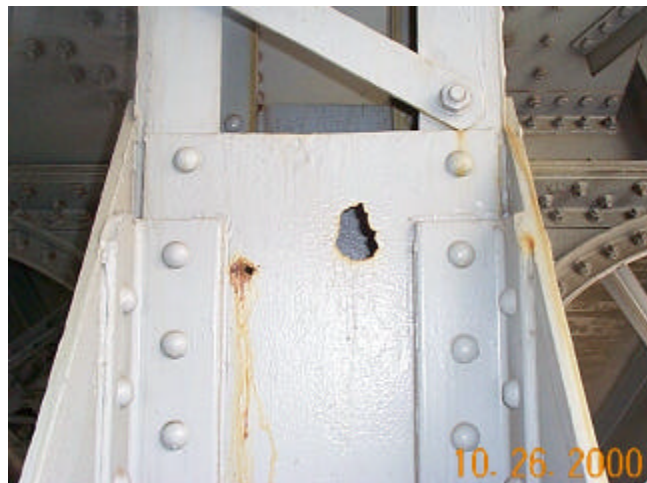
Photo 50 - South Arch Diagonal U3-L4

Stay plates and keeper plates have been holed through throughout the main steel span (Photo 50). Similar to lacing bars and channels, those areas were also cleaned and painted during the last rehabilitation. There was either no active corrosion or very minor corrosion noted.

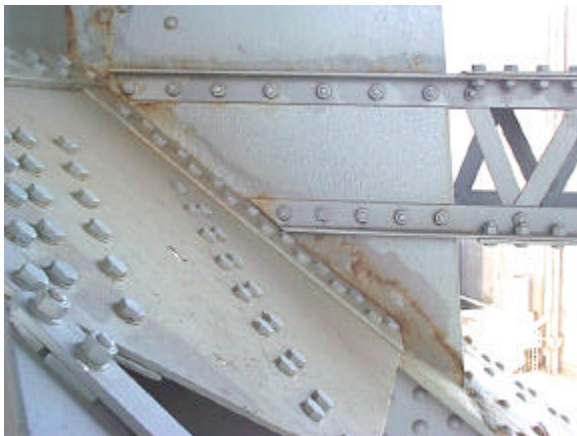
Photo 50a - South Arch North Gusset Plate
at L2'
dcp00329.jpg

The main truss gusset plates from Panel Points L1 to L4 and L1' to L4' have up to 30% section loss above the top flange of the lower chord (Photo 50a). Typically these plates have 1/8" to 1/4" loss in the area 2" above the lower chord and top lateral bracing gusset plates to both the exterior and interior faces. Throughout the life of the bridge, water has infiltrated through the upper deck truss openings and run along the top flange of the lower chord. This has caused early paint failure to the gusset plates, exposing the corrosion-resisting nickel steel. Currently, corrosion is beginning to reappear at these locations (Photo 50b).

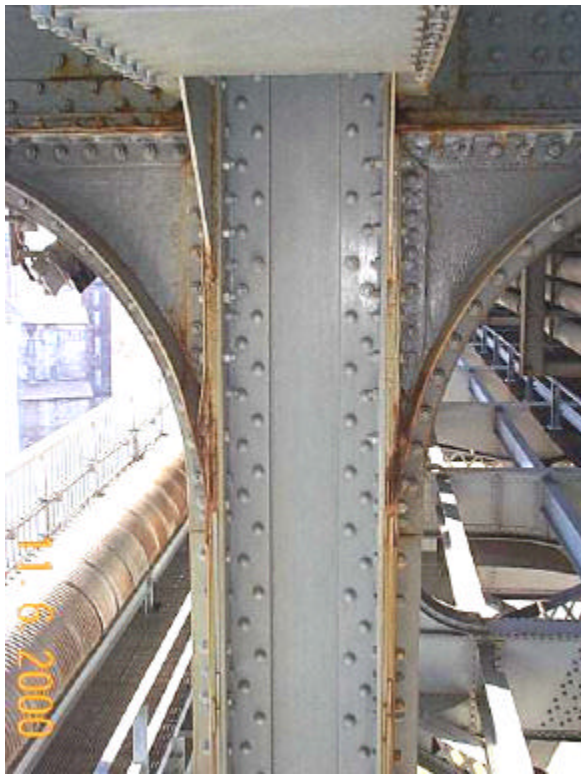
Photo 51 - South Arch at panel point 1'

The main span hangers are in good condition. Several vertical hangers were coped during the last rehabilitation at the lower deck floorbeam to minimize potential locations of packrust. Vertical hangers have section loss at the upper deck floorbeam. There is rust staining and minor active corrosion but no significant additional section loss has occurred since the last rehabilitation (Photo 51). Packrust between angles is common, especially at expansion joint locations (Photo 52).

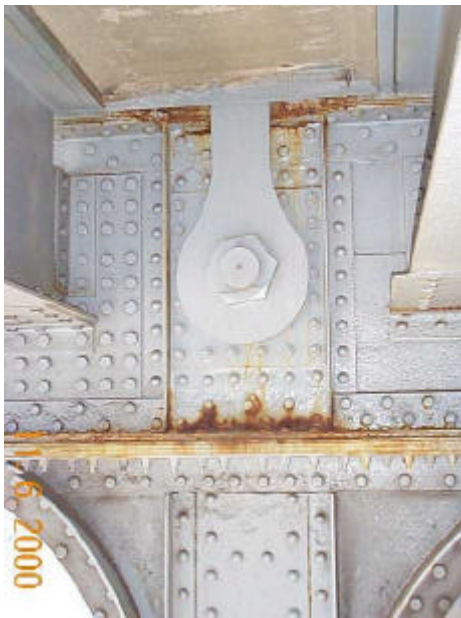
Photo 53 - Upper Deck Floorbeam at 7',
South Arch
dcp00158.jpg

The main span upper deck and lower deck floorbeams are generally in good condition. There is corrosion and rust staining to the upper deck floorbeam in the area around the pin and hanger assemblies (Photo 53). Holes through the web and bottom flange angles of the lower deck floorbeams occur throughout the steel arch span, but particularly at upper deck expansion joint locations at panel points 0, 5, 5' and 0'. Hole locations are typical near the upper deck hanger pins (photo 54) and in the cantilever ends at 0 and 0'.

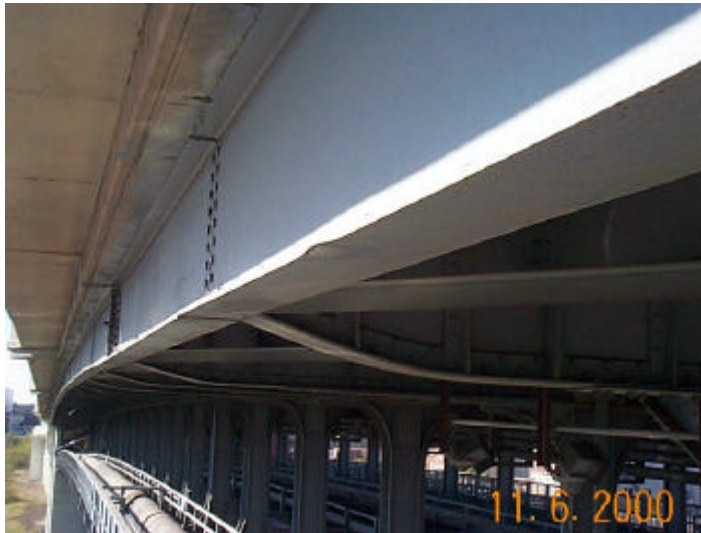
Photo 55 - South Exterior Upper Deck Stringer Span 4 near panel point 10'

The stringers are in fair condition. Minor deficiencies noted include several missing bolts at various locations and a horizontal and/or vertical offset of upper deck exterior stringers. There is a kink to upper deck stringer U between PP3' and PP4' (Photo 55), and upper deck stringer F at 6' is missing 2 of 4 bolts to the floor beam connection angle. There is also a loose nut at that same location.

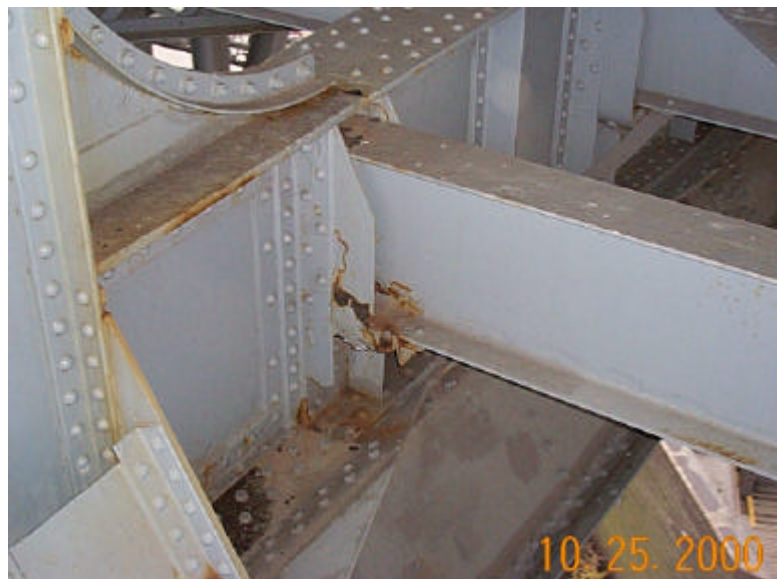
Photo 56 - Lower Deck Stringer 10 at panel point 3'

Section loss and holes through members were common to stringers 1-3 and 10-11 of the lower deck. Stringers 4-9 are typically in good condition with no significant section loss. The lower deck expansion stringer bearings at panel points 3 and 3' exhibit section loss and have some holed through seat hangers (Photo 56). The upper deck stringers near the expansion joints at panel points 5 and 5' were replaced in the 1995 rehabilitation and are in good condition.

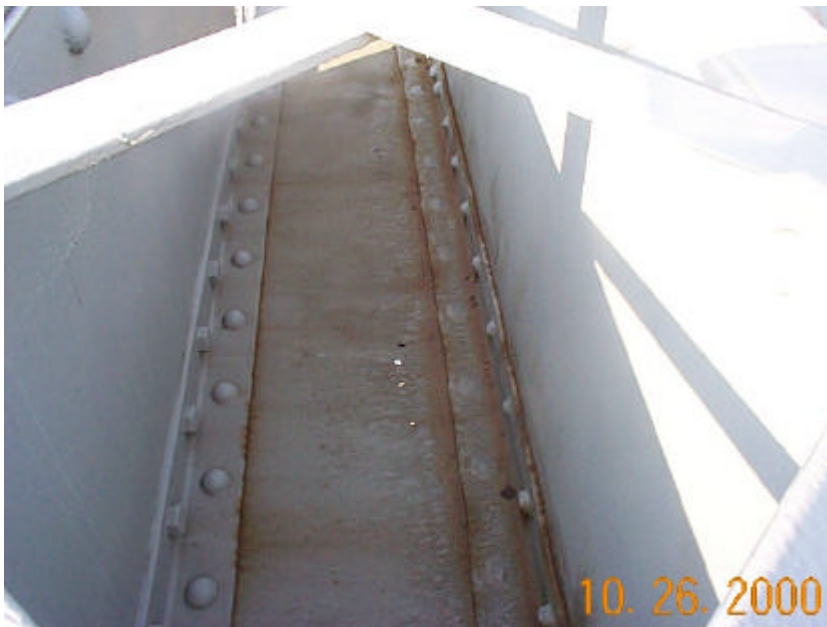
Minor rust staining and some active corrosion, especially near hanger locations was observed. The paint is beginning to breakdown, with areas of flaking and peeling paint and rust staining (Photo 57).

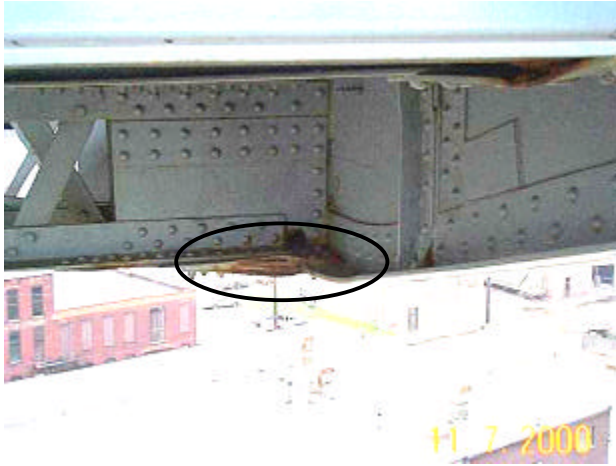
Packrust between the bottom bracing members and gusset plates was noted (Photo 58). Isolated areas of construction damage were also noted, including a bent horizontal gusset plate at U5' at the south arch (Photo 59). Water and debris accumulates in the uphill angle legs of horizontal bracing members.

Photo 58 - Packrust at 8', South Arch

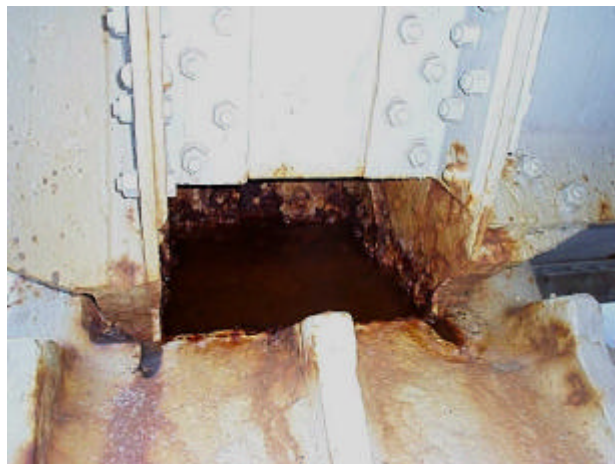
The main arch bearings at the tiebacks are pitted with minor active corrosion and rust staining. No additional section loss was observed. Accumulation of debris and water between stiffeners is typical. There is standing water above the pin inside the vertical member at all locations (Photo 60).

Photo 60 - Standing water at L0', North Bearing

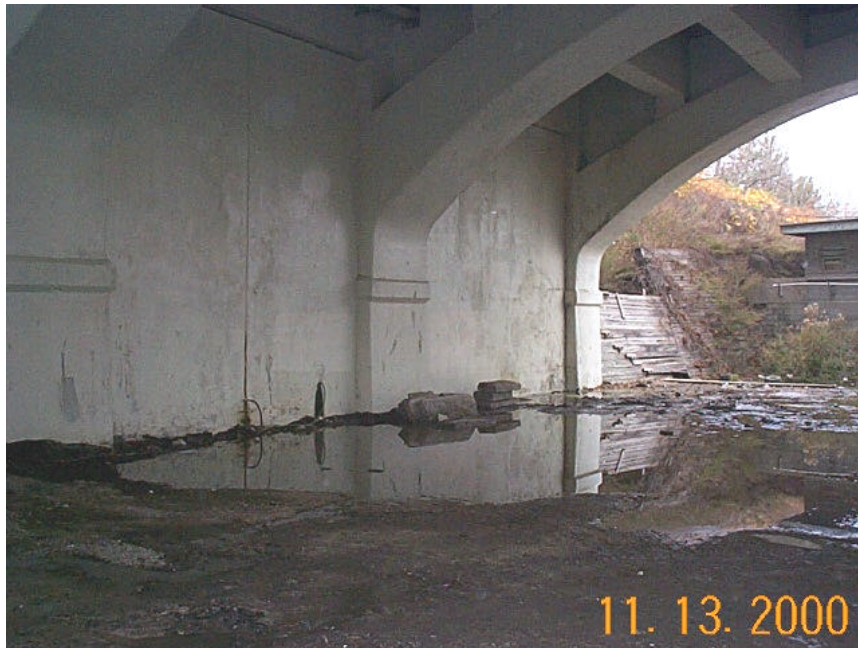
Photo 61 – East Abutment

The abutments are in good condition. There is ponding water adjacent to the east abutment (Photo 61). The epoxy sealer is in good condition with minor rust staining bleeding through in isolated locations.

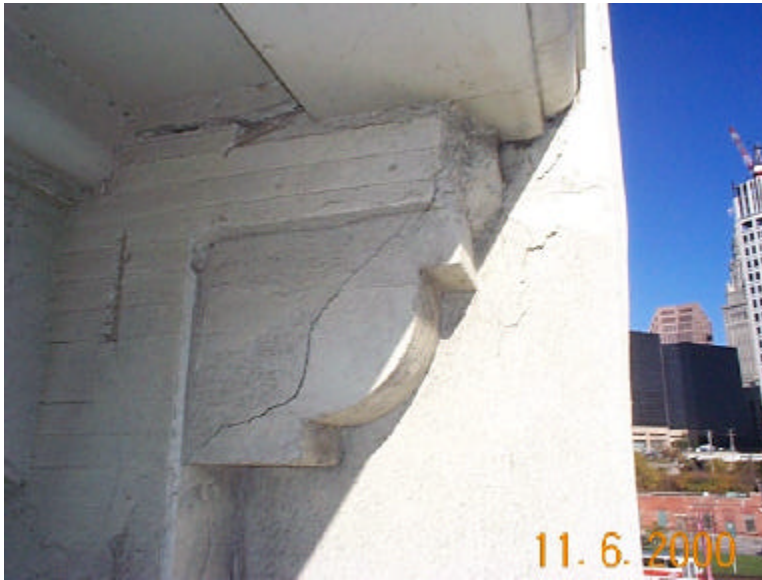
Photo 62 – Pier 9

The piers are in generally good condition. Cracks, delaminations, and/or spalls to the pier shafts are common, especially near corbel details and the interface between the lower pier shafts and adjacent end columns (Photos 62 & 63).

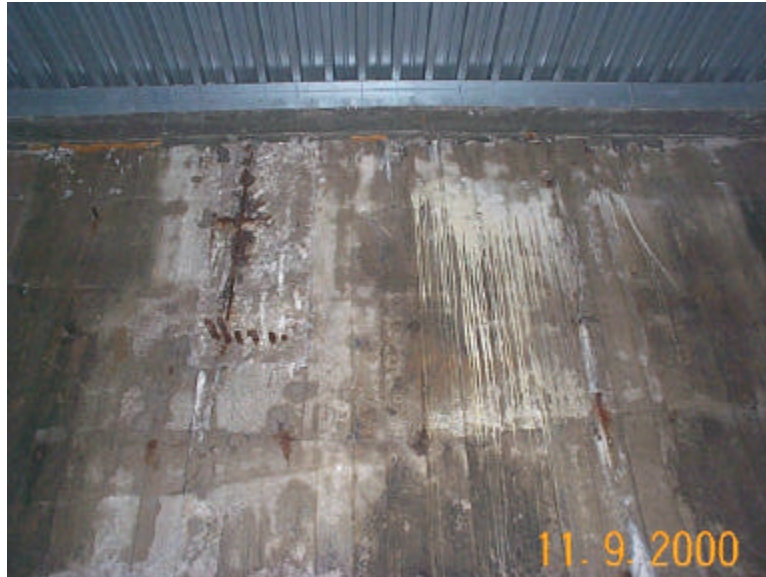
Photo 64 – Pier 3 North Interior Bay

Pier 3 and Pier 4 have extensive delaminations and spalls on the interior faces of the towers (Photo 64). The interior arches are also spalled with exposed reinforcing (Photo 65).

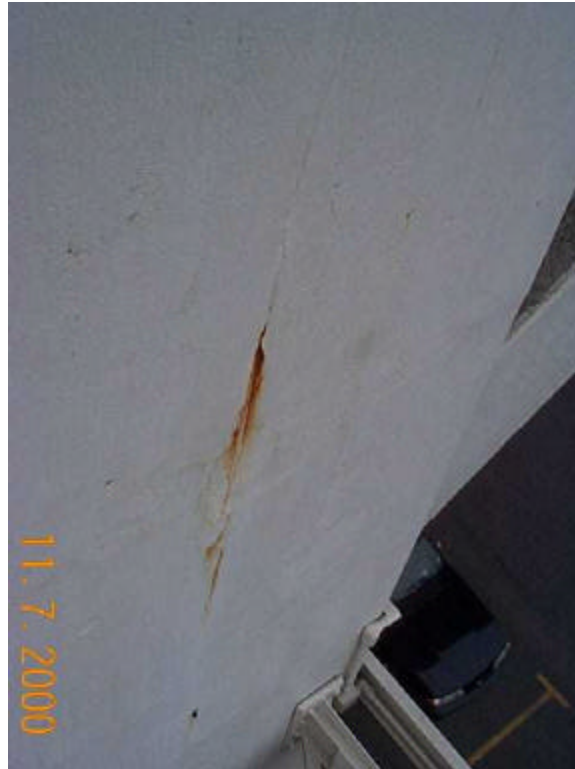
Photo 66 – Pier 9 North Face

Voids occur sporadically in the arch base. Rust staining of reinforcing is bleeding through at various locations (Photo 66), but otherwise the epoxy-urethane sealer is in good condition.

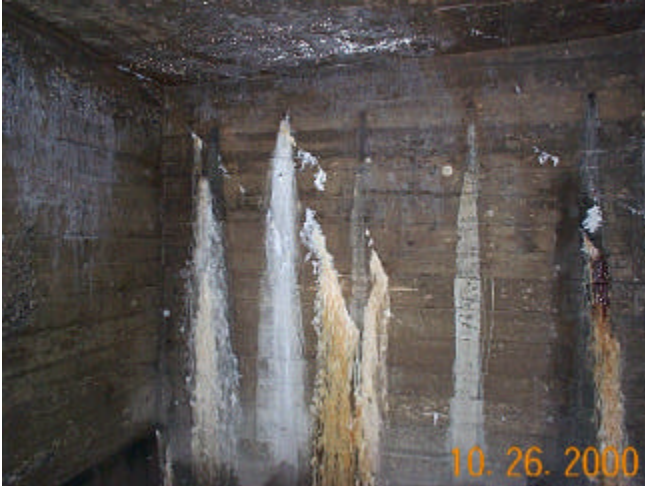
The condition of the cellular construction is fair. There are areas of heavy cracking with efflorescence and spalls with exposed reinforcing to the walls and roof slabs in both the south and north bays (Photo 67, 68 & 69)

Photo 67 – North Cell, North wall (4th from the West end)
