February 4, 2002

Re: Agreement No. 9862
PID No. 21390
Project No. CUY-6-1499
2001 Annual Bridge Inspection
Veterans Memorial Bridge

STATE OF OHIO DEPARTMENT OF TRANSPORTATION
BRIDGE INSPECTION REPORT

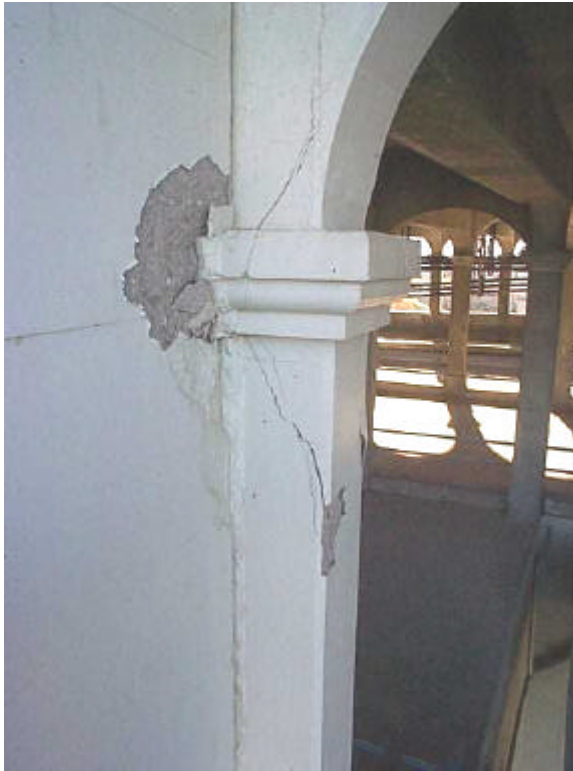
- The steel curb plates were repainted recently and the railing base (below the pedestrian fencing) resealed.
- The corners of several pier shafts have spalled and more are delaminated with open cracks. Some are over public areas where vehicles or pedestrians could be struck by falling concrete. (Photos 1 and 2)
- In Span 10, no growth was noted to the existing delaminations to the concrete arches. Overall, the repairs to the concrete arches from the 1995 rehabilitation are still sound.
- Water several feet deep in the pedestrian stairwells and tunnels of the West Station was noted during the 2000 inspection. The water has since been removed and the stairwells and tunnels are now clear of water, except for some minor standing water.

Photo 1 - Pier 12 Northwest corner spalled and cracked

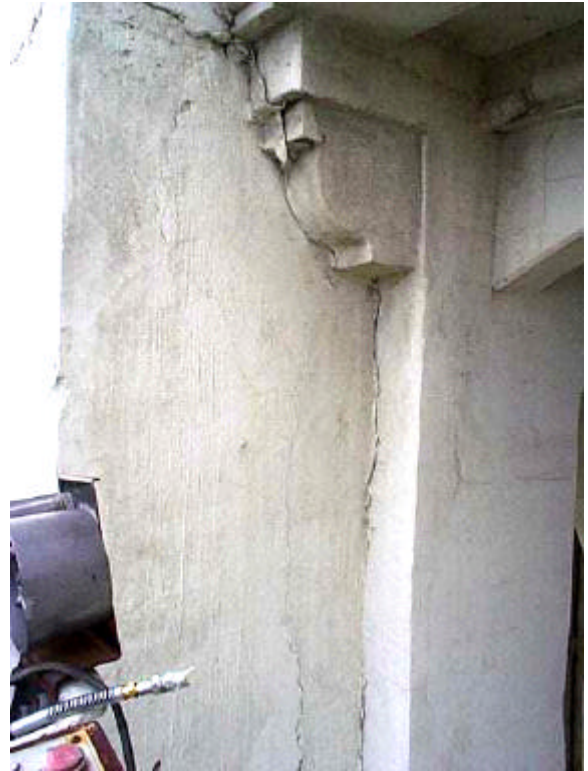
Photo 2 - Pier 6, Southeast corner delamination and spall forming

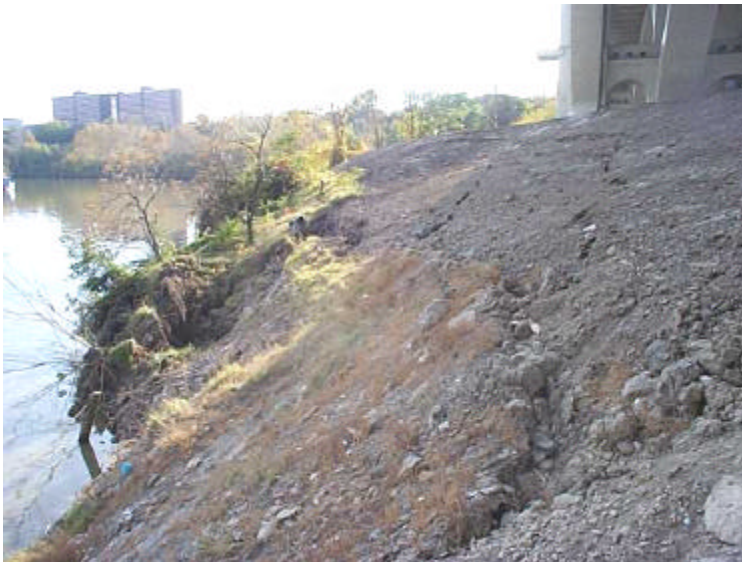
- During the two month long inspection, the embankment west of Pier 3 had slid with some slope failure into the Cuyahoga River. Early observations noted several cracks in the top of the slope with evidence of minor sliding. Cracks in the slope continued to develop followed by heavy sliding (Photo 3). Neither Cuyahoga County nor the State of Ohio owns this property.
- The architectural lighting on the steel arch span was restored. While some fixtures for the architectural lighting of the concrete approach spans lights are not functioning, these spans are generally illuminated.

Photo 3 - Span 3 Slope looking West 10/30/01 continued sliding into Cuyahoga River

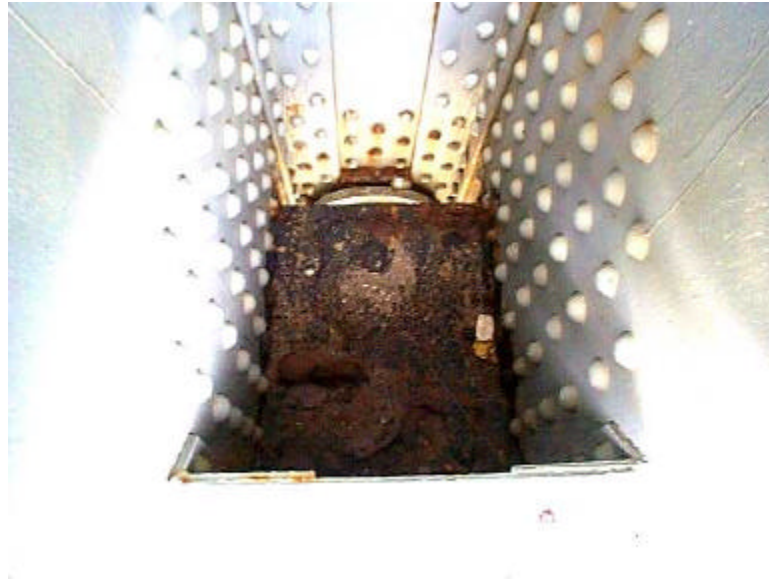
Steel Arch – There is an accumulation of steel shot and mastic paint at the upper deck level at panel points 5 and 5' (Photo 4). Below the upper deck, water and runoff through the hanger and arch block outs has caused the continued breakdown of the paint system and minor surface rust. Flake rust on the gusset plates above the lower chord was also noted.

Photo 4 - Accumulation of steel shot and debris at the North Arch panel point 5'

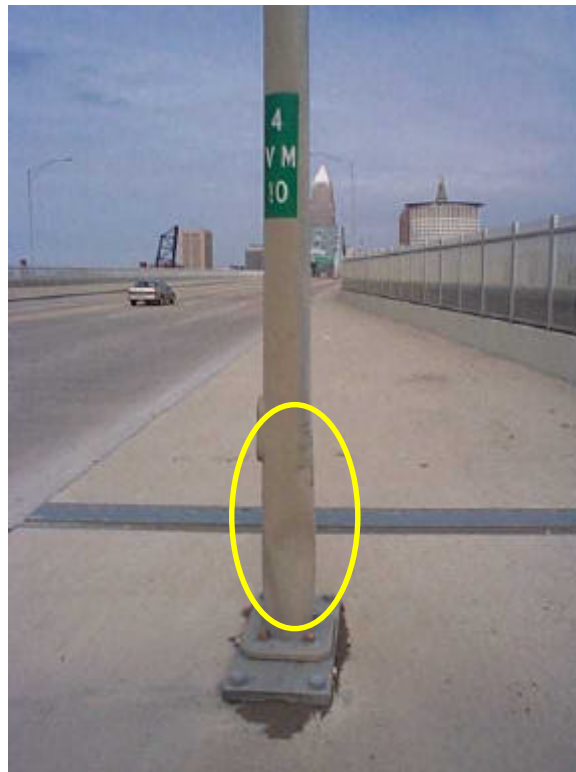
The asphalt patch on the East approach pavement has cracked and settled. Diagonal cracks extend from the West approach slab into the south sidewalk. Impact damage to the light post 4 VM 10 in the south sidewalk was observed (Photo 5).

Photo 5 - Impact damage to light post 4 VM 10 at the South sidewalk of the West approach
