## UNDERWATER BRIDGE INSPECTION REPORT

Bridge #: CUY-6-1499  
Detroit-Superior  
Waterway: Cuyahoga River  
City: Cleveland, Ohio

Diver: Jason Fischer  
Tender: Pat Murphy - Mark Maquire  
Date: 11 September 2001

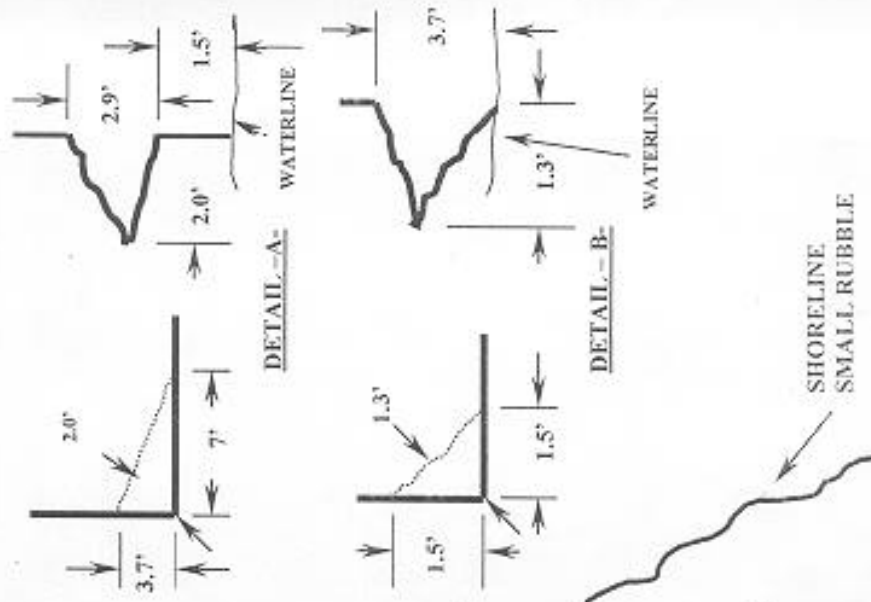
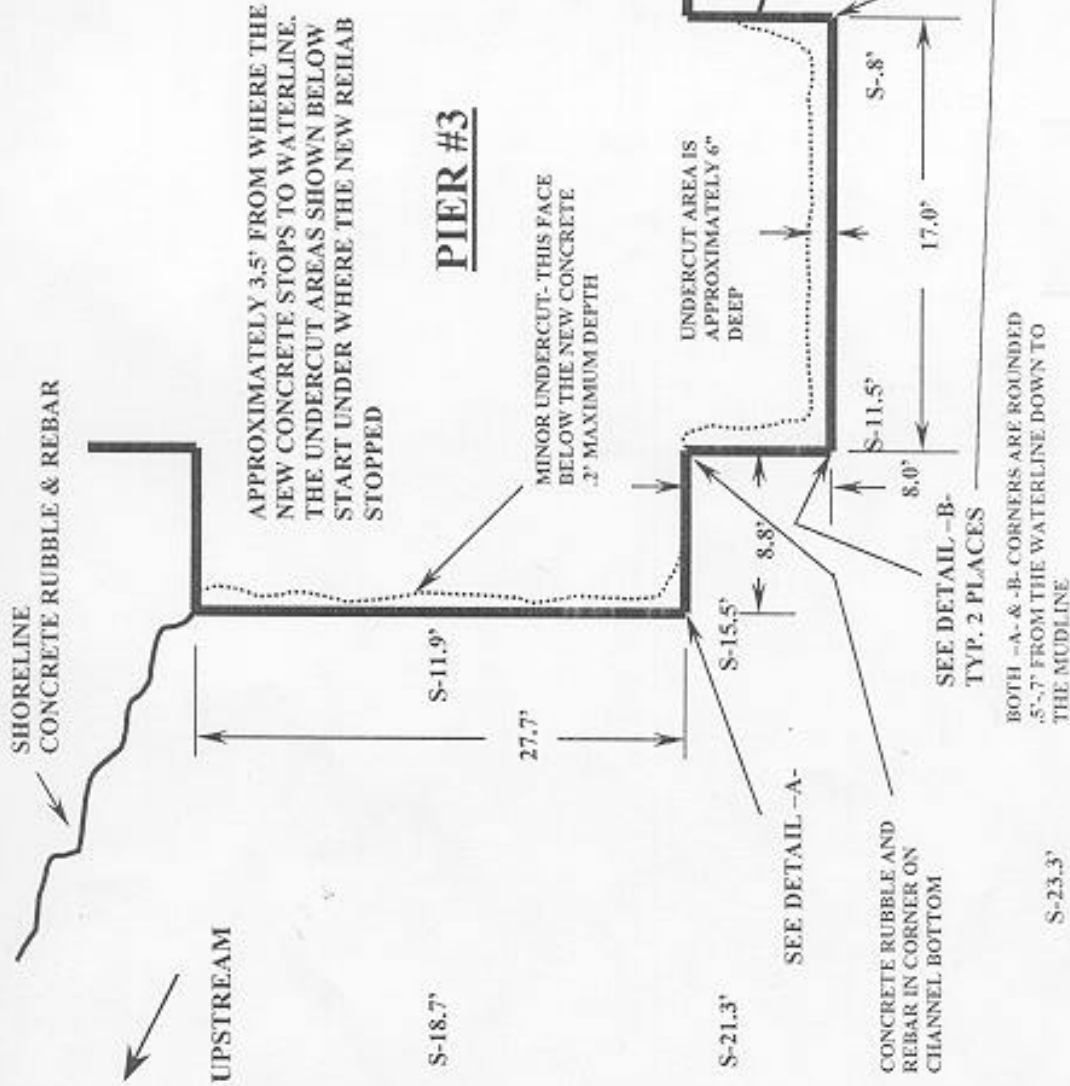
DETROIT SUPERIOR  
PIER #3 WEST BANK

**Impact Damage:** Pier corners are spalled above the waterline - see detail. Corners are rounded and spalled below the waterline.

**Unusual Conditions:** New concrete placed during rehab stopped 3.5' above waterline. Existing concrete below the new has spalling on the face with the corners rounded below the waterline.

NO ZEBRA MUSSEL COVERAGE ON  
CONCRETE FACES UNDERWATER

EXISTING STEEL  
SHEET PILING  
POOR CONDITION

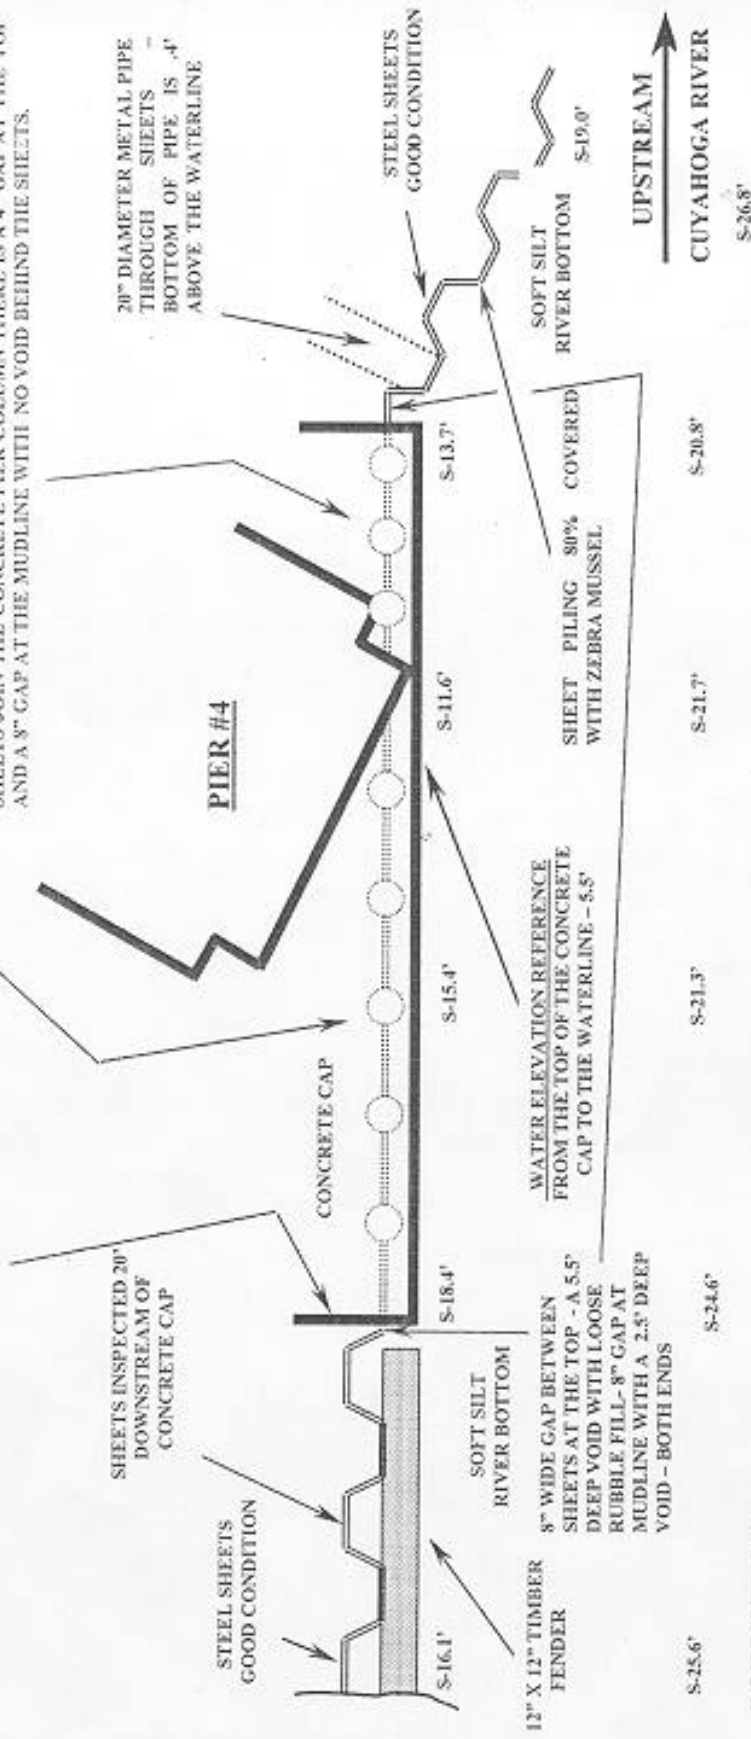
**DETROIT - SUPERIOR  
 PIER #4 - EAST BANK**

THE SHEET PILING UNDER THE CONCRETE CAP WAS FOUND NOT TO BE Z-SHAPED. WE BELIEVE THAT IT WAS CONSTRUCTED USING EIGHT CIRCULAR PILING WITH FLAT SHEETS BETWEEN. ALL SHEETS AND ROUND PILING ARE IN GOOD CONDITION AT THIS TIME.

**CONCRETE CAP**  
 CONCRETE CAP HAS MINOR SPALLING ON THE LOWER HALF WITH NO EXPOSED REBAR. EXCEPT WHERE THE PIER COLUMN JOINS THE CONCRETE CAP THERE IS HEAVY SPALLING THE ENTIRE HEIGHT. EIGHT HORIZONTAL REBAR ARE EXPOSED 3' DOWNSTREAM AND 10' UPSTREAM FROM THE PIER COLUMN CORNER. THE BOTTOM OF THE CONCRETE CAP IS 1.5' BELOW THE SURFACE AND EXTENDS OUT APPROXIMATELY 2' FROM THE STEEL SHEETS.

WHERE THE DOWNSTREAM SHEETS JOIN THE CONCRETE PIER COLUMN THERE IS APPROXIMATELY 5" OF THE CONCRETE FACE EXPOSED. WHERE THE STEEL SHEETS JOIN THE CONCRETE PIER COLUMN THERE IS 3" GAP AT THE TOP WITH A 6" DEEP VOID AND A 6" GAP AT THE MUDLINE WITH A 3" DEEP VOID BEHIND THE SHEETS.

WHERE THE UPSTREAM SHEETS JOIN THE CONCRETE PIER COLUMN THERE IS APPROXIMATELY 1" OF THE CONCRETE FACE EXPOSED. WHERE THE STEEL SHEETS JOIN THE CONCRETE PIER COLUMN THERE IS A 4" GAP AT THE TOP AND A 8" GAP AT THE MUDLINE WITH NO VOID BEHIND THE SHEETS.
